**FINAL REPORT
ROUND 10 DAM ASSESSMENT
DYNEGY MIDWEST GENERATION, LLC – BALDWIN ENERGY COMPLEX
PRIMARY FLY ASH POND, SECONDARY FLY ASH POND, SECONDARY POND,
INTERMEDIATE POND, FINAL POND
BALDWIN, ILLINOIS**

December 21, 2012
GZA File No. 170142.30

RE: FINAL Assessment of Dam Safety of Coal Combustion Surface Impoundments at the Baldwin Energy Complex

**FINAL REPORT
ROUND 10 DAM ASSESSMENT
DYNEGY MIDWEST GENERATION, LLC – HENNEPIN POWER STATION
ACTIVE EAST ASH POND SYSTEM, EAST ASH POND SYSTEM, WEST ASH POND
SYSTEM
HENNEPIN, ILLINOIS**

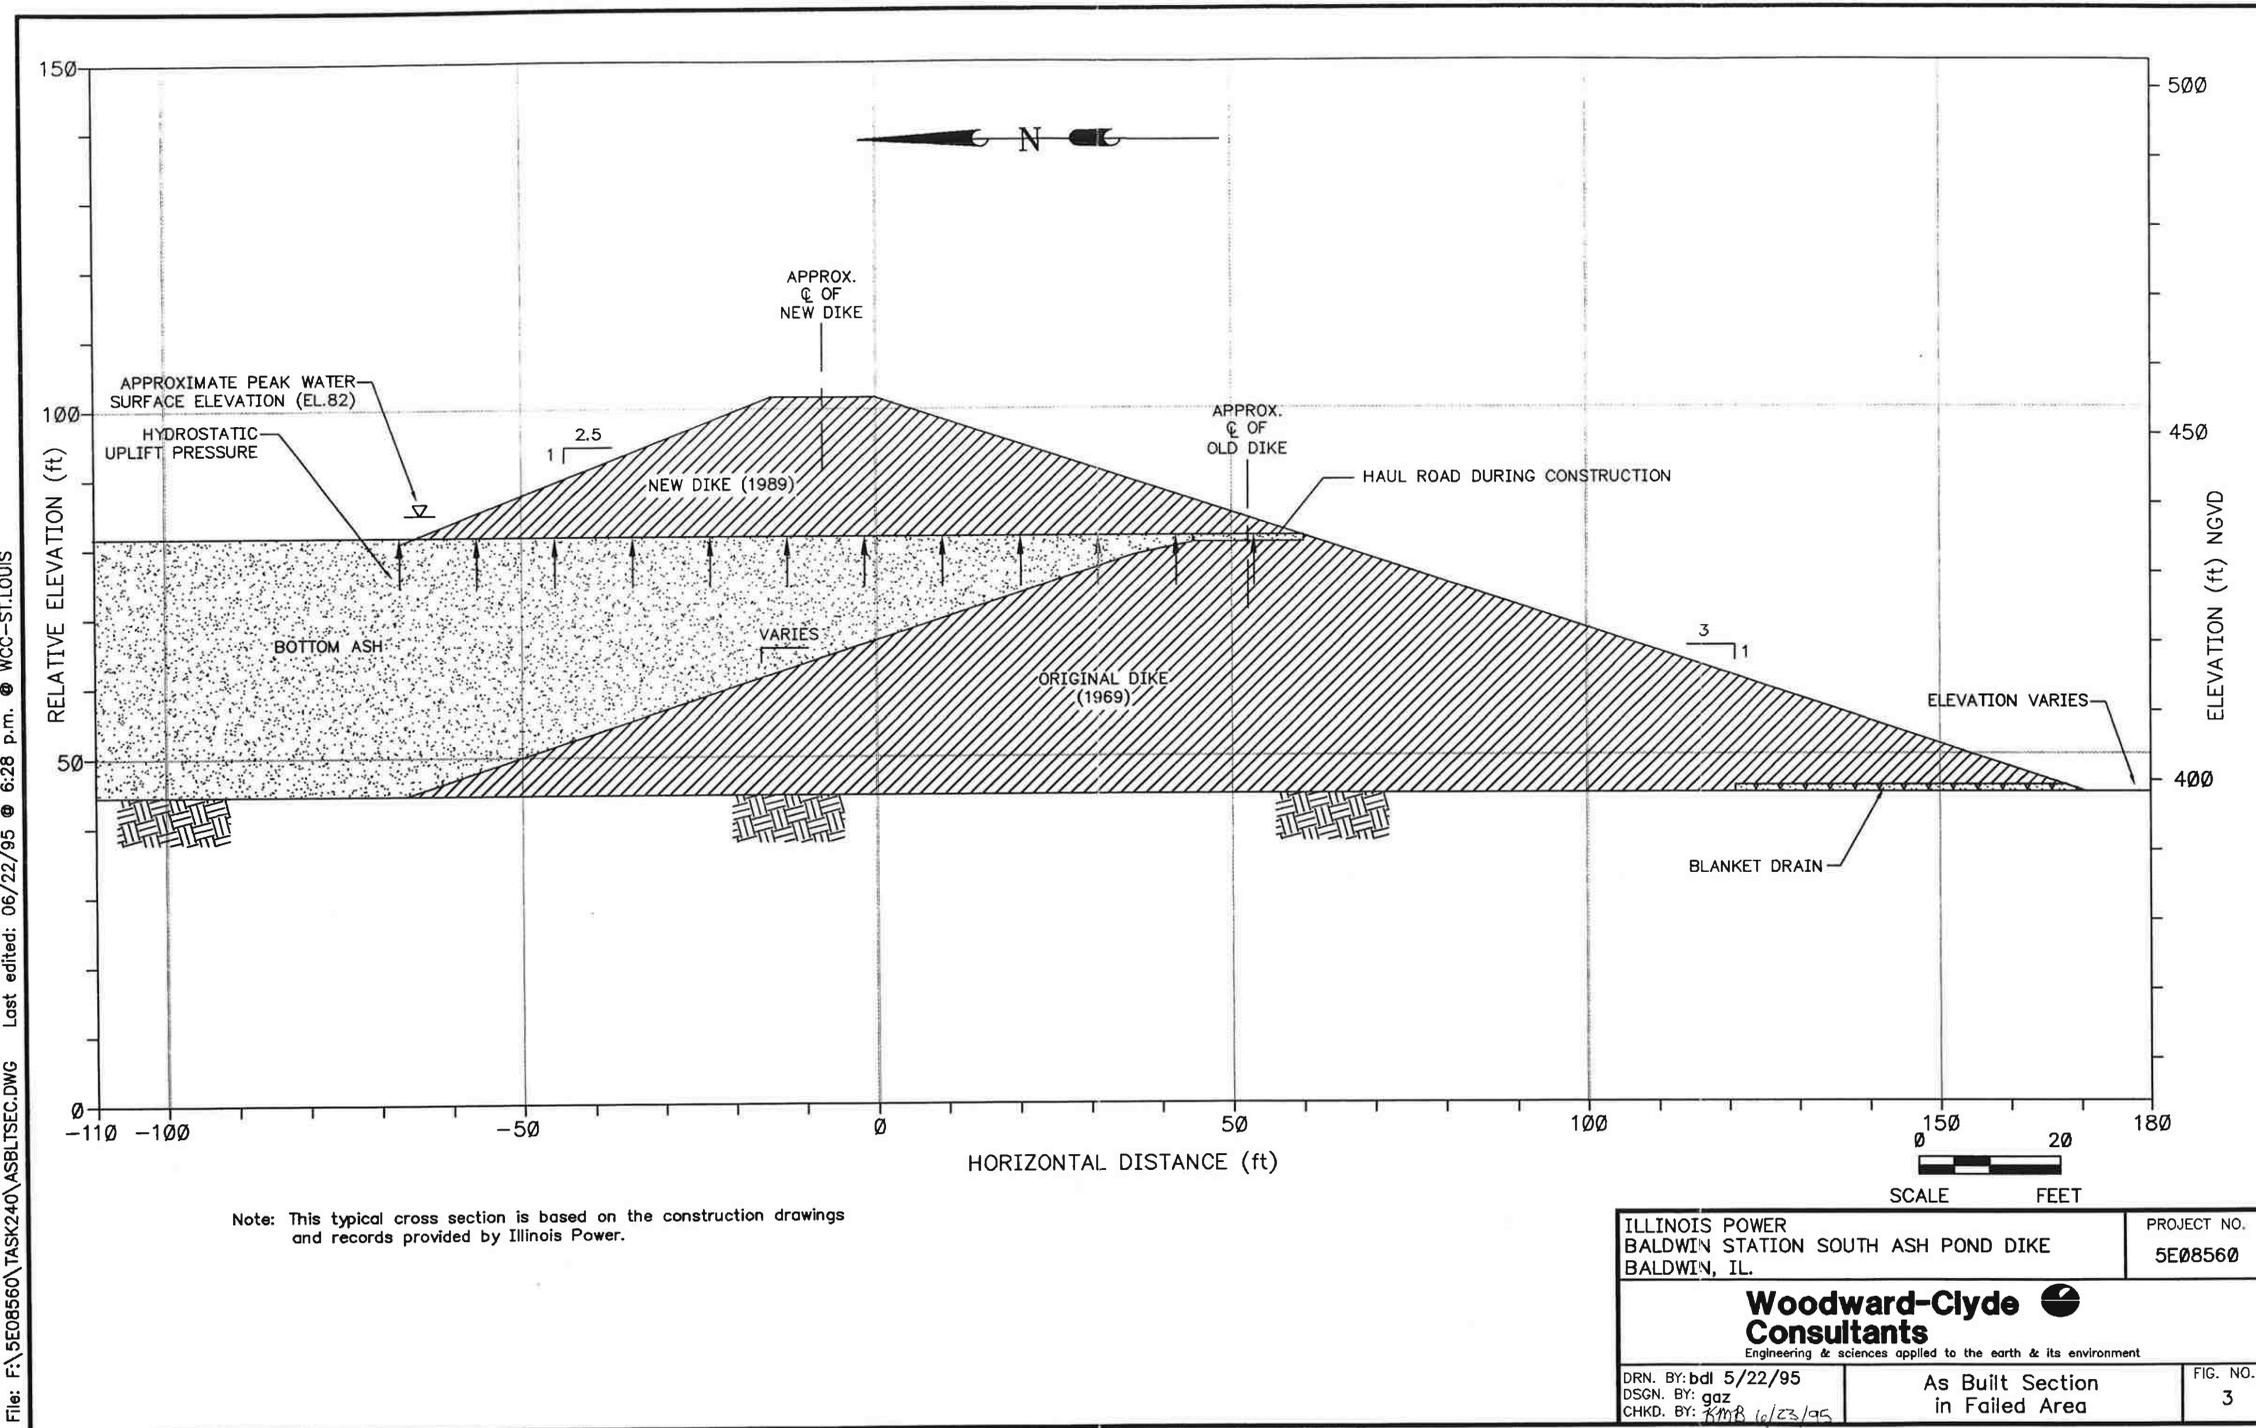
ILLINOIS POWER BALDWIN STATION SOUTH ASH POND DIKE BALDWIN, IL.		PROJECT NO. 5E08560
Woodward-Clyde Consultants <small>Engineering & sciences applied to the earth & its environment</small>		
DRN. BY: bdl 5/22/95 DSGN. BY: gaz CHKD. BY: KMB 6/23/95	As Built Section in Failed Area	FIG. NO. 3

A typical design cross section of the 1969 southern embankment of the PFAP is shown in **Figure 4**. The 'as built' cross section of the embankments after the 1989 raise, as recreated by Woodward Clyde and documented in the Failure Analysis, is provided as **Figure 5**. Based on the upstream construction shown on Figure 5, the 1989 raise was partially constructed over wet CCW.

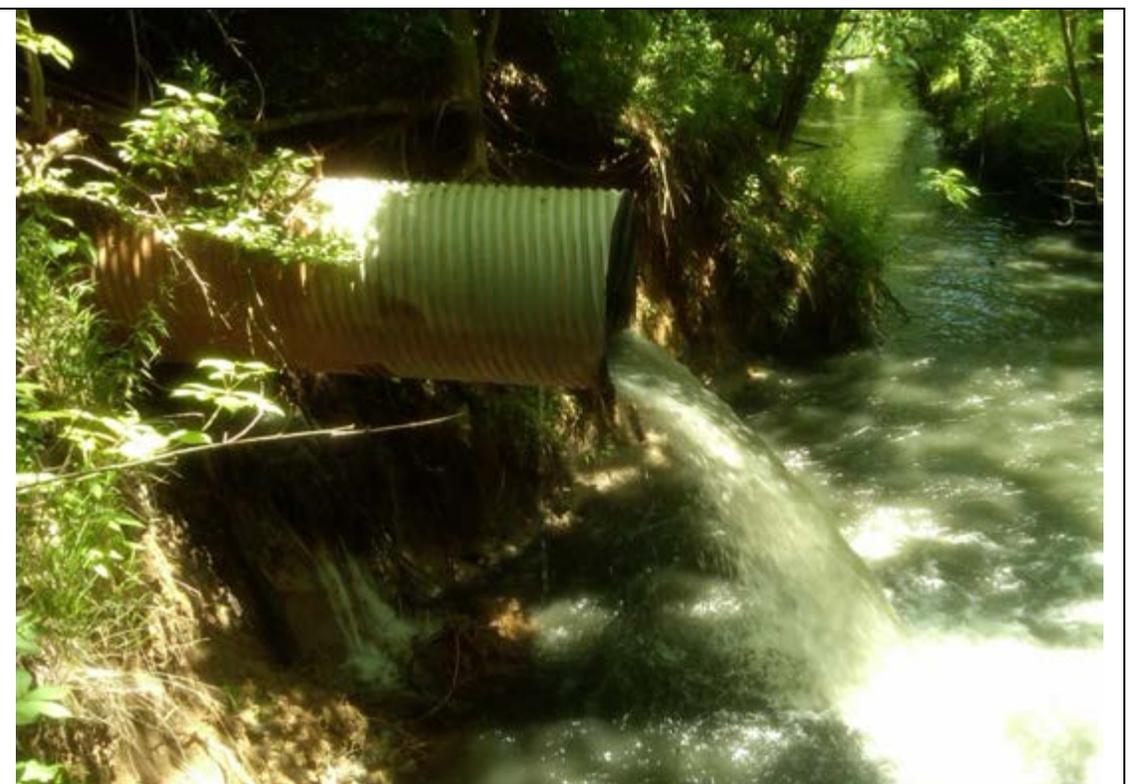
Photo No. 30	Date: 5/24/11
Direction Photo Taken: South

Description:
Discharge pipe for Bottom Ash Process water from the northern part of the Primary Fly Ash Pond to the Secondary Pond.

1. Repair the discharge pipe and the embankment erosion near the discharge pipe from PFAP's northern decant. Protect the embankment with riprap or other erosion control features.
2. Remove the concrete located on the downstream slope of the Ash Pond Dike. Repair any erosion observed beneath the concrete and replace with fill engineered to provide a stable embankment that is not susceptible to erosion or piping.
3. Pending the results of the hydraulic/hydrologic analysis, modify the design or operation of the impoundments to provide adequate capacity.
4. Pending the results of the complete seepage and stability analysis for each impoundment, modify the design or operation of the impoundments to provide conditions that result in embankments that meet the generally accepted factors of safety.

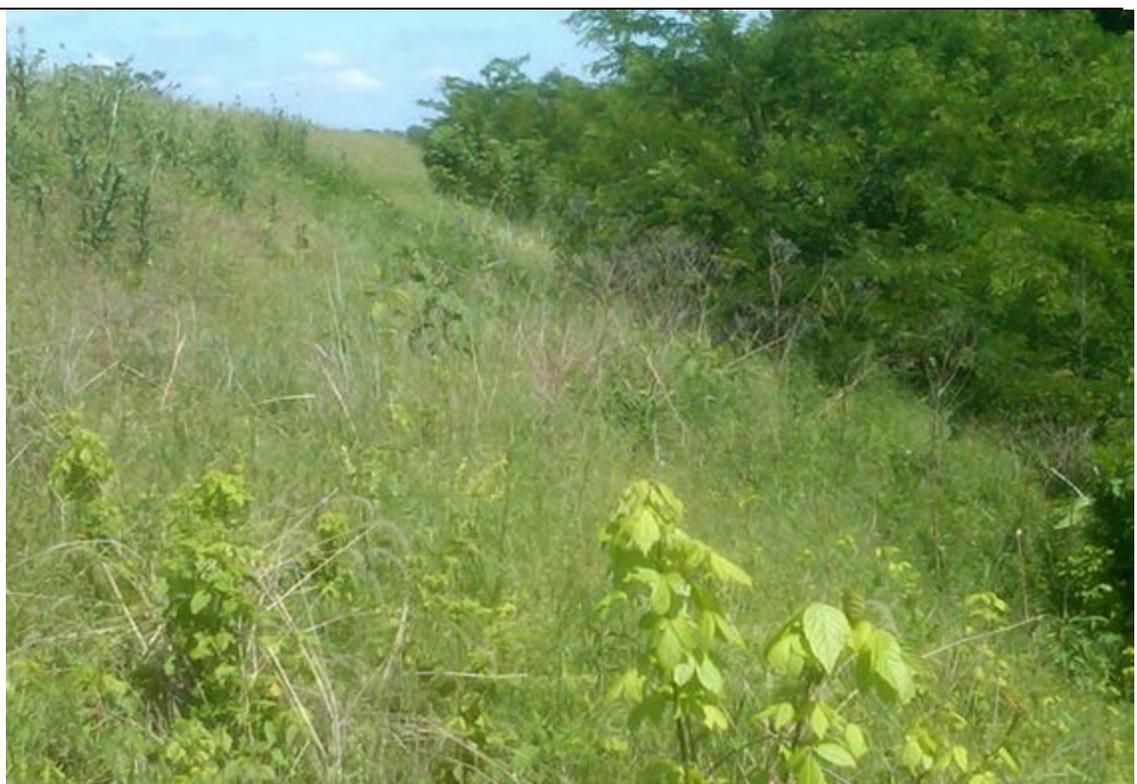
Photo No. 32	Date: 5/24/11

Direction Photo Taken: East		
Description: Downstream slope of the southern embankment of the Secondary Fly Ash Pond.

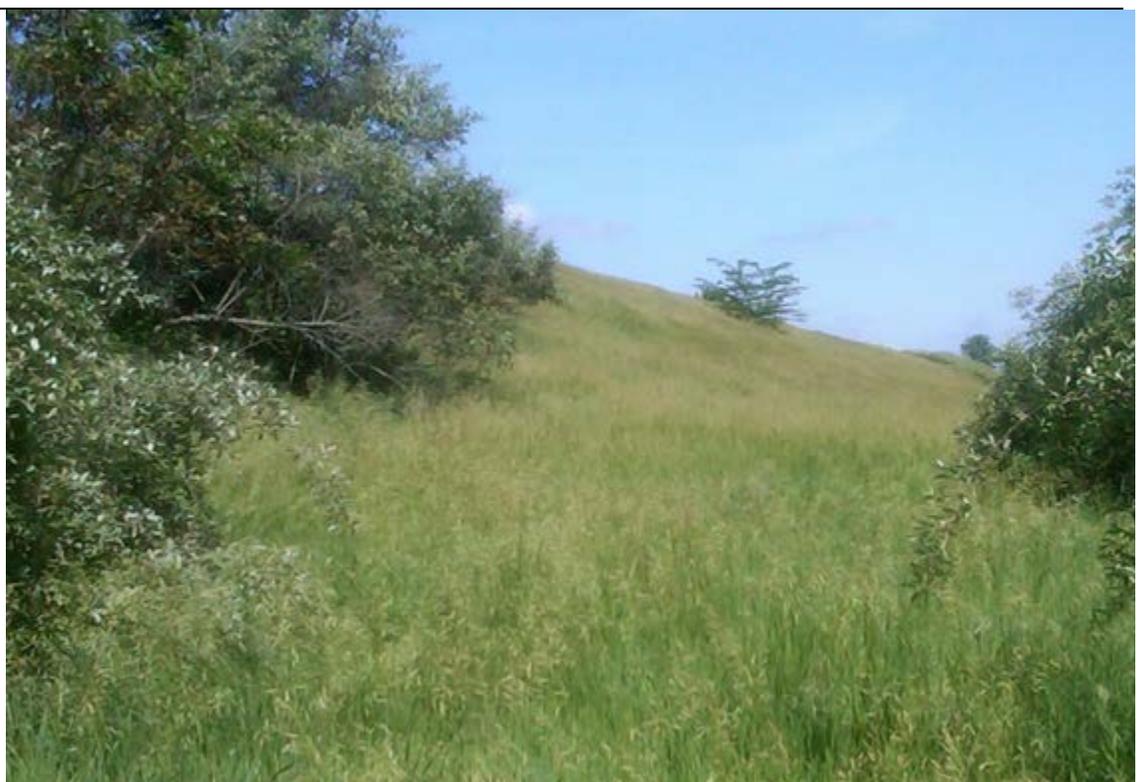
Photo No. 34	Date: 5/24/11
Direction Photo Taken: East

Description:
Downstream slope and toe of the southern embankment of the Secondary Fly Ash Pond.

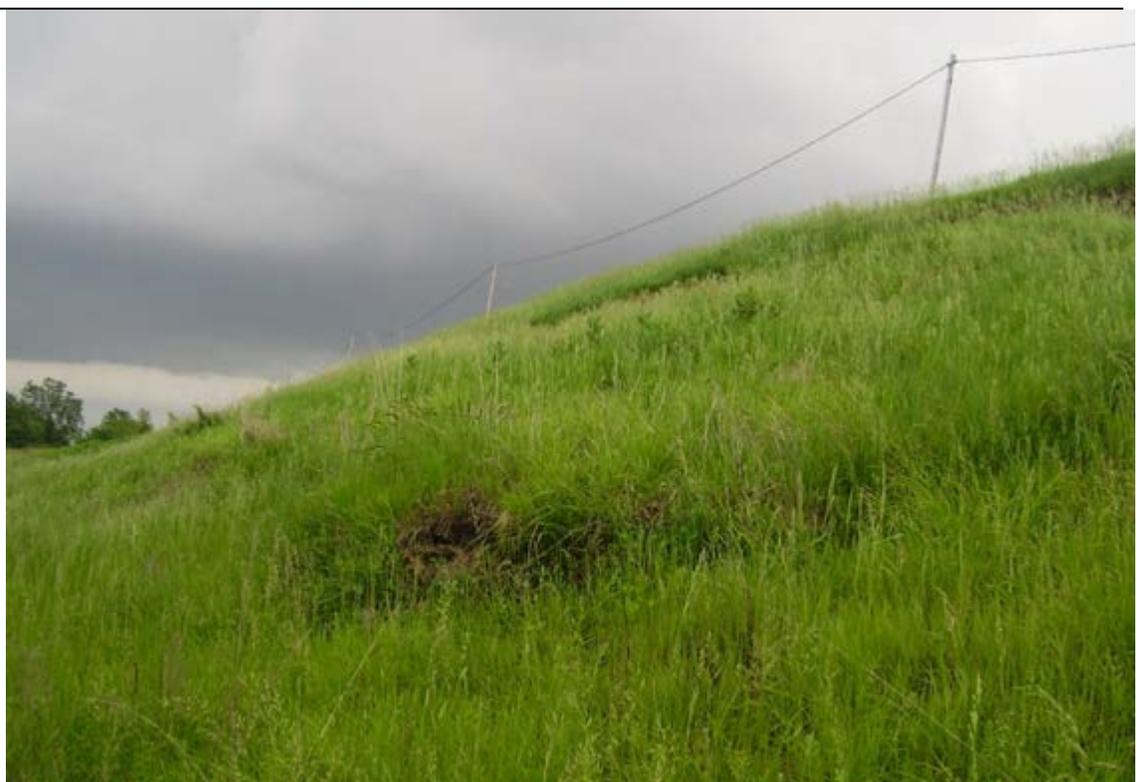
Photo No. 42	Date: 5/24/11
Direction Photo Taken: East	
Description: Scarp on downstream slope of the Northern Dike.

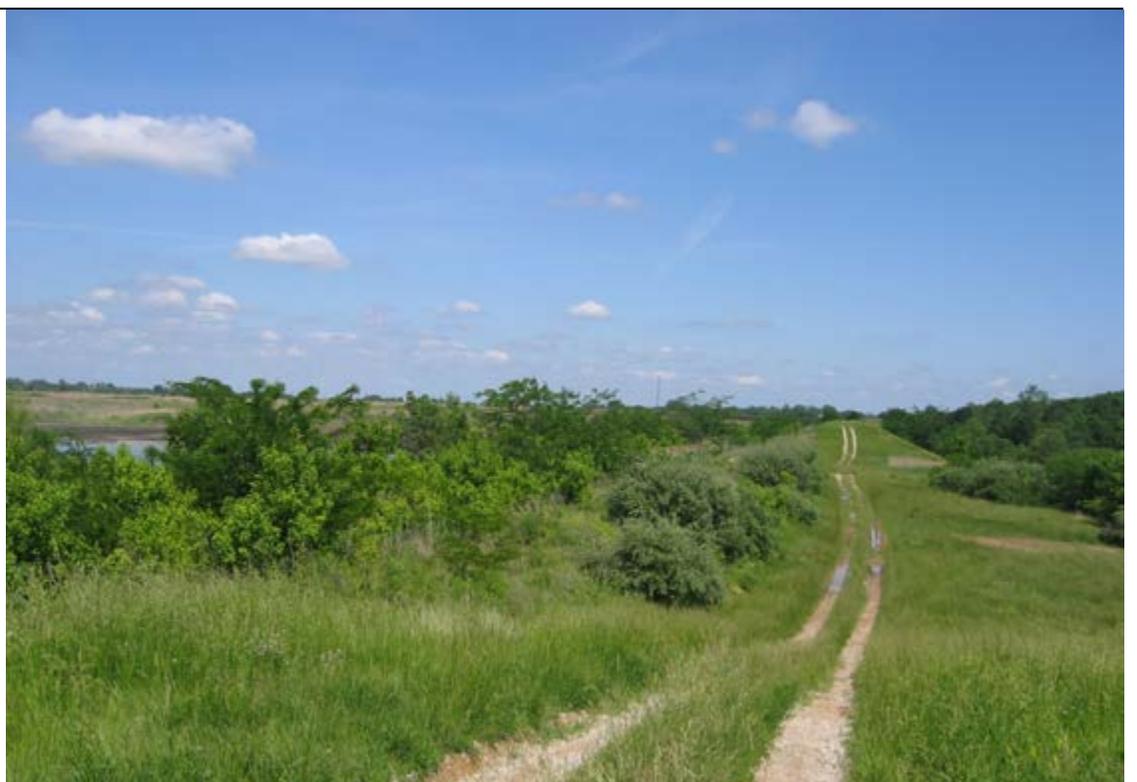
Photo No. 48	Date: 5/24/11
Direction Photo Taken: East

Description:
Crest and upstream slope of the Secondary Fly Ash Pond in the area of the 1995 Failure.

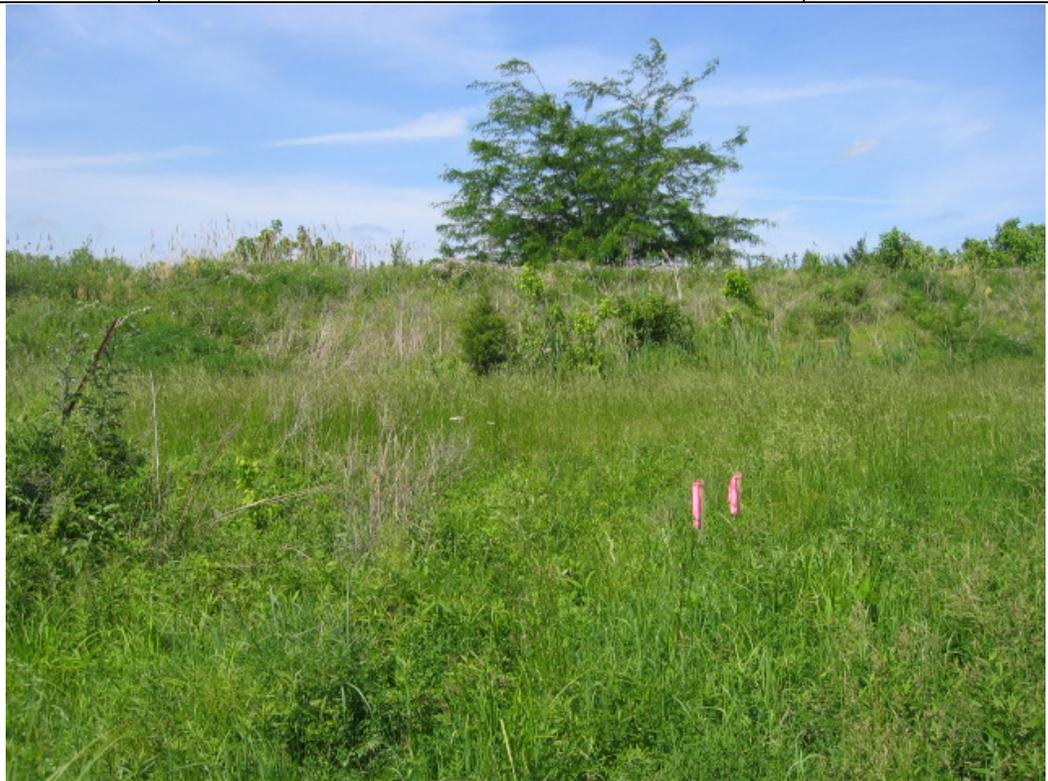
Photo No. 49	Date: 5/24/11
Direction Photo Taken: North

Description:
Downstream slope of the southern embankment of the Secondary Fly Ash Pond. Looking up slope in the area of the 1995 Failure.
