Subject Powerton Secondary Ash Basin Relining

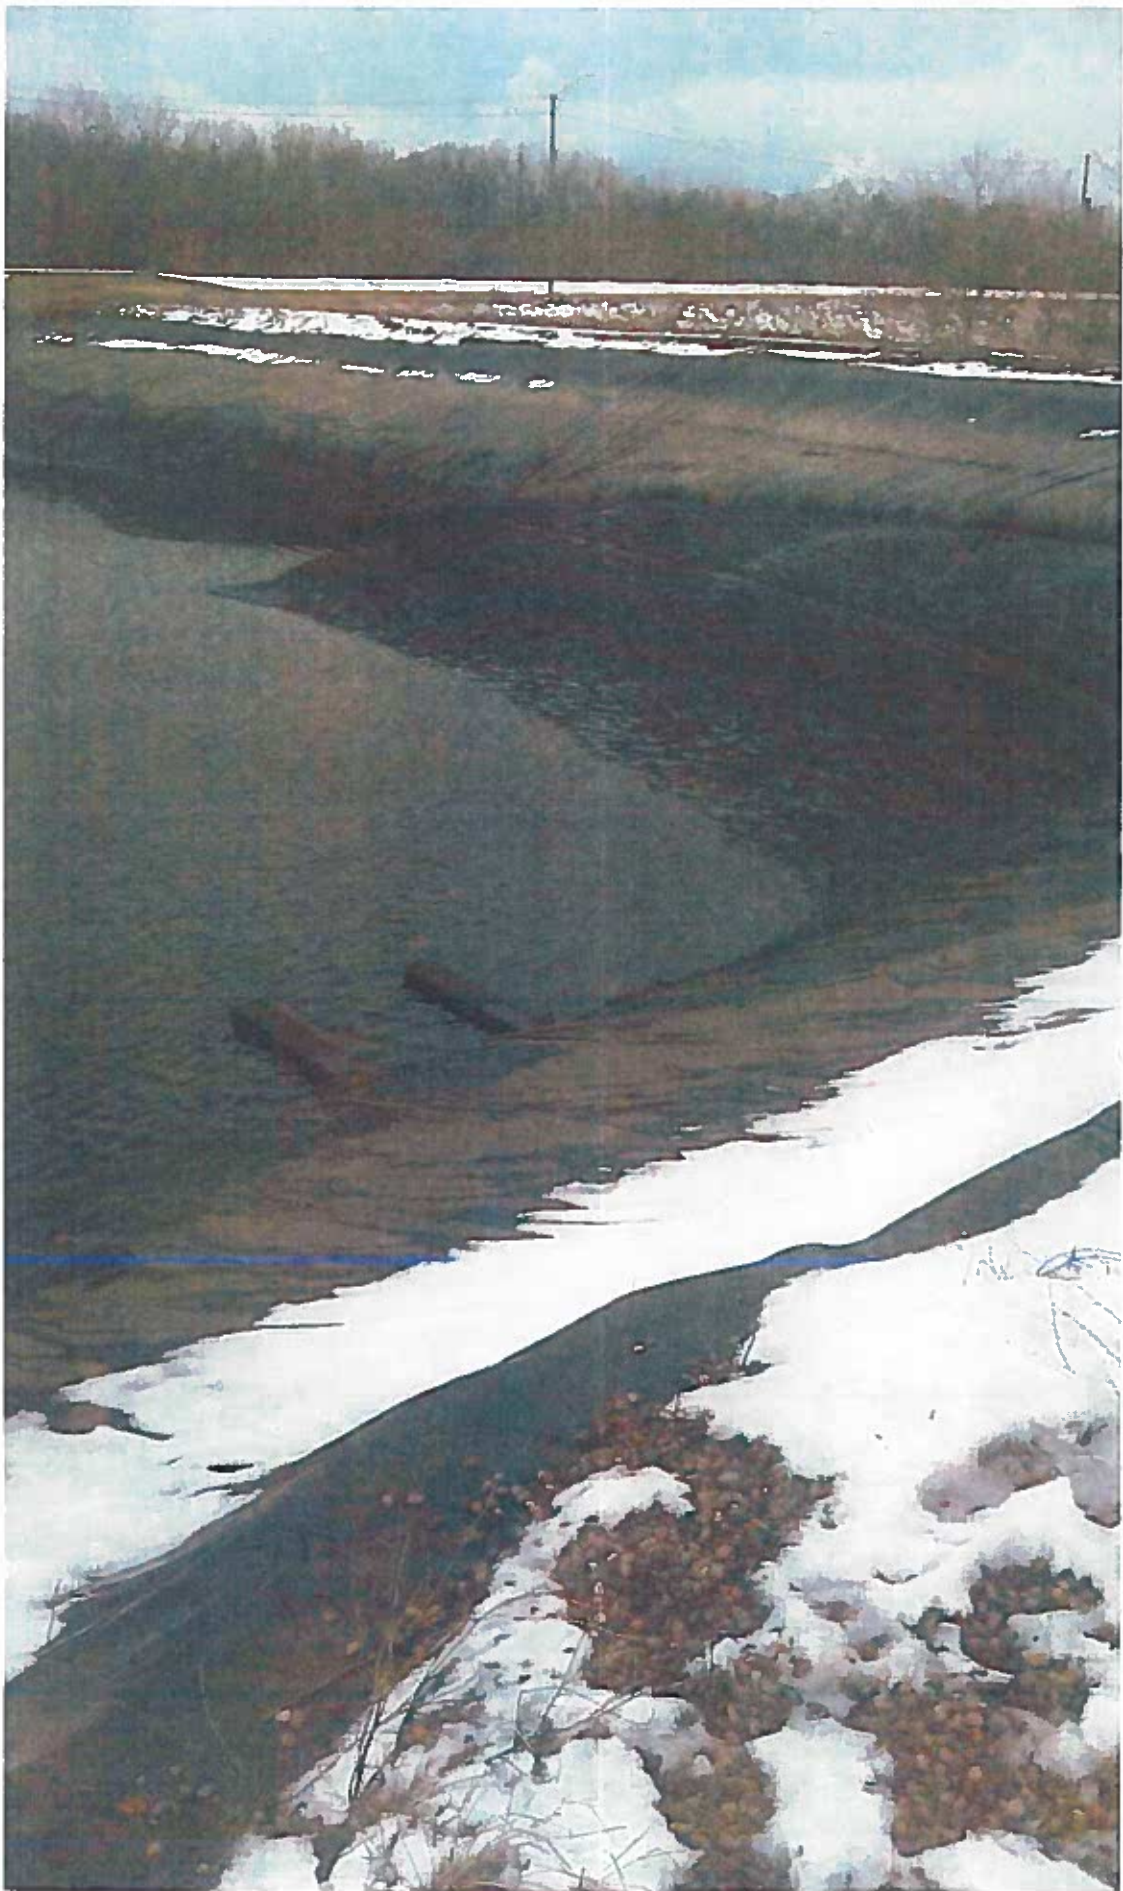
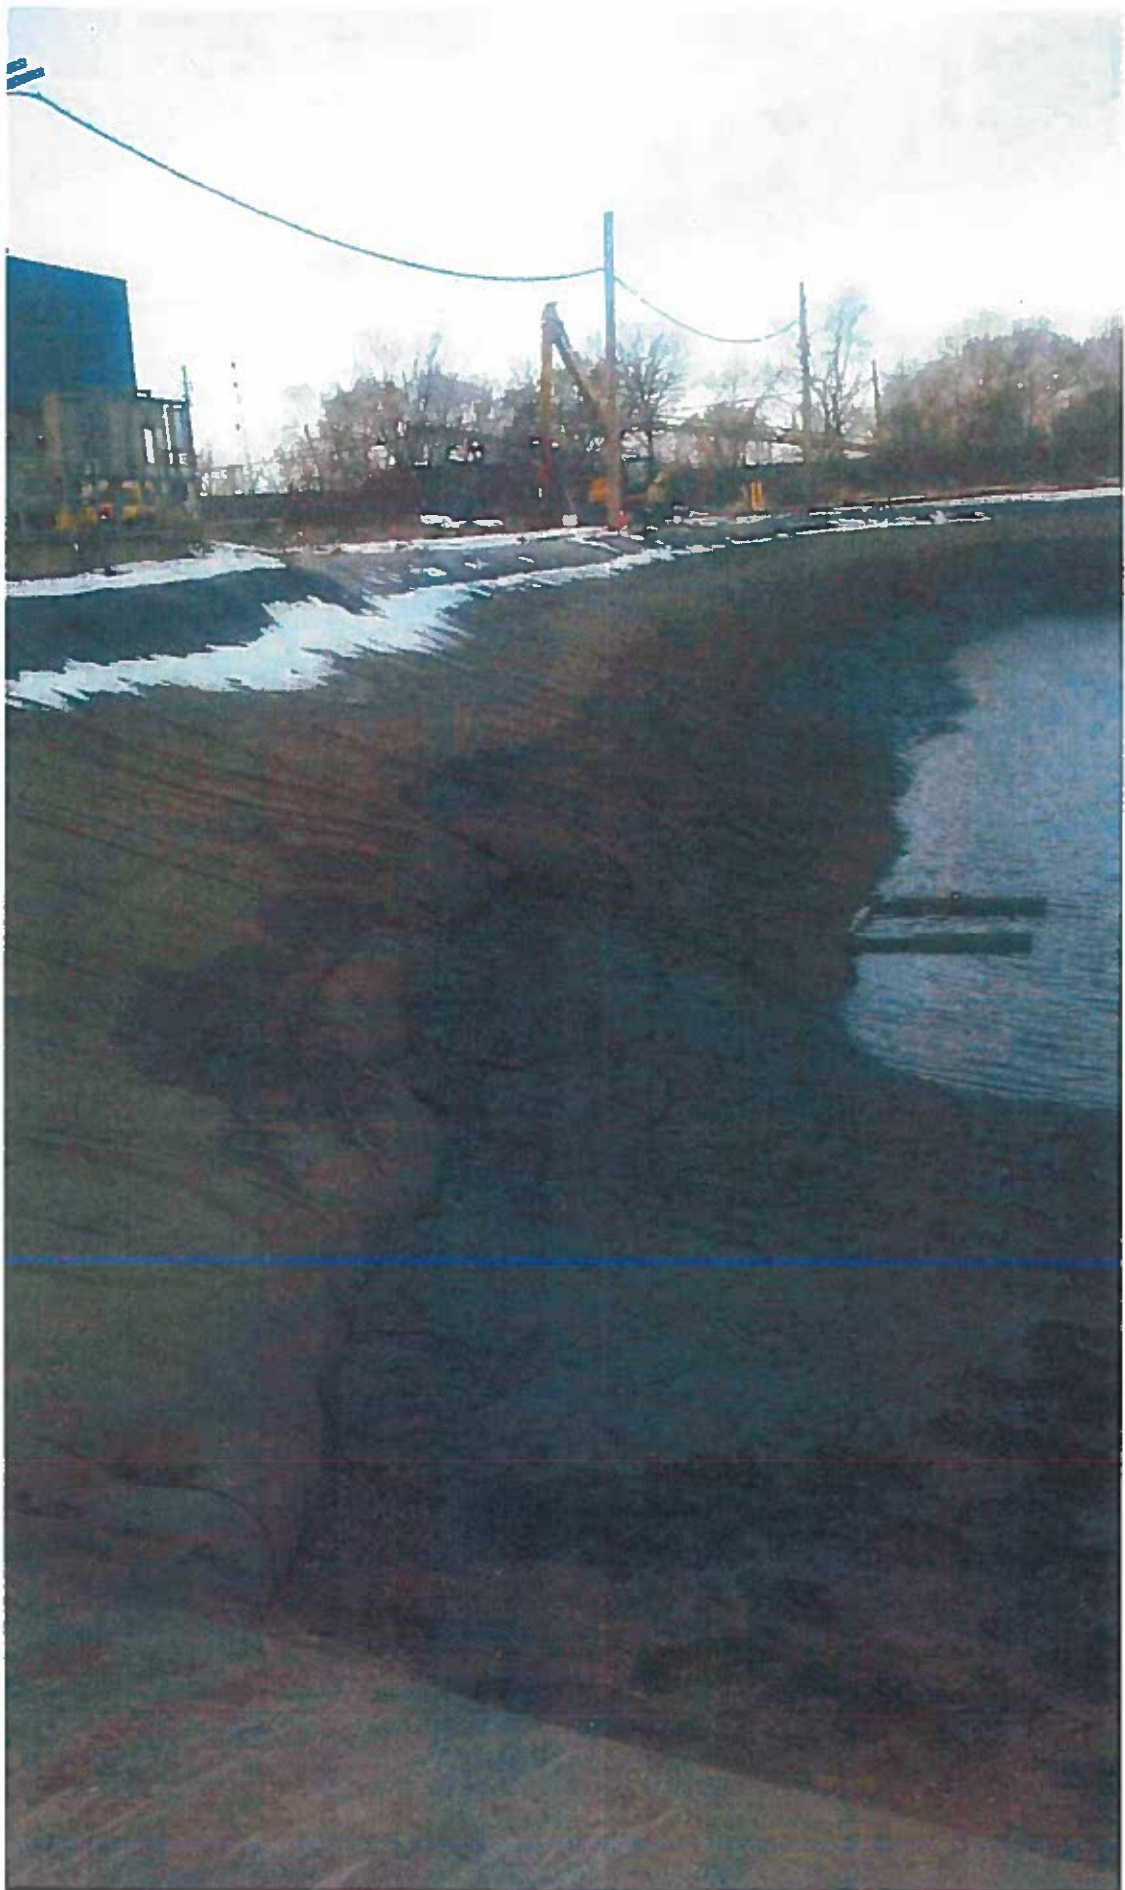
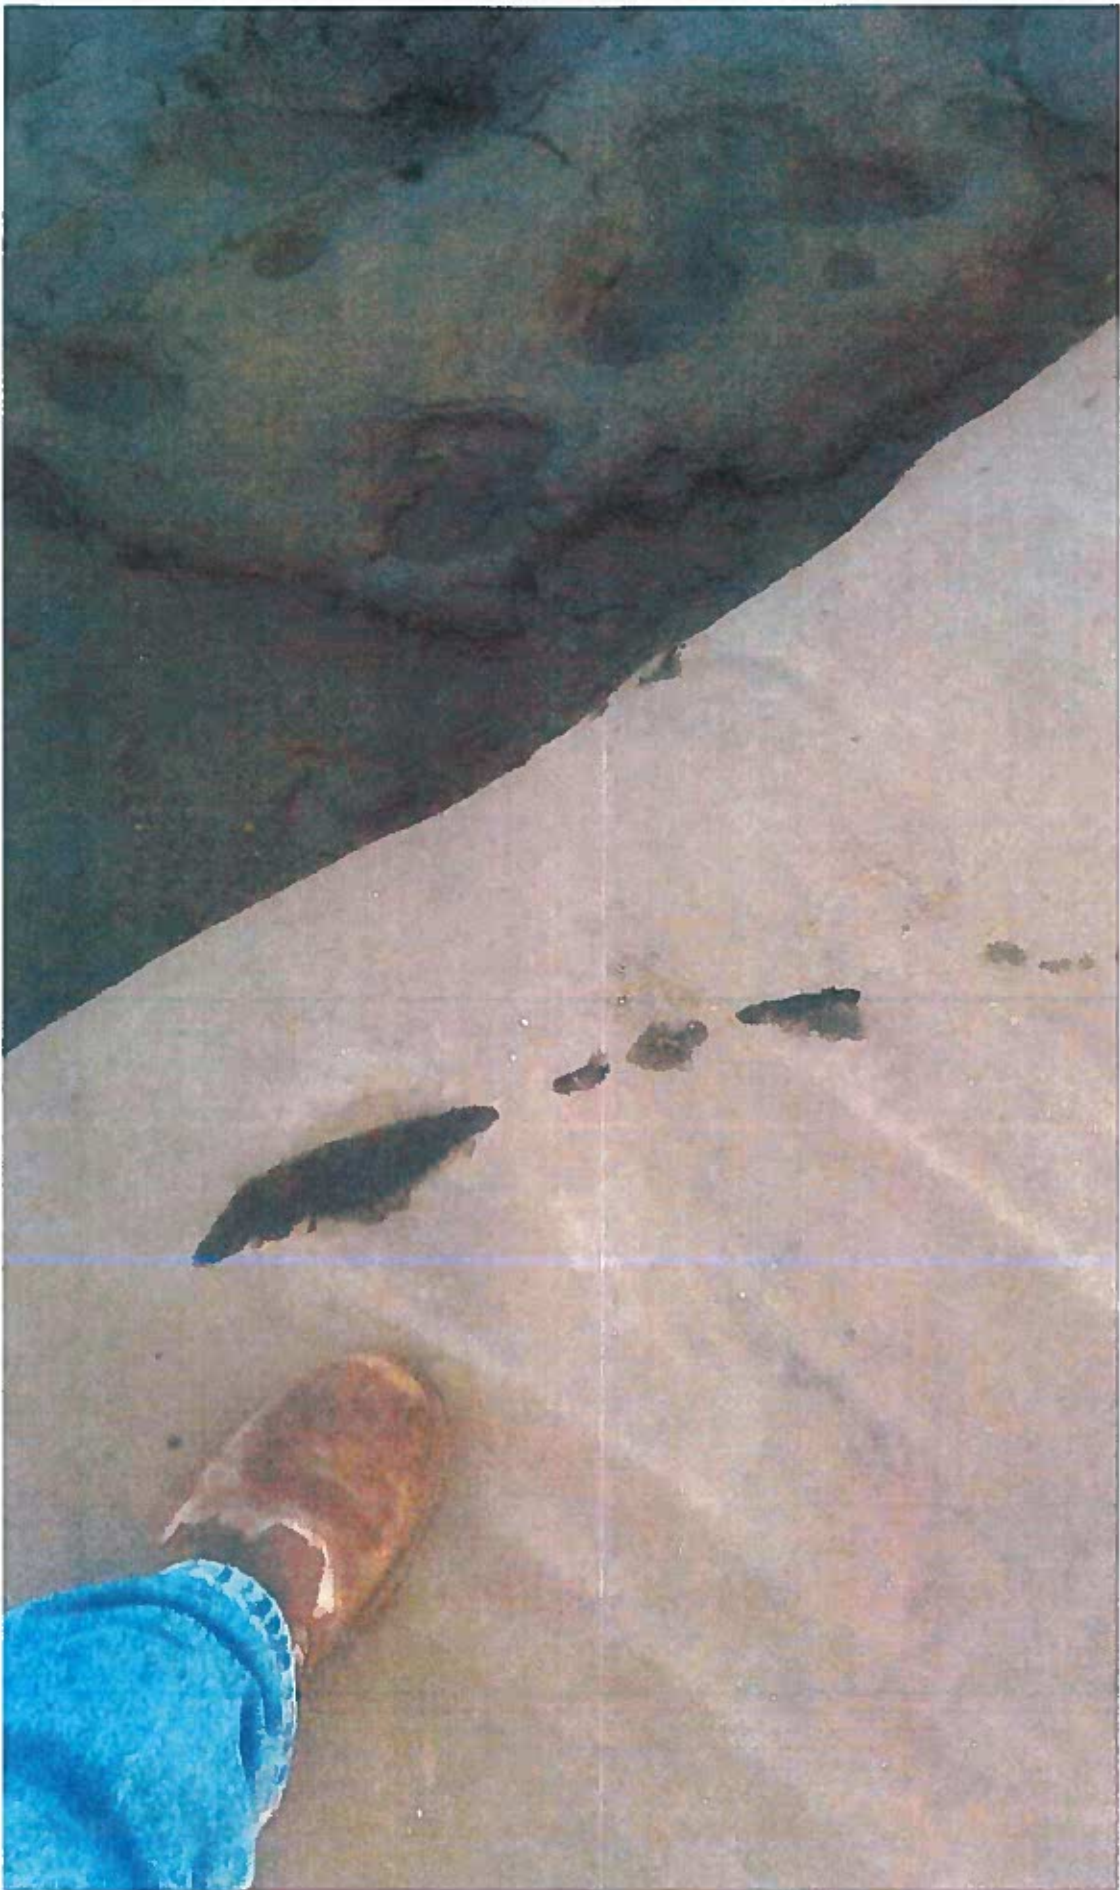
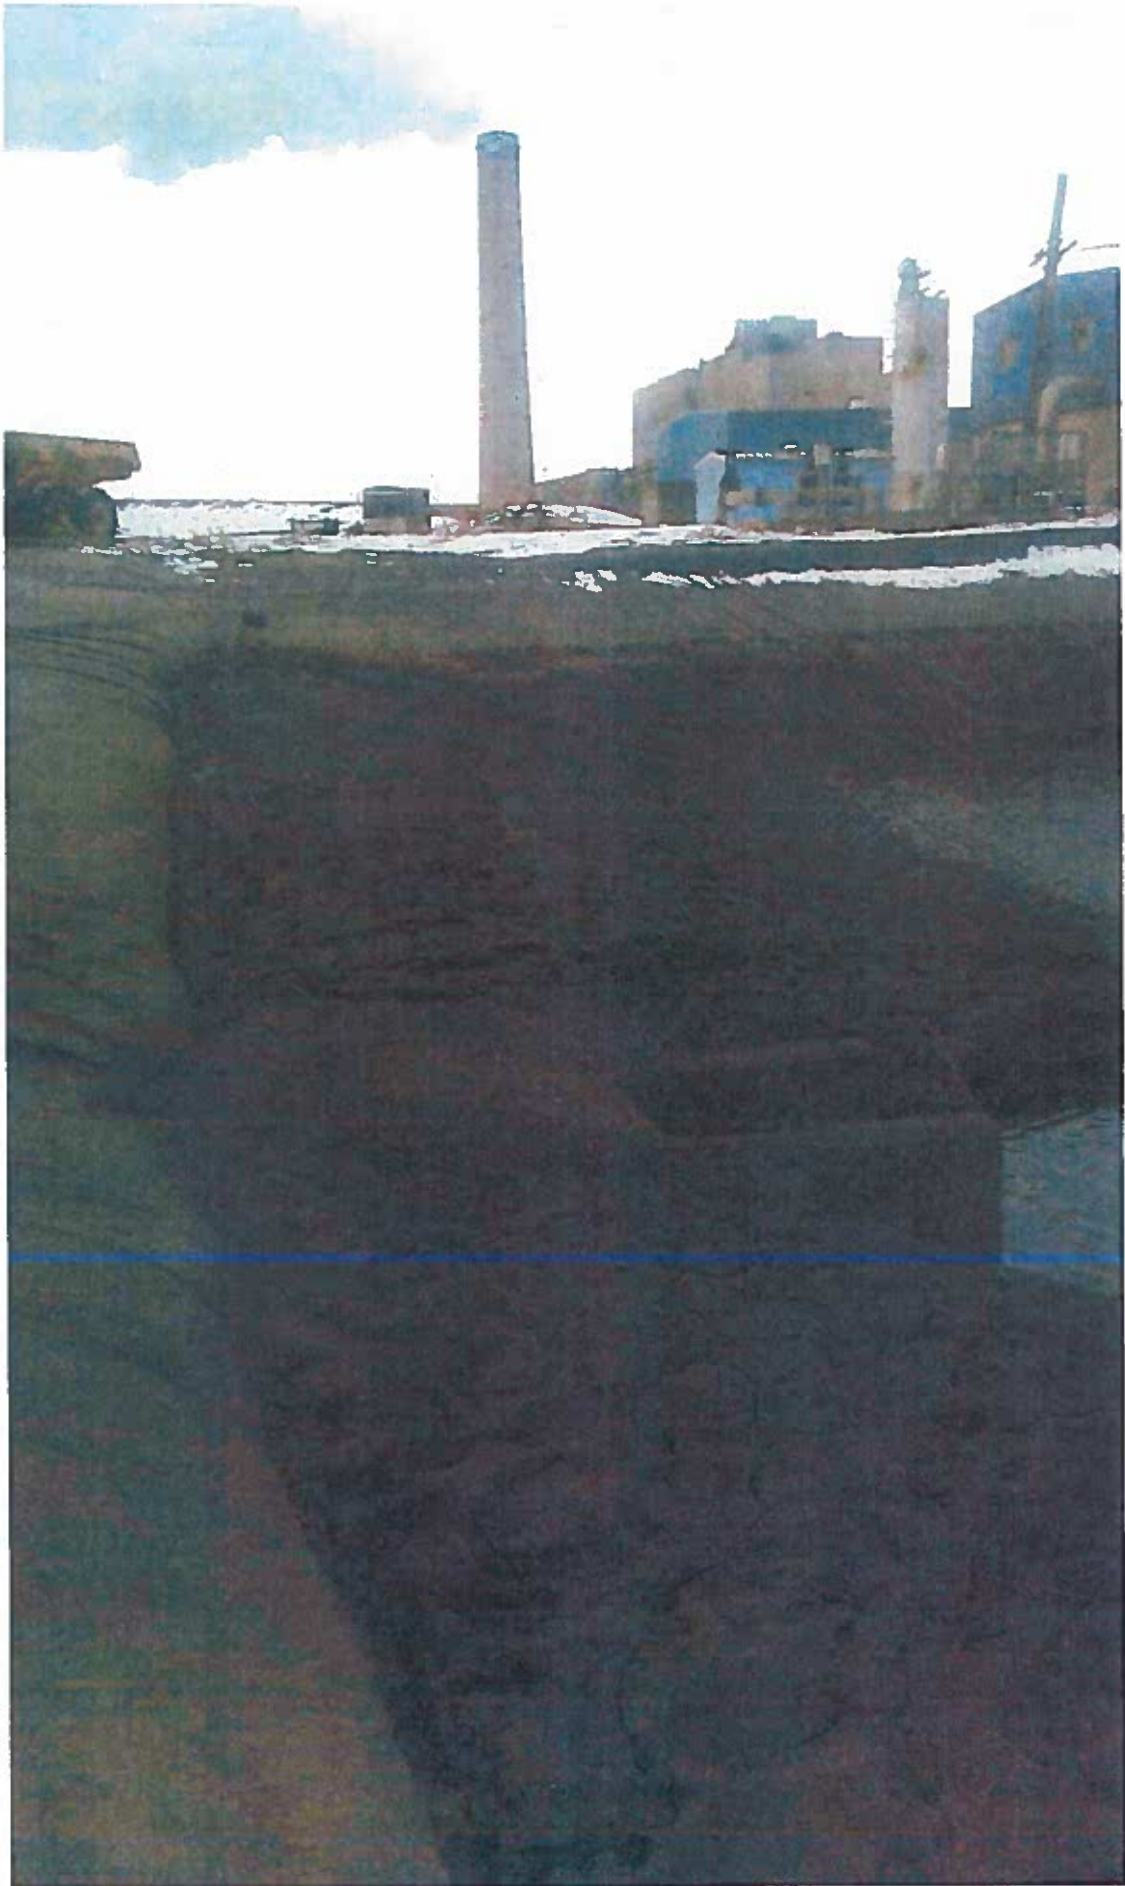
IMAG0054.jpg IMAG0060.jpg IMAG0062.jpg IMAG0064.jpg

A couple of issues have emerged while de-watering the Secondary Basin. I am not sure if either issue is of environmental concern, but they are impacting construction. First, the liner on the east wall of the basin may not have been constructed as designed or it may have been damaged in the past and altered. No one can recall a time when the basin liner was damaged or altered. Attached are some pictures of the east wall where it appears that the liner was rolled under and the remainder of the slop was left exposed or fill was place over a damaged liner. We are not sure how the basin liner got this way, but it will only have a slight impact to construction cost.

The second issue impacts construction cost and schedule. It appears that ground water is leaching into the basin and under the existing liner. The bottom of the basin is at approximately 440 elevation, the Illinois River is currently at 442. The leaching water is keeping the contractor from de-watering and entering the basin. Another de-watering pump will be here tomorrow and that should enable the contractor to empty the basin for cleaning and perhaps some construction. The river level has been dropping and hopefully will continue to drop to allow for a construction window, if not we may need an alternate plan.
