)  
)  
)  
)  
)  
)  
) PCB 2013-015  
) (Enforcement – Water)  
)  
)  
)  
)  
)  
)

# Expert Report on Ground-water Contamination

**James R. Kunkel, Ph.D., P.E.**

**July 1, 2015**

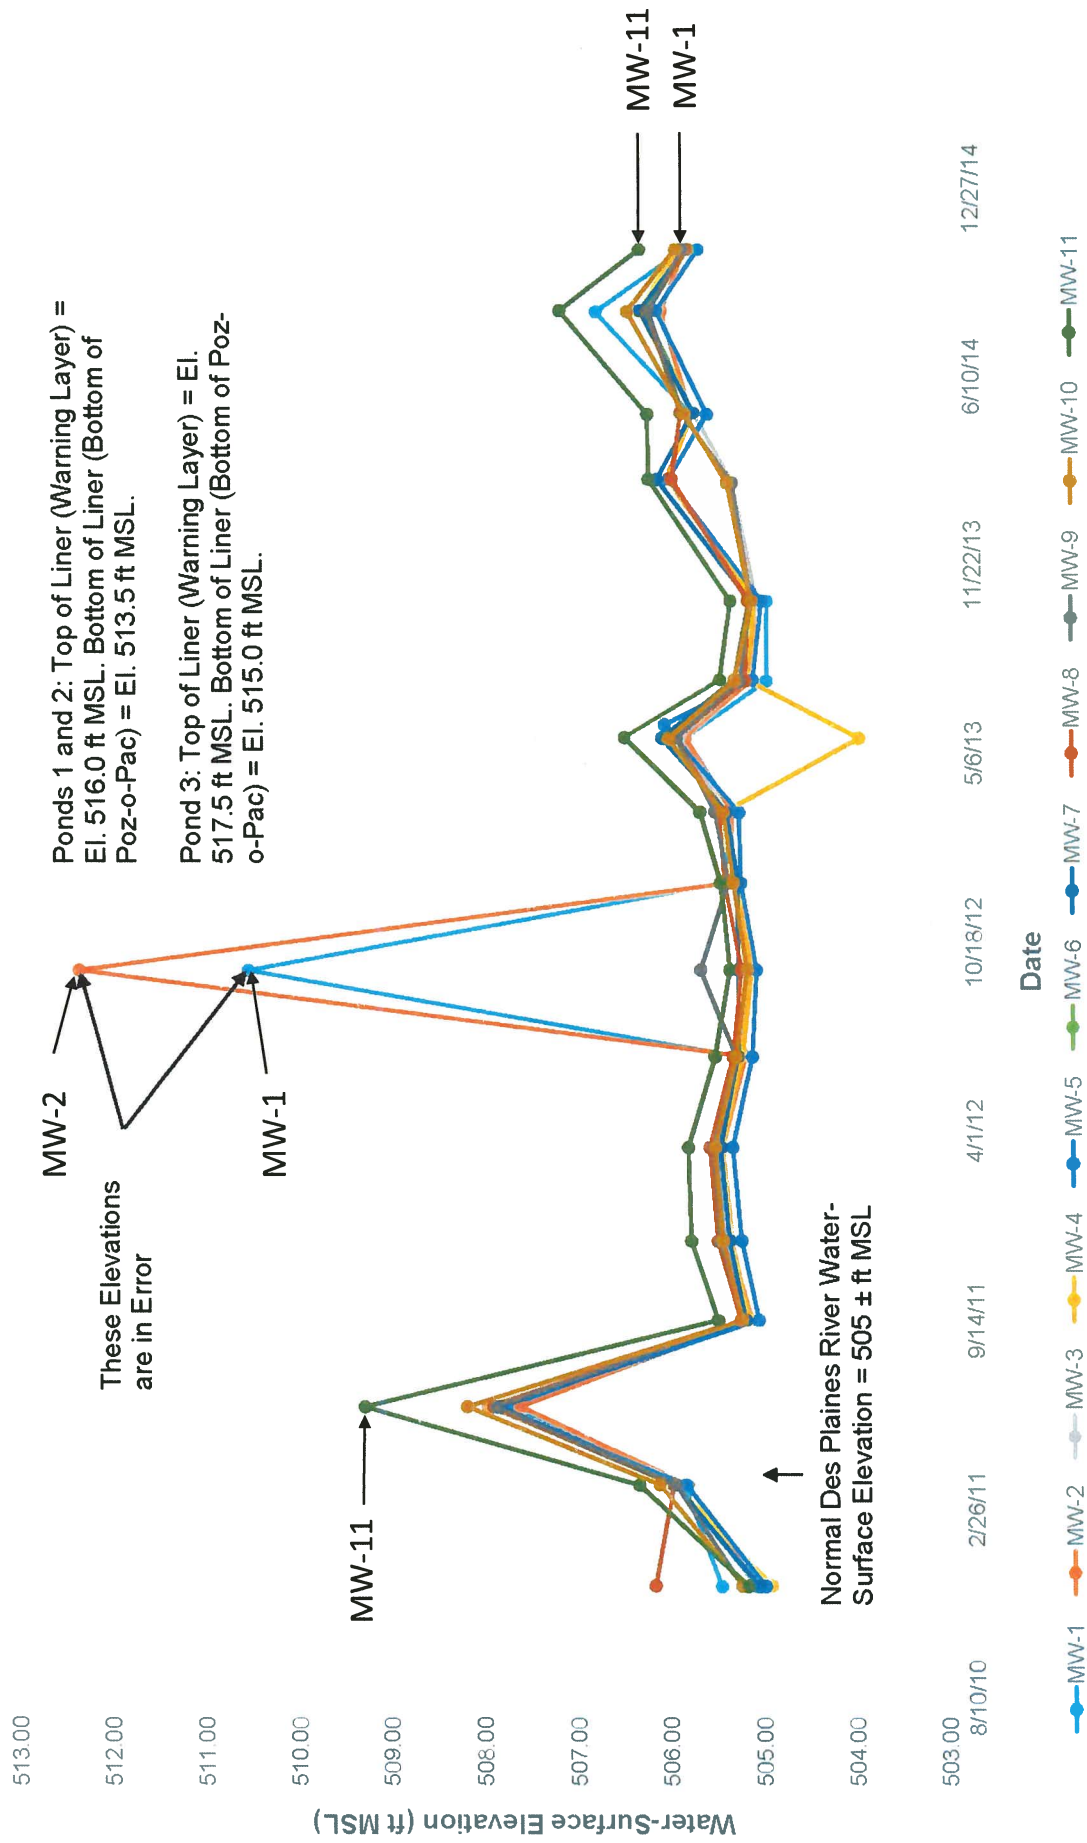
Figure 4 Joliet #29 Site Historical Ground-water Elevations (PCB 2013-015)

**Water Surface Elevations.** Ground-water at the Joliet #29 site is strongly influenced by changes in Des Plaines River surface-water elevations as well as potentially leaking ash ponds. Figure 4 graphically shows the time series of ground-water elevations at the 11 monitoring wells located around the ash ponds. The time series shows some interesting characteristics. During the March and June 2011 quarterly monitoring, the ground-water elevations in the wells rose sharply. This most likely was due to a large increase in runoff and rising Des Plaines River water-surface elevations. Based on discharge data from the USGS gaging station 05537980, water discharges in the River during the period March through June 2011 were as high as 27,300 cubic feet per second (cfs) or more than 4 times the average River discharge (6,412 cfs) for the same period. There were two other very high discharges in May 2011 (20,100 and 20,800 cfs) which also resulted in high Des Plaines River stages at the Joliet #29 site. These high stages are reflected in ground-water mounding beneath the ash ponds during this period as seen in MWG Second Quarter 2011 monitoring report and Figure 3. Similar ground-water mounding also is seen in the MWG subsequent quarterly monitoring reports and is the result of both high Des Plaines River stages during the spring and early summer and also due to ash pond liner leaks in Pond 3 until it was relined in 2013. The consequences of this mounding would be to saturate already contaminated soils from previous ash pond leaks or from previous coal ash leaching events. The high Des Plaines River discharges certainly caused river bank erosion

I conclude from interpretation of the ground-water elevations and presumed Des Plaines River water-surface elevations based on River discharge data that the River strongly influences the ground-water elevations and ground-water gradients at site, causing seasonal flow from the River into the unconsolidated materials beneath the ash ponds. However, not all of the ground-water mounding seen in the quarterly monitoring reports can be attributed to the Des Plaines River and I further conclude that the Joliet #29 ash ponds have leaked in the past and continue to leak.

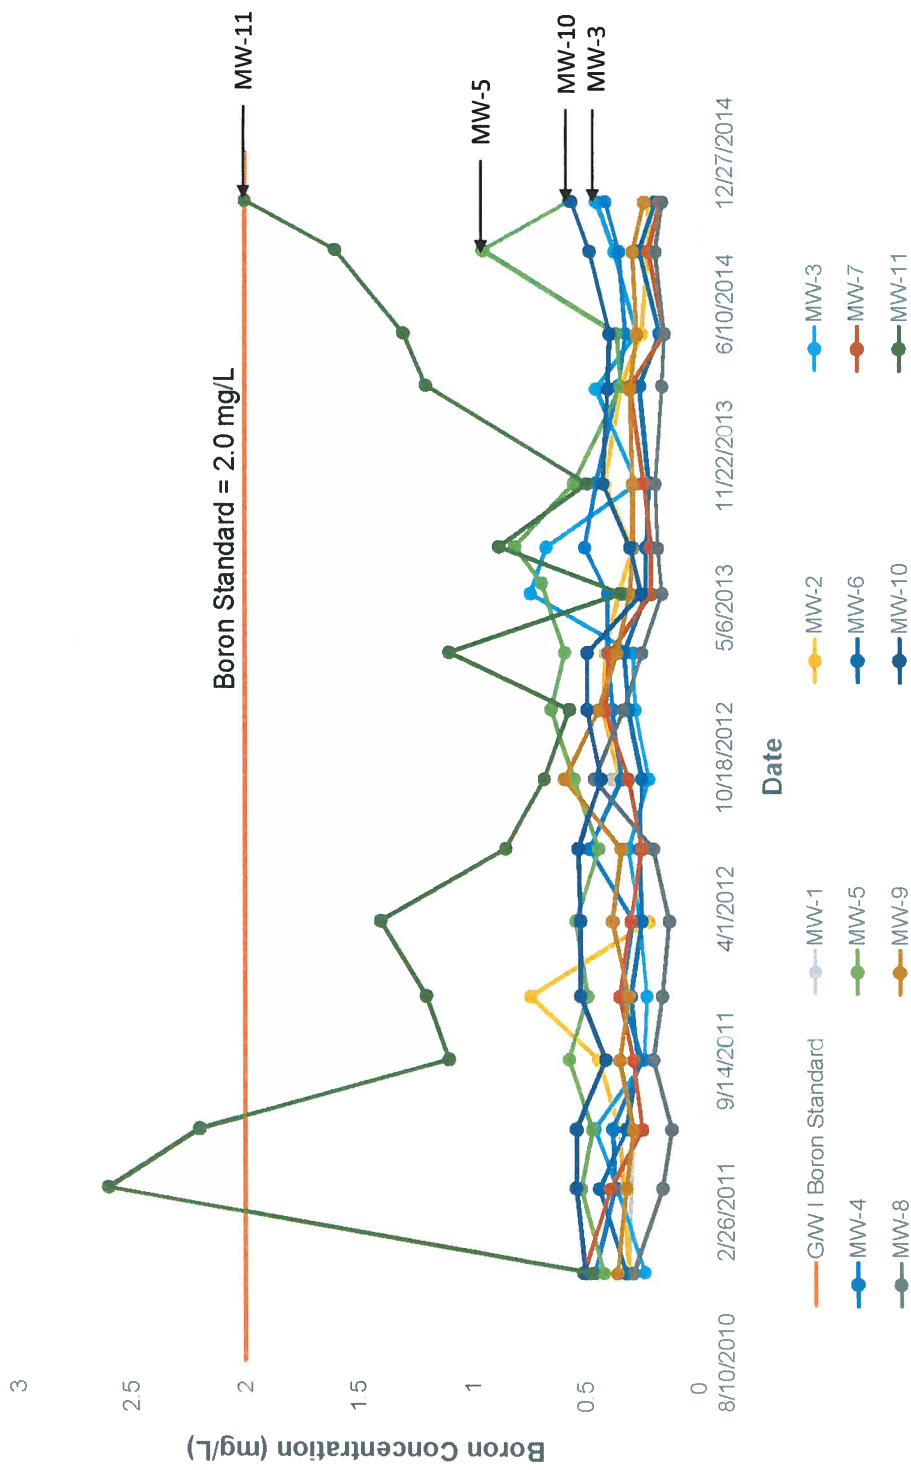
**Figure 5 Boron Concentrations in Ground Water  
Joliet #29 Site (PCB 2013-015)**

Figure 5 shows the time series of B concentrations in ground-water at the Joliet #29 site. Historically MW-11 has had B concentrations equal to or higher than the IEPA Class I ground-water standard of 2.0 mg/L during the monitoring period from December 2010 to present. Boron is known to be found in coal ash leachate (Table 2). It is noted that B concentrations in ground-water have recently increased dramatically in MW-5 and MW-11, with slightly increasing B concentration trends in all of the other 9 wells. Boron concentrations in ground water at all monitoring wells at the Joliet #29 site are higher than the background concentration of 0.12 mg/L for sand and gravel aquifers (Table 3). Therefore, I conclude that ground-water contamination by B at the Joliet #29 site was and is currently occurring as the result of ash pond liner leaks and/or leaching of coal ash deposits outside the ash ponds.

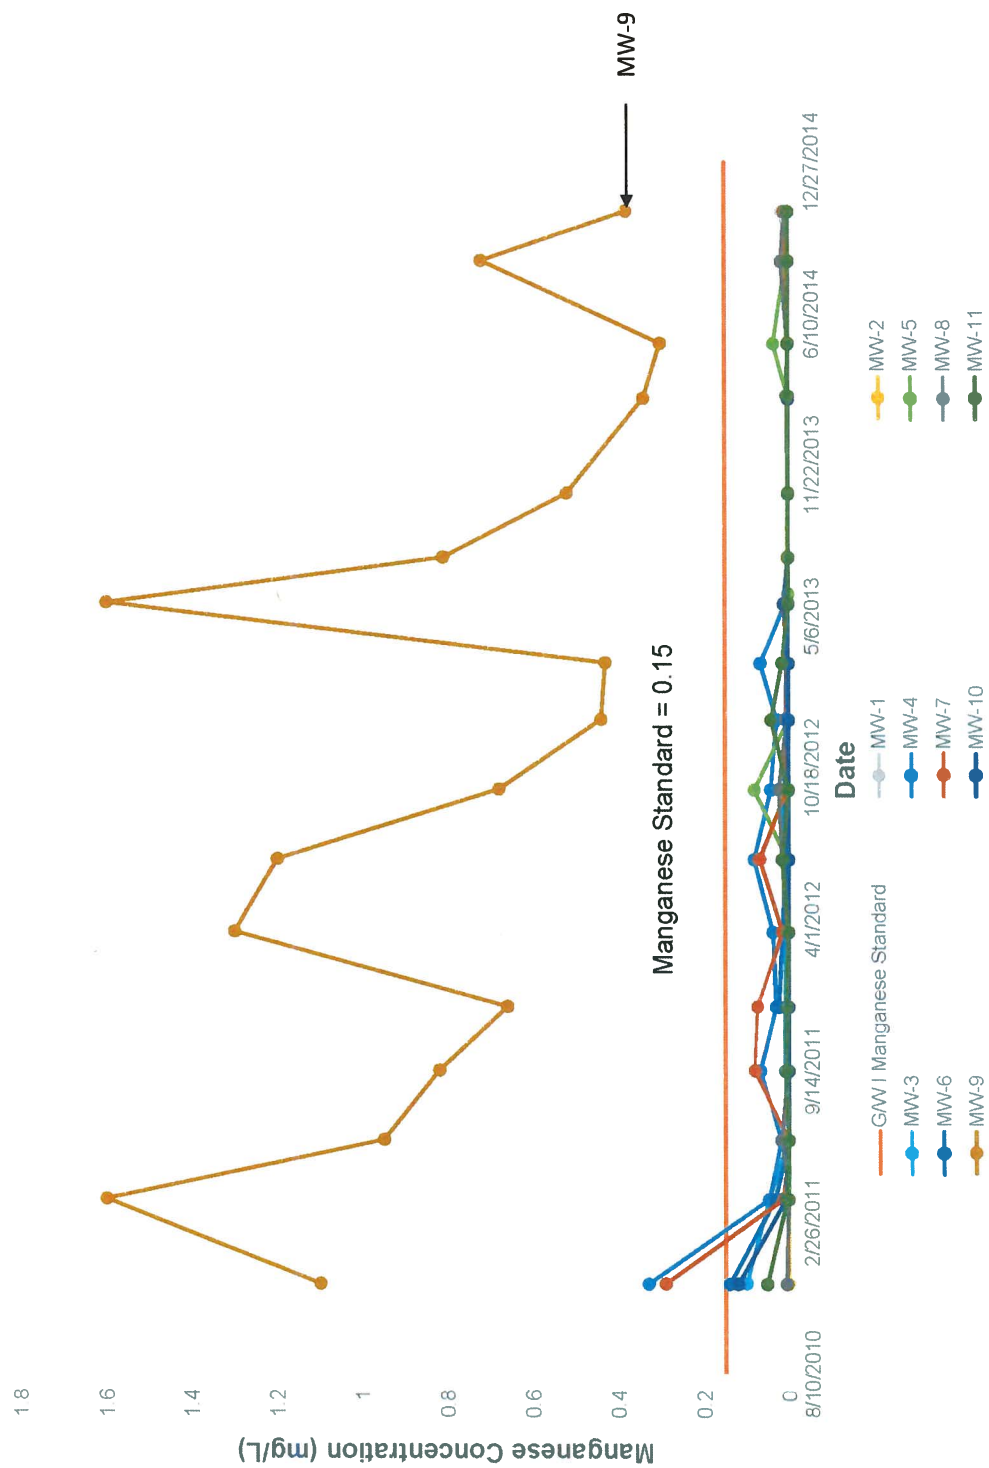
**Figure 6 Manganese Concentrations in Ground Water  
Joliet #29 Site (PCB 2013-015)**

Mn concentrations in ground water as shown in the time series on Figure 6 have historically been higher than the IEPA Class I ground-water standard of 0.15 mg/L in MW-9. Manganese is known to be found in coal ash leachate (Table 2). It is noted that Mn concentrations in ground-water have recently decreased in MW-9 and in all of the other 10 wells. The other monitoring wells historically have had Mn concentrations much less than the IEPA Class I ground-water standard, but sometimes higher than the background ground-water concentration of 0.072 mg/L for sand and gravel aquifers. Therefore, I conclude that ground-water contamination by Mn at the Joliet #29 site was and is currently occurring as the result of ash pond liner leaks and/or leaching of coal ash deposits outside the ash ponds.

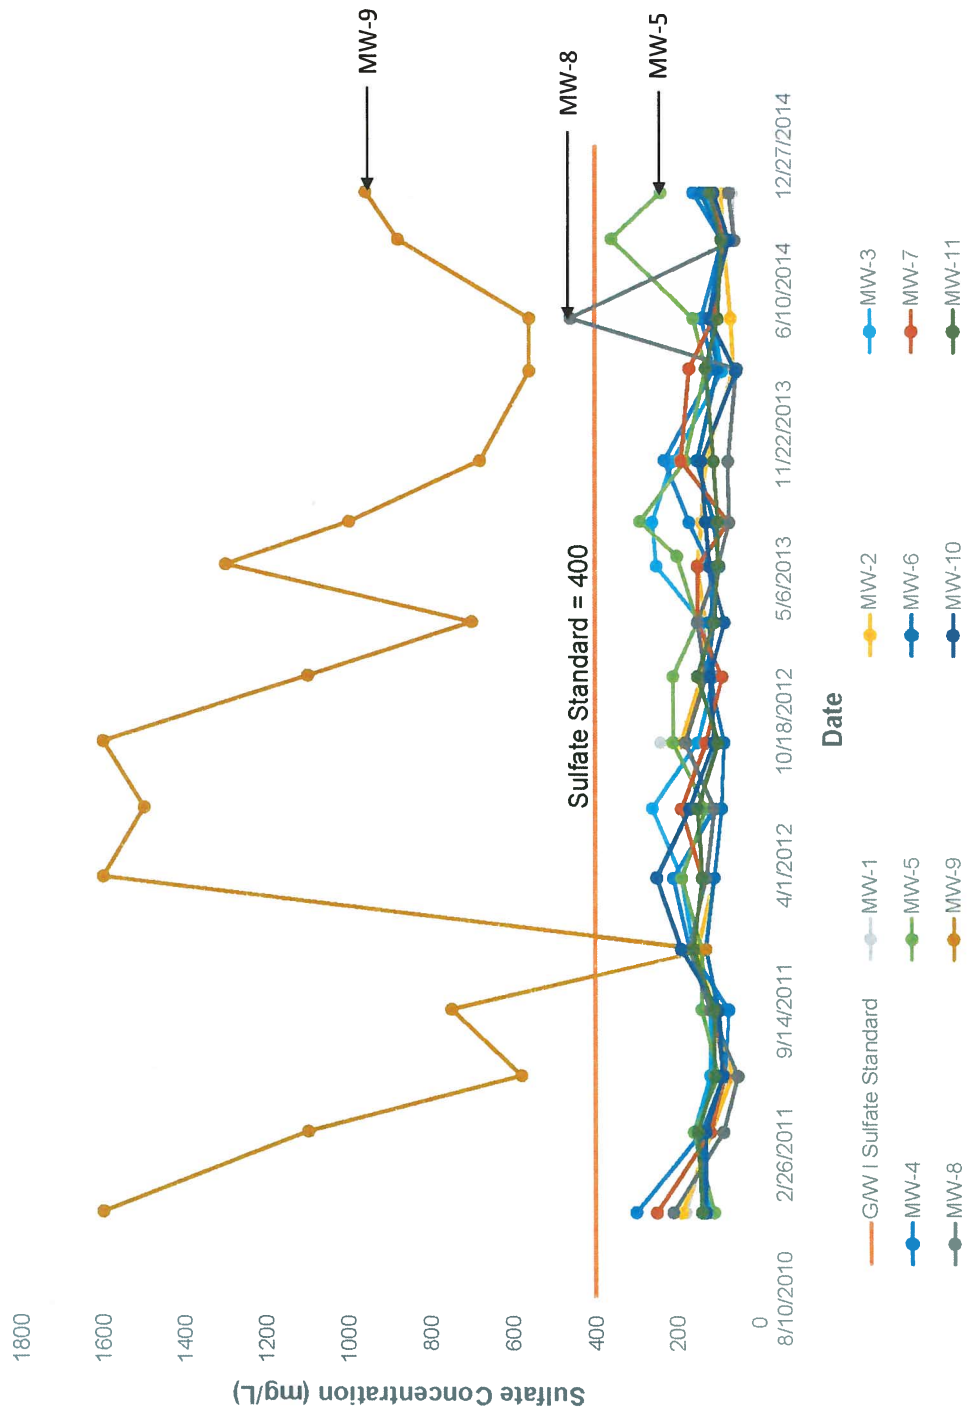
**Figure 7 Sulfate Concentrations in Ground Water  
Joliet #29 Site (PCB 2013-015)**

Figure 7 shows the time series of SO<sub>4</sub> concentrations in ground water at the Joliet #29 site with MW-9 having SO<sub>4</sub> concentrations consistently higher than the IEPA Class I ground-water standard of 400 mg/L. MW-8 has had one SO<sub>4</sub> concentration in ground water greater than the IEPA Class I standard during the Second Quarter of 2014. Sulfate is known to be found in coal ash leachate (Table 2). It is noted that SO<sub>4</sub> concentrations in ground-water have recently decreased in MW-5 and MW-8 and in all of the other 8 wells. It is noted that MW-9 is monitoring ground-water beneath ash Pond 3 which was relined in 2013. However, SO<sub>4</sub> concentrations in ground-water at MW-9 appear to be increasing since the Second Quarter of 2014, indicating that there most likely is a leak in the Pond 3 liner. An alternative explanation is that coal ash deposits outside the ash ponds continue to leach contaminants into the ground water at the Joliet #29 site.

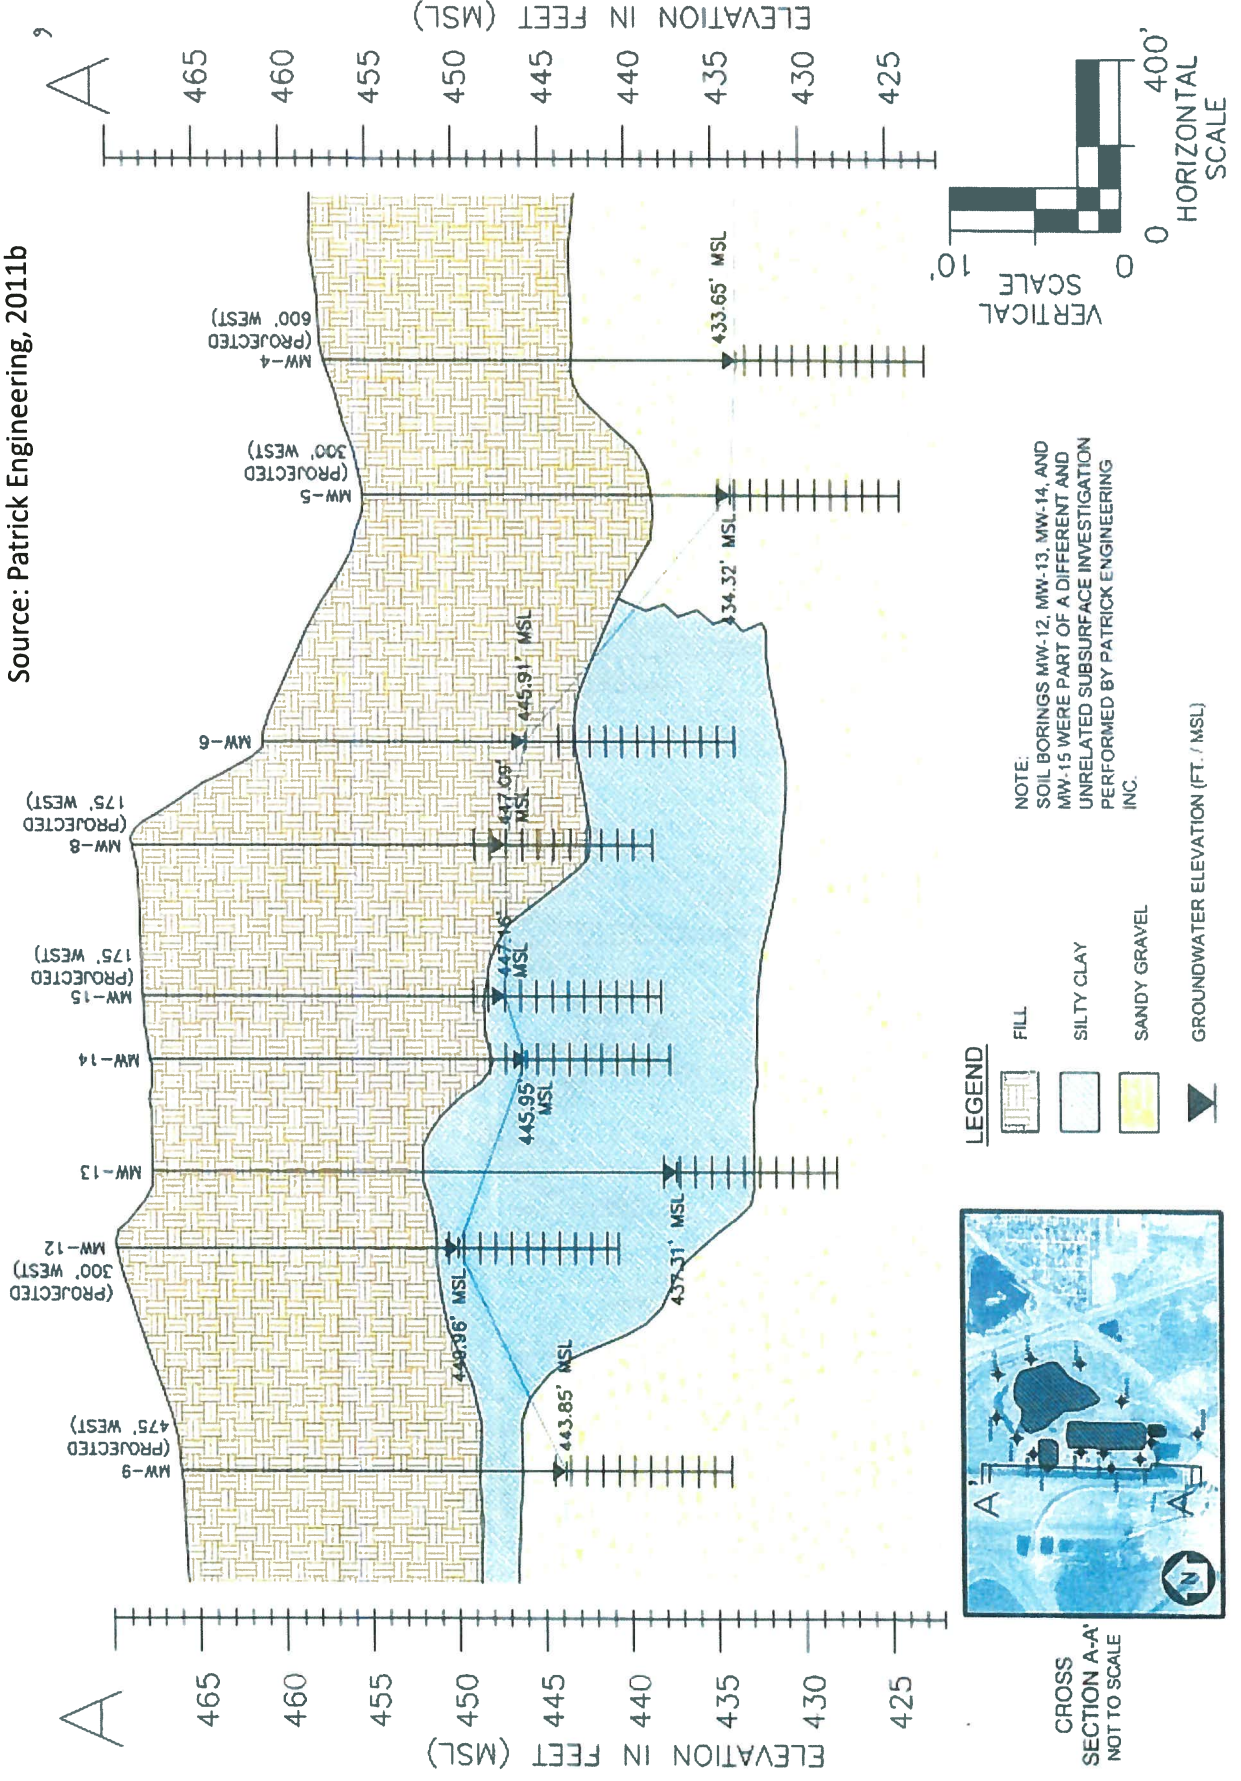
Figure 10 Powerton Soil Stratigraphy (PCB 2013-015)

**Water Surface Elevations.** Ground water at the Powerton site is strongly influenced by changes in Illinois River surface-water elevations via the channels connecting it to the site, as well as potentially leaking ash ponds. Interpretation of historical ground-water and surface-water elevations for the upper silt/clay and the lower gravelly sand units, as shown graphically on Figures 11 and 12, coupled with the soil stratigraphy shown on Figure 10, indicates the following:

- (1) The pond bottom elevation for the Secondary Ash Settling Basin is within the upper silt/clay unit but below the fill materials at the site;
- (2) The other pond bottom elevations appear to be within the fill materials at the site based on the incomplete information provided by MWG;
- (3) Ash pond water-surface elevations are nearly always at or above the ground-water and Illinois River water-surface elevations;
- (4) If there are leaks in the pond liners, it would be possible for contaminants to move opposite to the general ground-water flow direction at the site;

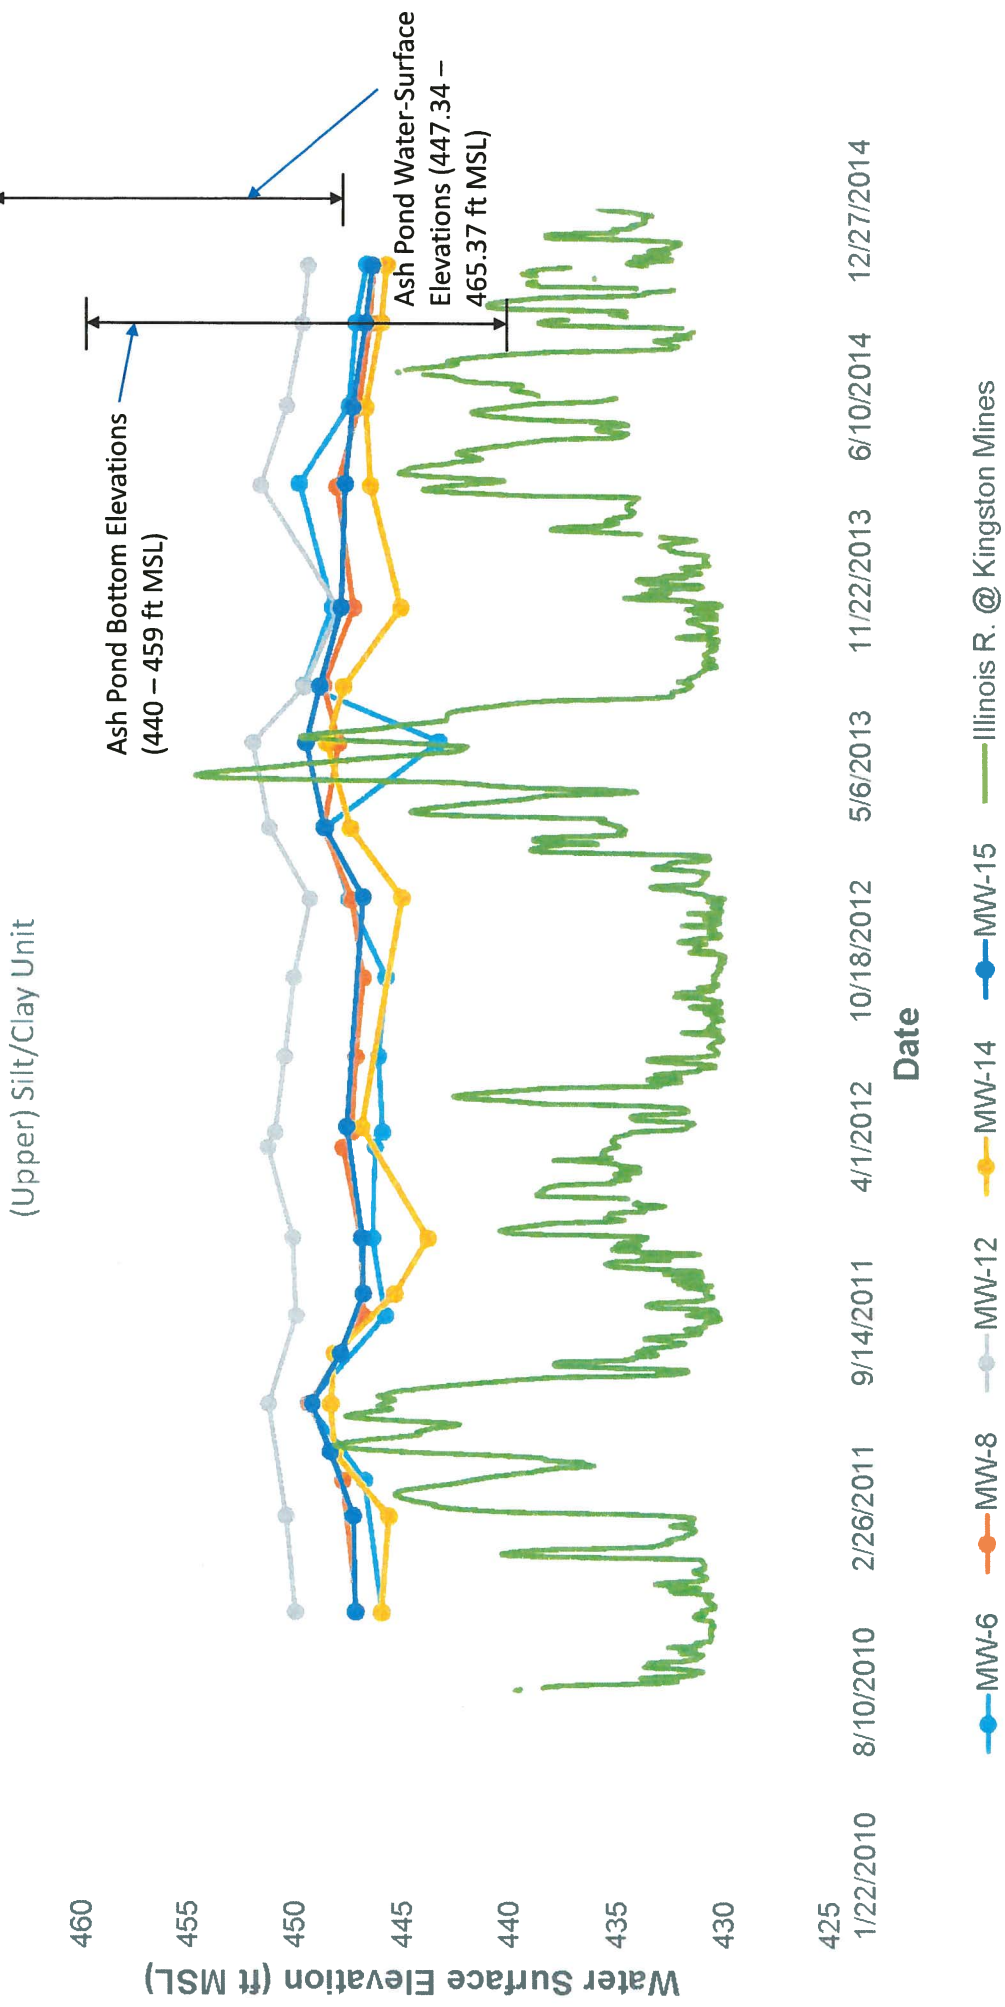
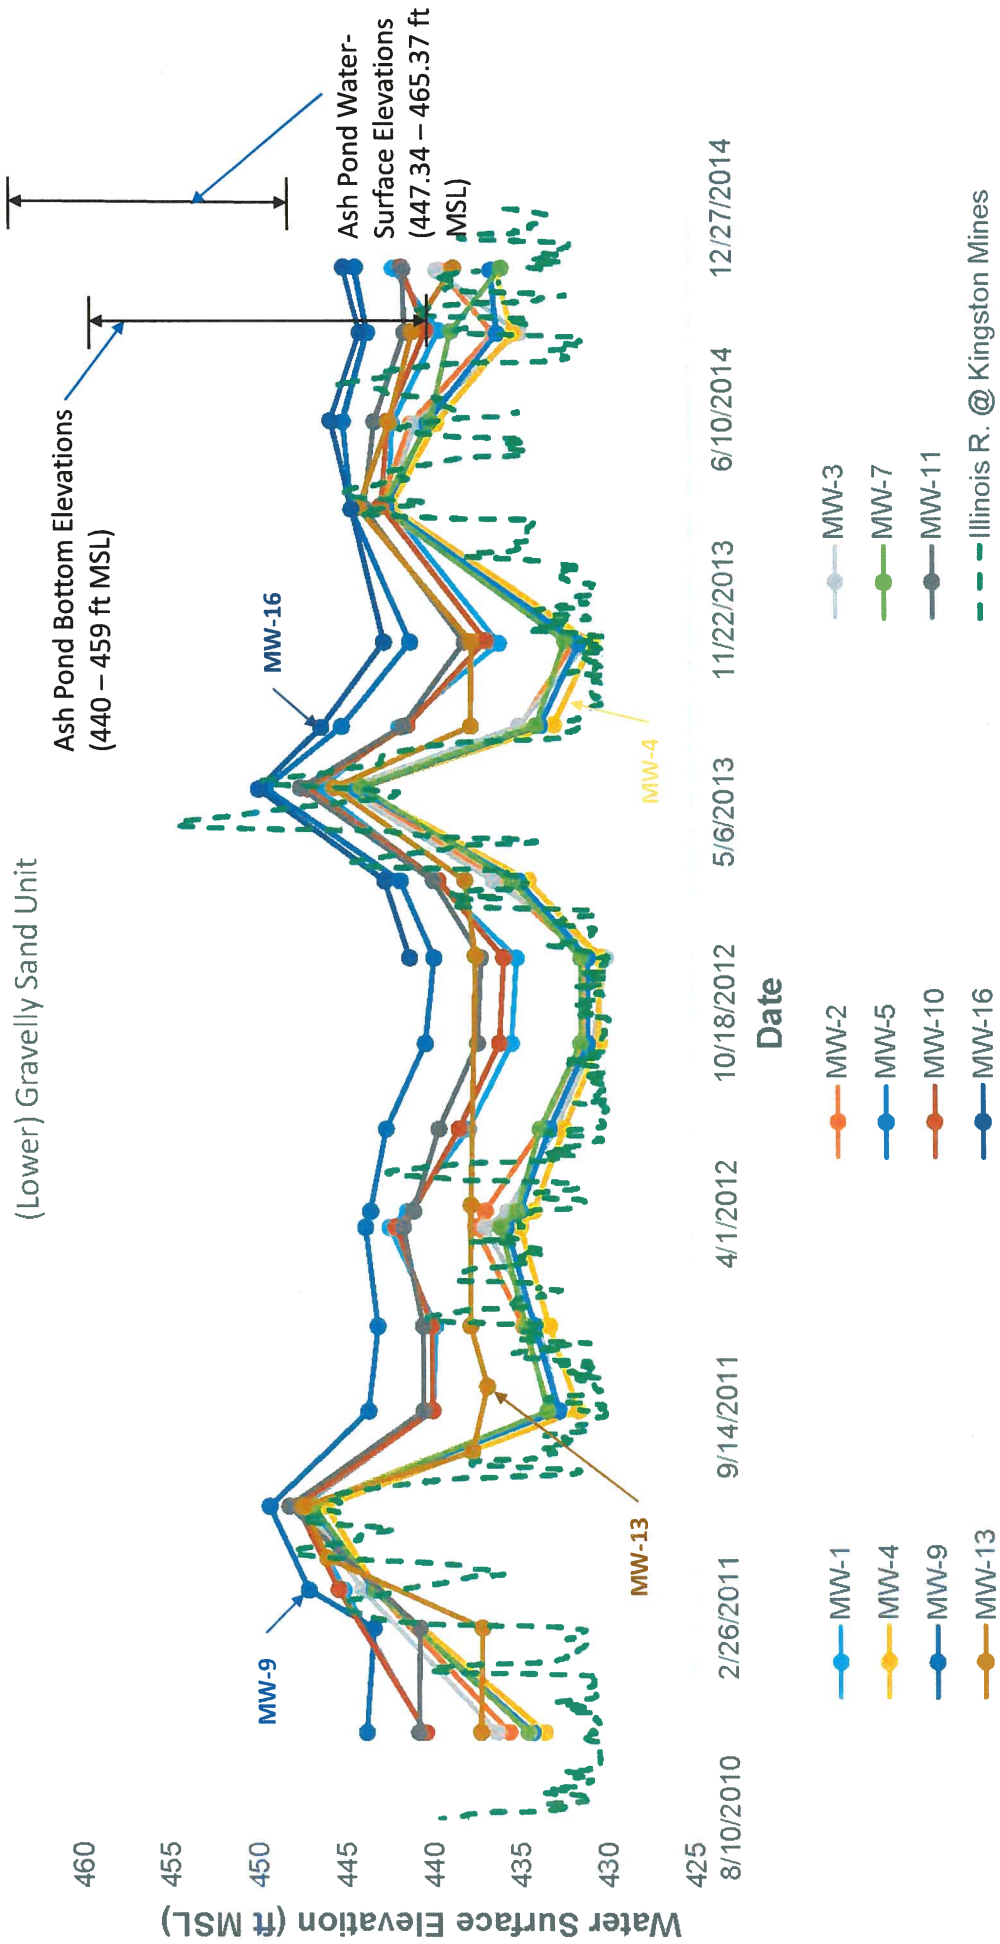
This conclusion is exemplified by the MW-8 and MW-15 time series elevation lines on Figure 11 in the upper silt/clay unit and MW-1 and MW-10 elevation lines on Figure 12 in the lower gravelly sand unit whose ground-water elevation lines cross depending on the season of the year. Therefore, contaminant movements from ash pond leaks and/or leaching of in-place coal ash "slosh" back and forth in the ground-water at the site.

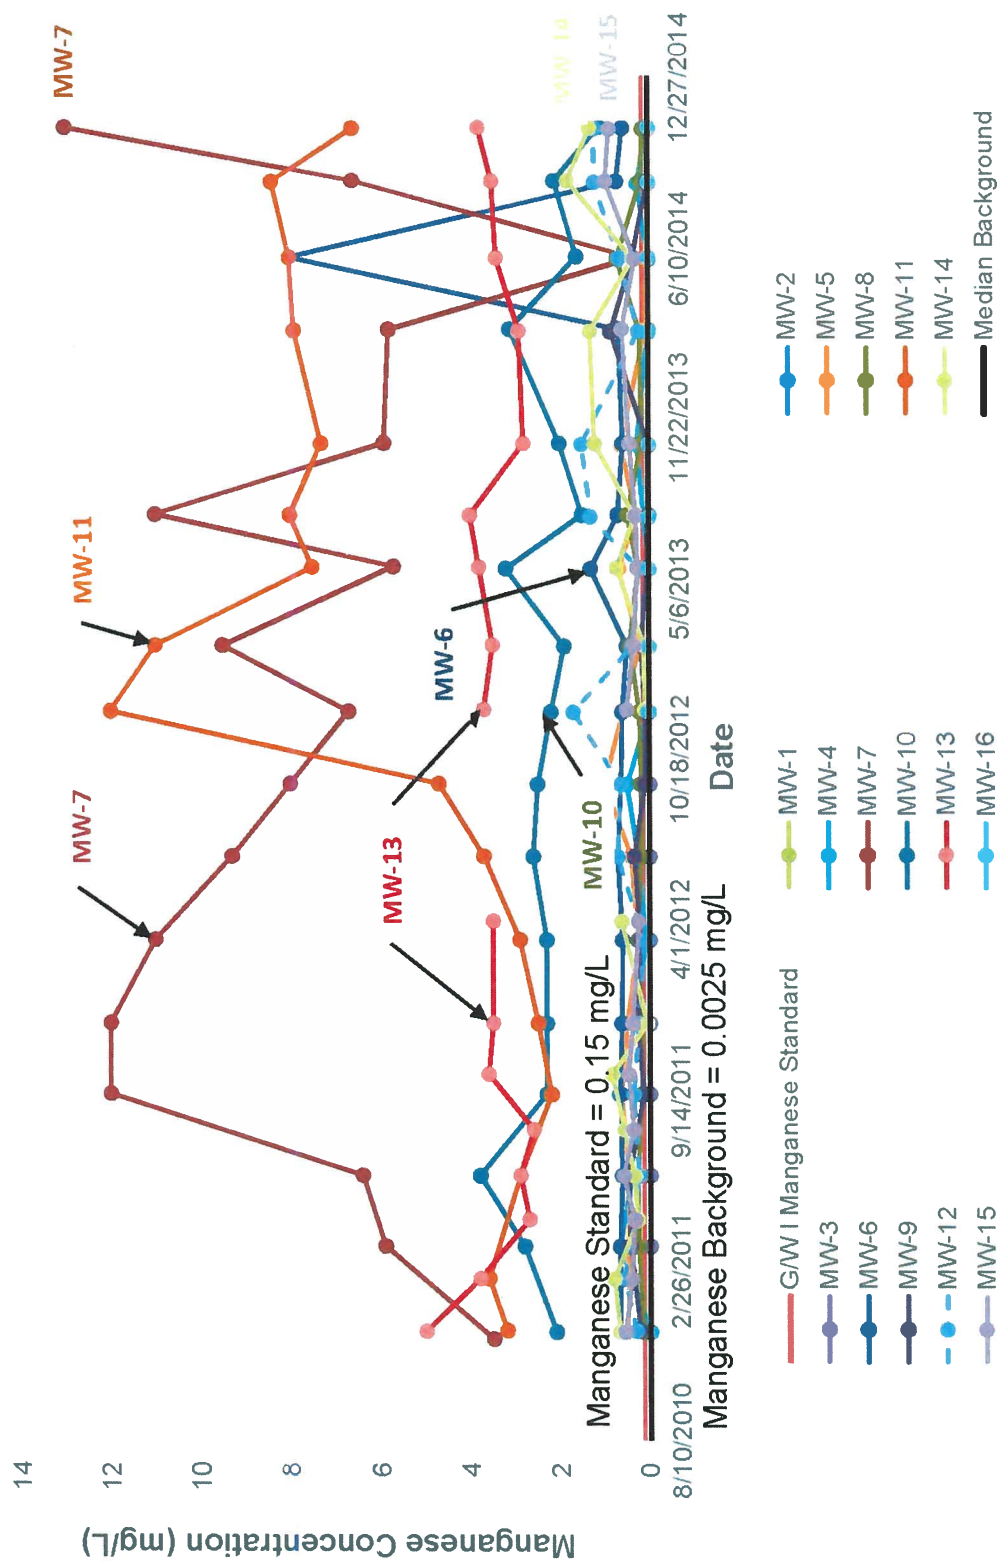
**Figure 14 Manganese Concentrations in Ground Water  
Powerton Site (PCB 2013-015)**

-15 (upper silt/clay unit) as shown by the time series on Figure 14. Mn concentrations have remained generally high, most notably in MW-6, -7, -10, -11 and -13. The highest Mn concentrations appear to be in the lower gravelly sand unit (e.g., MW-7 and MW-13) as a result of apparent ash pond liner leakage and, perhaps, also downward movement of Mn contamination from the overlying silt/clay unit and/or leaching of historical coal ash deposits outside the ash basins. The same trend in Mn concentrations as for B concentrations can be seen in MW-10 for the same reasons as stated above.
