RE: Construction Documentation Transmittal  
South Pond #3 Liner Replacement  
Midwest Generation, LLC Joliet Generating Station

Natural Resource Technology, Inc. (NRT) has prepared this correspondence to transmit construction record documents for the liner replacement completed in 2013 for South Pond #3 at the Joliet Generating Station. Major components of construction generally occurred as follows:

**Project Number / Task:** 2113.3 / 3.3  
**Project Name:** Ash Pond 3 Liner Replacement – Joliet Generating Station

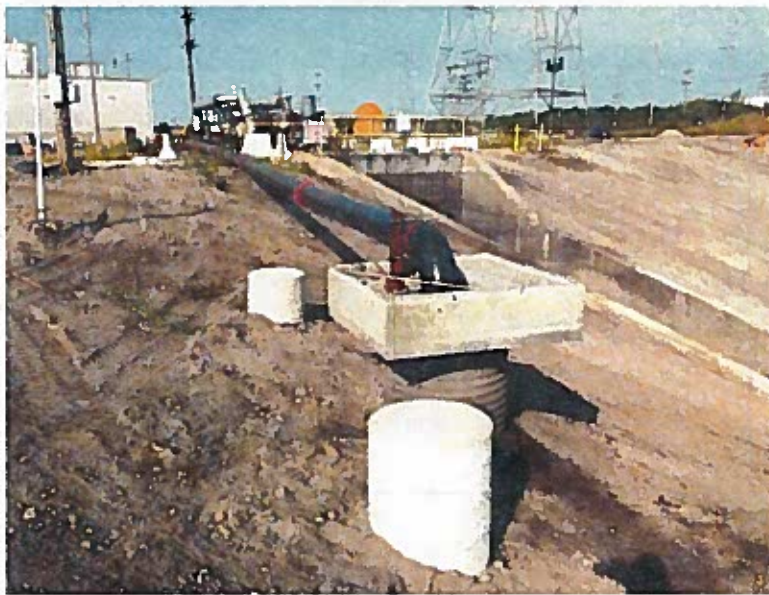
- Inspect downslope cylindrical foundations that were poured for sampling building foundations
- Joseph identifies issue with attaching liner to upslope Sampling Building foundation.

View of Sampling Building downslope cylindrical foundations, facing west

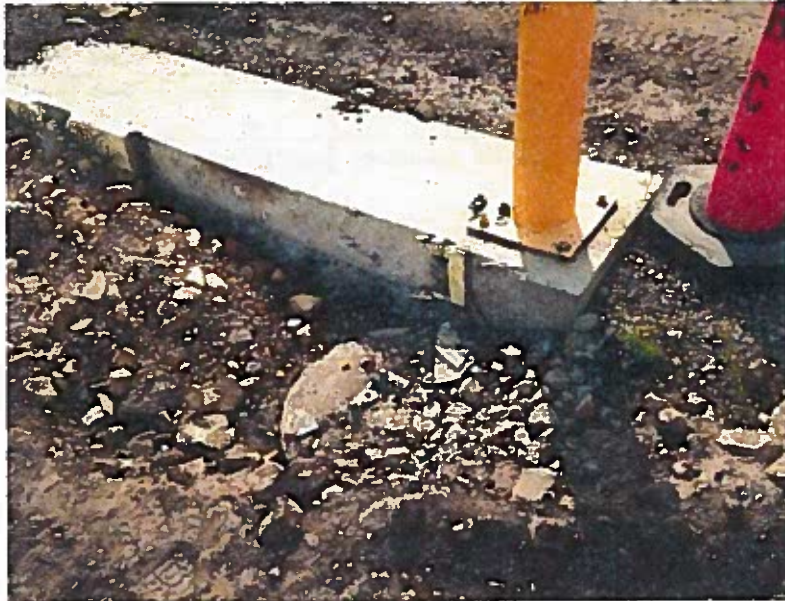
- Elevation issue, relative to overflow structure
  - Cylindrical foundations proximity to rectangular concrete pad makes attachment not possible
  - Discuss solution with Harrison with MWG and Dan Bobzin

View of Sampling Building upslope cylindrical foundations near rectangular concrete pad, facing south

- Brieser will remove rectangular concrete pad, cut cylindrical foundations down, pour new rectangular pad to rebuild foundation, and connect with new rectangular pad for bollard attachment and access to sampling building

- New foundation and concrete pad will allow liner attachment and increase elevation clearance of liner relative to overflow structure
- Joseph offsite at 12:00

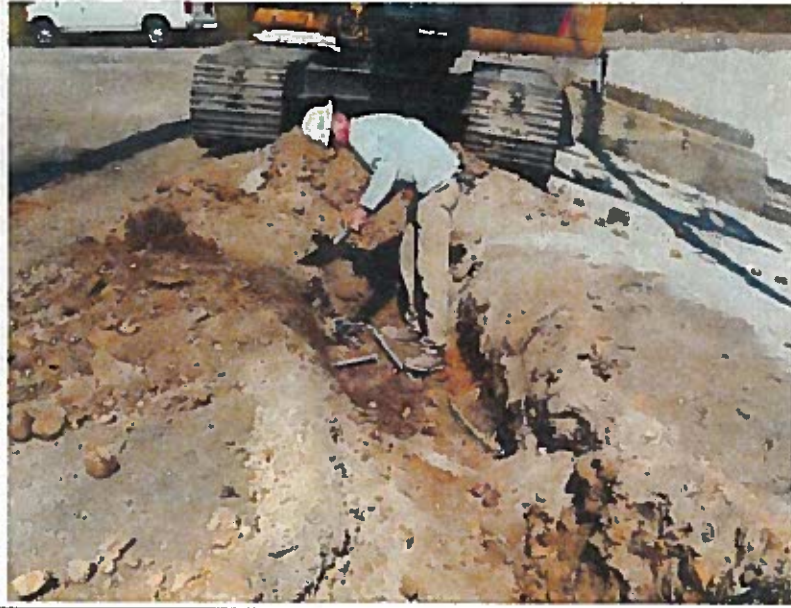
**Hand exposing  
damaged  
utility south of  
the North  
Concrete Inlet  
Structure**

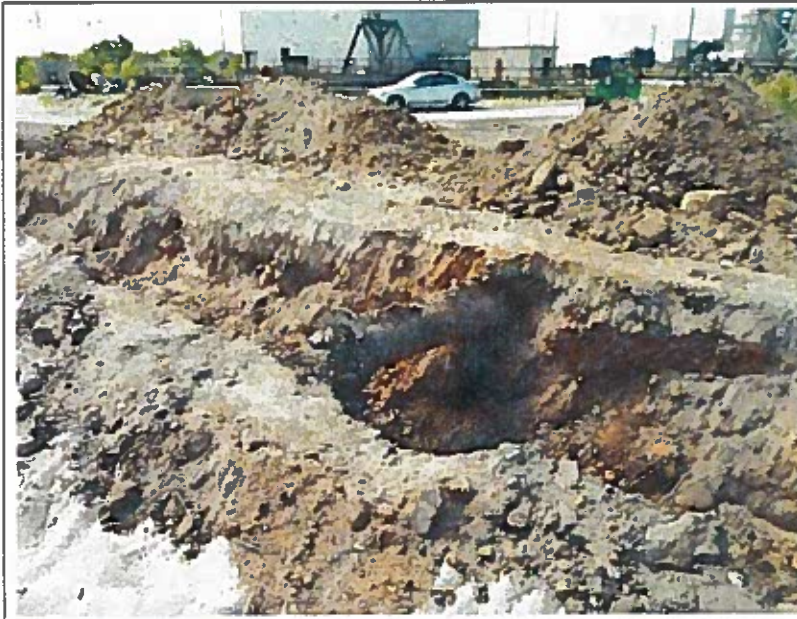
**Abandoned 8  
inch diameter  
pipe near the  
North  
Concrete Inlet  
Structure,  
looking south**

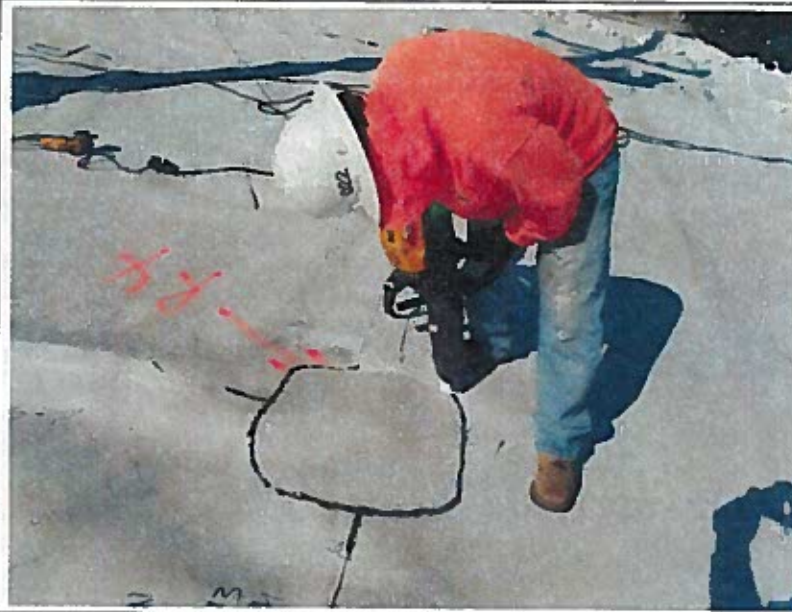
**Extrusion  
welding  
geomembrane  
repair, looking  
east**

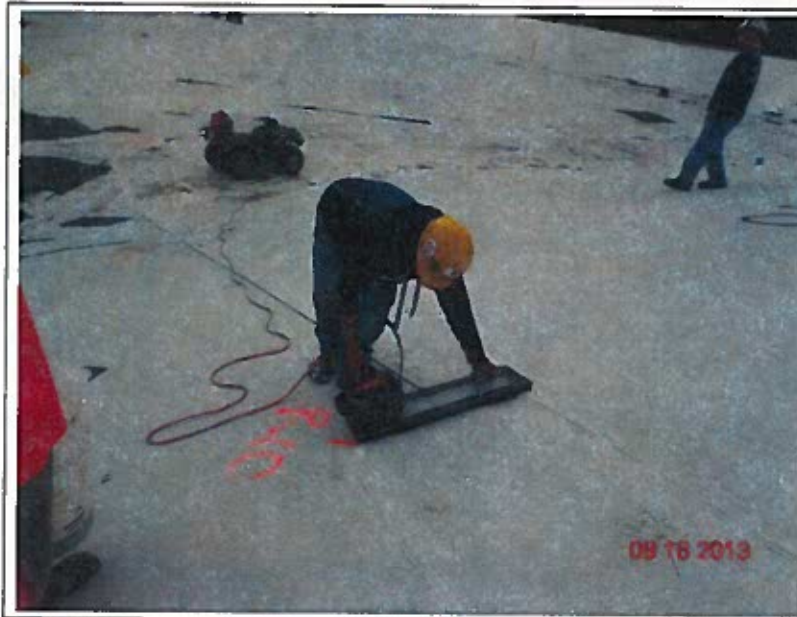
**Non-destructive testing geomembrane repairs (vacuum box), looking east**

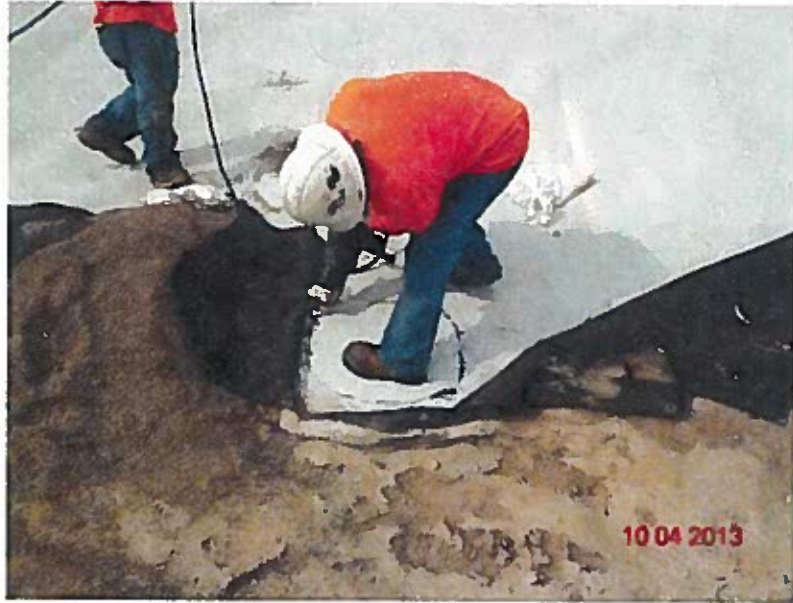
<b>Date:</b>	Friday, October 04, 2013
<b>Work Scope:</b>	Observe and document geosynthetics Repairs
<b>NRT Staff:</b>	Edwards-Sawyer Effiong
<b>Contractors:</b>	<u>Brieser Construction</u> 1 – Operator (Anthony Martin)  <u>Clean Air and Water Systems (CAAWS)</u> 3 - Technicians
<b>Weather:</b>	Low 64°F High 79°F, humid, Sunny
<b>Equipment:</b>	None
<b>Field Comments:</b>	13:15 ETE, Brieser, and CAAWS on-site All repairs on three riser poles and one patch on liner completed. Vacuum and spark tests on welded seams also conducted and documented. 16:00 work done for the day.
<b>Scope Changes:</b>	None
<b>Site Conditions:</b>	Humid and Hot
<b>A new patch on panel 54, looking north</b>

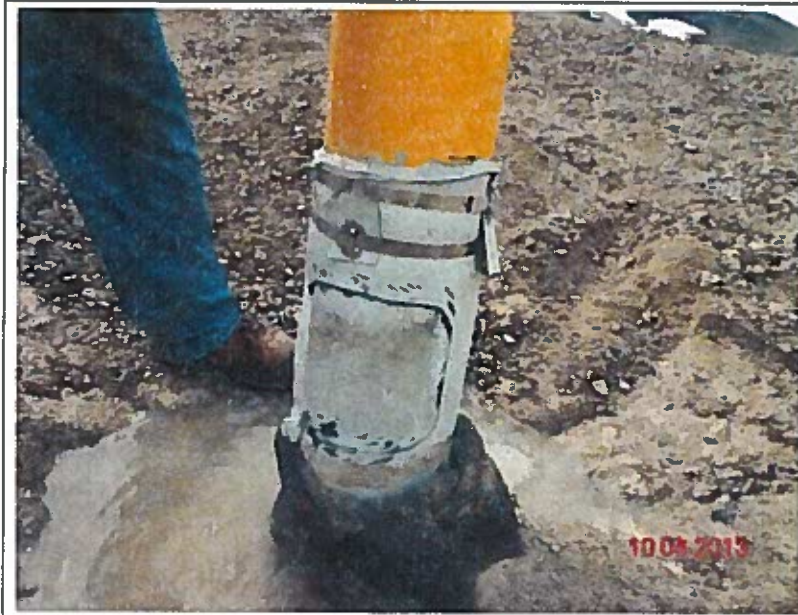
**New patch on riser on west slope**

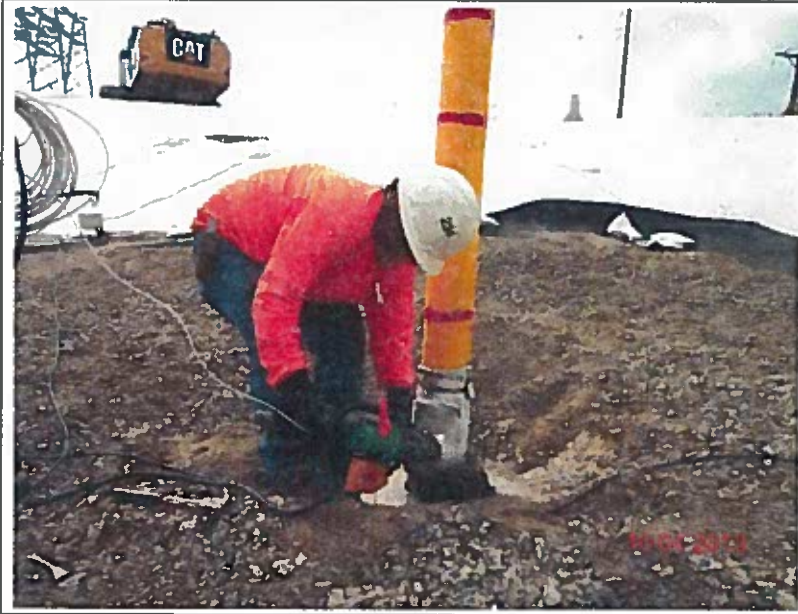
**Welding the new patch, looking west**

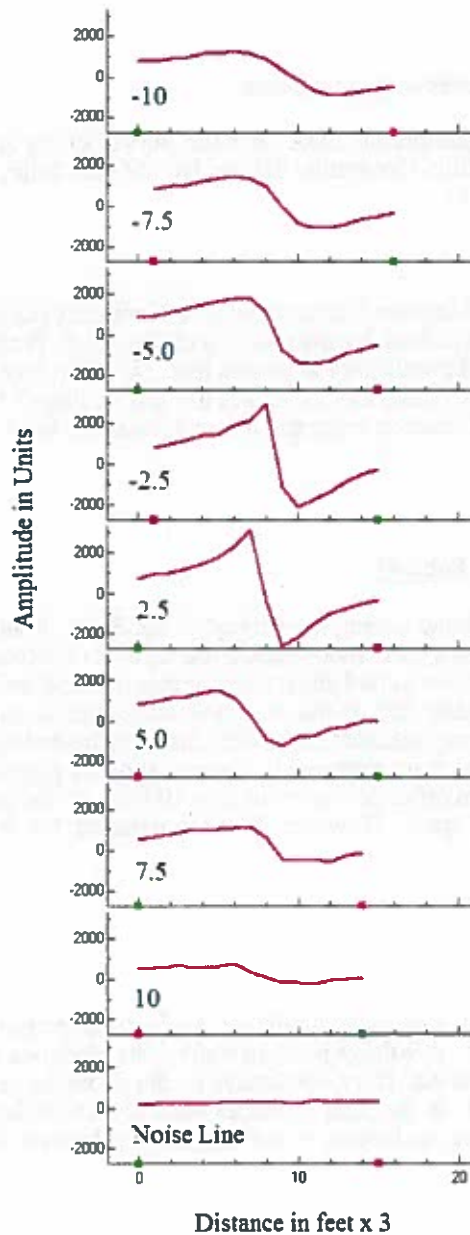
FIGURE 1. PLOT OF DATA TAKEN WITH A 0.25-INCH ARTIFICIAL LEAK

No leaks were found during the survey of the South Pond #3. The leak location equipment and survey procedures were demonstrated to be capable of detecting a 0.25 inch diameter artificial leak. The artificial leak was buried under the drainage material and placed on the top of the primary geomembrane. The other end of the wire was connected to an electrode between the geomembrane. Leak location survey measurements were made on the drainage material to determine the distance that the artificial leak can be detected. Figure 1 shows a plot of the data taken with the artificial leak. The leak detection distance was more than 10 feet. So the leak location survey lines could have been spaced 20 feet apart. However, for thoroughness, the survey was conducted on survey lines spaced 5 feet apart.
