**ATTACHMENT C**  
**NRT CQA DAILY FIELD REPORTS**

# FIELD NOTE SUMMARY

**Project Number / Task:** 1965.0/4.0  
**Project Names:** Metal Cleaning Basin Liner Replacement

Project Number / Task: 1965.5/5.3  
Project Names: Bypass Basin Liner Replacement

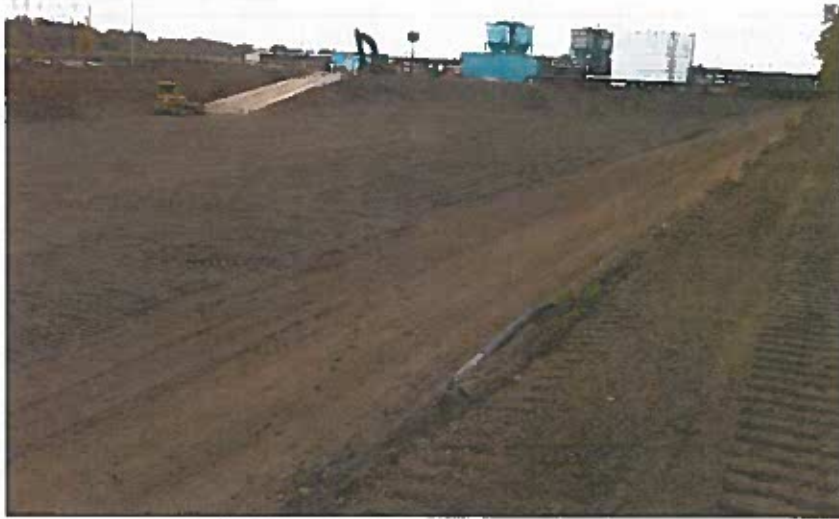
<b>Scope Changes:</b>	<ul style="list-style-type: none"><li>• None</li></ul>
<b>Site Conditions:</b>	In good condition, compaction of eastern side slope and grading of northern side slope required.

View of basin subgrade from the northwest corner of the basin facing southeast. Note concrete aprons and hypalon removed.

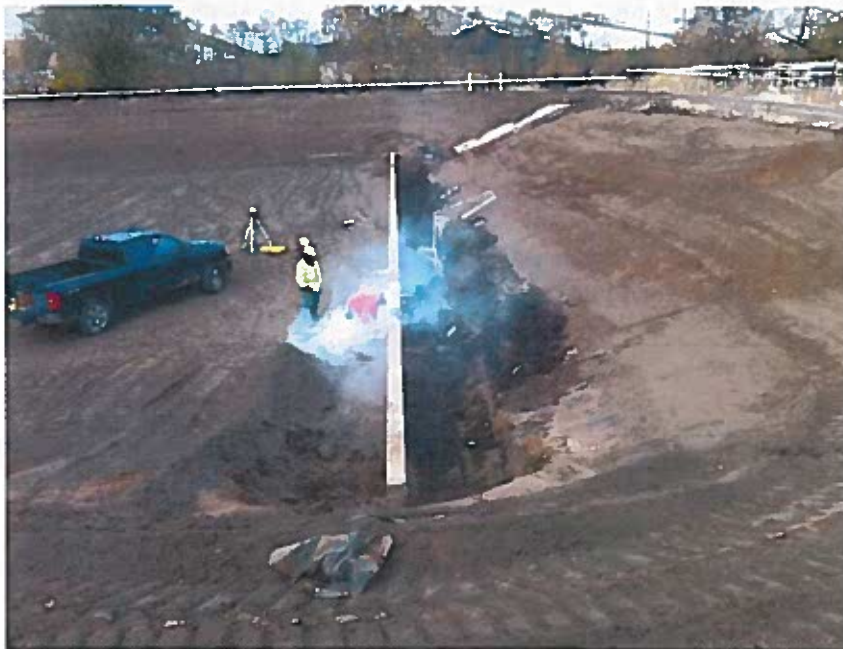
View of excavated weir wall during steel gate removal.

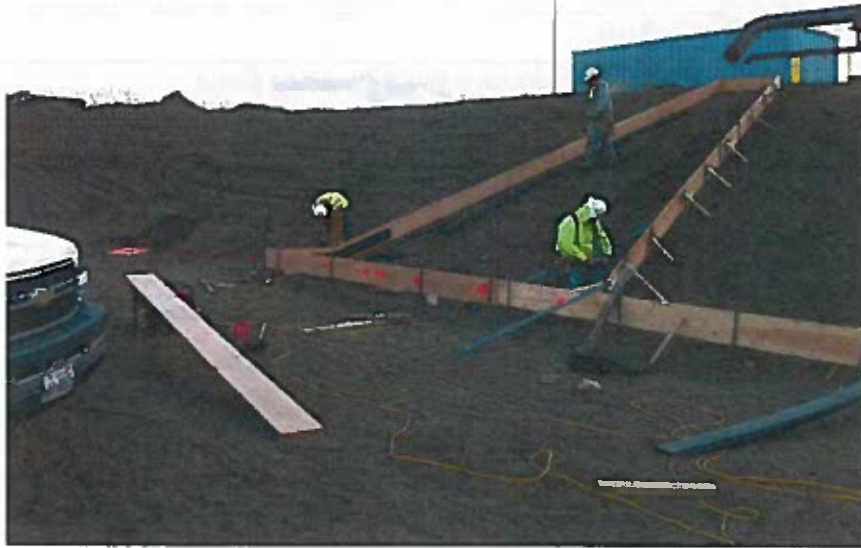
View of the concrete apron forms. Note HDPE weld strip.

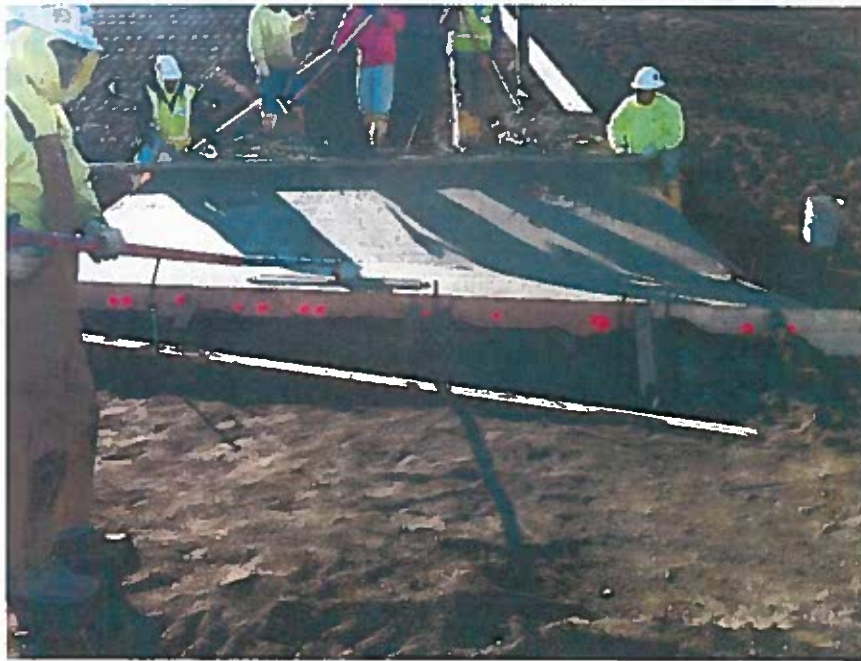
View of the construction of the concrete apron.

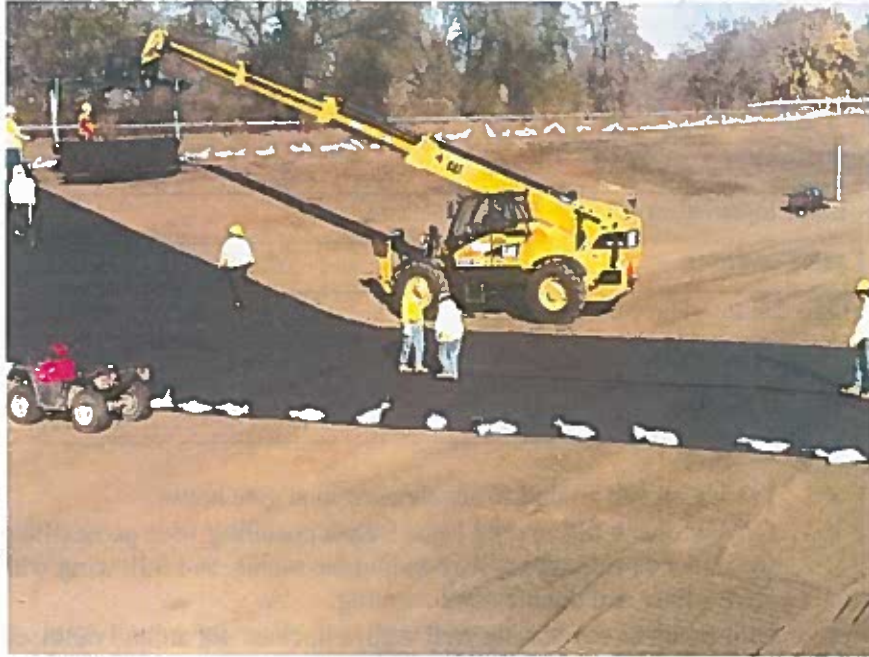
View of 16 oz geotextile being placed on the western slope and thermally bonded at the seams.

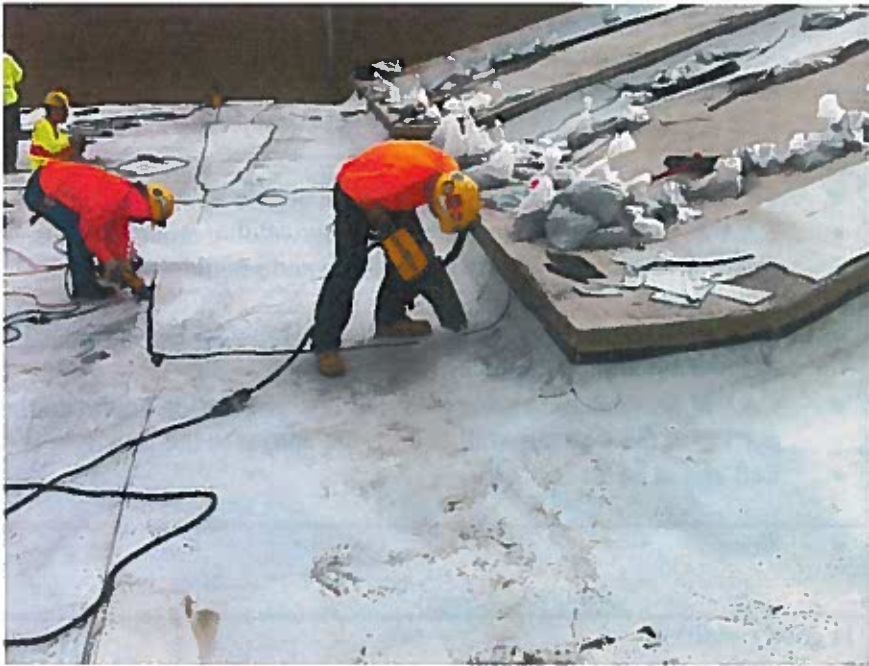
View of extrusion seaming around aprons.

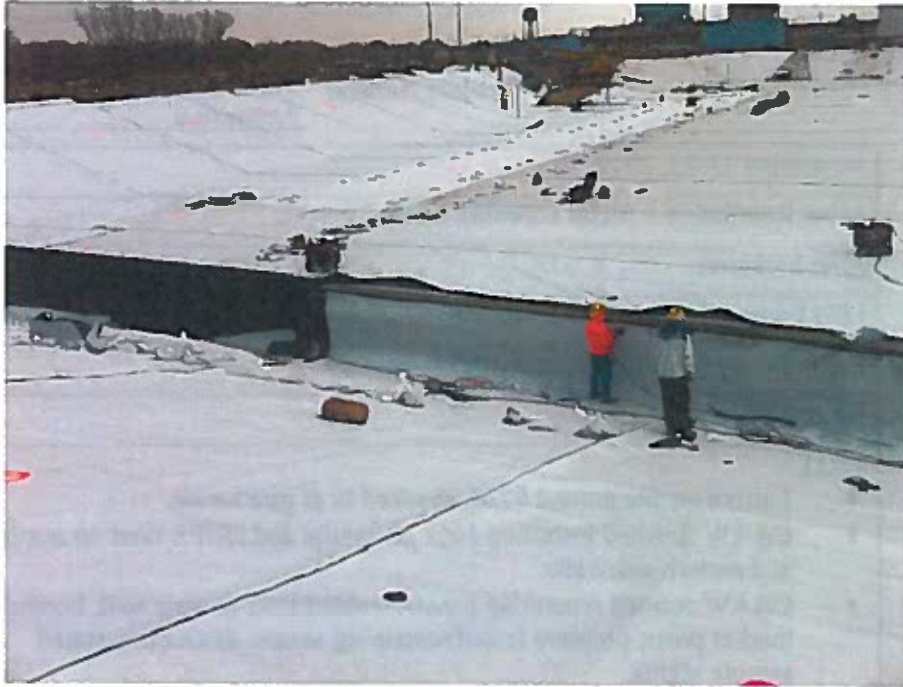
View of liner being attached to weir wall HDPE weld strip.

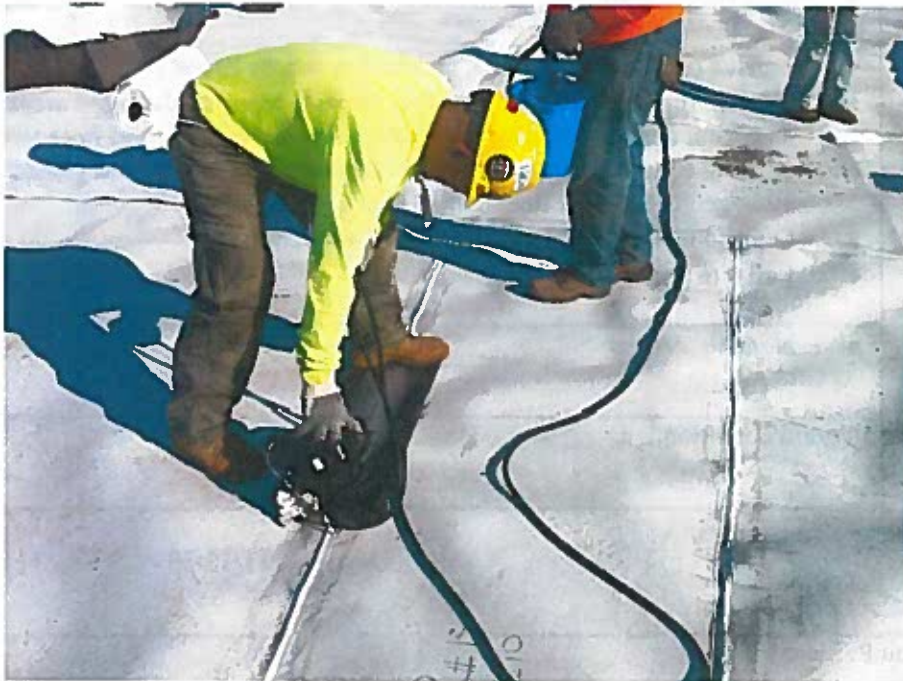
View of extrusion seaming vacuum testing.

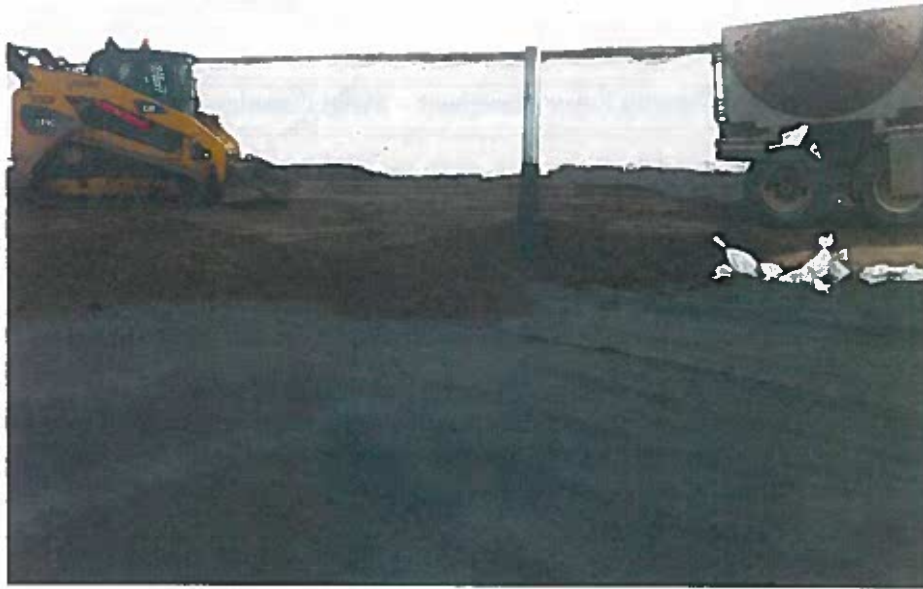
View of liner placement of cushion layer sand.

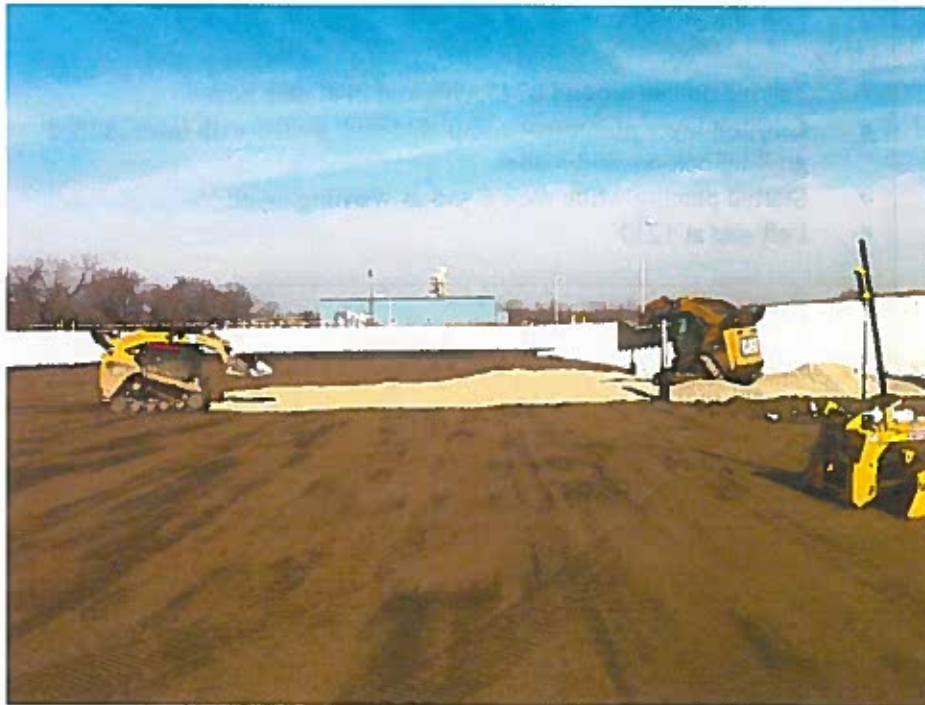
View of finished cushion layer and beginning of warning layer.

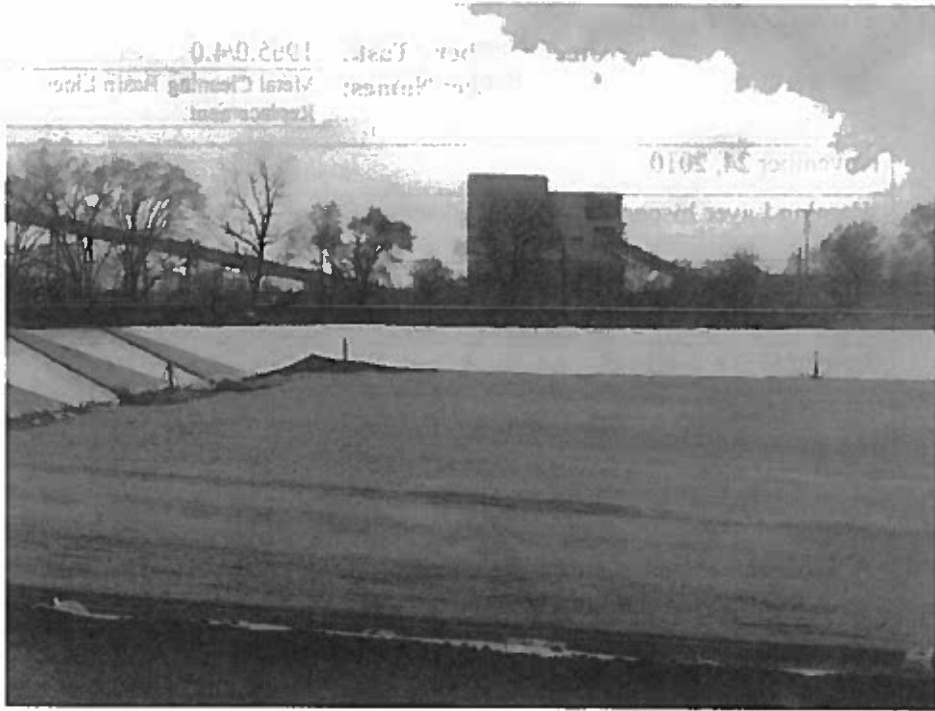
<b>Date:</b>	November 24, 2010
<b>Work Scope:</b>	Warning Layer Inspection – Metal Cleaning Basin
<b>NRT Staff:</b>	John Swanson
<b>Contractors:</b>	Offsite
<b>Weather:</b>	Rainy mid 30s degree F
<b>Equipment:</b>	Digital camera
<b>Field Comments:</b>	<u>11/24</u> <ul style="list-style-type: none"><li>• I arrive on site around 1115, checked in at gate house.</li><li>• Otto Baum left around 10:30 due to poor weather.</li><li>• Warning layer placed and compacted. Some clean up and finishing required around ramp, aprons, and marker posts. Called Dave with Otto Baum, scheduled to be completed before leak detection survey.</li><li>• Rip rap placed north of weir wall.</li><li>• Left site at 1230</li></ul>
<b>Scope Changes:</b>	<ul style="list-style-type: none"><li>• None</li></ul>
<b>Site Conditions:</b>	In good condition. Some cleanup and finishing/smoothing of warning layer required around ramp, aprons, and marker posts.

View of warning layer in the southern end of basin where additional cleanup and finishing is required.

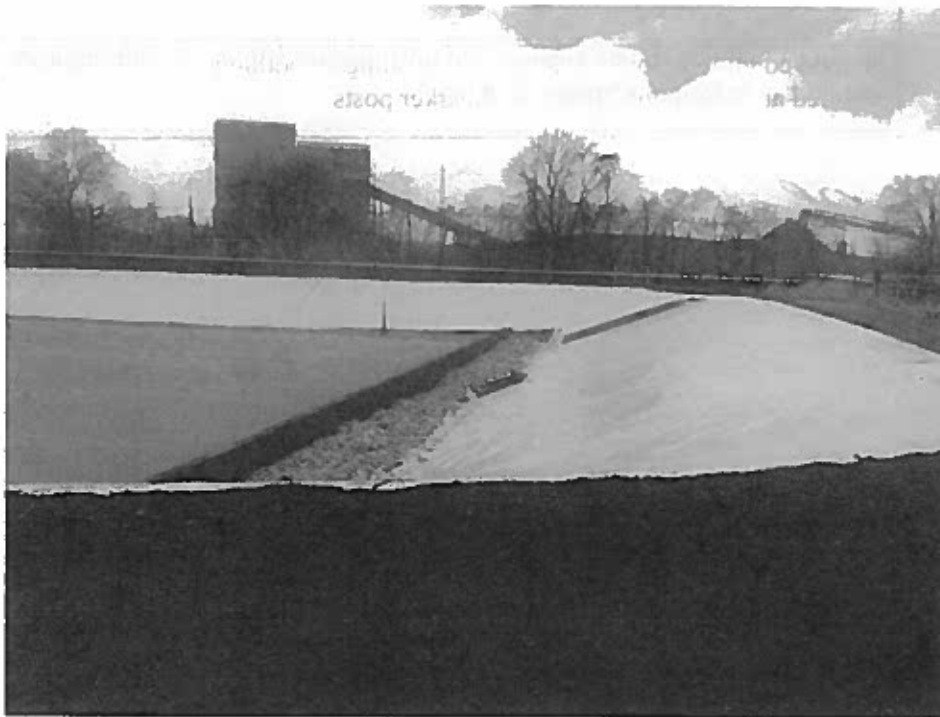
View of finished rip rap north of weir wall.

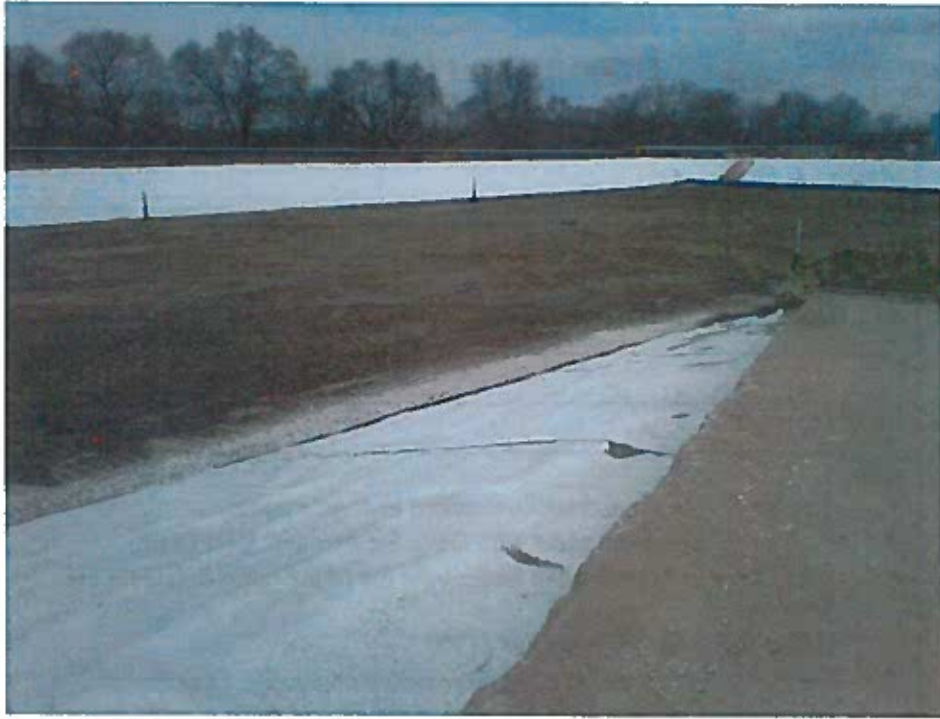
View Looking Northwest Along Ramp.

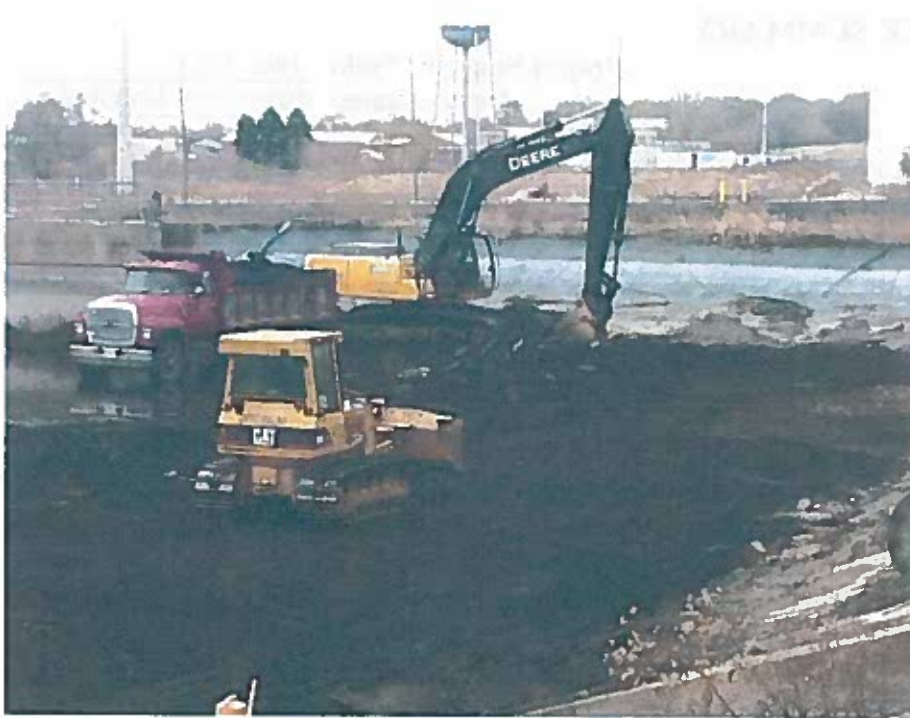
**View of pozopac removal and subgrade preparation.**

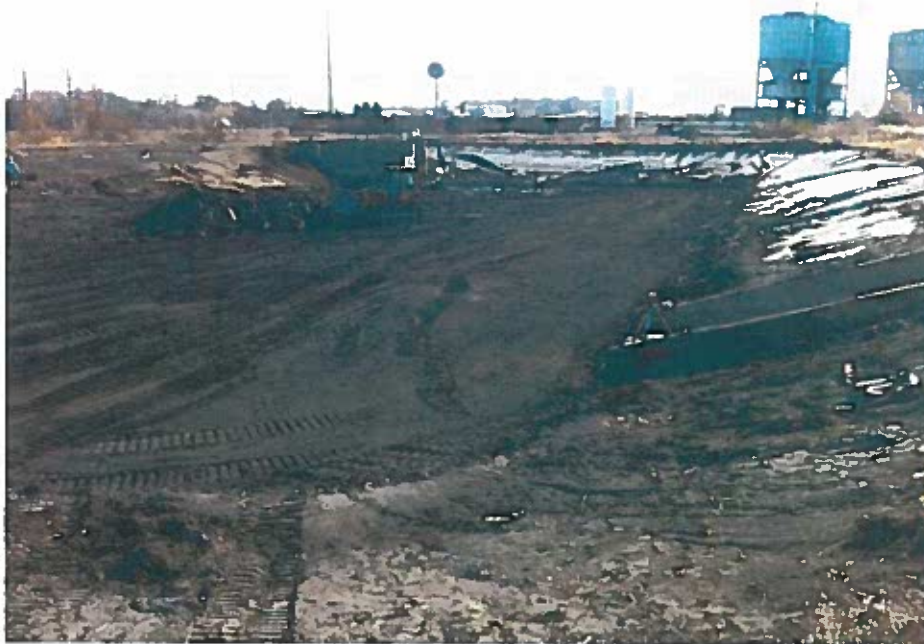
**View of pozopac load out and subgrade preparation.**

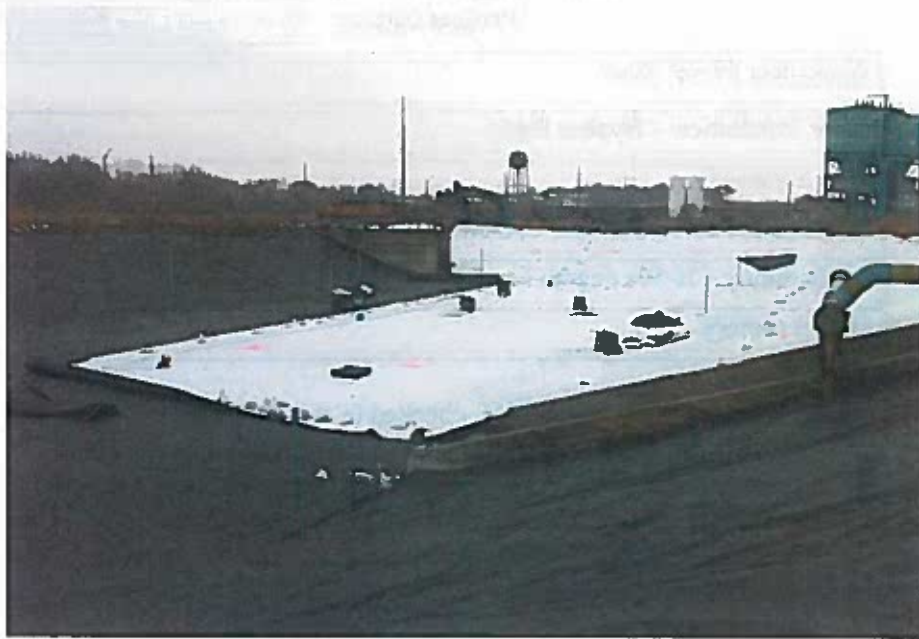
View of 16 oz geotextile in place and HDPE liner being placed.

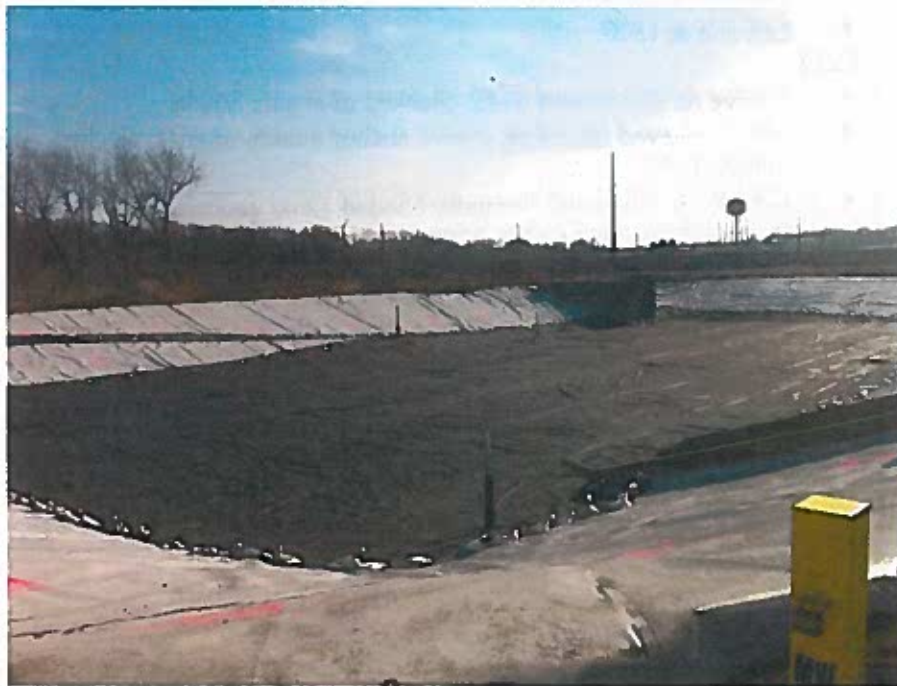
View of finished liner with finished 12 oz geotextile .

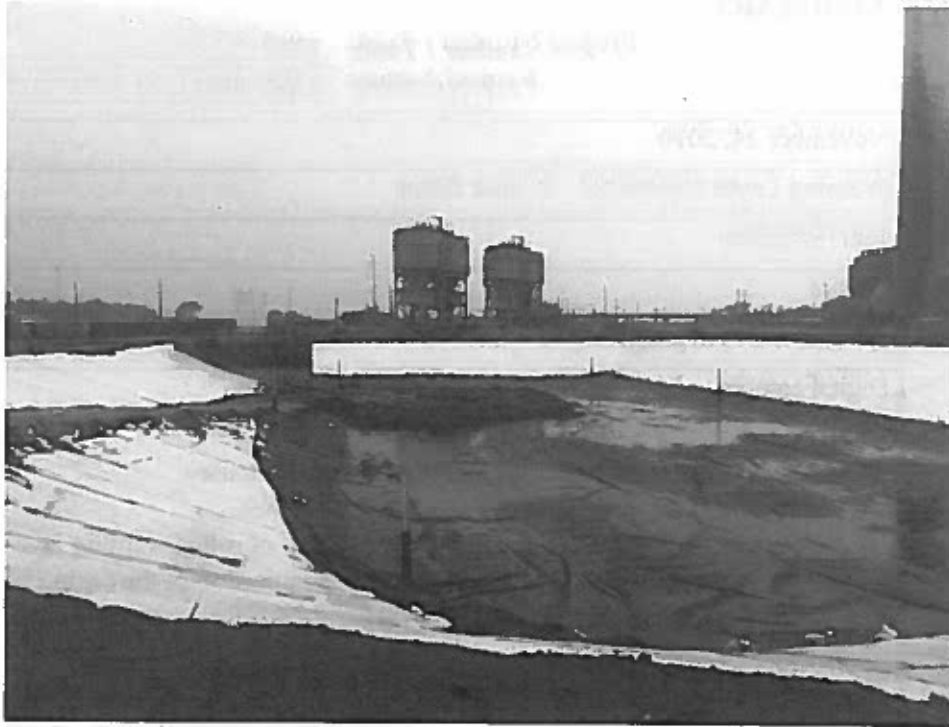
**View of partially placed cushion layer in southern portion of the basin.**

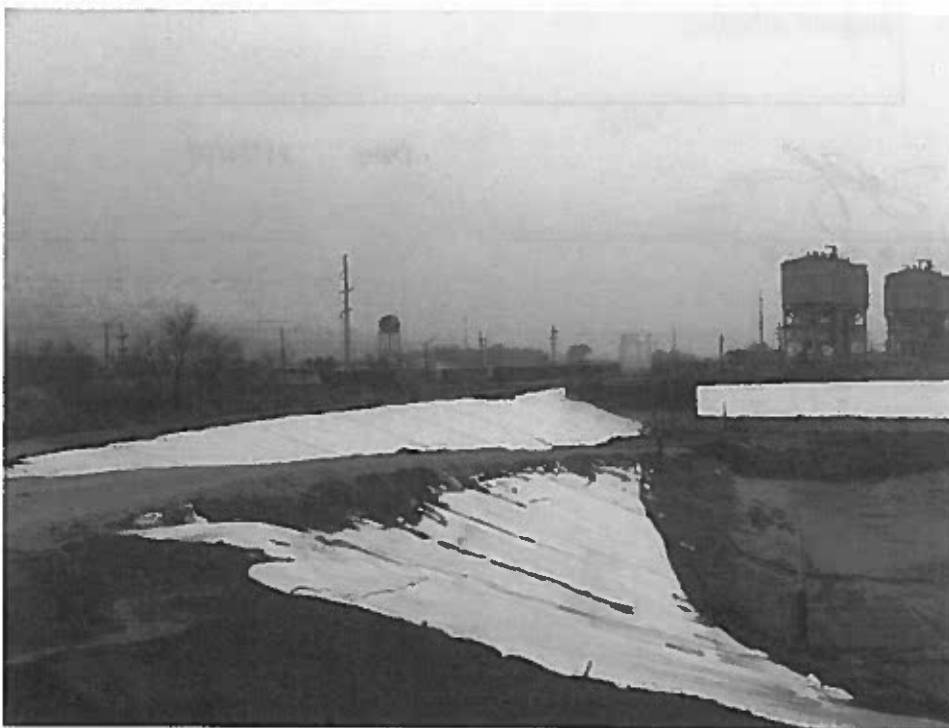
**View of finished ramp into bypass basin.**

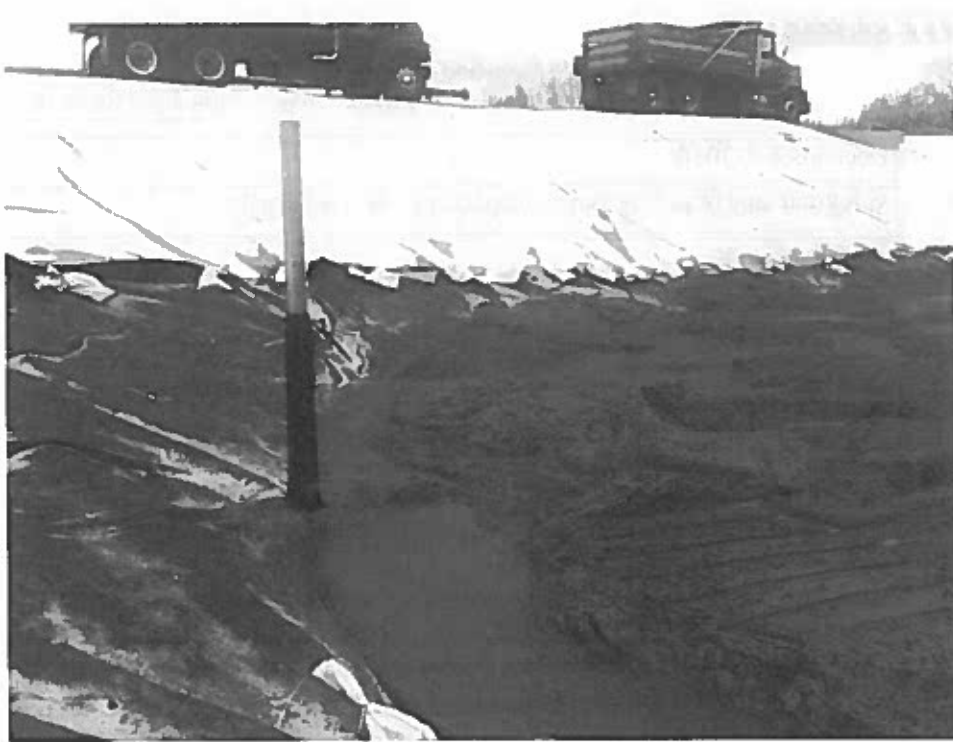
<b>Date:</b>	December 1, 2010
<b>Work Scope:</b>	Subgrade and Warning Layer Inspection – Bypass Basin
<b>NRT Staff:</b>	John Swanson
<b>Contractors:</b>	Otto Baum
<b>Weather:</b>	Overcast 25 degrees F
<b>Equipment:</b>	Digital camera
<b>Field Comments:</b>	<u>11/24</u> <ul style="list-style-type: none"><li>• I arrive on site around 0715, checked in at gate house.</li><li>• Otto Baum onsite pumping water and placing warning layer on the southern portion of the basin.</li><li>• Cushion layer is solid and holding up well to equipment with the exception of the a few areas in the northern portion of the basin. Otto Baum to continue pumping water out of basin.</li><li>• Soft material will be removed and replaced with dry material before warning layer is placed over.</li><li>• Left site at 1000</li></ul>
<b>Scope Changes:</b>	<ul style="list-style-type: none"><li>• None</li></ul>
<b>Site Conditions:</b>	In good condition. Pumping and material placement required in northern portion of basin.

**View of soft spots and ponding in the northern portion of the basin.**

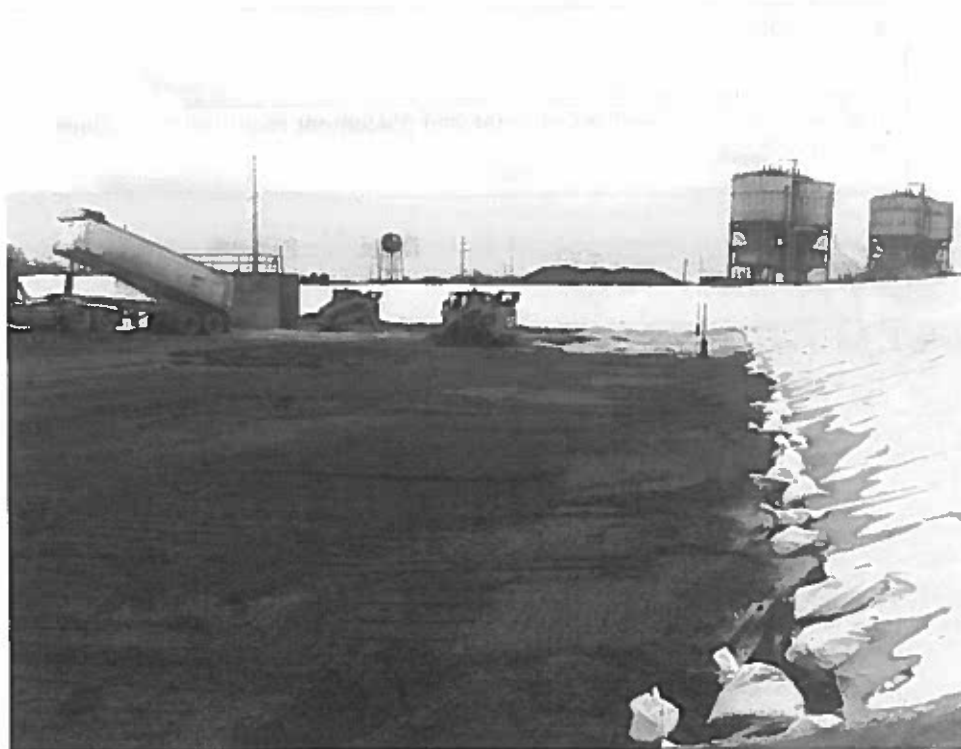
**View of placement of warning layer in the southern portion of the basin.**

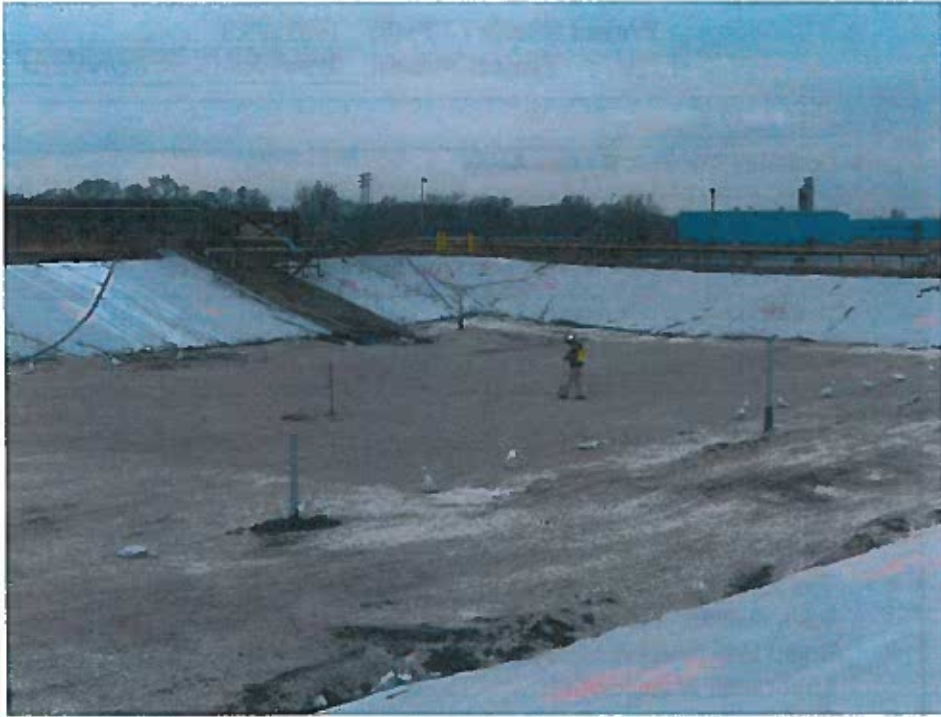
View of the bypass basin during the leak location survey.

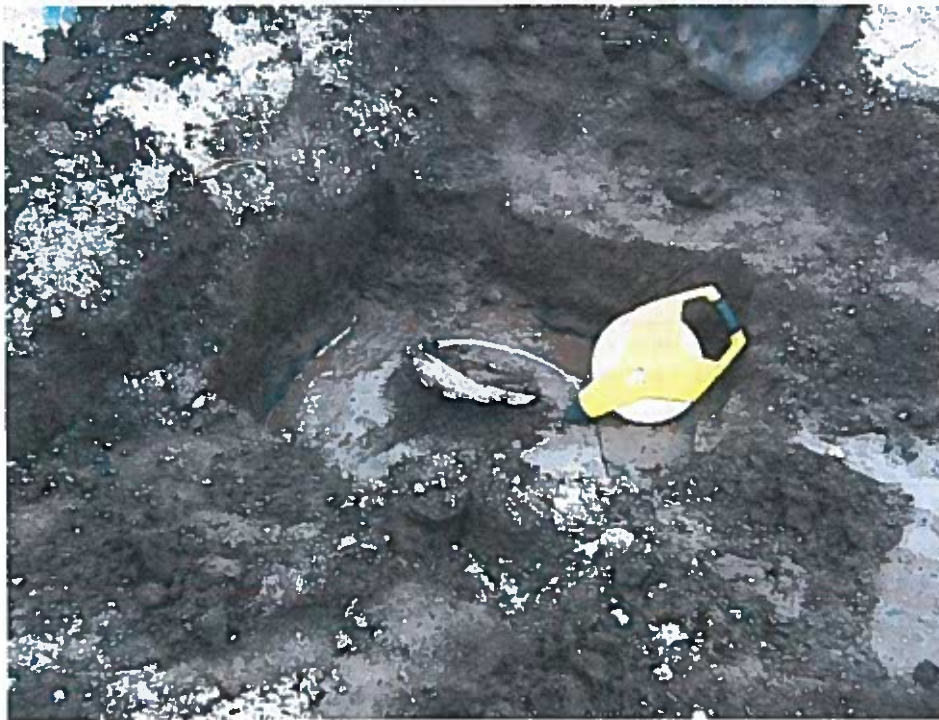
View of the uncovered leak in the bypass basin from the detection survey.
