**EROSION REPAIR DOCUMENTATION**

KPRG Project No 15209.3

Re: Joliet #29 Former Ash Burial Area Erosion Repair Documentation 2010

Photodocumentation - Joliet #29 Ash Burial Area Erosion Repairs 2010

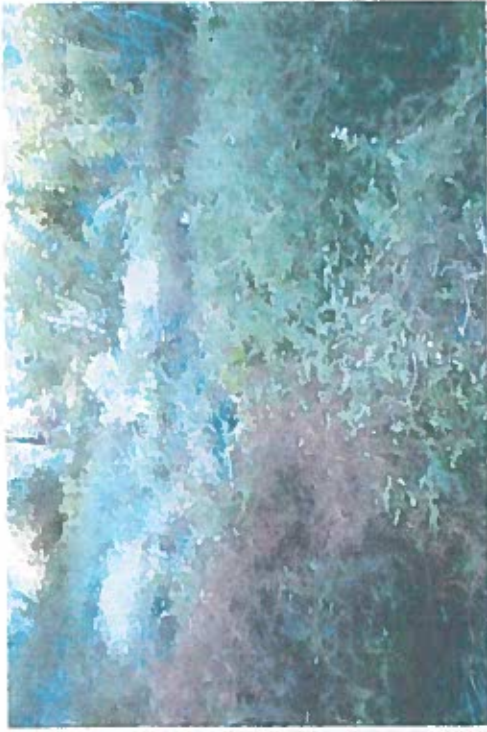
- Area 1 – Located at coordinates N41° 29.589'/W88° 07.012'. This was an area of rill development and ash exposure. The rill was forked at the top of the embankment and combined into one rill at the center of the embankment. It was approximately 30 feet long, 3 to 5 feet wide and 1.5 feet deep.

1. Side rill Area 1 before repair

The repair consisted of filling in the rill with clayey top soil which was then mechanically compacted and seeded with a mix of all purpose seed and annual rye. This was then covered with an erosion mat. A straw log was placed along the

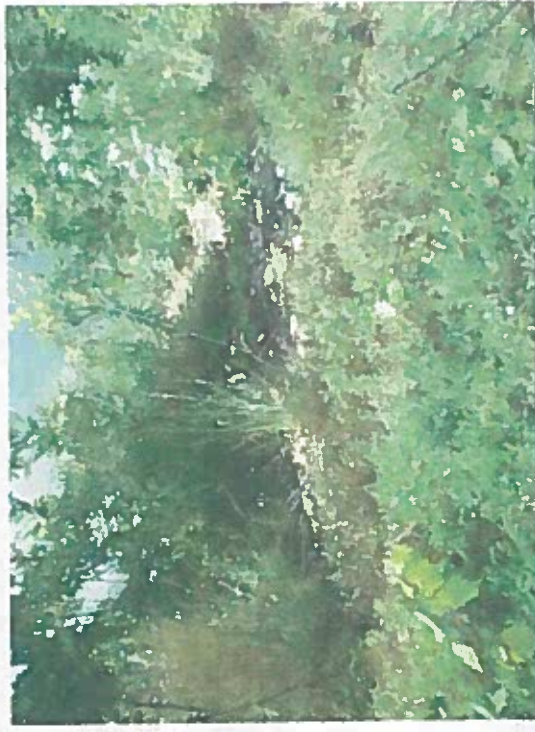
- Area 2 – Located at N41° 29.872'/W88° 06.992'. This was an area of exposed ash along the central portion of the embankment subject to sheet runoff. It area was approximately 25 feet long and 8 feet wide.

3. Exposed ash Area 2 before repair

The repair included prepping/grading an approximate 30' x 10' surface area (this included the subject area and a sufficient buffer around the area) and properly placing 4" to 6" of clayey top soil. The top soil was seeded with a mix of all purpose seed and annual rye. This was then covered with an erosion blanket. A series of straw logs were placed along the top of the subject area to help reduce sheet runoff erosional effects. Photographs are provided in Attachment 1.

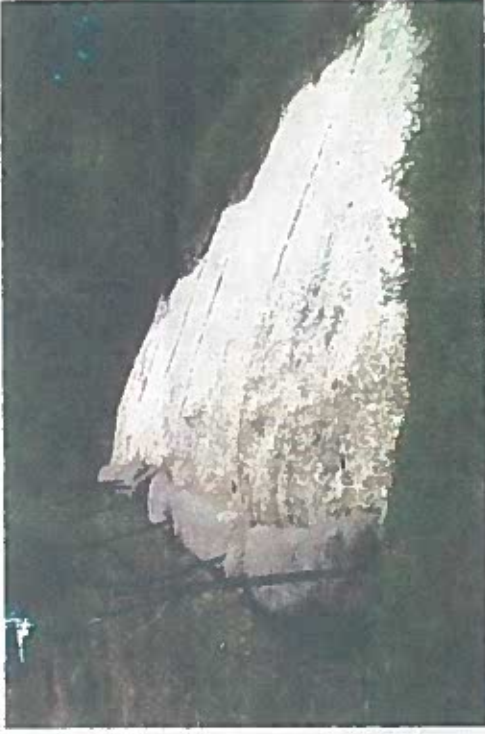
2. Area 1 after repair.

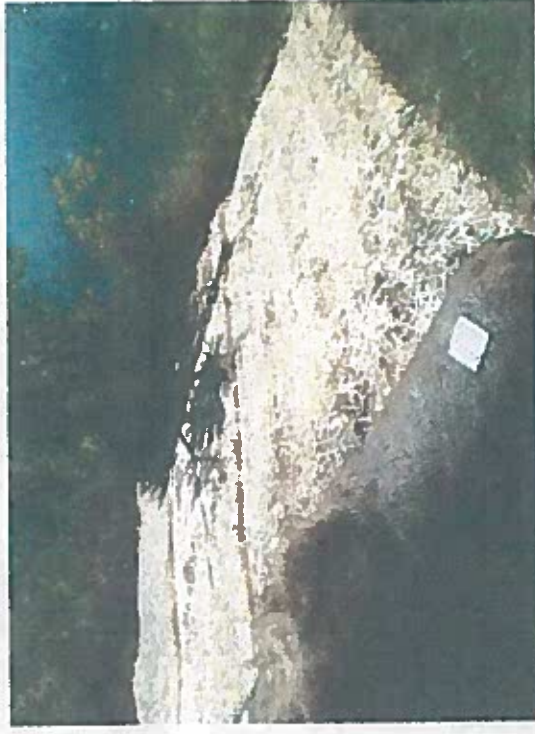
4. Area 2 after repair

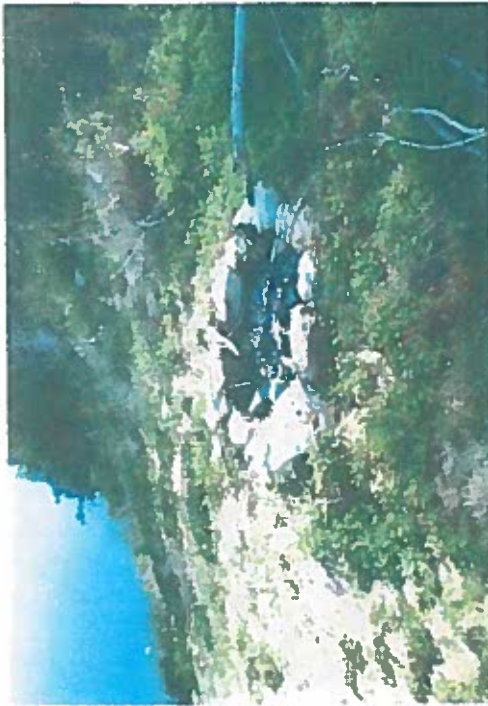
- Area 3 – Located at N41° 30.068'/W88° 06.419'. This was an area of some exposed soil and ash along the central portion of the bank slope which is exposed to sheet runoff. The area was approximately 40' x 15' in size.

3. Area 3 before repair.

The repair included prepping/grading the area and properly placing 4" to 6" of clayey top soil. The top soil was seeded with a mix of all purpose seed and annual rye. This was then covered with an erosion blanket. Photographs are provided in Attachment 1.

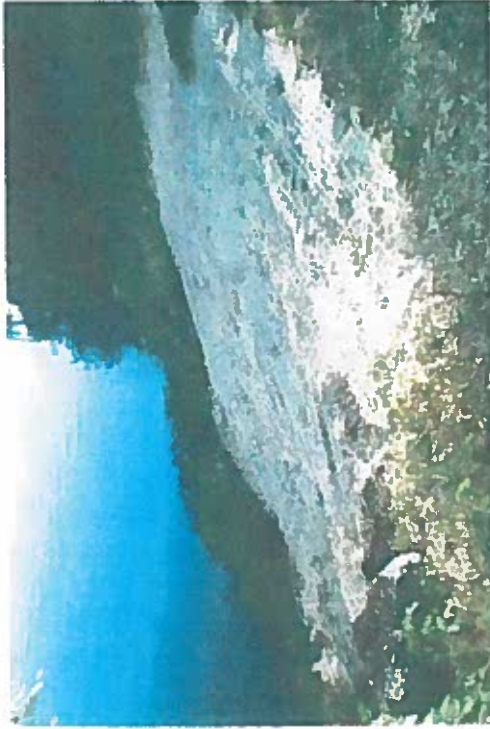
6. Area 3 after repair.

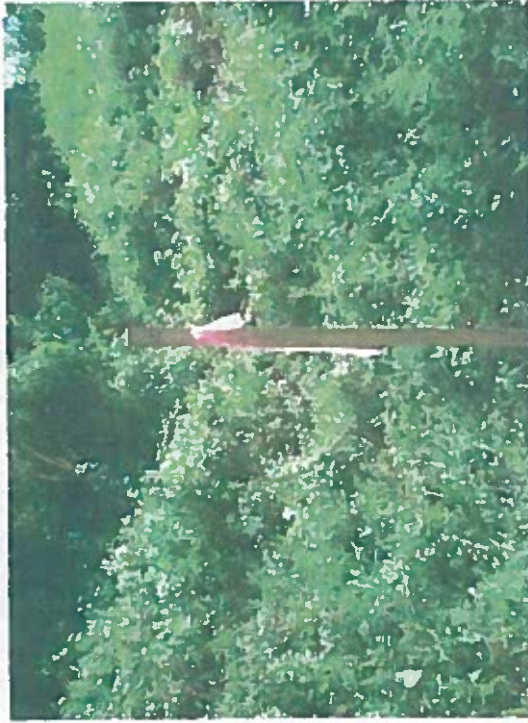
- Area 4 – Located at N41° 30.068'/W88° 06.834'. This was an area where a rill had developed and started to incise into the bank. The rill was about 25 feet long, 8 feet deep and 1.5 to 2 feet wide.

7. Area 4 hill before repair.

The repair consisted of filling in the rill with clayey top soil, mechanically compacting the material and seeding with a mix of all purpose seed and annual rye. This was then covered with an erosion mat. A straw log was placed along the top of the subject area to help reduce runoff erosional effects. Photographs are provided in Attachment 1.

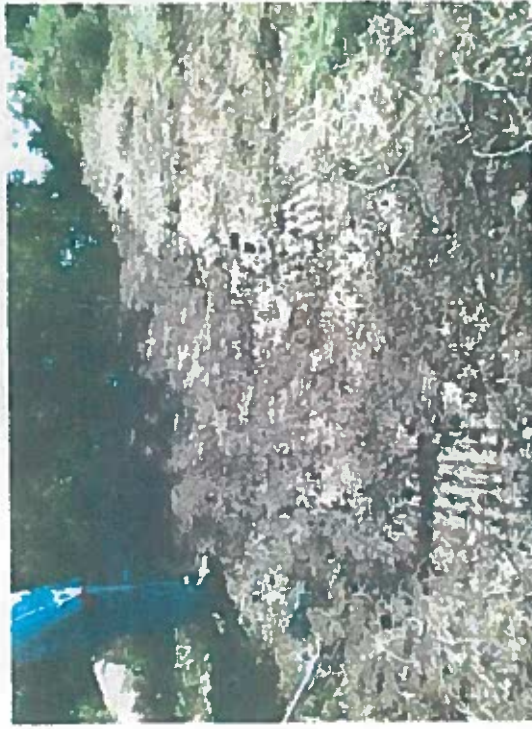
8. Area 4 hill filled and compacted.

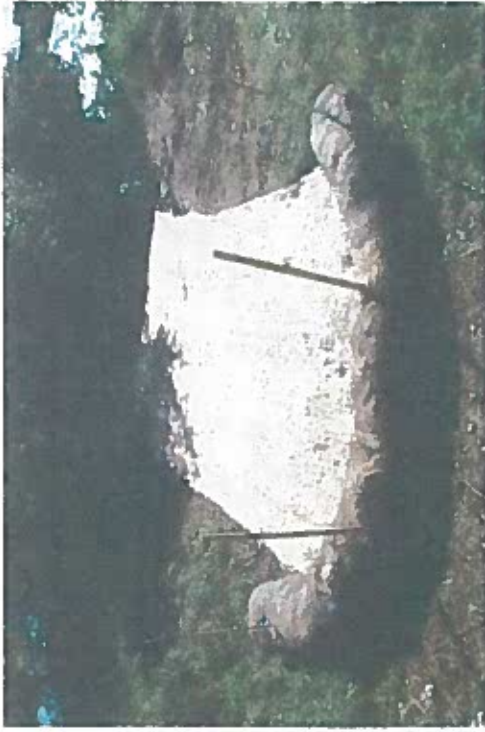
9 Area 4 after repair

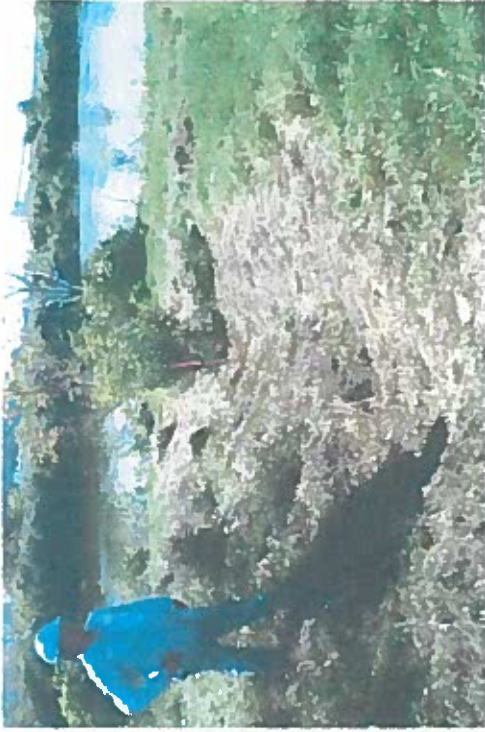
- Area 5 – Located at N41° 29.908/W88° 06.937'. This was an area where two rills had developed. One rill was forked and was approximately 120 feet long, 8 feet wide and 2 feet deep. The second rill was straight, approximately 125 feet long, 4 feet wide and 2 to 2.5 feet deep. Both rills dissipated prior to incising into the side of the bank.

10 Area 5 straight rill before repair (prepped).

The repair consisted of filling in the rills with clayey top soil, mechanically compacting the material and seeding with a mix of all purpose seed and annual rye. This was then covered with an erosion mat. Straw logs were placed along the top of each subject rill to help reduce runoff erosional effects. Photographs are provided in Attachment 1.

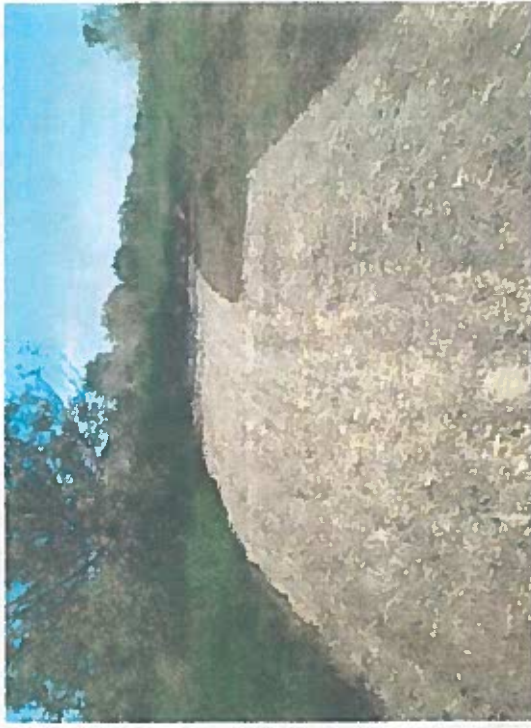
11 Area 5 straight rill after repair looking north.

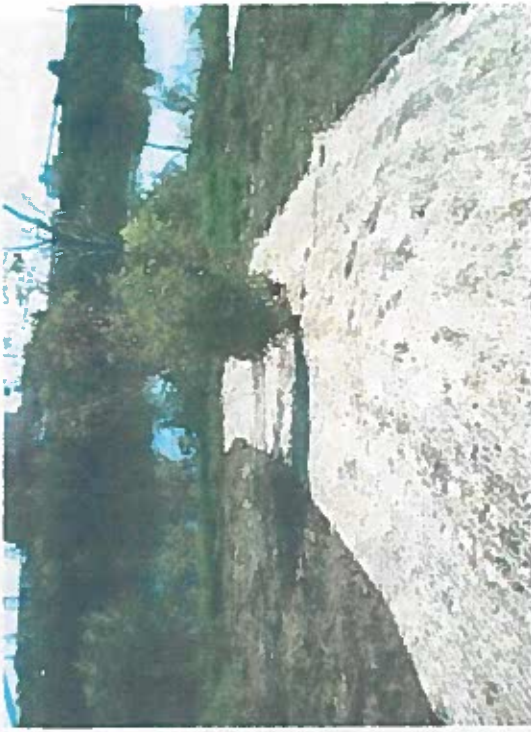
12 Area 5 straight rill after repair looking south.

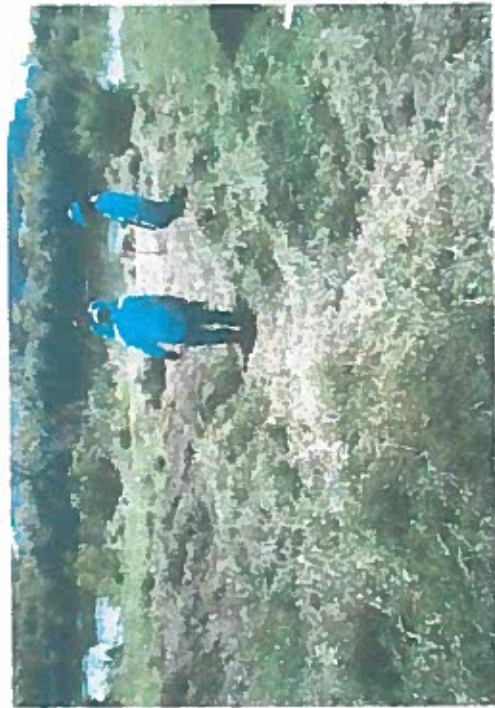
13. Area 5 forked till before repair (prepped)

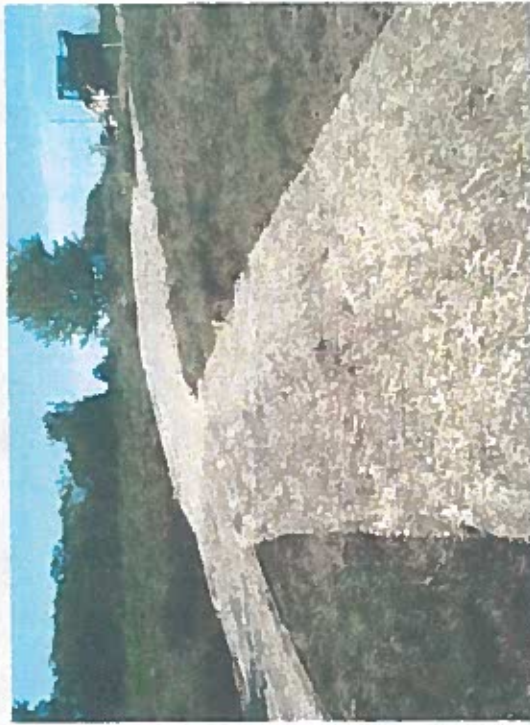
15. Area 5 forked till after repair looking north

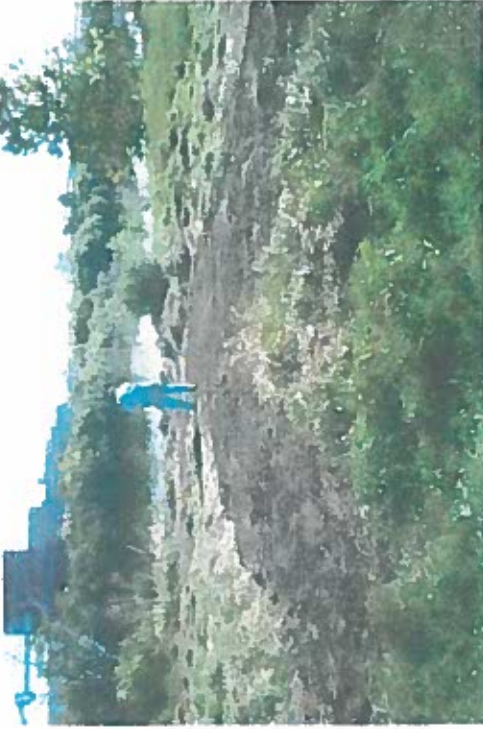
14. Area 5 forked till after filling and being seeded.

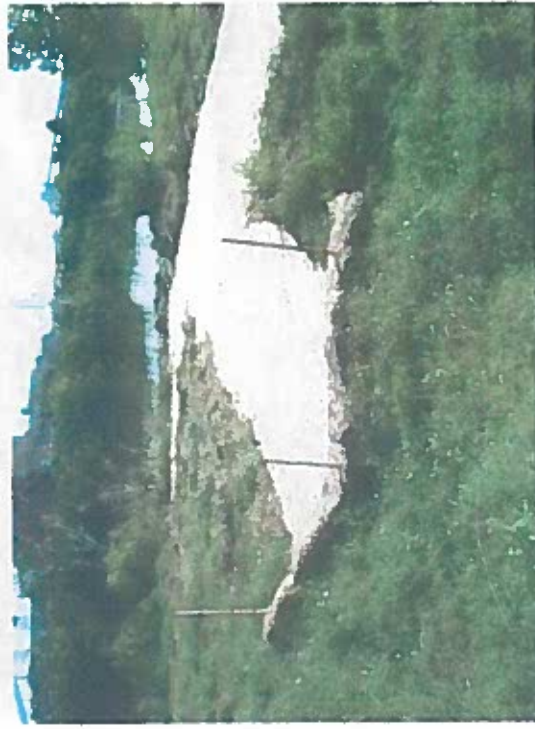
16. Area 5 forked till after repair looking south.
