EROSION REPAIR DOCUMENTATION

September 22, 2011

KPRG Project No. 15209.4

Re: Joliet #29 Former Ash Burial Area Erosion Repair Documentation 2011

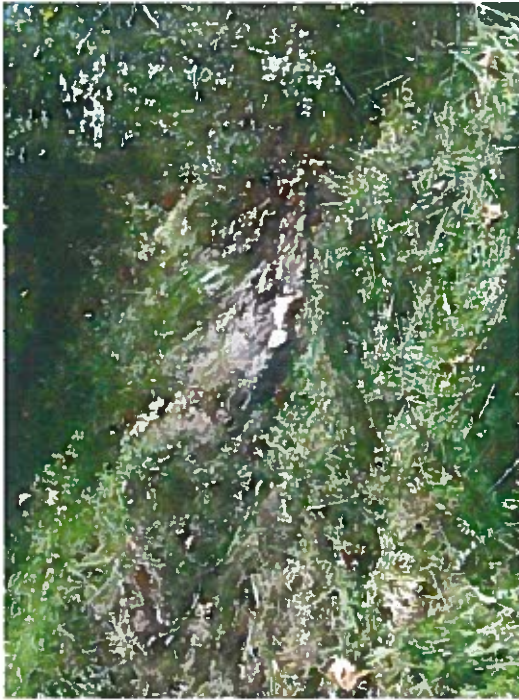
- Area 1 – Located at coordinates N41° 29.890'/W88° 06.957'. This was an area of some sheet runoff and rill development resulting in side bank cover erosion with potential ash exposure. The rill was curved with one side incised into the bank. It was approximately 30 feet long, 3 to 5 feet wide and 1.5 feet deep.

1. Area 1 prior to repair work.

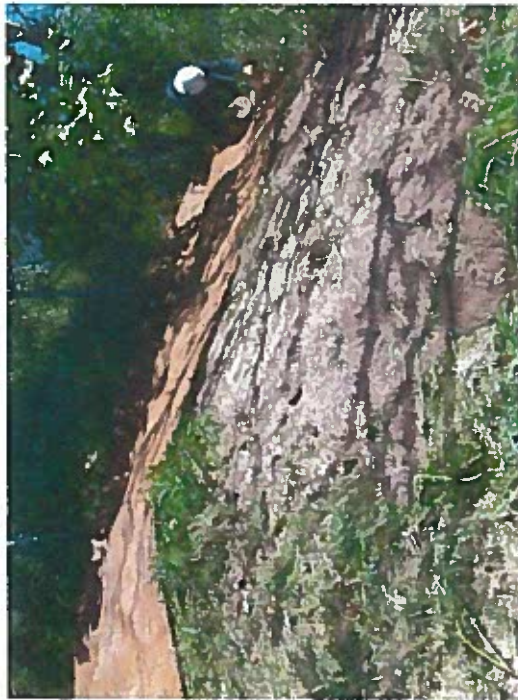
3. Area 1 placement of erosion blanket.

The repair consisted of filling in the rill with clayey top soil which was seeded with a mix of all purpose seed and annual rye. This was then covered with a wood

fiber erosion blanket. A straw log and 3-inch stone were placed along the top of the bank to reduce the runoff flow energy prior to flowing down the side of the bank.

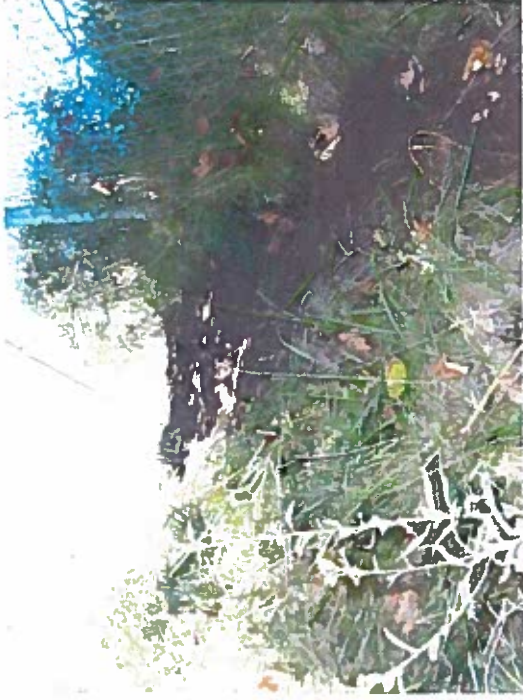
2. Area 1 rill filled in with clayey topsoil.

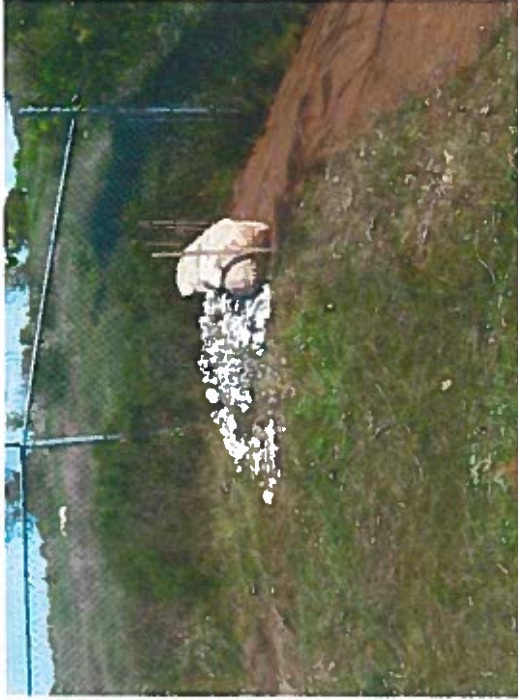
4. Area 1 with straw log and 3-inch stone to impede channeling runoff.

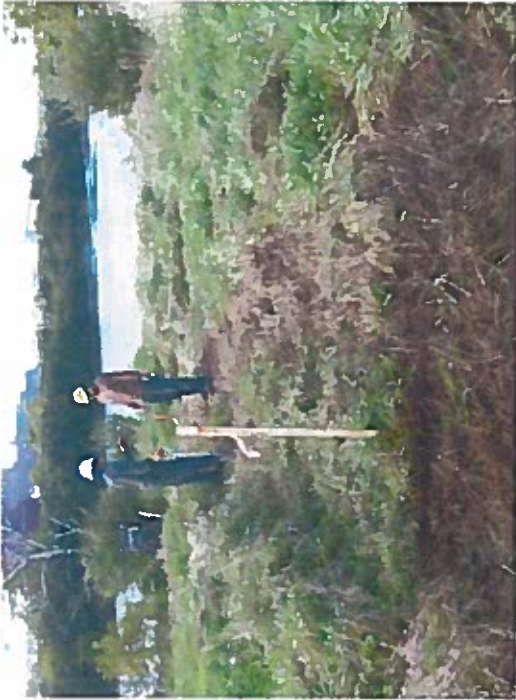
- Area 2 – Located at N41° 29.899'/W88° 06.937'. This was an area of rill development prior to the runoff flowing down the channel bank. The rill was approximately 60 feet long, 2 to 3 feet wide and up to 1.5 feet deep. There was a slight forking in the rill toward the south end.

5. Area 2 prior to repair work.

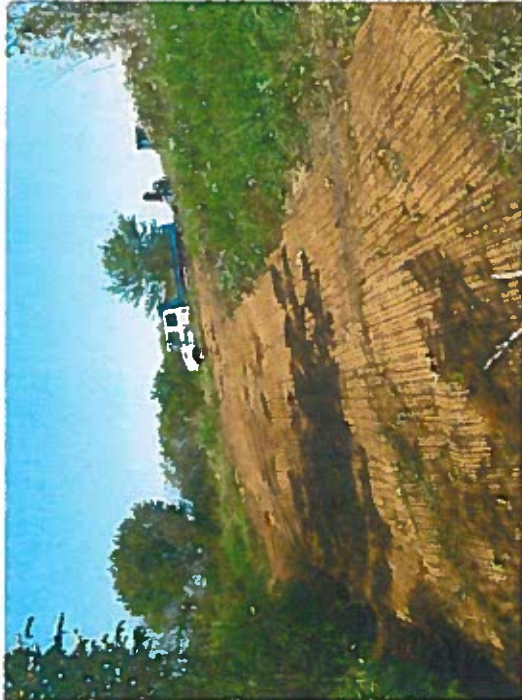
7. Area 2 placement of erosion blanket.

The repair consisted of filling in the rill with clayey top soil which was seeded with a mix of all purpose seed and annual rye. This was then covered with a wood fiber erosion blanket. A straw log and 3-inch stone were placed along the top of the subject area to help reduce sheet runoff erosional effects.

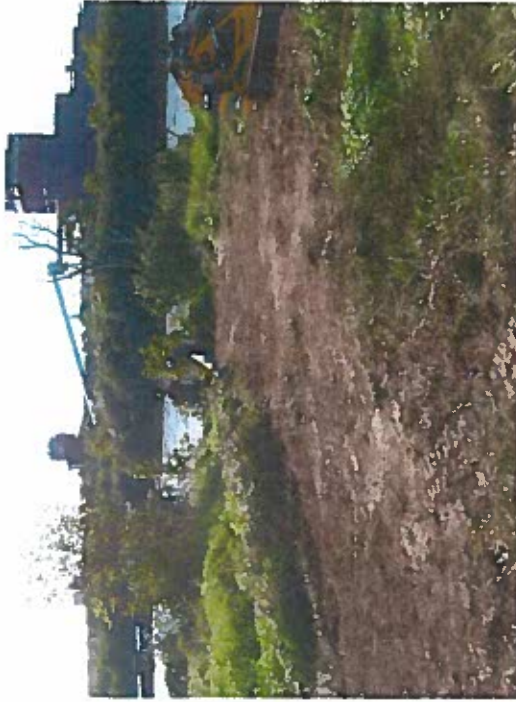
6. Area 2 fill with clayey topsoil.

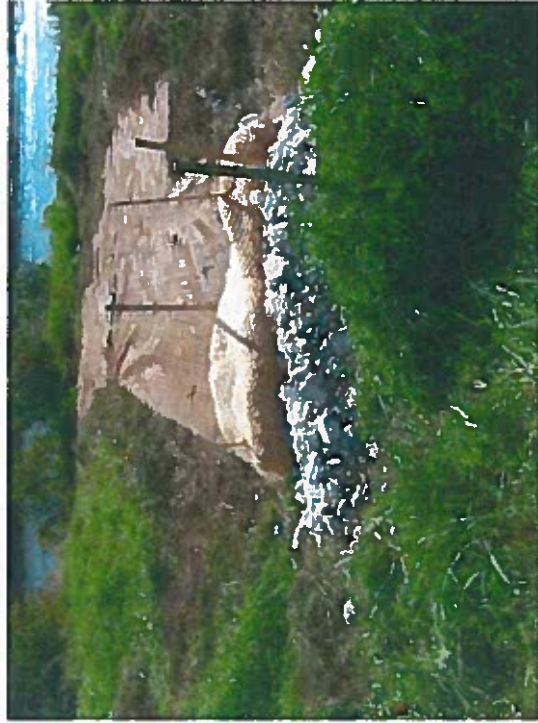
8. Area 2 with straw log and 3-inch stone to impede channeling of runoff.
