KPRG and Associates, Inc.

September 26, 2012

Re: Joliet #29 Former Ash Burial Area Runoff Erosion Repair 2012

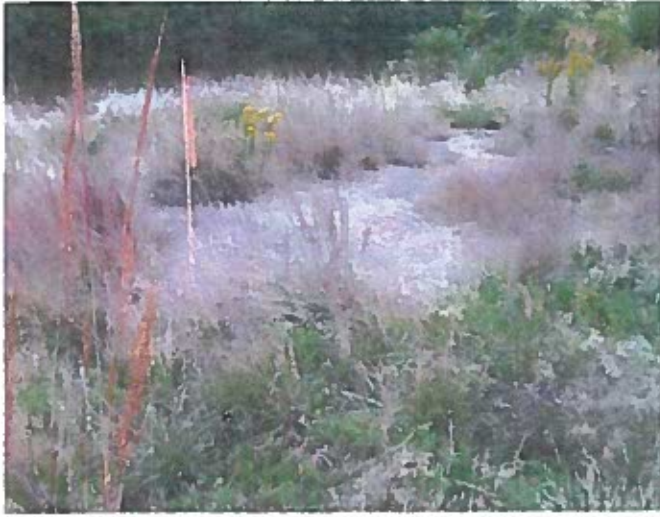
Photo 1 – Area 1, prior to repairs.

- Area 1 – Located at coordinates N41° 29.846'/W88° 07.021'. This was a flat area at the top of the embankment where the vegetal cover had been eroded and ash exposed. This area was approximately 450 square feet in size.

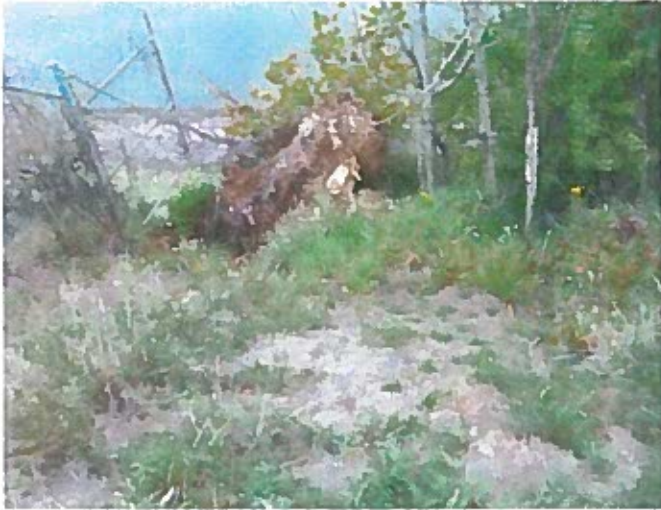
Photo 4 – Area 2, prior to repairs.

- Area 2 – Located at N41° 29.883'/W88° 06.954'. At this location, a storm event uprooted a small tree at the base of the slope/water interface of the intake channel. The toppled tree had resulted in an escarpment. Although no visible ash was exposed, the presence of the escarpment would facilitate continued erosion into the toe of the embankment.

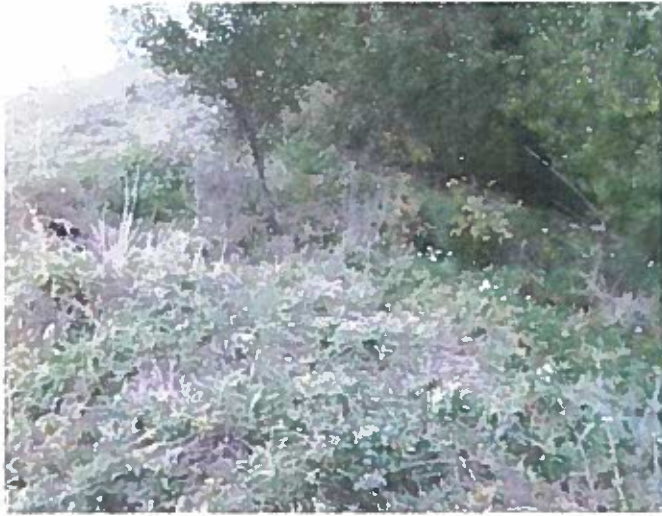
Photo 7 – Area 3, prior to repairs.

- Area 3 – Located at N41° 29.884'/W88° 06.932'. This was an area where there was a small incision into the top of the bank. The incised feature was approximately 25 feet long, 15 feet wide and up to 1 foot deep.

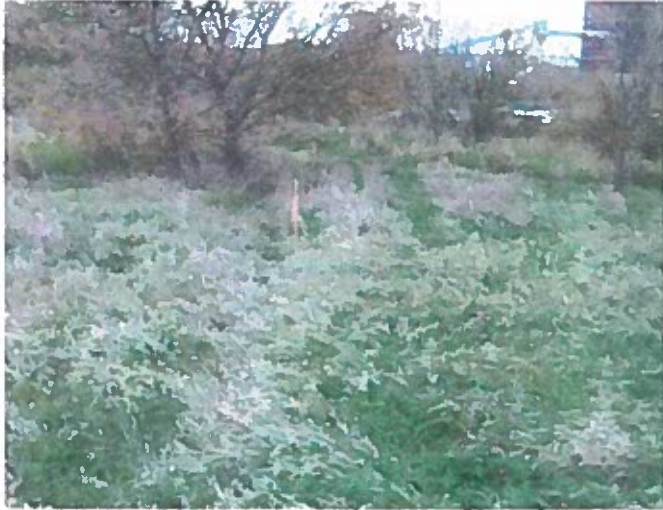
Photo 10 – Area 4, prior to repairs.

- Area 4 – Located at N41° 29.886'/W88° 06.854'. This was an upland area of rill development which eventually turned into sheet runoff as the ground flattens prior to flowing toward the channel bank. The rill was approximately 75 feet long, 3 feet wide and up to 1.5 feet deep.
