AC 04-66

ADMINISTRATIVE CITATION

ILLINOIS ENVIRONMENTAL)	
PROTECTION AGENCY,)	
)	
Complainant,)	AC
)	
v.)	(IEPA No. 217-04-AC)
)	
CURRY ICE & COAL OF SPRINGFIELD,)	
INC., and CURRY READY-MIX &)	
BUILDER'S SUPPLY, INC.,)	
)	
Respondent.)

Open Dump Inspection Checklist

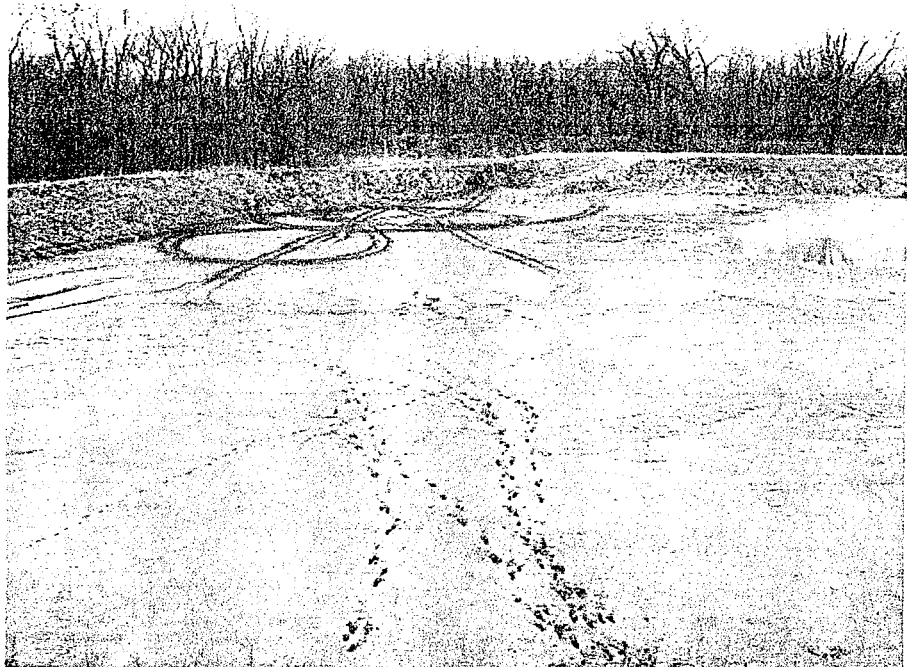
1671205697~03032004-001

The muddy conditions of the floor showed what appeared to be all-terrain vehicle tracks in the southwest region of the pit (see photo 1). The only other tracks noted in the excavation were footprints that Mr. Jansen and I added. There was no sign of pumps or trucks being in the excavation.

Comments: Photograph shows the southwest corner of a pit excavated along the west side of the north parking.

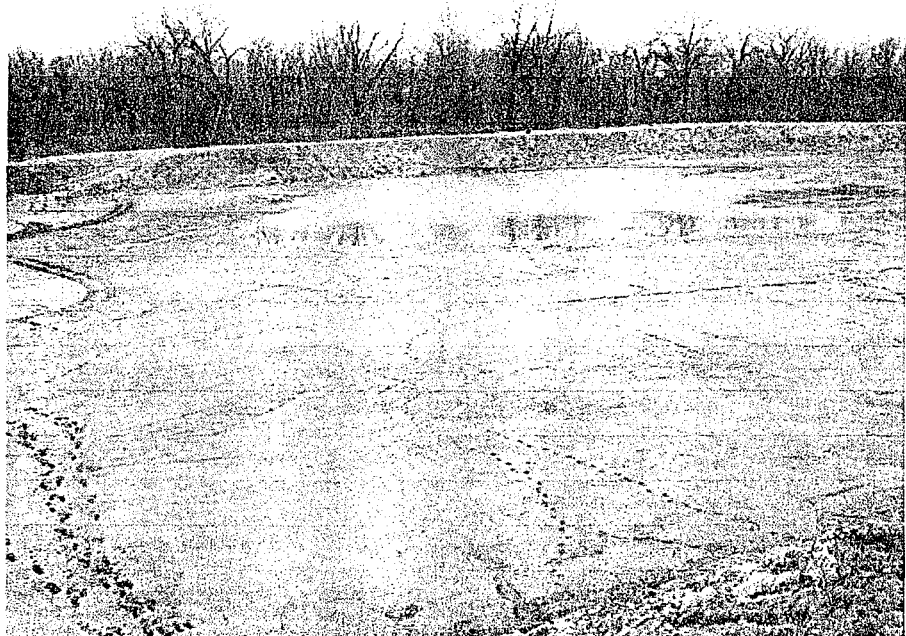
1671205697~03032004-002

Comments: Photograph shows the western and southwest regions of a pit excavated along the west side of the north parking lot.

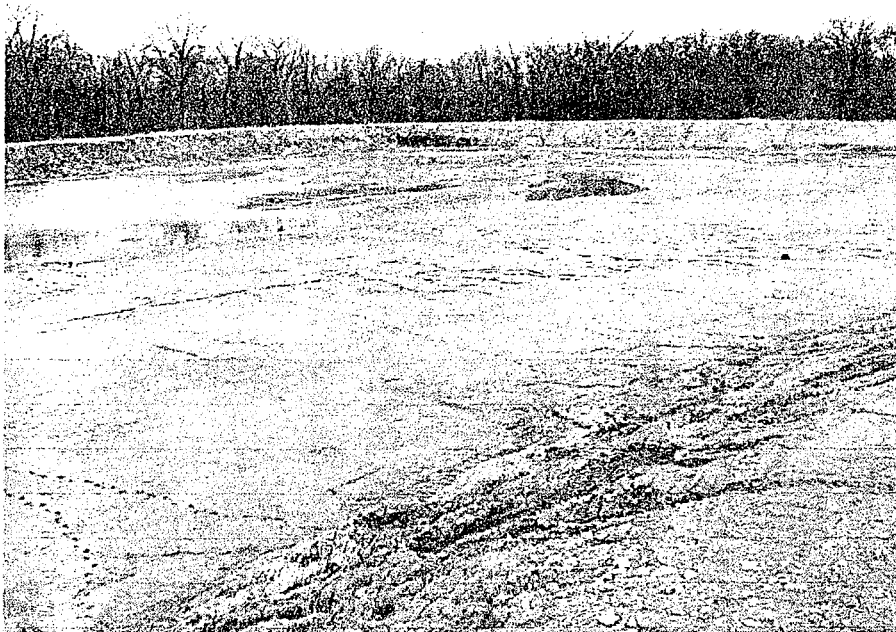
1671205697~03032004-003

Comments: Photograph shows the central and northwest regions of a pit excavated along the west side of the north parking lot.

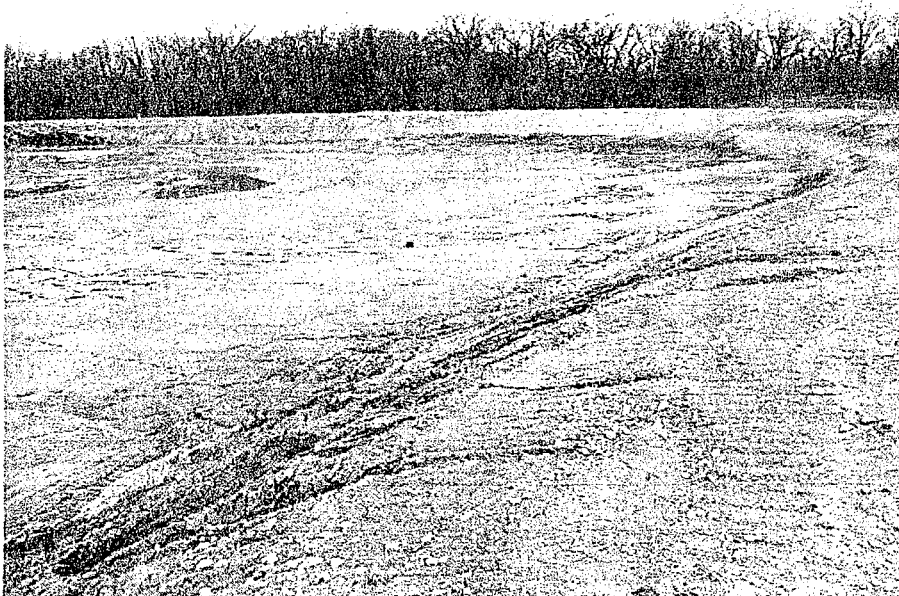
1671205697~03032004-004

Comments: Photograph shows the northeast corner of a pit excavated along the west side of the north parking lot.

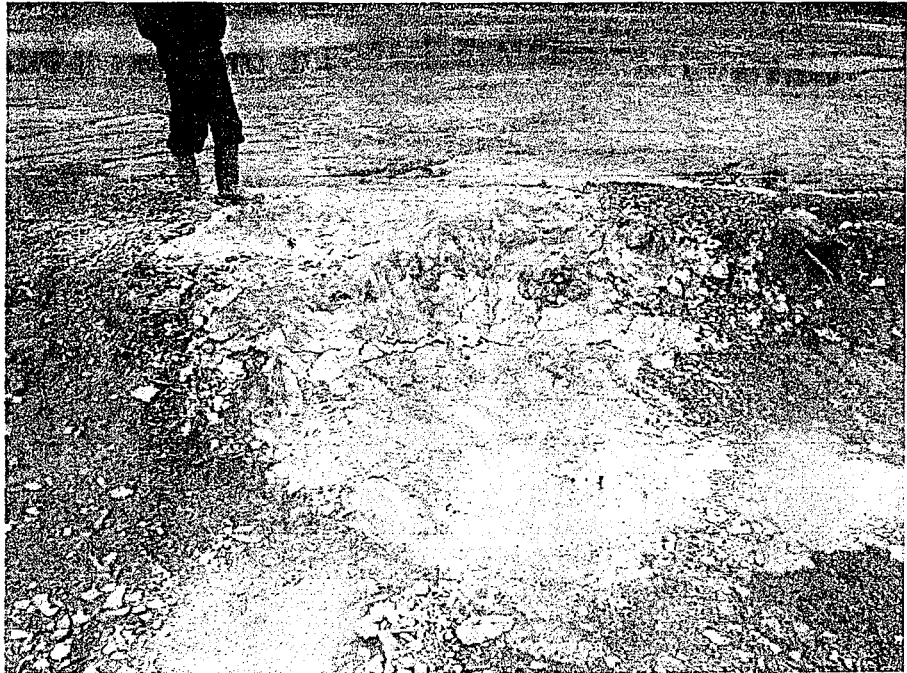
1671205697~03032004-005

North of the ADM ash was a hardened white to gray material along the east edge of the pit (see photos 5 and 6). The material appeared to have been dumped as a liquid and had flowed from the edge of the excavation down the sidewall. From its coloration and its changing from a liquid to a solid state, the material is believed to be concrete or cement cleaned out of a truck.

Comments: Photograph shows hardened white material on the east edge of a pit excavated along the west side of the north parking lot.

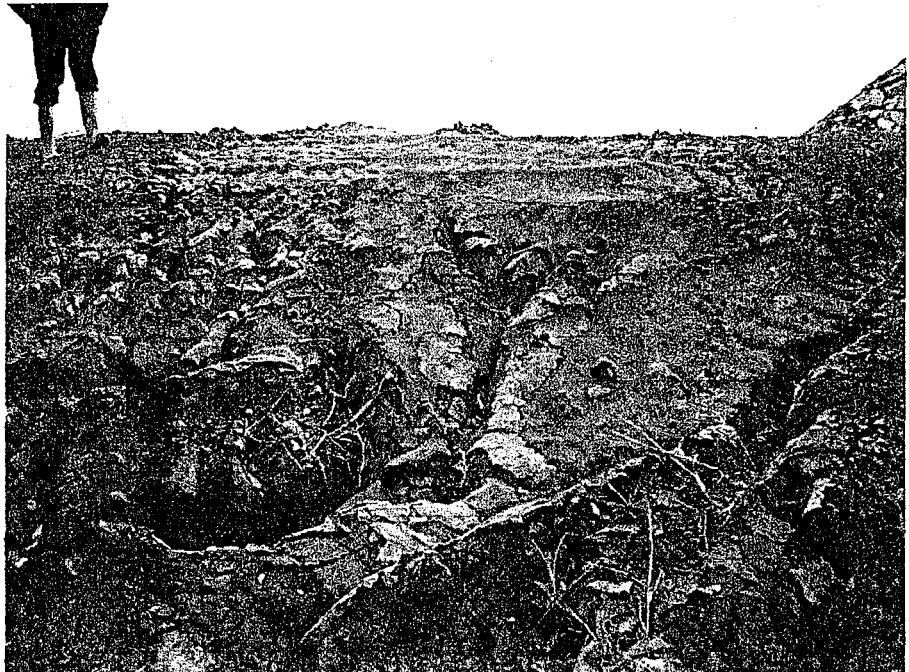
1671205697~03032004-006

Comments: Photograph shows the east sidewall of a pit excavated along the west side of the north parking lot. Note the hardened white material found on the sidewall.

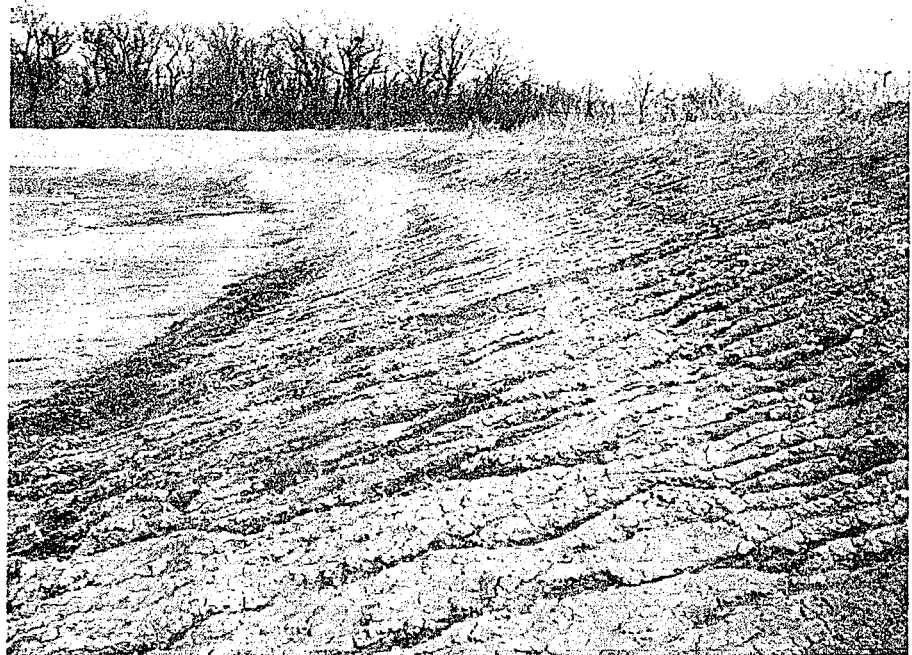
1671205697~03032004-007

Comments: Photograph shows the east sidewall of a pit excavated along the west side of the north parking lot. Note the erosion channels found on the sidewall.

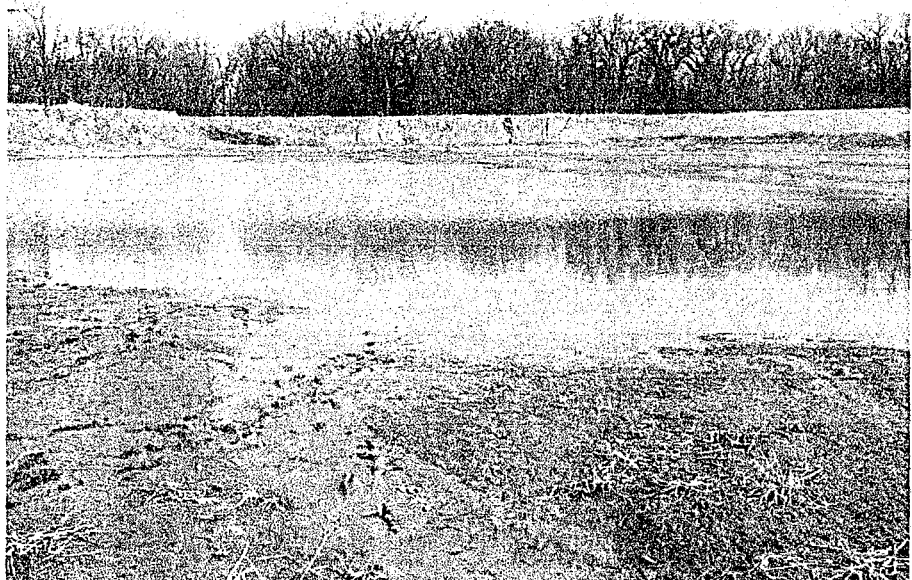
1671205697~03032004-008

Comments: Photograph shows the western portion of a pit excavated along the west side of the north parking lot.

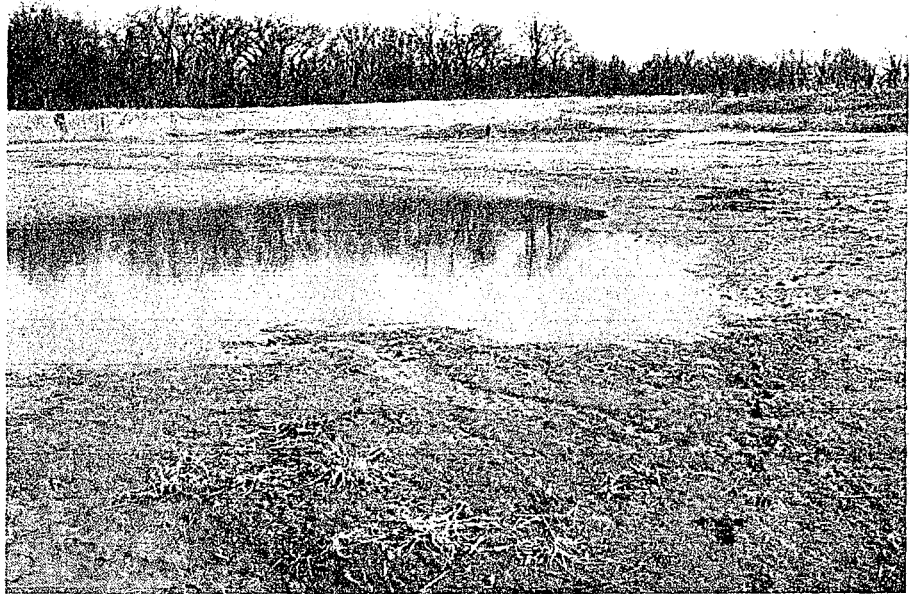
1671205697~03032004-009

Comments: Photograph shows the eastern portion of a pit excavated along the west side of the north parking lot.

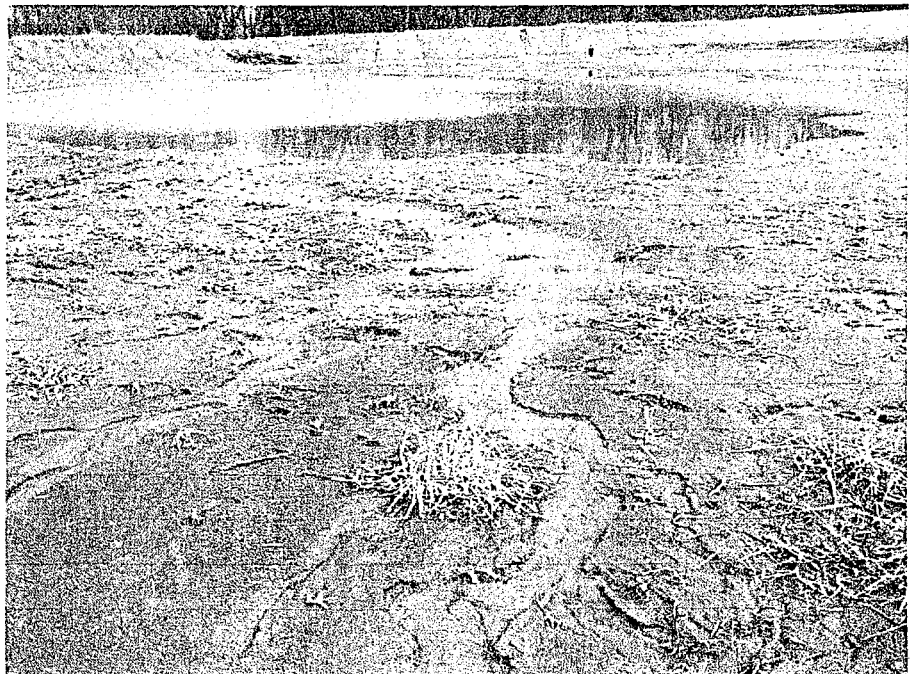
1671205697~03032004-010

Comments: Photograph shows the western region of a pit excavated along the west side of the north parking lot.

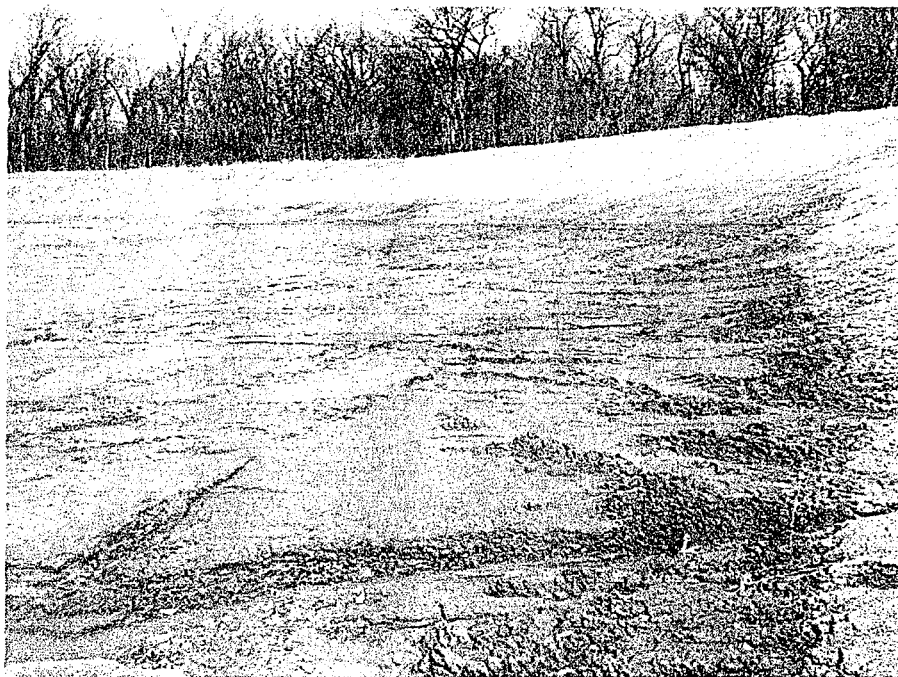
1671205697~03032004-011

No groundwater or stormwater was observed flowing into the pit at the time of the inspection. However, the bottom half of the pit's northeast sidewall was moist, and it is suspected that the moisture is caused by groundwater (see photo 11). A small flow of groundwater had been noted in the northeast corner of the pit on previous inspections.

Comments: Photograph shows the northeast corner of a pit excavated along the west side of the north parking lot. Note the wet area found in the bottom and sidewall at the northeast corner.

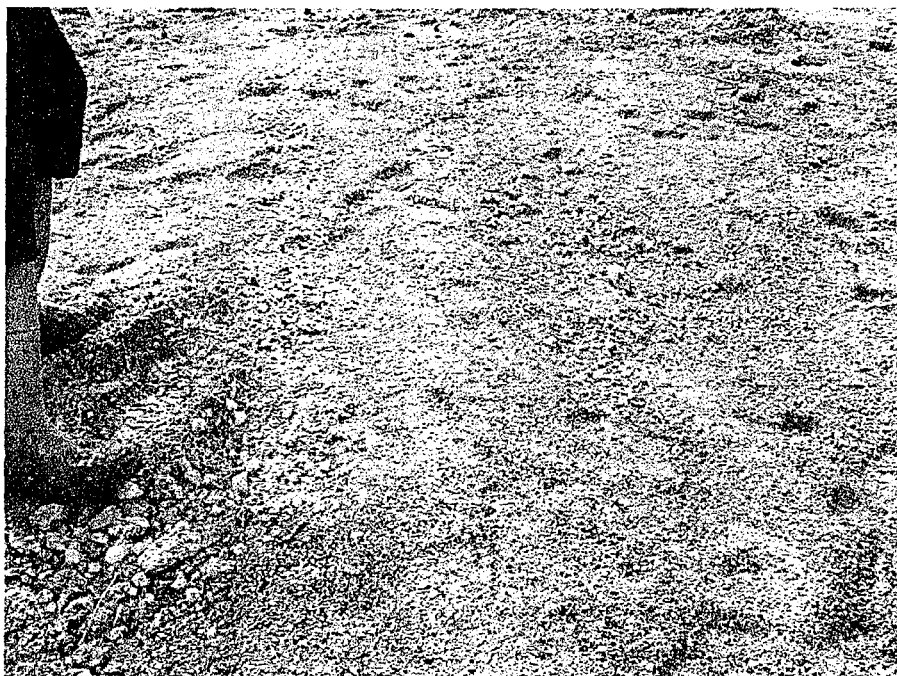
1671205697~03032004-012

Near the northwest region of the excavation was an area of moist, white material on the floor. This material is ADM bed ash that had been deposited last year to help soak up a wet area. Curry is interested in disposing the ADM bed ash in the pit in the future to generate revenue. One of the characteristics of the bed ash is its absorbent properties. Reportedly, once the ash dries out it becomes as hard as concrete. What was found during the inspection is that the ADM bed ash, after it experiencing wet and dry cycles, breaks

down from a hardened state into a mud-like consistency. Photos 12 and 13 show our footprints in the moist, soft bed ash.

Comments: Photograph shows the northwest region of a pit excavated along the west side of the north parking lot. Note the white, moist material on the floor of the excavation that is apparently ADM bed ash.

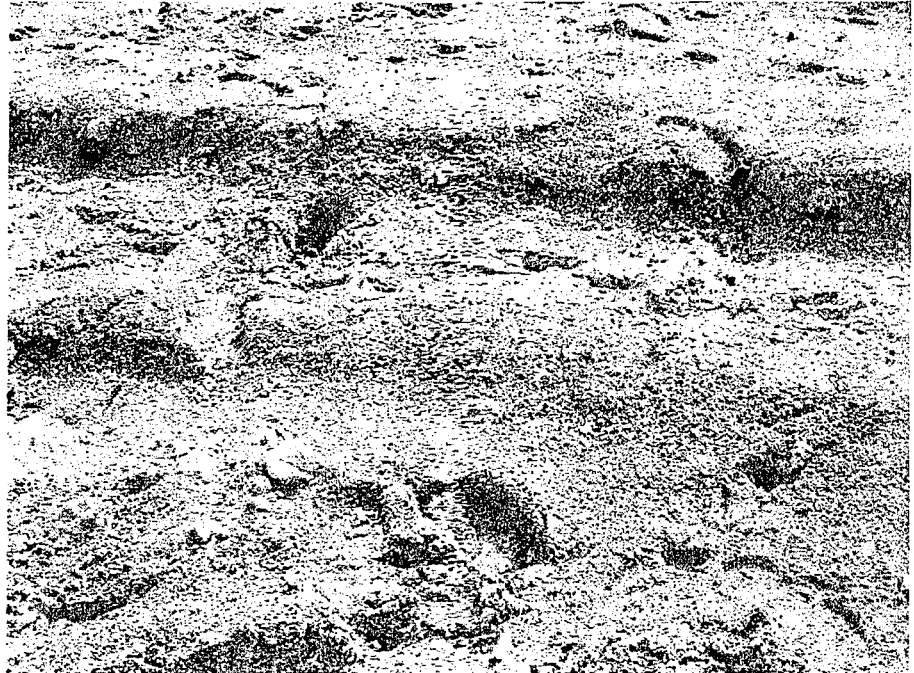
1671205697~03032004-013

Comments: Photograph shows the northwest region of a pit excavated along the west side of the north parking lot. Note the white, moist material on the floor of the excavation that is apparently ADM bed ash.

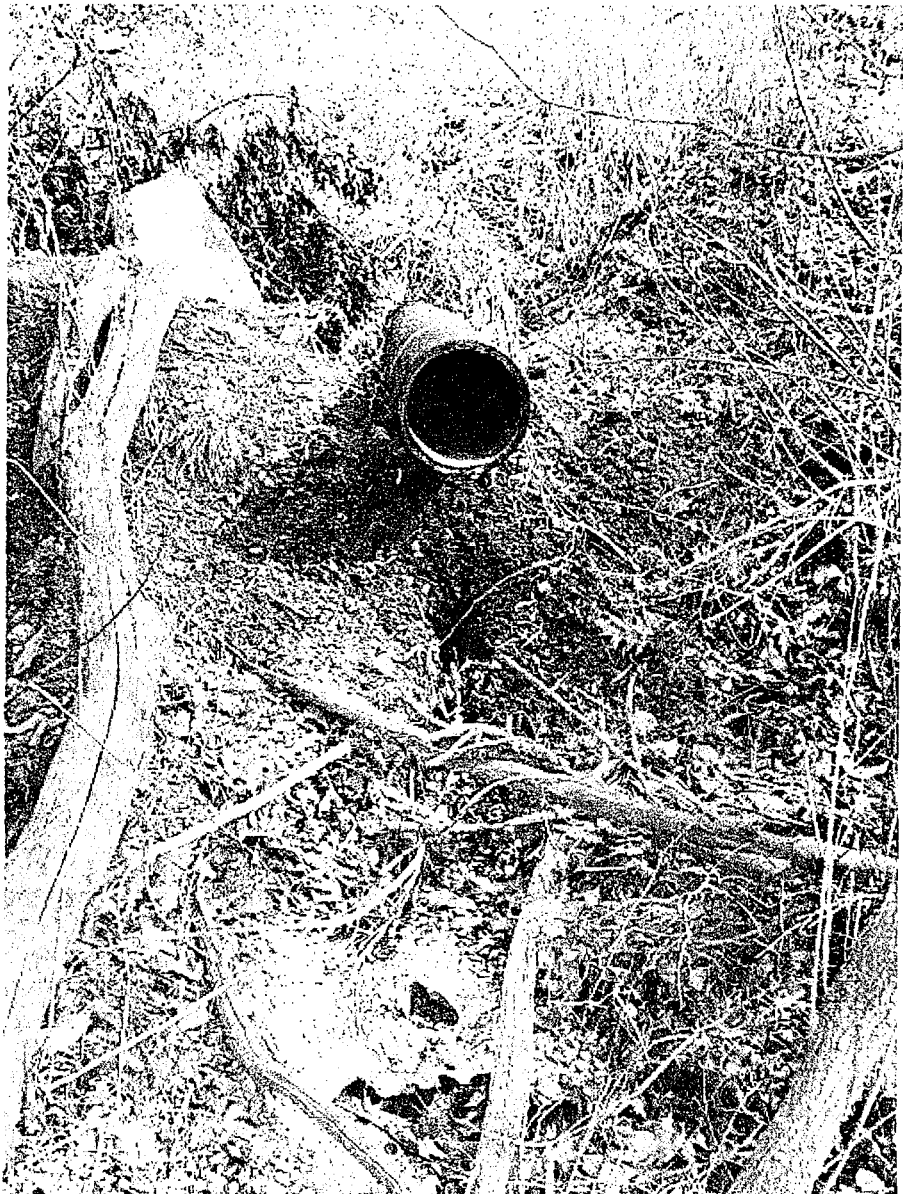
1671205697~03032004-014

Comments: Photo taken from the out-let pipe found south and east of the pit excavated along the west side of the north parking lot. The pipe is connected to a stormwater drain located east of the pit.

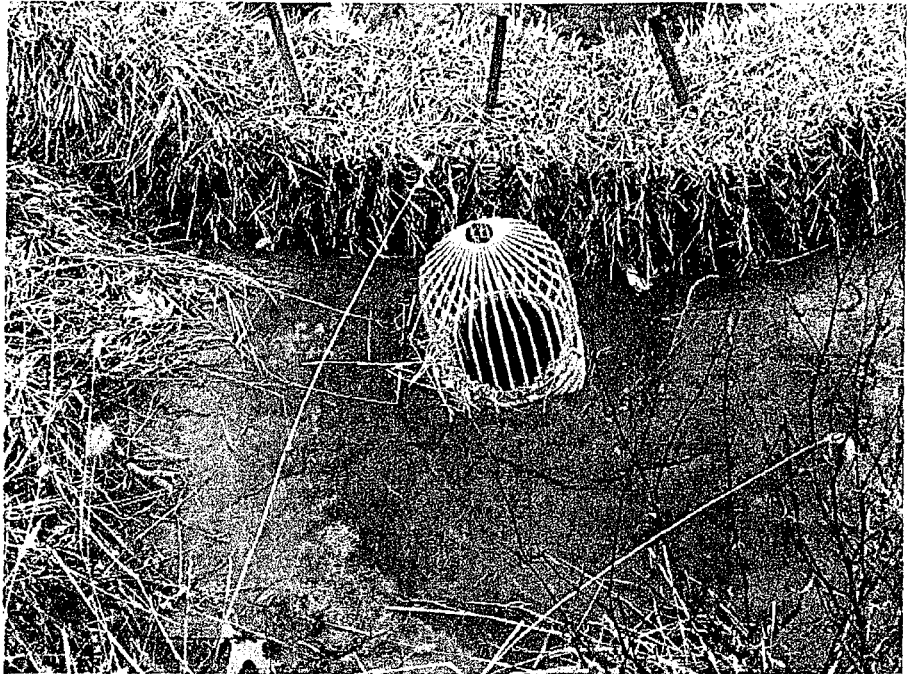
1671205697~03032004-015

Comments: Photo shows the stormwater drainage pipe located east of the pit excavated on the west side of the north parking lot.

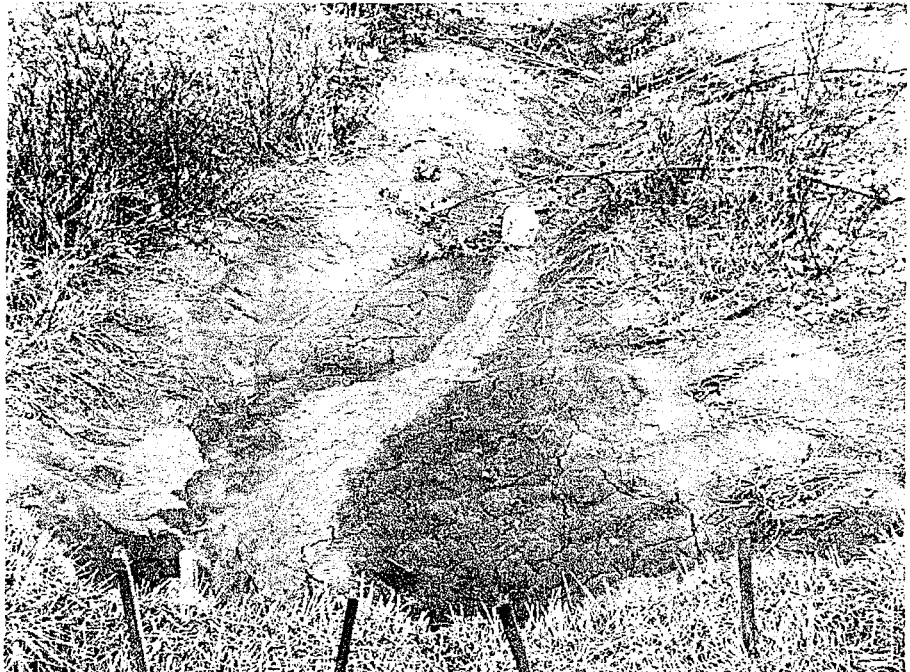
1671205697~03032004-016

Comments: Photo shows the drainage ditch for stormwater from the west edge of the north parking lot leading to the straw bale dikes and to the drainage pipe.

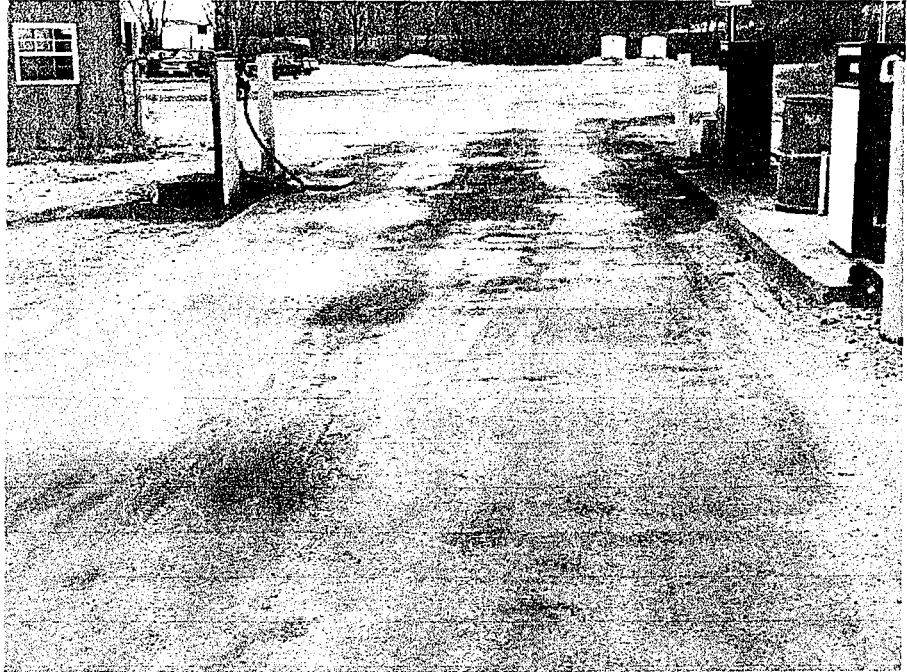
1671205697~03032004-017

During the inspection we observed the fueling station located at the north parking lot near the southeast corner of the excavation. It was noted that there were some staining of the 2 concrete pads where the Curry trucks park to pump diesel fuel (see photo 17). We then observed a dark stain on the gravel south of a concrete pad located north of the pumps (see photo 18). The concrete pad covers an underground tank for diesel. Stained gravel was also observed on the east and north sides of the pad (see photo 19), though dark stains were not evident on top of the concrete. Finally, a large stain on the gravel was observed east and south of the pumps (see photo 20). From the location and configuration of the stain it appeared that fuel had been allowed to overflow from a pump, or from a saddle tank on a truck. A strong diesel smell was detected in the area directly adjacent to the fueling station, and in the stained gravel. If the fuel had continued flowing south and east, it would have eventually reached the creek. The stained gravel indicated it had not reached the creek. Hazardous and special waste determinations will be needed before any stained gravel and/or soil can be removed for proper disposal.

Comments: Photo shows a stained concrete pad at the fueling station located at the north parking lot.

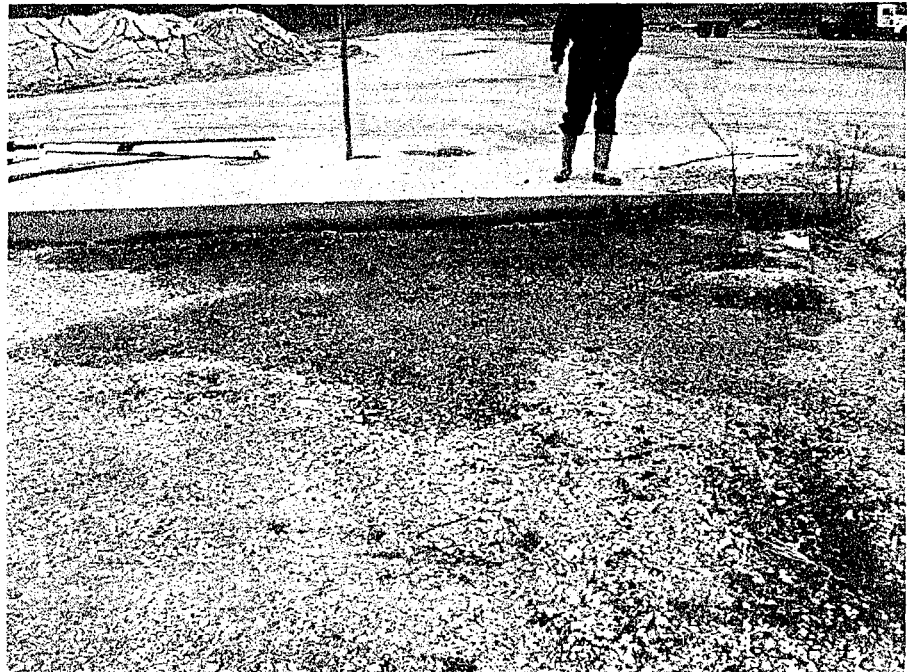
1671205697~03032004-018

Comments: Photo shows stained gravel just south of a concrete pad located in the fueling station area of the north parking lot. The concrete pad sets over an underground tank for diesel fuel.

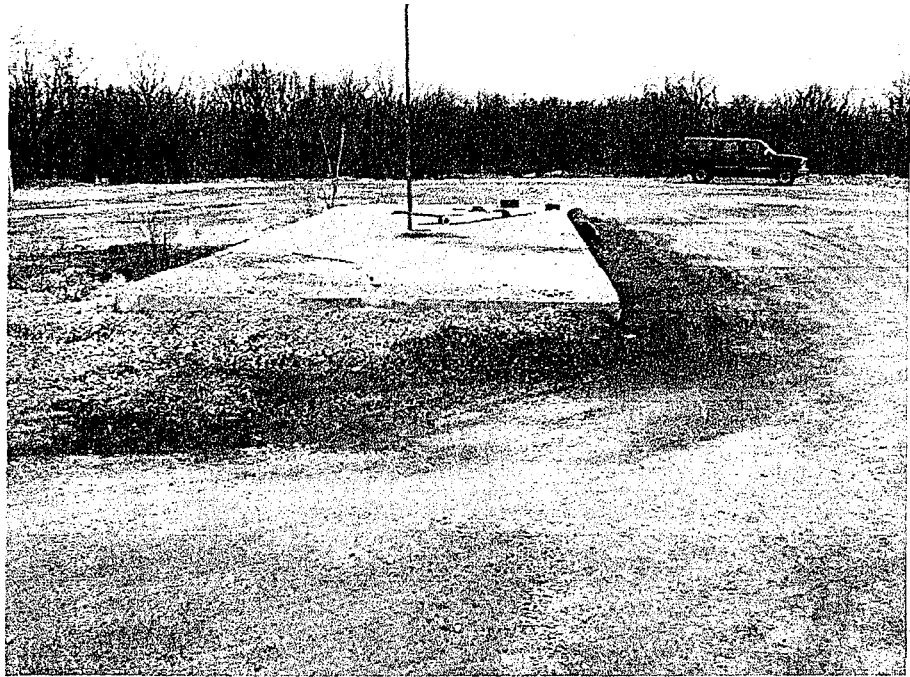
1671205697~03032004-019

Comments: Photo shows stained gravel south, east and north of a concrete pad located in the fueling station area of the north parking lot. The concrete pad sets over an underground tank for diesel fuel.

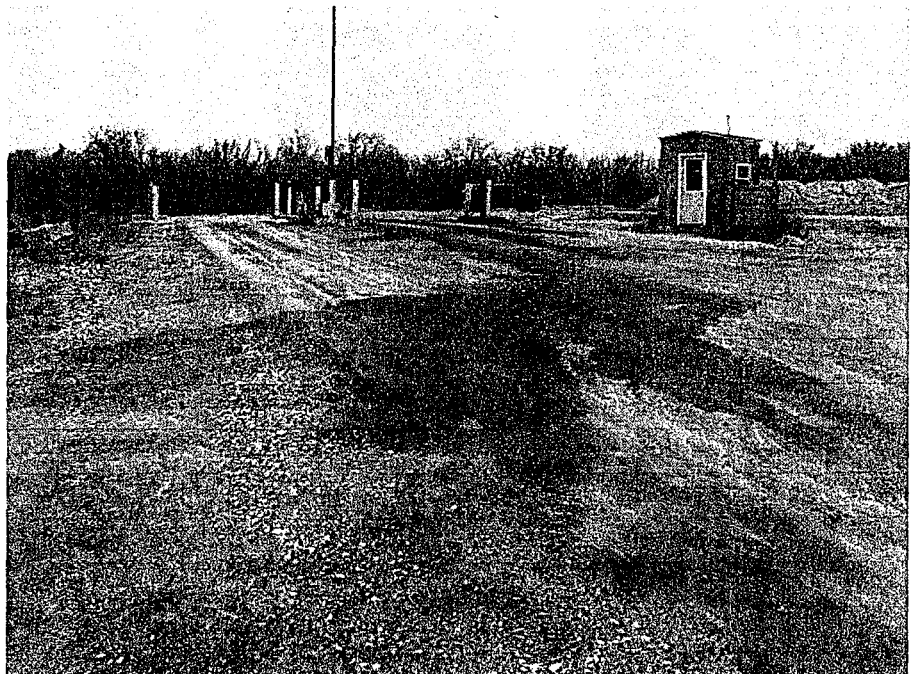
1671205697~03032004-020

Comments: Photo shows stained gravel east and south of the fueling station area of the north parking lot.

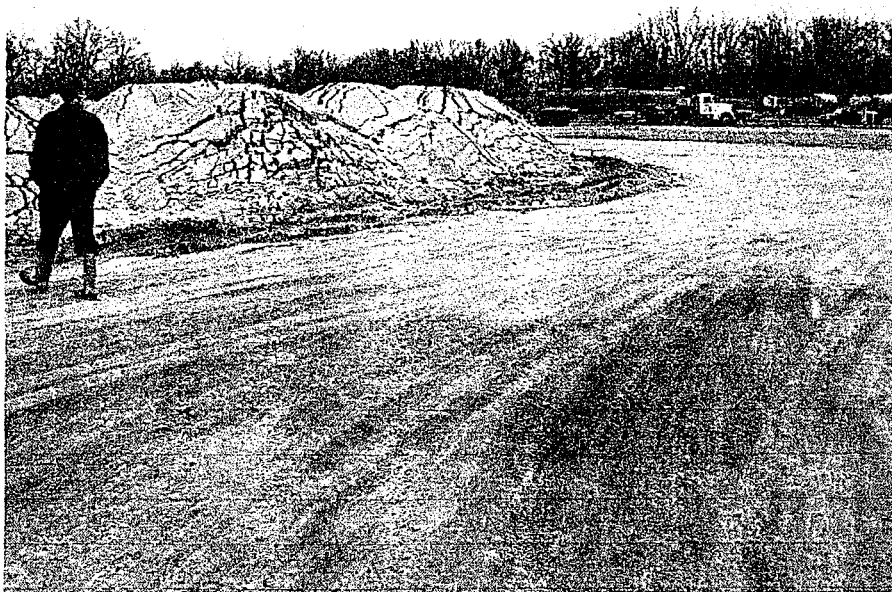
1671205697~03032004-021

At the southwest edge of the north parking lot are piles of ADM bed ash (see photo 21). The stockpiled ash is surrounded on the north, south and east sides by a small un-compacted earthen berm. Truck tire prints in the southeast region of the berm indicate one or more trucks had run over the soil, flattening the berm (see photo 21).

Comments: Photo shows ADM bed ash piles, with the remnants of the earthen berm around them, near the east edge of the excavated pit in the north parking lot.

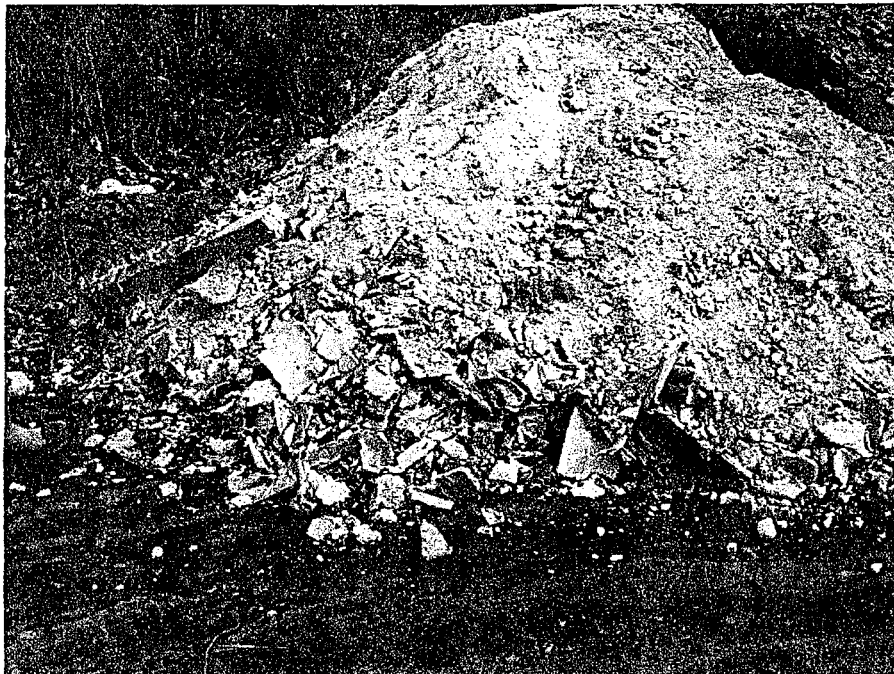
1671205697~03032004-022

Photo 22 was taken of a pile of what appeared to be broken drywall located in the northeast region of the north parking lot. Walking south from the northeast region, more piles of assorted general refuse were found. Photos 23, 24 and 25 are of different piles of waste found in the northeast/eastcentral region of the north parking lot. Photo 23 and 25 show a discarded metal hoist, abandoned hard piping, a used tire, a chain-link fence, a crushed metal 55-gallon drum, etc. Photo 24 shows what may be more broken drywall or gypsum. Further south of these piles was a pile of wood pallets, and near the southeast corner of north parking lot was a large metal tank on its side (see photo 26). The tank was empty except for a small amount of water and rusty scale, and it was observed to have several corrosion holes in it. A pile of general refuse was setting on the ground east of the tank (see photo 27). In the pile were heavy rubber hoses, metal scrap, concrete, wood and some soil.

Comments: Photo shows a pile of what appears to be broken up drywall setting in the northeast region of the north parking lot.

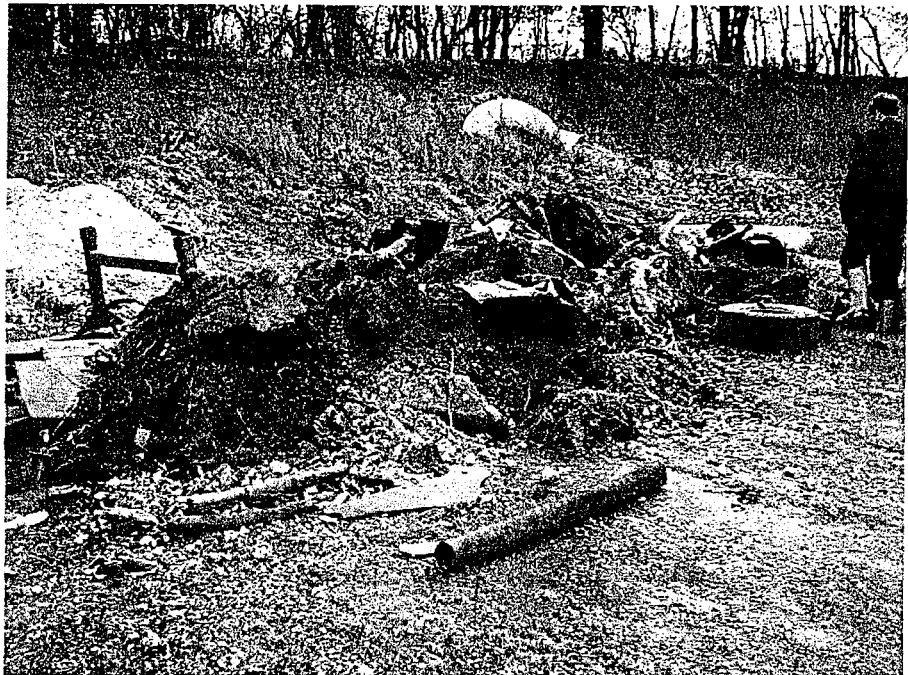
1671205697~03032004-023

Comments: Photo shows solid waste dumped in the northeast/eastcentral region of the north parking lot.

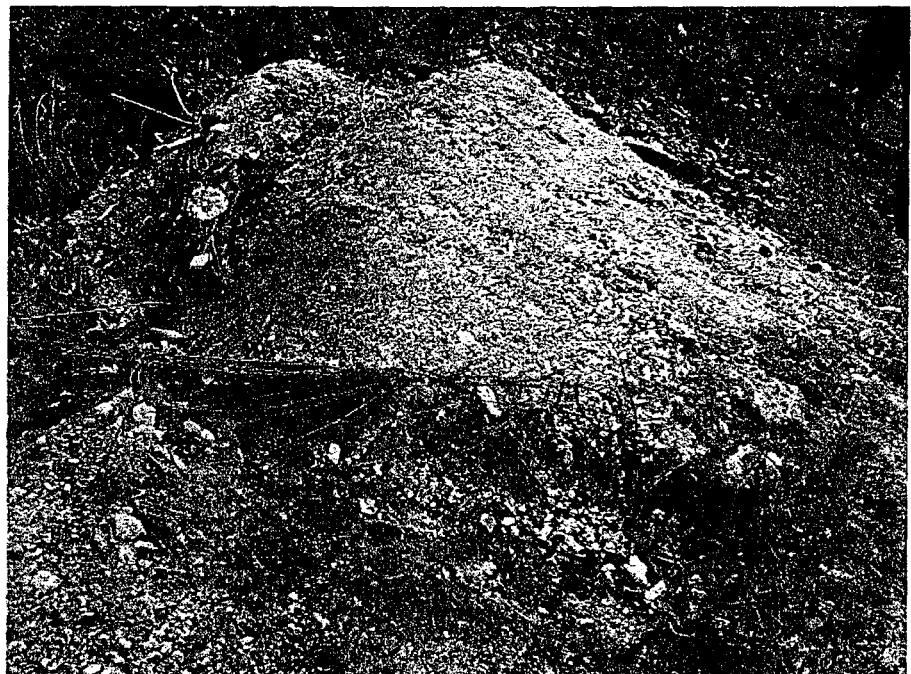
1671205697~03032004-024

Comments: Photo shows a pile of white material dumped in the northeast/eastcentral region of the north parking lot.

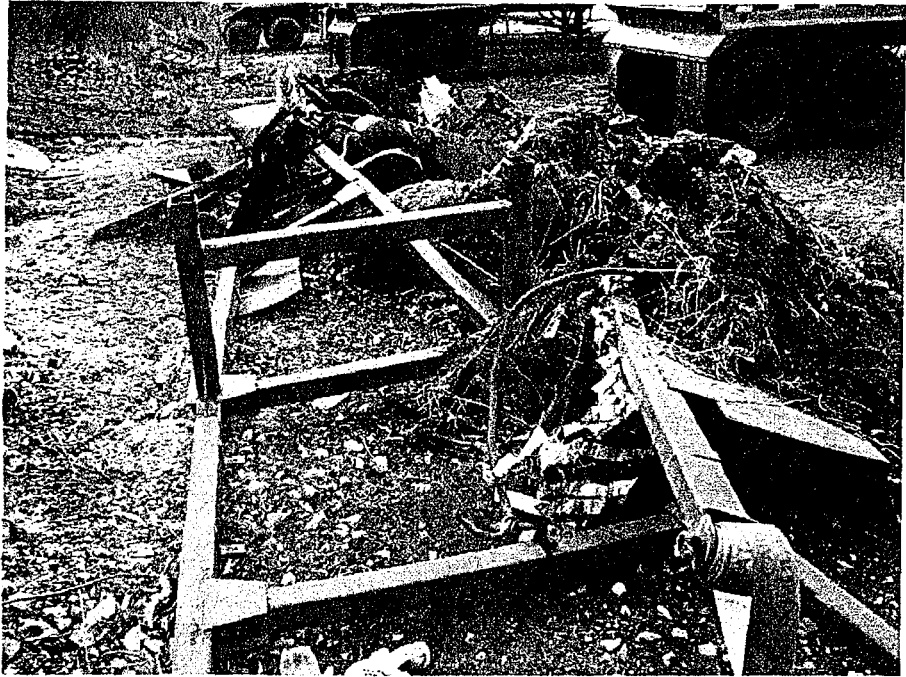
1671205697~03032004-025

Comments: Photo shows general refuse dumped on the northeast/eastcentral region of the north parking lot.

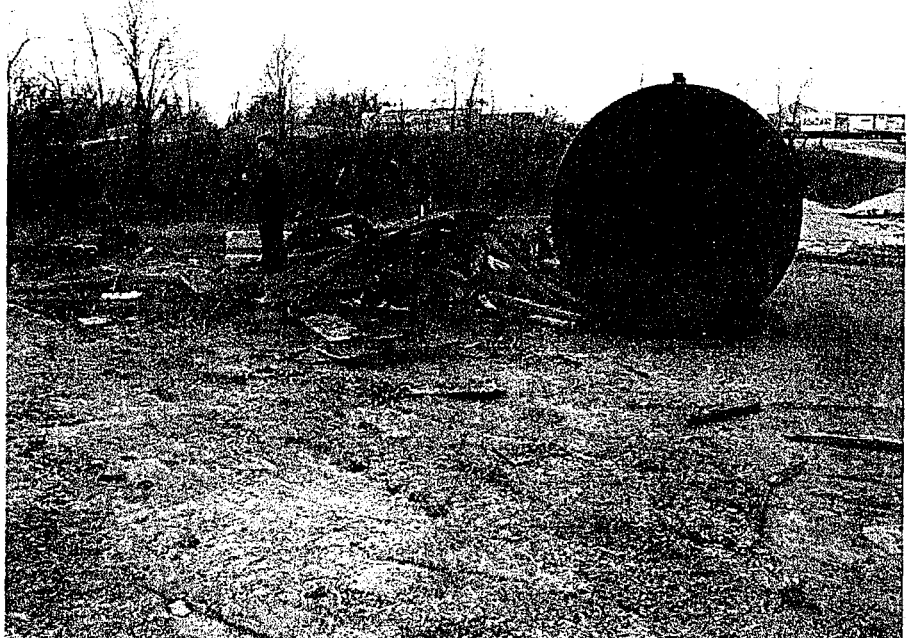
1671205697~03032004-026

Comments: Photo shows general refuse and an empty metal tank setting in the southeast region of the north parking lot.

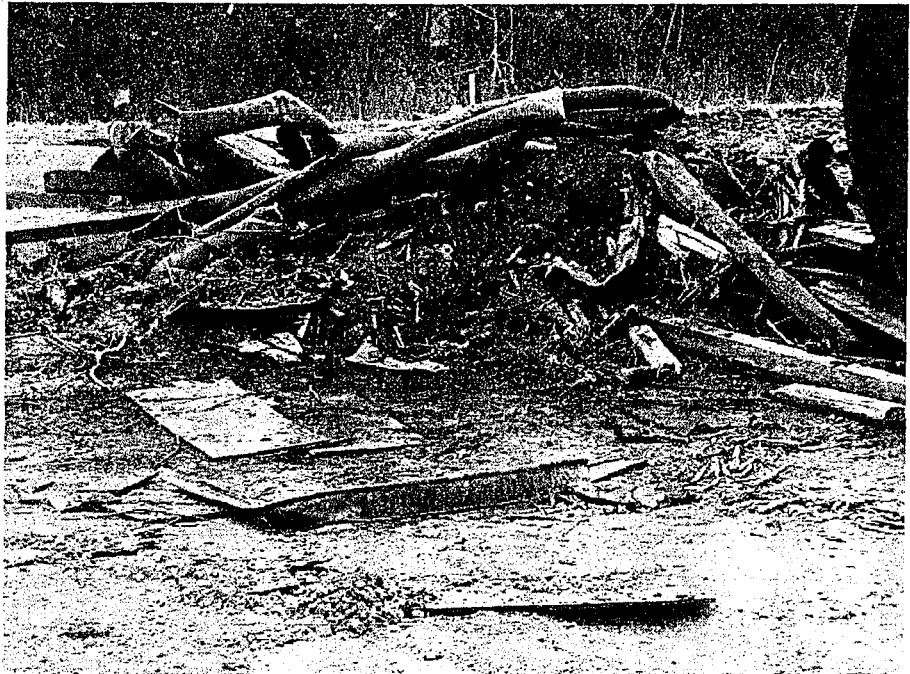
1671205697~03032004-027

Comments: Photo shows a pile of general refuse setting by an empty metal tank in the southeast region of the north parking lot.

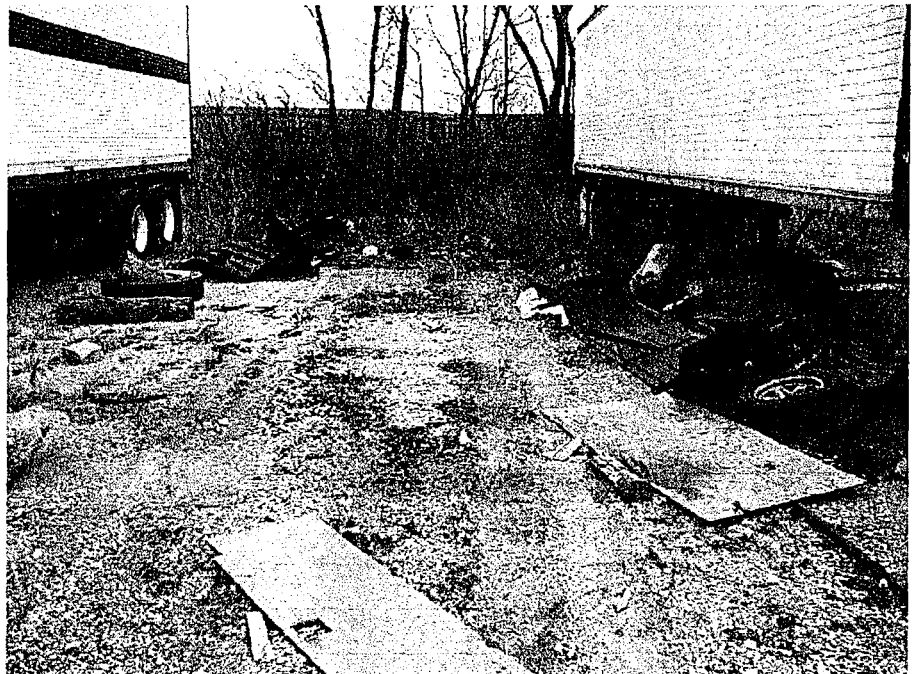
1671205697~03032004-028

Northeast of the metal tank were two trailers parked along the east property line. Between the two trailers were scattered pieces of wood, some heavy plastic sheets that may be some type of mud guard for the trucks, and a couple of used tires. Not pictured, but observed discarded on the south slope of the creek, were 2 used tires, wood, and other debris. This waste appeared to have been dumped down the slope from the northeast corner of the south parking lot.

Comments: Photo shows some general refuse setting on the ground between two semi-trailers in the southeast region of the north parking lot.
