ILLINOIS ENVIRONMENTAL PROTECTION AGENCY

Re: Illinois Environmental Protection Agency v. C. John Blickhan
IEPA File No.23-08-AC; 0010650002—Adams County

BEFORE THE ILLINOIS POLLUTION CONTROL BOARD
ADMINISTRATIVE CITATION

C. JOHN BLICKHAN,

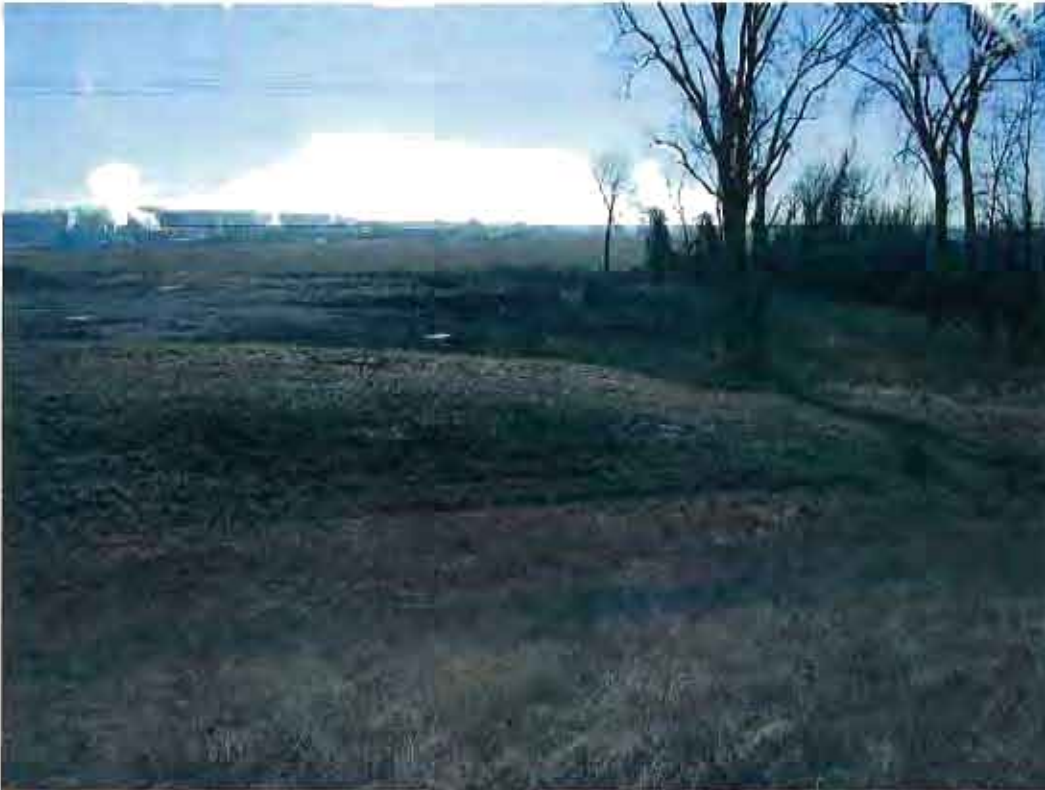
Photographs 001, 002, 003, and 004 show the west side of Site No. 1 landfill. No debris was observed on this side of Site No. 1 or in the visible tree line to the south.

Date: January 15, 2008
Time: 10:14 AM
Direction: SE
Photo by: Eisenbrandt
Exposure #: 001
Comments: West end of Site No. 1. No debris observed.

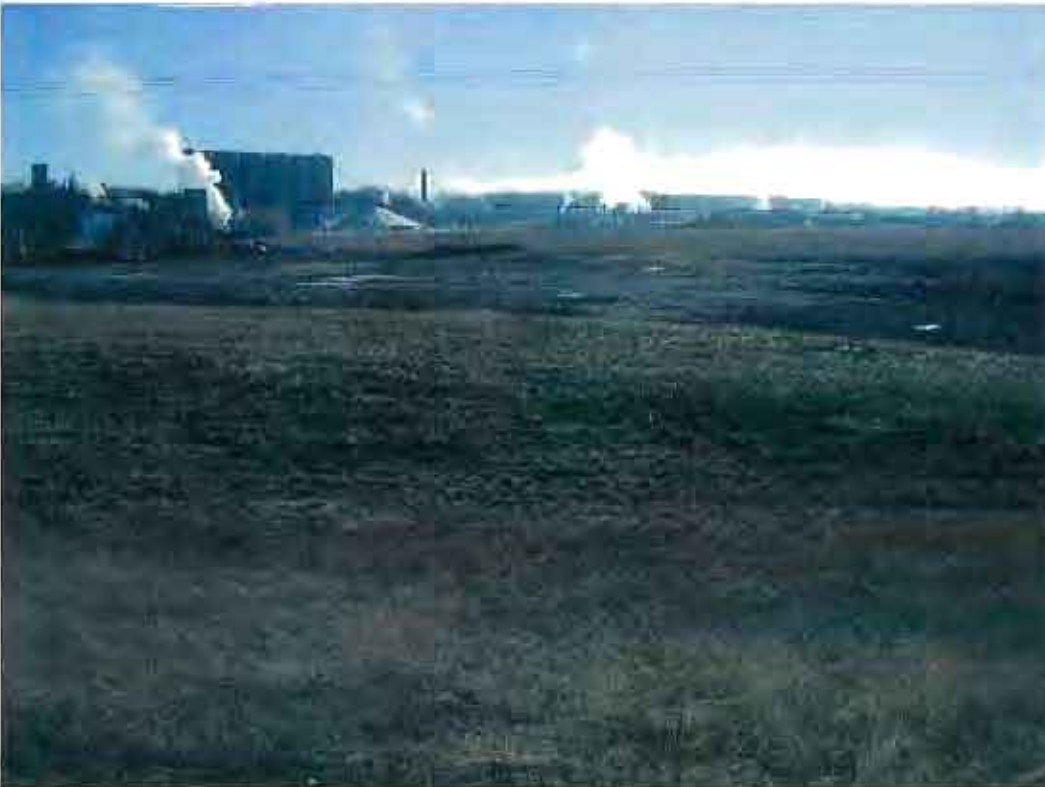
Date: January 15, 2008
Time: 10:14 AM
Direction: E
Photo by: Eisenbrandt
Exposure #: 002
Comments: West side of Site No. 1.

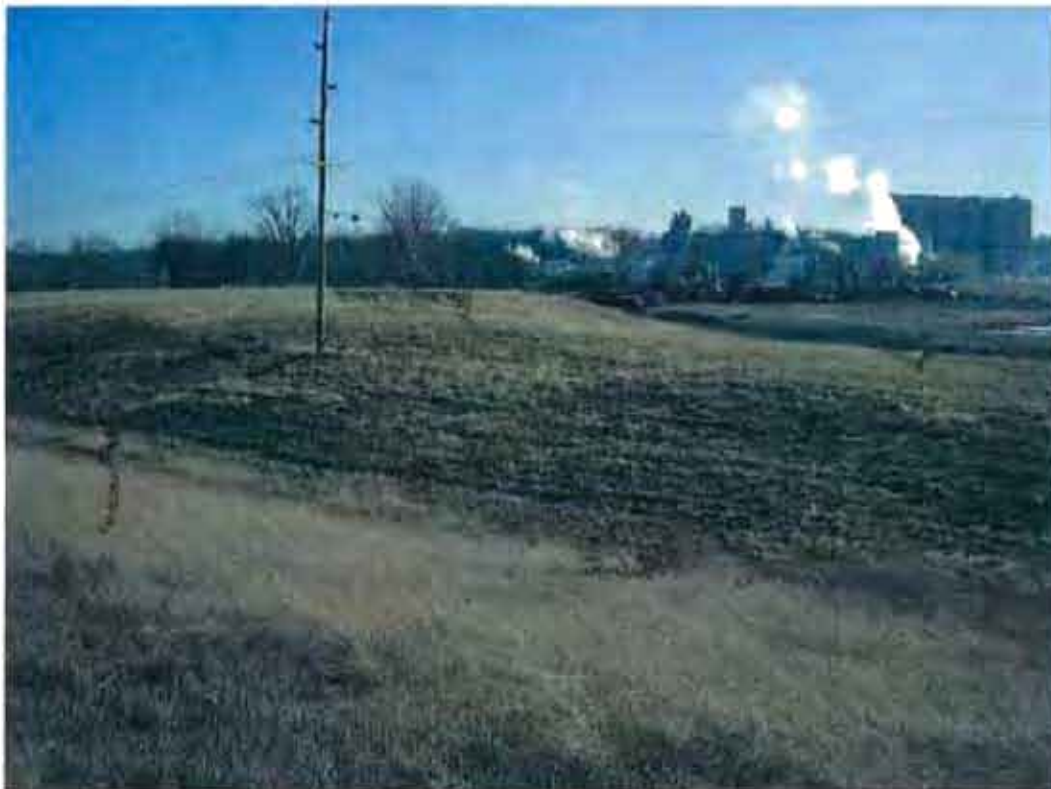
Date: January 15, 2008
Time: 10:15 AM
Direction: E
Photo by: Eisenbrandt
Exposure #: 003
Comments: West side
of Site No. 1.

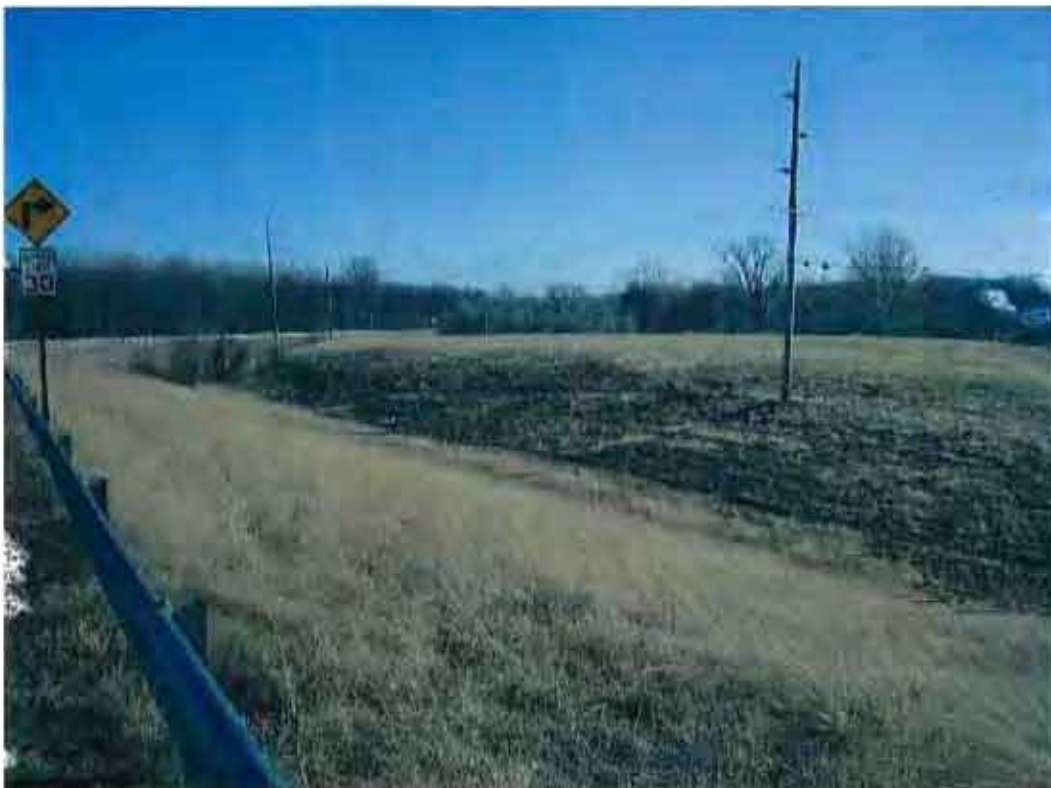
Date: January 15, 2008
Time: 10:15 AM
Direction: NE
Photo by: Eisenbrandt
Exposure #: 004
Comments: West side
of Site No. 1.

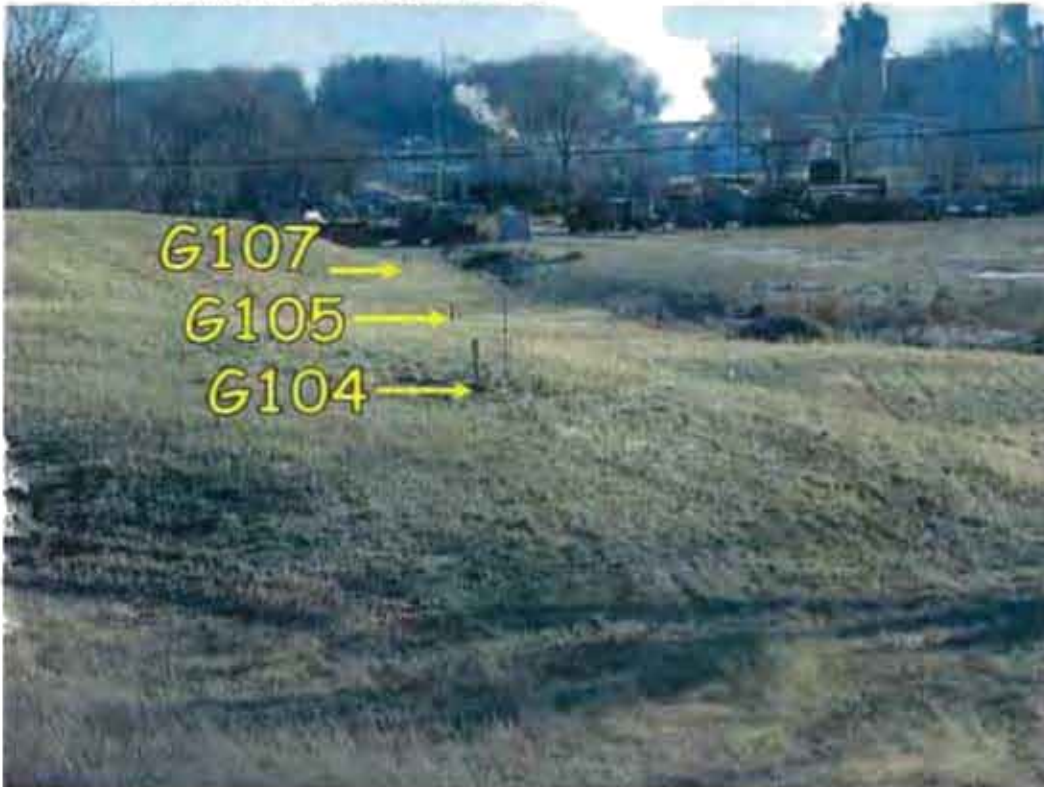
Date: January 15, 2008
Time: 10:17 AM
Direction: E
Photo by: Eisenbrandt
Exposure #: 005
Comments: Three groundwater monitoring wells and protective casings are visible in center of photograph
Text in photograph imported.

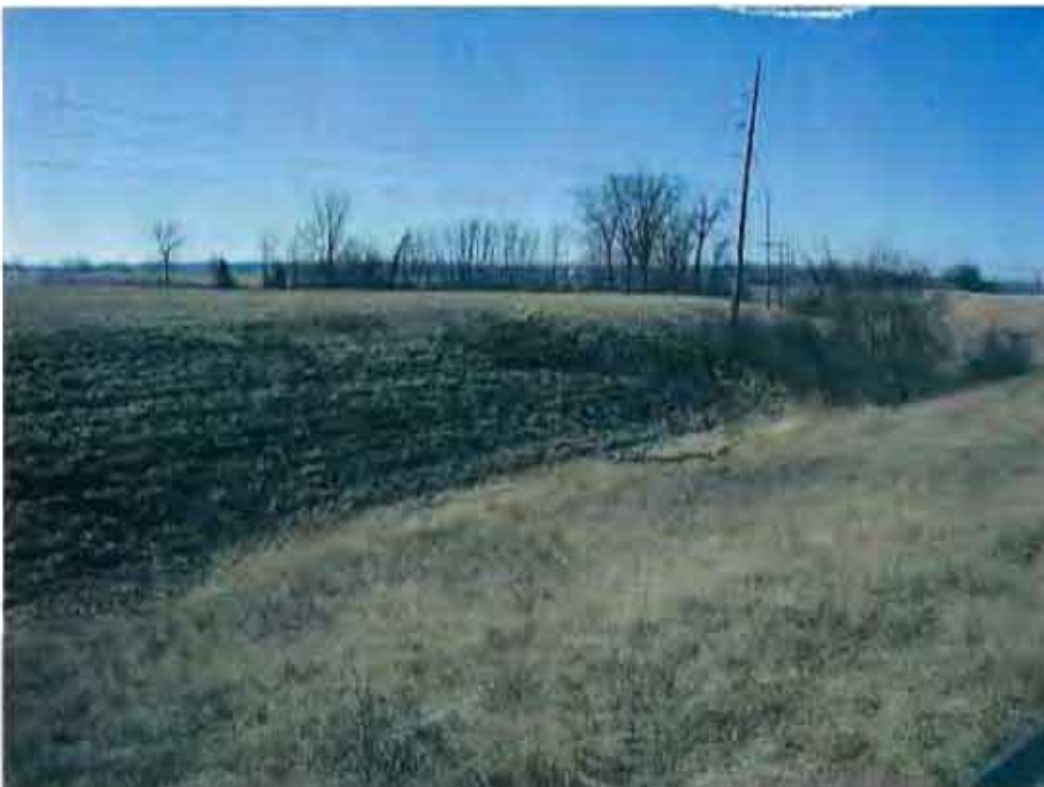
Photograph 006 shows the northwest side of Site No. 1. No debris was observed.

Date: January 15, 2008
Time: 10:18 AM
Direction: S
Photo by: Eisenbrandt
Exposure #: 006
Comments: North west side of Site No. 1.

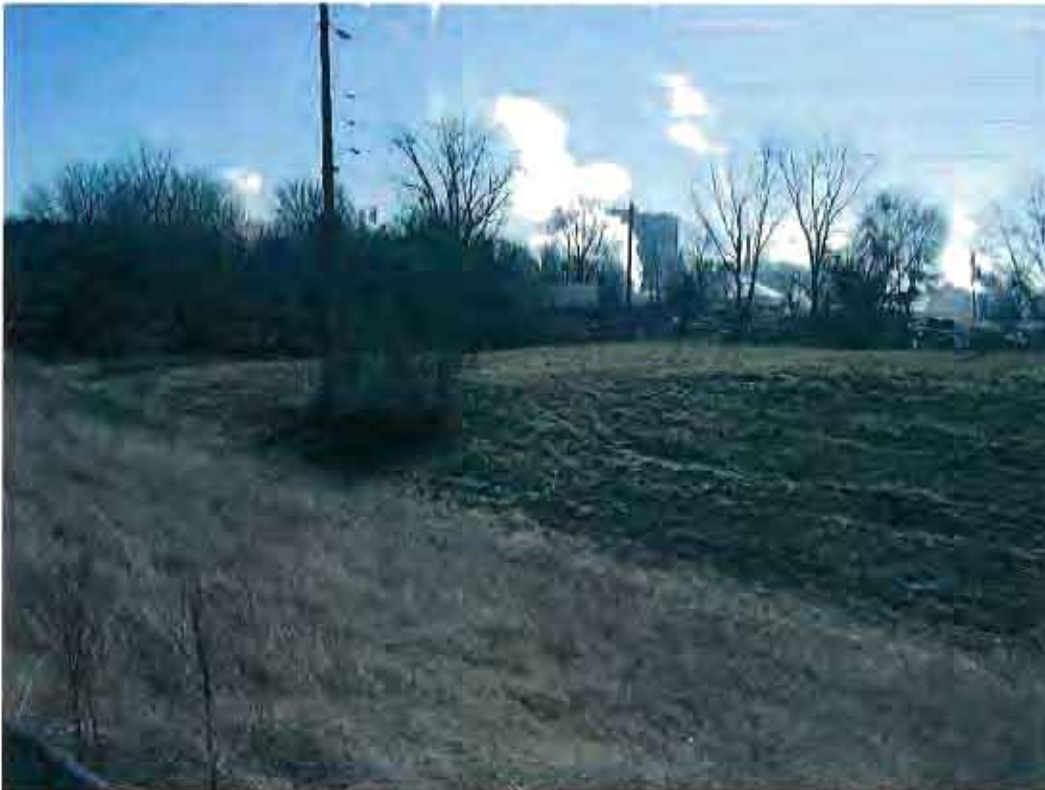
Photographs 007 and 008 show the north side of Site No. 1. No debris was observed. Photograph 008 shows groundwater monitoring well G101.

Date: January 15, 2008
Time: 10:18 AM
Direction: SE
Photo by: Eisenbrandt
Exposure #: 007
Comments: North side of Site No. 1.

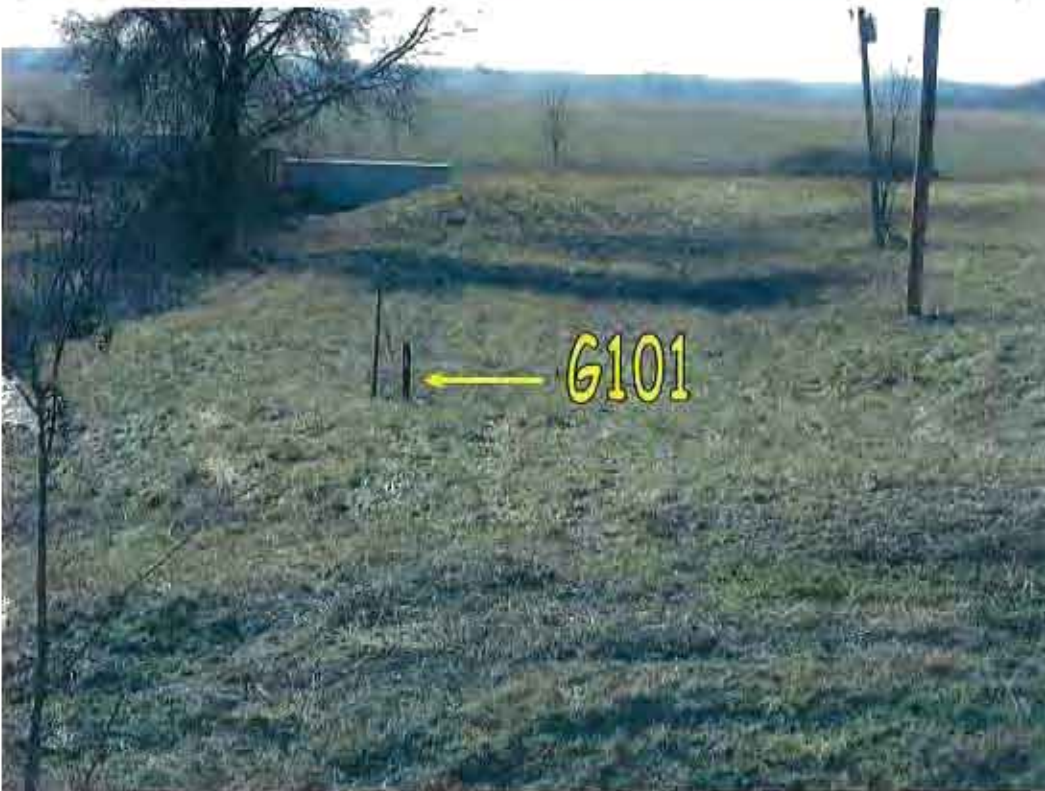
Date: January 15, 2008
Time: 10:19 AM
Direction: S
Photo by: Eisenbrandt
Exposure #: 008
Comments: Groundwater monitoring well and protective casing visible in center of photograph. Text in photograph imported.

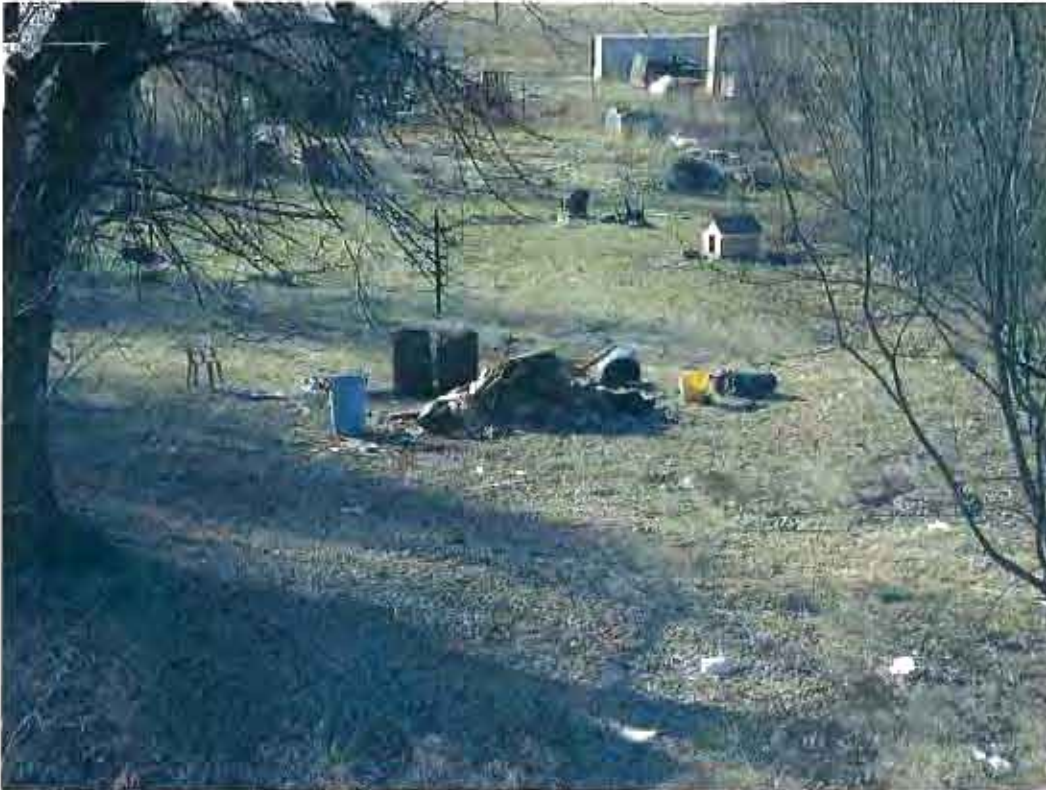
Photograph 009 shows the backyard of House No. 6, in Blick's Village, from Lock and Dam Road. Two rusty metal barrels (one of which is smoking), a blue plastic barrel (seen tipped on its

side), and a light blue trash can are surrounding a pile of debris. Scattered litter was also observed in the yard.

Date: January 15, 2008
Time: 10:20 AM
Direction: S
Photo by: Eisenbrandt
Exposure #: 009
Comments: Open dumped waste, open burning, and burn barrels observed behind House No. 6 in Blick's Village Court.

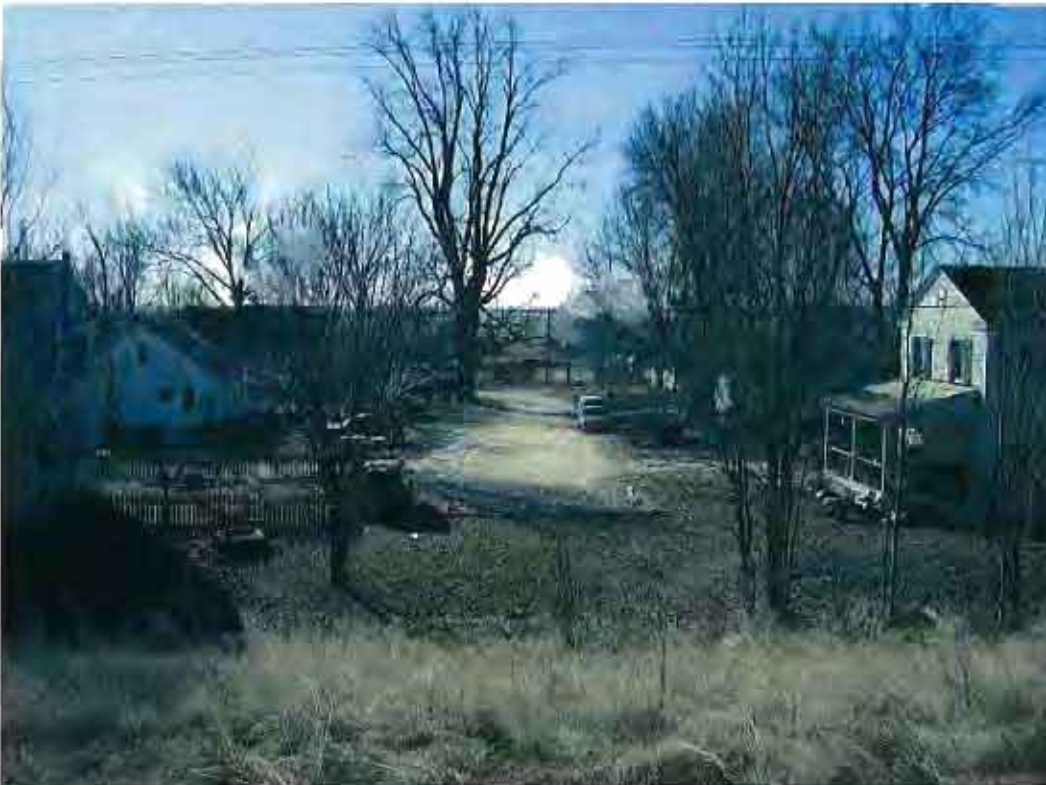
Date: January 15, 2008
Time: 10:21AM
Direction: S
Photo by: Eisenbrandt
Exposure #: 010
Comments: Main Street of Blick's Village Court.

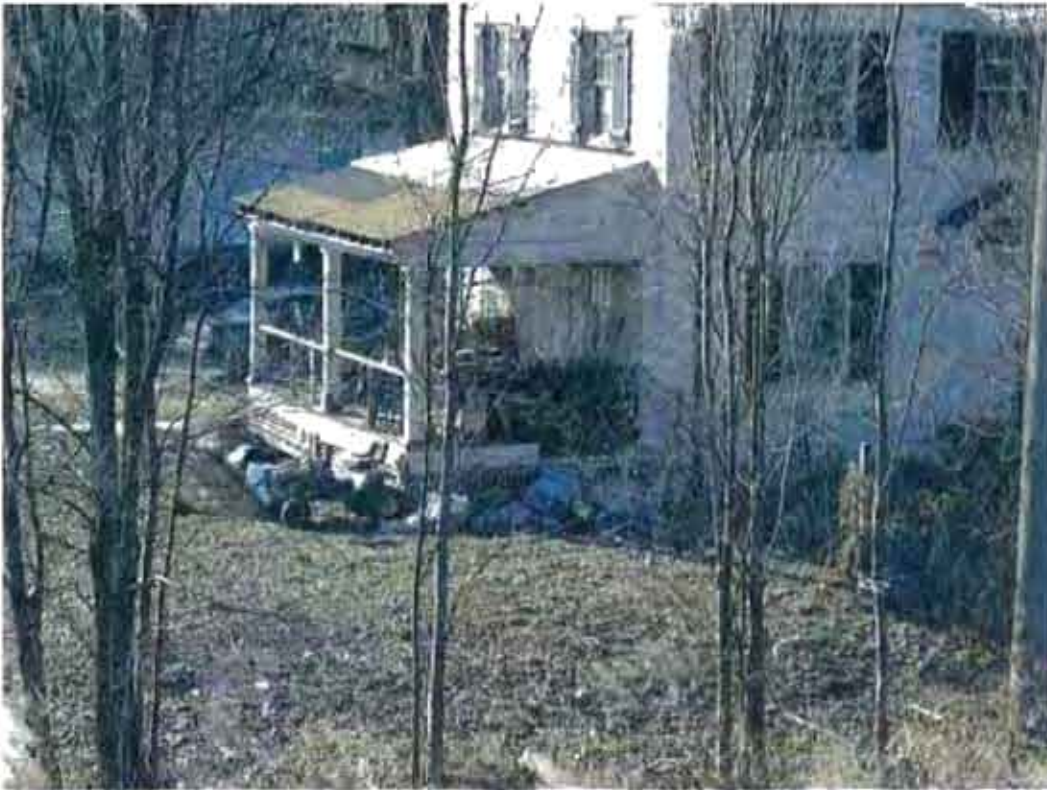
Photograph 011 shows several bags of open dumped waste observed off the north side of House No. 6's porch.

Date: January 15, 2008
Time: 10:22 AM
Direction: SW
Photo by: Eisenbrandt
Exposure #: 011
Comments: Open
dumped household
waste beside porch at
House No. 6.

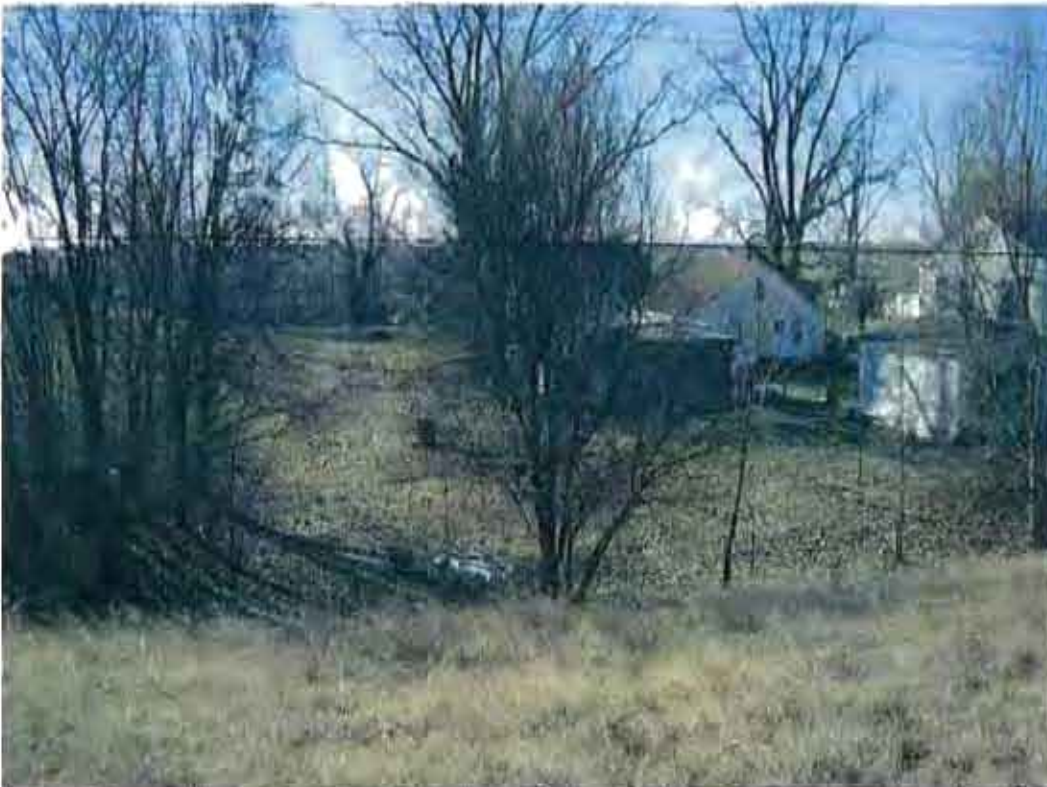
Photograph 012 shows burn barrels observed behind House No. 3 (west of Site No. 2).

Date: January 15, 2008
Time: 10:22 AM
Direction: SW
Photo by: Eisenbrandt
Exposure #: 012
Comments: Burn barrels
observed behind House
No. 3 west of Site No. 2.

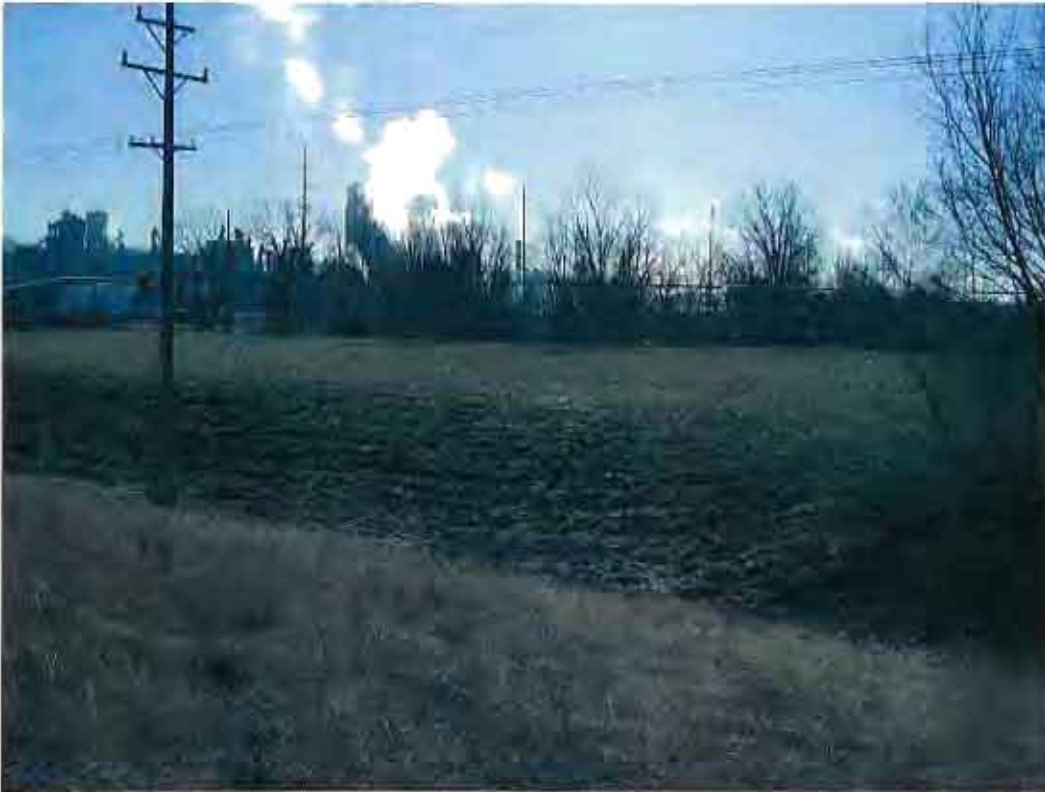
Photographs 013 and 014 show the north west and north east side of Site No 2, respectively. No debris was observed.

Date: January 15, 2008
Time: 10:23 AM
Direction: SE
Photo by: Eisenbrandt
Exposure #: 013
Comments: North west side of Site No. 2. No debris observed.

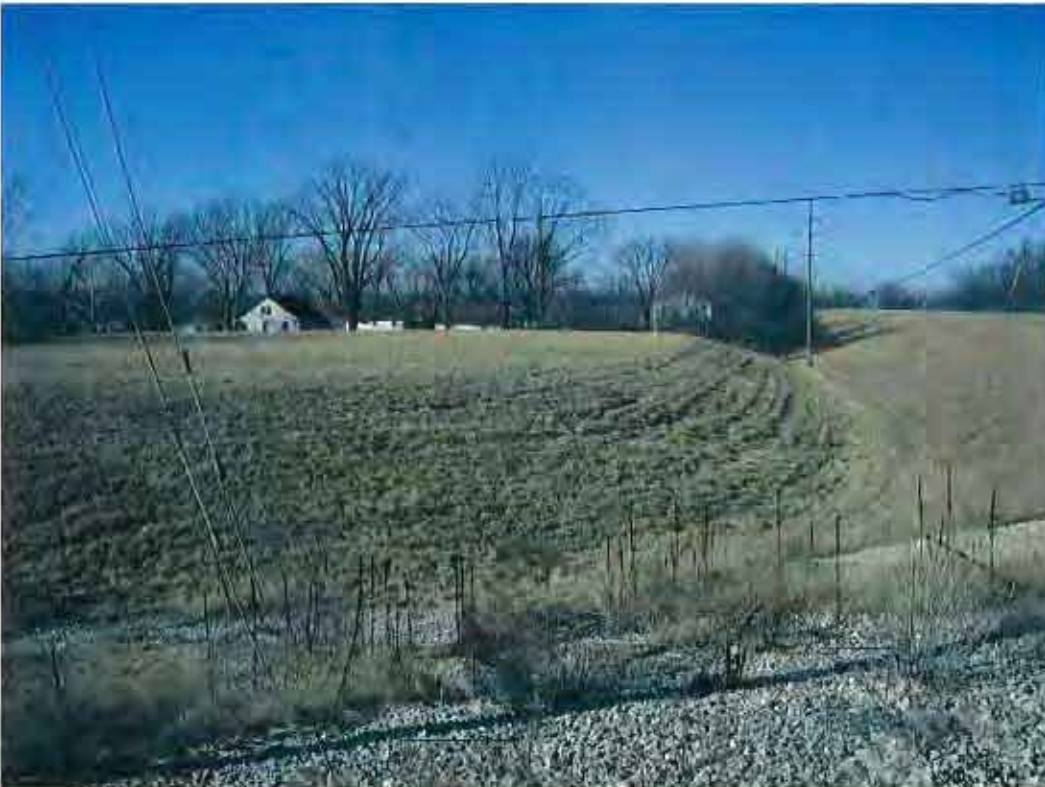
Date: January 15, 2008
Time: 10:23 AM
Direction: W
Photo by: Eisenbrandt
Exposure #: 014
Comments: North east side of Site No. 2.

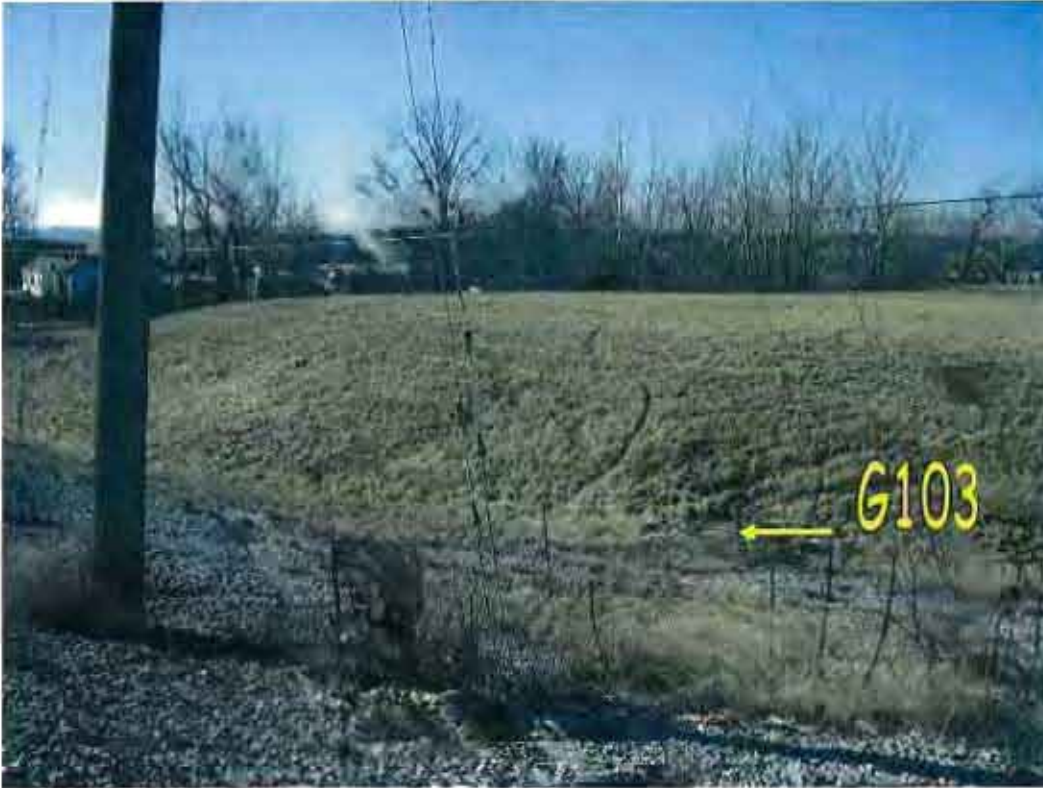
Photographs 015 and 016 show the east side and southeast side of Site no. 2., respectively. No debris was observed. Groundwater monitoring well G103 and its protective casing are visible in Photograph 015. The gate seen to the left in Photograph 016 was closed.

Date: January 15, 2008
Time: 10:24 AM
Direction: SW
Photo by: Eisenbrandt
Exposure #: 015
Comments: East side of Site No. 2. Groundwater monitoring well G103 and its protective casing visible in foreground. Text in photograph imported.

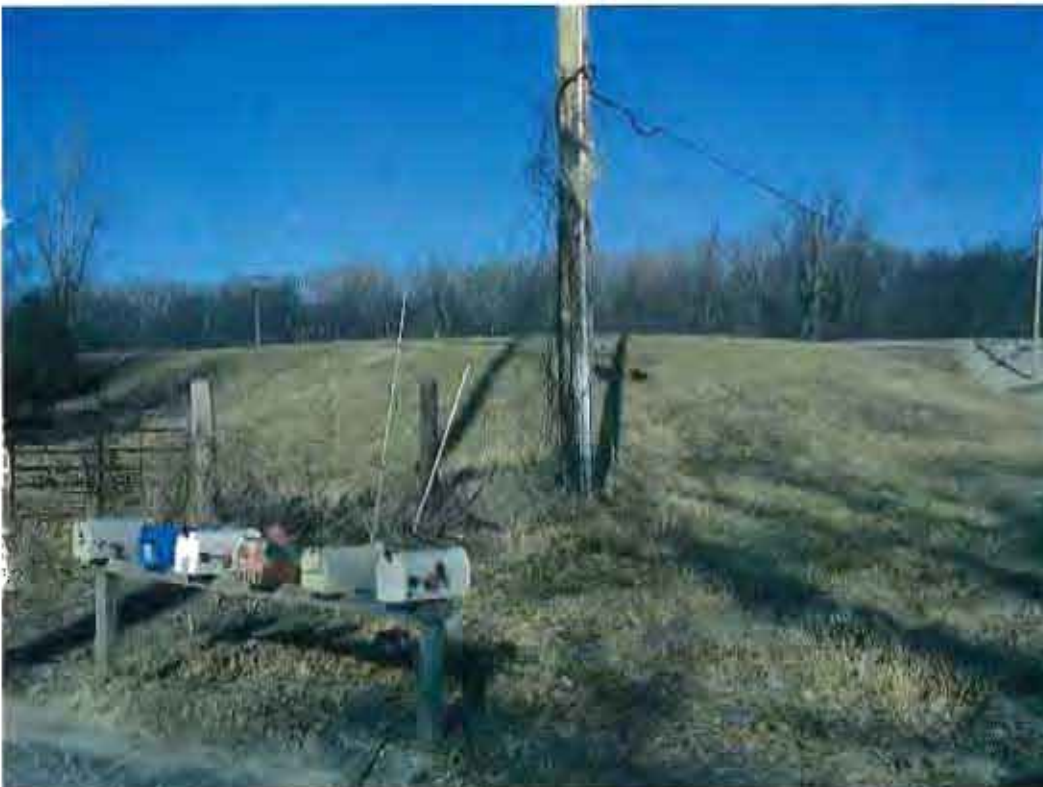
Date: January 15, 2008
Time: 10:25 AM
Direction: NW
Photo by: Eisenbrandt
Exposure #: 016
Comments: South east corner of Site No. 2. The gate was observed closed.

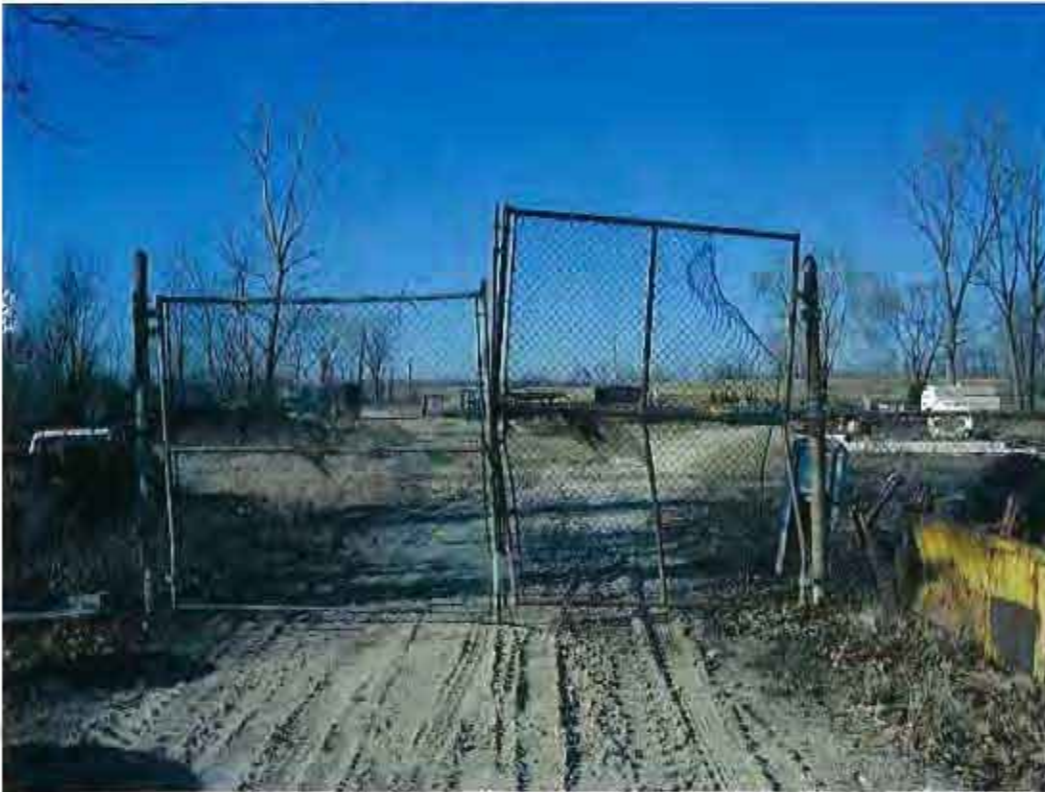
Date: January 15, 2008
Time: 10:46 AM
Direction: W
Photo by: Eisenbrandt
Exposure #: 017
Comments: Access to Site No. 1 and the Construction Fill Area is restricted with this secondary gate. The primary gate is adjacent to Blick's Construction Office.

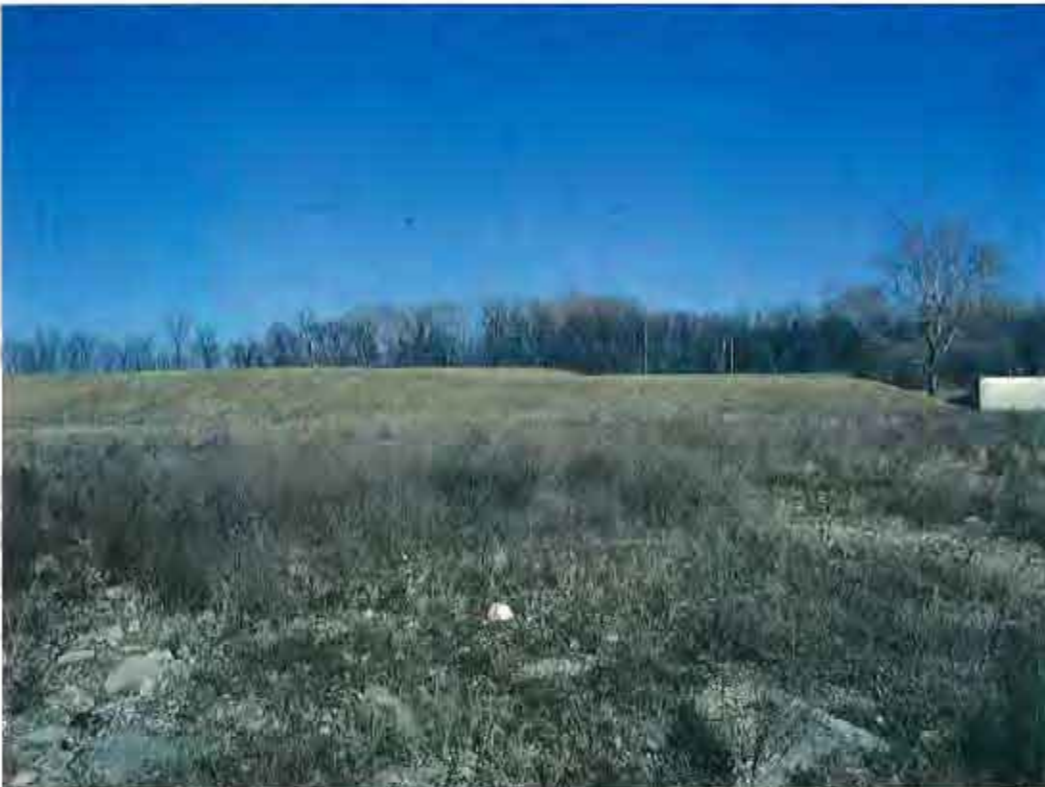
Photographs 018 and 019 show the Construction Fill Area in the foreground of the photographs. The south side of Site No. 1 can be seen in the background of the photographs. No debris was observed on the south side of the Site No.1.

Date: January 15, 2008
Time: 10:53 AM
Direction: N
Photo by: Eisenbrandt
Exposure #: 018
Comments: Construction Fill Area in foreground of photograph. South side of Site No. 1 seen in background of photograph.

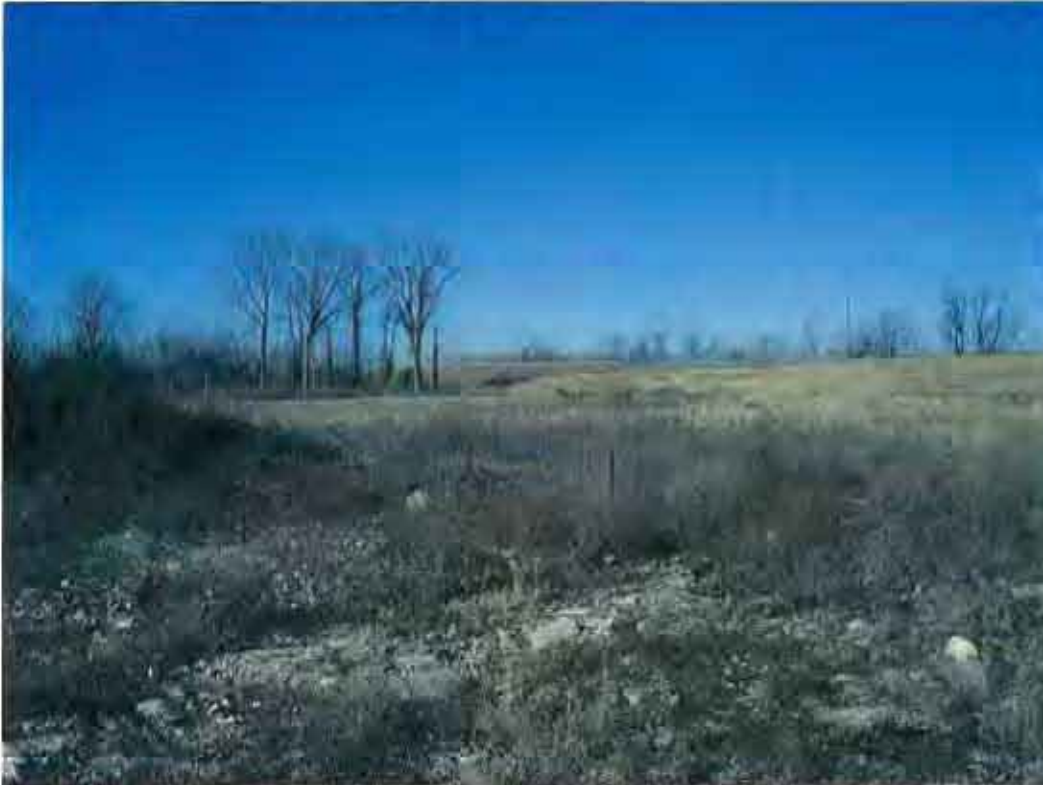
Date: January 15, 2008
Time: 10:53 AM
Direction: NW
Photo by: Eisenbrandt
Exposure #: 019
Comments:
Construction Fill Area in foreground of photograph. South side of Site No. 1 seen in background of photograph.

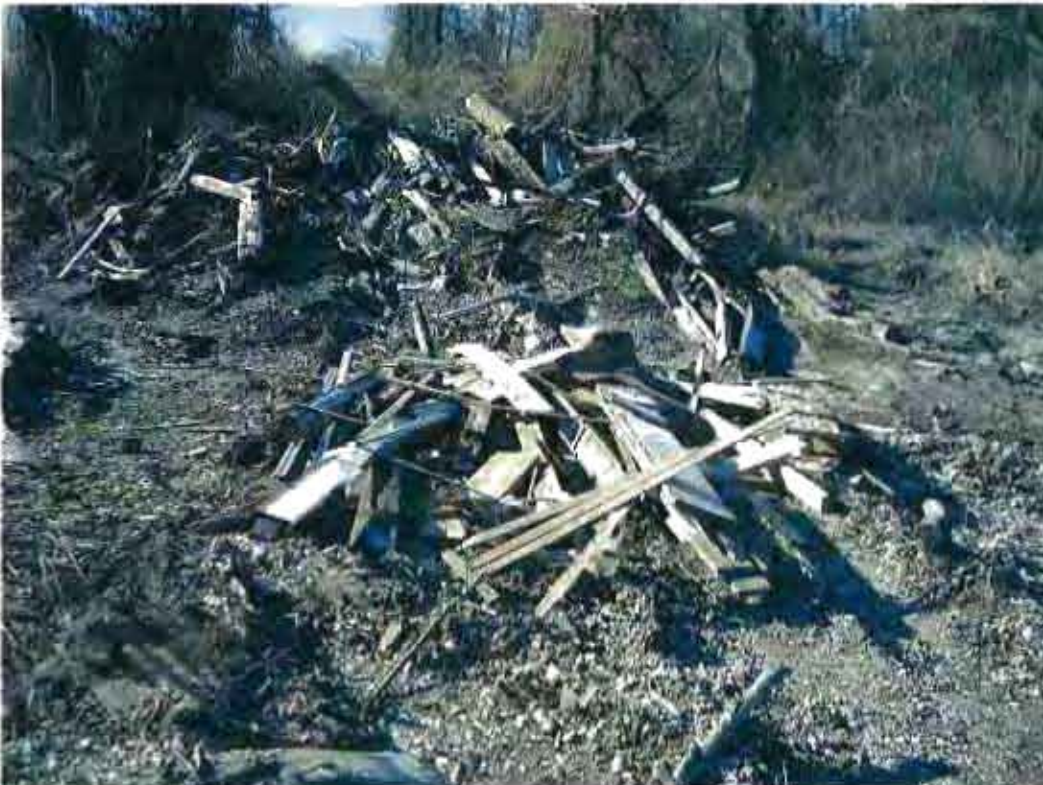
Date: January 15, 2008
Time: 10:56 AM
Direction: SW
Photo by: Eisenbrandt
Exposure #: 020
Comments: Two debris piles located in the south west corner of the Construction Fill Area were observed. Demolition debris is seen in the foreground and landscape waste is seen in the background of the photograph.

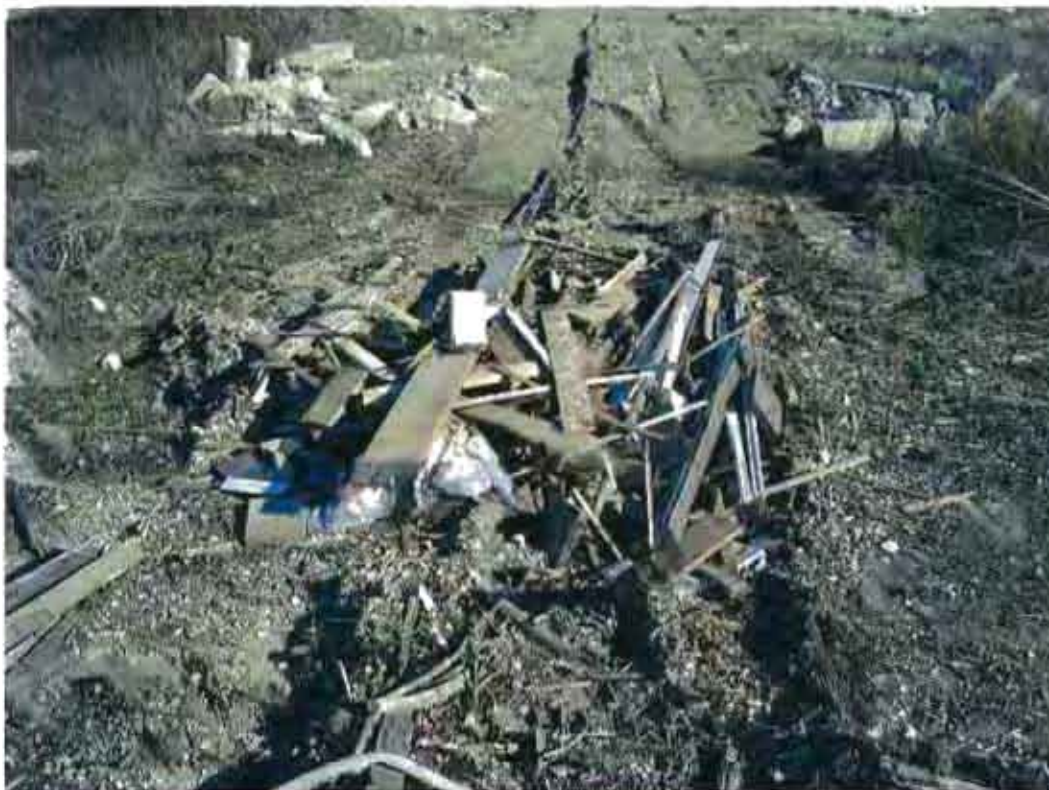
Date: January 15, 2008
Time: 10:59 AM
Direction: NE
Photo by: Eisenbrandt
Exposure #: 021
Comments: Alternate view of the open dumped demolition debris.

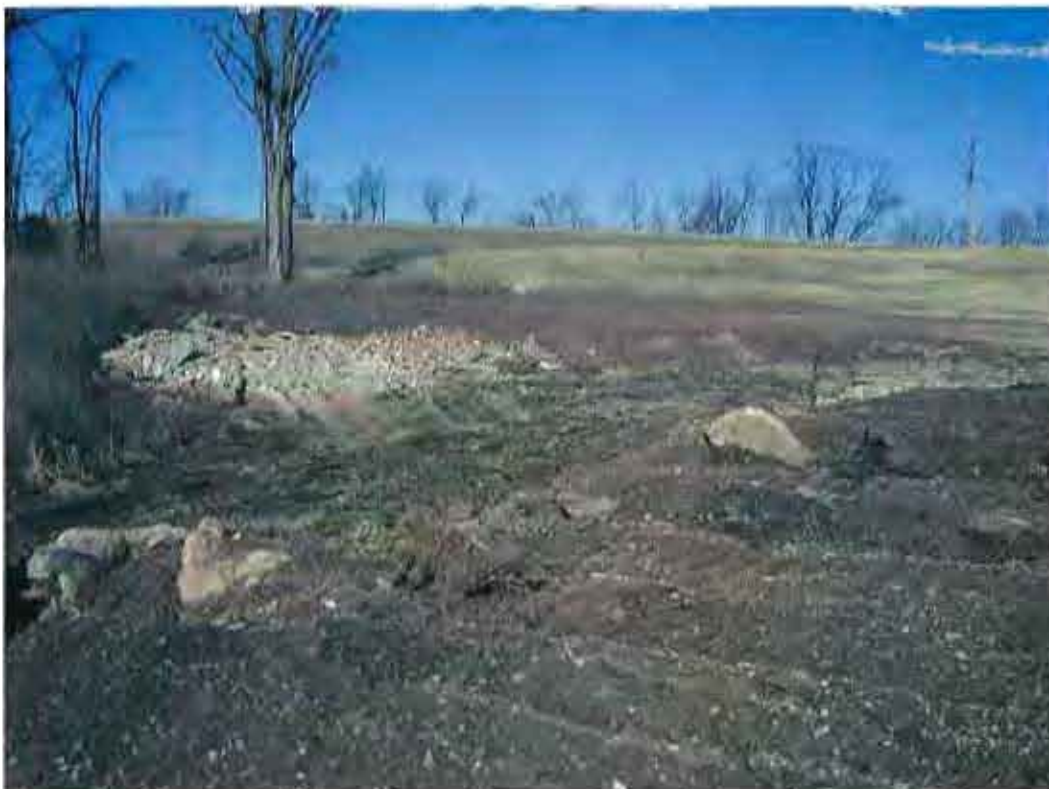
Date: January 15, 2008
Time: 11:01 AM
Direction: NW
Photo by: Eisenbrandt
Exposure #: 022
Comments: More fill has been added to the Construction Fill Area since the last inspection.

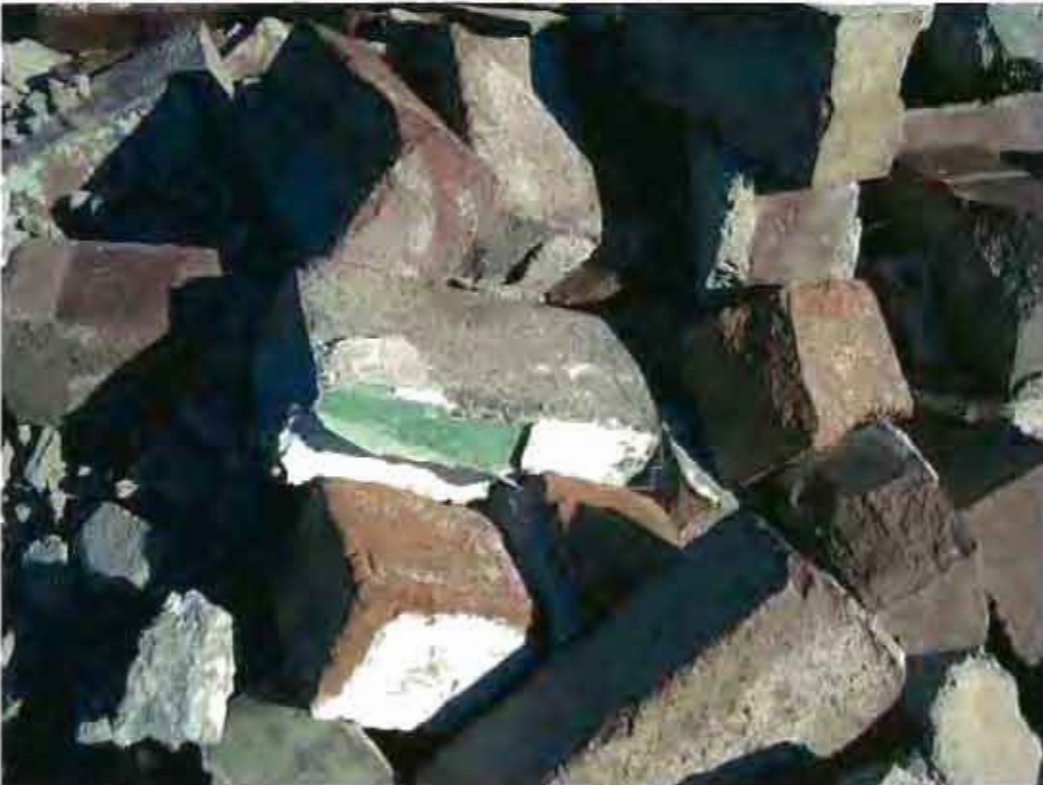
Date: January 15, 2008
Time: 11:03 AM
Direction: NE
Photo by: Eisenbrandt
Exposure #: 024
Comments: White and green paint was observed on brick.

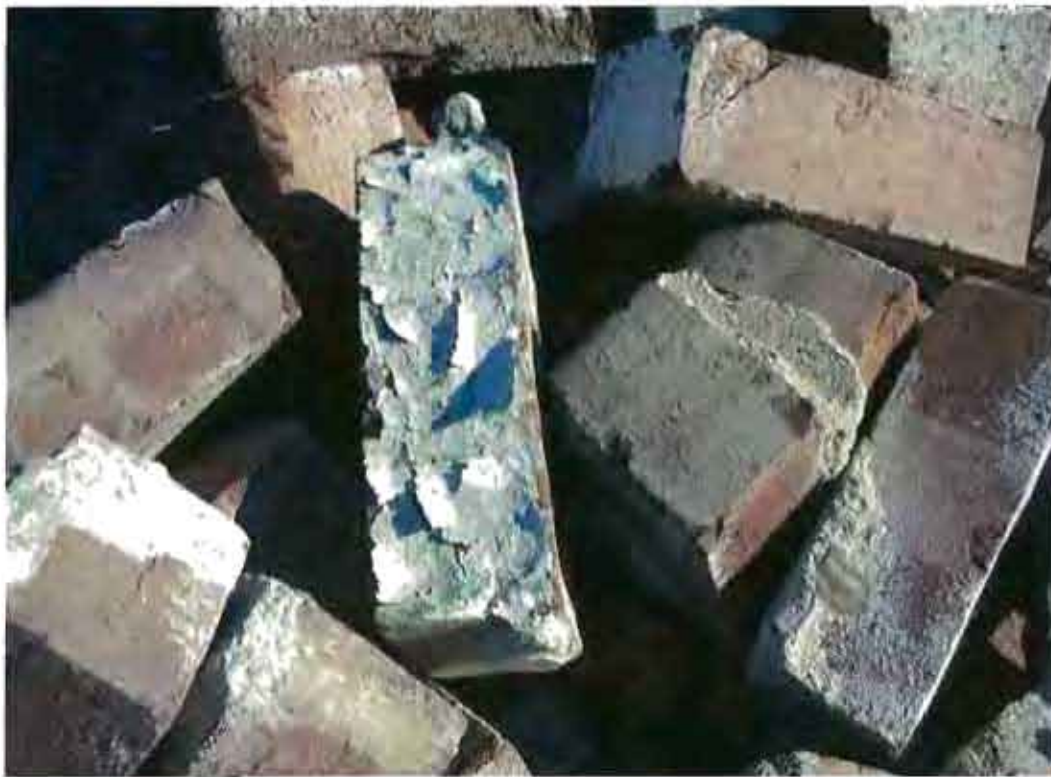
Date: January 15, 2008
Time: 11:03 AM
Direction: N
Photo by: Eisenbrandt
Exposure #: 025
Comments: Peeling white and green paint was observed on brick.

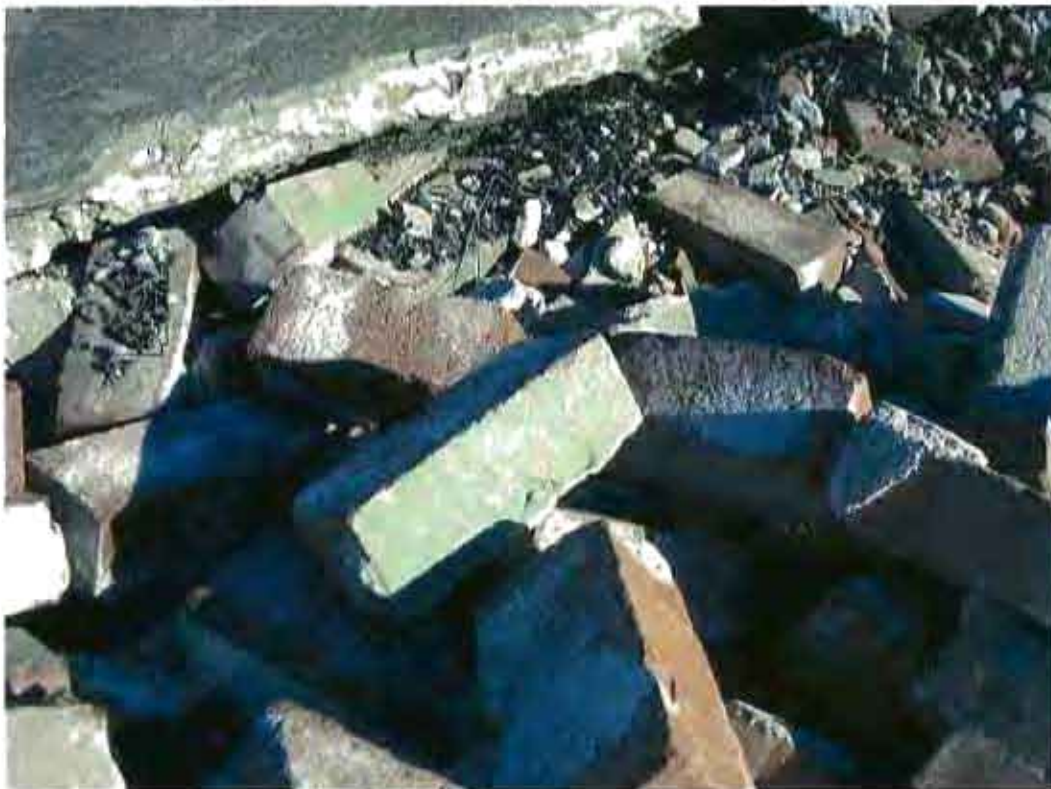
Date: January 15, 2008
Time: 11:03 AM
Direction: N
Photo by: Eisenbrandt
Exposure #: 026
Comments: Green painted surface on brick.

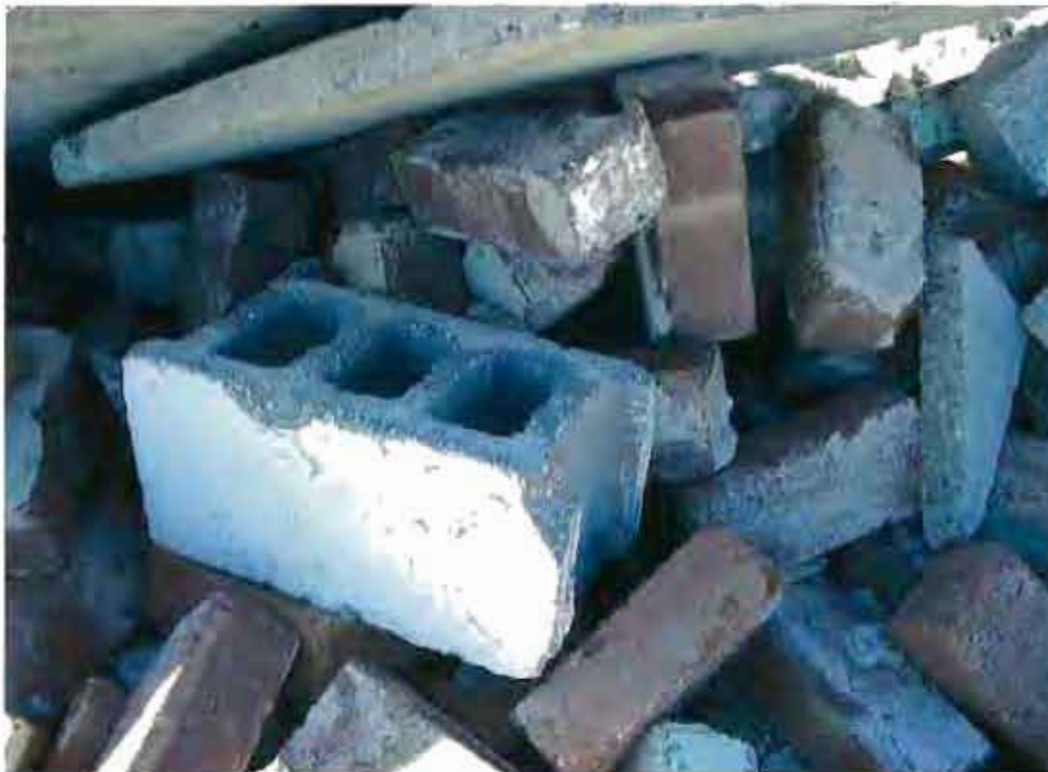
Date: January 15, 2008
Time: 11:03 AM
Direction: SW
Photo by: Eisenbrandt
Exposure #: 027
Comments: White painted surface on cinder block.
