ILLINOIS ENVIRONMENTAL PROTECTION AGENCY

Re: Illinois Environmental Protection Agency v. C. John Blickhan
IEPA File No.23-08-AC; 0010650002—Adams County

BEFORE THE ILLINOIS POLLUTION CONTROL BOARD
ADMINISTRATIVE CITATION

C. JOHN BLICKHAN,

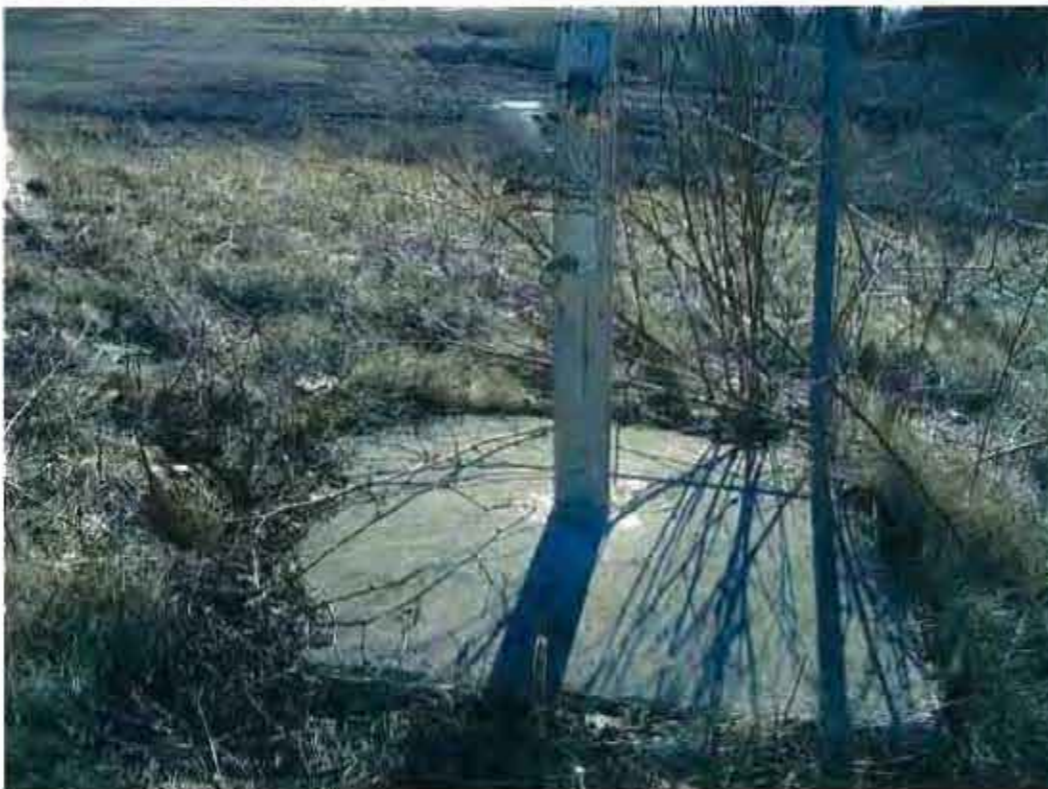
Date: January 15, 2008
Time: 11:07 AM
Direction: SE
Photo by: Eisenbrandt
Exposure #: 028
Comments: Groundwater monitoring Well G104.

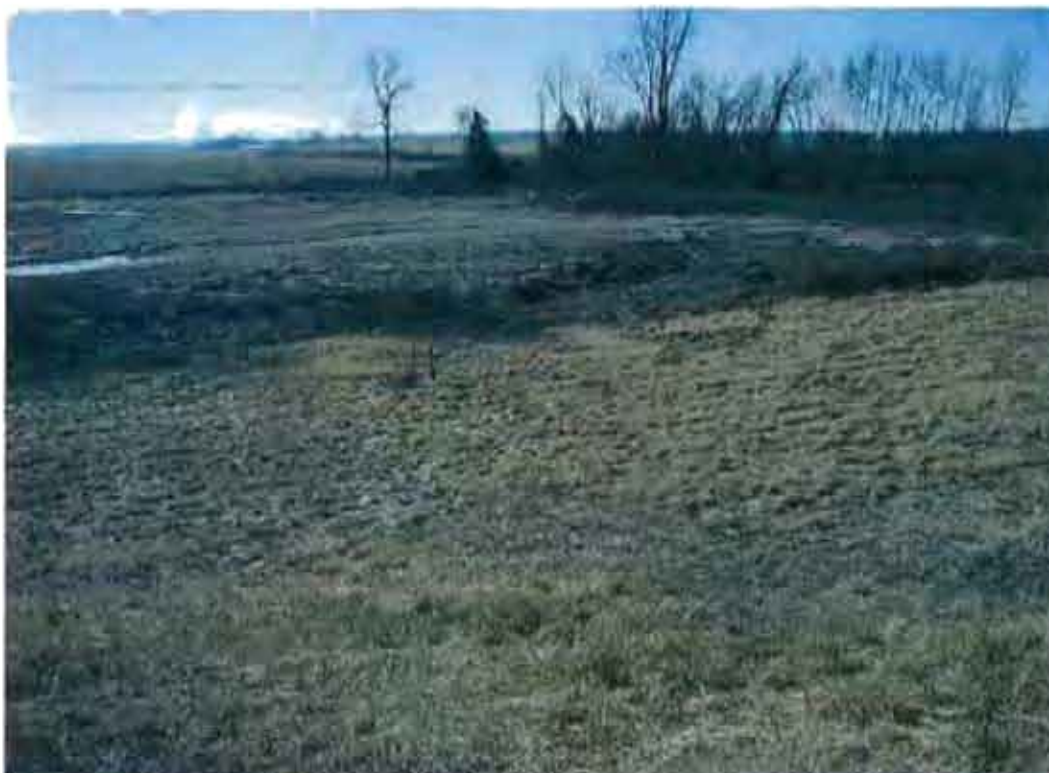
Date: January 15, 2008
Time: 11:09 AM
Direction: S
Photo by: Eisenbrandt
Exposure #: 029
Comments: South slope
of Site No. 1 and the
Construction Fill Area.

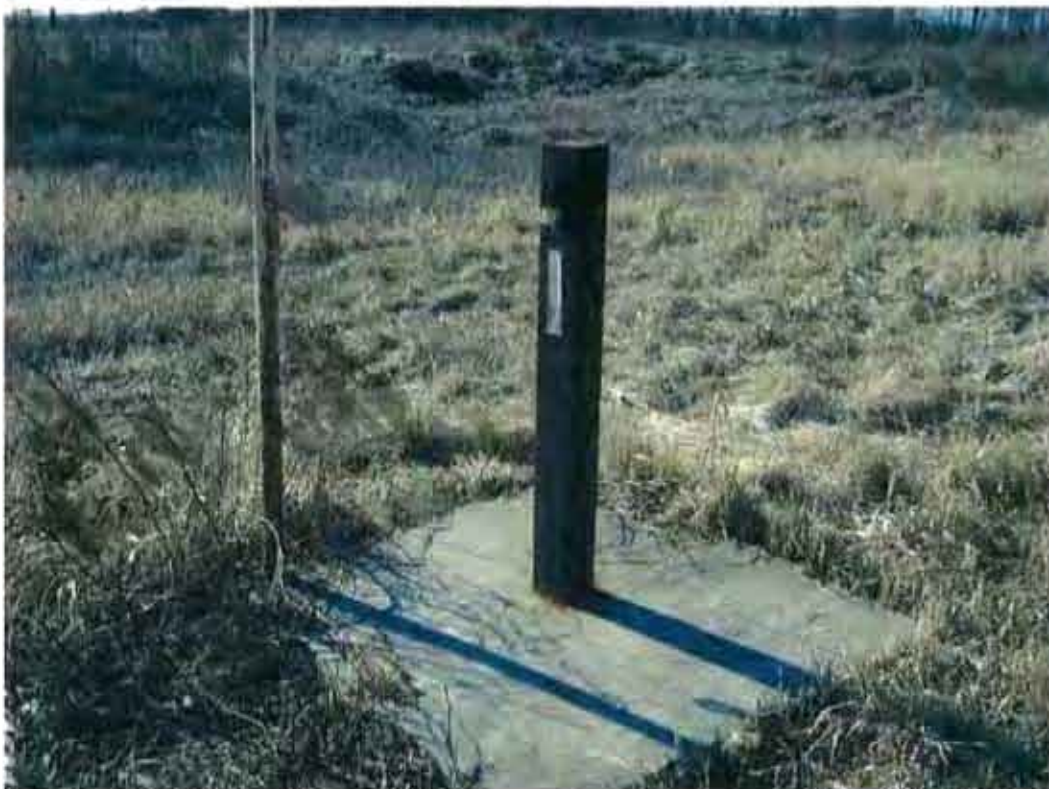
Date: January 15, 2008
Time: 11:11 AM
Direction: SW
Photo by: Eisenbrandt
Exposure #: 030
Comments:
Groundwater monitoring
Well G105.

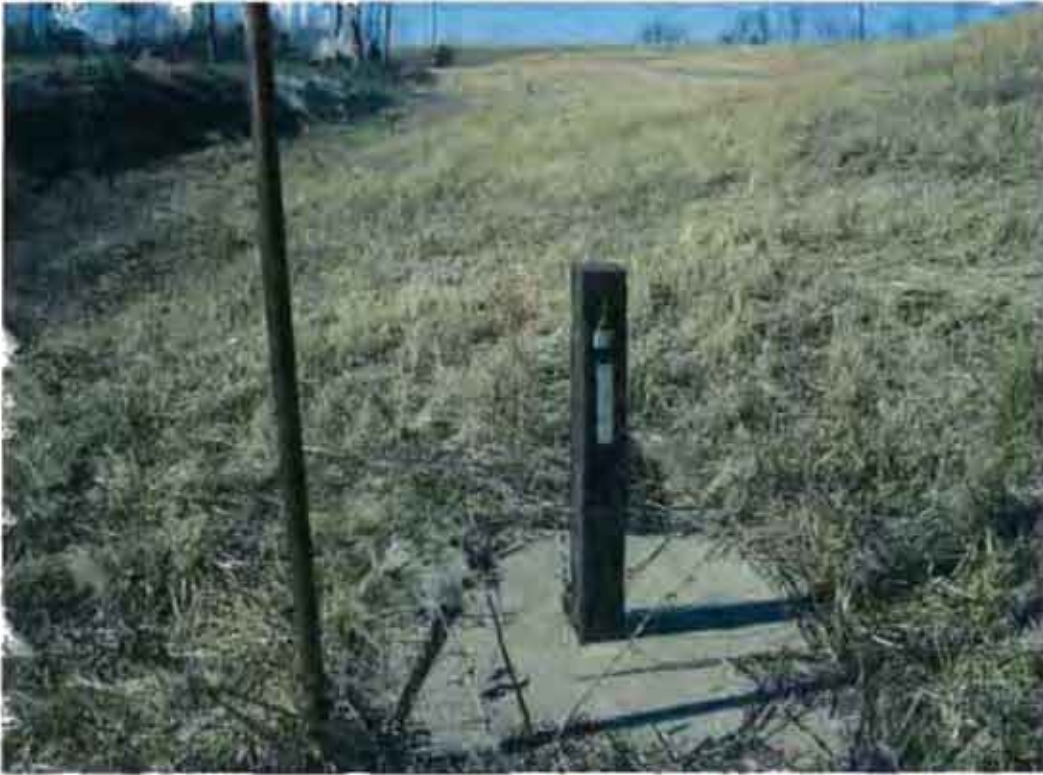
Date: January 15, 2008
Time: 11:13 AM
Direction: W
Photo by: Eisenbrandt
Exposure #: 031
Comments:
Groundwater monitoring
Well G107.

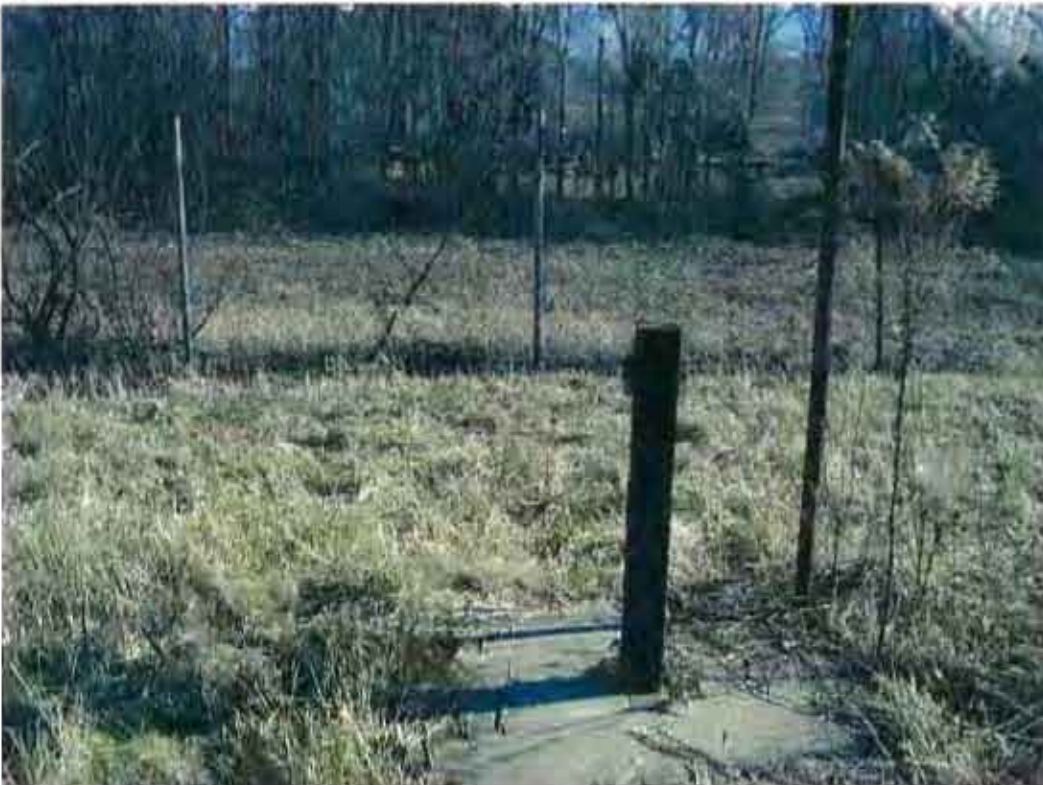
Date: January 15, 2008
Time: 11:16 AM
Direction: E
Photo by: Eisenbrandt
Exposure #: 032
Comments:
Groundwater monitoring
Well G101

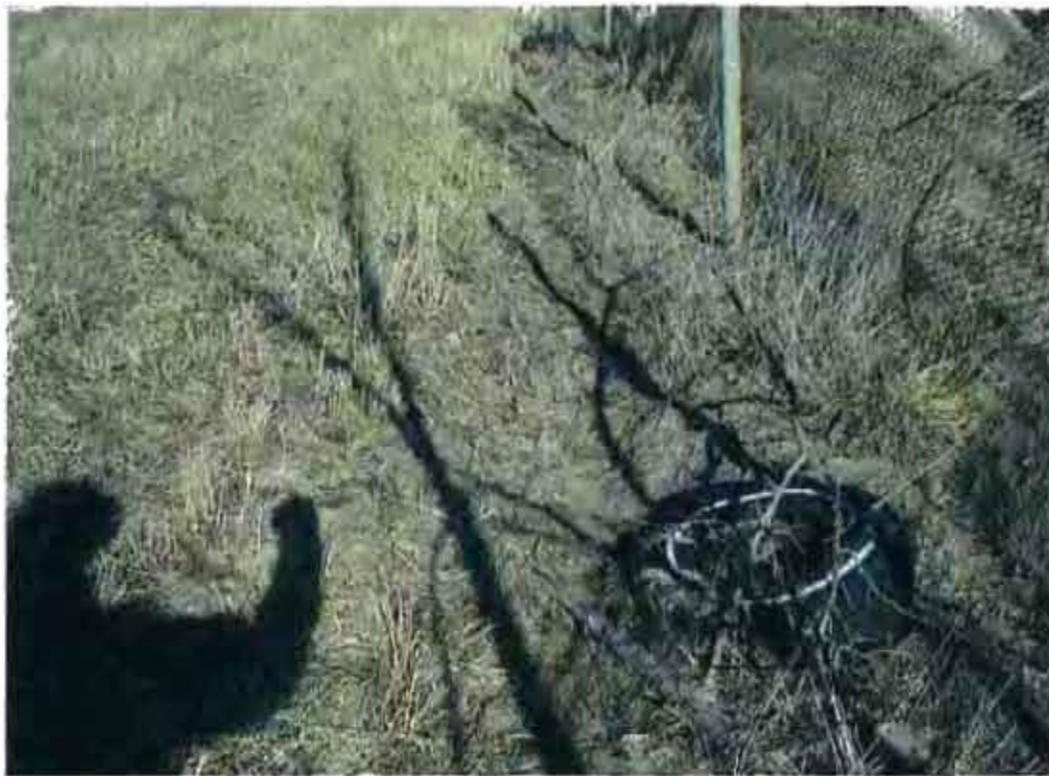
Photograph 033 shows two open dumped off-rim used tires and carpet scrap observed along the fence line east of Site No. 1.

Date: January 15, 2008
Time: 11:17 AM
Direction: N
Photo by: Eisenbrandt
Exposure #: 033
Comments: Two used tires and carpet scrap observed along fence line east of Site No. 1.

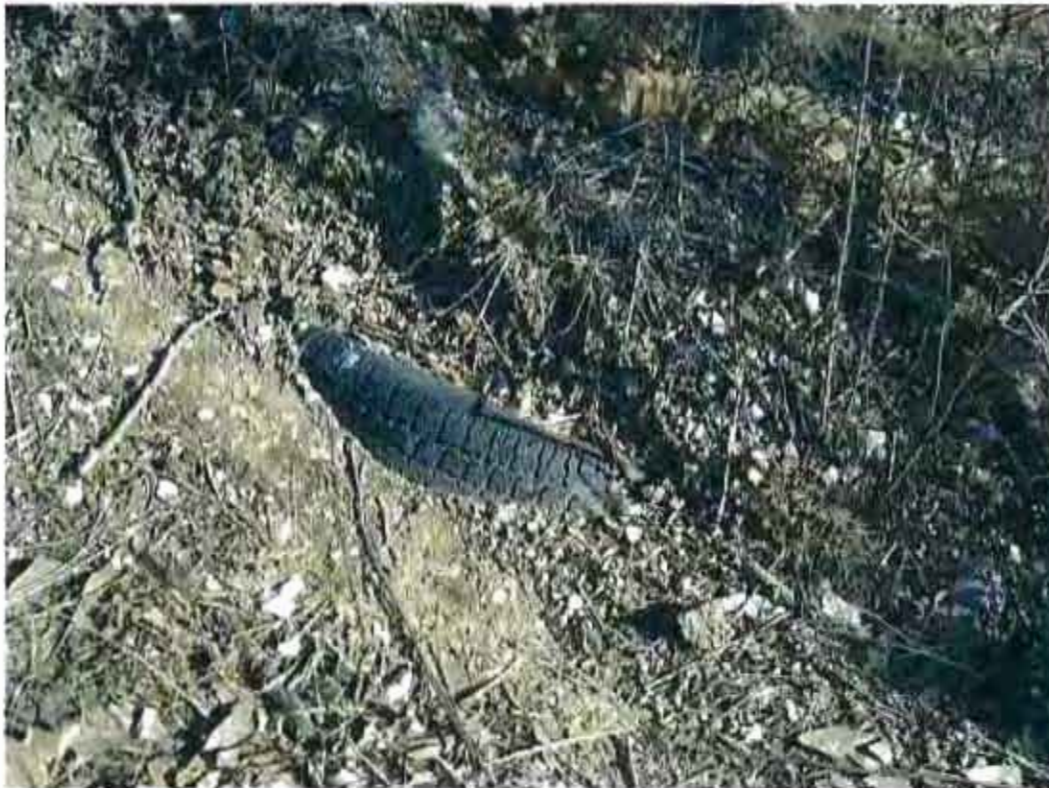
Date: January 15, 2008
Time: 11:19 AM
Direction: NE
Photo by: Eisenbrandt
Exposure #: 034
Comments: Used tire partially buried along fence line east of Site No. 1.

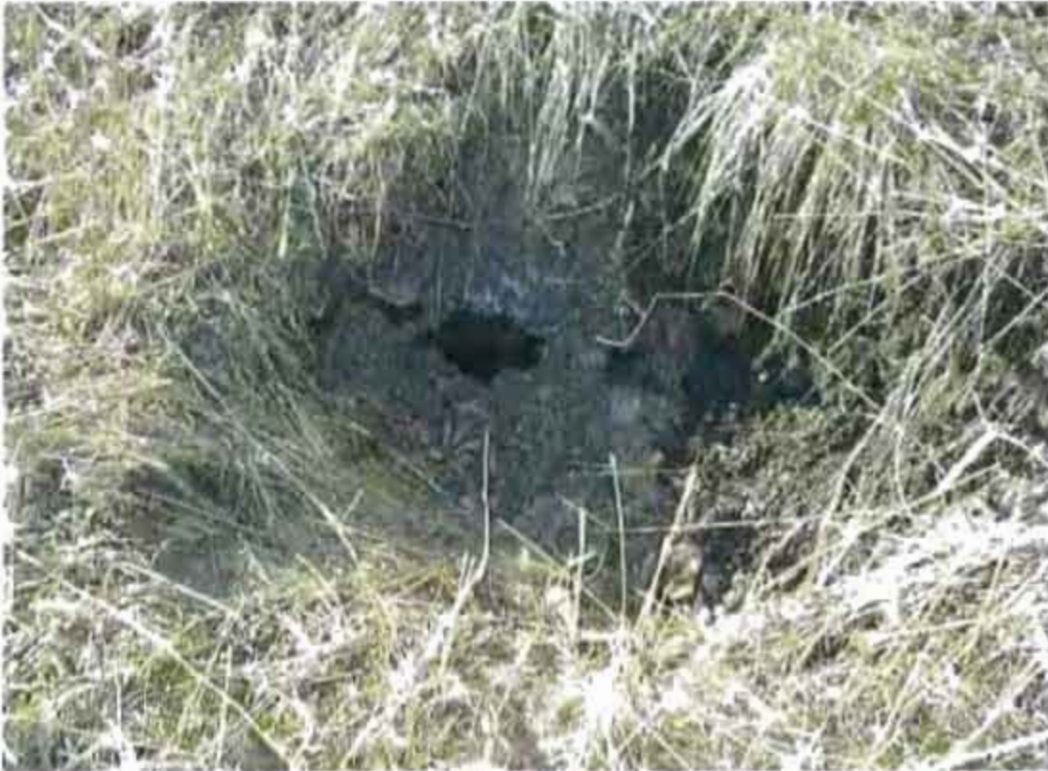
Date: January 15, 2008
Time: 11:32 AM
Direction: W
Photo by: Eisenbrandt
Exposure #: 035
Comments: Hole observed in the side of the landfill cap.

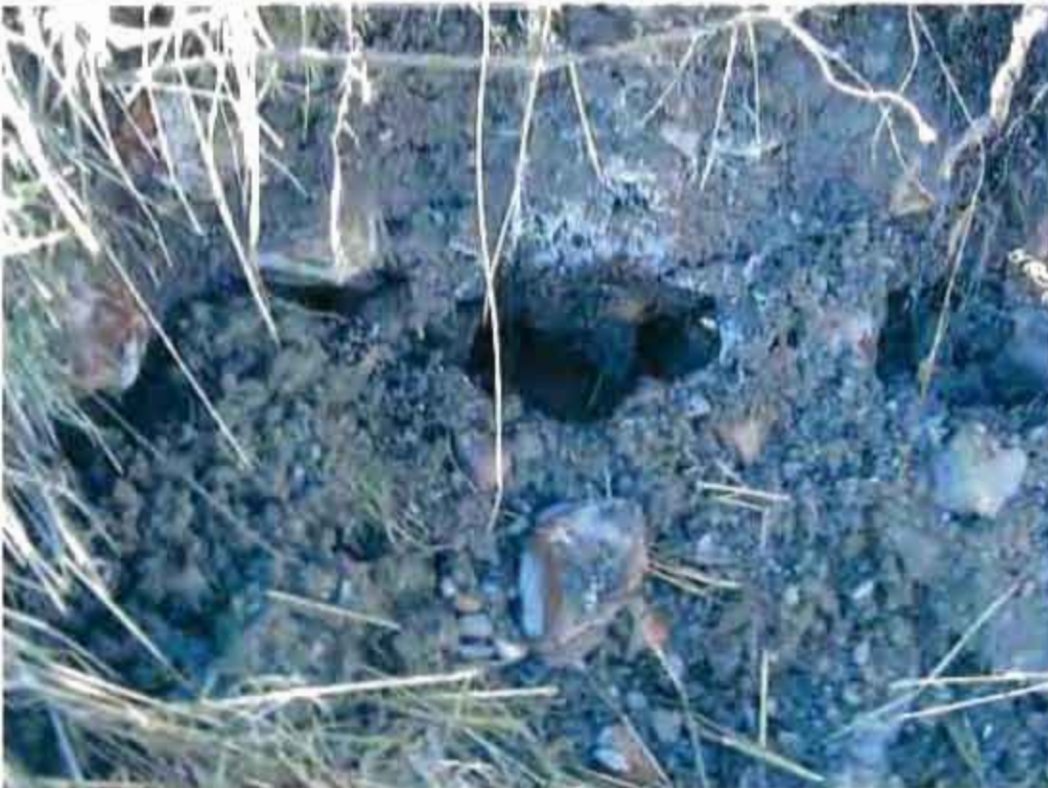
Date: January 15, 2008
Time: 11:32 AM
Direction: W
Photo by: Eisenbrandt
Exposure #: 036
Comments: Brick and dirty gravel observed within the approximate 3.0 ft diameter by 2.0 ft deep hole.

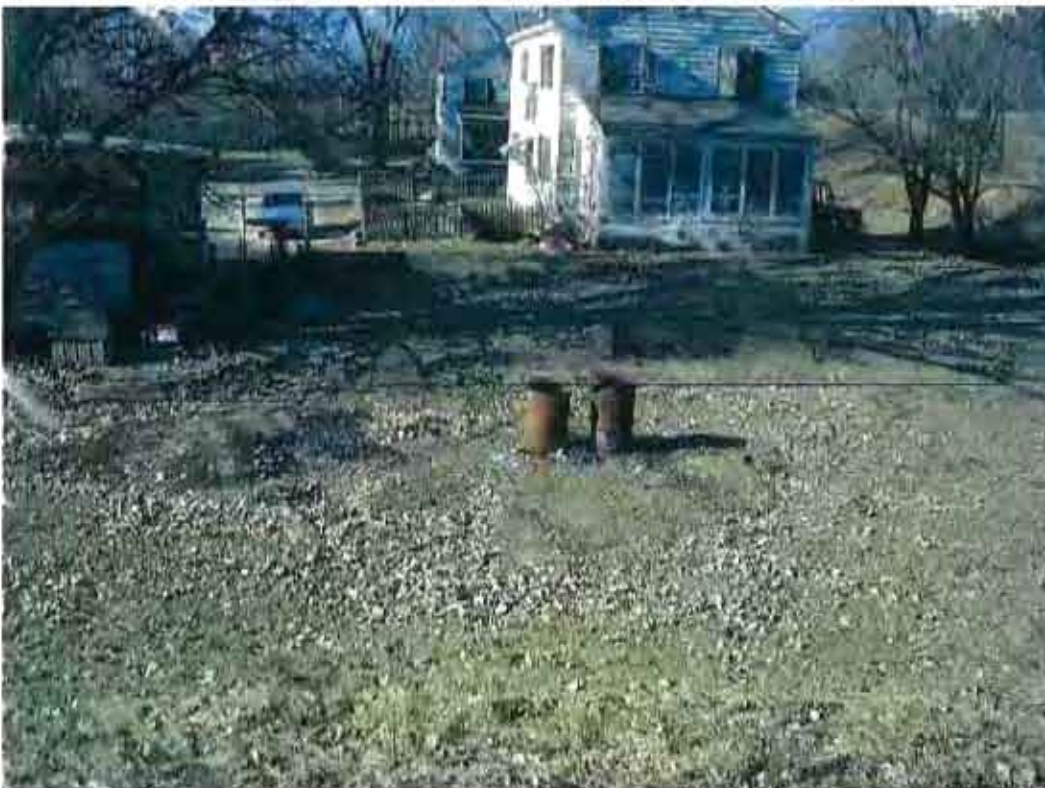
Date: January 15, 2008
Time: 11:37 AM
Direction: W
Photo by: Eisenbrandt
Exposure #: 038
Comments: Two burn
barrels observed west of
Site No. 2, behind House
No. 3 in the northeast
corner of Blick's Village
Court.

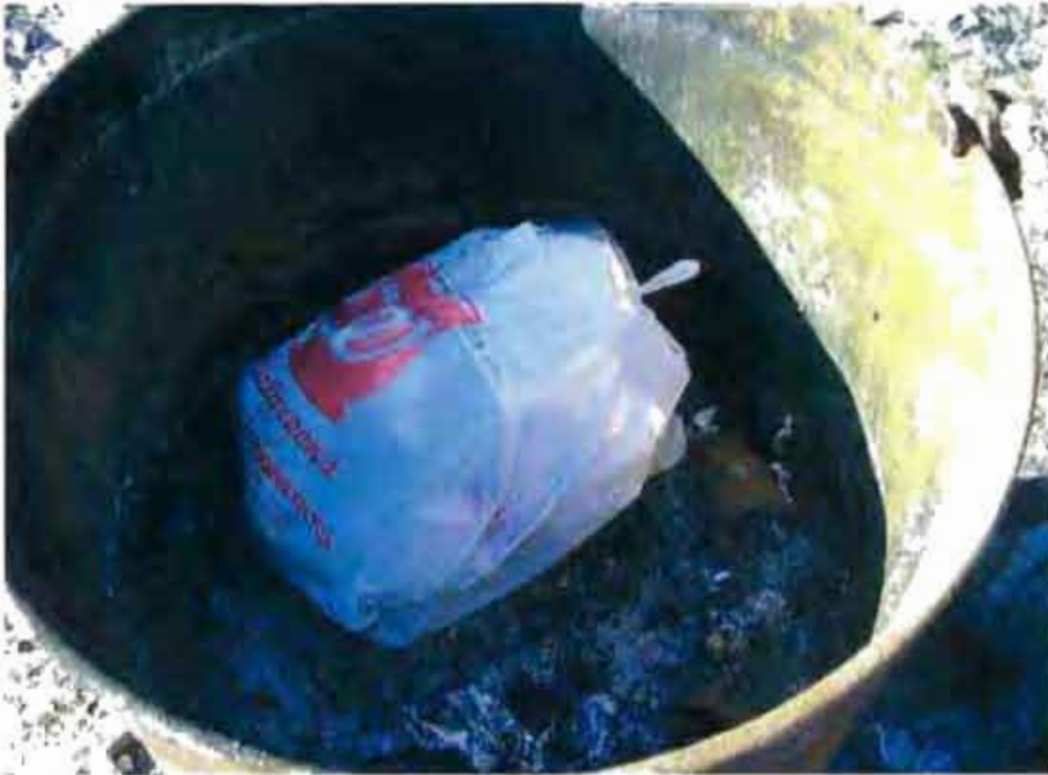
Date: January 15, 2008
Time: 11:37 AM
Direction: S
Photo by: Eisenbrandt
Exposure #: 039
Comments: Household waste and charred debris in burn barrel behind House No.3.

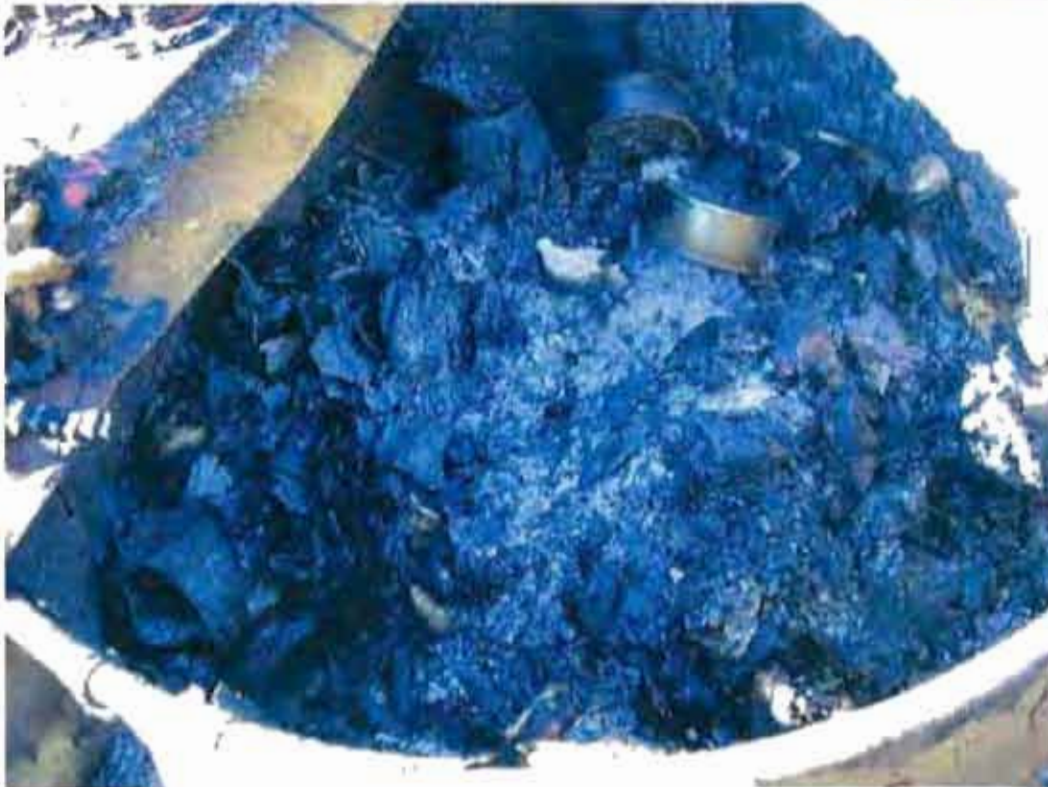
Date: January 15, 2008
Time: 11:37 AM
Direction: SW
Photo by: Eisenbrandt
Exposure #: 040
Comments: Tin cans and plastic were observed among the burnt garbage, charred waste, and ashes in the burn barrels behind House No. 3.

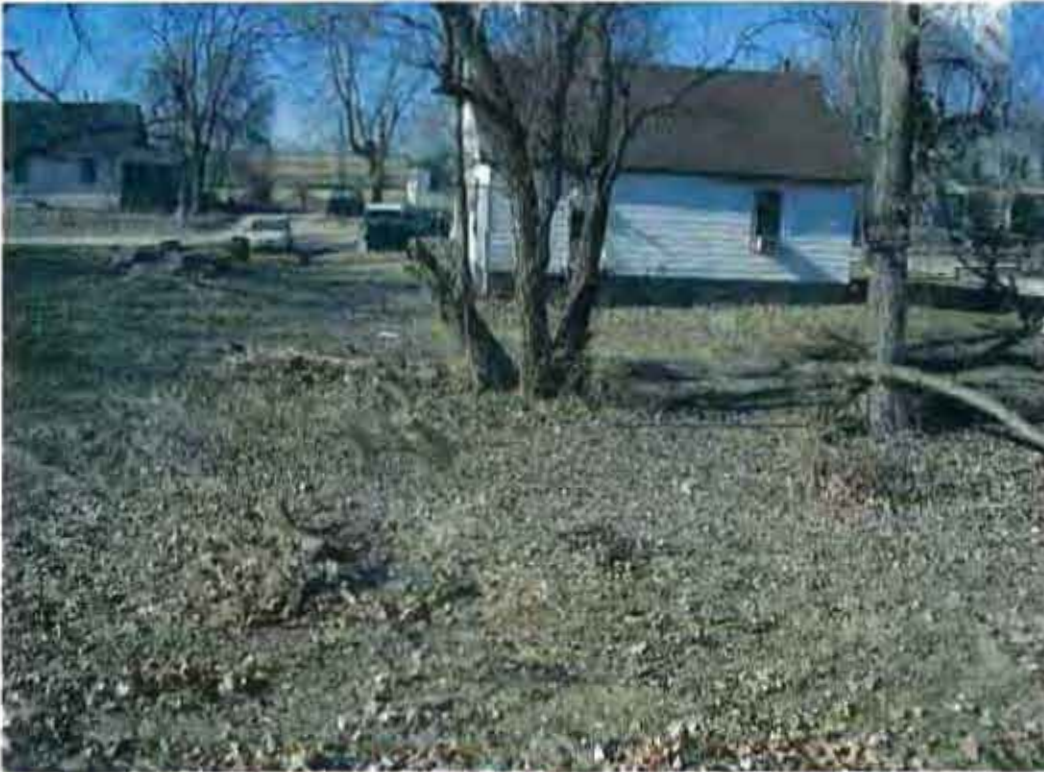
Date: January 15, 2008
Time: 11:39 AM
Direction: W
Photo by: Eisenbrandt
Exposure #: 041
Comments: Landscape waste pile covered with leaves in foreground of picture observed behind House No 2.

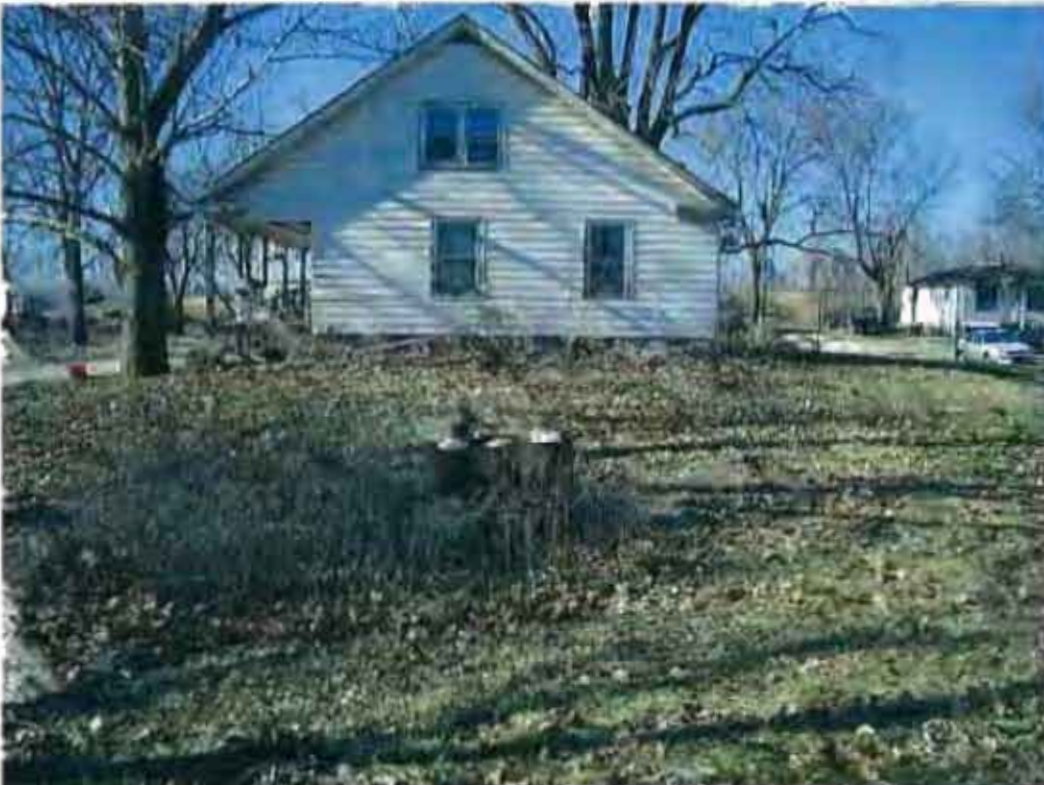
Date: January 15, 2008
Time: 11:39 AM
Direction: W
Photo by: Eisenbrandt
Exposure #: 042
Comments: Three burn barrels observed east of House No 1.

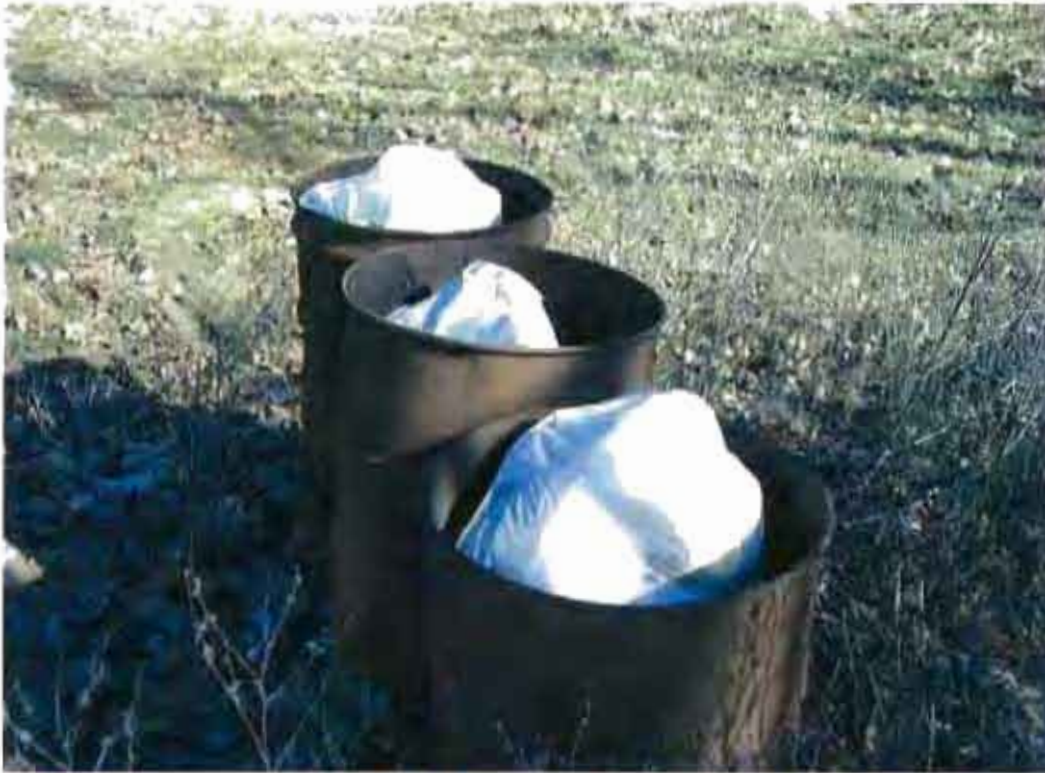
Date: January 15, 2008
Time: 11:40 AM
Direction: NE
Photo by: Eisenbrandt
Exposure #: 043
Comments: Household waste observed on top of charred debris in the burn barrels at House No. 1.

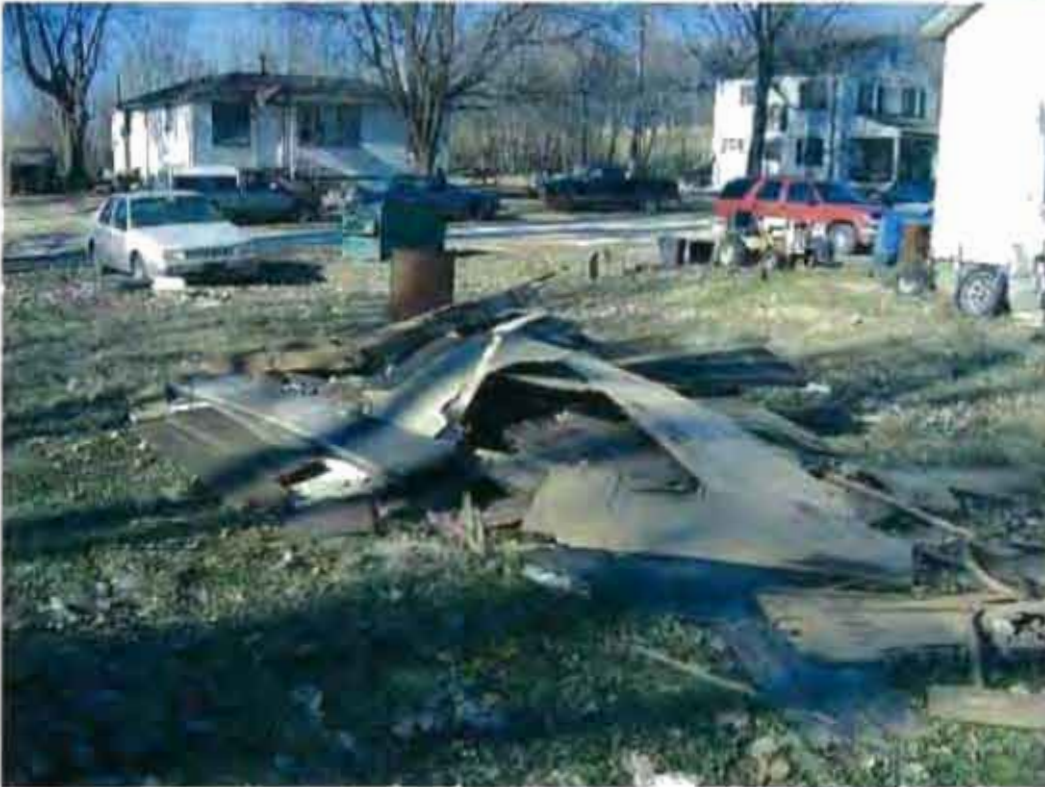
Date: January 15, 2008
Time: 11:40 AM
Direction: NW
Photo by: Eisenbrandt
Exposure #: 044
Comments: Demolition debris located south of House No. 2.

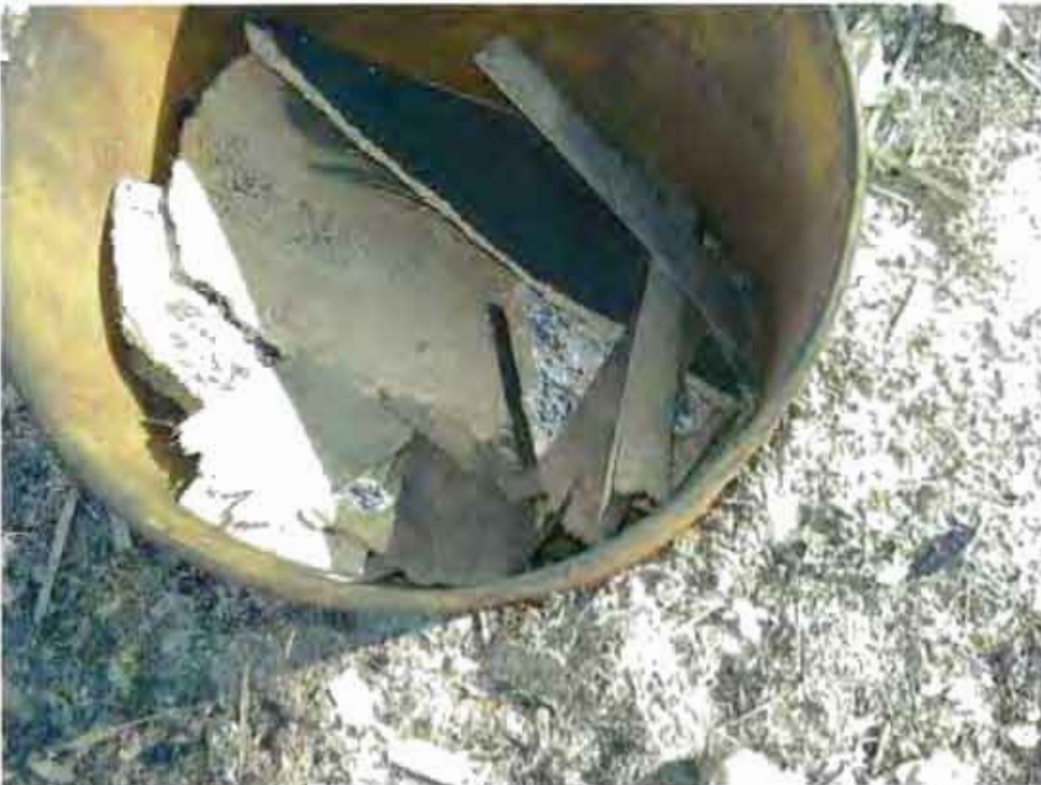
Date: January 15, 2008
Time: 11:41 AM
Direction: E
Photo by: Eisenbrandt
Exposure #: 046
Comments: Demolition debris in burn barrel at House No. 2.

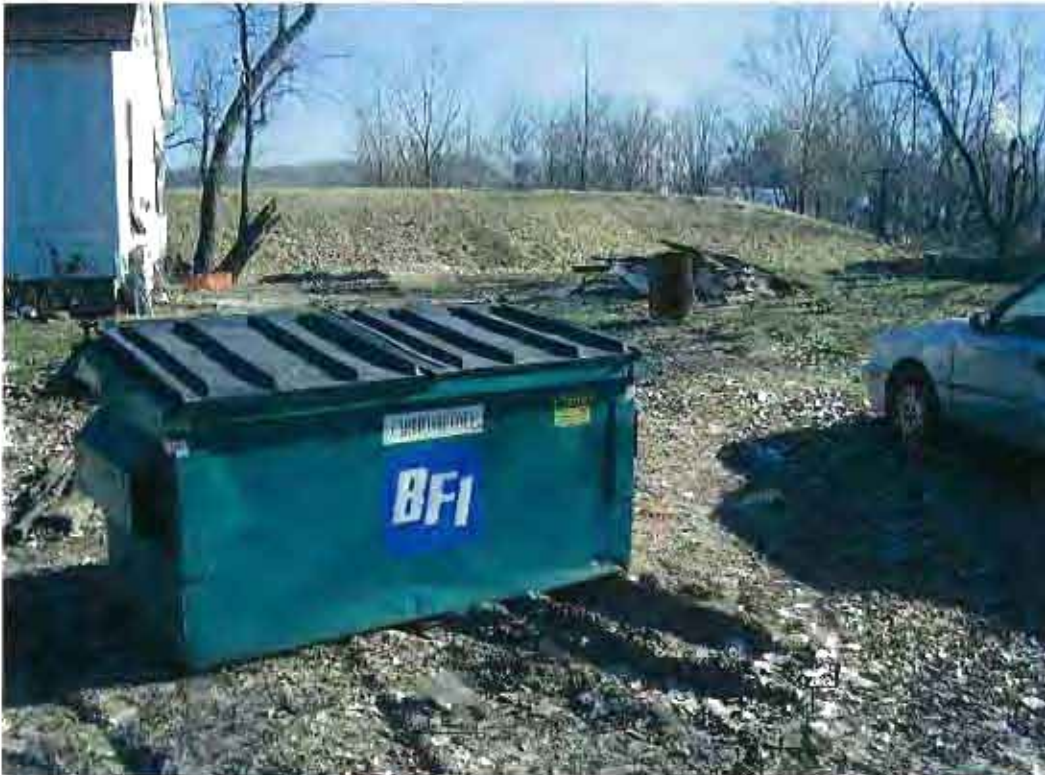
Date: January 15, 2008
Time: 11:42 AM
Direction: E
Photo by: Eisenbrandt
Exposure #: 047
Comments: Dumpster in front of House No. 2.

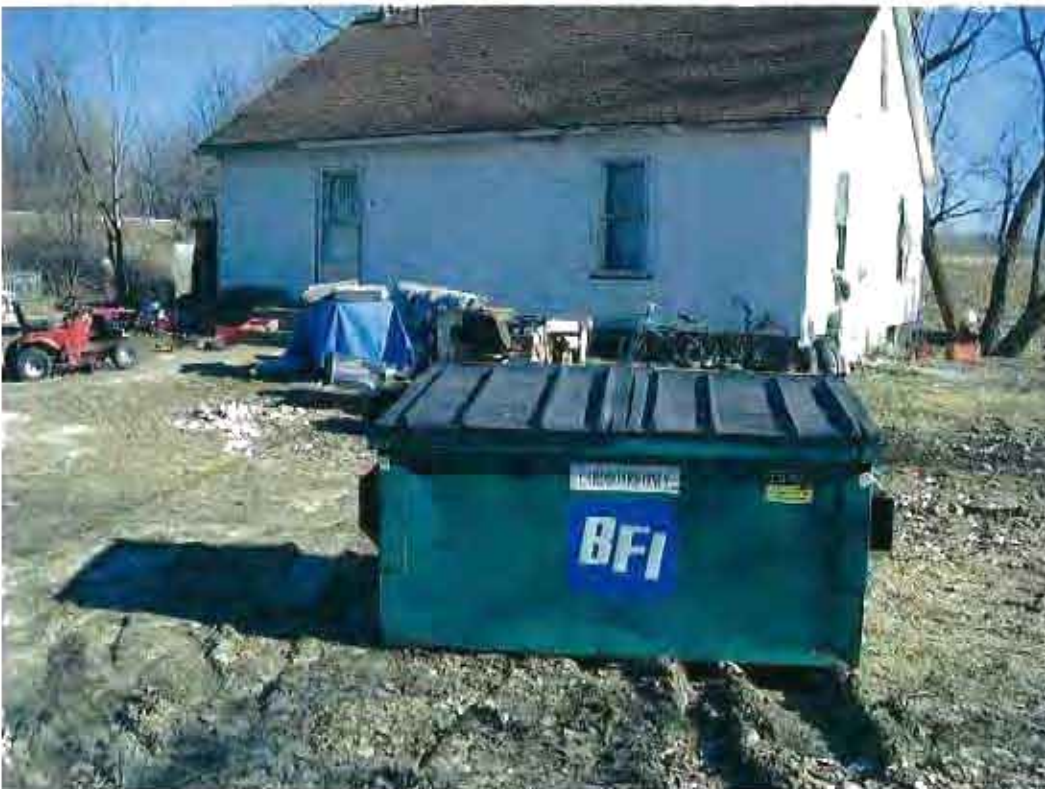
Date: January 15, 2008
Time: 11:42 AM
Direction: NE
Photo by: Eisenbrandt
Exposure #: 048
Comments: Dumpster in front of House No. 2. Household furniture exposed to the weather outside of front door.

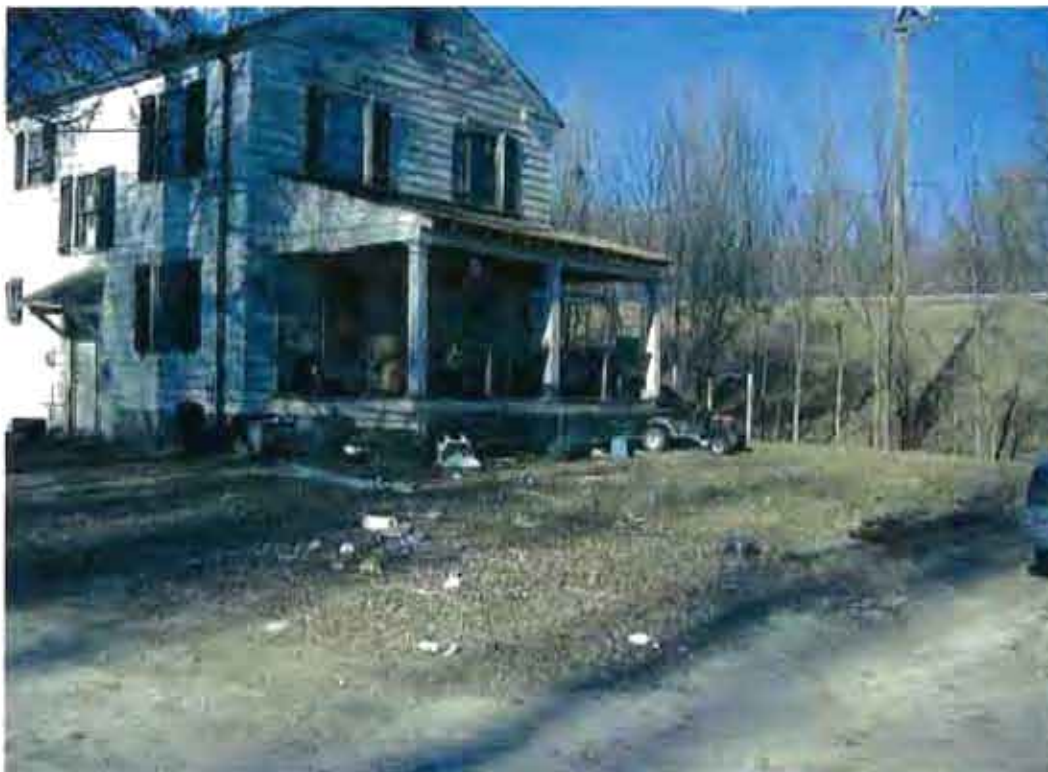
Date: January 15, 2008
Time: 11:42 AM
Direction: NW
Photo by: Eisenbrandt
Exposure #: 049
Comments: Trash and garbage strewn across the front yard of House No. 6.

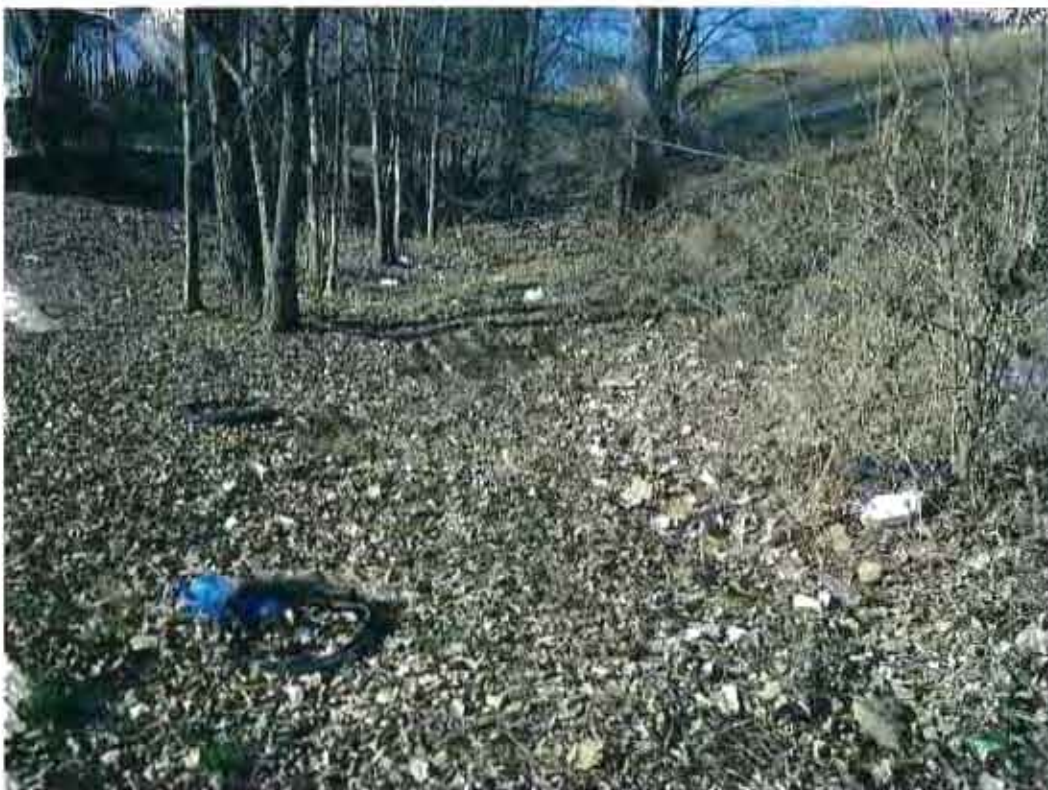
Date: January 15, 2008
Time: 11:42 AM
Direction: W
Photo by: Eisenbrandt
Exposure #: 050
Comments: Trash and garbage observed North of House No. 6.

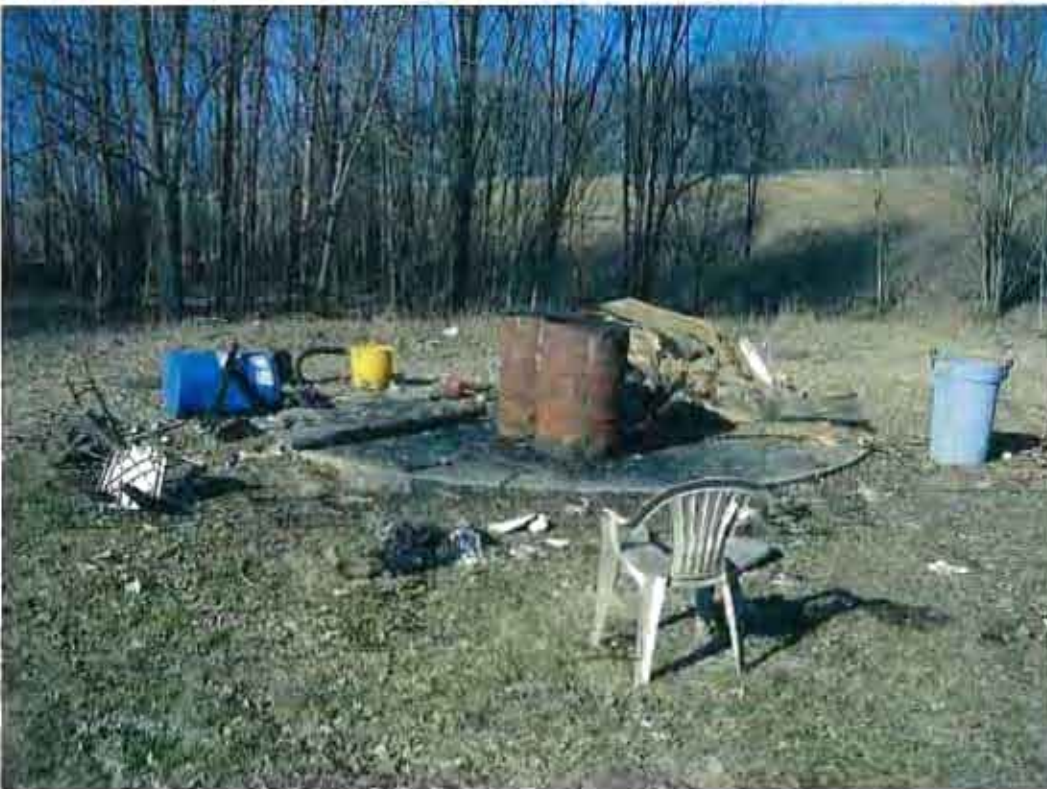
Date: January 15, 2008
Time: 11:43 AM
Direction: NW
Photo by: Eisenbrandt
Exposure #: 052
Comments: Open dumped demolition debris, garbage and two burn barrels located behind House No. 6.

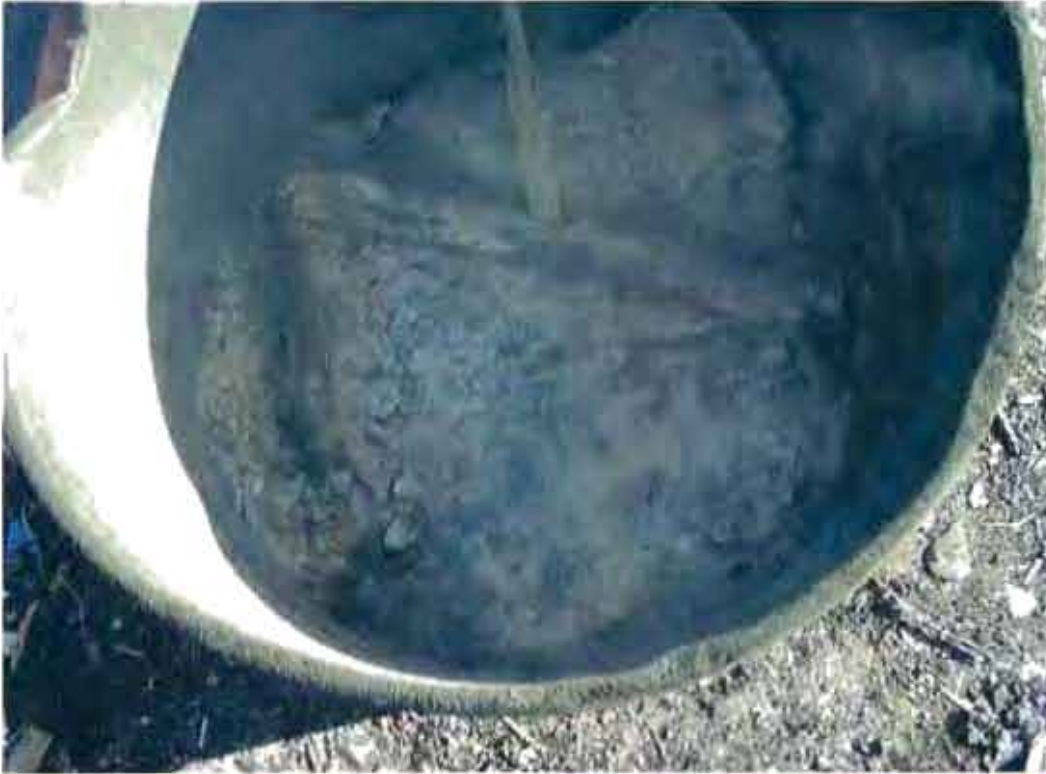
Date: January 15, 2008
Time: 11:44 AM
Direction: NE
Photo by: Eisenbrandt
Exposure #: 053
Comments: Smoldering waste in burn barrel located behind House No. 6.

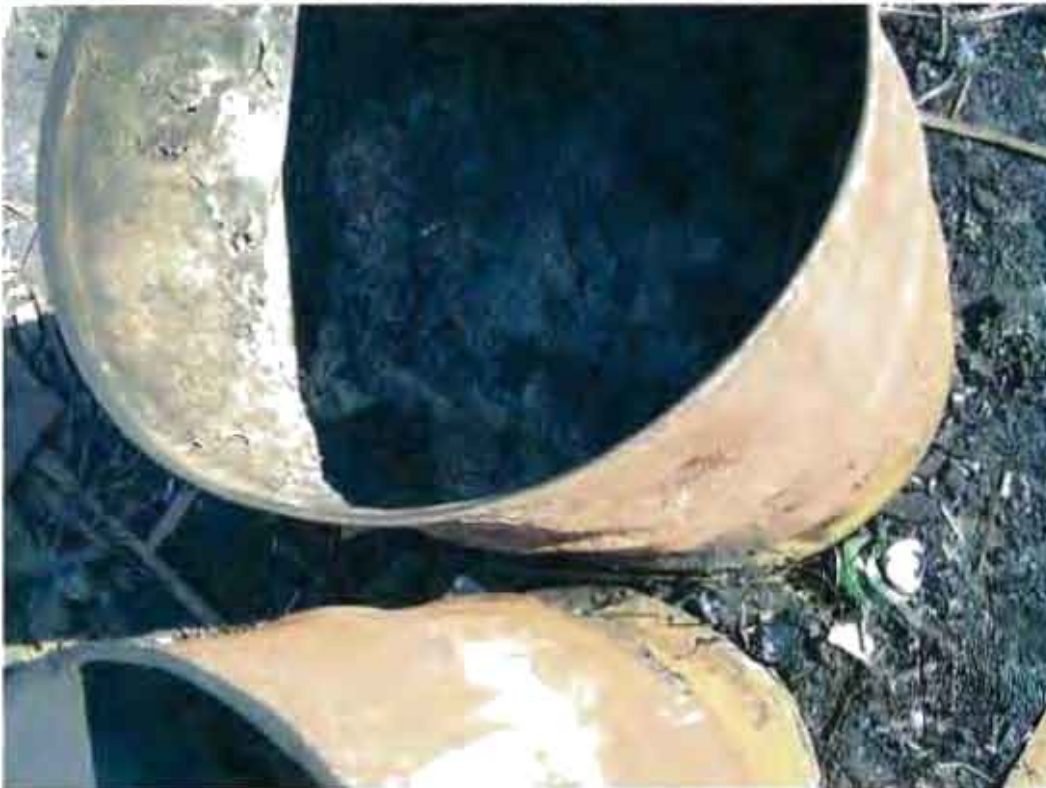
Date: January 15, 2008
Time: 11:44 AM
Direction: NE
Photo by: Eisenbrandt
Exposure #: 054
Comments: Charred waste observed in burn barrel behind House No. 6.

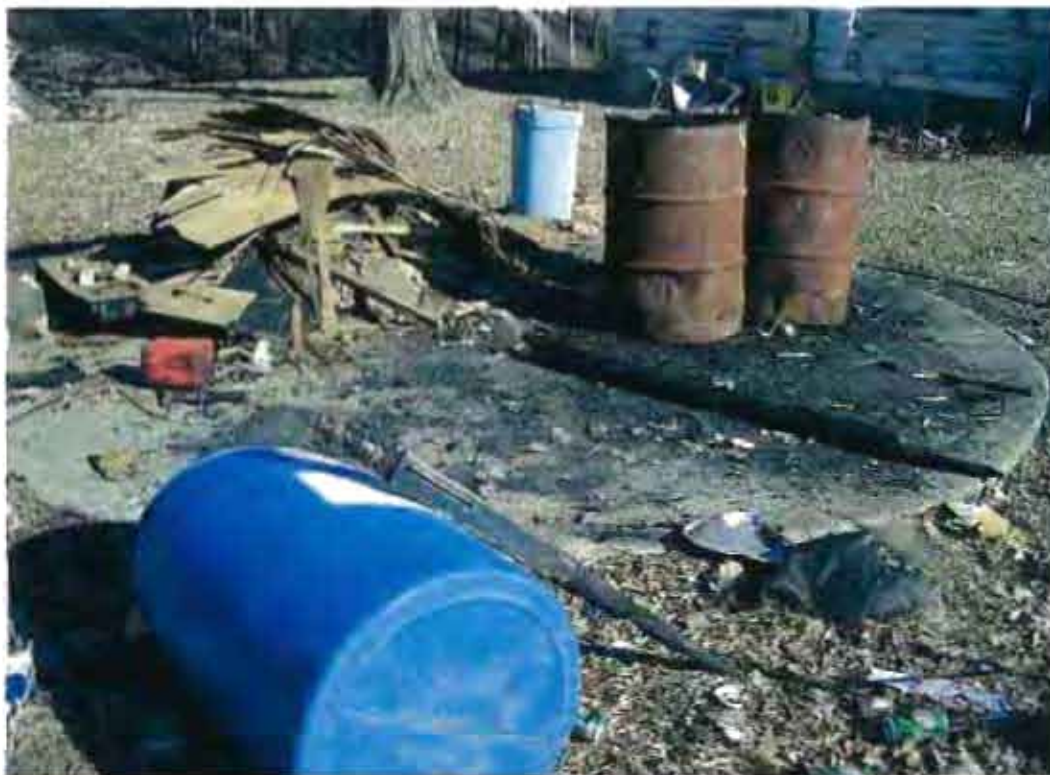
Date: January 15, 2008
Time: 11:44 AM
Direction: NE
Photo by: Eisenbrandt
Exposure #: 055
Comments: Alternate view of burn barrels and demolition debris behind House No. 6.

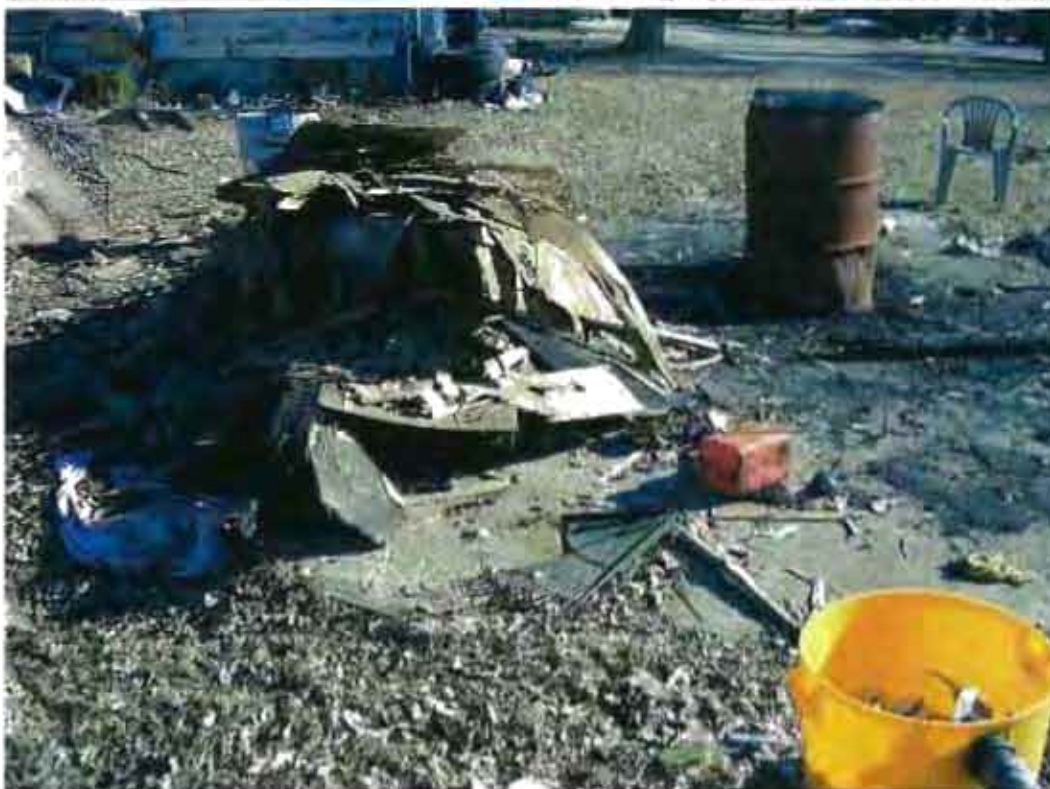
Date: January 15, 2008
Time: 11:45 AM
Direction: E
Photo by: Eisenbrandt
Exposure #: 056
Comments: Alternate view of burn barrels and demolition debris behind House No. 6.
