ILLINOIS ENVIRONMENTAL PROTECTION AGENCY

Re: Illinois Environmental Protection Agency v. C. John Blickhan
IEPA File No.23-08-AC; 0010650002—Adams County

BEFORE THE ILLINOIS POLLUTION CONTROL BOARD
ADMINISTRATIVE CITATION

C. JOHN BLICKHAN,

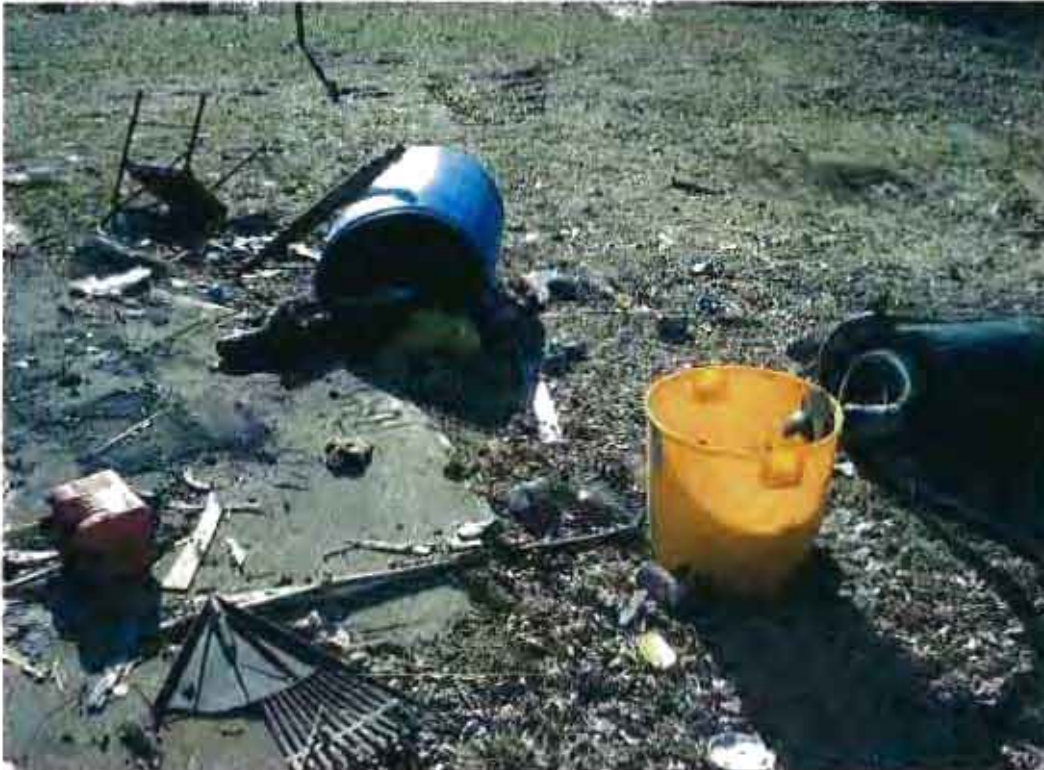
Date: January 15, 2008
Time: 11:45 AM
Direction: S
Photo by: Eisenbrandt
Exposure #: 057
Comments: Alternate view of burn barrels and demolition debris behind House No. 6.

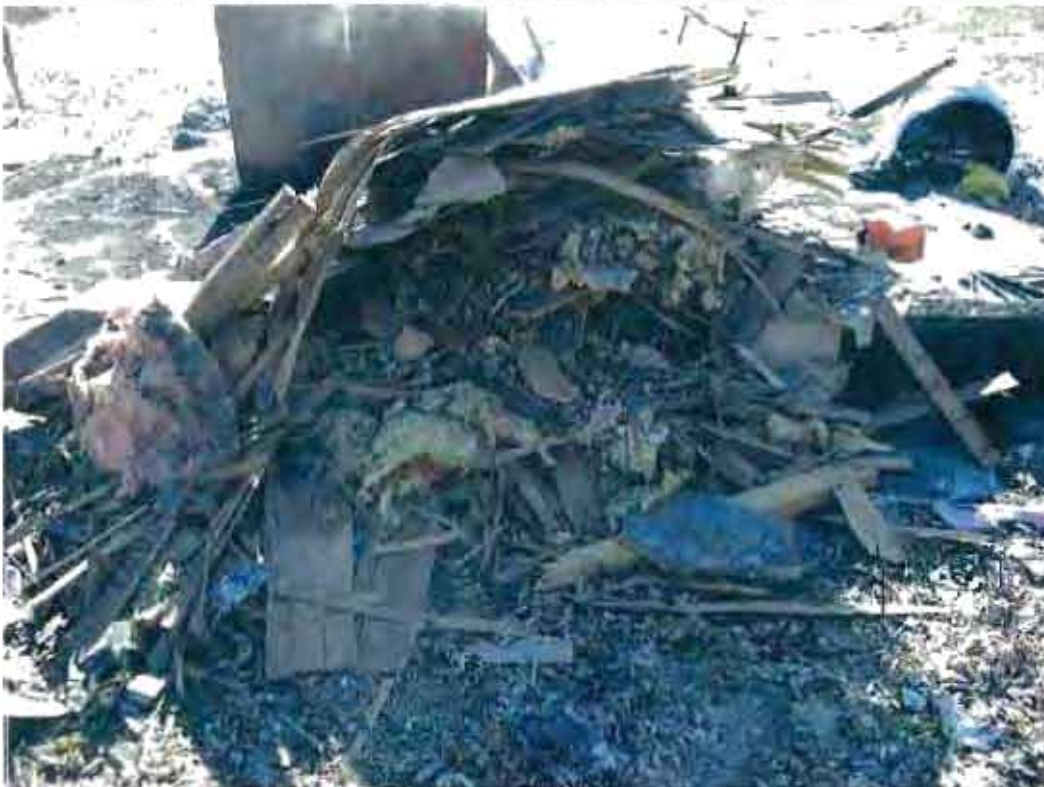
Date: January 15, 2008
Time: 11:45 AM
Direction: S
Photo by: Eisenbrandt
Exposure #: 058
Comments: Alternate view of burn barrels and demolition debris behind House No. 6.

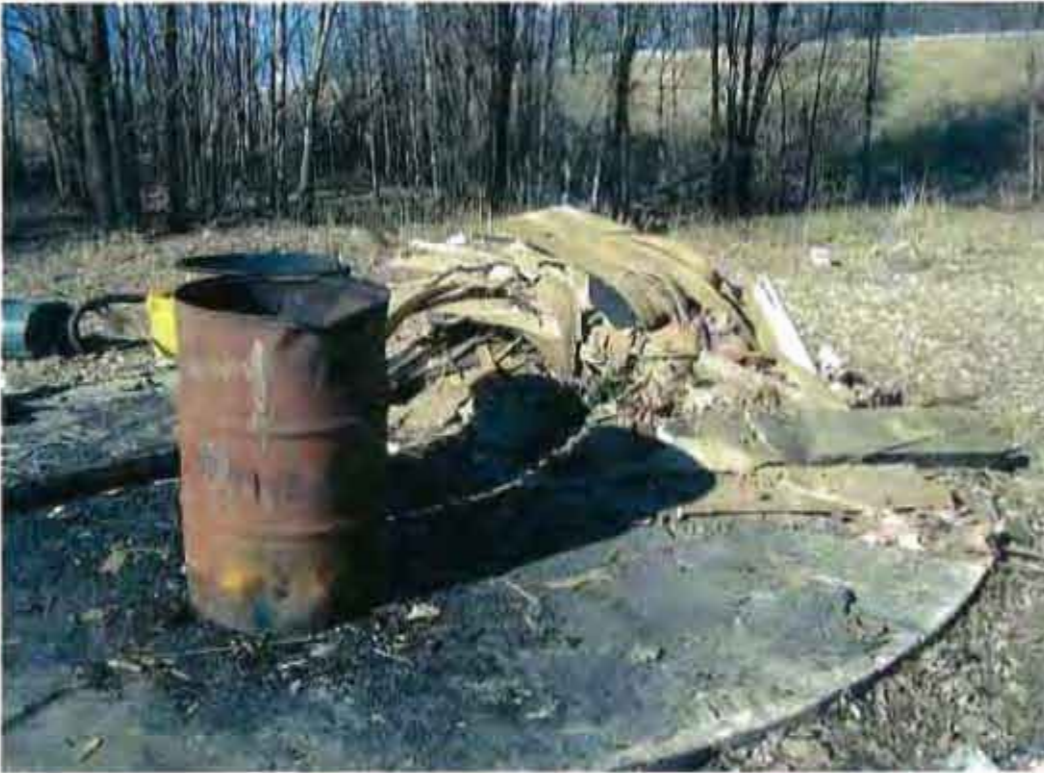
Date: January 15, 2008
Time: 11:47 AM
Direction: W
Photo by: Eisenbrandt
Exposure #: 059
Comments: Alternate view of burn barrels and demolition debris behind House No. 6.

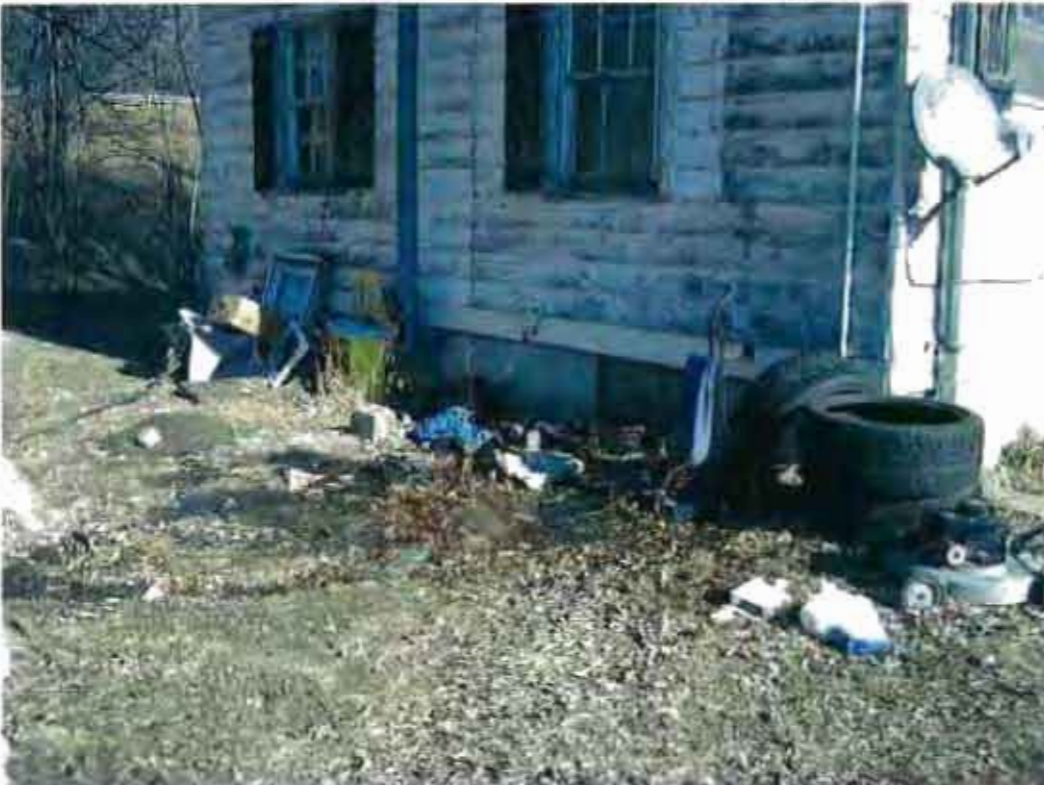
Date: January 15, 2008
Time: 11:47 AM
Direction: NE
Photo by: Eisenbrandt
Exposure #: 060
Comments: Garbage strewn behind House No. 6. Off rim used tires were also observed.

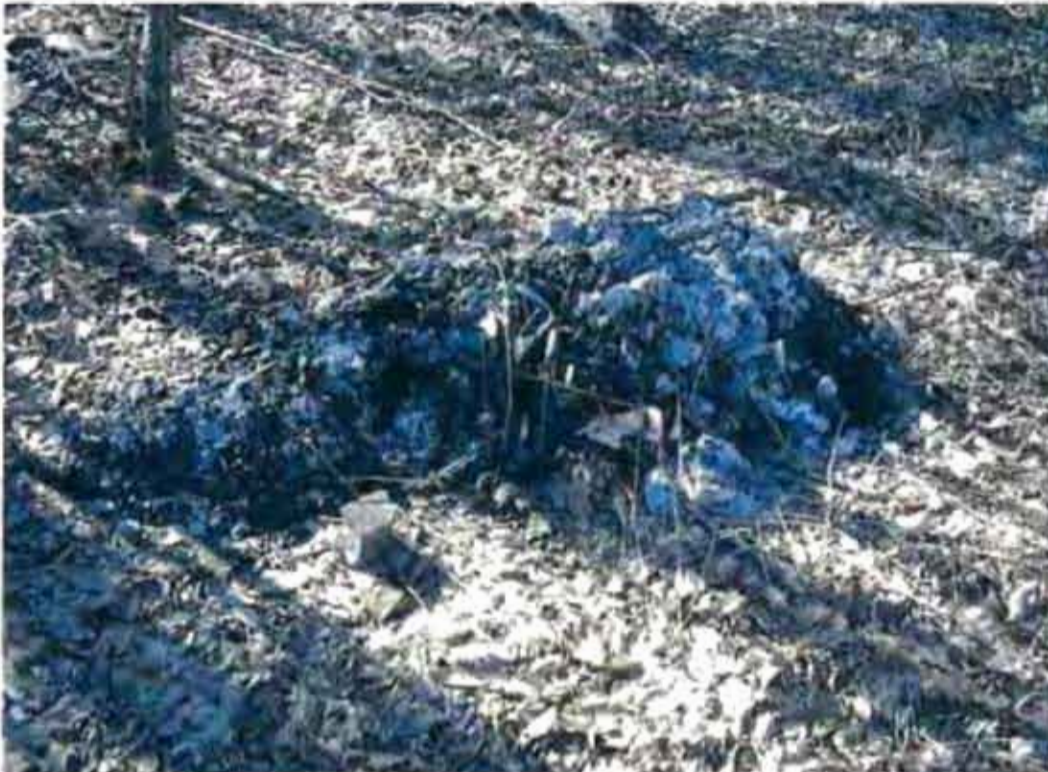
Date: January 15, 2008
Time: 11:48 AM
Direction: SW
Photo by: Eisenbrandt
Exposure #: 061
Comments: Charred waste open dumped in coppice behind House No. 6.

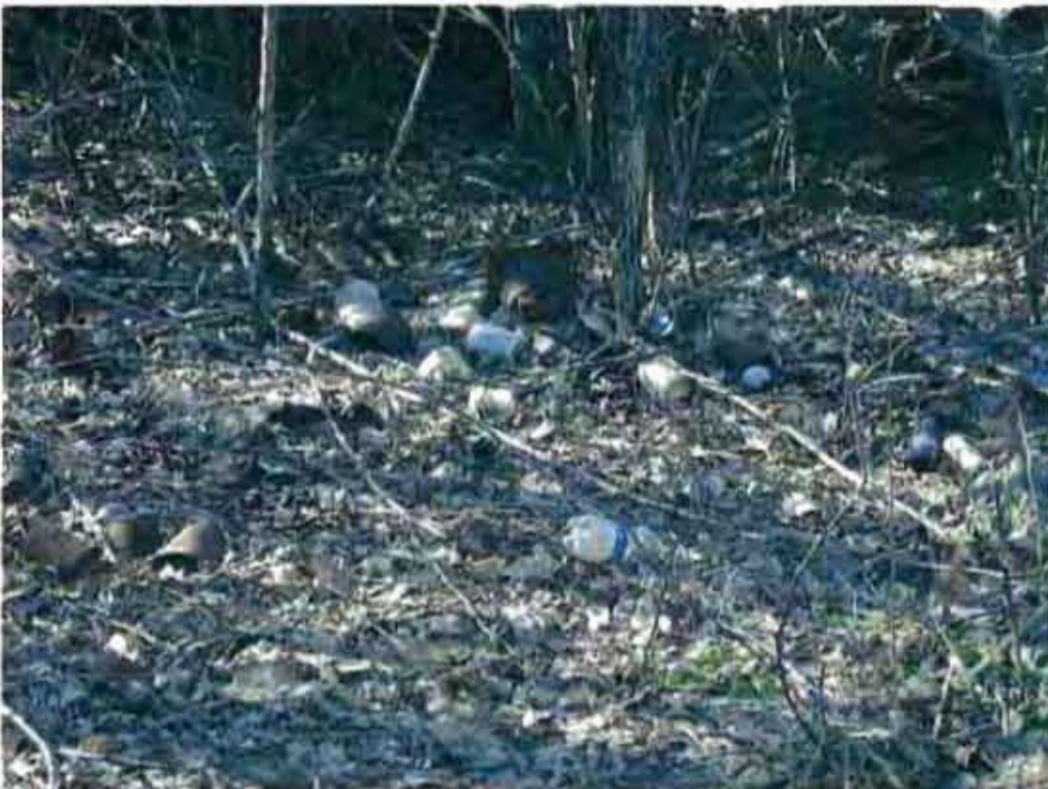
Date: January 15, 2008
Time: 11:48 AM
Direction: SW
Photo by: Eisenbrandt
Exposure #: 062
Comments: Rusty cans, glass bottles, and plastic bottles open dumped in coppice behind House No. 6.

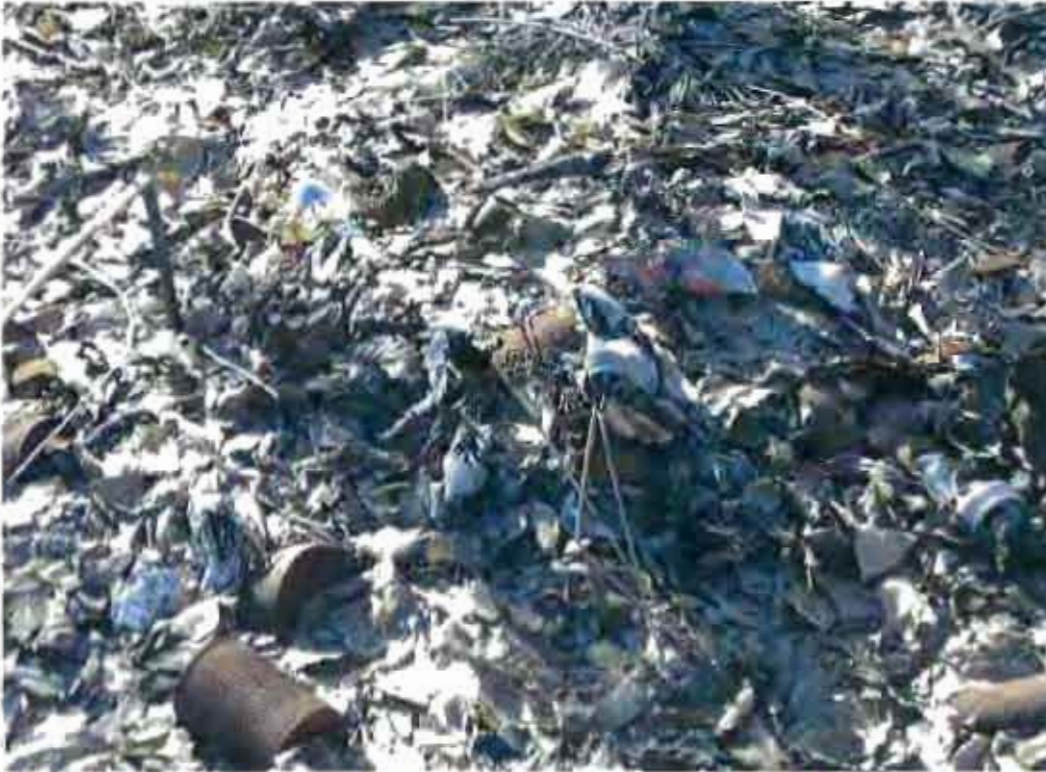
Date: January 15, 2008
Time: 11:49 AM
Direction: S
Photo by: Eisenbrandt
Exposure #: 063
Comments: More rusty cans, aluminum cans, etc. covered with leaves in the coppice behind House No. 6

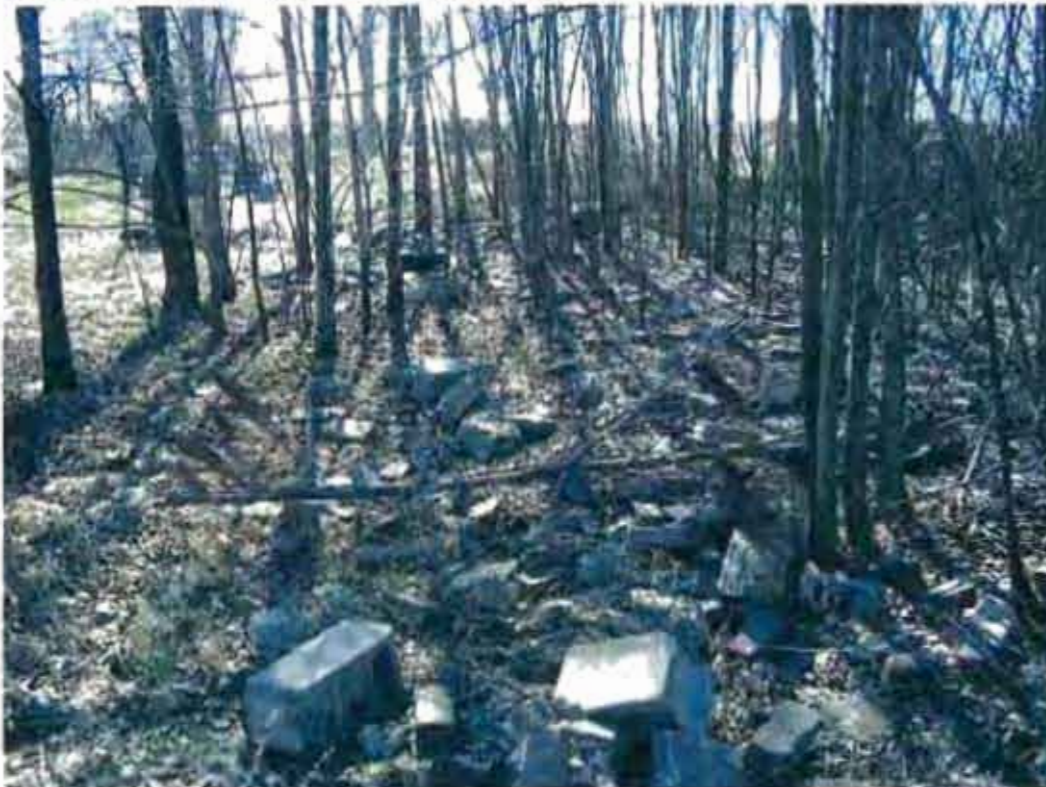
Date: January 15, 2008
Time: 11:49 AM
Direction: S
Photo by: Eisenbrandt
Exposure #: 064
Comments: Copious amount of brick and cinder block demolition waste among the thicket of small trees behind house No. 5.

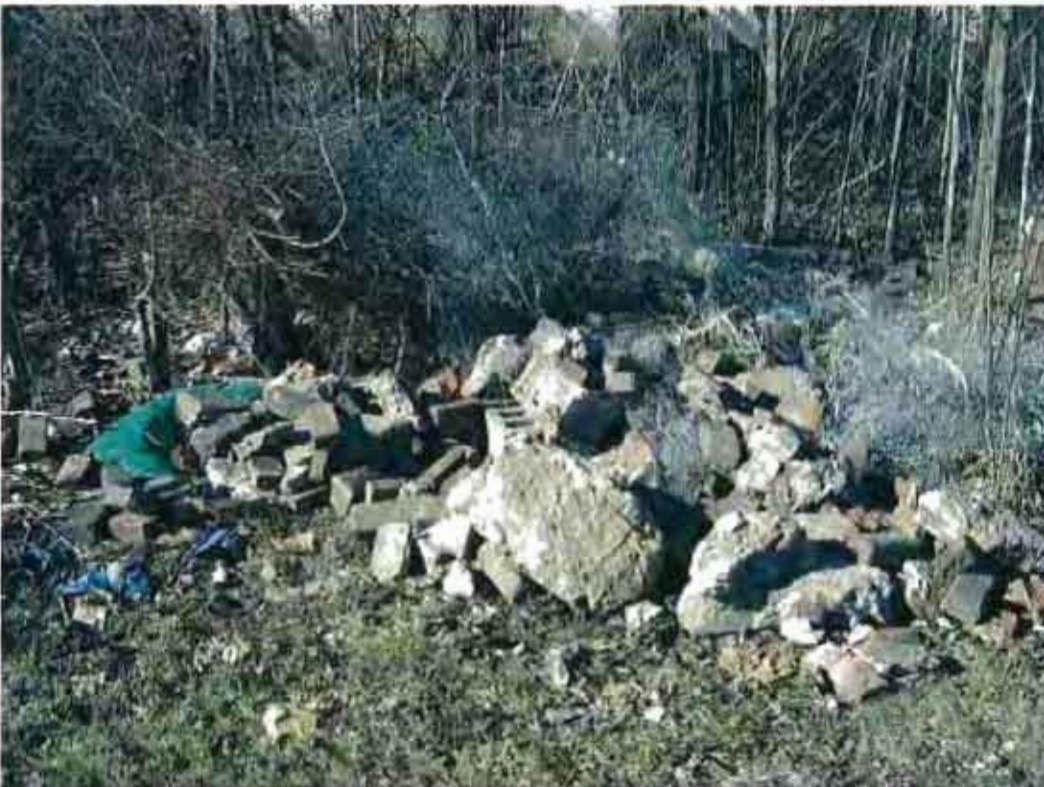
Date: January 15, 2008
Time: 11:50 AM
Direction: NW
Photo by: Eisenbrandt
Exposure #: 066
Comments: Open dumped demolition waste behind House No. 5.

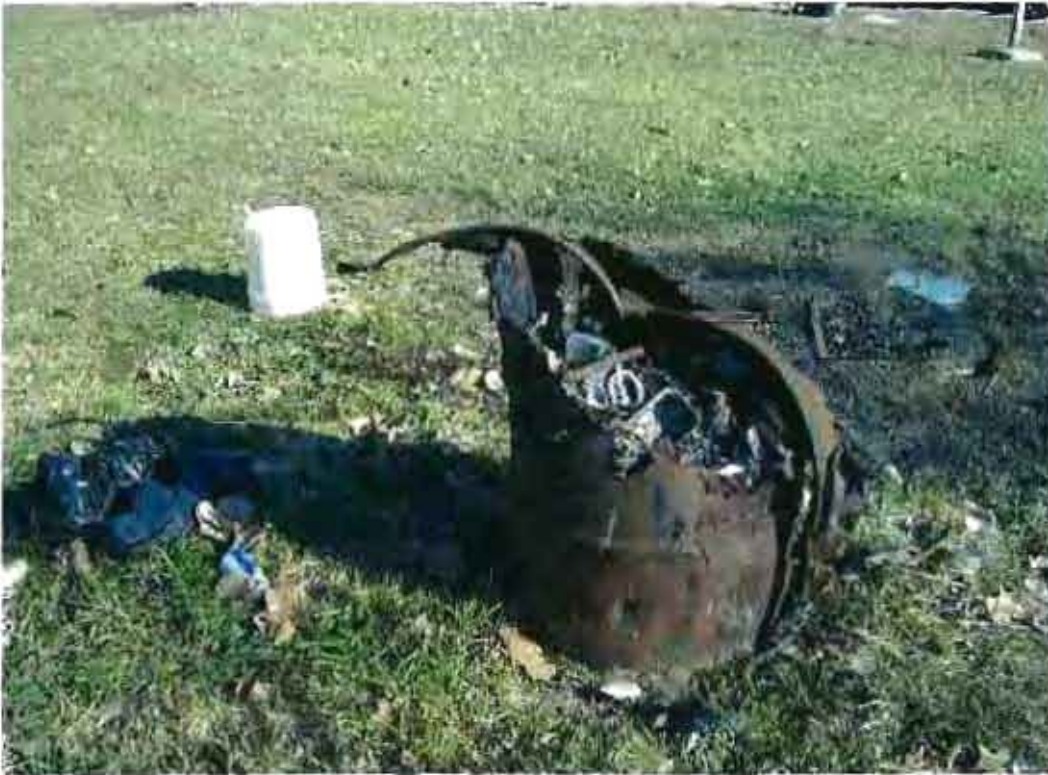
Date: January 15, 2008
Time: 11:50 AM
Direction: N
Photo by: Eisenbrandt
Exposure #: 067
Comments: Remnants of a rusty burn barrel filled with charred waste behind House No. 5.

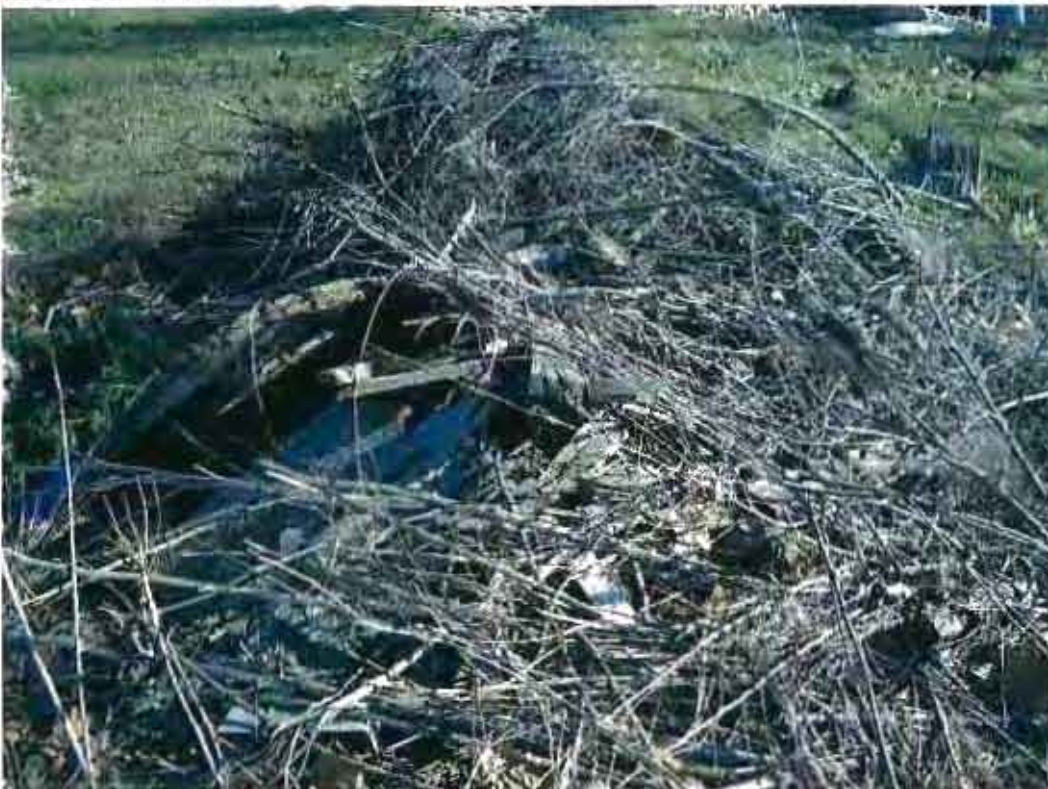
Date: January 15, 2008
Time: 11:51 AM
Direction: E
Photo by: Eisenbrandt
Exposure #: 068
Comments: A pile of demolition debris covered with woody vegetation behind House No. 4.

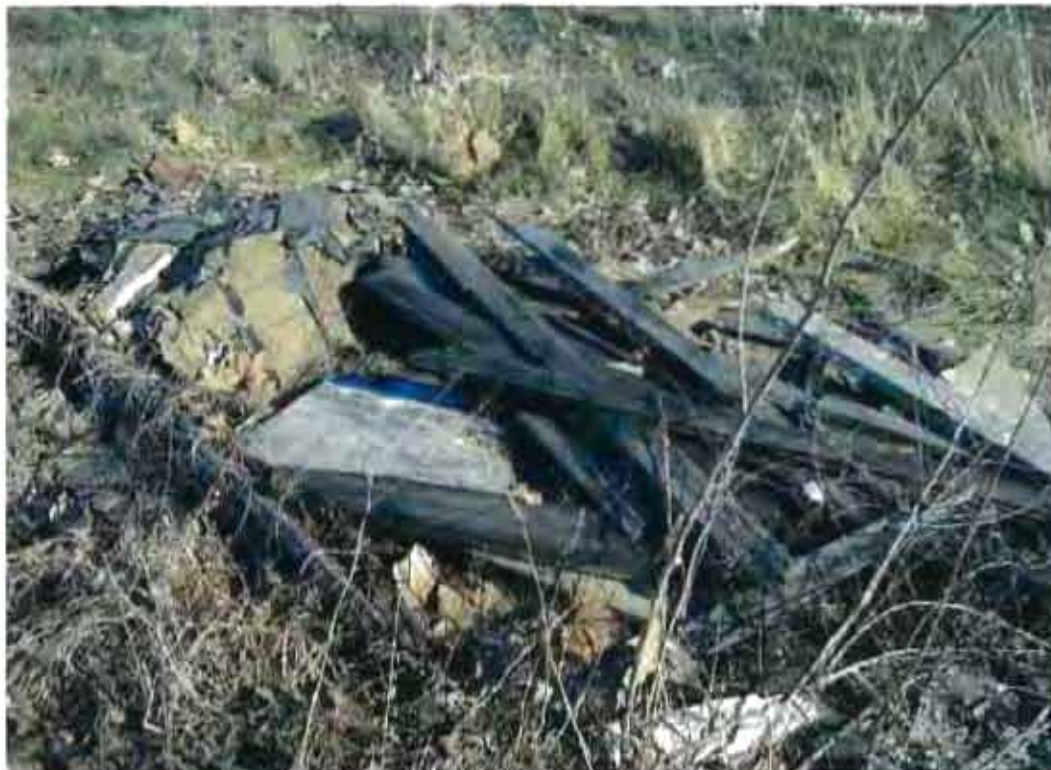
Date: January 15, 2008
Time: 11:51 AM
Direction: N
Photo by: Eisenbrandt
Exposure #: 069
Comments: Demolition debris behind House No. 4.

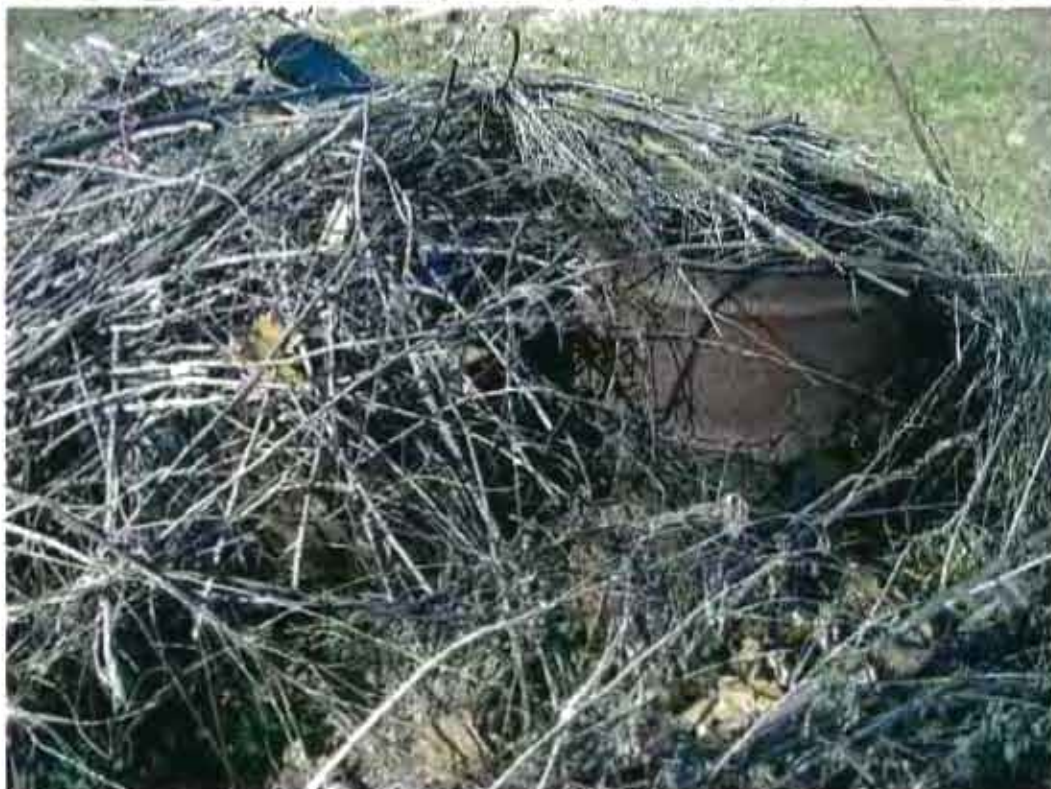
Date: January 15, 2008
Time: 11:51 AM
Direction: NW
Photo by: Eisenbrandt
Exposure #: 070
Comments: Alternate view of burn barrel and demolition debris behind House No. 4.

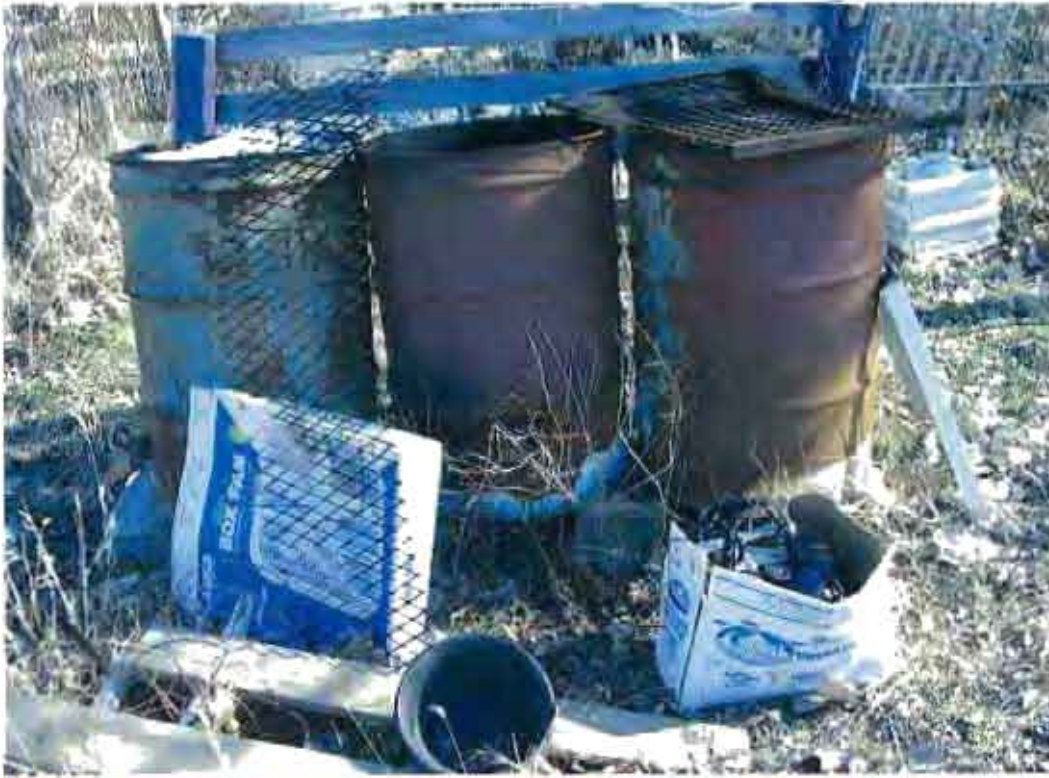
Date: January 15, 2008
Time: 11:52 AM
Direction: E
Photo by: Eisenbrandt
Exposure #: 071
Comments: Three burn barrels located behind House No. 4. Open dumped waste observed on the ground around the burn barrels.

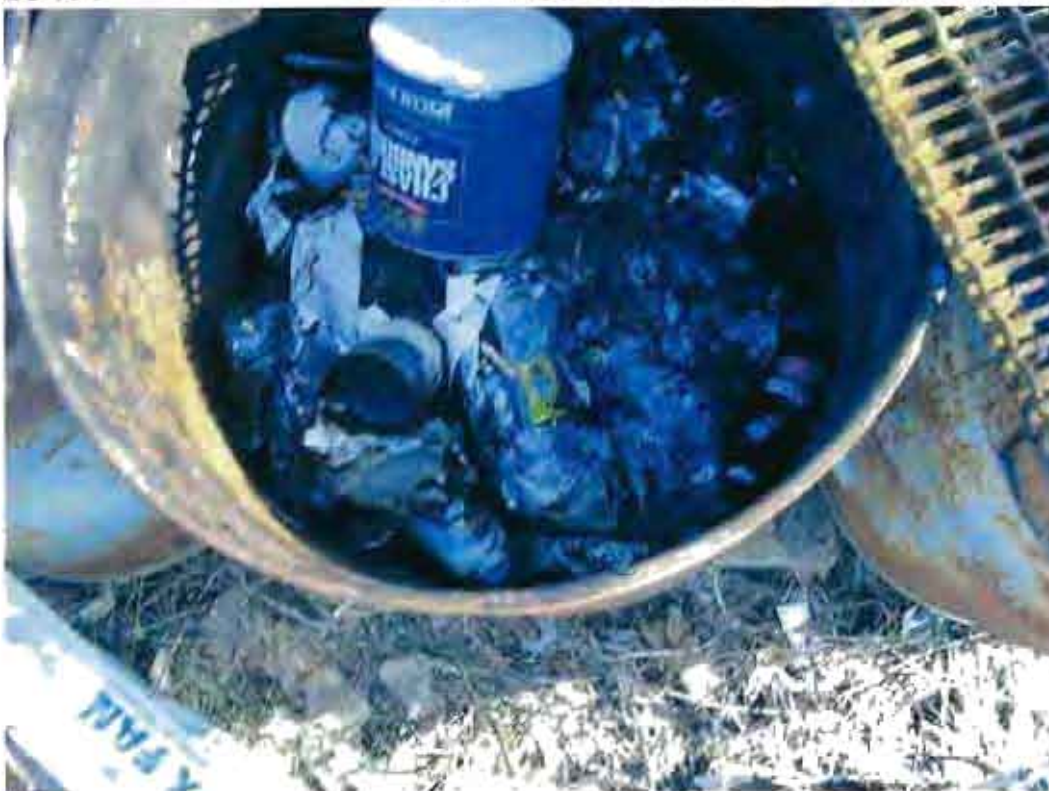
Date: January 15, 2008
Time: 11:52 AM
Direction: E
Photo by: Eisenbrandt
Exposure #: 072
Comments: Charred household waste and garbage behind house No. 4.
