ILLINOIS ENVIRONMENTAL PROTECTION AGENCY

ADMINISTRATIVE CITATION

AC 08-26
(IEPA No. 29-08-AC)

File
February 7, 2008 Inspection

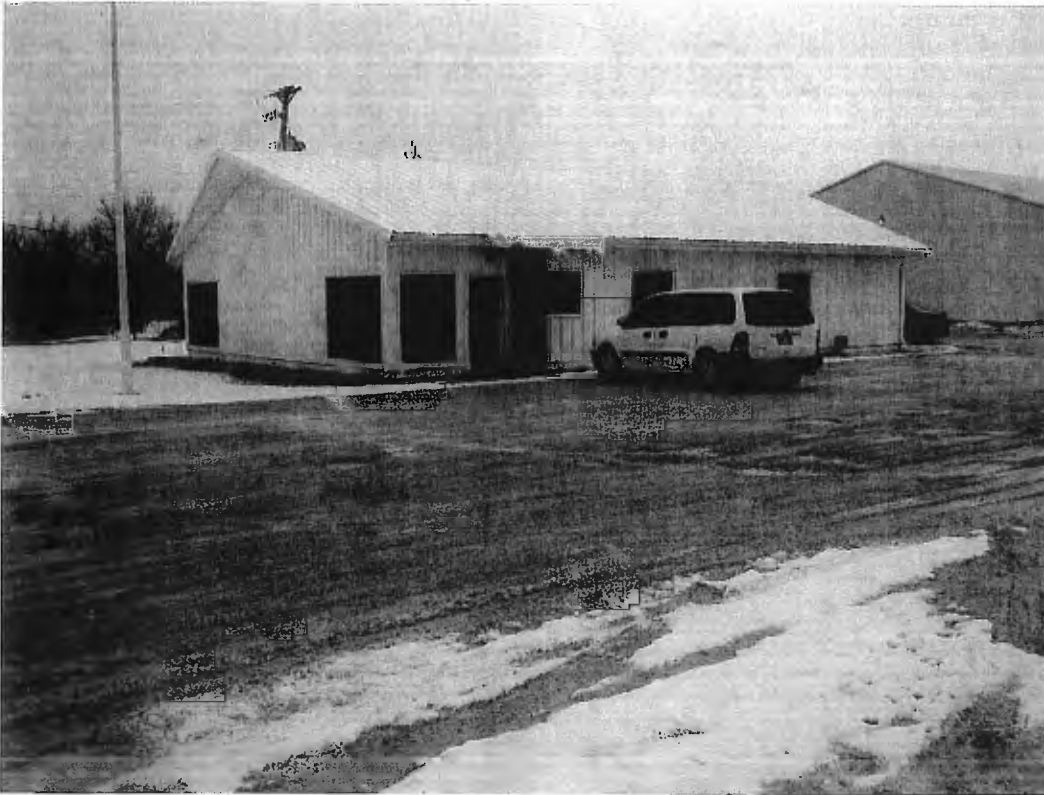
Photograph 001 shows a street elevation view of the DEM/EX Group office building. A two cubic yard dumpster was observed behind the building. The waste in the dumpster was overfull, but appeared consistent with office operations.

Date: February 7, 2008
Time: 10:09 AM
Direction: SW
Photo by: Eisenbrandt
Exposure #: 001
Comments: Street elevation view of the DEM/EX Group office building.

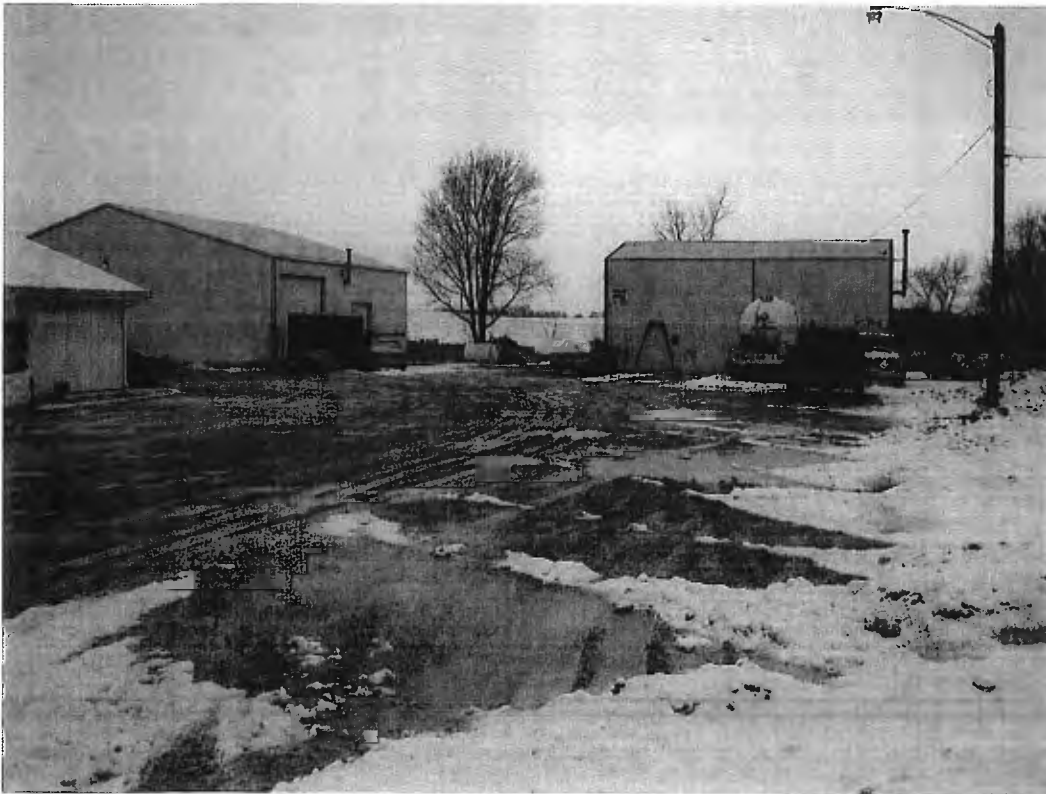
Photograph 002 shows the northeast parking lot. No debris was observed.

Date: February 7, 2008
Time: 10:09 AM
Direction: W
Photo by: Eisenbrandt
Exposure #: 002
Comments: Northeast parking lot clear of debris.

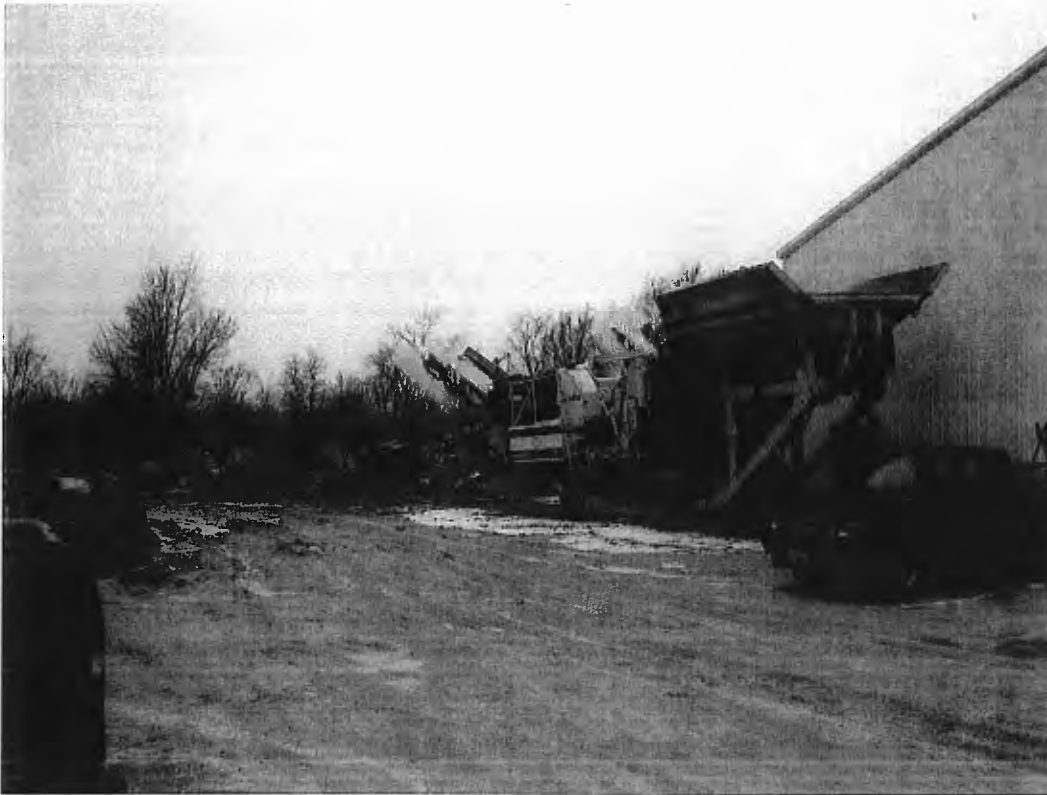
Date: February 7, 2008
Time: 10:10 AM
Direction: SW
Photo by: Eisenbrandt
Exposure #: 003
Comments: A crusher located between the maintenance garage and the office building.

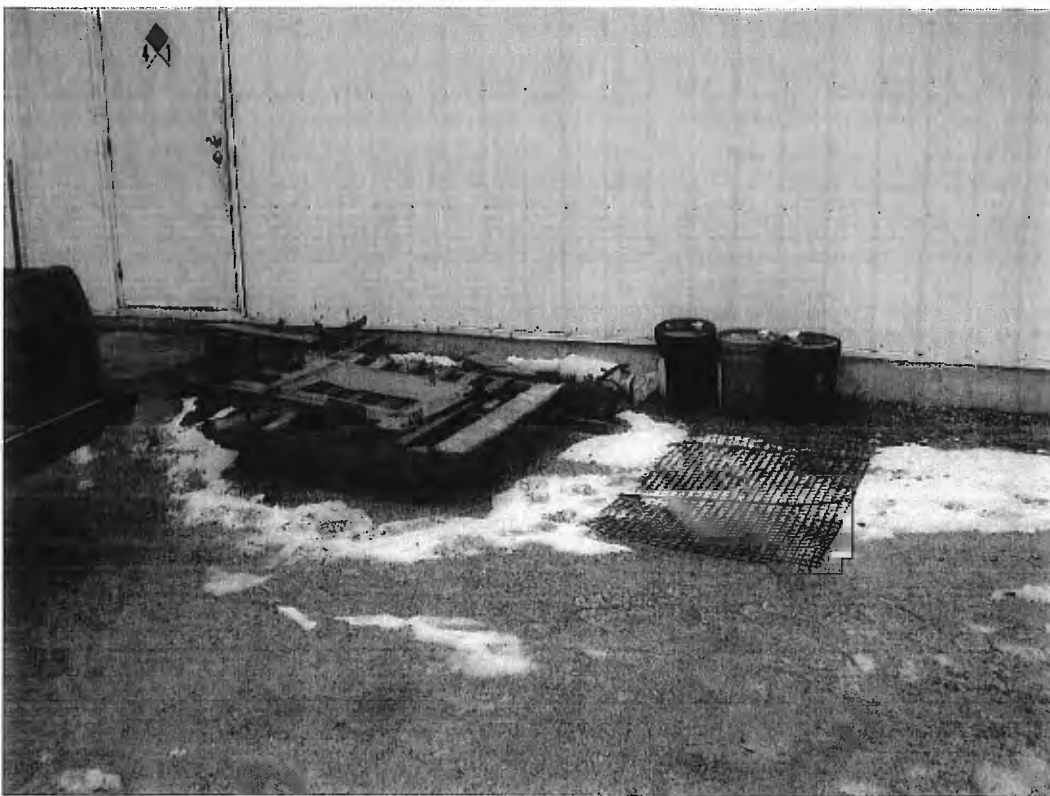
Photograph 004 shows three empty 5-gallon buckets of oil, five lead acid batteries, and scrap metal located along the southeast side of the maintenance garage. Mr. Fisher claimed the DEM/EX employees had just placed the items there but that they were still good. The inspector recommended to Mr. Fisher that the lead acid batteries be stored off the ground on a pallet or inside the maintenance shop until recycled. The inspector also recommended reusable materials be stored neatly and to discard or store the empty oil buckets inside.

Date: February 7, 2008
Time: 10:10 AM
Direction: W
Photo by: Eisenbrandt
Exposure #: 004
Comments: Three empty 5-gallon buckets of oil, five lead acid batteries, and scrap metal located outside the southeast side of the maintenance garage.

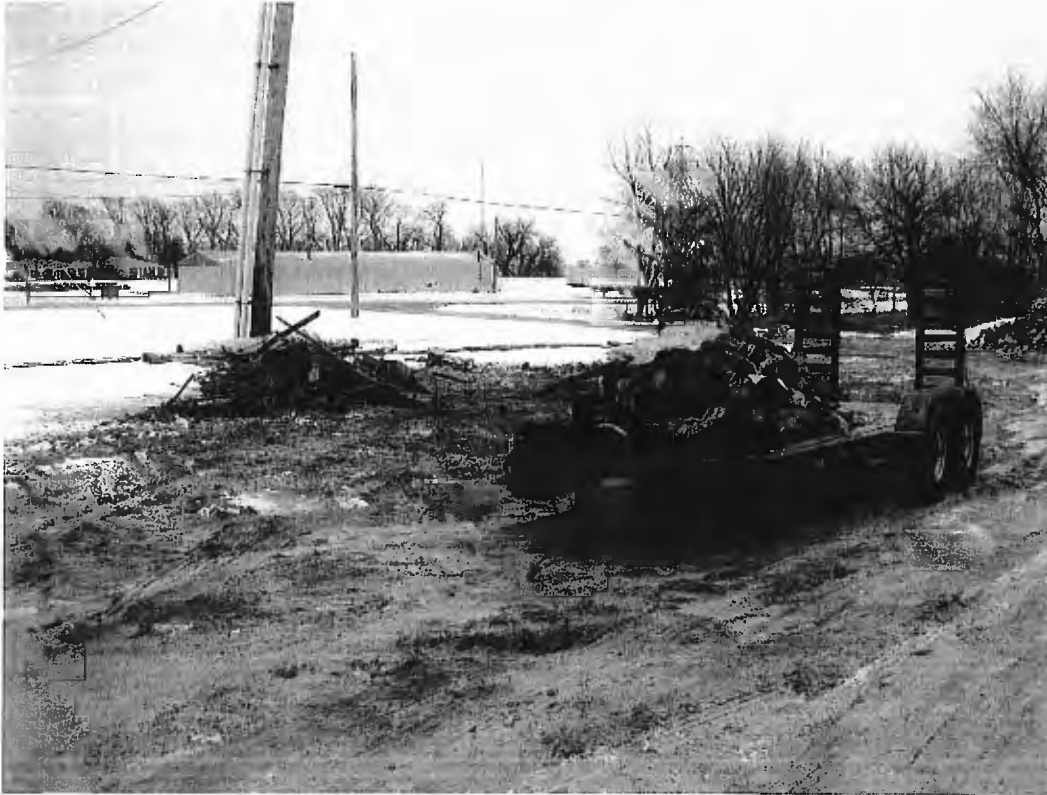
Date: February 7, 2008
Time: 10:15 AM
Direction: SE
Photo by: Eisenbrandt
Exposure #: 005
Comments: A pile of scrap metal on the trailer and another pile of scrap metal in the background were observed south of the office building.

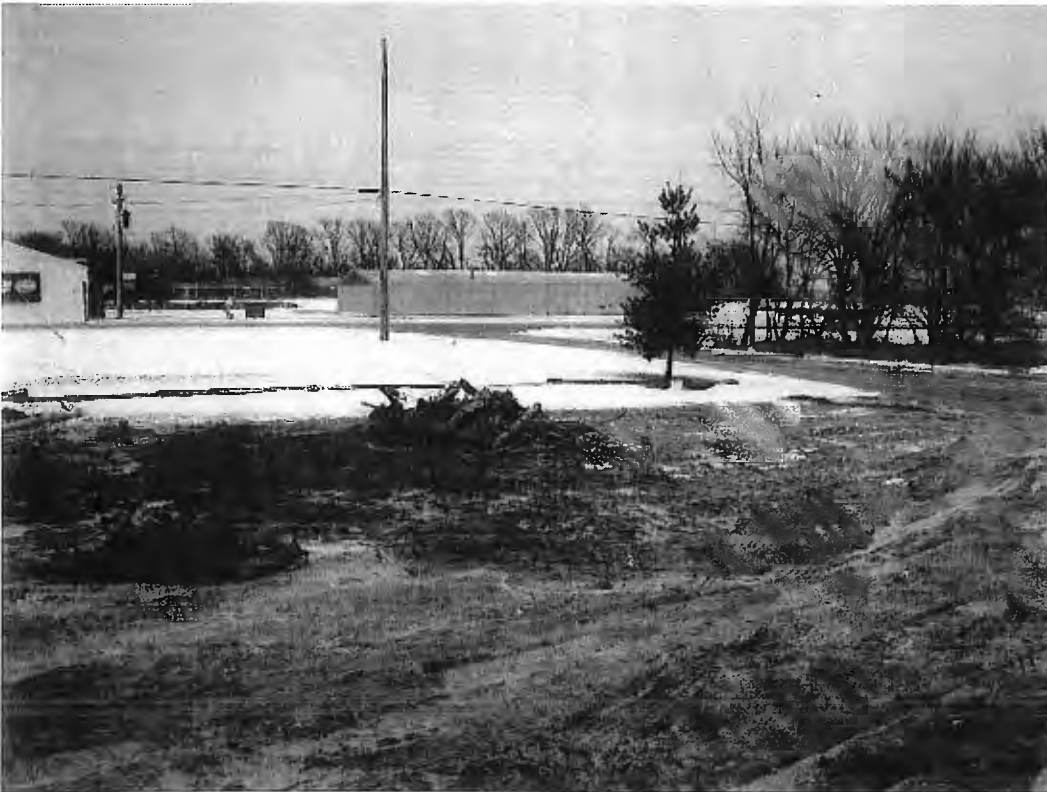
Date: February 7, 2008
Time: 10:16 AM
Direction: SE
Photo by: Eisenbrandt
Exposure #: 006
Comments: Two additional pile of scrap metal observed south of the office building.

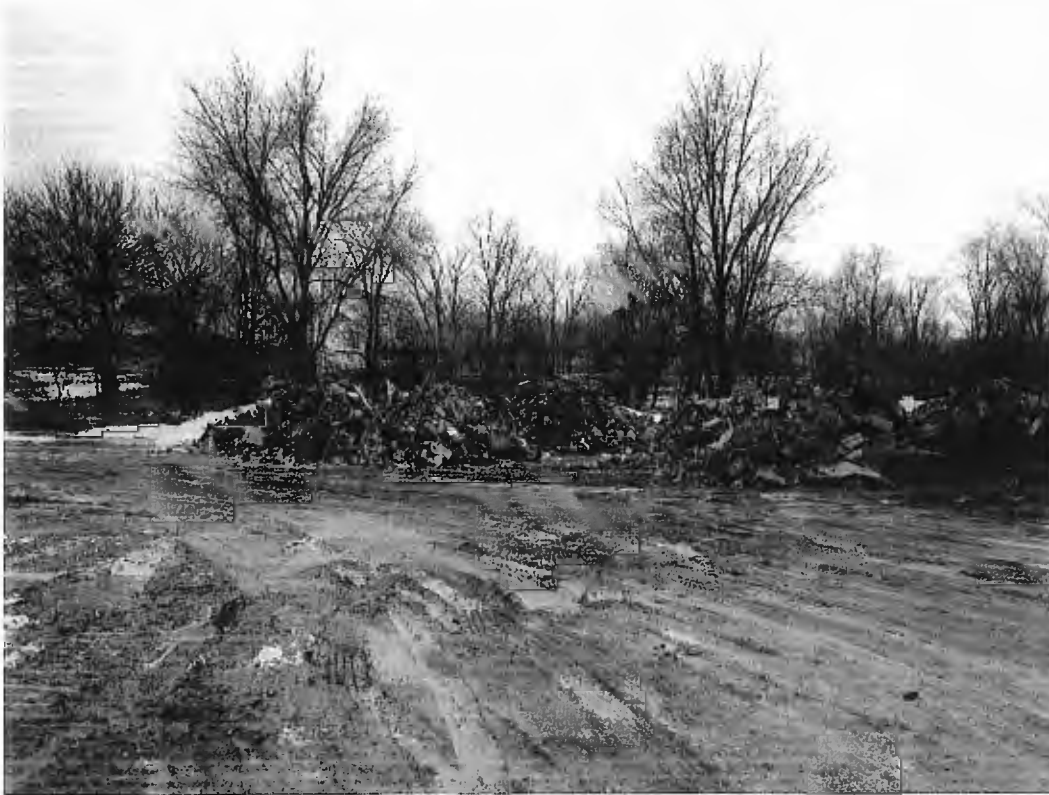
Date: February 7, 2008
Time: 10:16 AM
Direction: S
Photo by: Eisenbrandt
Exposure #: 007
Comments: Numerous piles of demolition debris were observed on the south side of the facility.

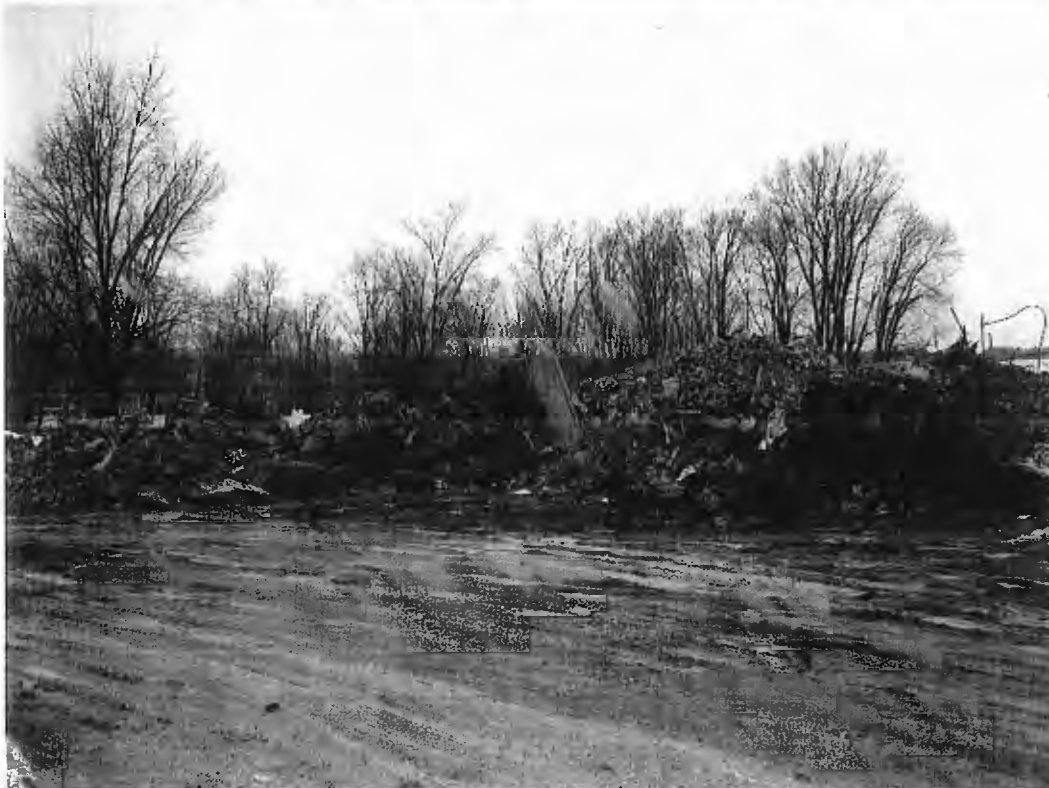
Date: February 7, 2008
Time: 10:16 AM
Direction: SW
Photo by: Eisenbrandt
Exposure #: 008
Comments: Observed demolition debris.

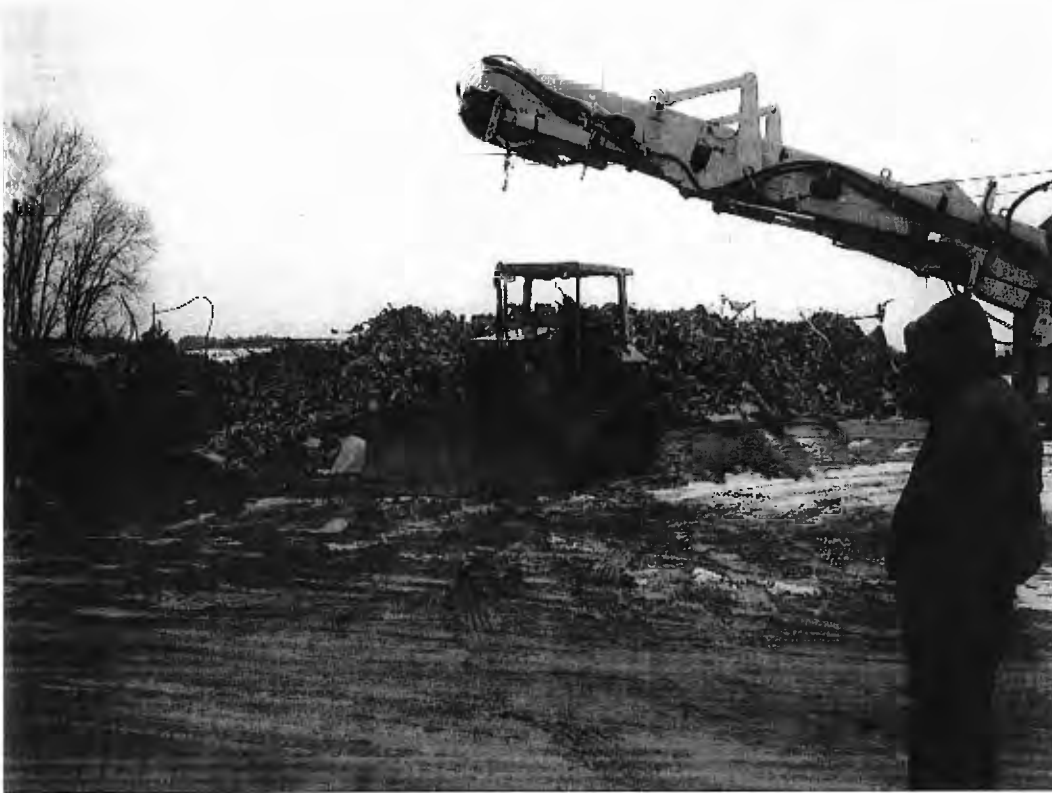
Date: February 7, 2008
Time: 10:16 AM
Direction: W
Photo by: Eisenbrandt
Exposure #: 009
Comments: Piles of demolition debris Mr. Fisher called aggregate.

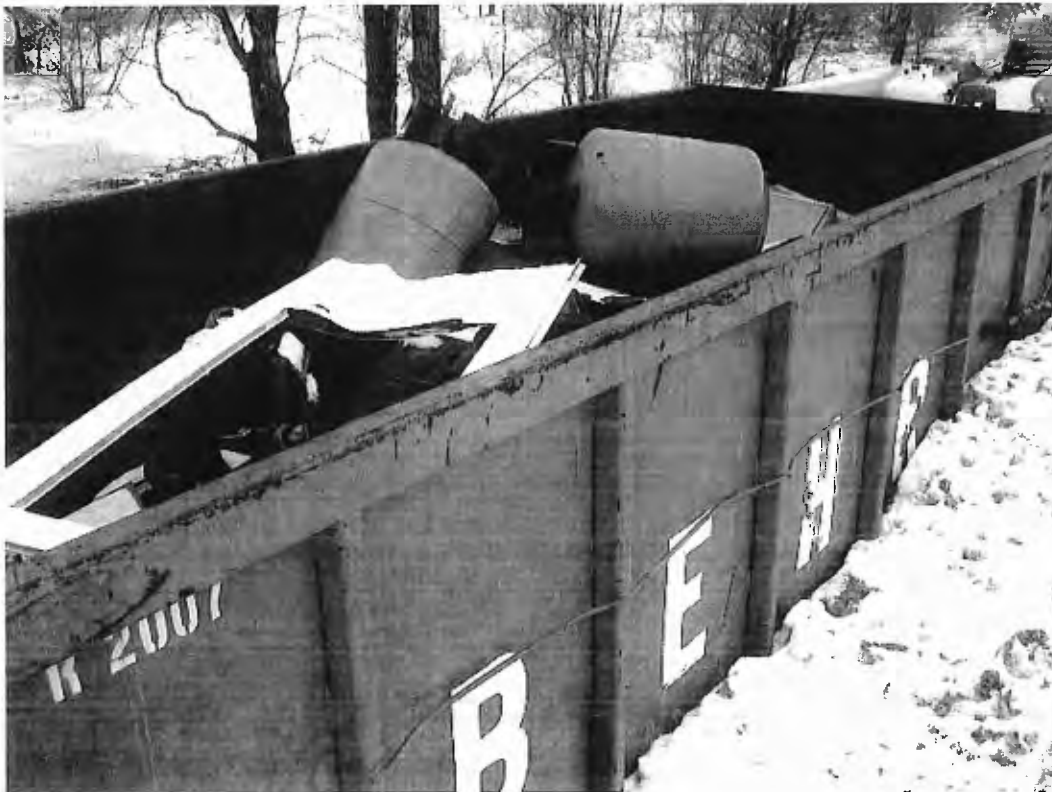
Date: February 7, 2008
Time: 10:17AM
Direction: SW
Photo by: Eisenbrandt
Exposure #: 010
Comments: BEHR Recycling dumpster.

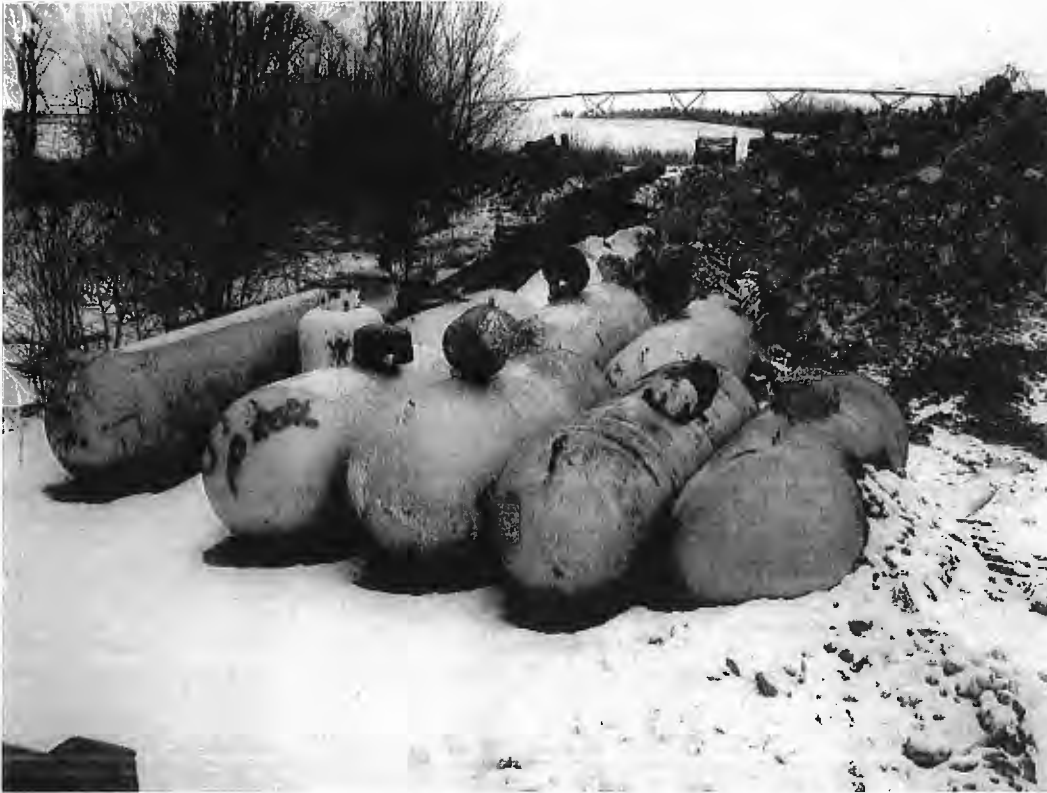
Photograph 011 shows eight large and two smaller propane tanks observed on the south side of the demolition debris. The planned use or disposal of the tanks was not discussed with Mr. Fisher.

Date: February 7, 2008
Time: 10:18 AM
Direction: W
Photo by: Eisenbrandt
Exposure #: 011
Comments: Eight large and two smaller propane tanks observed on the south side of the facility.

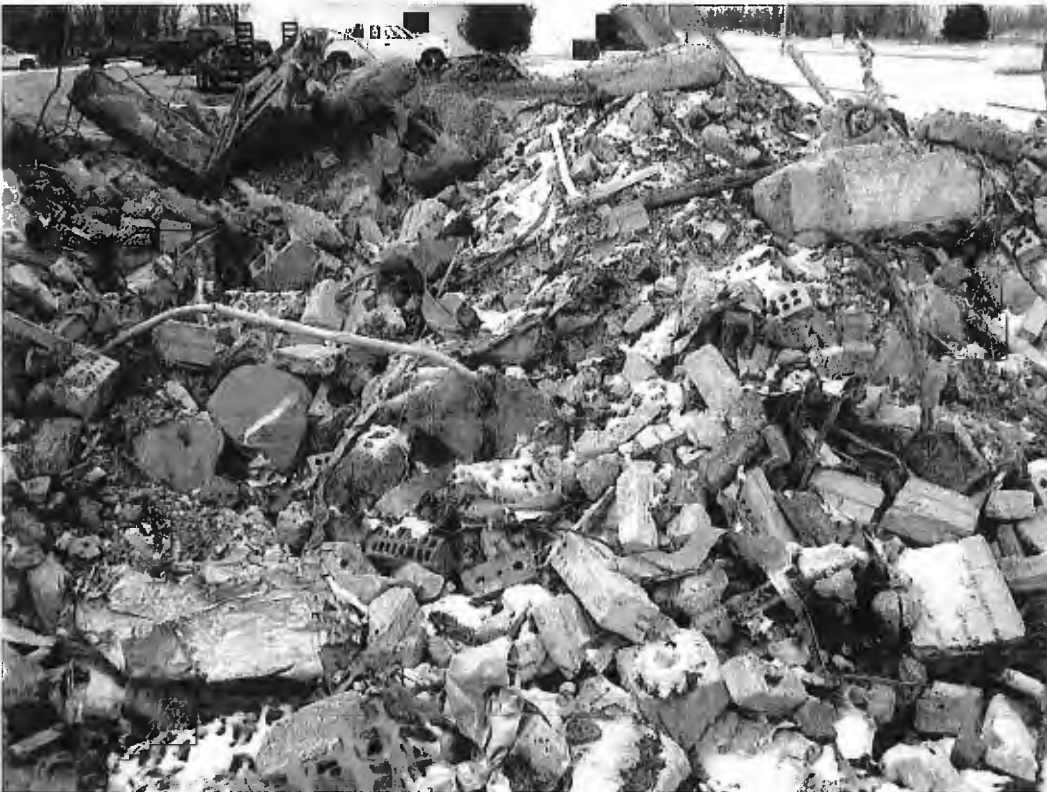
Photographs 012, 013, 014, and 015 show part of the massive demolition debris pile. There are likely more than 200 cubic yards of demolition debris on site that were not present during the July 24, 2007 inspection. Chunks of concrete, broken brick, orange safety fencing, cast iron and galvanized plumbing pipes, electrical conduits, electrical wiring, splinted dimensional lumber, scrap metal, smashed electrical components, fragmented porcelain plumbing fixtures, metal drywall corner bead, linoleum flooring, plastic, burlap, asphalt sheeting, and doorknobs, were among the observed demolition debris. Green and beige painted brick was also observed intermixed in the demolition debris waste pile.

Date: February 7, 2008
Time: 10:20 AM
Direction: NE
Photo by: Eisenbrandt
Exposure #: 012
Comments: Demolition debris that includes concrete, brick, orange safety fencing, plumbing pipes, electric conduits, electric wiring, plastic, rebar, scrap metal, and splintered dimensional lumber.

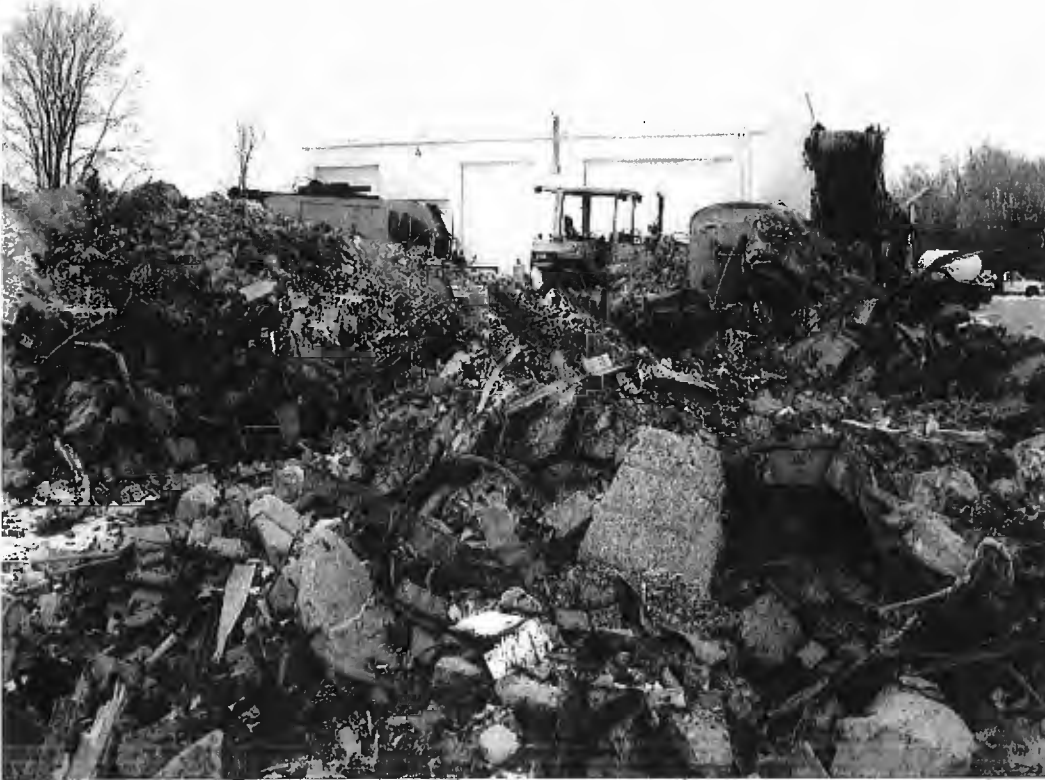
Date: February 7, 2008
Time: 10:20 AM
Direction: N
Photo by: Eisenbrandt
Exposure #: 013
Comments: Demolition debris including broken concrete and brick, scrap metal, crushed electrical components, fragments of porcelain, metal drywall corner bead, and cast iron waste pipe were observed.

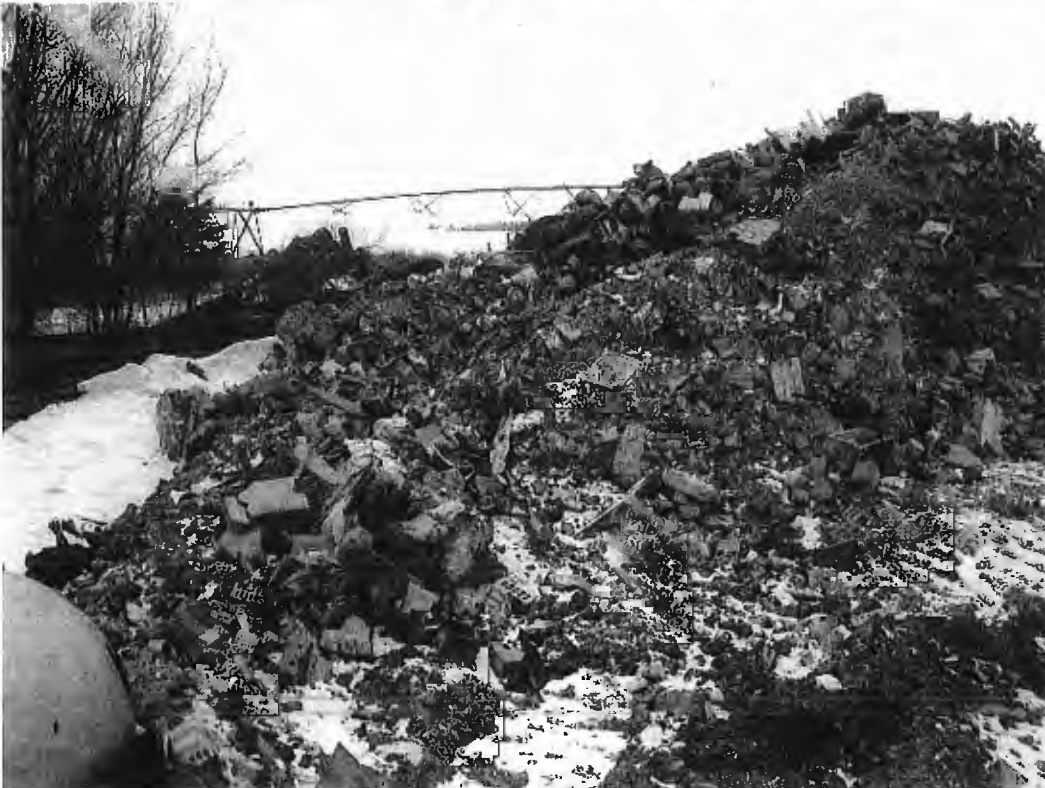
Date: February 7, 2008
Time: 10:20 AM
Direction: NW
Photo by: Eisenbrandt
Exposure #: 014
Comments: Concrete, brick, scrap metal linoleum flooring, burlap, asphalt sheeting, and door knobs were observed among the demolition debris.

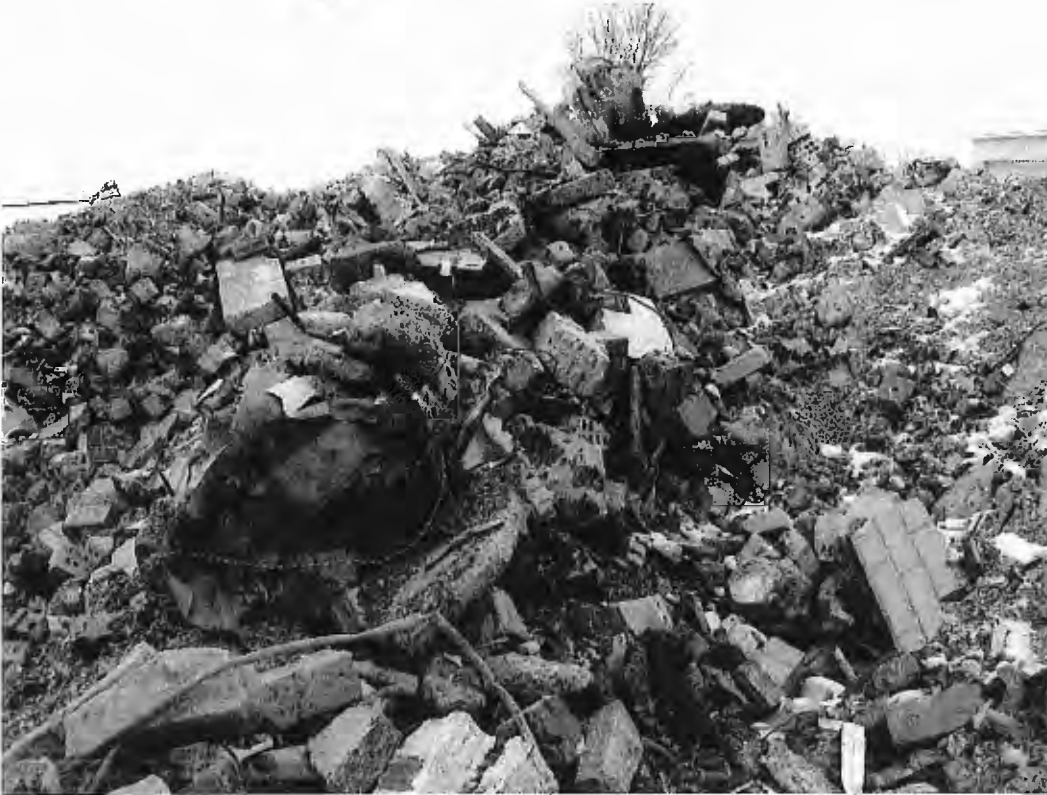
Date: February 7, 2008
Time: 10:22 AM
Direction: NW
Photo by: Eisenbrandt
Exposure #: 015
Comments: Green painted brick, lumber, concrete, and scrap metal were observed among the demolition debris.

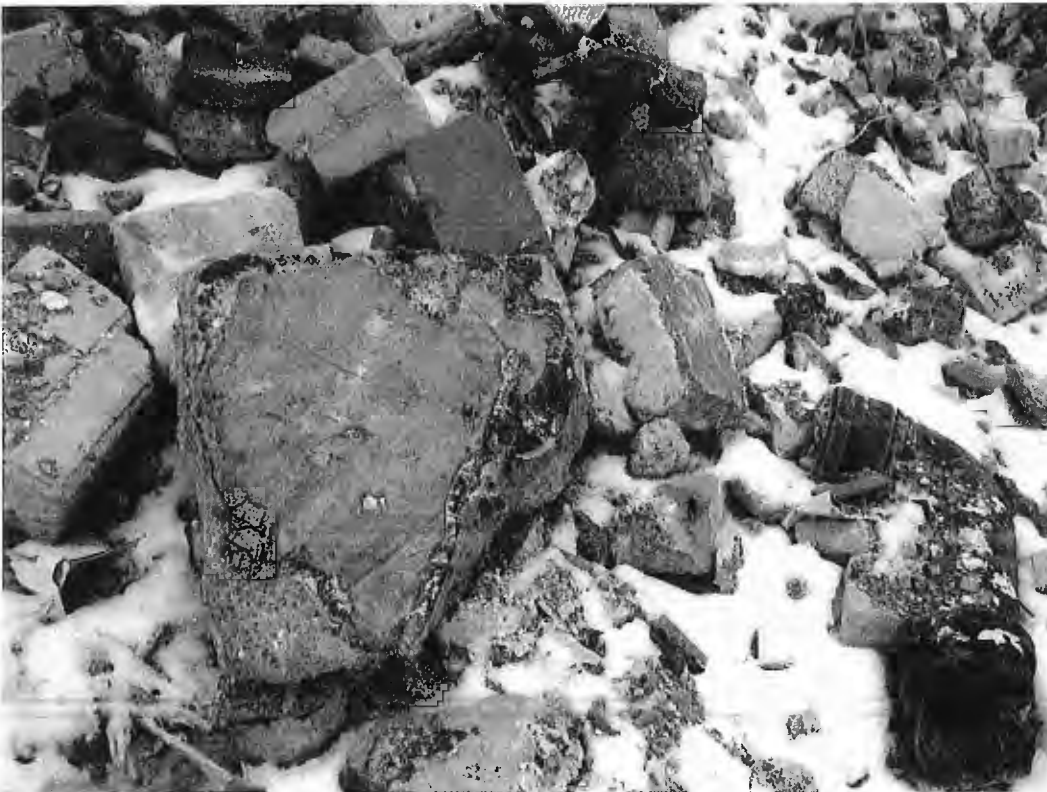
Photograph 016 shows broken brick, cast iron waste pipe, rusty scrap metal, and a large chunk of concrete with a black tar like adhesive and brown coating on the flat floor-like surface.

Date: February 7, 2008
Time: 10:27 AM
Direction: NW
Photo by: Eisenbrandt
Exposure #: 016
Comments: Broken brick, cast iron waste pipe, and concrete debris. The large chunk of concrete had a black tar like adhesive and a brown coating on the flat floor like surface.

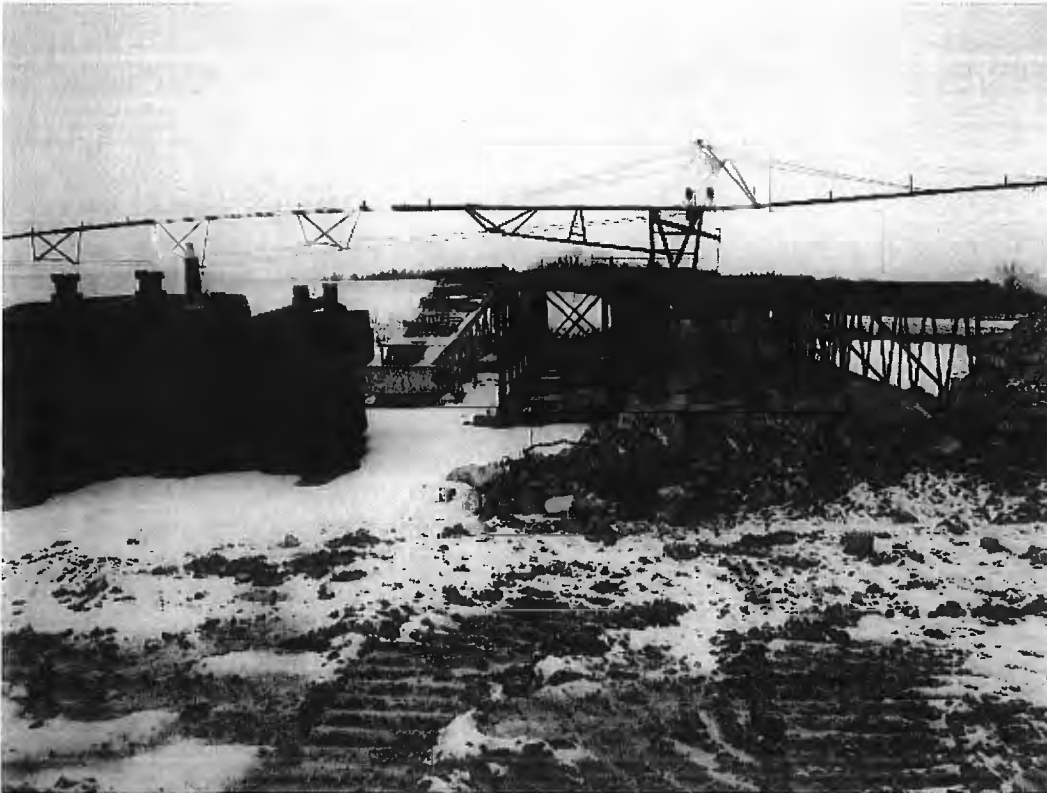
Date: February 7, 2008
Time: 10:28 AM
Direction: NW
Photo by: Eisenbrandt
Exposure #: 017
Comments: Crane equipment stored in the southwest corner of the facility.

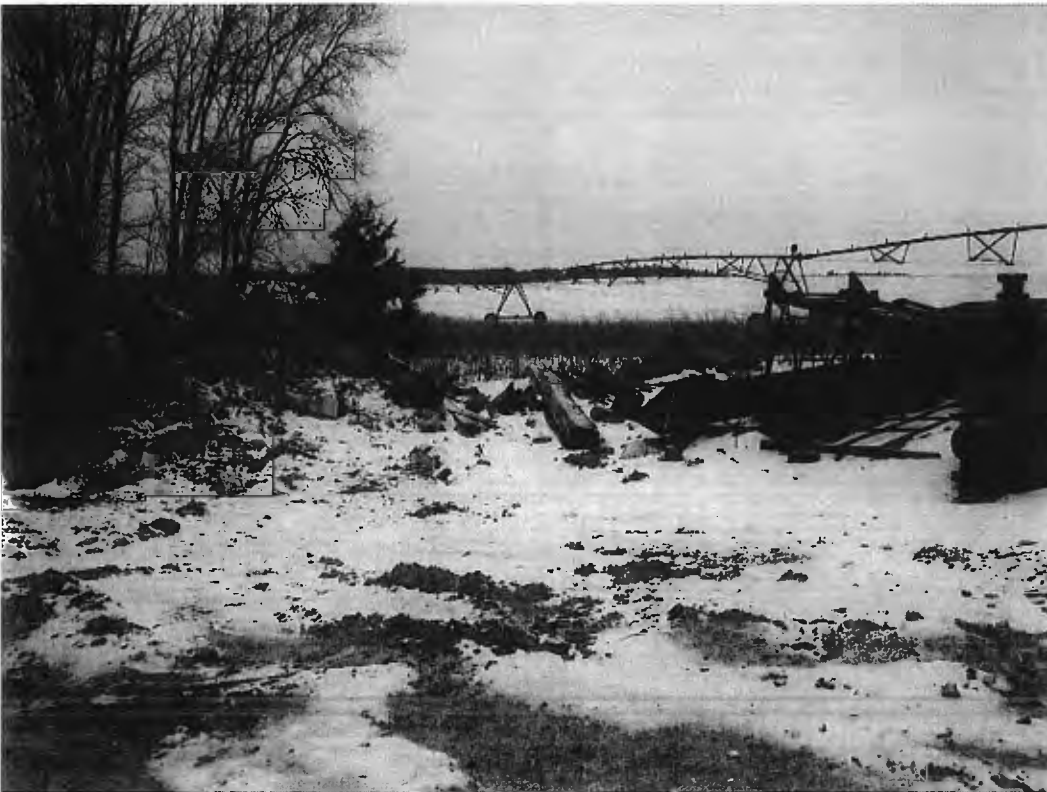
Date: February 7, 2008
Time: 10:28 AM
Direction: W
Photo by: Eisenbrandt
Exposure #: 018
Comments: Timbers, rock, concrete, dirt, and landscape waste located in the south west corner of the facility.

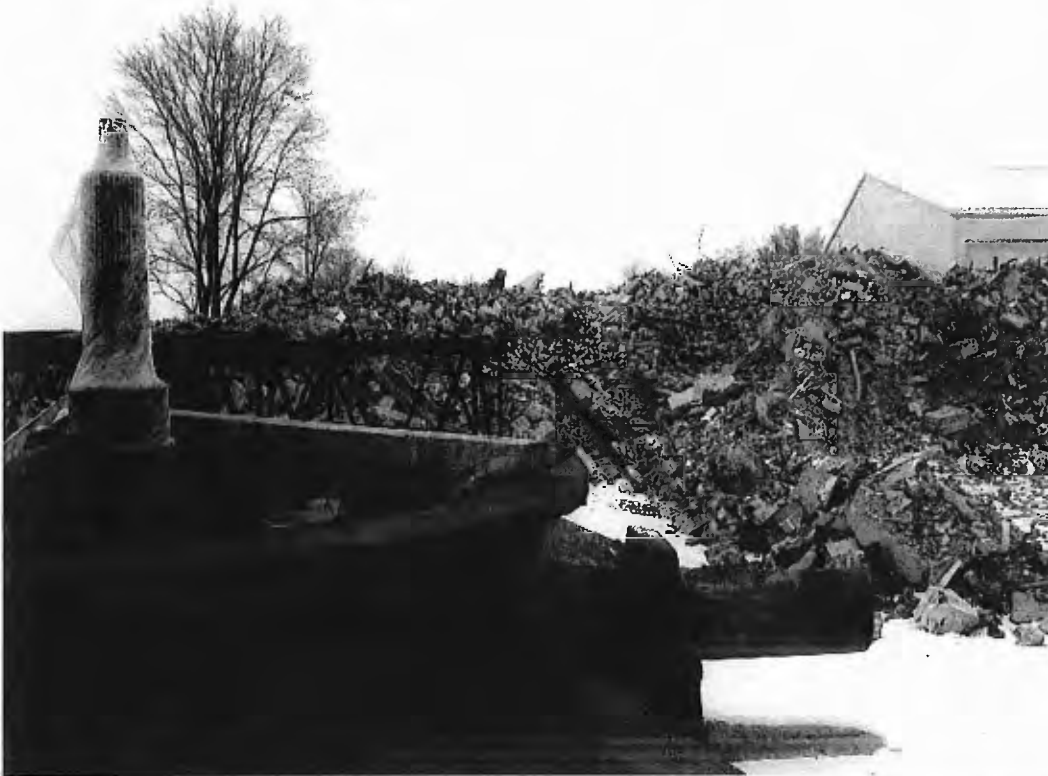
Date: February 7, 2008
Time: 10:28 AM
Direction: NE
Photo by: Eisenbrandt
Exposure #: 019
Comments: Demolition equipment in foreground and piles of demolition debris in background of photograph.

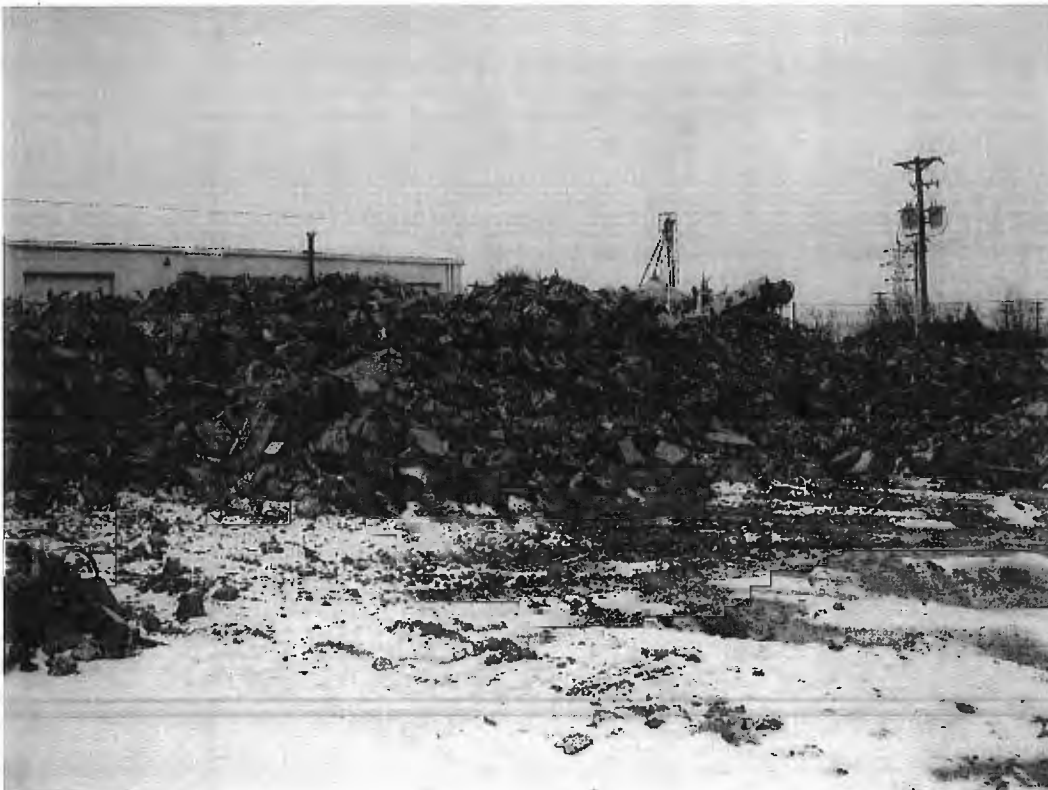
Date: February 7, 2008
Time: 10:28 AM
Direction: NE
Photo by: Eisenbrandt
Exposure #: 020
Comments: Demolition debris.

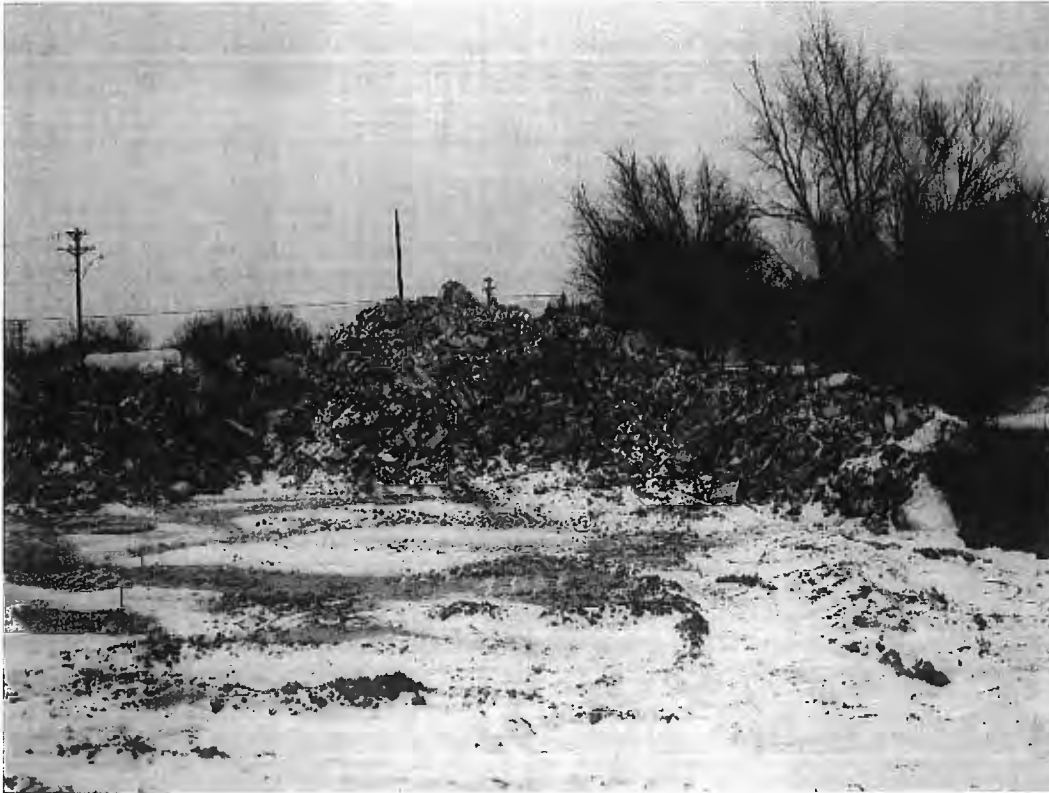
Date: February 7, 2008
Time: 10:28 AM
Direction: SE
Photo by: Eisenbrandt
Exposure #: 021
Comments: Demolition debris.

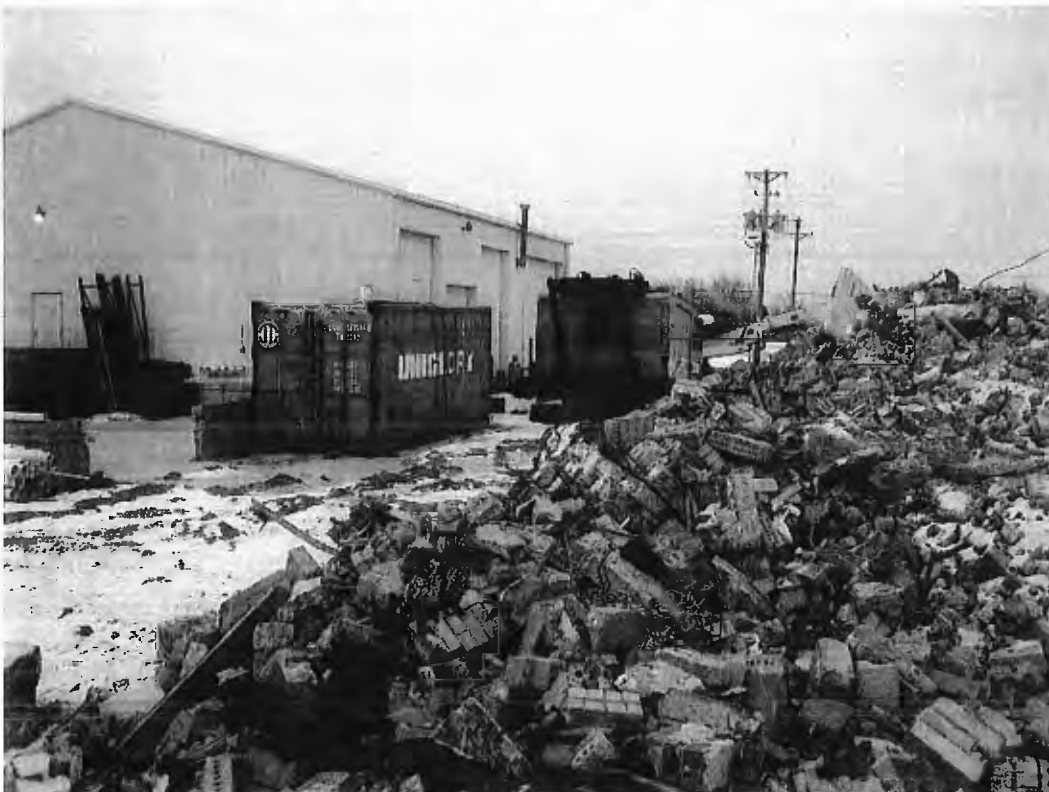
Date: February 7, 2008
Time: 10:31 AM
Direction: E
Photo by: Eisenbrandt
Exposure #: 022
Comments: Demolition debris.

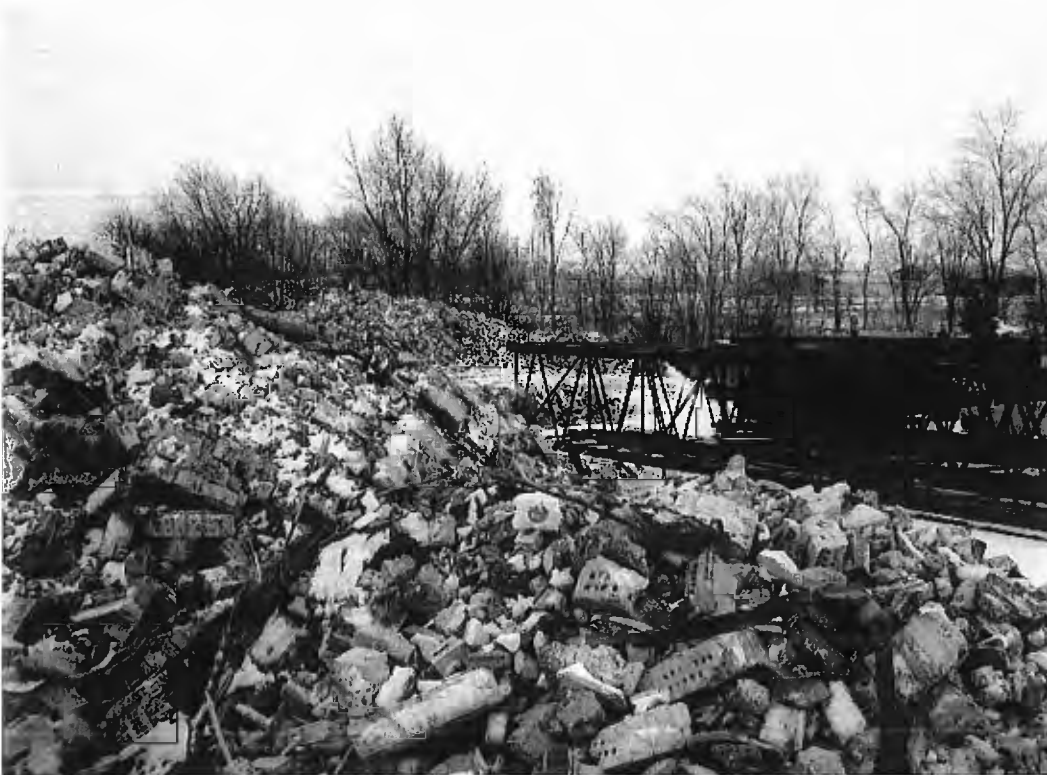
Date: February 7, 2008
Time: 10:31 AM
Direction: S
Photo by: Eisenbrandt
Exposure #: 023
Comments: Alternate view of demolition debris.

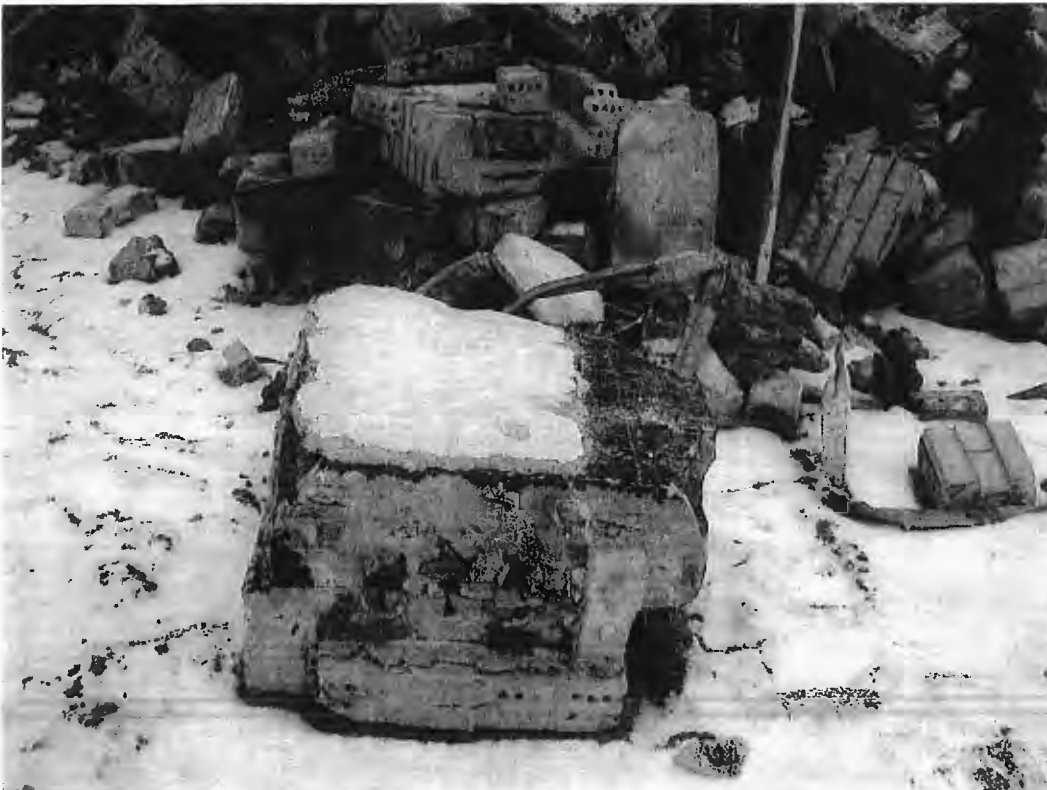
Date: February 7, 2008
Time: 10:31 AM
Direction: S
Photo by: Eisenbrandt
Exposure #: 024
Comments: Material adhered on side of concrete and brick block.

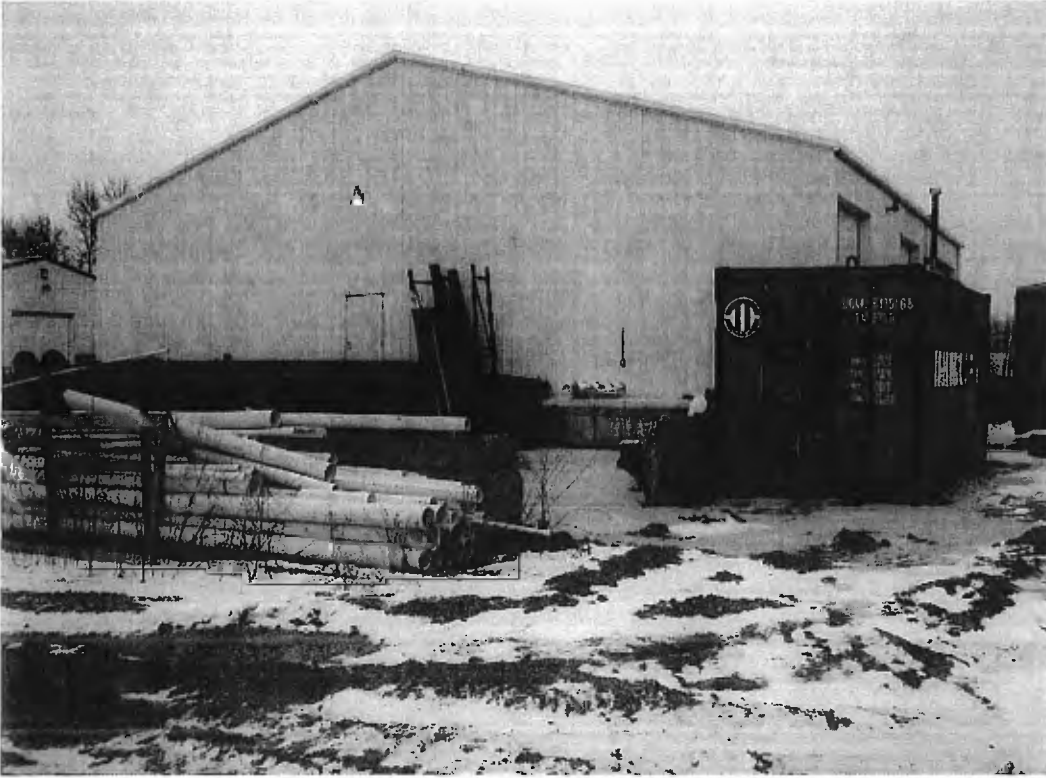
Date: February 7, 2008
Time: 10:32 AM
Direction: E
Photo by: Eisenbrandt
Exposure #: 025
Comments: Material and equipment storage on the northwest side of the maintenance garage.
