ILLINOIS ENVIRONMENTAL PROTECTION AGENCY

ADMINISTRATIVE CITATION

AC 08-26
(IEPA No. 29-08-AC)

File
February 7, 2008 Inspection

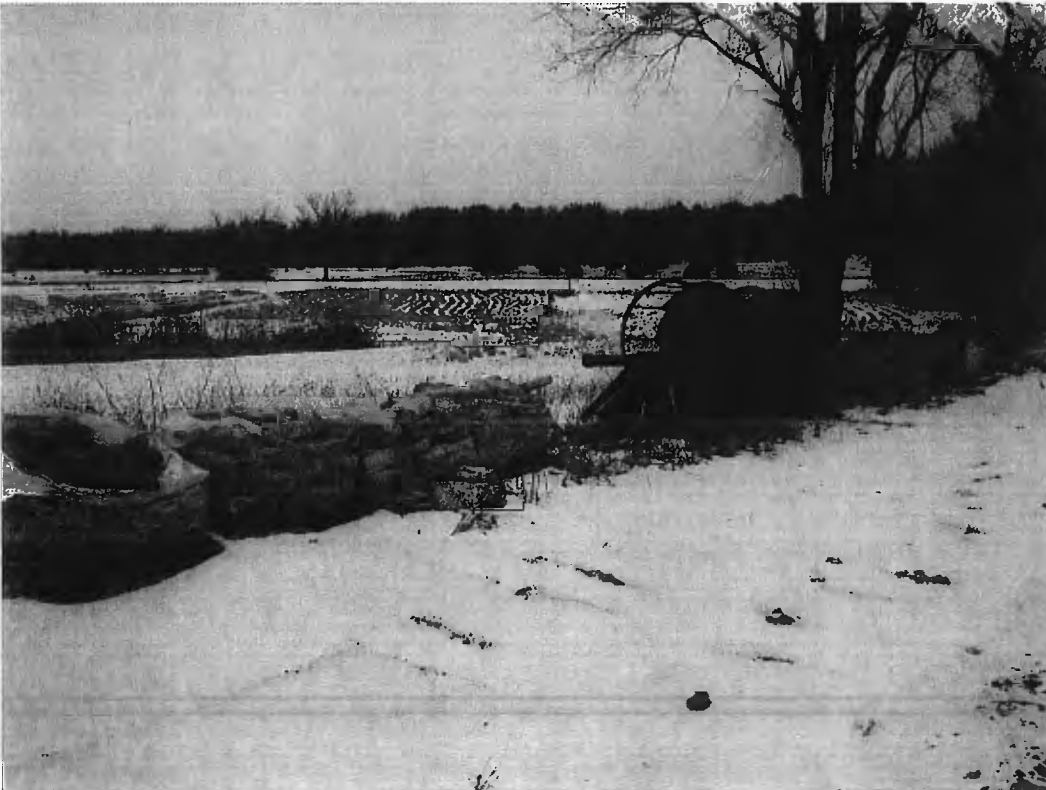
Date: February 7, 2008
Time: 10:32 AM
Direction: NW
Photo by: Eisenbrandt
Exposure #: 026
Comments: Neatly stacked pallets of rock and building materials along western property boundary.

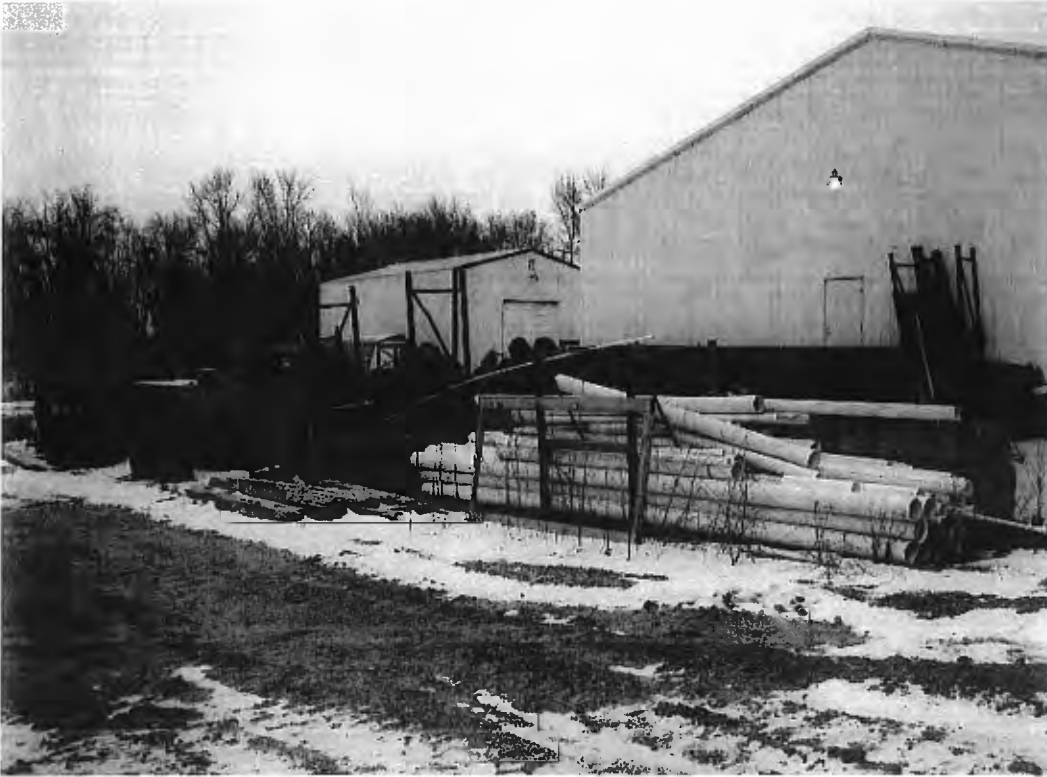
Date: February 7, 2008
Time: 10:32 AM
Direction: NE
Photo by: Eisenbrandt
Exposure #: 027
Comments: Material and equipment storage on the northwest side of the maintenance garage.

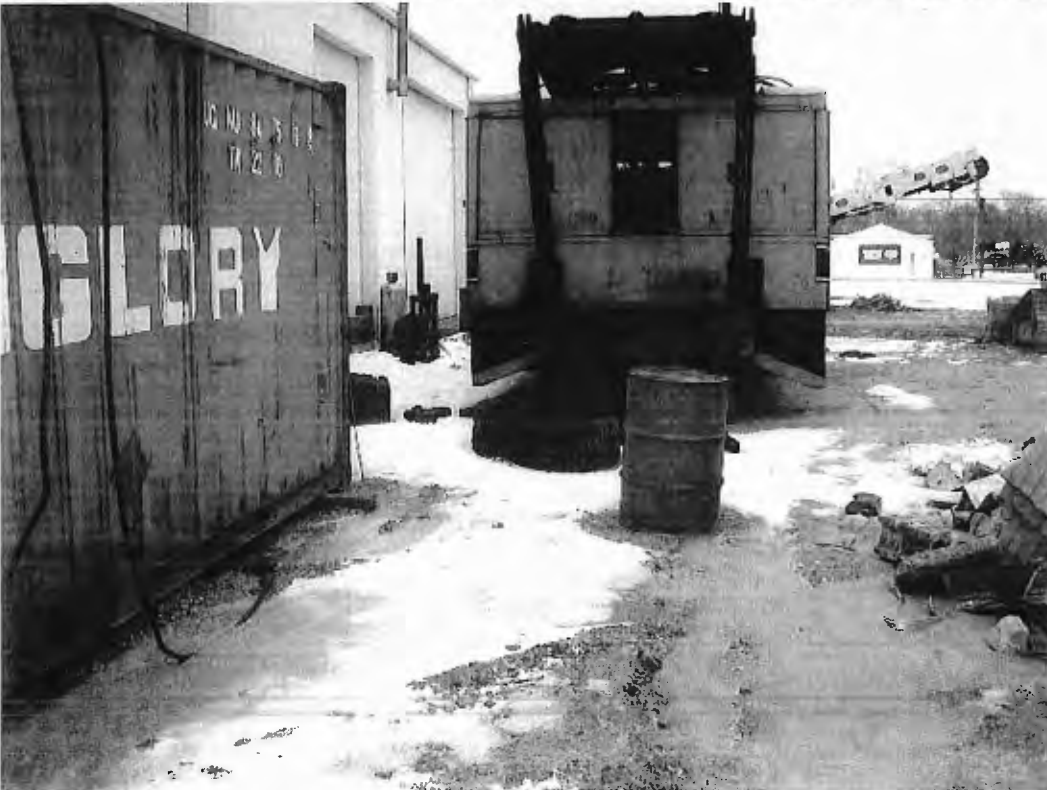
Date: February 7, 2008
Time: 10:33 AM
Direction: SE
Photo by: Eisenbrandt
Exposure #: 028
Comments: A red 55-gallon drum located south of the concrete containment area.

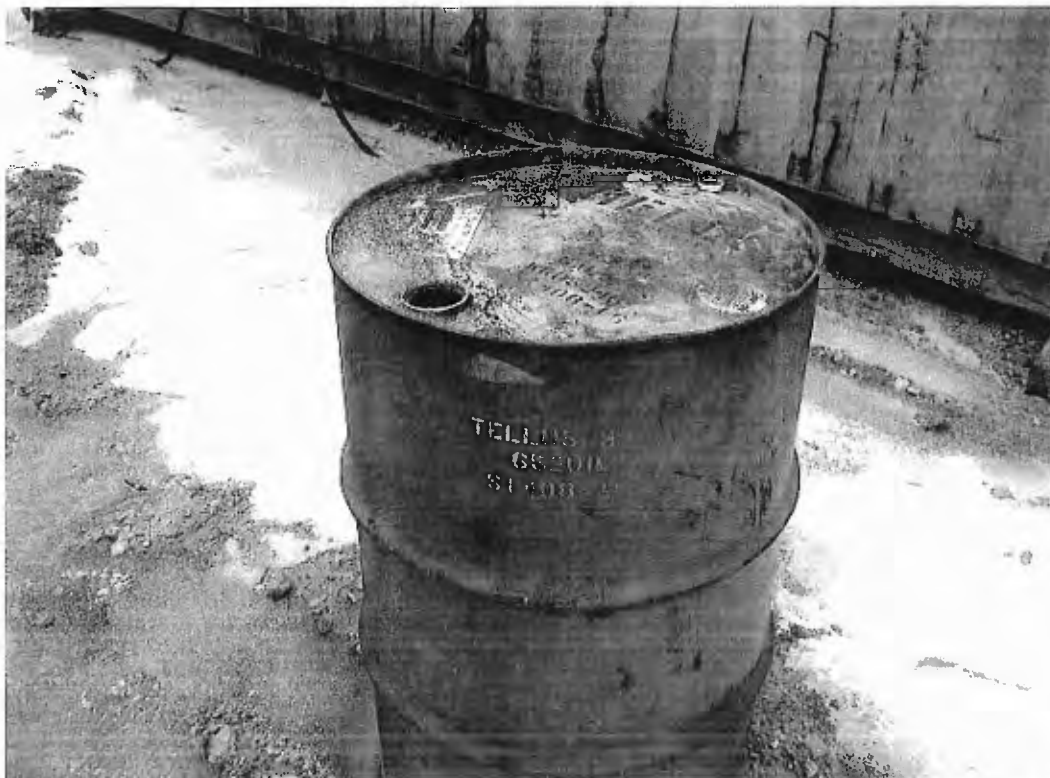
Date: February 7, 2008
Time: 10:33 AM
Direction: N
Photo by: Eisenbrandt
Exposure #: 029
Comments: The drum was open allowing precipitation to enter. The drum was 1/2 full of an oily looking substance.

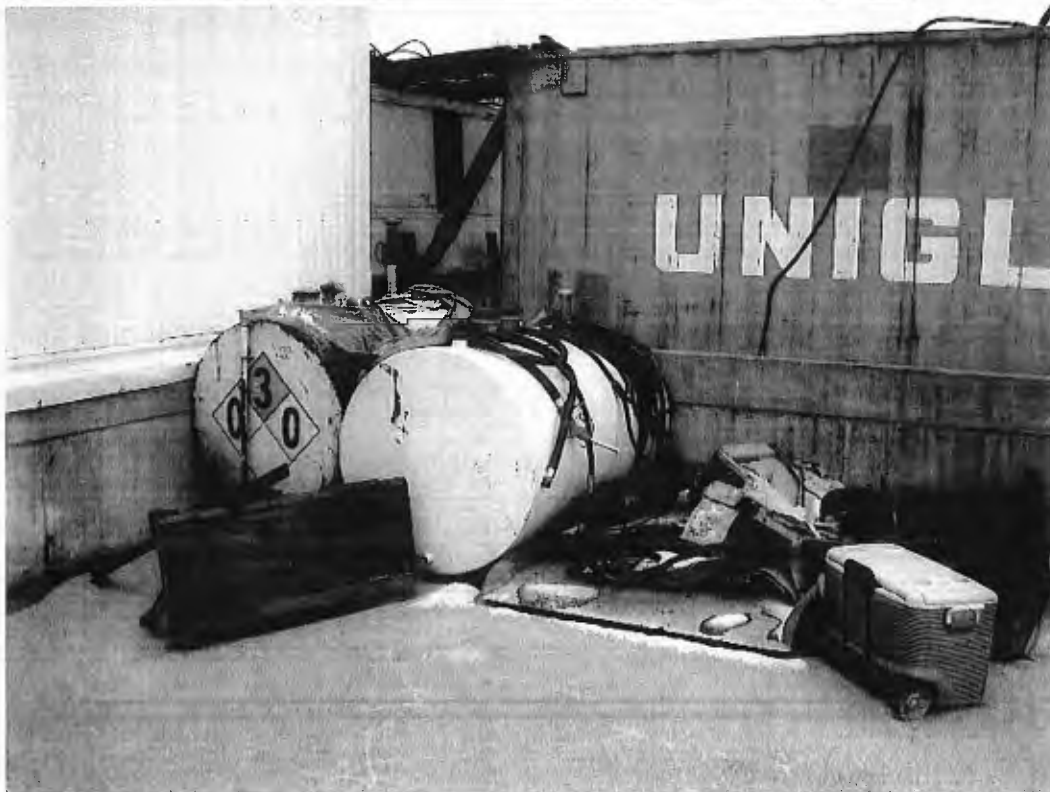
Date: February 7, 2008
Time: 10:35 AM
Direction: SE
Photo by: Eisenbrandt
Exposure #: 030
Comments: Empty storage tanks in the southeast corner of the concrete containment area.

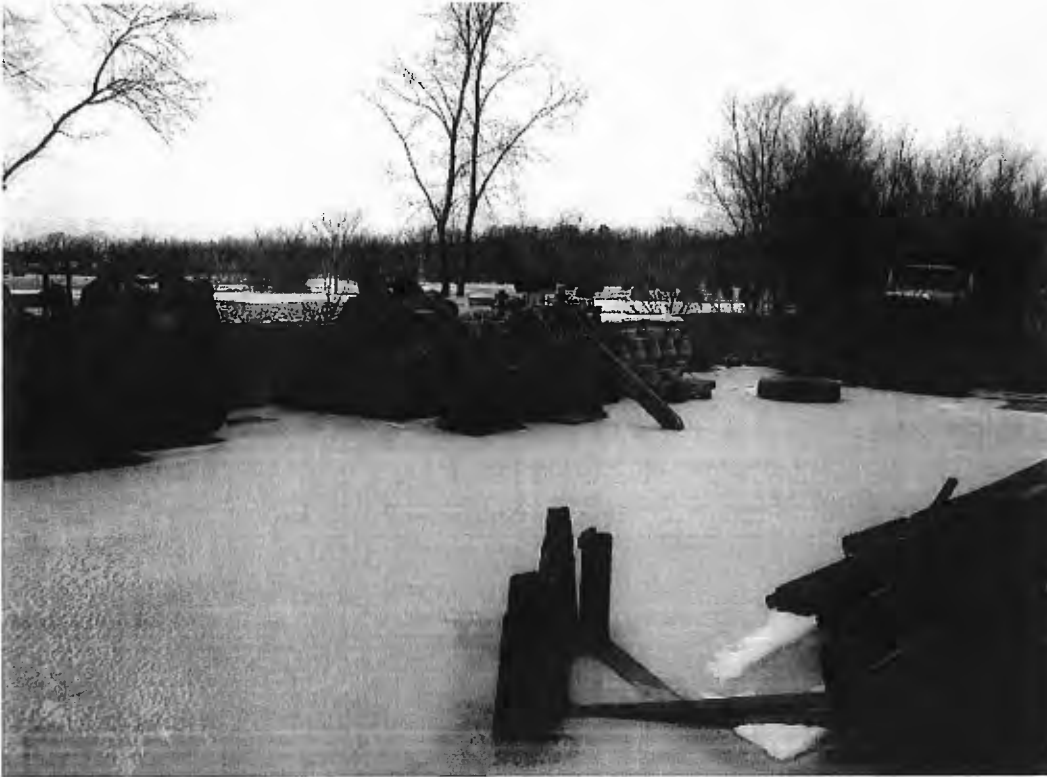
Photograph 031 shows equipment and material storage within the concrete containment area. The concrete deck was covered with one inch thick ice over water. The oil drums previously observed within this area have been moved. Due to the ice and water, it could not be determined if the spilled oil (approximately 15 ft by 25 ft spill observed in July) had been cleaned up.

Date: February 7, 2008
Time: 10:35 AM
Direction: NW
Photo by: Eisenbrandt
Exposure #: 031
Comments: Equipment and material storage in the concrete containment area.

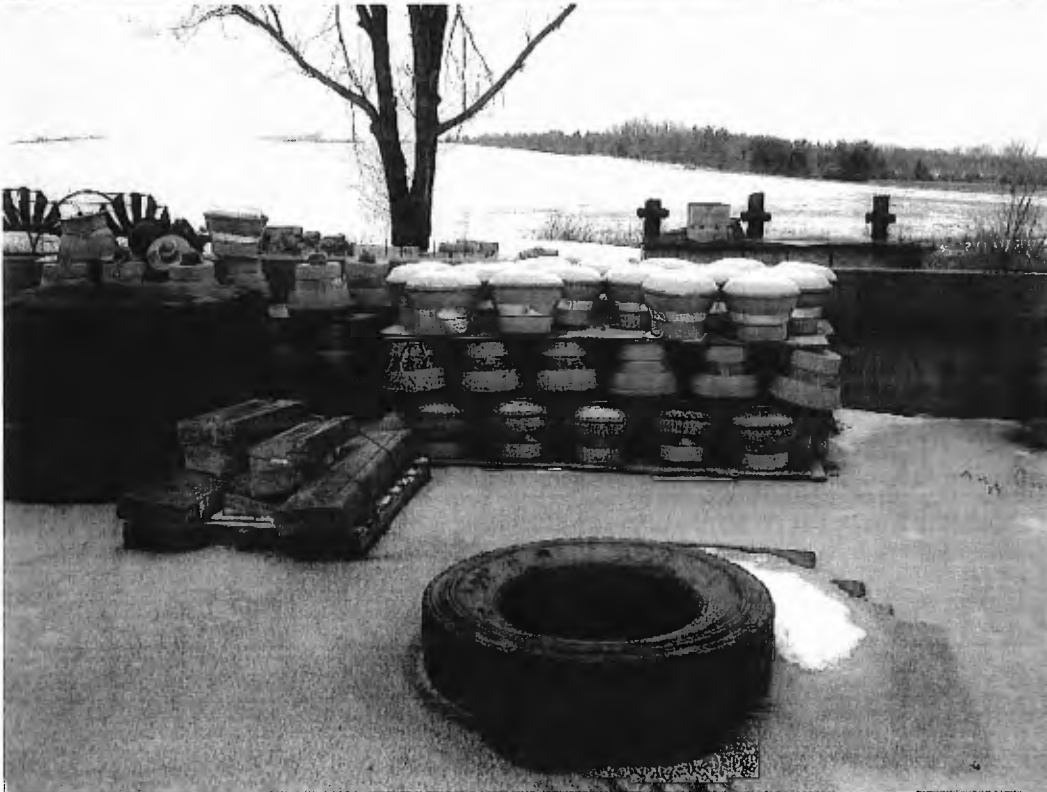
Photograph 032 shows an improperly stored off rim used tire. Used tires must be stored inside or neatly stacked and covered to prevent water accumulation and proliferation of water born insects. The photograph also shows the high pressure sodium industrial lights have been neatly stacked within the concrete containment area. Mr. Fisher claimed a building would be constructed over the concrete containment area and the industrial lights would be used for the building.

Date: February 7, 2008
Time: 10:35 AM
Direction: W
Photo by: Eisenbrandt
Exposure #: 032
Comments: A used off-rim truck tire and neatly stacked high pressure sodium industrial lights within the concrete containment area.

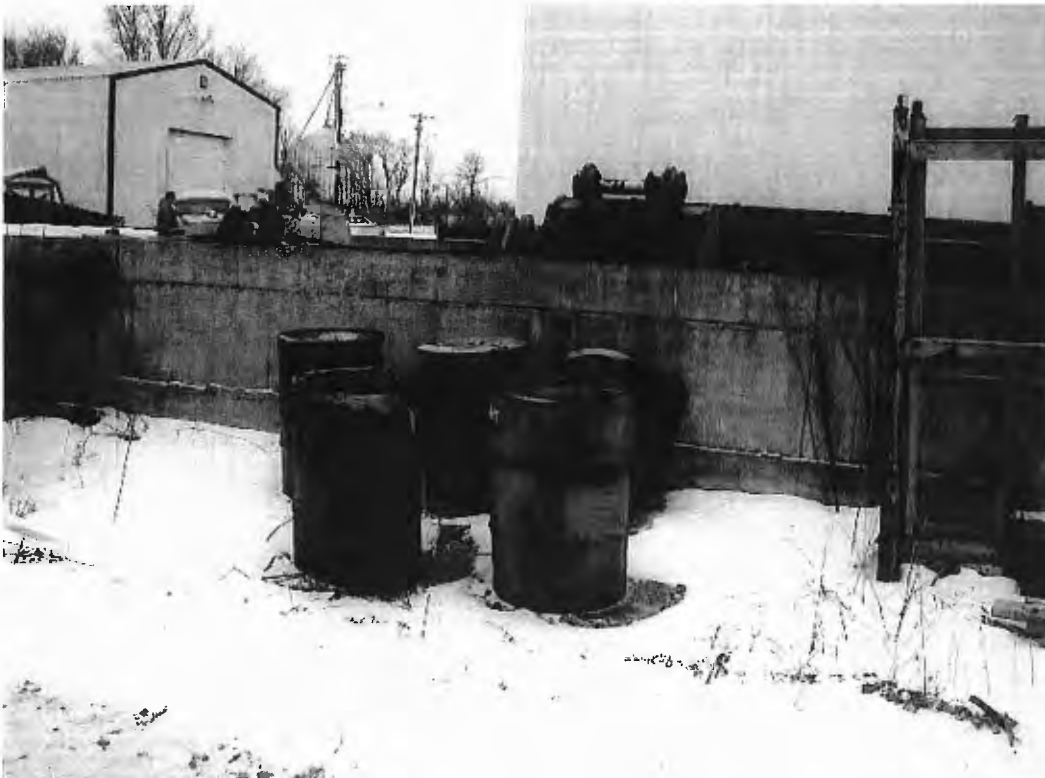
Photograph 033 shows five 55-gallon drums resting on the ground west of the concrete containment area. Initially Mr. Fisher stated the drums were empty. The inspector found two drums to contain fluid. Mr. Fisher stated they were used oil and not properly marked. Mr. Fisher immediately called someone and began asking that person why they were not labeled. The empty black drum was observed tipped up against the concrete wall. The black drum and one of the red drums had make-shift covers out of wrapped black plastic. The nearest drum in the photograph was empty and slightly crushed. One of the drums containing used oil was also not capped allowing precipitation to enter the drum. None of the drums were labeled "Used Oil." All containers of used oil must be labeled with the words "Used Oil."

Date: February 7, 2008
Time: 10:36 AM
Direction: E
Photo by: Eisenbrandt
Exposure #: 033
Comments: Five 55-gallon drums resting on the ground west of the concrete containment area. Two of the drums contained used oil and were not properly marked. The empty black drum was tipped against the concrete wall. One of the drums was open allowing precipitation to enter.

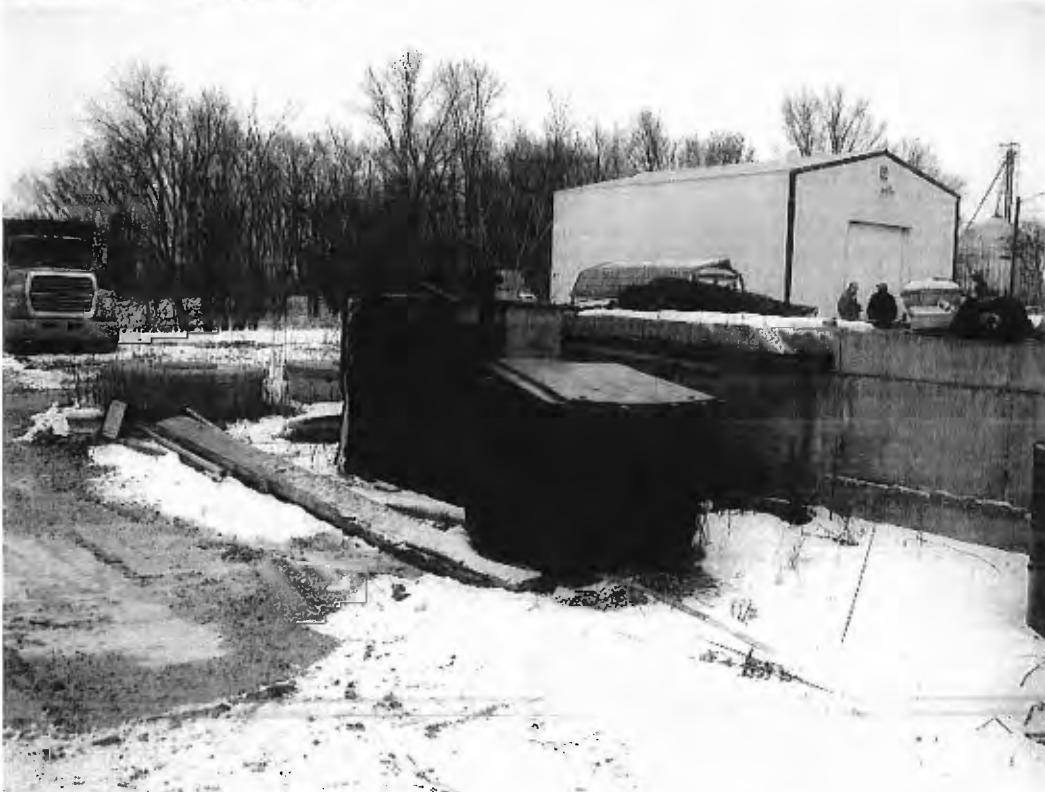
Date: February 7, 2008
Time: 10:36 AM
Direction: NE
Photo by: Eisenbrandt
Exposure #: 034
Comments: Two truck tires that Mr. Fisher claimed were useable.

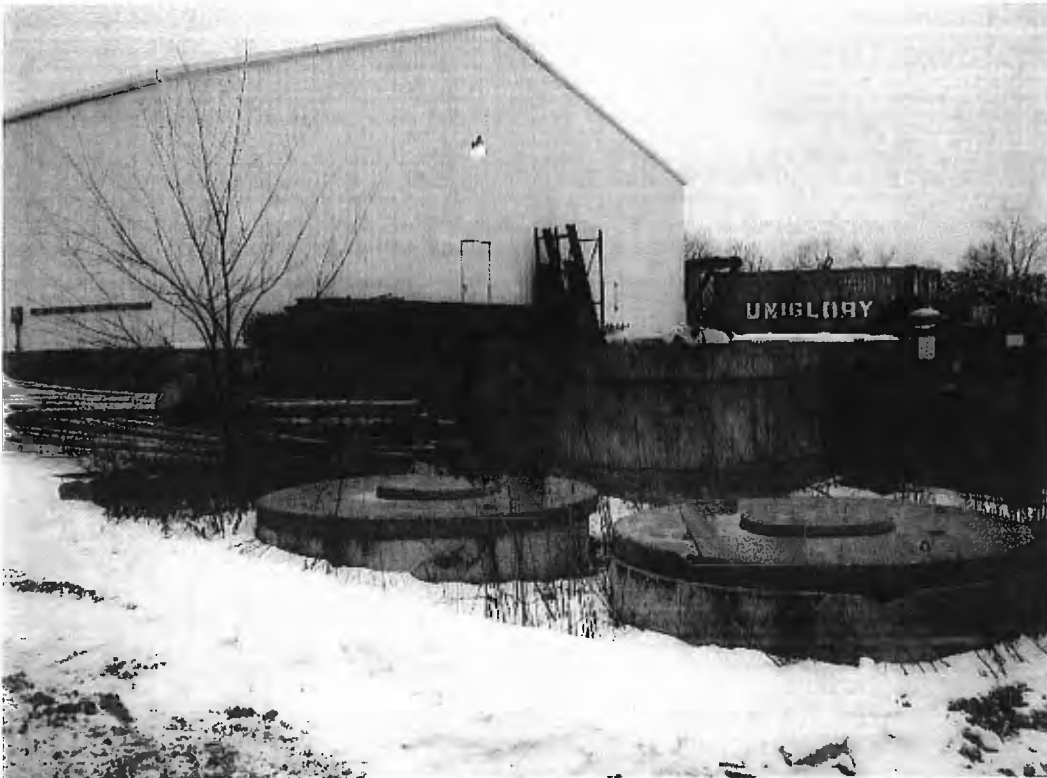
Date: February 7, 2008
Time: 10:41 AM
Direction: SE
Photo by: Eisenbrandt
Exposure #: 035
Comments: Pipe storage and two concrete collection tanks outside the north wall of the containment area.

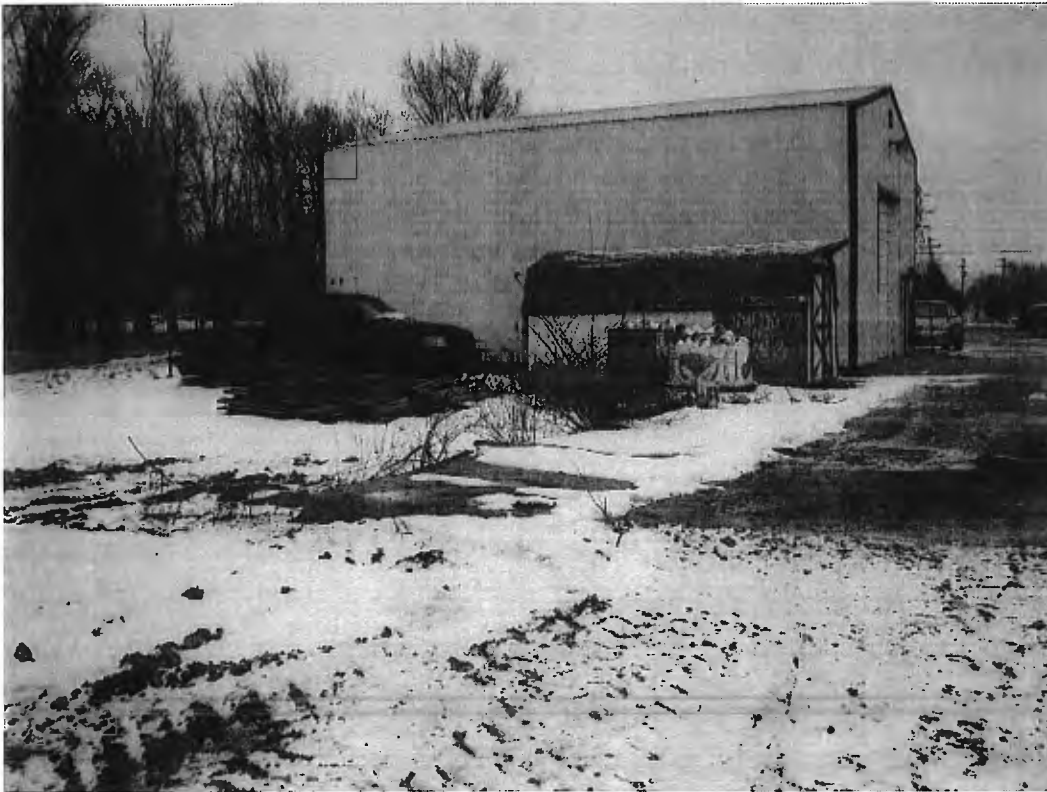
Photograph 036 shows the western side of the building rented by Ferrellgas. The inoperable black Ford F150 pickup was still observed behind the building. The two 55-gallon drums and the steel tank used for open during have been removed since the July 24, 2007 inspection. The open dumped weathered countertop has been cleaned up. No charred waste was observed during this second inspection.

Date: February 7, 2008
Time: 10:41 AM
Direction: E
Photo by: Eisenbrandt
Exposure #: 036
Comments: The two 55-gallon drums and the steel tank used for open burning have been removed since the July 2007 inspection. The inoperable black Ford pick remains west of the Ferrellgas building.

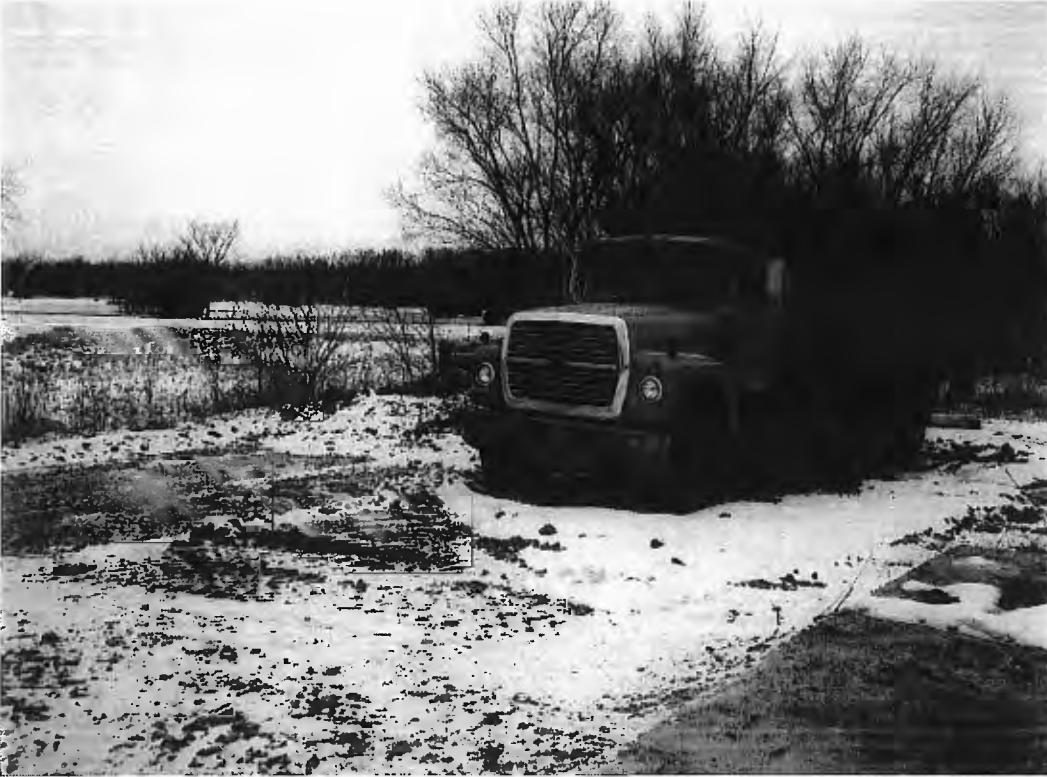
Photograph 037 shows a yellow and black dump truck located in the northeast corner of the facility. It appears as if the vehicle is in operational condition. During the July inspection a partially buried used tire was observed northwest of the containment area. Snow cover prevented the inspector from finding the location.

Date: February 7, 2008
Time: 10:41 AM
Direction: NW
Photo by: Eisenbrandt
Exposure #: 037
Comments: Yellow and black Ford dump truck located in the northwest corner of the facility.

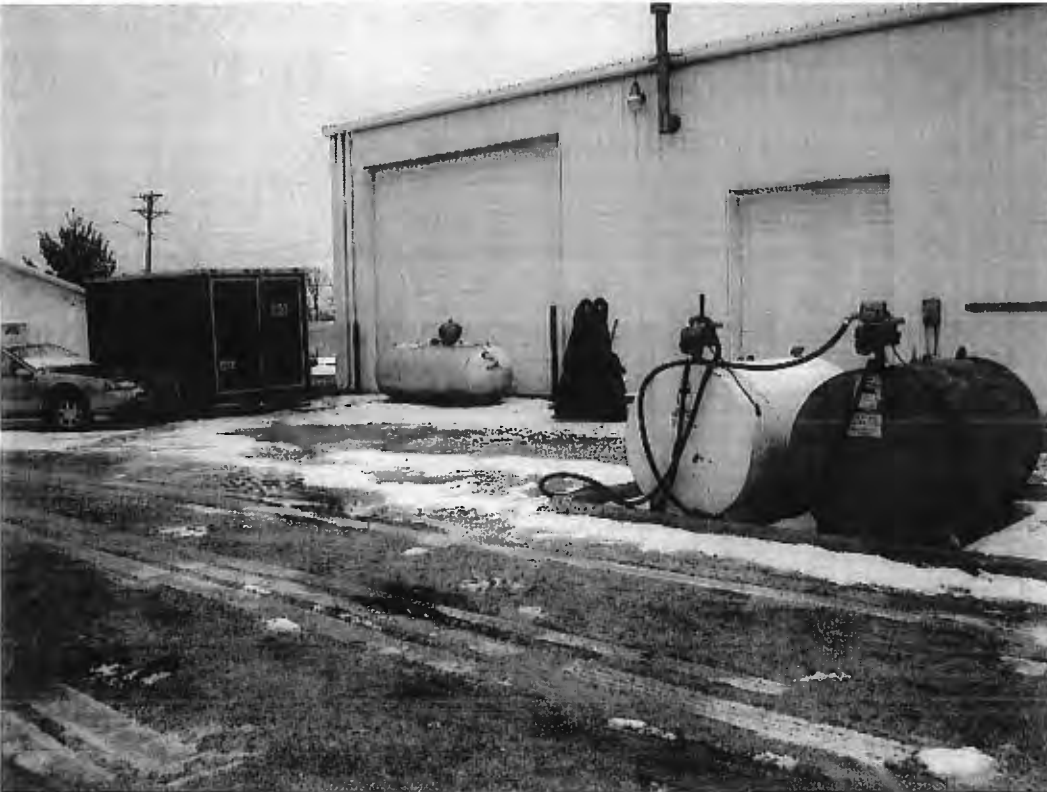
Photograph 038 shows two operational above ground storage tanks on the northeast side of the maintenance garage. No spilled fluids were observed.

Date: February 7, 2008
Time: 10:42 AM
Direction: SE
Photo by: Eisenbrandt
Exposure #: 038
Comments: Operational storage tanks on the north east side of the maintenance garage.

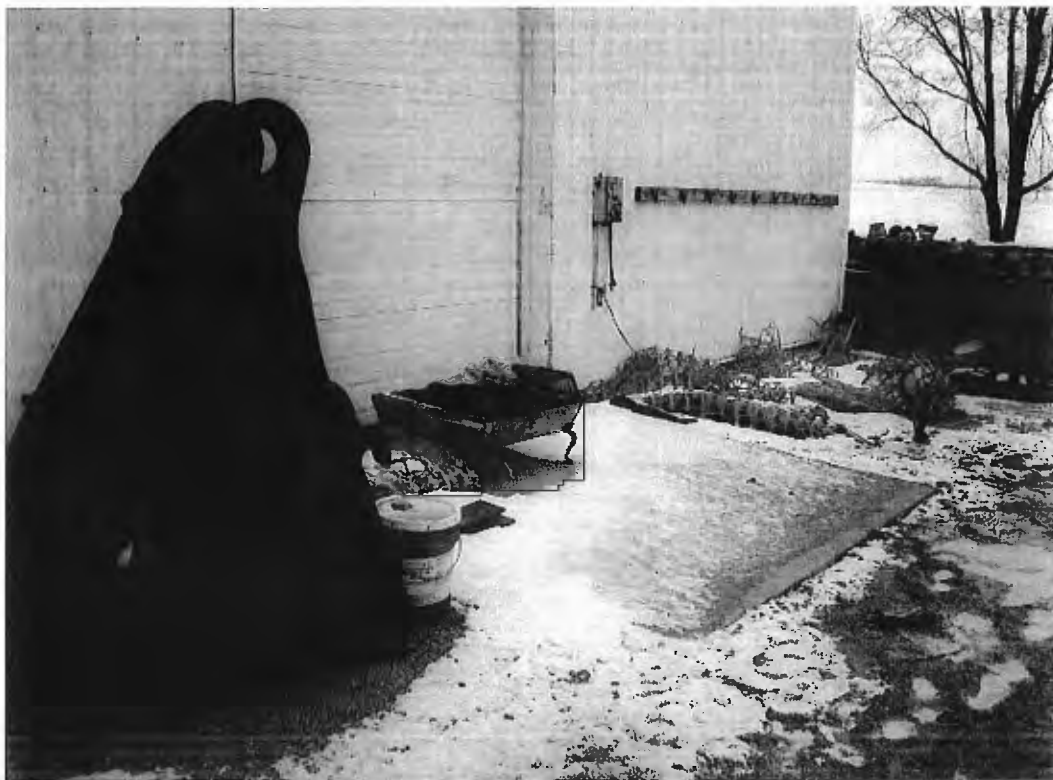
Photographs 039 and 040 show heavy equipment, orange safety fencing, an emergency eye wash station, dimensional lumber, a small barbeque grill, a patio fireplace, a cardboard box, and two empty hydraulic oil buckets along the northeast side of the maintenance garage. The oil buckets and some of the other items appeared in disarray and should be cleaned up. The burn barrel/waste can observed here during the July inspection has been removed.

Date: February 7, 2008
Time: 10:43 AM
Direction: SW
Photo by: Eisenbrandt
Exposure #: 039
Comments: Heavy equipment, orange safety fencing, an emergency eye wash station, a patio fireplace, and an empty hydraulic oil bucket located on northeast side of maintenance garage.

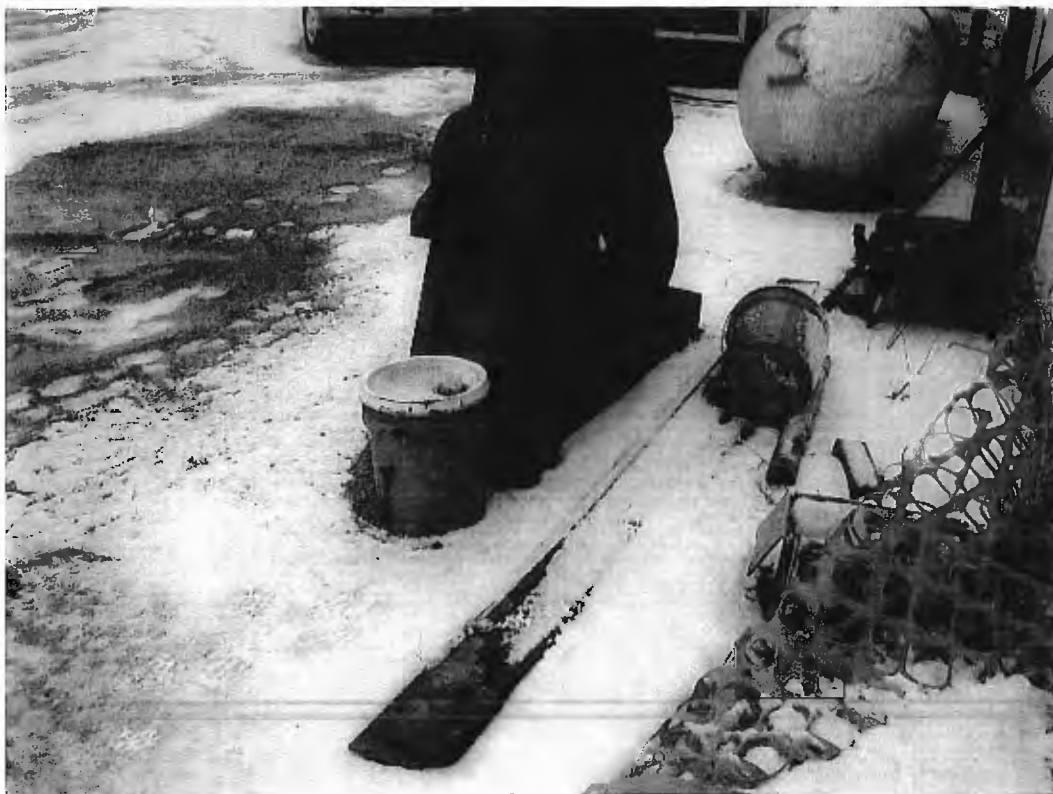
Date: February 7, 2008
Time: 10:43 AM
Direction: E
Photo by: Eisenbrandt
Exposure #: 040
Comments: Two empty hydraulic oil buckets on the northeast side of the maintenance garage.

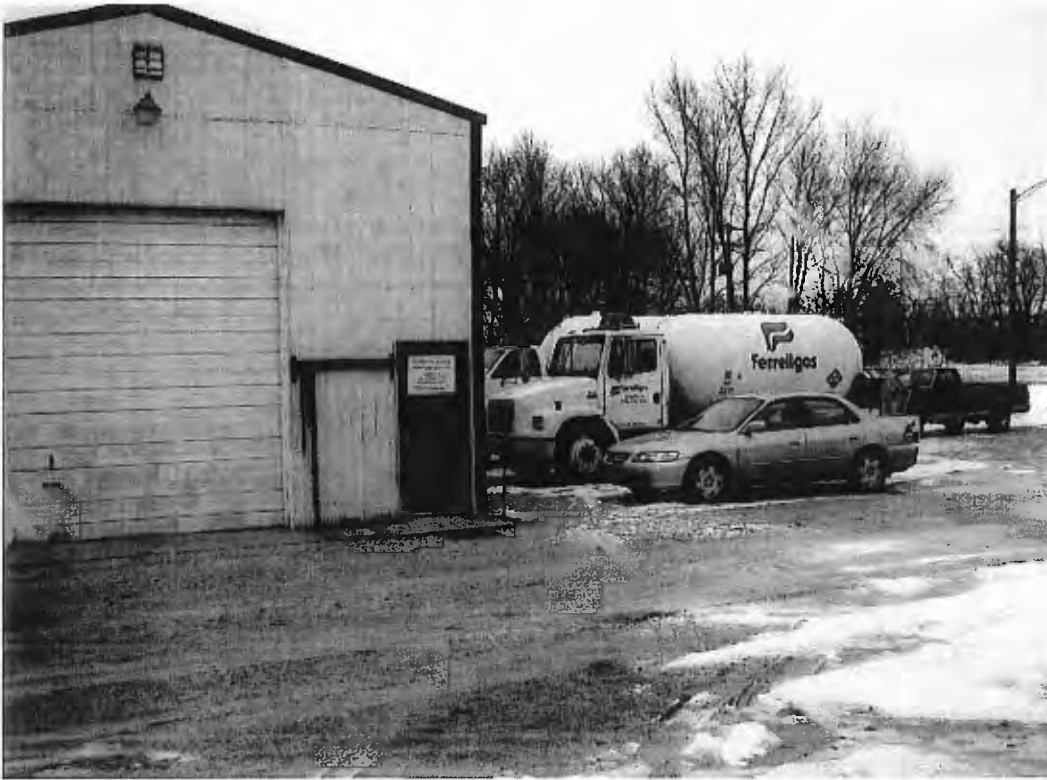
Date: February 7, 2008
Time: 10:44 AM
Direction: NE
Photo by: Eisenbrandt
Exposure #: 041
Comments: Ferrelgas of Manito is still renting the north building, shed, and parking spaces.

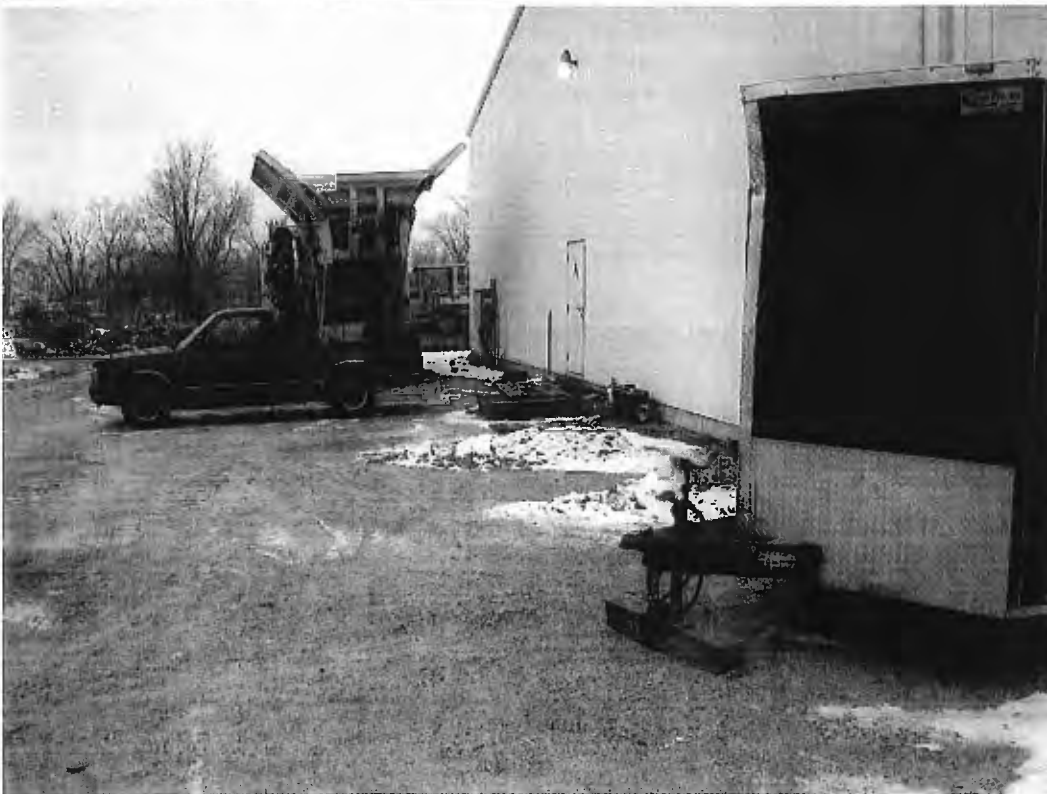
Date: February 7, 2008
Time: 10:44 AM
Direction: SW
Photo by: Eisenbrandt
Exposure #: 042
Comments: Alternate view of southeast side of maintenance garage.

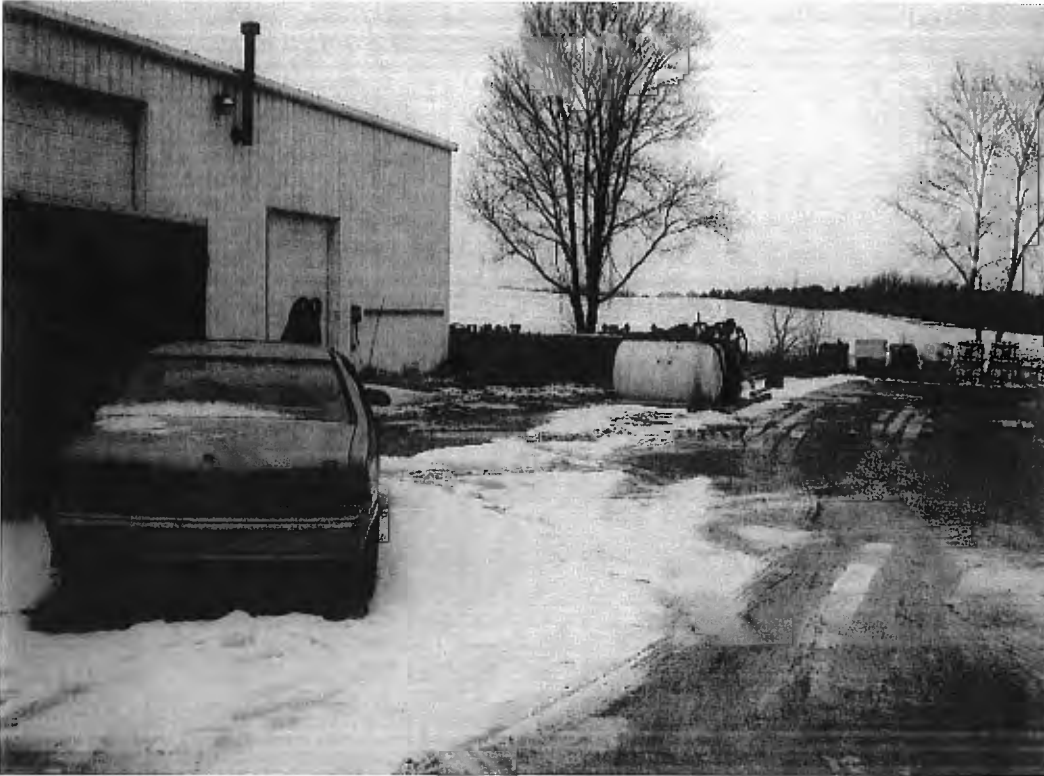
Photograph 043 shows a Ford Thunderbird without current tags. The engine hood was also missing and the vehicle appears inoperable.

Date: February 7, 2008
Time: 10:44 AM
Direction: SW
Photo by: Eisenbrandt
Exposure #: 043
Comments: The Ford Thunderbird without current tags or engine hood appears inoperable.

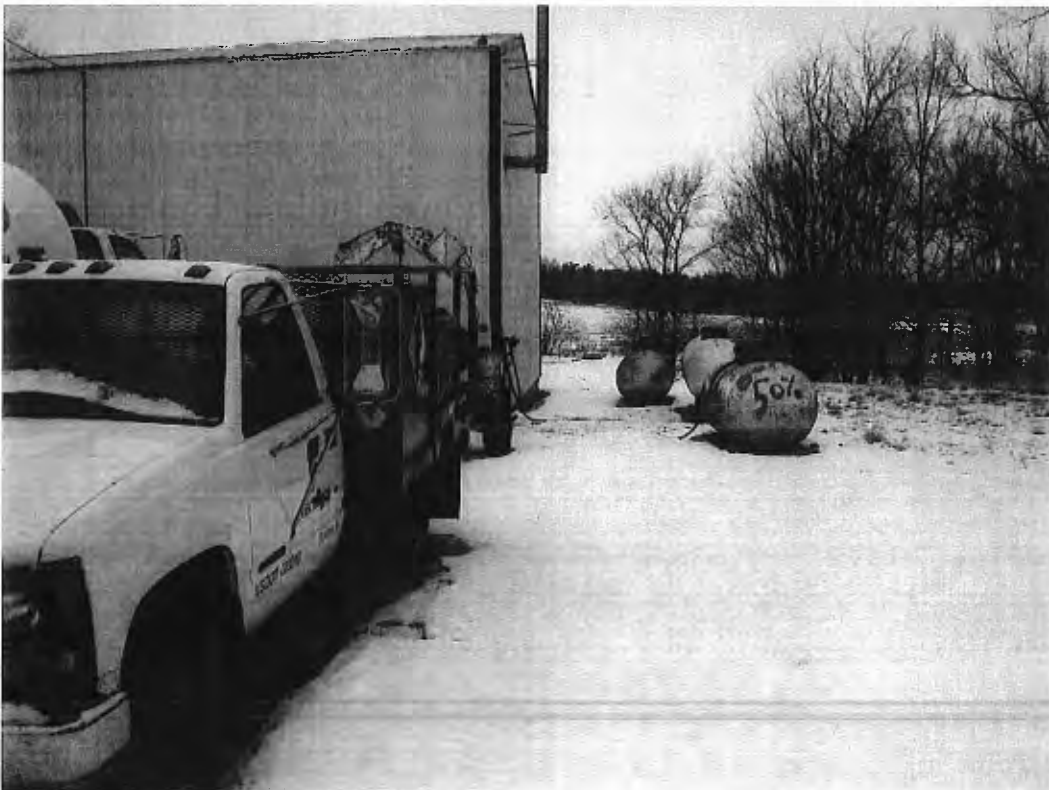
Date: February 7, 2008
Time: 10:45 AM
Direction: NW
Photo by: Eisenbrandt
Exposure #: 044
Comments: View of northern property line facing northwest. Ferrellgas has three propane tanks, one in use for the building.

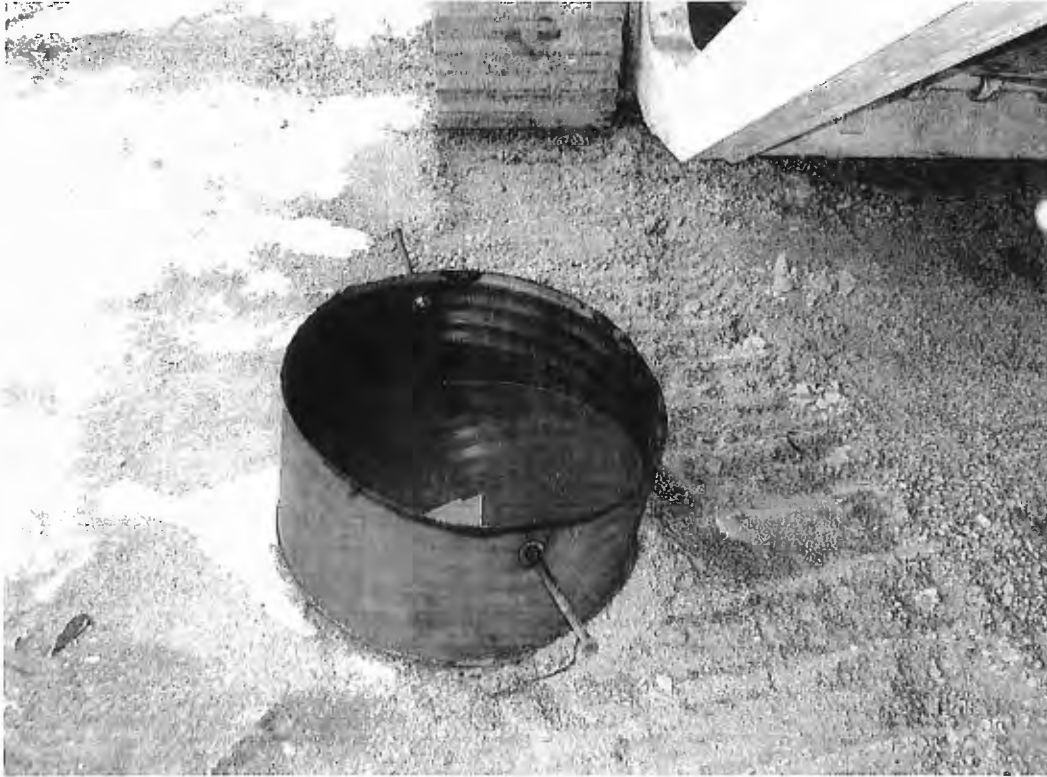
Date: February 7, 2008
Time: 10:48 AM
Direction: N
Photo by: Eisenbrandt
Exposure #: 045
Comments: One-half full open top container of an oily liquid and sludge substance located near the crusher and the southeast corner of the maintenance garage.

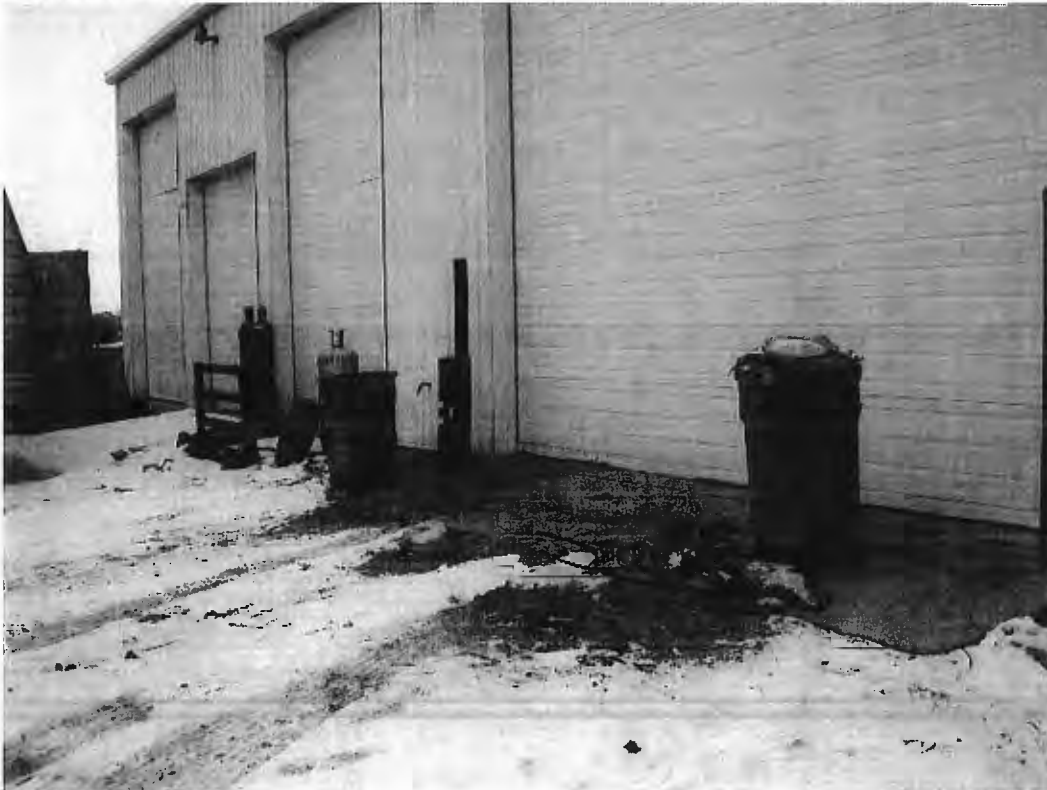
Photograph 046 shows a used tire, two garbage cans (one spilling waste onto the ground) and gas cylinders observed on the southwest side of the maintenance garage. Although some items may not be waste, their haphazard storage around the building appears as open dumped waste and careless housekeeping. Due to the snow cover, the minor petroleum staining previously observed on the gravel in front of the large overhead door could not be inspected. The inspector did not investigate the inside of the maintenance garage.

Date: February 7, 2008
Time: 10:48 AM
Direction: NW
Photo by: Eisenbrandt
Exposure #: 046
Comments: A used tire, two garbage cans (one spilling waste onto the ground) and gas cylinders observed on the southwest side of the maintenance garage.

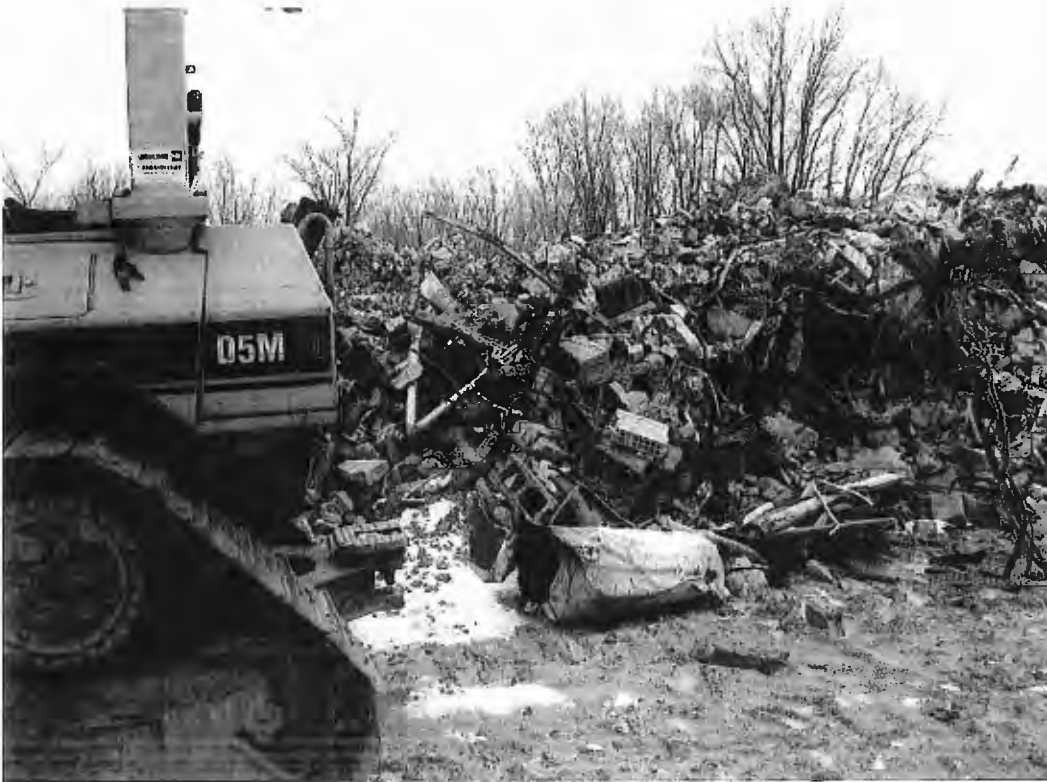
Photographs 047 and 048 show additional views of the demolition debris. A hot water heater, brick, concrete, cinder block, carpet, rebar, insulation material, cyclone fencing, aluminum blinds, and scrap metal were observed among the demolition debris.

Date: February 7, 2008
Time: 10:48 AM
Direction: SW
Photo by: Eisenbrandt
Exposure #: 047
Comments: A hot water heater, brick, concrete, cinder block, insulation material, carpet, cyclone fencing, aluminum window blinds, and scrap metal were among the demolition debris observed.

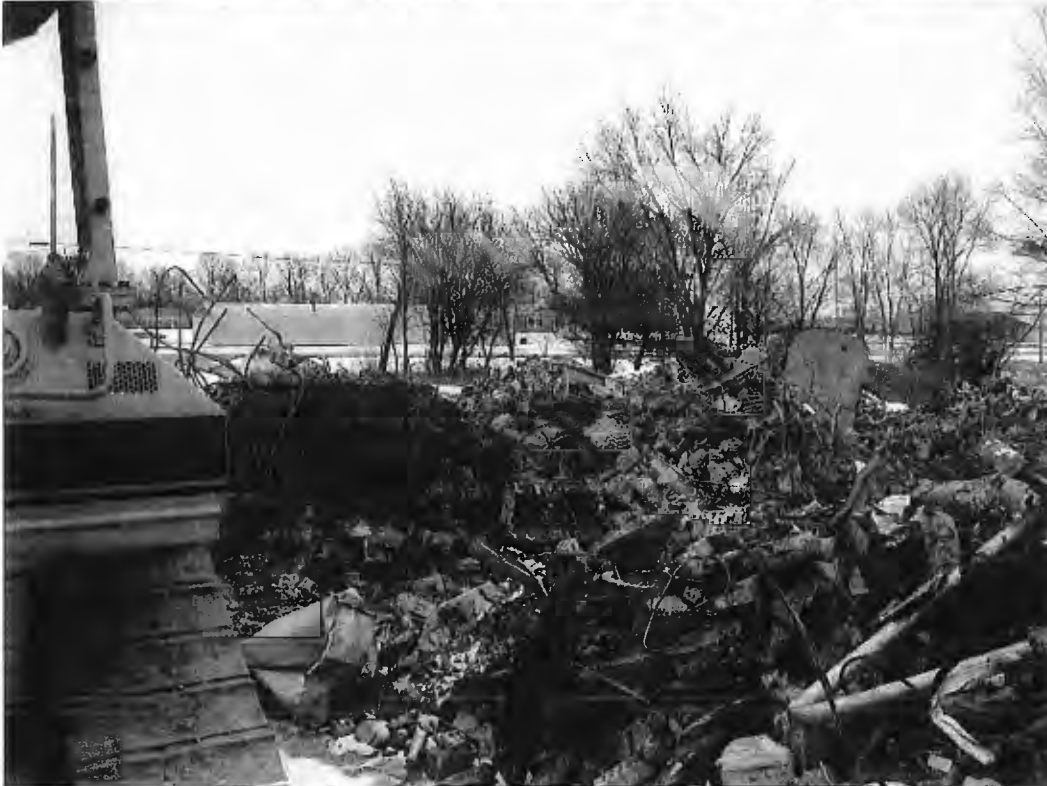
Date: February 7, 2008
Time: 10:48 AM
Direction: S
Photo by: Eisenbrandt
Exposure #: 048
Comments: Alternate view of demolition debris.

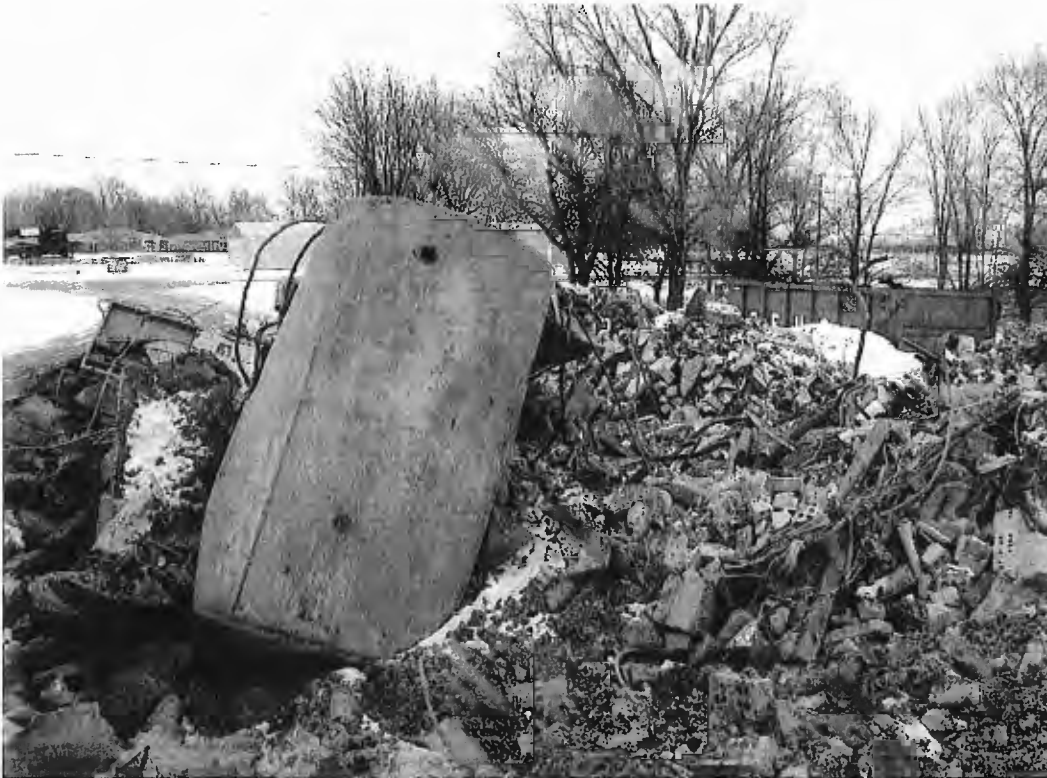
Photographs 049 and 050 show a large steel tank and a compressor cylinder observed with the demolition debris.

Date: February 7, 2008
Time: 10:49 AM
Direction: SE
Photo by: Eisenbrandt
Exposure #: 049
Comments: A large steel tank was observed with the demolition debris.

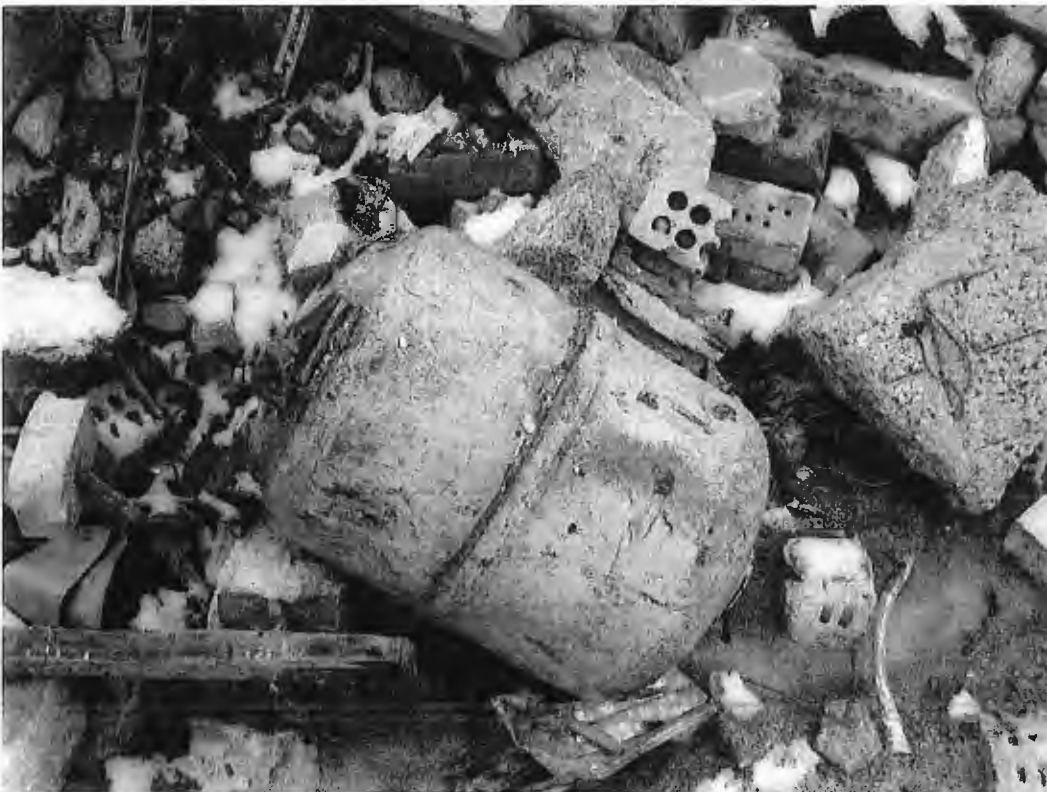
Date: February 7, 2008
Time: 10:51 AM
Direction: SW
Photo by: Eisenbrandt
Exposure #: 050
Comments: A compressor cylinder was observed among the demolition debris.
