ILLINOIS ENVIRONMENTAL PROTECTION AGENCY

ADMINISTRATIVE CITATION

AC 08-26
(IEPA No. 29-08-AC)

File
February 7, 2008 Inspection

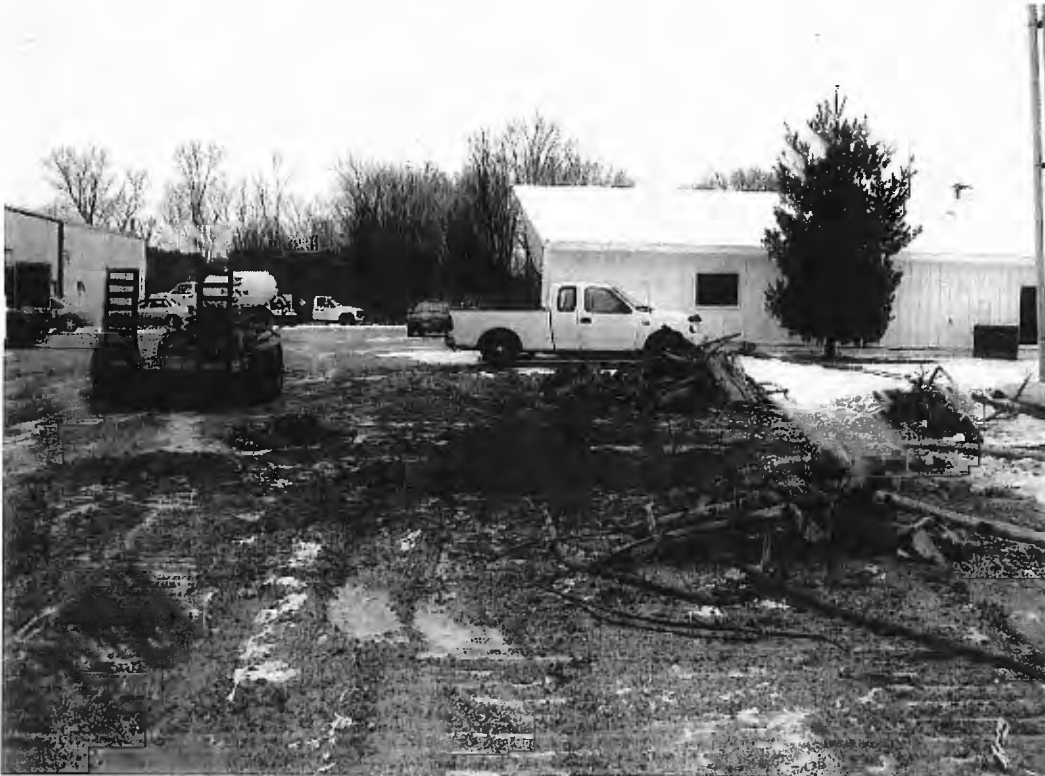
Date: February 7, 2008
Time: 10:52 AM
Direction: NE
Photo by: Eisenbrandt
Exposure #: 051
Comments: Alternate view of the scrap metal piles.

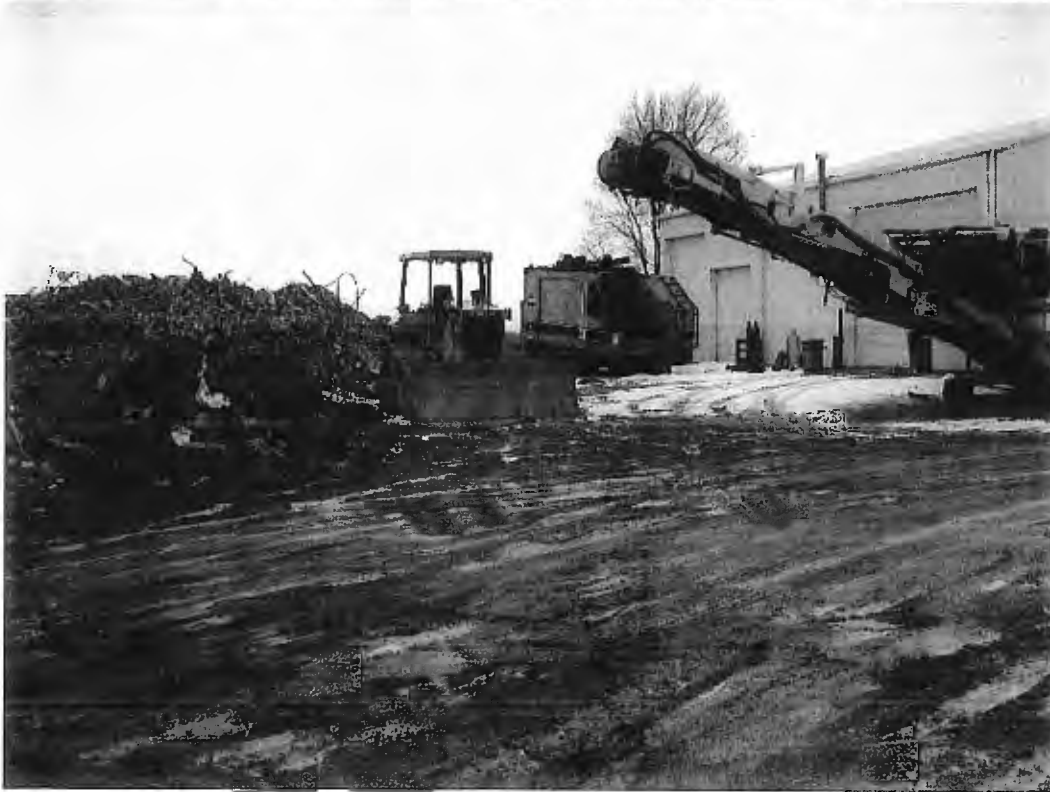
Date: February 7, 2008
Time: 10:52 AM
Direction: NW
Photo by: Eisenbrandt
Exposure #: 052
Comments: Alternate view of demolition debris and heavy equipment.
