MEMORANDUM

DATE: December 18, 2008  
TO: Regional File  
FROM: Karen Katamay, DWPC/FOS – Des Plaines  
SUBJECT: Super Mix Inc. – Spring Grove, IL  
NPDES No. ILR006479

On November 12, 2008, an industrial stormwater site inspection was conducted at the subject property. The inspection was conducted as the result of a referral from the McHenry County SWCD about contaminated runoff from the property. Accompanying me on the inspection was Tom Mattingly of the McHenry County SWCD. The facility is located at 2203 Spring Ridge Drive in Spring Grove, IL.

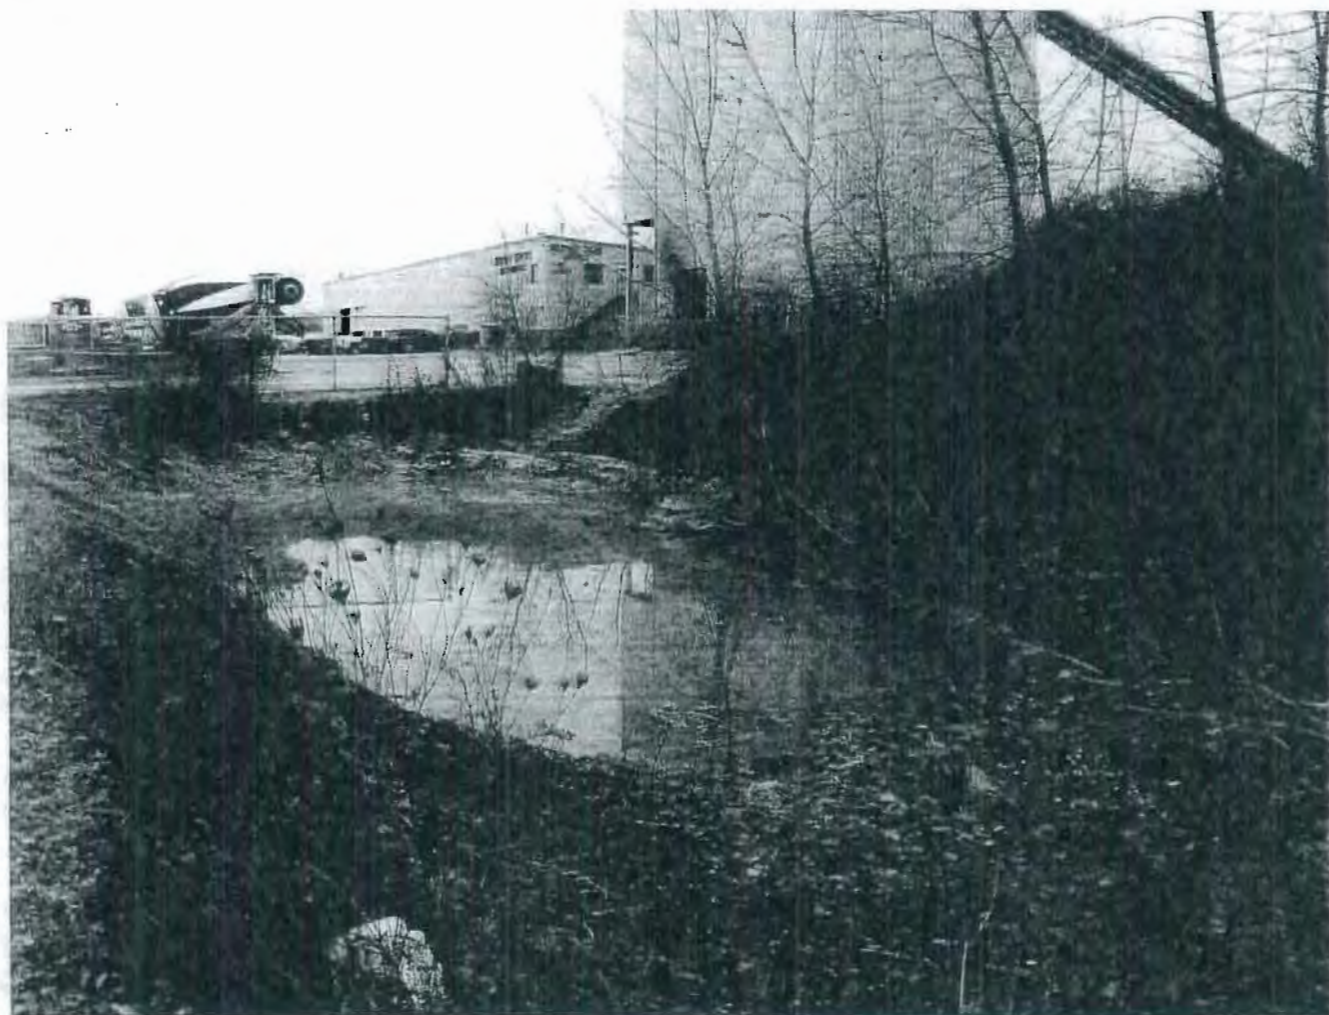
The site has their truck washout area near the front edge of the property (northwest corner) and allows the runoff from the washout area to go to a settling basin that is located in the road ditch for Spring Ridge Drive. This settling basin is located outside of the property's fence line and is able to overflow to the road ditch. The flow path of this discharge was followed and deposits from the wash water were shown to travel well beyond the facility and also across the street to the north road ditch and into a storm sewer catch basin.

Photo 1 – Settling pond for concrete truck wash water adjacent to Spring Ridge Drive

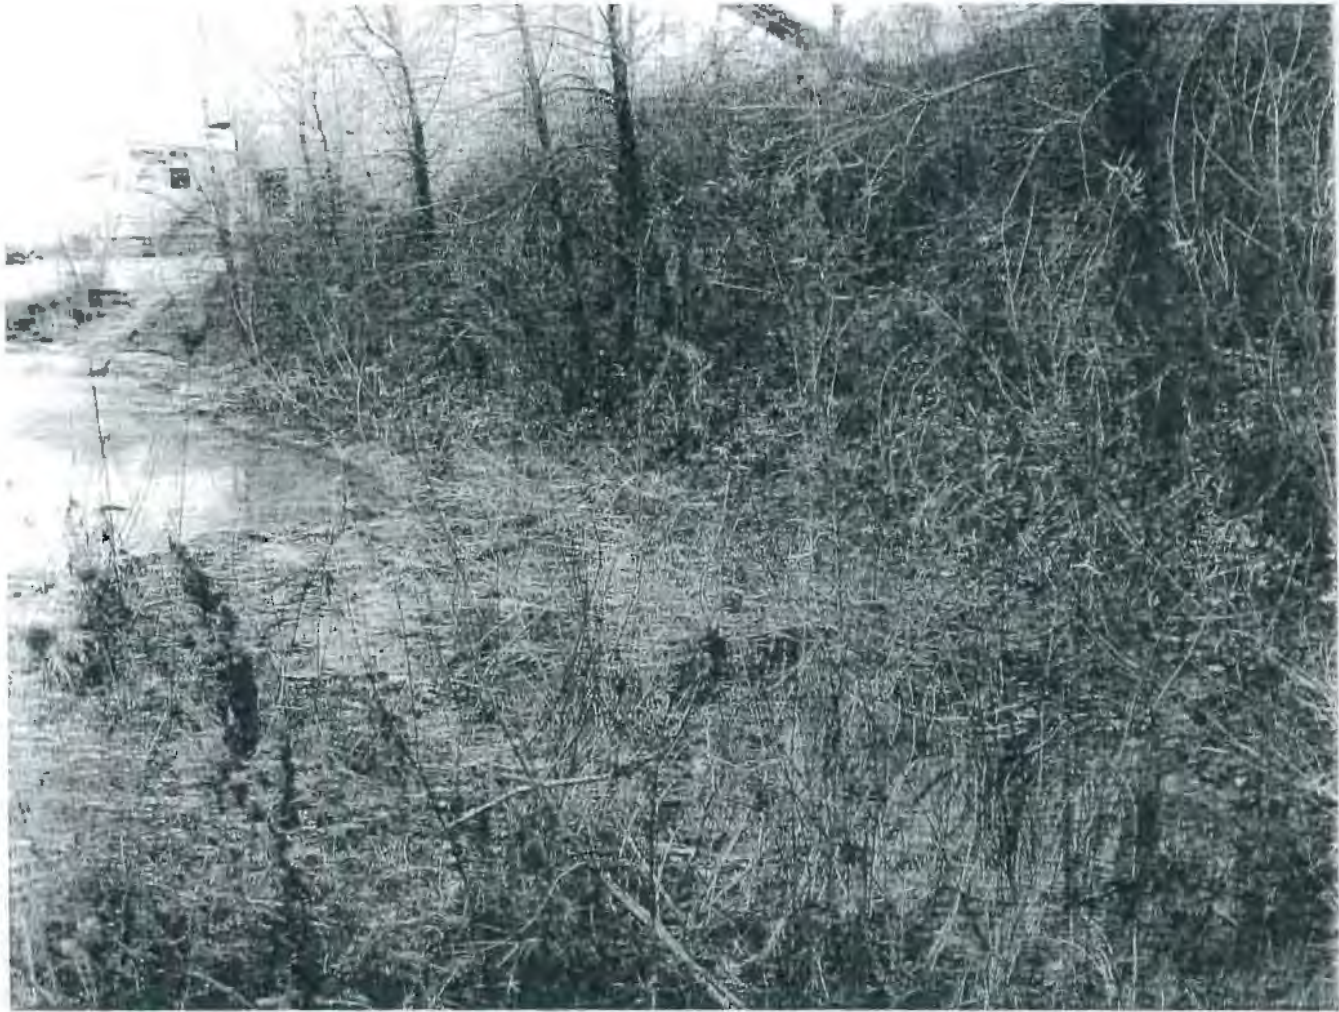
Photo 2 – Flow path of contaminated water to west through the road ditch

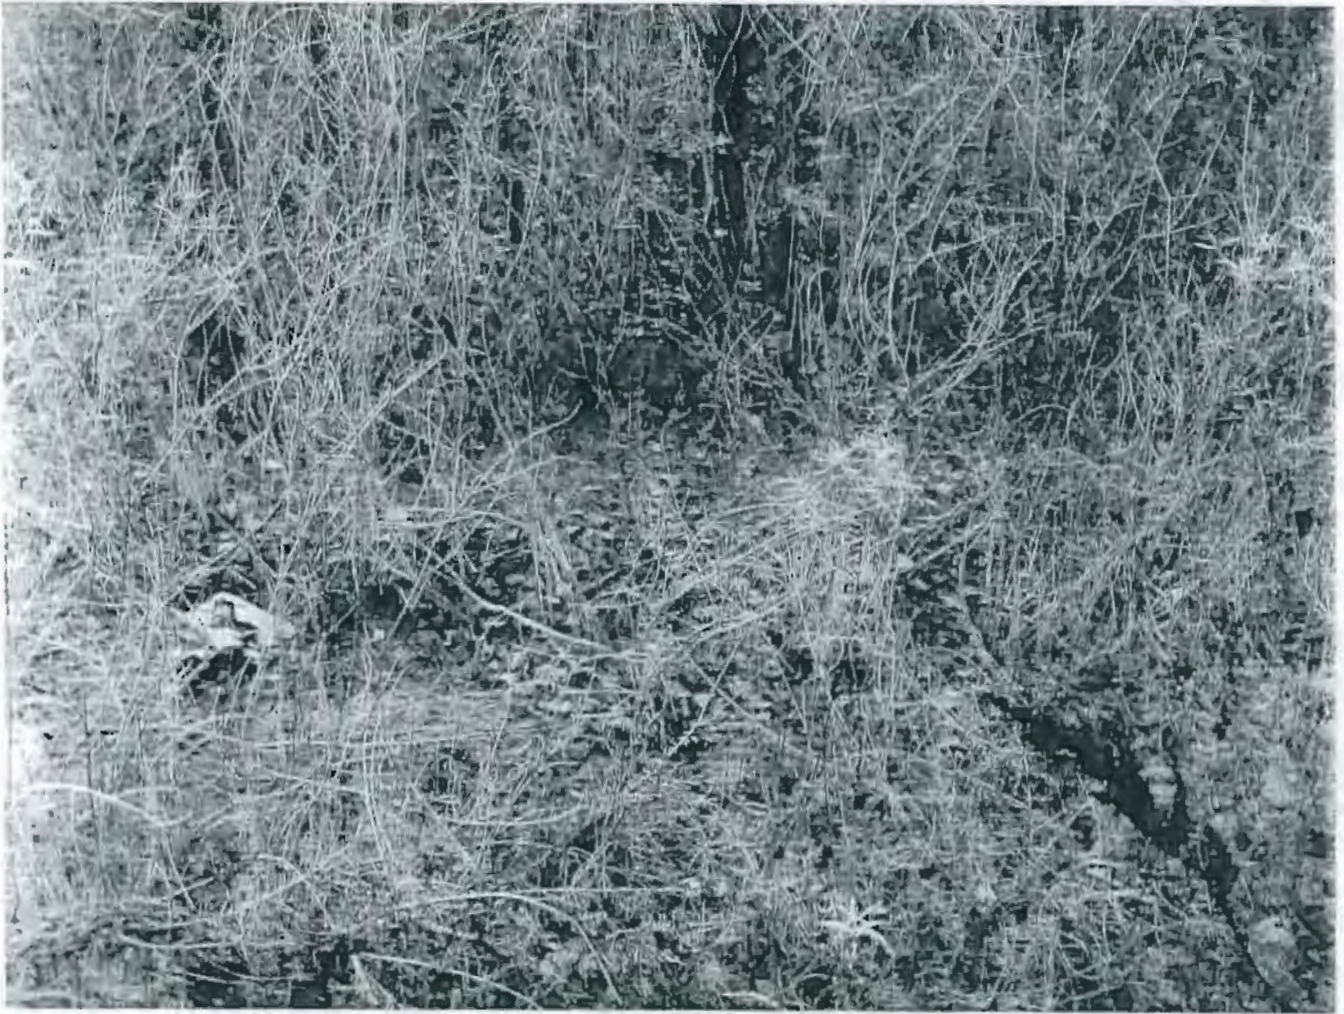
Photo 3 – Flow path continuing to the west through the ditch

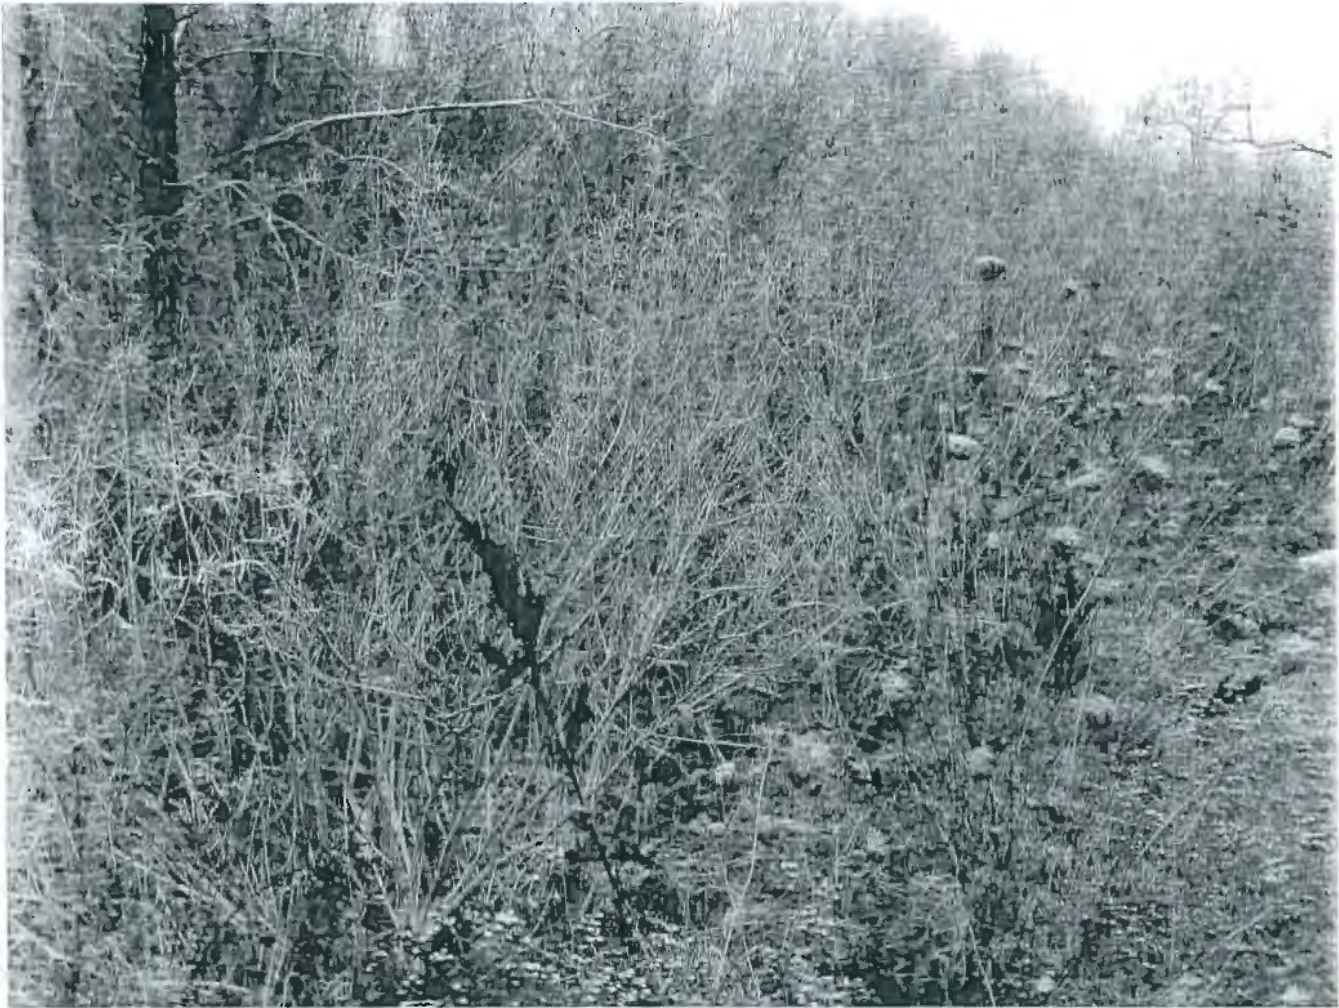
Photo 4 – Flow continues through the ditch behind the brush

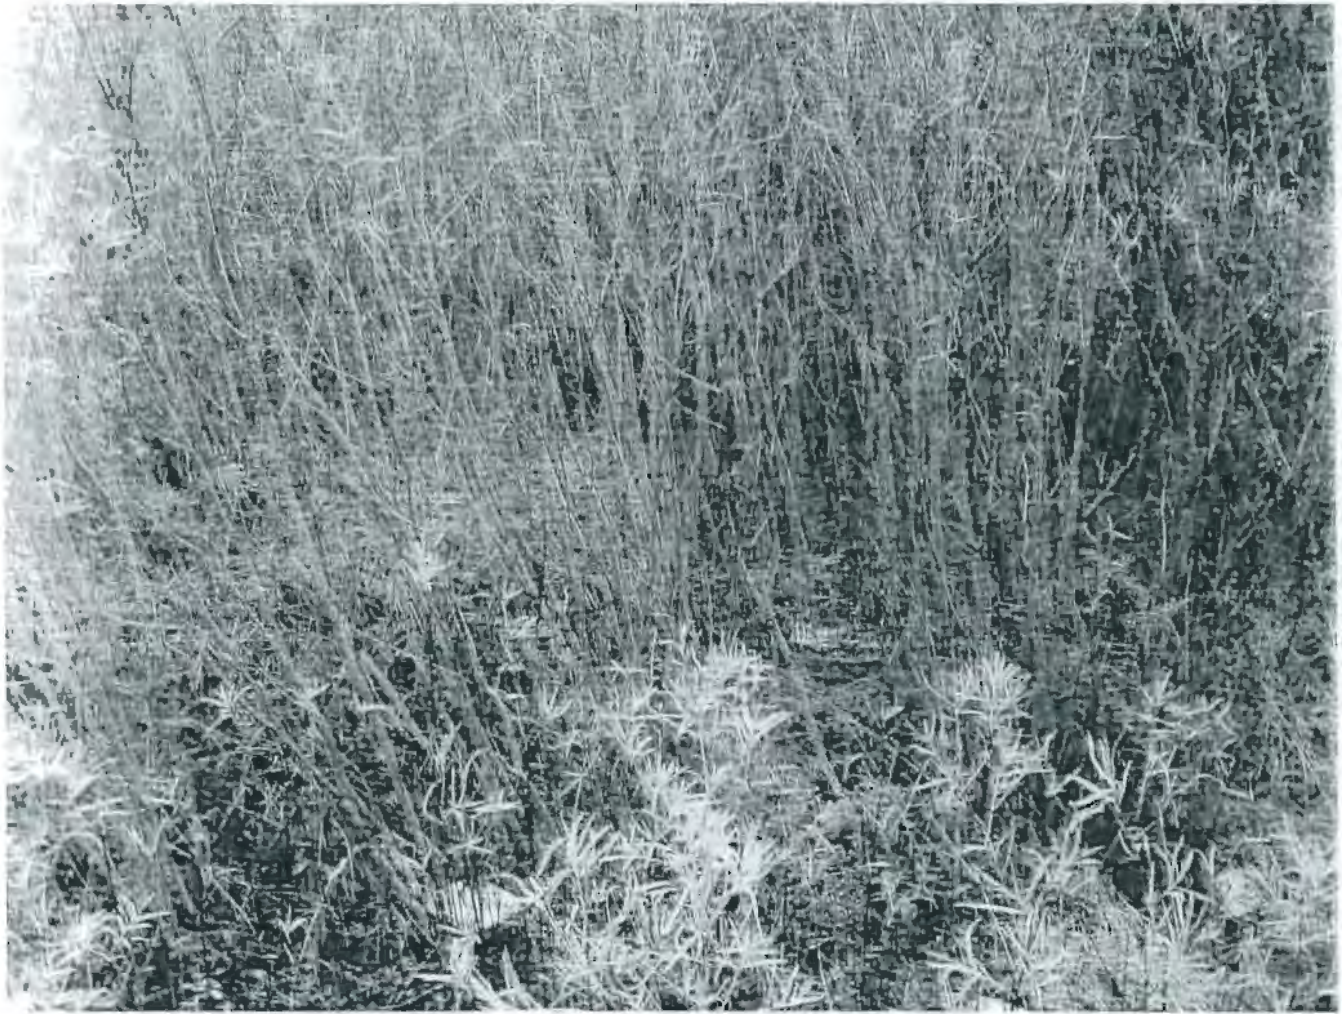
Photo 5 – Continuance of flow through the ditch line behind the brush

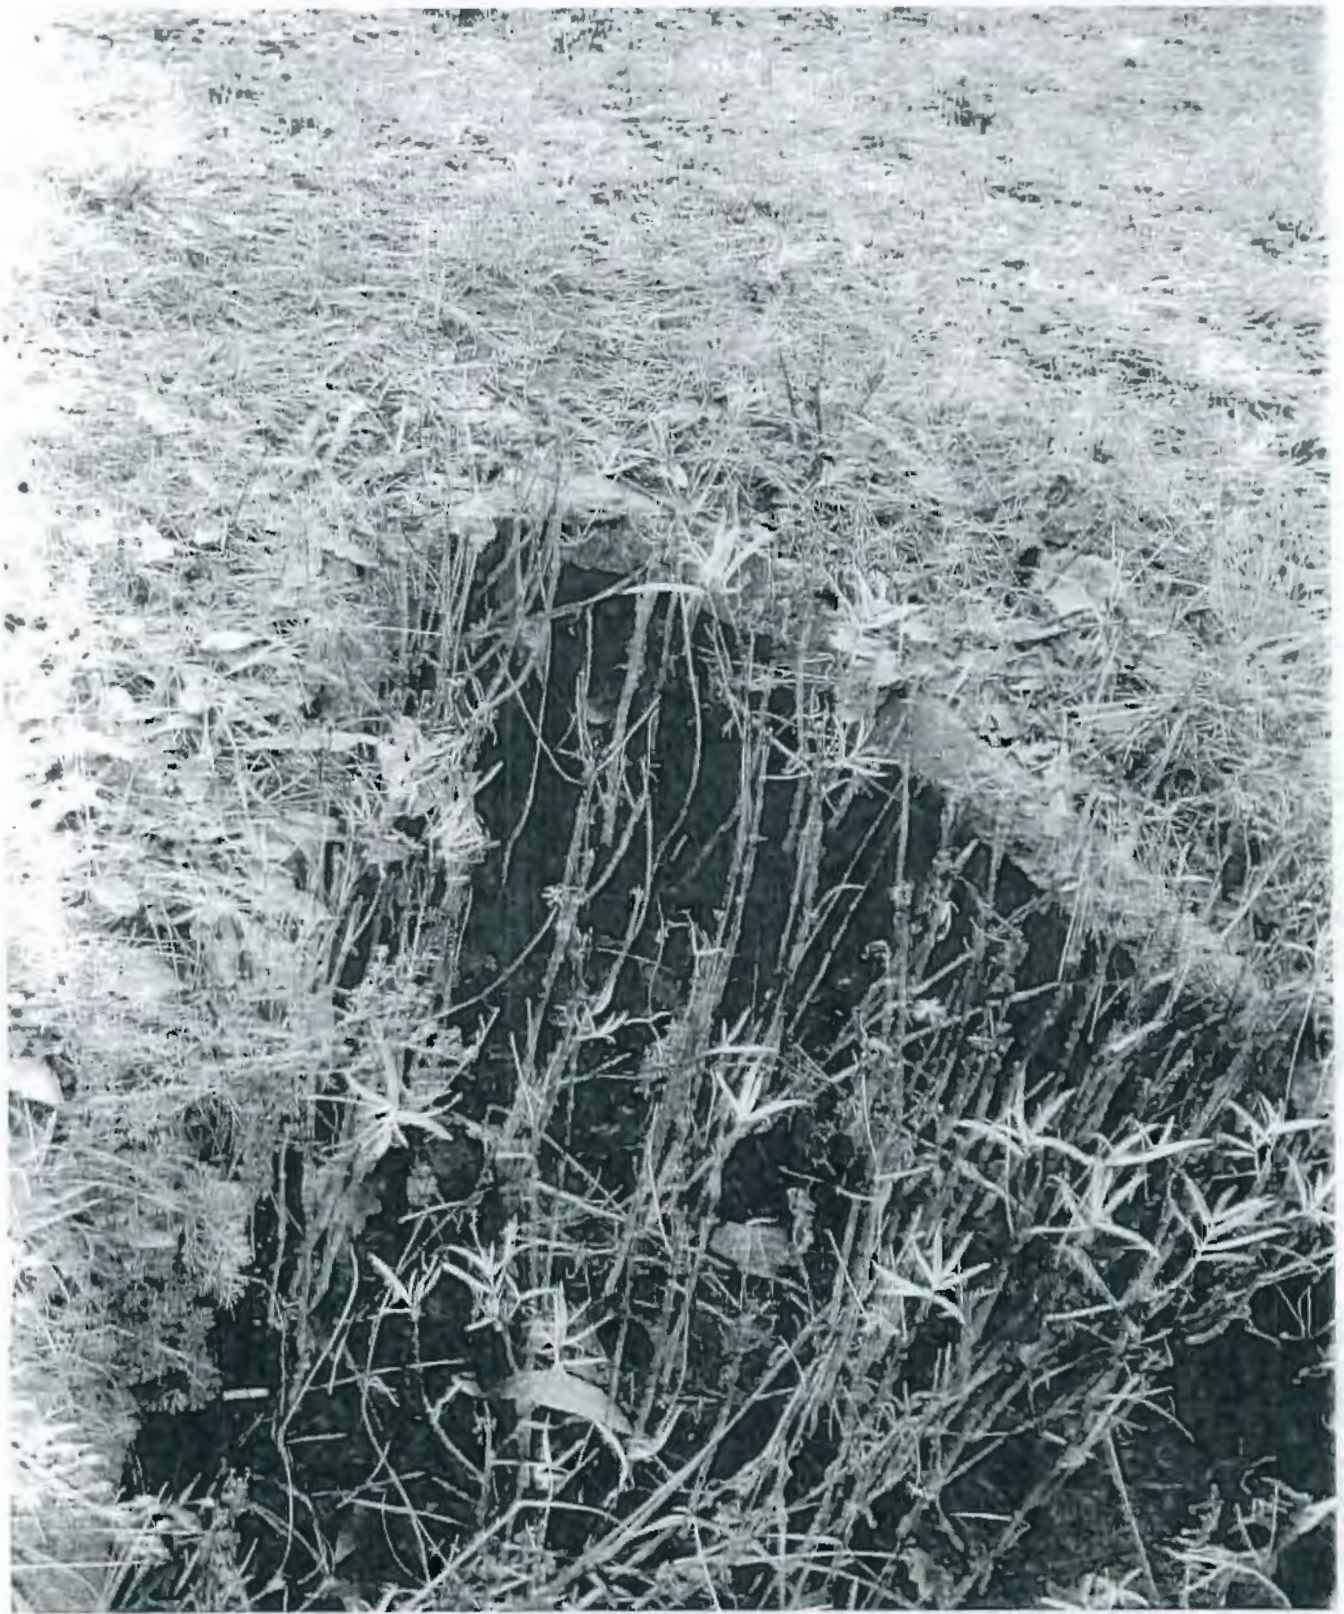
Photo 6 – Flow enters the culvert at this point and goes north under the road. Note deposits in culvert that are the same color as the wash water in the settling basin.

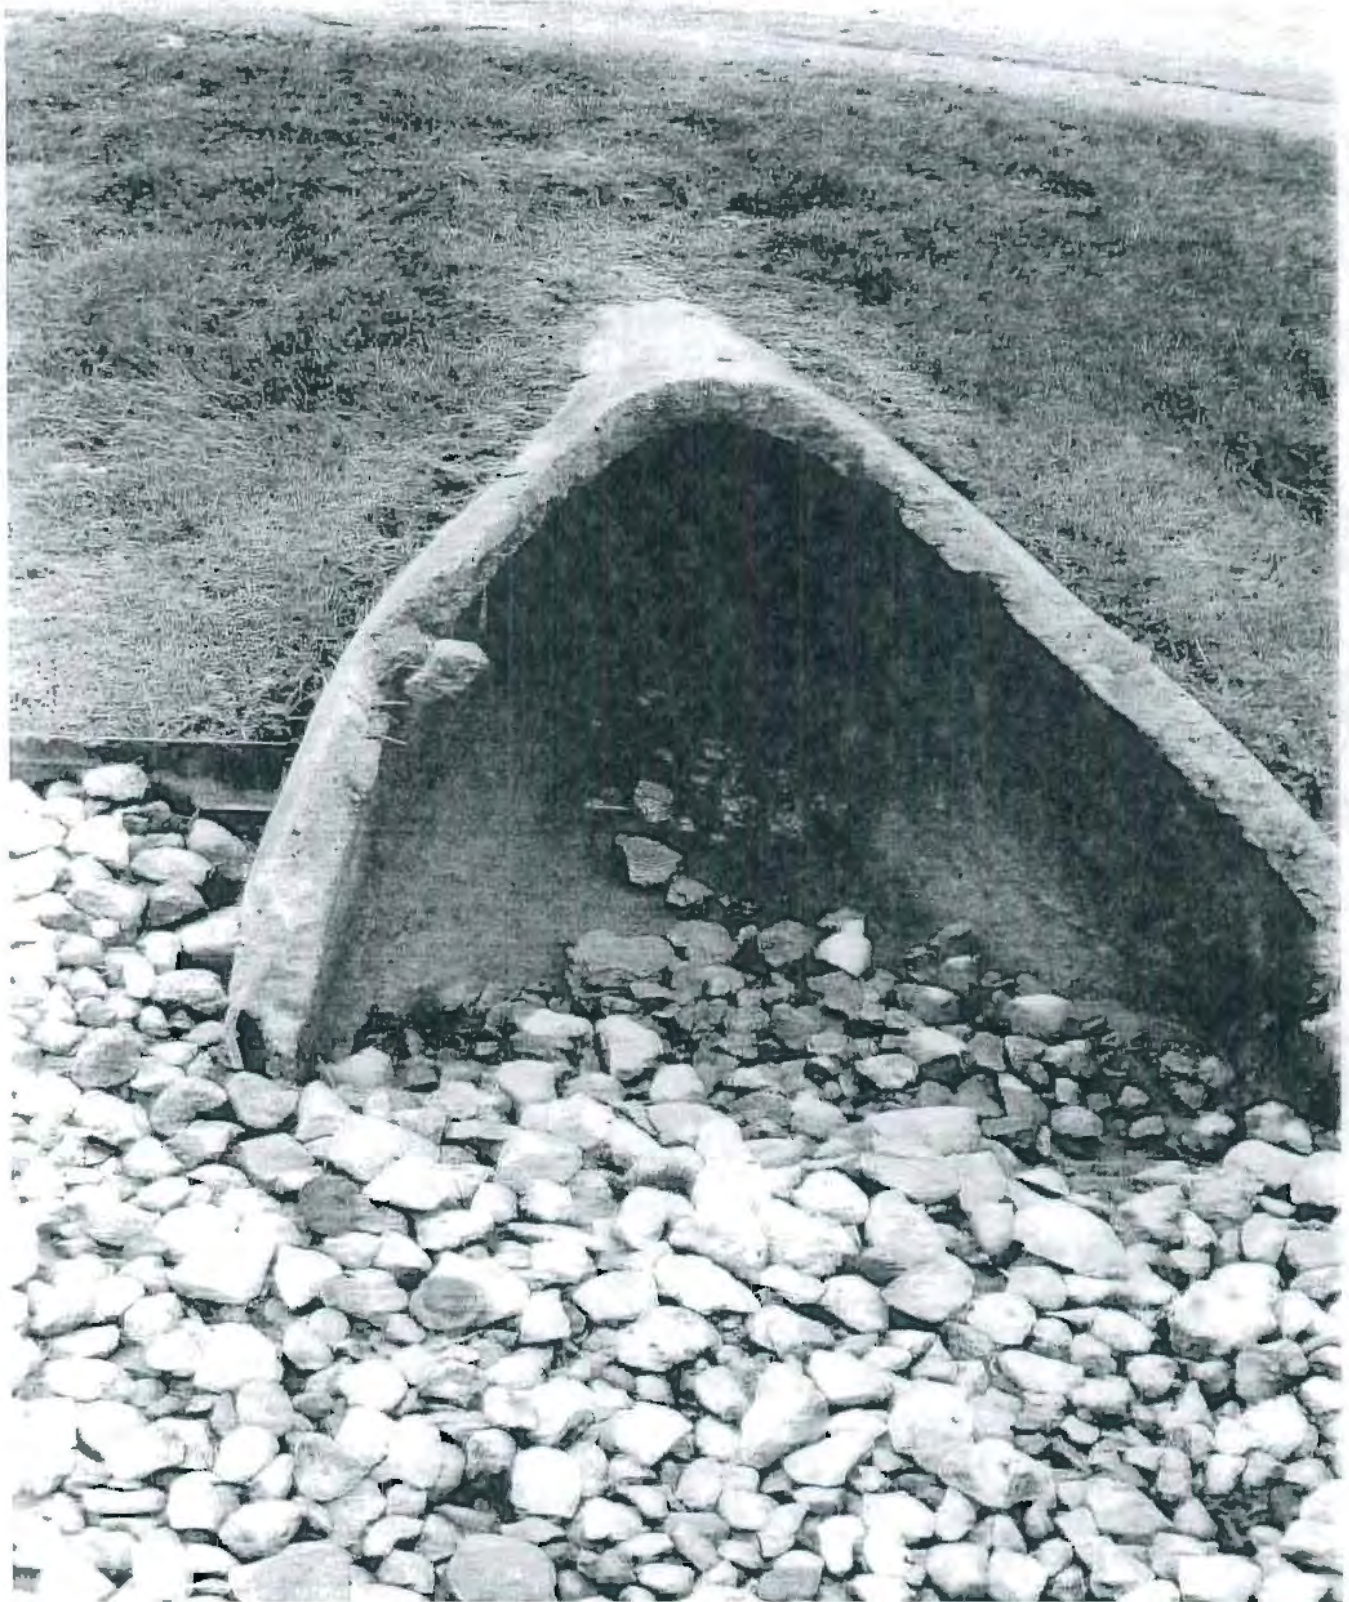
Photo 7 – Culvert exit on north side of road. Note the deposits on the pipe wall and rocks that are the same color as the wash water in the basin.

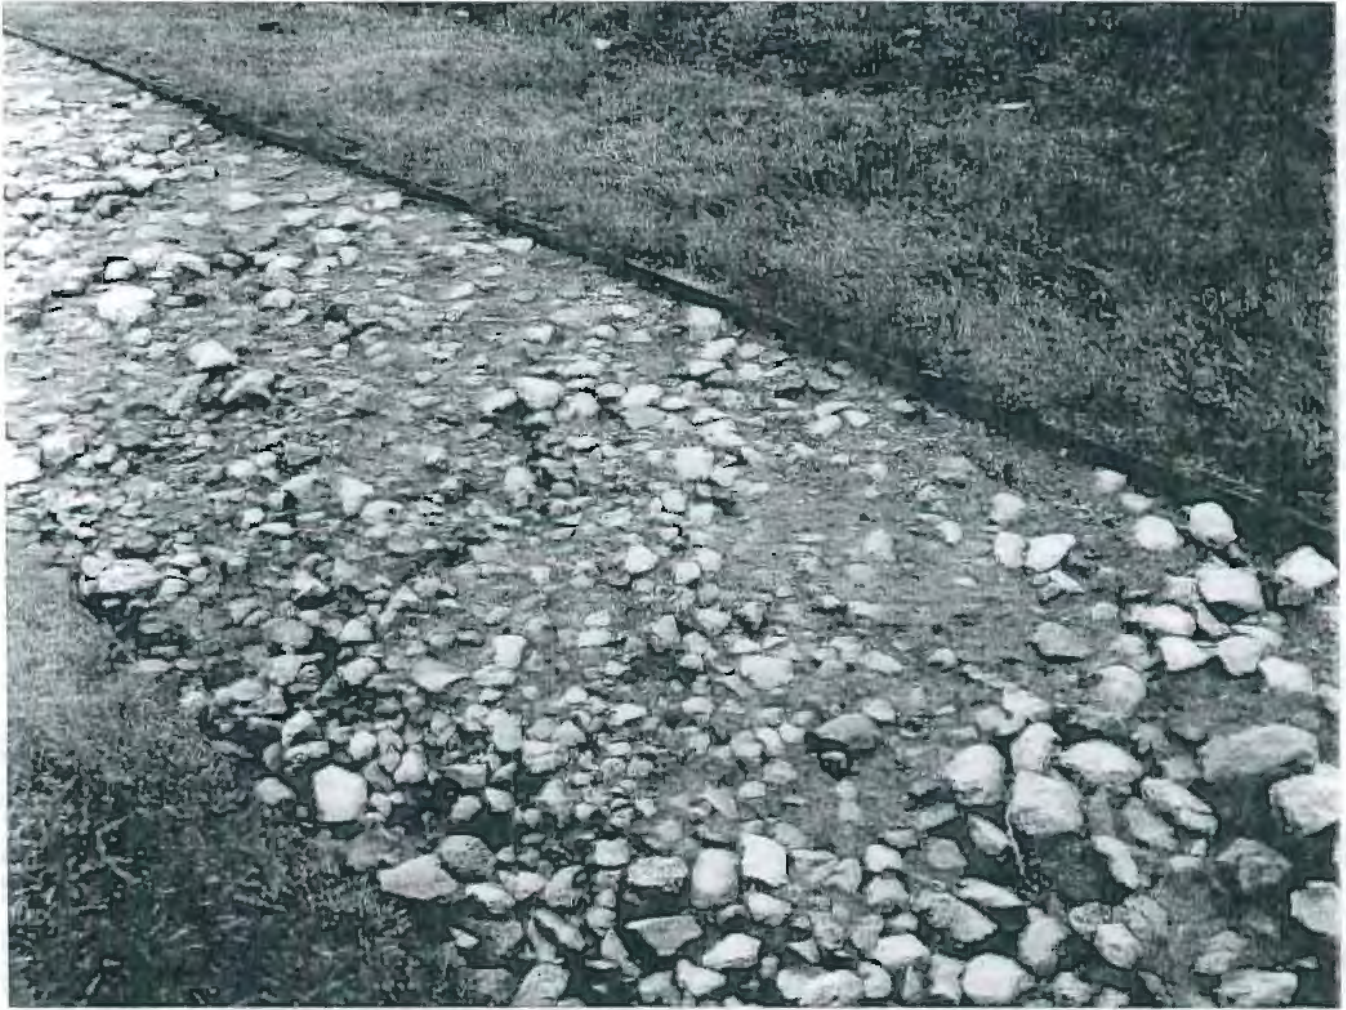
Photo 8 – Road ditch on north side of street with deposits on rocks.

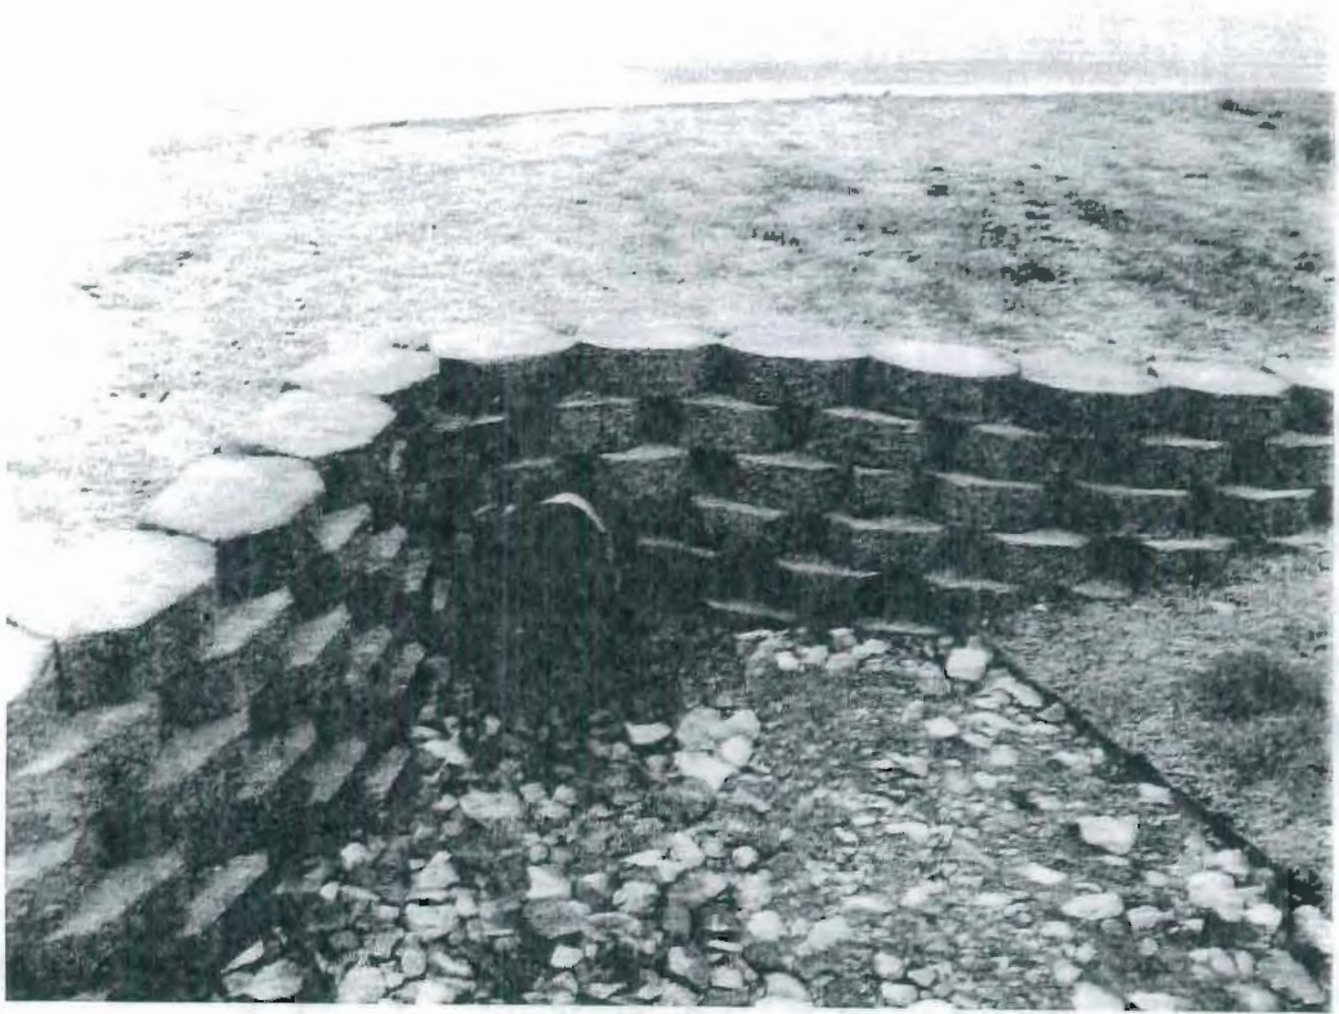
Photo 9 – Flow path continuing east showing deposits entering culvert under driveway

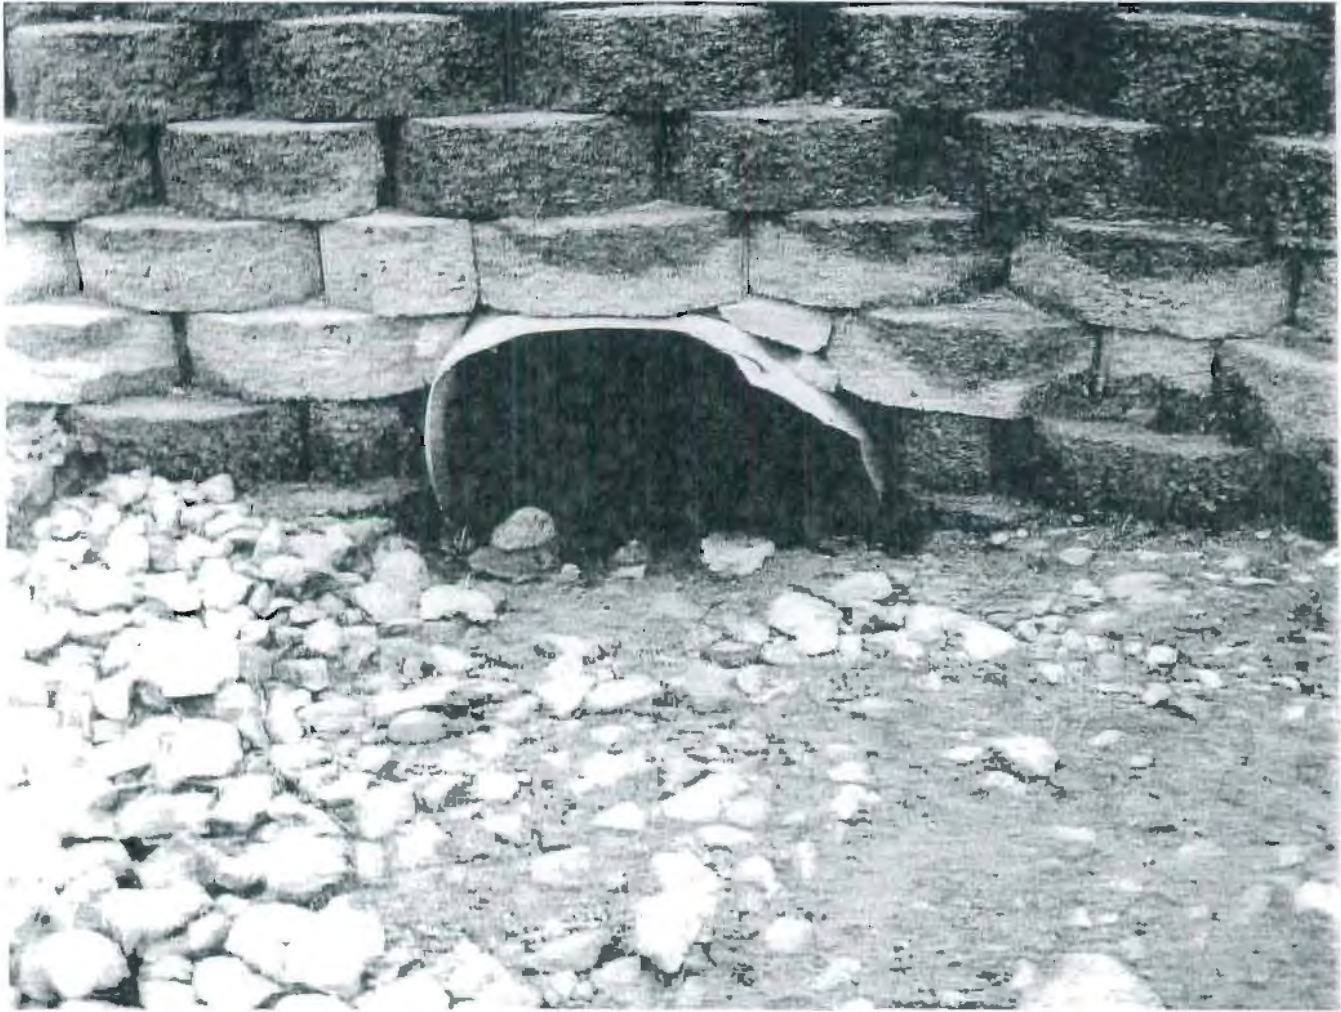
Photo 10 – Close up of culvert entrance

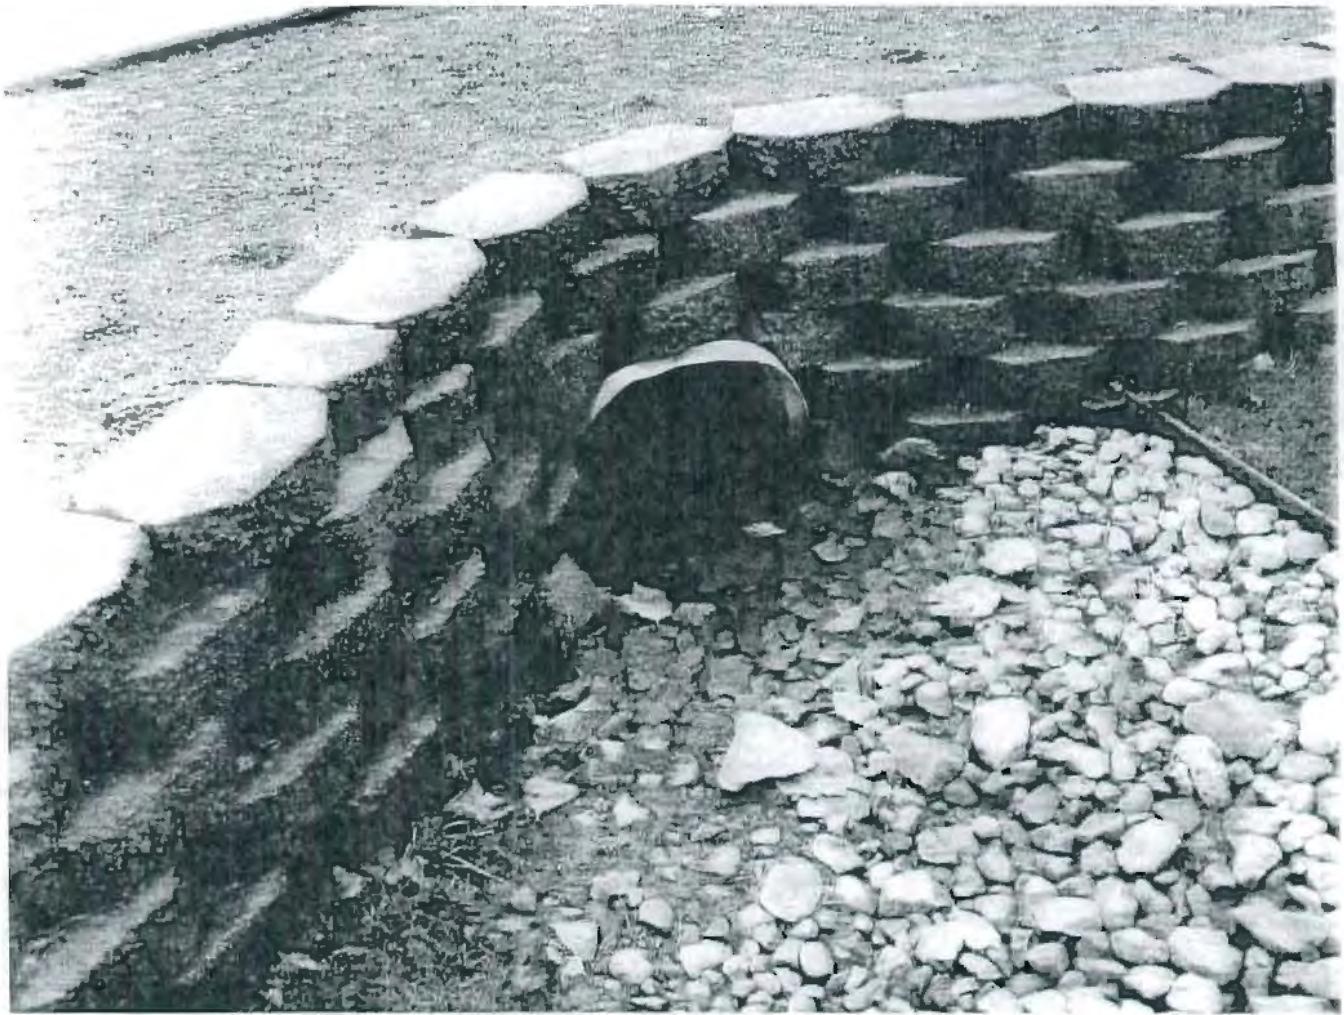
Photo 11 – Culvert exit on other side of driveway showing murky water and deposits on stones

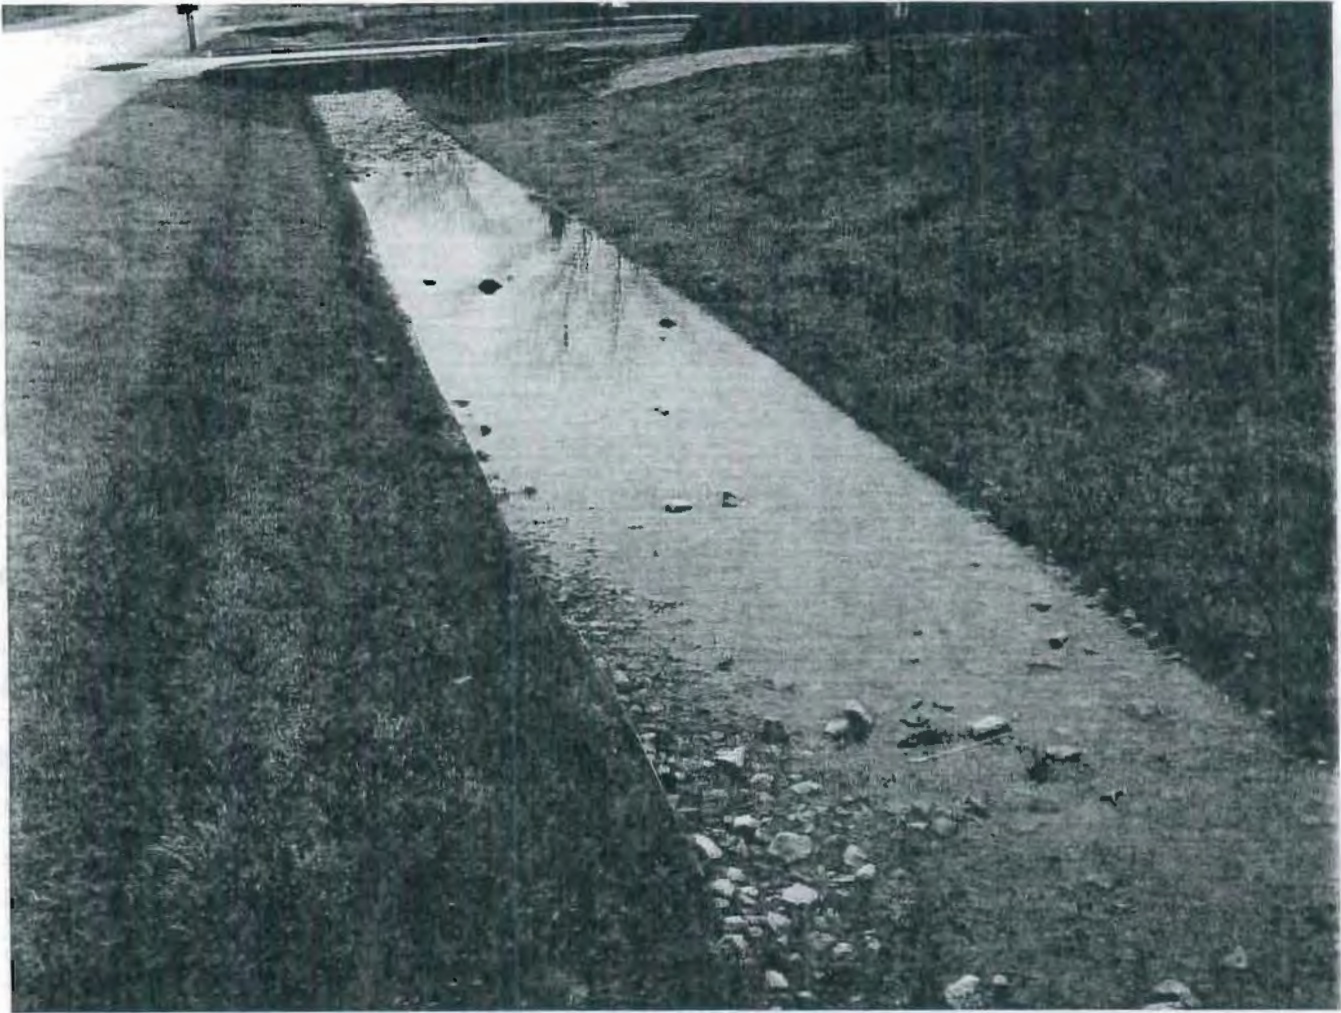
Photo 12 - Flow continuing east with deposits on stones

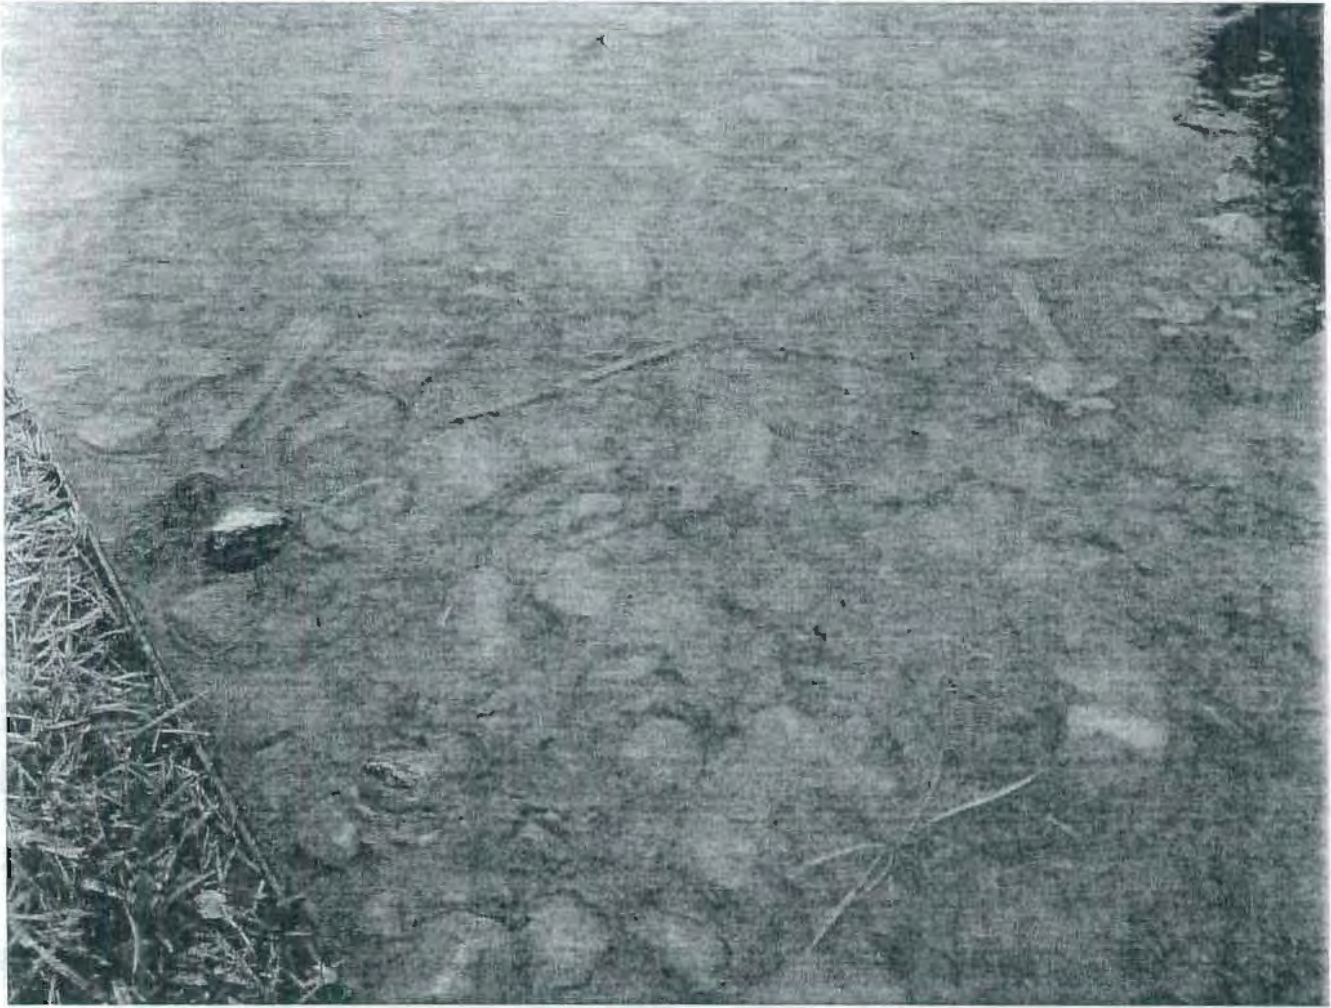
Photo 13 – Close up photo showing the deposits on the stones.

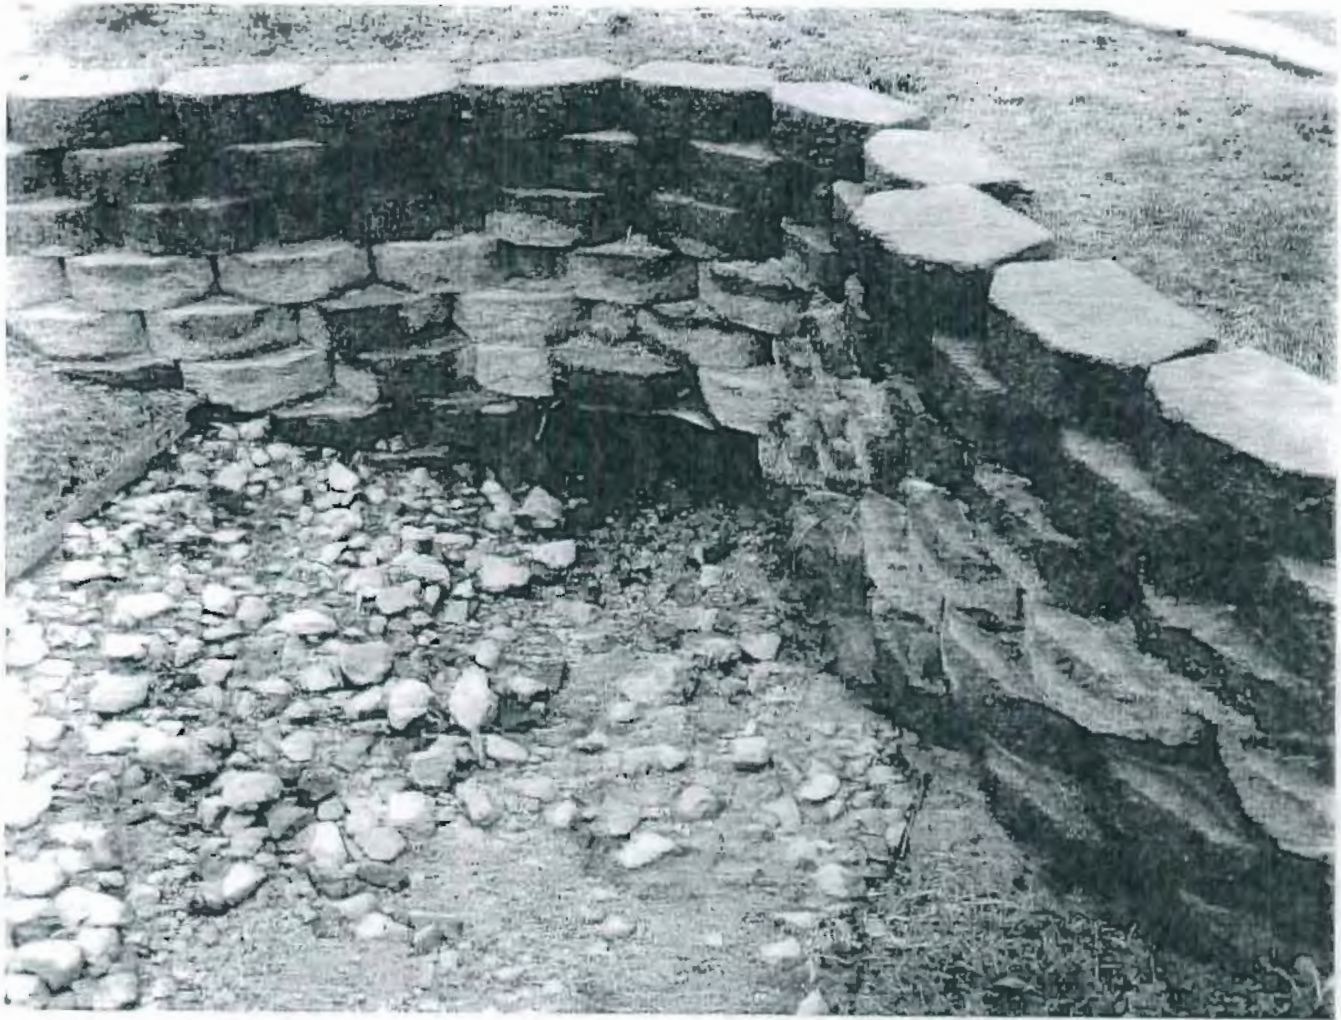
Photo 14 – Next culvert, filling with deposits

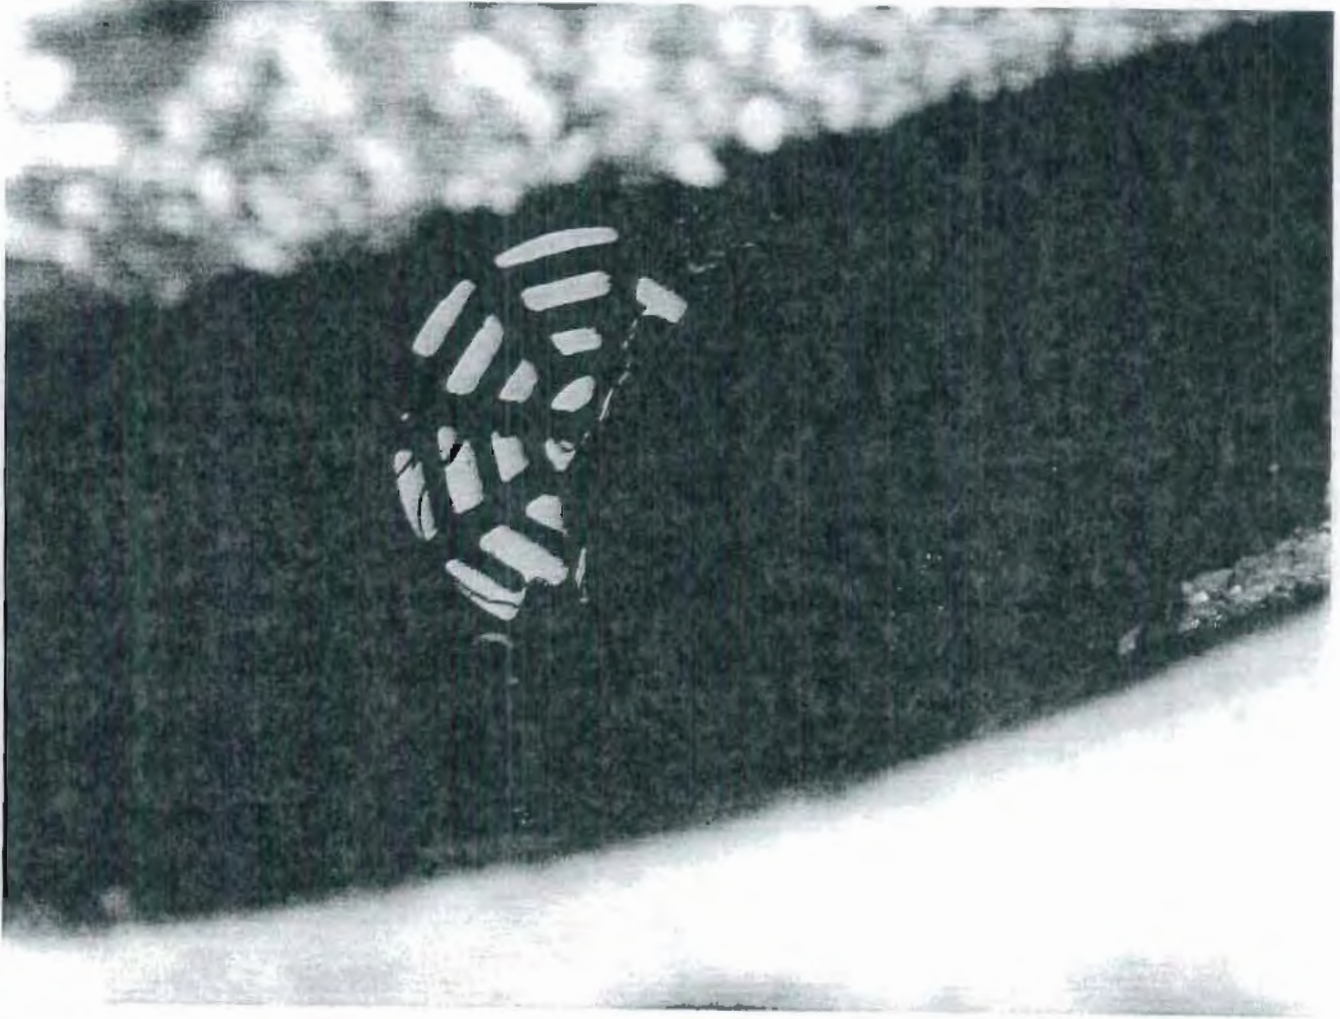
Photo 15 – Flow then enters a storm sewer catch basin. Photo is looking at sediments inside the catch basin.
