MEMORANDUM

DATE: December 18, 2008  
TO: Regional File  
FROM: Karen Katamay, DWPC/FOS – Des Plaines  
SUBJECT: Super Mix Inc. – Spring Grove, IL  
NPDES No. ILR006479

On November 12, 2008, an industrial stormwater site inspection was conducted at the subject property. The inspection was conducted as the result of a referral from the McHenry County SWCD about contaminated runoff from the property. Accompanying me on the inspection was Tom Mattingly of the McHenry County SWCD. The facility is located at 2203 Spring Ridge Drive in Spring Grove, IL.

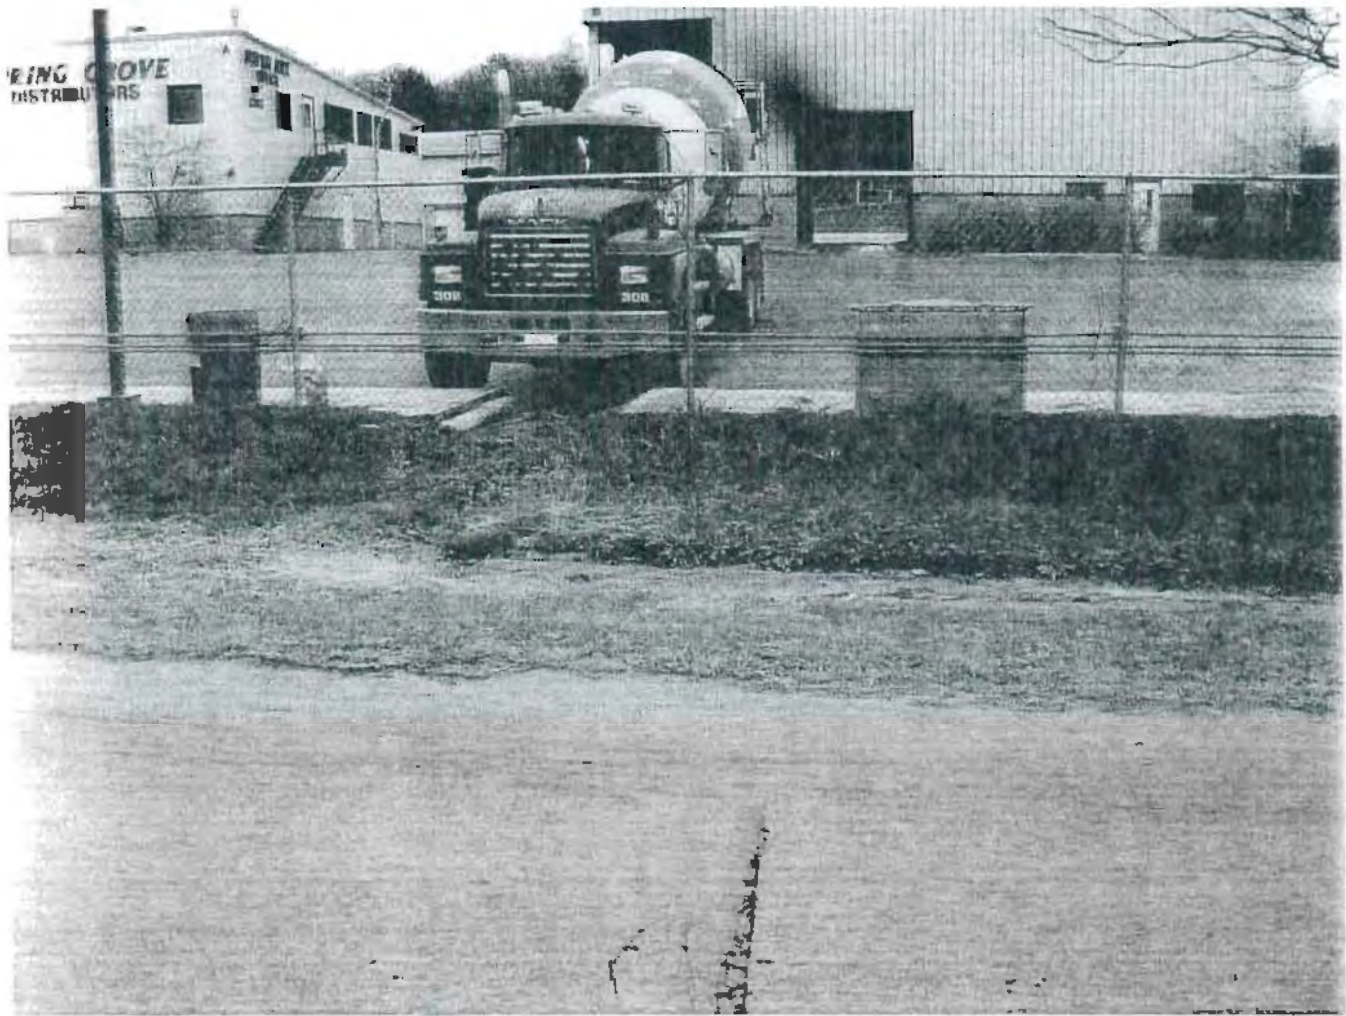
Photo 16 – Looking south again at the Super Mix property. Note how runoff from the parking lot is directed to the road ditch.

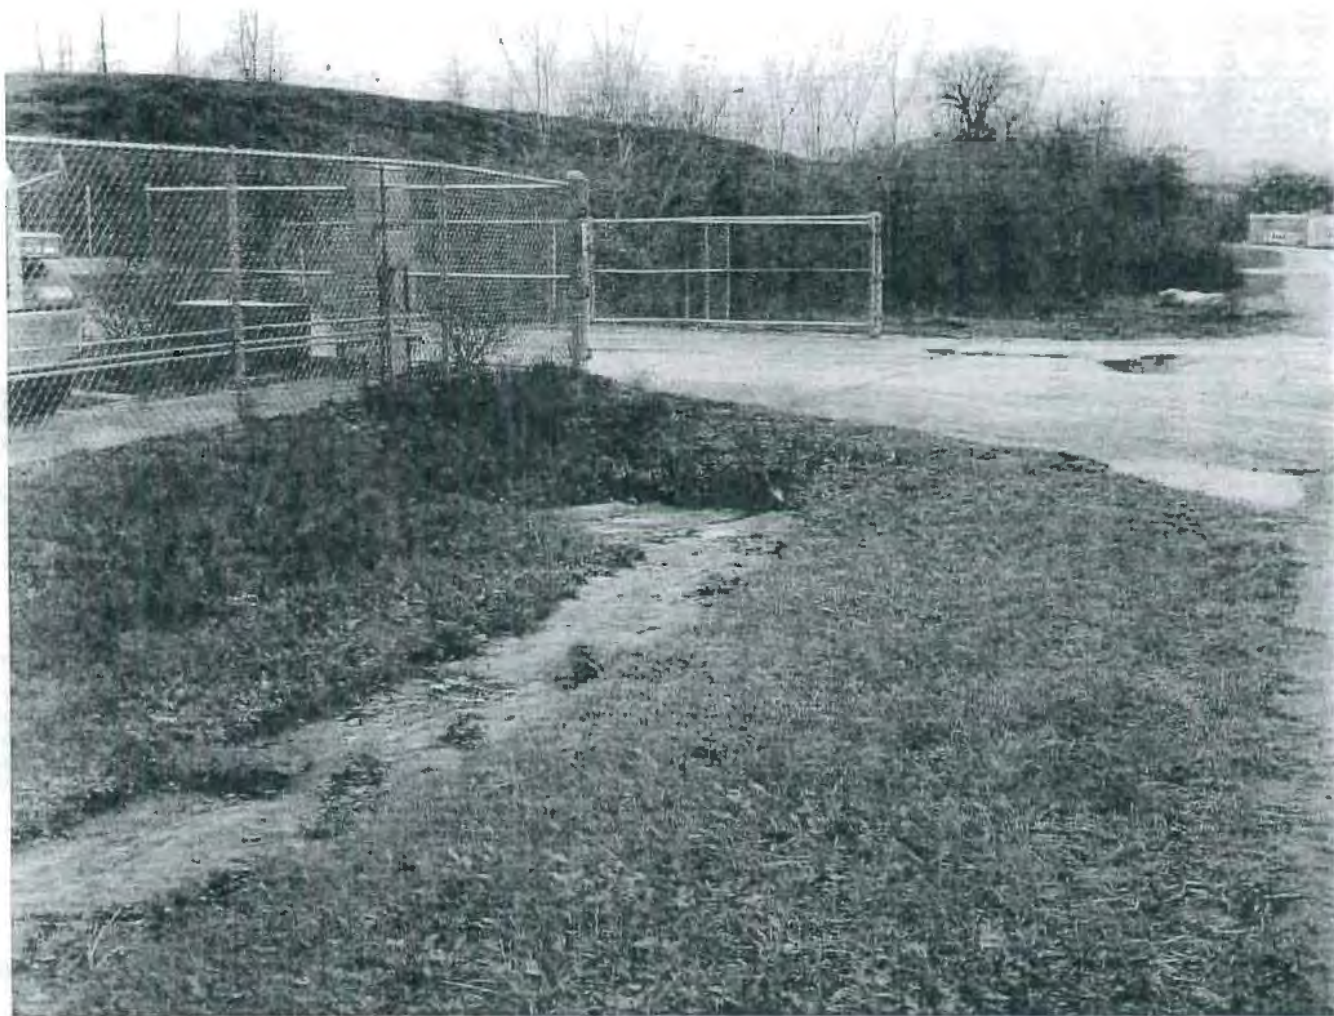
Photo 17 – Following road ditch west, showing another discharge point and the deposits in the ditch.

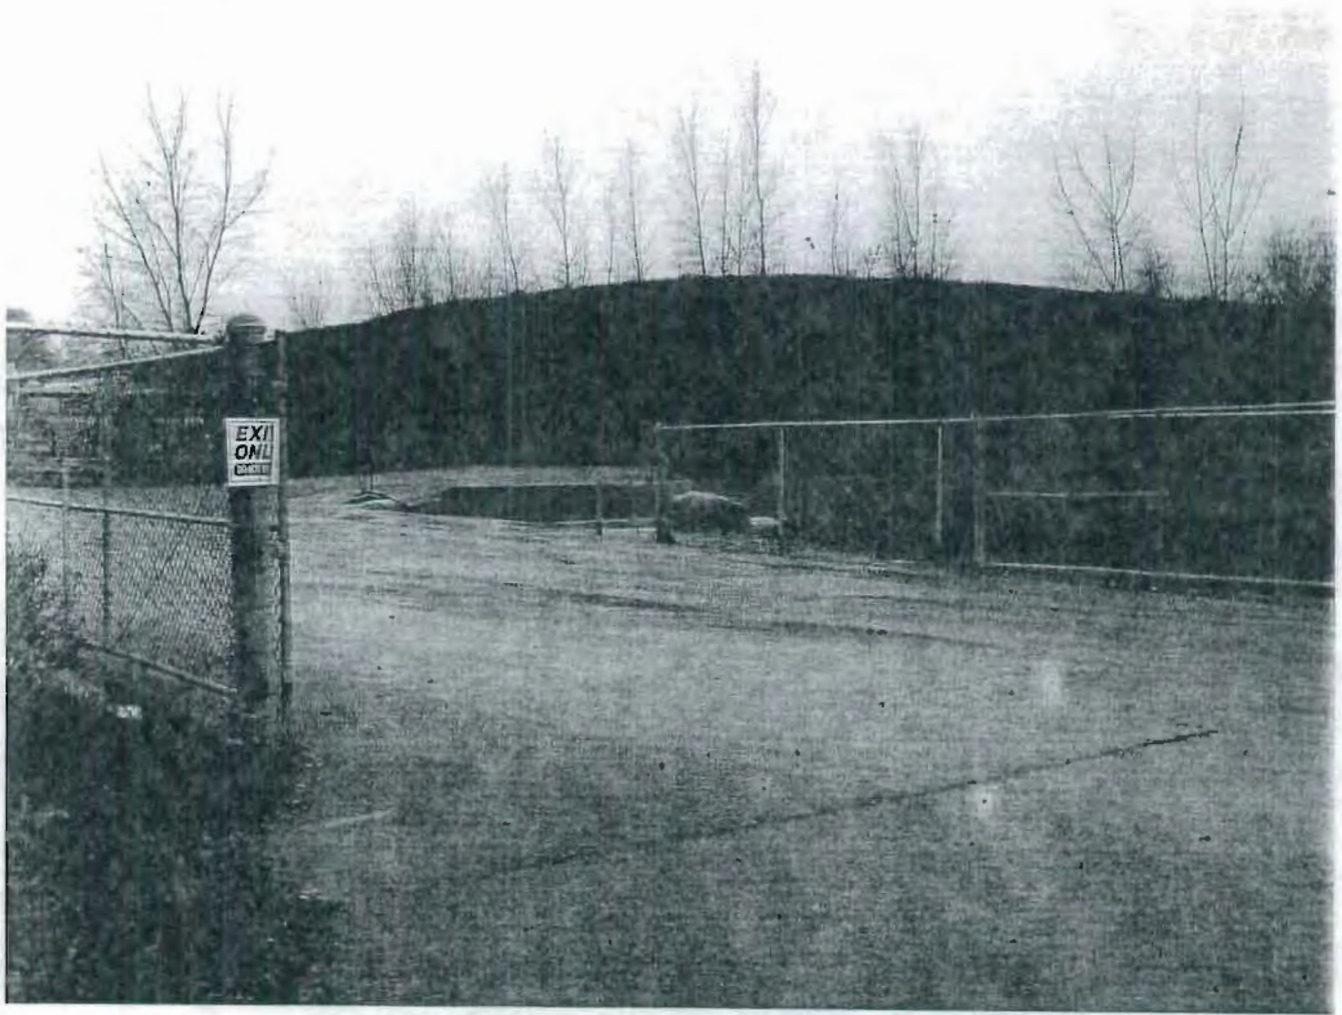
Photo 18 – Concrete truck wash out area on northeast corner of property near facility exit.

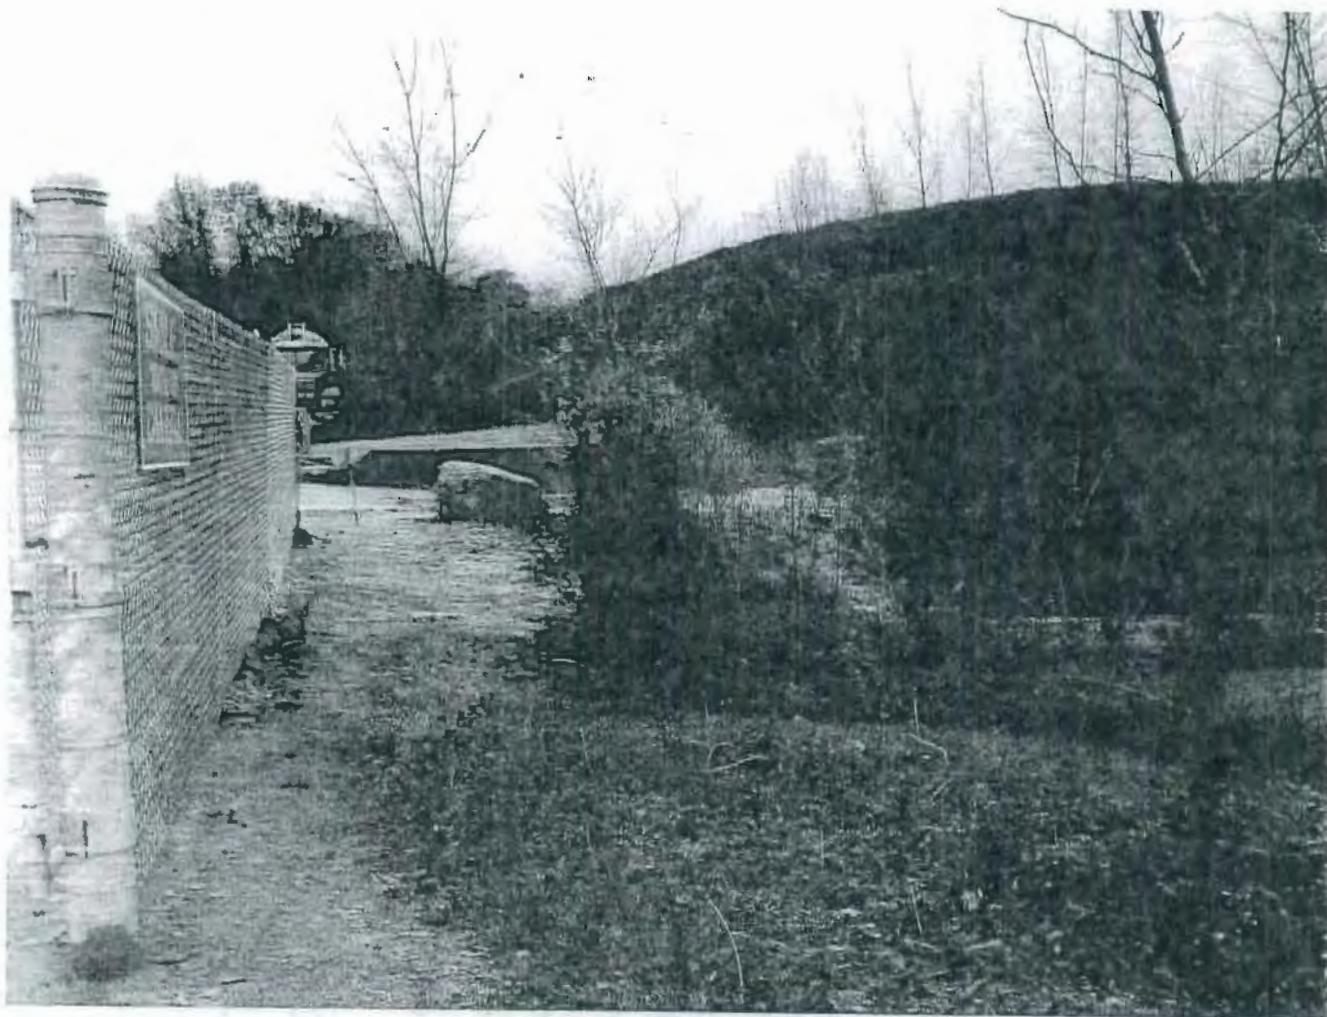
Photo 19 – shows how flow is able to run off the property from the wash area into the settling basin in the road ditch.

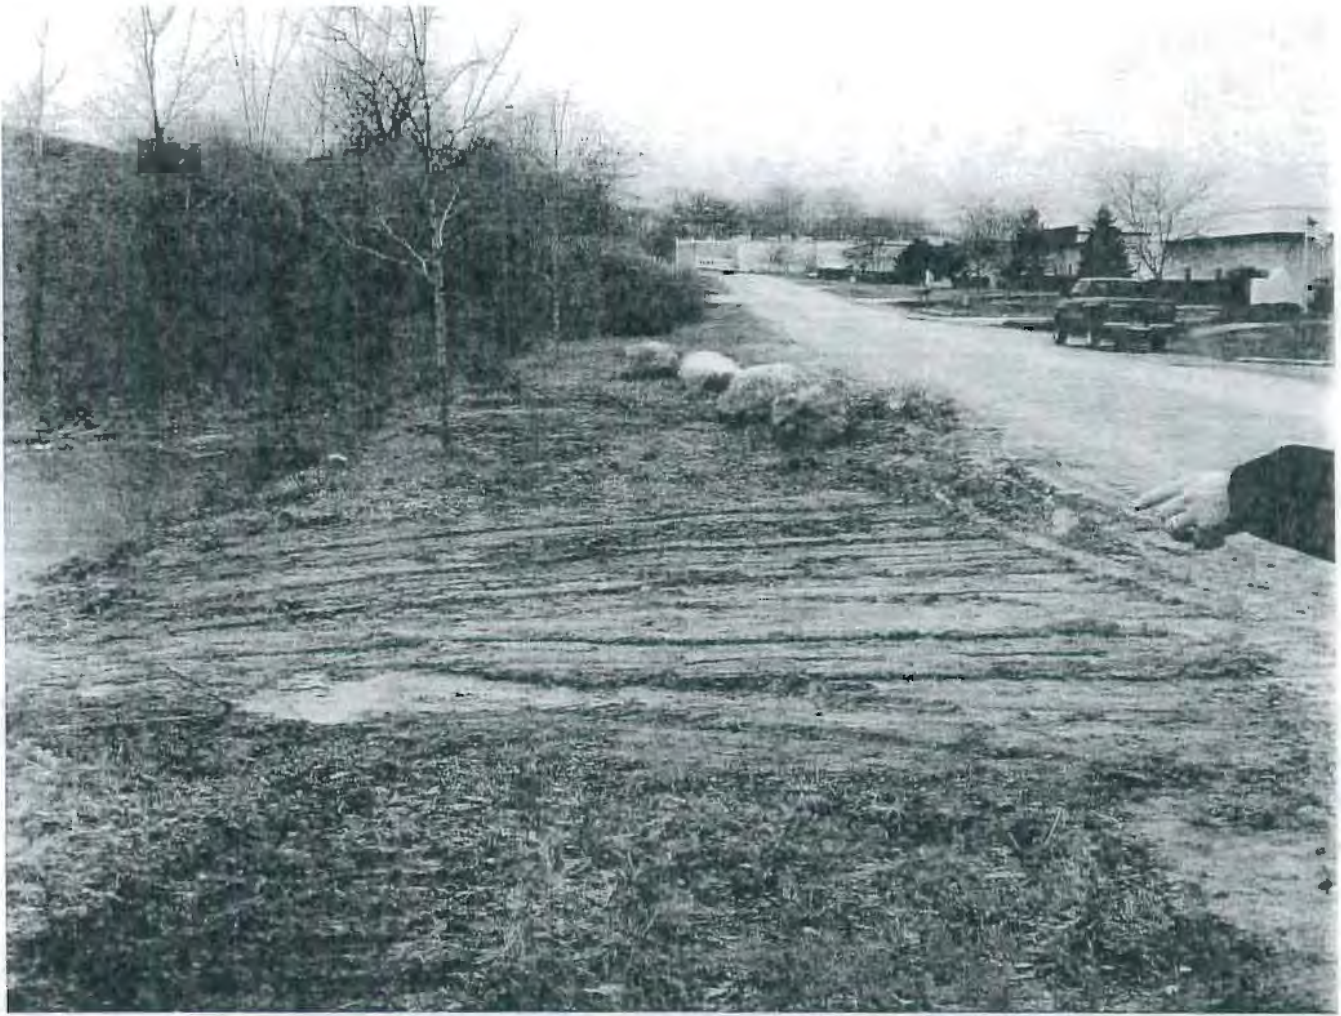
Photo 20 – indication that the basin may have been recently excavated to remove deposit build-up.

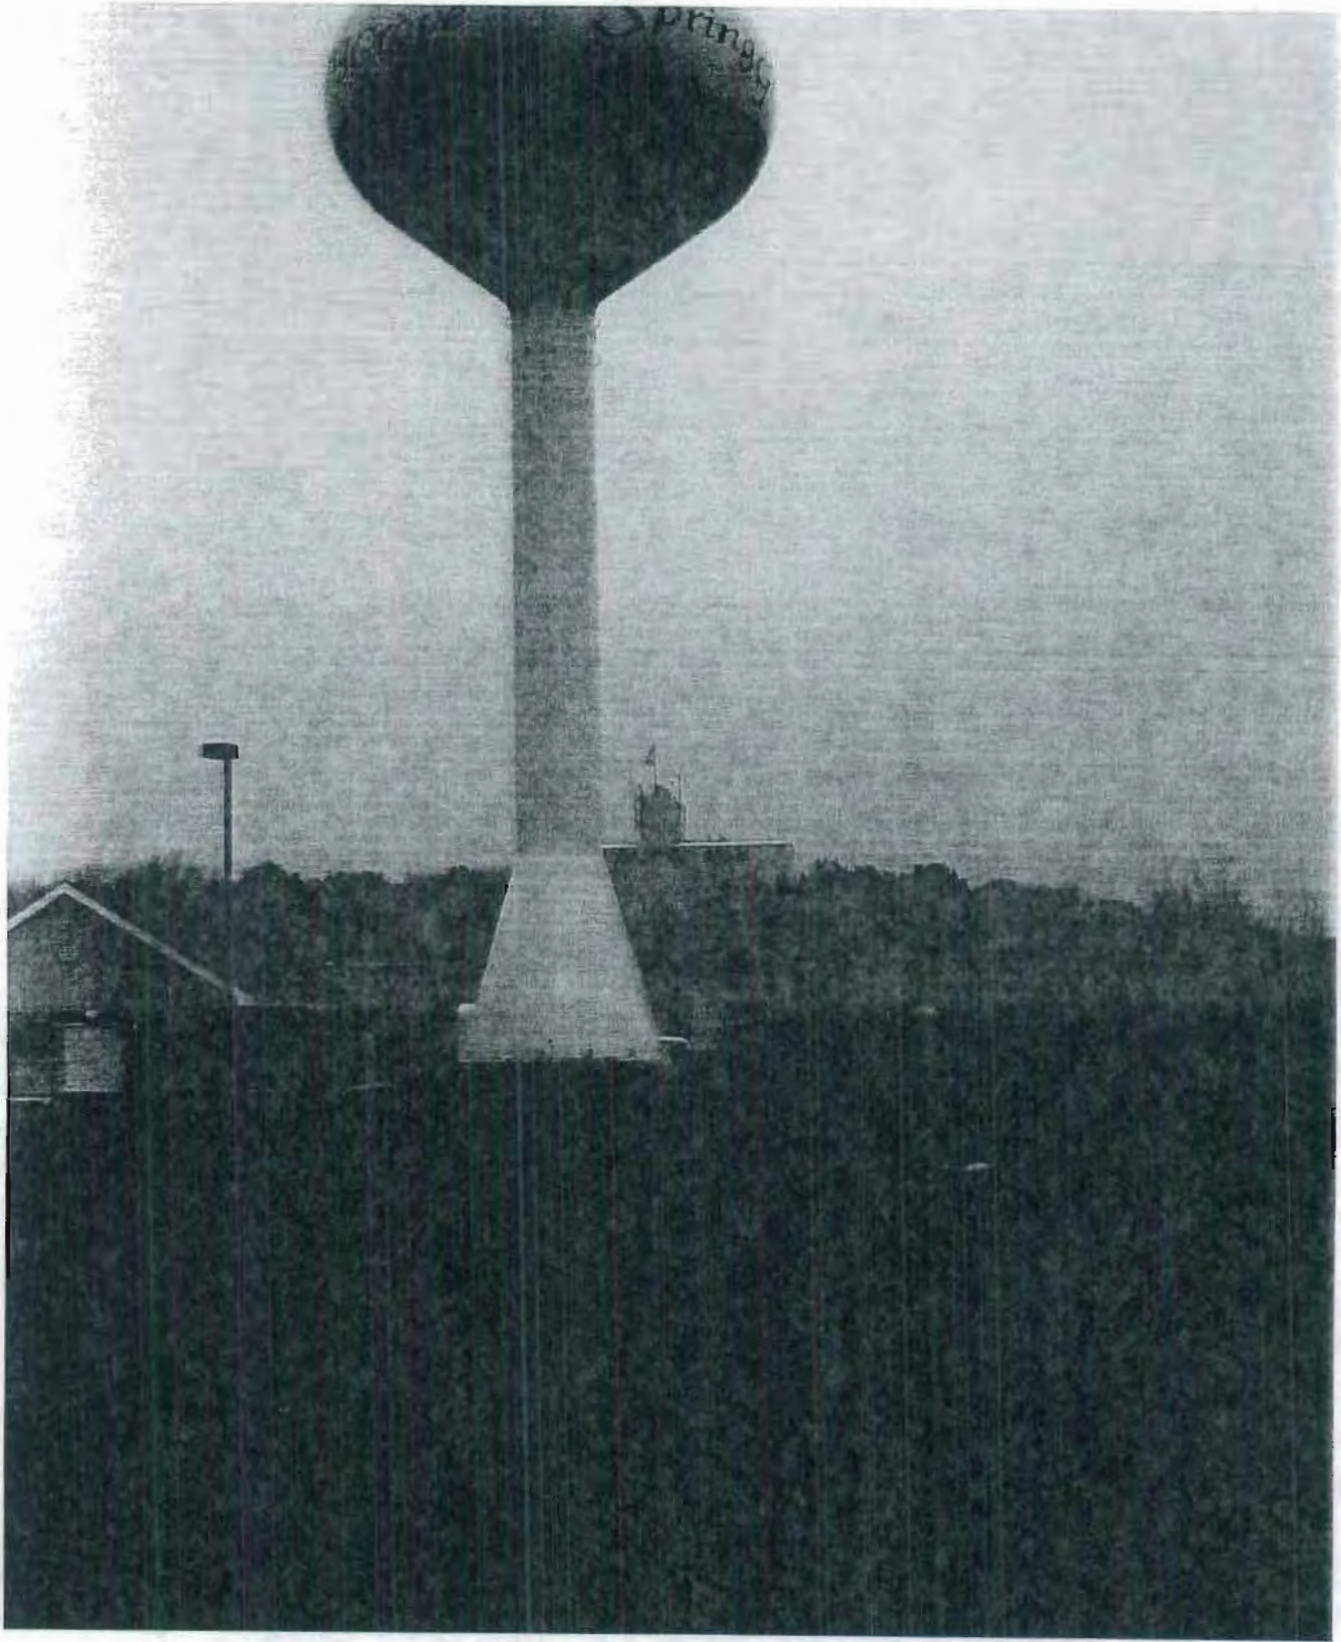
Photo 21 – Proximity of industry to the village's well house and water tower.

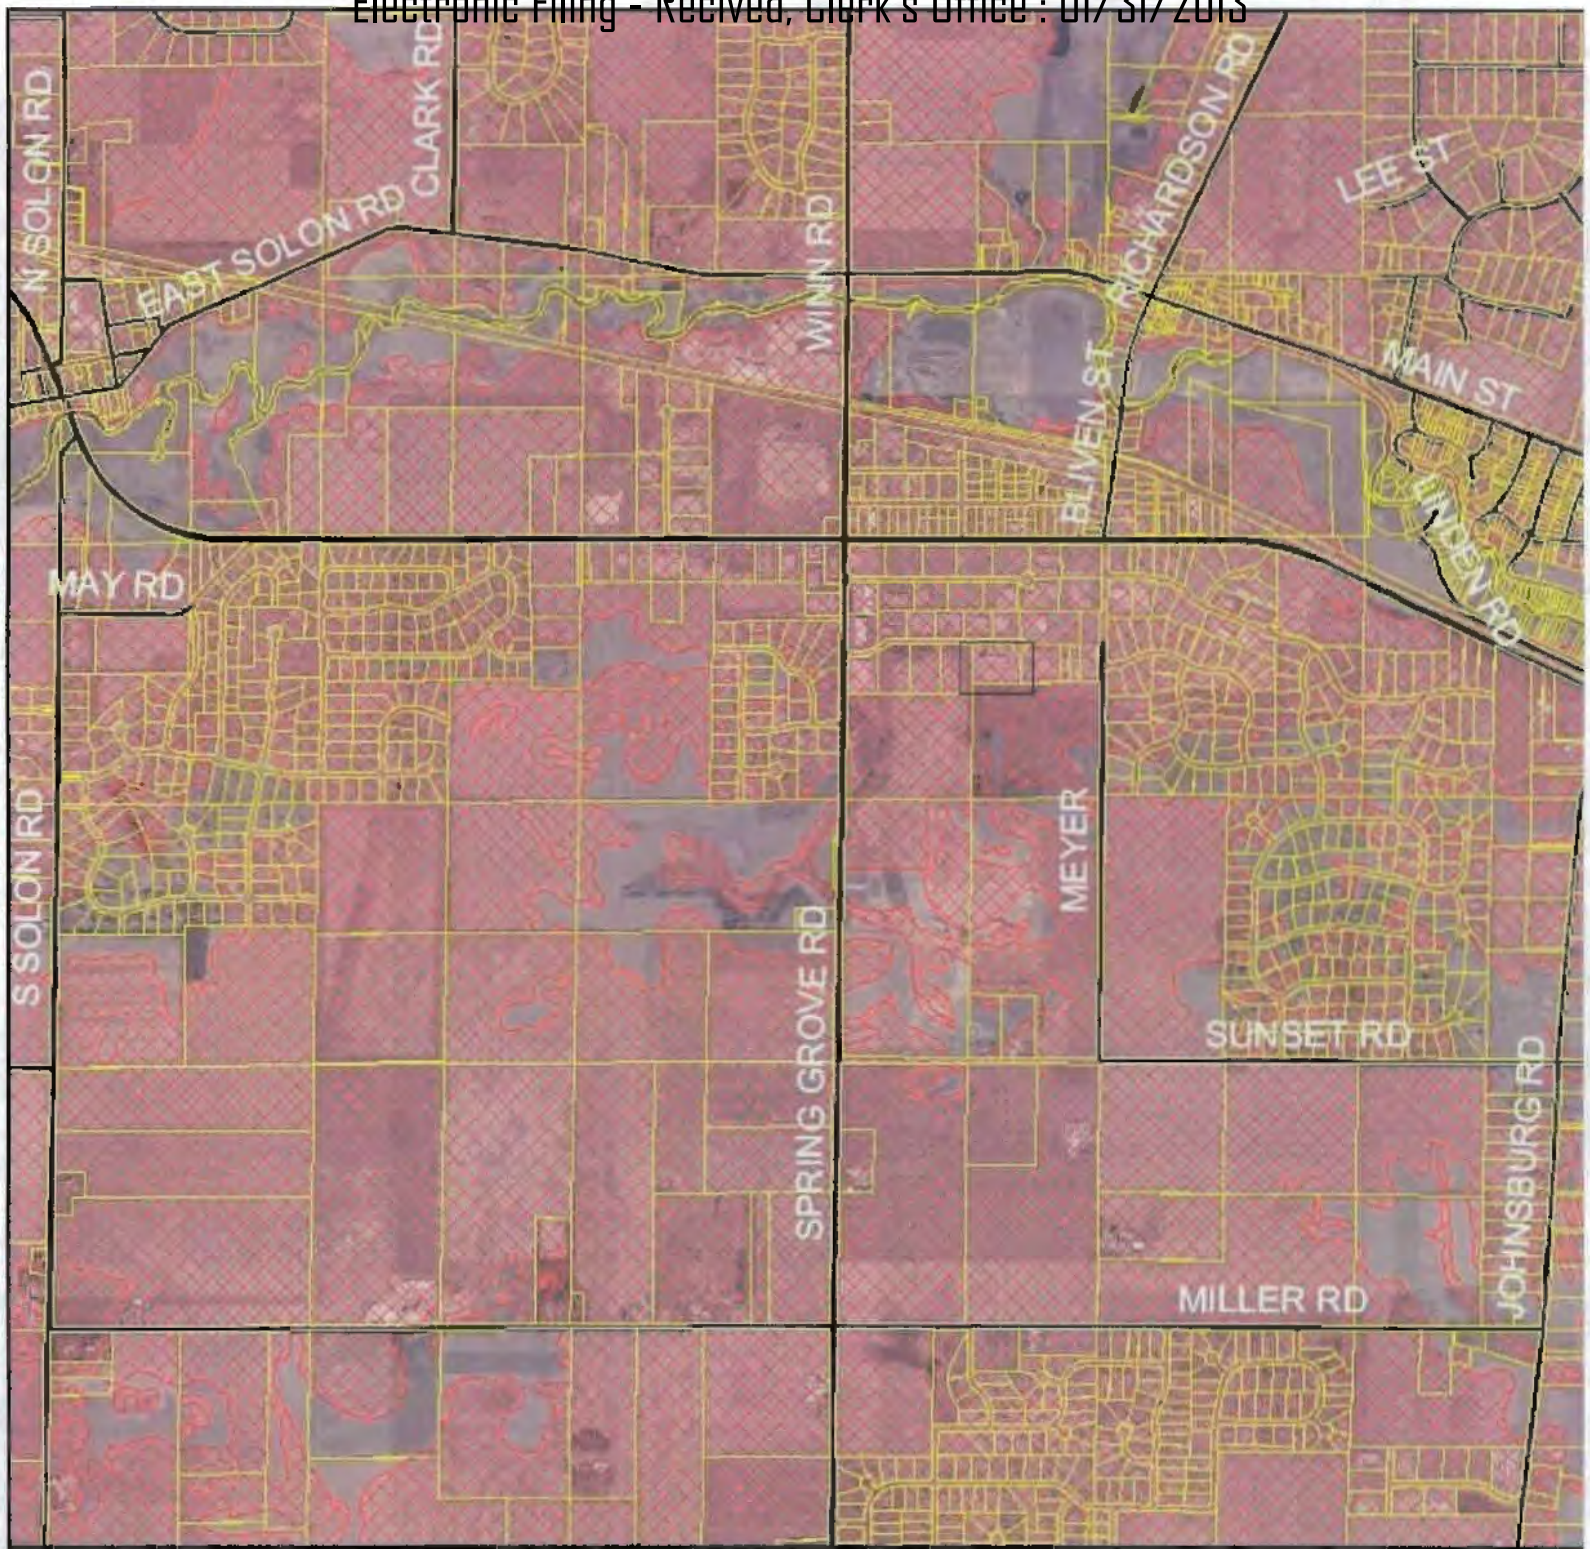
**Sensitive Recharge**

Photos showing the flow path and the wash water deposits in the road ditch are attached to this report. Also attached is a groundwater recharge map, indicating that this industry is located in a sensitive recharge area (industry location is indicated by the black rectangle). The facility is also located close to a village well house and water tower.
