**BEFORE THE ILLINOIS POLLUTION CONTROL BOARD**

**CHAMPION ENVIRONMENTAL SERVICES, INC.,  
A Wisconsin corporation,**

**No. PCB 2005-199**

**REQUEST FOR ADMISSION OF FACT AND GENUINENESS OF DOCUMENTS**

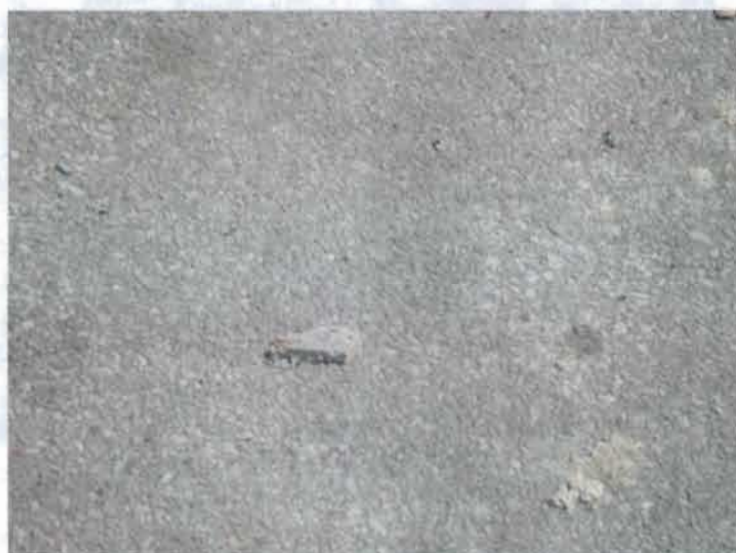
**Date: May 5, 2005  
Time: ~ 10:30 am  
Direction: West  
Photo by: D. Hancock  
File No: DAH050505~05052005-001  
Comments: Suspect transite lying on the  
ground outside of dumpster area**

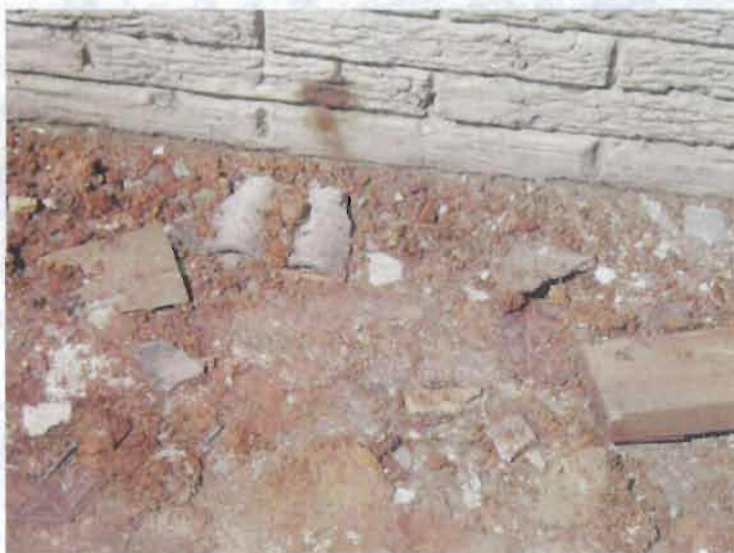
Comments: More transite material lying among the regular debris along this section of the building outside

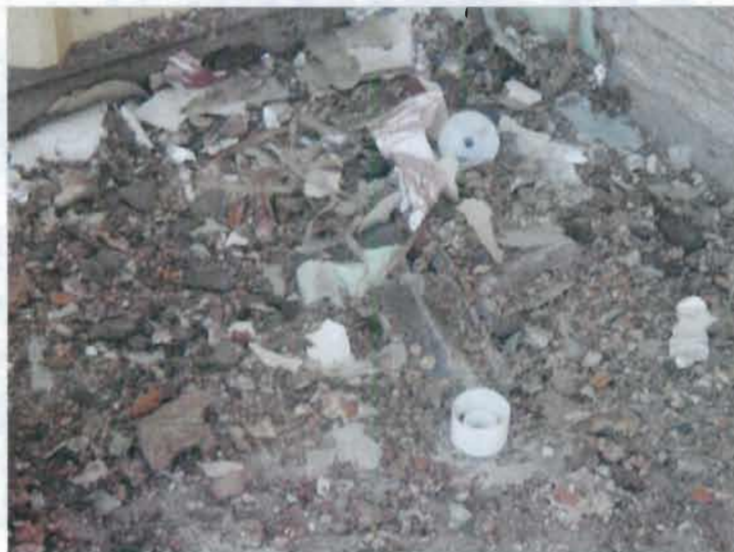
**Comments:** More suspect transite debris lying on the ground outside of the east side of the building where the transite roof was removed

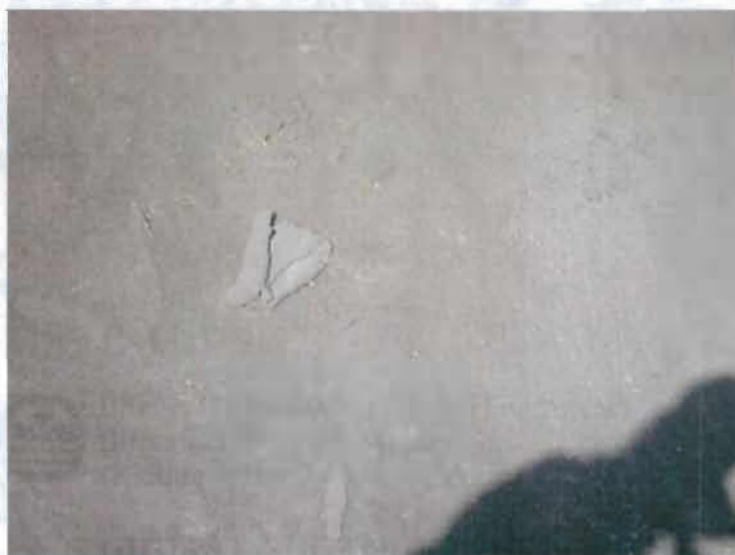
**Comments: Small pieces of transite material lying on the ground area**

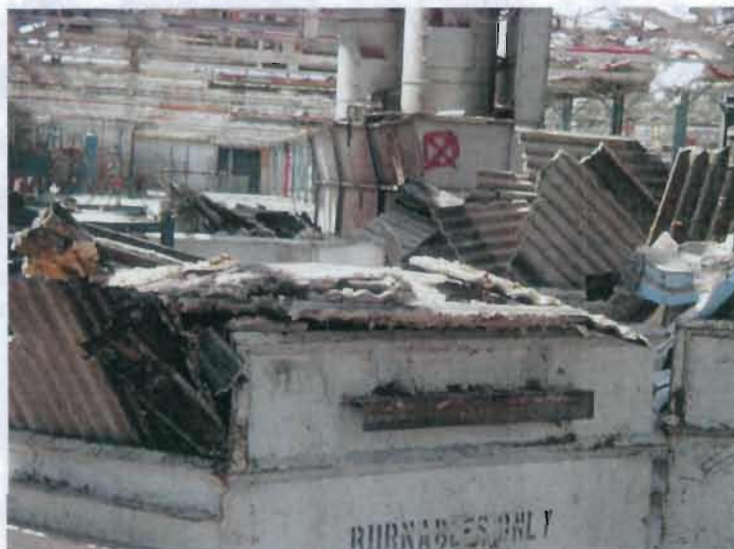
Comments: Broken transite material lying inside of one of the 8 gondolas inside of the building

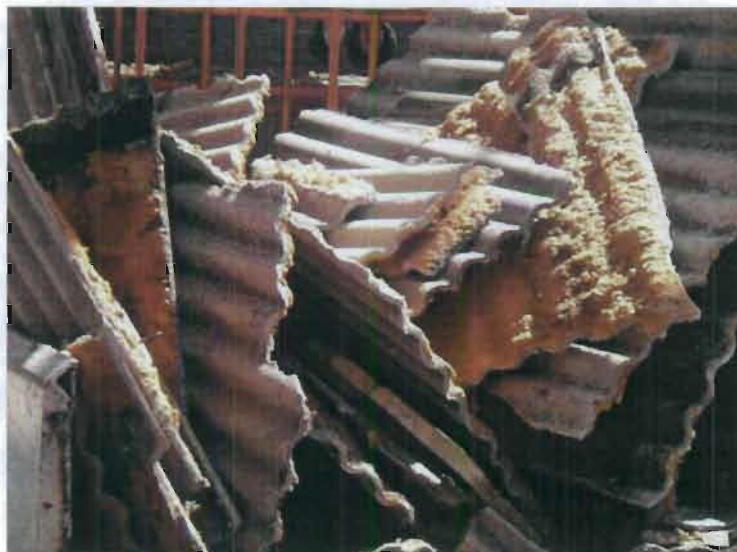
**Comments: Closer view of broken transite material lying in the gondola inside of the building**

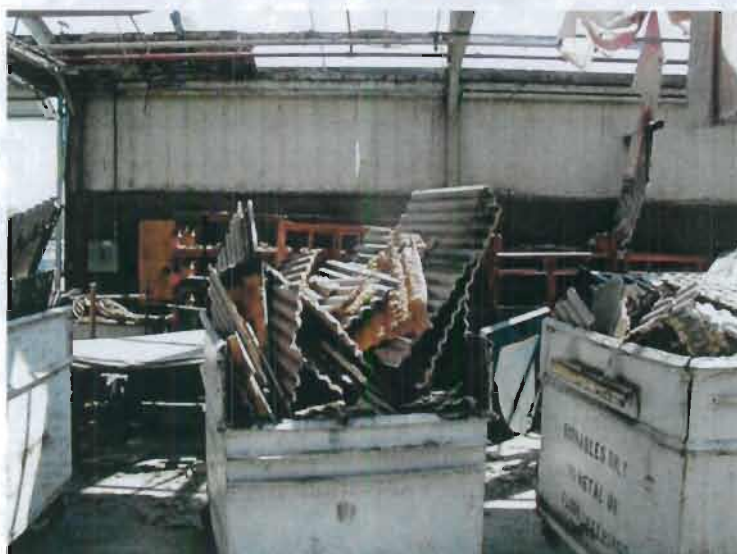
**Comments: Another view of the gondolas filled with broken transite that was among the 8 gondolas that were filled with dry material**

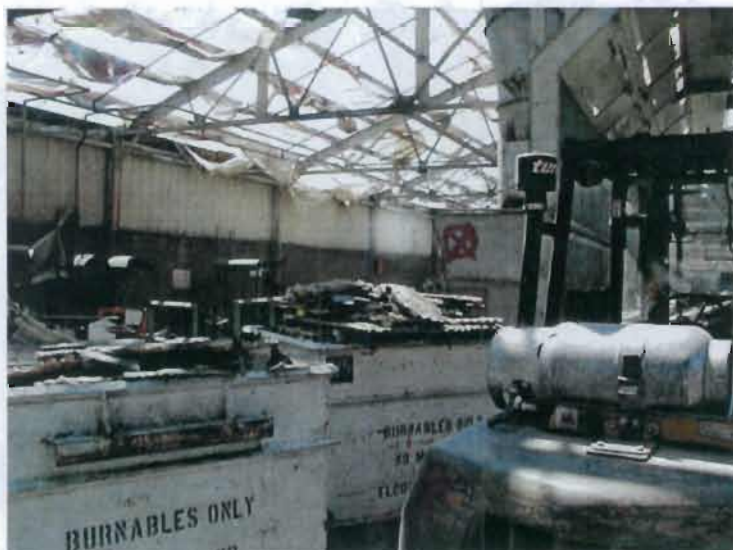
Comments: Another photo of the gondola boxes containing dry broken transite material

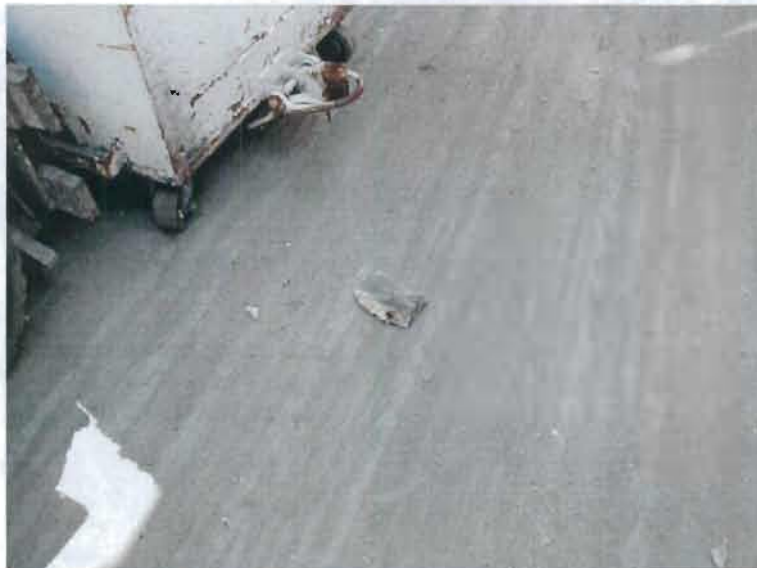
**Date:** May 5, 2005  
**Time:** ~ 11:00 am  
**Direction:** Southeast  
**Photo by:** D. Hancock  
**File No:** DAH050505~05052005-029  
**Comments:** A piece of dry broken transite material lying on the ground away from the gondola box.

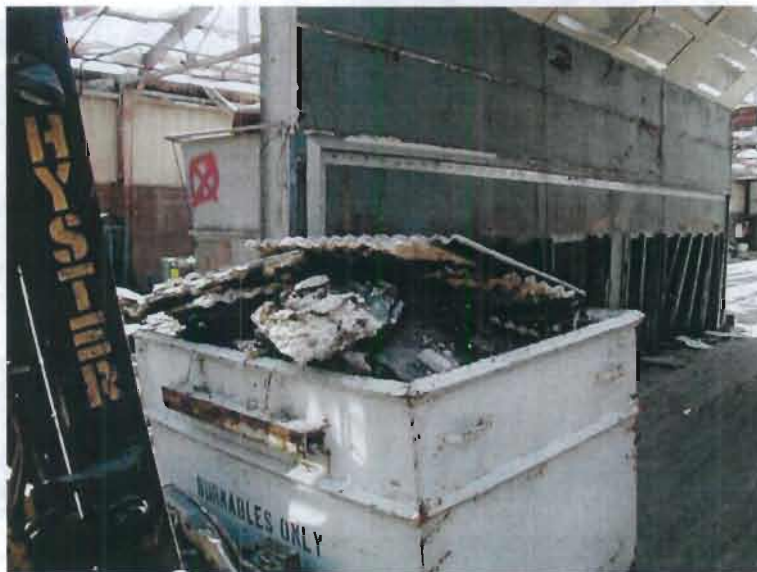
**Date:** May 5, 2005  
**Time:** ~11:05 am  
**Direction:** Southeast  
**Photo by:** D. Hancock  
**File No:** DAH050505~05052005-030  
**Comments:** final gondola box in this area showing the dry broken transite material lying inside

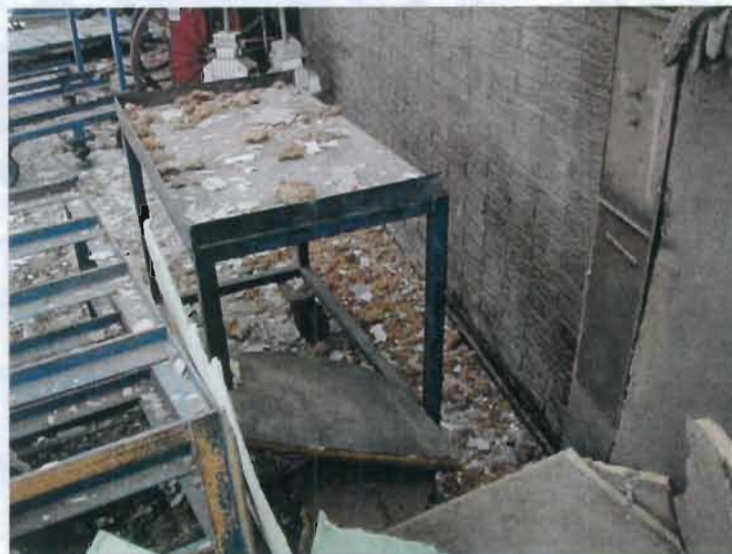
**Comments: Scattered transite debris lying on tables and floor area inside of the building material was dry at this time**

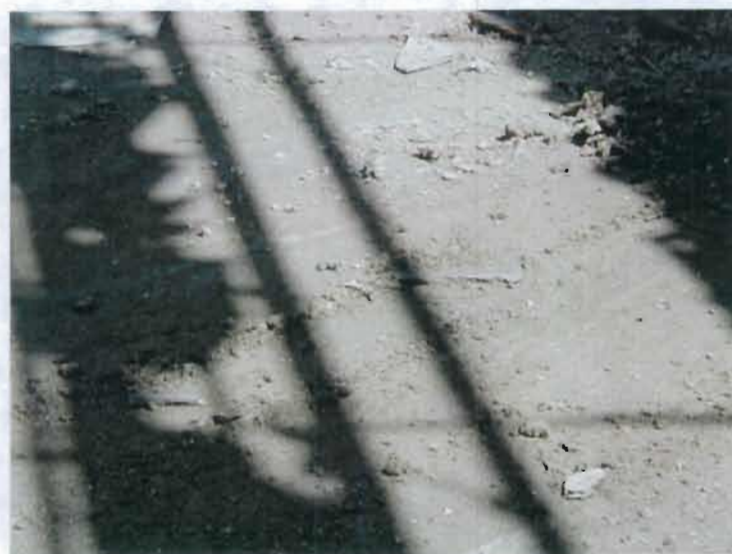
**Comments: Photo of scattered broken dry transite material lying on the floor inside of the building on the east section of building below where transite roofing was removed**

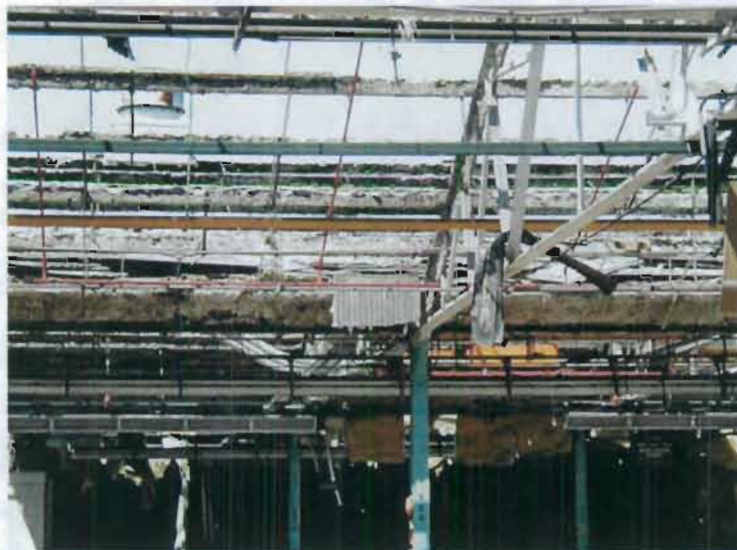
Comments: Photo showing a section of broken transite hanging down from the center of the roof next to the green stanchion.

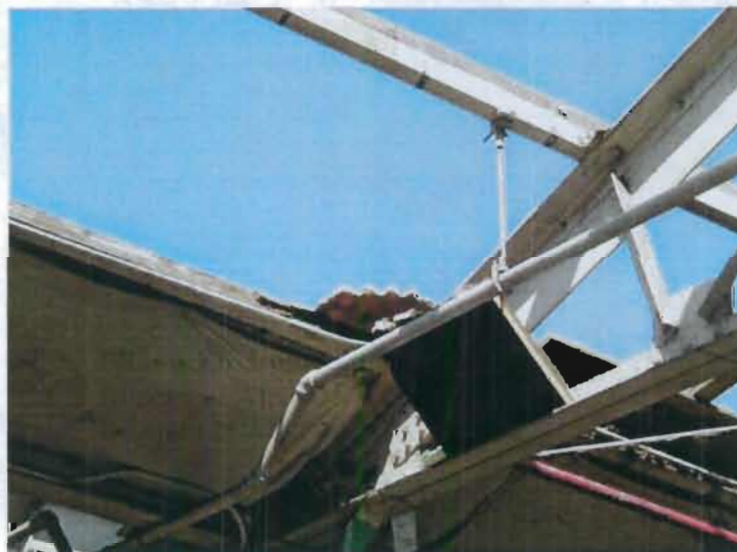
Comments: another photo showing another piece of broken transite at the corner of the beam showing it was a broken piece and not removed in a full section.

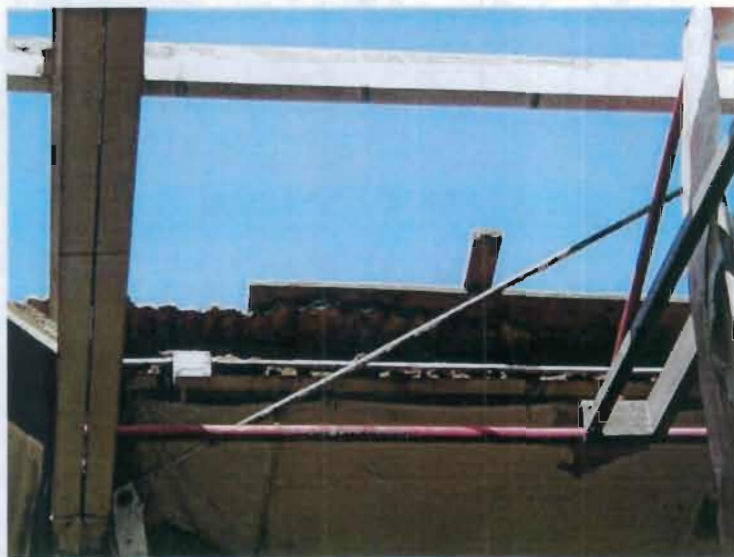
Comments: Photo showing broken transite still up on the roof at the left side of photo

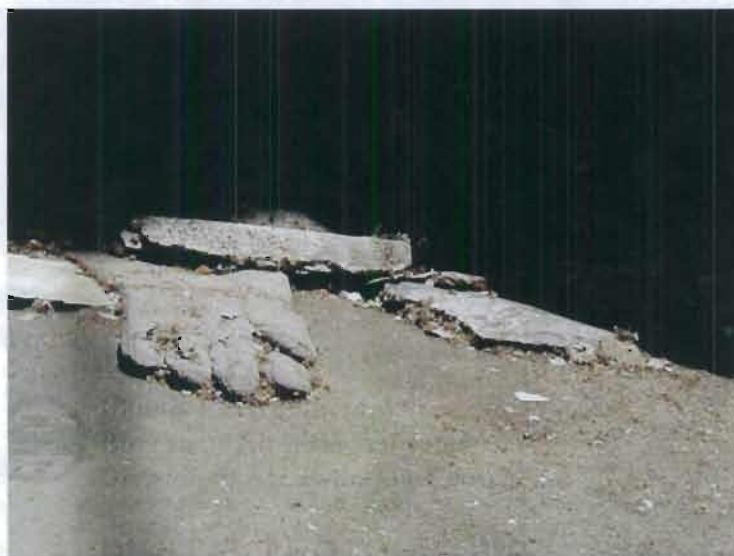
Comments: Broken dry transite lying on the floor next to a pair of gloves

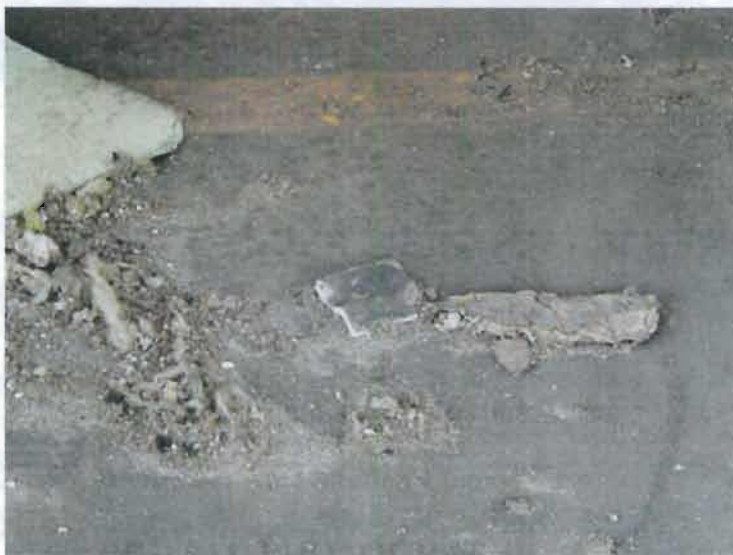
Comments: More photos of broken dry transite lying on the floor inside of the open building some of it is crushed by either the bobcat or forklift

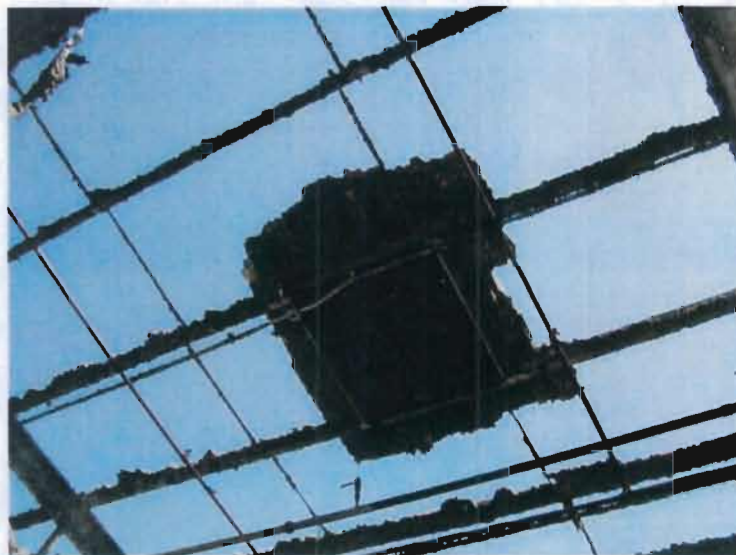
Comments: Photo showing a section of broken transite material lying on the beams of the roof this piece again shows that the transite sheet was not removed in as full a sheet as possible

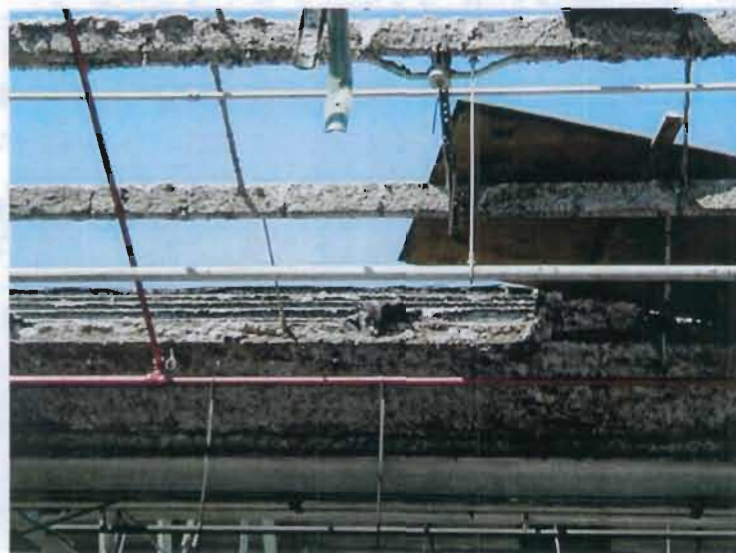
Comments: Photo showing broken pieces of transite that was between two beams and not removed at this time

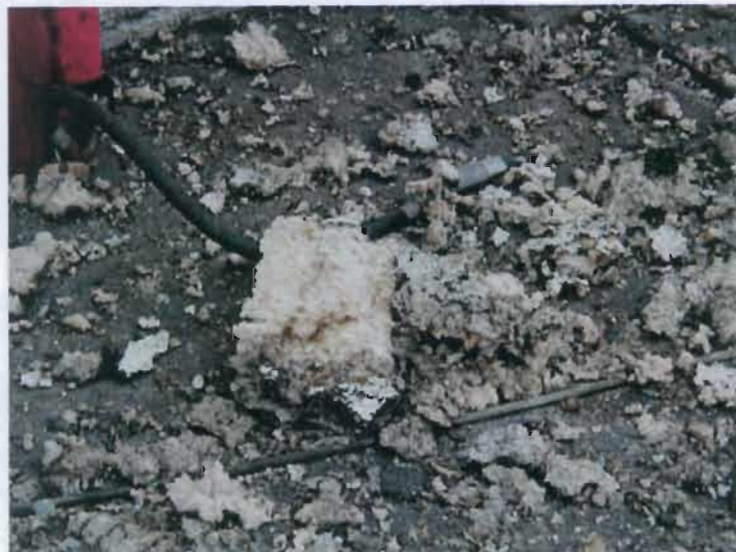
Comments: Photo showing pieces of broken dr  
transite lying in among the insulation debris on  
the floor in the center of the building

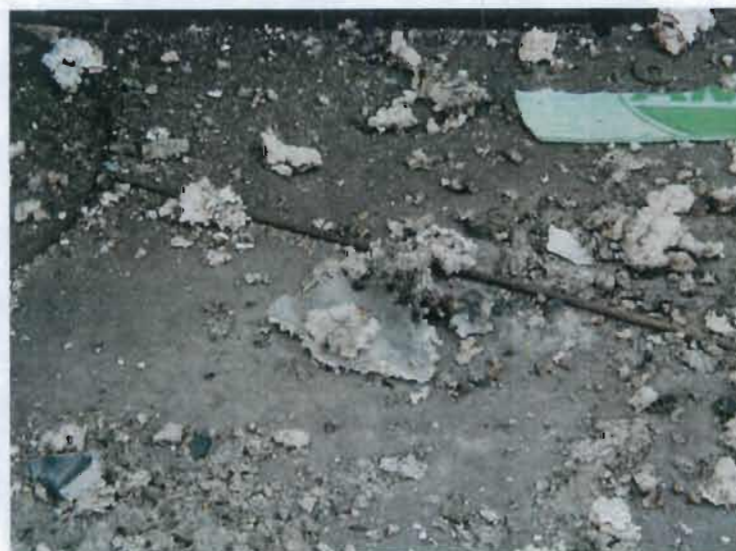
Comments: Photo showing broken and crushed  
transite material lying on the floor among  
insulation debris

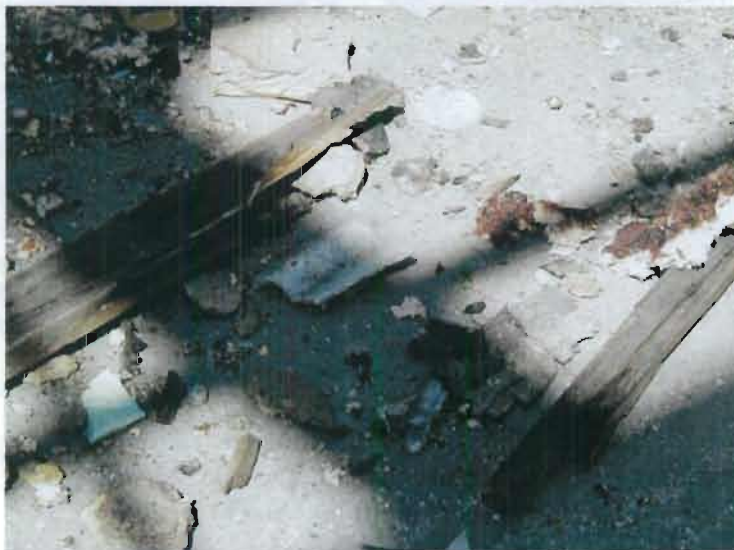
Comments: broken dry pieces of transite material lying on the floor among other debris

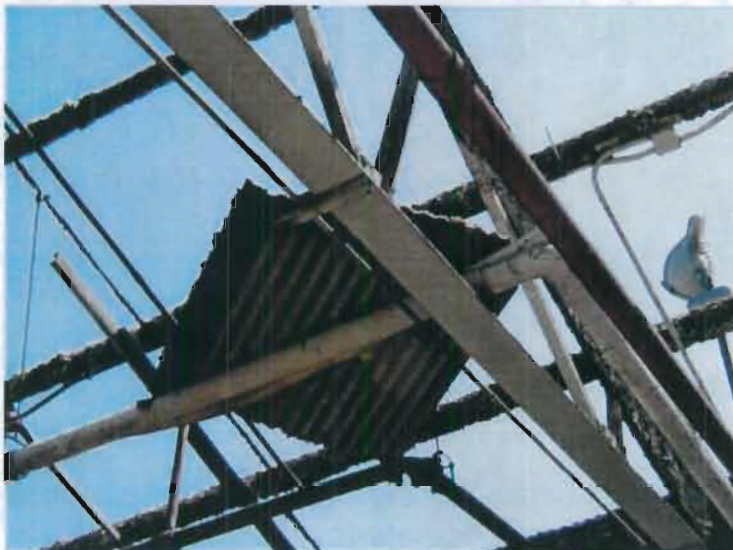
Comments: Photo showing a broken piece of transite still hung up between the beams of the roof

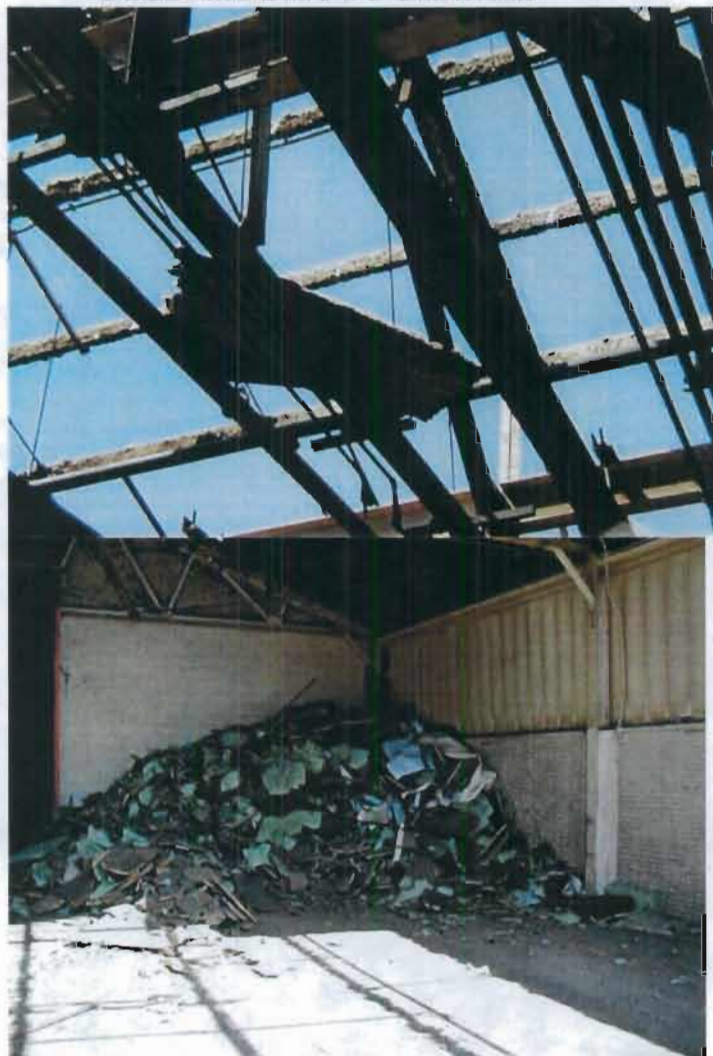
Comments: Photo showing another broken piece of transite lying on the beams of the roof

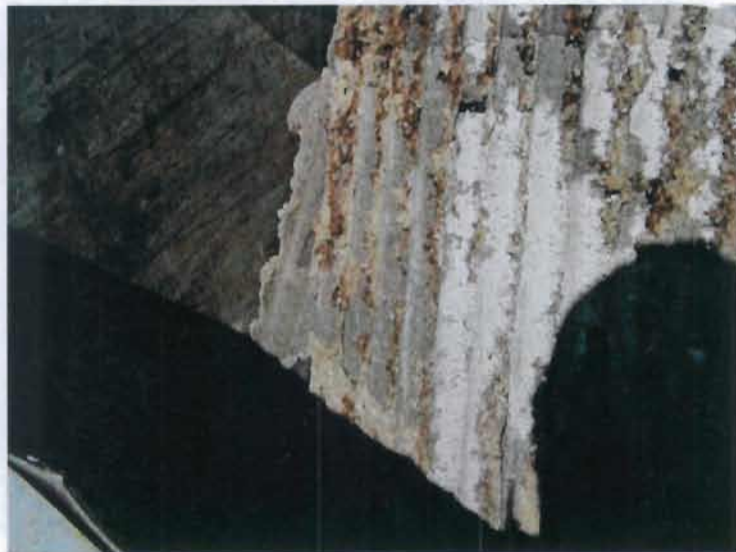
**Comments: Photo showing the uncovered and dry transite panels that were broken and inside of uncovered dumpster**

This inspector looked inside of the dumpsters and found that the material inside of them was dry and broken and the cover over the top was not sealed up. This inspector then told the supervisor that this needed to be wet down and fully covered.

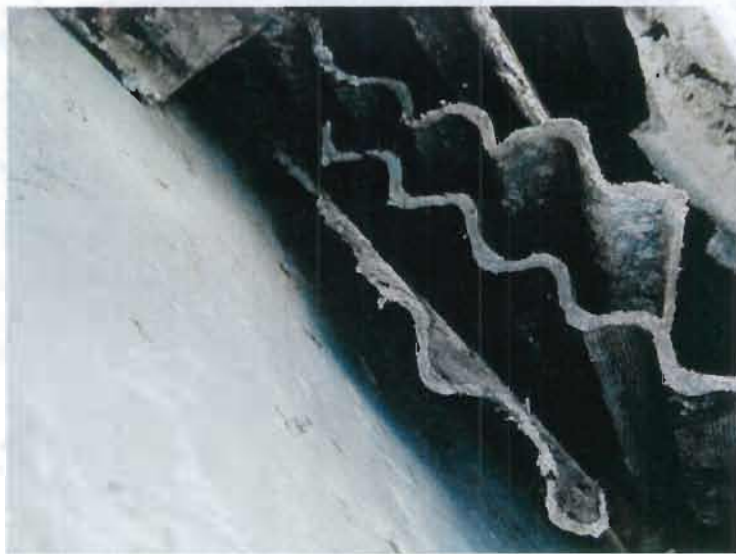
**Comments: Another photo of dry broken uncovered transite inside of the dumpster**

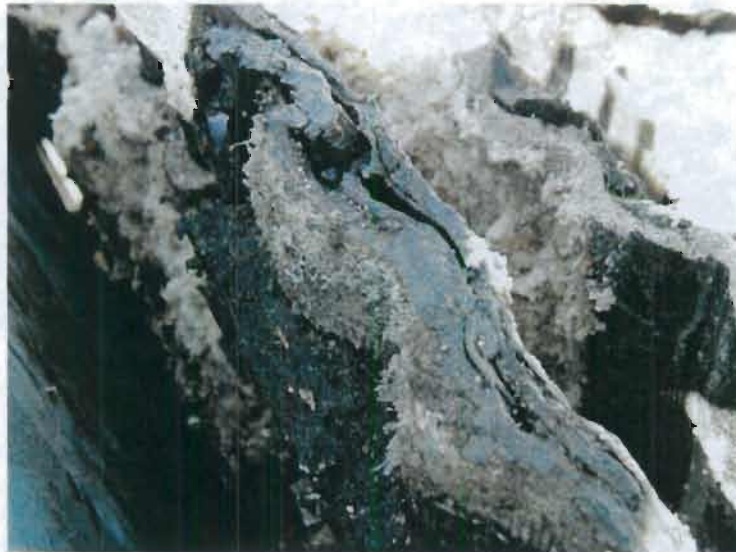
**Comments: Another photo of uncovered broken and dry transite inside of the dumpster**

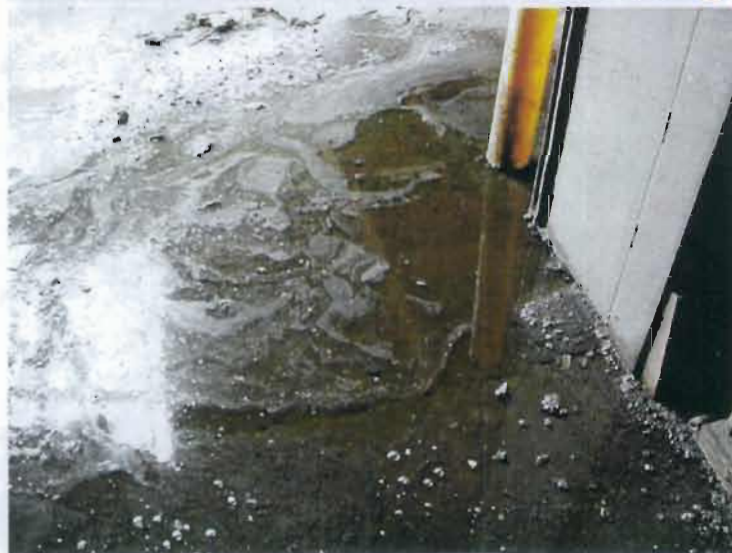
**Comments: Photo of loading dock area that appeared to have at least 3 inches more of rain water from the storm. Asbestos was found at the entrance to this doorway on first inspection and appeared to have been cleaned up.**

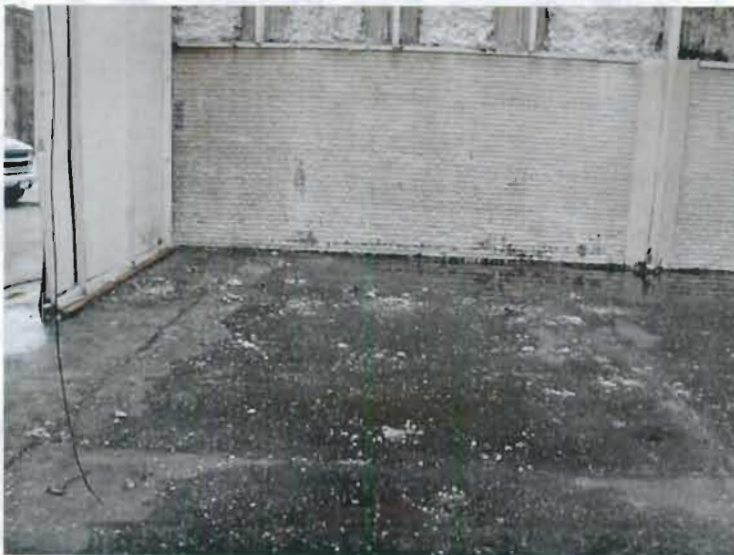
Date: May 11, 2005  
Time: ~10:30 am  
Direction: South  
Photo by: D. Hancock  
File No: DAH051105~05112005-012  
Comments: Area where transite and insulation had been piled up during initial inspection has been cleaned up

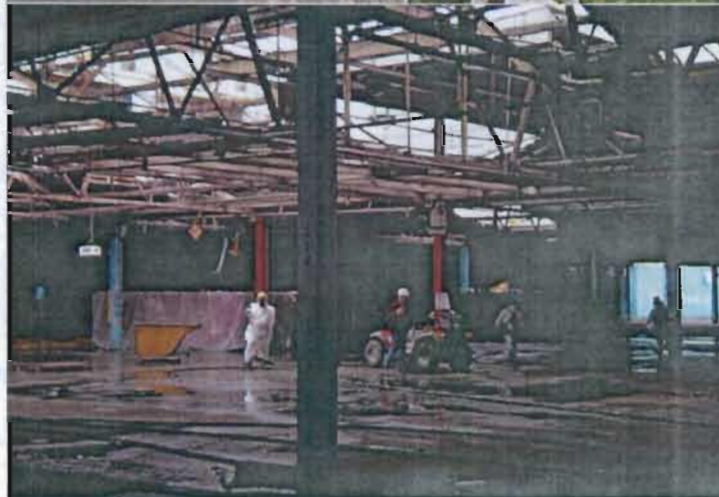
Date: September 28, 2005  
Time: ~ 11:10 am  
Direction: North  
Photo by: D. Hancock  
File No: DAH092805~09282005-004  
Comments: Workers inside of building under area where transite was removed using brooms and shovels to clean up the floor. The dumpster was lined with poly but filled with broken transite pieces. Supervisor stated that he busted them up after putting them in the dumpster so it would make more room and the poly would not poke holes from the transite. A violation of crumbling by forces used upon it to make it friable

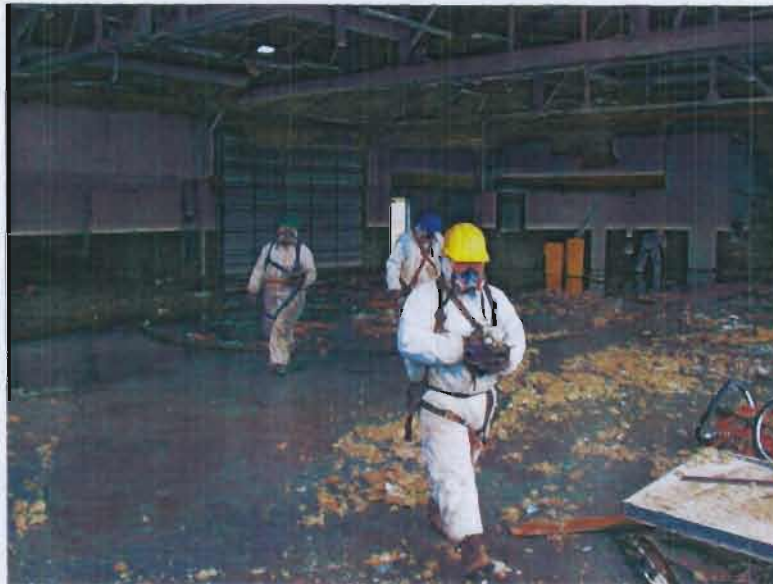
**Date: March 1, 2006  
Time: ~10:35 am  
Direction: Facing Southeast  
Photo by: D. Hancock  
File No: DAH030106~03012006-003  
Comments: Workers carrying handfuls of broken pieces of transite material picked u from the floor and carried to the dumpster**

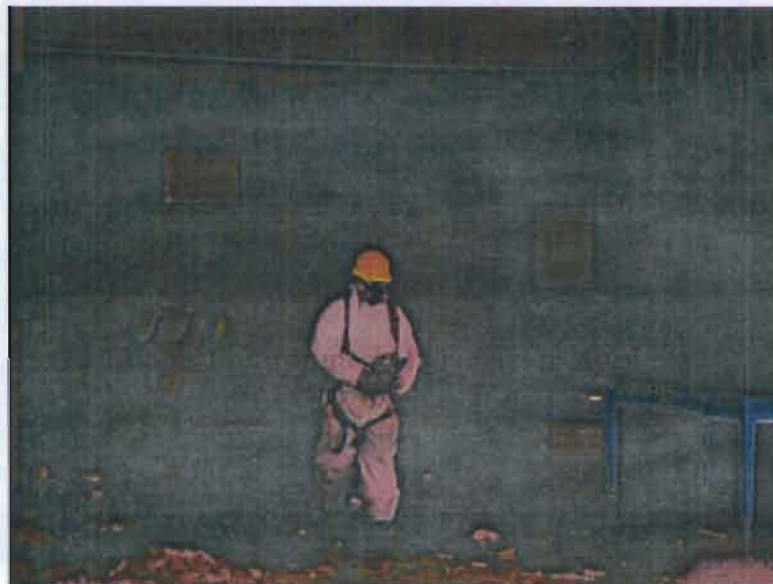
**Date: March 1, 2006  
Time: 10:45 am  
Direction: Facing East  
Photo by: D. Hancock  
File No: DAH030106~03012006-004  
Comments: Another photo of worker carry another handful of broken pieces of transit from the concrete floor to the dumpster.**

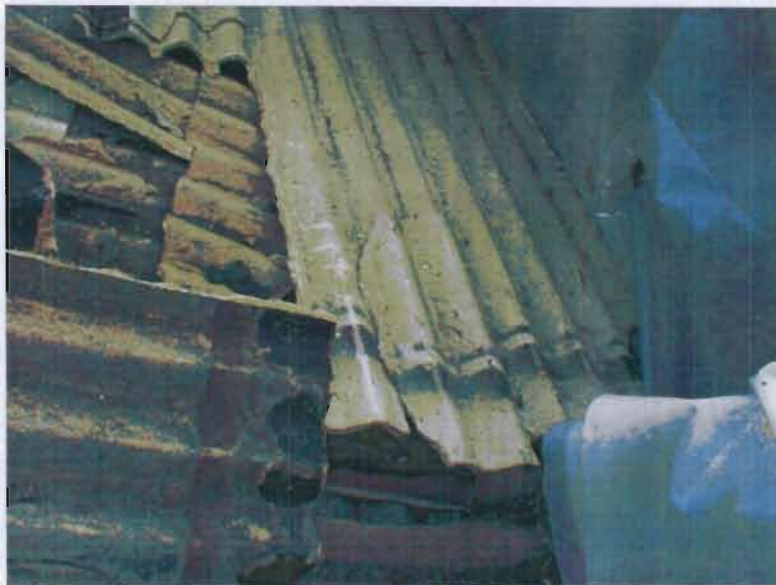
Date: March 1, 2006  
Time: ~10:45 am  
Direction: Down  
Photo by: D. Hancock  
File No: DAH030106~03012006-005  
Comments: Photo of broken transite roofing sheets inside of the dumpsters. No full sheet with just the corners broken were seen inside this dumpster.

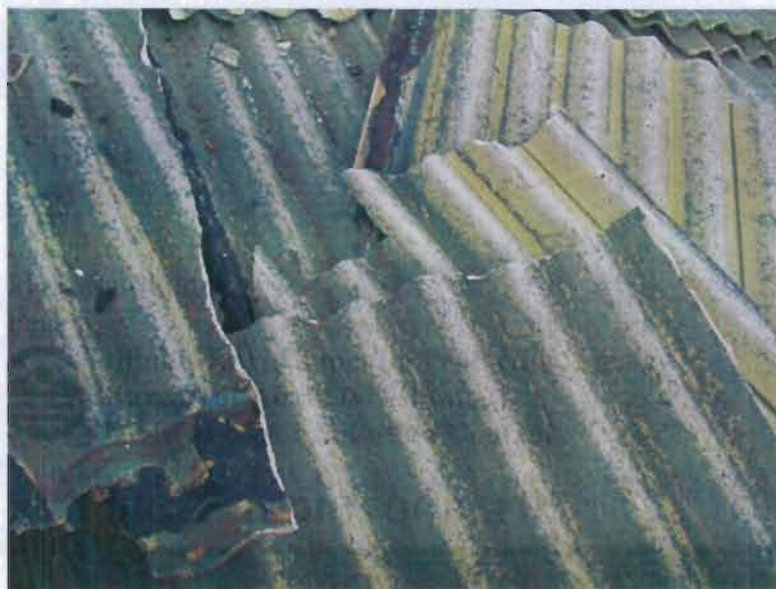
Date: March 1, 2006  
Time: ~10:55 am  
Direction: Inside of dumpster  
Photo by: D. Hancock  
File No: DAH030106~03012006-006  
Comments: More transite inside of another dumpster showing more broken transite material again not in full sheets

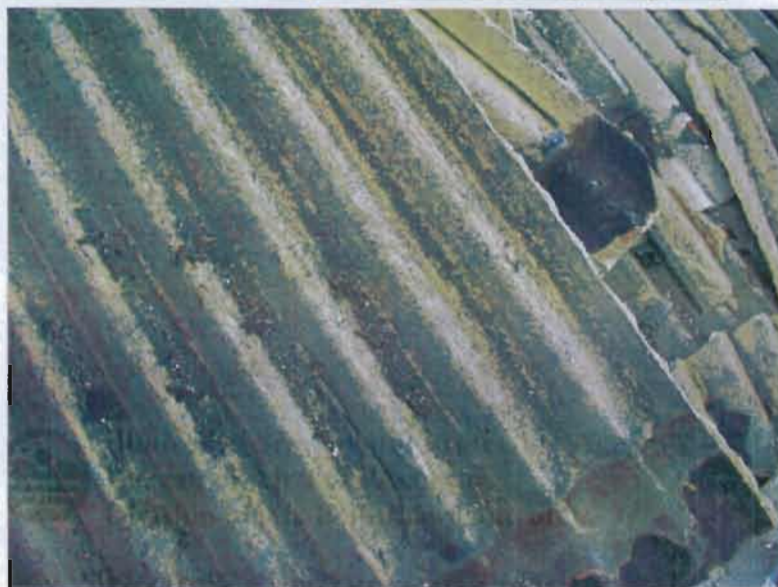
**Date: March 1, 2006  
Time: ~11:10 am  
Direction: Inside of dumpster  
Photo by: D. Hancock  
File No: DAH030106~03012006-008  
Comments: Another photo of broken trans dumpster from different location**

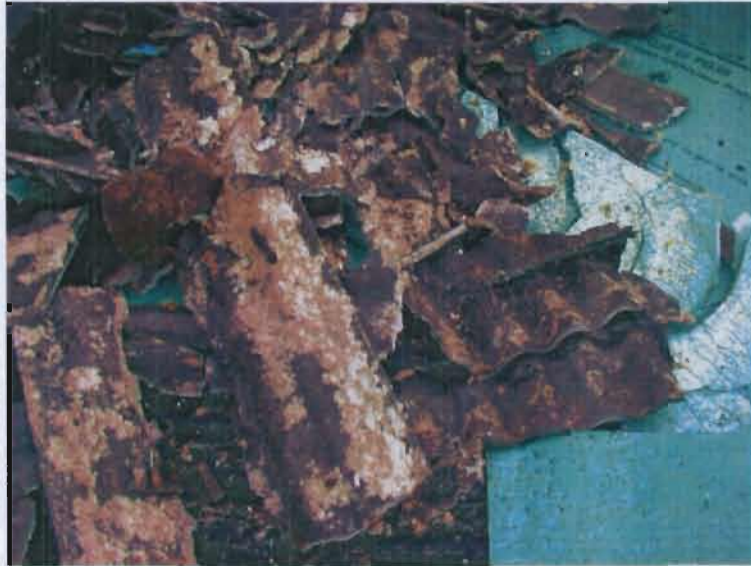
Date: March 1, 2006  
Time: ~11:10 am  
Direction: Inside dumpster  
Photo by: D. Hancock  
File No: DAH030106~03012006-009  
Comments: Photo of several small broken pieces of transite material inside of dumpst

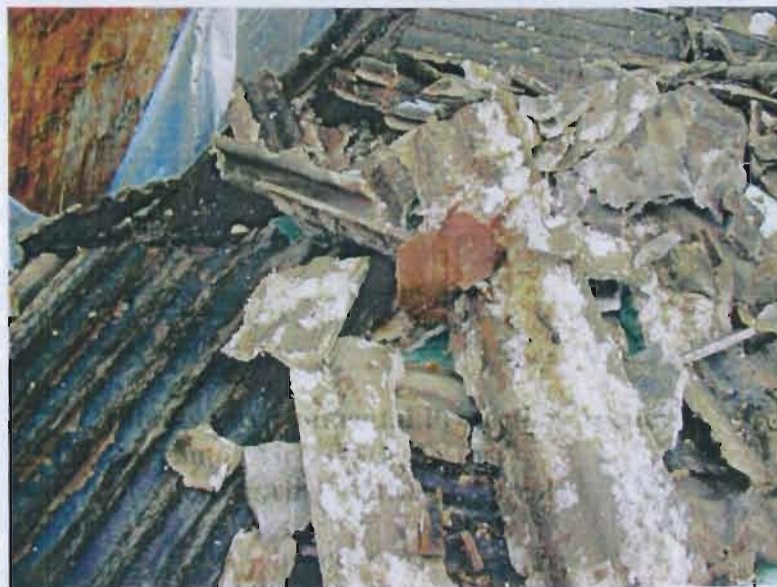
Date: March 1, 2006  
Time: ~11:20 am  
Direction: Inside of dumpster  
Photo by: D. Hancock  
File No: DAH030106~03012006-010  
Comments: Another photo of several broken small pieces of transite inside of dumpster. full pieces
