STATE OF ILLINOIS                     )  
  )  
COUNTY OF LA SALLE                )                     PCB 2005-199

**AFFIDAVIT**

4.       On May 5, 2005, I inspected the facility known as the Case Manufacturing Facility, located at 1100 Third Street in East Moline, Rock Island County, Illinois (facility). The facility was approximately two million five hundred thousand (2,500,000) square feet.

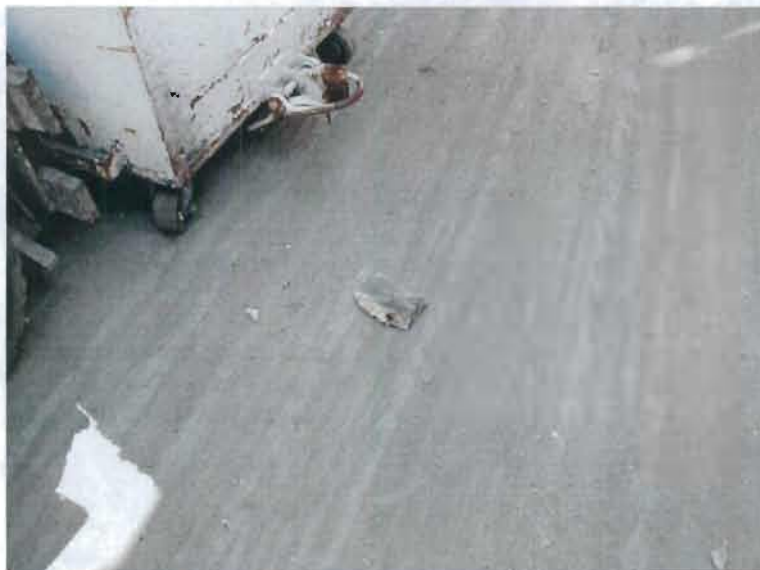
**Date:** May 5, 2005  
**Time:** ~ 11:00 am  
**Direction:** Southeast  
**Photo by:** D. Hancock  
**File No:** DAH050505~05052005-029  
**Comments:** A piece of dry broken transite material lying on the ground away from the gondola box.

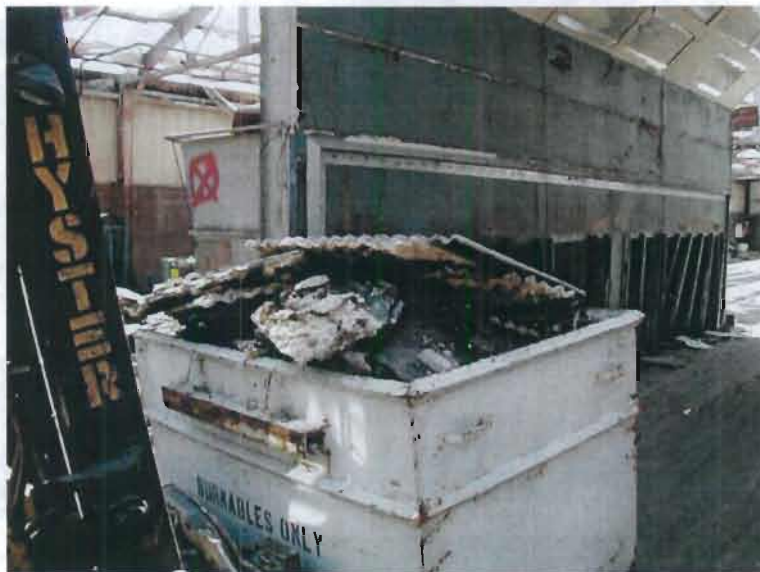
**Date:** May 5, 2005  
**Time:** ~11:05 am  
**Direction:** Southeast  
**Photo by:** D. Hancock  
**File No:** DAH050505~05052005-030  
**Comments:** final gondola box in this area showing the dry broken transite material lying inside

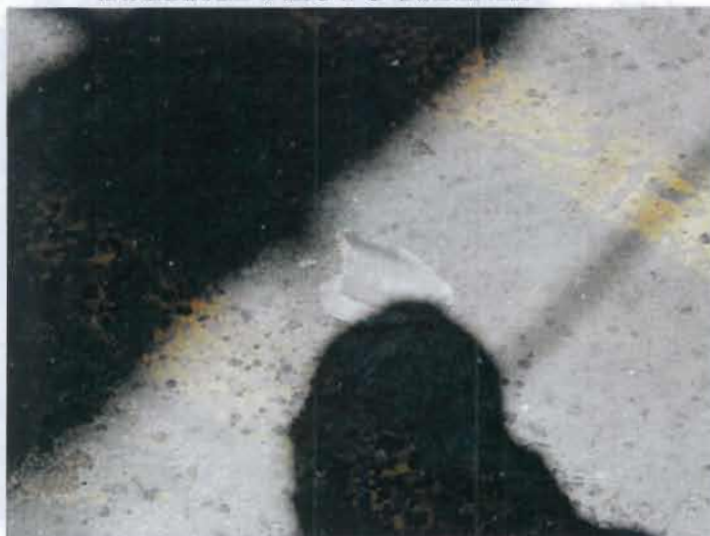
**Date: May 5, 2005  
Time: ~11:30 am  
Direction: Northwest  
Photo by: D. Hancock  
File No: DAH050505~05052005-051  
Comments: Photo showing another piece of dry, broken transite lying in the middle of the floor area**

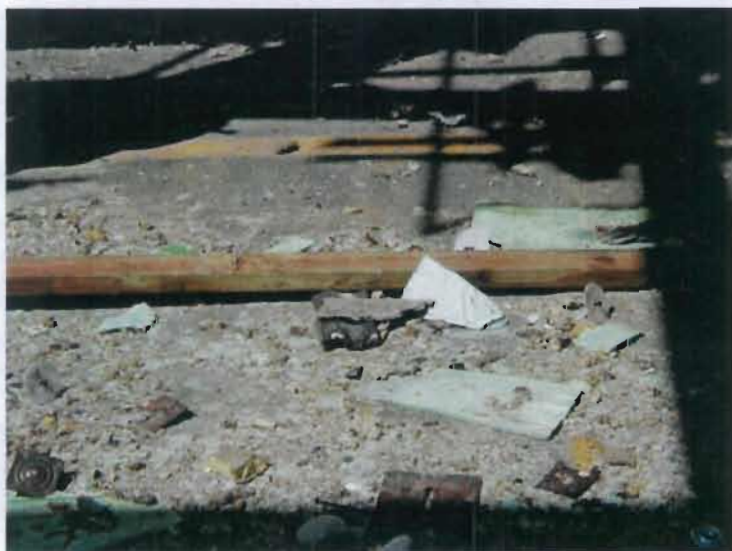
**Date: May 5, 2005  
Time: ~11:30 am  
Direction: North  
Photo by: D. Hancock  
File No: DAH050505~05052005-052  
Comments: Photo showing transite lying on the floor among insulation debris**

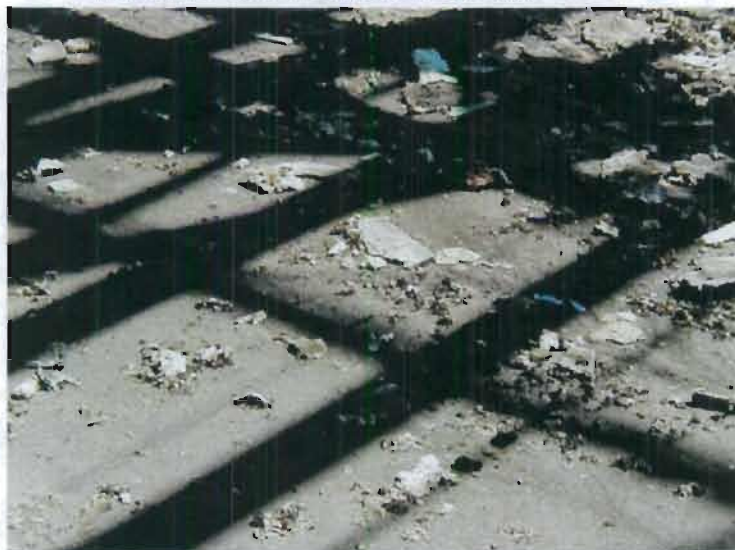
**Date:** May 5, 2005  
**Time:** ~11:50 am  
**Direction:** South  
**Photo by:** D. Hancock  
**File No:** DAH050505~05052005-077  
**Comments:** Photo showing more broken transite lying on the floor underneath where transite roofing was removed

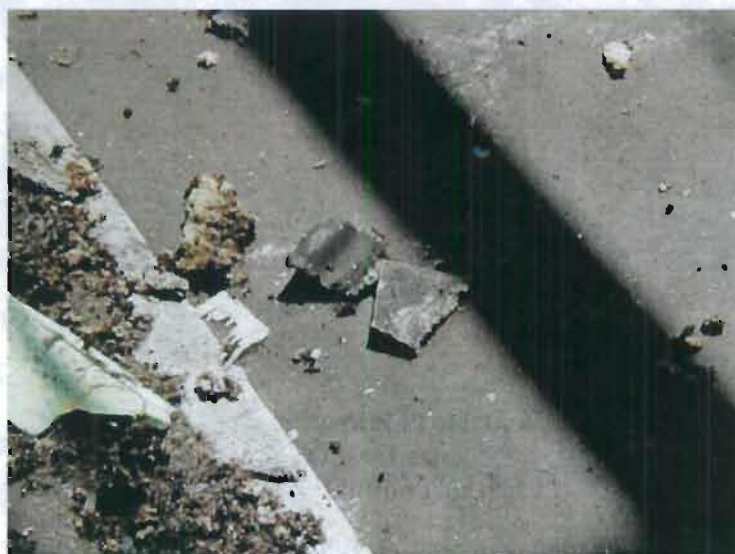
**Date:** May 5, 2005  
**Time:** ~11:50 am  
**Direction:** East  
**Photo by:** D. Hancock  
**File No:** DAH050505~05052005-078  
**Comments:** photo showing transite broken and dry lying on the floor on the South side of the building

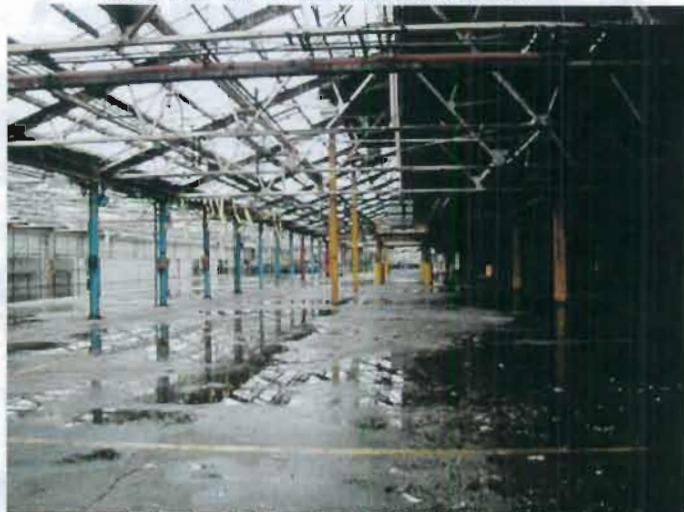
Date: May 11, 2005  
Time: ~10:10 am  
Direction: North  
Photo by: D. Hancock  
File No: DAH051105~05112005-007  
Comments: Photo showing that the area where the gondolas were at are now gone and area cleaned up. A couple of small pieces were found during this inspection but were picked up by the supervisor during the inspection

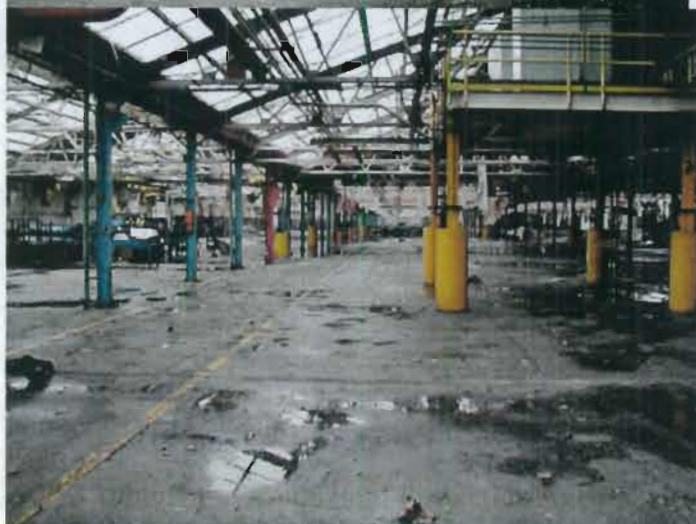
Date: May 11, 2005  
Time: ~10:10 am  
Direction: South  
Photo by: D. Hancock  
File No: DAH051105~05112005-008  
Comments: Photo showing where asbestos material had been observed during initial inspection and now appears to have been cleaned up.

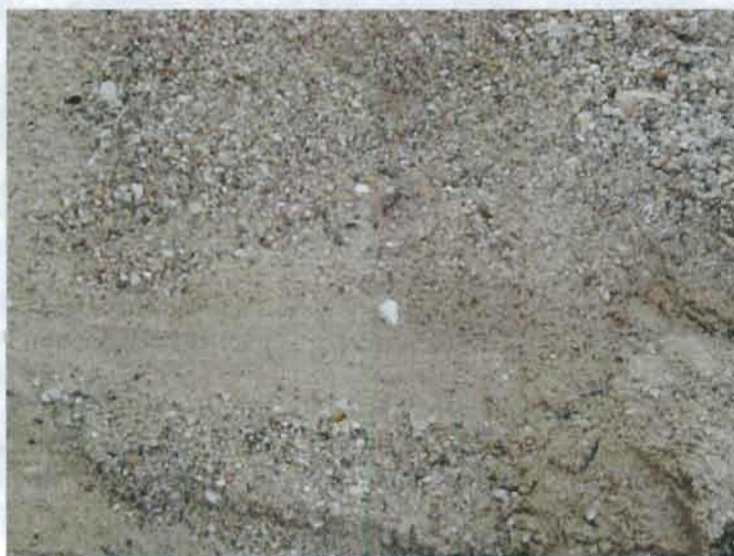
**Date: May 11, 2005  
Time: ~12:20 pm  
Direction: South  
Photo by: D. Hancock  
File No: DAH051105~05112005-020  
Comments: Another piece of green insulation board lying in the sand area next to the Mississippi river**

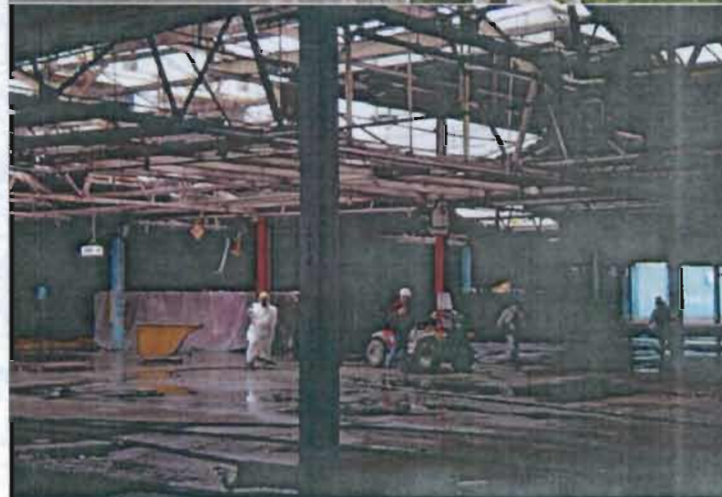
Date: September 28, 2005  
Time: ~ 11:10 am  
Direction: North  
Photo by: D. Hancock  
File No: DAH092805~09282005-004  
Comments: Workers inside of building under area where transite was removed using brooms and shovels to clean up the floor. The dumpster was lined with poly but filled with broken transite pieces. Supervisor stated that he busted them up after putting them in the dumpster so it would make more room and the poly would not poke holes from the transite. A violation of crumbling by forces used upon it to make it friable

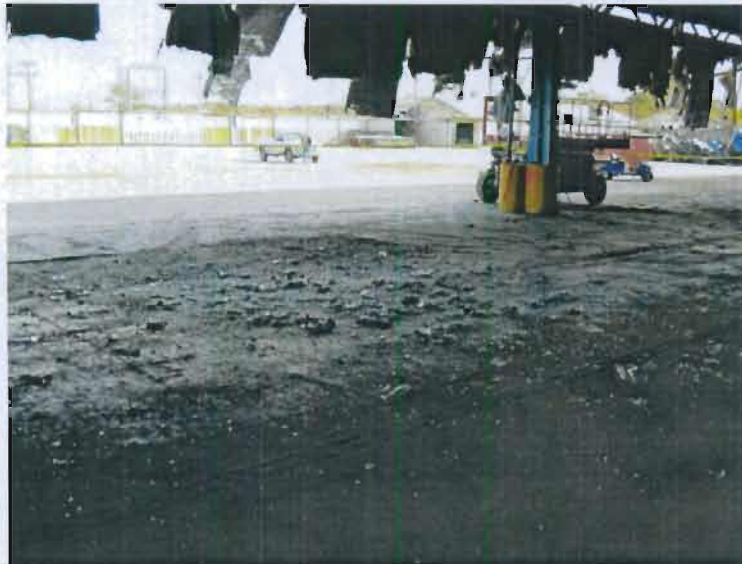
Date: November 3, 2005  
Time: ~ 1:54 pm  
Direction: Facing Southeast  
Photo by: D. Hancock  
File No: DAH110305~11032005-001  
Comments: Photo looking at material on the concrete floor and to the outside area of the building

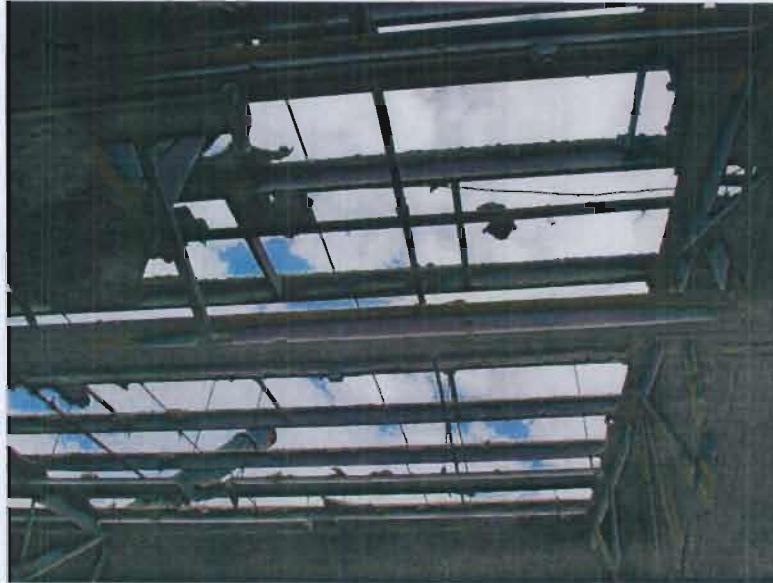
**Date:** March 1, 2006  
**Time:** ~10:30 am  
**Direction:** East  
**Photo by:** D. Hancock  
**File No:** DAH030106~03012006-001  
**Comments:** Broken pieces of transite lying on the steel beams

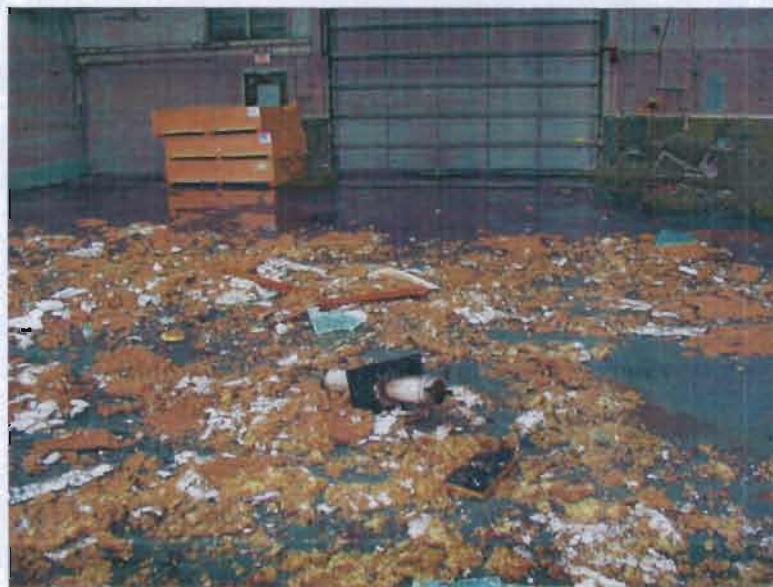
**Date:** March 1, 2006  
**Time:** ~10:30 am  
**Direction:** South  
**Photo by:** D. Hancock  
**File No:** DAH030106~03012006-002  
**Comments:** Transite and trash lying on the concrete floor also showing no poly covering the floor like the SOP states would be done during the project.

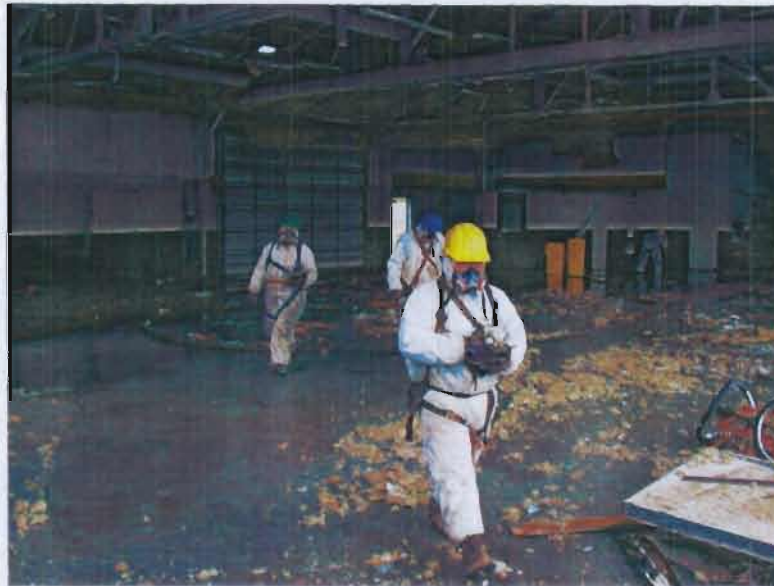
**Date: March 1, 2006  
Time: ~10:35 am  
Direction: Facing Southeast  
Photo by: D. Hancock  
File No: DAH030106~03012006-003  
Comments: Workers carrying handfuls of broken pieces of transite material picked up from the floor and carried to the dumpster**

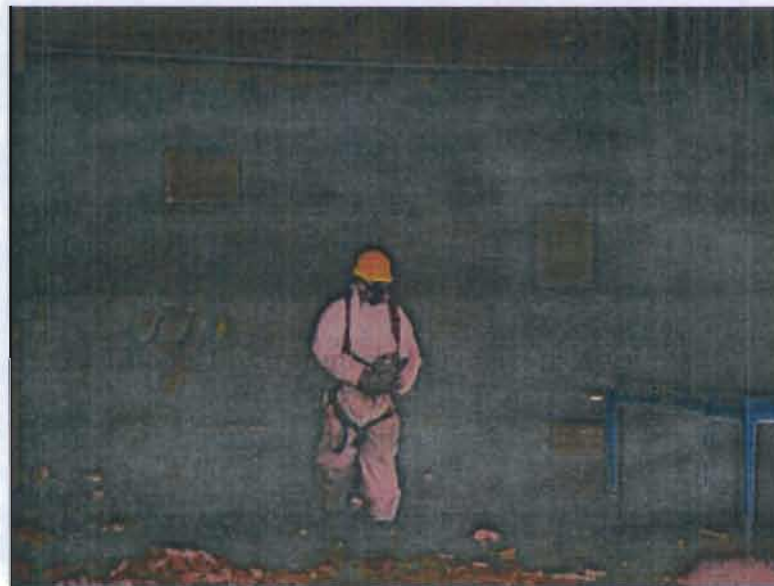
**Date: March 1, 2006  
Time: 10:45 am  
Direction: Facing East  
Photo by: D. Hancock  
File No: DAH030106~03012006-004  
Comments: Another photo of worker carry another handful of broken pieces of transit from the concrete floor to the dumpster.**

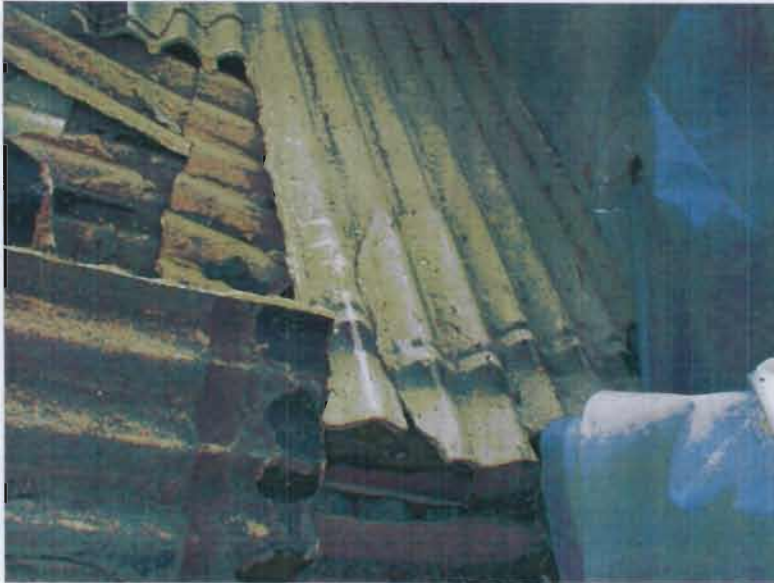
Date: March 1, 2006  
Time: ~10:45 am  
Direction: Down  
Photo by: D. Hancock  
File No: DAH030106~03012006-005  
Comments: Photo of broken transite roofing sheets inside of the dumpsters. No full sheet with just the corners broken were seen inside this dumpster.

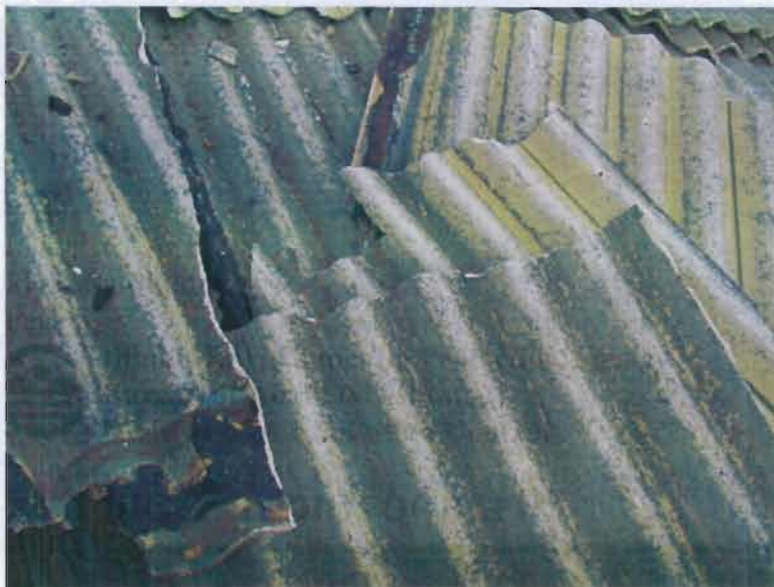
Date: March 1, 2006  
Time: ~10:55 am  
Direction: Inside of dumpster  
Photo by: D. Hancock  
File No: DAH030106~03012006-006  
Comments: More transite inside of another dumpster showing more broken transite material again not in full sheets

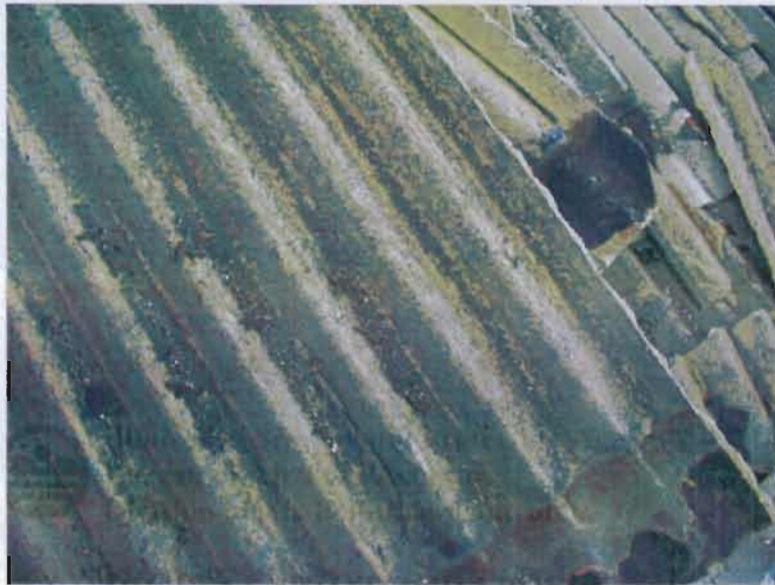
**Date: March 1, 2006  
Time: ~11:10 am  
Direction: Inside of dumpster  
Photo by: D. Hancock  
File No: DAH030106~03012006-008  
Comments: Another photo of broken trans dumpster from different location**

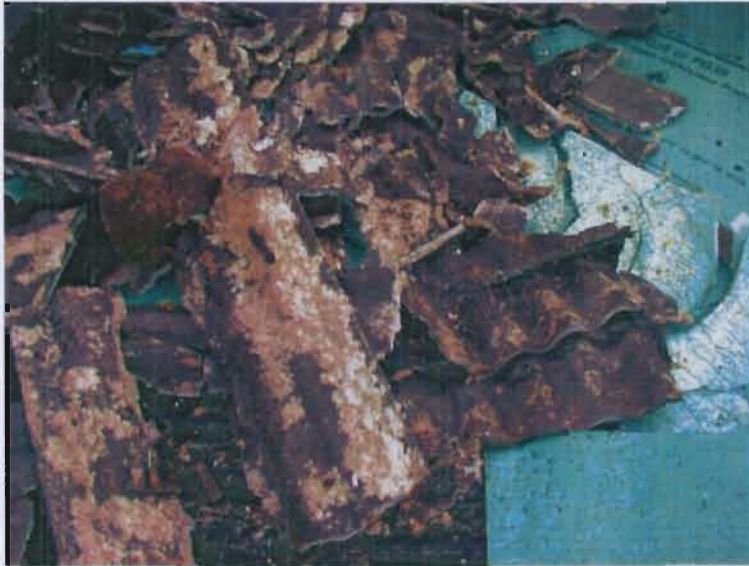
Date: March 1, 2006  
Time: ~11:10 am  
Direction: Inside dumpster  
Photo by: D. Hancock  
File No: DAH030106~03012006-009  
Comments: Photo of several small broken pieces of transite material inside of dumpst

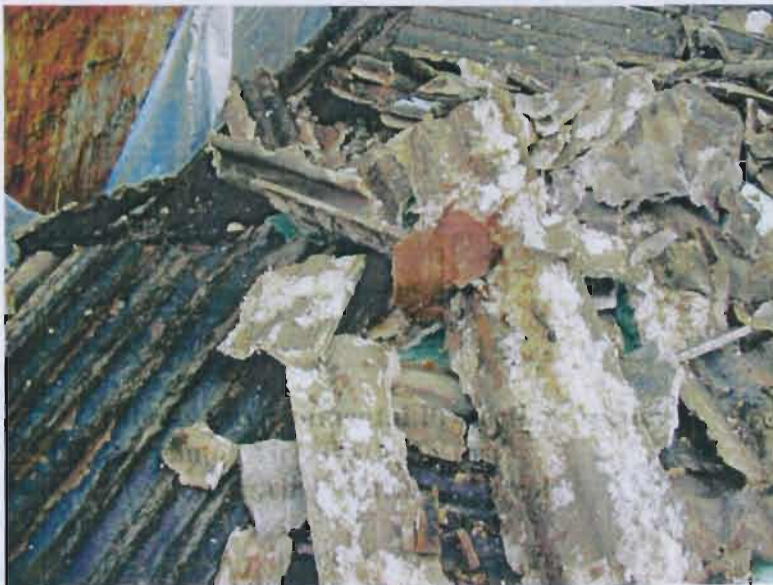
Date: March 1, 2006  
Time: ~11:20 am  
Direction: Inside of dumpster  
Photo by: D. Hancock  
File No: DAH030106~03012006-010  
Comments: Another photo of several broke small pieces of transite inside of dumpster. full pieces
