**ILLINOIS POLLUTION CONTROL BOARD**

BLAKE LEASING COMPANY, LLC – REAL	)	
ESTATE SERIES, as owner of KIRKLAND	)	
QUICK STOP,	)	
	)	
Petitioner,	)	PCB 2018-026
	)	(Water Well Setback Exception)
v.	)	
	)	
ILLINOIS ENVIRONMENTAL PROTECTION	)	
AGENCY, VILLAGE OF KIRKLAND, ILLINOIS	)	
and SOO LINE RAILROAD COMPANY (d/b/a	)	
CANADIAN PACIFIC RAILWAY and	)	
CANADIAN PACIFIC),	)	
	)	
Respondents.	)

**TECHNICAL MEMORANDUM**

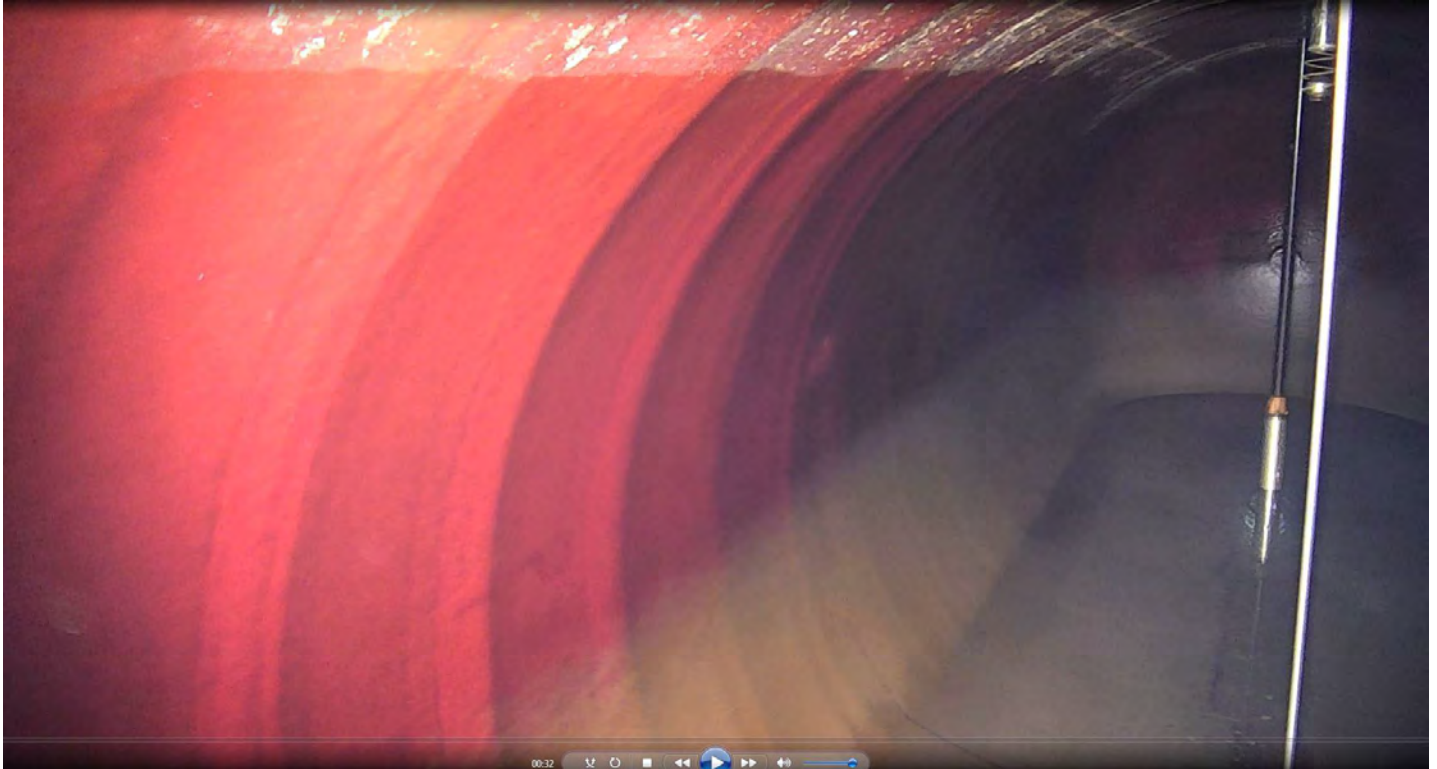
Figure 1-1: Residue build-up on lower half of tank walls (00:32)

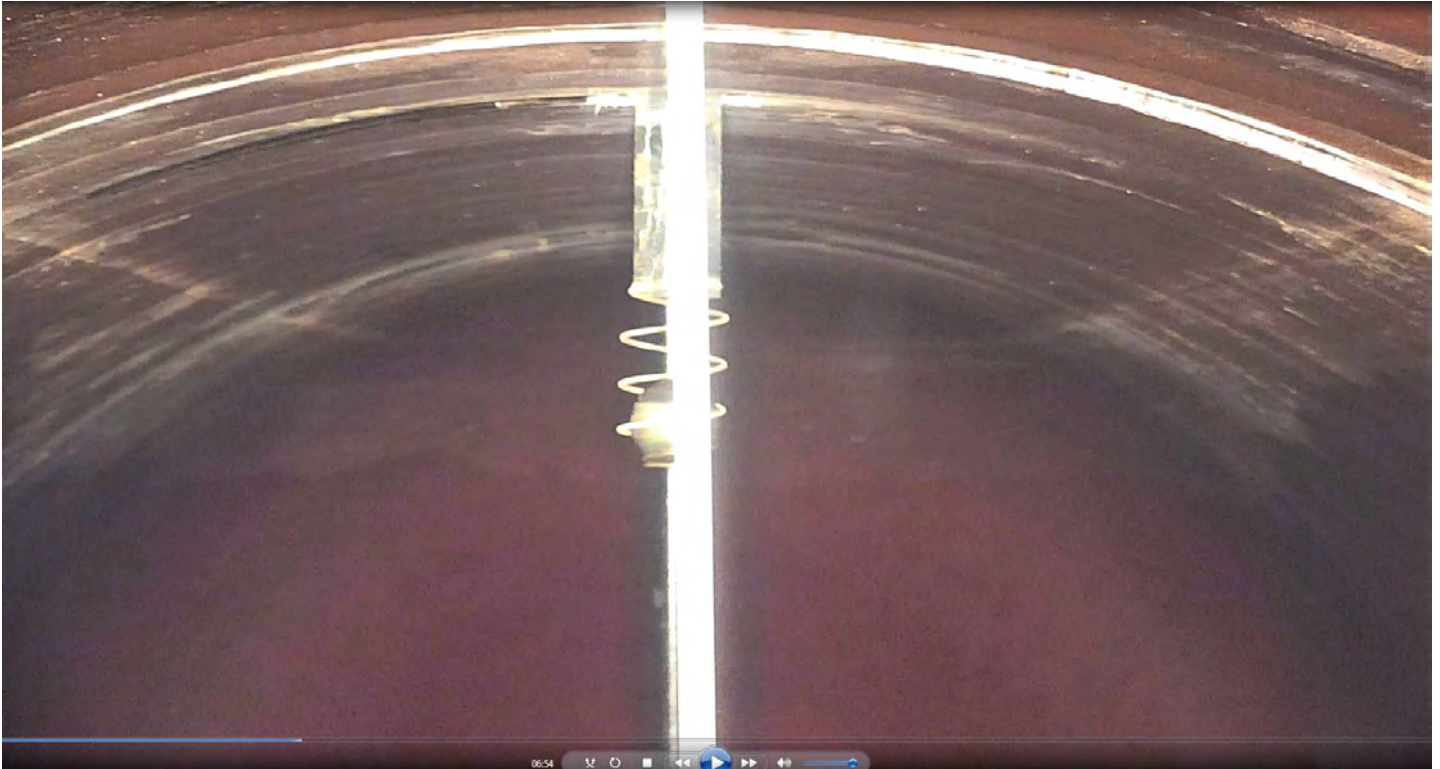
Figure 1-3: White residue on top of tank; possible oxidation or corrosion on ball float assembly (06:54)

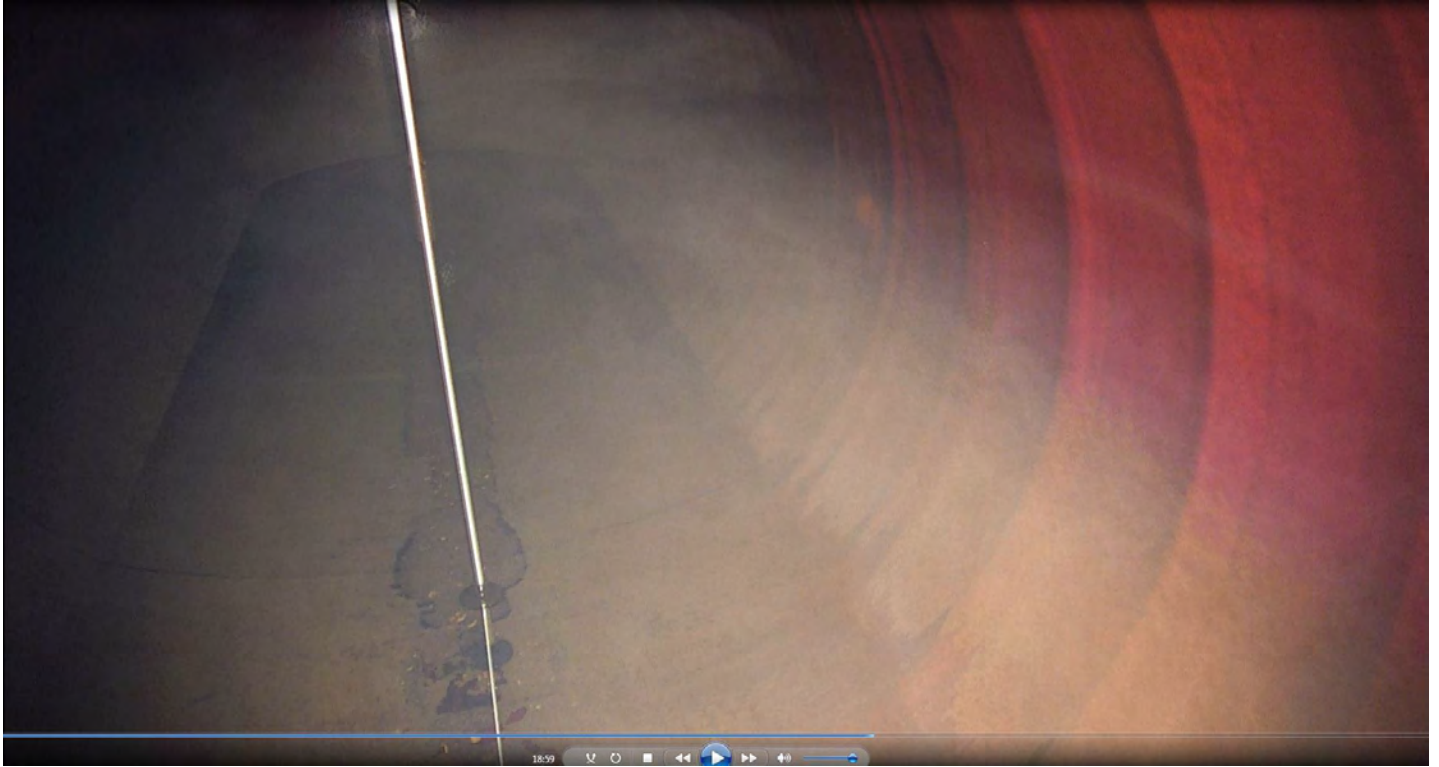
Figure 1-5: Sediment/residue on tank bottom (18:59)

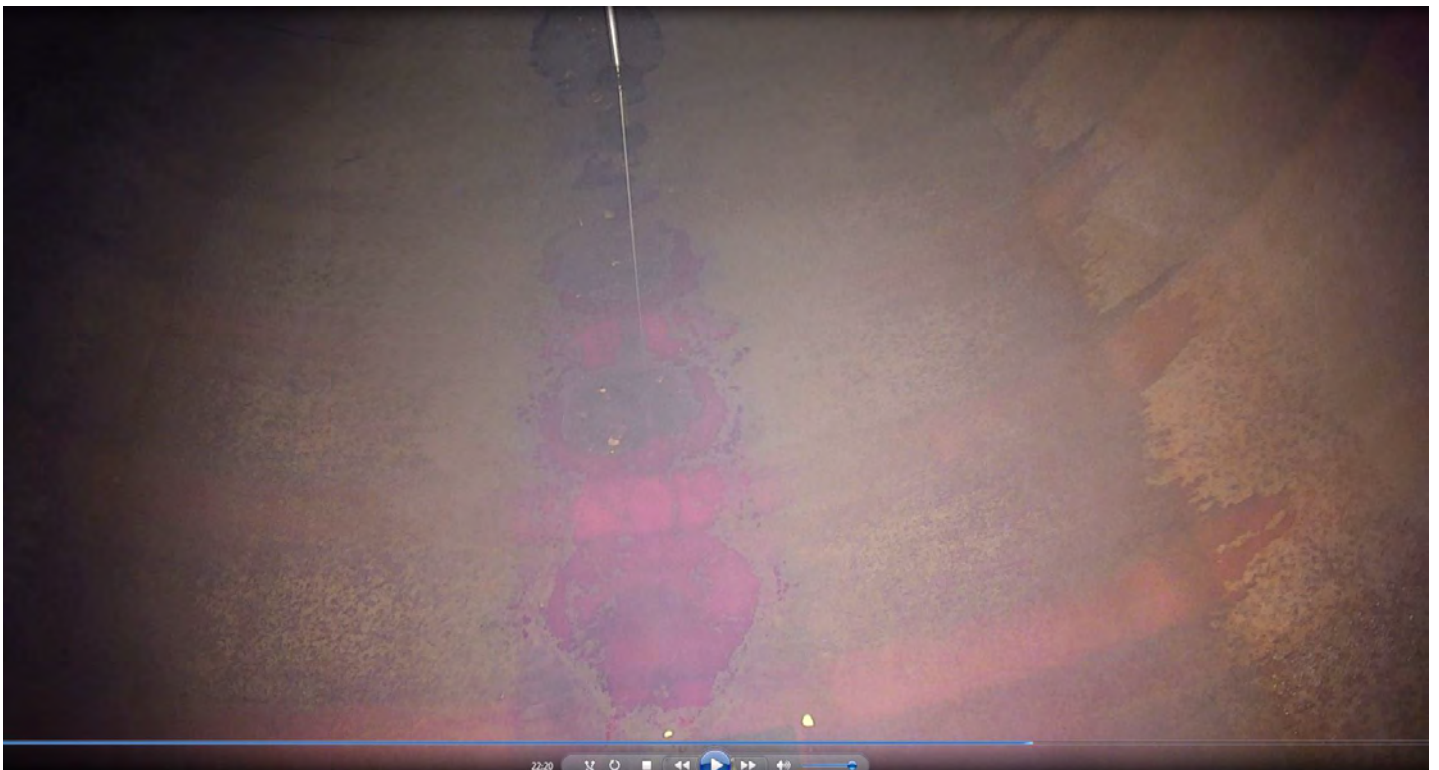
Figure 1-6: Sediment/residue on tank bottom (22:20)

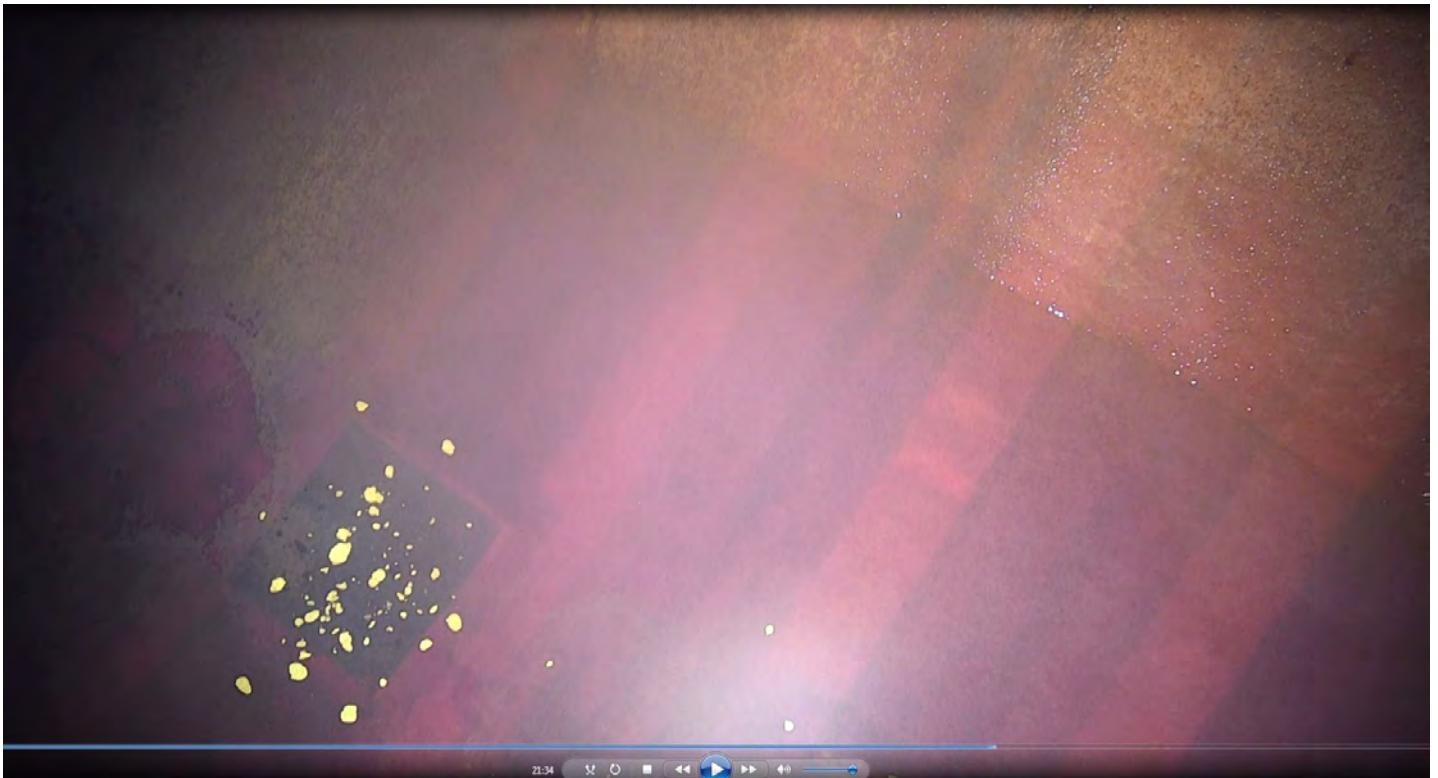
Figure 1-7: Possible gravel on tank bottom (21:34)

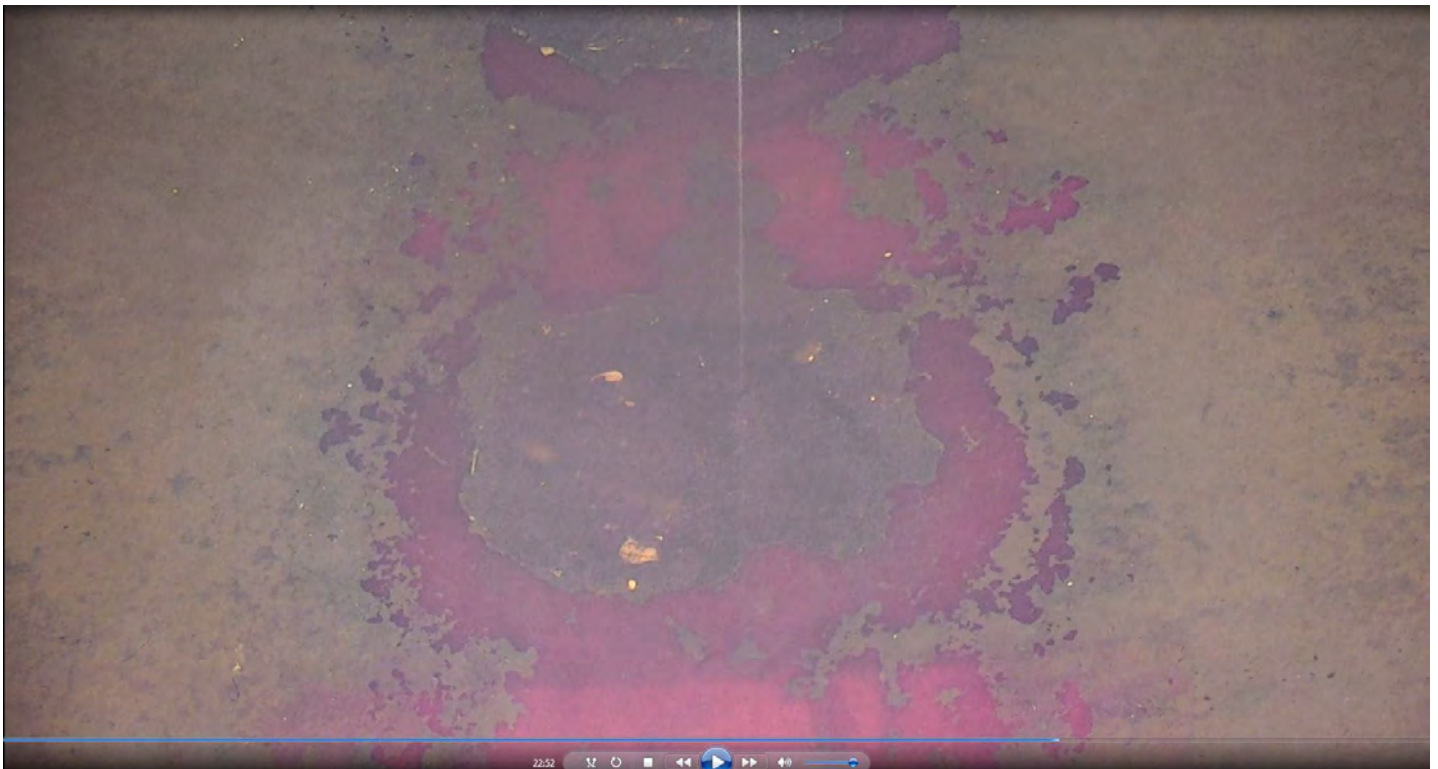
Figure 1-8: Sediment/residue on tank bottom (22:52)

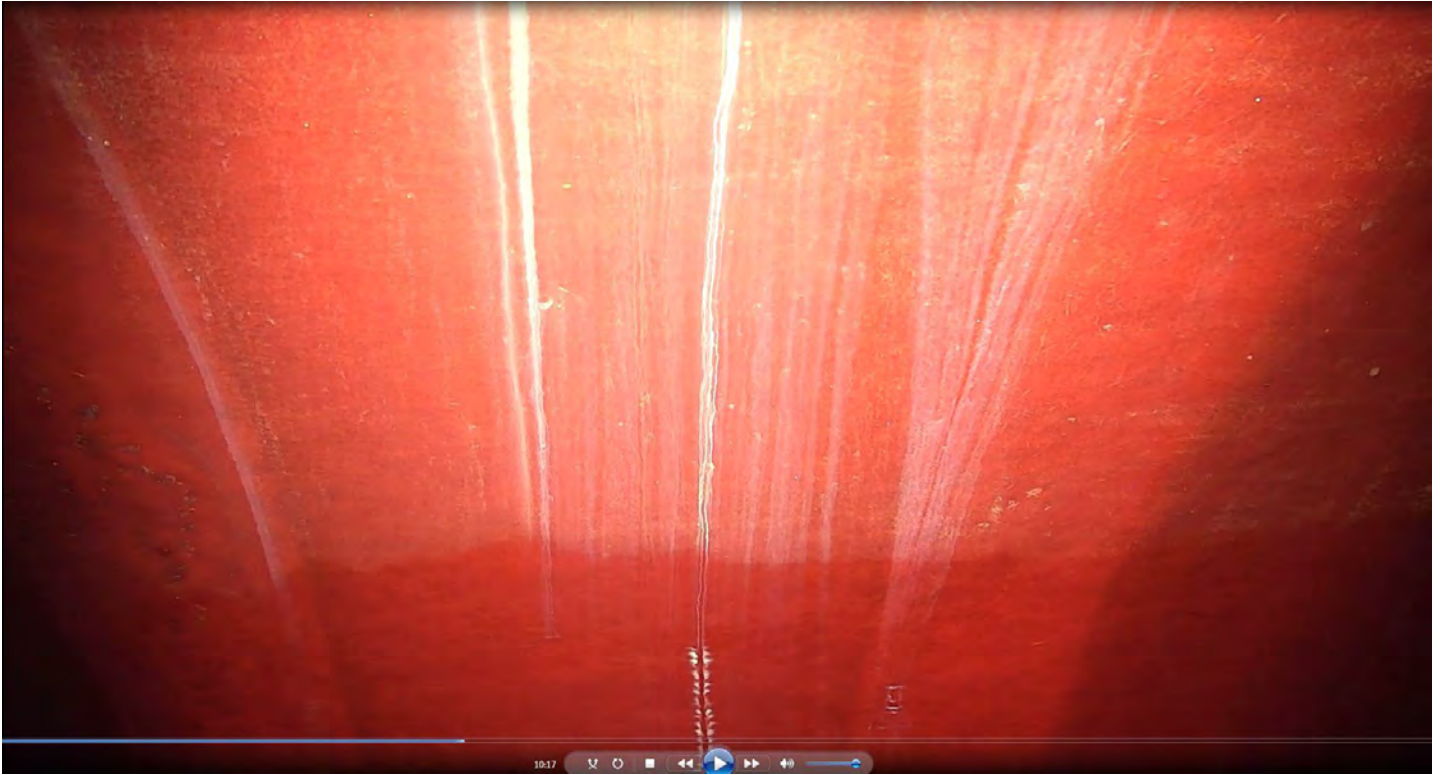
- White streaking and staining were noted in both the 10,000-gallon regular unleaded UST and the 4,000-gallon premium UST. Since water was not identified in the USTs, the streaking and staining is most likely associated with atmospheric humidity entering the UST through vent lines and fill ports;

Figure 1-9: White residue staining on tank wall (10:17)

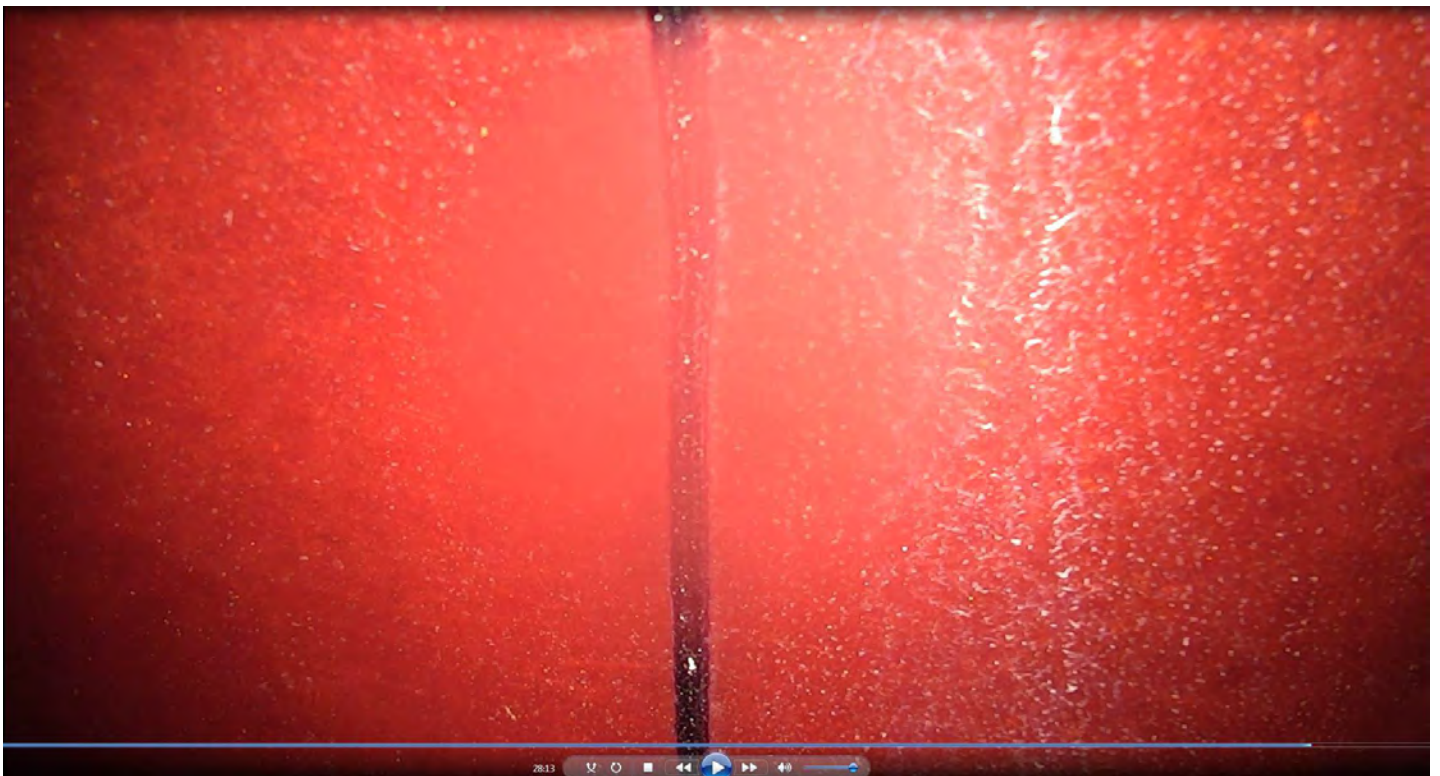
Figure 1-10: Streaking on tank wall (28:13)

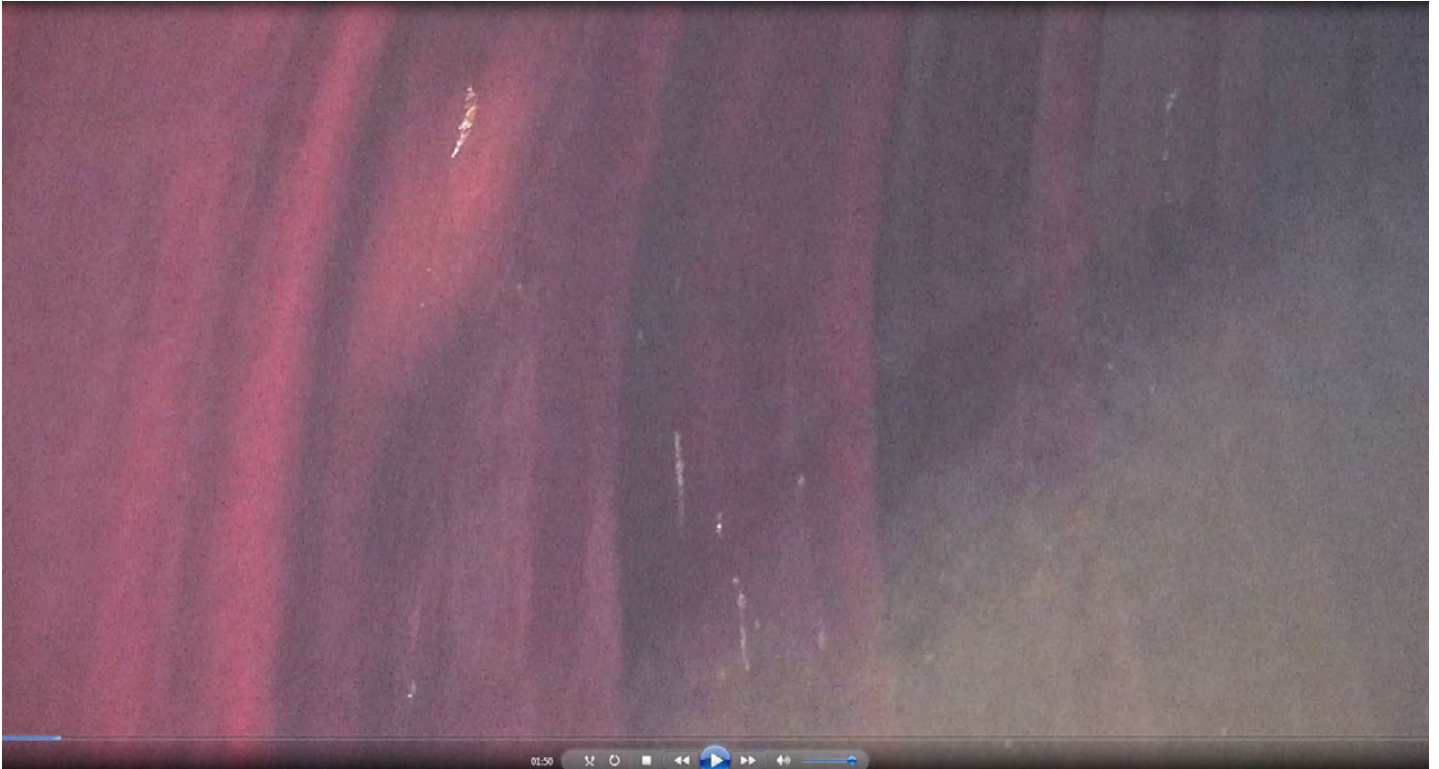
Figure 1-11: Blemishes/discoloration on tank wall (01:50)

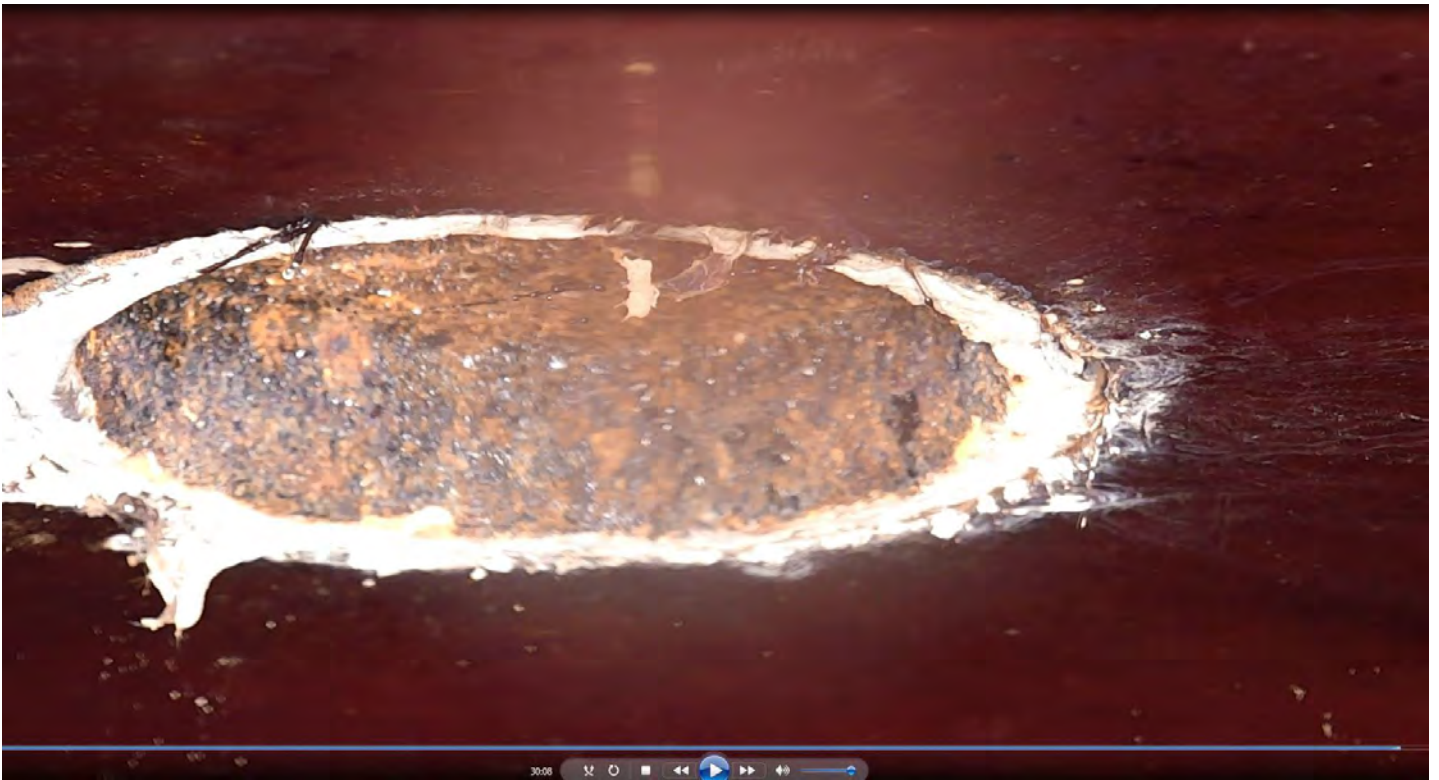
- Surface corrosion was noted on the unused bungs at the top of the 10,000-gallon regular unleaded UST and the 6,000-gallon diesel UST;
- Possible surface corrosion was noted on the ball float assembly and the shaft on the submersible turbine pump on the 6,000-gallon diesel UST;

Figure 1-12: Corrosion in bung (30:08)

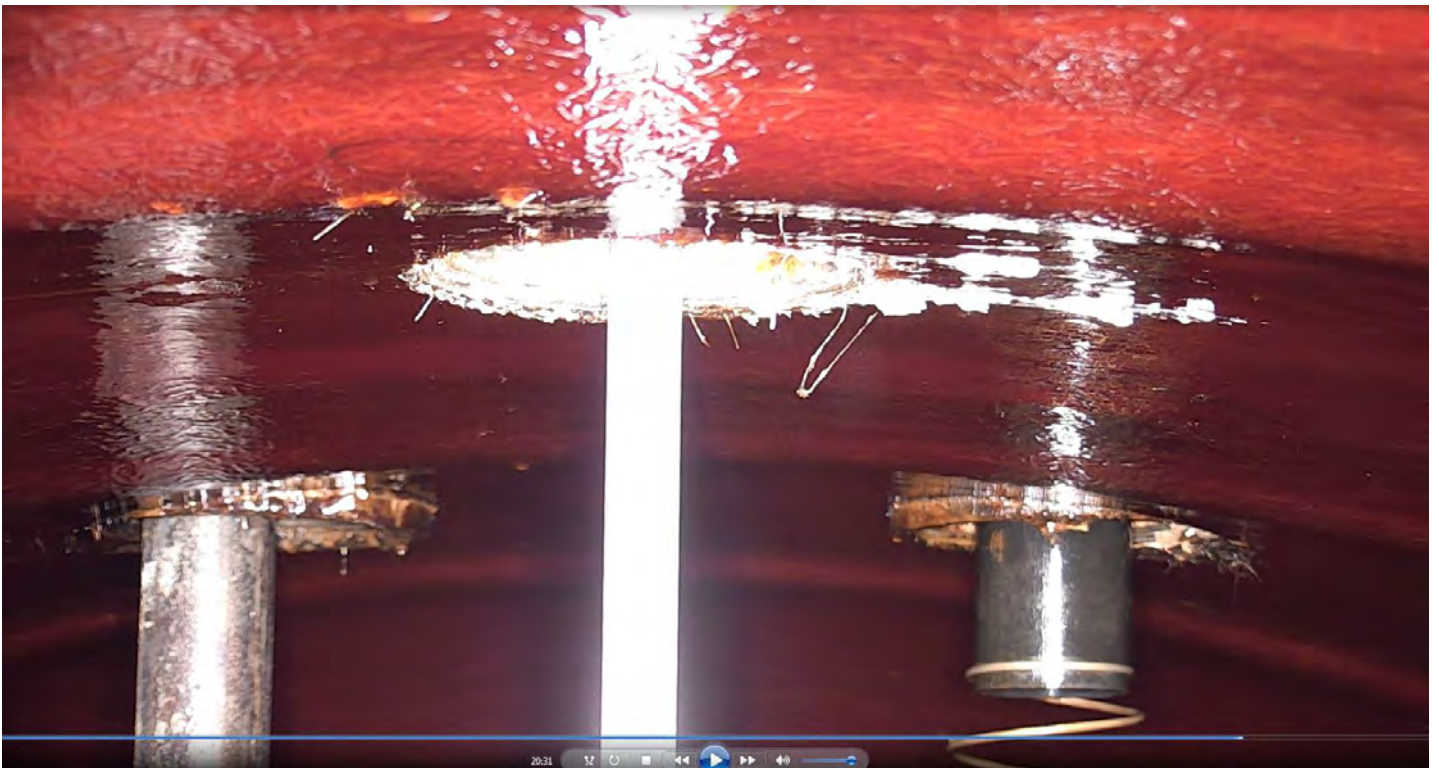
Figure 2-2: Possible corrosion on ball float bung (20:31)

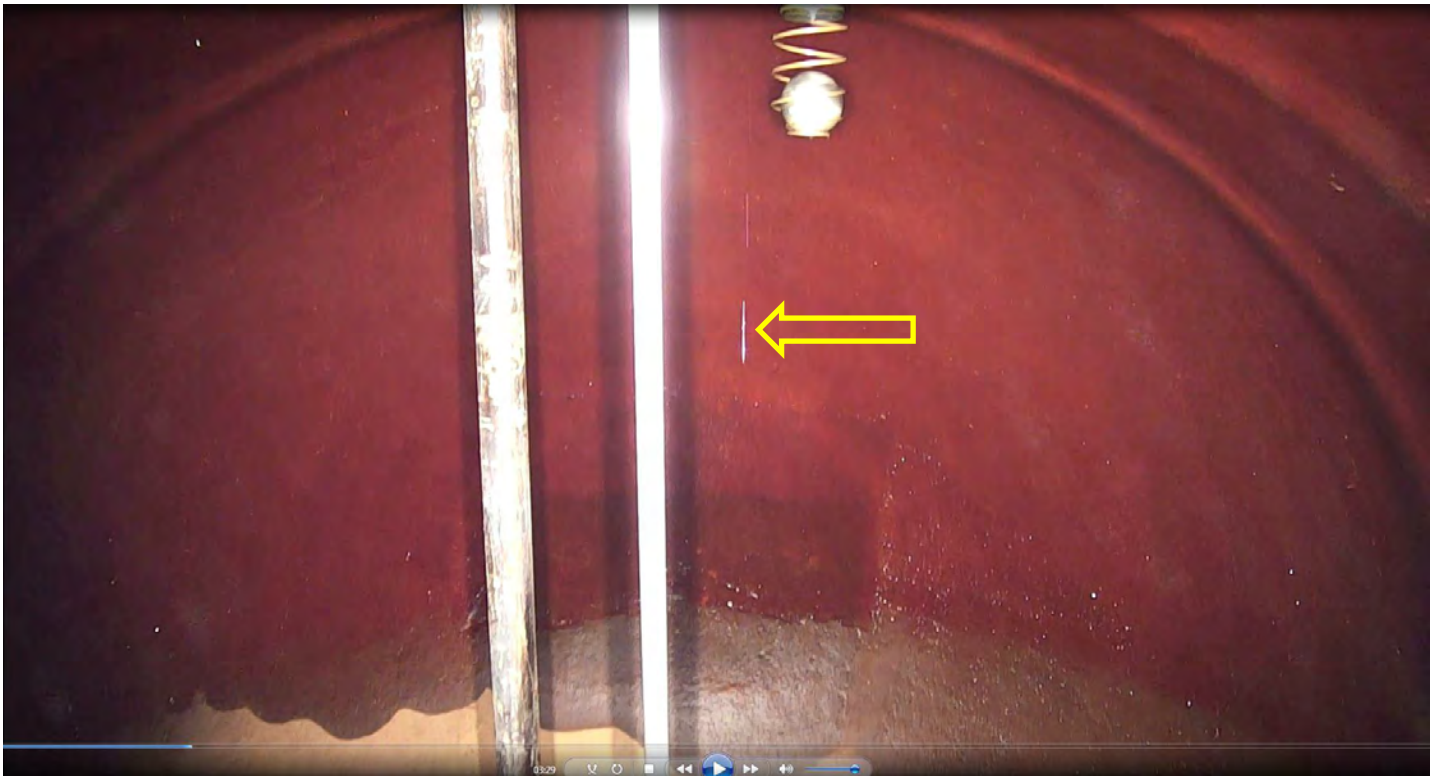
Figure 2-3: Drip falling from top of tank; possible moisture staining on end cap (03:29)

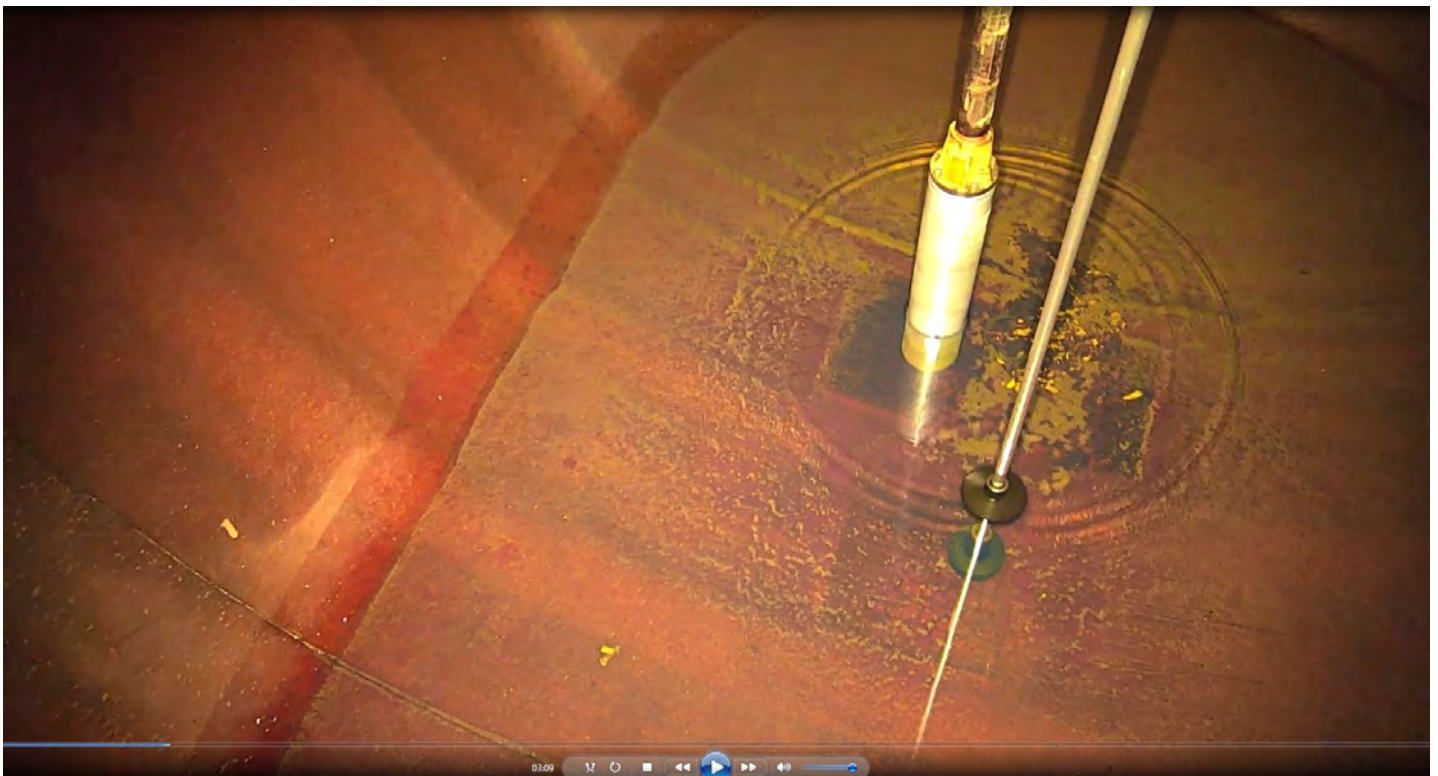
Figure 2-4: Possible oxidation on STP; debris and residue on tank bottom (03:09)

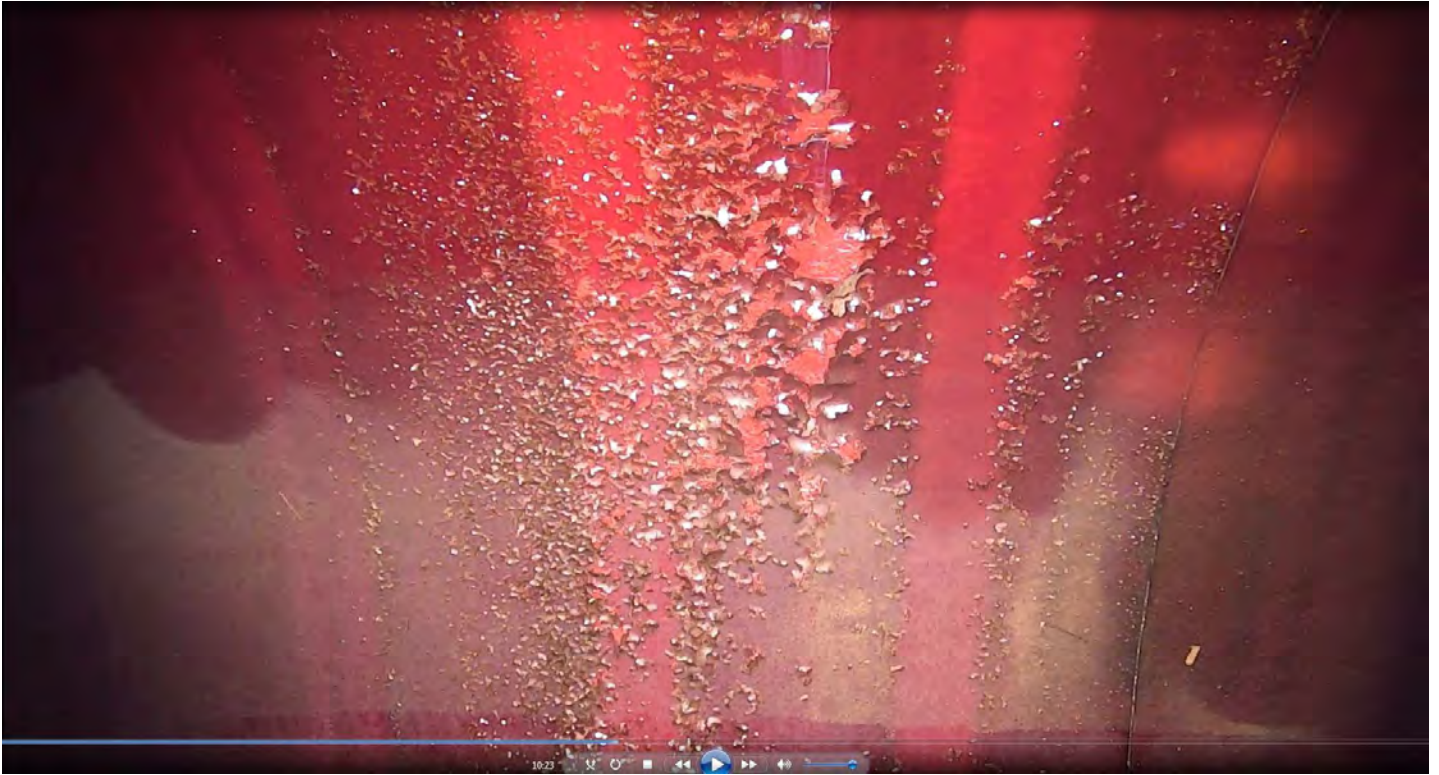
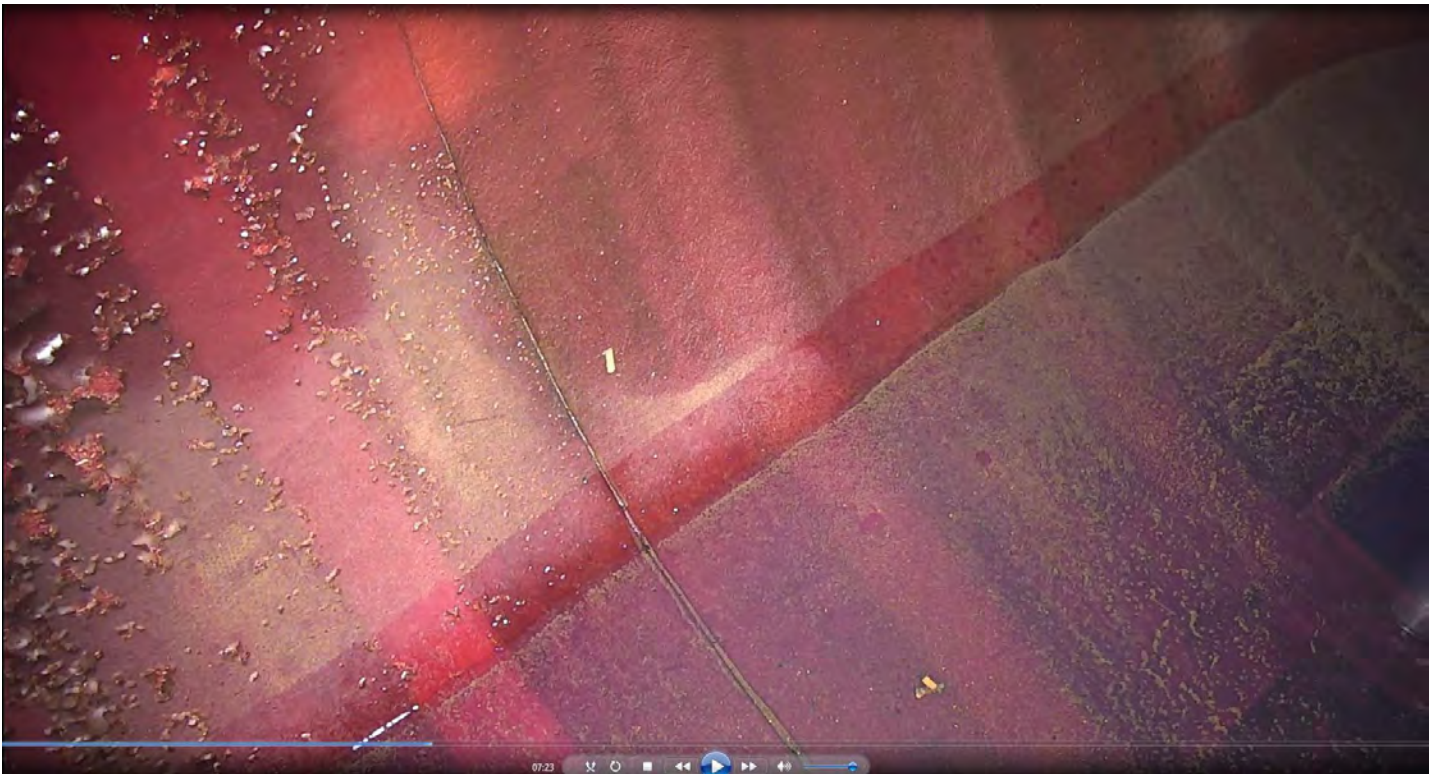
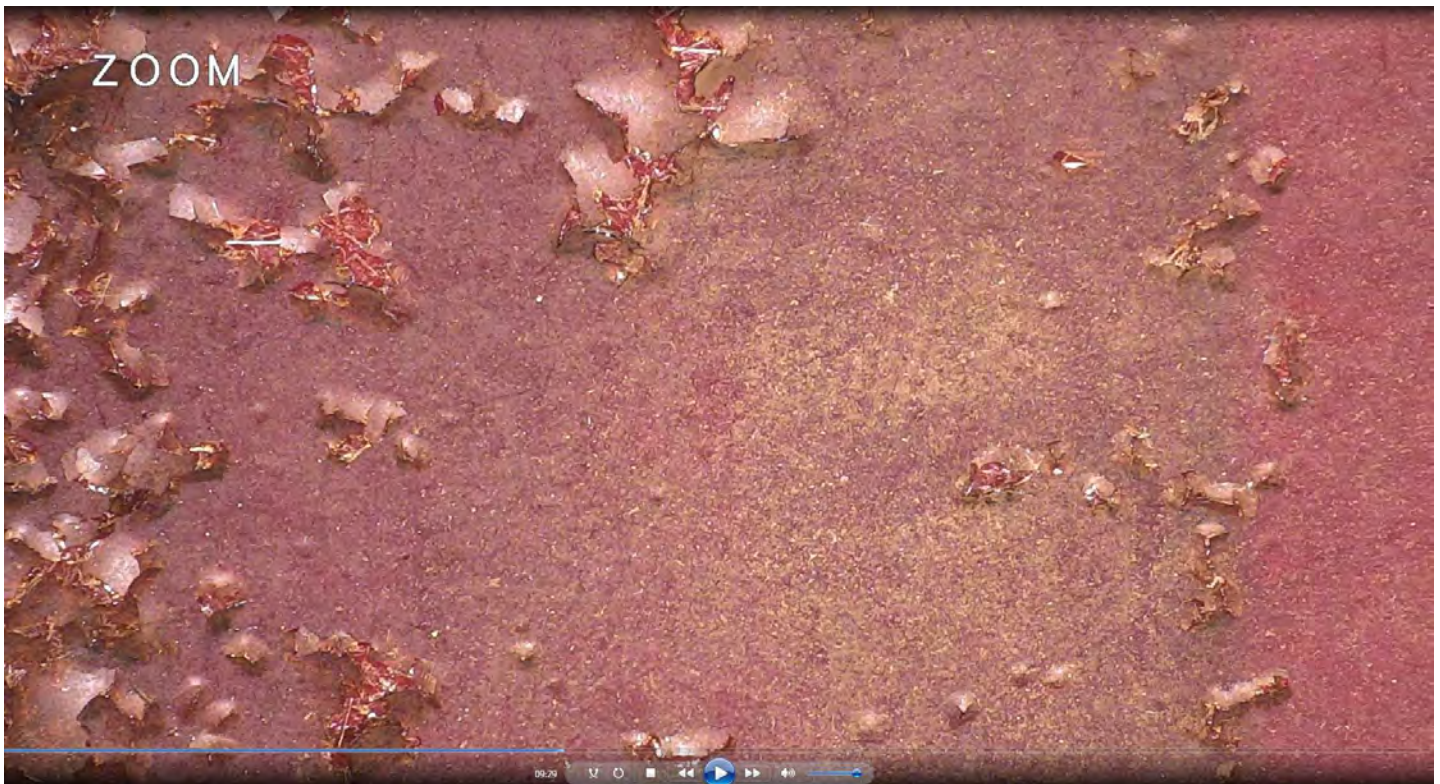
- Evidence of peeling and flaking of the interior surface was noted on portions of the interior surface of the 4,000-gallon and 3,000-gallon compartmentalized UST. The UST is constructed of epoxy resin with layers of fiberglass fibers embedded within for strength. A final coat of epoxy resin is applied to provide a smooth finish. The peeling and flaking of the final coat of epoxy resin coat has exposed some of the fiberglass fibers on the interior of the UST. However, there is no indication that the peeling and flaking extends beyond the surface coat or that the integrity of the UST system is potentially compromised. Going further, it has been SMA's observation from overseeing the removal of countless fiberglass composite USTs that where

these types of USTs were broken up for disposal, the walls of the USTs are essentially a solid resin material containing well-imbedded fibers, and, consequently, any surficial flaking or peeling is cosmetic in nature only.

Figure 2-5: Flaking and peeling on tank wall (10:23)

Figure 2-6: Flaking and peeling on tank wall (07:23)

Figure 2-8: Flaking and peeling on tank wall (09:29)

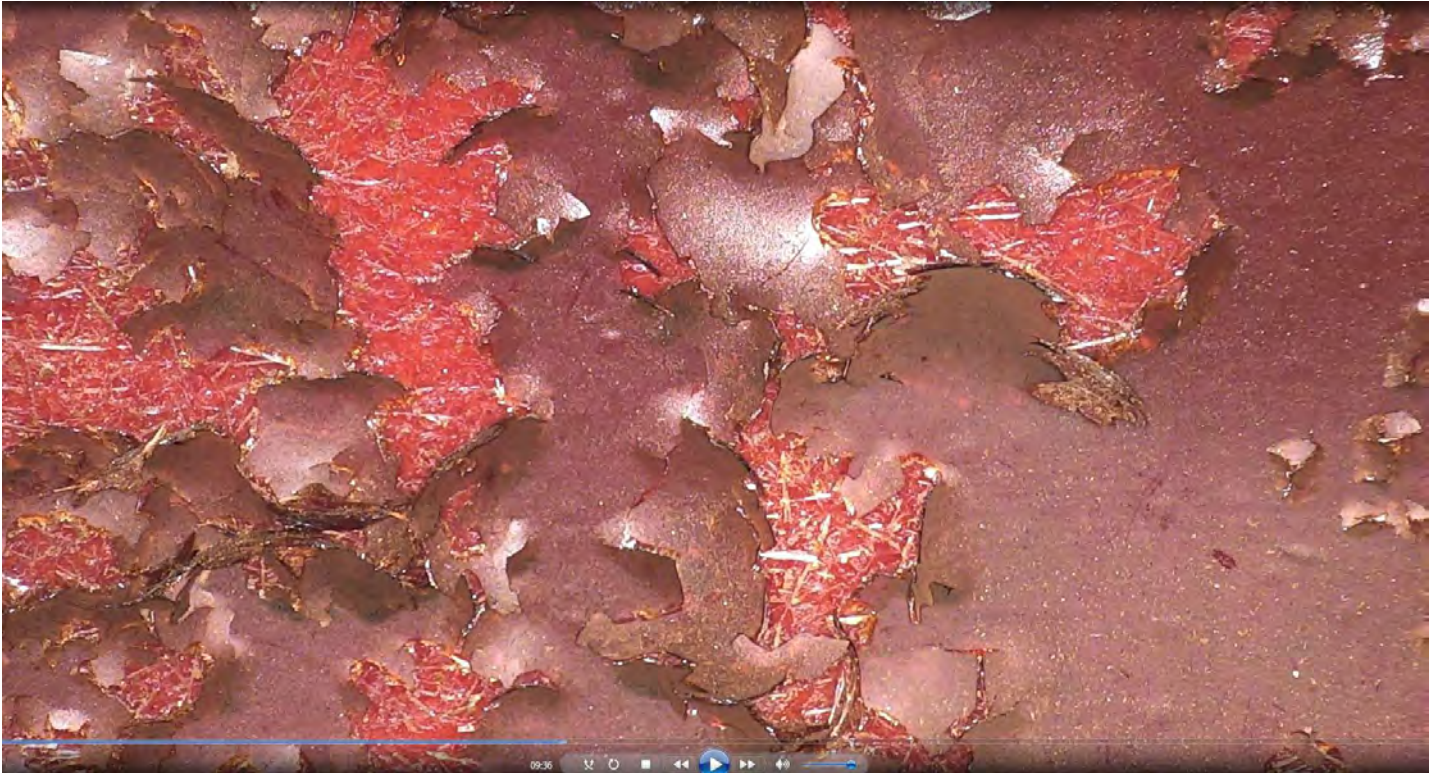
Figure 2-7: Close-up of peeling and flaking (09:36)

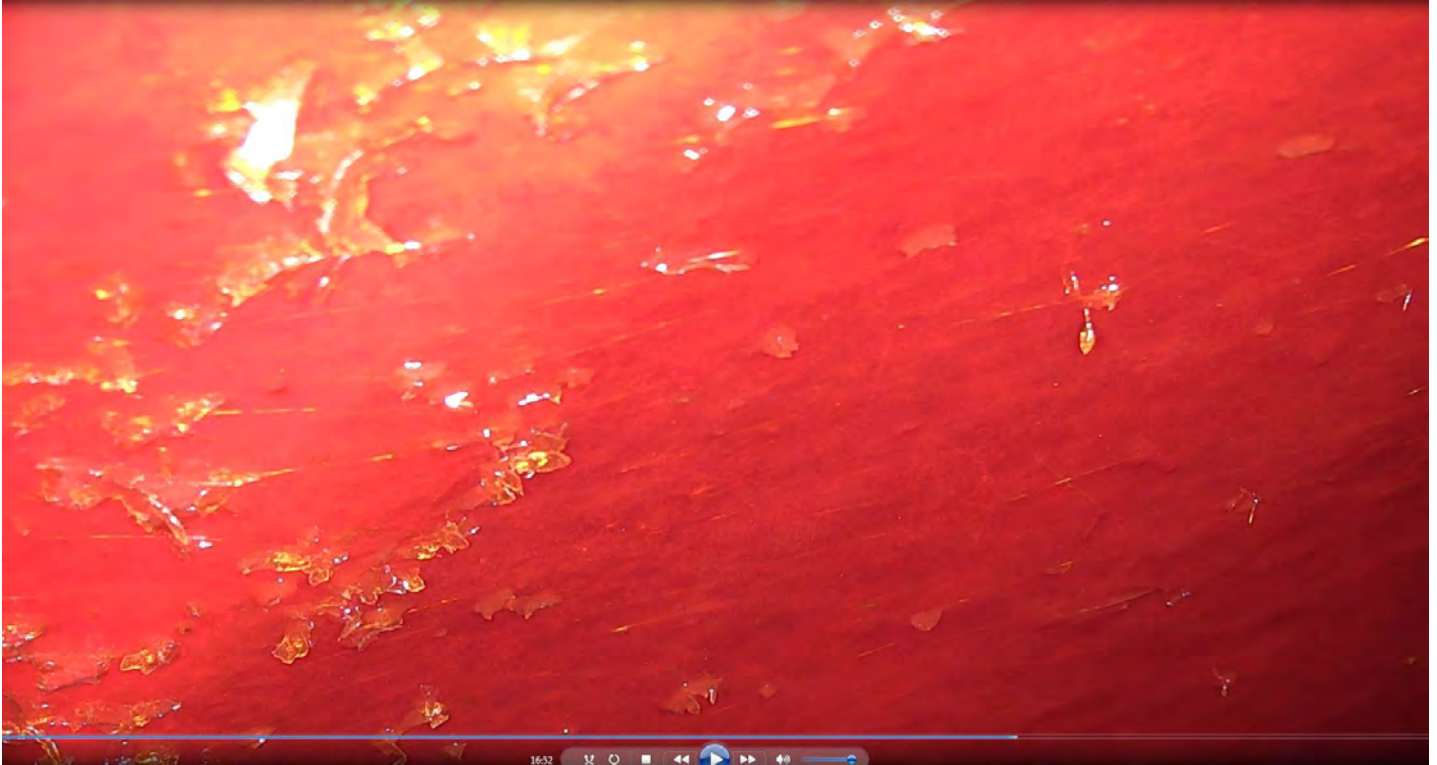
Figure 2-9: Flaking and peeling on top of tank (16:52)

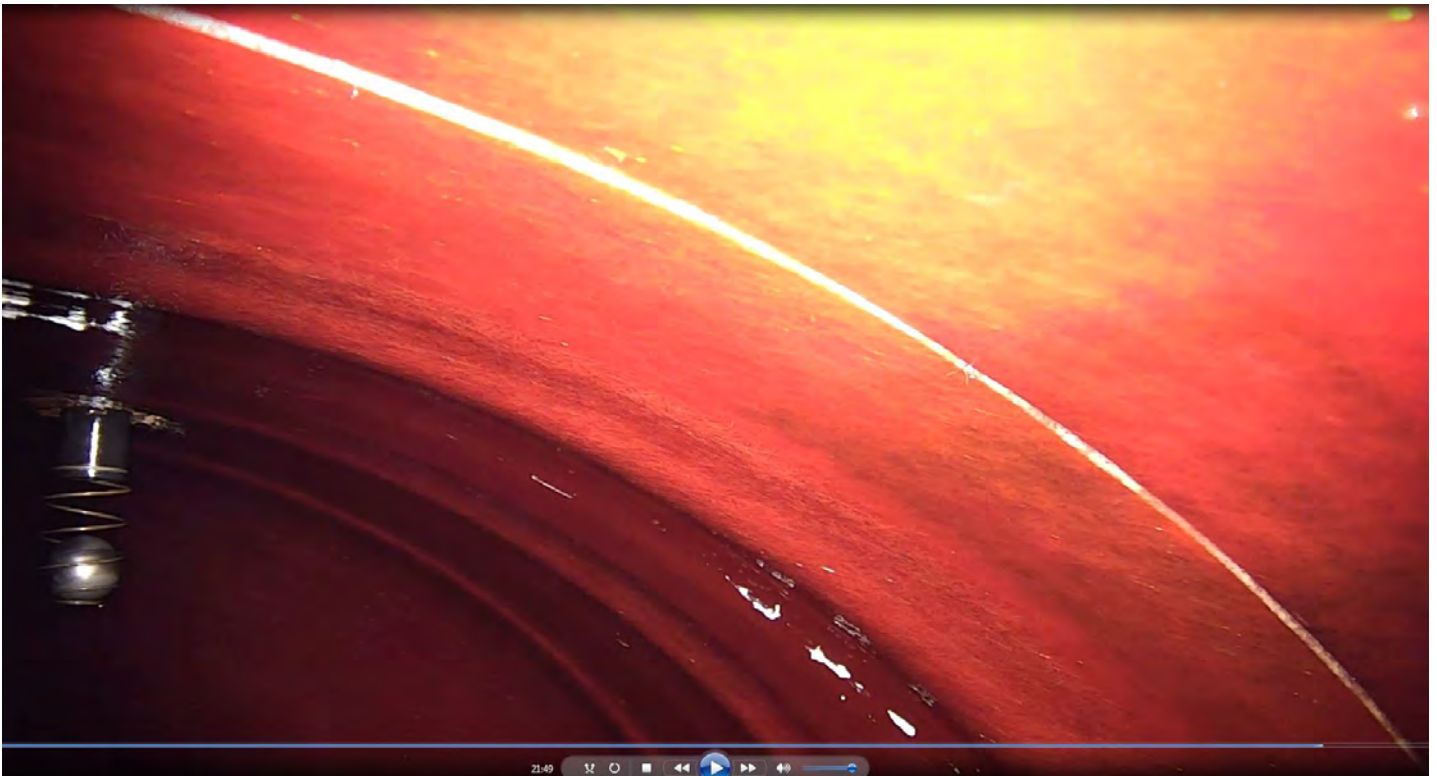
Figure 2-10: Discoloration on tank wall near seam (21:49)

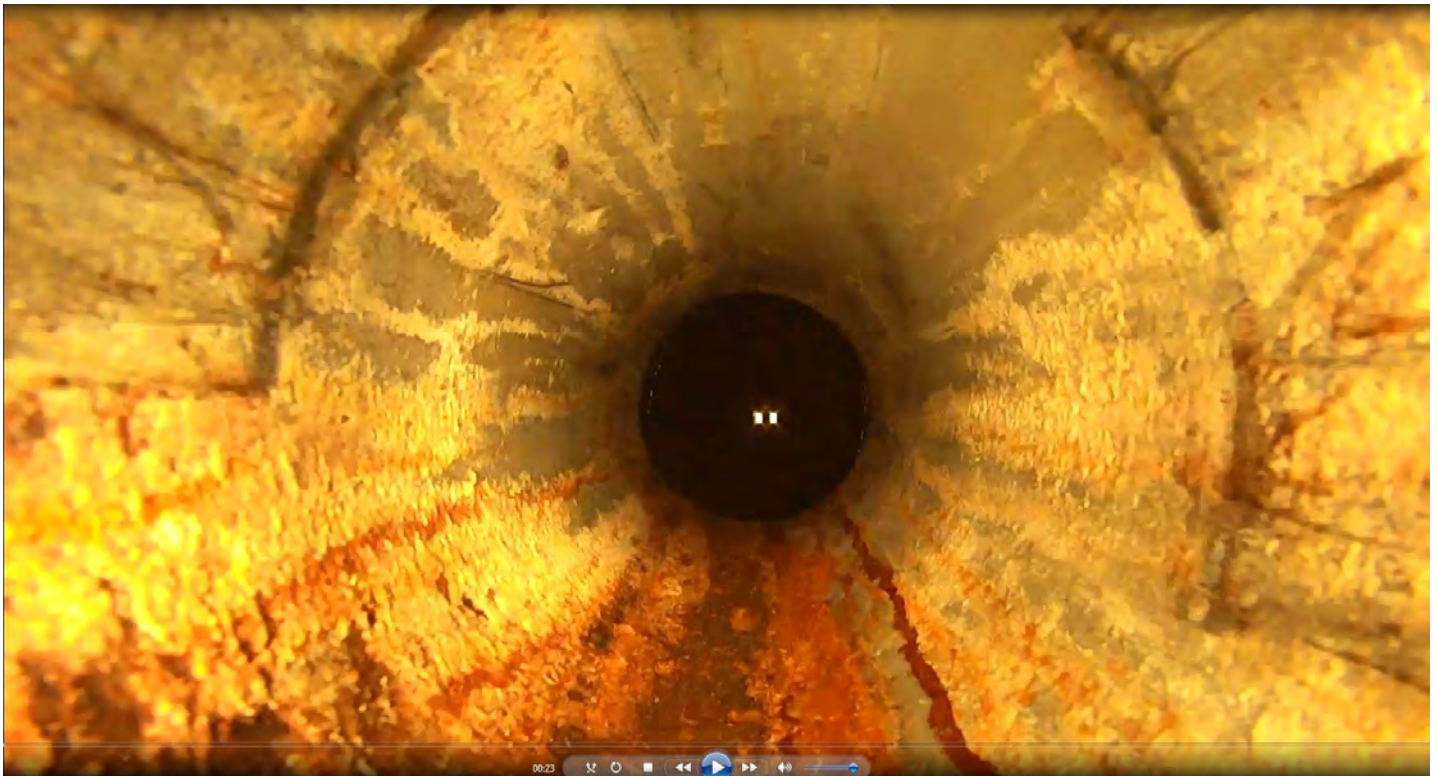
Figure 3-1: Oxidation in riser (00:23)
