**ILLINOIS POLLUTION CONTROL BOARD**

BLAKE LEASING COMPANY, LLC – REAL	)	
ESTATE SERIES, as owner of KIRKLAND	)	
QUICK STOP,	)	
	)	
Petitioner,	)	PCB 2018-026
	)	(Water Well Setback Exception)
v.	)	
	)	
ILLINOIS ENVIRONMENTAL PROTECTION	)	
AGENCY, VILLAGE OF KIRKLAND, ILLINOIS	)	
and SOO LINE RAILROAD COMPANY (d/b/a	)	
CANADIAN PACIFIC RAILWAY and	)	
CANADIAN PACIFIC),	)	
	)	
Respondents.	)

**TECHNICAL MEMORANDUM**

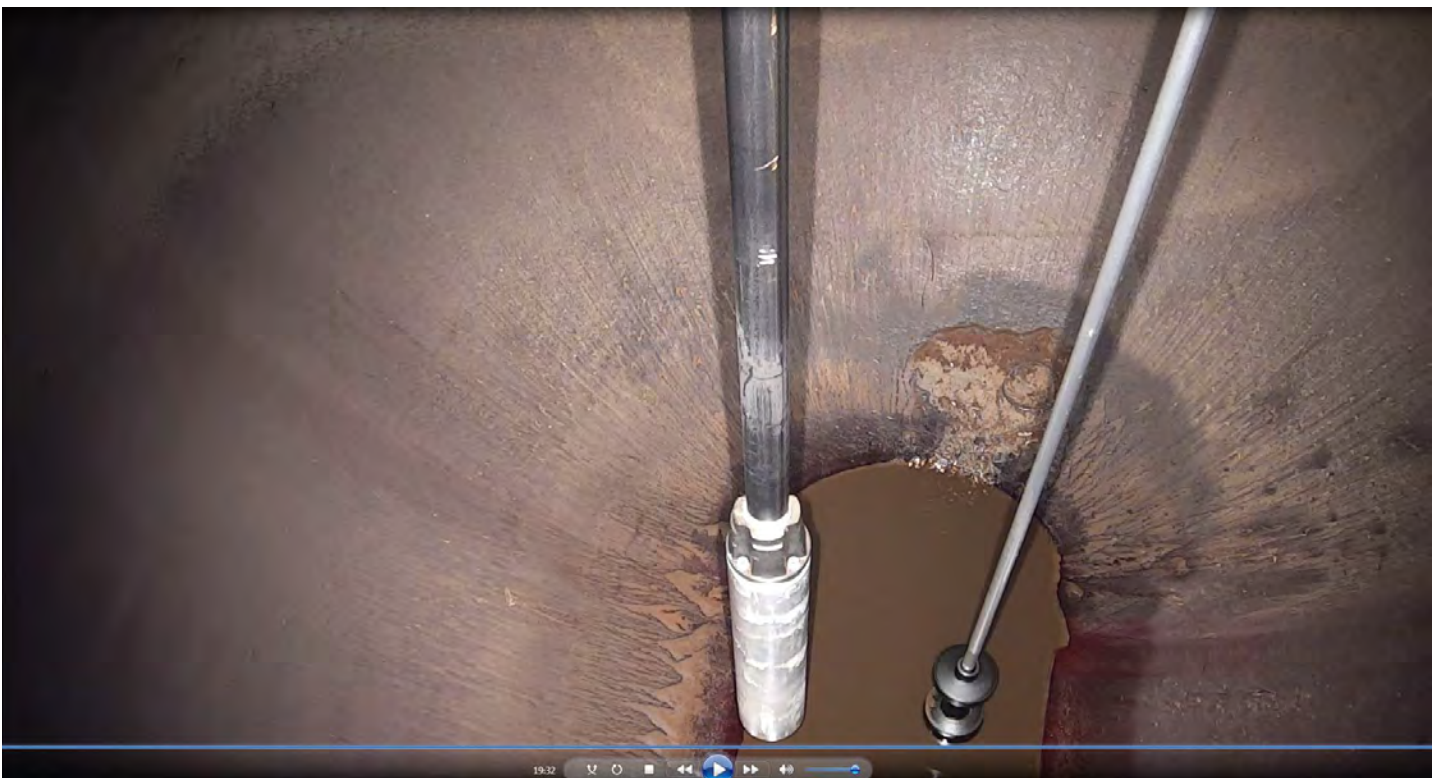
Figure 3-2: Sediment/residue on tank bottom (19:32)

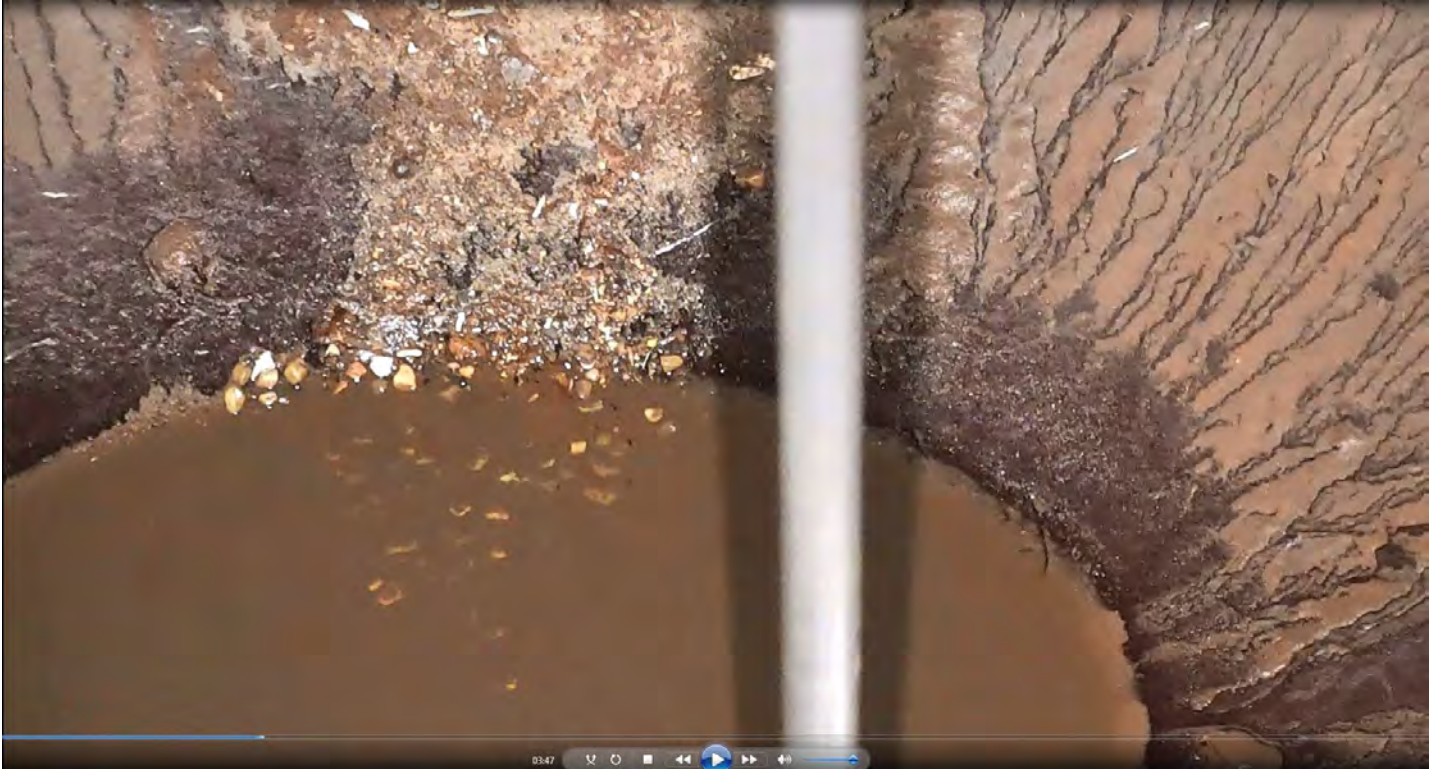
Figure 3-3: Sludge and pea gravel on tank bottom (03:47)

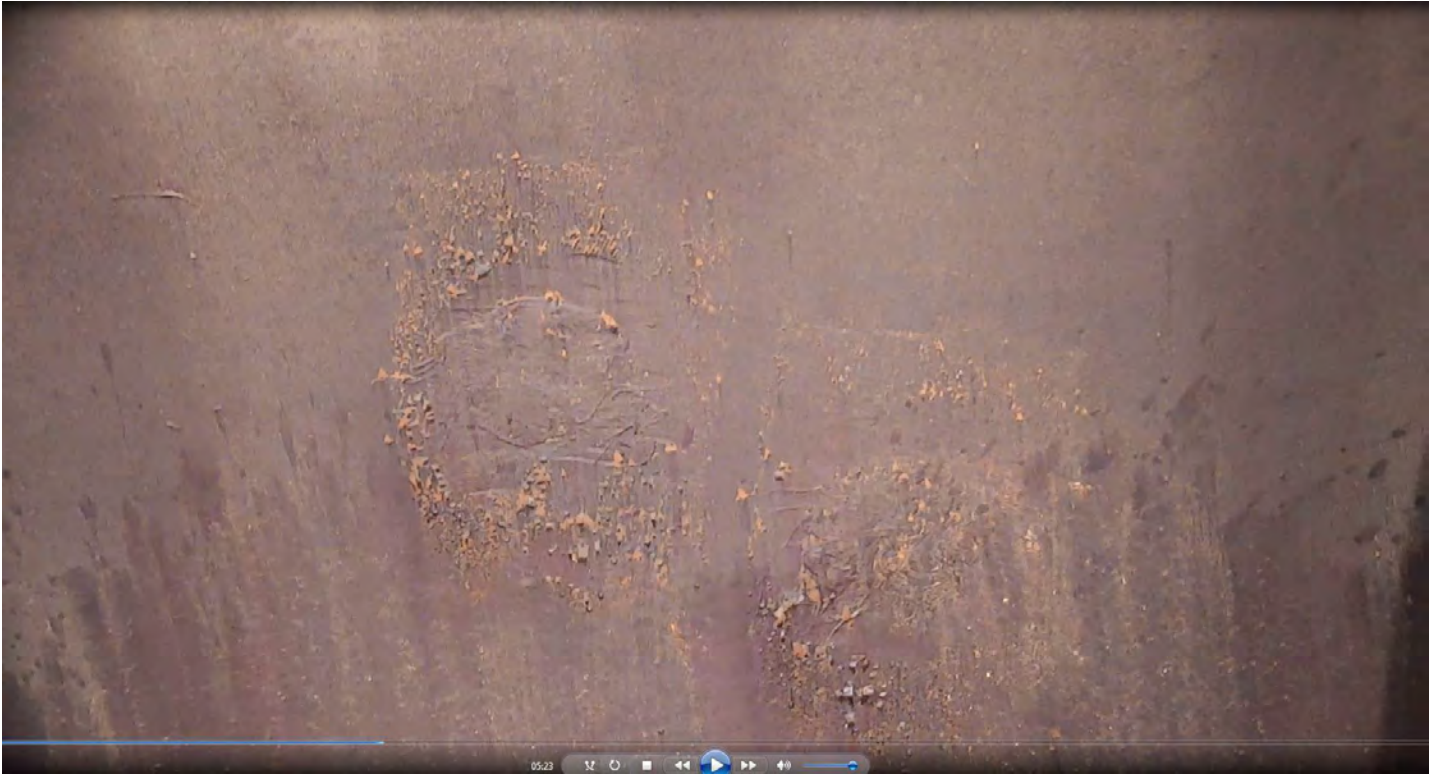
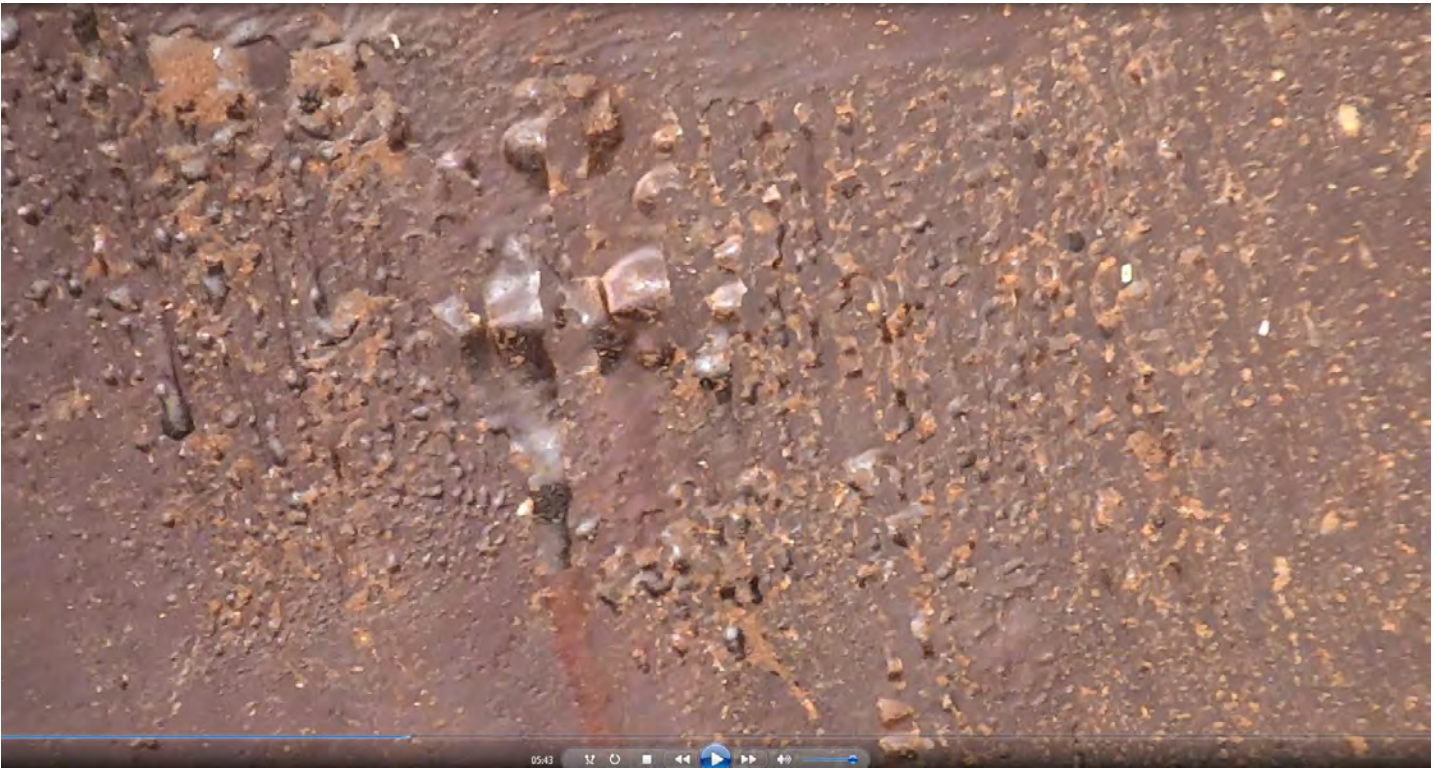
- Evidence of peeling and flaking of the interior surface was noted on portions of the interior surface of the 4,000-gallon and 3,000-gallon compartmentalized UST. The UST is constructed of epoxy resin with layers of fiberglass fibers embedded within for strength. A final coat of epoxy resin is applied to provide a smooth finish. The peeling and flaking of the final coat of epoxy resin coat has exposed some of the fiberglass fibers on the interior of the UST. However, there is no indication that the peeling and flaking extends beyond the surface coat or that the integrity of the UST system is potentially compromised. Going further, it has been SMA's observation from overseeing the removal of countless fiberglass composite USTs that where

Figure 3-5: Possible peeling on tank wall (05:23)

Figure 3-6: Possible peeling on tank wall (05:43)

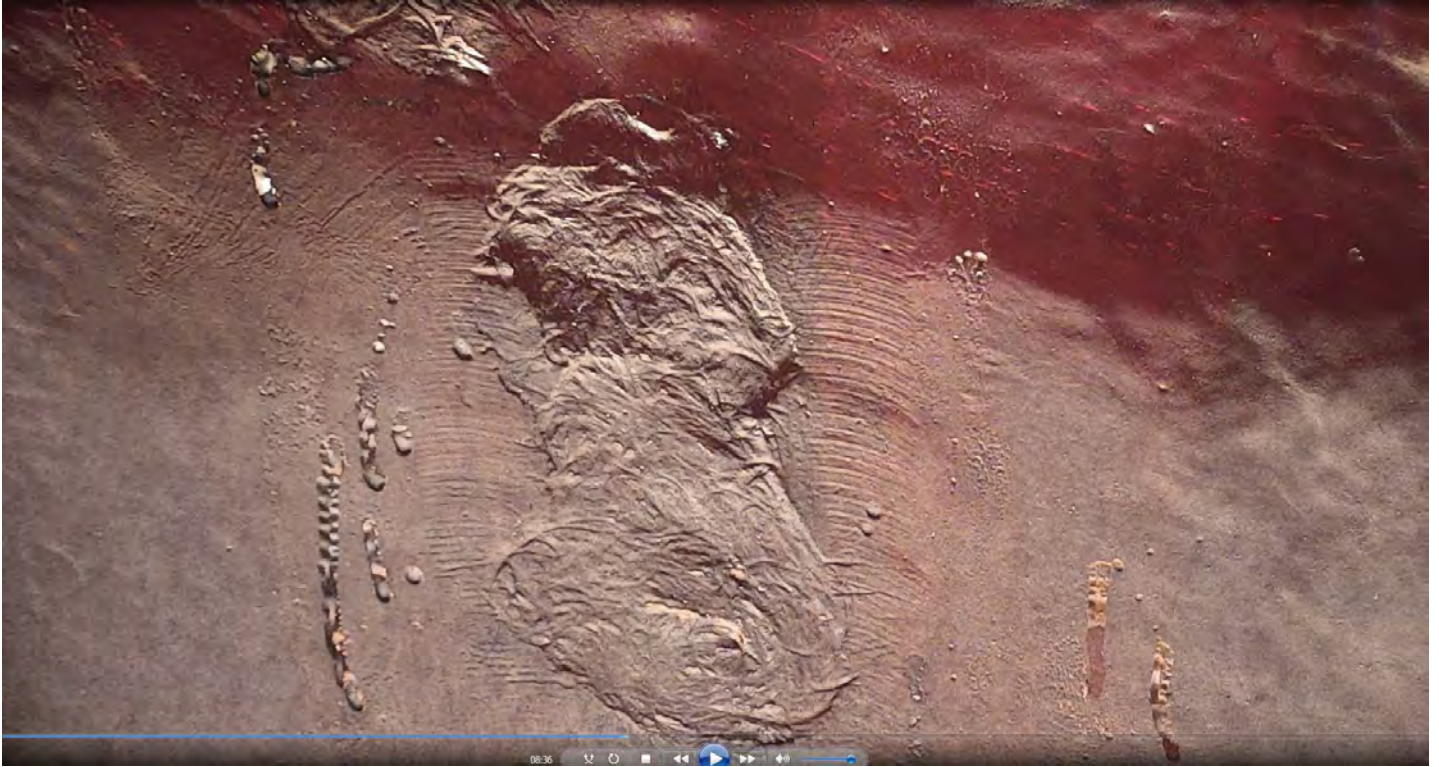
Figure 3-7: Possible patch on tank wall (08:36)

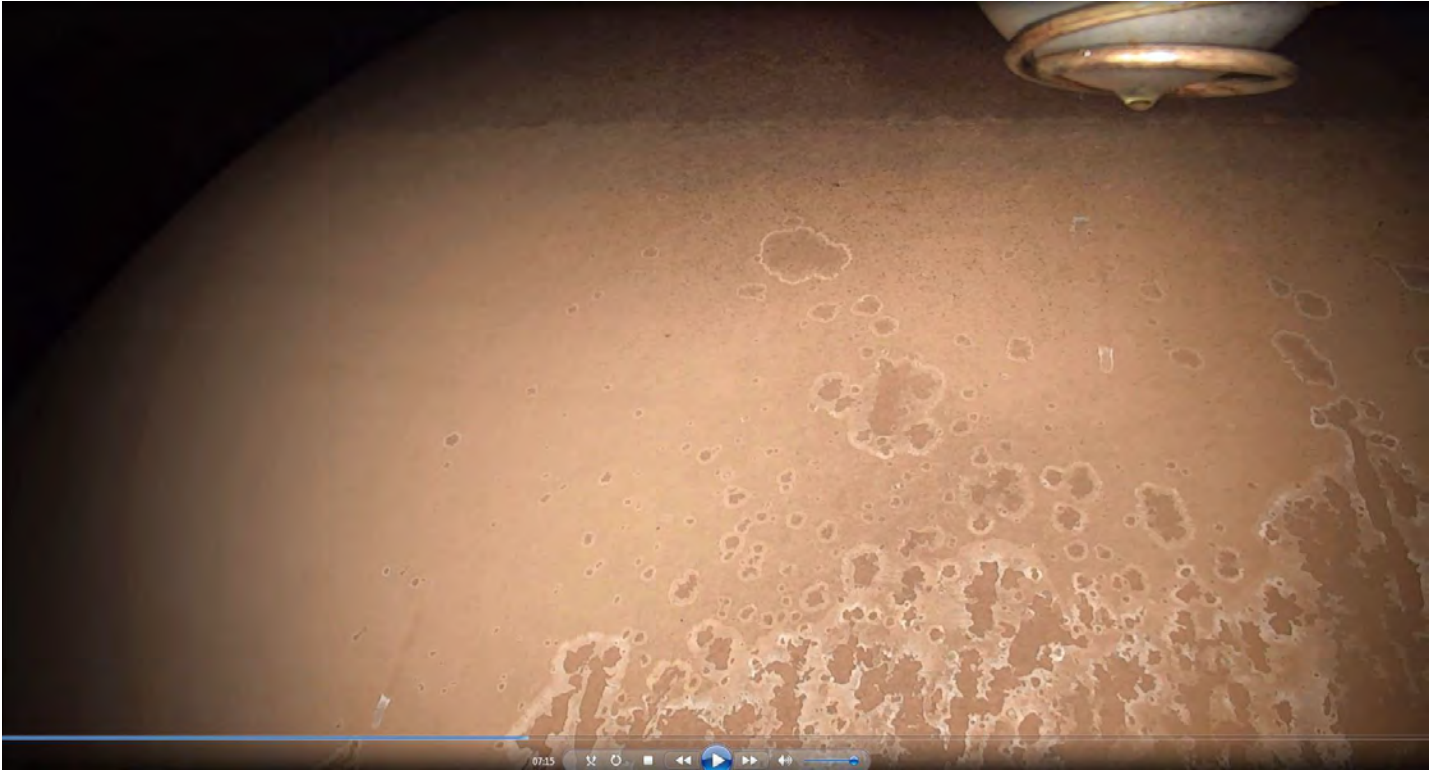
Figure 3-9: Staining on end dome; liquid drip on ball float (07:15)

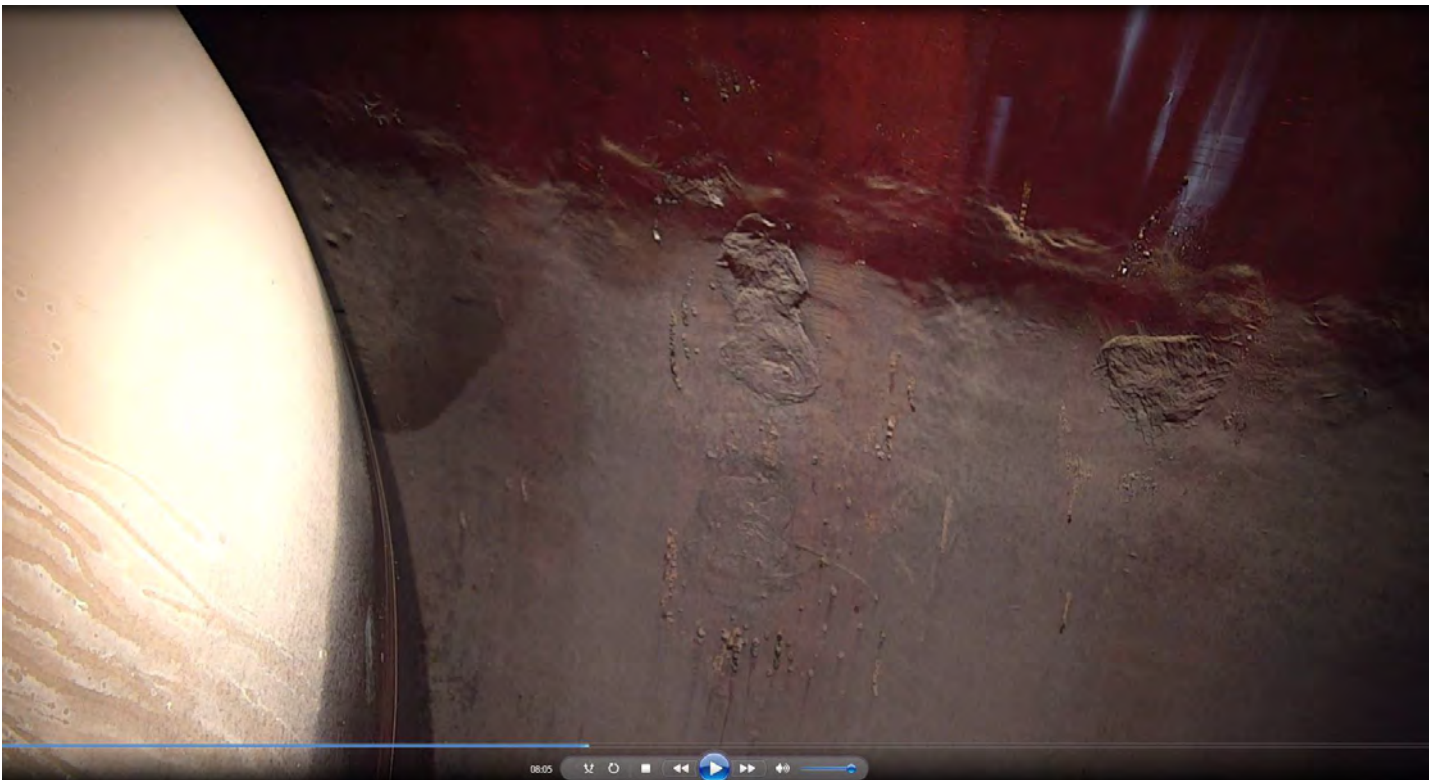
Figure 3-10: Possible moisture staining next to end dome (08:05)

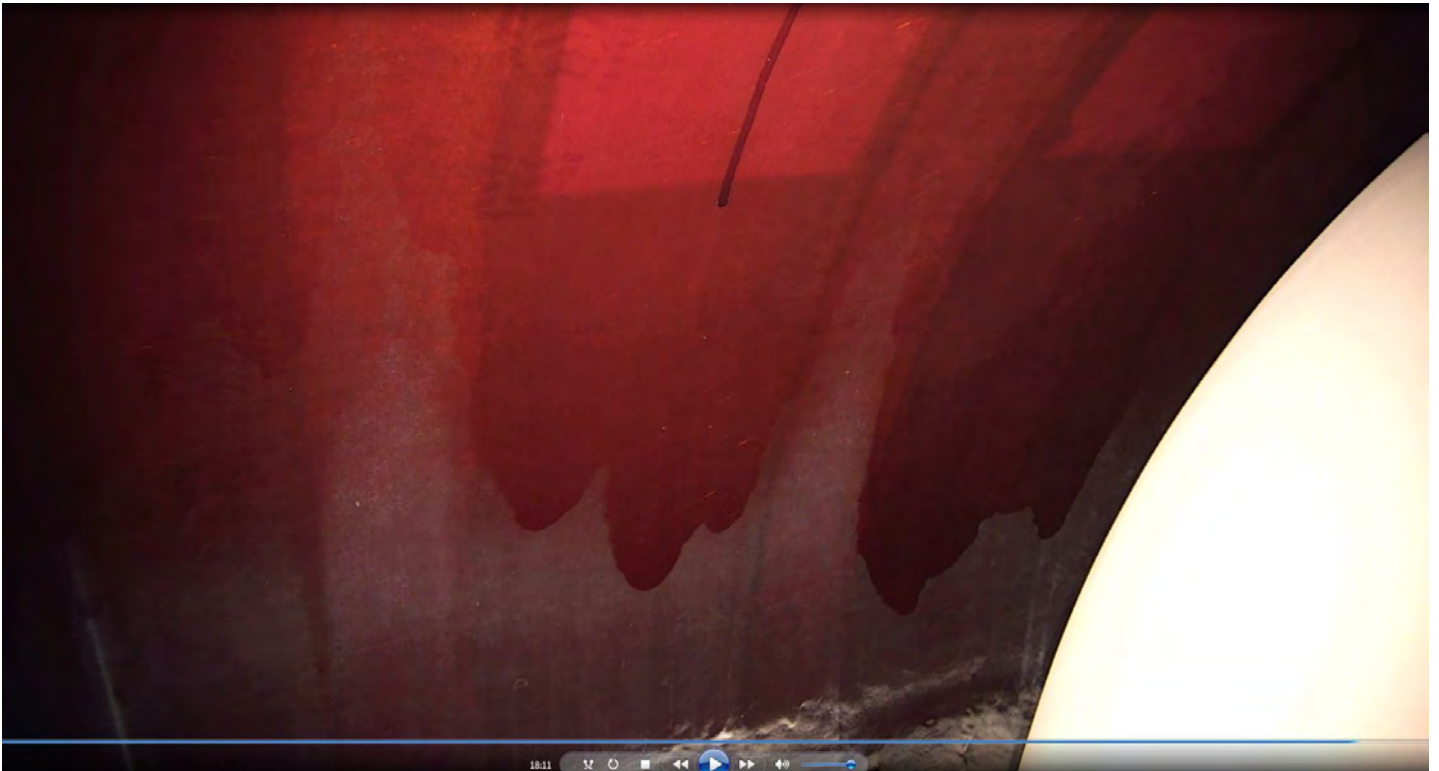
Figure 3-12: Discoloration on tank wall (18:11)

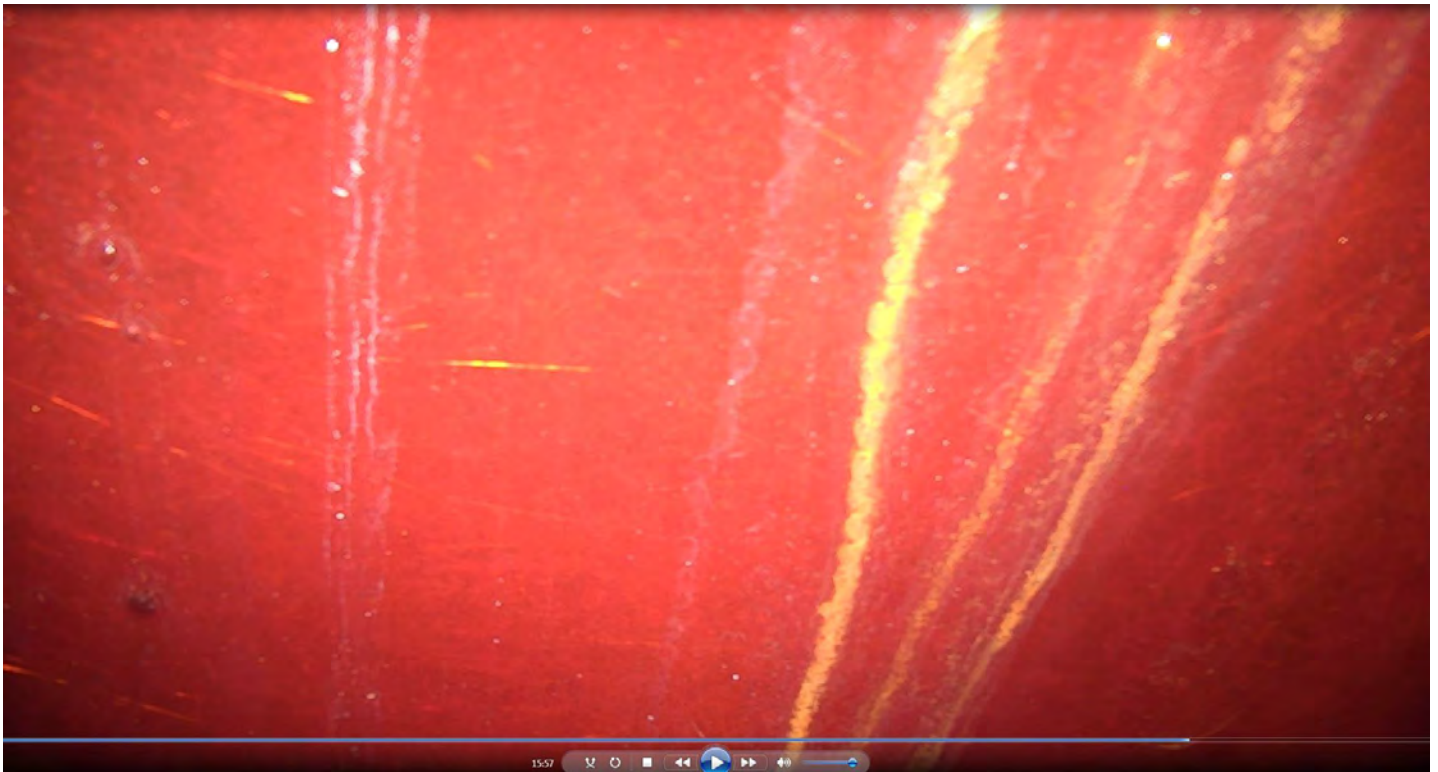
Figure 3-13: Staining on top of tank (15:57)

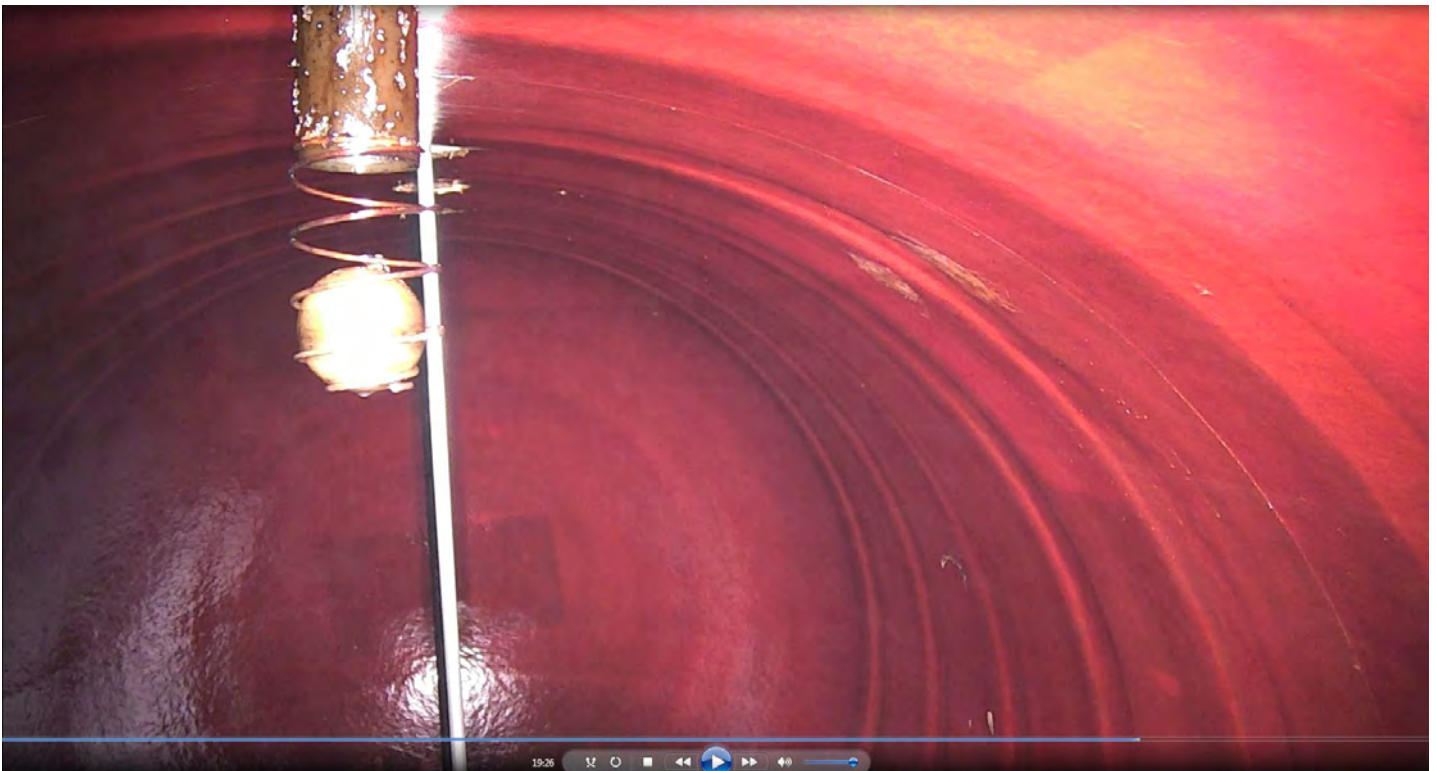
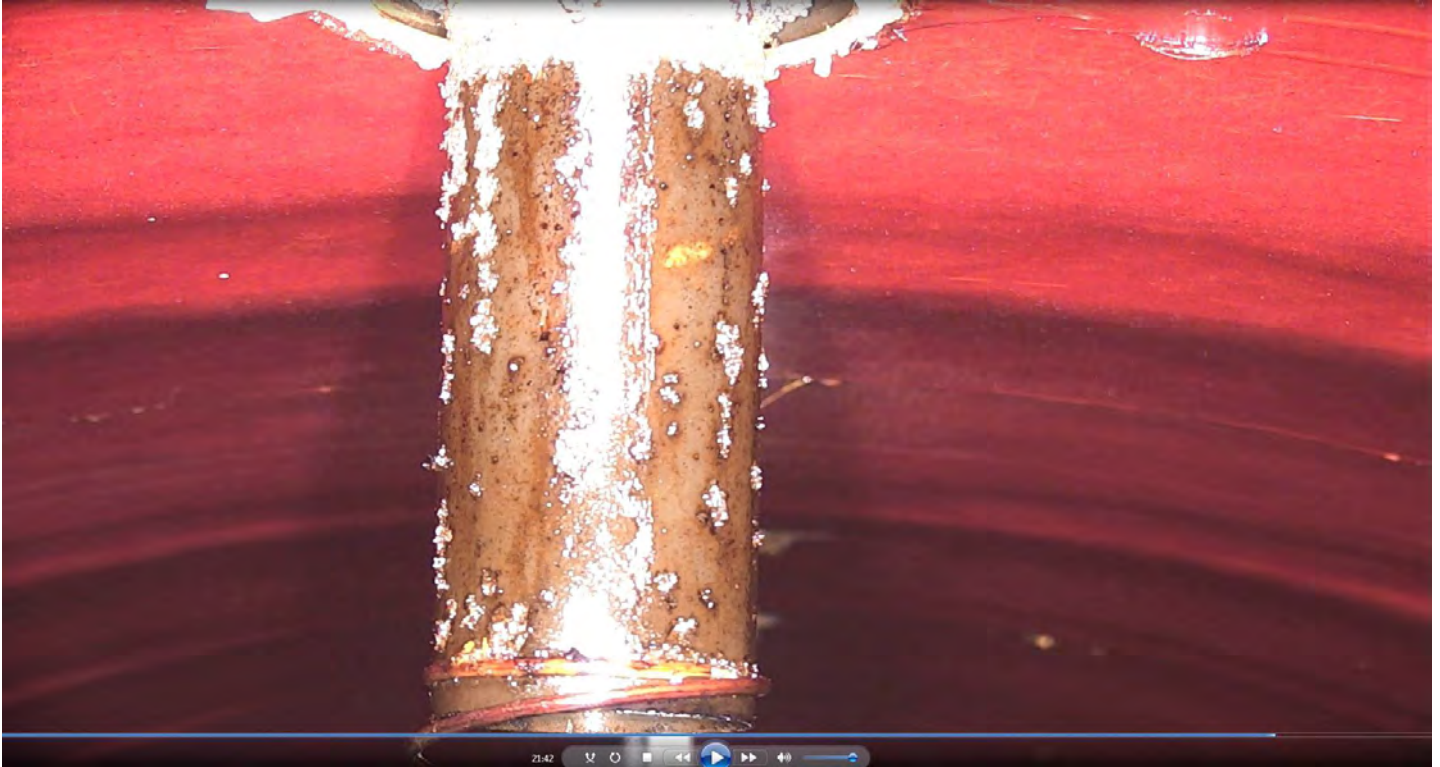
- Surface corrosion was noted on the unused bungs at the top of the 10,000-gallon regular unleaded UST and the 6,000-gallon diesel UST;
- Possible surface corrosion was noted on the ball float assembly and the shaft on the submersible turbine pump on the 6,000-gallon diesel UST;

Figure 4-2: Corrosion on ball float assembly (19:26)

Figure 4-3: Corrosion on ball float assembly (21:42)

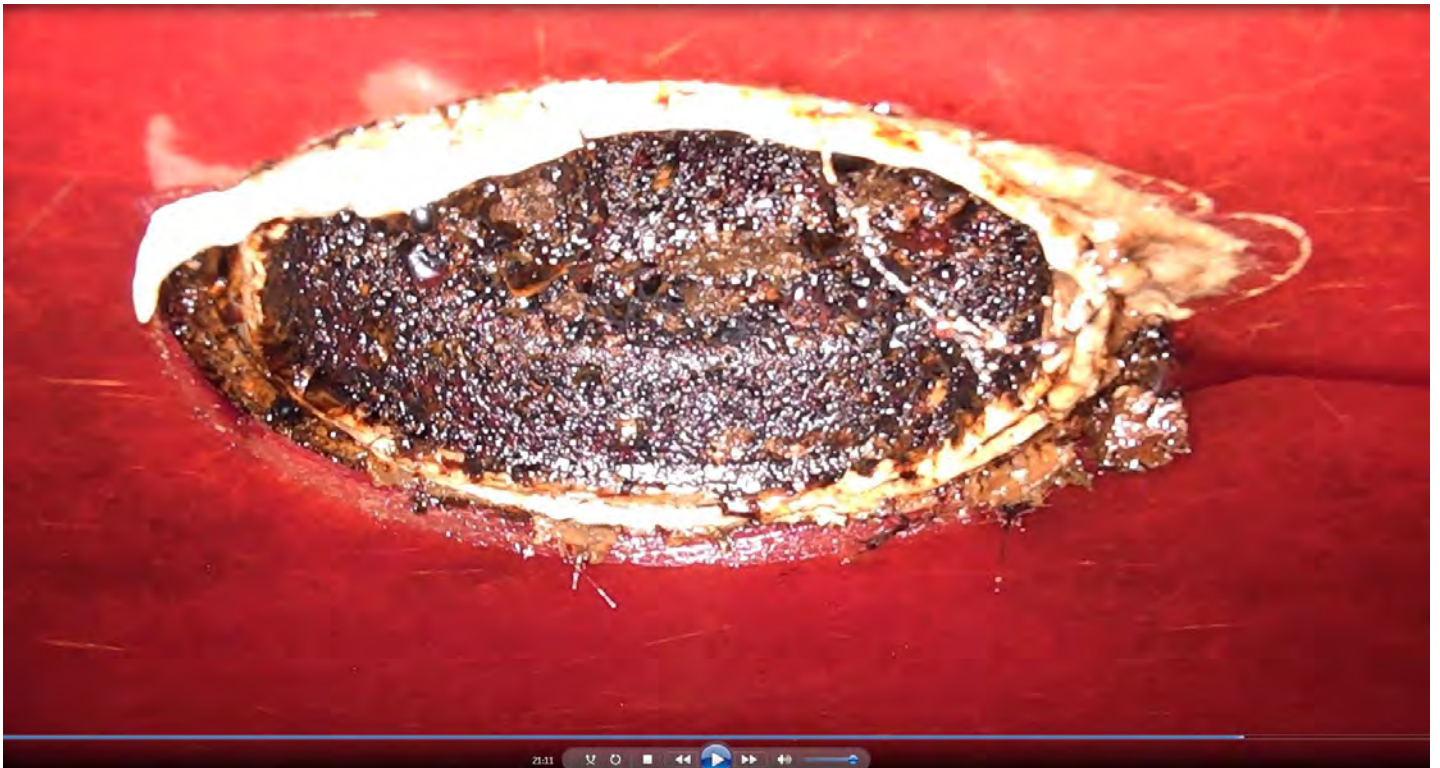
Figure 4-4: Corrosion in bung (21:11)

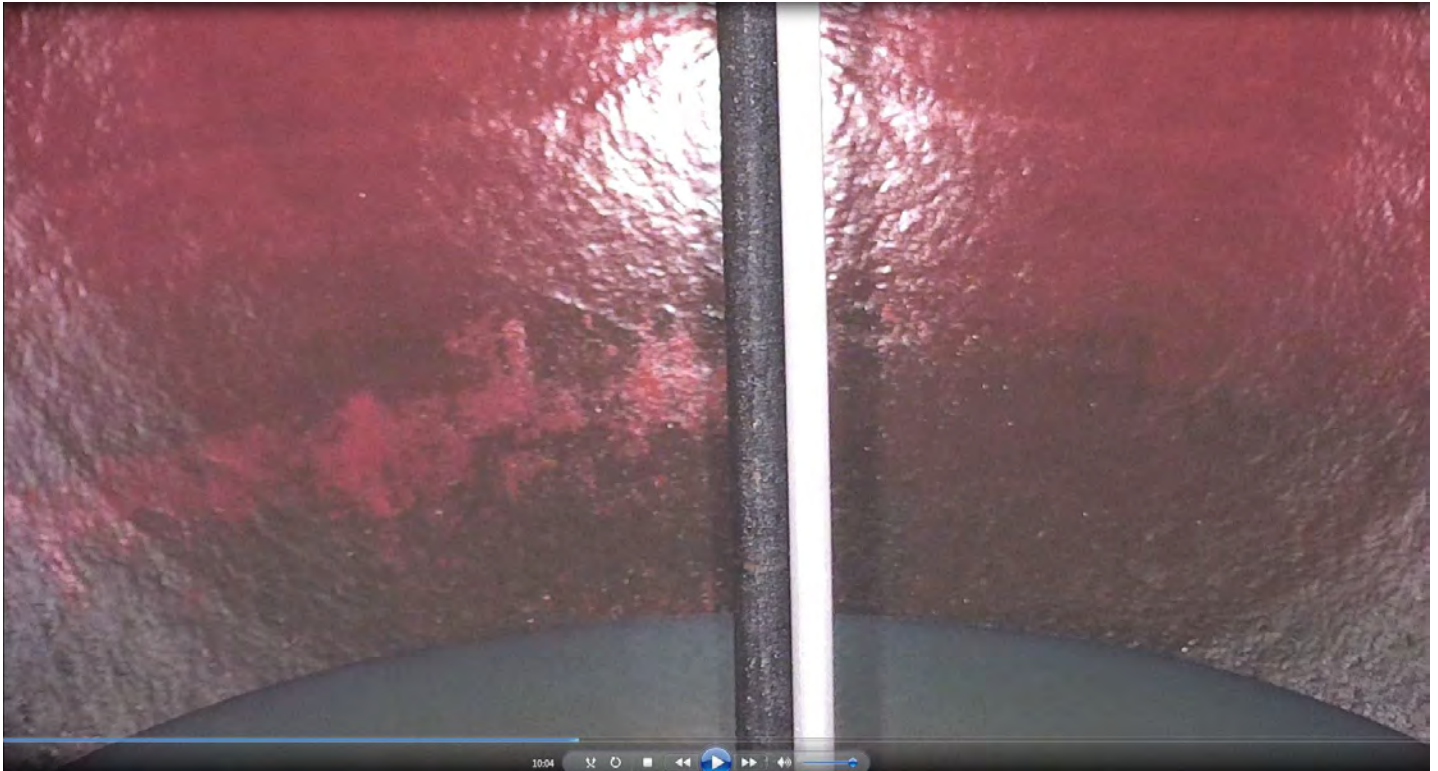
Figure 4-5: Possible corrosion on STP shaft (10:04)

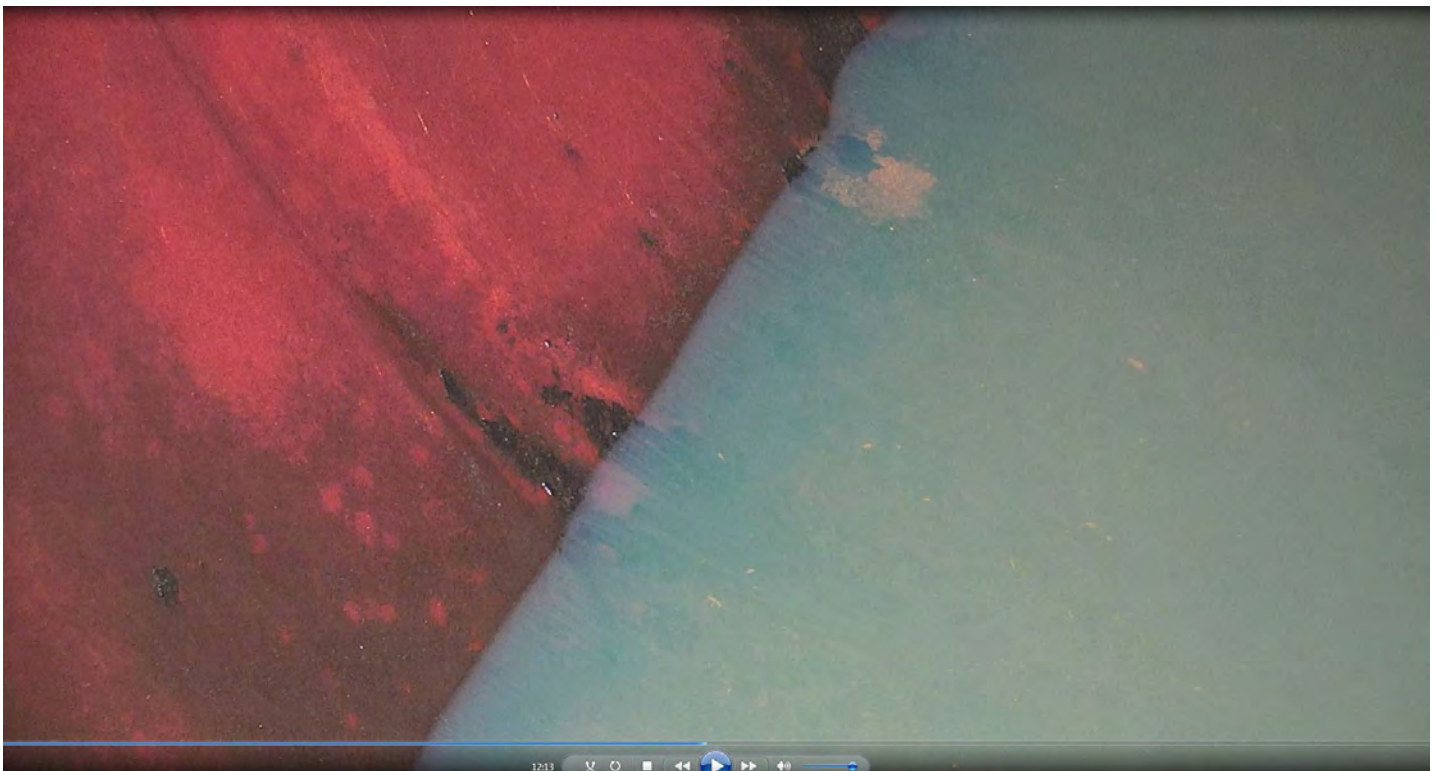
Figure 4-6: Residue build-up on tank wall (12:13)

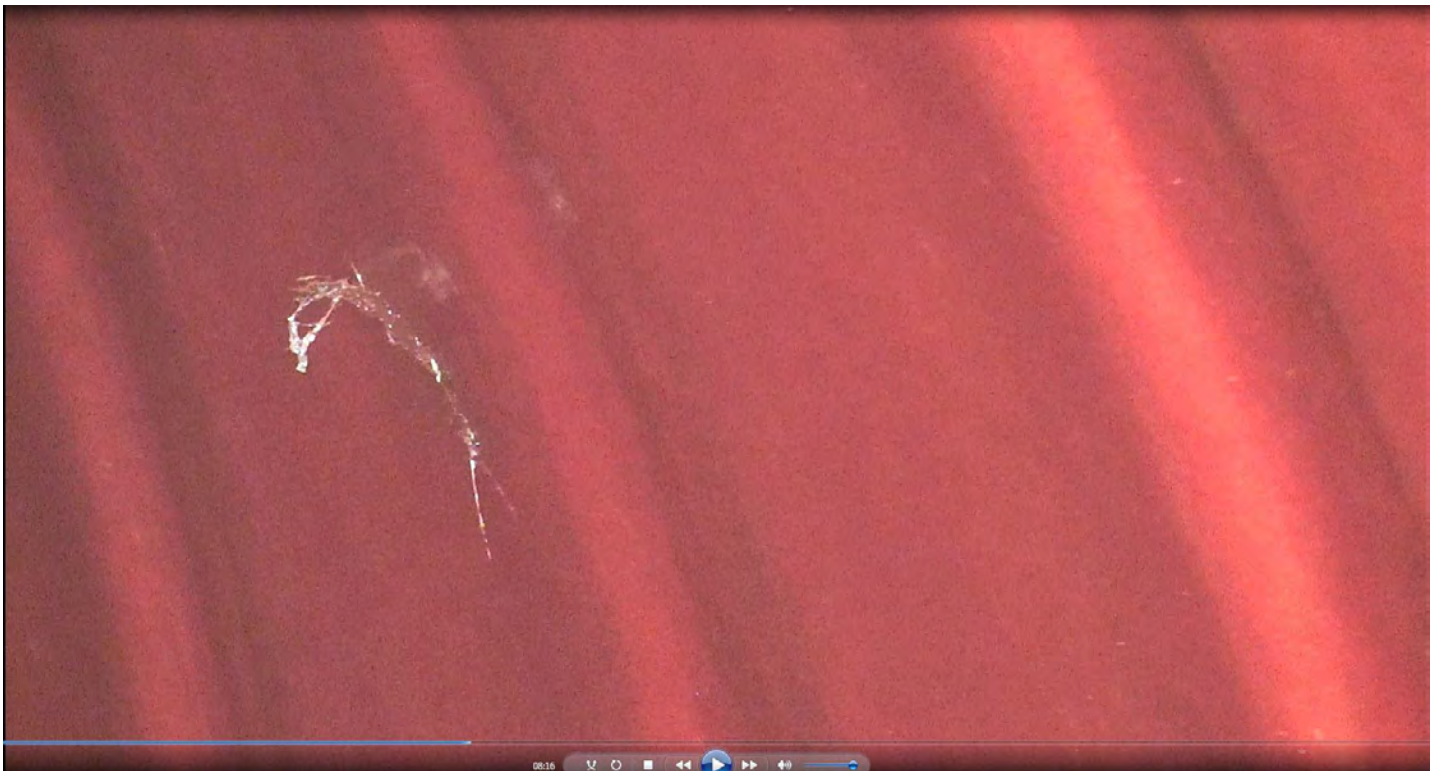
Figure 4-10: Exposed fibers on tank wall (08:16)
