STATE OF ILLINOIS  
Pollution Control Board

AC06-35

*State of Illinois*  
**ENVIRONMENTAL PROTECTION AGENCY**  
**Narrative Inspection Report**

**Subject:** Open Dump Site Inspection At Jerry L. Watson Property

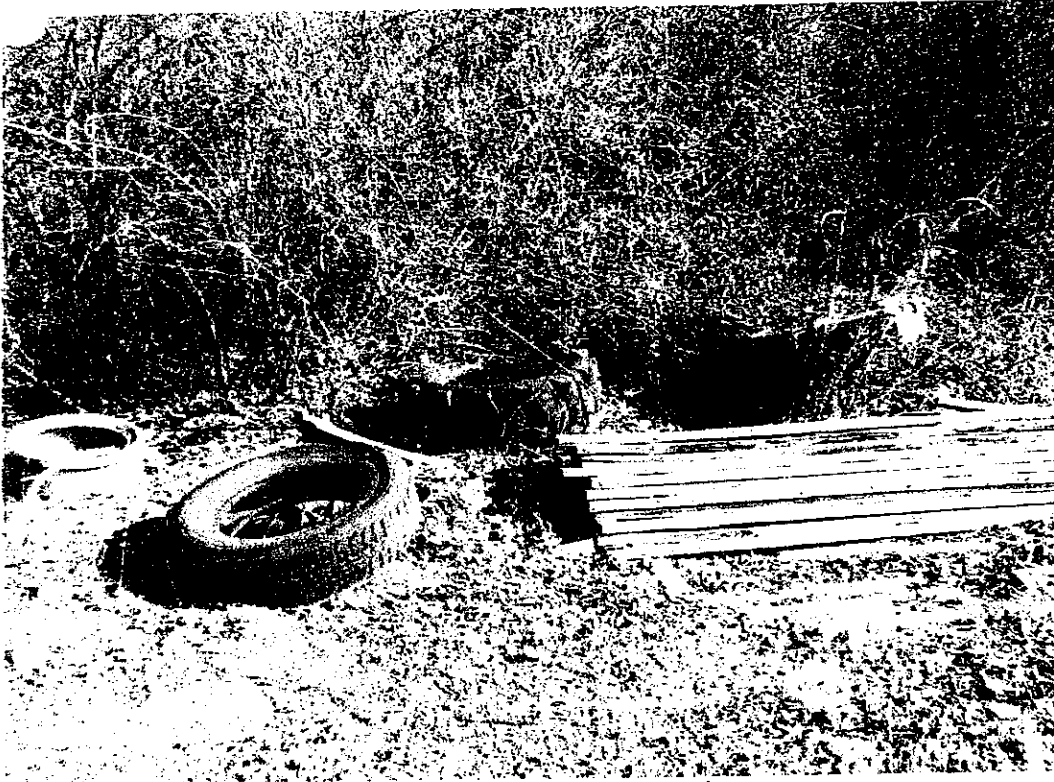
Date: 03/02/2006  
Time: 9:21 AM  
Direction: North  
Photo by: G. Gross  
Exposure #: 001  
Comments:

The inspection began at 9:15 AM. We were unable to access by site by vehicle due to a metal gate blocking the entrance to the property. We parked the vehicle and walked toward the gate. Before entering the site we observed waste tires and dimensional lumber partially overgrown with vegetation (photo 001). We proceeded up a small hill around the gate. The inspection began at the southern portion of the property. At the time of the previous inspection, this was the area where we focused our attention on open dumped waste items. Proceeding beyond the gate we observed two waste mobile homes and three waste vehicles (photos 002 and 003). Construction and demolition waste (dimensional lumber) was observed just north of the waste vehicles (photo 004). Woody and non-woody vegetation was growing up around these areas.

*These tires & lumber have been removed & disposed of. The site is clean.*

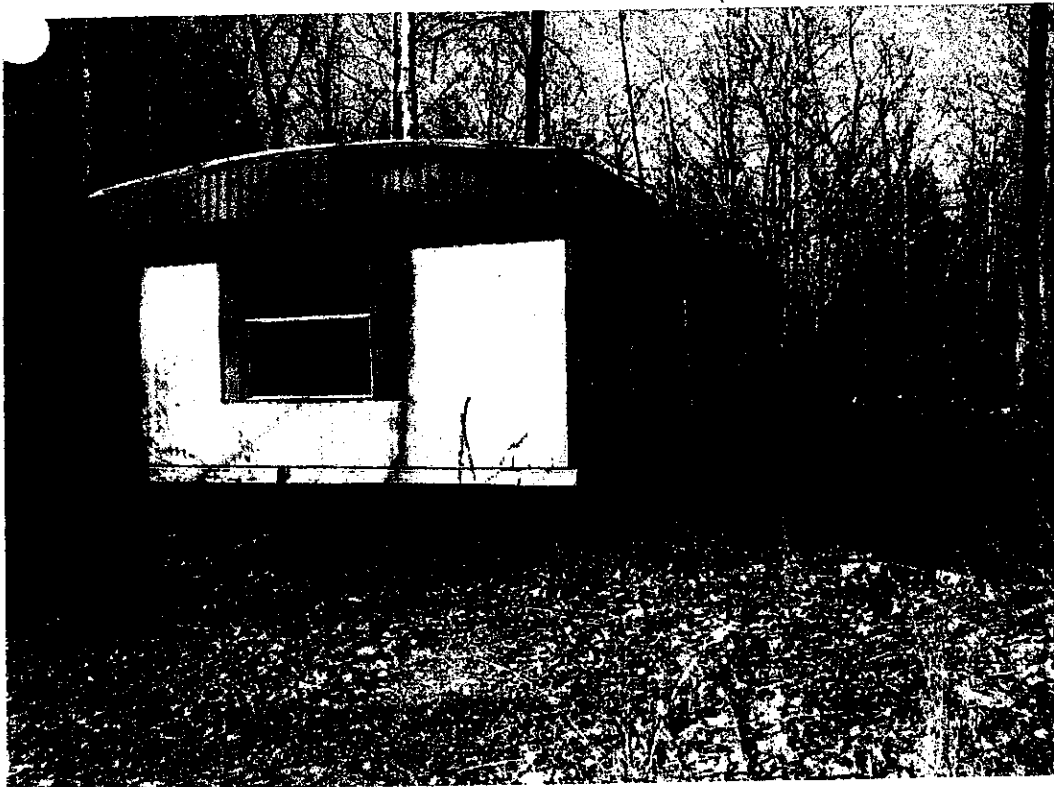
Date: 03/02/2006  
Time: 9:22 AM  
Direction: West  
Photo by: G. Gross  
Exposure #: 002  
Comments:

*This mobile home is usable and for sale*

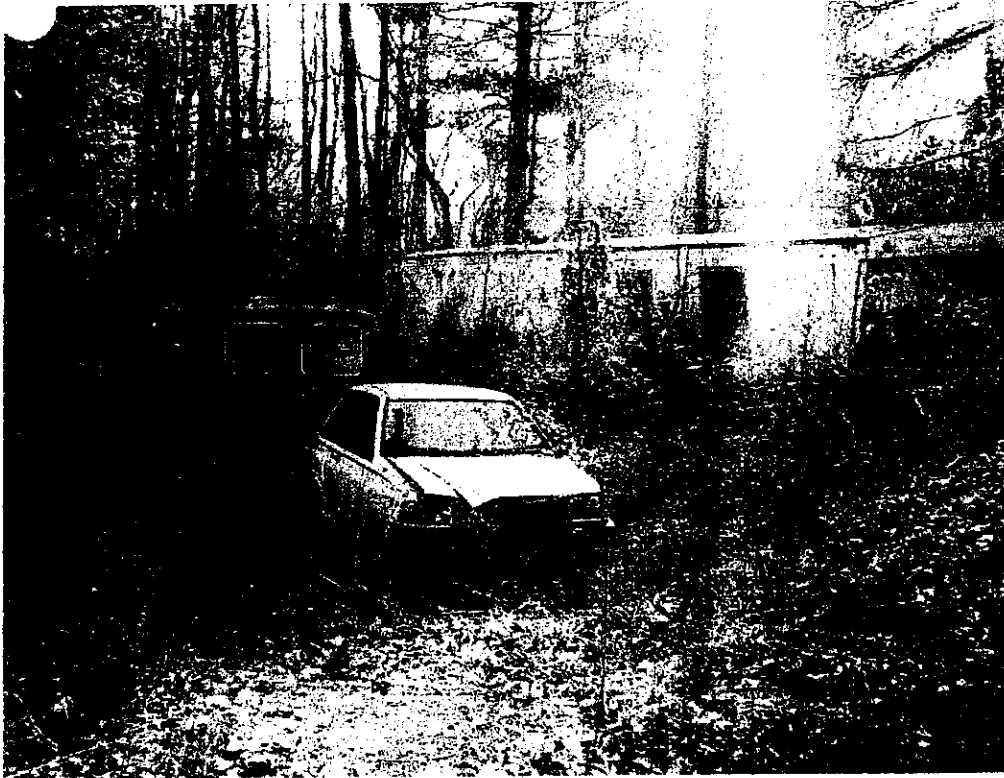
**Date: 03/02/2006  
Time: 9:23 AM  
Direction: Southeast  
Photo by: G. Gross  
Exposure #: 003  
Comments:**

- 1) Front white car does not belong to me & is being removed by owner soon.
- 2) Van is a service vehicle for business.
- 3) Vehicle runs - belongs to my son.
- 4) Trailer is a storage unit for my business.

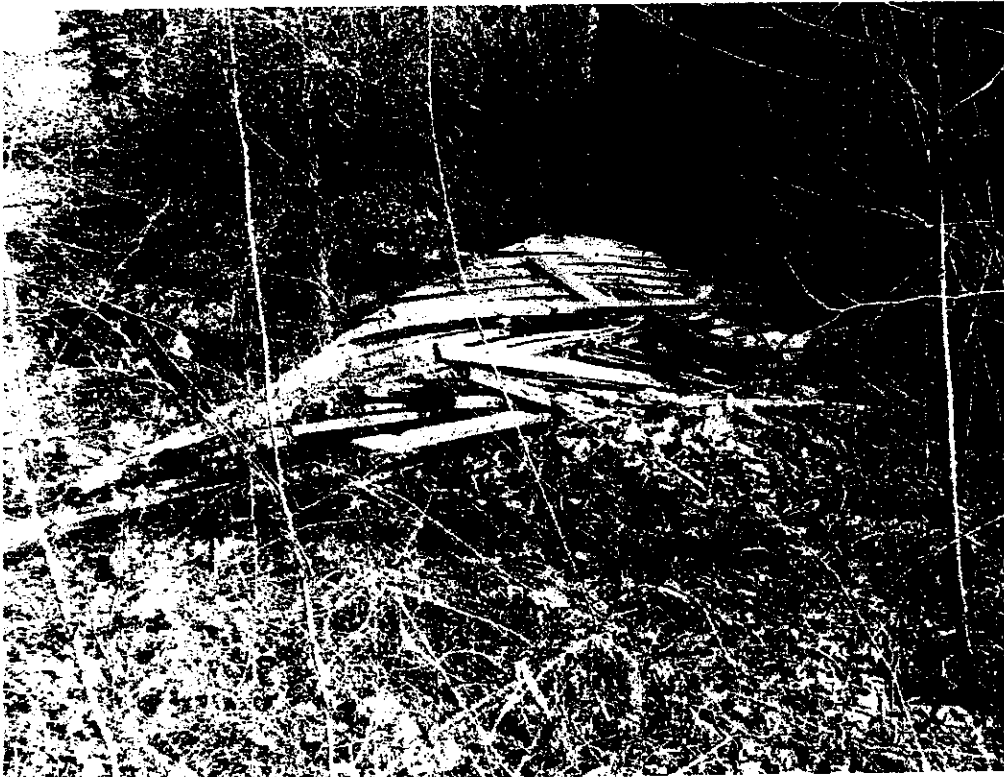
**Date: 03/02/2006  
Time: 9:23 AM  
Direction: Northeast  
Photo by: G. Gross  
Exposure #: 004  
Comments:**

This lumber was an old mine shed that was on the property when I bought it, I tore it down & will remove it soon.

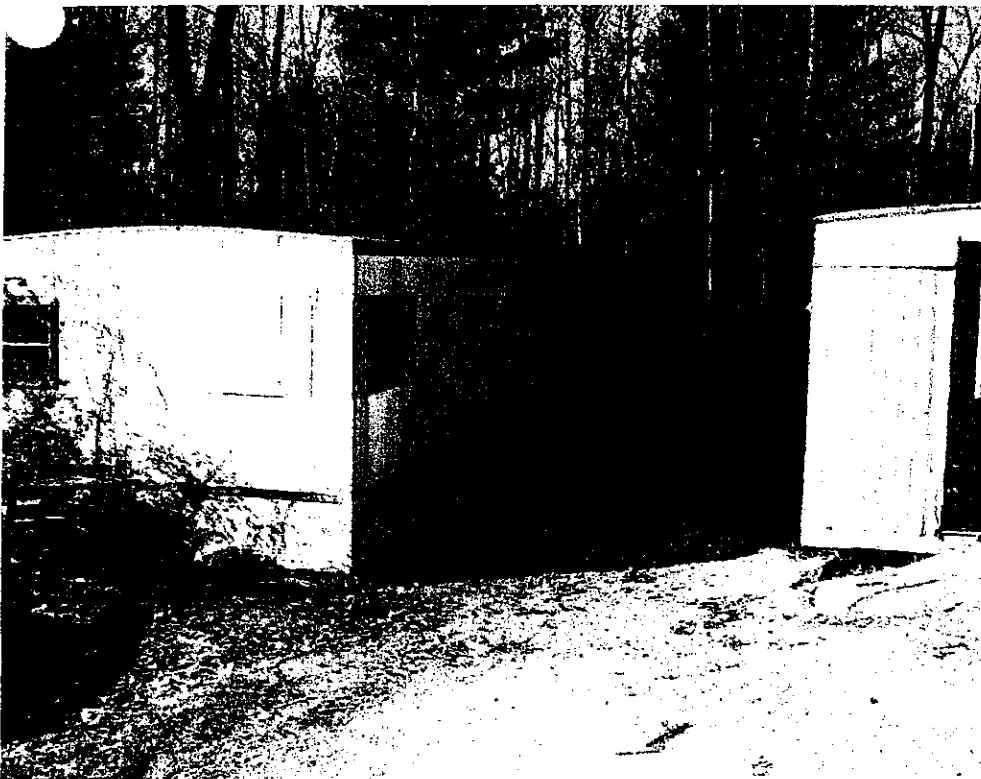
Date: 03/02/2006  
Time: 9:24 AM  
Direction: West  
Photo by: G. Gross  
Exposure #: 006  
Comments:

*These are storage units for my business. Both units have steps + access doors + are used daily.*

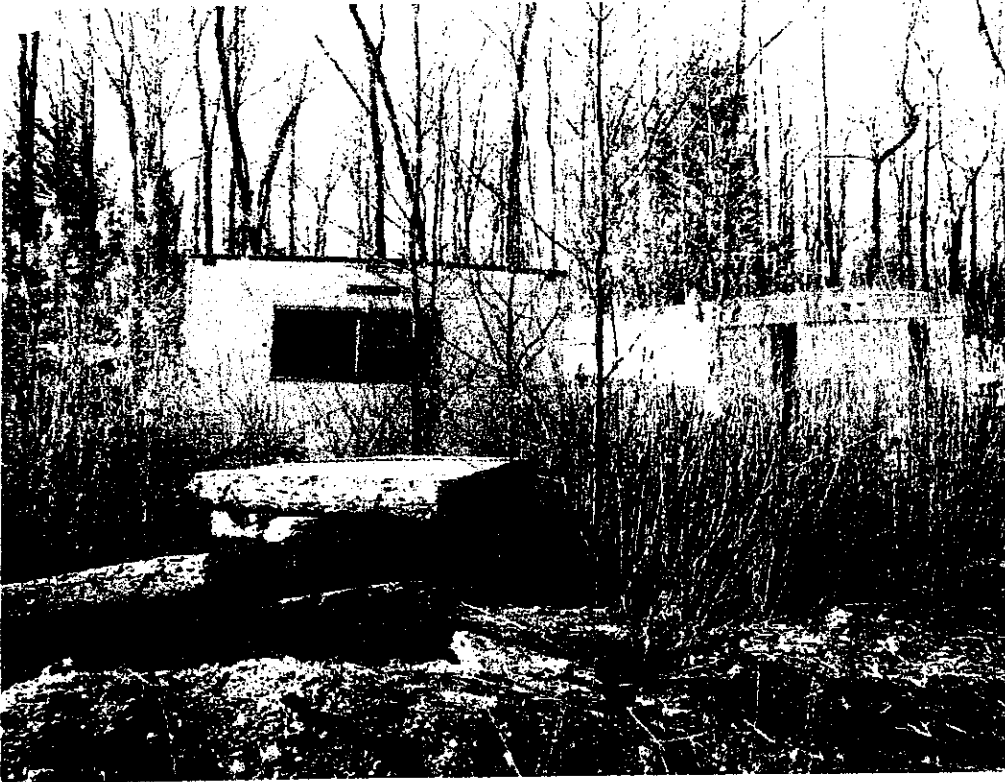
Date: 03/02/2006  
Time: 9:27 AM  
Direction: Southwest  
Photo by: G. Gross  
Exposure #: 011  
Comments:

*These are storage units for my business. Over-growth will be cleared properly.*

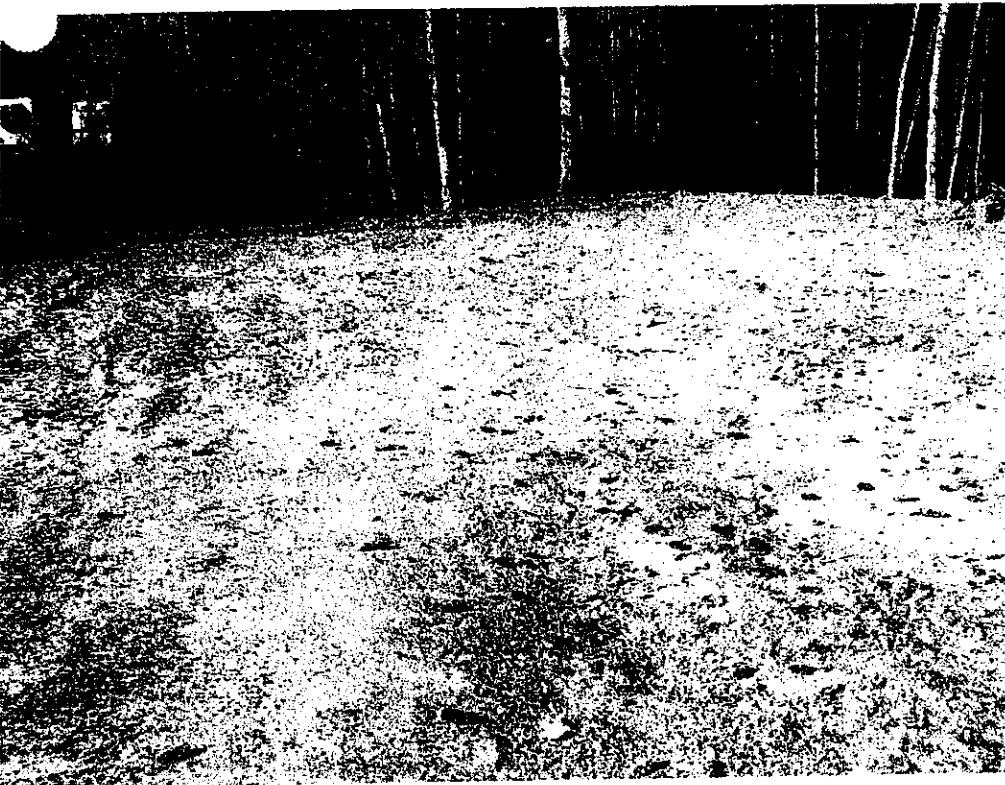
Date: 03/02/2006  
Time: 9:28 AM  
Direction: West  
Photo by: G. Gross  
Exposure #: 012  
Comments:

*This site was from the 1st inspection & I have complied with all requests & submitted receipts and photos.*

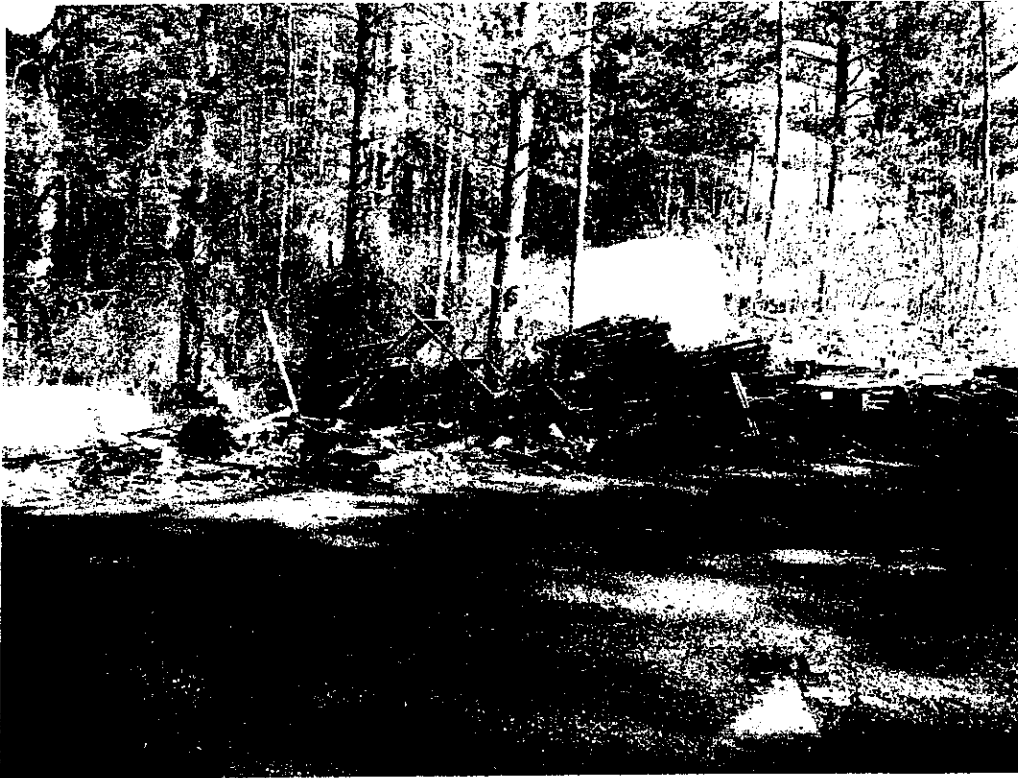
Date: 03/02/2006  
Time: 9:30 AM  
Direction: North  
Photo by: G. Gross  
Exposure #: 013  
Comments:

*This site is  
being cleaned  
up.*

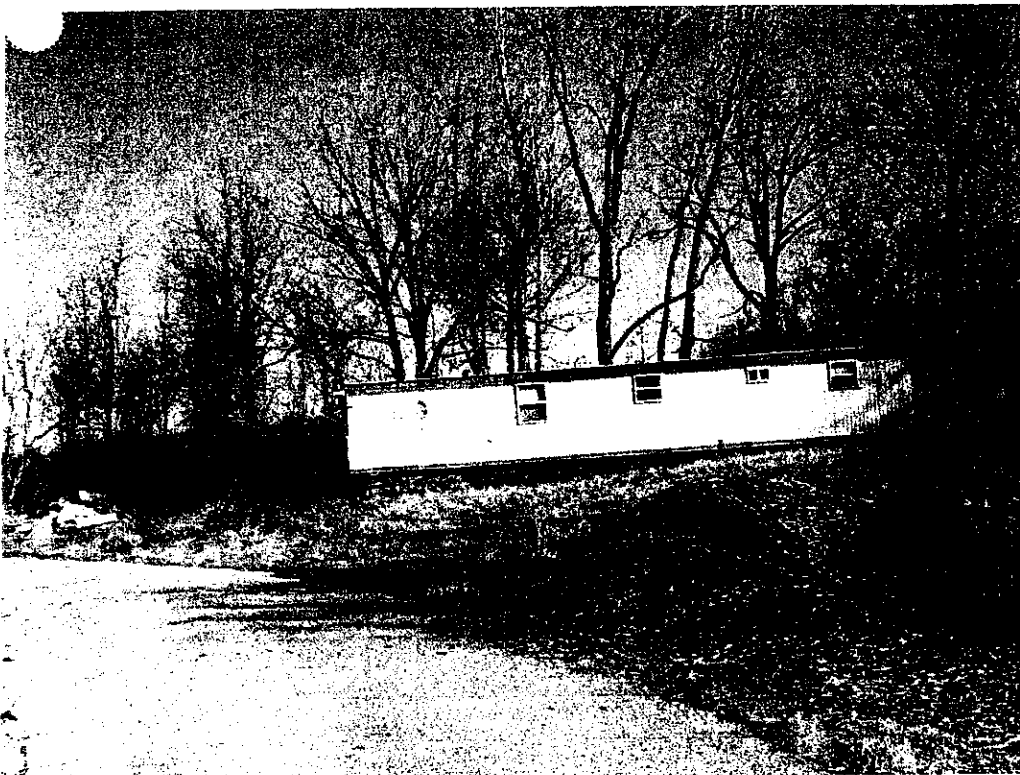
Date: 03/02/2006  
Time: 9:33 AM  
Direction: North  
Photo by: G. Gross  
Exposure #: 014  
Comments:

We headed north on the main access road and proceeded to the northern part of the property. At the time of the previous inspection, this area was not investigated. We observed a waste mobile home that had not been leveled and did not appear to be in use (photo 014). Several waste vehicles, vehicle parts and machinery were observed on either side of the main access road (photos 015-019). Three more waste mobile homes were observed in the northwestern portion of the site (photo 020). All were unlevelled and haphazardly placed on the slope of the hill. Two boats, a truck bed, and other unidentifiable machinery were observed near the edge of the main access road. All of these waste items were overgrown in vegetation and did not appear to have been used for sometime.

*This mobile  
construction  
office will be  
moved to  
proper storage  
area or job  
site, as needed.*

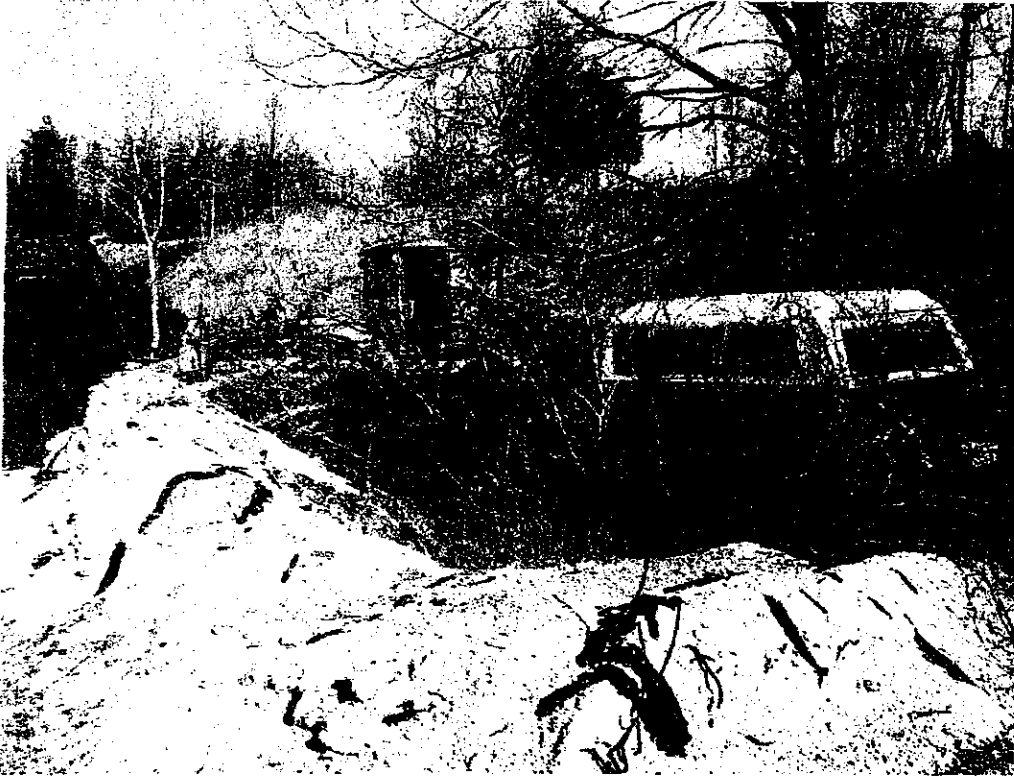
**Date: 03/02/2006  
Time: 9:33 AM  
Direction: Northwest  
Photo by: G. Gross  
Exposure #: 015  
Comments:**

*This is usable equipment for parts for my business & will be stored properly.*

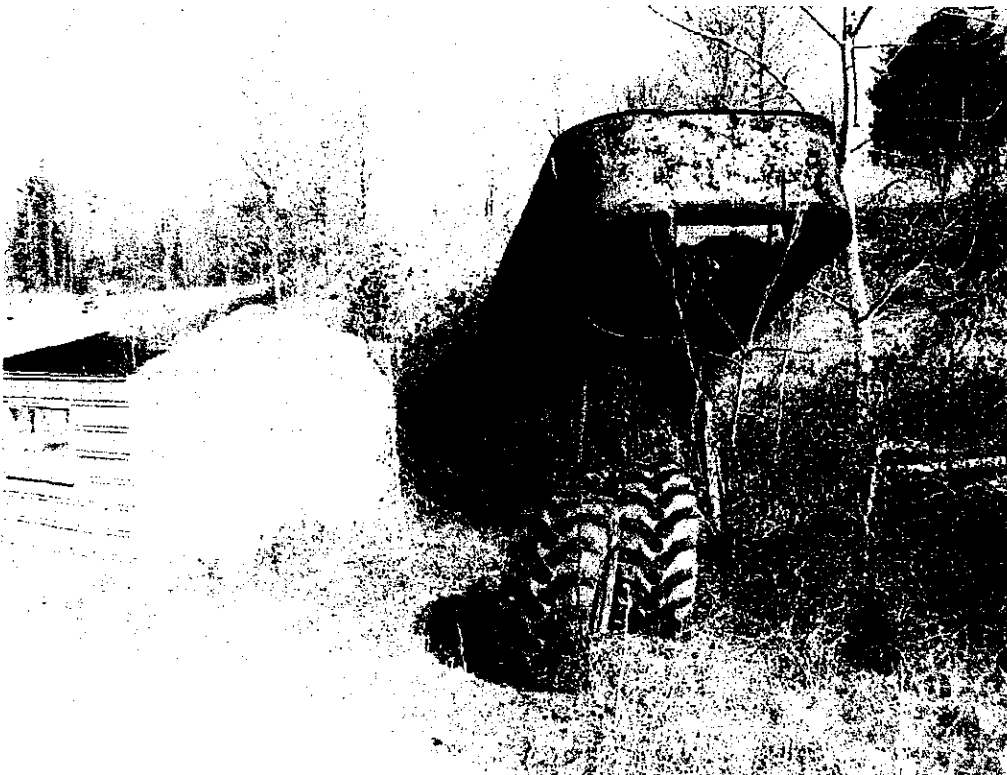
**Date: 03/02/2006  
Time: 9:34 AM  
Direction: Northwest  
Photo by: G. Gross  
Exposure #: 016  
Comments:**

*This is a dump trailer & two spare tires for my back hoe. They will be stored properly.*

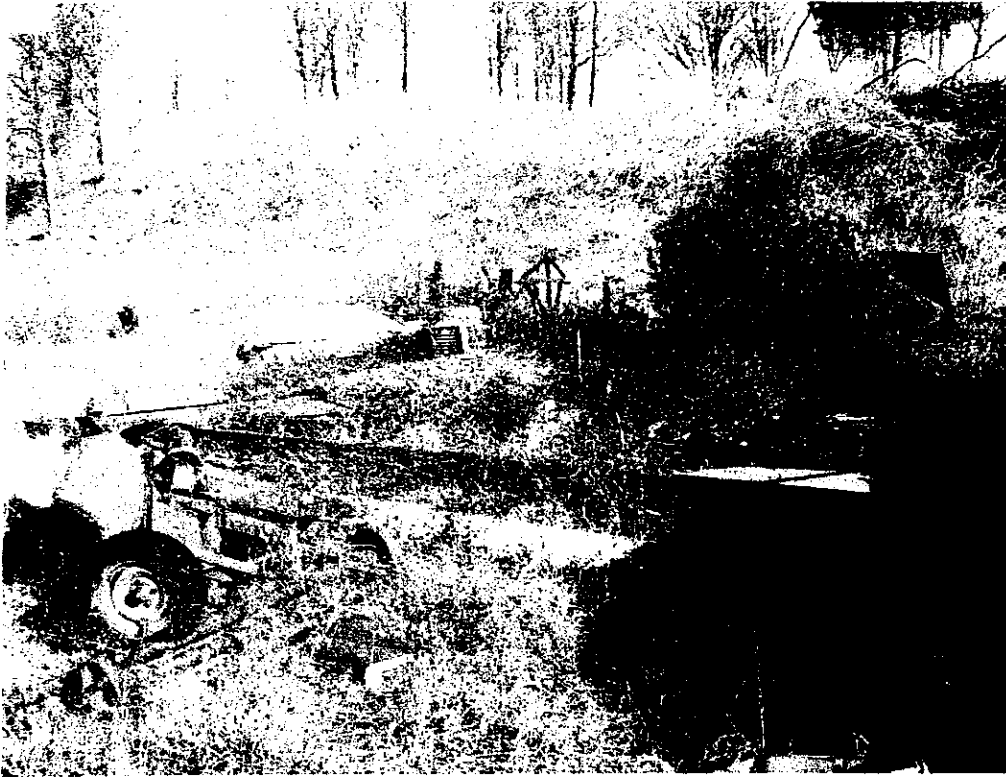
**Date: 03/02/2006  
Time: 9:34 AM  
Direction: North  
Photo by: G. Gross  
Exposure #: 017  
Comments:**

*This is usable  
equipment for  
my business &  
will be stored  
properly.*

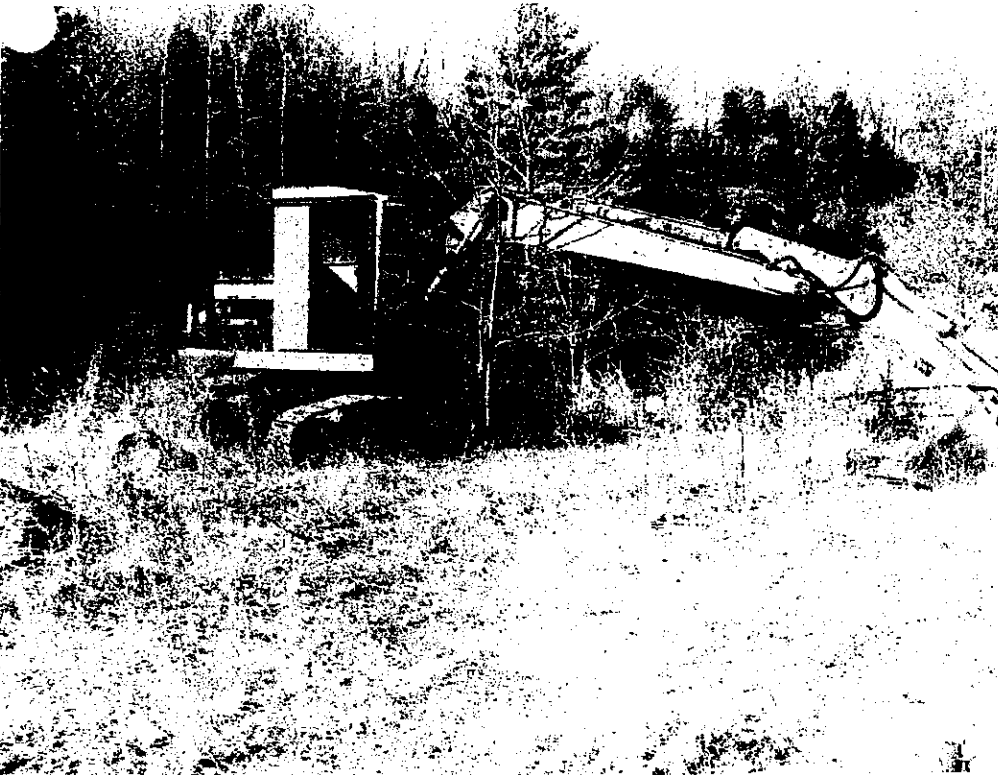
**Date: 03/02/2006  
Time: 9:34 AM  
Direction: Southwest  
Photo by: G. Gross  
Exposure #: 018  
Comments:**

*This piece of  
equipment has  
been sold & will  
be removed  
soon.*

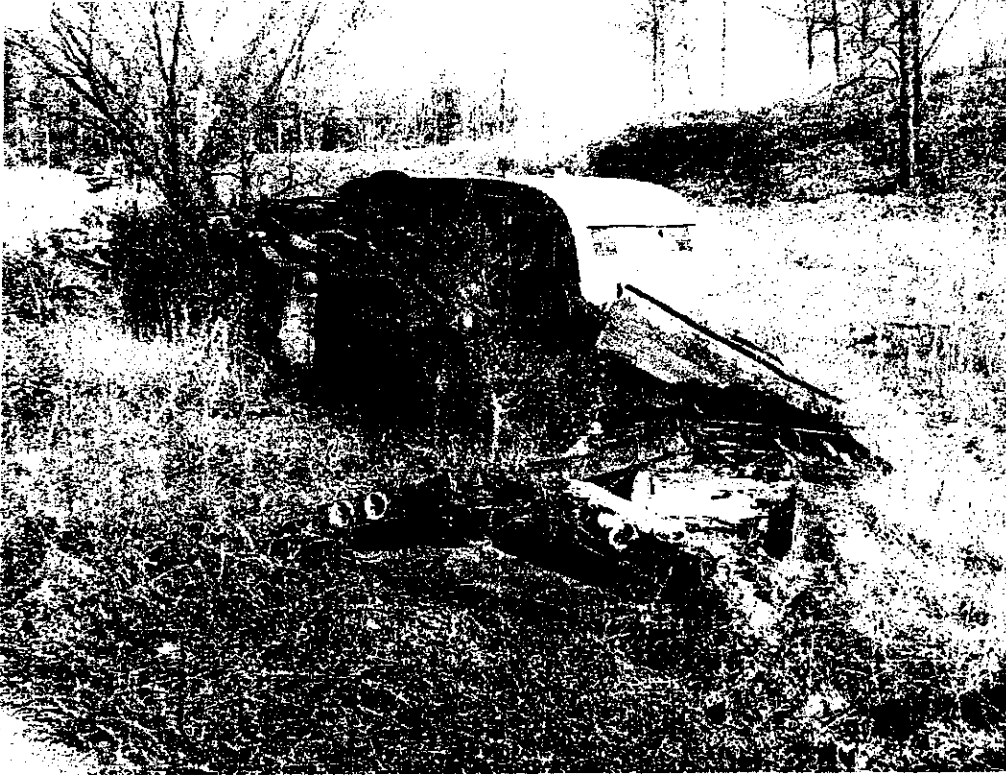
**Date: 03/02/2006  
Time: 9:35 AM  
Direction: Northwest  
Photo by: G. Gross  
Exposure #: 019  
Comments:**

*This is scrap  
metal which  
will be sold.*

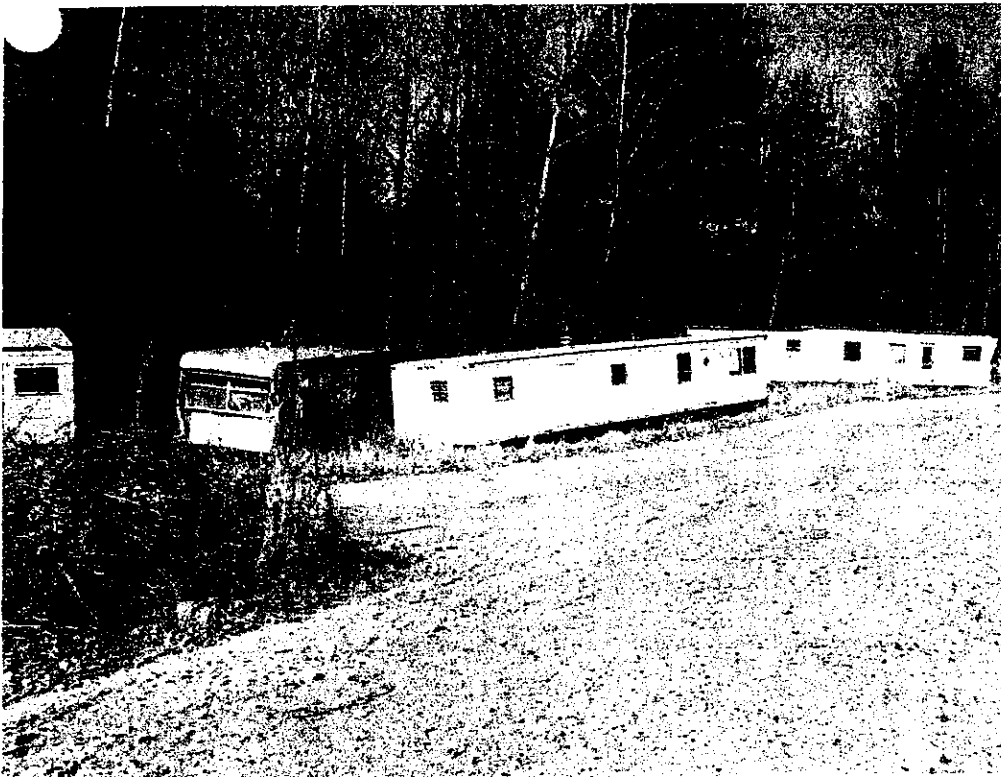
**Date: 03/02/2006  
Time: 9:36 AM  
Direction: Northwest  
Photo by: G. Gross  
Exposure #: 020  
Comments:**

*These storage  
units were  
moved to build  
access roads &  
will be properly  
leveled for  
storage again.*

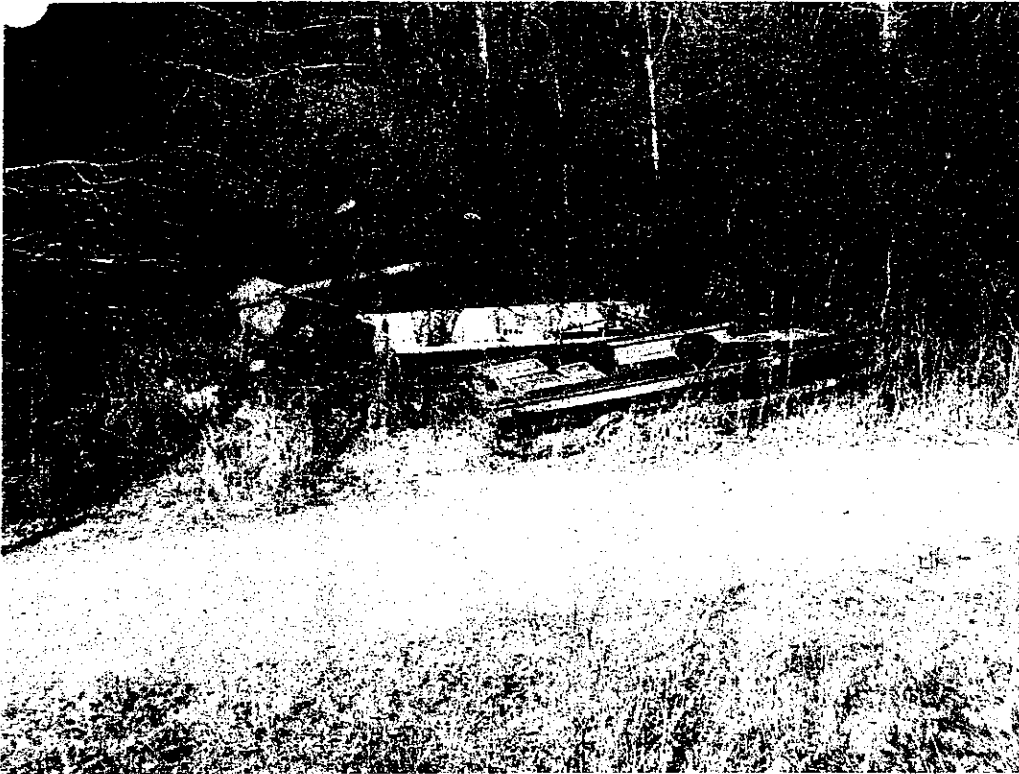
Date: 03/02/2006  
Time: 9:37 AM  
Direction: North  
Photo by: G. Gross  
Exposure #: 021  
Comments:

*Boat is personal property used for parts & all other items will be cleaned up.*

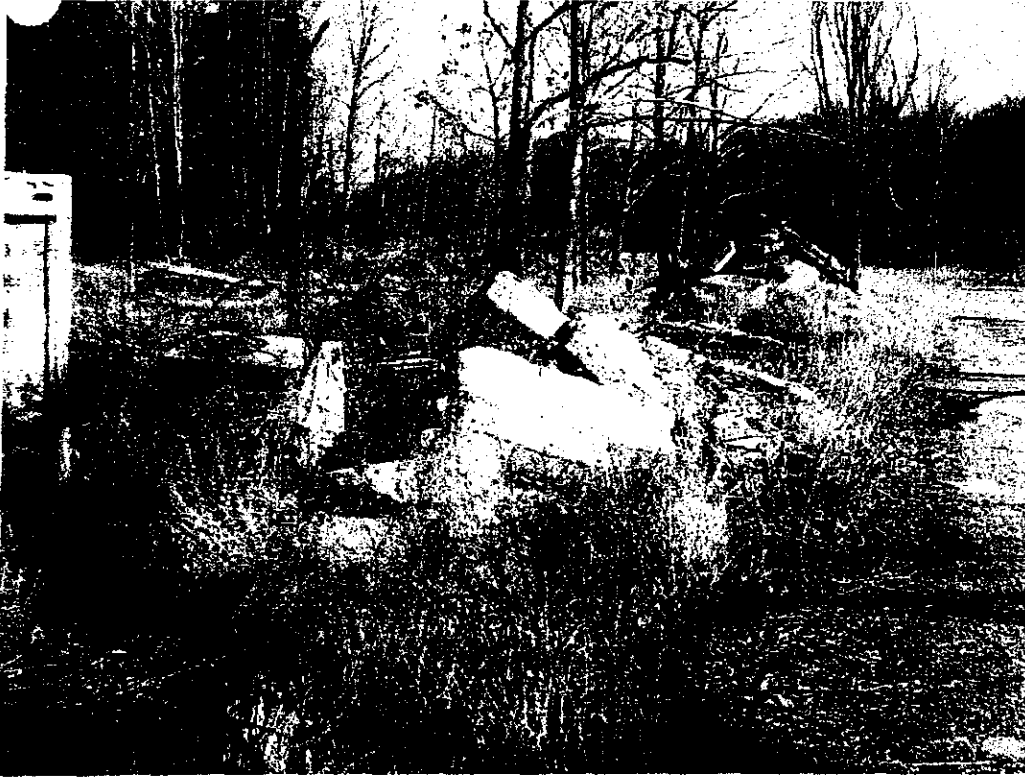
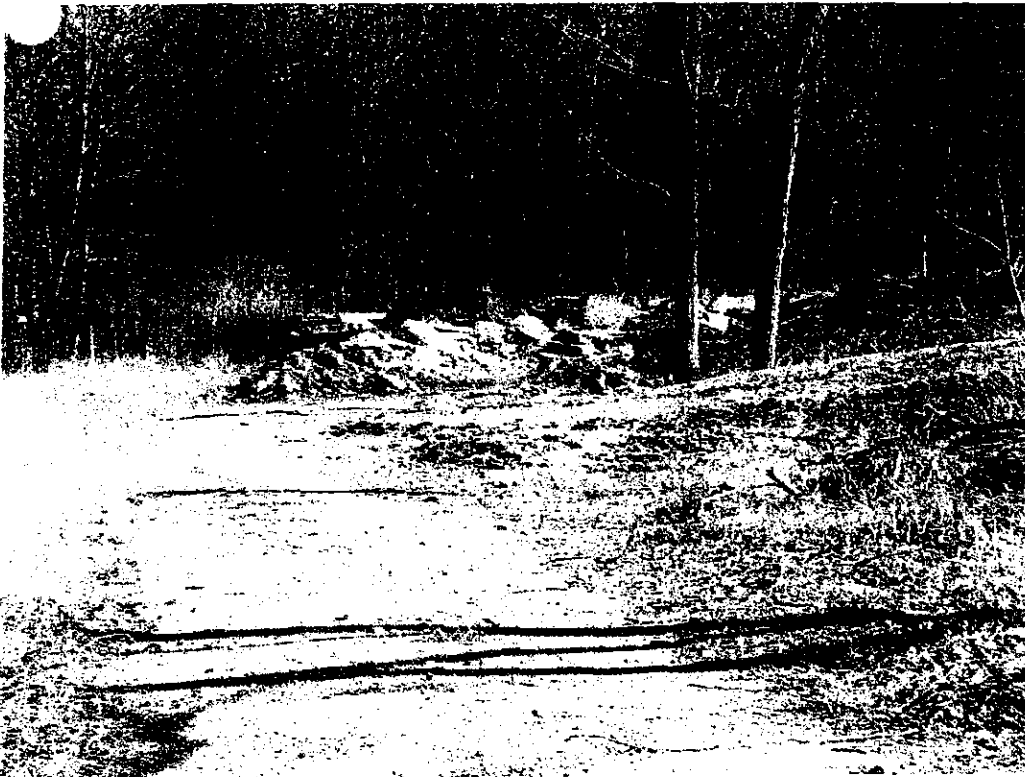
We continued walking north on the main access road and observed three piles of construction and demolition wastes in the form of busted concrete (photos 023 and 024). The busted concrete was not being properly used for fill material because it was piled higher than the surrounding property elevation. It was also noted that extensive excavation work was taking place (photos 025 and 026). The area was approximately 2-3 acres and consisted of a 3-walled berm located on a hill. Due to the extreme topographical variations and the existence of 2 small lakes, it's speculated use is unknown. Because an NPDES Storm Water Construction Permit is required for soil disturbances involving more than one acre, the Illinois EPA Bureau of Water was notified of the excavation work.

*This is excess  
pieces broken  
from slabs (see  
photo # 5) which  
will be used for  
fill. It is the  
excess from build-  
ing the roads.*

*See comments  
in photo # 23  
above. (same  
area)*
