ILLINOIS ENVIRONMENTAL PROTECTION AGENCY

Re: Illinois Environmental Protection Agency v. Edward W. Fisher & Rhonda L. Fisher and  
DEM/EX Group, Inc.  
IEPA File No. 29-08-AC; 1250305011—Mason County

BEFORE THE ILLINOIS POLLUTION CONTROL BOARD  
ADMINISTRATIVE CITATION

February 7, 2008 Inspection

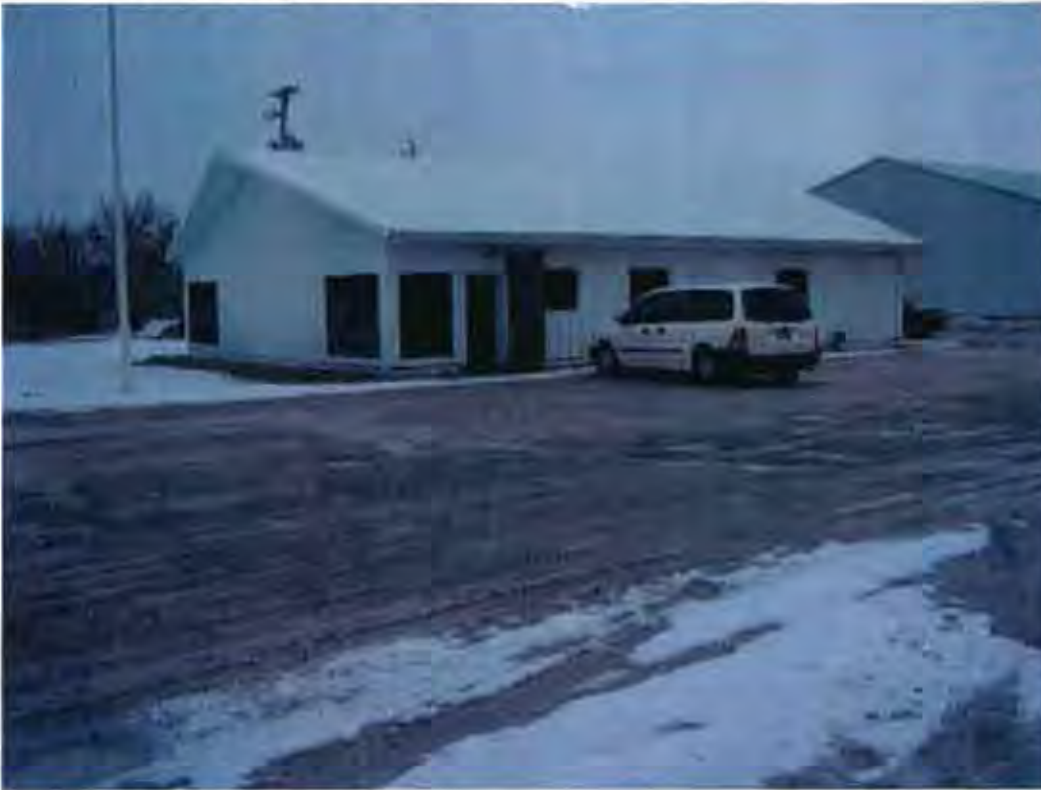
Photograph 001 shows a street elevation view of the DEM/EX Group office building. A two cubic yard dumpster was observed behind the building. The waste in the dumpster was overfull, but appeared consistent with office operations.

**Date:** February 7, 2008  
**Time:** 10:09 AM  
**Direction:** SW  
**Photo by:** Eisenbrandt  
**Exposure #:** 001  
**Comments:** Street elevation view of the DEM/EX Group office building.

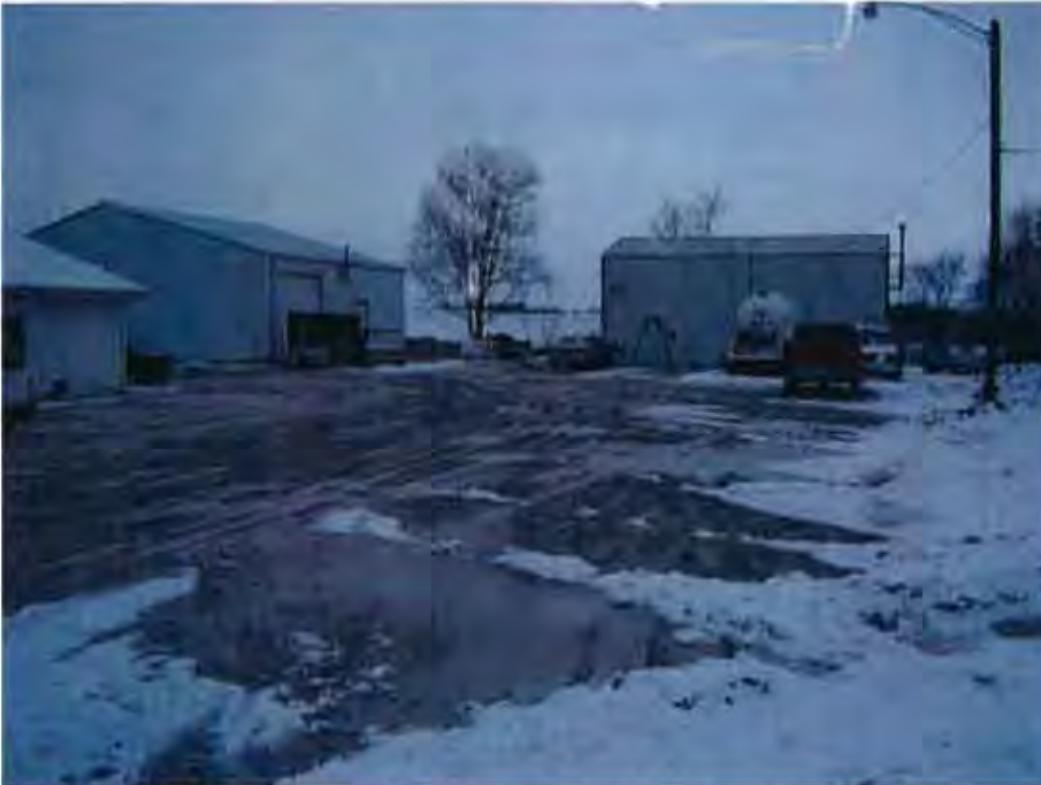
Photograph 002 shows the northeast parking lot. No debris was observed.

**Date:** February 7, 2008  
**Time:** 10:09 AM  
**Direction:** W  
**Photo by:** Eisenbrandt  
**Exposure #:** 002  
**Comments:** Northeast parking lot clear of debris.

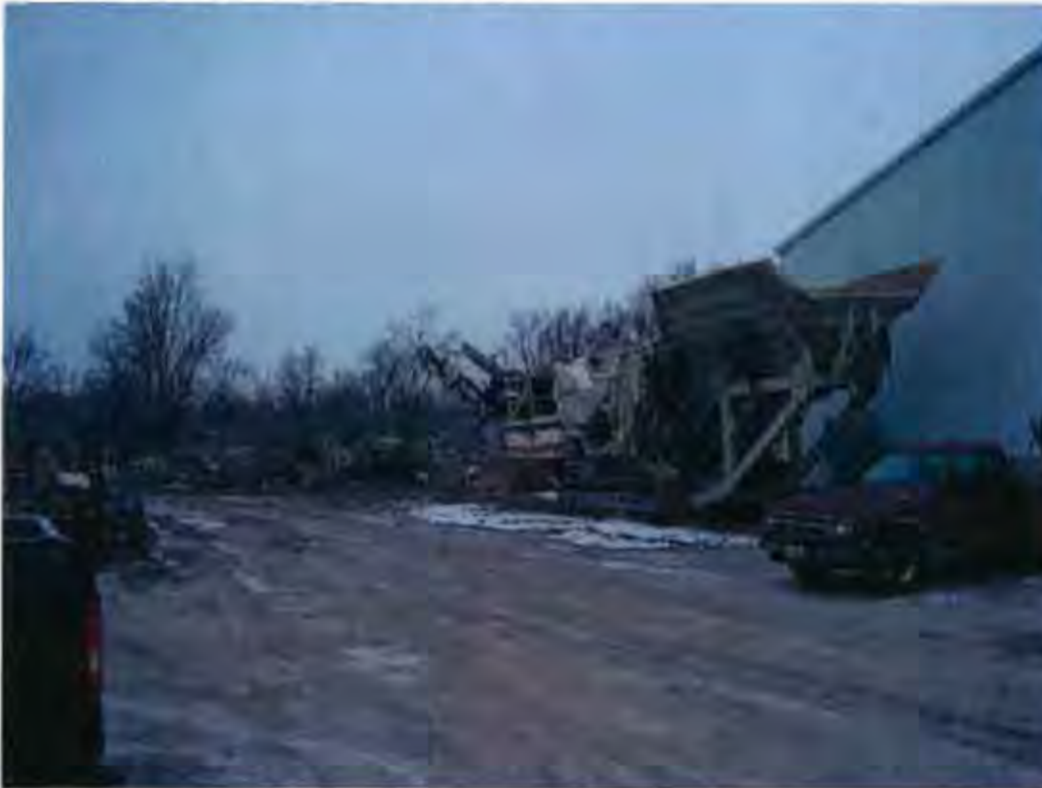
**Date:** February 7, 2008  
**Time:** 10:10 AM  
**Direction:** SW  
**Photo by:** Eisenbrandt  
**Exposure #:** 003  
**Comments:** A crusher located between the maintenance garage and the office building.

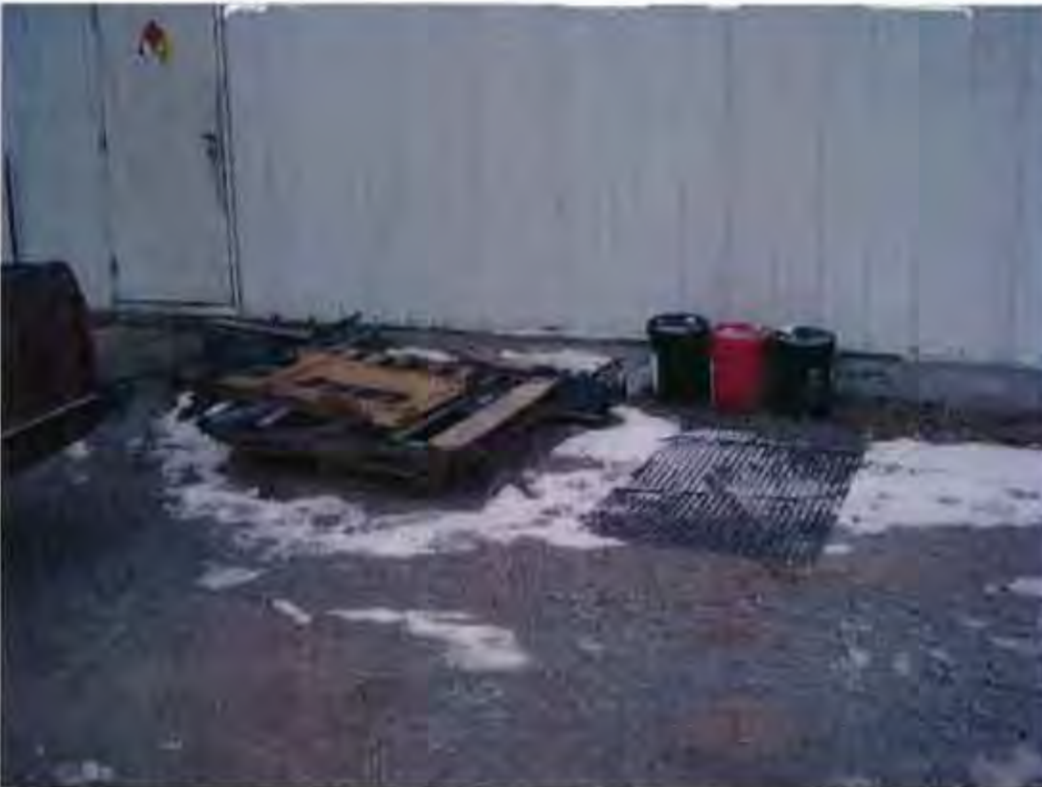
Photograph 004 shows three empty 5-gallon buckets of oil, five lead acid batteries, and scrap metal located along the southeast side of the maintenance garage. Mr. Fisher claimed the DEM/EX employees had just placed the items there but that they were still good. The inspector recommended to Mr. Fisher that the lead acid batteries be stored off the ground on a pallet or inside the maintenance shop until recycled. The inspector also recommended reusable materials be stored neatly and to discard or store the empty oil buckets inside.

**Date:** February 7, 2008  
**Time:** 10:10 AM  
**Direction:** W  
**Photo by:** Eisenbrandt  
**Exposure #:** 004  
**Comments:** Three empty 5-gallon buckets of oil, five lead acid batteries, and scrap metal located outside the southeast side of the maintenance garage.

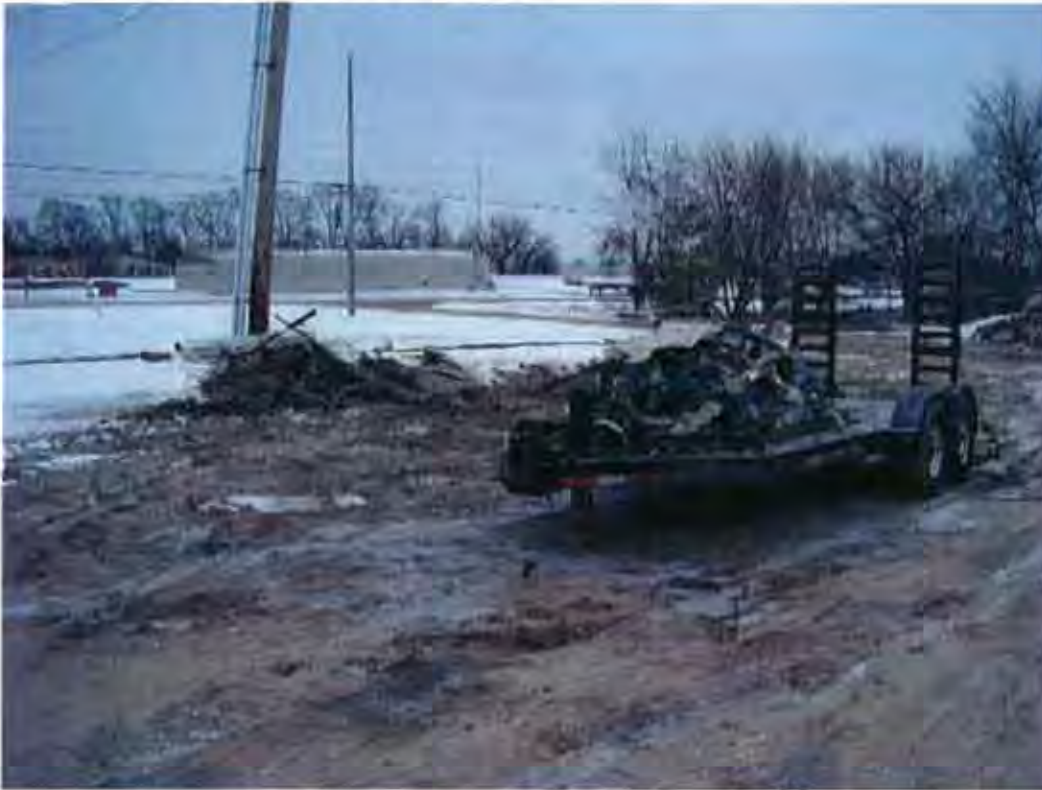
**Date:** February 7, 2008  
**Time:** 10:15 AM  
**Direction:** SE  
**Photo by:** Eisenbrandt  
**Exposure #:** 005  
**Comments:** A pile of scrap metal on the trailer and another pile of scrap metal in the background were observed south of the office building.

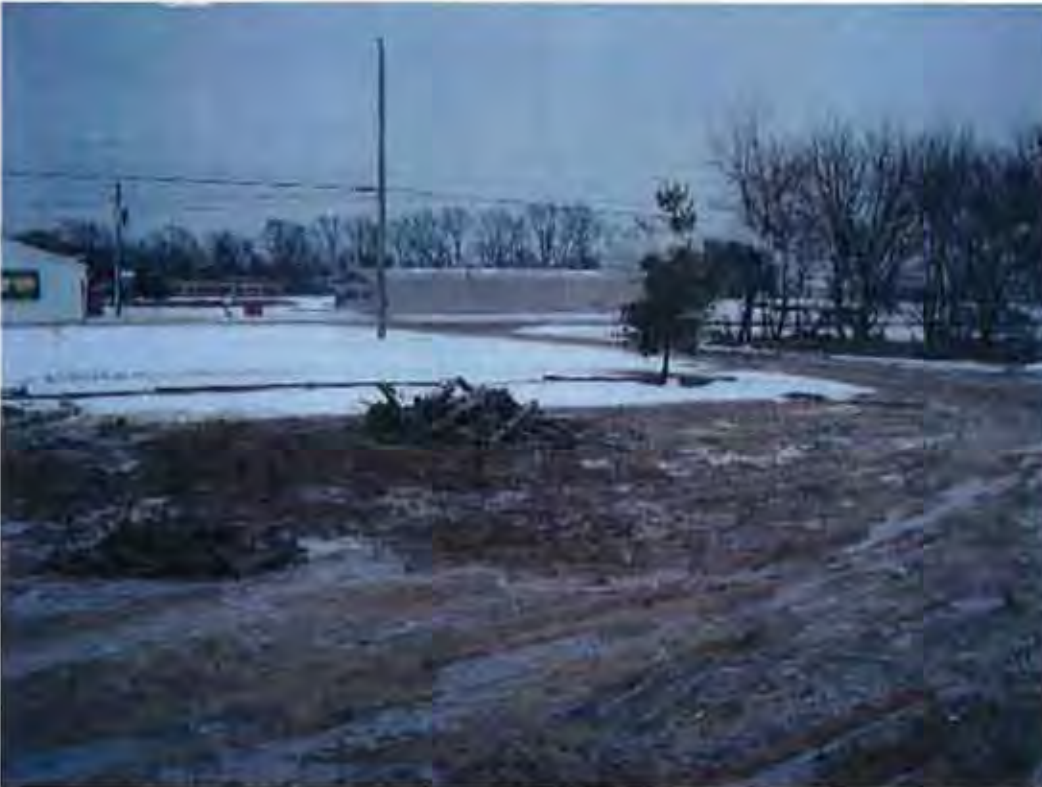
**Date:** February 7, 2008  
**Time:** 10:16 AM  
**Direction:** SE  
**Photo by:** Eisenbrandt  
**Exposure #:** 006  
**Comments:** Two additional pile of scrap metal observed south of the office building.

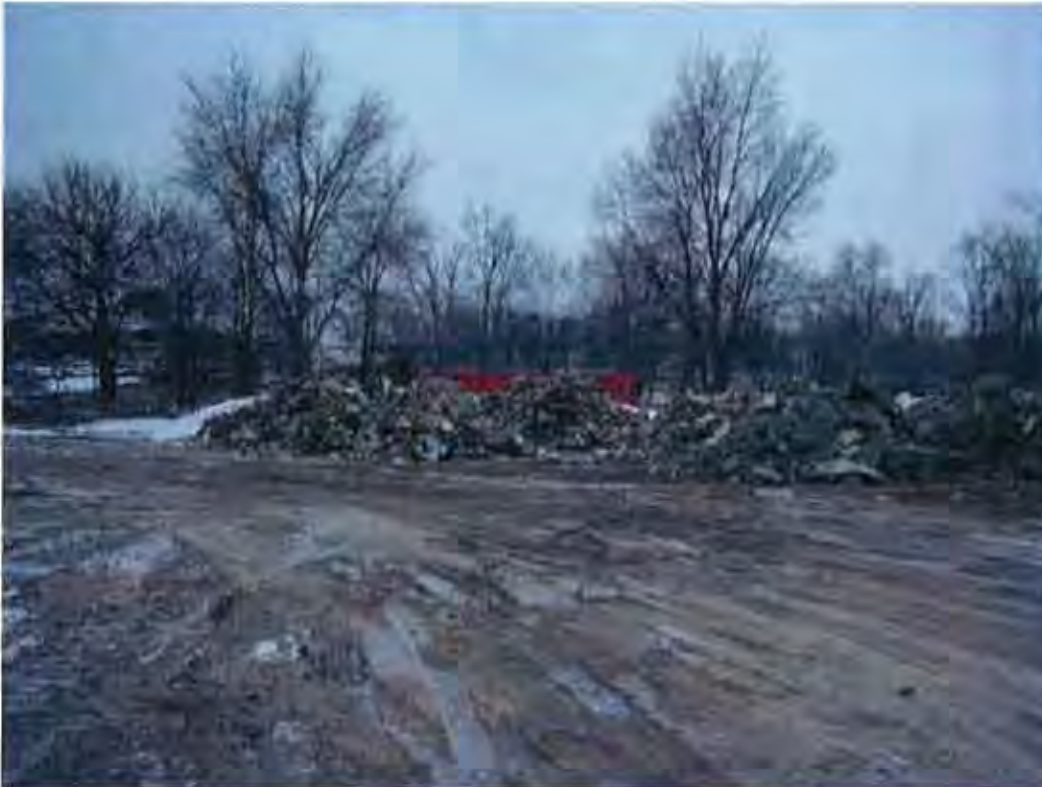
**Date:** February 7, 2008  
**Time:** 10:16 AM  
**Direction:** S  
**Photo by:** Eisenbrandt  
**Exposure #:** 007  
**Comments:** Numerous piles of demolition debris were observed on the south side of the facility.

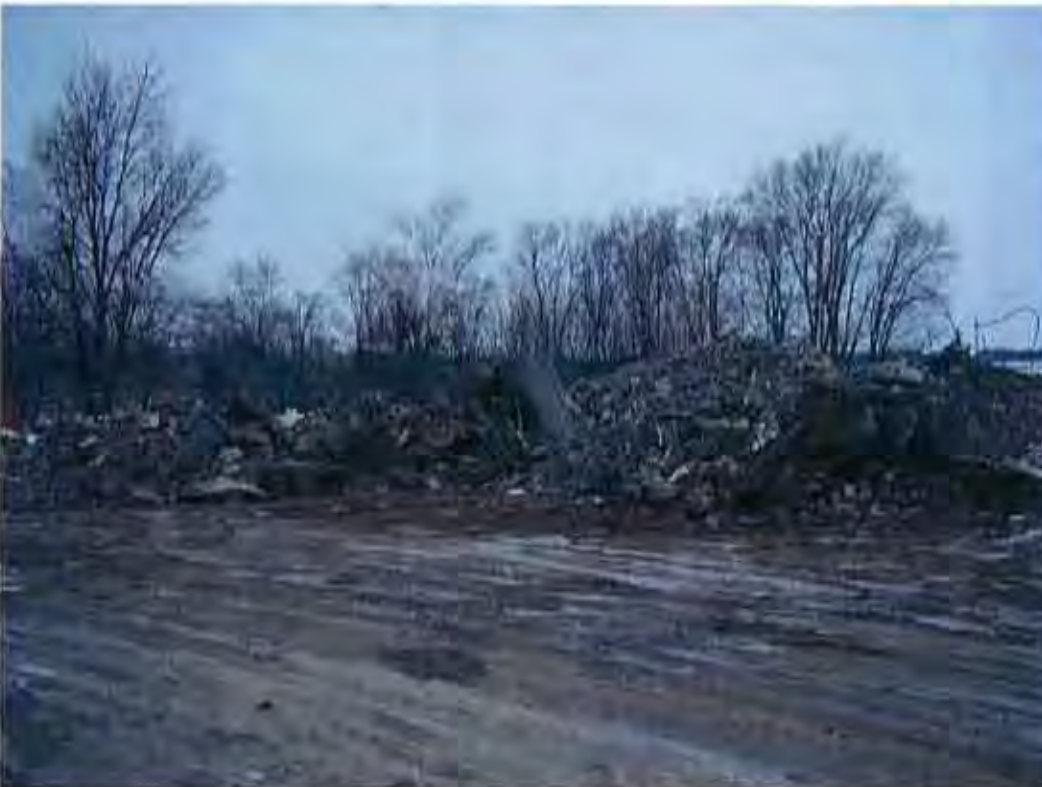
**Date:** February 7, 2008  
**Time:** 10:16 AM  
**Direction:** SW  
**Photo by:** Eisenbrandt  
**Exposure #:** 008  
**Comments:** Observed demolition debris.

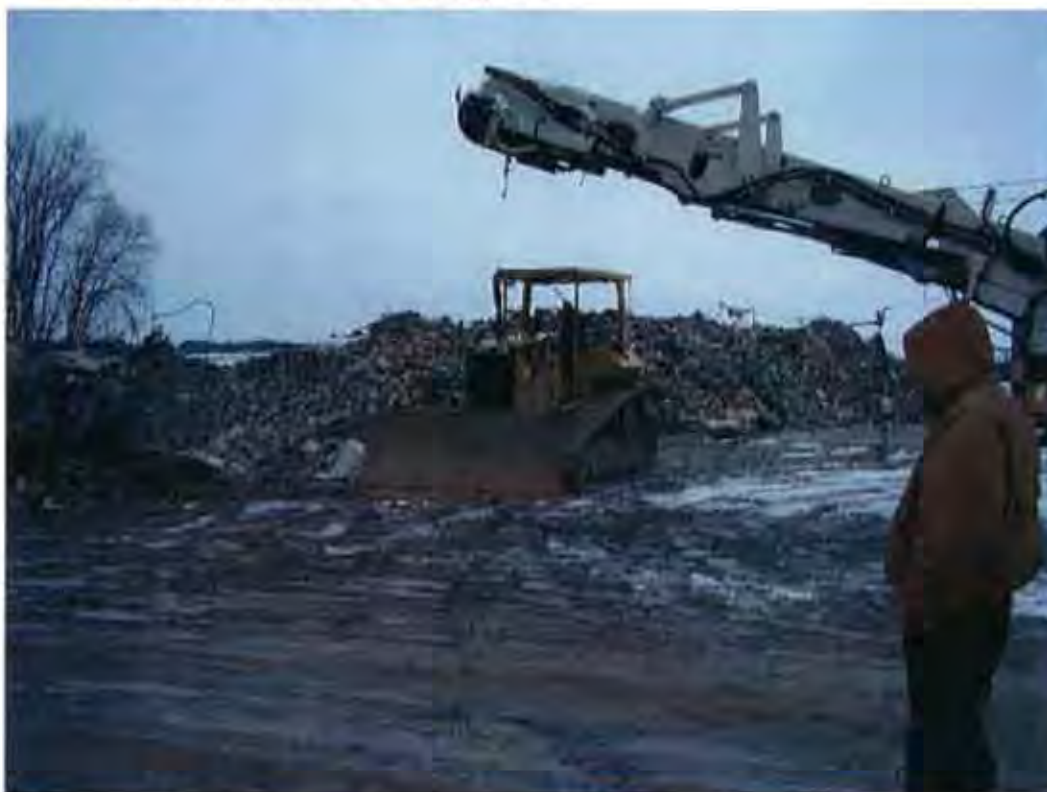
**Date:** February 7, 2008  
**Time:** 10:16 AM  
**Direction:** W  
**Photo by:** Eisenbrandt  
**Exposure #:** 009  
**Comments:** Piles of demolition debris Mr. Fisher called aggregate.

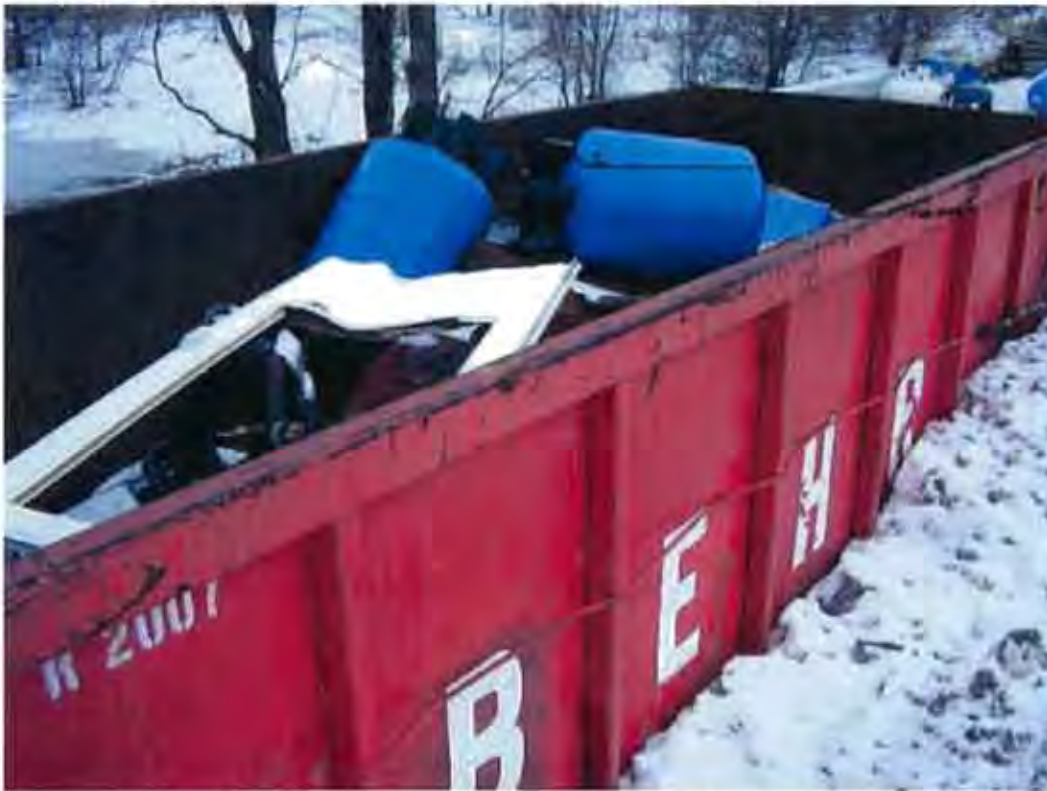
**Date:** February 7, 2008  
**Time:** 10:17AM  
**Direction:** SW  
**Photo by:** Eisenbrandt  
**Exposure #:** 010  
**Comments:** BEHR Recycling dumpster.

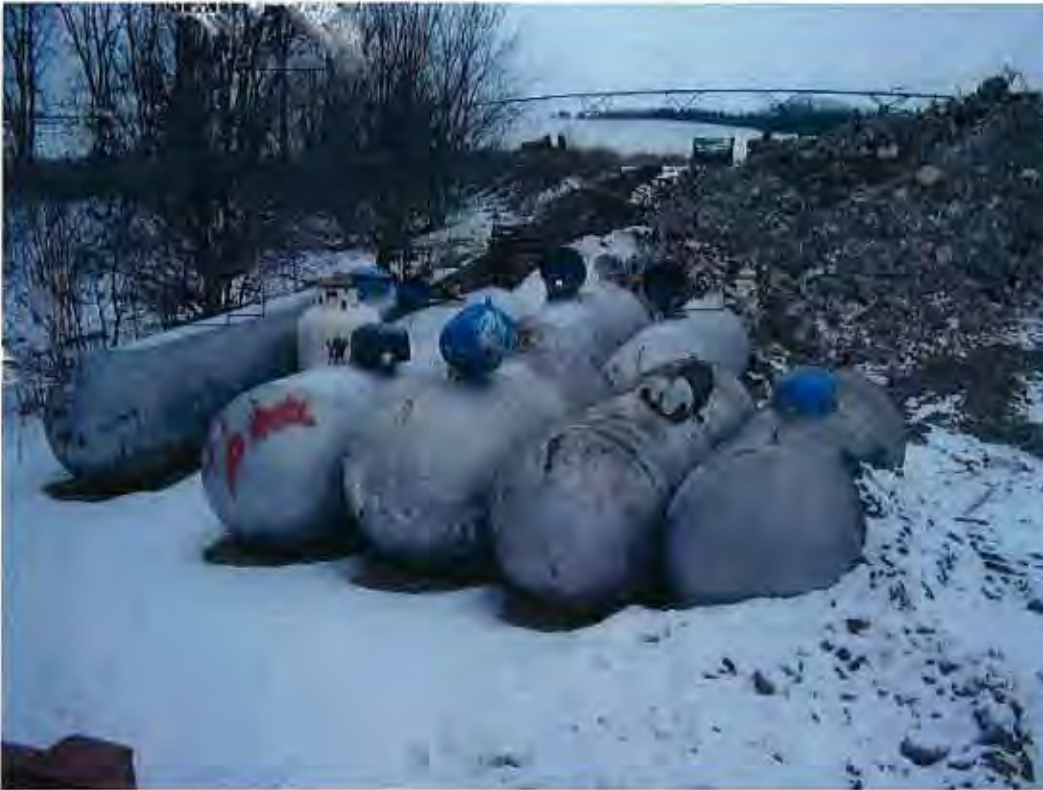
Photograph 011 shows eight large and two smaller propane tanks observed on the south side of the demolition debris. The planned use or disposal of the tanks was not discussed with Mr. Fisher.

**Date:** February 7, 2008  
**Time:** 10:18 AM  
**Direction:** W  
**Photo by:** Eisenbrandt  
**Exposure #:** 011  
**Comments:** Eight large and two smaller propane tanks observed on the south side of the facility.

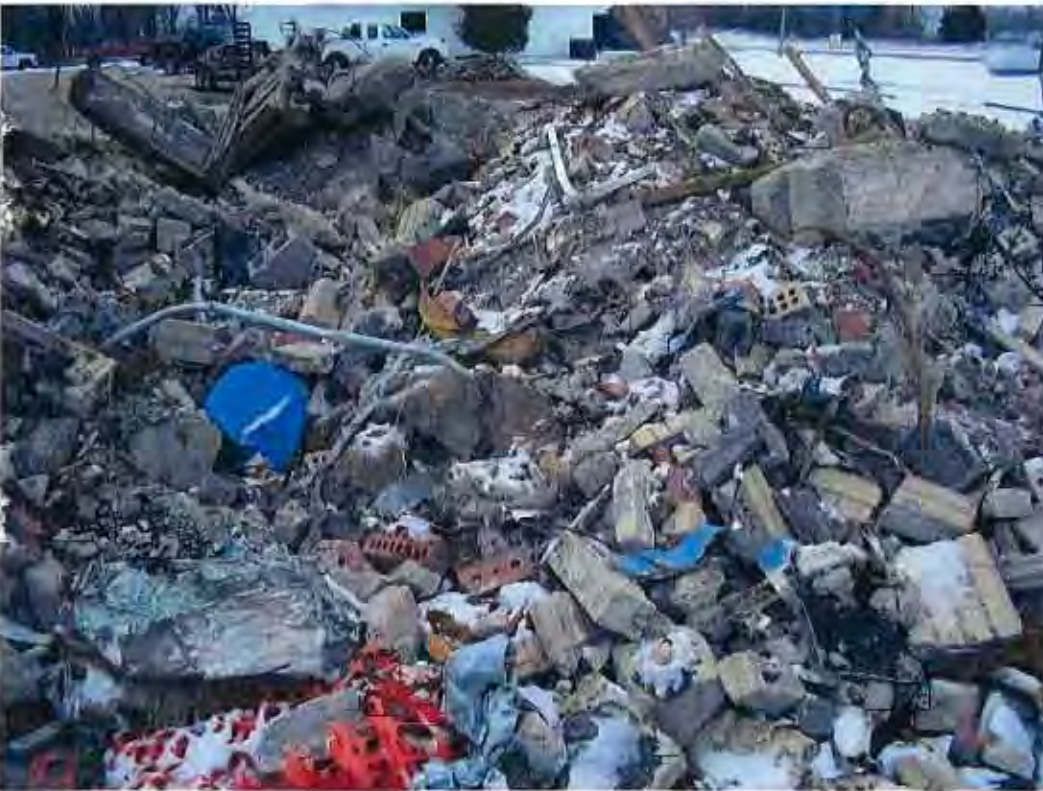
Photographs 012, 013, 014, and 015 show part of the massive demolition debris pile. There are likely more than 200 cubic yards of demolition debris on site that were not present during the July 24, 2007 inspection. Chunks of concrete, broken brick, orange safety fencing, cast iron and galvanized plumbing pipes, electrical conduits, electrical wiring, splinted dimensional lumber, scrap metal, smashed electrical components, fragmented porcelain plumbing fixtures, metal drywall corner bead, linoleum flooring, plastic, burlap, asphalt sheeting, and doorknobs, were among the observed demolition debris. Green and beige painted brick was also observed intermixed in the demolition debris waste pile.

**Date:** February 7, 2008  
**Time:** 10:20 AM  
**Direction:** NE  
**Photo by:** Eisenbrandt  
**Exposure #:** 012  
**Comments:** Demolition debris that includes concrete, brick, orange safety fencing, plumbing pipes, electric conduits, electric wiring, plastic, rebar, scrap metal, and splintered dimensional lumber.

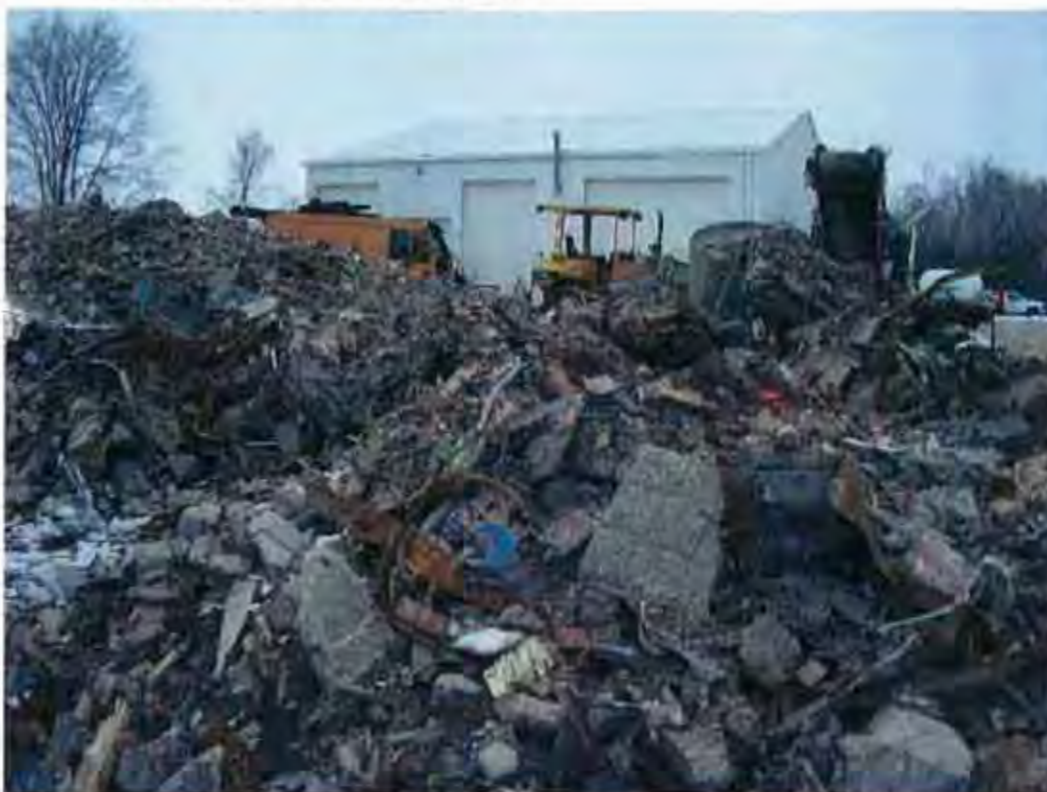
**Date:** February 7, 2008  
**Time:** 10:20 AM  
**Direction:** N  
**Photo by:** Eisenbrandt  
**Exposure #:** 013  
**Comments:** Demolition debris including broken concrete and brick, scrap metal, crushed electrical components, fragments of porcelain, metal drywall corner bead, and cast iron waste pipe were observed.

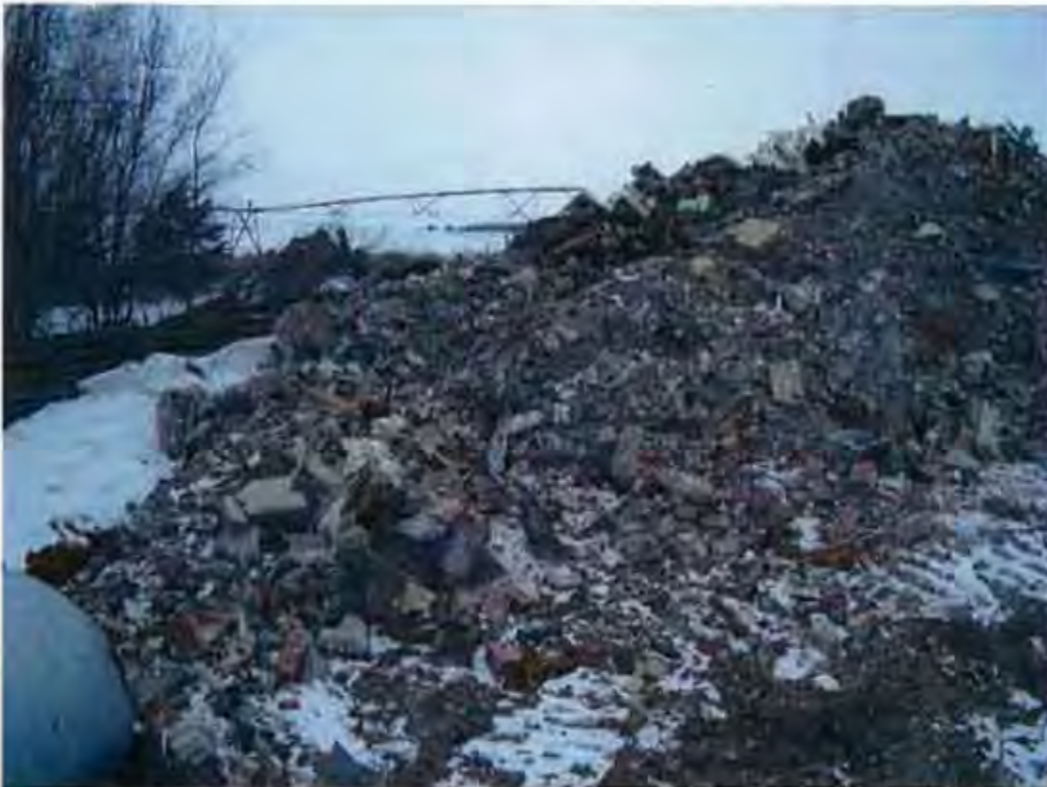
**Date:** February 7, 2008  
**Time:** 10:20 AM  
**Direction:** NW  
**Photo by:** Eisenbrandt  
**Exposure #:** 014  
**Comments:** Concrete, brick, scrap metal linoleum flooring, burlap, asphalt sheeting, and door knobs were observed among the demolition debris.

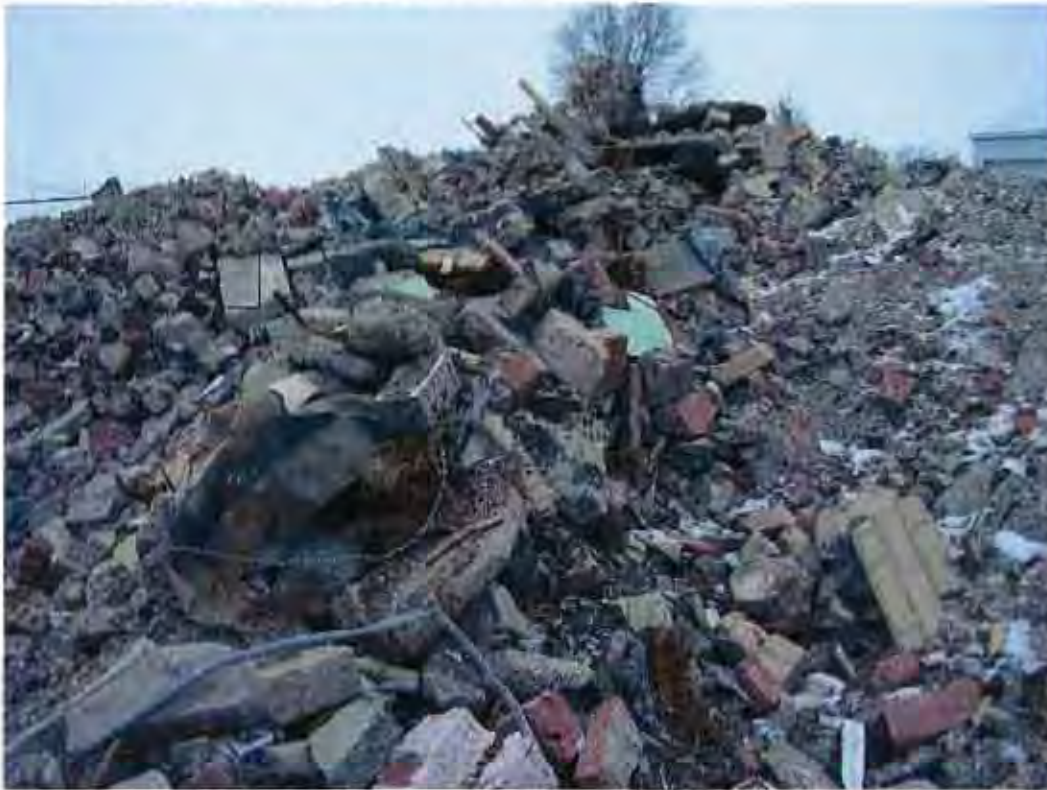
**Date:** February 7, 2008  
**Time:** 10:22 AM  
**Direction:** NW  
**Photo by:** Eisenbrandt  
**Exposure #:** 015  
**Comments:** Green painted brick, lumber, concrete, and scrap metal were observed among the demolition debris

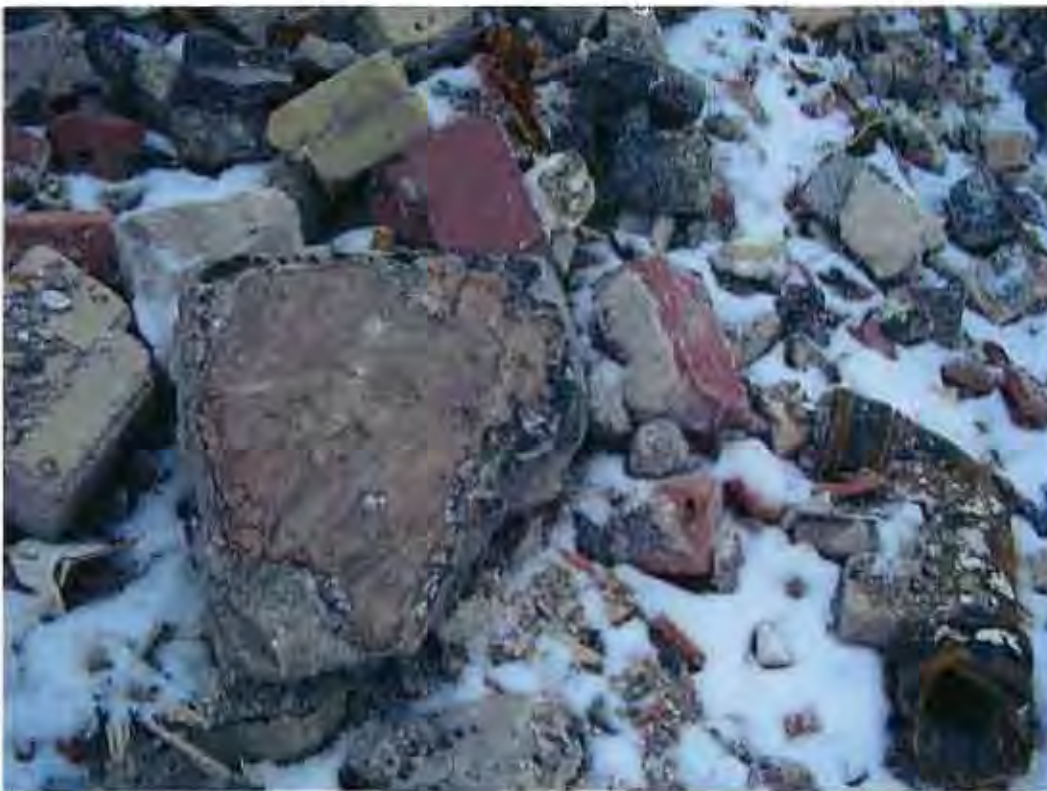
Photograph 016 shows broken brick, cast iron waste pipe, rusty scrap metal, and a large chunk of concrete with a black tar like adhesive and brown coating on the flat floor-like surface.

**Date:** February 7, 2008  
**Time:** 10:27 AM  
**Direction:** NW  
**Photo by:** Eisenbrandt  
**Exposure #:** 016  
**Comments:** Broken brick, cast iron waste pipe, and concrete debris. The large chunk of concrete had a black tar like adhesive and a brown coating on the flat floor like surface.

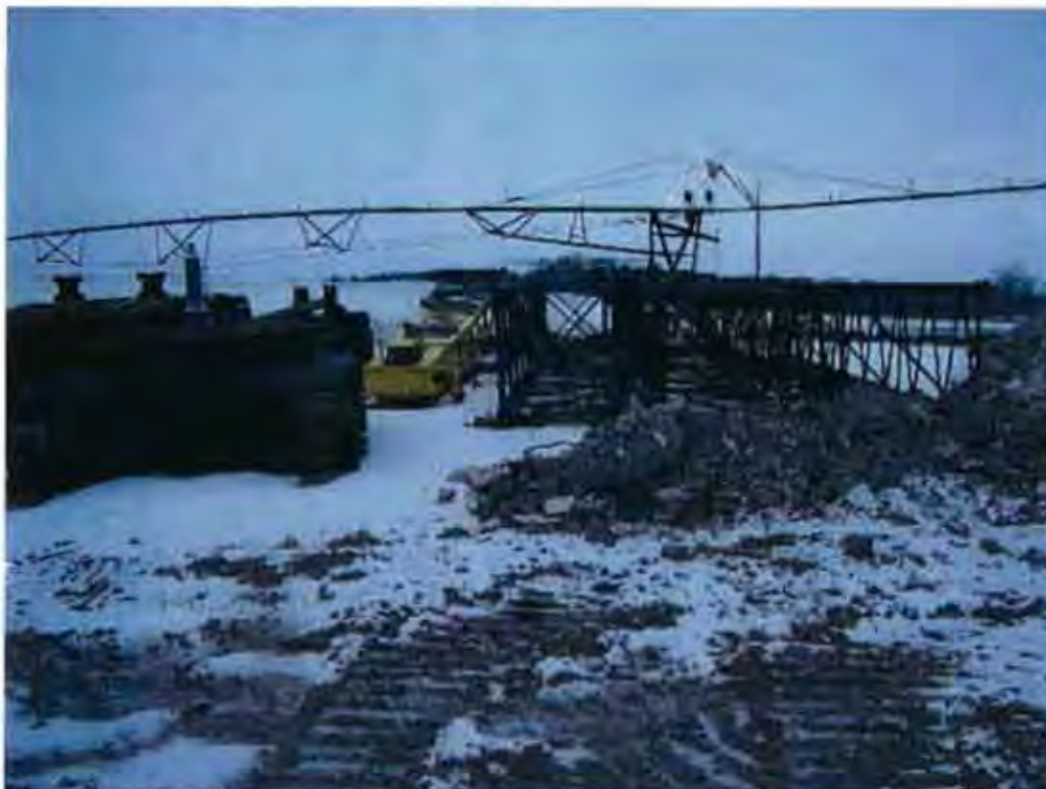
**Date:** February 7, 2008  
**Time:** 10:28 AM  
**Direction:** NW  
**Photo by:** Eisenbrandt  
**Exposure #:** 017  
**Comments:** Crane equipment stored in the southwest corner of the facility.

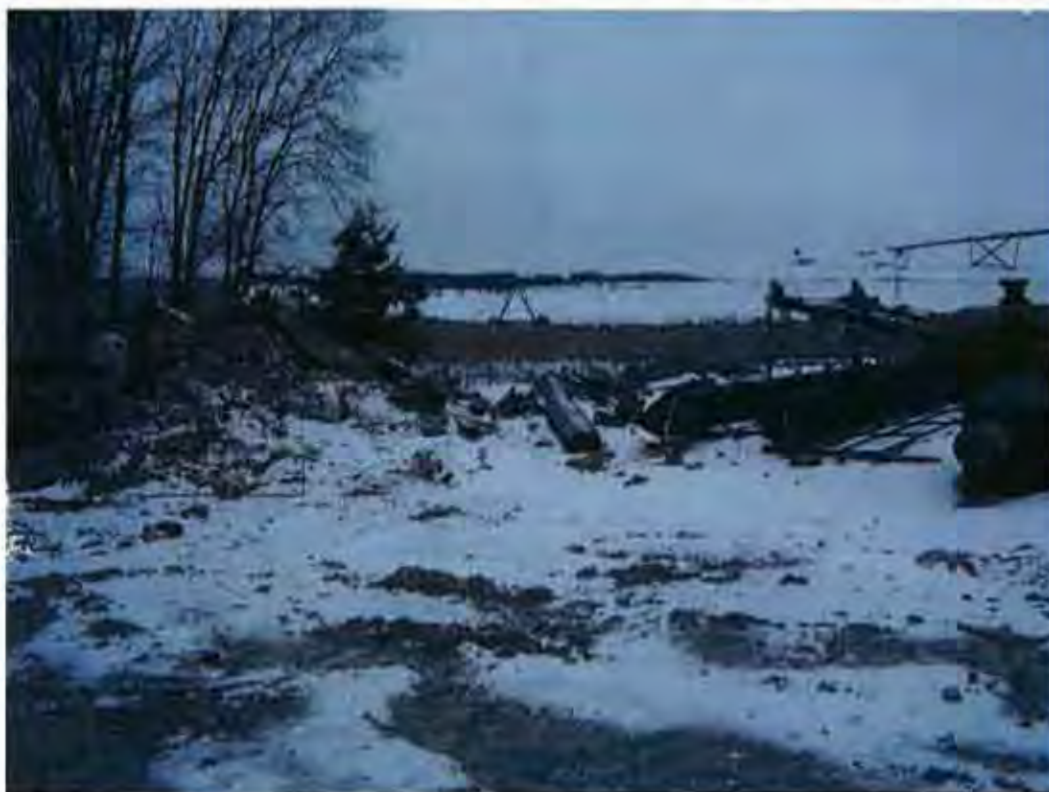
**Date:** February 7, 2008  
**Time:** 10:28 AM  
**Direction:** W  
**Photo by:** Eisenbrandt  
**Exposure #:** 018  
**Comments:** Timbers, rock, concrete, dirt, and landscape waste located in the south west corner of the facility.

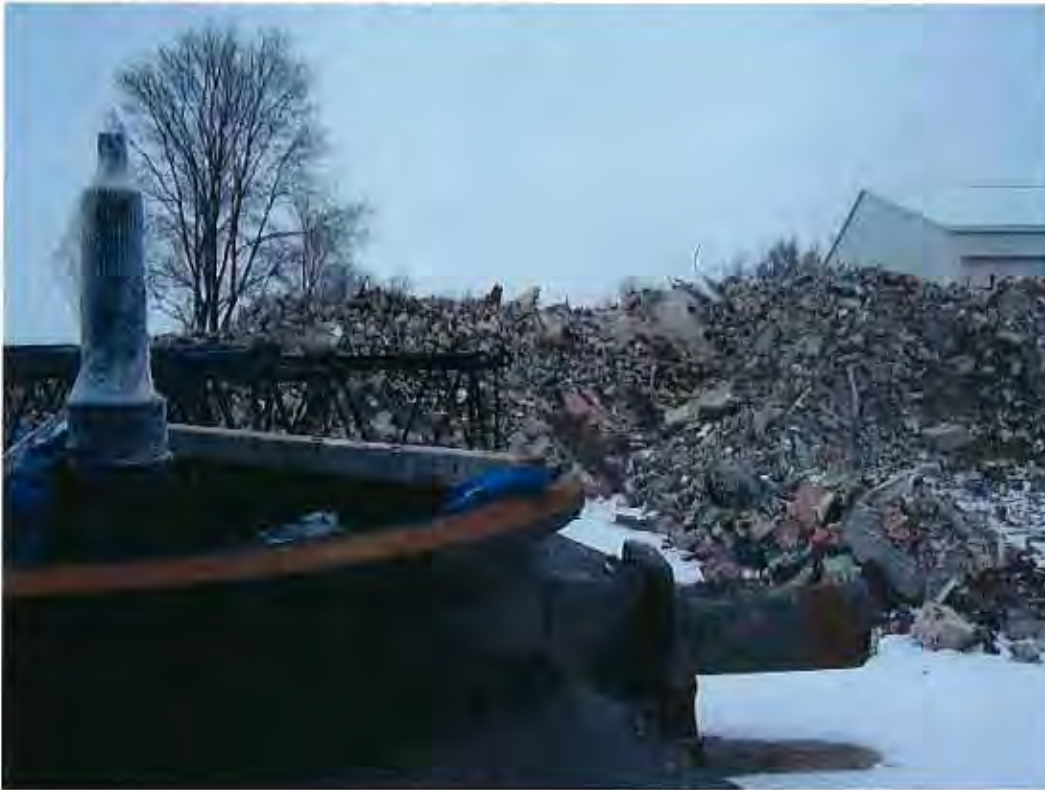
**Date:** February 7, 2008  
**Time:** 10:28 AM  
**Direction:** NE  
**Photo by:** Eisenbrandt  
**Exposure #:** 019  
**Comments:** Demolition equipment in foreground and piles of demolition debris in background of photograph.

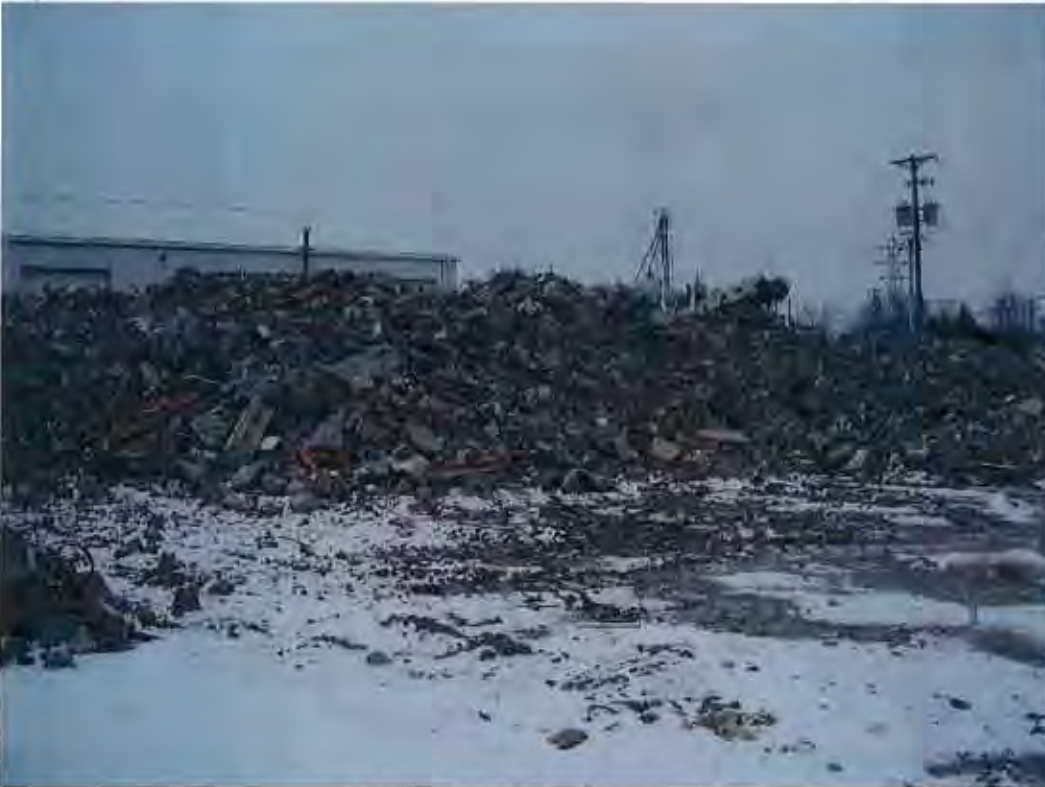
**Date:** February 7, 2008  
**Time:** 10:28 AM  
**Direction:** NE  
**Photo by:** Eisenbrandt  
**Exposure #:** 020  
**Comments:** Demolition debris.

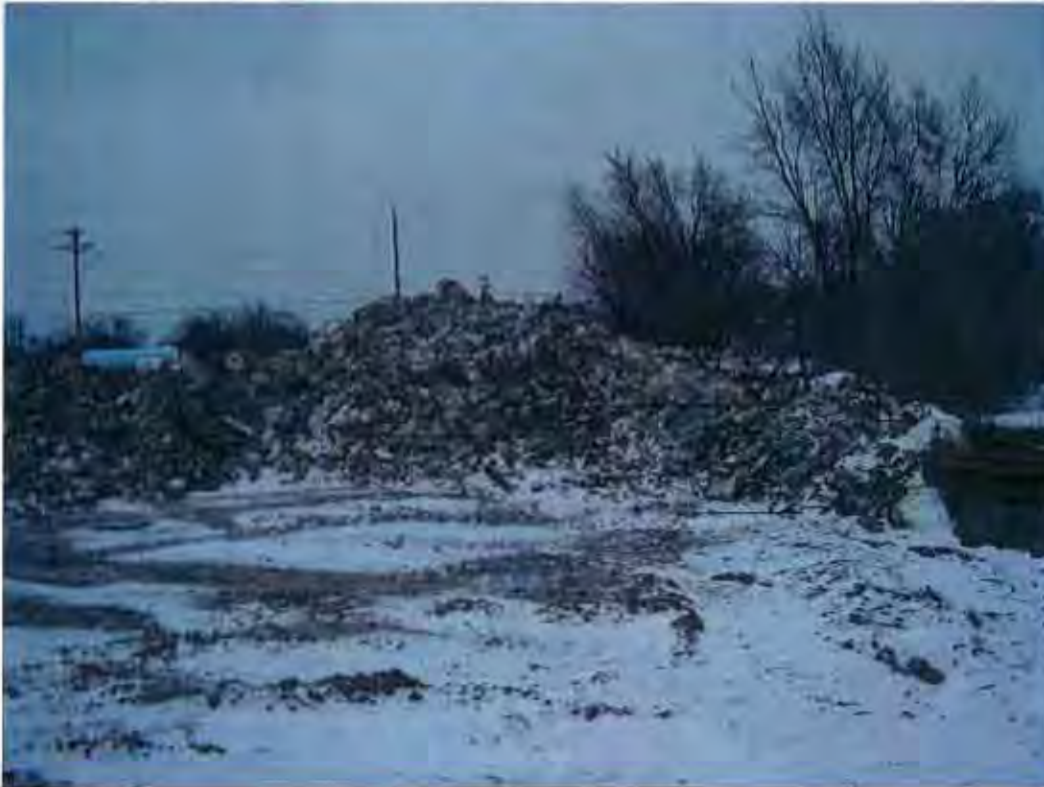
**Date:** February 7, 2008  
**Time:** 10:28 AM  
**Direction:** SE  
**Photo by:** Eisenbrandt  
**Exposure #:** 021  
**Comments:** Demolition debris.

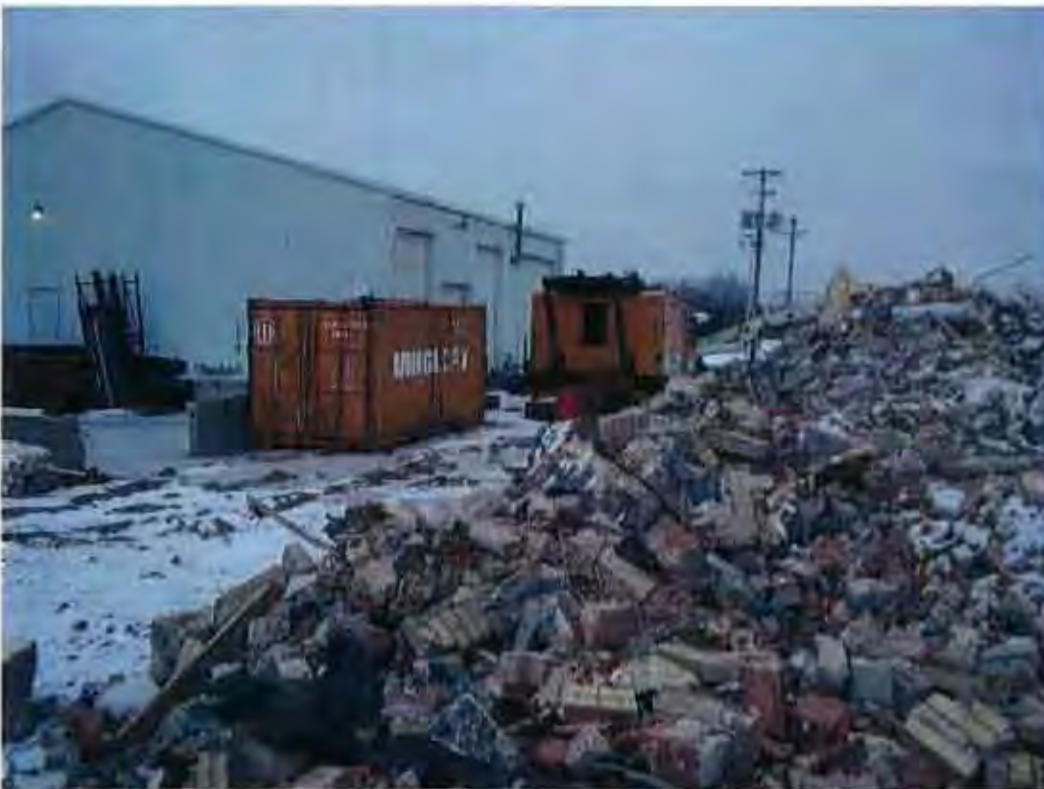
**Date:** February 7, 2008  
**Time:** 10:31 AM  
**Direction:** E  
**Photo by:** Eisenbrandt  
**Exposure #:** 022  
**Comments:** Demolition debris.

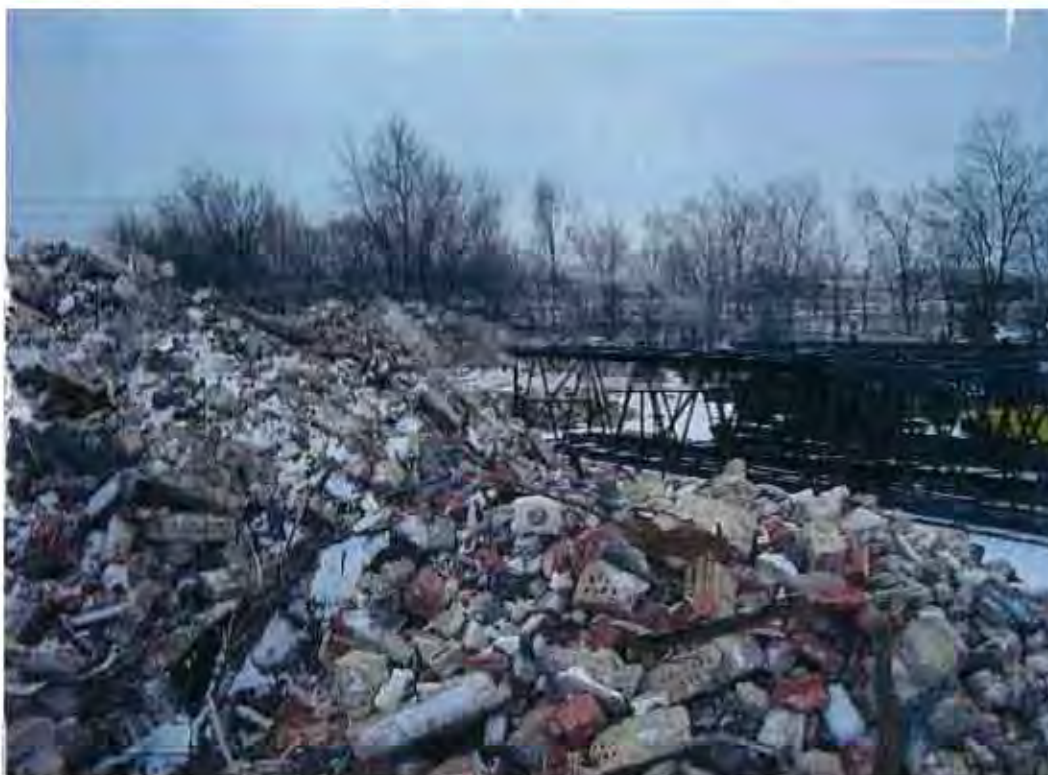
**Date:** February 7, 2008  
**Time:** 10:31 AM  
**Direction:** S  
**Photo by:** Eisenbrandt  
**Exposure #:** 023  
**Comments:** Alternate view of demolition debris.

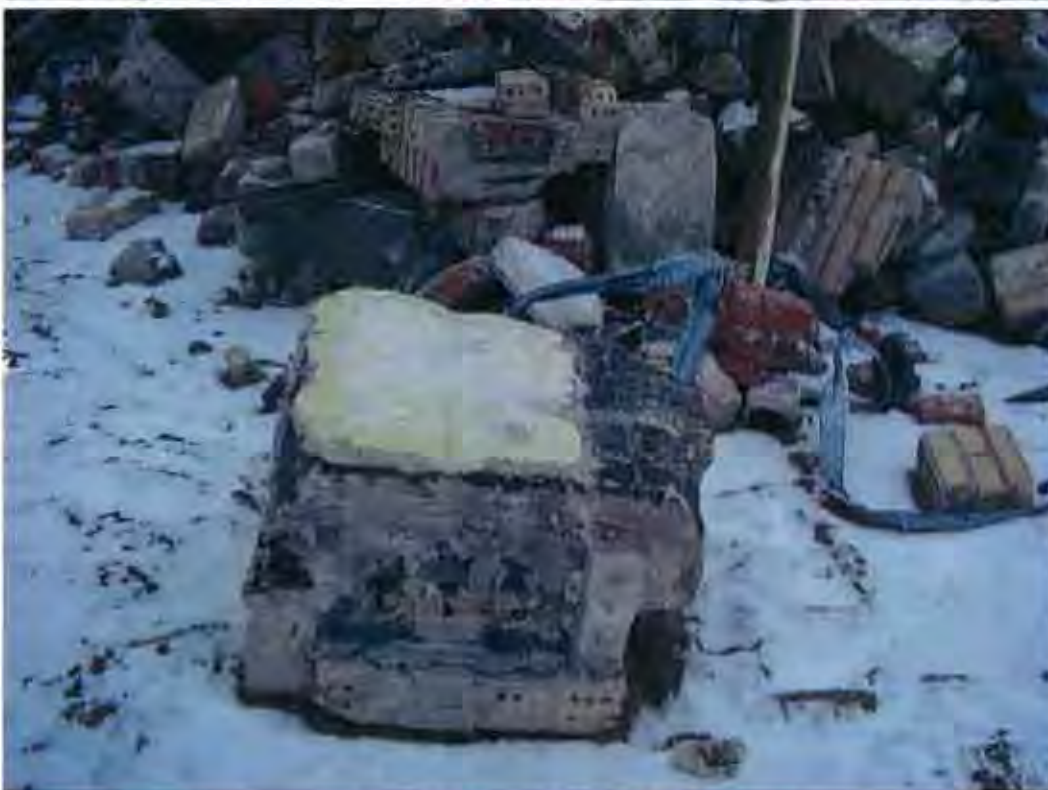
**Date:** February 7, 2008  
**Time:** 10:31 AM  
**Direction:** S  
**Photo by:** Eisenbrandt  
**Exposure #:** 024  
**Comments:** Material adhered on side of concrete and brick block.

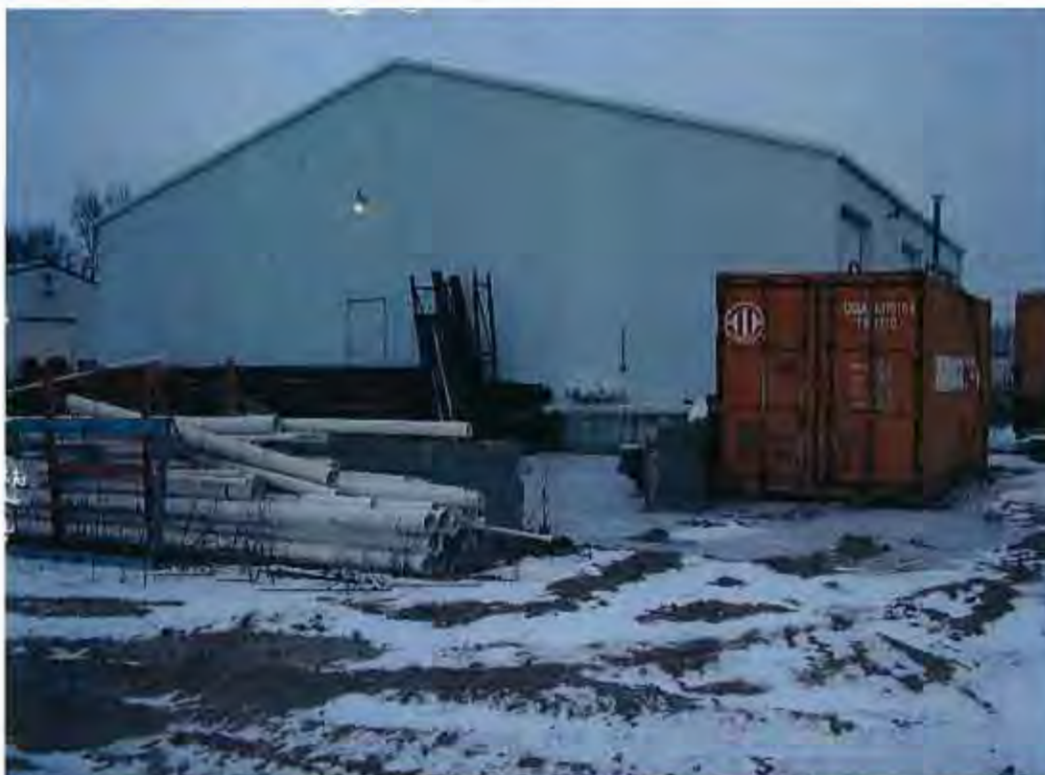
**Date:** February 7, 2008  
**Time:** 10:32 AM  
**Direction:** E  
**Photo by:** Eisenbrandt  
**Exposure #:** 025  
**Comments:** Material and equipment storage on the northwest side of the maintenance garage.
