ILLINOIS ENVIRONMENTAL PROTECTION AGENCY

Re: Illinois Environmental Protection Agency v. Edward W. Fisher & Rhonda L. Fisher and  
DEM/EX Group, Inc.  
IEPA File No. 29-08-AC; 1250305011—Mason County

BEFORE THE ILLINOIS POLLUTION CONTROL BOARD  
ADMINISTRATIVE CITATION

February 7, 2008 Inspection

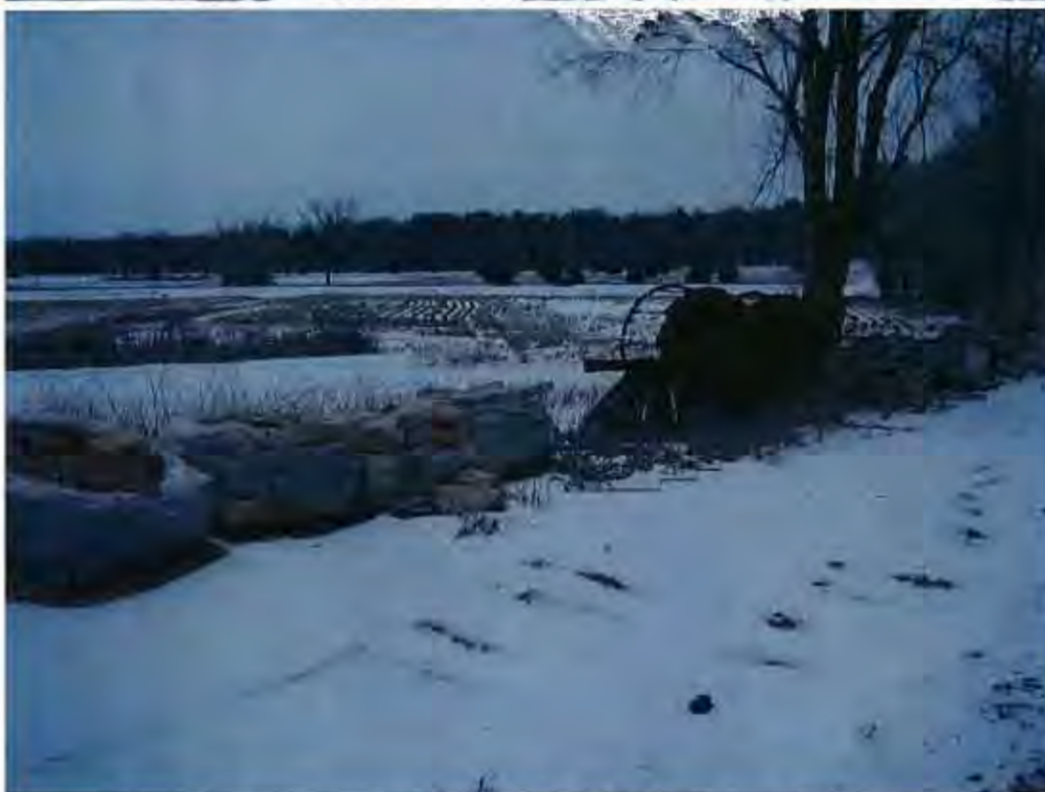
**Date:** February 7, 2008  
**Time:** 10:32 AM  
**Direction:** NW  
**Photo by:** Eisenbrandt  
**Exposure #:** 026  
**Comments:** Neatly stacked pallets of rock and building materials along western property boundary.

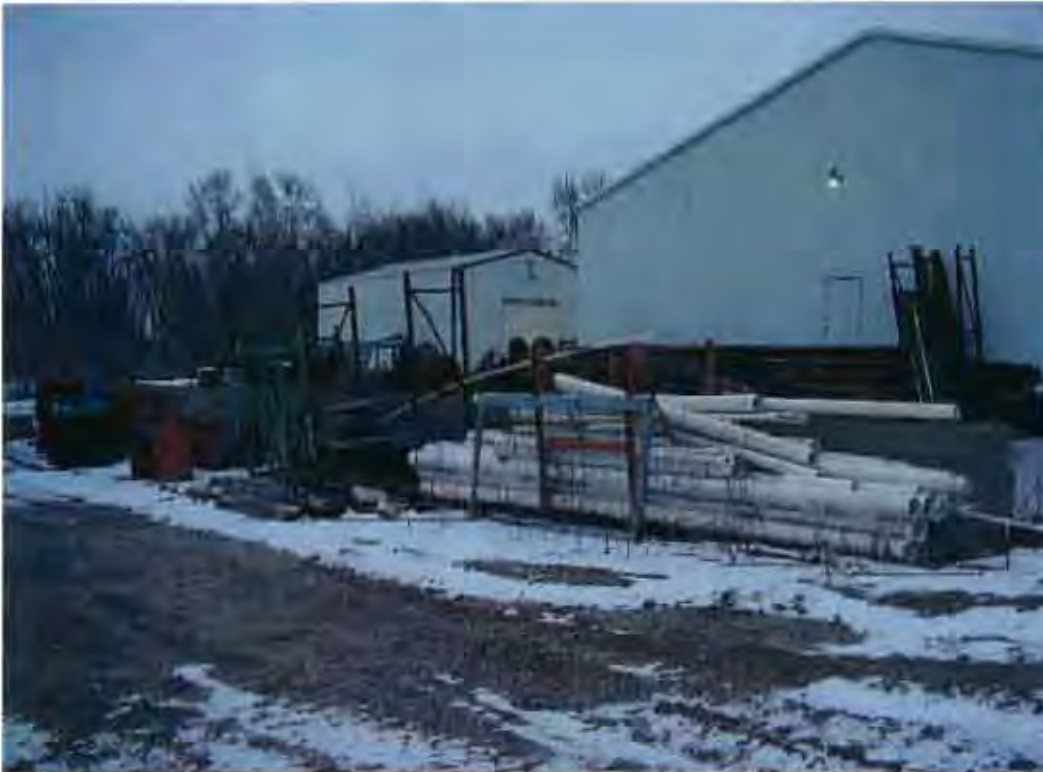
**Date:** February 7, 2008  
**Time:** 10:32 AM  
**Direction:** NE  
**Photo by:** Eisenbrandt  
**Exposure #:** 027  
**Comments:** Material and equipment storage on the northwest side of the maintenance garage.

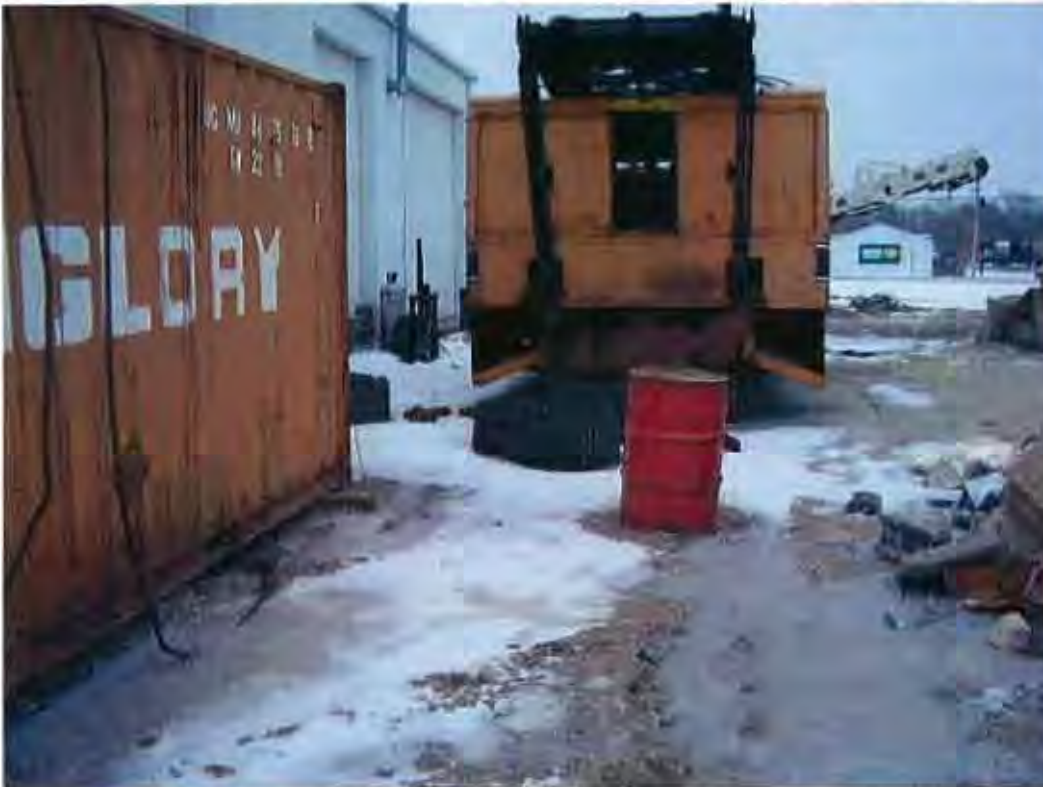
**Date:** February 7, 2008  
**Time:** 10:33 AM  
**Direction:** SE  
**Photo by:** Eisenbrandt  
**Exposure #:** 028  
**Comments:** A red 55-gallon drum located south of the concrete containment area.

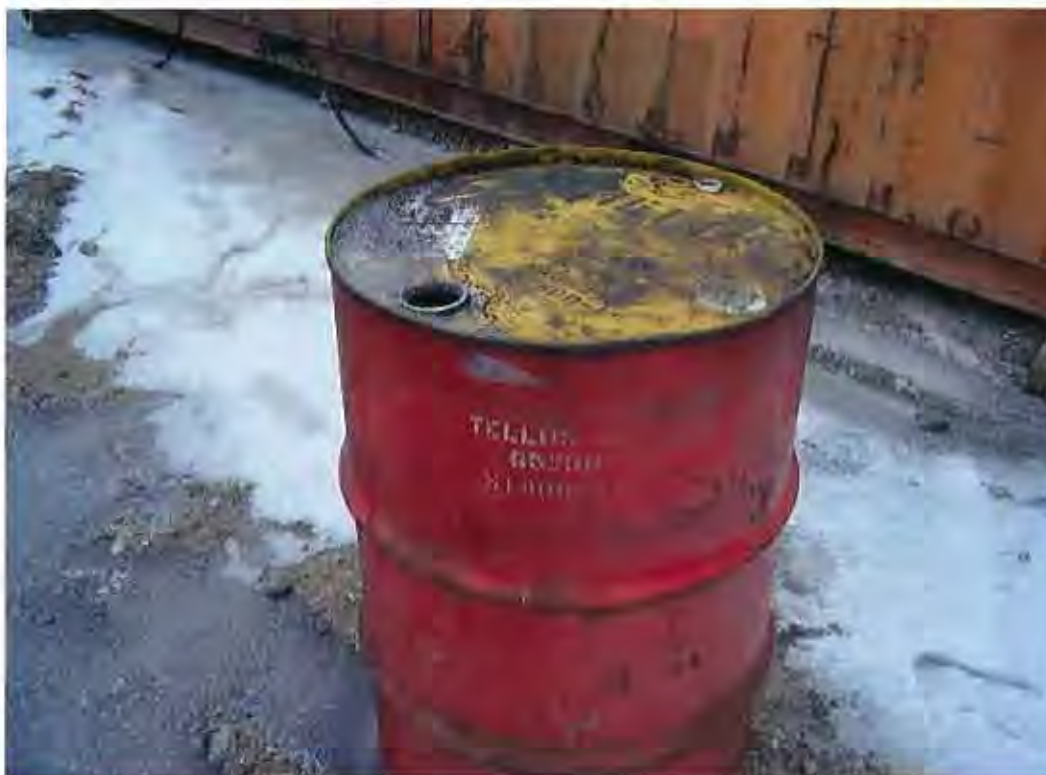
**Date:** February 7, 2008  
**Time:** 10:33 AM  
**Direction:** N  
**Photo by:** Eisenbrandt  
**Exposure #:** 029  
**Comments:** The drum was open allowing precipitation to enter. The drum was 1/2 full of an oily looking substance.

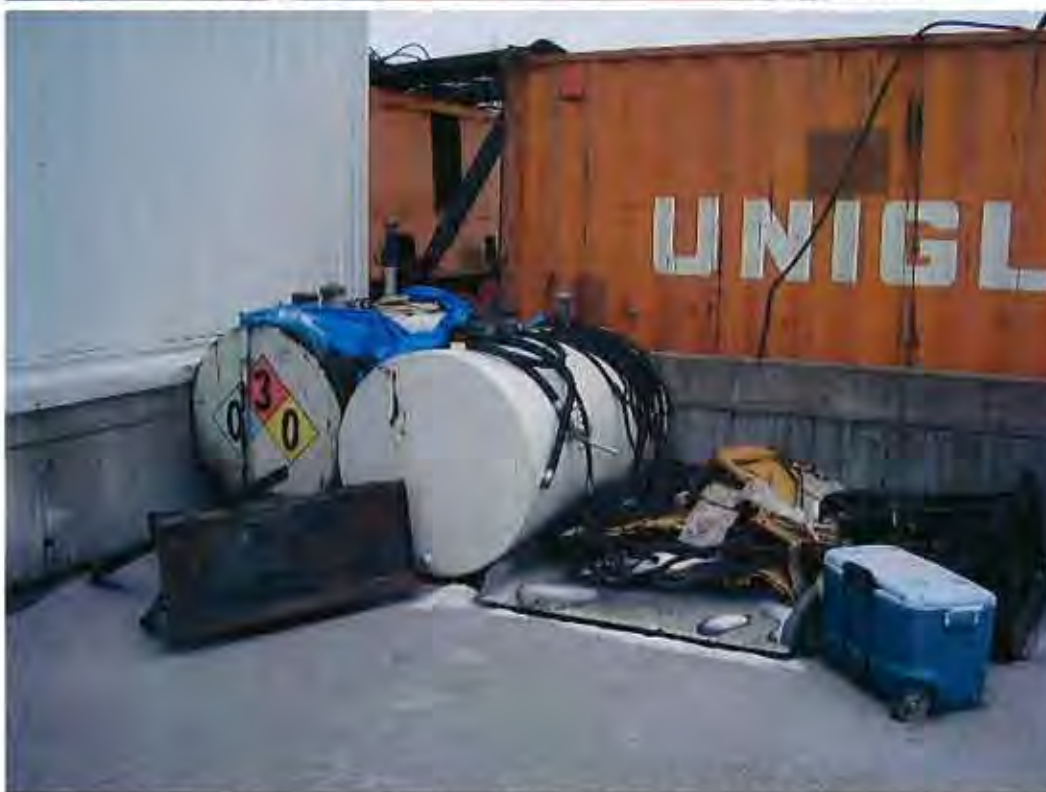
**Date:** February 7, 2008  
**Time:** 10:35 AM  
**Direction:** SE  
**Photo by:** Eisenbrandt  
**Exposure #:** 030  
**Comments:** Empty storage tanks in the southeast corner of the concrete containment area.

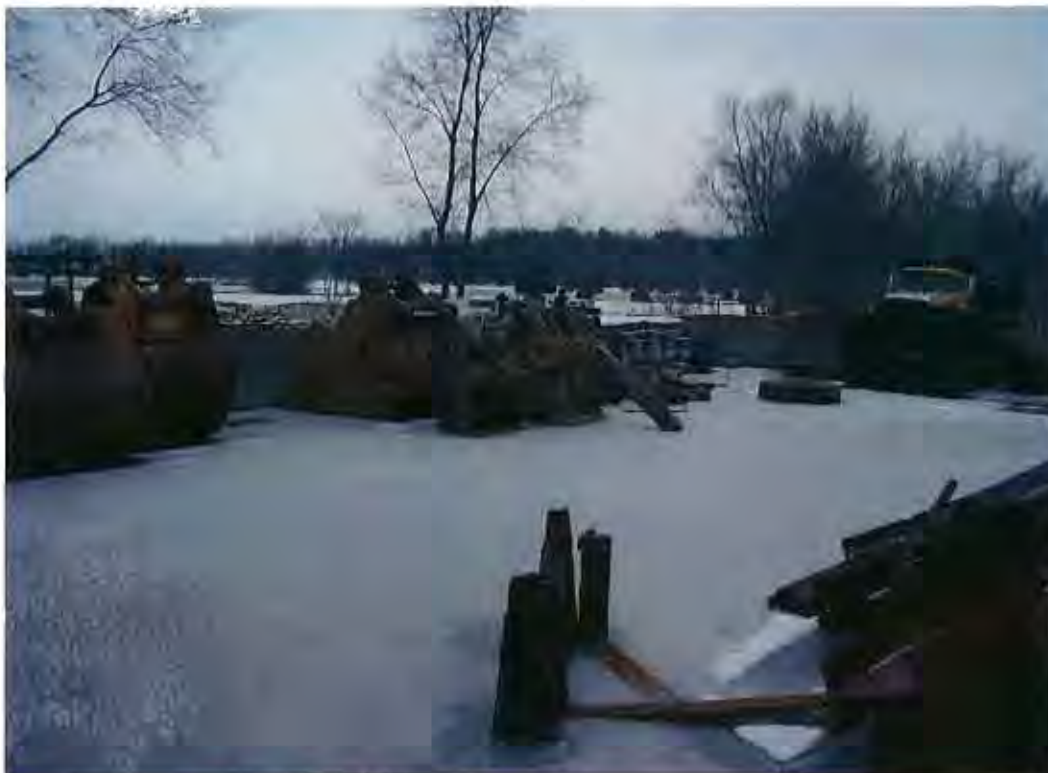
Photograph 031 shows equipment and material storage within the concrete containment area. The concrete deck was covered with one inch thick ice over water. The oil drums previously observed within this area have been moved. Due to the ice and water, it could not be determined if the spilled oil (approximately 15 ft by 25 ft spill observed in July) had been cleaned up.

**Date:** February 7, 2008  
**Time:** 10:35 AM  
**Direction:** NW  
**Photo by:** Eisenbrandt  
**Exposure #:** 031  
**Comments:** Equipment and material storage in the concrete containment area.

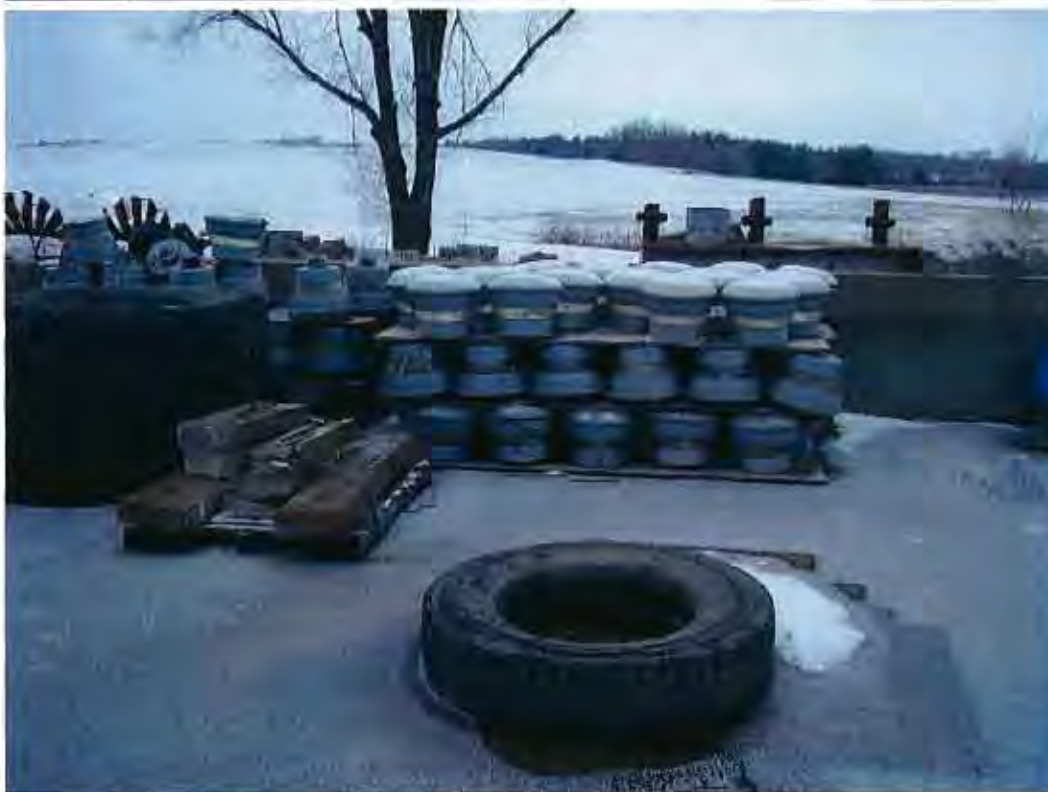
Photograph 032 shows an improperly stored off rim used tire. Used tires must be stored inside or neatly stacked and covered to prevent water accumulation and proliferation of water born insects. The photograph also shows the high pressure sodium industrial lights have been neatly stacked within the concrete containment area. Mr. Fisher claimed a building would be constructed over the concrete containment area and the industrial lights would be used for the building.

**Date:** February 7, 2008  
**Time:** 10:35 AM  
**Direction:** W  
**Photo by:** Eisenbrandt  
**Exposure #:** 032  
**Comments:** A used off-rim truck tire and neatly stacked high pressure sodium industrial lights within the concrete containment area.

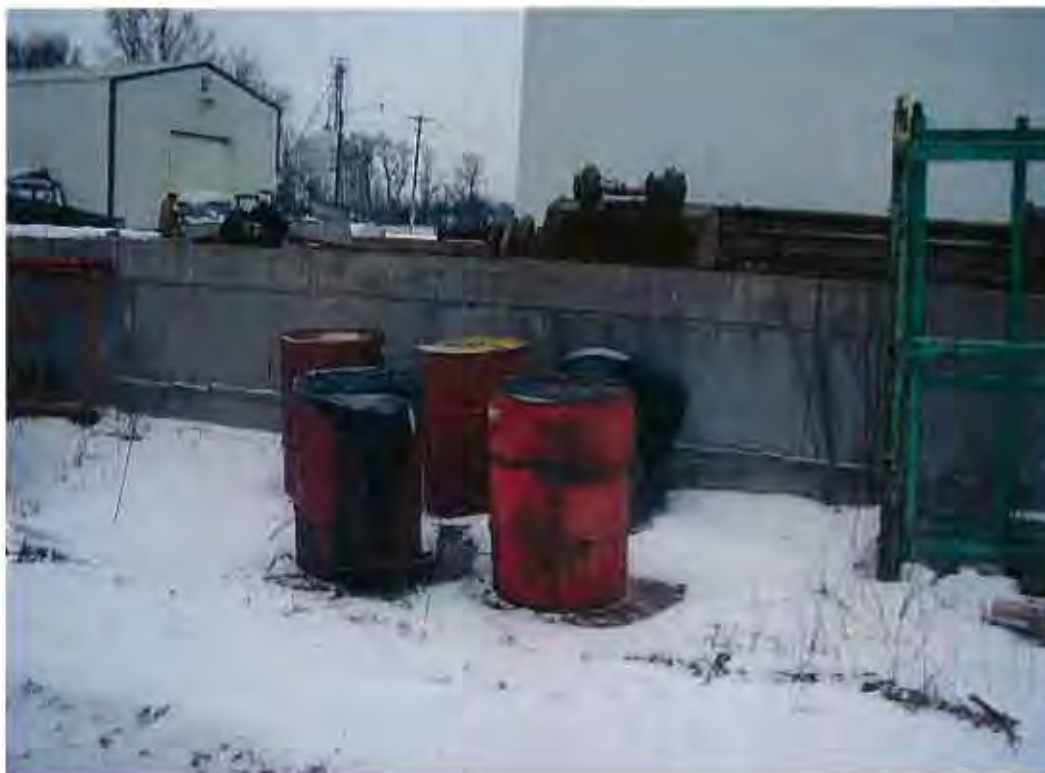
Photograph 033 shows five 55-gallon drums resting on the ground west of the concrete containment area. Initially Mr. Fisher stated the drums were empty. The inspector found two drums to contain fluid. Mr. Fisher stated they were used oil and not properly marked. Mr. Fisher immediately called someone and began asking that person why they were not labeled. The empty black drum was observed tipped up against the concrete wall. The black drum and one of the red drums had make-shift covers out of wrapped black plastic. The nearest drum in the photograph was empty and slightly crushed. One of the drums containing used oil was also not capped allowing precipitation to enter the drum. None of the drums were labeled "Used Oil." All containers of used oil must be labeled with the words "Used Oil."

**Date:** February 7, 2008  
**Time:** 10:36 AM  
**Direction:** E  
**Photo by:** Eisenbrandt  
**Exposure #:** 033  
**Comments:** Five 55-gallon drums resting on the ground west of the concrete containment area. Two of the drums contained used oil and were not properly marked. The empty black drum was tipped against the concrete wall. One of the drums was open allowing precipitation to enter.

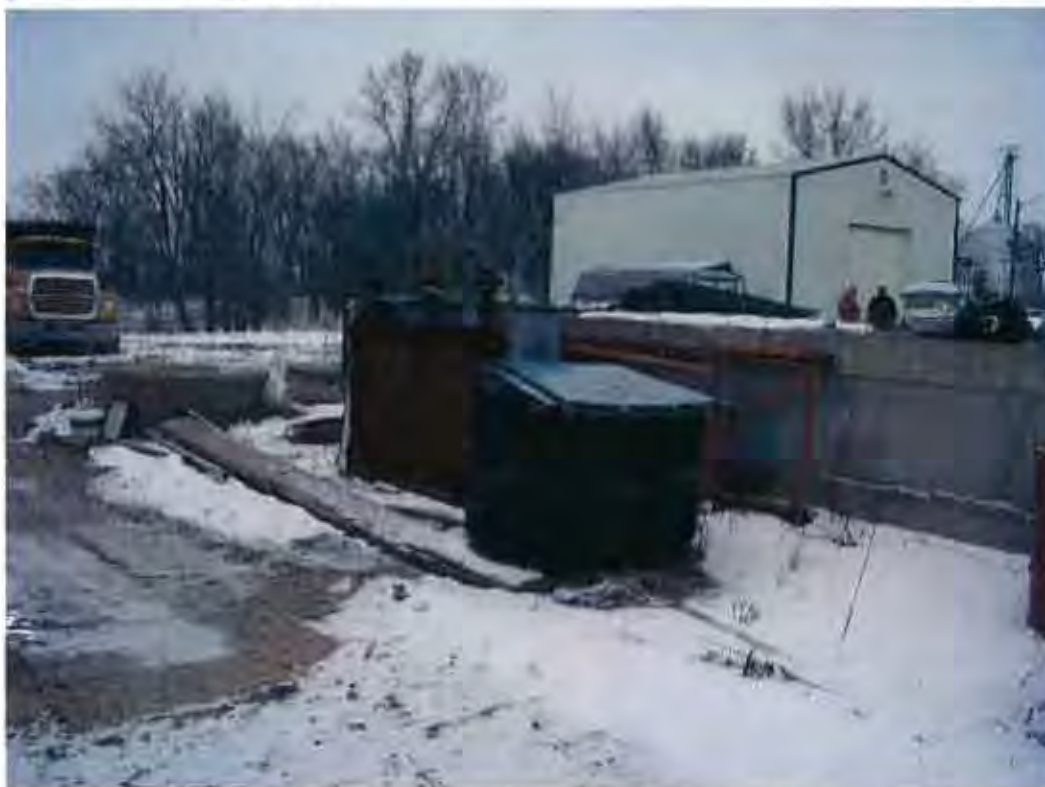
**Date:** February 7, 2008  
**Time:** 10:36 AM  
**Direction:** NE  
**Photo by:** Eisenbrandt  
**Exposure #:** 034  
**Comments:** Two truck tires that Mr. Fisher claimed were useable.

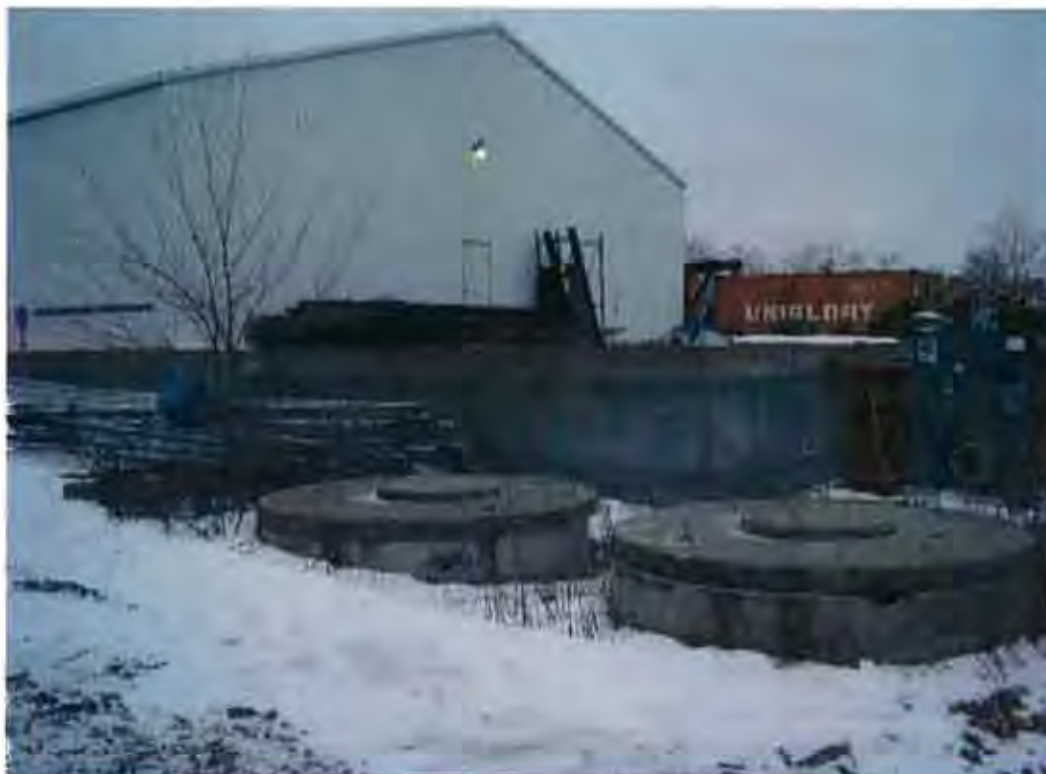
**Date:** February 7, 2008  
**Time:** 10:41 AM  
**Direction:** SE  
**Photo by:** Eisenbrandt  
**Exposure #:** 035  
**Comments:** Pipe storage and two concrete collection tanks outside the north wall of the containment area.

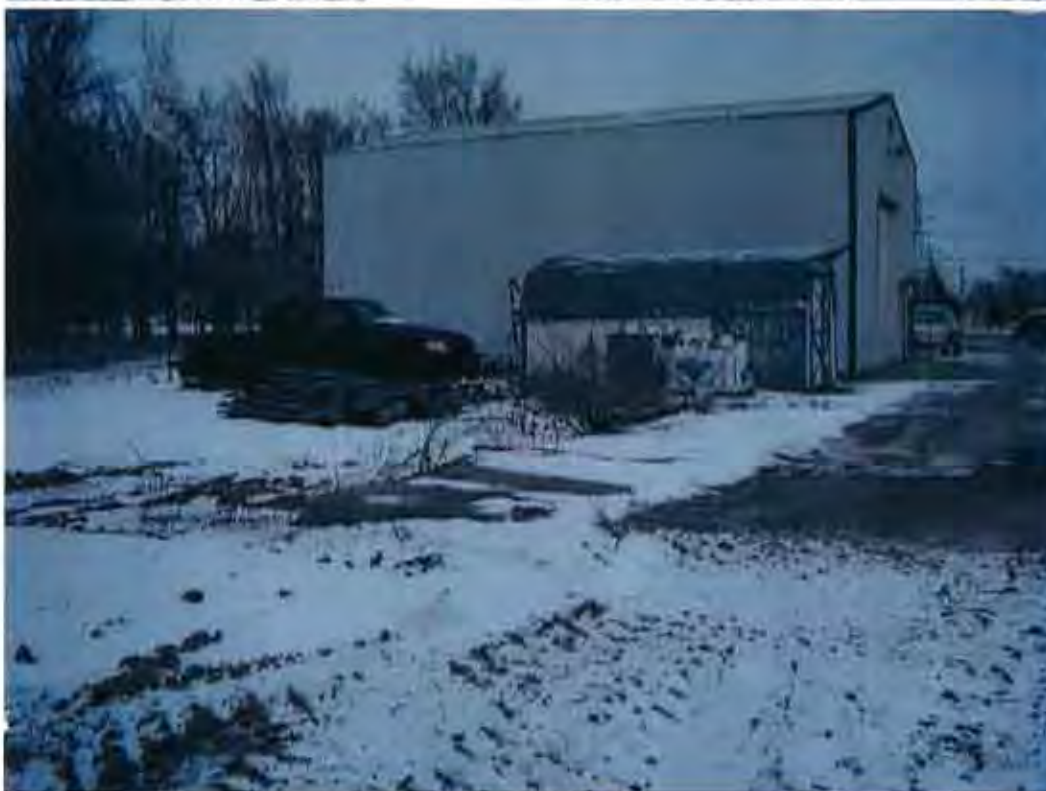
Photograph 036 shows the western side of the building rented by Ferrellgas. The inoperable black Ford F150 pickup was still observed behind the building. The two 55-gallon drums and the steel tank used for open during have been removed since the July 24, 2007 inspection. The open dumped weathered countertop has been cleaned up. No charred waste was observed during this second inspection.

**Date:** February 7, 2008  
**Time:** 10:41 AM  
**Direction:** E  
**Photo by:** Eisenbrandt  
**Exposure #:** 036  
**Comments:** The two 55-gallon drums and the steel tank used for open burning have been removed since the July 2007 inspection. The inoperable black Ford pick remains west of the Ferrellgas building.

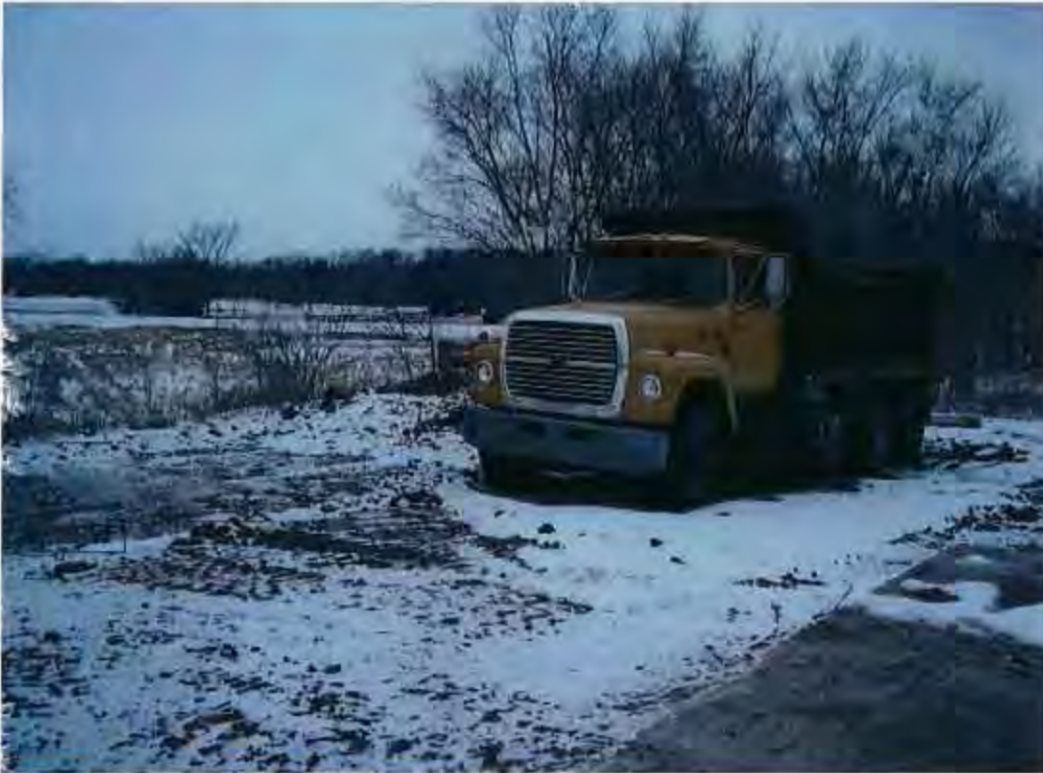
Photograph 037 shows a yellow and black dump truck located in the northeast corner of the facility. It appears as if the vehicle is in operational condition. During the July inspection a partially buried used tire was observed northwest of the containment area. Snow cover prevented the inspector from finding the location.

**Date:** February 7, 2008  
**Time:** 10:41 AM  
**Direction:** NW  
**Photo by:** Eisenbrandt  
**Exposure #:** 037  
**Comments:** Yellow and black Ford dump truck located in the northwest corner of the facility.

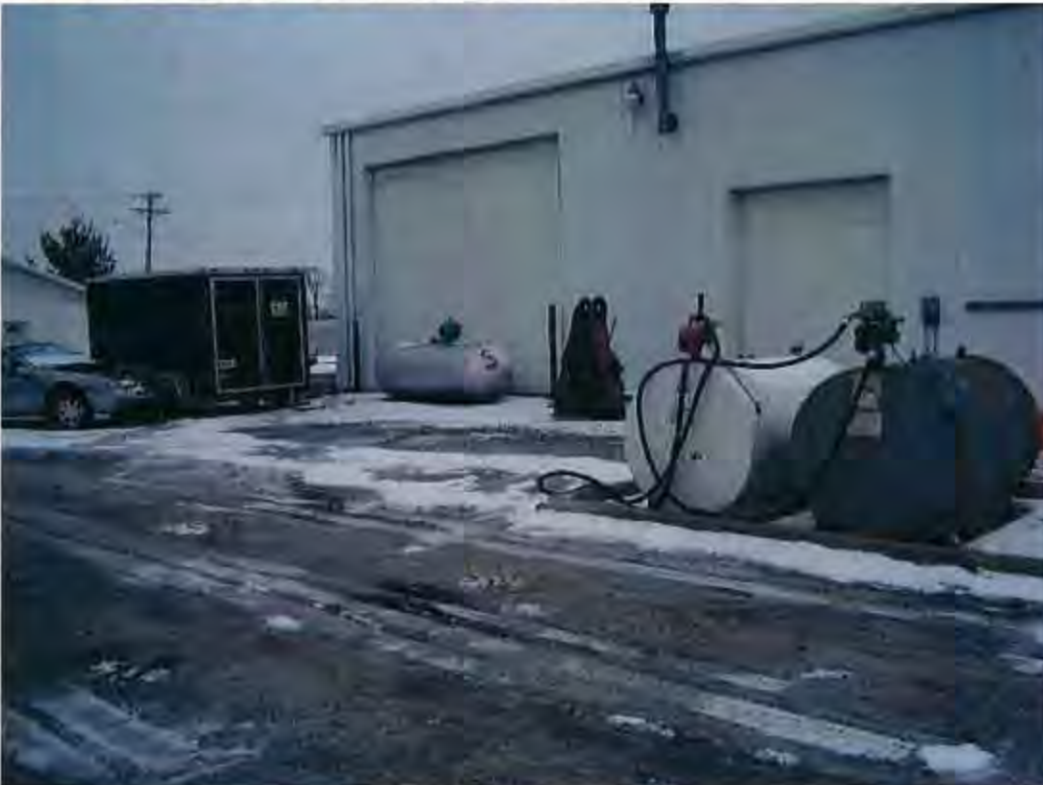
Photograph 038 shows two operational above ground storage tanks on the northeast side of the maintenance garage. No spilled fluids were observed.

**Date:** February 7, 2008  
**Time:** 10:42 AM  
**Direction:** SE  
**Photo by:** Eisenbrandt  
**Exposure #:** 038  
**Comments:** Operational storage tanks on the north east side of the maintenance garage.

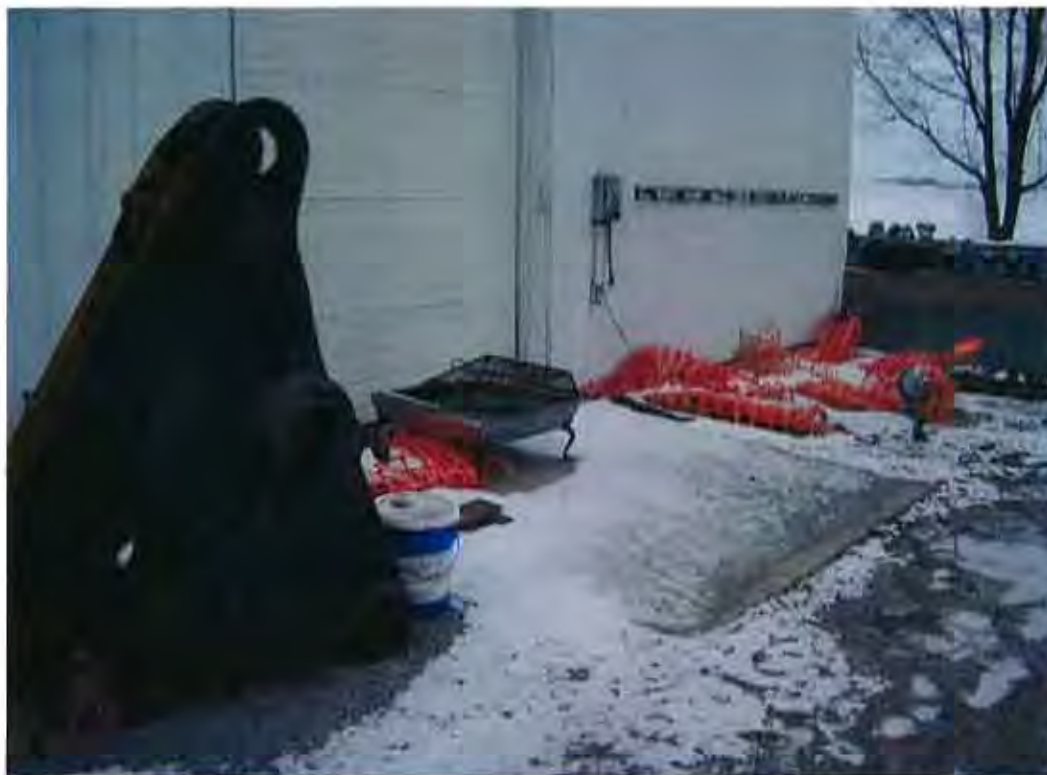
Photographs 039 and 040 show heavy equipment, orange safety fencing, an emergency eye wash station, dimensional lumber, a small barbeque grill, a patio fireplace, a cardboard box, and two empty hydraulic oil buckets along the northeast side of the maintenance garage. The oil buckets and some of the other items appeared in disarray and should be cleaned up. The burn barrel/waste can observed here during the July inspection has been removed.

**Date:** February 7, 2008  
**Time:** 10:43 AM  
**Direction:** SW  
**Photo by:** Eisenbrandt  
**Exposure #:** 039  
**Comments:** Heavy equipment, orange safety fencing, an emergency eye wash station, a patio fireplace, and an empty hydraulic oil bucket located on northeast side of maintenance garage.

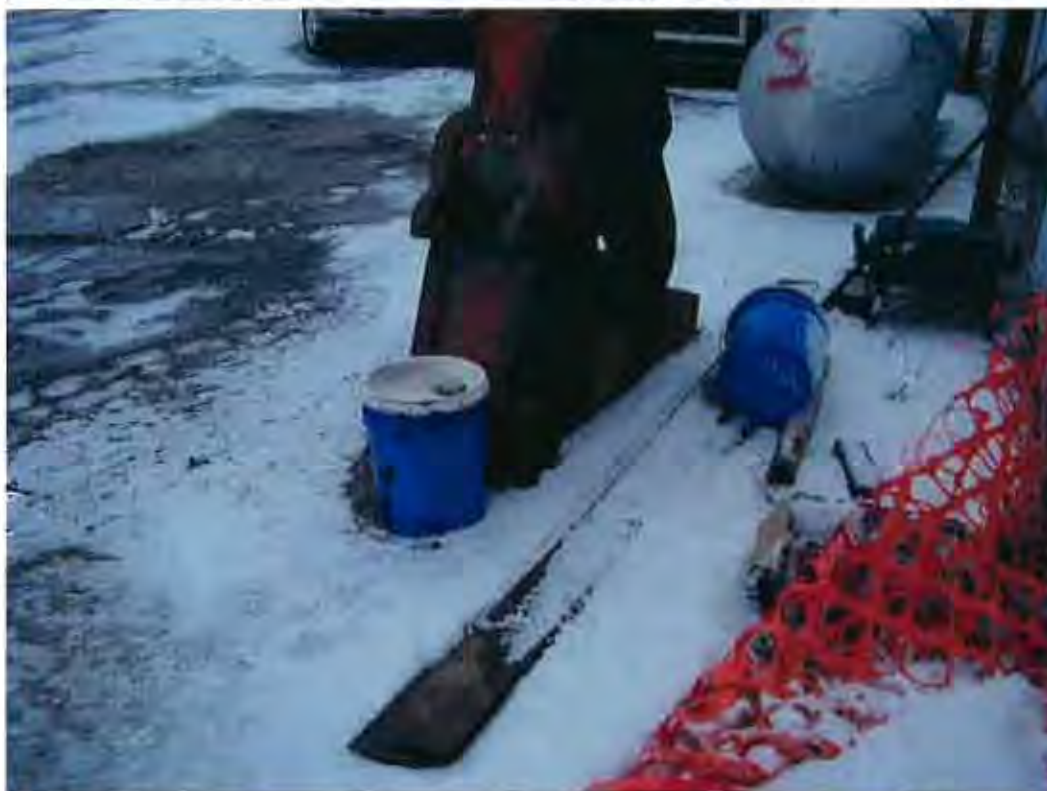
**Date:** February 7, 2008  
**Time:** 10:43 AM  
**Direction:** E  
**Photo by:** Eisenbrandt  
**Exposure #:** 040  
**Comments:** Two empty hydraulic oil buckets on the northeast side of the maintenance garage.

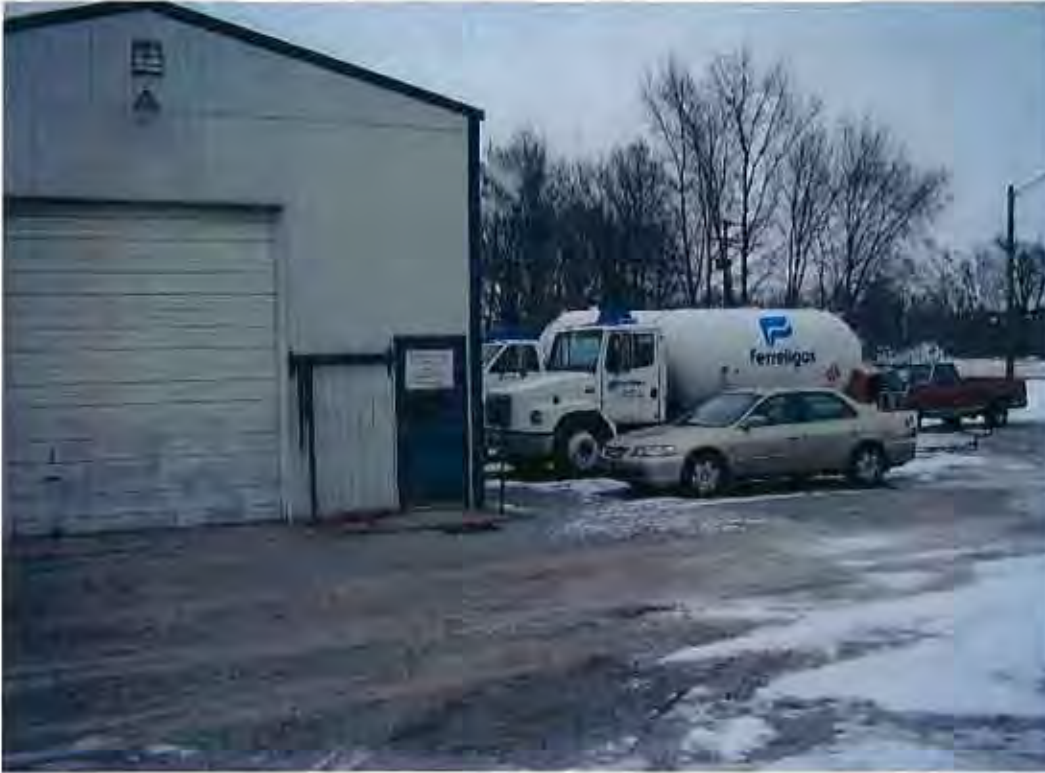
**Date:** February 7, 2008  
**Time:** 10:44 AM  
**Direction:** NE  
**Photo by:** Eisenbrandt  
**Exposure #:** 041  
**Comments:** Ferrelgas of Manito is still renting the north building, shed, and parking spaces.

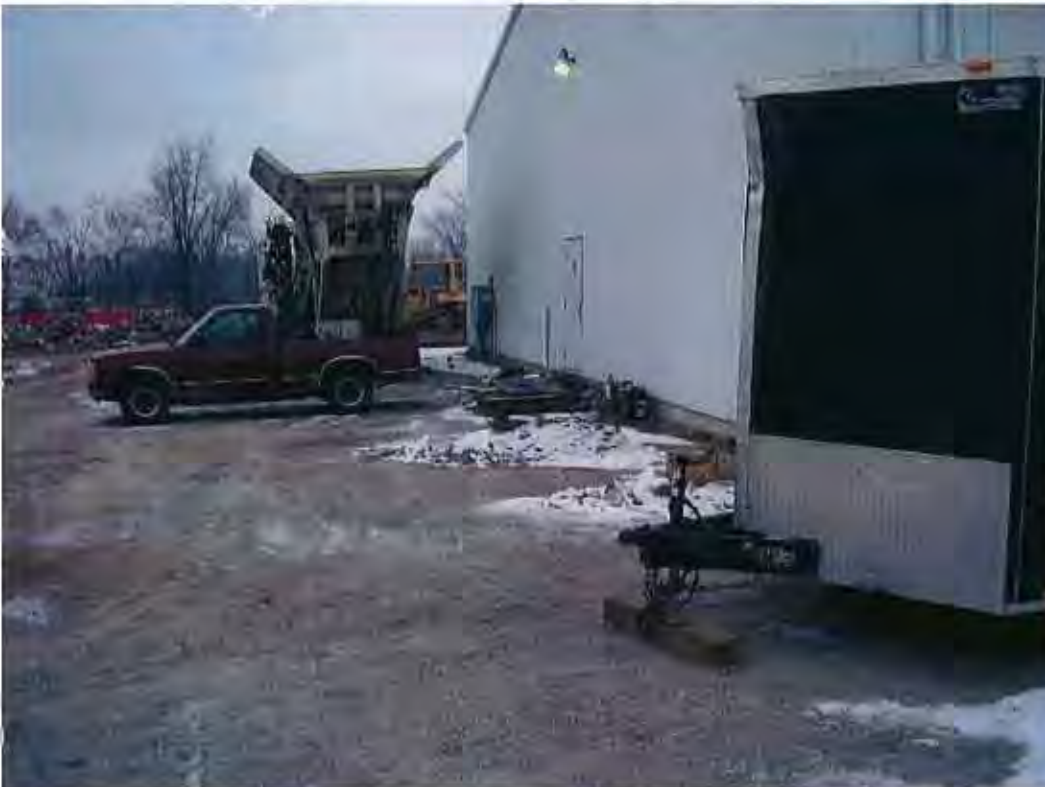
**Date:** February 7, 2008  
**Time:** 10:44 AM  
**Direction:** SW  
**Photo by:** Eisenbrandt  
**Exposure #:** 042  
**Comments:** Alternate view of southeast side of maintenance garage.

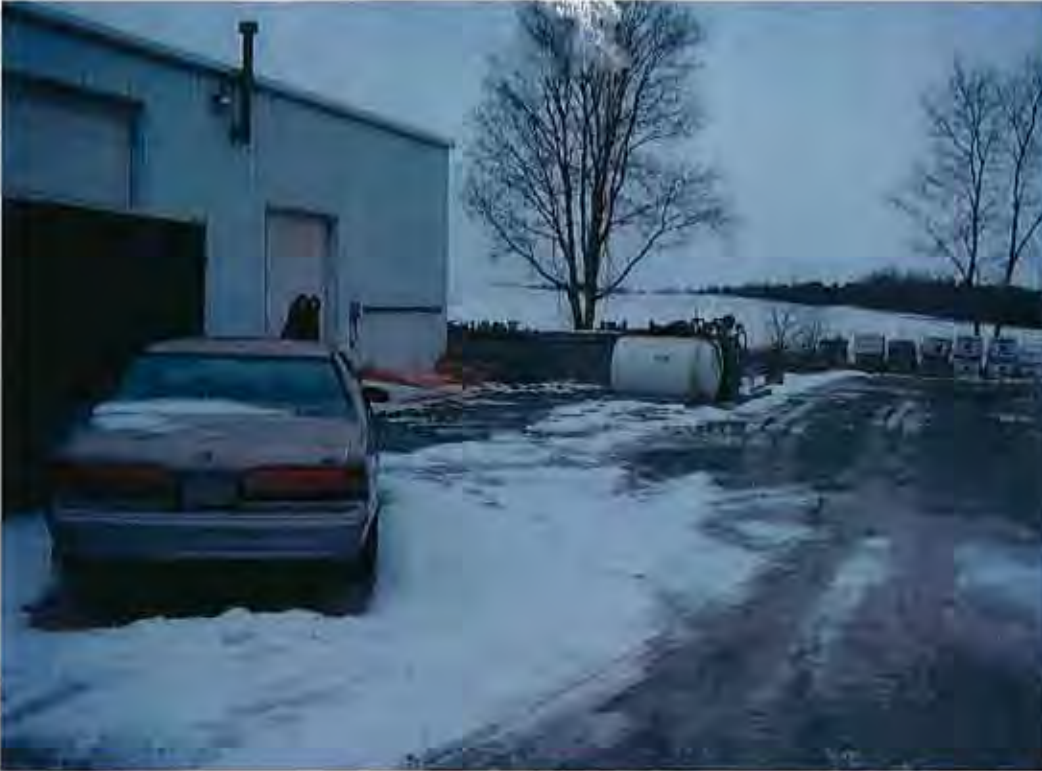
Photograph 043 shows a Ford Thunderbird without current tags. The engine hood was also missing and the vehicle appears inoperable.

**Date:** February 7, 2008  
**Time:** 10:44 AM  
**Direction:** SW  
**Photo by:** Eisenbrandt  
**Exposure #:** 043  
**Comments:** The Ford Thunderbird without current tags or engine hood appears inoperable.

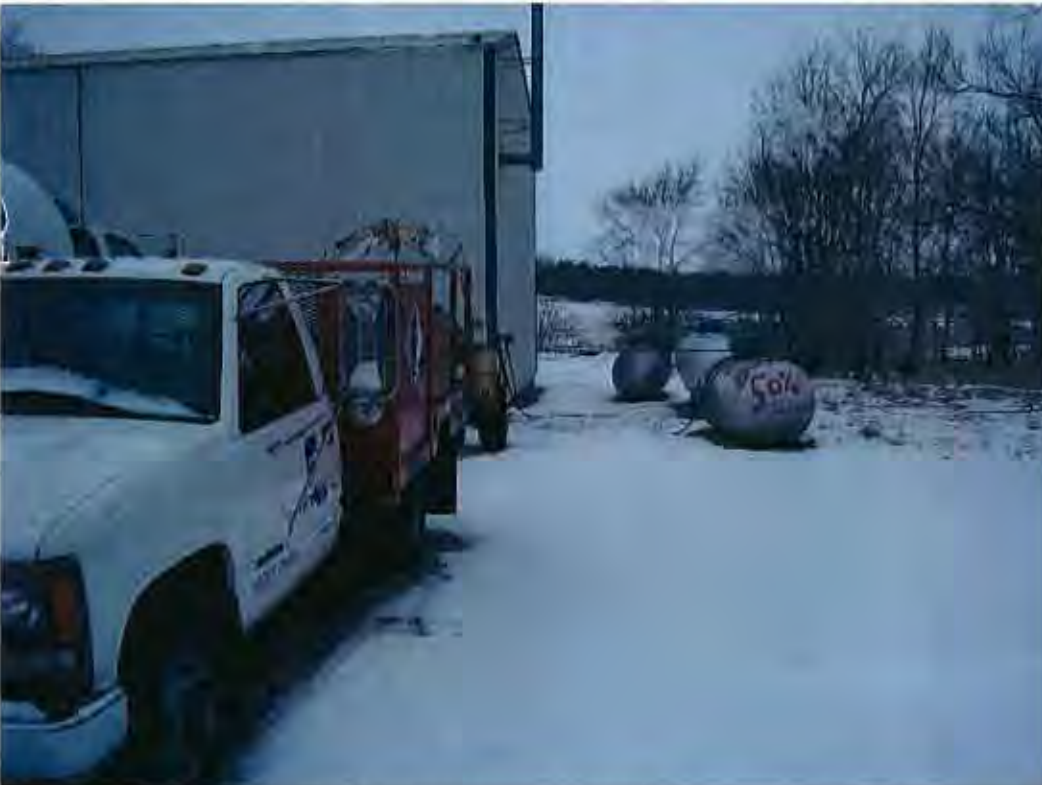
**Date:** February 7, 2008  
**Time:** 10:45 AM  
**Direction:** NW  
**Photo by:** Eisenbrandt  
**Exposure #:** 044  
**Comments:** View of northern property line facing northwest. Ferrellgas has three propane tanks, one in use for the building.

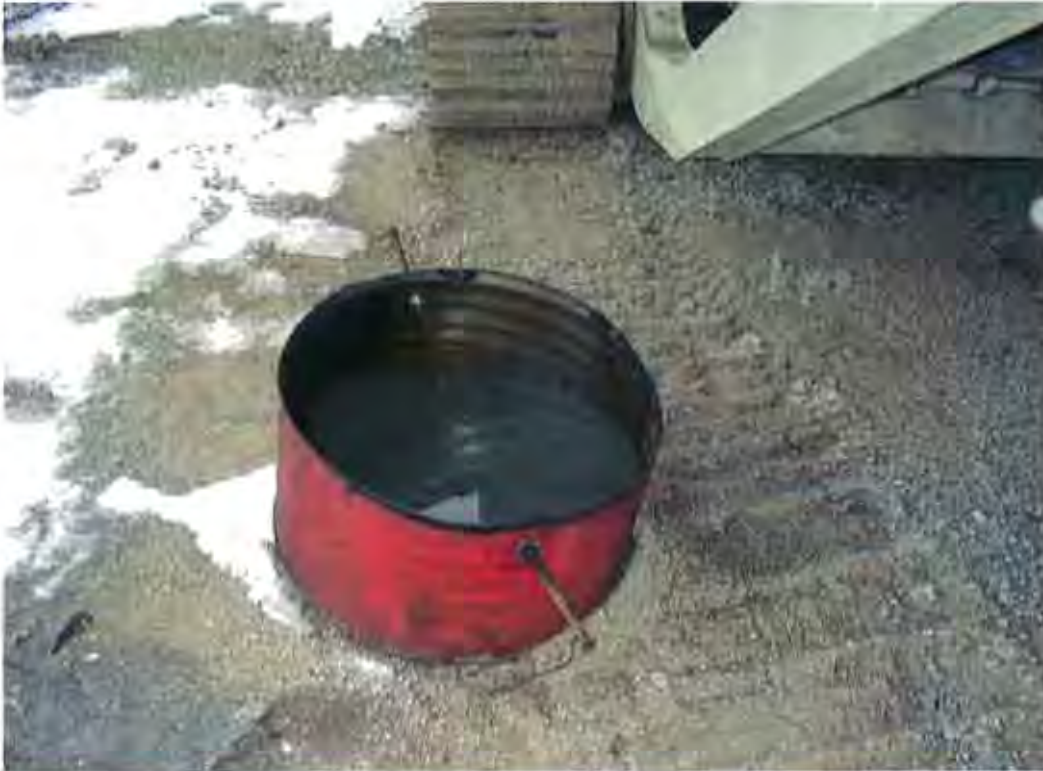
**Date:** February 7, 2008  
**Time:** 10:48 AM  
**Direction:** N  
**Photo by:** Eisenbrandt  
**Exposure #:** 045  
**Comments:** One-half full open top container of an oily liquid and sludge substance located near the crusher and the southeast corner of the maintenance garage.

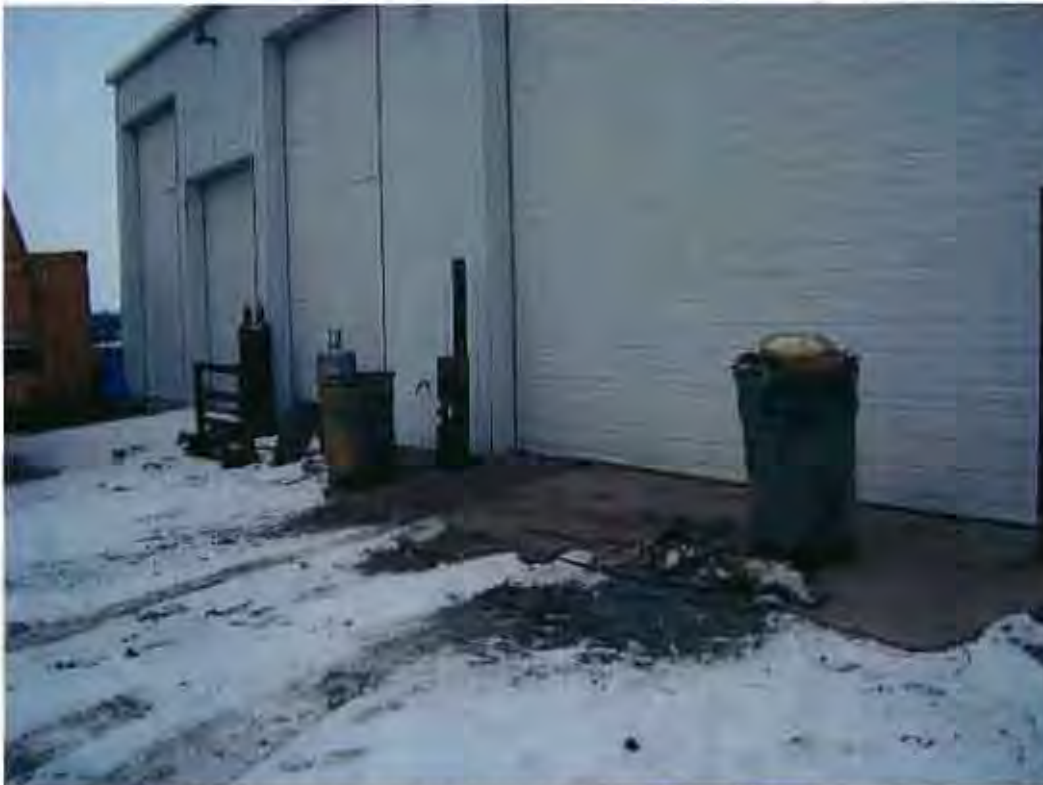
Photograph 046 shows a used tire, two garbage cans (one spilling waste onto the ground) and gas cylinders observed on the southwest side of the maintenance garage. Although some items may not be waste, their haphazard storage around the building appears as open dumped waste and careless housekeeping. Due to the snow cover, the minor petroleum staining previously observed on the gravel in front of the large overhead door could not be inspected. The inspector did not investigate the inside of the maintenance garage.

**Date:** February 7, 2008  
**Time:** 10:48 AM  
**Direction:** NW  
**Photo by:** Eisenbrandt  
**Exposure #:** 046  
**Comments:** A used tire, two garbage cans (one spilling waste onto the ground) and gas cylinders observed on the southwest side of the maintenance garage.

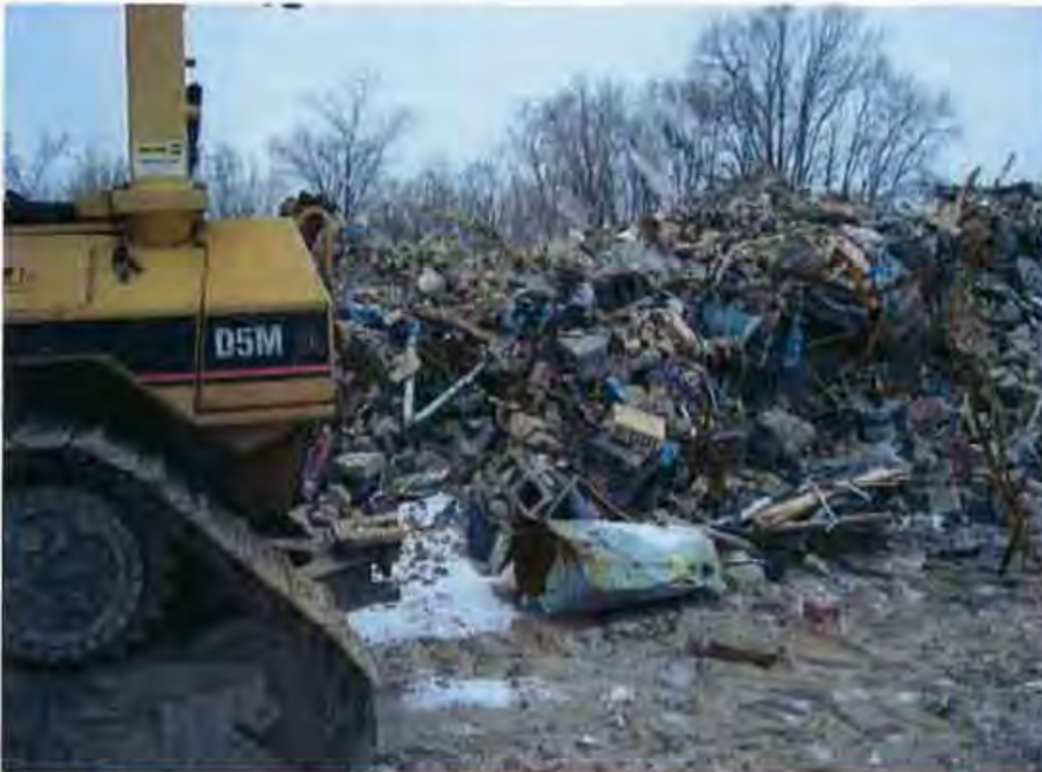
Photographs 047 and 048 show additional views of the demolition debris. A hot water heater, brick, concrete, cinder block, carpet, rebar, insulation material, cyclone fencing, aluminum blinds, and scrap metal were observed among the demolition debris.

**Date:** February 7, 2008  
**Time:** 10:48 AM  
**Direction:** SW  
**Photo by:** Eisenbrandt  
**Exposure #:** 047  
**Comments:** A hot water heater, brick, concrete, cinder block, insulation material, carpet, cyclone fencing, aluminum window blinds, and scrap metal were among the demolition debris observed.

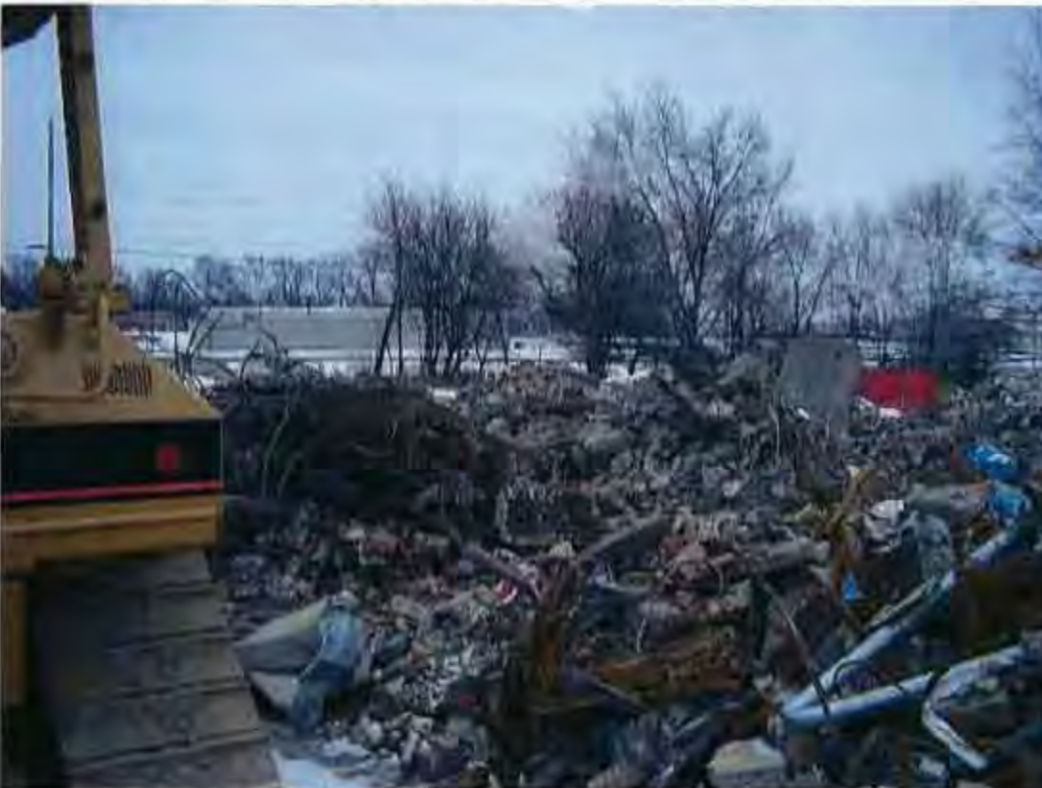
**Date:** February 7, 2008  
**Time:** 10:48 AM  
**Direction:** S  
**Photo by:** Eisenbrandt  
**Exposure #:** 048  
**Comments:** Alternate view of demolition debris.

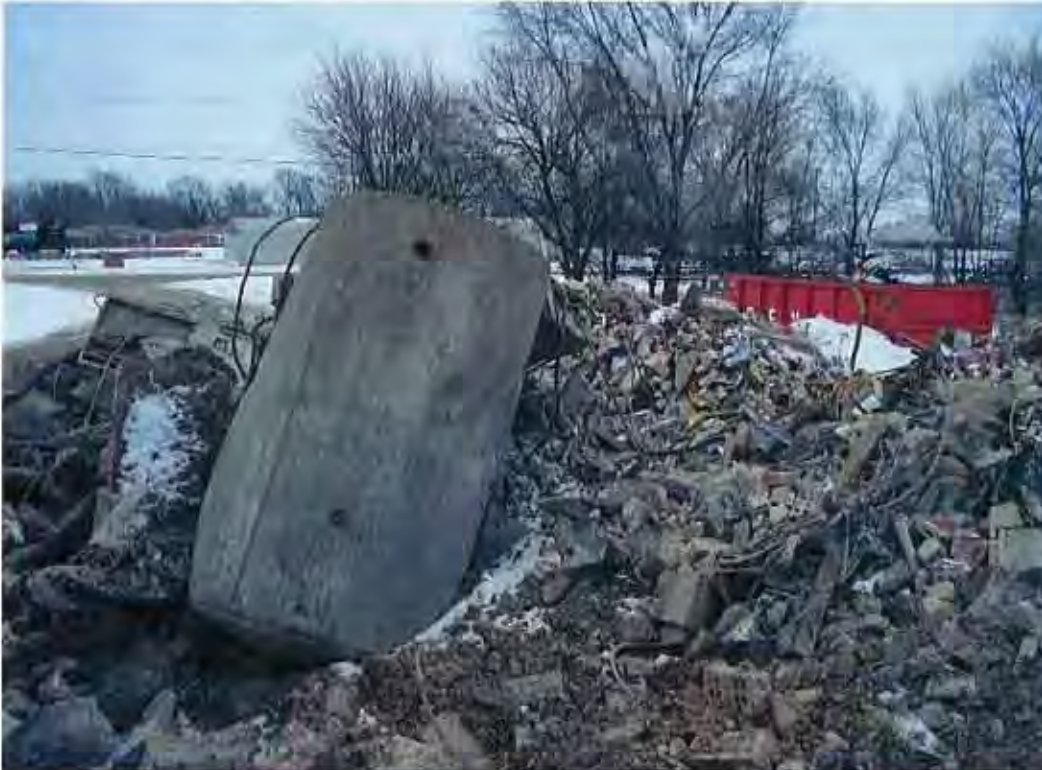
Photographs 049 and 050 show a large steel tank and a compressor cylinder observed with the demolition debris.

**Date:** February 7, 2008  
**Time:** 10:49 AM  
**Direction:** SE  
**Photo by:** Eisenbrandt  
**Exposure #:** 049  
**Comments:** A large steel tank was observed with the demolition debris.
