ILLINOIS ENVIRONMENTAL PROTECTION AGENCY

Re: Illinois Environmental Protection Agency v. Edward W. Fisher & Rhonda L. Fisher and  
DEM/EX Group, Inc.  
IEPA File No. 29-08-AC; 1250305011—Mason County

BEFORE THE ILLINOIS POLLUTION CONTROL BOARD  
ADMINISTRATIVE CITATION

February 7, 2008 Inspection

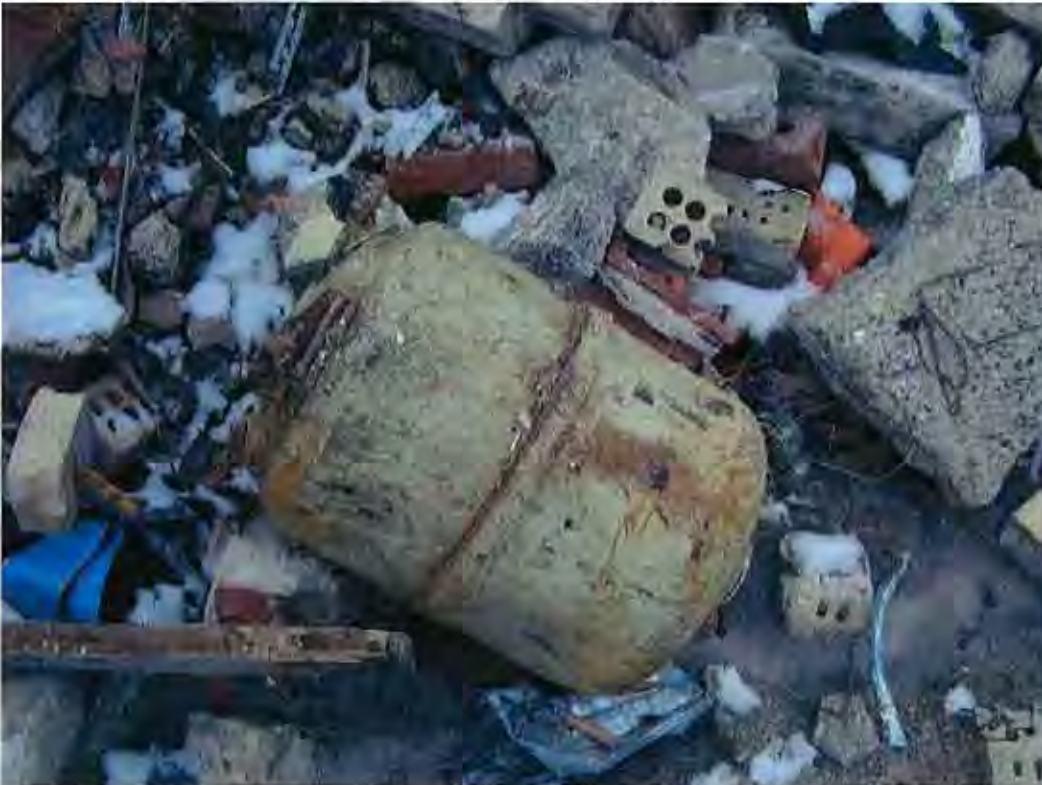
Photographs 049 and 050 show a large steel tank and a compressor cylinder observed with the demolition debris.

**Date:** February 7, 2008  
**Time:** 10:51 AM  
**Direction:** SW  
**Photo by:** Eisenbrandt  
**Exposure #:** 050  
**Comments:** A compressor cylinder was observed among the demolition debris.

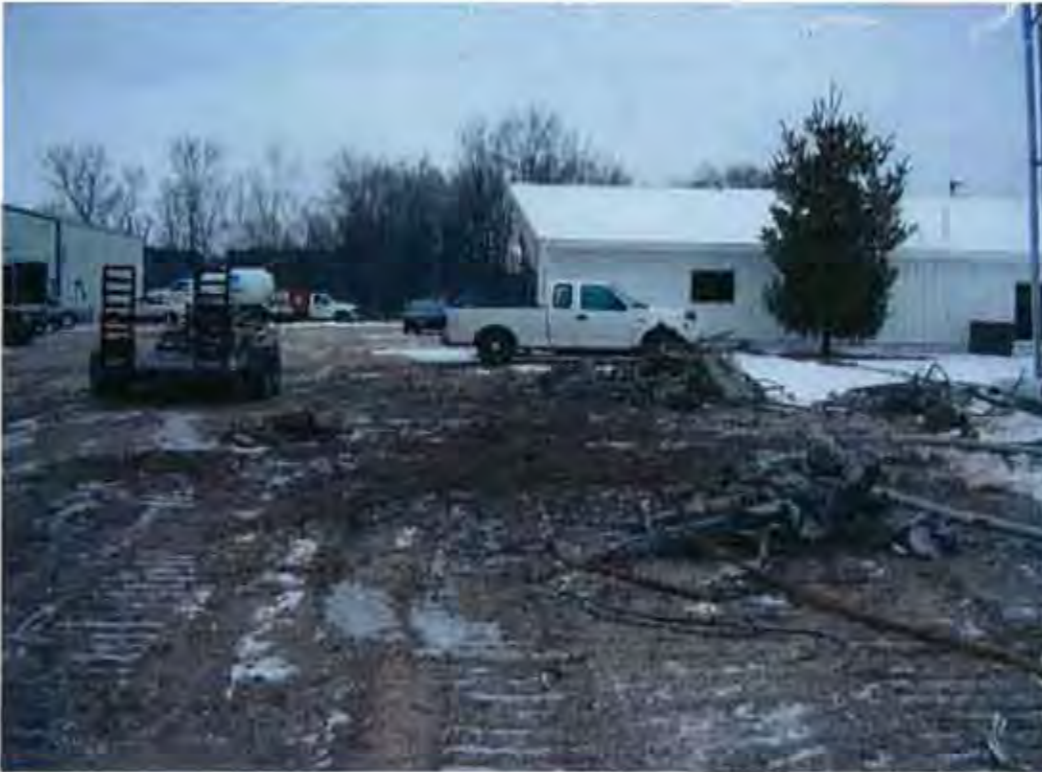
**Date:** February 7, 2008  
**Time:** 10:52 AM  
**Direction:** NE  
**Photo by:** Eisenbrandt  
**Exposure #:** 051  
**Comments:** Alternate view of the scrap metal piles.

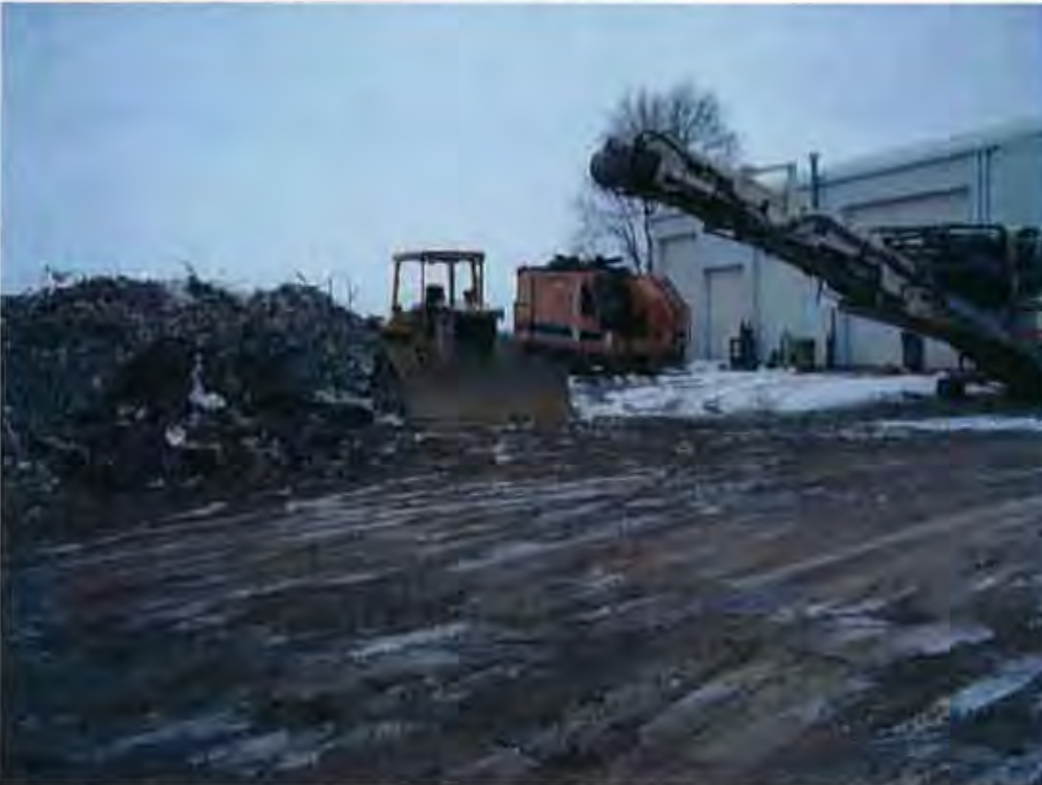
**Date:** February 7, 2008  
**Time:** 10:52 AM  
**Direction:** NW  
**Photo by:** Eisenbrandt  
**Exposure #:** 052  
**Comments:** Alternate view of demolition debris and heavy equipment.
