ILLINOIS ENVIRONMENTAL PROTECTION AGENCY

Re: Illinois Environmental Protection Agency v. Hiram Vanderheiden, Jr.
IEPA File No. 51-08-AC; 1258075004—Mason County

BEFORE THE ILLINOIS POLLUTION CONTROL BOARD
ADMINISTRATIVE CITATION

LPC #1258075004 - Mason County
 Manito / Vanderheiden
 FOS File
 February 7, 2008 Inspection

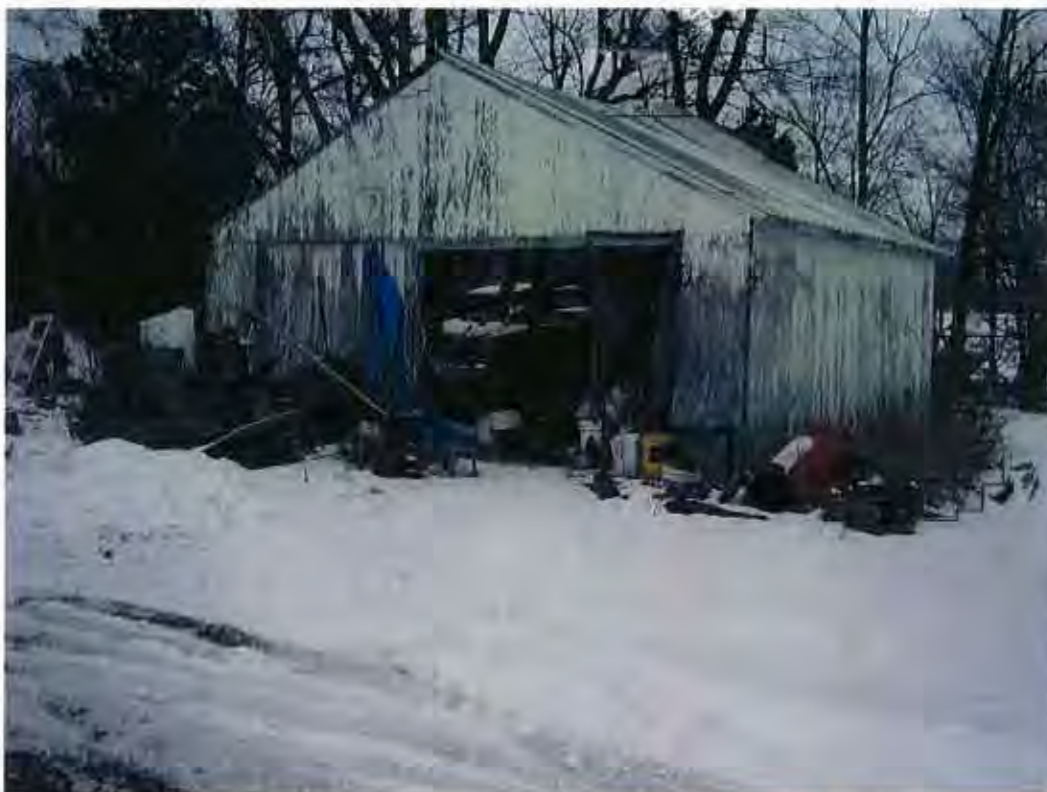
Photograph 001 shows a dilapidated garage in the southwest corner of the Vanderheiden property. The garage was still missing a garage door. The other side of the door opening was partially closed off with two plastic tarps as they were during the September 2006 inspection. One of the tarps was torn and mostly on the ground (this has not changed in a year). Access to the garage remains unrestricted. As previously observed, the ridge board, of the garage roof, was noticeably sagging. Several of the roof rafters and exterior sheeting have been removed from the northeast corner since the January 2007 inspection. The remaining exterior paint was flaking off the building and exposing raw wood siding. No improvements have been made to the structure since that last inspection. The brown rusty heater, which was observed on the southwest corner of the garage in September 2006, has been moved, however other miscellaneous wastes now occupy its place.

Date: February 7, 2008
Time: 11:09 AM
Direction: NE
Photo by: Eisenbrandt
Exposure #: 001
Comments: Dilapidated garage in the southwest corner of the Vanderheiden property. No improvements have been made since the January 8, 2007 inspection. More debris is now present than previously observed.

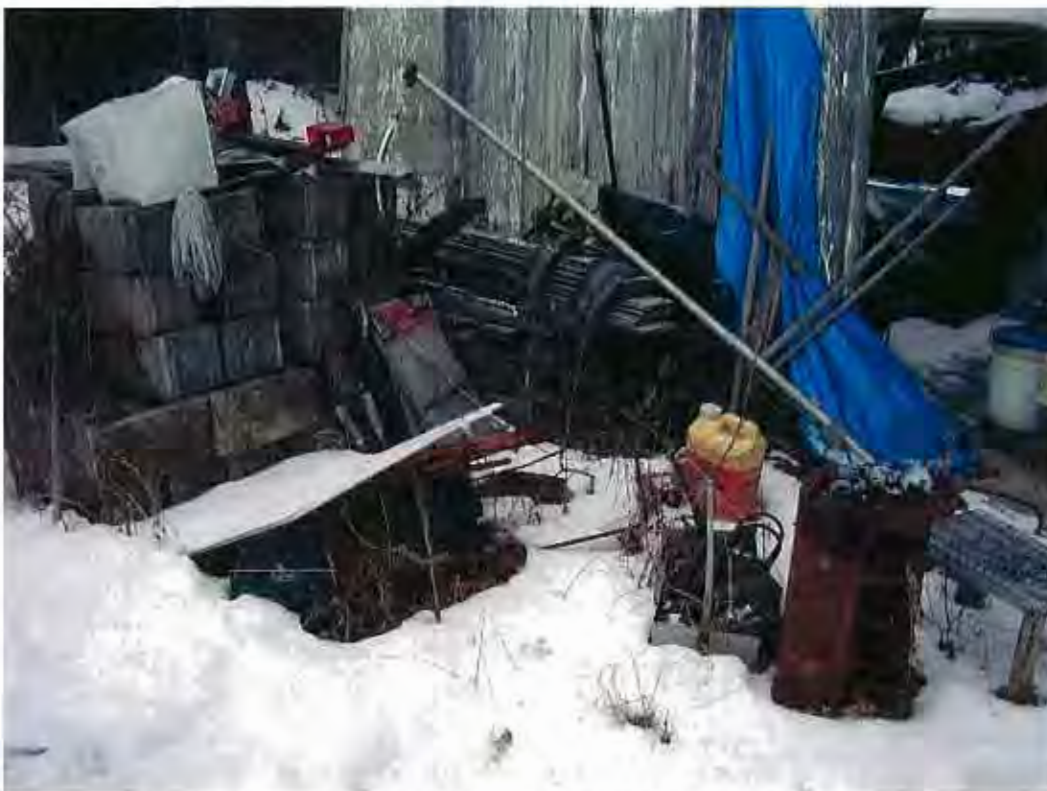
Photograph 002 shows a large pile of miscellaneous items in front of the dilapidated garage. Stacked cinder block, various pieces of scrap metal, lawn tools, a stack of tongue and groove siding, and a torn plastic garbage can, among other items were still observed in front of the garage. The weeds and leaves on the woody vegetation are down for the season. Between the first and second inspections, a propane tank and several rail snow sleds had been removed. Now an engine block and a variety of items appear to be accumulating. In the last year and a half not much has changed at this location.

Date: February 7, 2008
Time: 11:09 AM
Direction: NE
Photo by: Eisenbrandt
Exposure #: 002
Comments: Stacked cinder block, scrap metal, lawn tools, wood tongue and groove siding, a torn plastic garbage can, and an engine block were among miscellaneous items observed in front of the dilapidated garage. No appreciable clean up was observed.

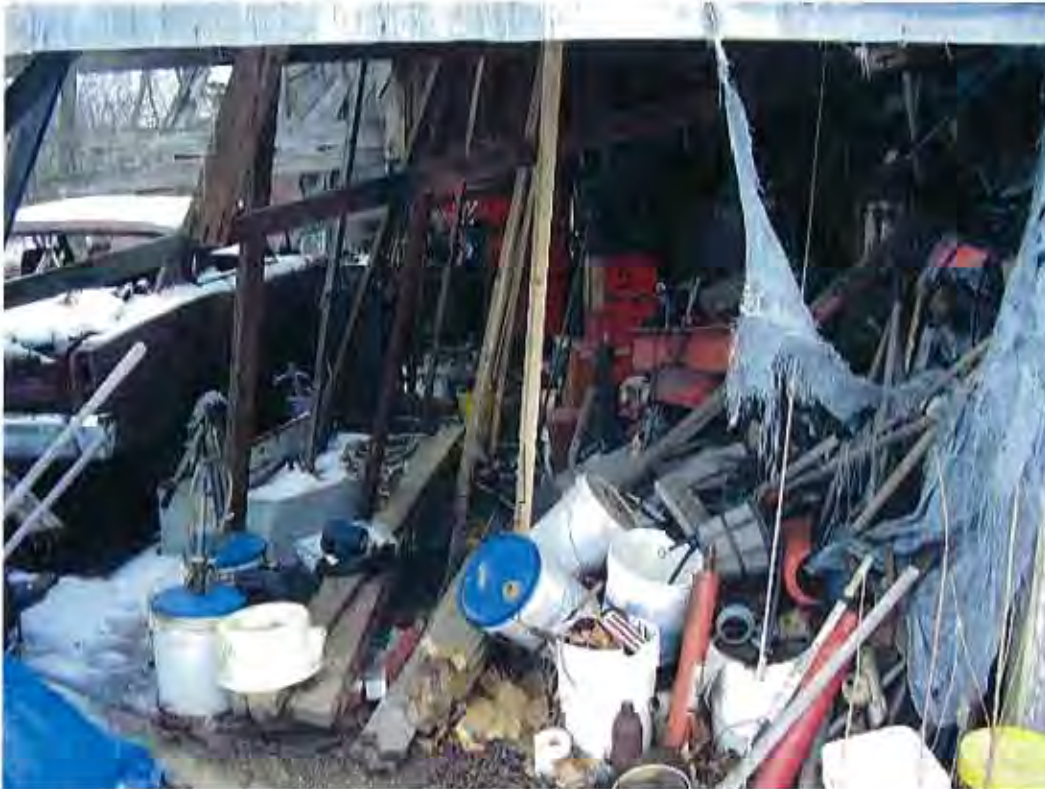
Photograph 003 is a view looking into the dilapidated garage. The garage is still filled wall to wall with a variety of items including a vehicle, tools, and miscellaneous stuff. Comparing photographs from the three inspections it appears as if things are being shuffled around, yet the amount of items has not decreased. The roof sheeting and shingles are still missing on the northern half of the garage, and several rafters and pieces of siding have also been removed. The

condition of the garage structure has worsened as repairs have not been made. Entry to the hazardous structure is still not restricted. The unprotected contents of the garage are considered waste.

Date: February 7, 2008
Time: 11:10 AM
Direction: E
Photo by: Eisenbrandt
Exposure #: 003
Comments: View into the dilapidated garage. One-half of the roof sheeting and shingles were missing during the previous inspection. Now more of the garage structure has been removed. The roof rafters and ceiling joists are well weathered. Although miscellaneous debris inside the garage has been shifted around, no changes to the overall condition of the contents of the garage were observed.

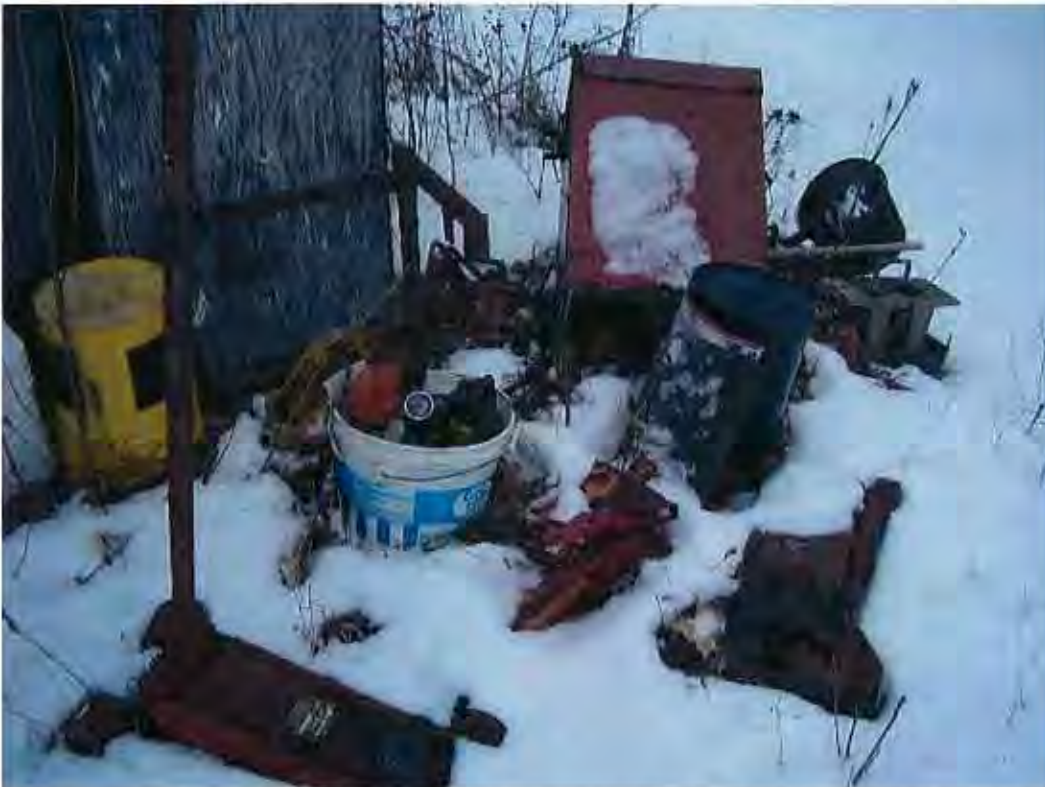
Date: February 7, 2008
Time: 11:10 AM
Direction: SE
Photo by: Eisenbrandt
Exposure #: 004
Comments: Additional waste open dumped outside the southwest corner of the dilapidated garage since the last inspection.

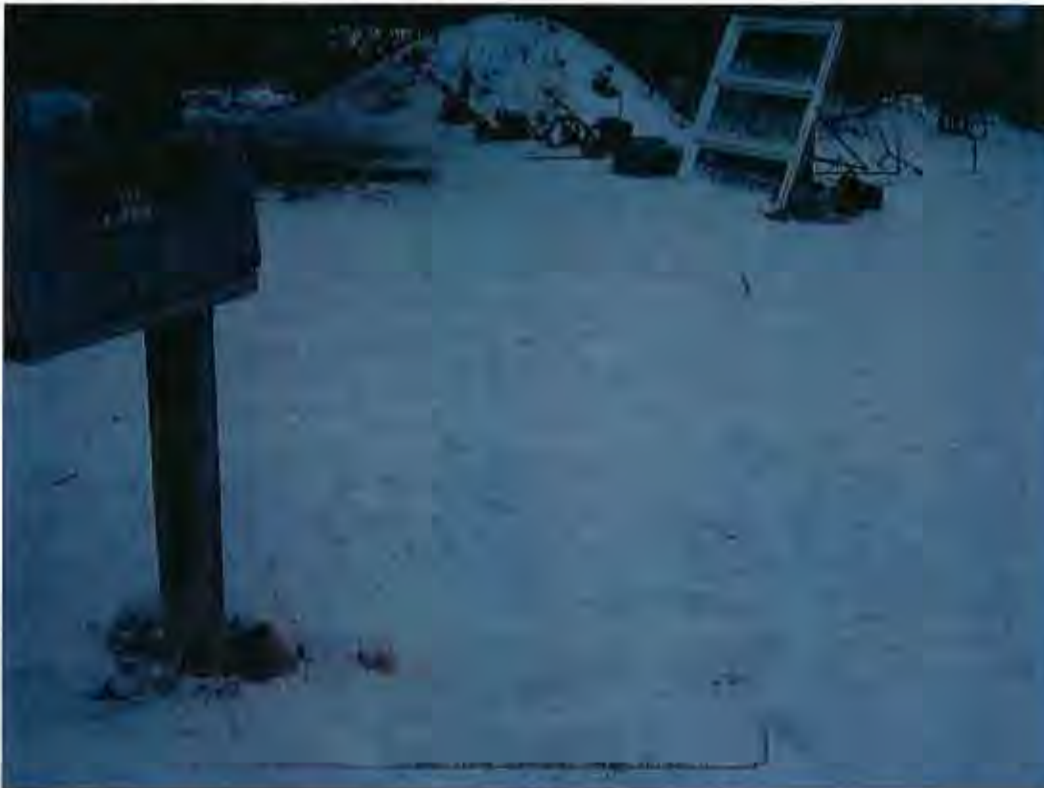
Photograph 005 shows the approximate location of a burn pile located near the street on the west side of the property. The burn pile contained mostly landscape waste during the last inspection. During this inspection the exact location was not identified due to the snow cover. No debris was observed.

Date: February 7, 2008
Time: 11:11 AM
Direction: NE
Photo by: Eisenbrandt
Exposure #: 005
Comments: A landscape waste burn pile, previously observed near the mailbox, was not observed during this inspection.

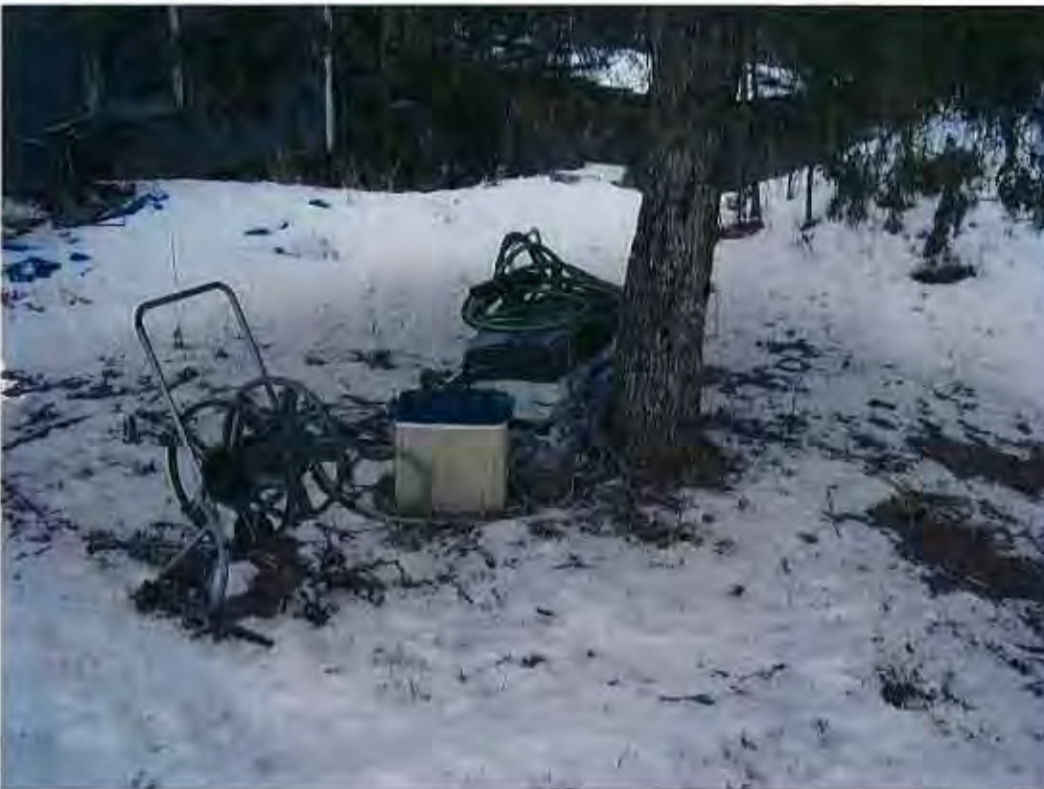
Date: February 7, 2008
Time: 11:11 AM
Direction: NE
Photo by: Eisenbrandt
Exposure #: 006
Comments: Several sections of garden hose, a plastic cooler, a stack of roofing shingles, and plastic lawn chairs were observed south the house as they were during previous inspections. A blue tarp, an aluminum folding lawn chair, and a hot water heater have been removed.

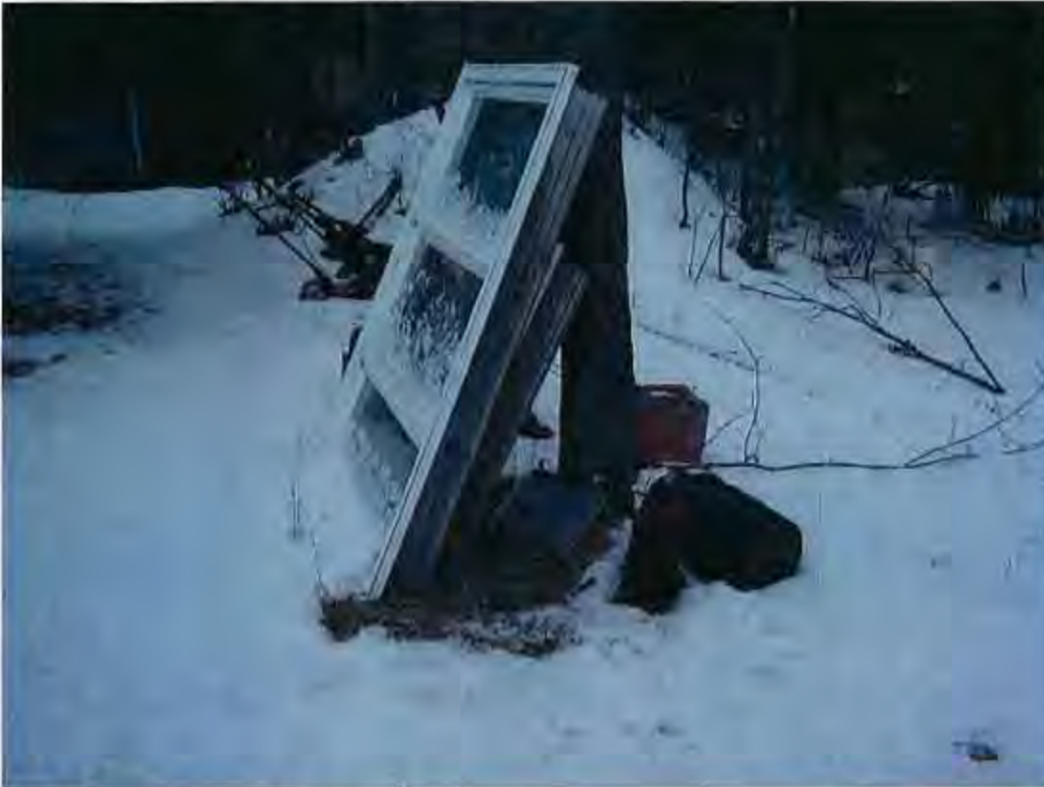
Photographs 007 and 011 show a weathered red gasoline can, two weathered wooden window units, a floor jack, a black bucket, a blue plastic bin, and miscellaneous debris. A red lawnmower and a fiber barrel containing stagnant water have been moved since the last inspection. Most of the items remain as observed during the September 2006 inspection

Date: February 7, 2008
Time: 11:11 AM
Direction: N
Photo by: Eisenbrandt
Exposure #: 007
Comments: A weathered red gasoline can, two weathered wooden window units, and a black metal bucket are still observed at the base of one of the trees. This area has not been cleaned up.

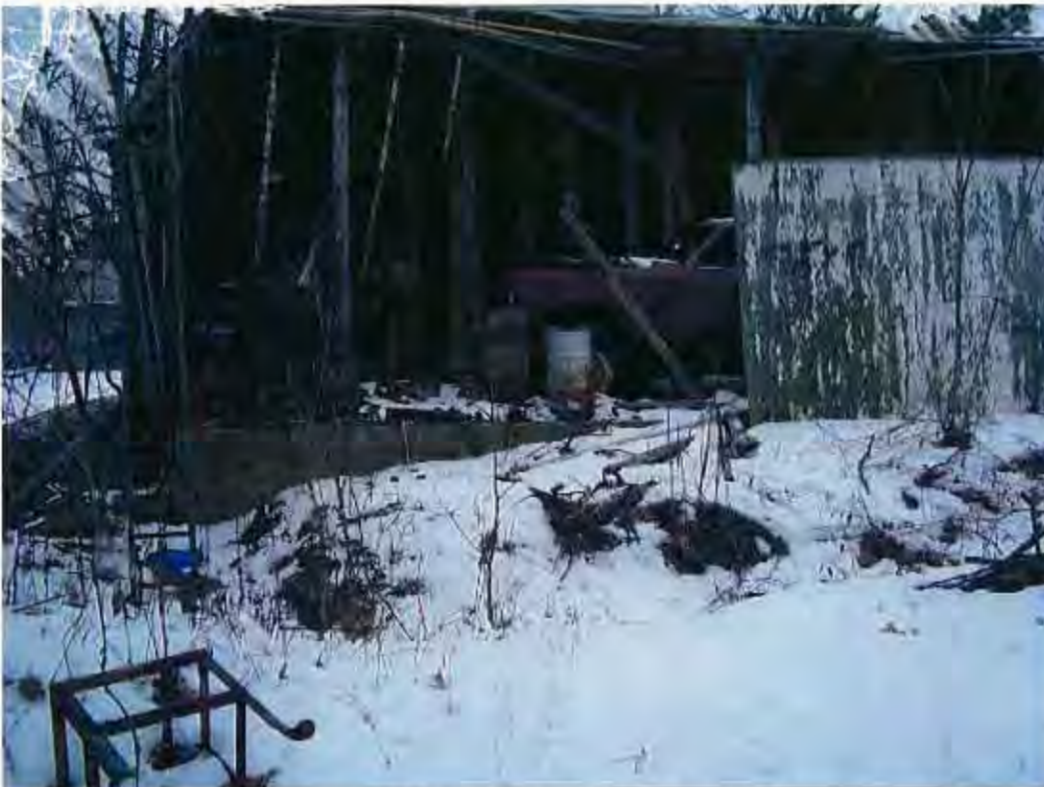
Photograph 008 is a view of the northeast side of the collapsing garage. It appears as someone has removed several roof rafters and wall sheeting since the January 2007 inspection. The structure is still severally damaged and repairs have not been made in the last year and a half. Two exterior "street style" lights and several pieces of grey PVC conduit have been moved from this location.

Date: February 7, 2008
Time: 11:12 AM
Direction: S
Photo by: Eisenbrandt
Exposure #: 008
Comments: View of the northeast side of the collapsing garage. Wall sheathing and numerous exposed rafters have been removed from the garage structure. Exterior "street style" lights and a stack of grey PVC conduit appear to have been moved. A metal cart is (seen in the foreground of the photograph) was not previously observed. No appreciable improvements have been made in this area.

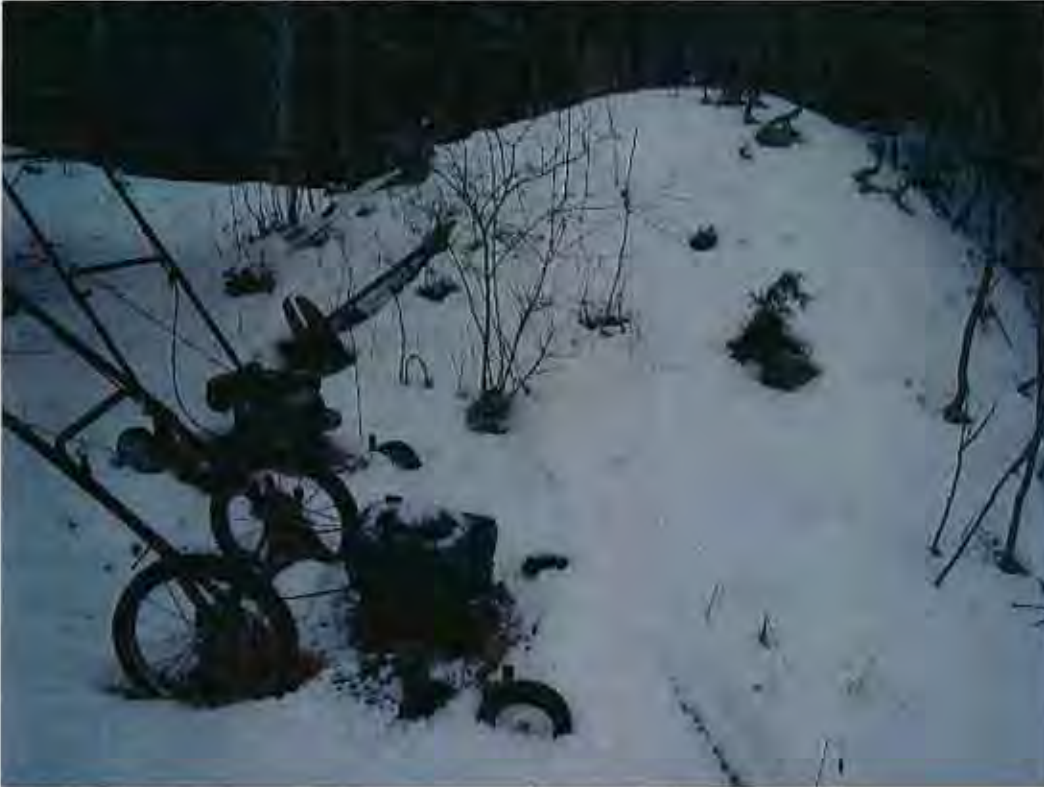
Date: February 7, 2008
Time: 11:12 AM
Direction: N
Photo by: Eisenbrandt
Exposure #: 009
Comments: Two red lawn mowers and miscellaneous debris surround a pile of dirt in the yard. It appears that this area has not been cleaned up.

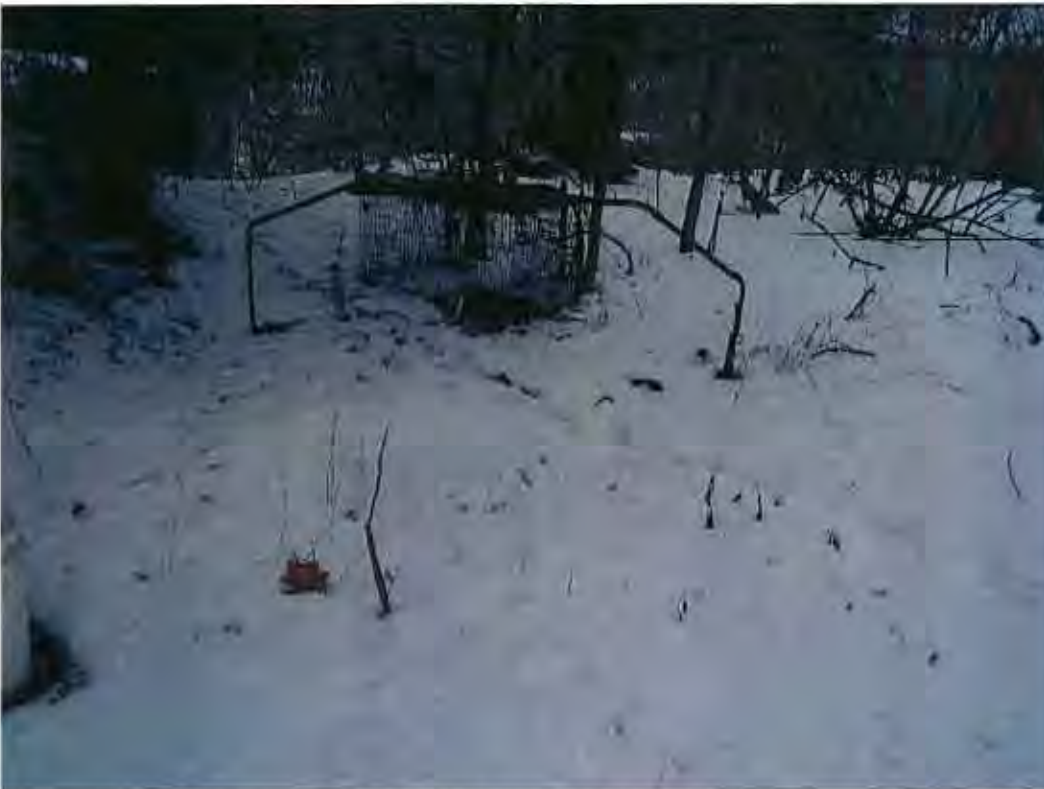
Photograph 010 shows a white plastic bucket and other miscellaneous debris that were previously observed under the trees in this area.

Date: February 7, 2008
Time: 11:12 AM
Direction: NE
Photo by: Eisenbrandt
Exposure #: 010
Comments: A white plastic bucket and miscellaneous debris are still observed under the trees.

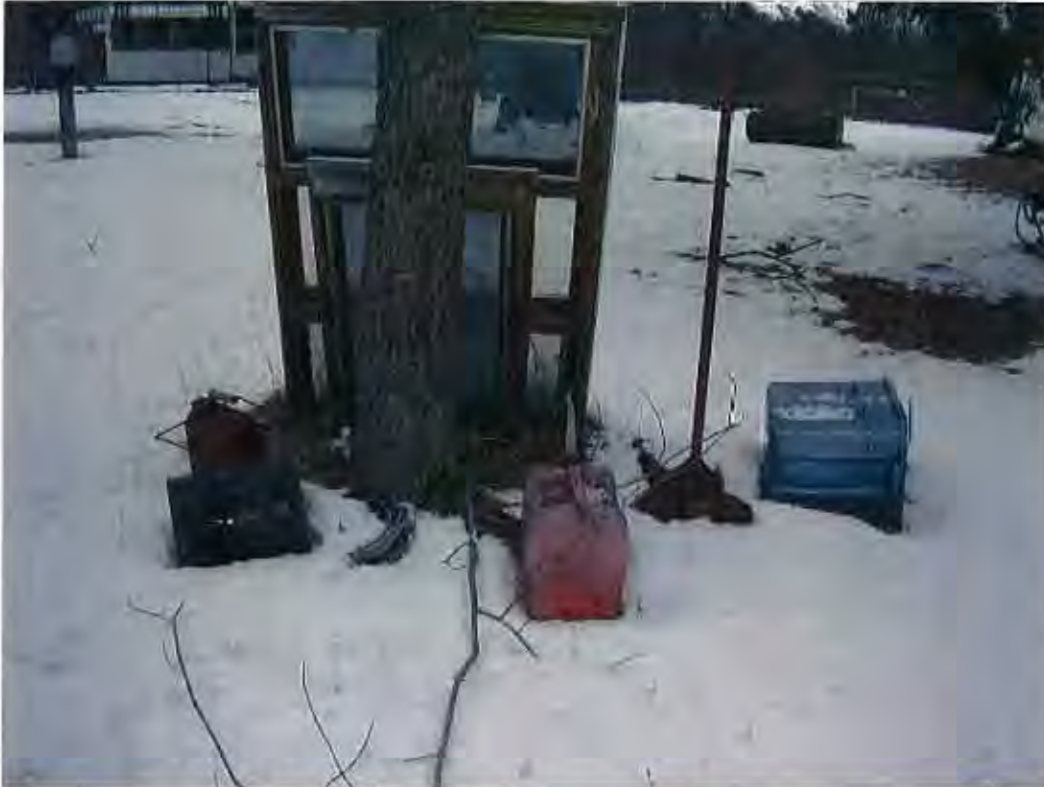
Date: February 7, 2008
Time: 11:13 AM
Direction: W
Photo by: Eisenbrandt
Exposure #: 011
Comments: A weathered red gasoline can, two weathered wooden window units, a floor jack, a blue bin, a black metal bucket, and miscellaneous automotive parts, were observed at the base of the tree. This area has not changed.

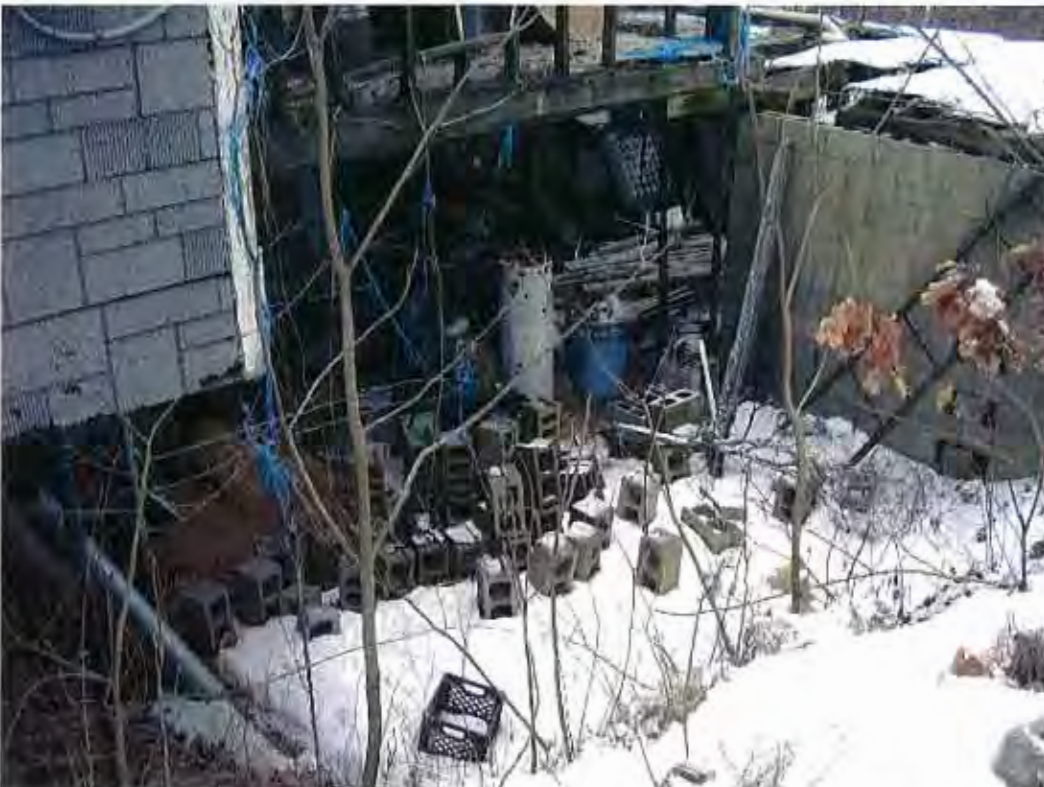
Date: February 7, 2008
Time: 11:13 AM
Direction: NE
Photo by: Eisenbrandt
Exposure #: 012
Comments: View looking down into the basement of the home. The south basement wall is still exposed. An unfinished basement addition can be seen to the right in the photograph. The decking and protective covering appeared to be rotten. Nothing has been cleaned up at this location.

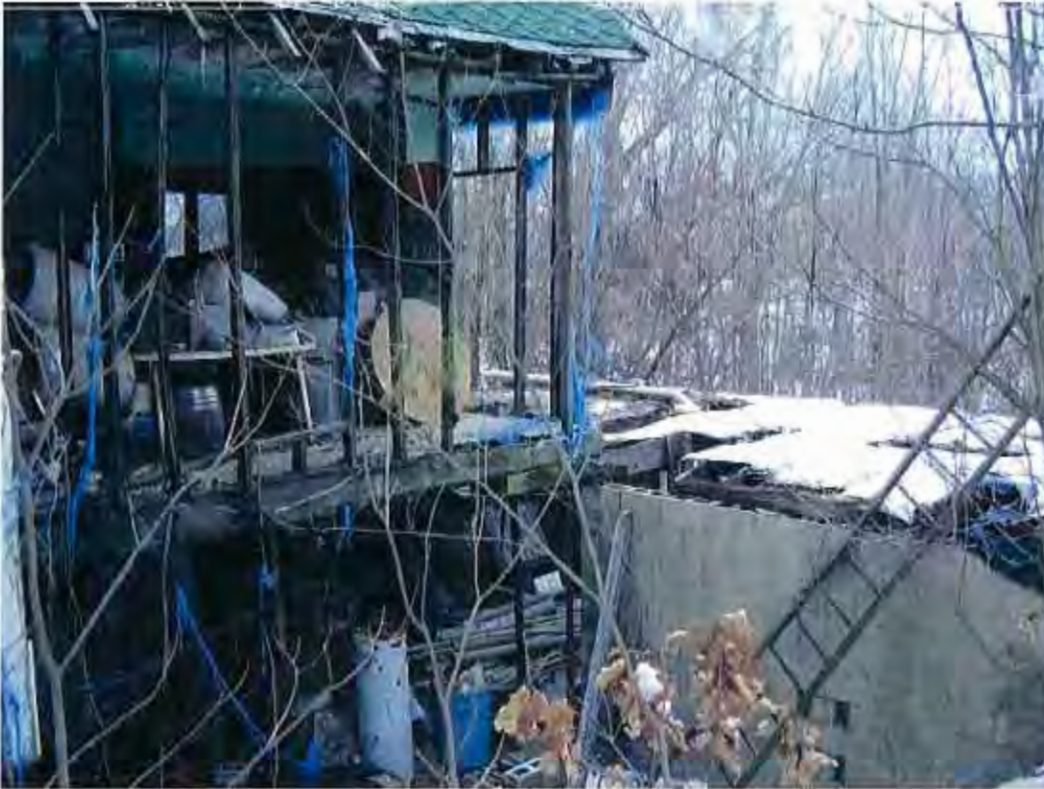
Photograph 013 shows the exposed stud walls on the south and east portion of the house. The blue tarpaulin has weathered away. Nothing has changed since the initial inspection. The structure and contents of the home are still exposed to the weather and their condition has worsened.

Date: February 7, 2008
Time: 11:13 AM
Direction: NE
Photo by: Eisenbrandt
Exposure #: 013
Comments: The south and east stud walls of the back portion of the house were still exposed. The blue tarpaulin has weathered away. The house is exposed to the weather and its condition has worsened.

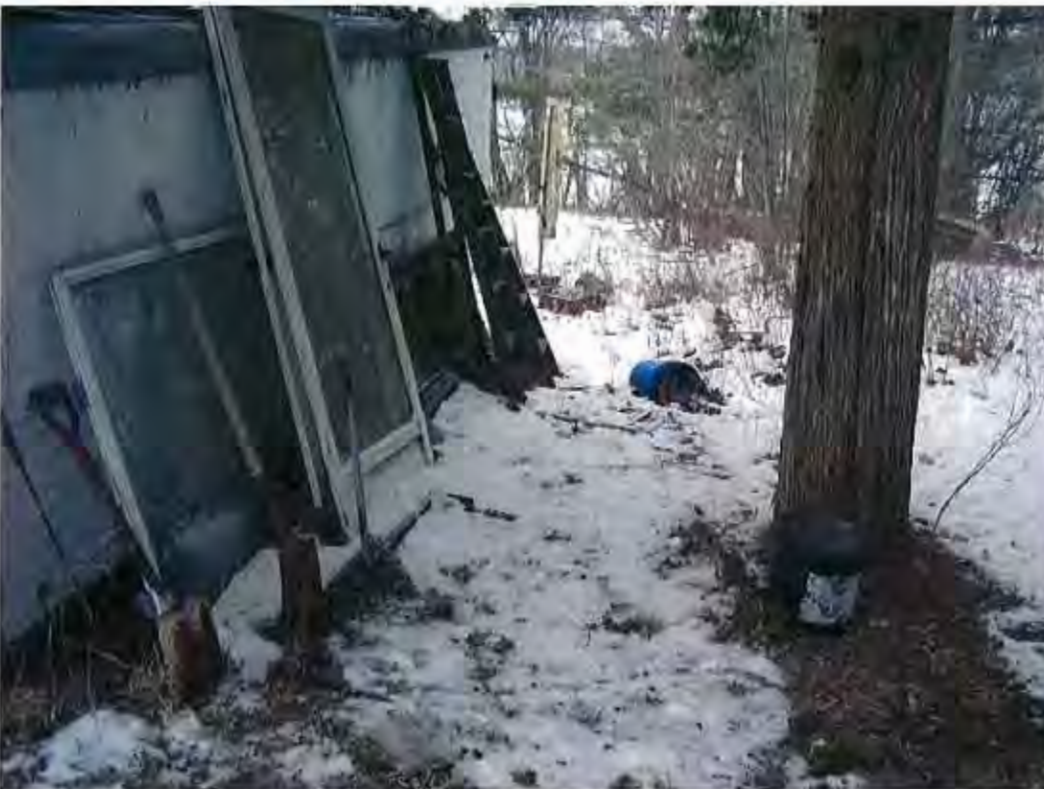
Date: February 7, 2008
Time: 11:14 AM
Direction: N
Photo by: Eisenbrandt
Exposure #: 014
Comments: A bucket of roof cement, storm doors, glass windows, and wooden ladders, were observed between the house and the covered trailer. This area has not been cleaned up.

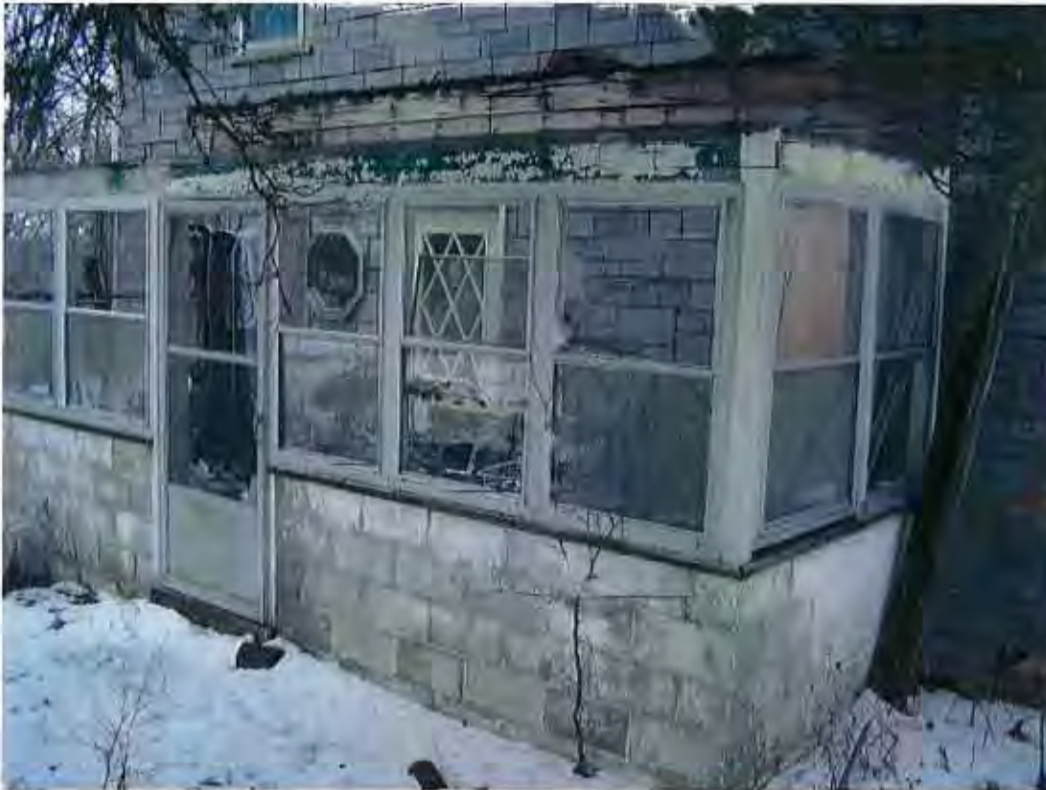
Photograph 015 shows the roof and the rafters of the front porch are still missing. The porch was full of miscellaneous items and exposed to the winter weather. Nothing has changed since the initial inspection.

Date: February 7, 2008
Time: 11:14 AM
Direction: NE
Photo by: Eisenbrandt
Exposure #: 015
Comments: The roof and rafters of the front porch are still missing. The porch was full of miscellaneous items exposed to the weather. The porch has not been repaired.

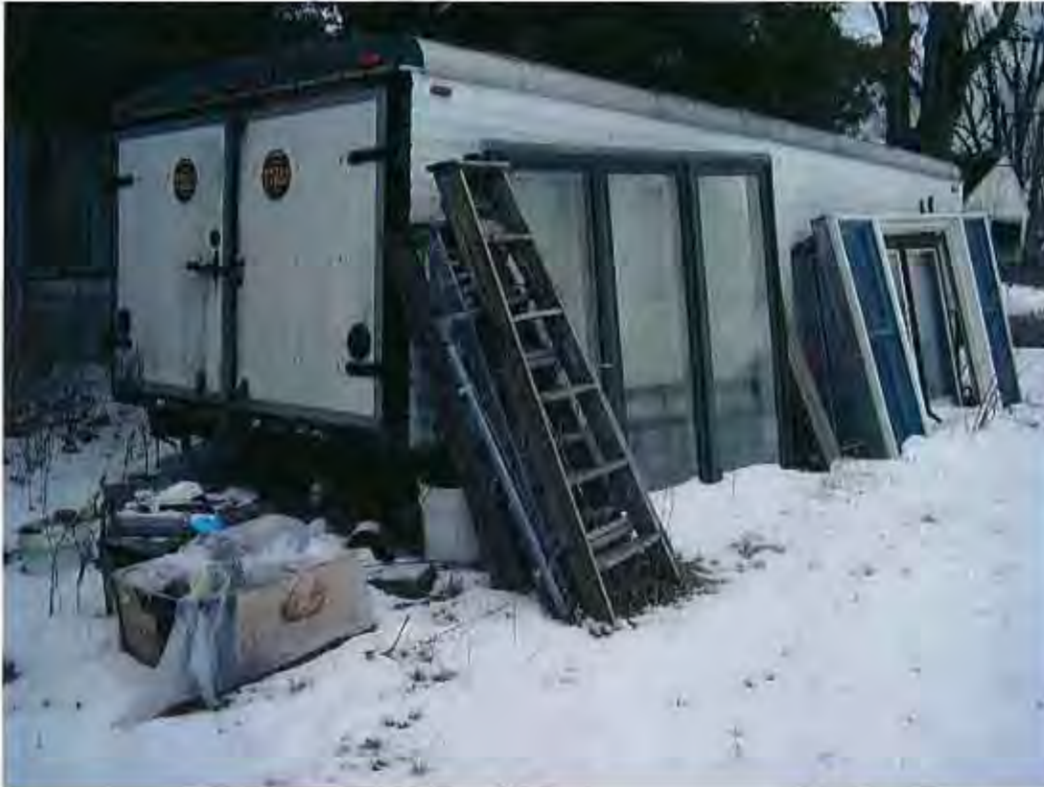
Photograph 017 shows a covered trailer that has been parked in front of the house since the first inspection in September 2006. Several ladders, window units, chain link fencing, and several boxes of miscellaneous nails and construction materials were still observed against and around the trailer. No appreciable change has occurred.

Date: February 7, 2008
Time: 11:14 AM
Direction: SE
Photo by: Eisenbrandt
Exposure #: 017
Comments: A covered trailer was observed in front of the house. Several ladders, windows units, chain link fencing, and boxes of miscellaneous nails and construction materials were observed against the trailer. No improvements have been made near the covered trailer.

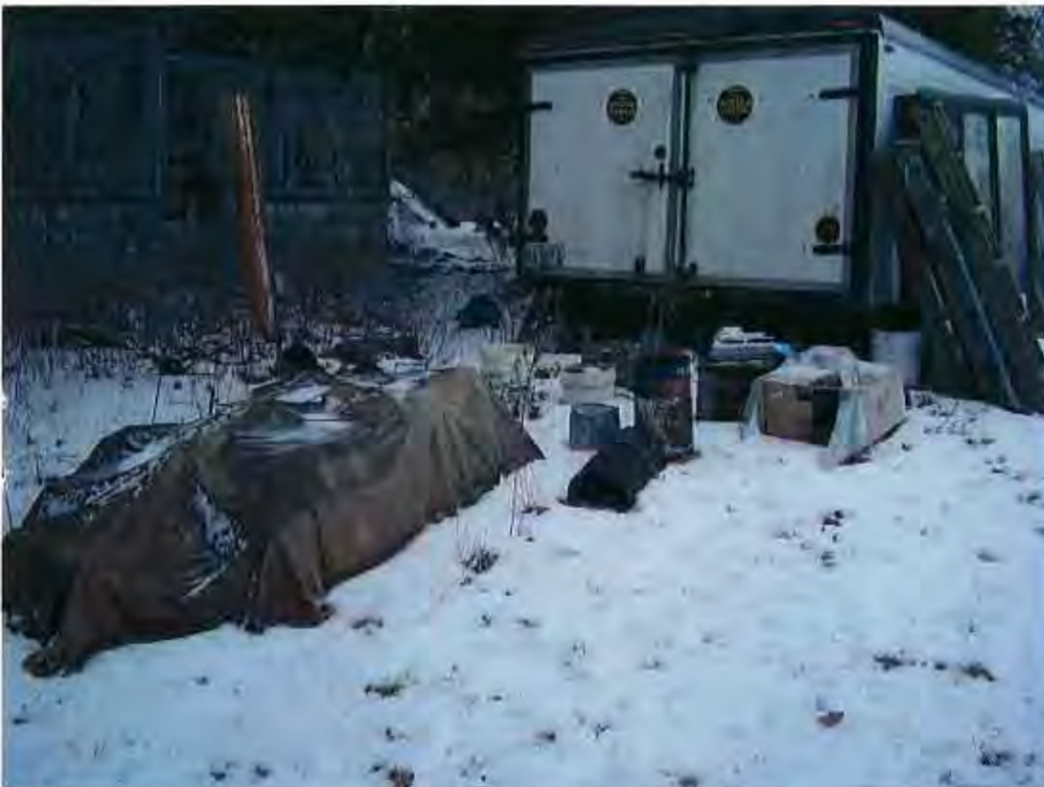
Date: February 7, 2008
Time: 11:14 AM
Direction: SE
Photo by: Eisenbrandt
Exposure #: 018
Comments: A cooler and numerous boxes of miscellaneous items (covered with a canvas tarp) are still on the ground north of the trailer. This area remains unchanged.

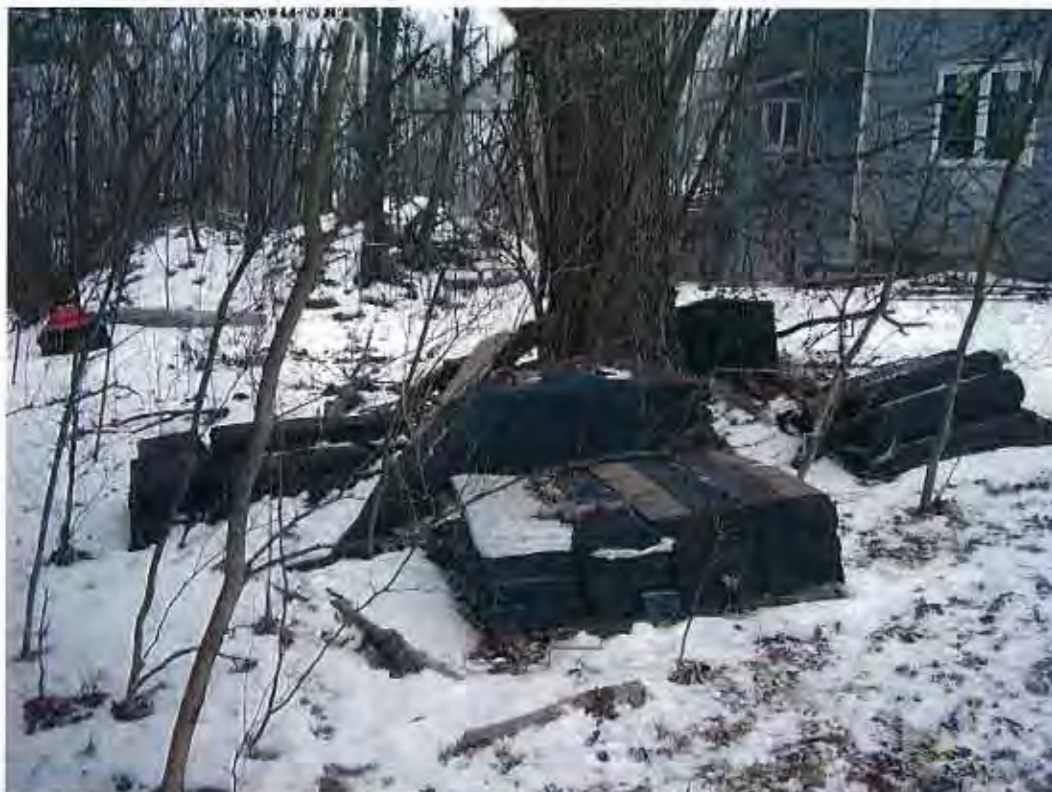
Photograph 019 shows four pallets of unwrapped stacked shingles and tar paper rolls, and an air conditioning condenser northwest of the house. These items remain unchanged.

Date: February 7, 2008
Time: 11:15 AM
Direction: SE
Photo by: Eisenbrandt
Exposure #: 019
Comments: Several pallets of stacked shingles and roofing paper, and an air conditioning condenser were still observed northwest of the house.

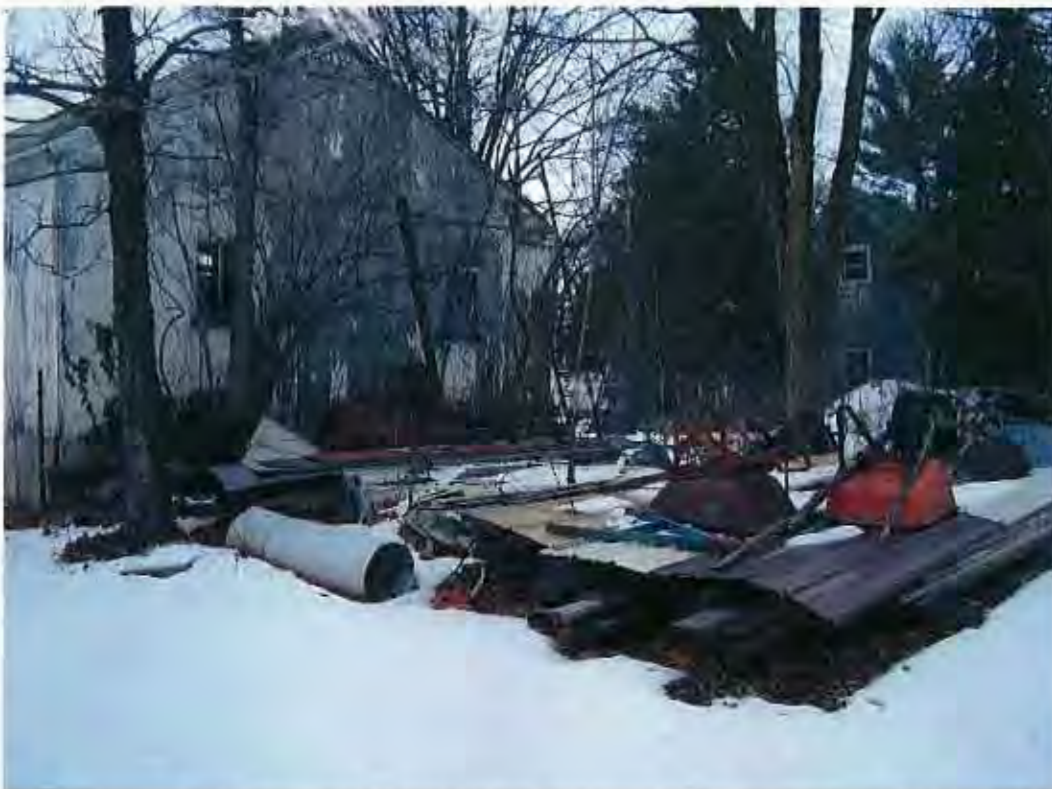
Photograph 020 shows several stacks of dimensional lumber, vinyl siding, and sheet metal on the east side of the garage. The lumber piles were covered between the first two inspections; however it appears as if more building supplies are accumulating. A gasoline can, several garage door sections, and multiple wheelbarrows were still observed to the rear of the garage.

Date: February 7, 2008
Time: 11:16 AM
Direction: NW
Photo by: Eisenbrandt
Exposure #: 020
Comments: Stacks of dimensional lumber, vinyl siding, and sheet metal were observed along with miscellaneous debris, and wheel barrows to the rear of the garage. Sheet metal is still covering stacks of lumber.

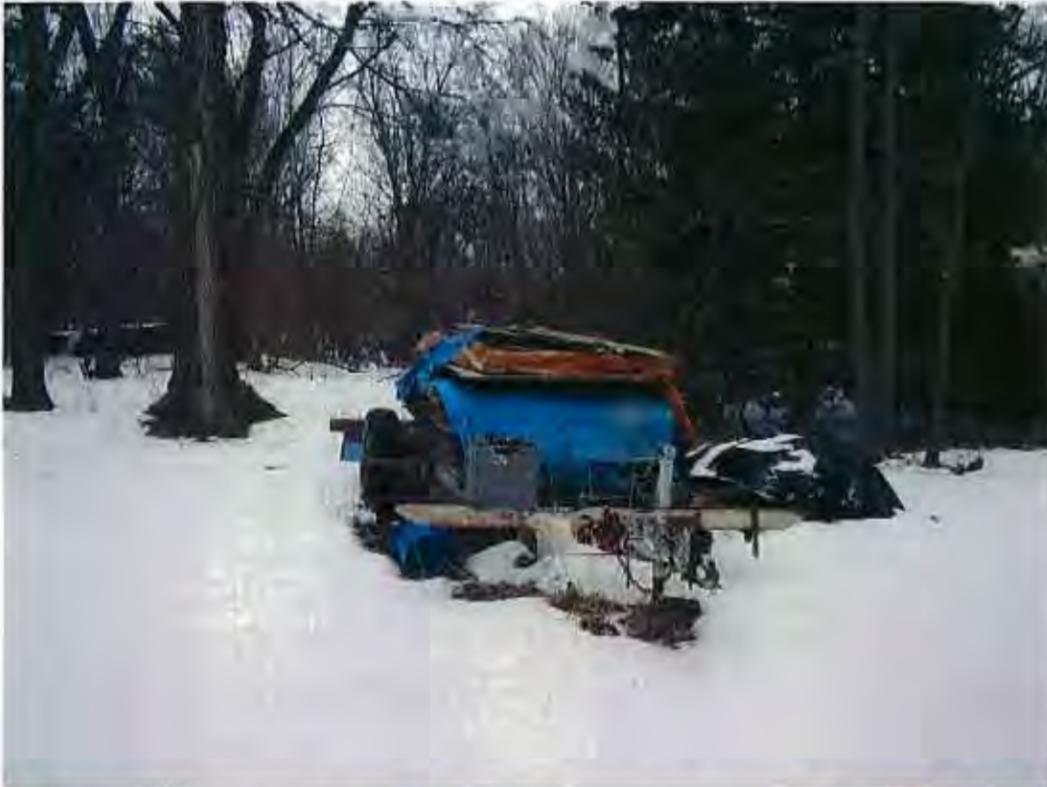
Photograph 021 shows a trailer stacked with plywood and covered with tarps. It appears as if the trailer has not moved since the initial inspection. A Dixie Chopper mower has been removed from the area and as previous noted, the blue Oldsmobile and an air tank were removed prior to the last inspection.

Date: February 7, 2008
Time: 11:16 AM
Direction: N
Photo by: Eisenbrandt
Exposure #: 021
Comments: A stack of plywood covered with a blue tarp has not moved since previous inspections.

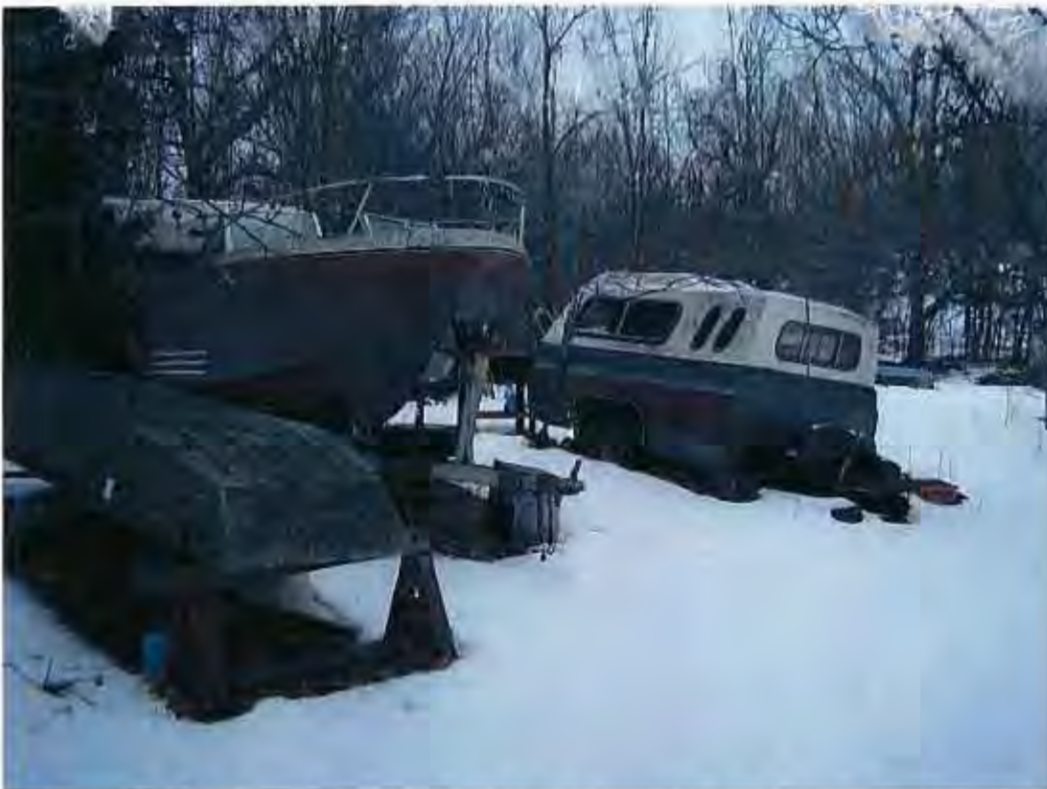
Photograph 022 shows a truck bed trailer, two boats, and miscellaneous debris as observed during this inspection. The area is the same as it was during previous inspections of 2006 and 2007.

Date: February 7, 2008
Time: 11:17 AM
Direction: NE
Photo by: Eisenbrandt
Exposure #: 022
Comments: A truck bed trailer, two boats, and miscellaneous debris were observed in the yard. This area is mostly unchanged.

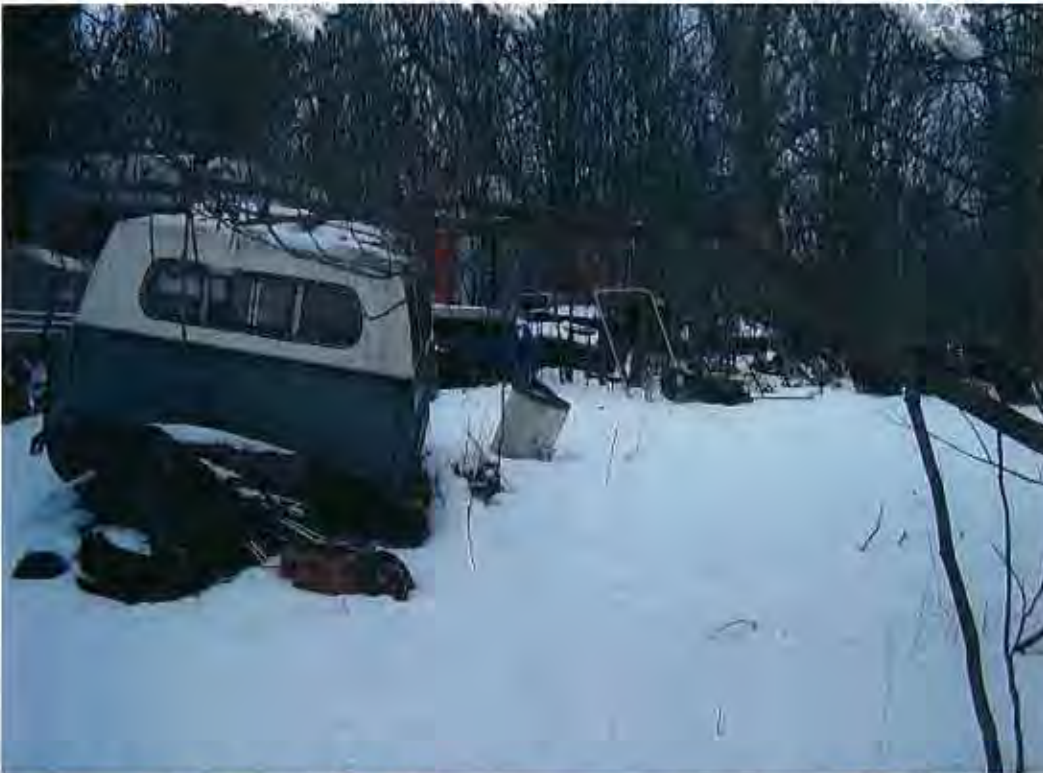
Date: February 7, 2008
Time: 11:17 AM
Direction: N
Photo by: Eisenbrandt
Exposure #: 023
Comments: Vehicles parts and miscellaneous waste were still observed around the truck bed trailer.

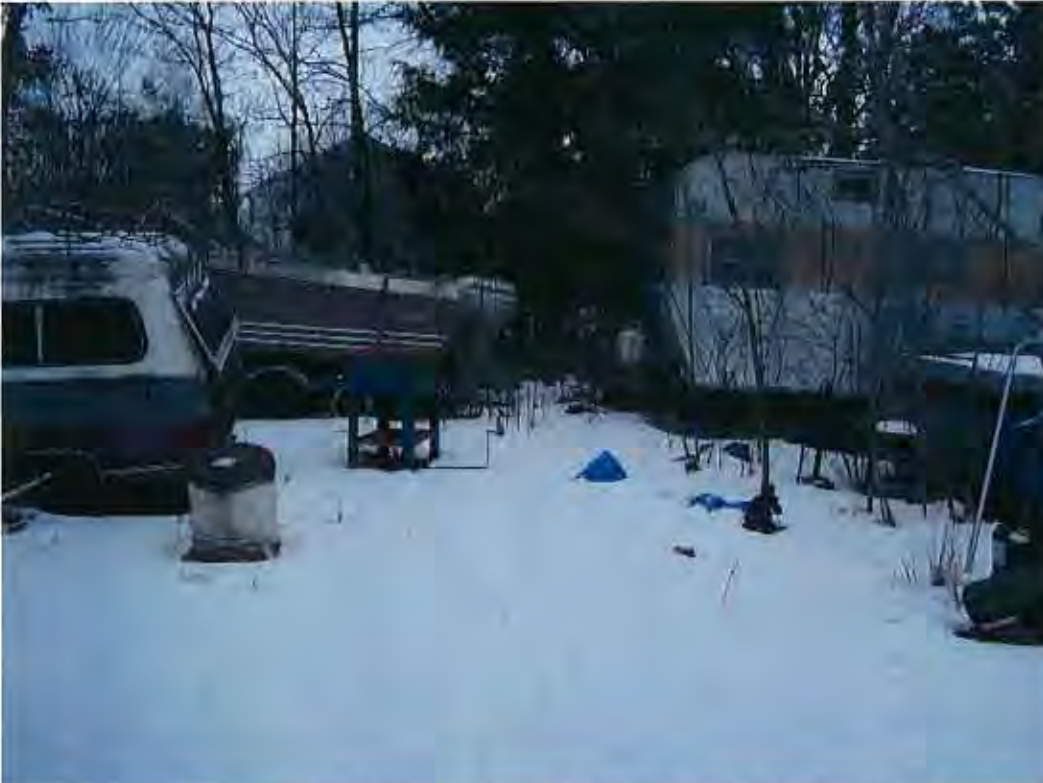
Photograph 024 shows an area between a camper, a boat, and a truck bed trailer. The blue parts cleaner seen in the photograph appears to have been moved from closer to the dilapidated garage. Also, the partially crushed fiber drum may have been moved from around the tree seen in Photographs 007 and 011. The red and silver Chevy pickup truck, and its debris filled bed were not observed again during this inspection.

Date: February 7, 2008
Time: 11:18 AM
Direction: W
Photo by: Eisenbrandt
Exposure #: 024
Comments: The blue parts cleaner (?) table has been moved from behind the garage to this area near the multicolored shed. Other miscellaneous weathered wastes were observed scattered throughout the area.
