ILLINOIS ENVIRONMENTAL PROTECTION AGENCY

Re: Illinois Environmental Protection Agency v. Hiram Vanderheiden, Jr.
IEPA File No. 51-08-AC; 1258075004—Mason County

BEFORE THE ILLINOIS POLLUTION CONTROL BOARD
ADMINISTRATIVE CITATION

LPC #1258075004 - Mason County
 Manito / Vanderheiden
 FOS File
 February 7, 2008 Inspection

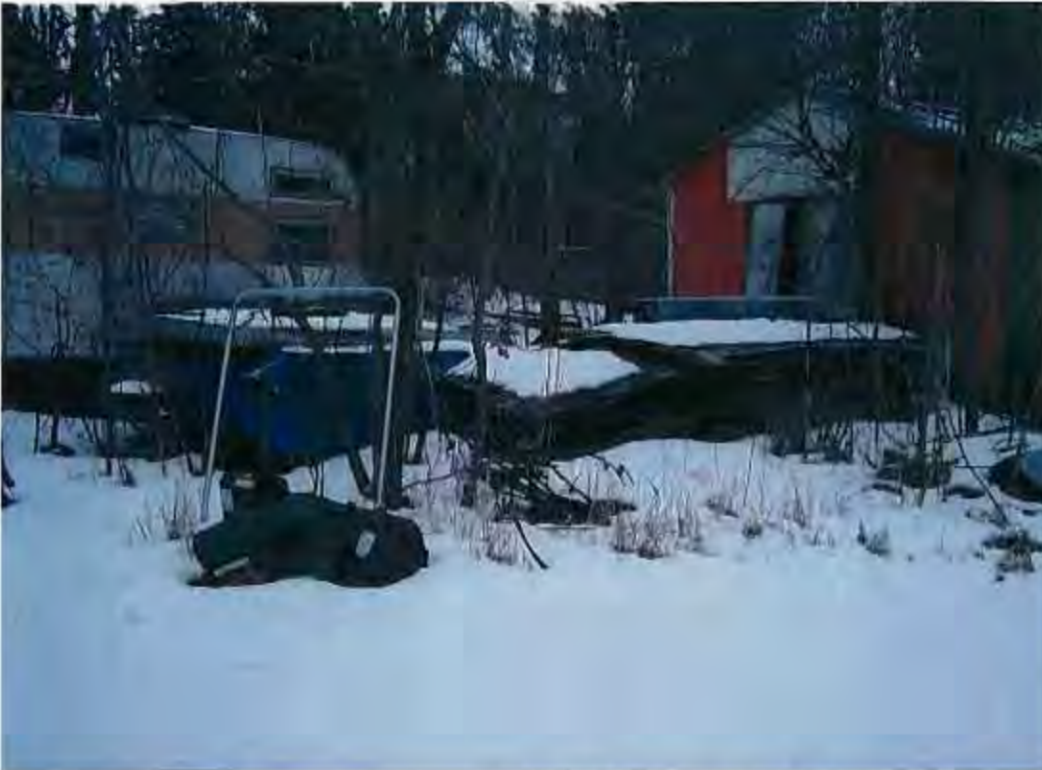
Photographs 025 and 026 show a camper, a trailer, a stack of sheet metal, a broadcast seeder, a rusty barrel, and miscellaneous debris. Much of this waste has remained unchanged. Small diameter trees were still observed grown up around the debris indicating most of it had not been used for several years.

Date: February 7, 2008
Time: 11:18 AM
Direction: NW
Photo by: Eisenbrandt
Exposure #: 025
Comments: A camper, a trailer, and stacks of sheet metal, and miscellaneous debris have not been moved.

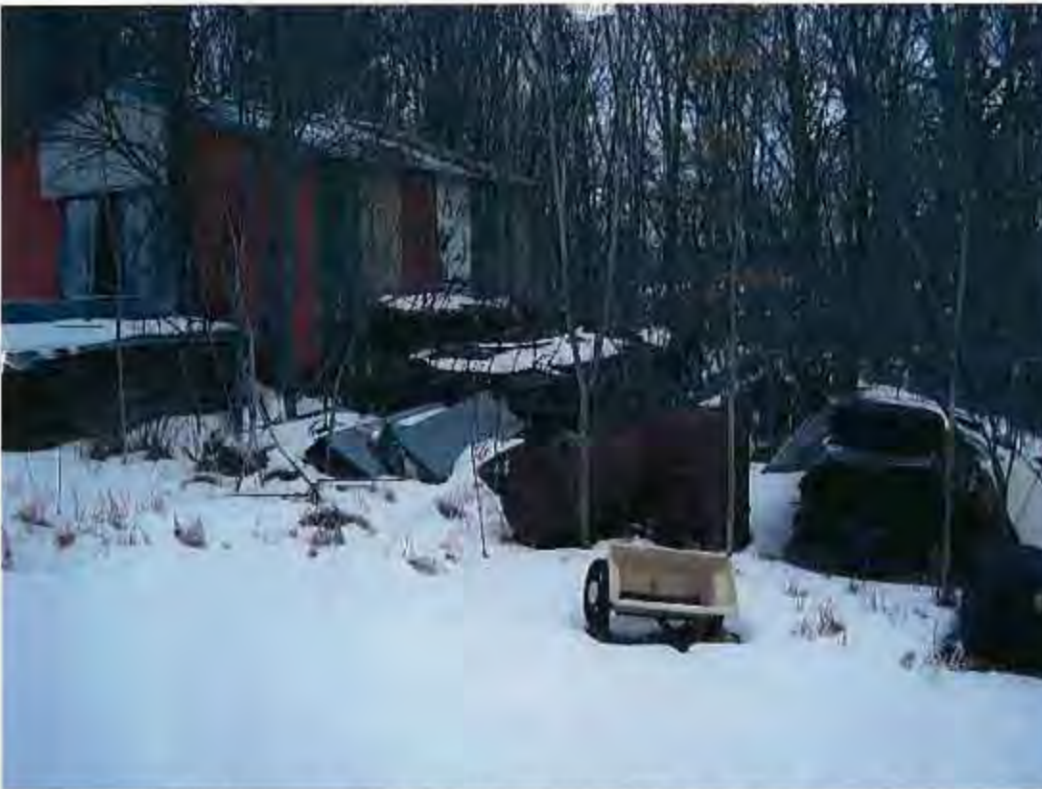
Date: February 7, 2008
Time: 11:18 AM
Direction: NW
Photo by: Eisenbrandt
Exposure #: 026
Comments: Piles of debris on the ground near the multicolored shed.

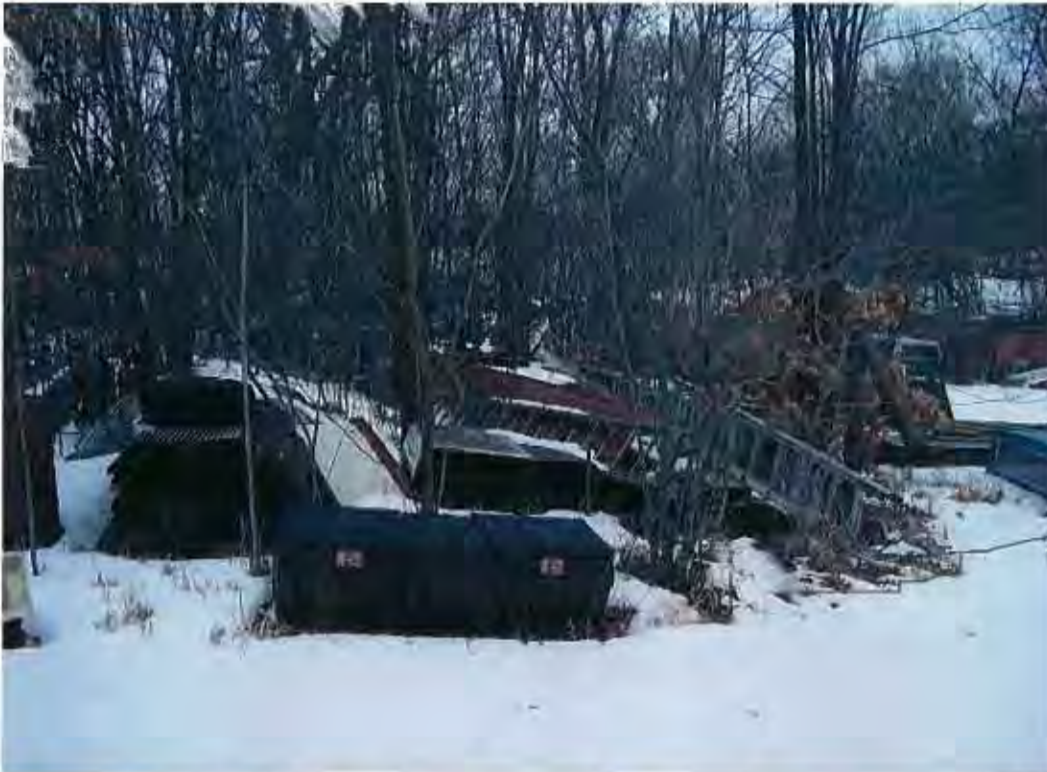
Photograph 027 shows piles of debris stored on the ground near the multi colored sheet metal building and within the scrub trees. A storage box, an on rim used tire, several wooden ladders, and piles of miscellaneous materials were again observed. It does not appear as if much has changed or been cleaned up in this area. The quantity of weathered materials remains similar to previous inspections.

Date: February 7, 2008
Time: 11:18 AM
Direction: N
Photo by: Eisenbrandt
Exposure #: 027
Comments: The tree line east of the house and the garage was still littered with building materials, truck toppers, trailers, ladders, truck storage boxes, and miscellaneous waste.

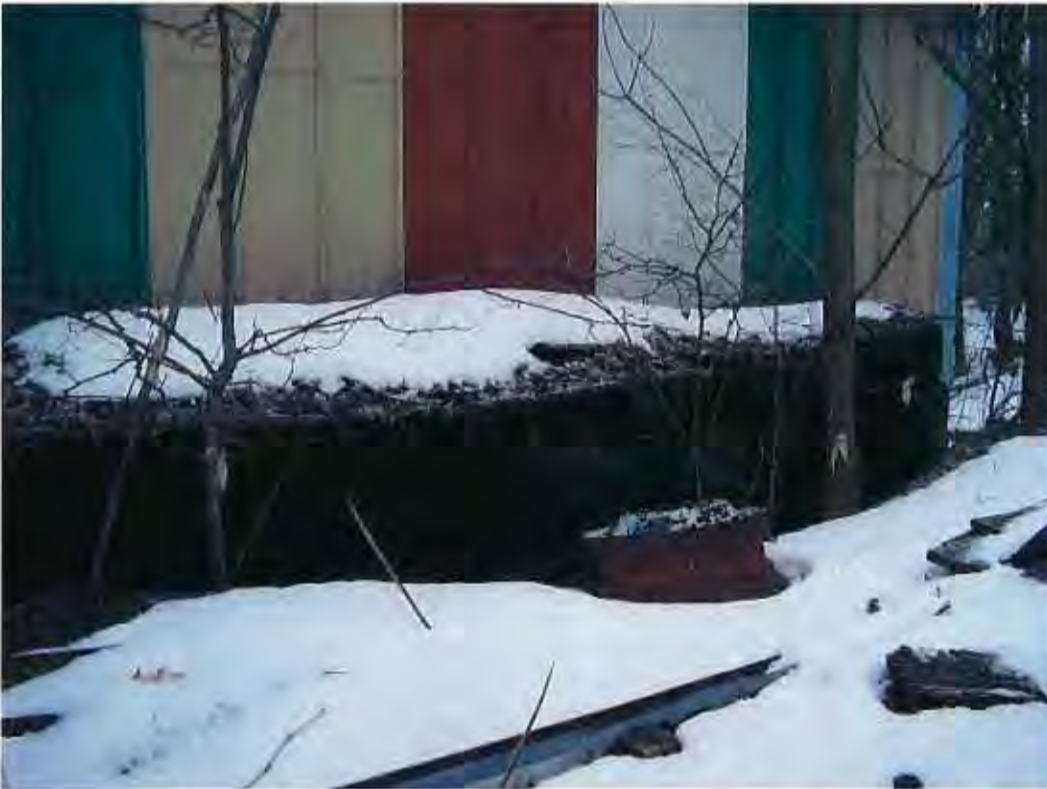
Photograph 028 shows twenty seven used tires stacked and covered outside the east side of the multicolored shed. Snow and leaves covered the metal or wood sheeting, and shielded the used tires from precipitation. There are other used tires observed on site as can be seen in Photographs 027, 032, & 033. At least thirty used tires were observed at this site.

Date: February 7, 2008
Time: 11:19 AM
Direction: NW
Photo by: Eisenbrandt
Exposure #: 028
Comments: Twenty seven used tires were observed stacked outside the east side of the multicolored shed. Sheeting stretched across the top of the tires to shield them from precipitation.

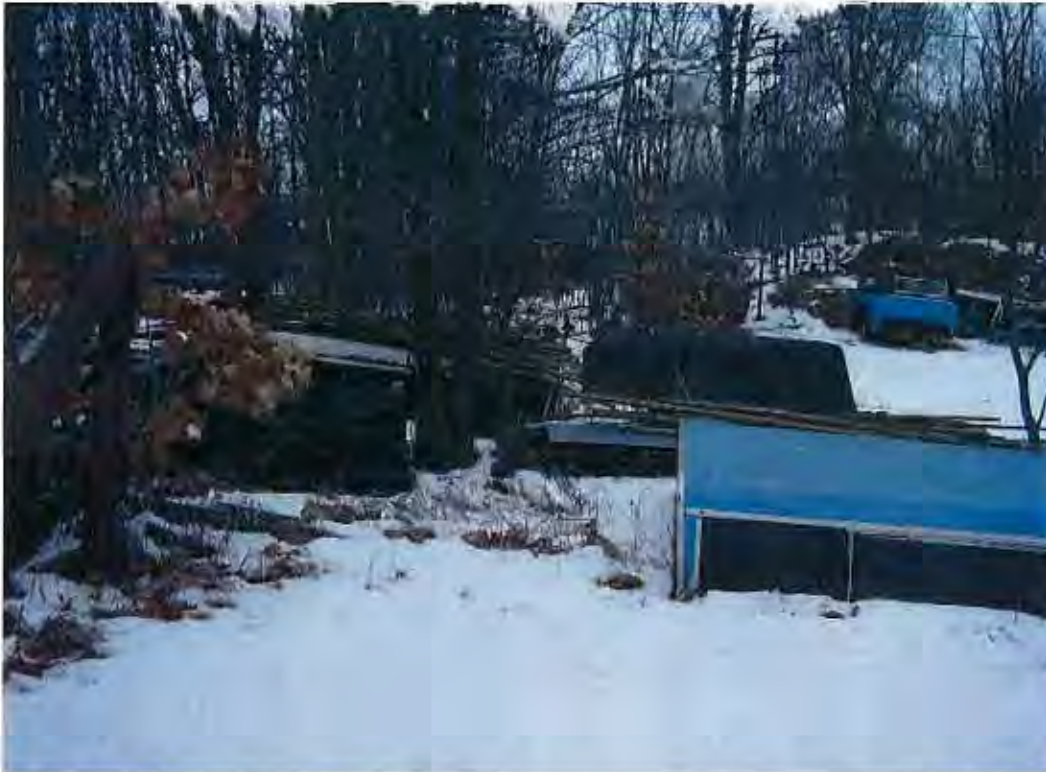
Photographs 029, 030, and 031 show the tree line east of the house, garage, and shed. The tree line was littered with building materials, truck toppers, trailers, and miscellaneous debris as it was during the September 2006 inspection. A blue topper, a white and maroon topper, and two black truck toppers, black corrugated drain tile, and stacks of wood and sheet metal were observed in this vicinity. A hot water heater appears to have been moved from this location.

Date: February 7, 2008
Time: 11:22 AM
Direction: N
Photo by: Eisenbrandt
Exposure #: 029
Comments: The numerous truck toppers and debris still litter the tree line.

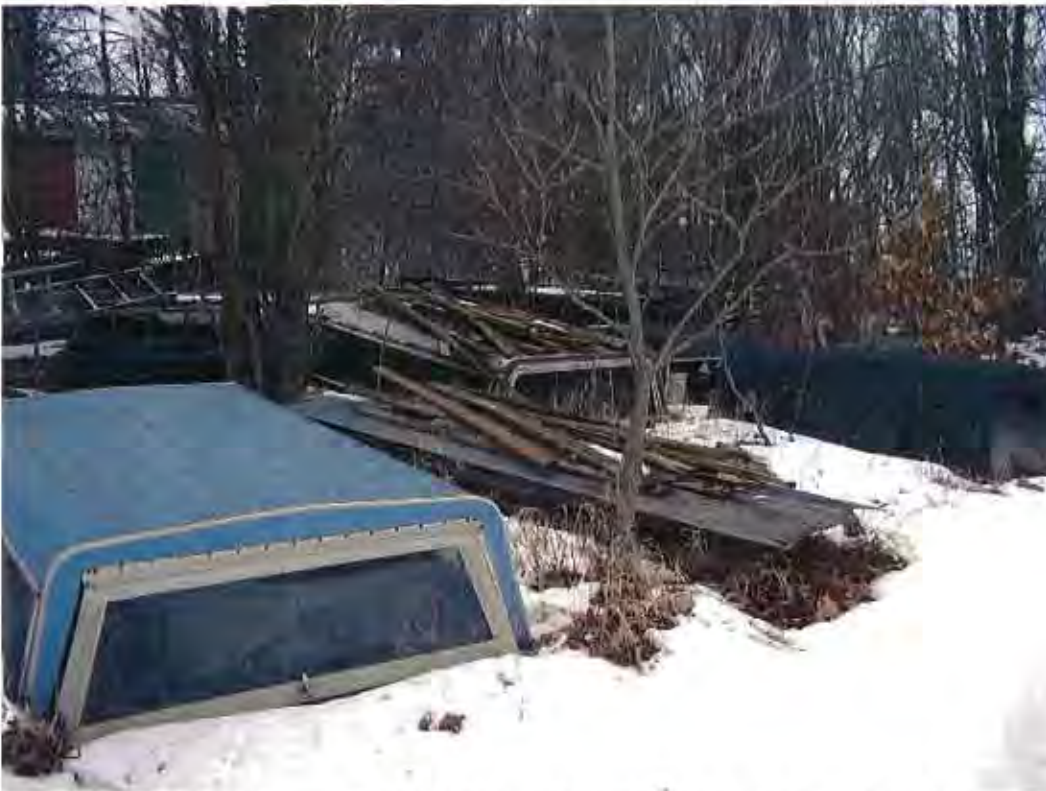
Date: February 7, 2008
Time: 11:22 AM
Direction: NW
Photo by: Eisenbrandt
Exposure #: 030
Comments: The numerous truck toppers, scrap metal, black corrugated plastic drain pipe, and debris still litter the tree line.

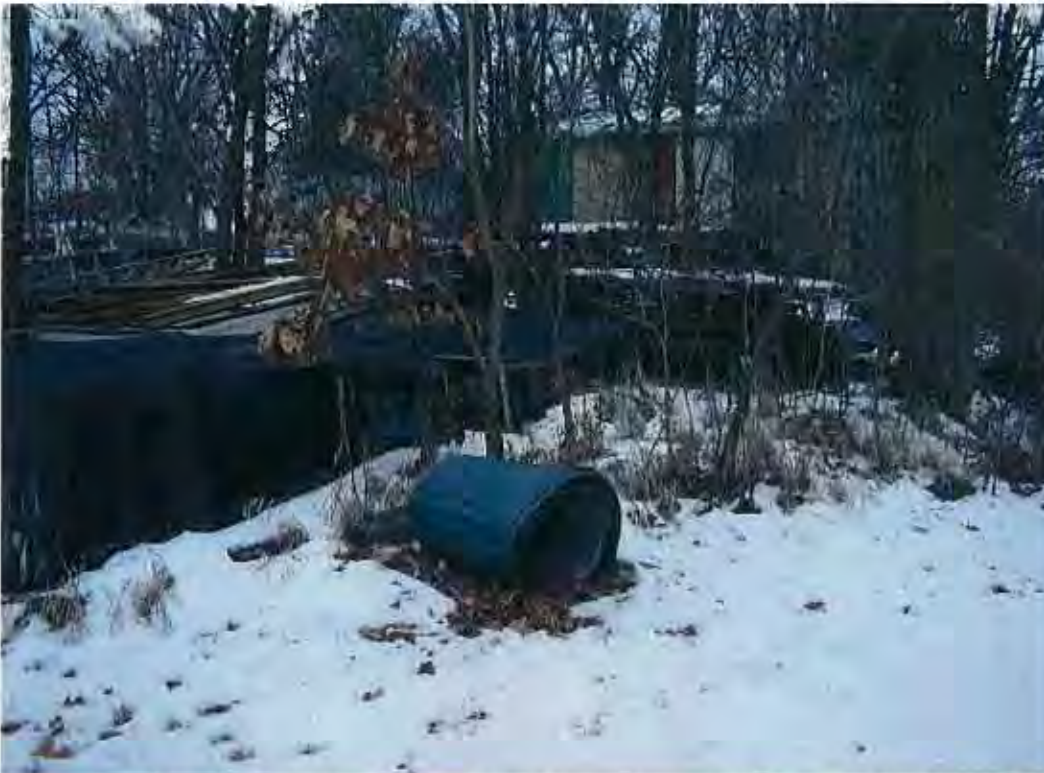
Date: February 7, 2008
Time: 11:22 AM
Direction: SW
Photo by: Eisenbrandt
Exposure #: 031
Comments: More debris
in tree line east of
multicolored shed.

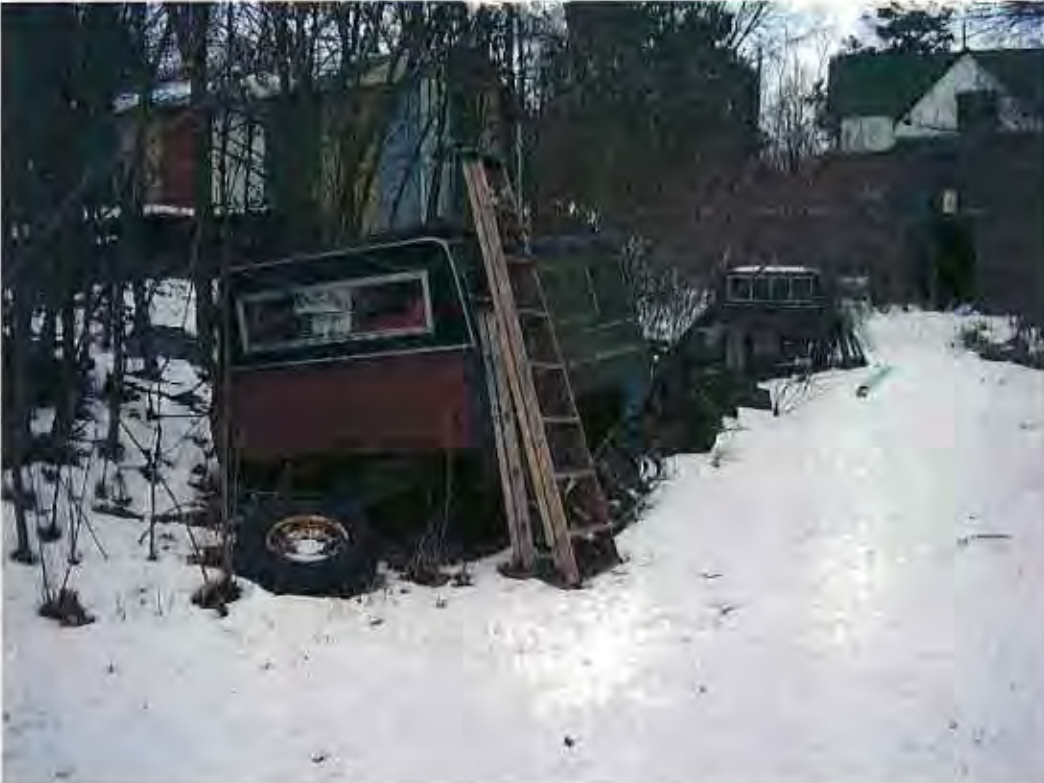
Date: February 7, 2008
Time: 11:22 AM
Direction: W
Photo by: Eisenbrandt
Exposure #: 032
Comments: View facing
west towards the house.
A pickup truck trailer, an
on rim used tire, three
wooden ladders, and
miscellaneous debris
were scattered
throughout this area.

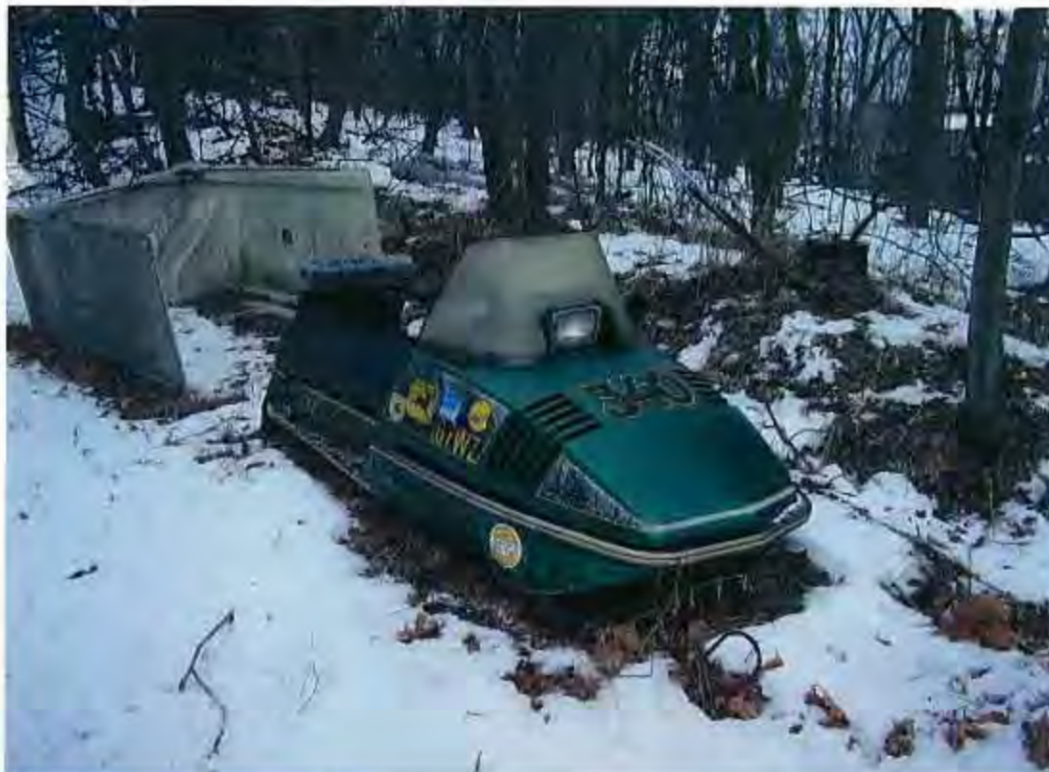
Date: February 7, 2008
Time: 11:22 AM
Direction: NW
Photo by: Eisenbrandt
Exposure #: 033
Comments: A green snowmobile, and a well weathered shower stall were among the debris behind the house.

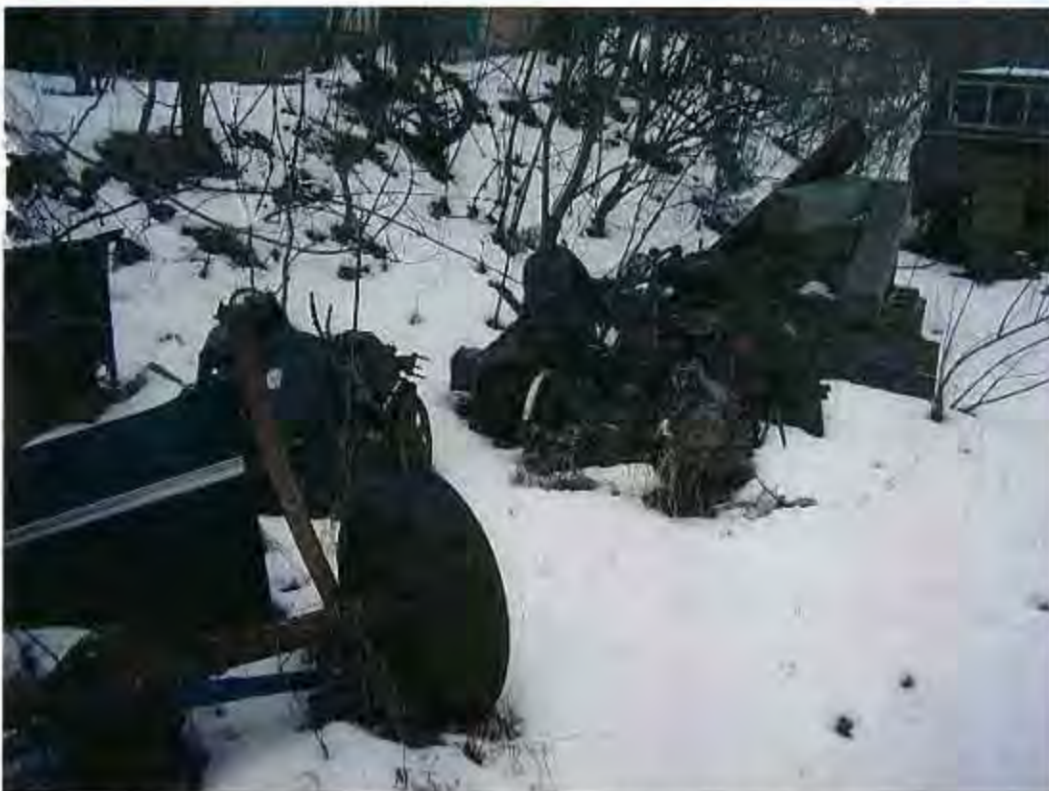
Date: February 7, 2008
Time: 11:22 AM
Direction: SW
Photo by: Eisenbrandt
Exposure #: 034
Comments: Heavy timbers, two engines, and motor vehicle parts were observed on the ground behind the house.

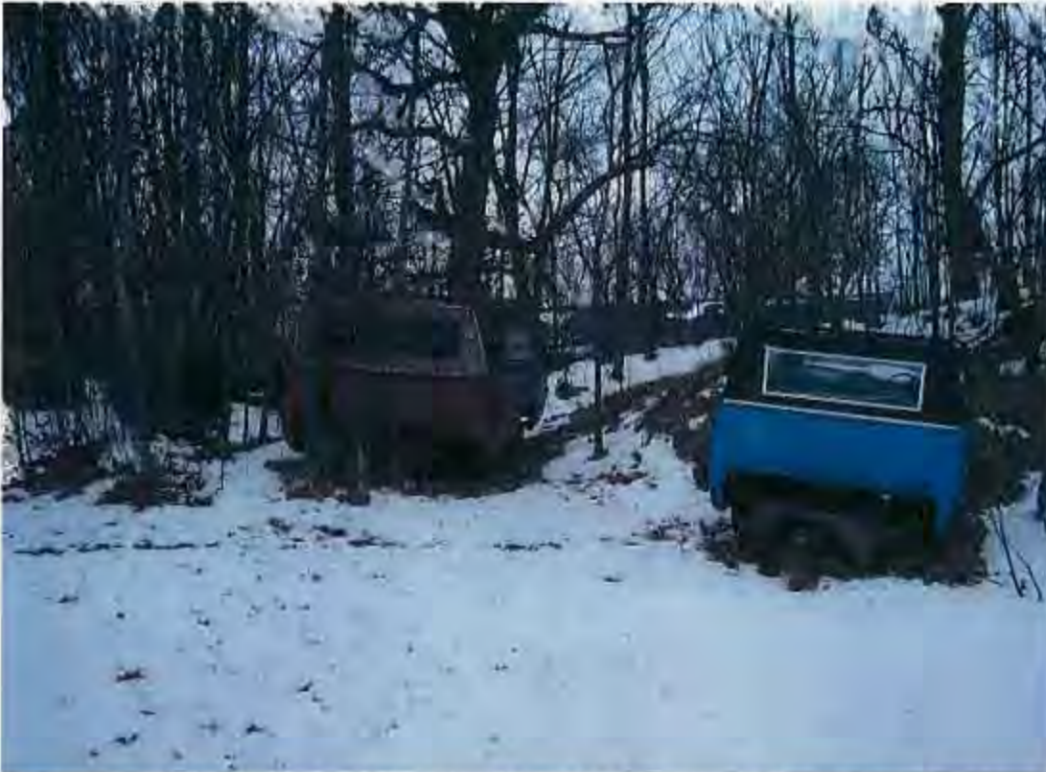
Date: February 7, 2008
Time: 11:30 AM
Direction: NW
Photo by: Eisenbrandt
Exposure #: 035
Comments: More trailers, truck toppers, and stacked shingles were still observed in the scrub trees.

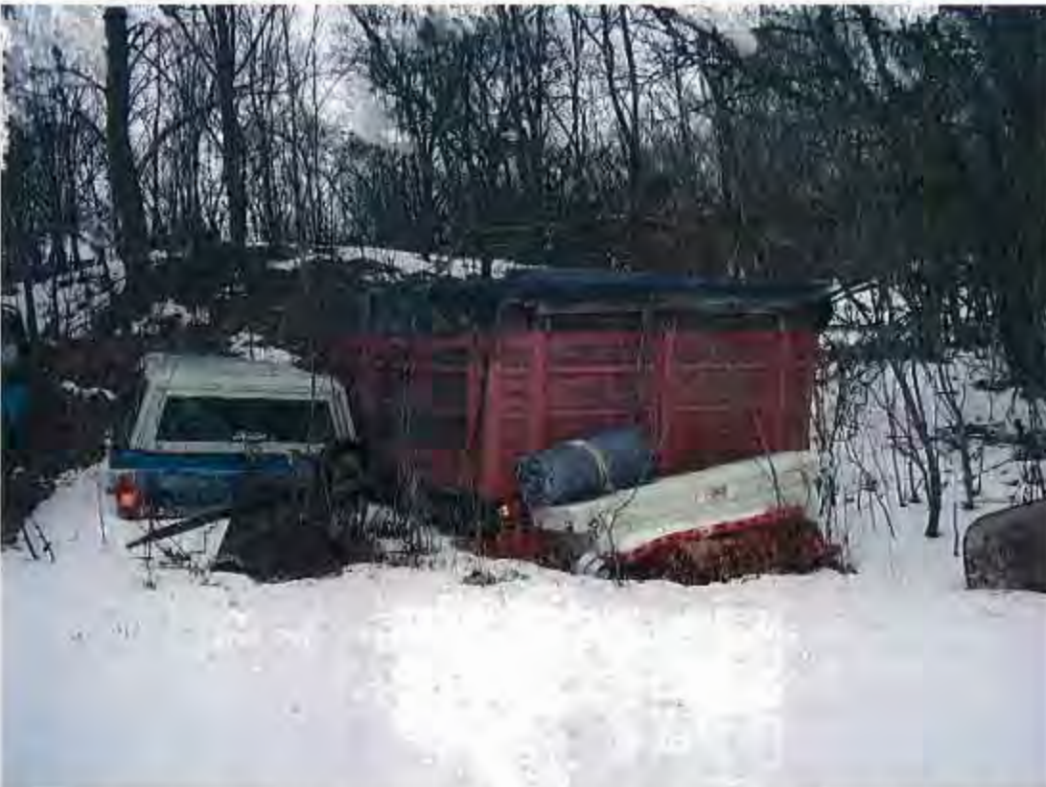
Date: February 7, 2008
Time: 11:30 AM
Direction: N
Photo by: Eisenbrandt
Exposure #: 036
Comments: A red trailer, a truck bed trailer, a wheel barrow, snow fencing, a truck storage box, and a tarp were observed on the north edge of the property. It appears that more items have been added to this area since the last inspection.

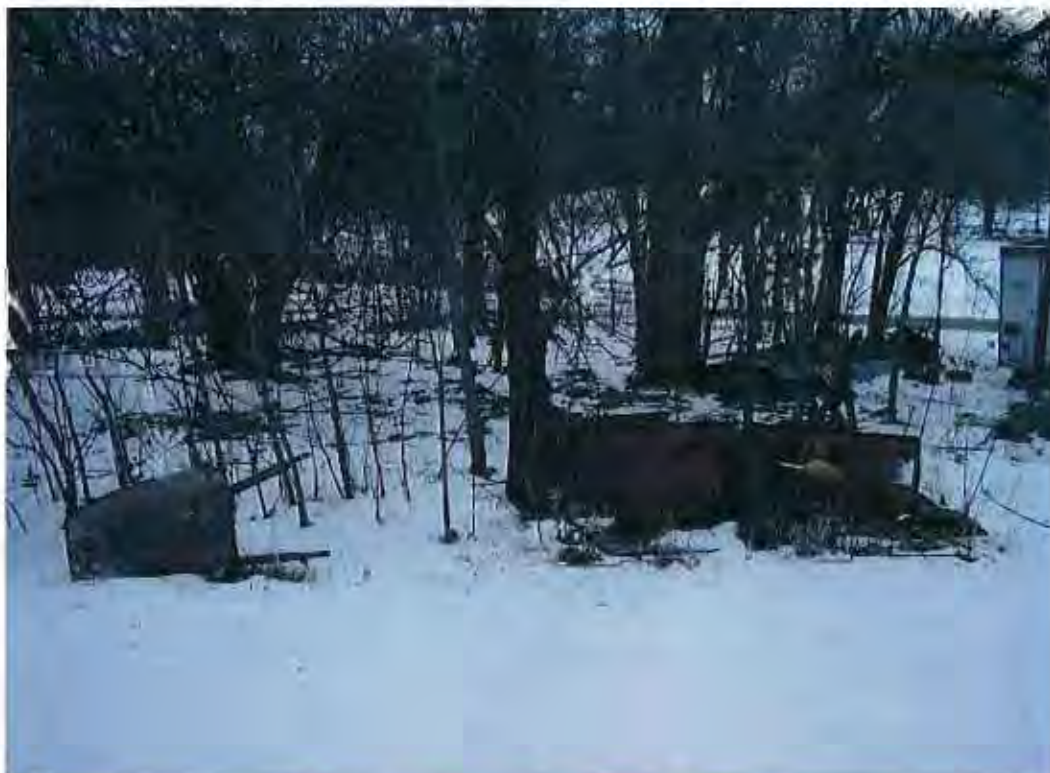
Date: February 7, 2008
Time: 11:30 AM
Direction: NE
Photo by: Eisenbrandt
Exposure #: 037
Comments:
Miscellaneous waste is still in the tree line

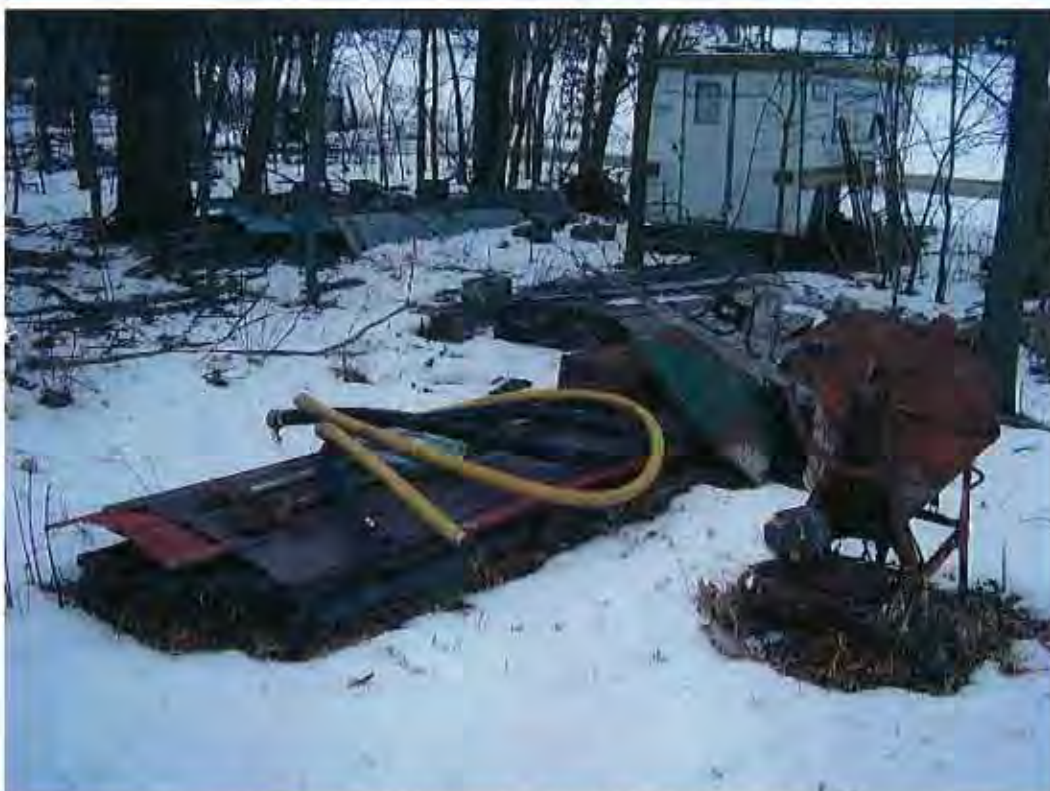
Date: February 7, 2008
Time: 11:30 AM
Direction: NE
Photo by: Eisenbrandt
Exposure #: 038
Comments:
Miscellaneous waste is still in the tree line

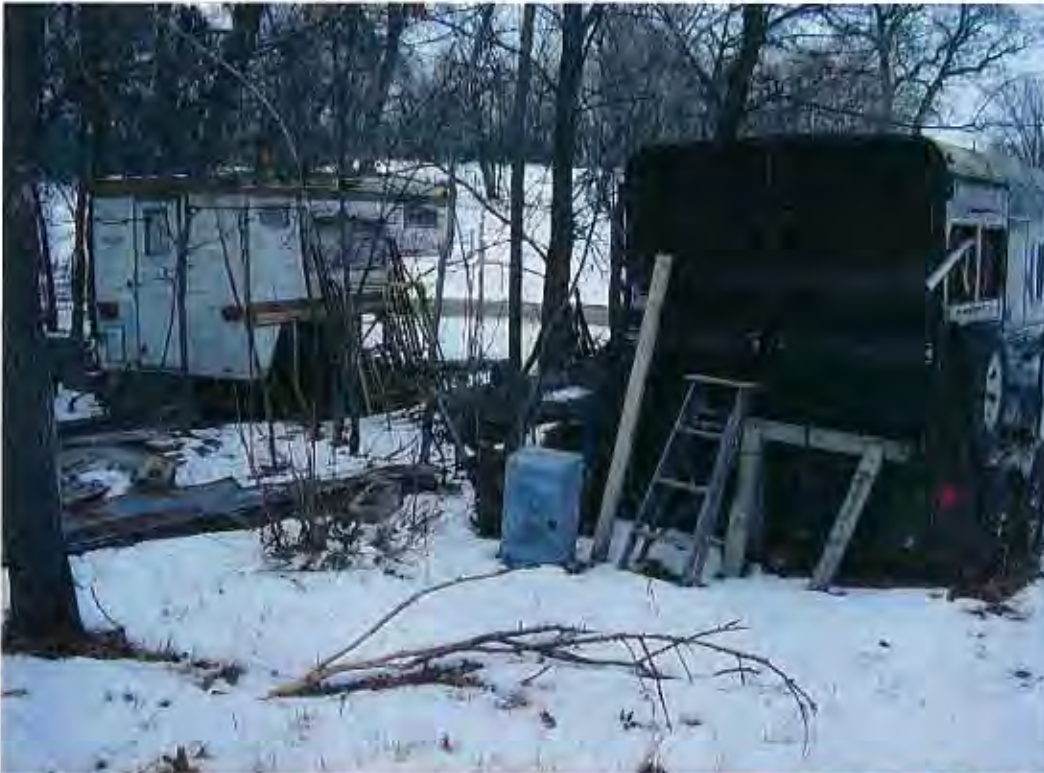
Date: February 7, 2008
Time: 11:30 AM
Direction: NE
Photo by: Eisenbrandt
Exposure #: 039
Comments: A camper, a trailer, piles of scrap metal, and miscellaneous waste in the northeast corner of the site.

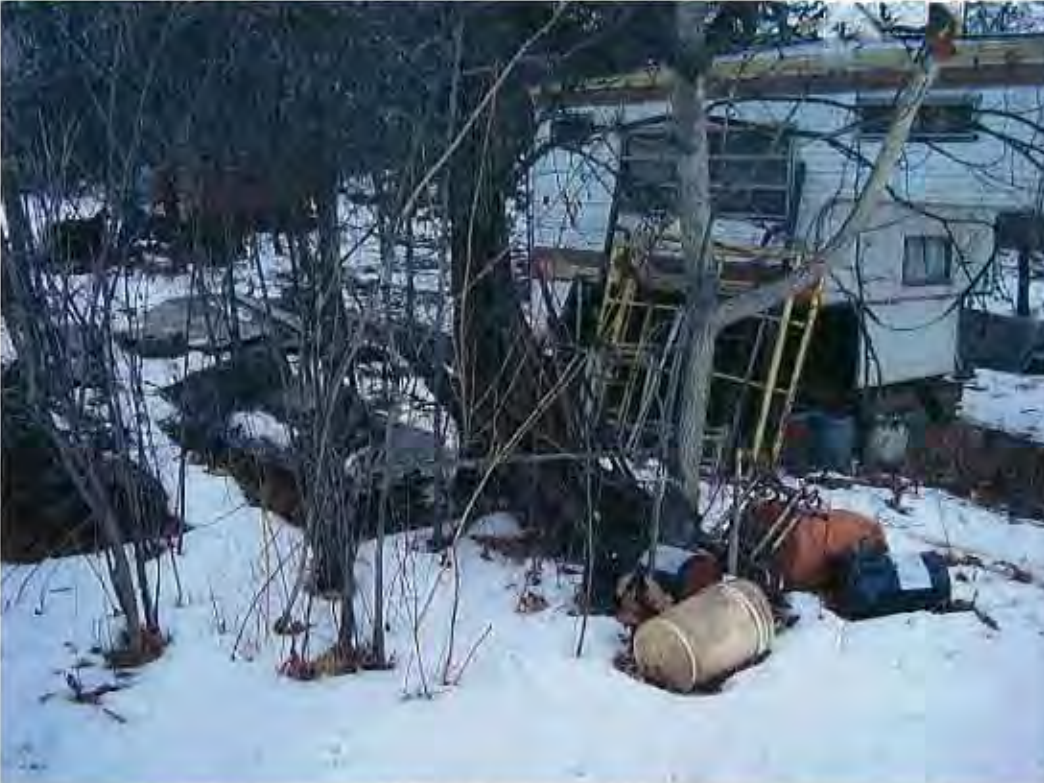
Date: February 7, 2008
Time: 11:31 AM
Direction: NW
Photo by: Eisenbrandt
Exposure #: 040
Comments: Stacks of scrap metal, yellow scaffolding, plastic buckets, and miscellaneous waste stored in tree line.

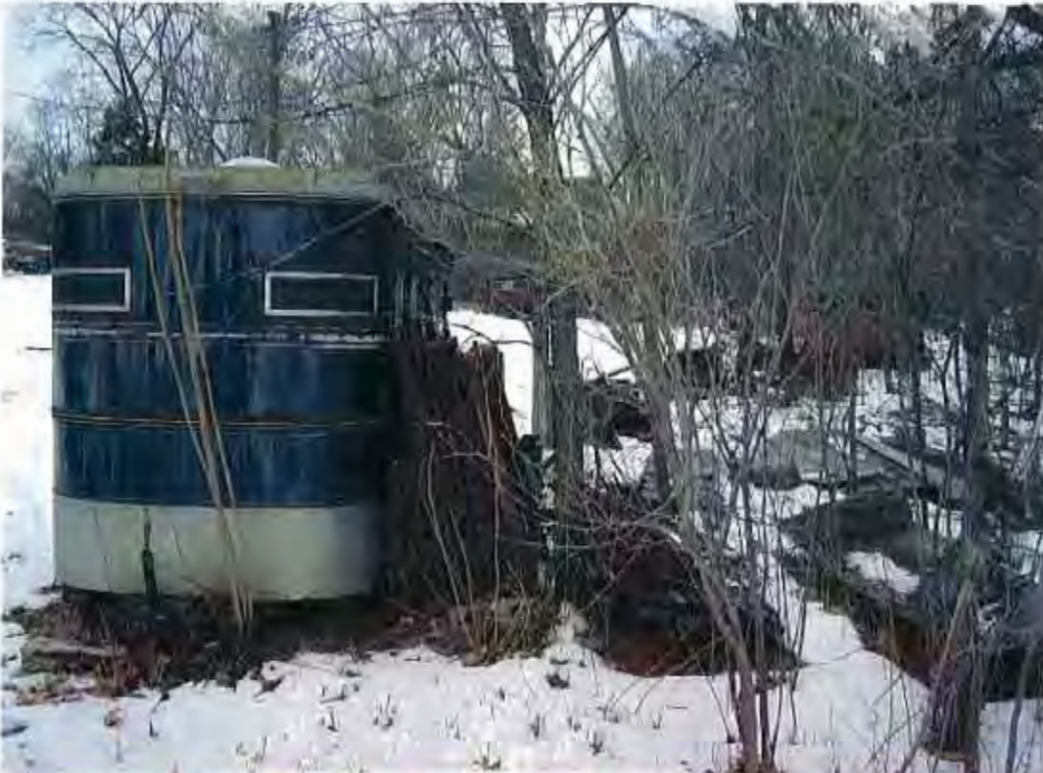
Date: February 7, 2008
Time: 11:31 AM
Direction: W
Photo by: Eisenbrandt
Exposure #: 041
Comments:
Miscellaneous waste in
tree line.

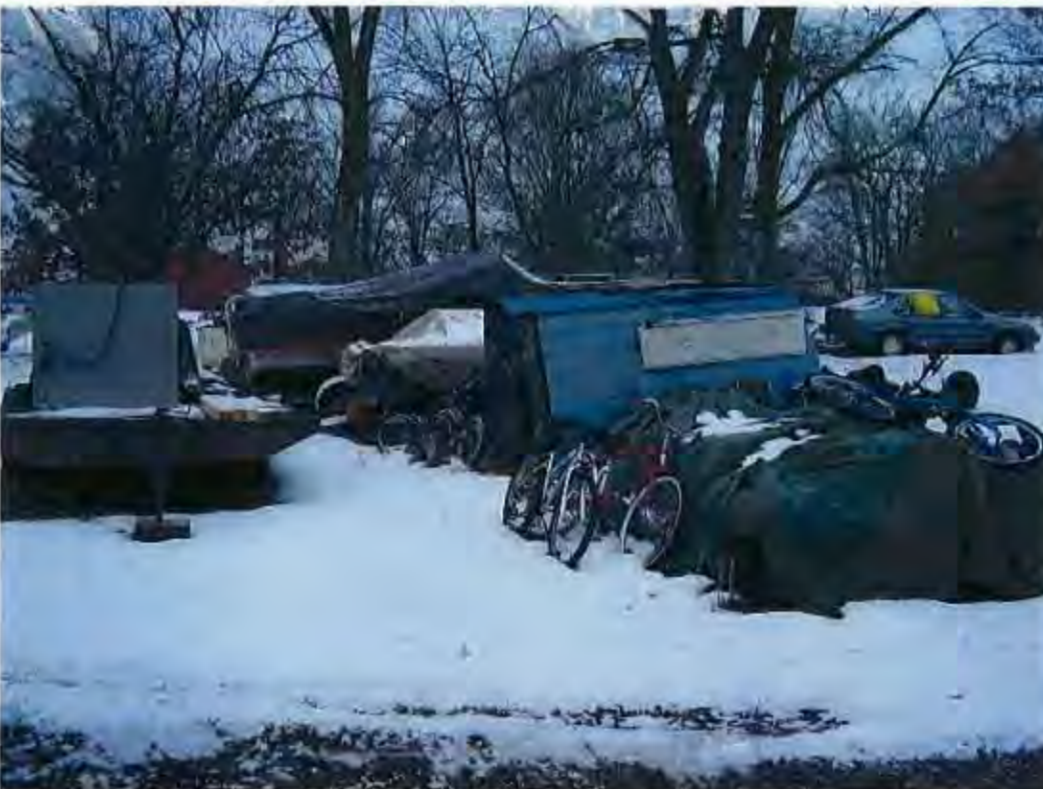
Date: February 7, 2008
Time: 11:31 AM
Direction: S
Photo by: Eisenbrandt
Exposure #: 042
Comments: A large flat
bed trailer is new since
the last inspection. Four
bicycles, several
snowmobiles covered
with green tarpaulins,
were observed on the
east end of the property.
This area has not
changed much since the
last inspection.

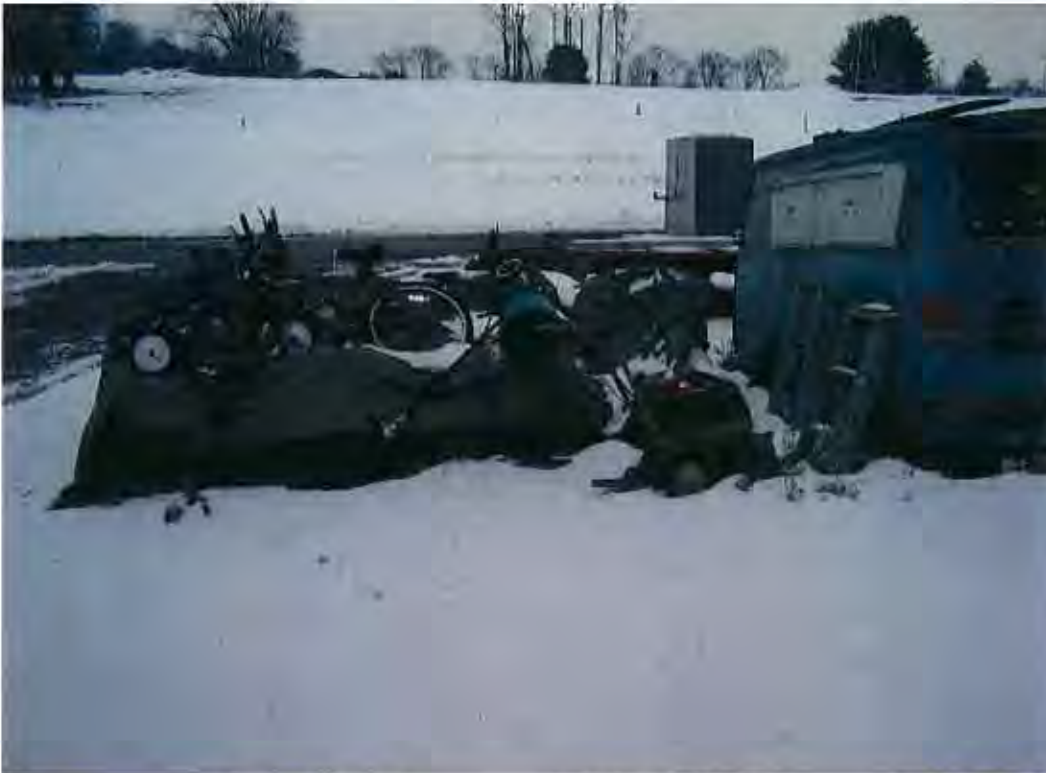
Date: February 7, 2008
Time: 11:31 AM
Direction: E
Photo by: Eisenbrandt
Exposure #: 043
Comments: Wooden ladders, bicycles, a green rotary tiller, and miscellaneous debris were observed.

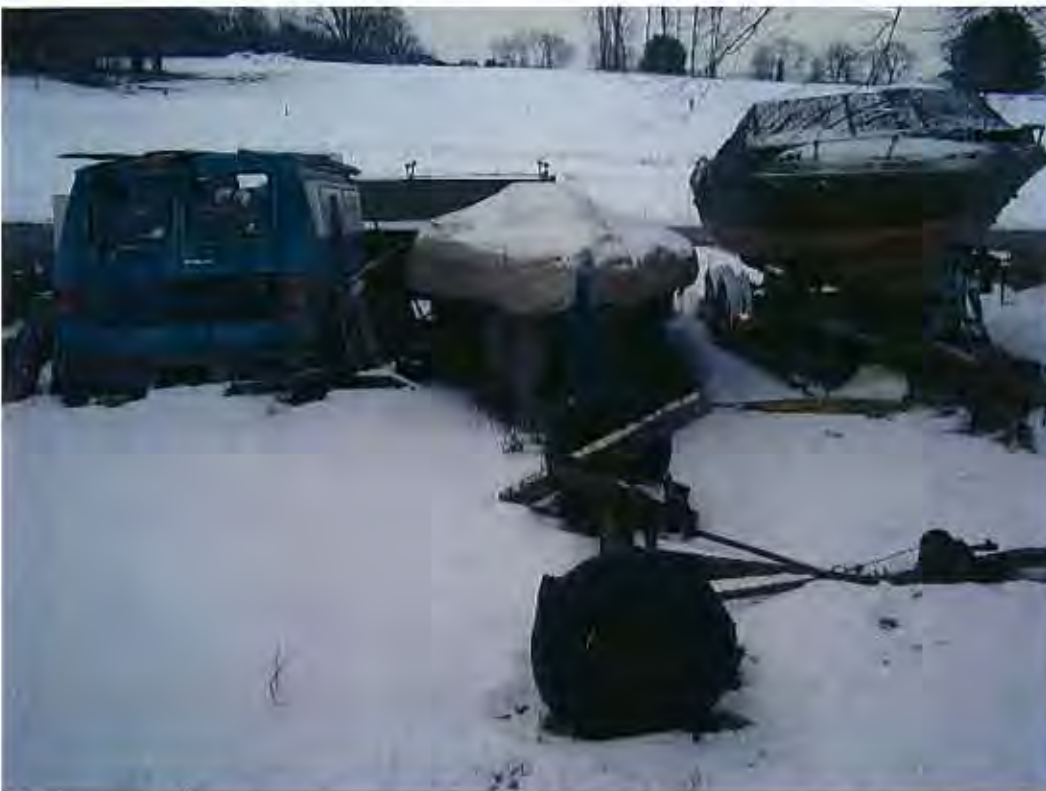
Date: February 7, 2008
Time: 11:31 AM
Direction: E
Photo by: Eisenbrandt
Exposure #: 044
Comments: Alternate view of scrap metal, boats, a blue van, two boats, and an axle were observed.

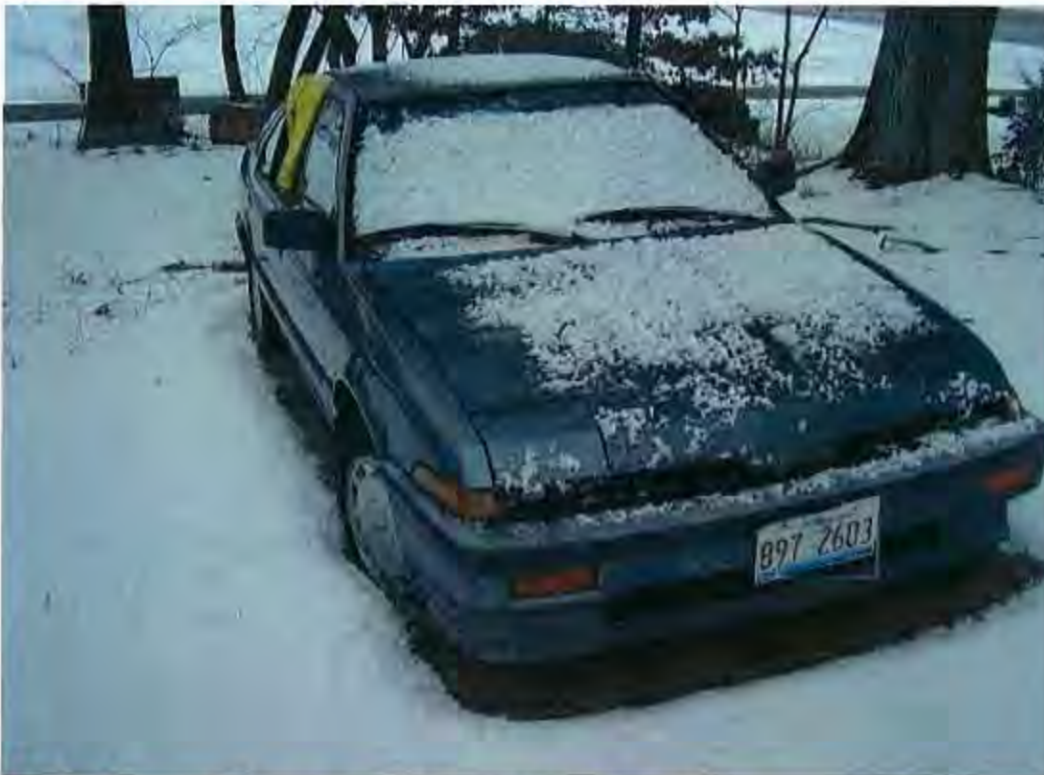
Date: February 7, 2008
Time: 11:32 AM
Direction: E
Photo by: Eisenbrandt
Exposure #: 045
Comments:, A gray Acura with a broken rear window is still on site. The vehicle has been moved since the last inspection

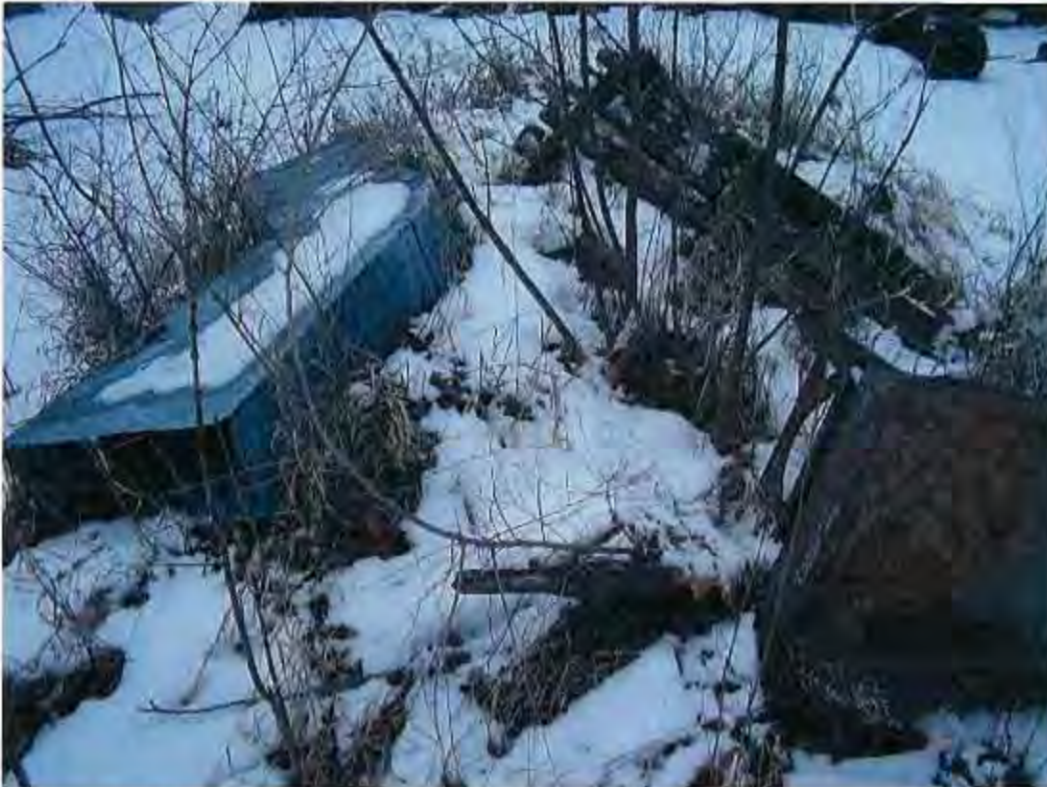
Date: February 7, 2008
Time: 11:32 AM
Direction: E
Photo by: Eisenbrandt
Exposure #: 046
Comments: Sheet metal air duct, another wheel barrow, and debris on a small weedy dirt hill.

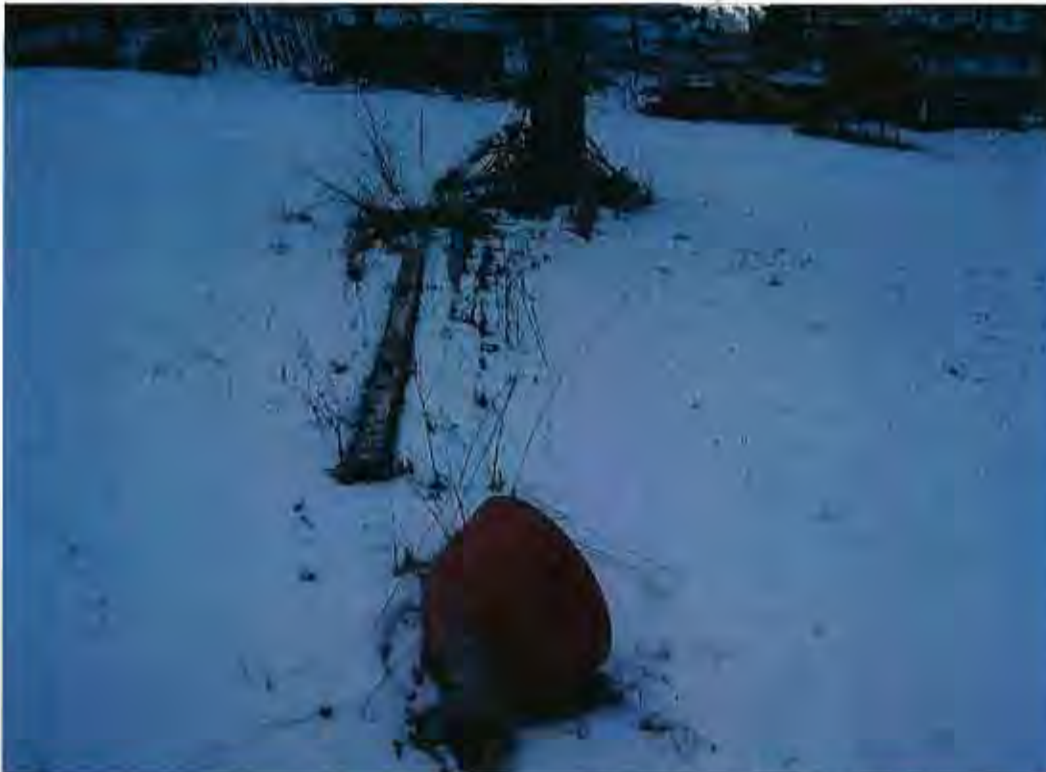
Date: February 7, 2008
Time: 11:32 AM
Direction: N
Photo by: Eisenbrandt
Exposure #: 047
Comments: A large exterior light, dimensional lumber, and miscellaneous items near eastern section of site

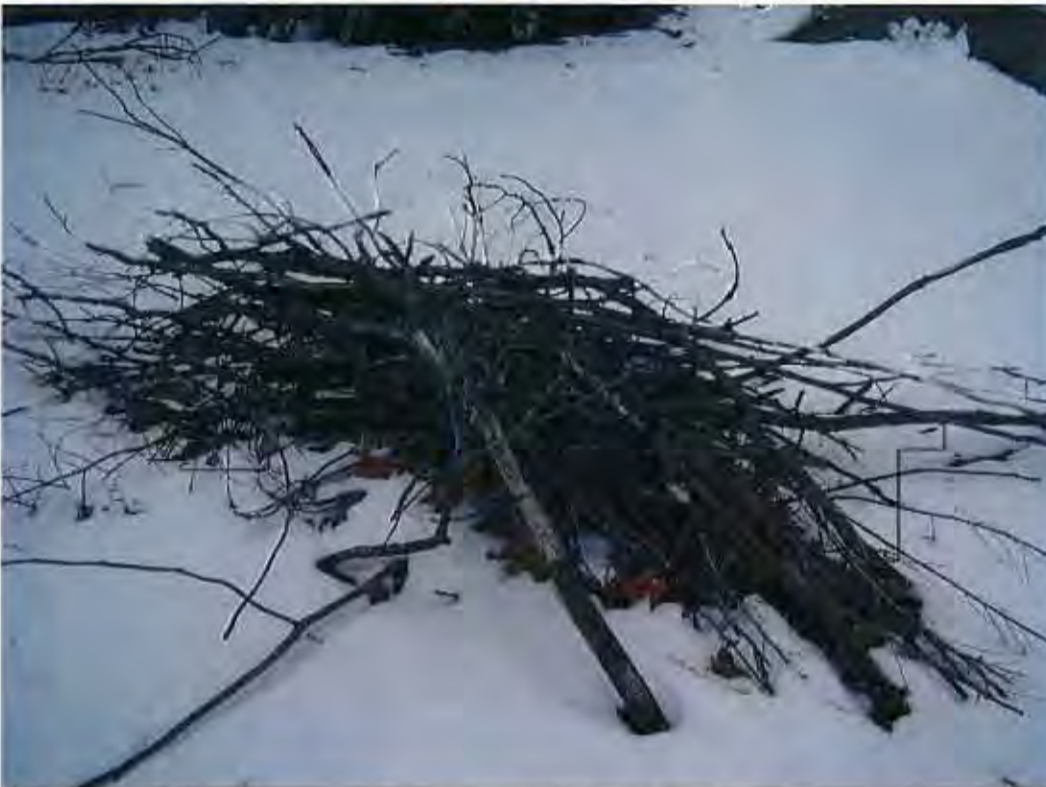
Date: February 7, 2008
Time: 11:32 AM
Direction: NE
Photo by: Eisenbrandt
Exposure #: 048
Comments: Landscape waste on the burn pile located in the rear yard.

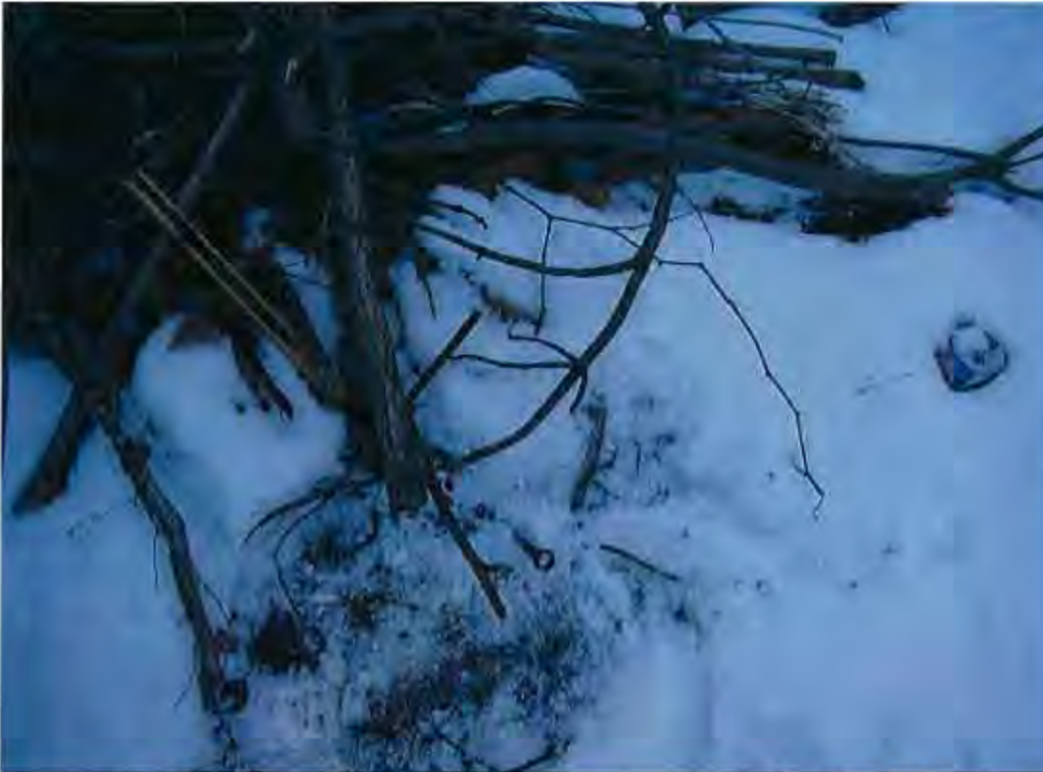
Date: February 7, 2008
Time: 11:33 AM
Direction: W
Photo by: Eisenbrandt
Exposure #: 049
Comments: A beer can, charred processed wood, a hose clamp, a wrench, and a rusty saw blade were among the ash and charred waste beneath the landscape waste and snow covered. It does not appear as if the open burnt waste previously observed at this fire pit has been cleaned up.
