ILLINOIS ENVIRONMENTAL PROTECTION AGENCY

Re: Illinois Environmental Protection Agency v. Hiram Vanderheiden, Jr.
IEPA File No. 51-08-AC; 1258075004—Mason County

BEFORE THE ILLINOIS POLLUTION CONTROL BOARD
ADMINISTRATIVE CITATION

LPC #1258075004 - Mason County
 Manito / Vanderheiden
 FOS File
 February 7, 2008 Inspection

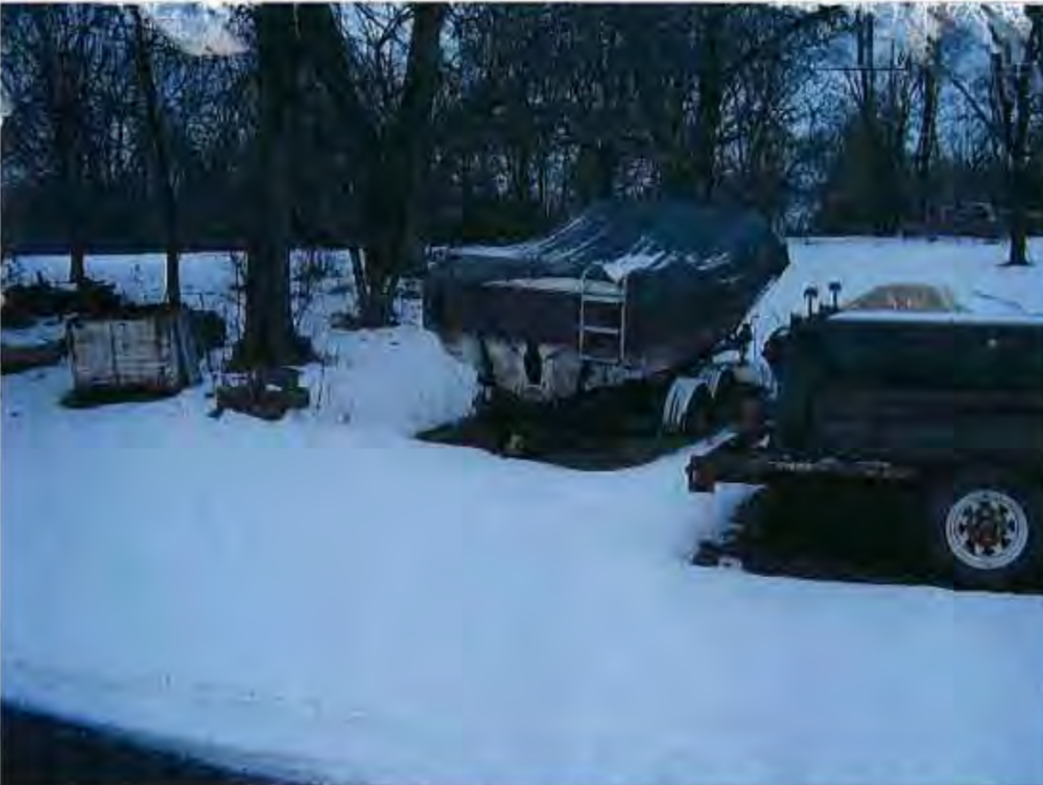
Photograph 050 and 051 are alternate views of the debris from East Avenue. Several pallets full of brick and pavers were also observed in the southeast corner of the lot.

Date: February 7, 2008
Time: 11:35 AM
Direction: SW
Photo by: Eisenbrandt
Exposure #: 050
Comments: Alternate view of the recently added flat bed trailer, and the previous observed boat in the southeast section of the lot.

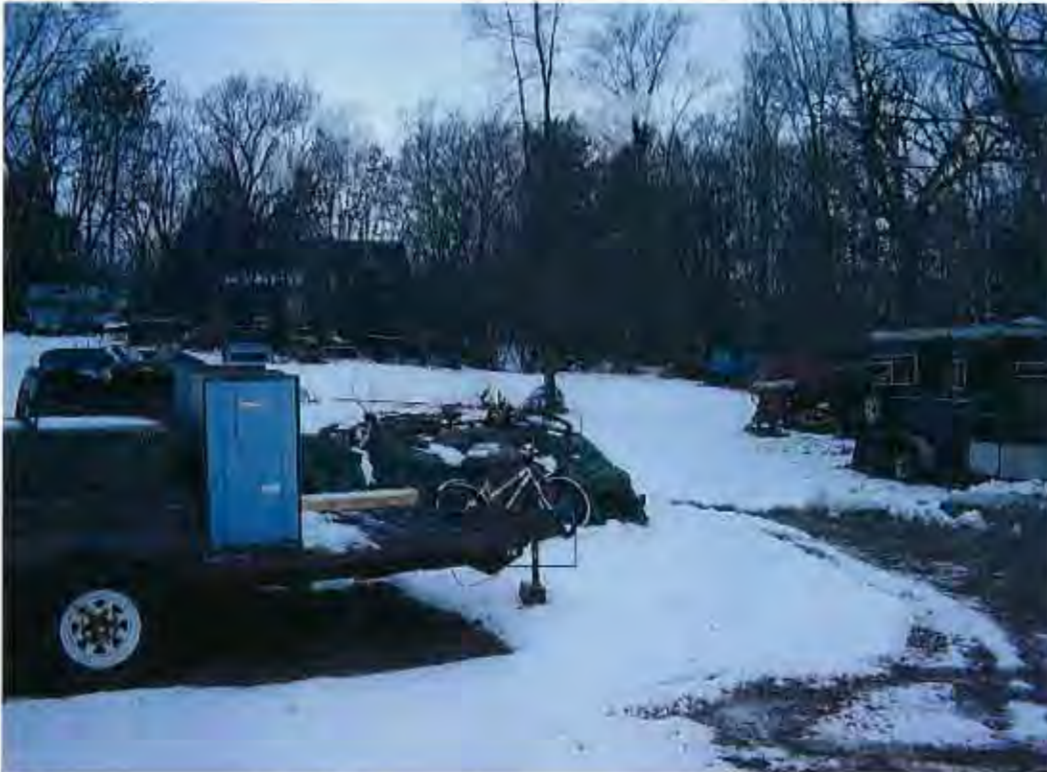
Date: February 7, 2008
Time: 11:35 AM
Direction: NW
Photo by: Eisenbrandt
Exposure #: 051
Comments: Alternate view of the items stored in the rear yard.
