RE: Administrative Citation
Landers' Children Family, LLC
IEPA Site Code No. 1678005010
Inspection Date: January 8, 2009

ADMINISTRATIVE CITATION

LPC #1678005010 – Sangamon County
Auburn / Landers' Children Family, LLC
FOS File
January 8, 2009 Inspection

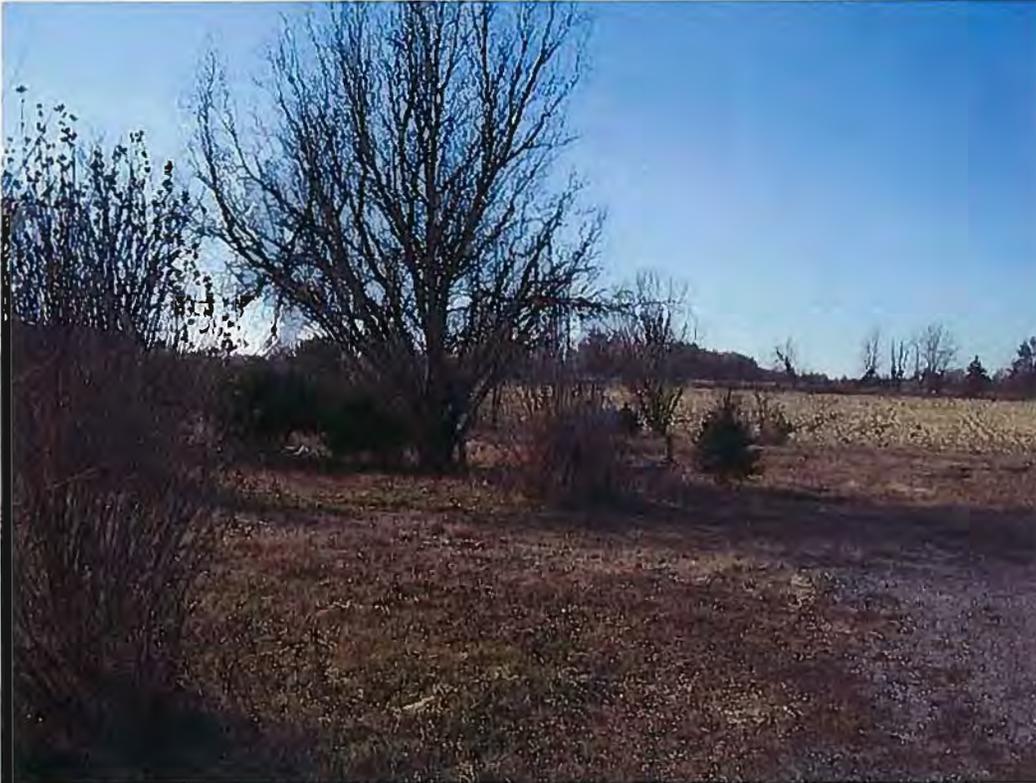
Date: January 8, 2009
Time: 1:41 PM
Direction: SW
Photo by: Eisenbrandt
Exposure #: 001
Comments: Street elevation view showing the mobile home has been moved off the property. The wood deck and wooden stair platform from the north side of the home were still onsite.

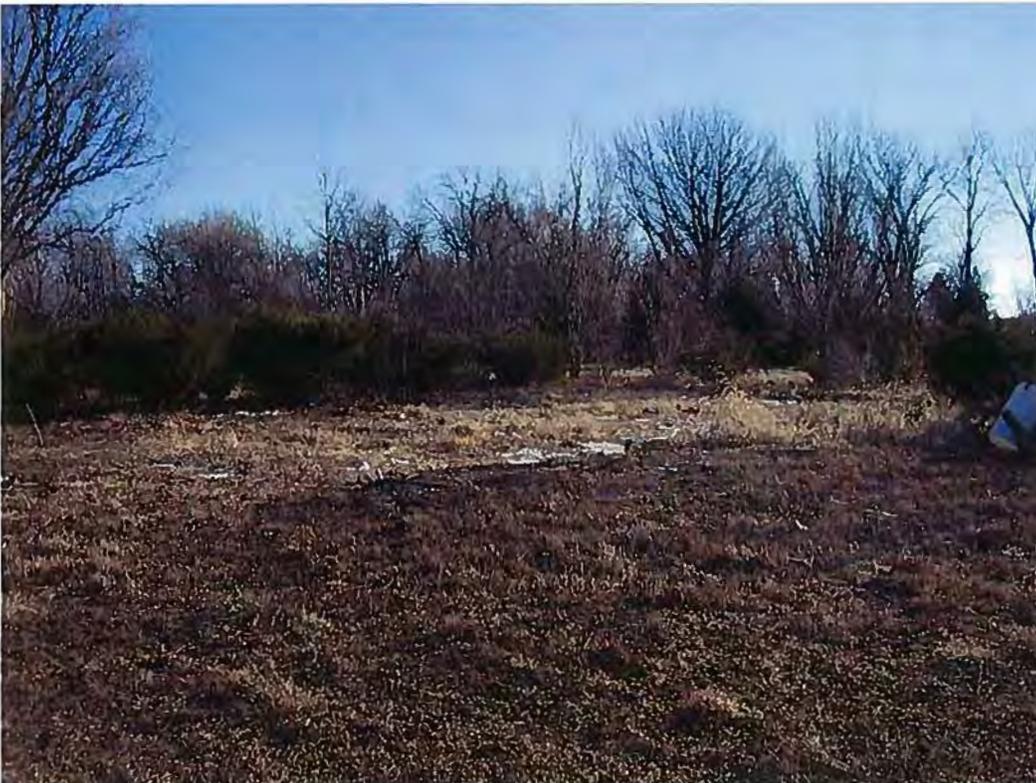
Photograph 002 is a view showing the footprint of the modular home site. Electric feeder lines, metal tie down straps, black plastic pipe, concrete and cinder blocks, aluminum skirting, cardboard, and miscellaneous debris was observed around the home footprint. This waste was not observed during the first inspection as an inhabitable home was still onsite. In the photograph a second set of wooden stairs can be seen.

Date: January 8, 2009
Time: 1:42 PM
Direction: SE
Photo by: Eisenbrandt
Exposure #: 002
Comments: View showing the footprint of the modular home site. Electric feeder lines, metal tie downs, black plastic pipe, concrete and cinder blocks, white PVC pipe, wooden stair platforms, aluminum skirting, cardboard, and miscellaneous debris were observed around the home footprint.

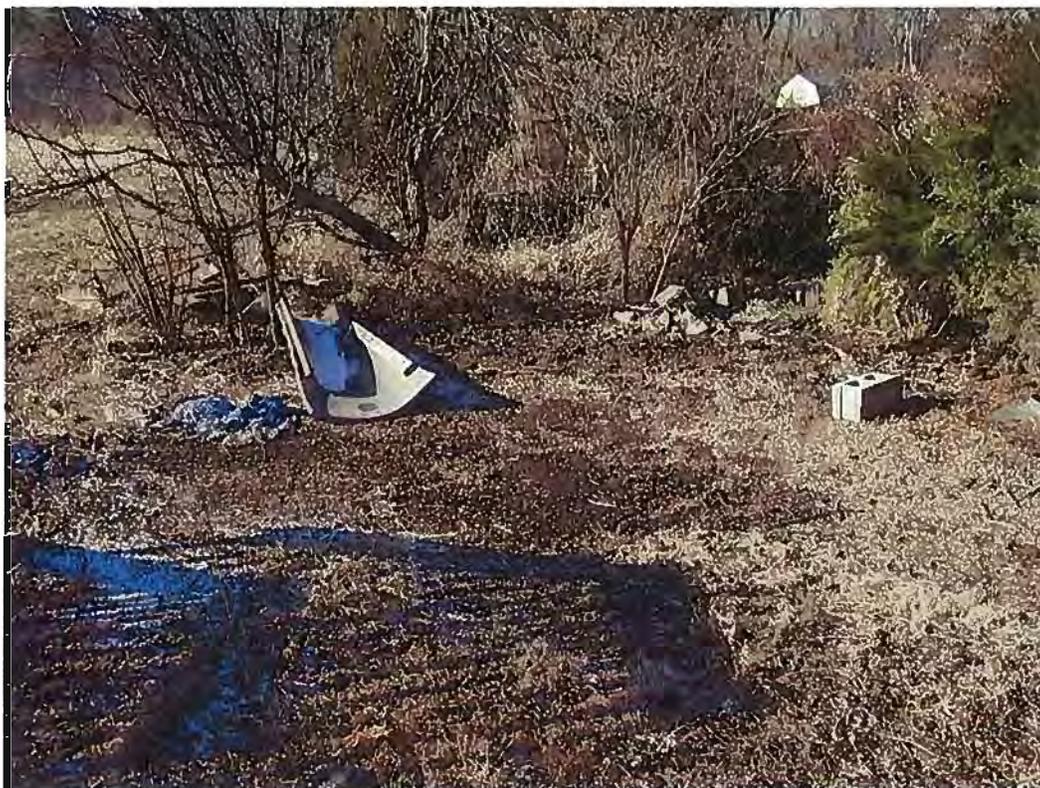
Photograph 003 shows the area from where the metal canopy was removed. It appears most of the items originally seen in the garage-like structure have been moved. However, cinder block, concrete block, cut up pieces of wood furniture, weathered landscaping timbers, an old bleached basketball, a rag rug, a blanket, grey closed-cell Styrofoam and dimensional lumber (attached to form a primitive slide-like object), and other miscellaneous debris were observed. In the tall vegetation in the background of the photograph, a black truck topper can be seen.

Date: January 8, 2009
Time: 1:42 PM
Direction: NW
Photo by: Eisenbrandt
Exposure #: 003
Comments: Area where the metal canopy was removed from. Cinder block, concrete block, cut up pieces of wood furniture, weathered landscape timbers, an old basket ball, a rag rug, grey closed cell Styrofoam and dimensional lumber, a blanket, and miscellaneous debris were observed. In the tall vegetation a black truck topper can be seen.

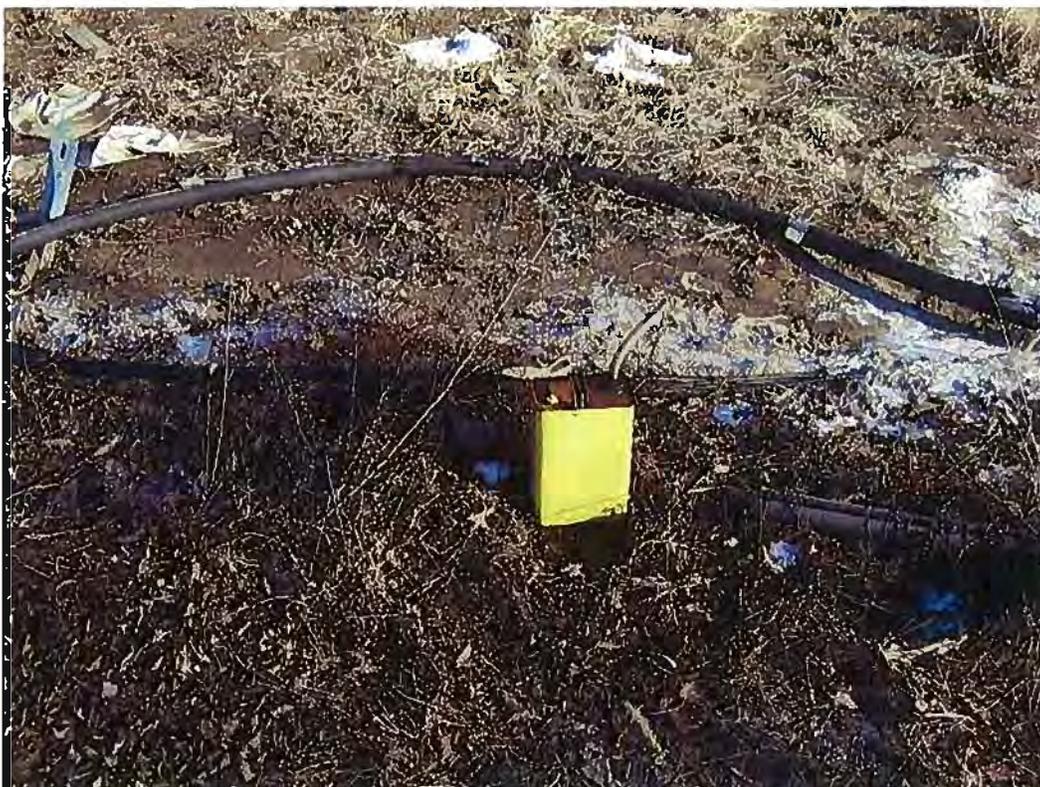
Photograph 004 shows a yellow metal gallon gasoline can that was observed on its side. The can contained at least ¼ gallon of strong gasoline like smelling liquid. The inspector adjusted the

Date: January 8, 2009
Time: 1:46 PM
Direction: E
Photo by: Eisenbrandt
Exposure #: 004
Comments: A yellow metal gallon gasoline can was observed on its side. The can contained at least ¼ gallon of strong gasoline like smelling liquid. The inspector adjusted the can so no additional fluid would be released to the environment.

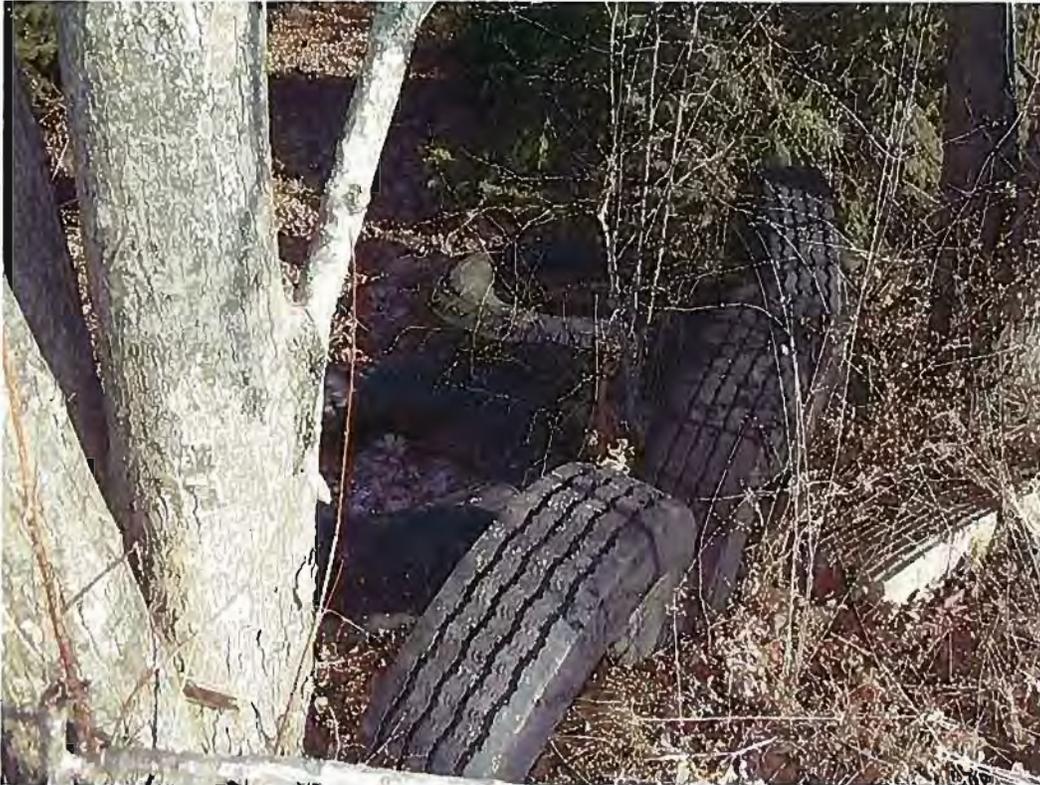
Photograph 005 shows five used truck tires observed in the trees north on the modular home footprint. All of the waste tires were off-rim and three were partially buried upright.

Date: January 8, 2009
Time: 1:50 PM
Direction: E
Photo by: Eisenbrandt
Exposure #: 005
Comments: Five truck tires were observed in the trees. All were without rims and three were partially buried upright.

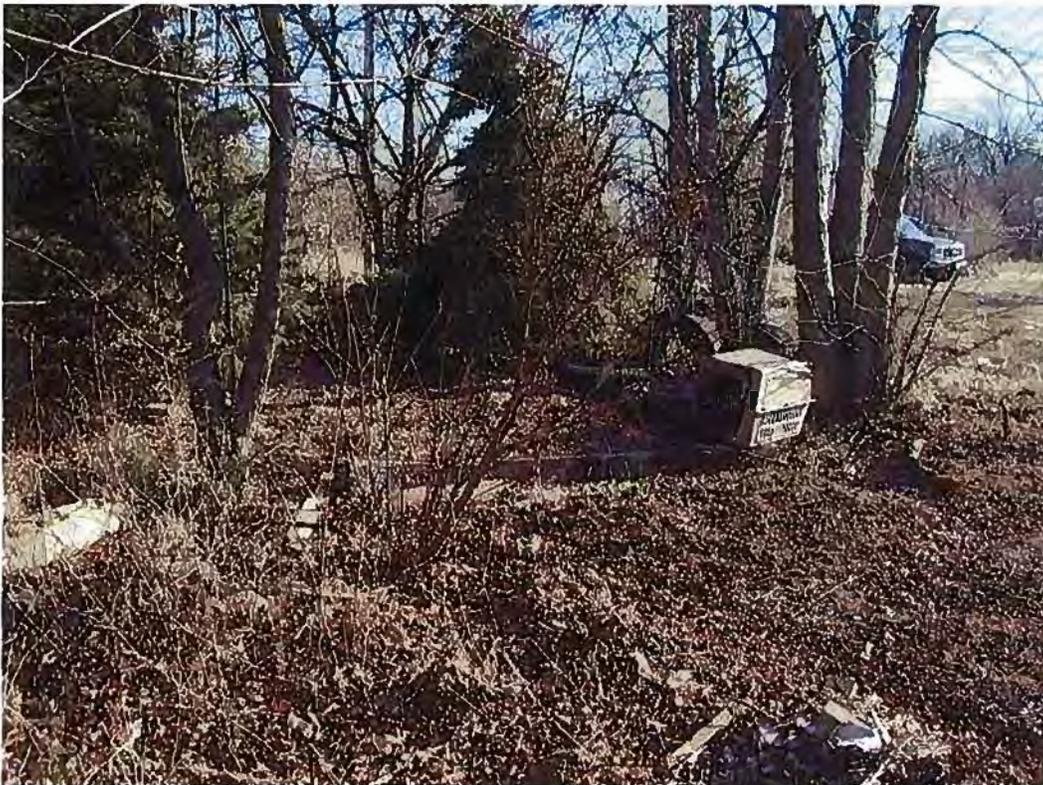
Photograph 006 shows rotting dimensional lumber, a weather brown pet carrier, landscape timbers, scraps of carpet, pieces of wood paneling, and miscellaneous debris that were observed in the trees in the northeast corner of the property. The tires described in Photograph 005 can also be seen in Photograph 006.

Date: January 8, 2009
Time: 1:51 PM
Direction: SE
Photo by: Eisenbrandt
Exposure #: 006
Comments: Rotting dimensional lumber, a weathered brown pet carrier, landscape timbers, scraps of carpet, pieces of wood paneling, and miscellaneous debris were also observed in the trees in the northeast corner of the property.

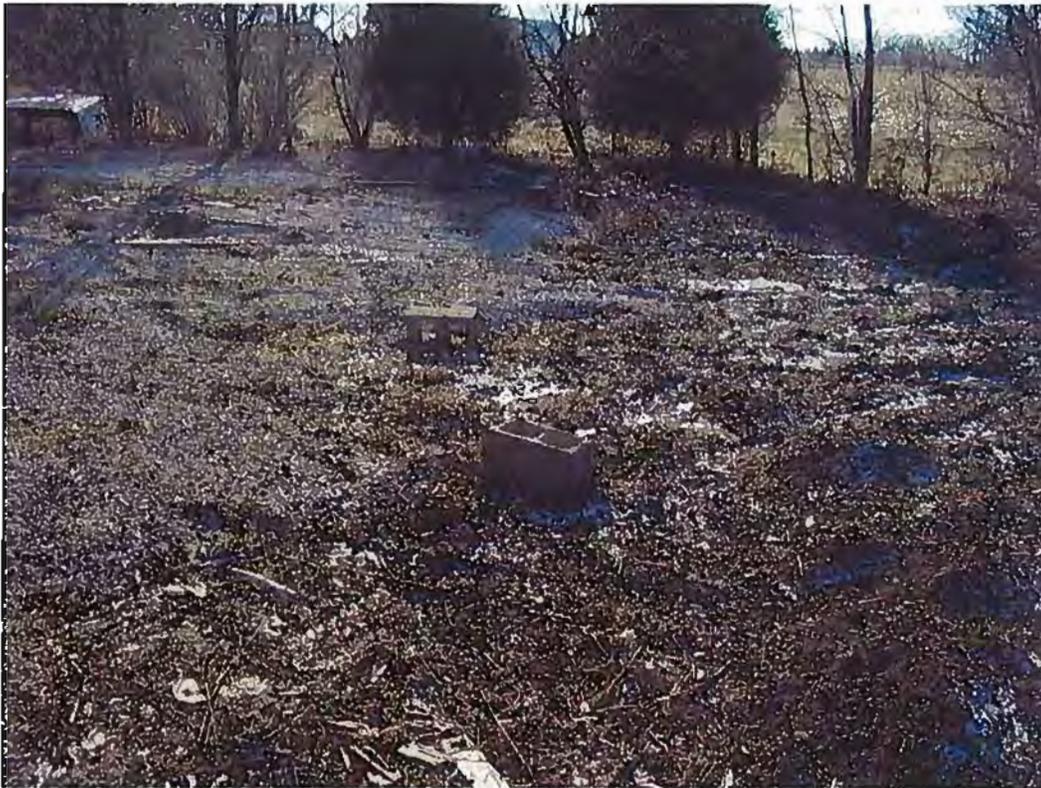
Photograph 007 shows an alternate view of the black truck topper described in Photograph 003. Cinder block, small scraps of processed lumber, railroad ties, and miscellaneous waste were scattered throughout this graveled area. A grey garbage can with a skin to a trampoline were also observed nearby. During the previous inspection on July 1, 2008 a large debris pile of weathered waste was observed roughly near this location. A dresser, paneling, beige vinyl siding, particle board shelving, cinder block, a yellow bathtub, a rusty wheel rim with tire beads, waste pipe, carpet, children toys, and charred lumber were among the weathered wastes that have been removed from the property.

Date: January 8, 2009
Time: 1:54 PM
Direction: SW
Photo by: Eisenbrandt
Exposure #: 007
Comments: Alternate view of the black truck topper described in Photograph 003. Cinder block, small scraps of processed lumber, railroad ties, and miscellaneous waste were scattered throughout this graveled area. A grey garbage can with a skin to a trampoline were also observed nearby.

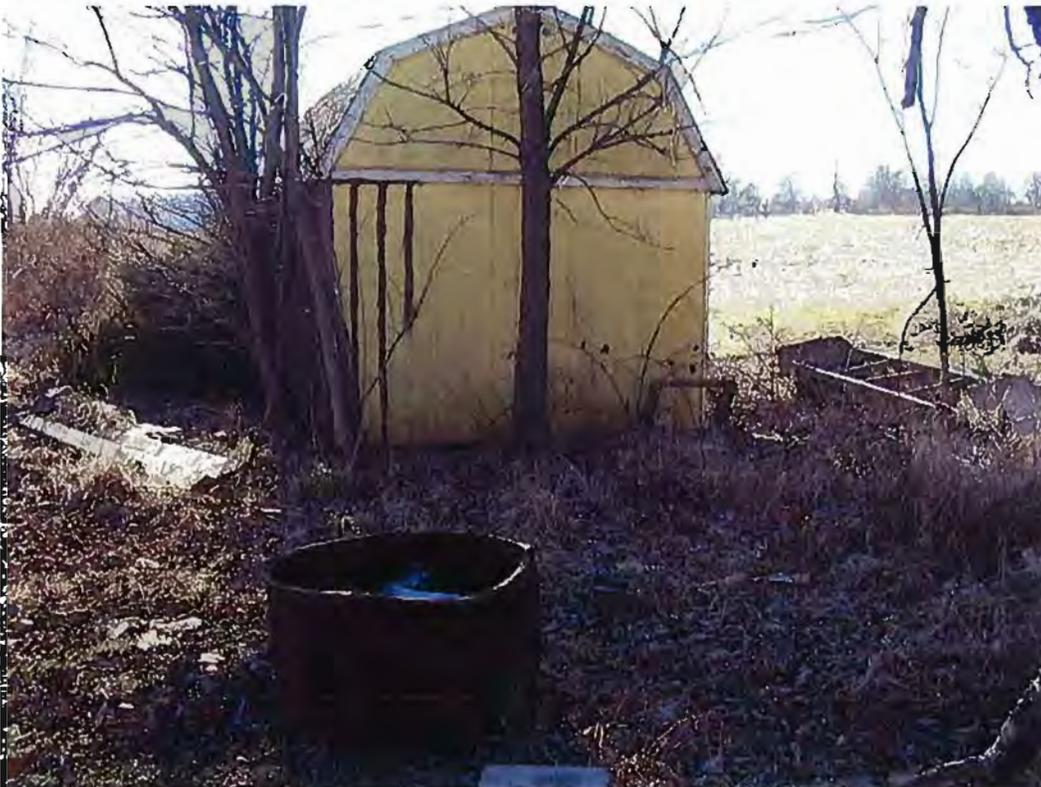
Photograph 008 shows an empty yellow and brown shed that was observed with its doors open. The burn barrel, a stack of weathered lumber, a broken small animal coop, and miscellaneous debris previously observed were still on the ground near the empty shed.

Date: January 8, 2009
Time: 1:57 PM
Direction: SW
Photo by: Eisenbrandt
Exposure #: 008
Comments: The yellow shed is now empty. The burn barrel, a stack of weathered lumber, a broken small animal coop, and miscellaneous debris previously observed were still on the ground near the shed.

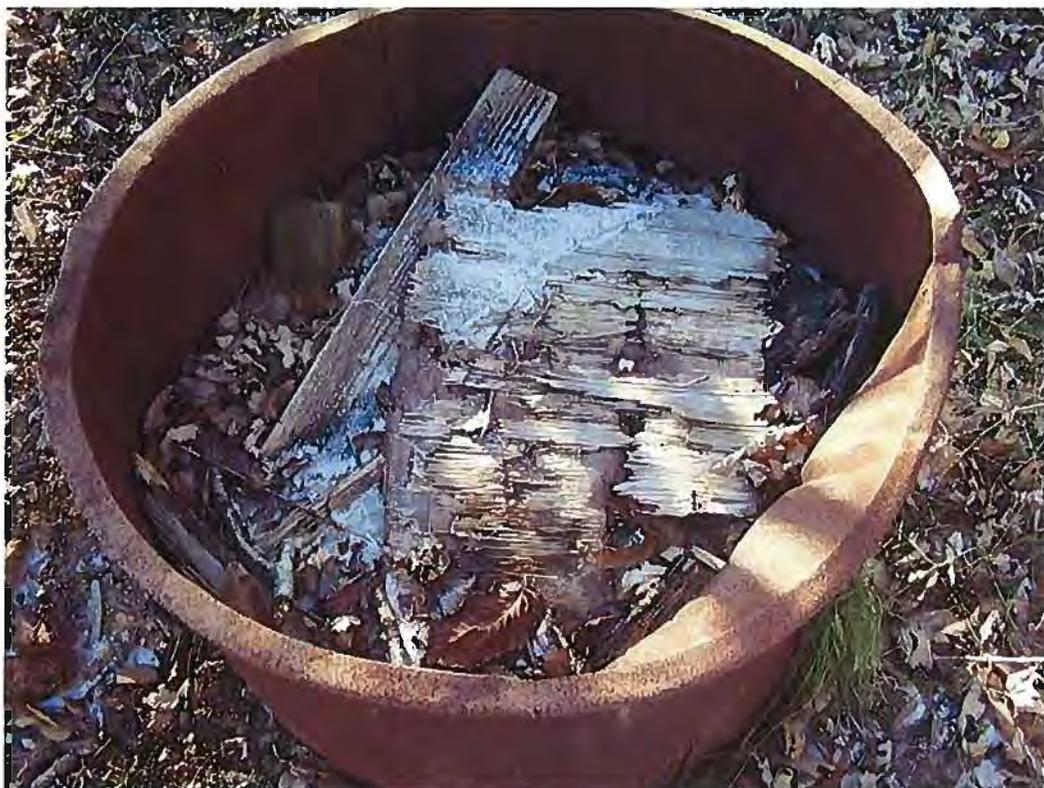
Photograph 009 shows plywood, broken glass, and charred lumber are still in the makeshift burn barrel. No waste from around this area has been cleaned up.

Date: January 8, 2009
Time: 1:58 PM
Direction: SW
Photo by: Eisenbrandt
Exposure #: 009
Comments: Plywood, broken glass, and charred lumber are still in the makeshift burn barrel.

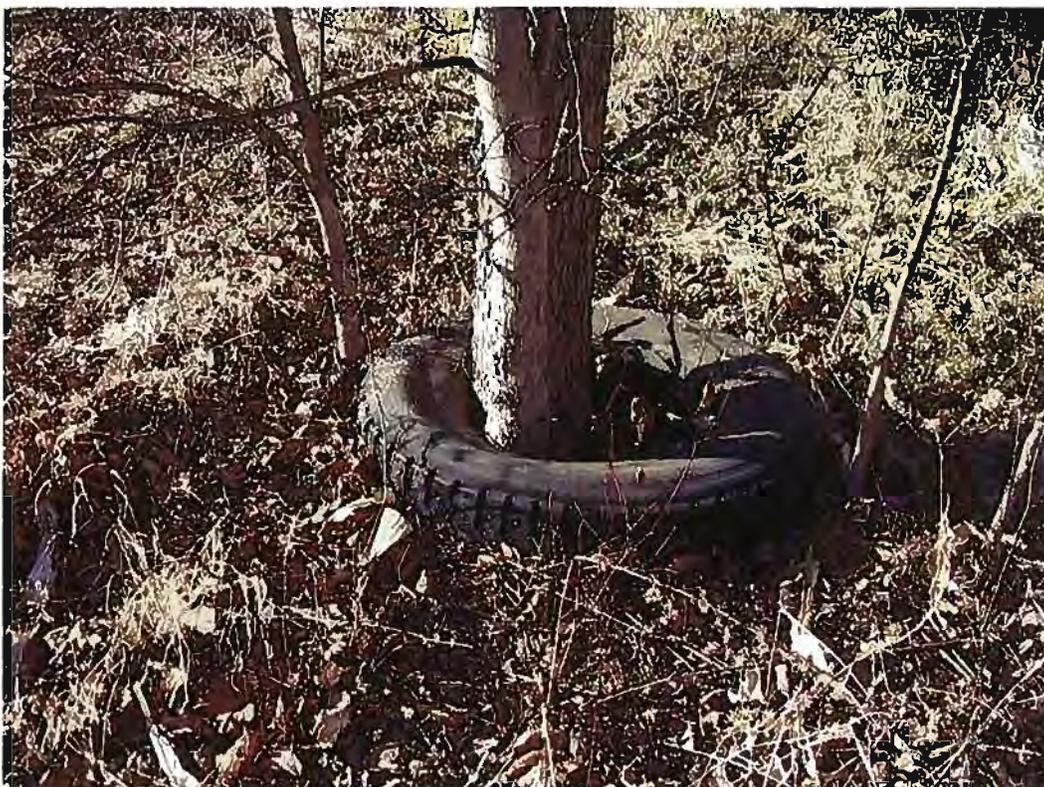
Date: January 8, 2009
Time: 1:59 PM
Direction: W
Photo by: Eisenbrandt
Exposure #: 010
Comments: A used tire with a tree growing through it illustrates the waste tire had been dumped years earlier.

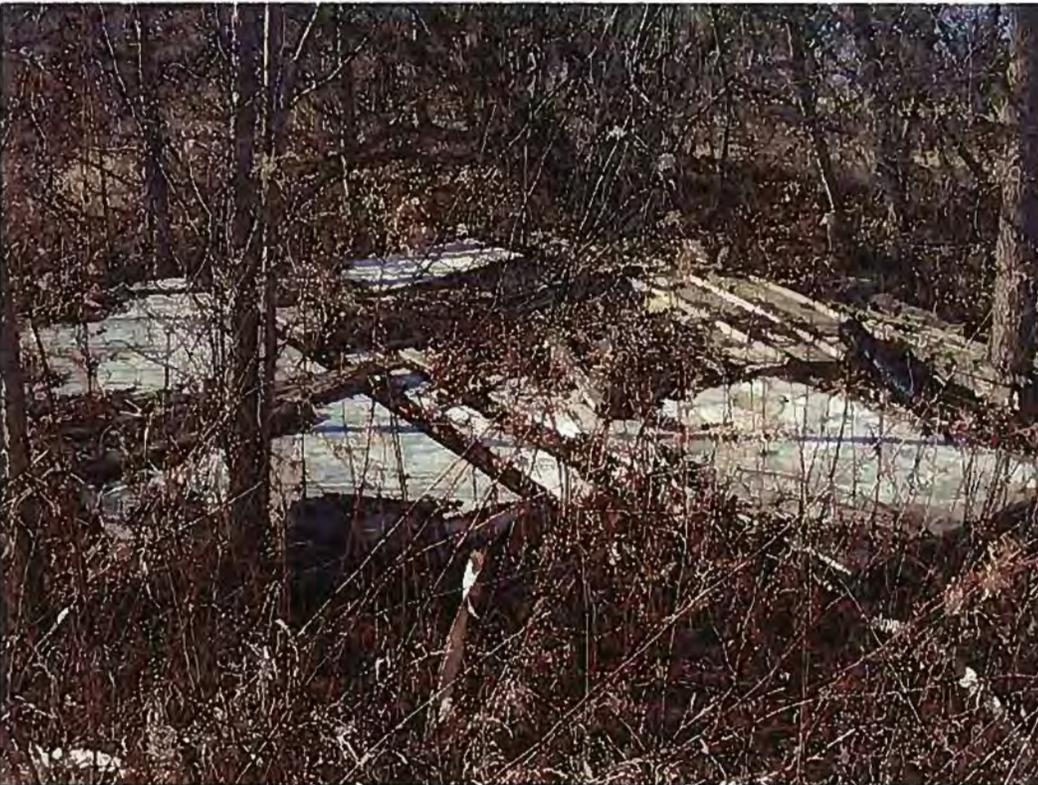
Photograph 012 shows fiberglass panels, rotting pallets, black plastic drain pipe, steel sheeting, rotting dimensional lumber, fiberglass insulation, a black plastic utility tub, and rotting debris were still observed in the northern tree line.

Date: January 8, 2009
Time: 2:03 PM
Direction: NW
Photo by: Eisenbrandt
Exposure #: 012
Comments: Fiberglass panels, rotting pallets, black plastic drain pipe, steel sheeting, rotting dimensional lumber, fiberglass insulation, a black plastic utility tub, and rotting debris were still observed in the northern tree line.

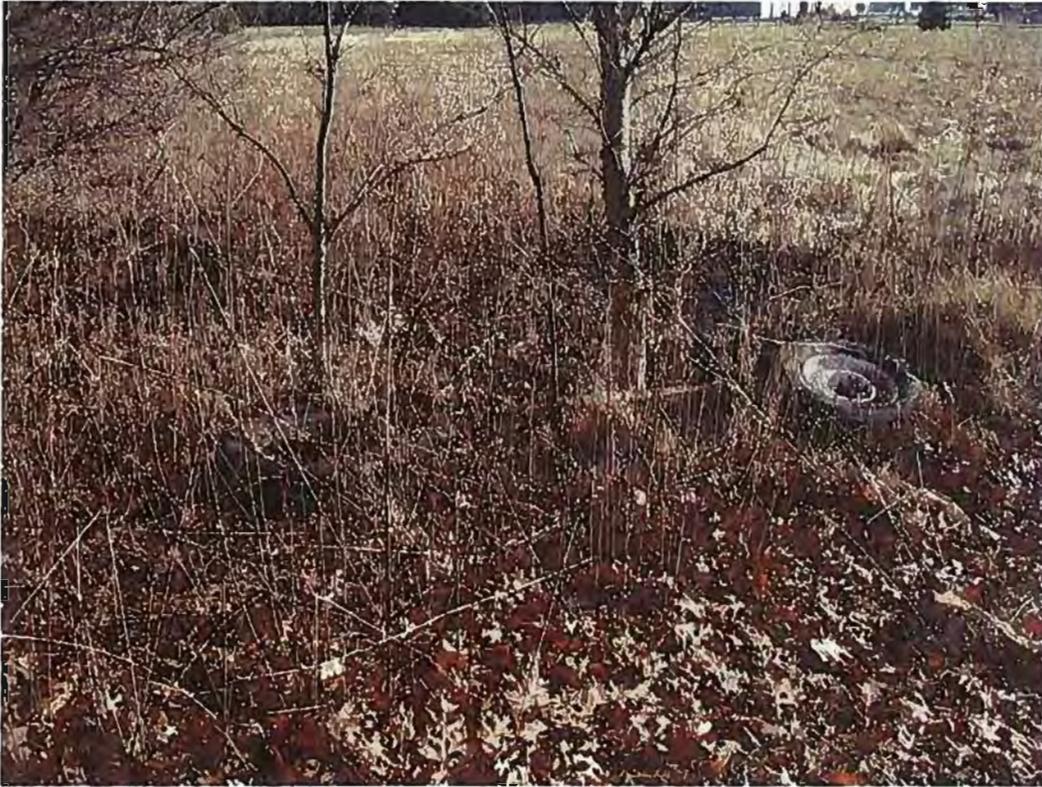
Photograph 013 shows five waste tires (two on-rim) that were observed in the northern tree line, just east of an opening in the weeds. These used tires were observed during the July 2008 inspection.

Date: January 8, 2009
Time: 2:05 PM
Direction: SE
Photo by: Eisenbrandt
Exposure #: 013
Comments: In the northern tree line, just east of an opening, five waste tires (two on-rim) were observed. These tires were observed during the July 2008 inspection.

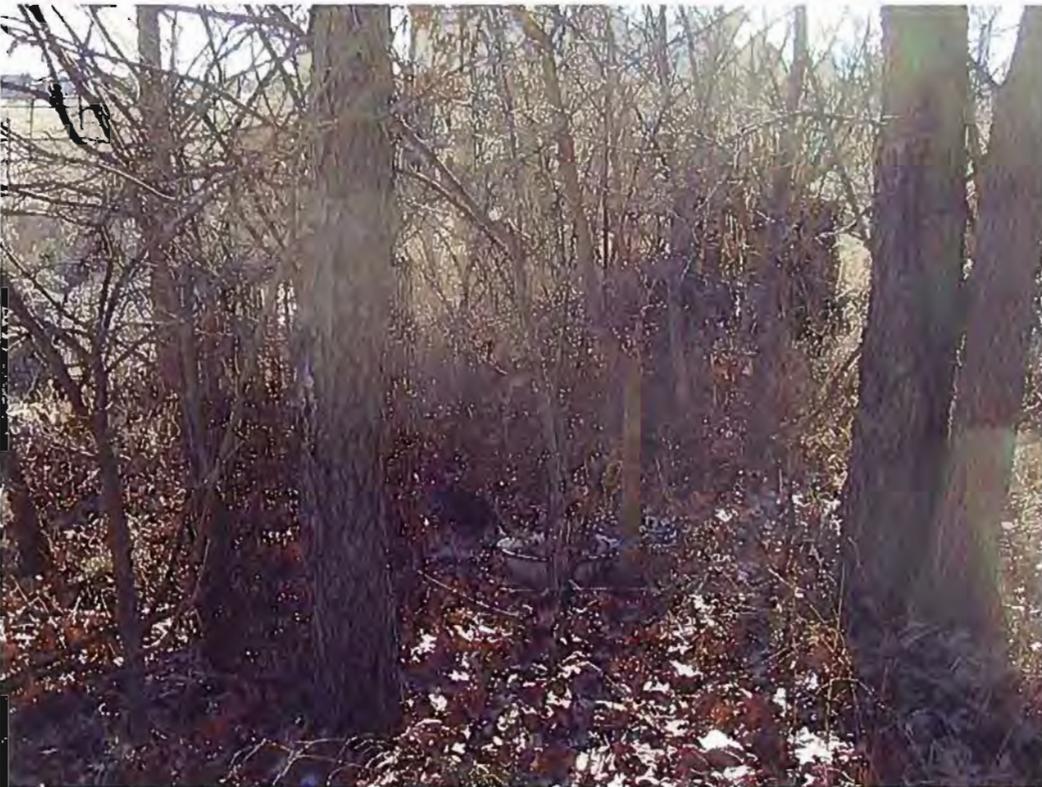
Photograph 014 shows several bundles of rusty wire fencing observed to the west of a path in the northern tree line.

Date: January 8, 2009
Time: 2:06 PM
Direction: SW
Photo by: Eisenbrandt
Exposure #: 014
Comments: Several bundles of rusty wire fencing were observed to the west of the path in the northern tree line.

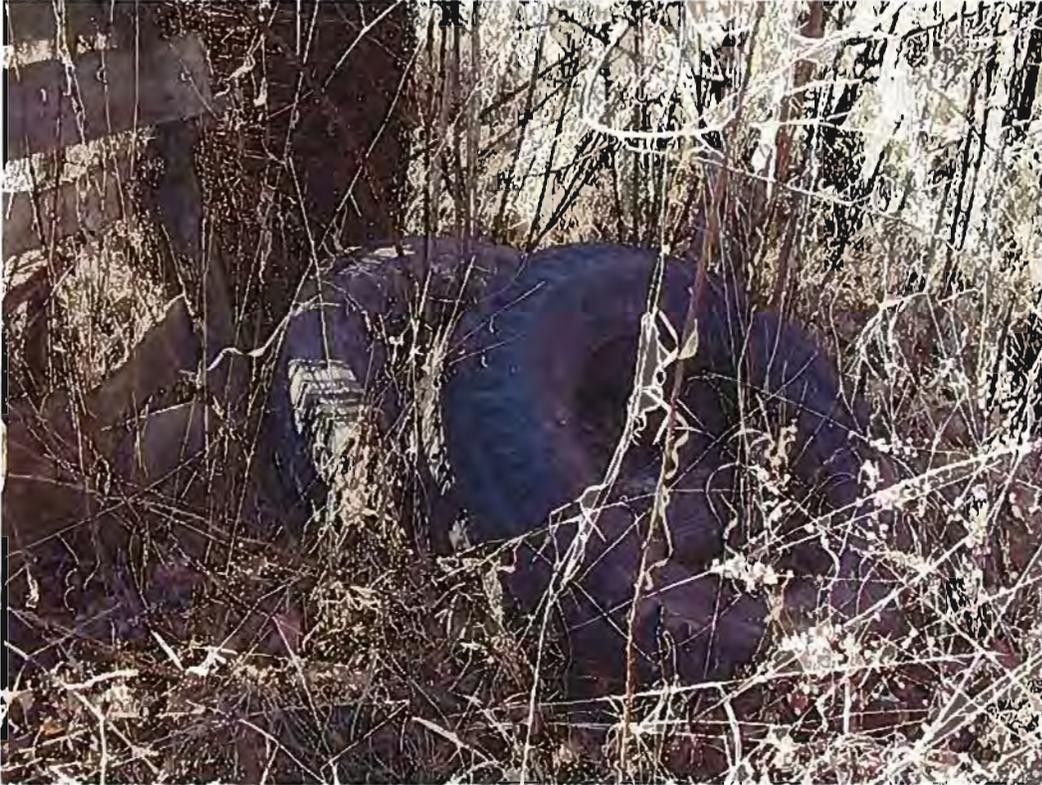
Photograph 015 show two off-rim used truck tires that were observed near the bundles of rusty wire fencing.

Date: January 8, 2009
Time: 2:06 PM
Direction: NW
Photo by: Eisenbrandt
Exposure #: 015
Comments: Two off-rim used truck tires were observed near the rusty wire fencing.

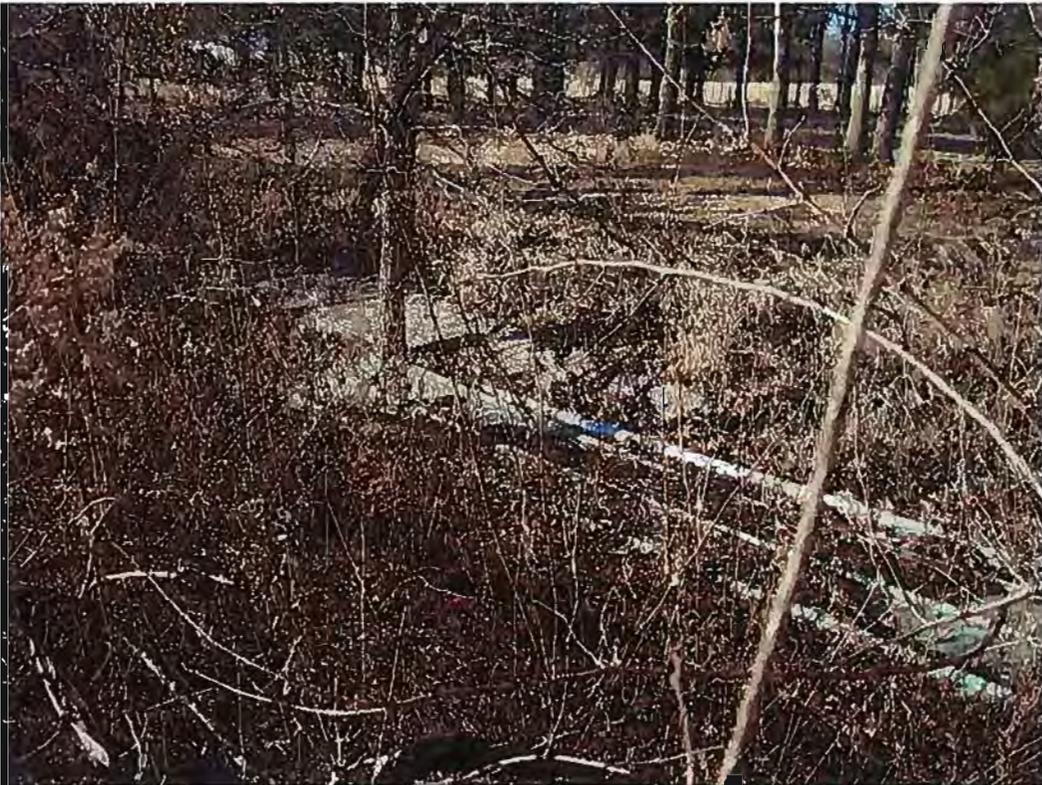
Photograph 016 shows rusty corrugated sheet metal and green fiberglass panels that were observed along the northern tree line further west of the path opening.

Date: January 8, 2009
Time: 2:08 PM
Direction: NW
Photo by: Eisenbrandt
Exposure #: 016
Comments: Rusty corrugated sheet metal and green fiberglass panels were observed along the northern tree line.

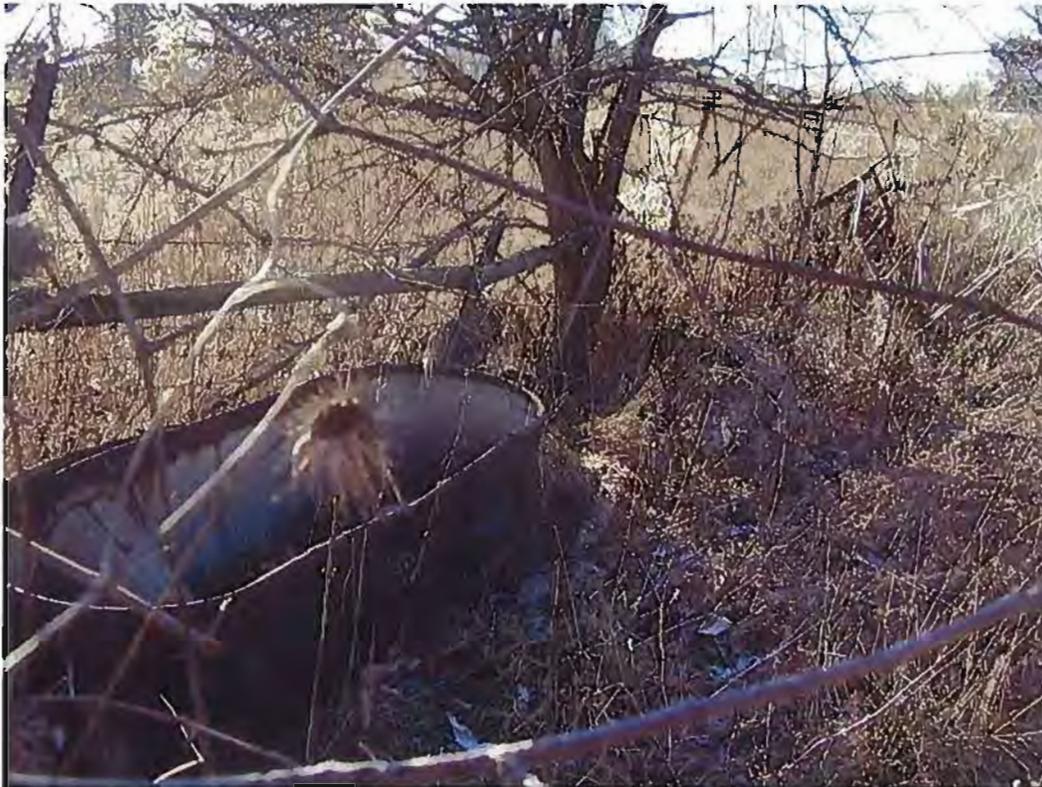
Photograph 017 shows an old rusty livestock feeder, a rusty metal frame to a bed or an old car seat, and a green John Deere mailbox observed in the tall weeds.

Date: January 8, 2009
Time: 2:08 PM
Direction: SW
Photo by: Eisenbrandt
Exposure #: 017
Comments: A livestock feeder, a rusty metal frame to a bed or an old car seat, and a green John Deere mailbox were observed in the weeds.

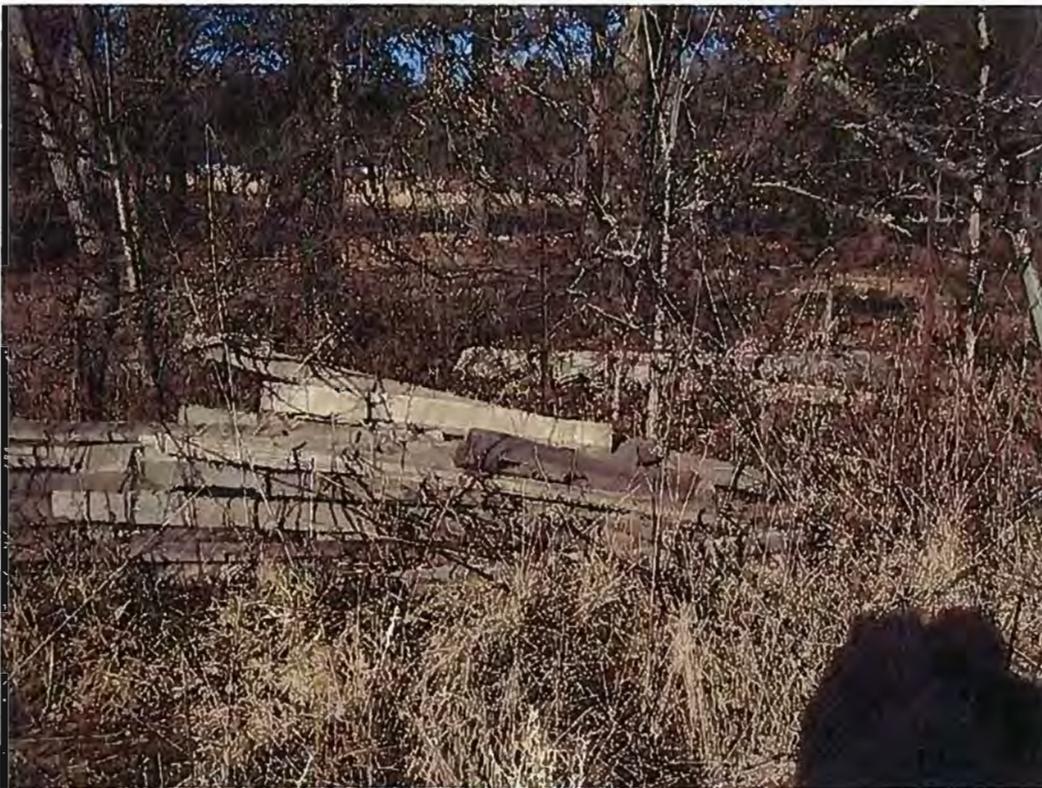
Photograph 018 shows a stack of wood split rail fencing that can be seen in the foreground of the photograph. In the background additional sheets of corrugated sheet metal were also observed.

Date: January 8, 2009
Time: 2:10 PM
Direction: N
Photo by: Eisenbrandt
Exposure #: 018
Comments: A stack of wood spilt rail fencing can be seen in the foreground of the photograph. In the background additional sheets of corrugated sheet metal were observed.

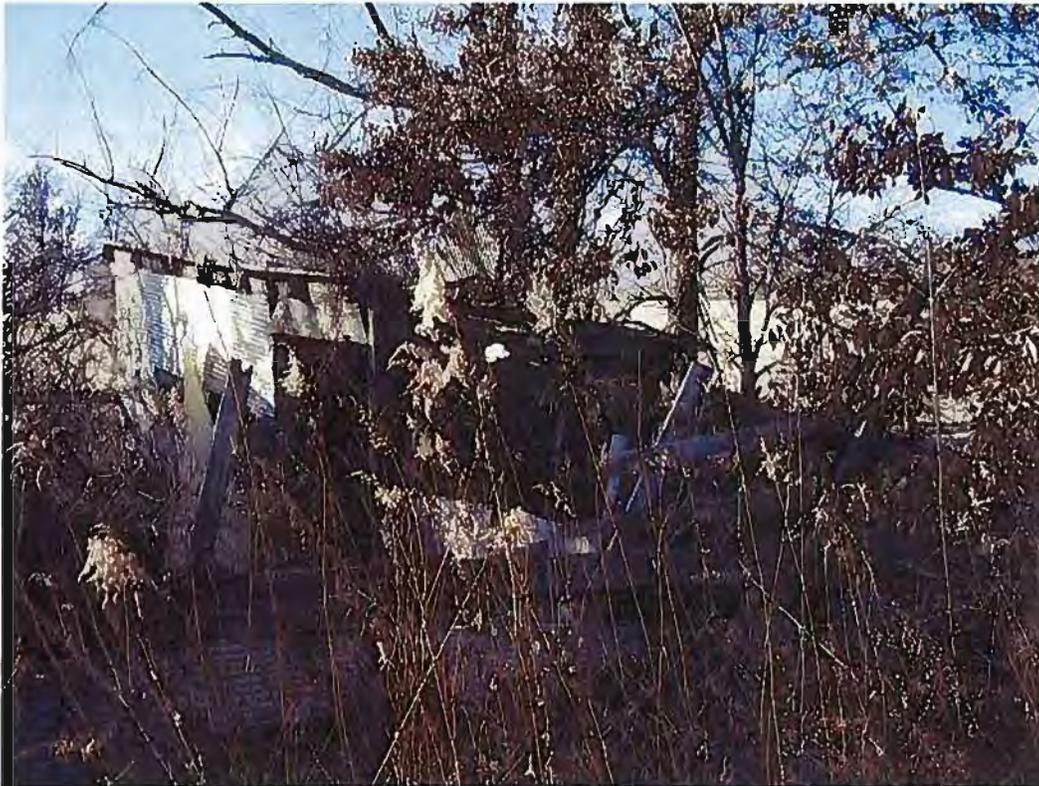
Photograph 019 shows a primitive building constructed of corrugated sheet metal, wooden pallets, and scrap lumber, which appears more dilapidated than when it was observed during the July 2008 inspection. The building is still surrounded by weeds approximately four to five feet high.

Date: January 8, 2009
Time: 2:11 PM
Direction: NW
Photo by: Eisenbrandt
Exposure #: 019
Comments: The primitive building constructed of corrugated sheet metal, wooden pallets, and scrap lumber appears more dilapidated than when it was observed during the July 2008 inspection.

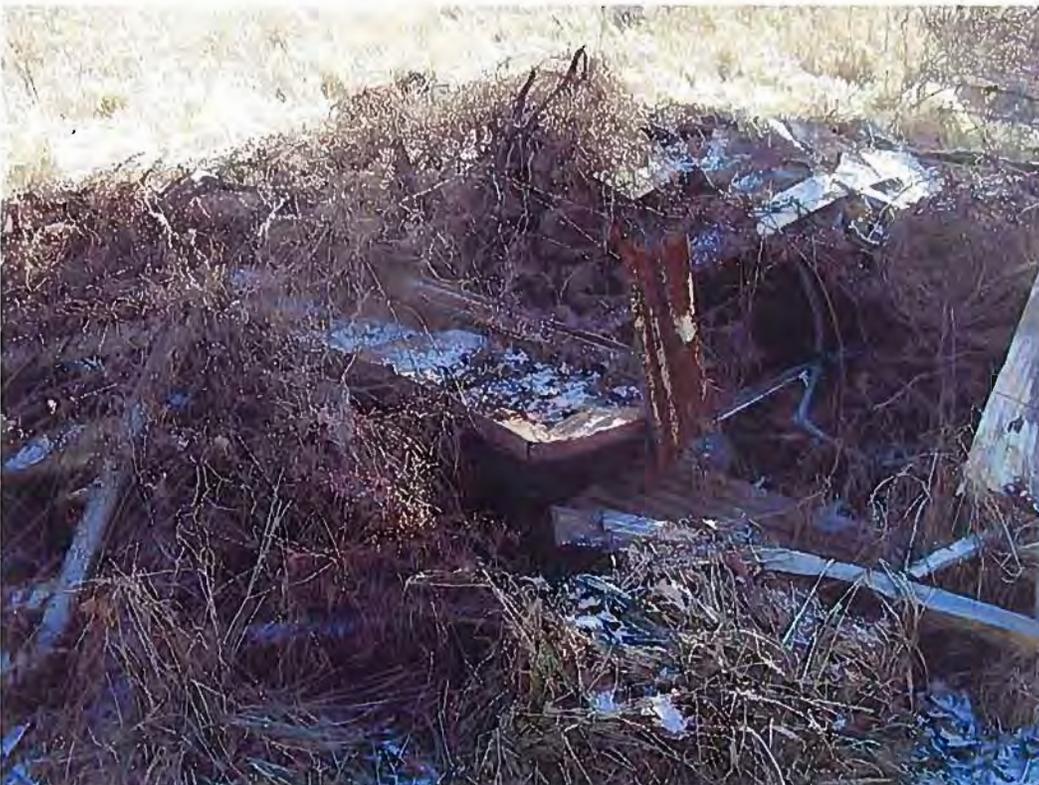
Photograph 020 shows a large debris pile containing wire fencing, scraps of corrugated sheet metal, rusty scrap metal, rotting processed lumber, plastic plumbing pipe, charred wood, and debris was newly observed. This debris pile was covered with thick vegetation during the previous inspection. The debris pile is approximately four feet high and fifteen feet across.

Date: January 8, 2009
Time: 2:12 PM
Direction: S
Photo by: Eisenbrandt
Exposure #: 020
Comments: A large debris pile containing wire fencing, scraps of corrugated sheet metal, rusty scrap metal, rotting processed lumber, plastic plumbing pipe, charred wood, and debris was newly observed. This debris pile was covered with thick vegetation during the previous inspection.

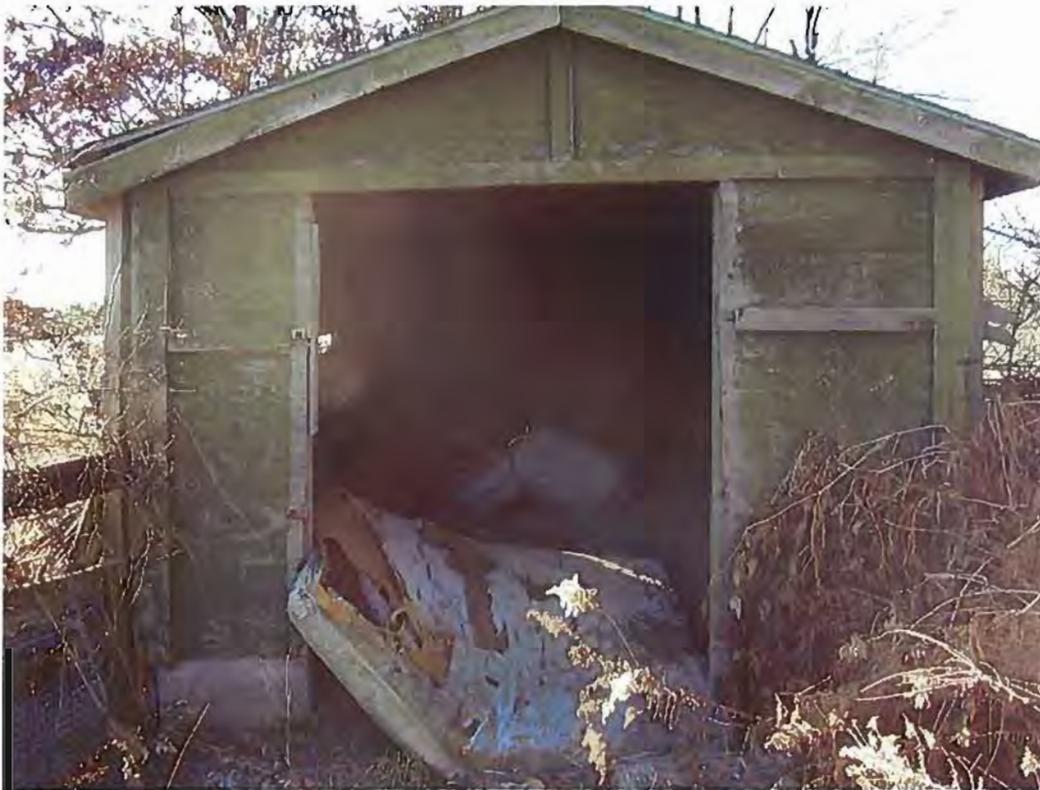
Photograph 021 shows the old wooden shed with debris spilling out of it appears as it did during the last inspection. A recliner, a wooden frame, a torn mattress, a box spring, and six used tires were again observed.

Date: January 8, 2009
Time: 2:12 PM
Direction: W
Photo by: Eisenbrandt
Exposure #: 021
Comments: The old wooden shed with debris spilling out of it appears as it did during the last inspection. A recliner, a wooden frame, a torn mattress, a box spring, and six used tires were again observed.

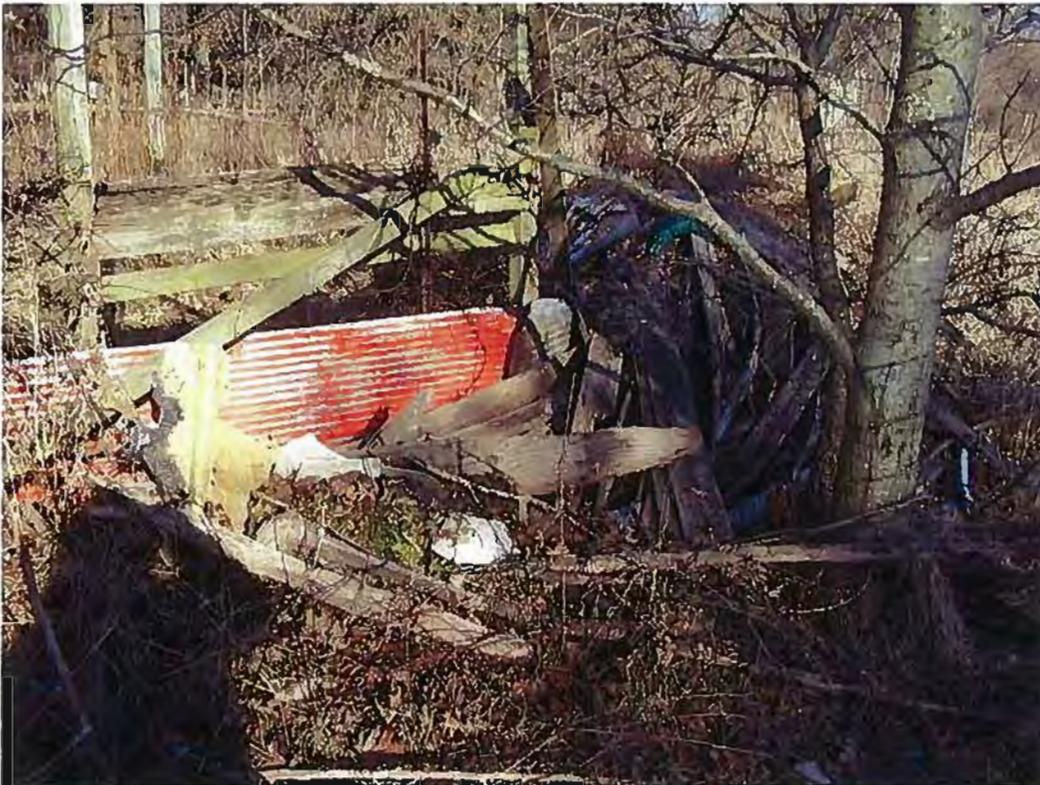
Date: January 8, 2009
Time: 2:16 PM
Direction: NE
Photo by: Eisenbrandt
Exposure #: 022
Comments: Additional waste was discovered southeast of the wooden shed. The large debris pile in the background is also seen in Photograph 020.

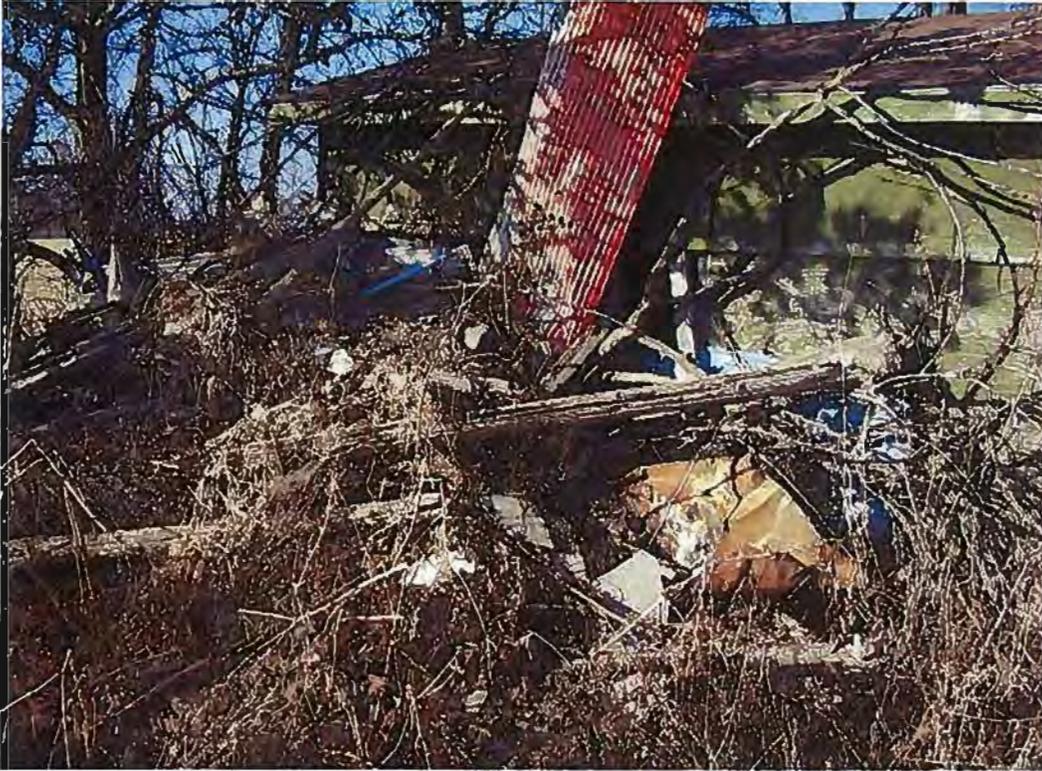
Photograph 023 shows more waste was discovered against the southern side of the old green shed. Corrugated sheet metal, scrap steel, rotten lumber, PVC pipe, cyclone fencing, concrete block, aluminum scrap, gravel and dirt laden with small debris, and slate-like tile was observed. The debris pile was approximately five feet high and greater than ten feet across.

Date: January 8, 2009
Time: 2:16 PM
Direction: NW
Photo by: Eisenbrandt
Exposure #: 023
Comments: Against the southern side of the green wooden shed more waste was discovered. Corrugated sheet metal, scrap steel, rotten lumber, PVC pipe, cyclone fencing, concrete block, aluminum scrap, gravel and dirt laden with small debris, and slate like tile were observed.

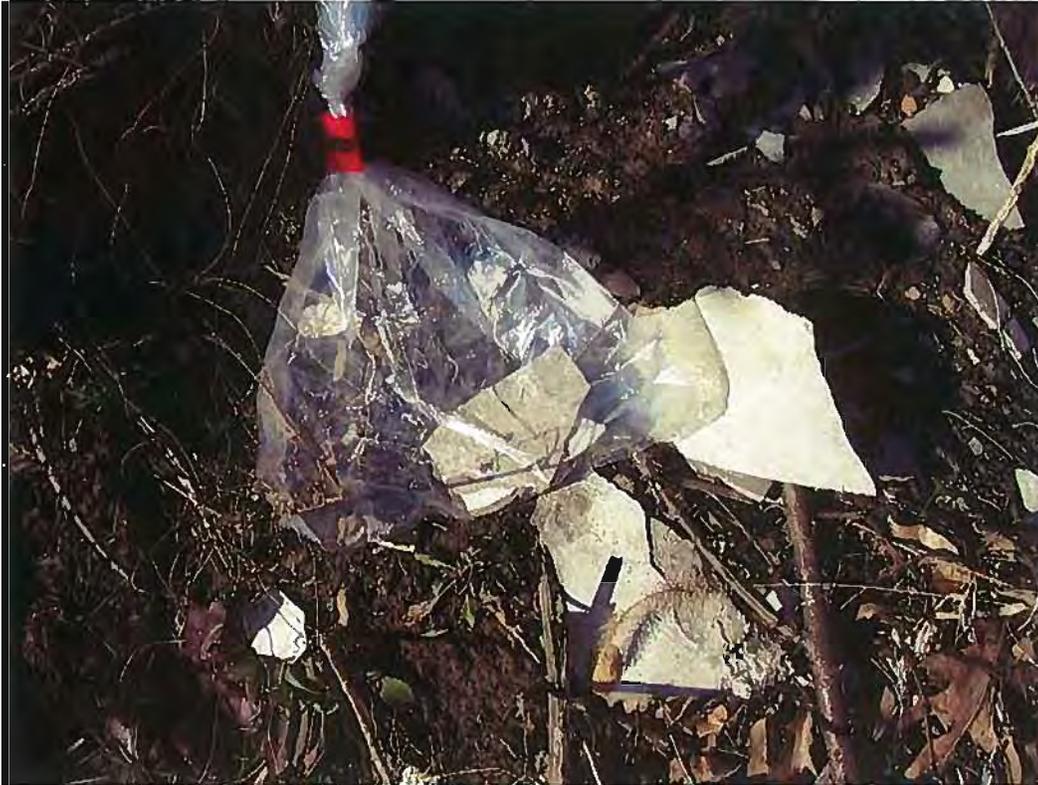
Date: January 8, 2009
Time: 2:34 PM
Direction: NW
Photo by: Eisenbrandt
Exposure #: 025
Comments: Samples of the slate like material were collected for laboratory examination.
