ILLINOIS ENVIRONMENTAL PROTECTION AGENCY

Re: Illinois Environmental Protection Agency v. Donald Sapp  
IEPA File No.18-09-AC: 1498005003—Pike County

ADMINISTRATIVE CITATION

AC 09-39  
(IEPA No. 18-09-AC)

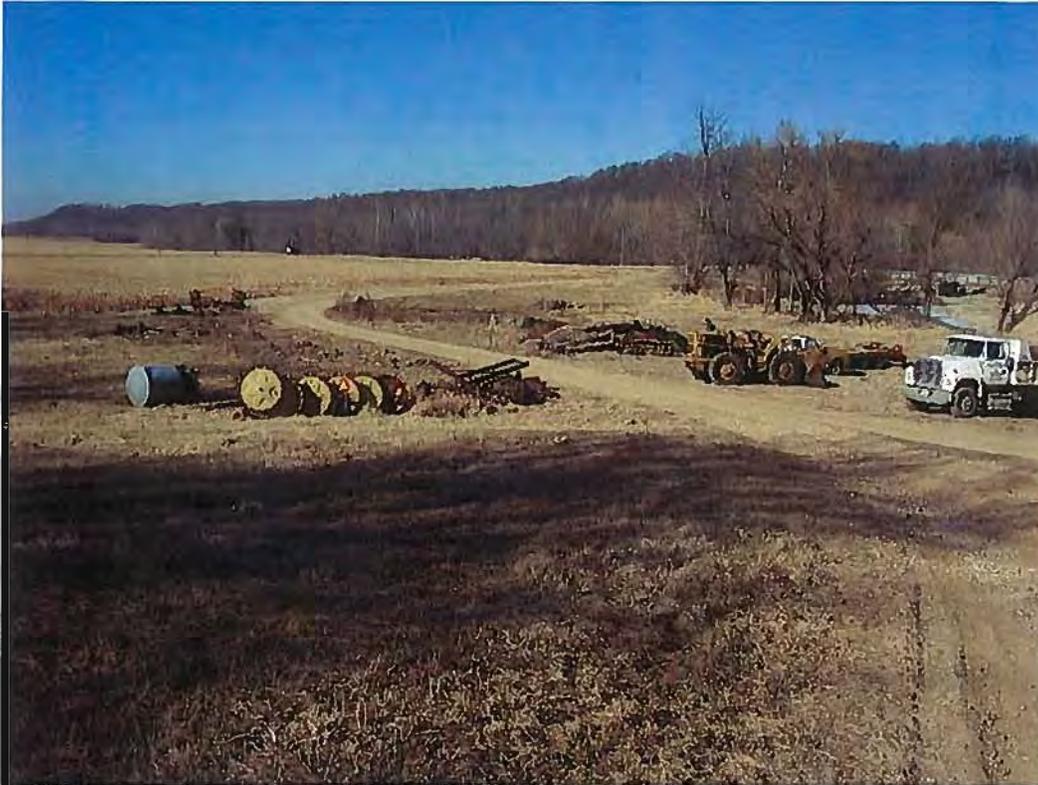
**Date:** January 22, 2009  
**Time:** 12:18 PM  
**Direction:** NW  
**Photo by:** Eisenbrandt  
**Exposure #:** 001  
**Comments:** Several farm bins, rusty farm equipment, scrap metal, and odds and ends are haphazardly stored on the south side of the driveway. Heavy machinery, a pickup truck, a dump truck, a flat bed trailer and miscellaneous equipment are on the north side of the driveway.

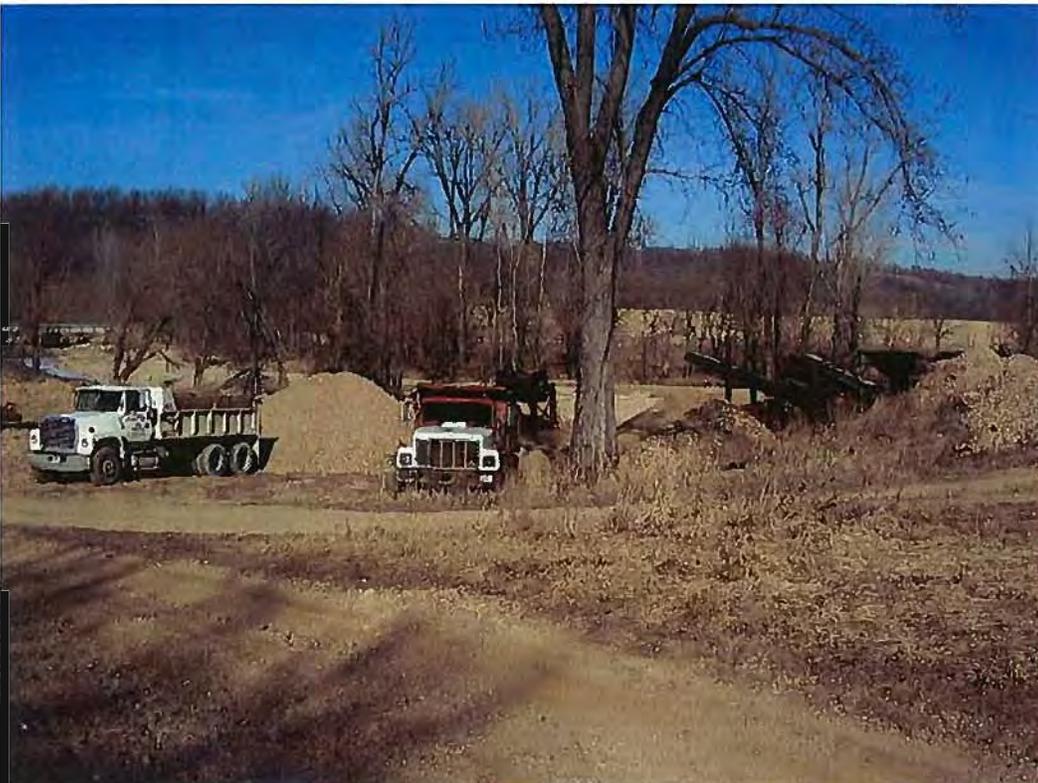
Photograph 2 shows two dump trucks, gravel screening equipment, and several screened piles of gravel that were observed between the driveway and Dutch Creek Road. Further down the drive near Dutch Creek Road, there were numerous tire tracks leading into and out of the creek bed. It

**Date:** January 22, 2009  
**Time:** 12:18 PM  
**Direction:** N  
**Photo by:** Eisenbrandt  
**Exposure #:** 002  
**Comments:** Two dump trucks, gravel screening equipment, and several screened piles of gravel were observed between the driveway and Dutch Creek.

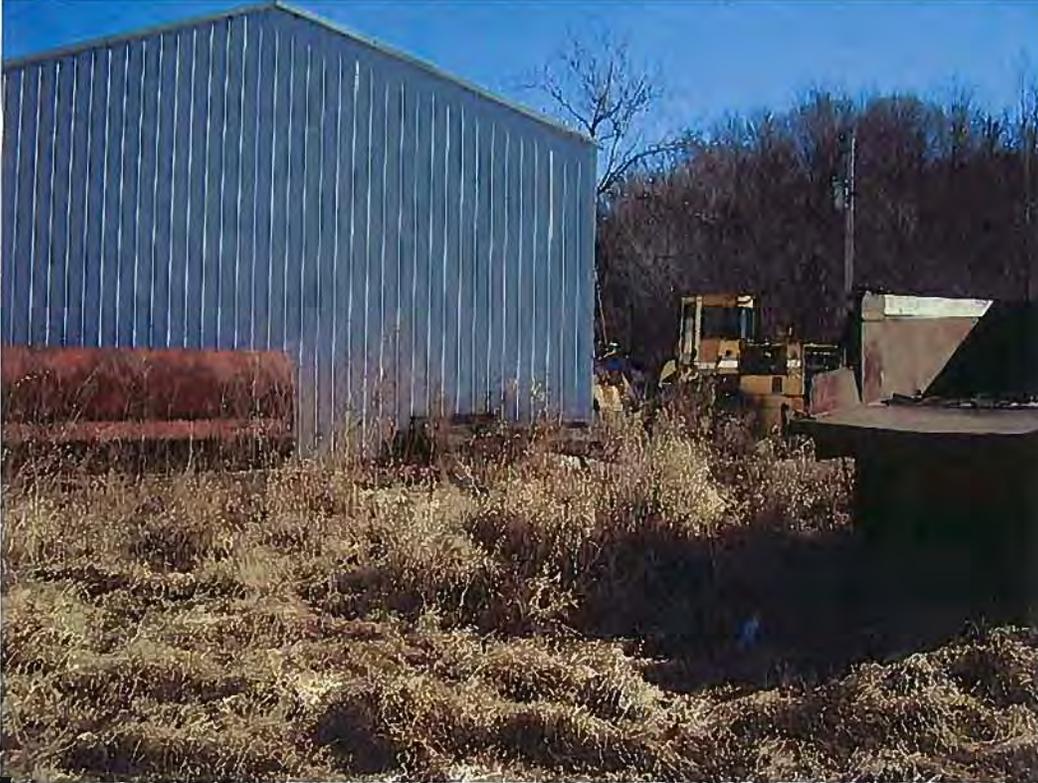
**Date:** January 22, 2009  
**Time:** 12:19 PM  
**Direction:** SE  
**Photo by:** Eisenbrandt  
**Exposure #:** 003  
**Comments:** A stack of railroad ties and a steel tank were observed against the west side of the pole building/shop. Another dump truck can be seen on the right side of the photograph.

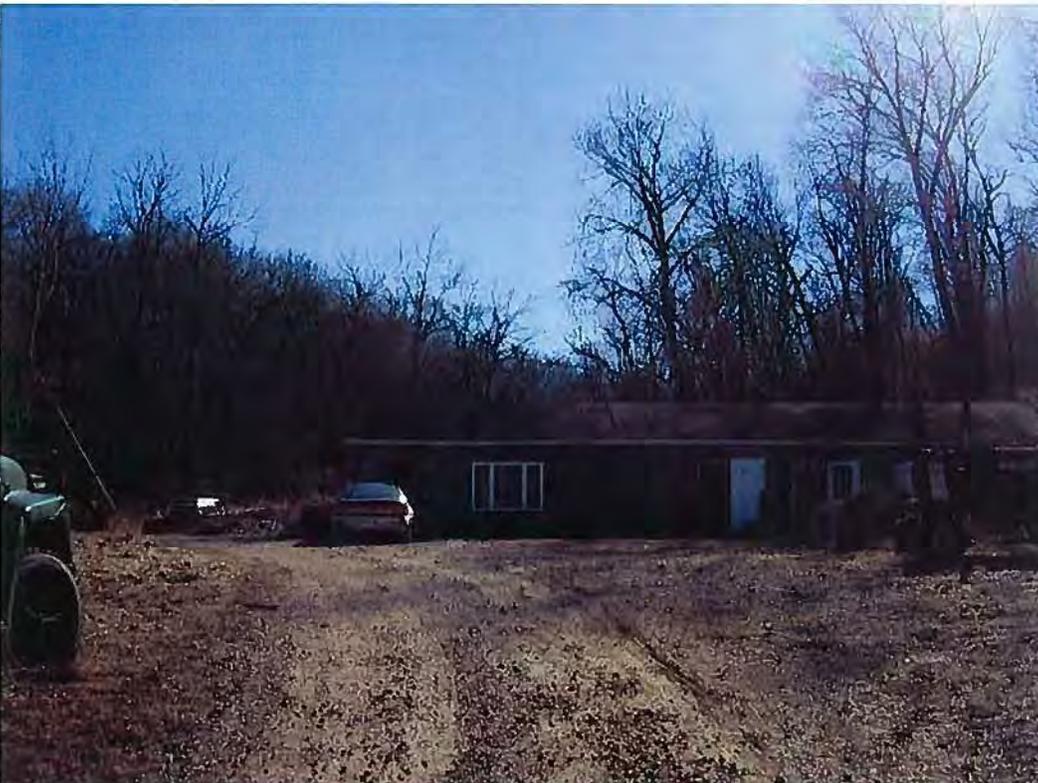
Photograph 4 shows the front elevation of the house. There was one vehicle in front of the house that appeared to be operational during this fourth inspection. It appears other inoperable cars parked here during the previous inspections have been removed. During the first inspection four large fuel tanks were on the west side of the driveway, and were removed by the second inspection. Currently, a red farm tractor was observed to the west of the driveway near a pig pen. The rest of the area is still clear of debris.

**Date:** January 22, 2009  
**Time:** 12:19 PM  
**Direction:** S  
**Photo by:** Eisenbrandt  
**Exposure #:** 004  
**Comments:** View facing south towards the Sapp residence.

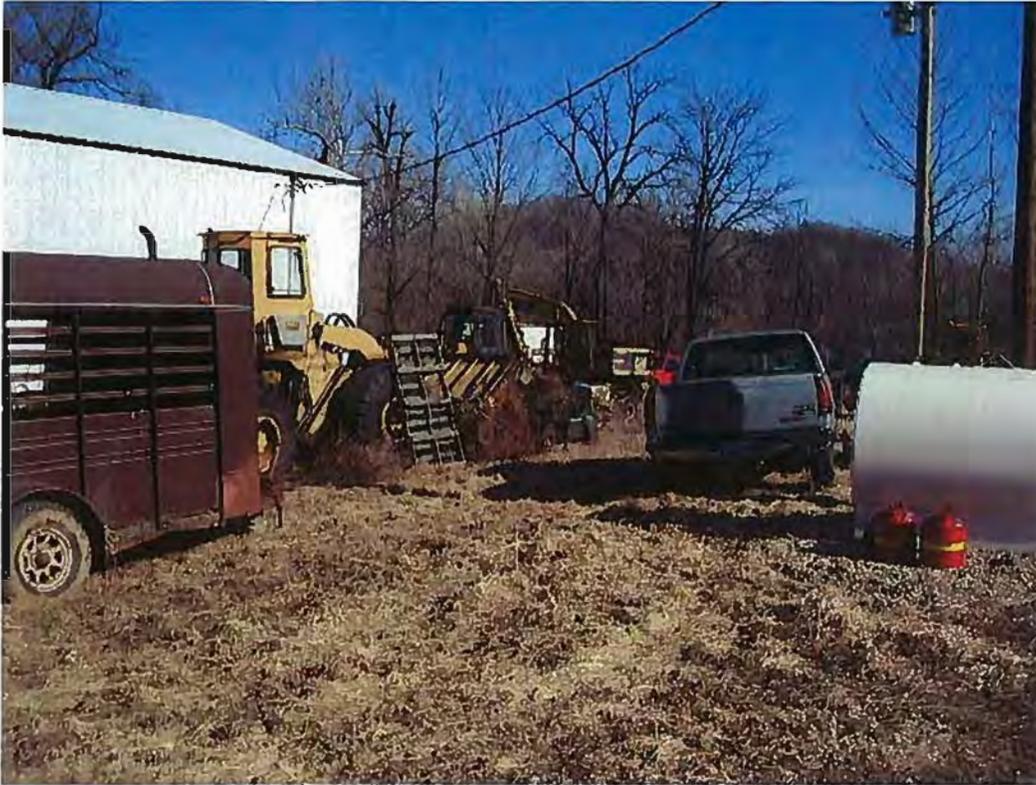
Photograph 5 shows part of the area immediately south of the pole building/shop. Several vehicles were removed from this area between the three previous inspection inspections. Heavy equipment, a horse trailer, a dented up blue pickup truck, an aboveground storage tank of fuel, and two gasoline cans were observed. Miscellaneous debris were still observed near the pole building.

**Date:** January 22, 2009  
**Time:** 12:19 PM  
**Direction:** NE  
**Photo by:** Eisenbrandt  
**Exposure #:** 005  
**Comments:** South of the pole building/shop heavy equipment, a horse trailer, a blue pickup truck, an aboveground storage tank of fuel, and gasoline cans were observed.

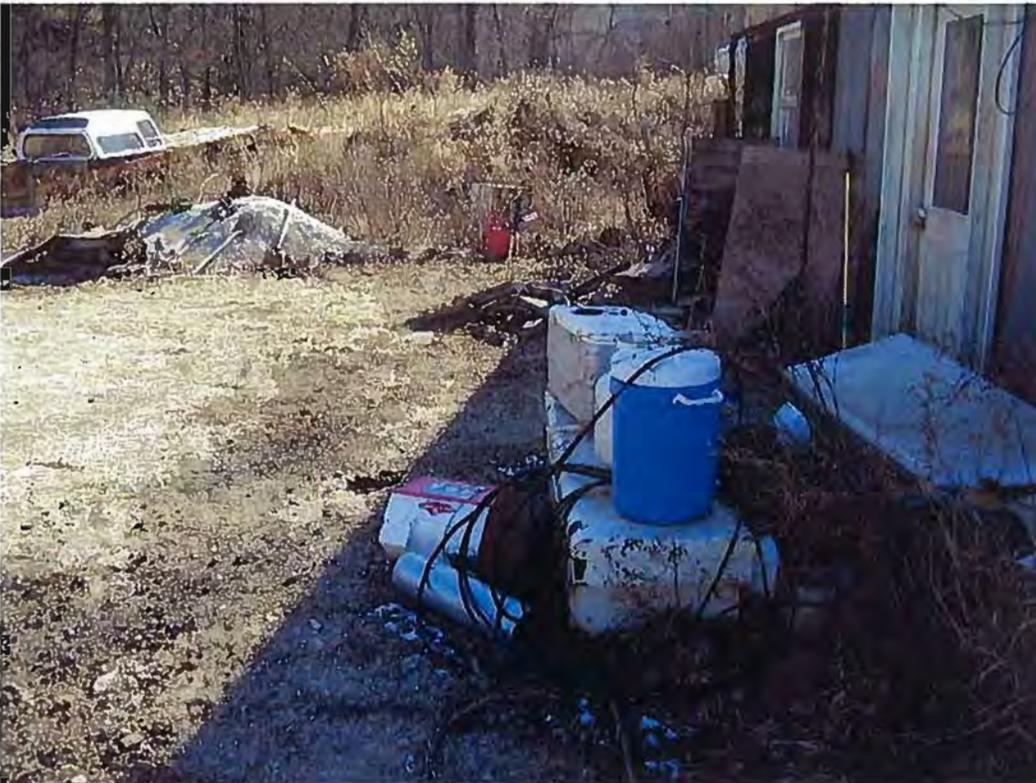
Photograph 6 shows two truck bed tool boxes, several coolers, cable, weathered dimensional lumber, processed lumber, duct work, a vehicle radiator, cinder block, a gasoline can, hand tools, and miscellaneous debris observed haphazardly against the house. The Illinois EPA inspector previously told Mr. Sapp not to store fuel containers in a careless fashion.

**Date:** January 22, 2009  
**Time:** 12:20 PM  
**Direction:** S  
**Photo by:** Eisenbrandt  
**Exposure #:** 006  
**Comments:** Two truck bed tool boxes, several coolers, cable, weathered dimensional lumber, processed lumber, duct work, a vehicle radiator, cinder block, a gasoline can, hand tools, and miscellaneous debris.

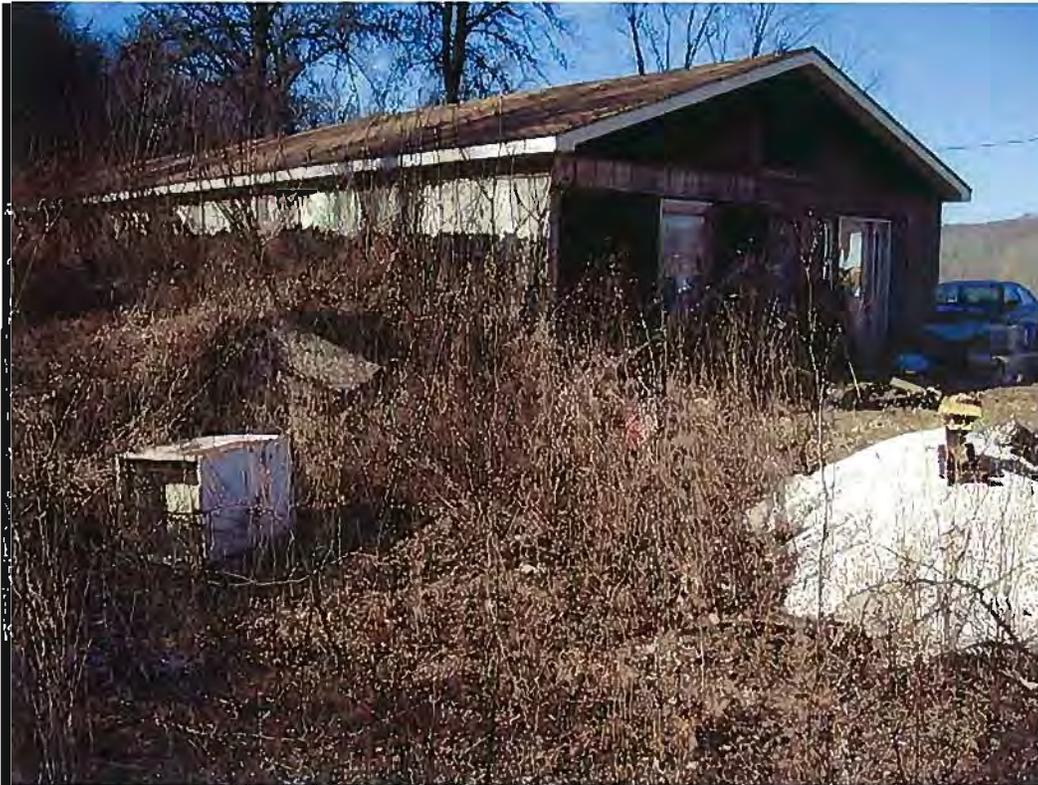
Photograph 7 shows a weedy area southeast of the rear corner of the home. A rusty metal cabinet, a piece of processed lumber, and a gasoline can were observed here.

**Date:** January 22, 2009  
**Time:** 12:20 PM  
**Direction:** NW  
**Photo by:** Eisenbrandt  
**Exposure #:** 007  
**Comments:** A rusty metal cabinet and processed lumber were observed in the weeds southeast of the residence.

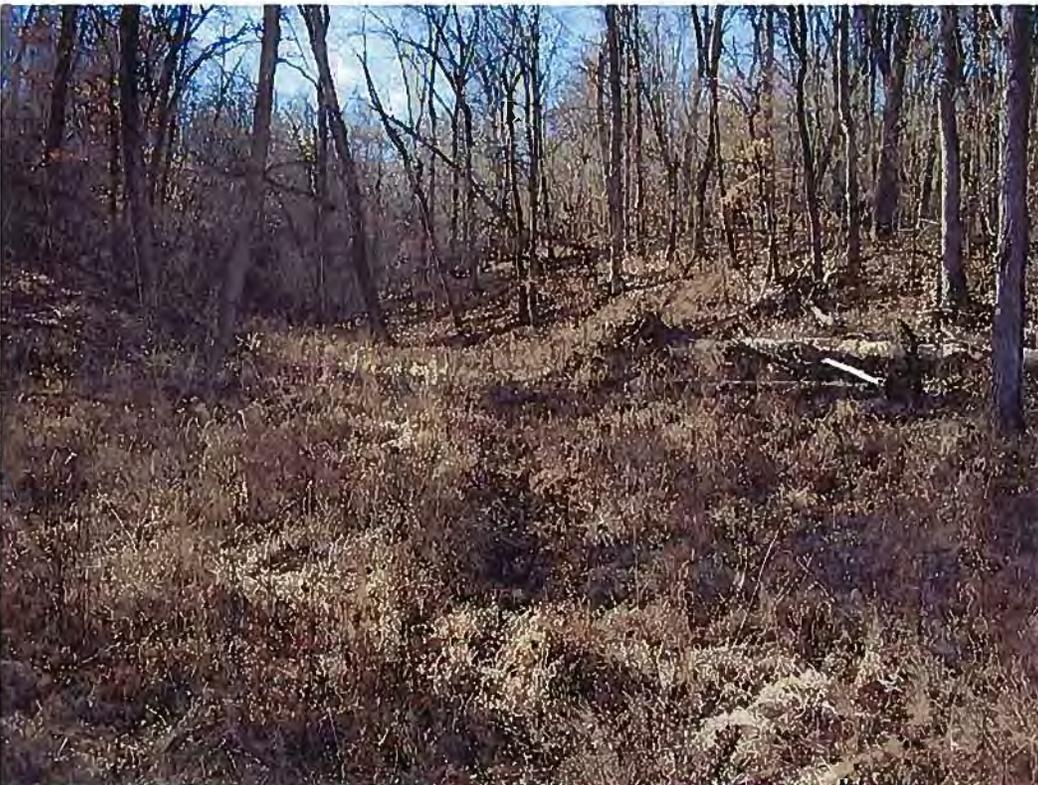
**Date:** January 22, 2009  
**Time:** 12:21 PM  
**Direction:** W  
**Photo by:** Eisenbrandt  
**Exposure #:** 008  
**Comments:** This area has been cleaned up and is clear of debris.

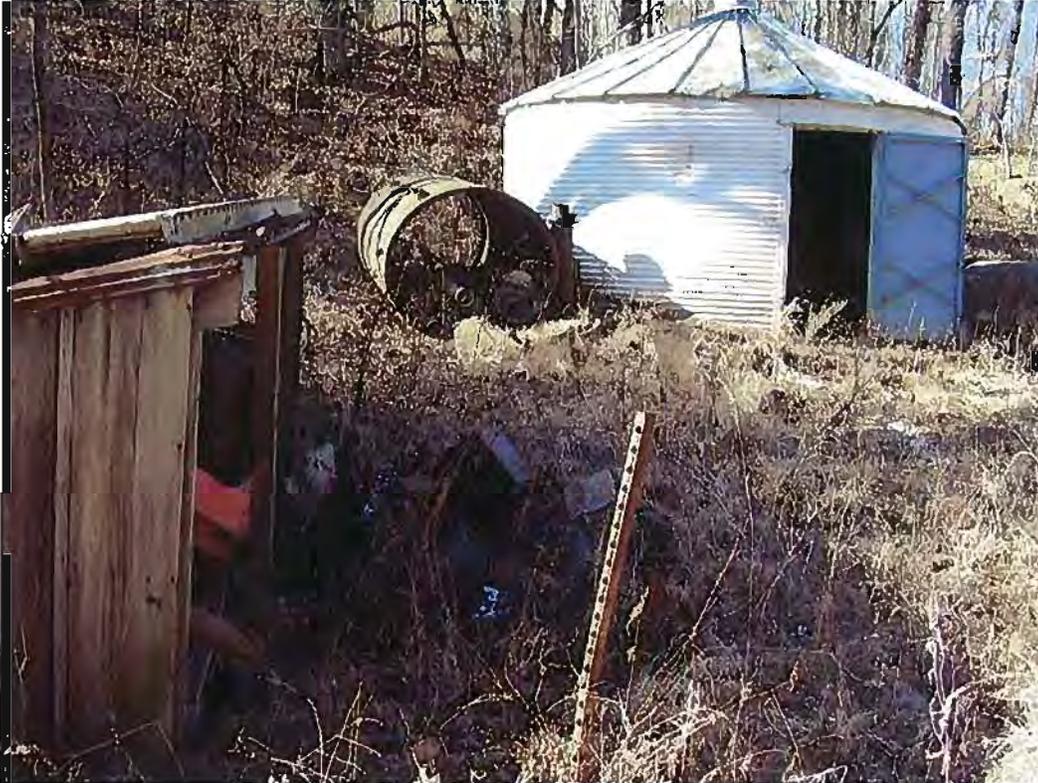
**Date:** January 22, 2009  
**Time:** 12:22 PM  
**Direction:** W  
**Photo by:** Eisenbrandt  
**Exposure #:** 009  
**Comments:** Miscellaneous farm equipment, vehicle parts, and surplus pipe are in this area. In the front of the picture miscellaneous equipment is spilling out of the lean-to structure.

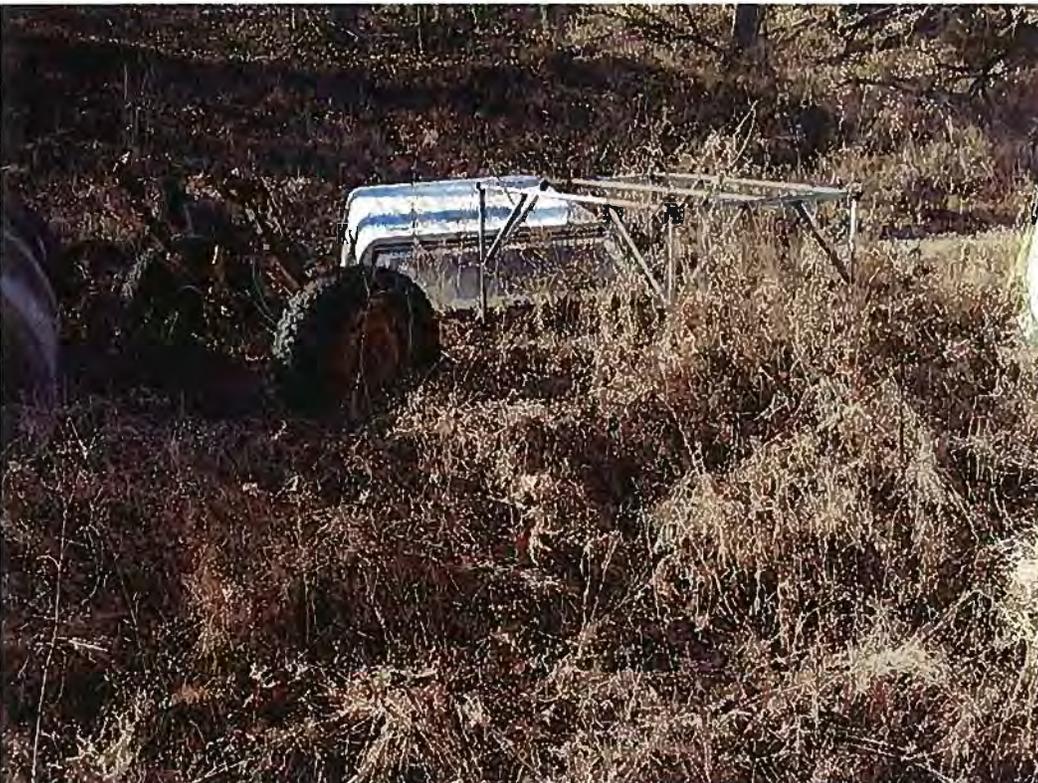
**Date:** January 22, 2009  
**Time:** 12:23 PM  
**Direction:** W  
**Photo by:** Eisenbrandt  
**Exposure #:** 010  
**Comments:** A truck topper and rack system were not previously observed in this area. Since the last inspection Mr. Sapp has removed several vehicle body parts, and miscellaneous debris.

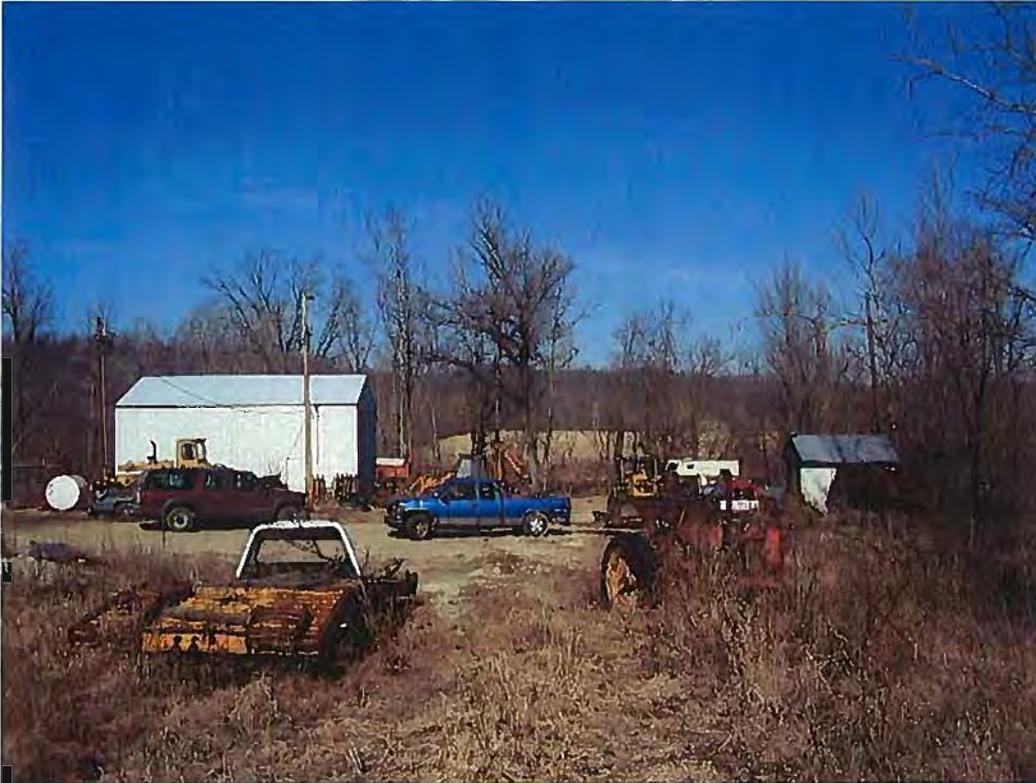
Photograph 11 shows a view facing north towards the pole building/shop. A heavy equipment flat bed trailer with a truck topper, and an old red tractor were observed. A Winnebago frame has been removed from this location.

**Date:** January 22, 2009  
**Time:** 12:23 PM  
**Direction:** N  
**Photo by:** Eisenbrandt  
**Exposure #:** 011  
**Comments:** View facing north towards the shop. A heavy equipment flat bed trailer with a truck topper, and an old red tractor were observed.

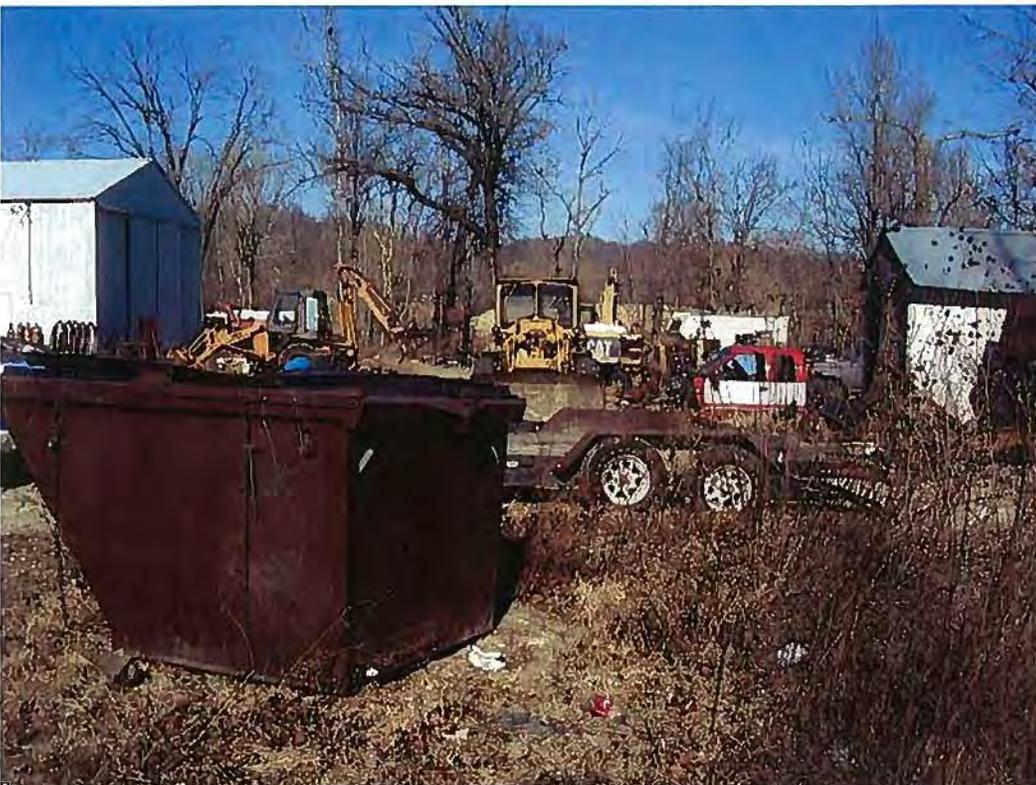
**Date:** January 22, 2009  
**Time:** 12:24 PM  
**Direction:** N  
**Photo by:** Eisenbrandt  
**Exposure #:** 012  
**Comments:** Mr. Sapp has dumpster service provided by Area Disposal Services however, the ground around the dumpster was littered with soda bottles, food wrappers, household waste, and weathered scrap lumber.

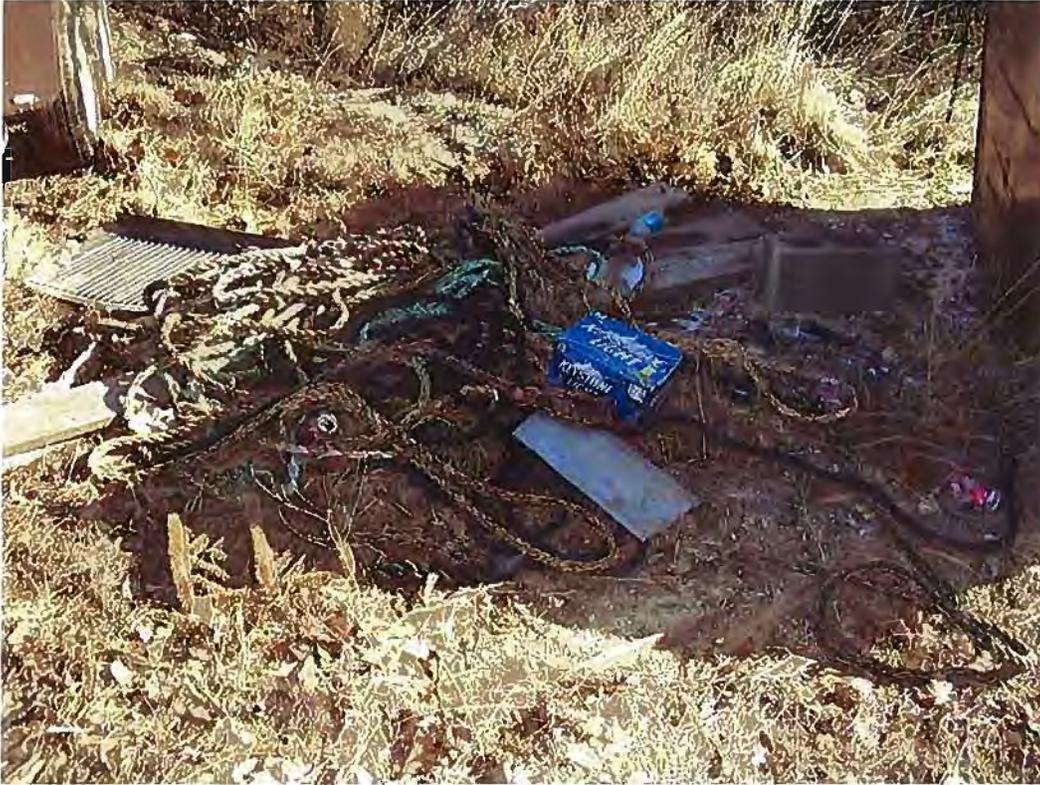
Photograph 13 shows several sections of nylon rope, a cinder block, a Keystone Light beer carton, several aluminum soda cans, weathered dimensional lumber, plastic bottles, scrap metal, and some type of plastic liner observed beside the dumpster.

**Date:** January 22, 2009  
**Time:** 12:24 PM  
**Direction:** E  
**Photo by:** Eisenbrandt  
**Exposure #:** 013  
**Comments:** Nylon rope, a cinder block, a Keystone Light beer carton, several aluminum soda cans, weathered dimensional lumber, plastic bottles, scrap metal, and some type of plastic liner, were observed beside the dumpster.

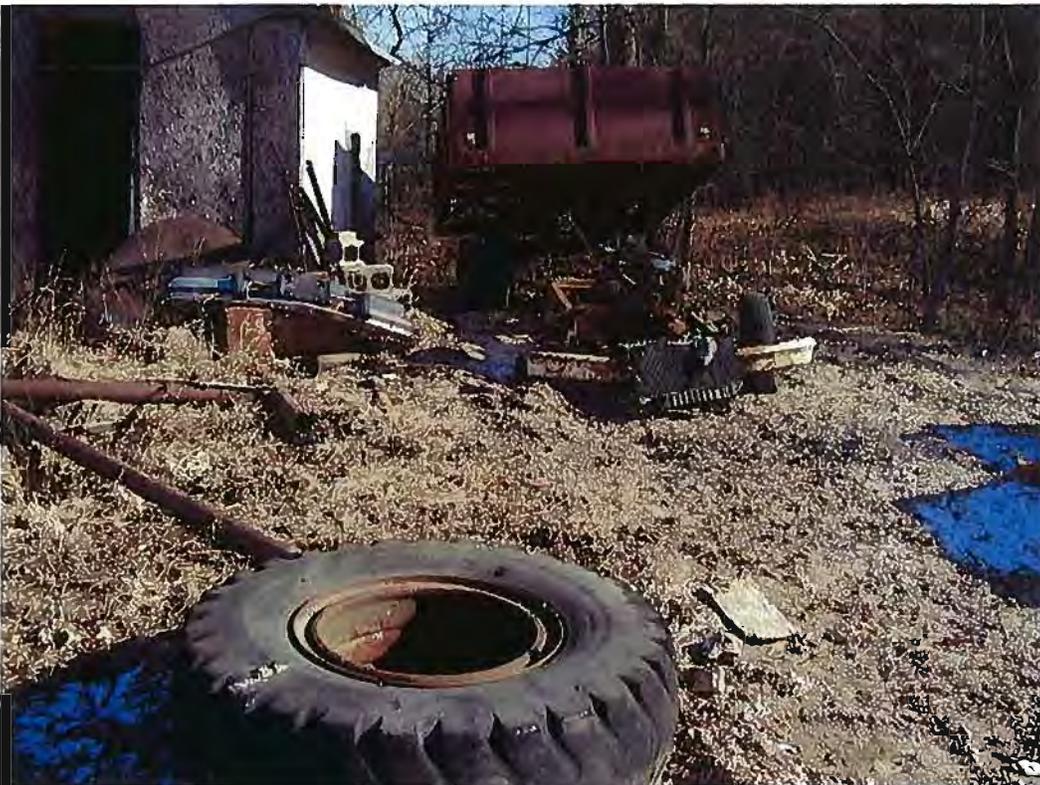
Photograph 14 shows rusty steel poles, an on-rim truck tire, and miscellaneous debris strewn on the ground near a shed. The dismantled remains of a truck were also observed. This area has continuously contained scrap metal, surplus vehicle parts, trailers, and other miscellaneous debris on the ground along the east edge of the property. The Illinois EPA inspector has told Mr. Sapp the surplus vehicle parts should be moved into the shop or another storage building. At the very least they must be consolidated to one area and organized off of the ground in a neat and orderly fashion. This has not been done.

**Date:** January 22, 2009  
**Time:** 12:25 PM  
**Direction:** E  
**Photo by:** Eisenbrandt  
**Exposure #:** 014  
**Comments:** Rusty steel poles, an on-rim truck tire, and miscellaneous debris were observed strewn on the ground near a shed. The dismantled remains of a truck were also observed in this area.

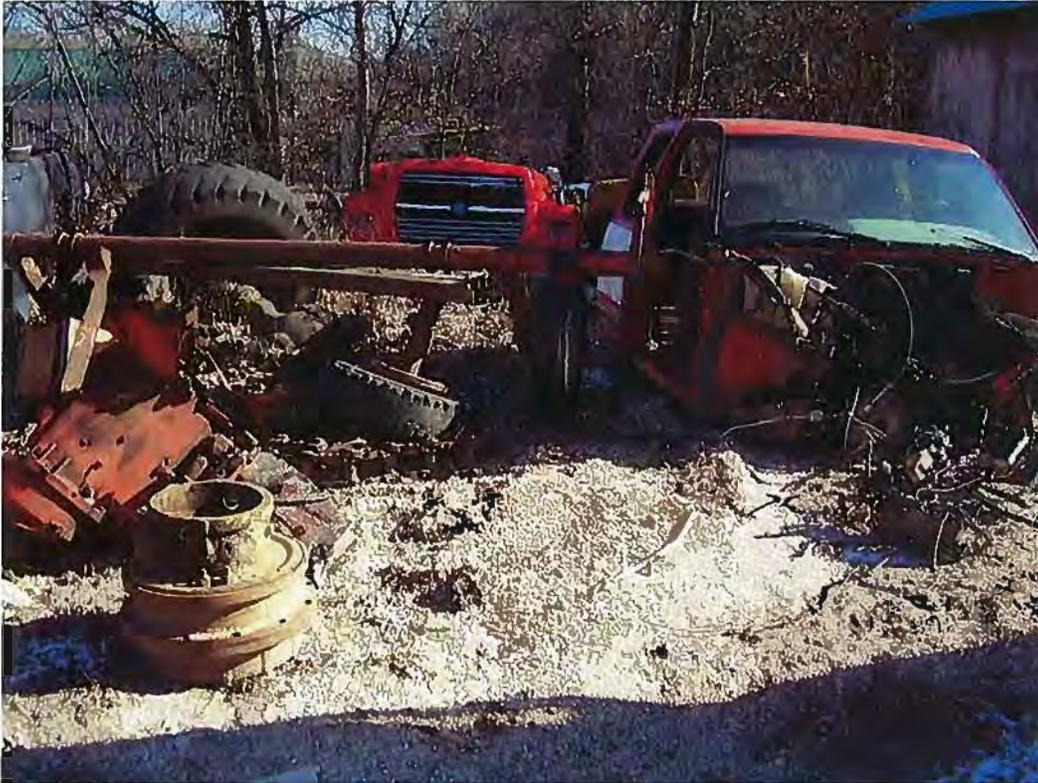
Photograph 15 shows a partially cut up pickup truck, truck tires, a piece of a vehicle motor, an exhaust header, the hood of a truck, and scrap metal littering the ground east of the driveway. This area used to have two pickup trucks planned for restoration and a car that was used for parts. The inspector told Mr. Sapp, in the past, that the vehicles could not be scattered throughout the site making his property resemble an open dump. Any inoperable vehicle not being repaired or restored must be removed from the property. This includes all vehicles that Mr. Sapp and his son are finished removing useful parts from. Improper storage of lead acid batteries was not observed during this January 2009 inspection.

**Date:** January 22, 2009  
**Time:** 12:25 PM  
**Direction:** E  
**Photo by:** Eisenbrandt  
**Exposure #:** 015  
**Comments:** A partially cut up pickup truck, truck tires, a piece of a vehicle motor, an exhaust header, the hood of a truck, and scrap metal litter the ground east of the driveway.

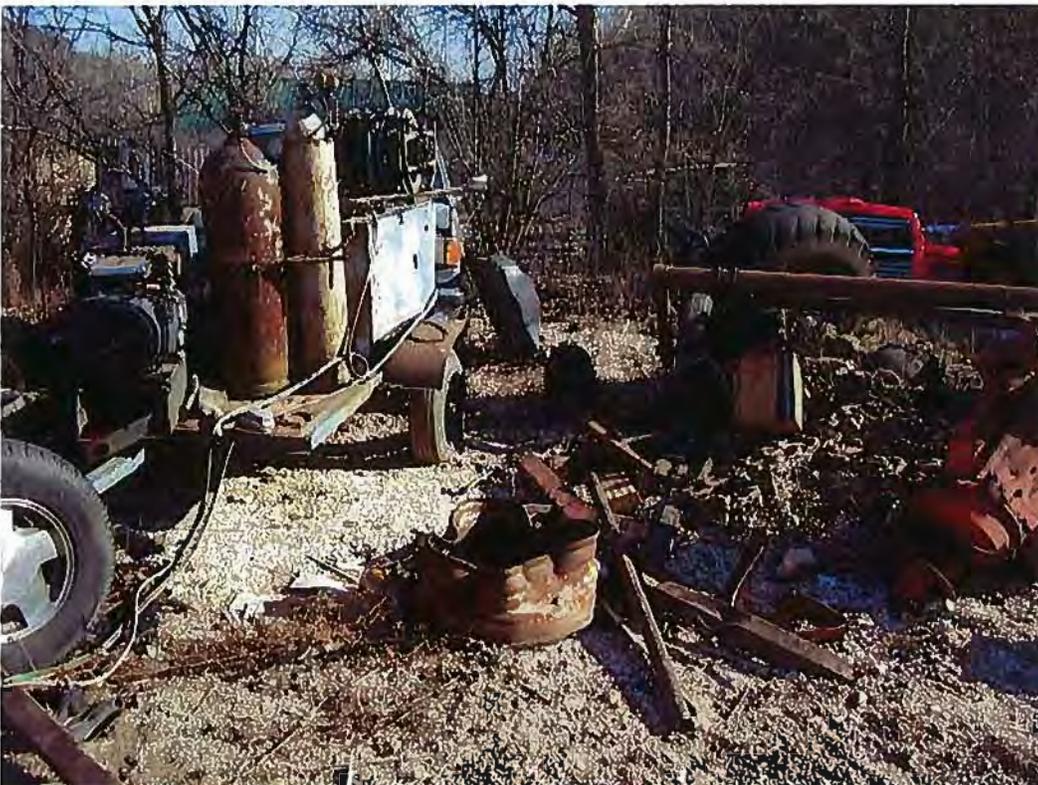
Photograph 16 shows a utility trailer housing acetylene and oxygen tanks and what appears to be a welding device or generator. A bent up truck rim, scrap metal, vehicle parts, and miscellaneous scrap metal were also observed.

**Date:** January 22, 2009  
**Time:** 12:25 PM  
**Direction:** E  
**Photo by:** Eisenbrandt  
**Exposure #:** 016  
**Comments:** A utility trailer housing acetylene and oxygen tanks and what appears to be a welding device or generator. A bent up truck rim, scrap metal, vehicle parts, and miscellaneous scrap metal were also observed.

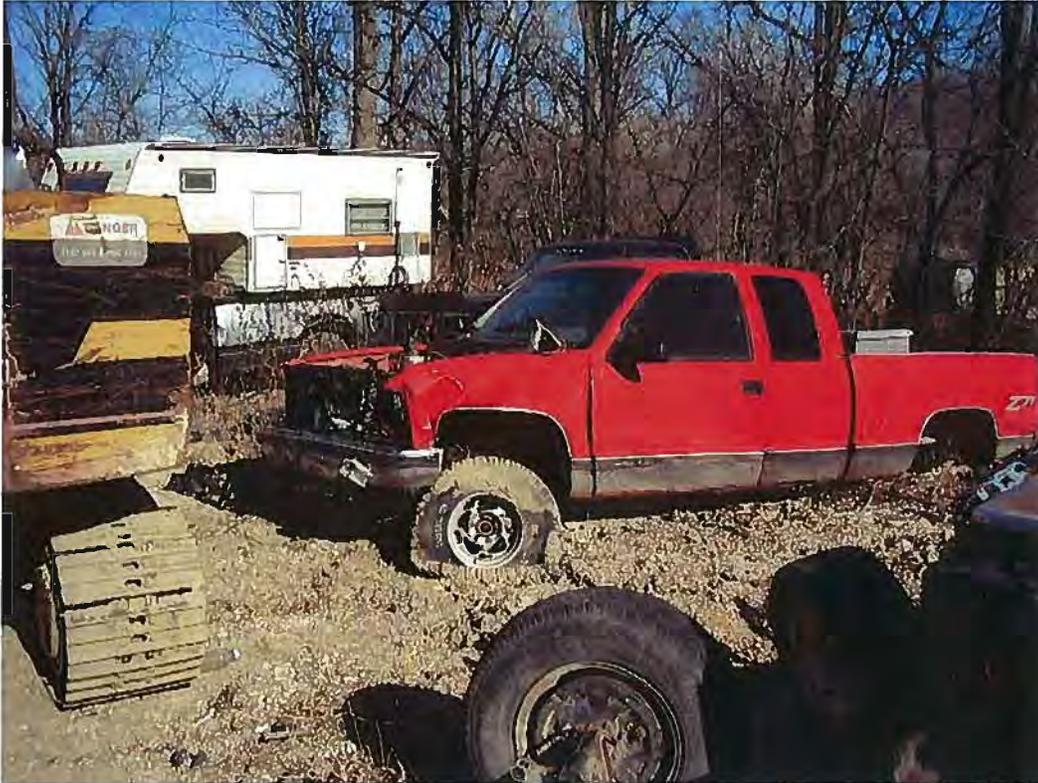
Photograph 17 shows three partially dismantled pickup trucks and a camper top observed east of

**Date:** January 22, 2009  
**Time:** 12:25 PM  
**Direction:** NE  
**Photo by:** Eisenbrandt  
**Exposure #:** 017  
**Comments:** Three partially dismantled pickup trucks and a camper top were observed east of the pole building/shop.

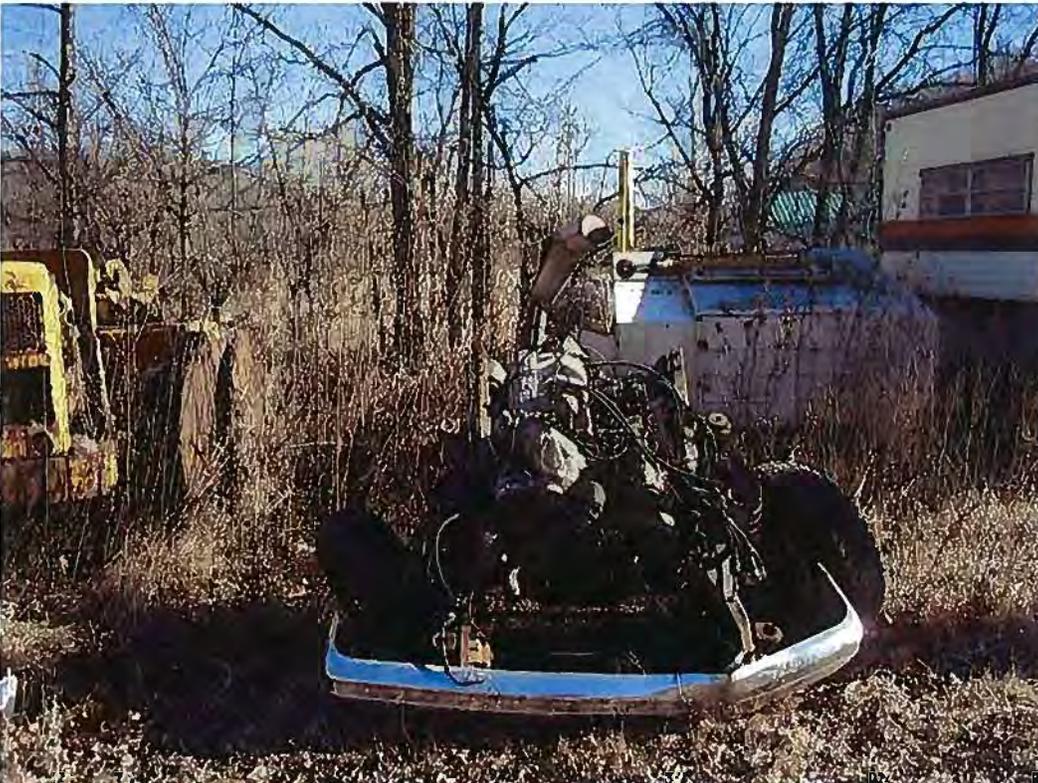
**Date:** January 22, 2009  
**Time:** 12:26 PM  
**Direction:** E  
**Photo by:** Eisenbrandt  
**Exposure #:** 018  
**Comments:** Another partially dismantled vehicle.

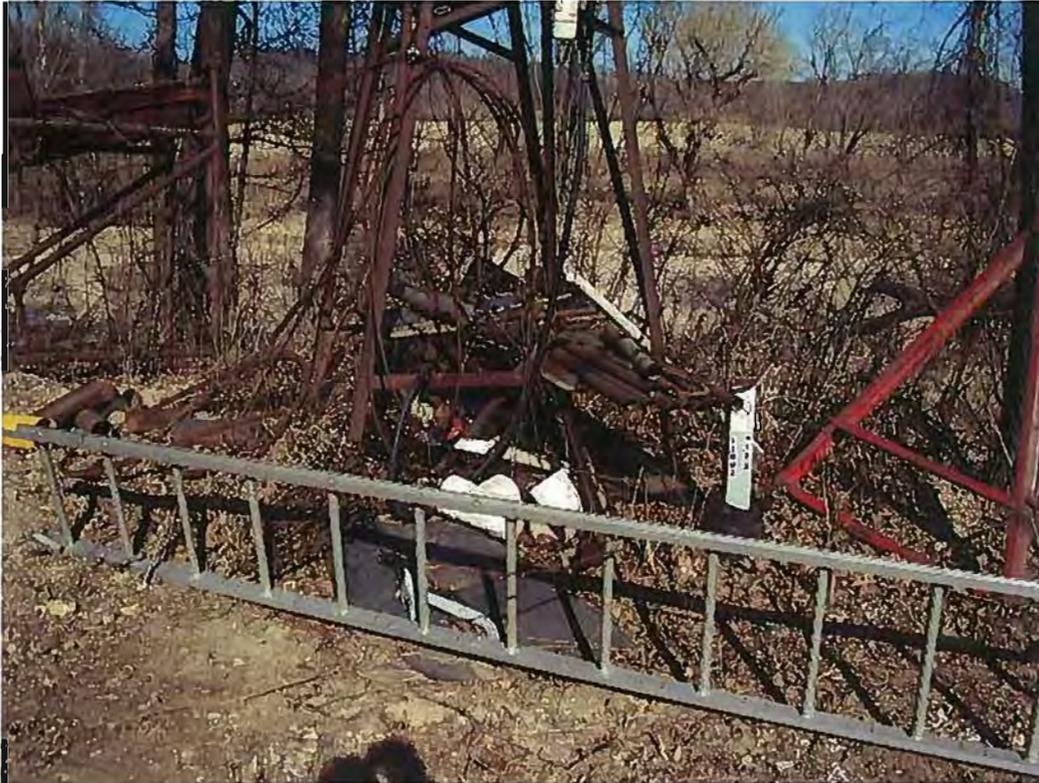
Photograph 19 shows a ladder, PVC pipe, steel pipe, rusty cable and miscellaneous debris under a petroleum tank near Dutch Creek. This area north of the access drive and the pole building used to be used by Mr. Sapp to cut up scrap metal. It appears that most of the scrap metal and waste have been removed from this area over the past year or two.

**Date:** January 22, 2009  
**Time:** 12:26 PM  
**Direction:** N  
**Photo by:** Eisenbrandt  
**Exposure #:** 019  
**Comments:** A ladder, PVC pipe, steel pipe, rusty cable, and miscellaneous debris under a petroleum tank near Dutch Creek.

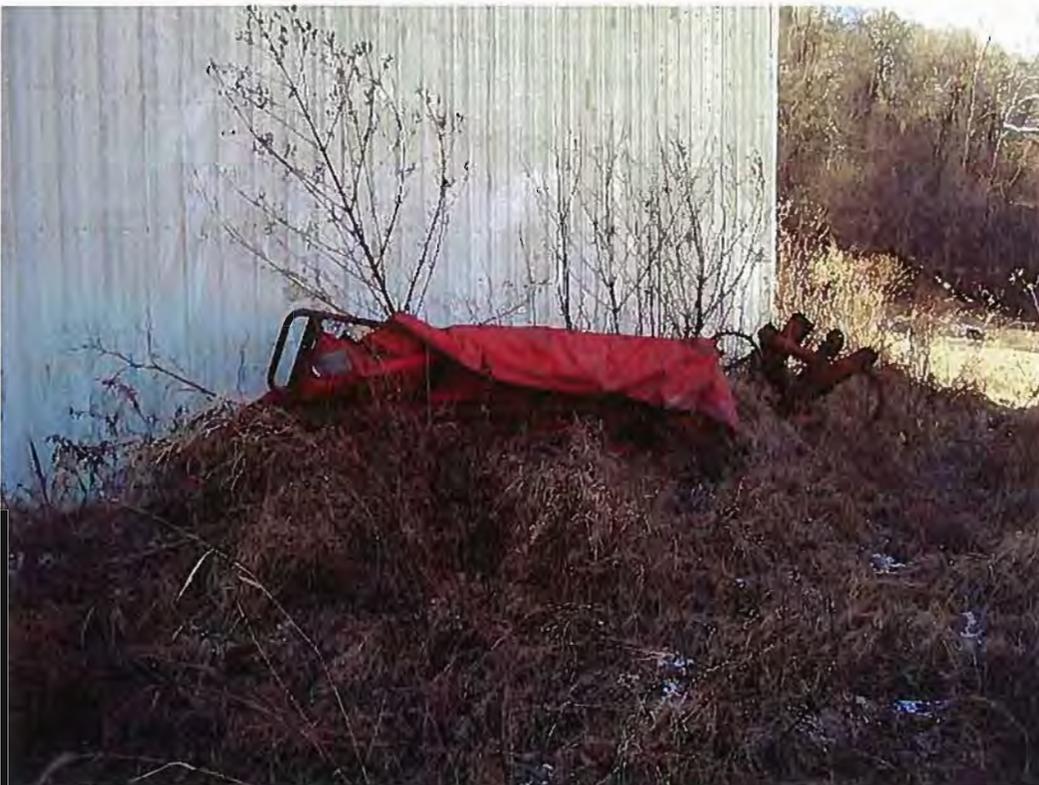
**Date:** January 22, 2009  
**Time:** 12:26 PM  
**Direction:** SW  
**Photo by:** Eisenbrandt  
**Exposure #:** 020  
**Comments:** A plow and equipment on the north side of the shop.

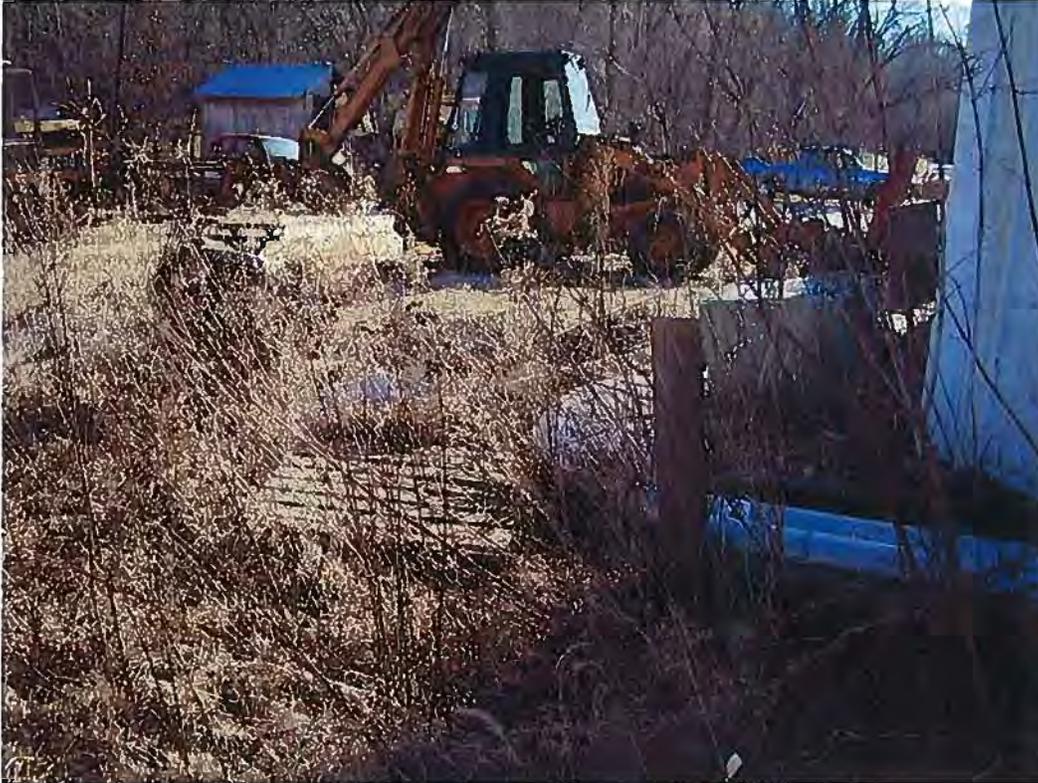
Photograph 21 shows a view of debris on the northeast side of the shop. An old pallet, piping, and scrap steel were observed in the weeds.

**Date:** January 22, 2009  
**Time:** 12:26 PM  
**Direction:** SE  
**Photo by:** Eisenbrandt  
**Exposure #:** 021  
**Comments:** View of debris on the east side of the shop. An old pallet, piping, and scrap steel were observed in the weeds.

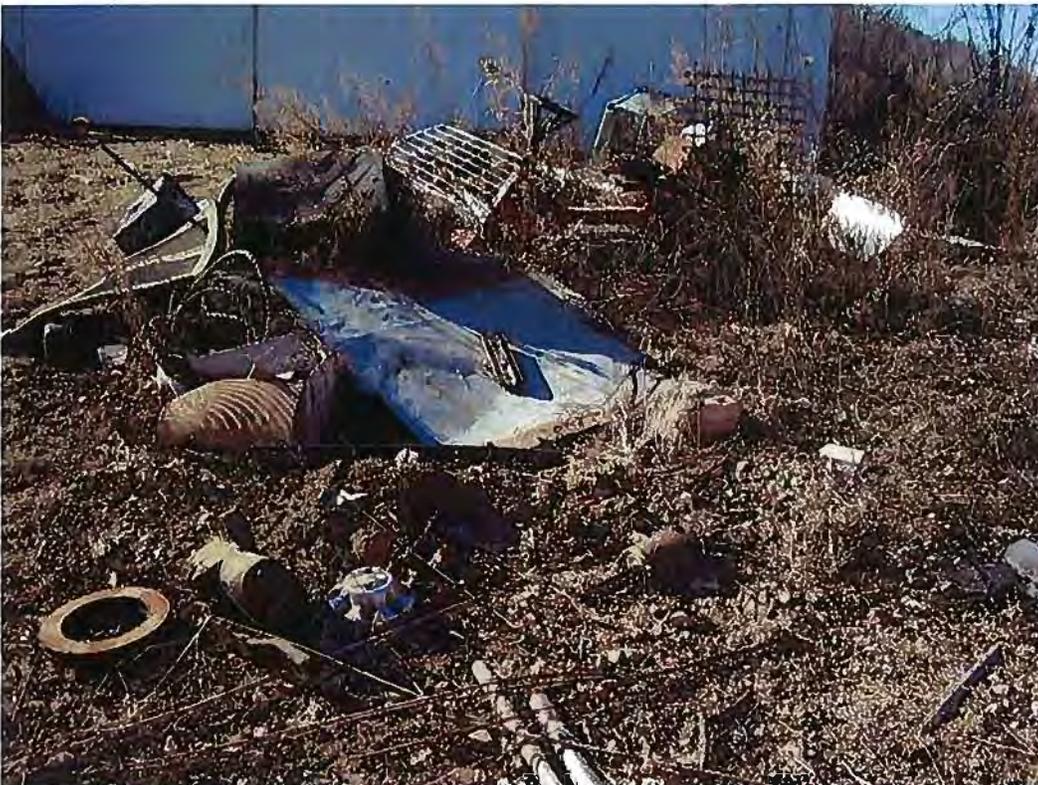
**Date:** January 22, 2009  
**Time:** 12:27 PM  
**Direction:** W  
**Photo by:** Eisenbrandt  
**Exposure #:** 022  
**Comments:** A truck grill, steel mesh, rope, sheet metal, a brake rotor, a hub cap, steel rods, a riding lawn mower, a cardboard box, vehicle parts, and miscellaneous debris were in front of the shop.

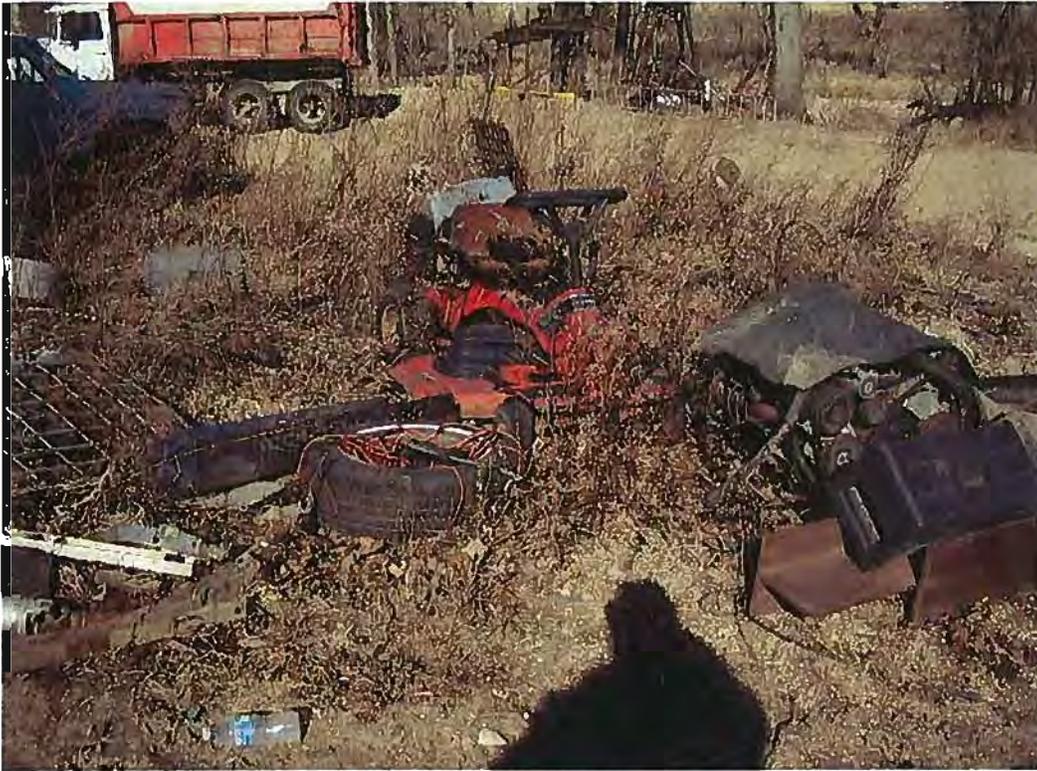
Photograph 23 shows an on-rim used tire, plastic beverage bottles, leaf springs, a steel I-beam, a drive shaft, an engine (partially under a tarp), and miscellaneous debris observed in front of the shop. The Illinois EPA inspector has told Mr. Sapp all salvaged vehicle parts must be stored inside a structure and cannot be left to rest on the ground. During the August 2005 inspection, Robert Sapp discussed building a lean-to to store spare vehicle body, engine, and chassis parts, used tires for reuse, and barrel storage. The lean-to has not been built. Miscellaneous debris were observed throughout this area.

**Date:** January 22, 2009  
**Time:** 12:27 PM  
**Direction:** N  
**Photo by:** Eisenbrandt  
**Exposure #:** 023  
**Comments:** An on-rim used tire, plastic beverage bottles, leaf springs, a steel I-beam, a drive shaft, an engine (partially under a tarp), and miscellaneous debris were observed in front of shop.

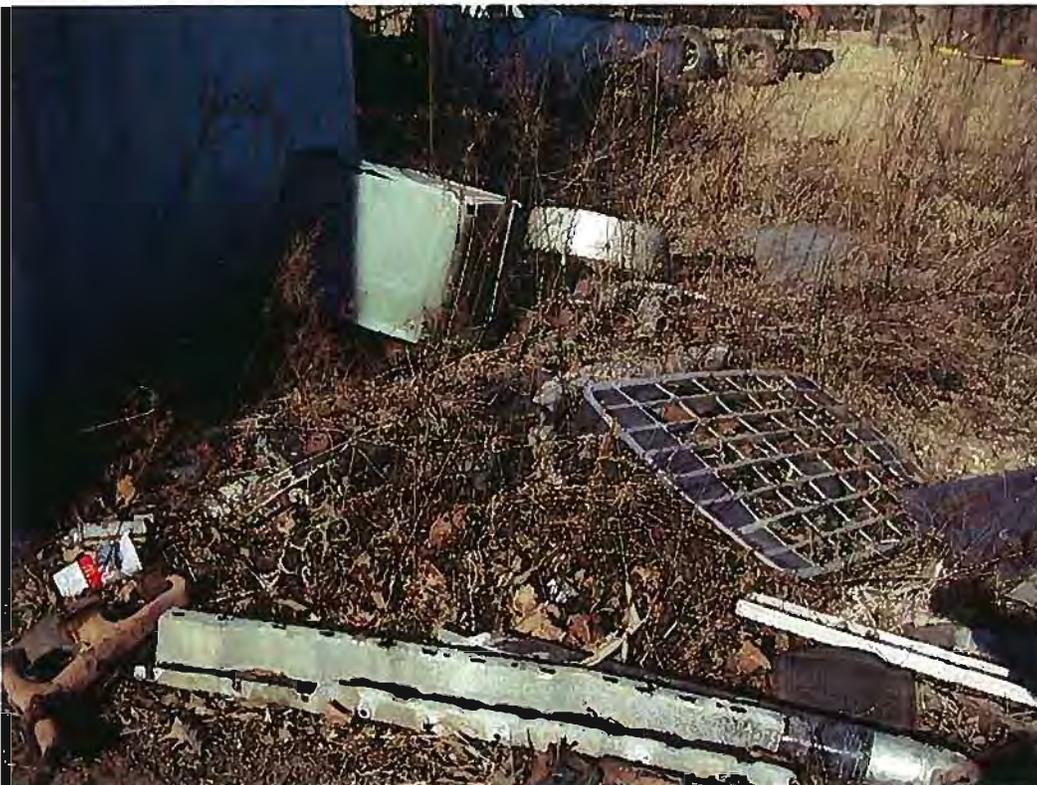
Photograph 24 shows aerosol cans, a McDonalds beverage cup, an exhaust header, metal scrap, a vehicle radiator, an engine (under the green plastic tote), and copious amounts of debris observed in the weeds in front of the shop.

**Date:** January 22, 2009  
**Time:** 12:27 PM  
**Direction:** NW  
**Photo by:** Eisenbrandt  
**Exposure #:** 024  
**Comments:** Aerosol cans, a McDonalds beverage cup, an exhaust header, metal scrap, a vehicle radiator, an engine (under the green plastic tote), and copious amounts of debris were observed in the weeds in front of the shop.
