ILLINOIS ENVIRONMENTAL PROTECTION AGENCY

Re: Illinois Environmental Protection Agency v. Donald Sapp  
IEPA File No.18-09-AC: 1498005003—Pike County

ADMINISTRATIVE CITATION

AC 09-39  
(IEPA No. 18-09-AC)

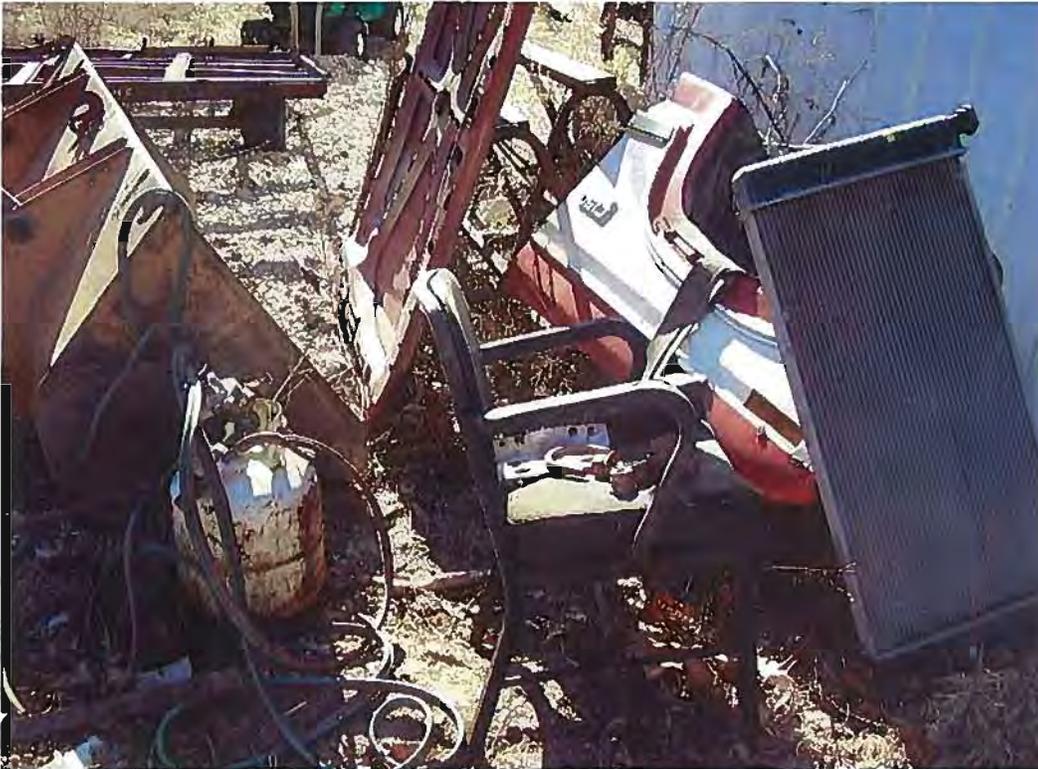
Photograph 25 shows another vehicle radiator, an office chair, a propane tank, a truck fender and engine hood, and miscellaneous debris observed in front of the shop.

**Date:** January 22, 2009  
**Time:** 12:27 PM  
**Direction:** SW  
**Photo by:** Eisenbrandt  
**Exposure #:** 025  
**Comments:** Another vehicle radiator, an office chair, a propane tank, a truck fender and engine hood, and miscellaneous debris were observed in front of the shop.

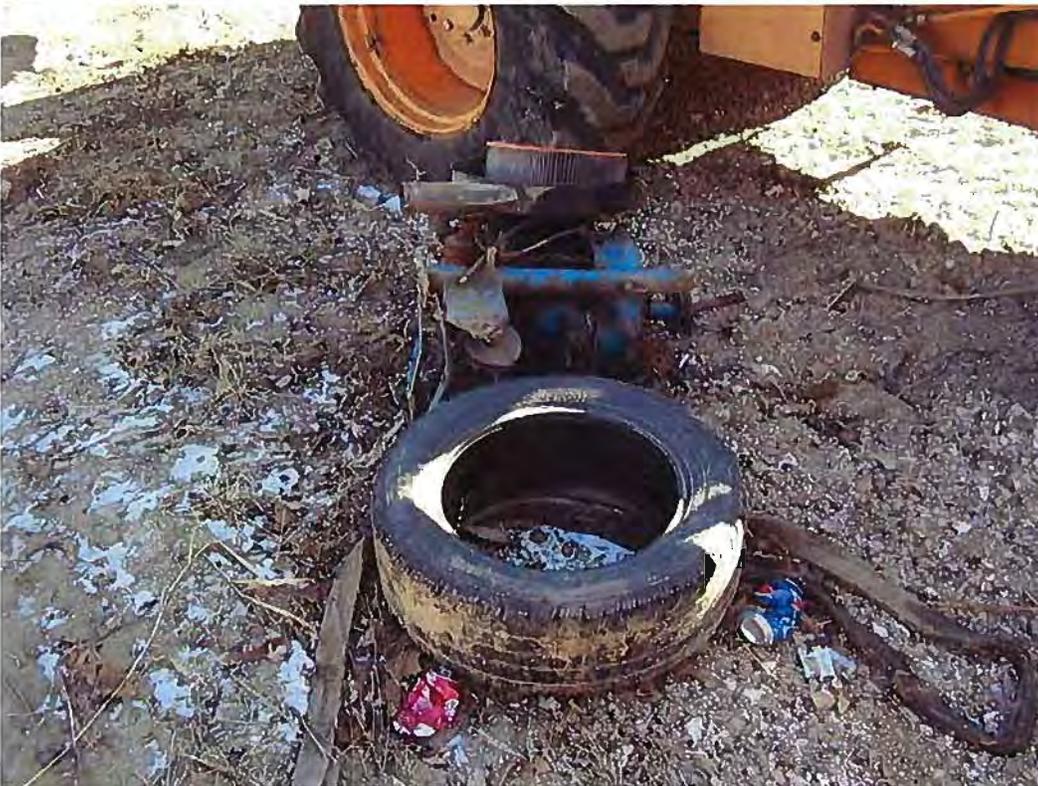
Photograph 26 shows an off-rim used tire, a tow strap, aluminum soda cans, and engine parts observed in front of the shop.

**Date:** January 22, 2009  
**Time:** 12:27 PM  
**Direction:** SE  
**Photo by:** Eisenbrandt  
**Exposure #:** 026  
**Comments:** An off-rim used tire, a tow strap, aluminum soda cans, and engine parts were observed in front of the shop.

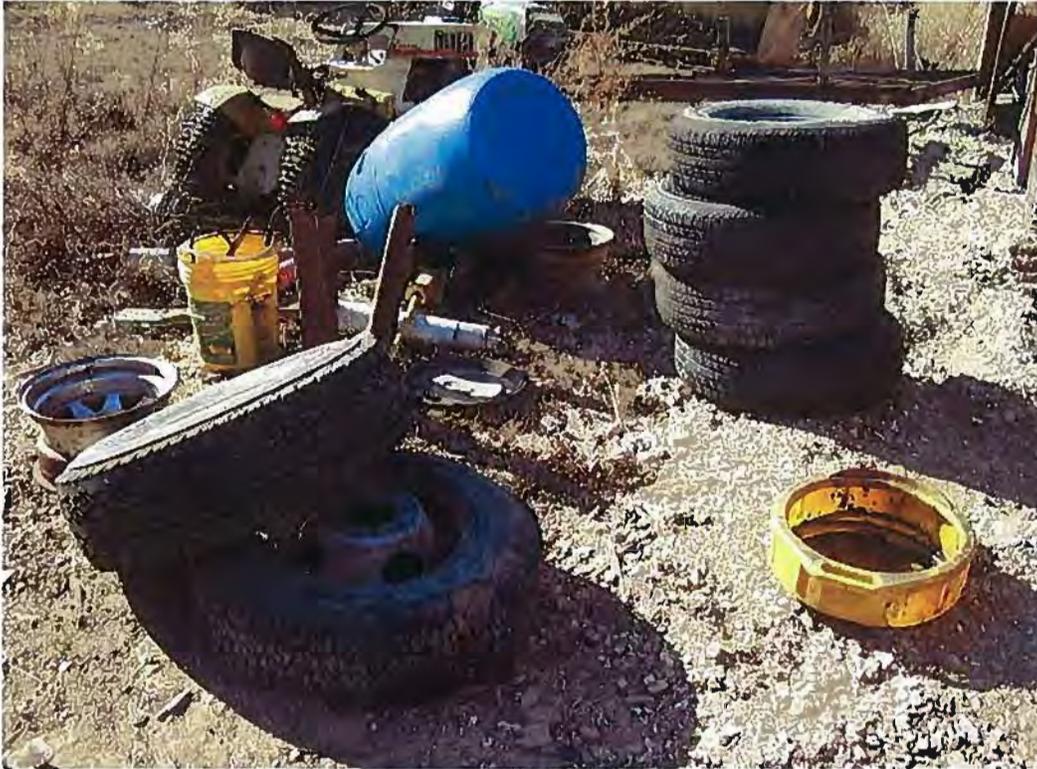
Photograph 27 shows a riding lawn mower, six on and off rim used tires, two wheel rims, an oil collection tray, a metal air filter cover, a yellow bucket of car items, and an empty blue barrel (on its side) were observed among other miscellaneous items and debris in front of the shop.

**Date:** January 22, 2009  
**Time:** 12:28 PM  
**Direction:** W  
**Photo by:** Eisenbrandt  
**Exposure #:** 027  
**Comments:** A riding lawn mower, six on and off rim used tires, two wheel rims, an oil collection tray, a metal air filter cover, a yellow bucket of car items, and an empty blue barrel (on its side) were observed among other miscellaneous items and debris in front of the shop.

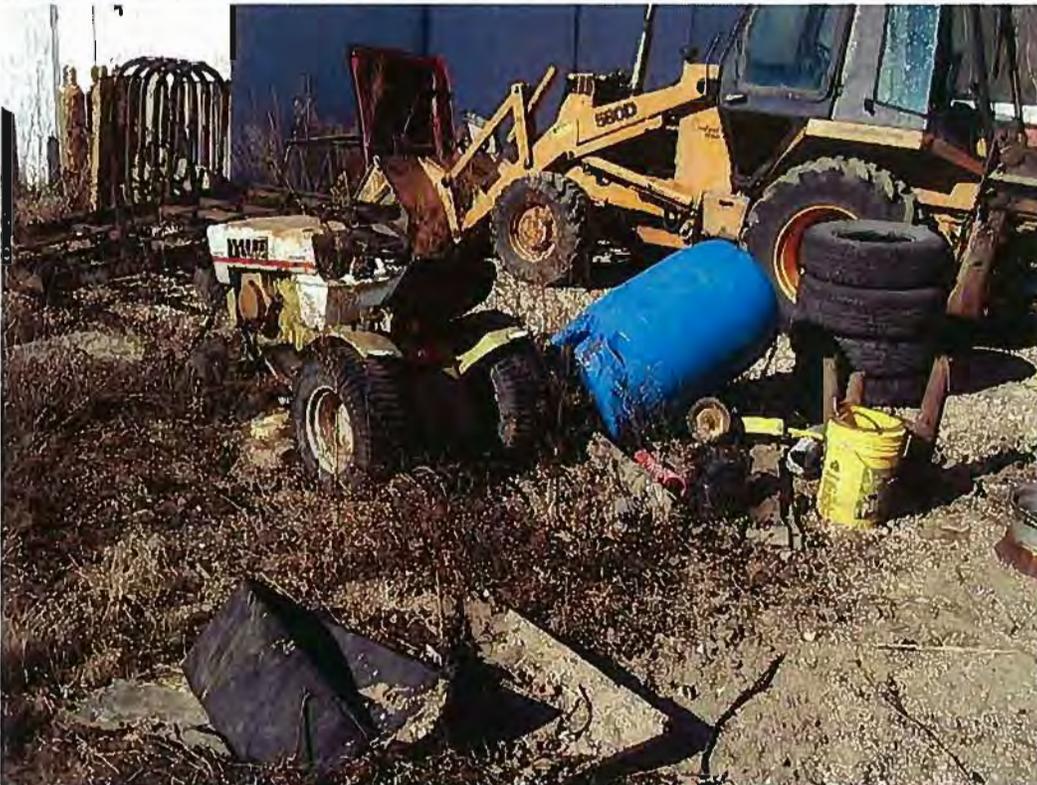
Photograph 28 shows weathered wood sheeting, off rim used tires, scrap metal and miscellaneous items and debris observed in front of the shop.

**Date:** January 22, 2009  
**Time:** 12:28 PM  
**Direction:** NW  
**Photo by:** Eisenbrandt  
**Exposure #:** 028  
**Comments:** Weathered wood sheeting, off rim used tires, scrap metal and miscellaneous items and debris were observed in front of the shop.

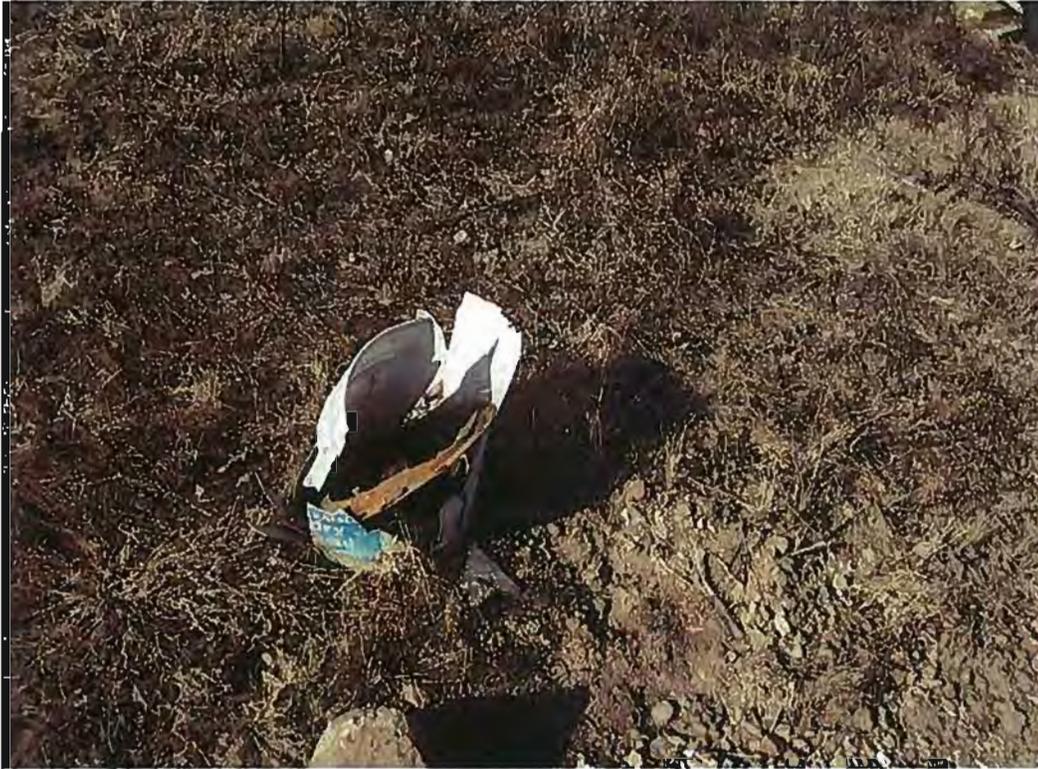
**Date:** January 22, 2009  
**Time:** 12:28 PM  
**Direction:** NW  
**Photo by:** Eisenbrandt  
**Exposure #:** 029  
**Comments:** A smashed plastic bucket near the driveway.

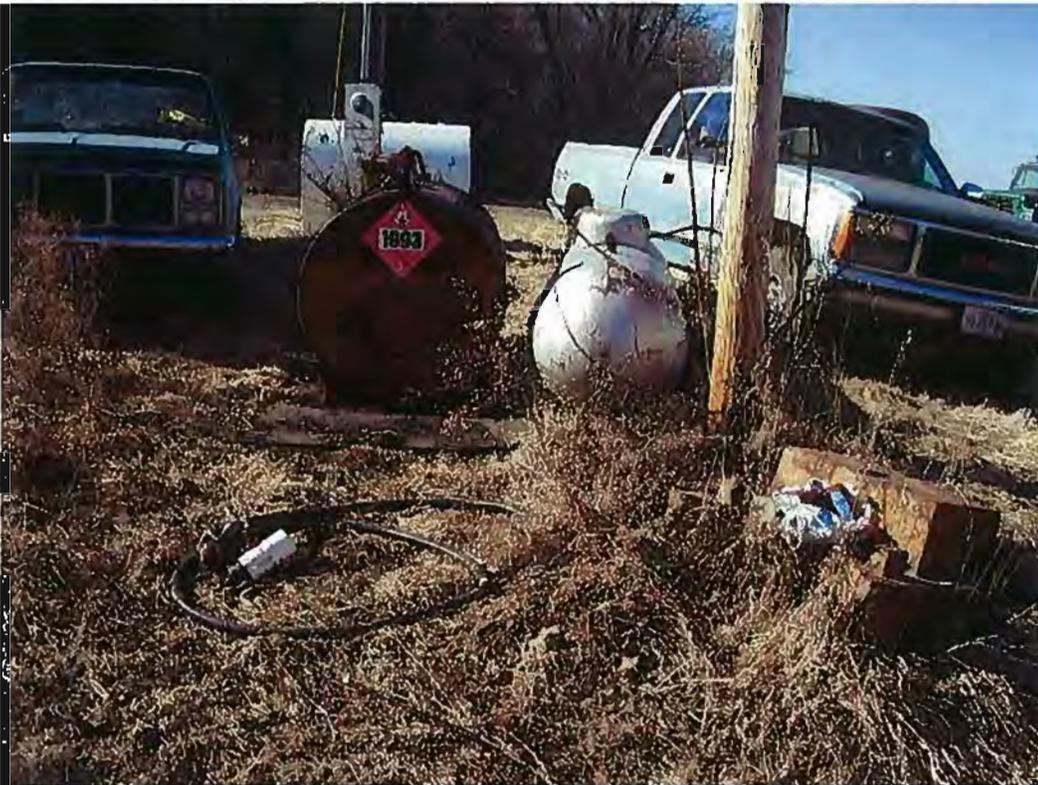
Photograph 30 shows two aboveground storage tanks of fuel, a fuel dispensing hose and filter, and plastic scrap, observed south of the shop.

**Date:** January 22, 2009  
**Time:** 12:28 PM  
**Direction:** W  
**Photo by:** Eisenbrandt  
**Exposure #:** 030  
**Comments:** Two aboveground storage tanks of fuel, a fuel dispensing hose and filter, and plastic scrap, were observed south of the shop.

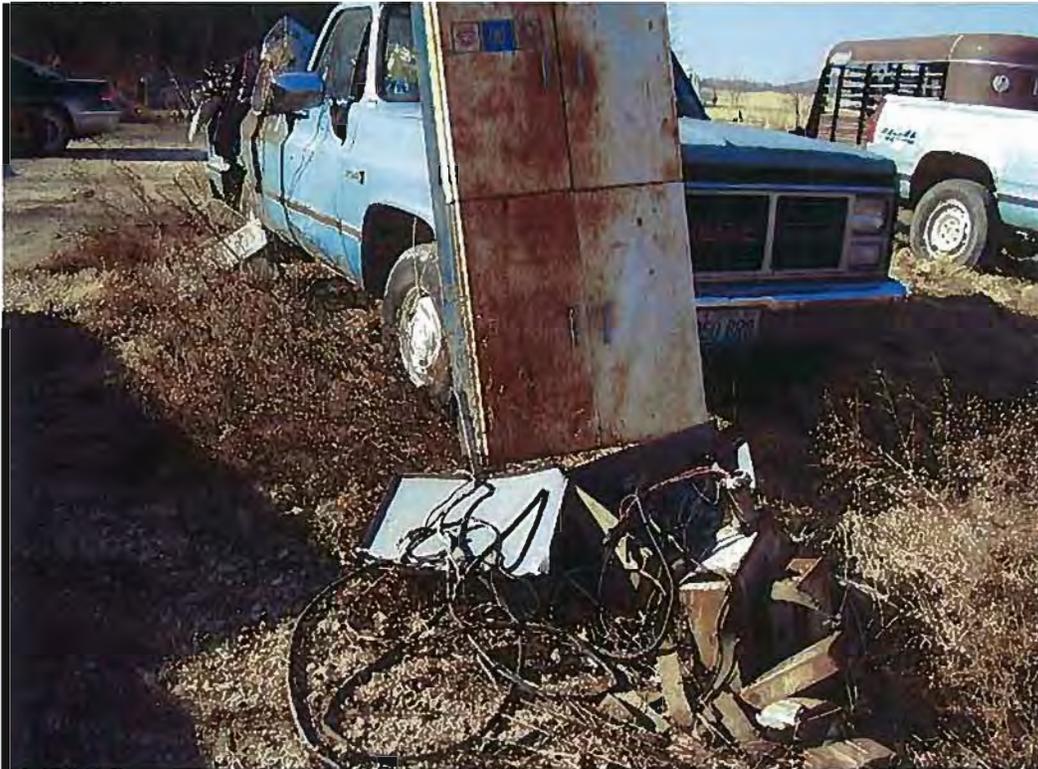
Photograph 31 shows another rusty pickup truck, a rusty steel cabinet, and several damaged electrical service panels, observed south of the shop.

**Date:** January 22, 2009  
**Time:** 12:28 PM  
**Direction:** W  
**Photo by:** Eisenbrandt  
**Exposure #:** 031  
**Comments:** Another pickup truck, a rusty steel cabinet, and several damaged electrical service panels, were observed south of the shop.

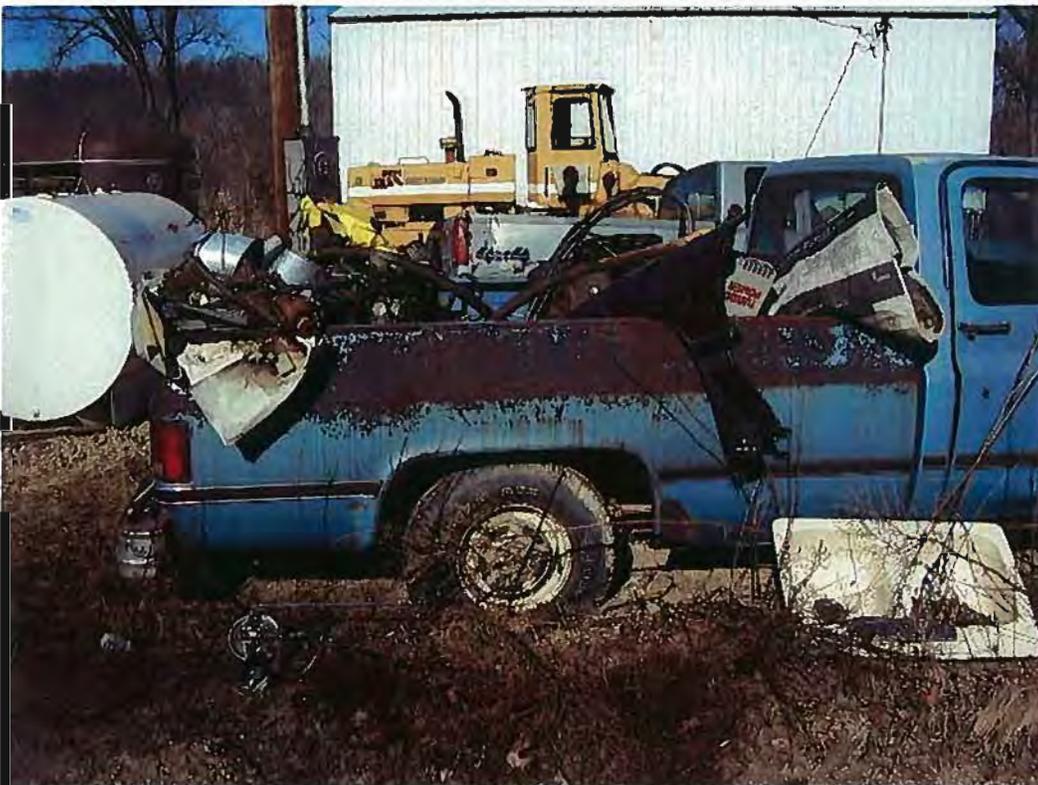
Photograph 32 shows the blue pickup truck bed full of scrap metal and debris. A kitchen sink was observed on the ground beside the truck, as was additional waste in the area.

**Date:** January 22, 2009  
**Time:** 12:28 PM  
**Direction:** N  
**Photo by:** Eisenbrandt  
**Exposure #:** 032  
**Comments:** The blue pickup truck bed was full of scrap metal and debris, a kitchen sink were observed on the ground beside the truck, as was additional waste in the area.

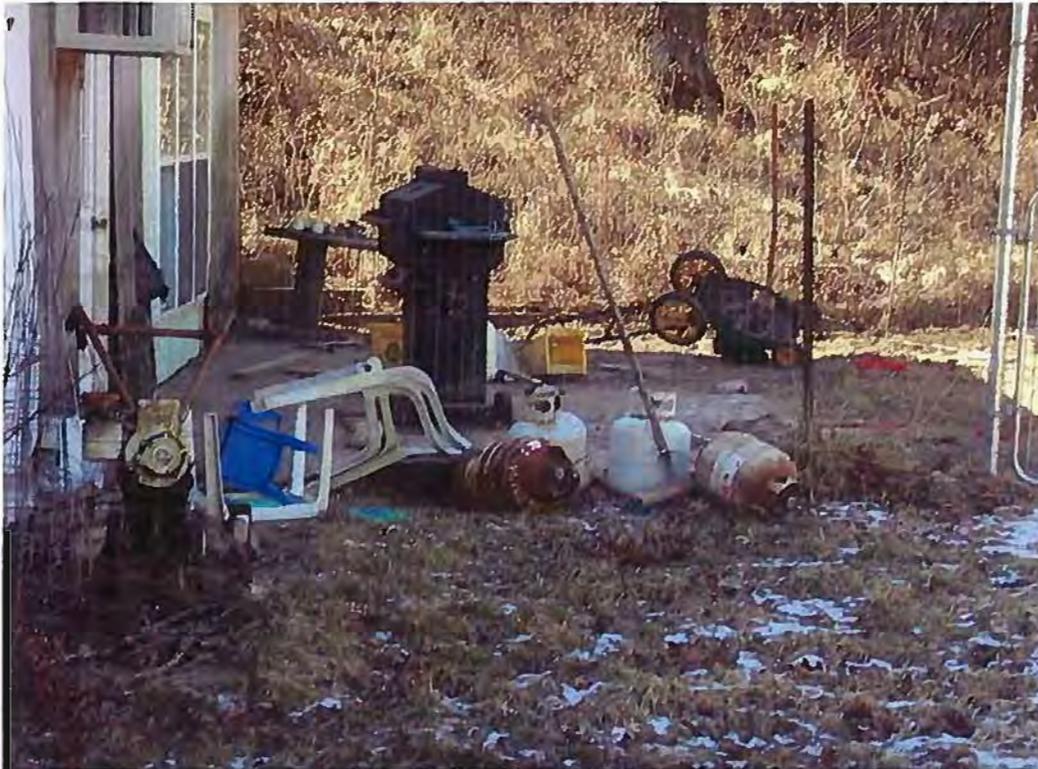
Photograph 33 shows four gas cylinders, an upside down push mower, and miscellaneous debris observed near a pig pen off the north west side of the home

**Date:** January 22, 2009  
**Time:** 12:29 PM  
**Direction:** W  
**Photo by:** Eisenbrandt  
**Exposure #:** 033  
**Comments:** Four gas cylinders, an upside down push mower, and miscellaneous debris were observed near a pig pen off the north west side of the home.

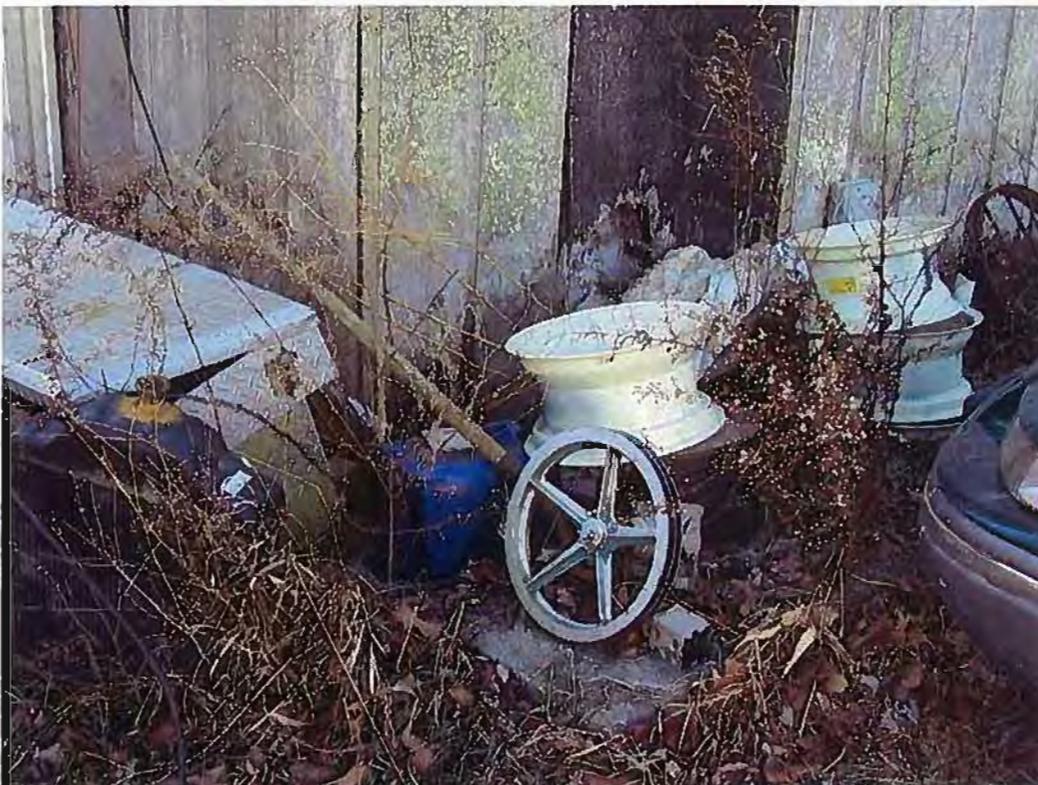
Photograph 34 shows a vehicle radiator, a diamond plate truck bed box, a pulley wheel, three wheel rims, a wagon wheel, and miscellaneous debris observed near the house.

**Date:** January 22, 2009  
**Time:** 12:29 PM  
**Direction:** NW  
**Photo by:** Eisenbrandt  
**Exposure #:** 034  
**Comments:** A vehicle radiator, a diamond plate truck bed box, a pulley wheel, three wheel rims, a wagon wheel, and miscellaneous debris were observed near the house.

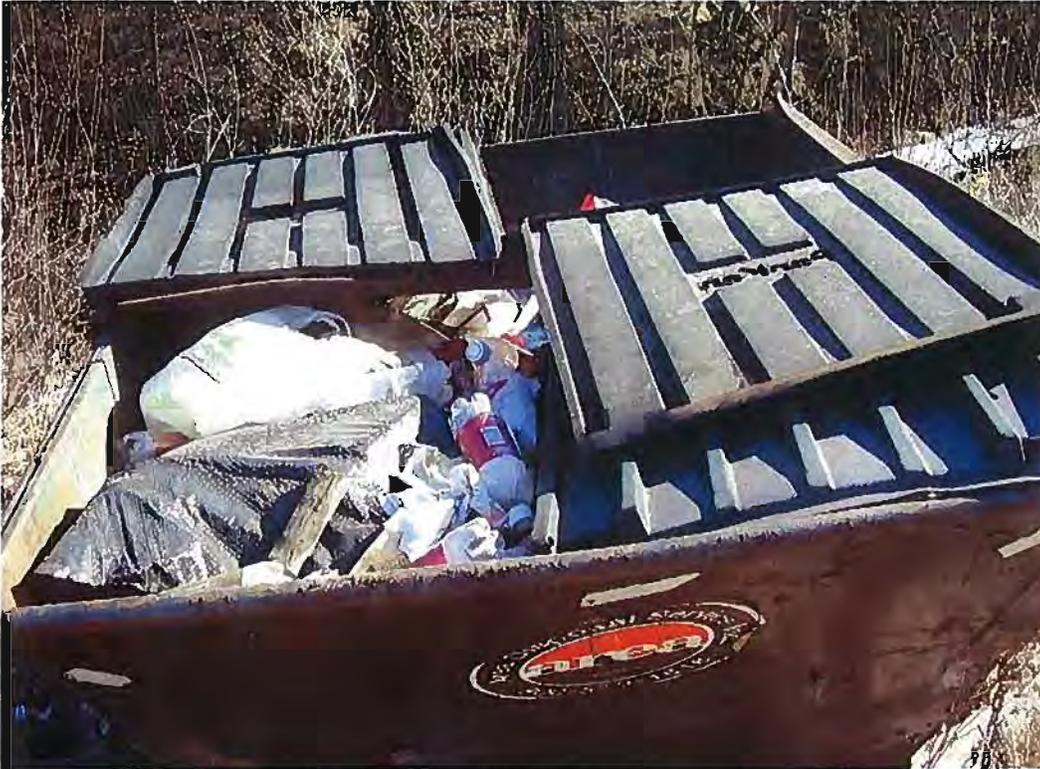
Photograph 35 shows the open plastic lids of the dumpster. This may have contributed to some of the waste observed in the weeds around the dumpster.

**Date:** January 22, 2009  
**Time:** 12:29 PM  
**Direction:** E  
**Photo by:** Eisenbrandt  
**Exposure #:** 035  
**Comments:** The plastic lids were observed open. This may have contributed to some of the waste observed in the weeds nearby.

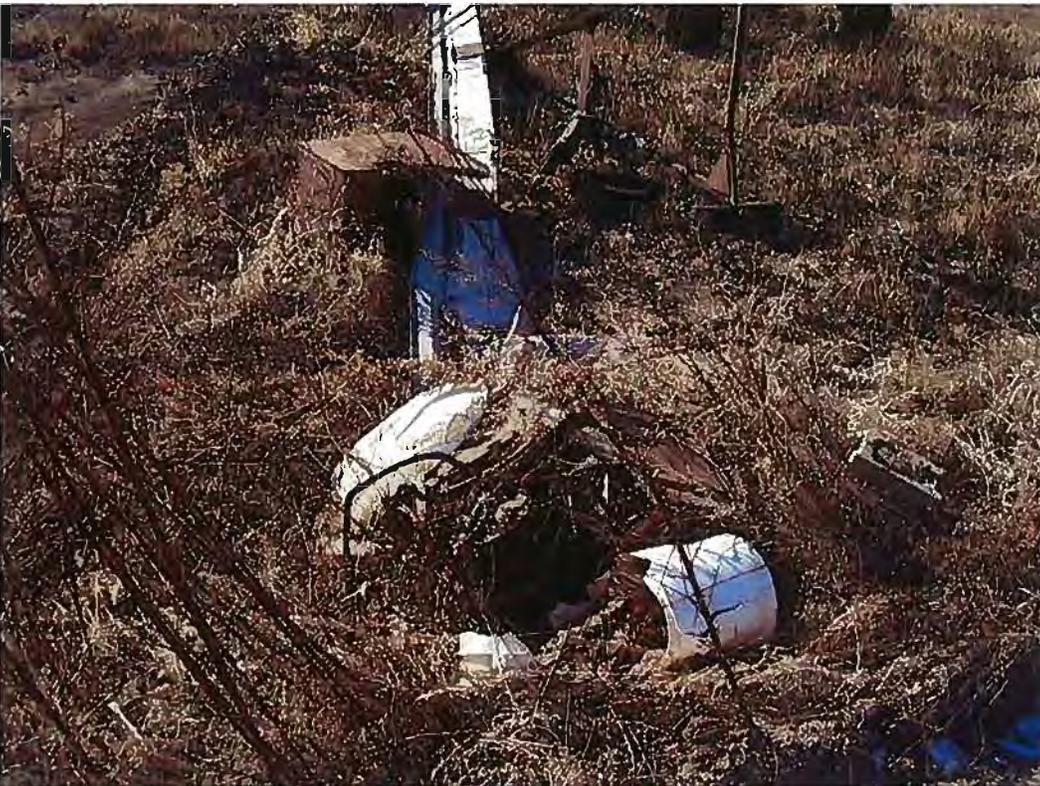
Photograph 36 shows a broken white plastic bucket, a cinder block, bent up scrap metal, a shovel head, and debris observed near the driveway.

**Date:** January 22, 2009  
**Time:** 12:32 PM  
**Direction:** S  
**Photo by:** Eisenbrandt  
**Exposure #:** 036  
**Comments:** A broken white plastic bucket, a cinder block, bent up scrap metal, a shovel head, and debris were observed south of the drive.
