ILLINOIS ENVIRONMENTAL PROTECTION AGENCY

Re: Illinois Environmental Protection Agency v. Springfield Iron & Metal Co., Inc. and Russell & Evelyn Weller.  
IEPA File No.105-09-AC; 1671205737—Sangamon County

ADMINISTRATIVE CITATION

**ILLINOIS ENVIRONMENTAL PROTECTION AGENCY**  
**Open Dump Inspection Checklist**

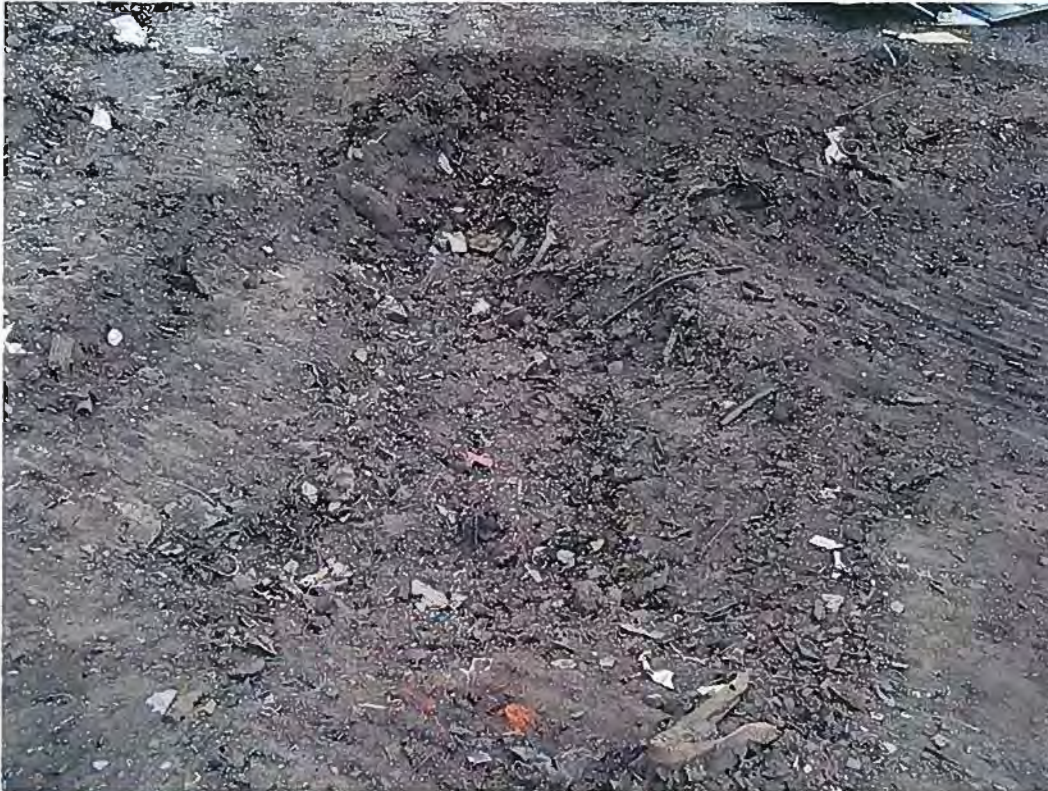
Mr. Williams and I initially inspected probes in the northeast region of SIMCO. The area affected by the soil mixed with waste was measure using a landscape measuring wheel and found to be about 146 by 138 feet. Photos 1, 2, 3 and 4 show a couple test areas in this area. Using a tape measure (see photos 1 and 2) I found waste down to be about 1.5 feet below surface level (BSL). In photos 3 and 4 a deeper cut was made down to about 3 feet BSL until it appeared that the waste had been no longer present. Photo 5 shows what was dug out from the test probe that went down about 3 feet (see photos 3 and 4).

**Date:** April 23, 2009  
**Time:** 2:06 pm  
**Direction:** East  
**Photo by:** Rich Johnson  
**Exposure #:** 001  
**Comments:** Photograph shows an area located in the northeast region of the site that was scraped with a track-hoe.

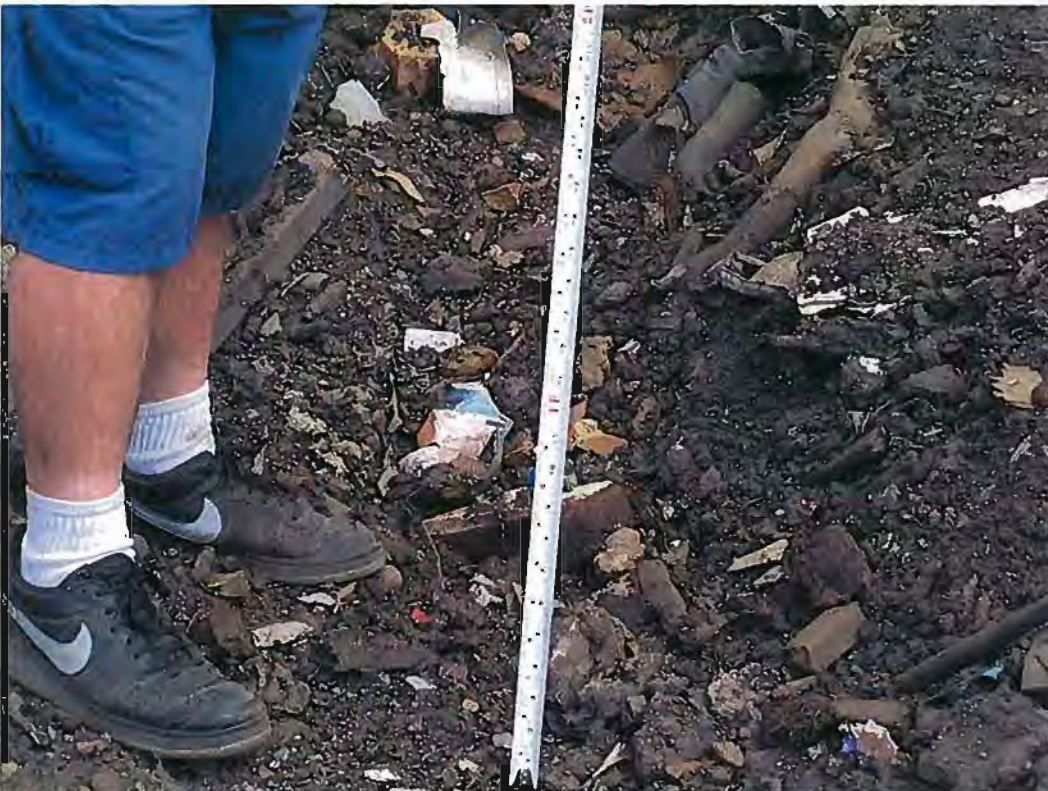
**Date:** April 23, 2009  
**Time:** 2:07 pm  
**Direction:** East  
**Photo by:** Rich Johnson  
**Exposure #:** 002  
**Comments:** Photograph shows a close up of photo 1. Note that the depth of waste in the area was found to be about 1.5 feet deep using a tape measure.

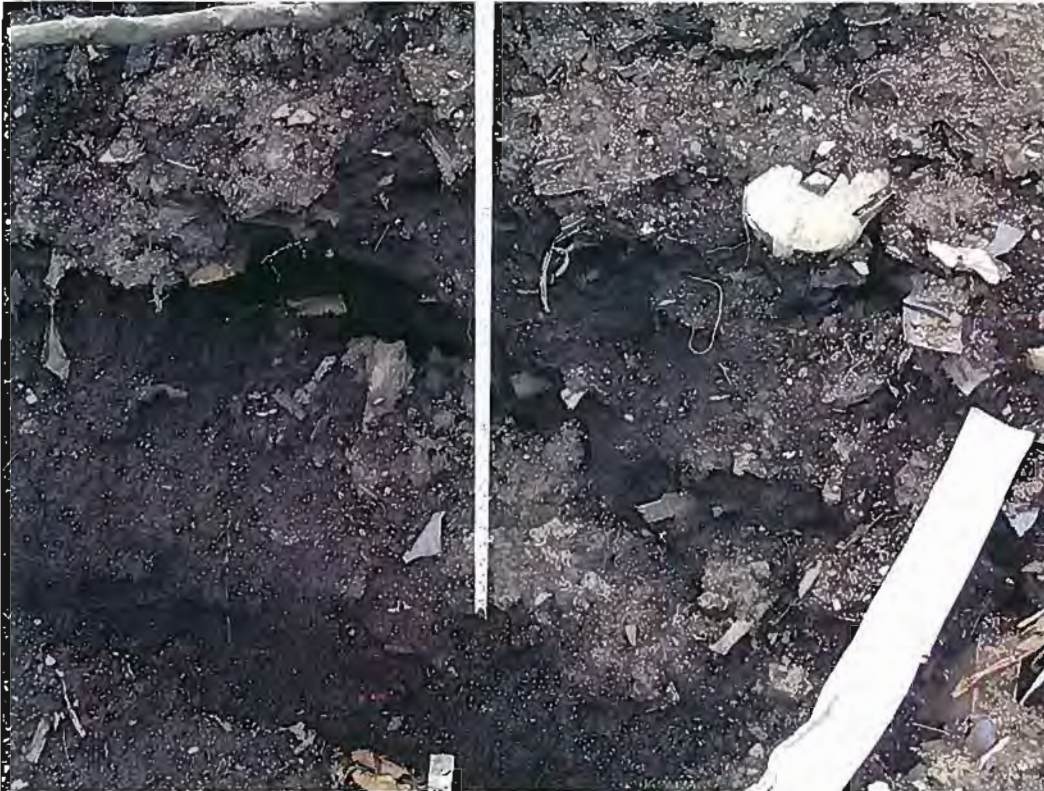
Date: April 23, 2009  
Time: 2:08 pm  
Direction: South  
Photo by: Rich Johnson  
Exposure #: 003  
Comments: Photograph shows another test probe located in the northeast region of the site. Note the tape measure indicates waste was found down about 3 feet below surface level.

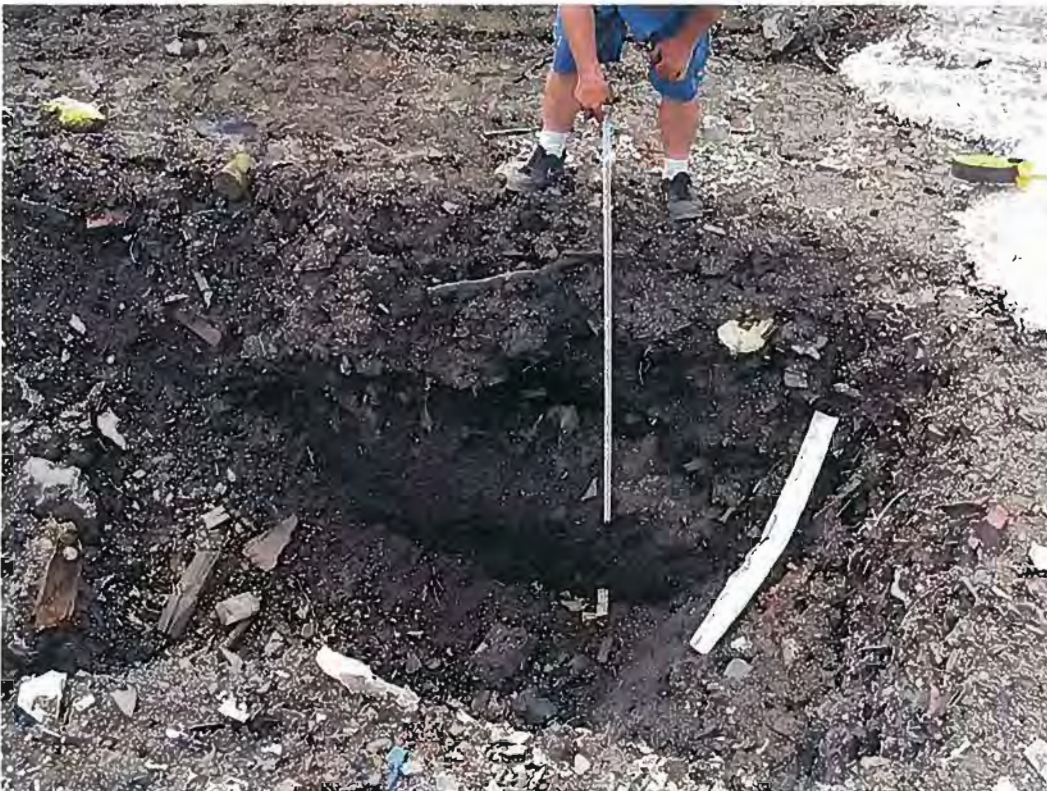
Date: April 23, 2009  
Time: 2:08 PM  
Direction: South  
Photo by: Rich Johnson  
Exposure #: 004  
Comments: Photograph shows the same test probe as in photo 3.

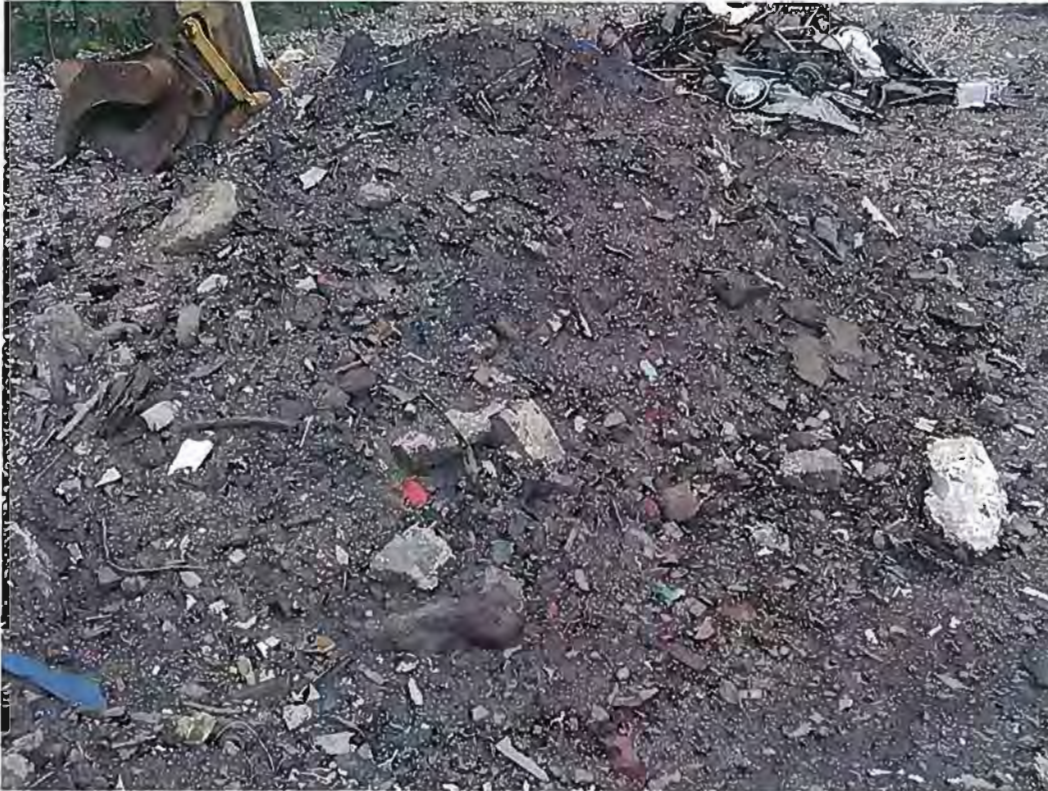
Photos 5, 6, 7, 8, 9 and 10 show various areas of the northeast region of the site where one of the mounds of soil and waste had been located. Photo 6 just shows the concentration of waste mixed with soil found at the surface of the northeast region. What appears to be a thin layer of the soil mixed with waste was noted in photos 7, 8, 9 and 10. It was speculated that most of the eastern edge of the northeast region was only a few inches deep with the soil/waste layer. Photos 22, 23, 24 and 25 were taken near the northeast corner of the site showing how much debris was on the surface. An indication of how deep the soil/waste layer from spreading the mound in the northeast region was found by observing a pile of landscape waste. The soil/waste had been pushed up and around the tree trunks and limbs (see photos 22 and 23). This soil/waste layer appeared to be about 3 feet thick.

**Date:** April 23, 2009  
**Time:** 2:10 pm  
**Direction:** Northeast  
**Photo by:** Rich Johnson  
**Exposure #:** 005  
**Comments:** Photograph shows a pile of the soil mixed with waste that was removed from the test hole shown in photos 3 and 4.

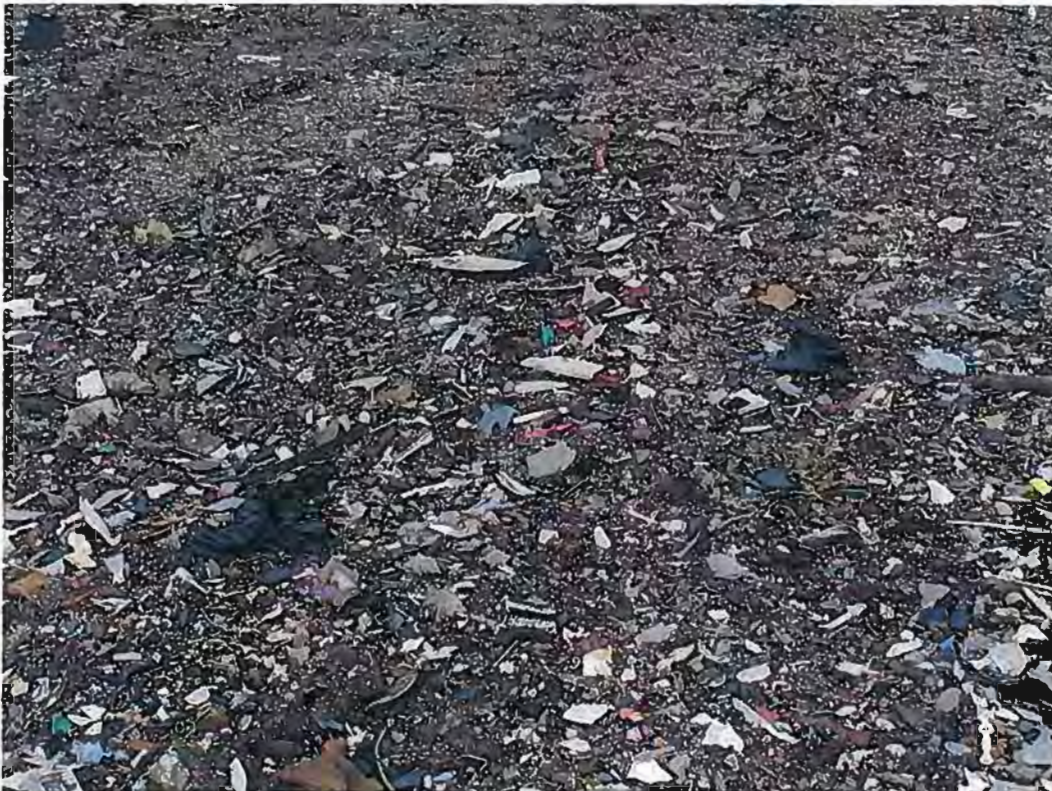
**Date:** April 23, 2009  
**Time:** 2:11 pm  
**Direction:** Northeast  
**Photo by:** Rich Johnson  
**Exposure #:** 006  
**Comments:** Photograph shows the surface in the northeast region of the site. Note the debris found at the surface.

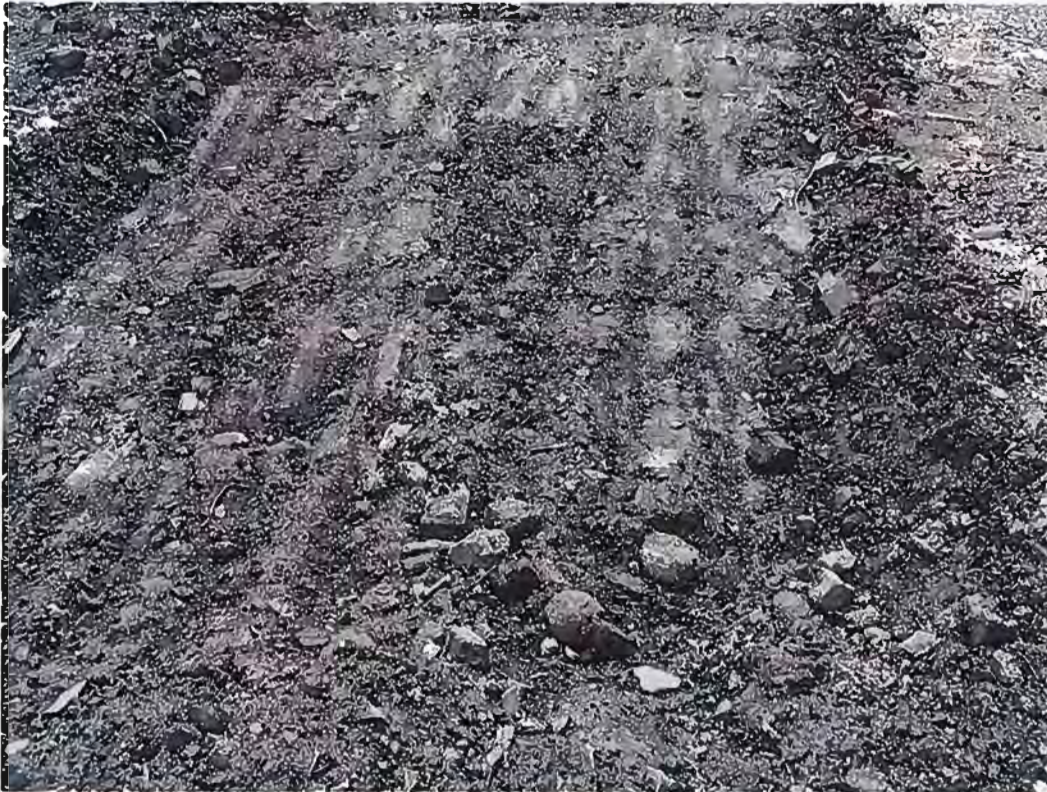
**Date:** April 23, 2009  
**Time:** 2:11 pm  
**Direction:** East  
**Photo by:** Rich Johnson  
**Exposure #:** 007  
**Comments:** Photograph shows an area scraped by a trackhoe in the northeast region of the site.

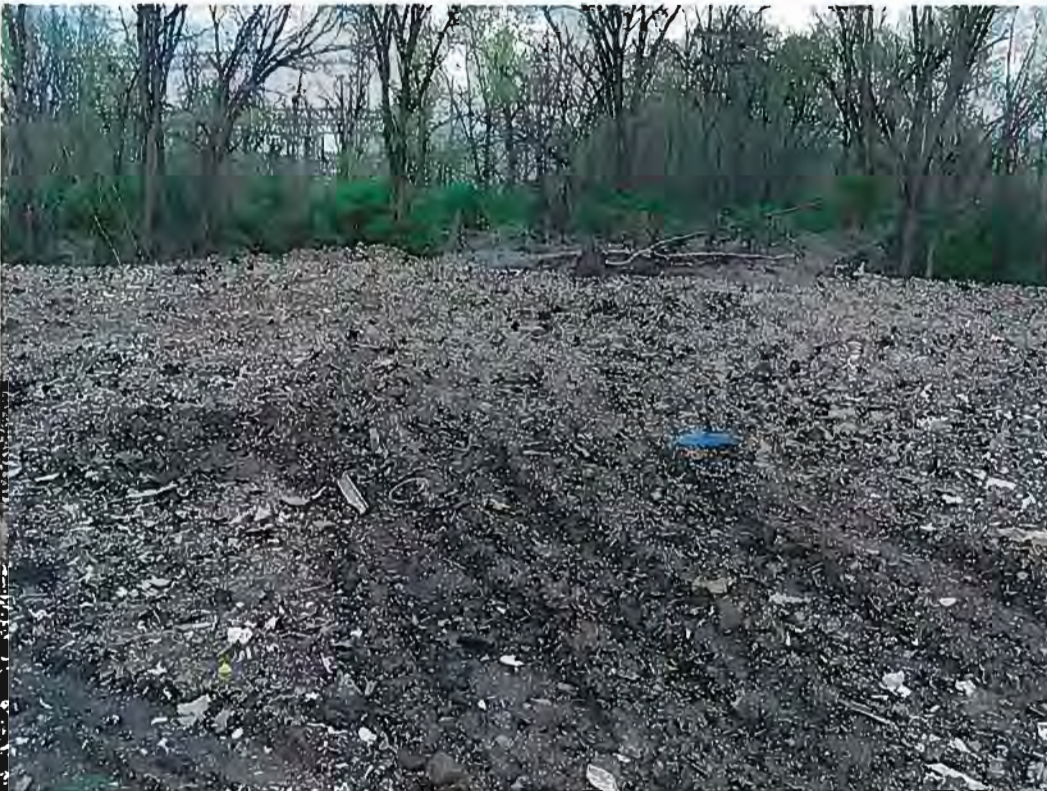
**Date:** April 23, 2009  
**Time:** 2:11 pm  
**Direction:** North  
**Photo by:** Rich Johnson  
**Exposure #:** 008  
**Comments:** Photograph shows the northeast region of the site. Note the scattered debris at the surface.

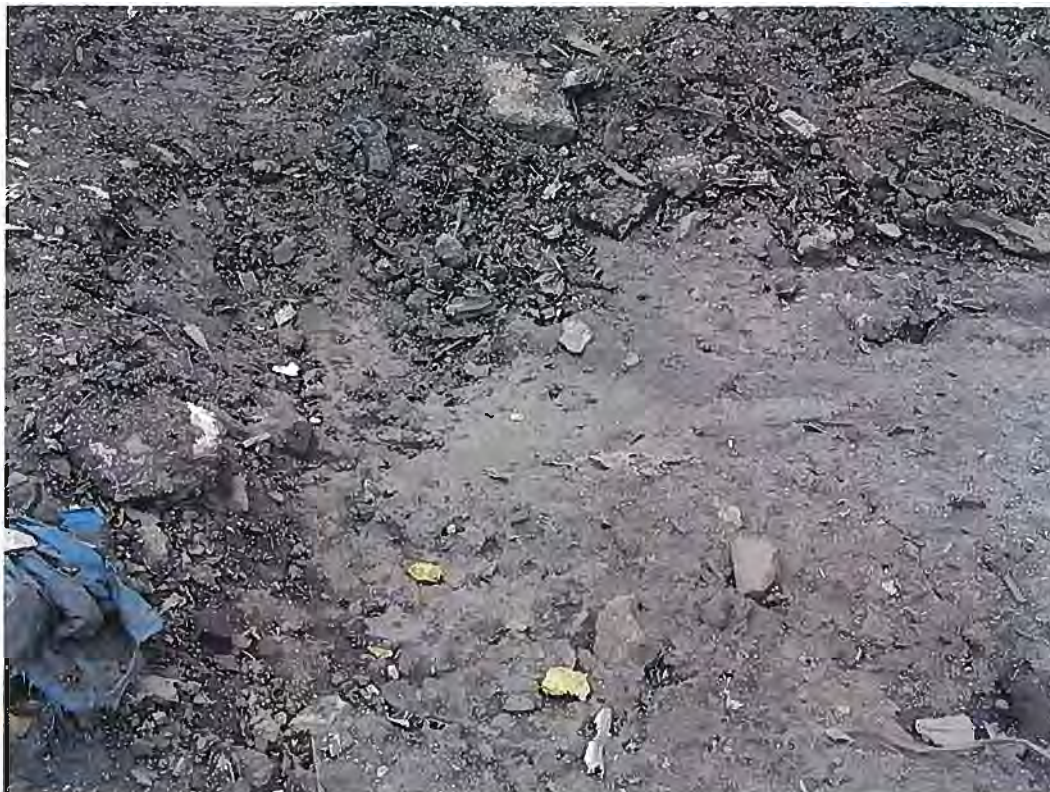
**Date:** April 23, 2009  
**Time:** 2:12 pm  
**Direction:**  
North/northwest  
**Photo by:** Rich Johnson  
**Exposure #:** 009  
**Comments:** Photograph shows an area in the northeast region of the site. Note the area was scraped with a trackhoe with some of the resulting waste accumulated near the top of the photo.

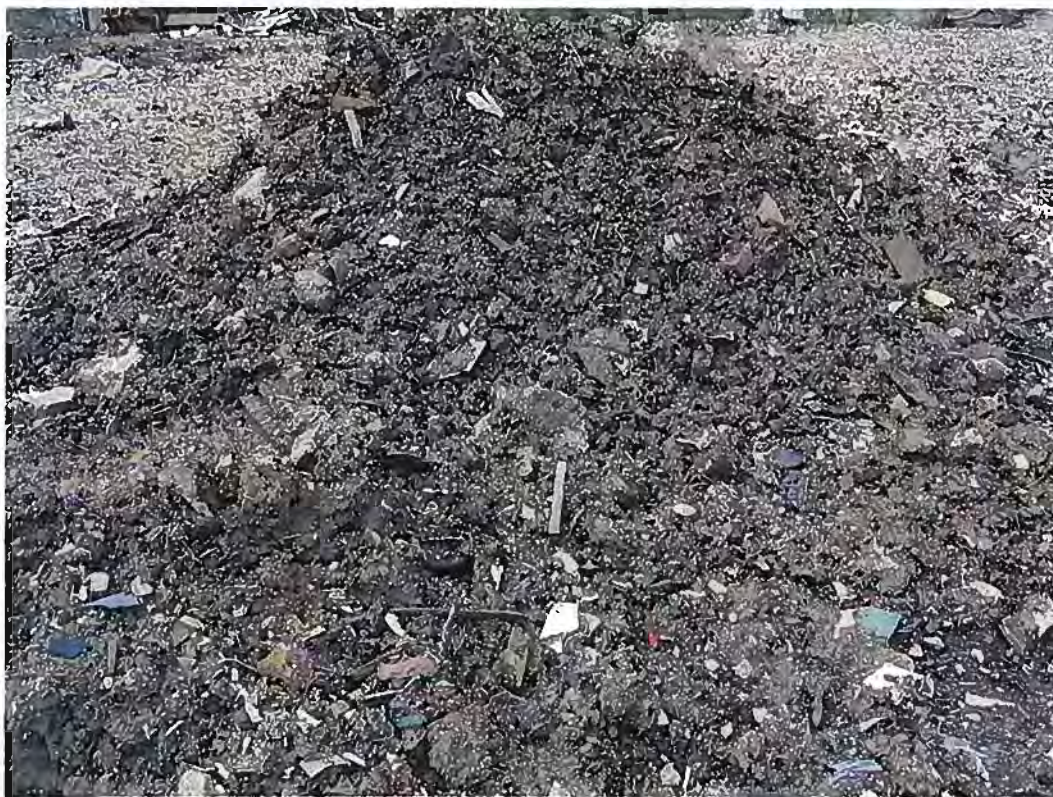
**Date:** April 23, 2009  
**Time:** 2:13 pm  
**Direction:** Northwest  
**Photo by:** Rich Johnson  
**Exposure #:** 010  
**Comments:** Photograph shows a pile of soil mixed with waste dug up by a trackhoe in the northeast region of the site.

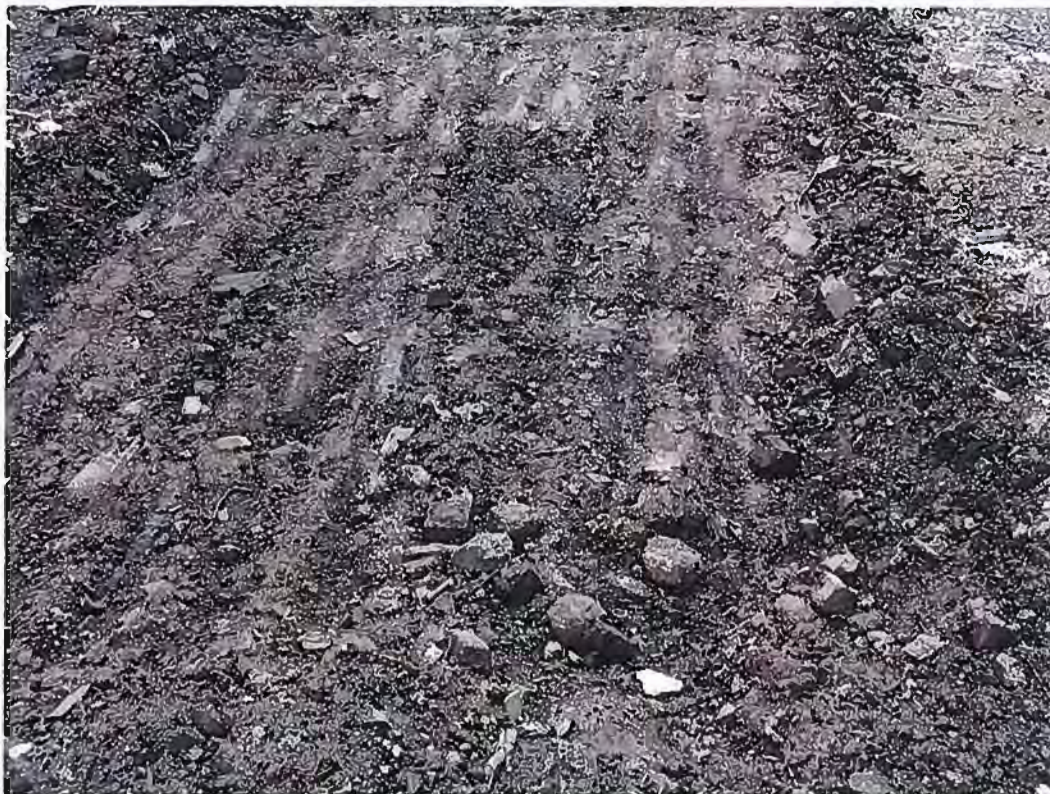
**Date:** April 23, 2009  
**Time:** 2:14 pm  
**Direction:** Southwest  
**Photo by:** Rich Johnson  
**Exposure #:** 011  
**Comments:** Photograph shows a test probe dug with a trackhoe located along the east boundary of the site in the northeast region.

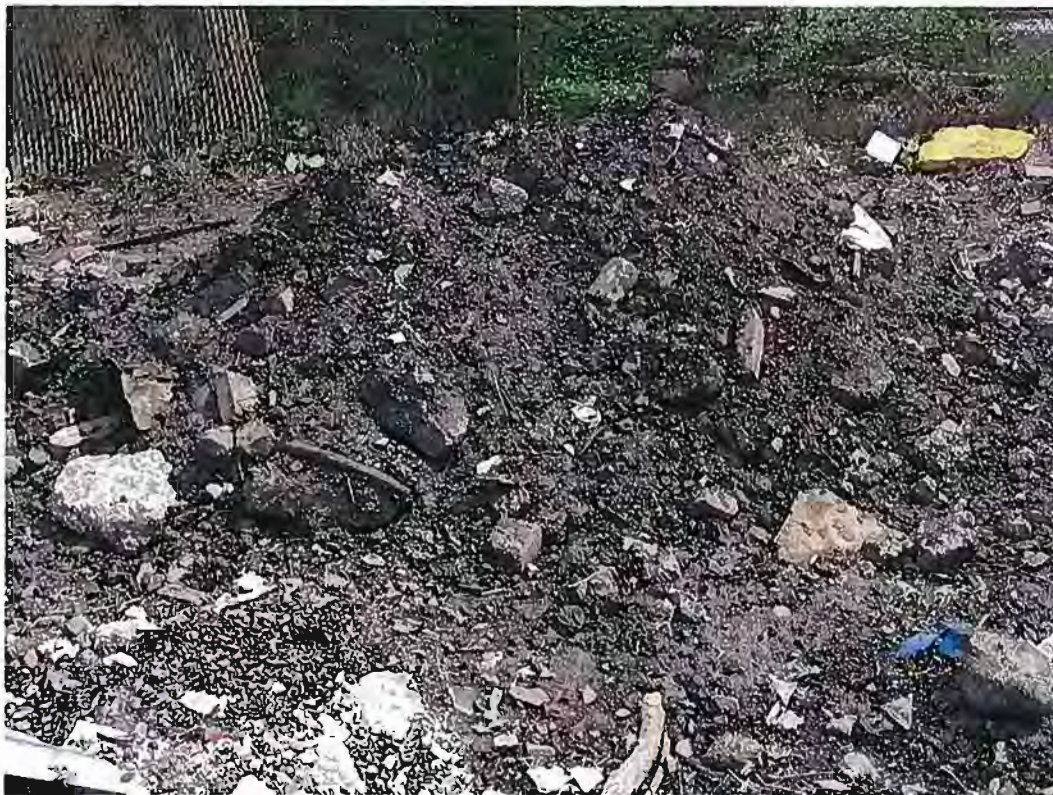
**Date:** April 23, 2009  
**Time:** 2:14 pm  
**Direction:** East  
**Photo by:** Rich Johnson  
**Exposure #:** 012  
**Comments:** Photograph shows a pile of soil mixed with waste along the east property line where a trackhoe has probed an area trying to find the depth of the soil mixed with waste.

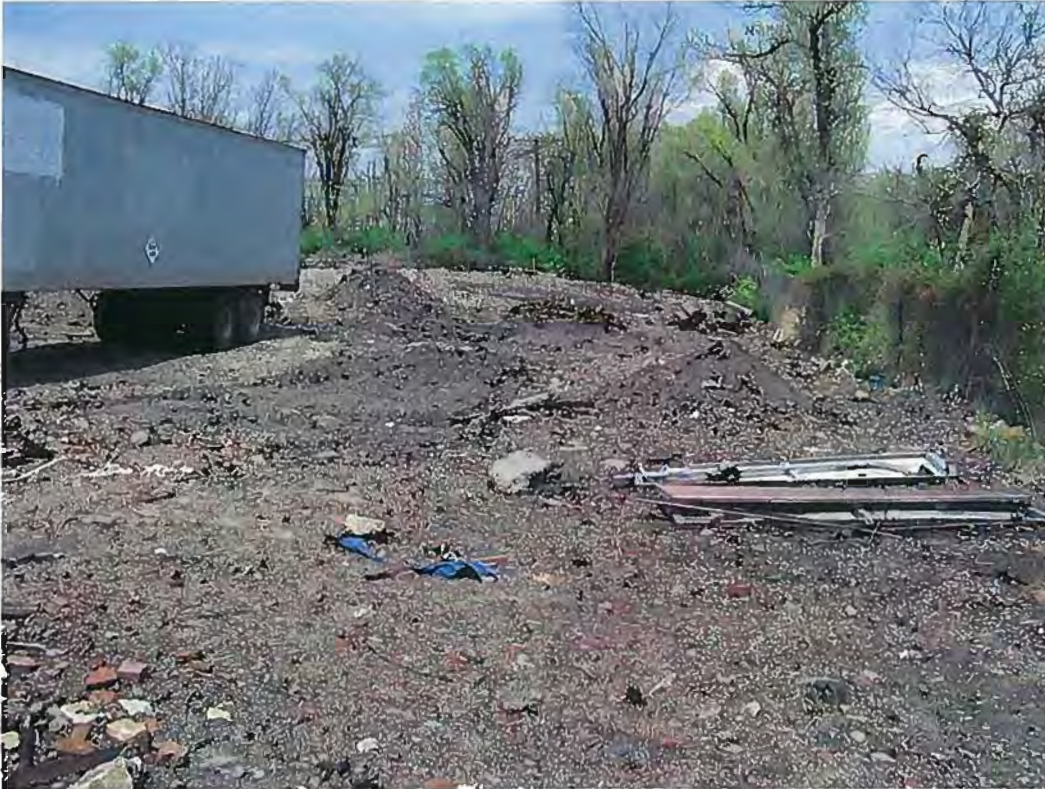
**Date:** April 23, 2009  
**Time:** 2:15 pm  
**Direction:** Northeast  
**Photo by:** Rich Johnson  
**Exposure #:** 013  
**Comments:** Photograph shows areas along the east property line where a trackhoe has probed trying to find the depth of the soil mixed with waste.

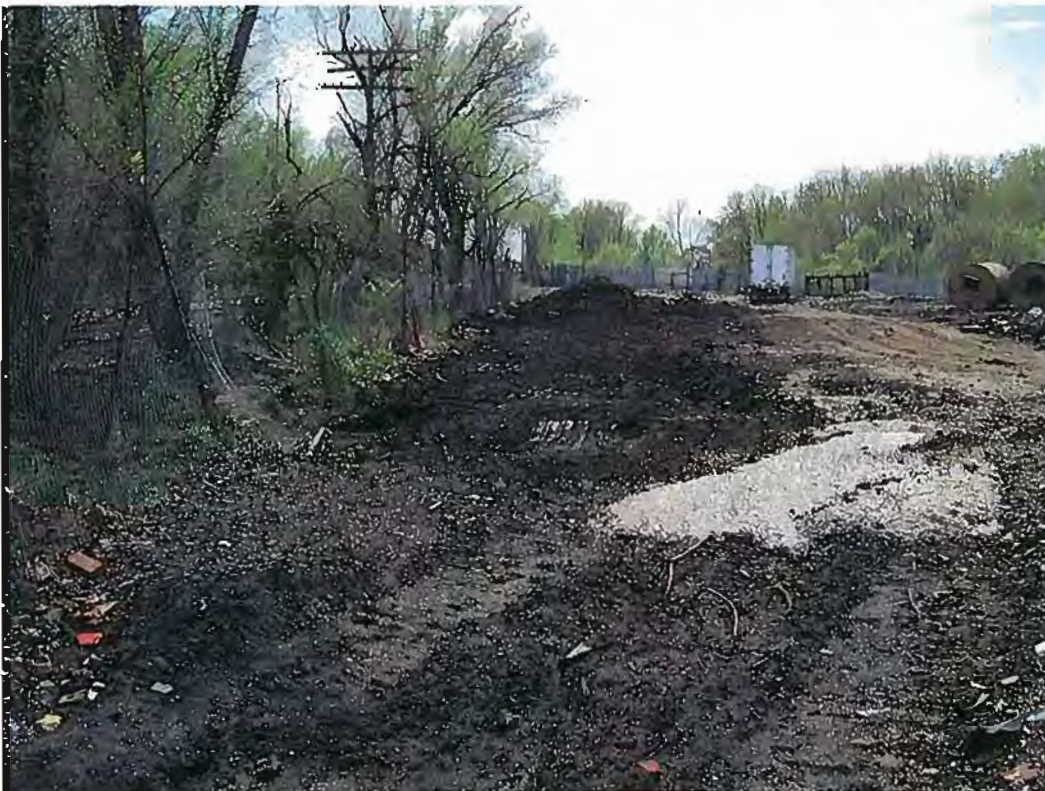
**Date:** April 23, 2009  
**Time:** 2:15 pm  
**Direction:** Southwest  
**Photo by:** Rich Johnson  
**Exposure #:** 014  
**Comments:** Photograph shows areas along the east property line where a trackhoe has probed trying to find the depth of the soil mixed with waste.

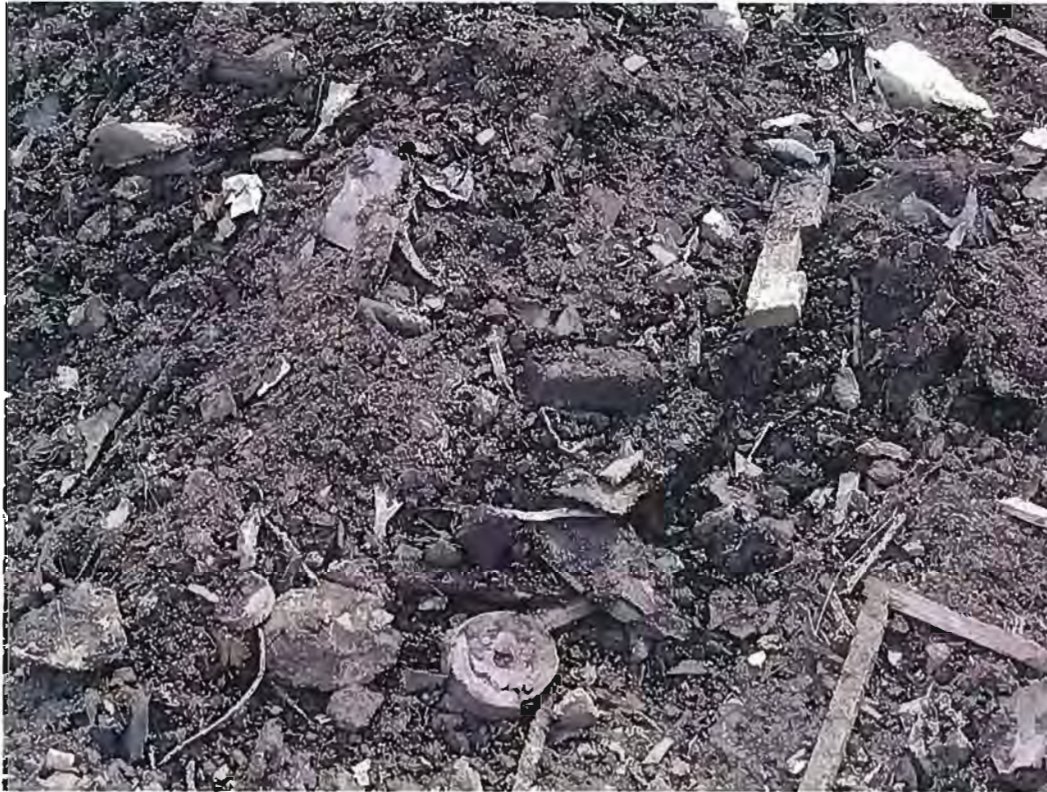
Date: April 23, 2009  
Time: 2:17 pm  
Direction: East/southeast  
Photo by: Rich Johnson  
Exposure #: 015  
Comments: Photograph shows a pile of soil mixed with waste along the east property line in the eastcentral region of the site.

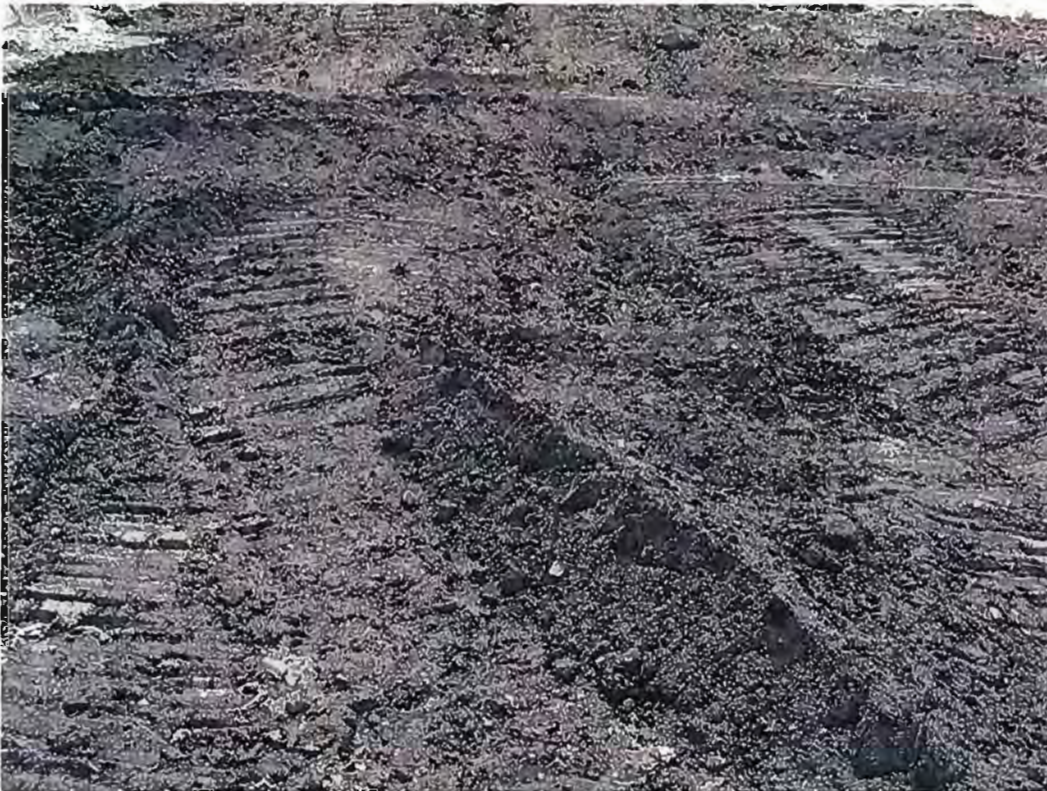
Date: April 23, 2009  
Time: 2:18 pm  
Direction: Southwest  
Photo by: Rich Johnson  
Exposure #: 016  
Comments: Photograph shows a test probe located along the east fence line in the eastcentral/southeast region of the site.

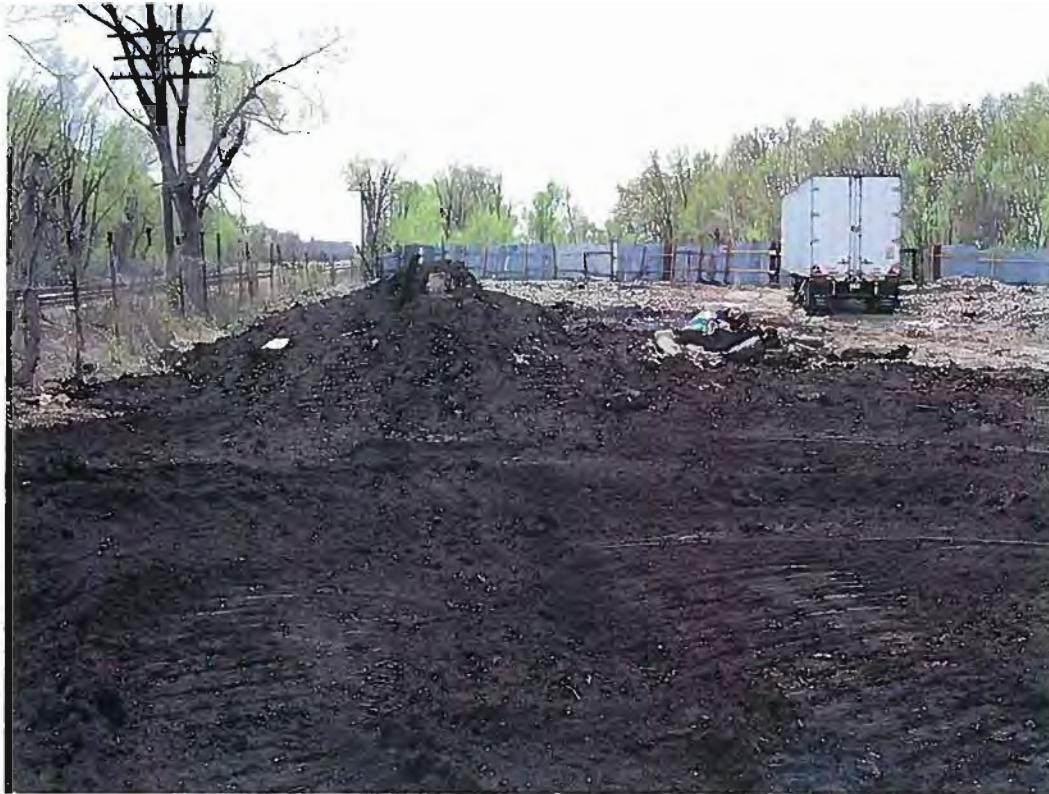
**Date:** April 23, 2009  
**Time:** 2:18 pm  
**Direction:** Southwest  
**Photo by:** Rich Johnson  
**Exposure #:** 017  
**Comments:** Photograph shows an area probed with a trackhoe located along the east fence line in the eastcentral/southeast region of the site.

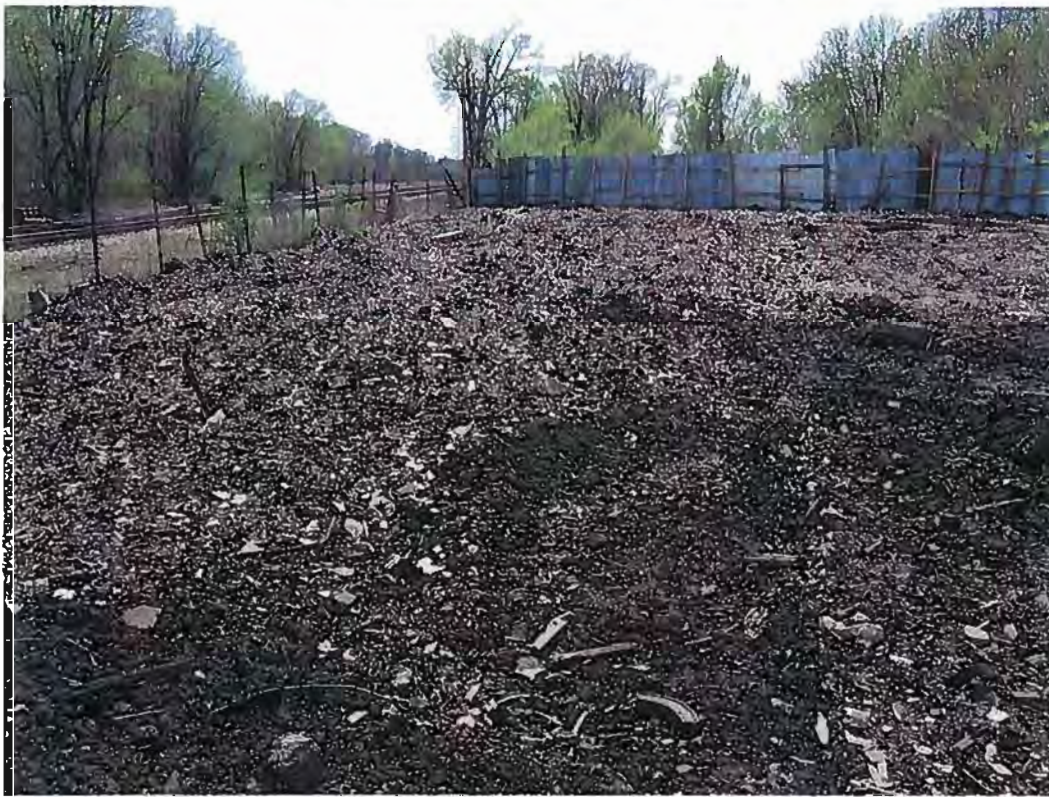
**Date:** April 23, 2009  
**Time:** 2:19 pm  
**Direction:** Southwest  
**Photo by:** Rich Johnson  
**Exposure #:** 018  
**Comments:** Photograph shows the south end of the site. Note the surface debris shown.

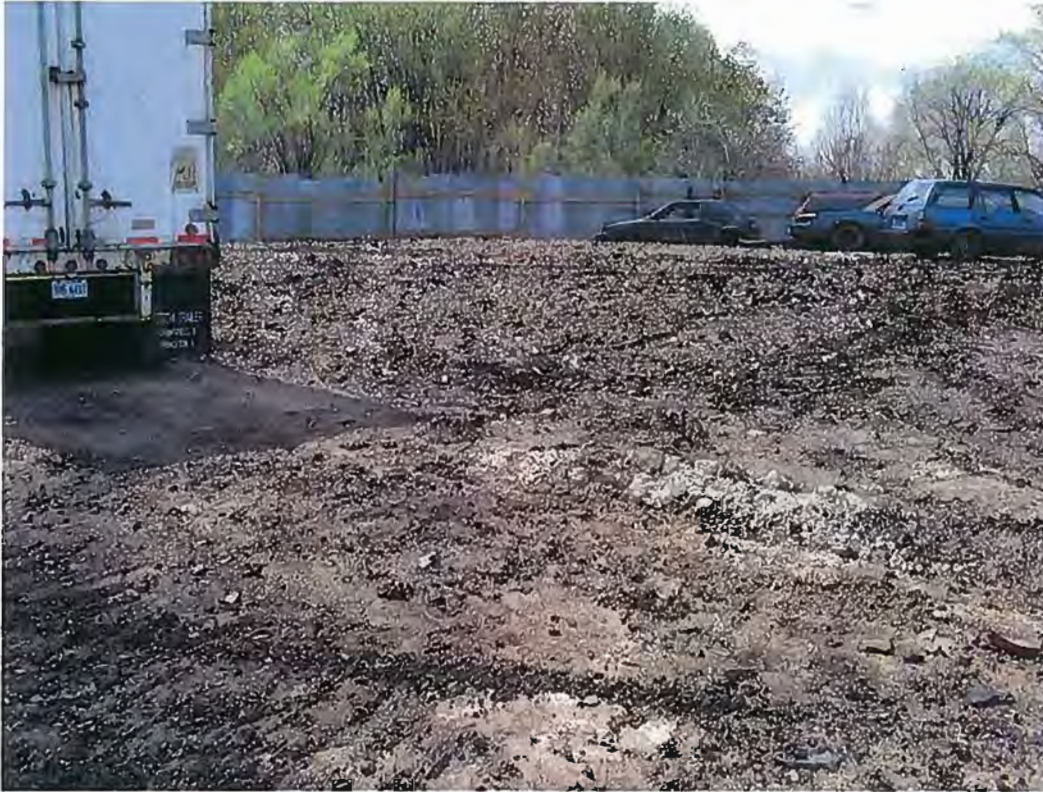
The second mound of soil and waste had been located in the south/southwest region of the site as shown in photos 19, 20, 26 and 27. Using the measuring wheel the area where the soil and waste layer is suspected to have been spread was about 156 by 93 feet. It was noted that no test probes have been placed in this area. It was currently used to park about 10 junk vehicles, and a couple of empty metal tanks. Visually, this area appeared to be about 4 or 5 feet higher than the adjacent interior road.

**Date:** April 23, 2009  
**Time:** 2:20 pm  
**Direction:** West  
**Photo by:** Rich Johnson  
**Exposure #:** 019  
**Comments:** Photograph shows the southwest region of the site. Note the debris on the surface of the area and some of the junk vehicles parked in the area.

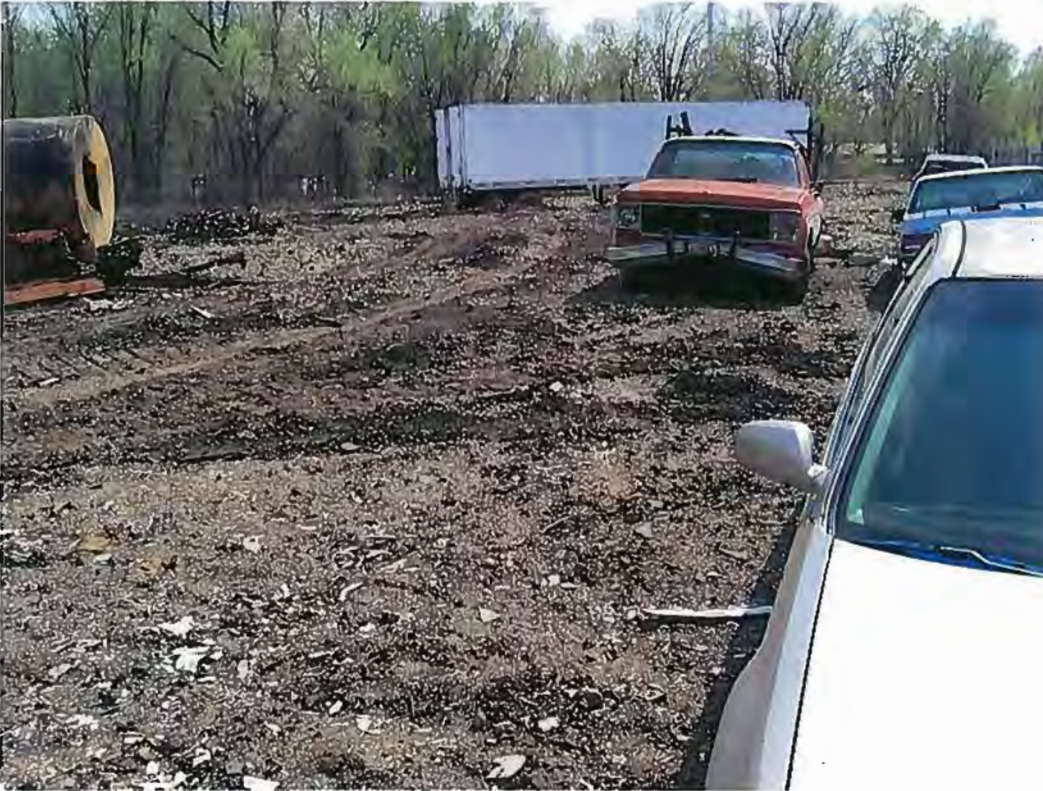
**Date:** April 23, 2009  
**Time:** 2:24 pm  
**Direction:** South/southeast  
**Photo by:** Rich Johnson  
**Exposure #:** 020  
**Comments:** Photograph shows some of the southwest region of the site with the debris on the surface and the junk vehicles. Note the trailer shown is for storing used tires.

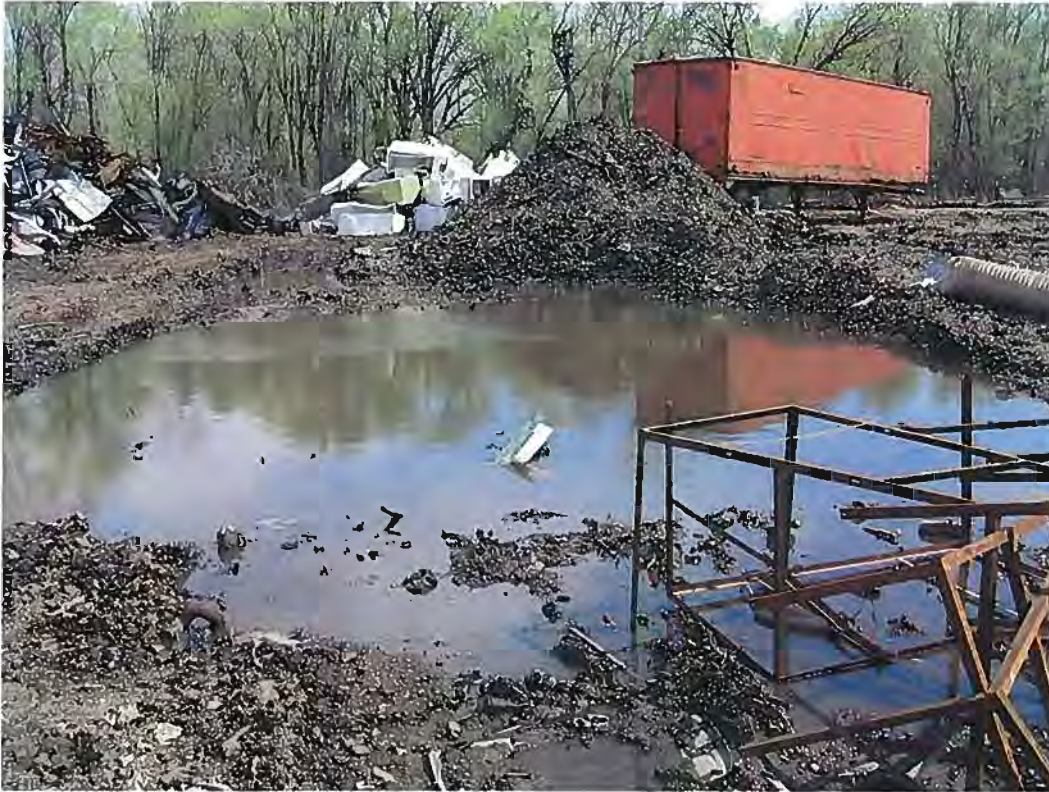
**Date:** April 23, 2009  
**Time:** 2:26 pm  
**Direction:** East  
**Photo by:** Rich Johnson  
**Exposure #:** 021  
**Comments:** Photograph shows test probe excavated with a trackhoe located in the central region of the site. Note that the water filled the probe and it was reportedly 4 or 5 feet deep.

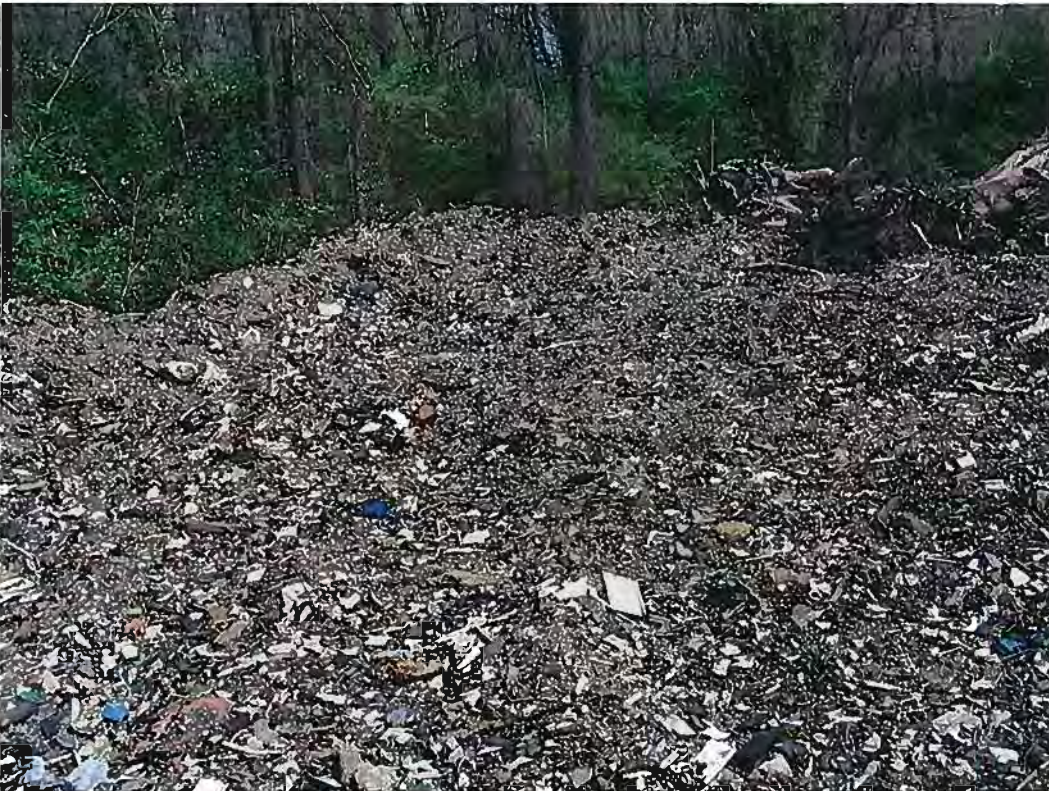
**Date:** April 23, 2009  
**Time:** 2:30 pm  
**Direction:** Northeast  
**Photo by:** Rich Johnson  
**Exposure #:** 022  
**Comments:** Photograph shows the surface near the northeast corner of the site. Note the debris found at the surface.

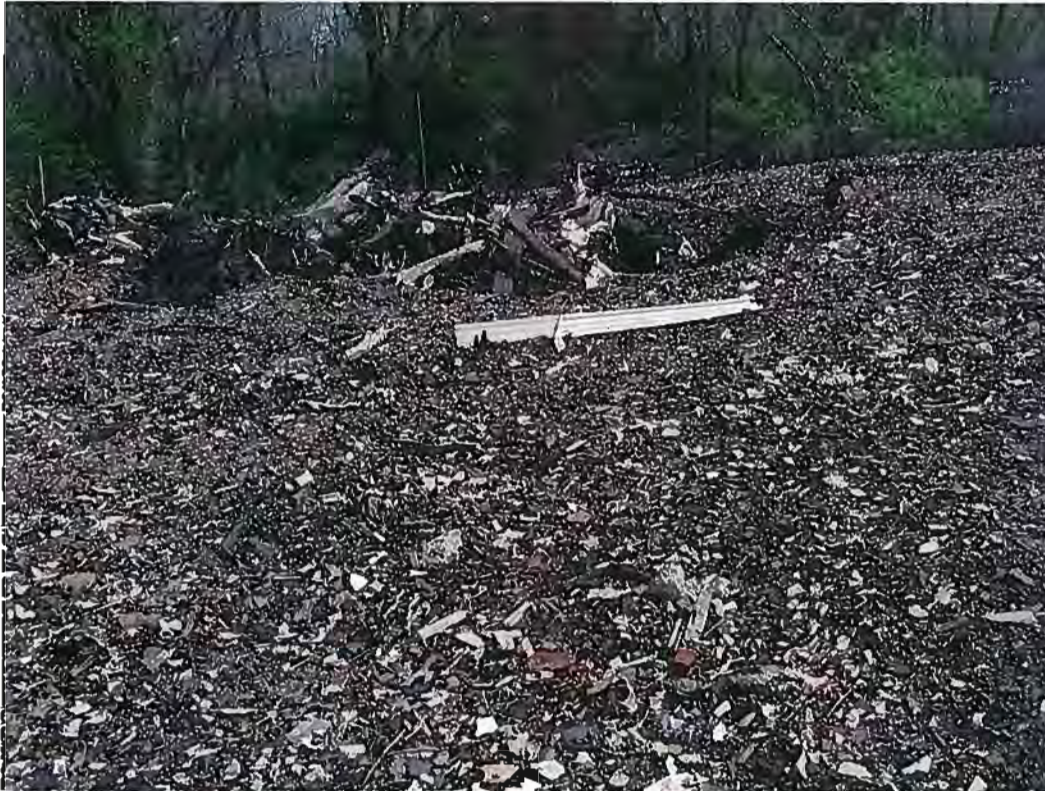
**Date:** April 23, 2009  
**Time:** 2:30 pm  
**Direction:** Northeast  
**Photo by:** Rich Johnson  
**Exposure #:** 023  
**Comments:** Photograph shows the surface near the northeast corner of the site. Note the debris found at the surface.

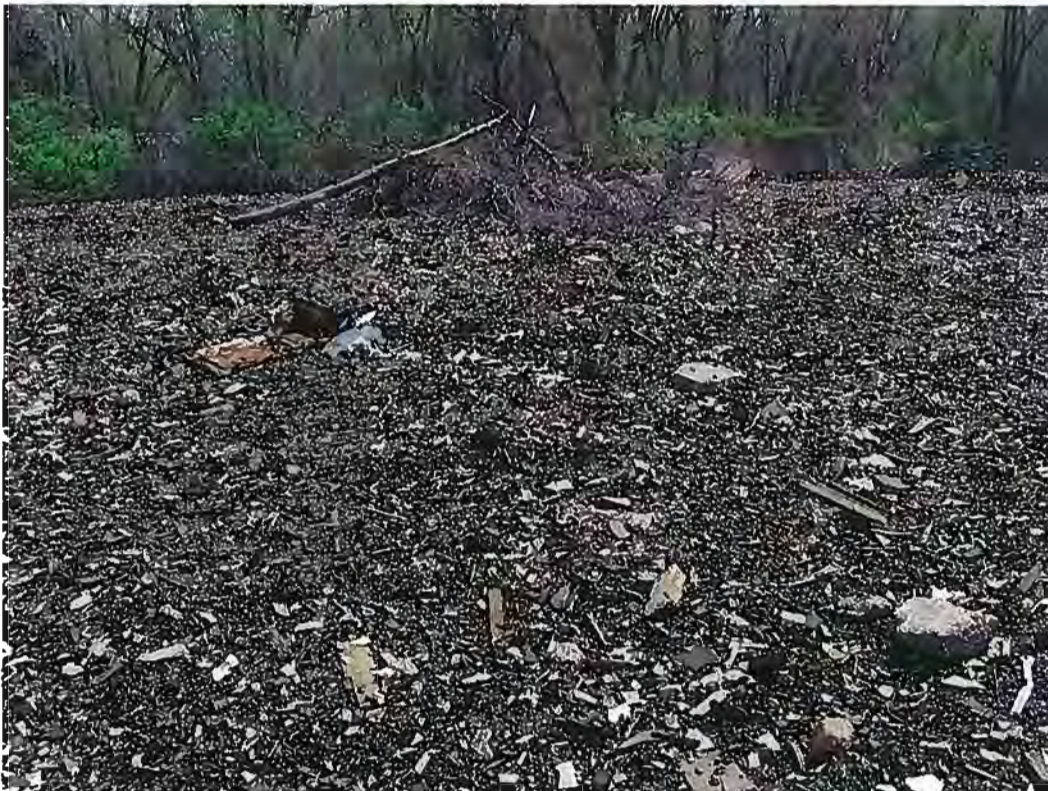
**Date:** April 23, 2009  
**Time:** 2:30 pm  
**Direction:** East  
**Photo by:** Rich Johnson  
**Exposure #:** 024  
**Comments:** Photograph shows the surface near the northeast corner of the site. Note the debris found at the surface.

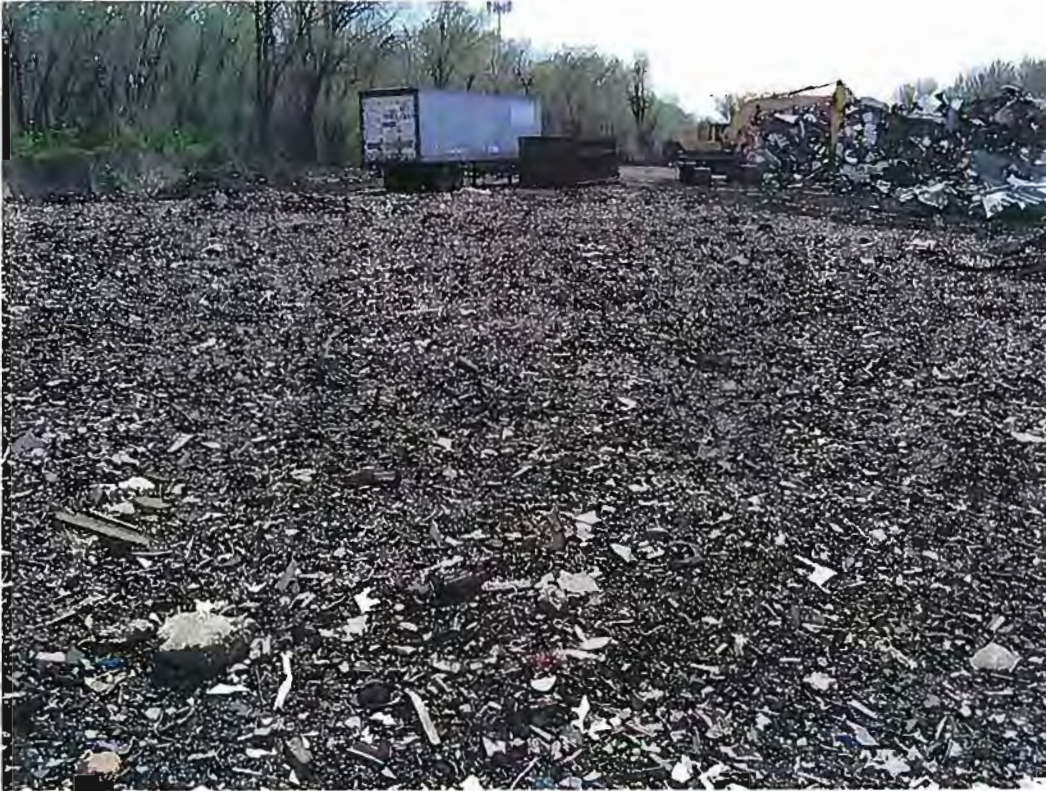
Date: April 23, 2009  
Time: 2:30 pm  
Direction: South  
Photo by: Rich Johnson  
Exposure #: 025  
Comments: Photograph shows the surface near the northeast corner of the site. Note the debris found at the surface.
