ILLINOIS ENVIRONMENTAL PROTECTION AGENCY

Re: Illinois Environmental Protection Agency v. Springfield Iron & Metal Co., Inc. and Russell & Evelyn Weller.  
IEPA File No.105-09-AC; 1671205737—Sangamon County

ADMINISTRATIVE CITATION

**ILLINOIS ENVIRONMENTAL PROTECTION AGENCY**  
**Open Dump Inspection Checklist**

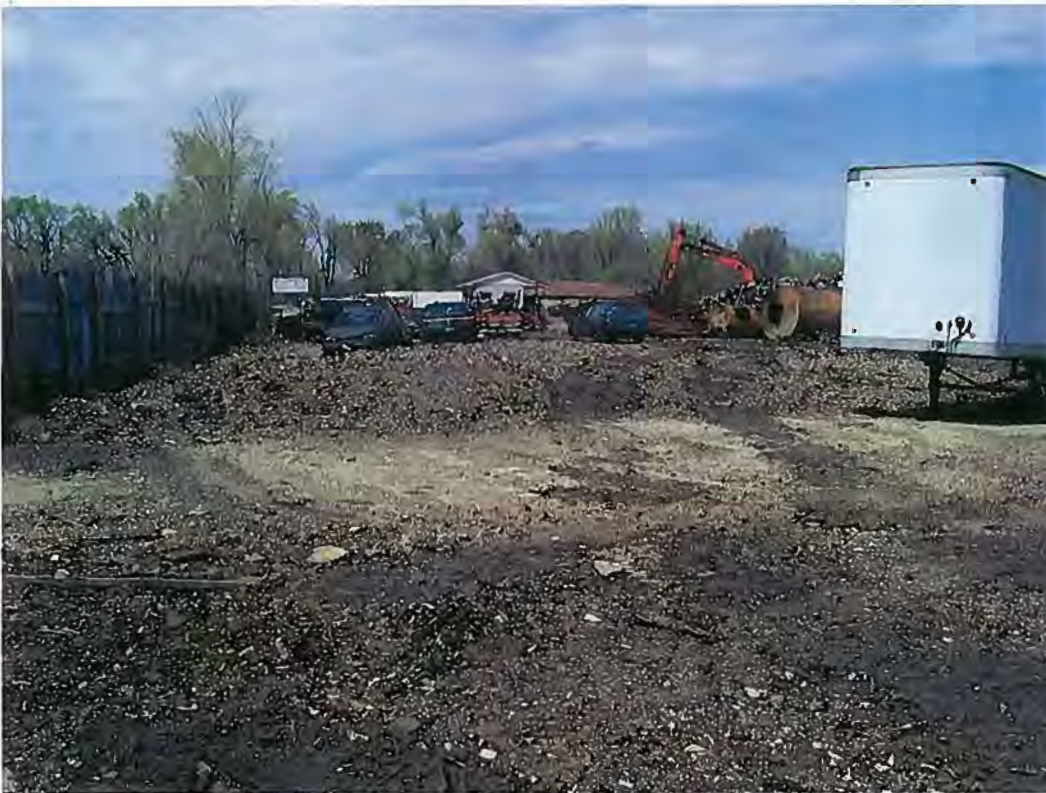
The second mound of soil and waste had been located in the south/southwest region of the site as shown in photos 19, 20, 26 and 27. Using the measuring wheel the area where the soil and waste layer is suspected to have been spread was about 156 by 93 feet. It was noted that no test probes have been placed in this area. It was currently used to park about 10 junk vehicles, and a couple of empty metal tanks. Visually, this area appeared to be about 4 or 5 feet higher than the adjacent interior road.

Date: April 23, 2009  
Time: 2:36 pm  
Direction: North  
Photo by: Rich Johnson  
Exposure #: 026  
Comments: Photograph shows the west property line of the site.

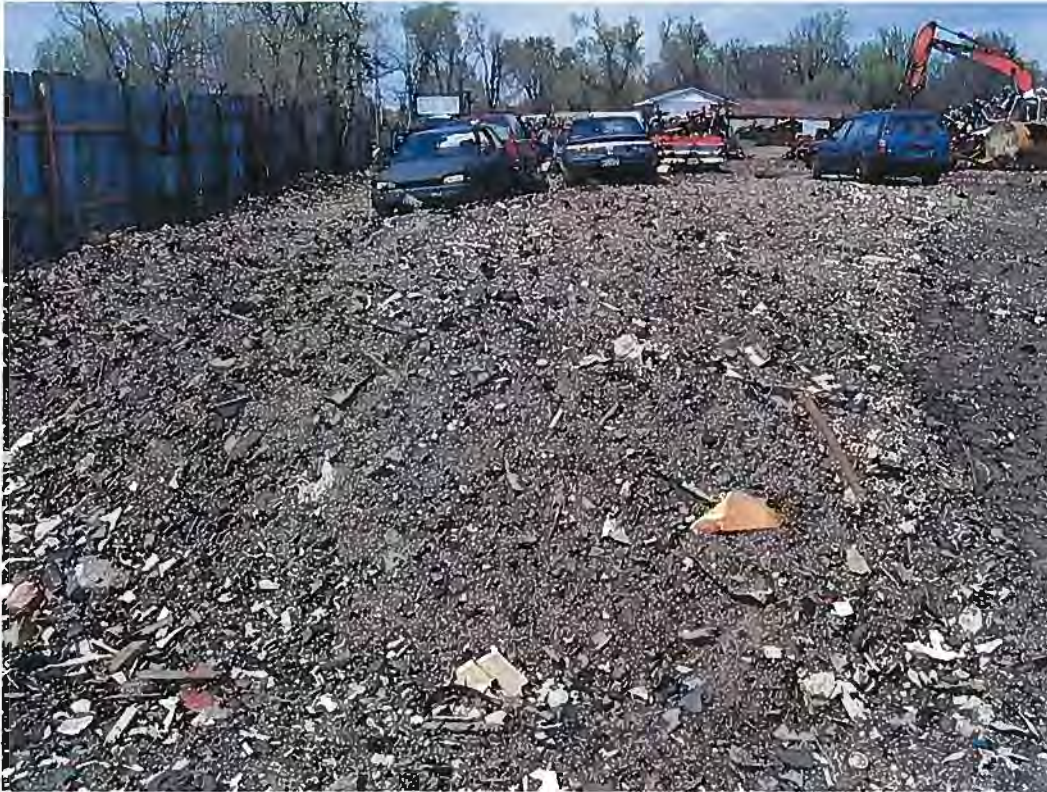
**Date:** April 23, 2009  
**Time:** 2:41 pm  
**Direction:** North  
**Photo by:** Rich Johnson  
**Exposure #:** 027  
**Comments:** Photograph shows the west property line of the site.
