Photo documentation - Joliet #29 Ash Burial Area Inspection 8/11

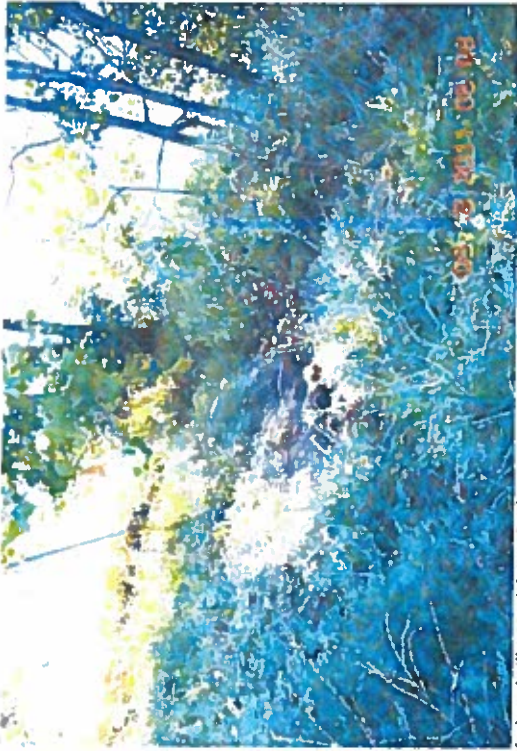
1. Area 1 rill incised down side bank.

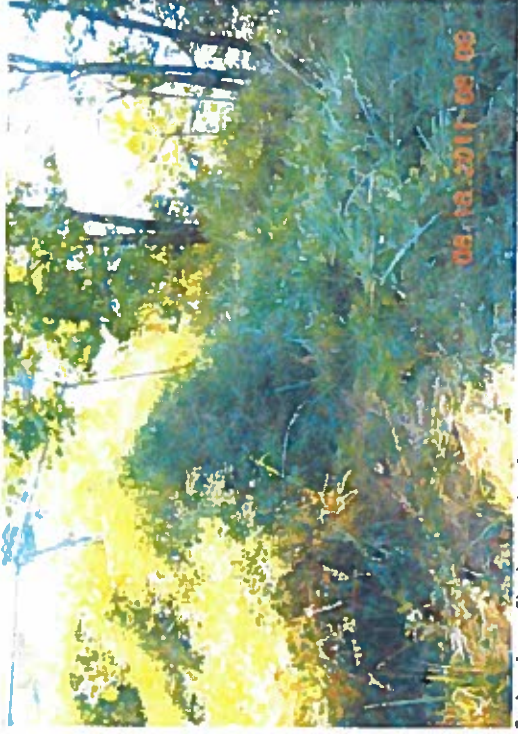
2. Area 1 top of bank exposed surface.

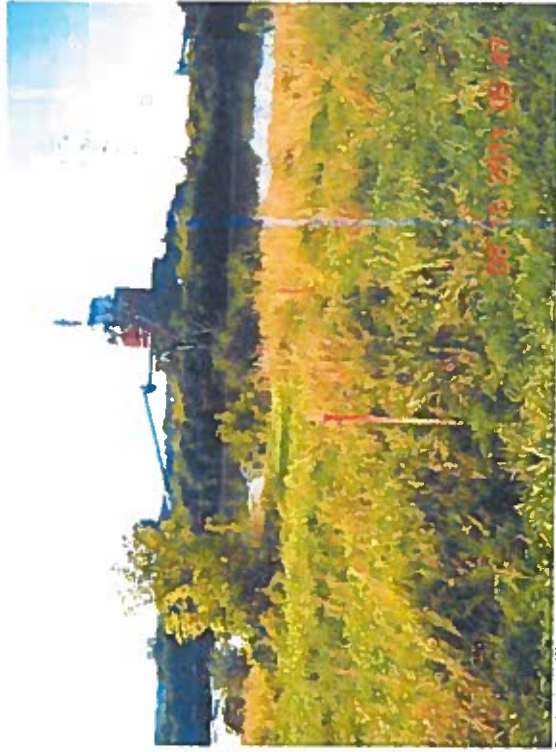
- Area 2 -- Located at N41° 29.899'/W88° 06.937'. This is an area of rill development prior to the runoff flowing down the channel bank. The rill is approximately 60 feet long, 2 to 3 feet wide and up to 1.5 feet deep. There is a slight forking in the rill toward the south end.

3. Area 2 rill marked with lathe.

The recommended repair should include fill in the rill with clayey top soil and seed with a mix of all purpose seed and annual rye. This should then be covered with a green wood fiber erosion blanket. A straw log should be placed along the top of the subject area to help reduce sheet runoff erosional effects.
