KPRG and Associates, Inc.

INSPECTION SUMMARY LETTER and REPAIR COST ESTIMATE

September 19, 2012

Re: Joliet #29 Former Ash Burial Area Runoff Inspection 2012

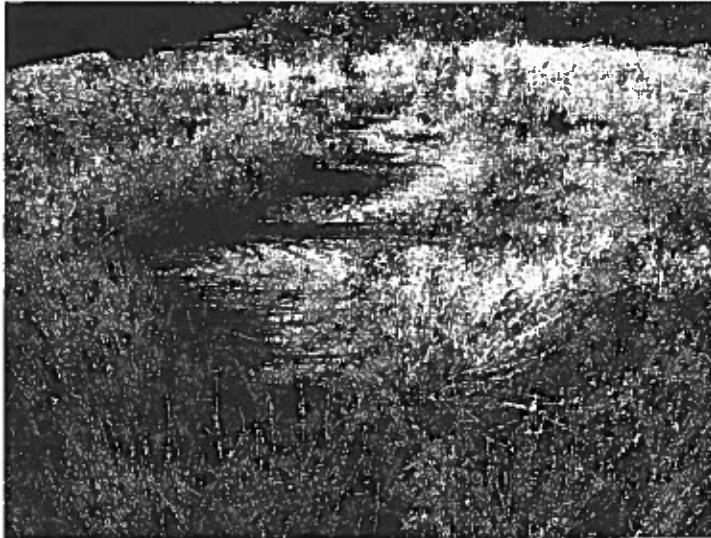
- Area 1 – Located at coordinates N41° 29.846'/W88° 07.021'. This is a flat area at the top of the embankment where the vegetal cover has been eroded and ash exposed. This area is approximately 450 square feet in size.

Area 1. Exposed ash at top of bank.

The recommended repair is to cover the area with topsoil and seed with a mix of all purpose seed and annual rye. This should then be covered with an erosion mat/blanket.

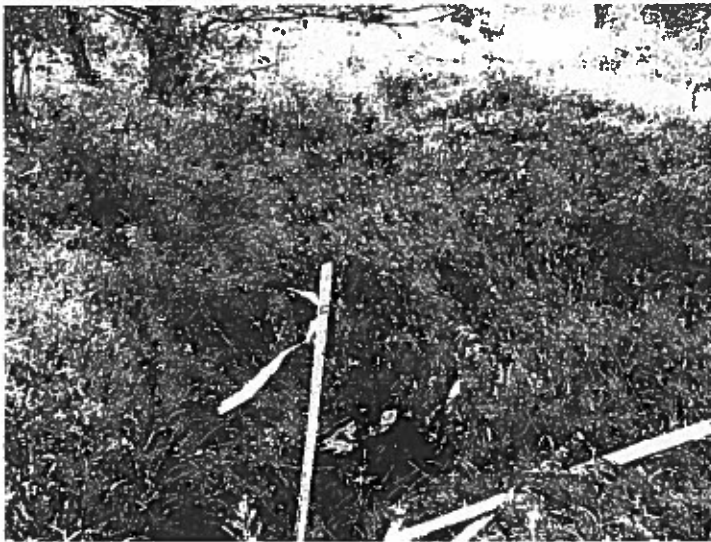
- Area 4 – Located at N41° 29.886'/W88° 06.854'. This is an upland area of rill development which eventually turns into sheet runoff as the ground flattens prior to flowing toward the channel bank. The rill is approximately 75 feet long, 3 feet wide and up to 1.5 feet deep.

Area 4. Upland rill.

The recommended repair should include filling in the rill with clayey top soil, mechanical compaction and seed with a mix of all purpose seed and annual rye. This should then be covered with a green wood fiber erosion blanket. A straw sediment log should be placed along the top of the subject area to help reduce sheet runoff erosional effects.
