KPRG and Associates, Inc.

**EROSION REPAIR DOCUMENTATION**

September 26, 2009

Re: Joliet #29 Former Ash Burial Area Runoff Erosion Repair Documentation

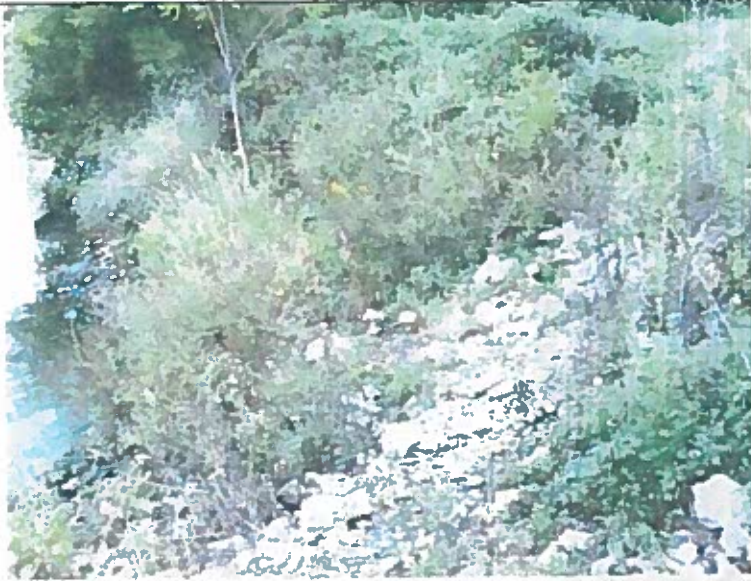
- Area 1 – Located at coordinates N41° 30.068'/W88° 06.419'. This was an area of sheet wash which had eroded some of the gravel/rock cover and had started to expose some underlying ash/slag. The area of ash exposure was about 30' wide and extended from the top of the slope to the river water interface.

Photo 1 – Area 1, before any work was conducted. View is from the east.

Repair: The repair included prepping/grading of an approximate 50' x 50' surface area (this included the subject area and a sufficient buffer around the area) and properly placing 4" to 6" of clayey top soil. The top soil was seeded with a mix of all purpose seed and annual rye. The annual rye will accommodate germination in the fall months. This was then covered with a green wood-fiber erosion

blanket. A series of straw logs was placed along the top of the subject area to help reduce sheet runoff erosional effects.

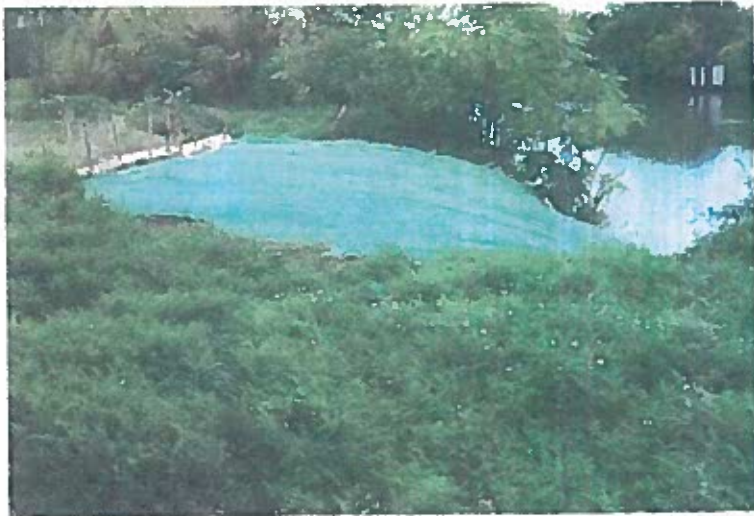
Photo 2 – Area 2, after repair work was completed. View is from the west.

Repair: As part of the repair, a 3' to 4' clay berm topped with rip rap was constructed to mend the breach in the existing berm. The gully was grubbed out to allow for sufficient sunlight penetration to accommodate subsequent seed germination. The gully was then dressed with clayey top soil and seeded with a mix of all purpose seed and annual rye. This was then covered with a green wood-fiber erosion blanket and straw logs were placed at the top of the gully to help reduce runoff energy while the seeds germinate.

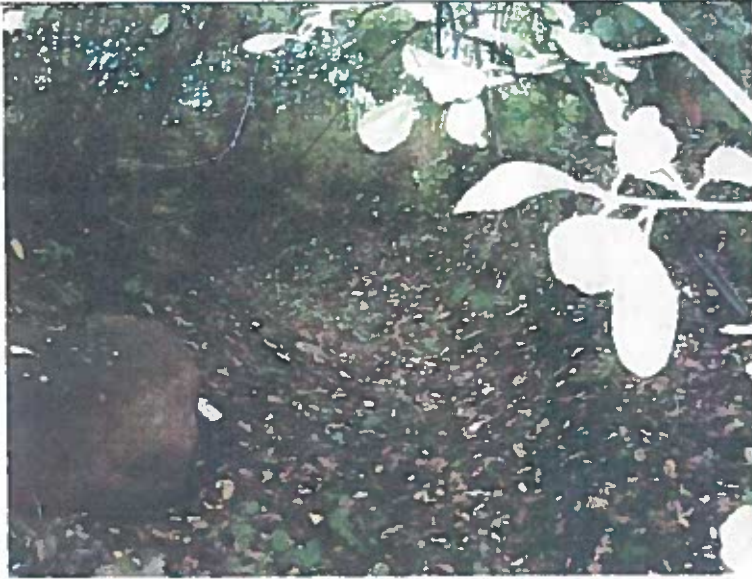
- Area 2 – Located at N41° 29.950/W88° 06.621'. This was an area of a deeply incised, sinuous gully that breached the existing earthen/rock berm within this area. It is located within a heavily vegetated area. The gully was approximately 50' long, up to 4' deep and 10' wide. There was evidence of ash/slag in the bottom of the gully.

Photo 3 – Area 2, before any work was conducted. View is from the south.

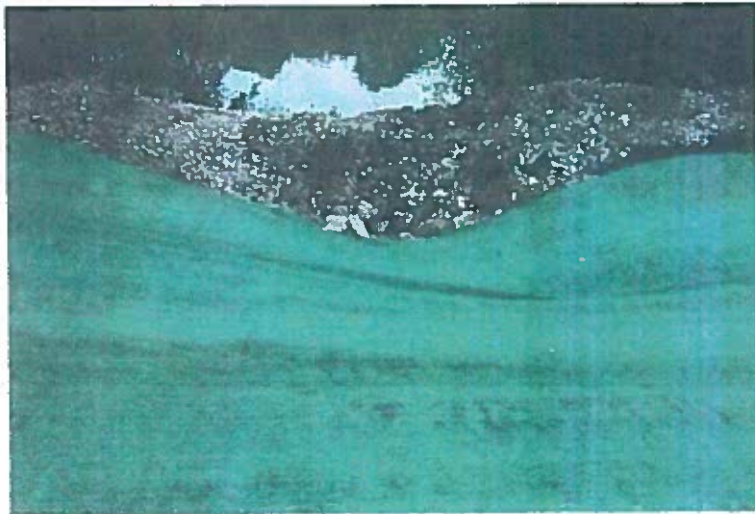
Photo 4 – Area 2, after repair work was completed. View is from the north.

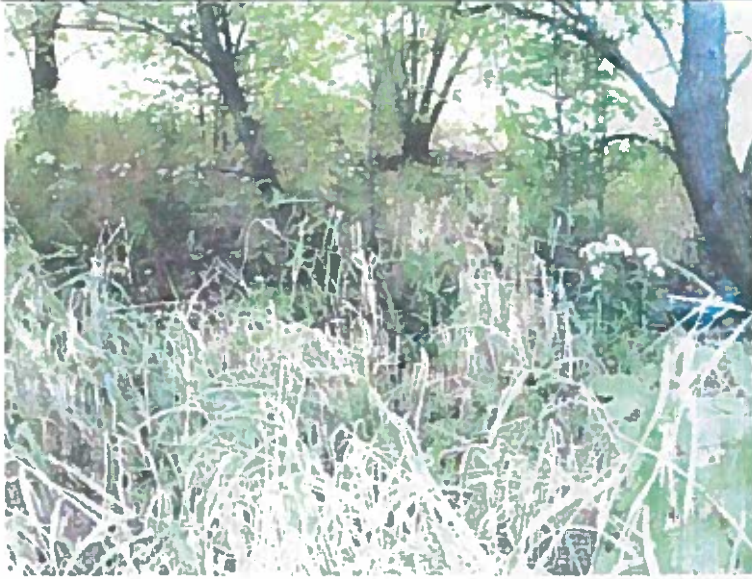
- Area 3 – Located at N41° 29.916'/W88° 06.683'. This was an area at the top of the bank which had ash/slag exposed to sheet runoff. The area was approximately 30' x 30' in size. The side slope of bank itself was in good condition.

Photo 5 – Area 3, before any work was conducted. View is from the south.

Repair: The area was cleared and 4" to 6" of top soil and seed with a mix of all purpose seed and annual rye was placed. The area was then covered with a green wood-fiber erosion blanket.

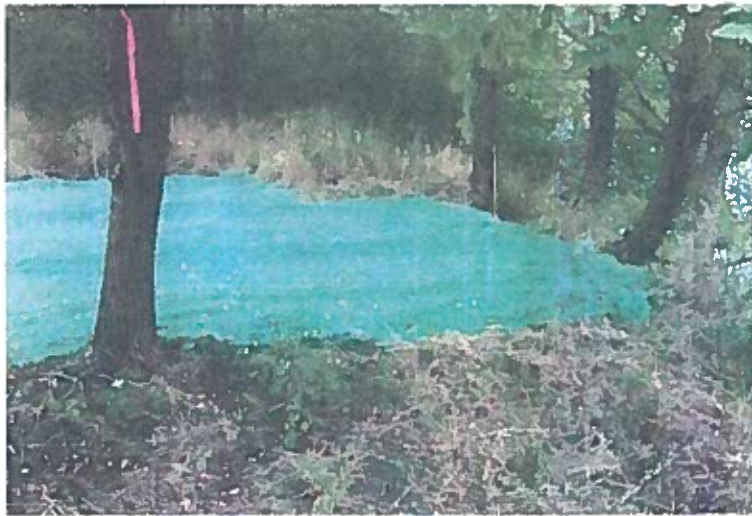
Photo 6 – Area 3, after repair work was completed. View is from the northwest.

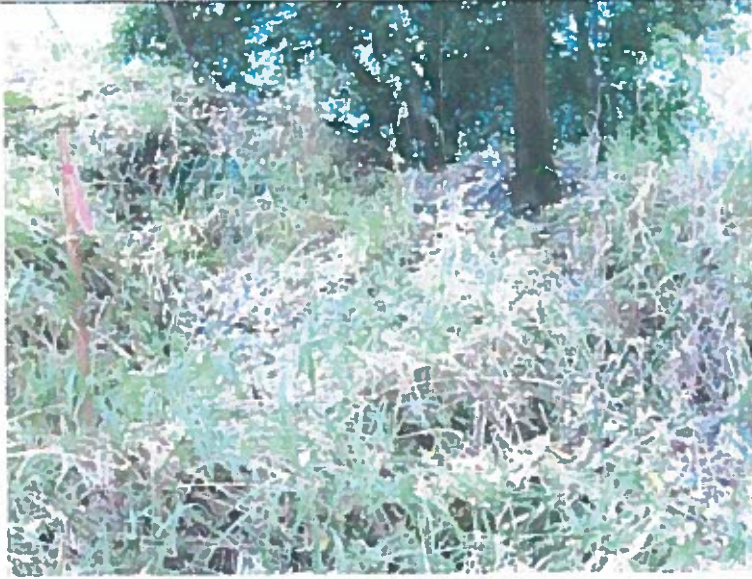
- Area 4 – Located at N41° 29.894'/W88° 06.732'. This area had a small rill that had started to form with some evidence of ash and slag toward the bottom. The rill was about 15' long, 2' deep and 3' to 4' wide. The remainder of the bank side slope was in good condition.

Photo 7 - Area 4, before any work was conducted. View is from the northwest.

Repair: The rill was filled in with clayey top soil and seeded with a mix of all purpose seed and annual rye. This was then covered with a green wood-fiber erosion mat. Straw logs were placed along the top of the subject area to help reduce runoff erosional effects.

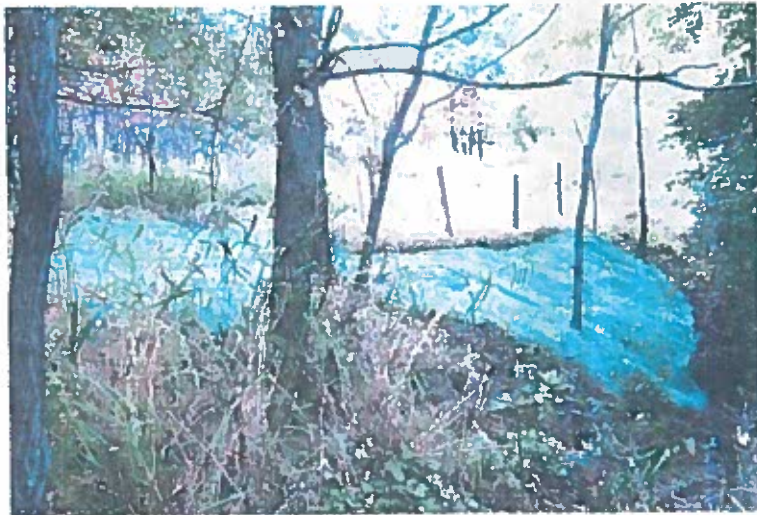
Photo 8 - Area 4, after repair work was completed. View is from the southwest.

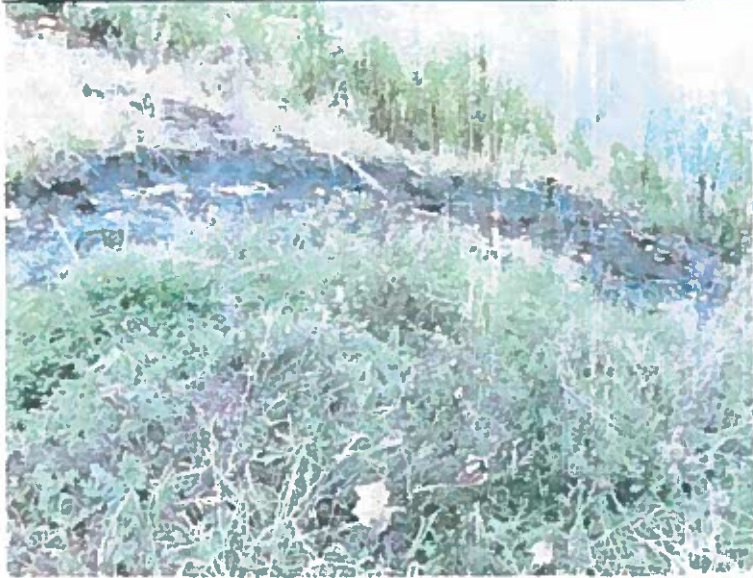
- Area 5 – Located at N41° 29.889/W88° 06.947'. This was an area of sheet wash which had eroded most of the cover and had exposed ash/slag along the side of the bank. The area of ash exposure was about 50' wide and extended from the top of the slope to the river water interface. The slope was fairly steep at this location.

Photo 9 – Area 5, before any work was conducted. View is from the northwest.

Repair: The area was graded and clayey top soil and seed with a mix of all purpose seed and annual rye was placed. Due to the steepness of the slope, the area was covered with a properly anchored, specialty three-layer netting structure

that firmly helps secure and promote vegetal growth along slopes. The matting configuration includes a layer of 100% coconut matrix material. The underlying seed will germinate and grow directly through the blanket. The length of the blanket extended to beyond the area of exposure. The top of the blanket was additionally anchored into a small excavated trench to preclude underwashing. The top of the area was then lined with rip-rap to help disperse and reduce sheet runoff effects.

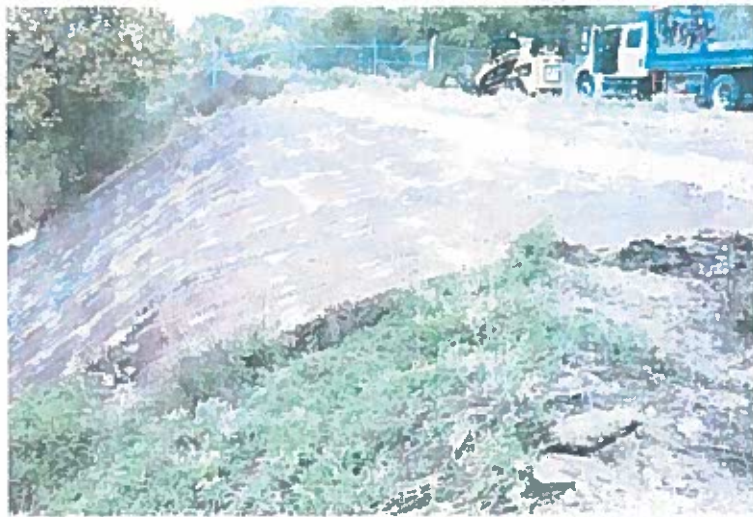
Photo 10 – Area 5, after repair work was completed. View is from the southeast.

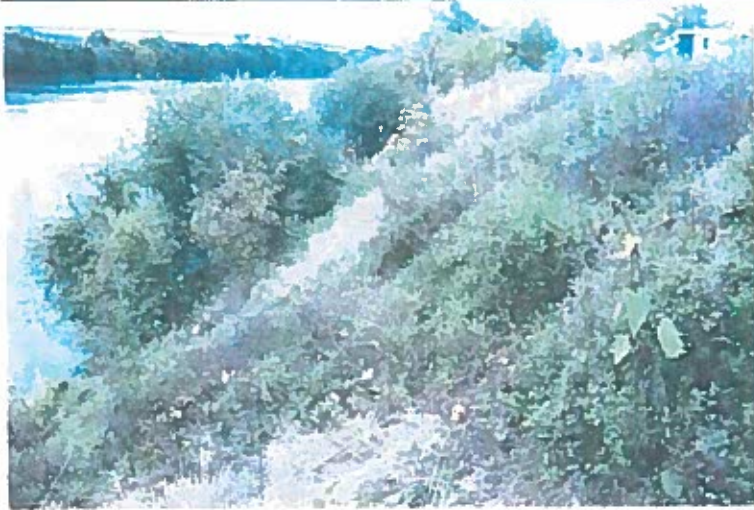
- Area 6 is located within the fenced boundary of the Joliet #29 facility. The area consisted of exposed ash erosional features identified for repair description purposes as Area 6a and 6b which are separated by about 50' of stable side slope and vegetal cover.

Photo 11 - Area 6A, before any work was conducted. View is from the east.

Repair: The repairs in Areas 6a and 6b were basically the same as defined above for Area 5. However, some additional exposed ash identified along the top of the bank, along the service road, was also covered with top soil, seeded and covered with a green wood-fiber erosion blanket.

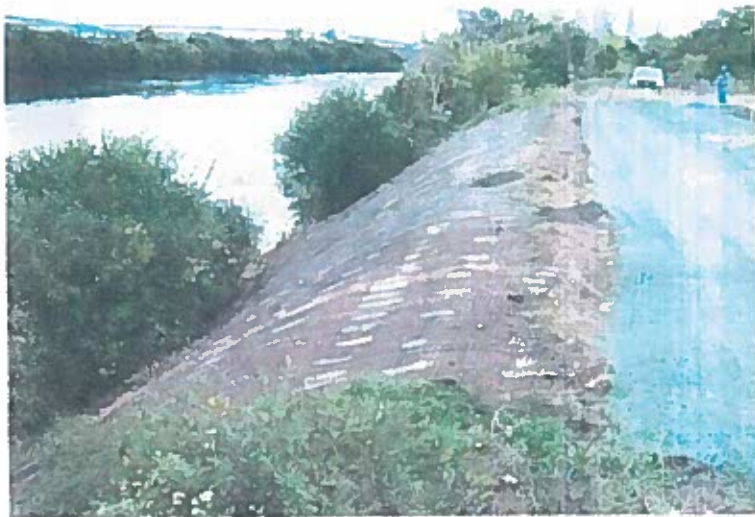
Photo 12 - Area 6A, after repair work was completed. View is from the east.

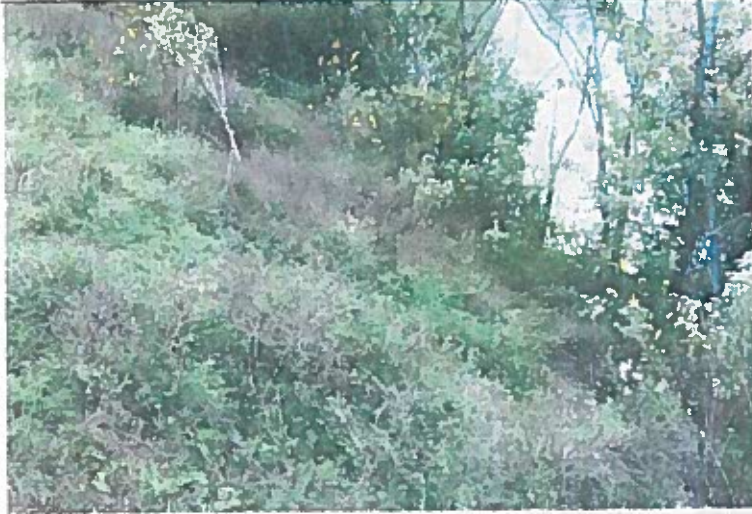
Photo 13 - Area 6B, before any work was conducted. View is from the west.

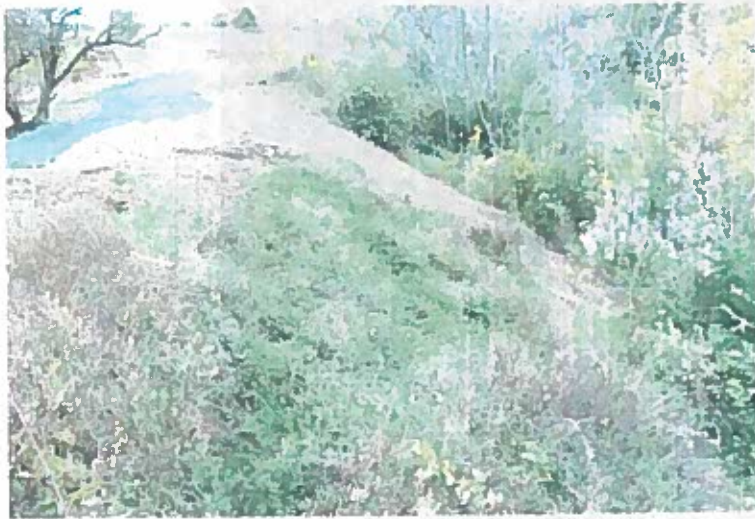
Photo 12 - Area 6B, after repair work was completed. View is from the west.
