*SIERRA CLUB, ET AL. V. MIDWEST GENERATION, LLC* PCB 13-15

**EXPERT REPORT ON GROUNDWATER  
CONTAMINATION BY JAMES R. KUNKEL  
JULY 1, 2015**

# Expert Report on Ground-water Contamination

**James R. Kunkel, Ph.D., P.E.**

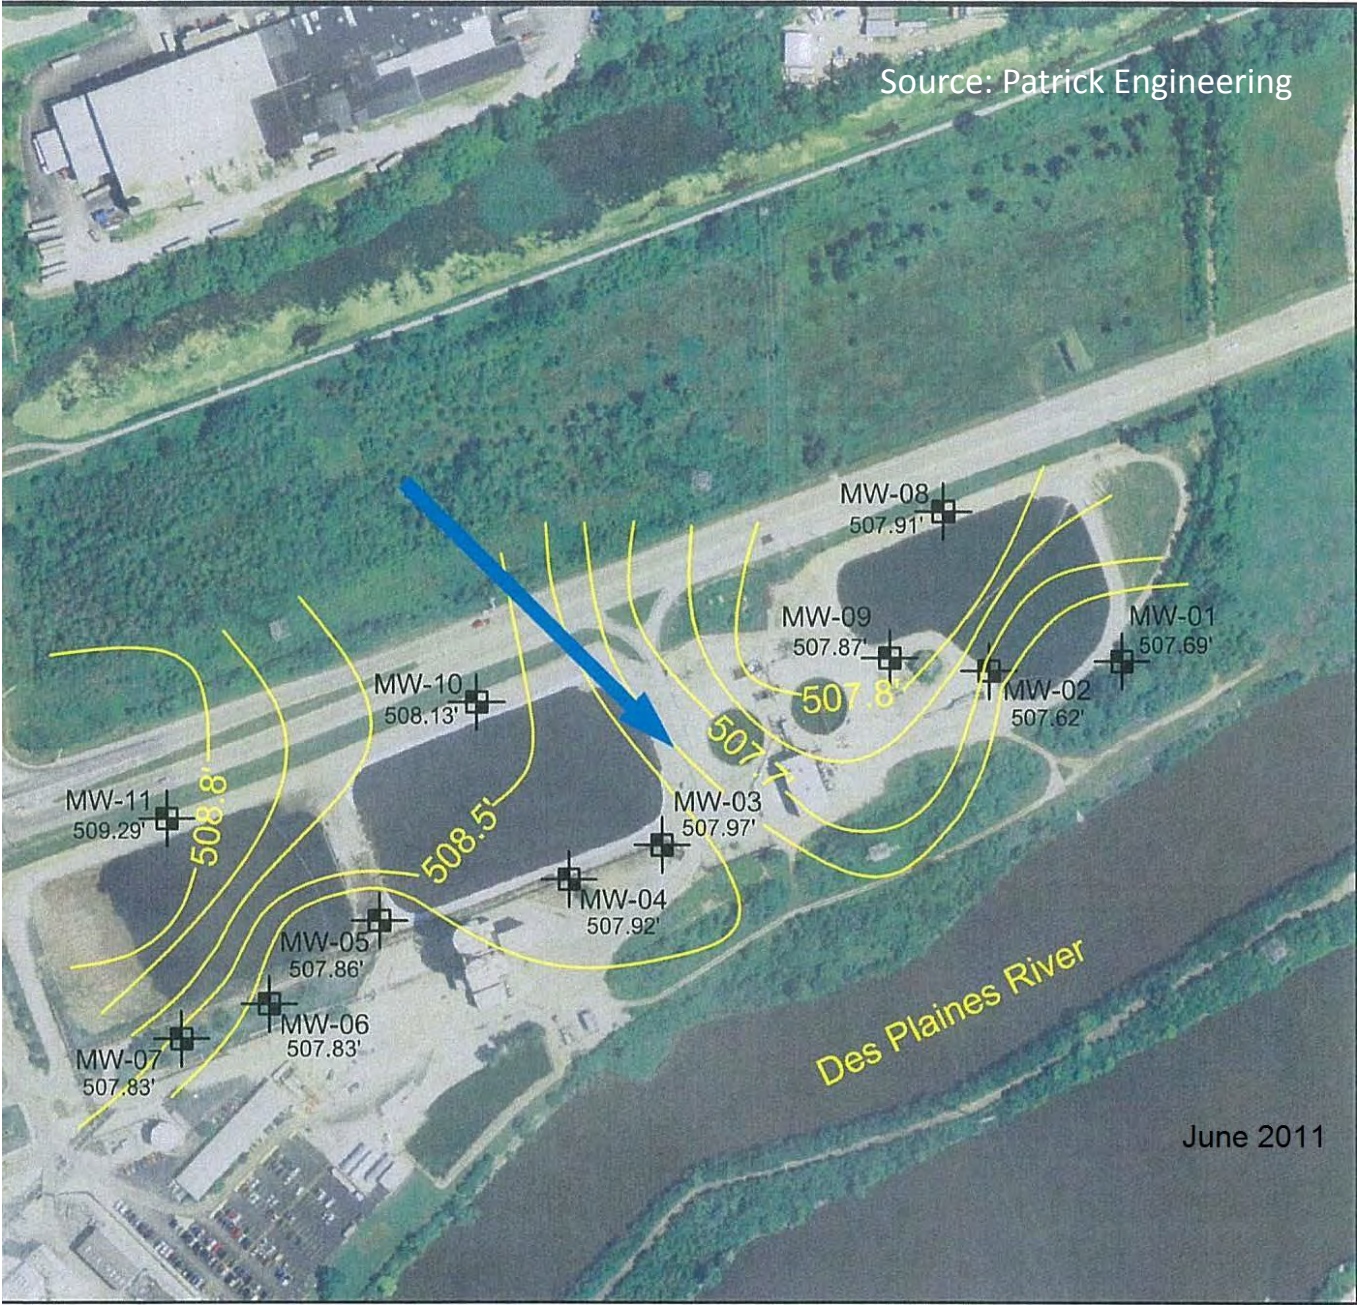
**Figure 3 June 2011 Second Quarter Ground-water Contours Showing Mounding Beneath the Joliet Ash Ponds (PCB 2013-015)**

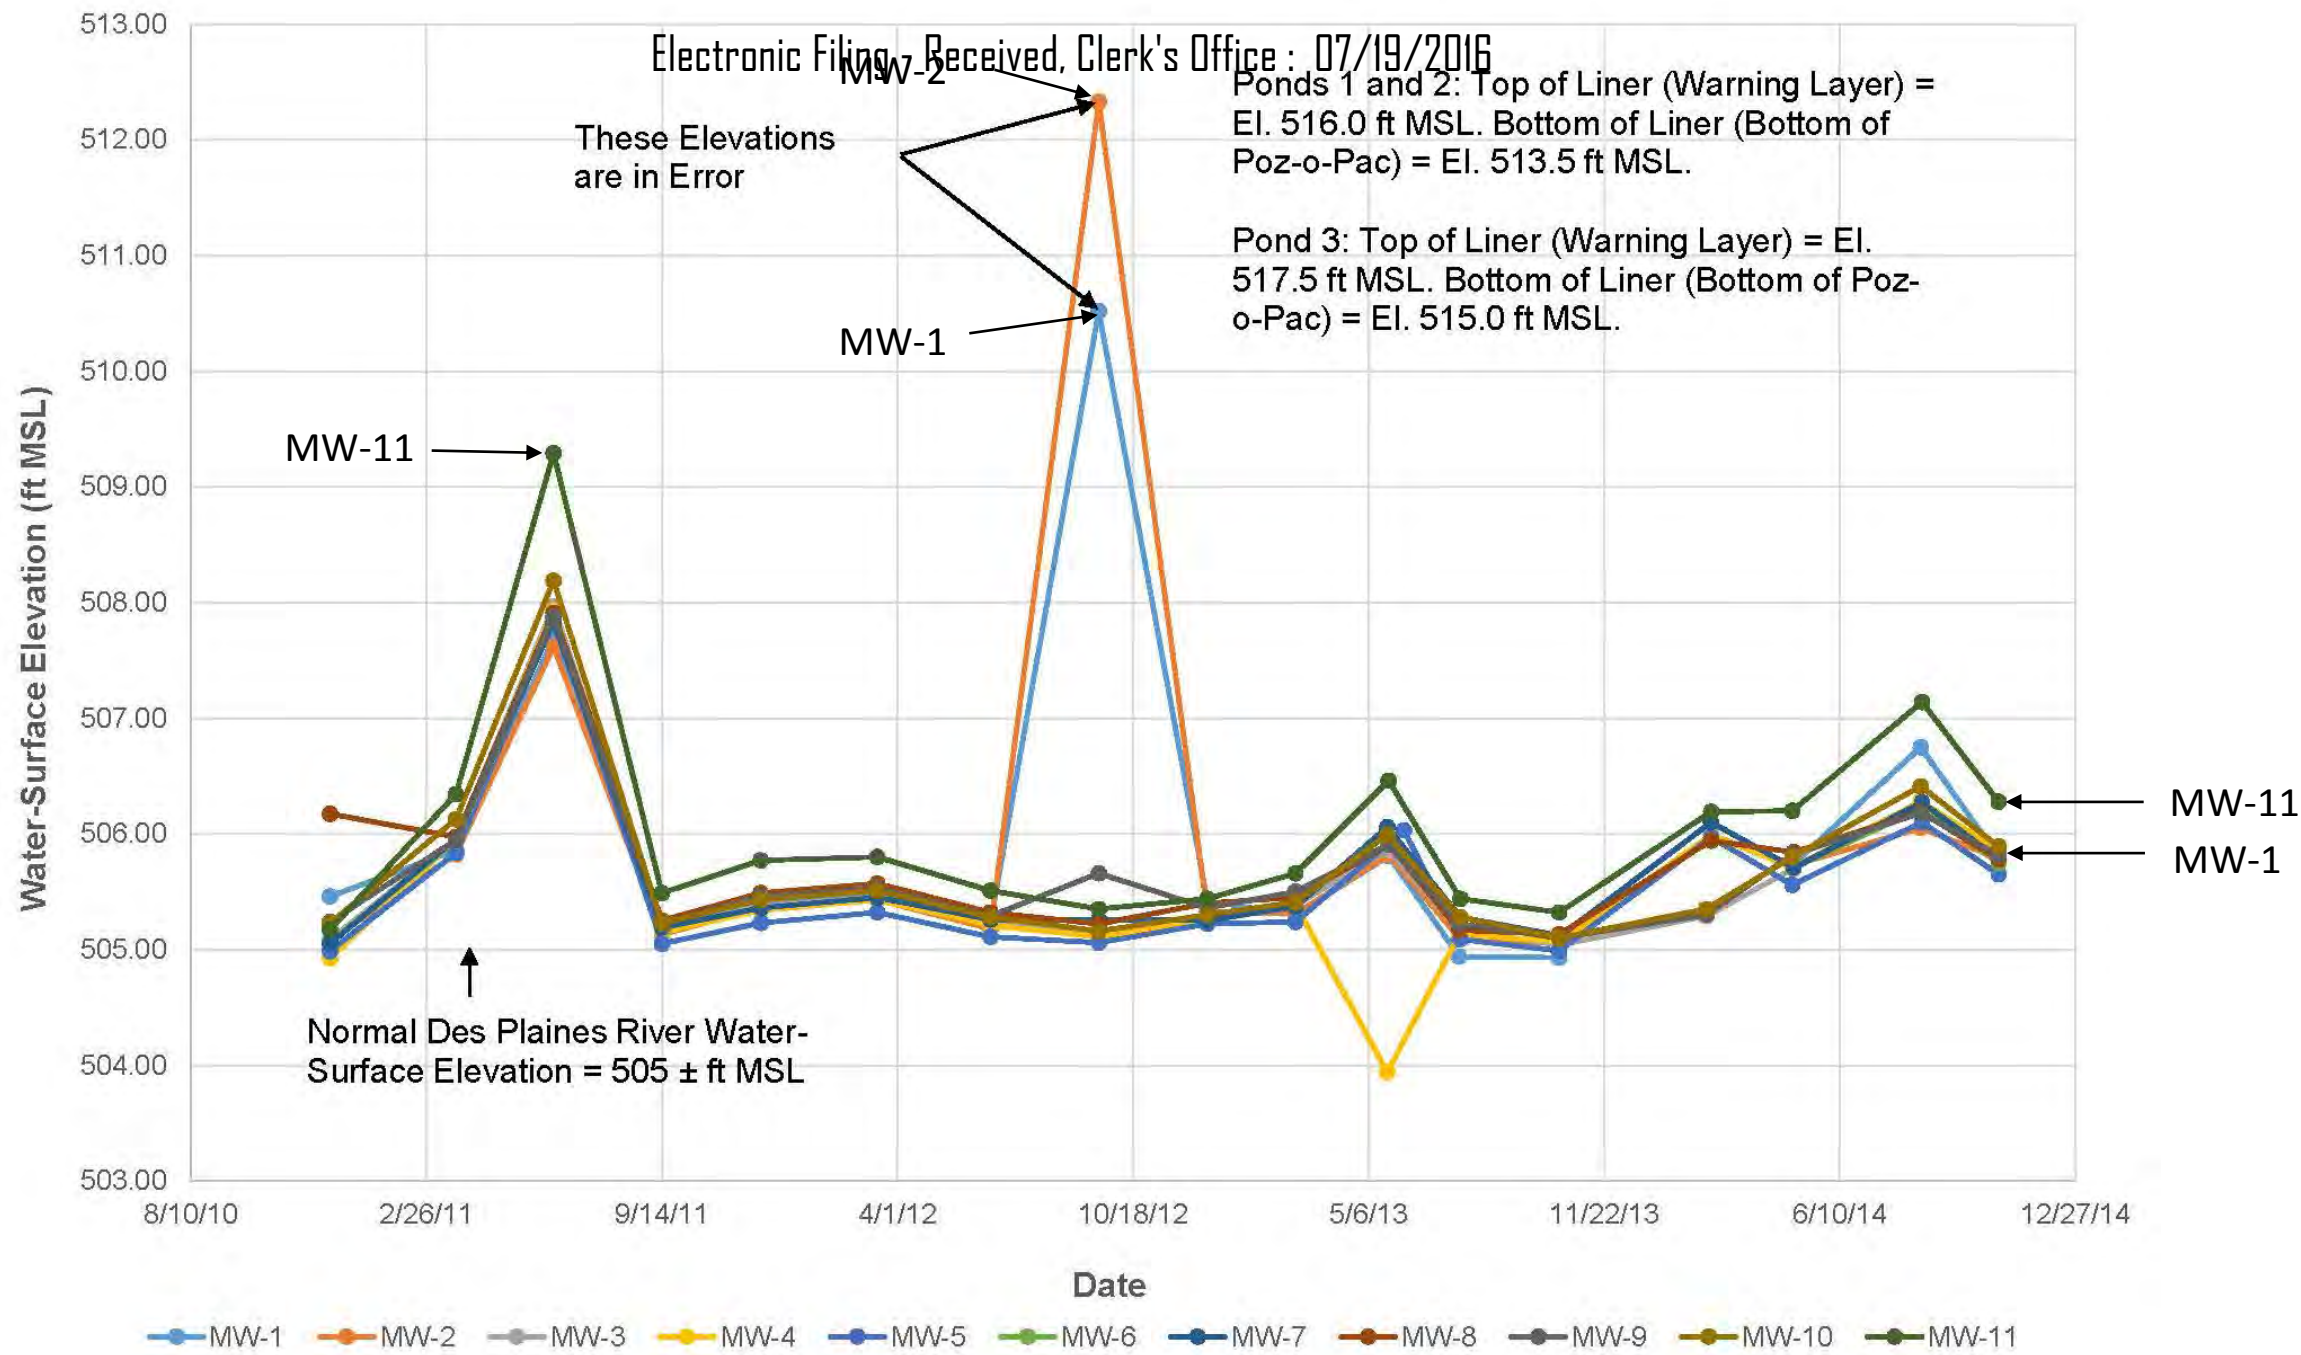
Figure 4 Joliet #29 Site Historical Ground-water Elevations (PCB 2013-015)

**Water Surface Elevations.** Ground-water at the Joliet #29 site is strongly influenced by changes in Des Plaines River surface-water elevations as well as potentially leaking ash ponds. Figure 4 graphically shows the time series of ground-water elevations at the 11 monitoring wells located around the ash ponds. The time series shows some interesting characteristics. During the March and June 2011 quarterly monitoring, the ground-water elevations in the wells rose sharply. This most likely was due to a large increase in runoff and rising Des Plaines River water-surface elevations. Based on discharge data from the USGS gaging station 05537980, water discharges in the River during the period March through June 2011 were as high as 27,300 cubic feet per second (cfs) or more than 4 times the average River discharge (6,412 cfs) for the same period. There were two other very high discharges in May 2011 (20,100 and 20,800 cfs) which also resulted in high Des Plaines River stages at the Joliet #29 site. These high stages are reflected in ground-water mounding beneath the ash ponds during this period as seen in MWG Second Quarter 2011 monitoring report and Figure 3. Similar ground-water mounding also is seen in the MWG subsequent quarterly monitoring reports and is the result of both high Des Plaines River stages during the spring and early summer and also due to ash pond liner leaks in Pond 3 until it was relined in 2013. The consequences of this mounding would be to saturate already contaminated soils from previous ash pond leaks or from previous coal ash leaching events. The high Des Plaines River discharges certainly caused river bank erosion

I conclude from interpretation of the ground-water elevations and presumed Des Plaines River water-surface elevations based on River discharge data that the River strongly influences the ground-water elevations and ground-water gradients at site, causing seasonal flow from the River into the unconsolidated materials beneath the ash ponds. However, not all of the ground-water mounding seen in the quarterly monitoring reports can be attributed to the Des Plaines River and I further conclude that the Joliet #29 ash ponds have leaked in the past and continue to leak.

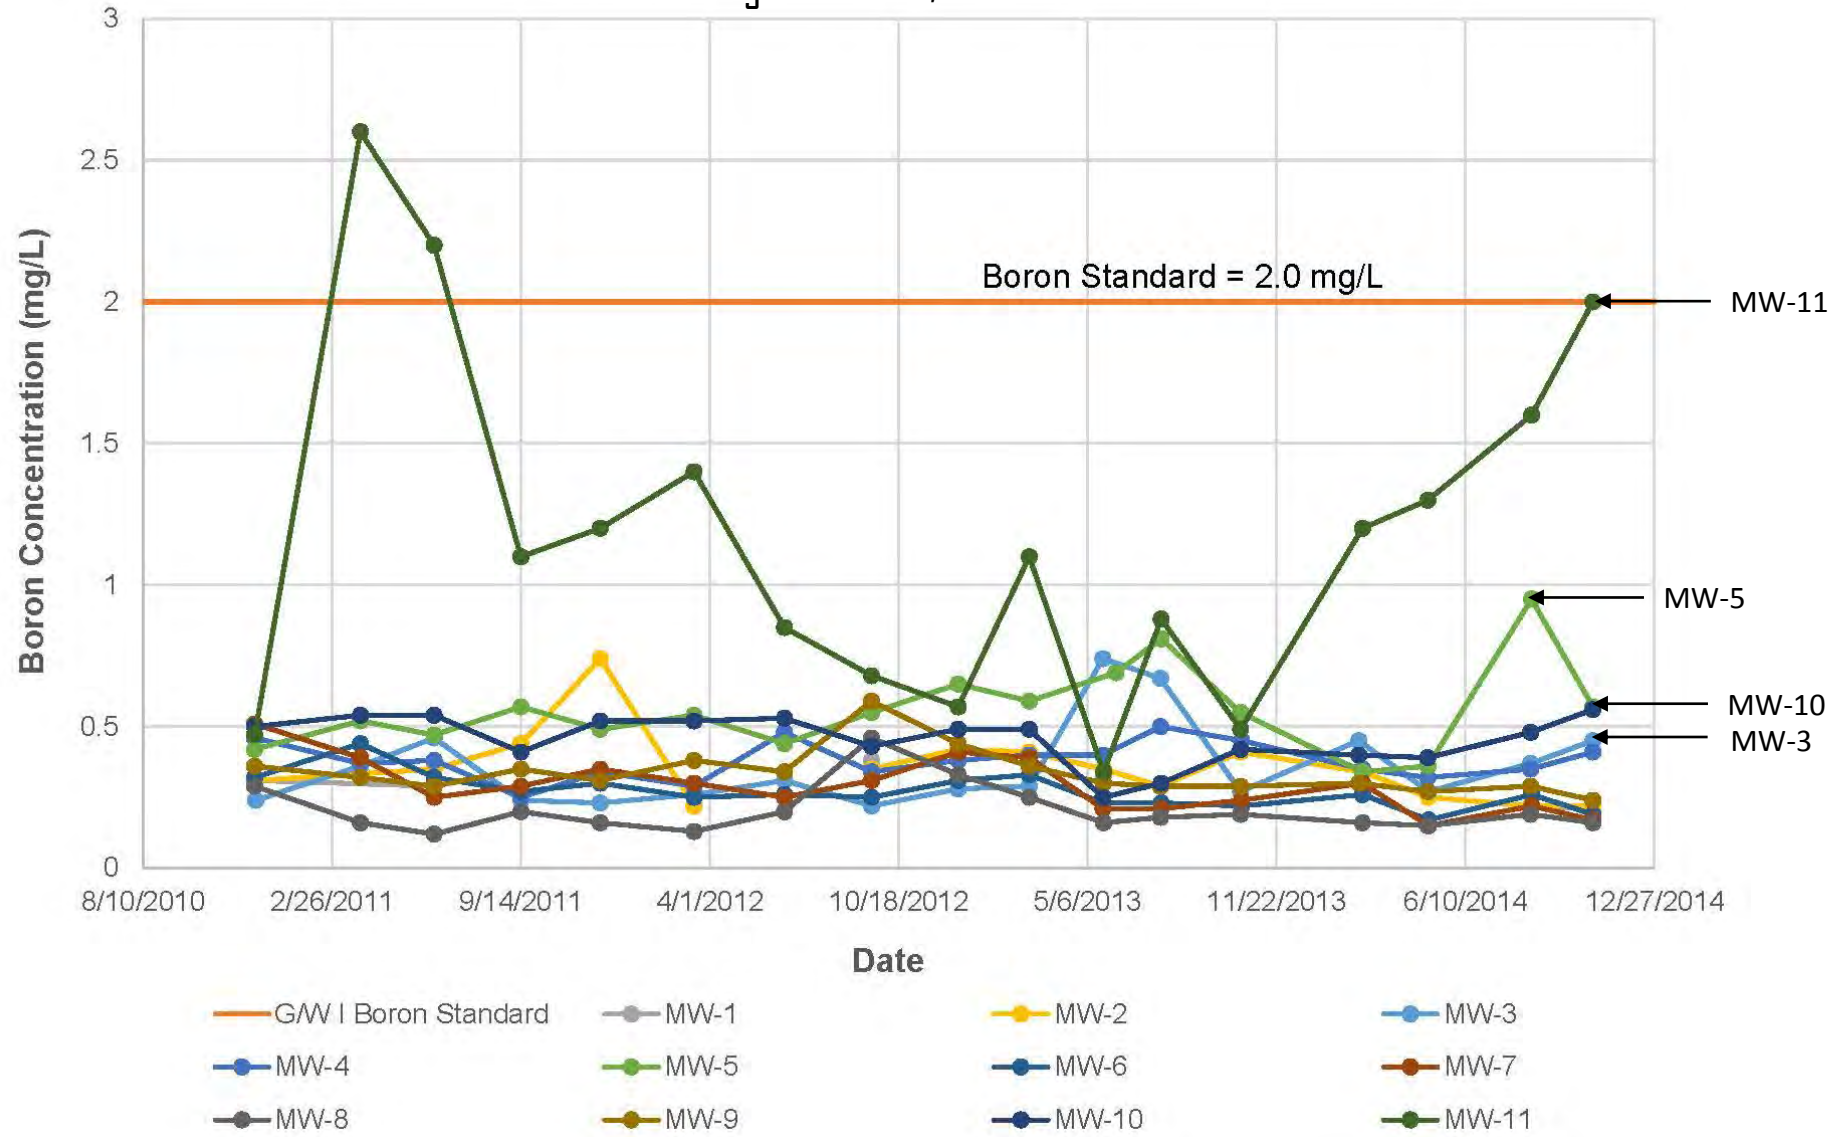
Figure 5 Boron Concentrations in Ground Water  
Joliet #29 Site (PCB 2013-015)

Figure 5 shows the time series of B concentrations in ground-water at the Joliet #29 site. Historically MW-11 has had B concentrations equal to or higher than the IEPA Class I ground-water standard of 2.0 mg/L during the monitoring period from December 2010 to present. Boron is known to be found in coal ash leachate (Table 2). It is noted that B concentrations in ground-water have recently increased dramatically in MW-5 and MW-11, with slightly increasing B concentration trends in all of the other 9 wells. Boron concentrations in ground water at all monitoring wells at the Joliet #29 site are higher than the background concentration of 0.12 mg/L for sand and gravel aquifers (Table 3). Therefore, I conclude that ground-water contamination by B at the Joliet #29 site was and is currently occurring as the result of ash pond liner leaks and/or leaching of coal ash deposits outside the ash ponds.

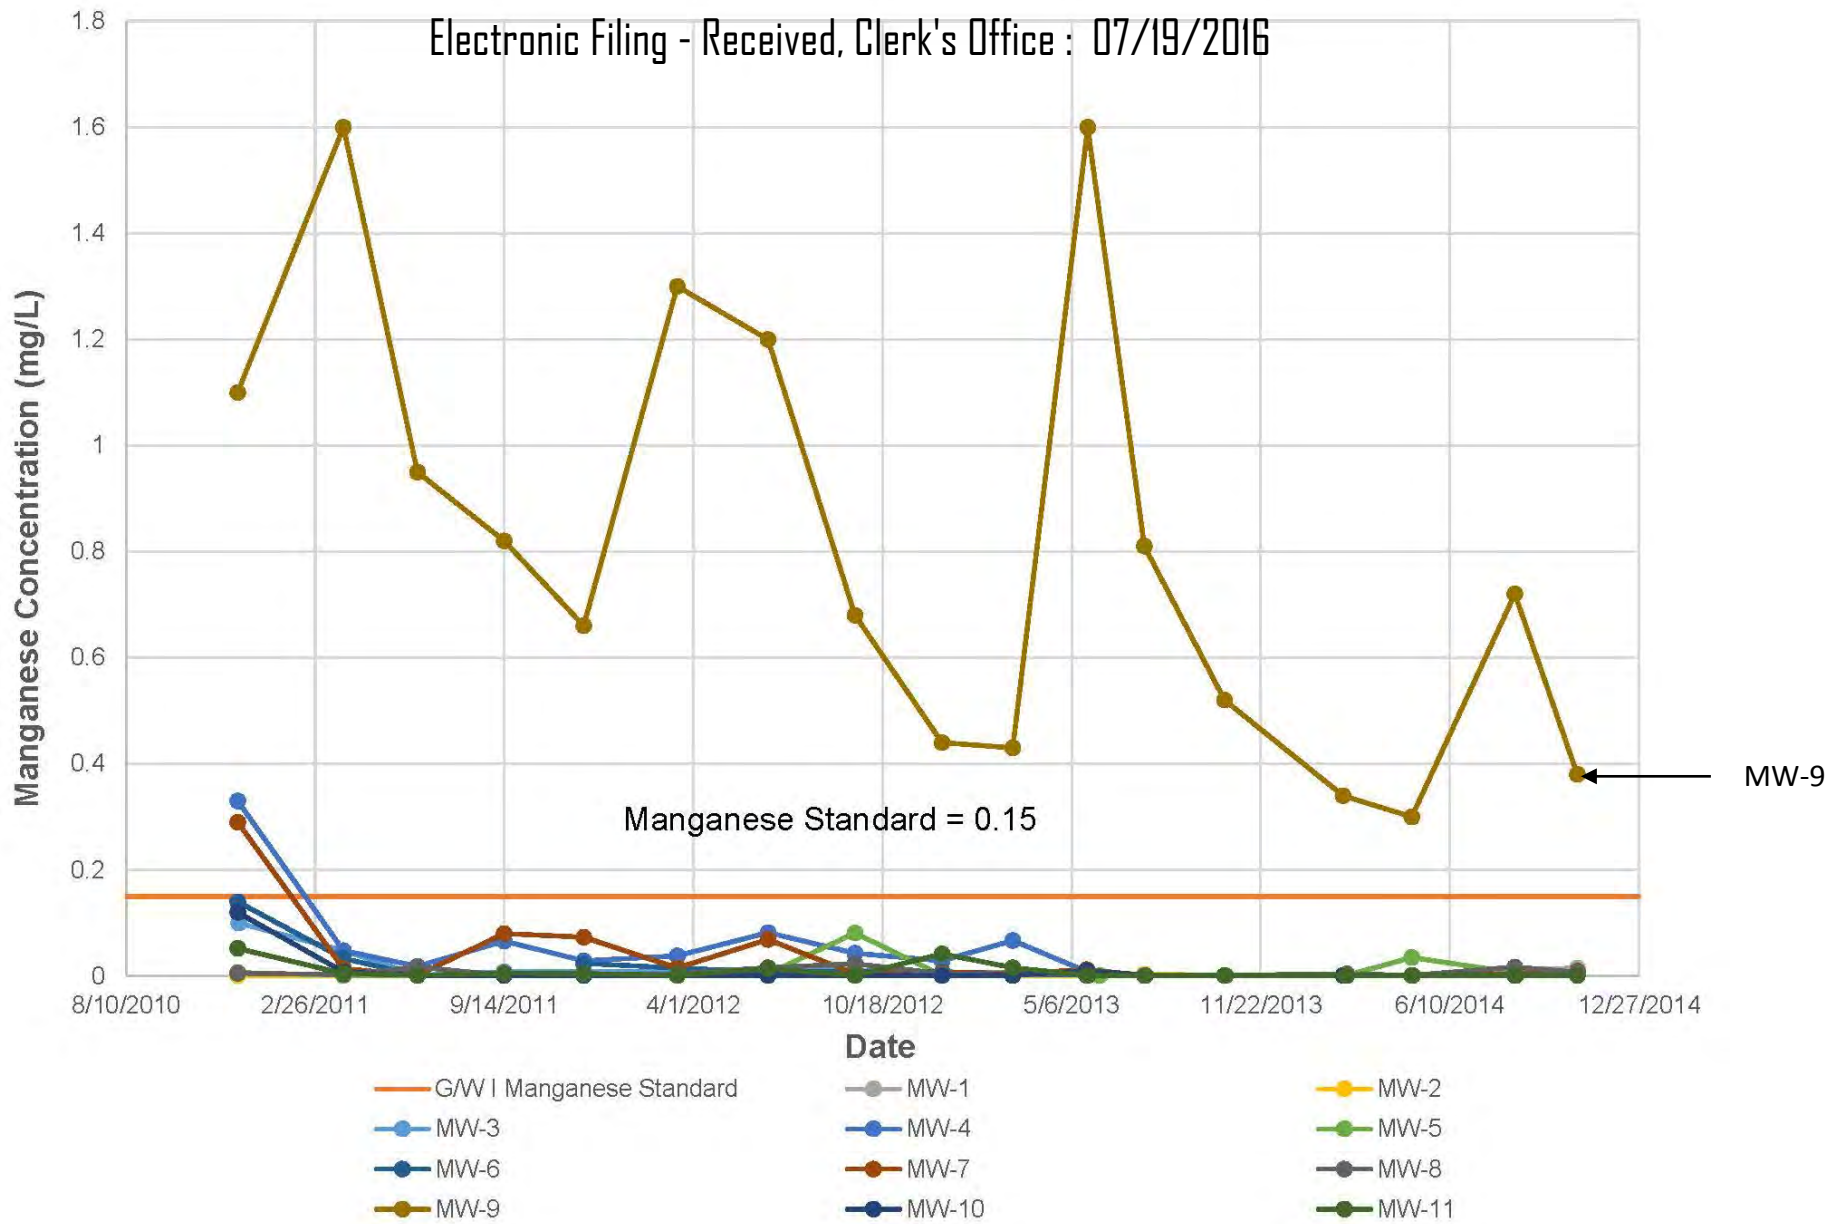
**Figure 6 Manganese Concentrations in Ground Water  
Joliet #29 Site (PCB 2013-015)**

Mn concentrations in ground water as shown in the time series on Figure 6 have historically been higher than the IEPA Class I ground-water standard of 0.15 mg/L in MW-9. Manganese is known to be found in coal ash leachate (Table 2). It is noted that Mn concentrations in ground-water have recently decreased in MW-9 and in all of the other 10 wells. The other monitoring wells historically have had Mn concentrations much less than the IEPA Class I ground-water standard, but sometimes higher than the background ground-water concentration of 0.072 mg/L for sand and gravel aquifers. Therefore, I conclude that ground-water contamination by Mn at the Joliet #29 site was and is currently occurring as the result of ash pond liner leaks and/or leaching of coal ash deposits outside the ash ponds.

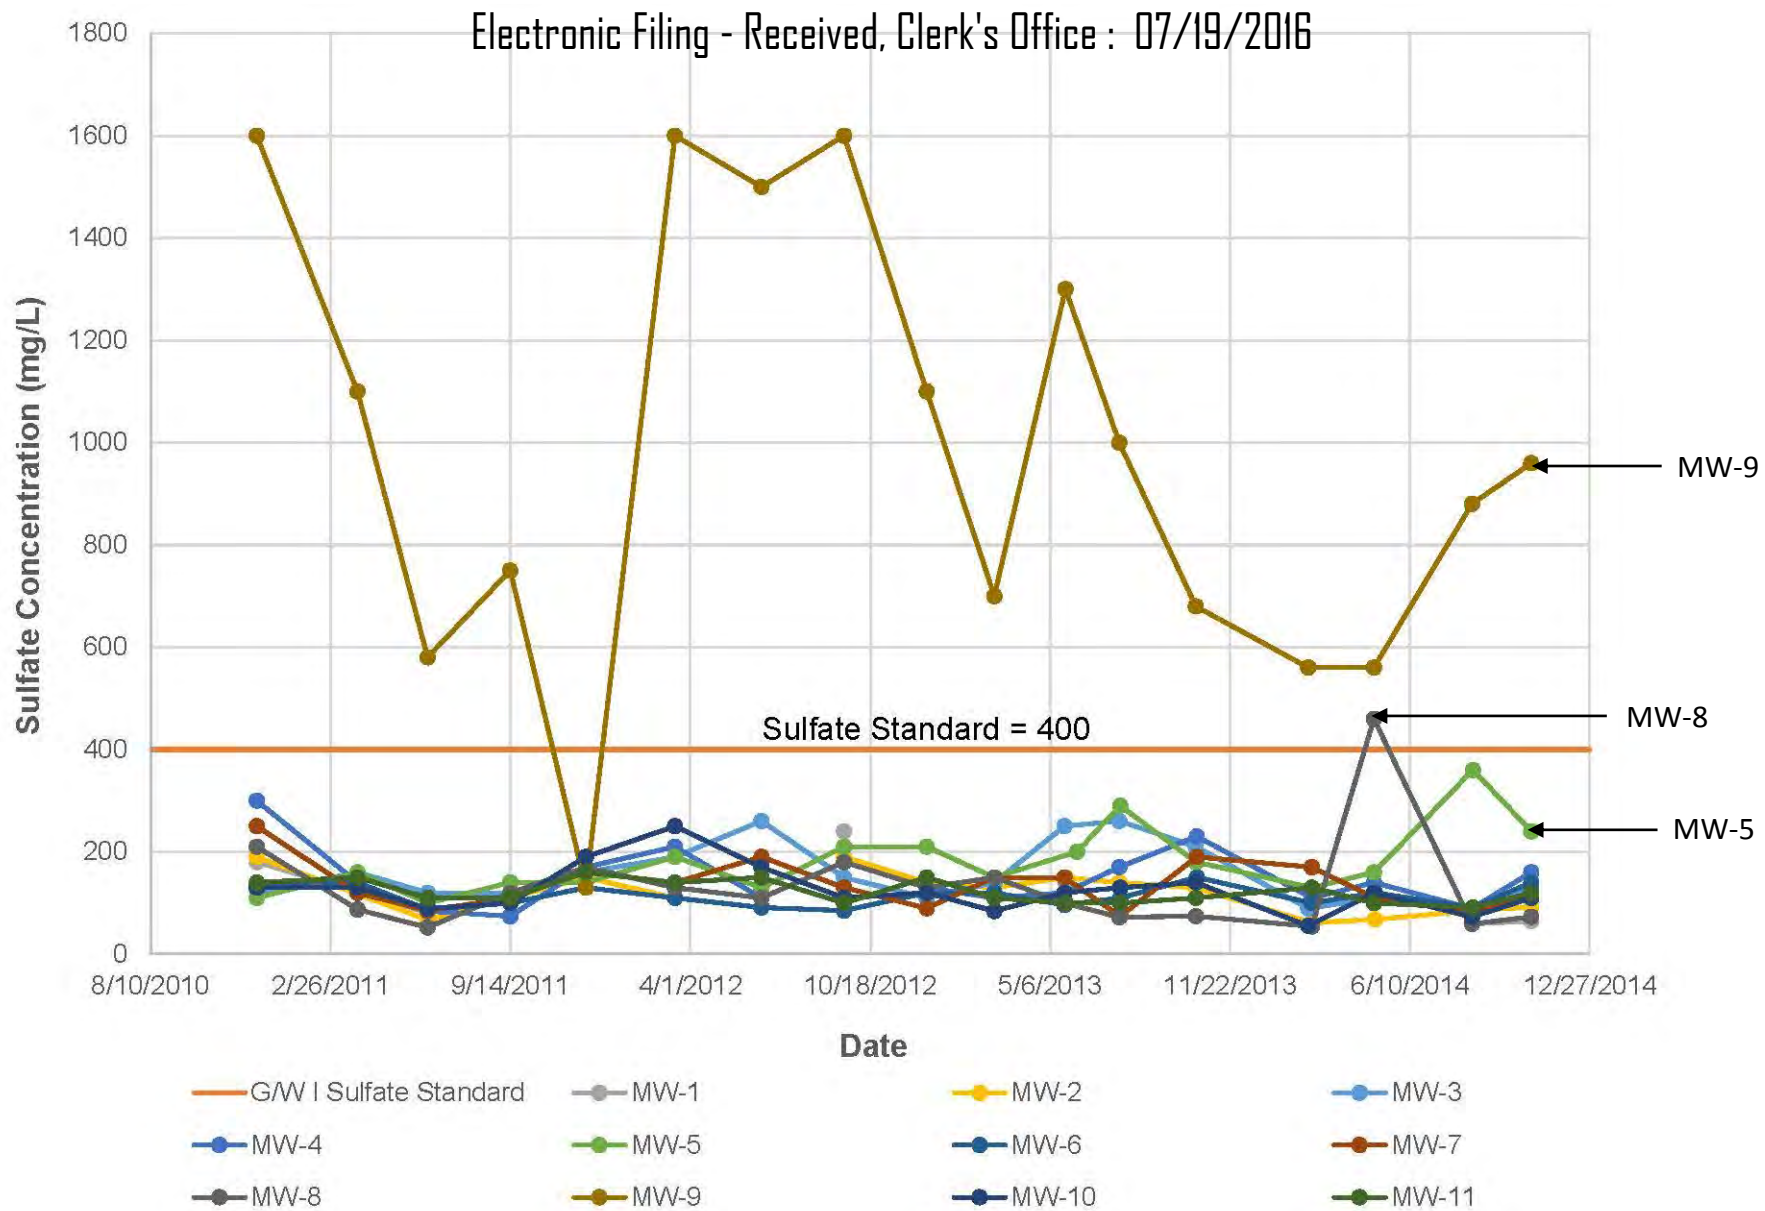
**Figure 7 Sulfate Concentrations in Ground Water  
Joliet #29 Site (PCB 2013-015)**

Figure 7 shows the time series of SO<sub>4</sub> concentrations in ground water at the Joliet #29 site with MW-9 having SO<sub>4</sub> concentrations consistently higher than the IEPA Class I ground-water standard of 400 mg/L. MW-8 has had one SO<sub>4</sub> concentration in ground water greater than the IEPA Class I standard during the Second Quarter of 2014. Sulfate is known to be found in coal ash leachate (Table 2). It is noted that SO<sub>4</sub> concentrations in ground-water have recently decreased in MW-5 and MW-8 and in all of the other 8 wells. It is noted that MW-9 is monitoring ground-water beneath ash Pond 3 which was relined in 2013. However, SO<sub>4</sub> concentrations in ground-water at MW-9 appear to be increasing since the Second Quarter of 2014, indicating that there most likely is a leak in the Pond 3 liner. An alternative explanation is that coal ash deposits outside the ash ponds continue to leach contaminants into the ground water at the Joliet #29 site.

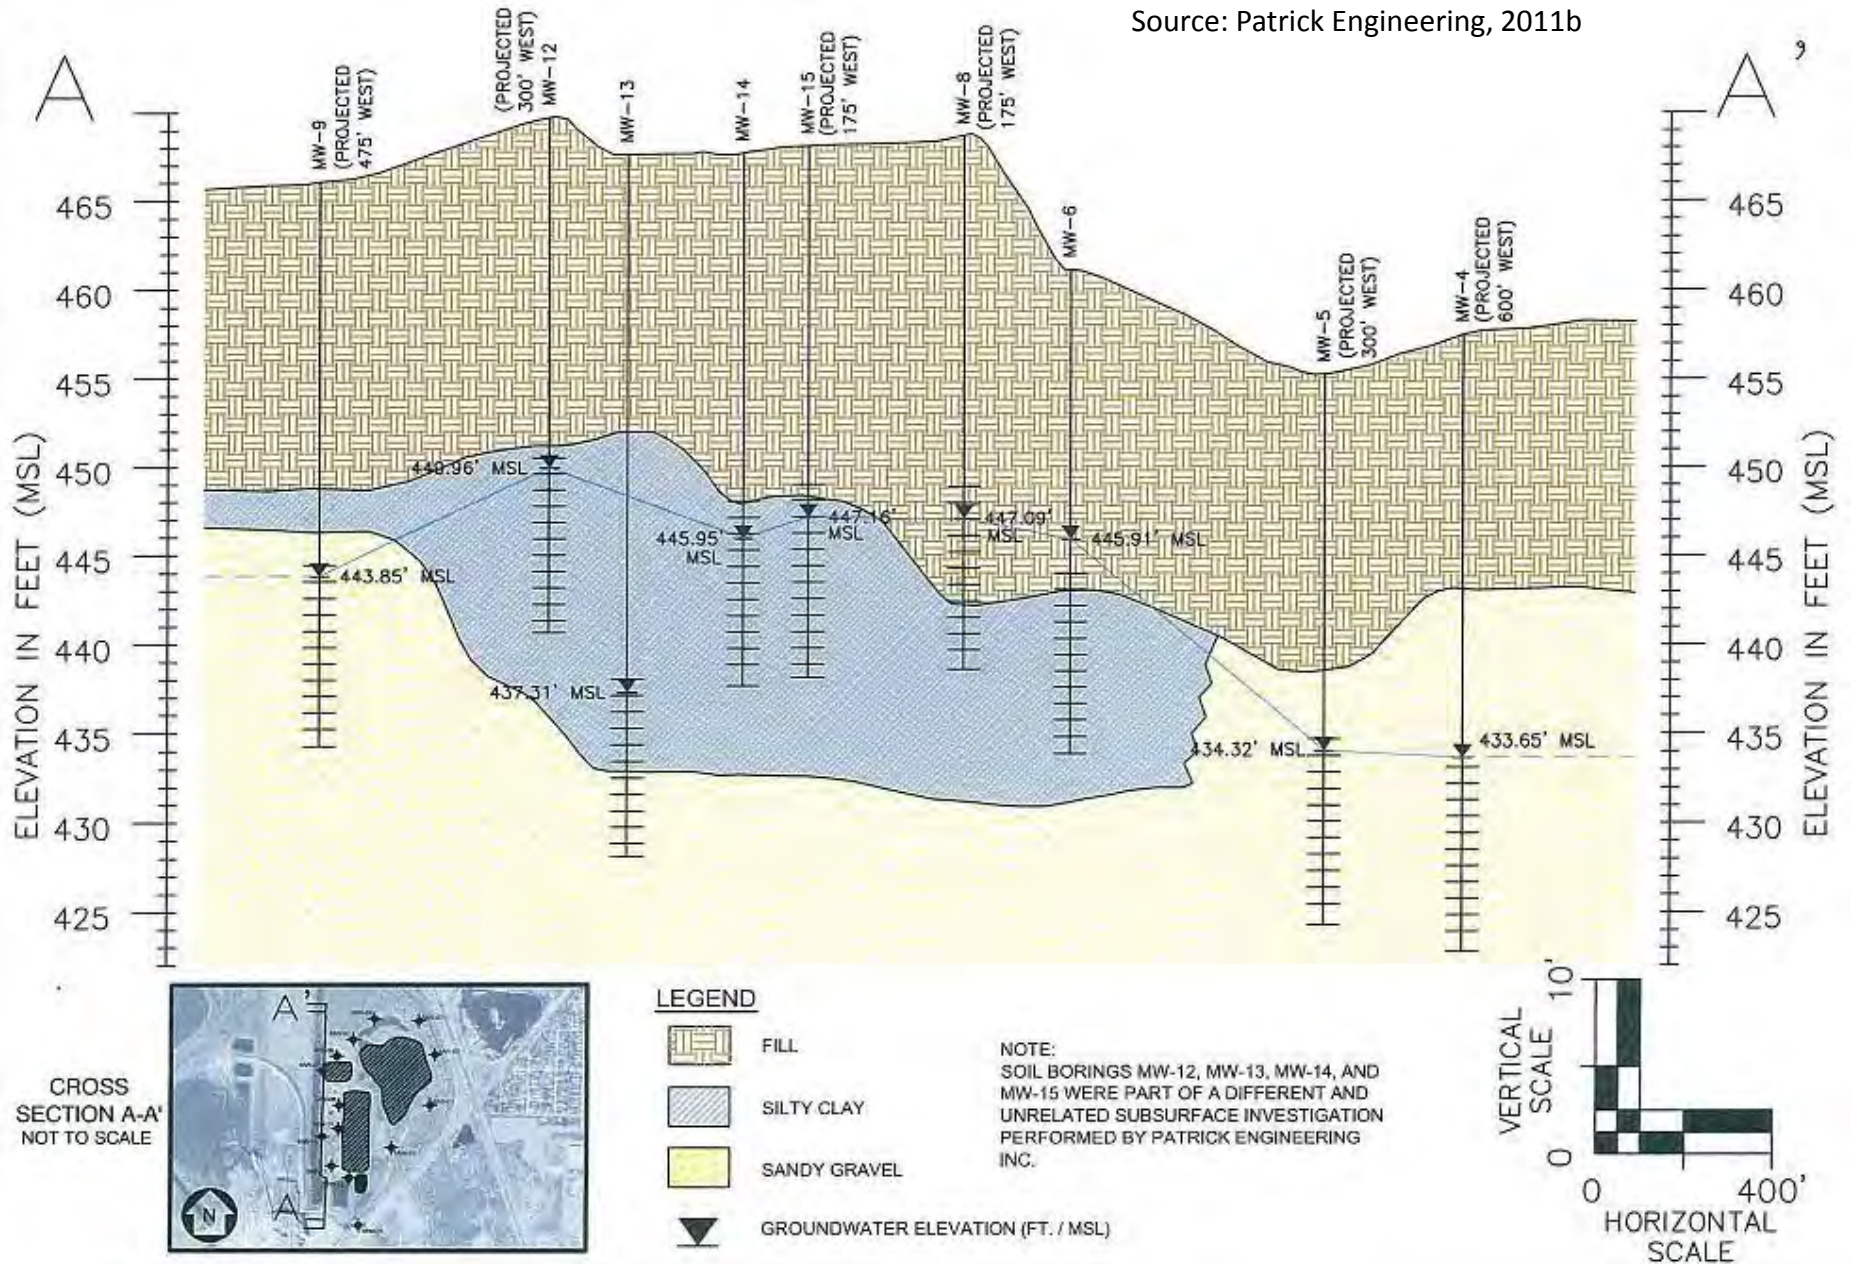
Figure 10 Powerton Soil Stratigraphy (PCB 2013-015)

**Water Surface Elevations.** Ground water at the Powerton site is strongly influenced by changes in Illinois River surface-water elevations via the channels connecting it to the site, as well as potentially leaking ash ponds. Interpretation of historical ground-water and surface-water elevations for the upper silt/clay and the lower gravelly sand units, as shown graphically on Figures 11 and 12, coupled with the soil stratigraphy shown on Figure 10, indicates the following:

- (1) The pond bottom elevation for the Secondary Ash Settling Basin is within the upper silt/clay unit but below the fill materials at the site;
- (2) The other pond bottom elevations appear to be within the fill materials at the site based on the incomplete information provided by MWG;
- (3) Ash pond water-surface elevations are nearly always at or above the ground-water and Illinois River water-surface elevations;
- (4) If there are leaks in the pond liners, it would be possible for contaminants to move opposite to the general ground-water flow direction at the site;

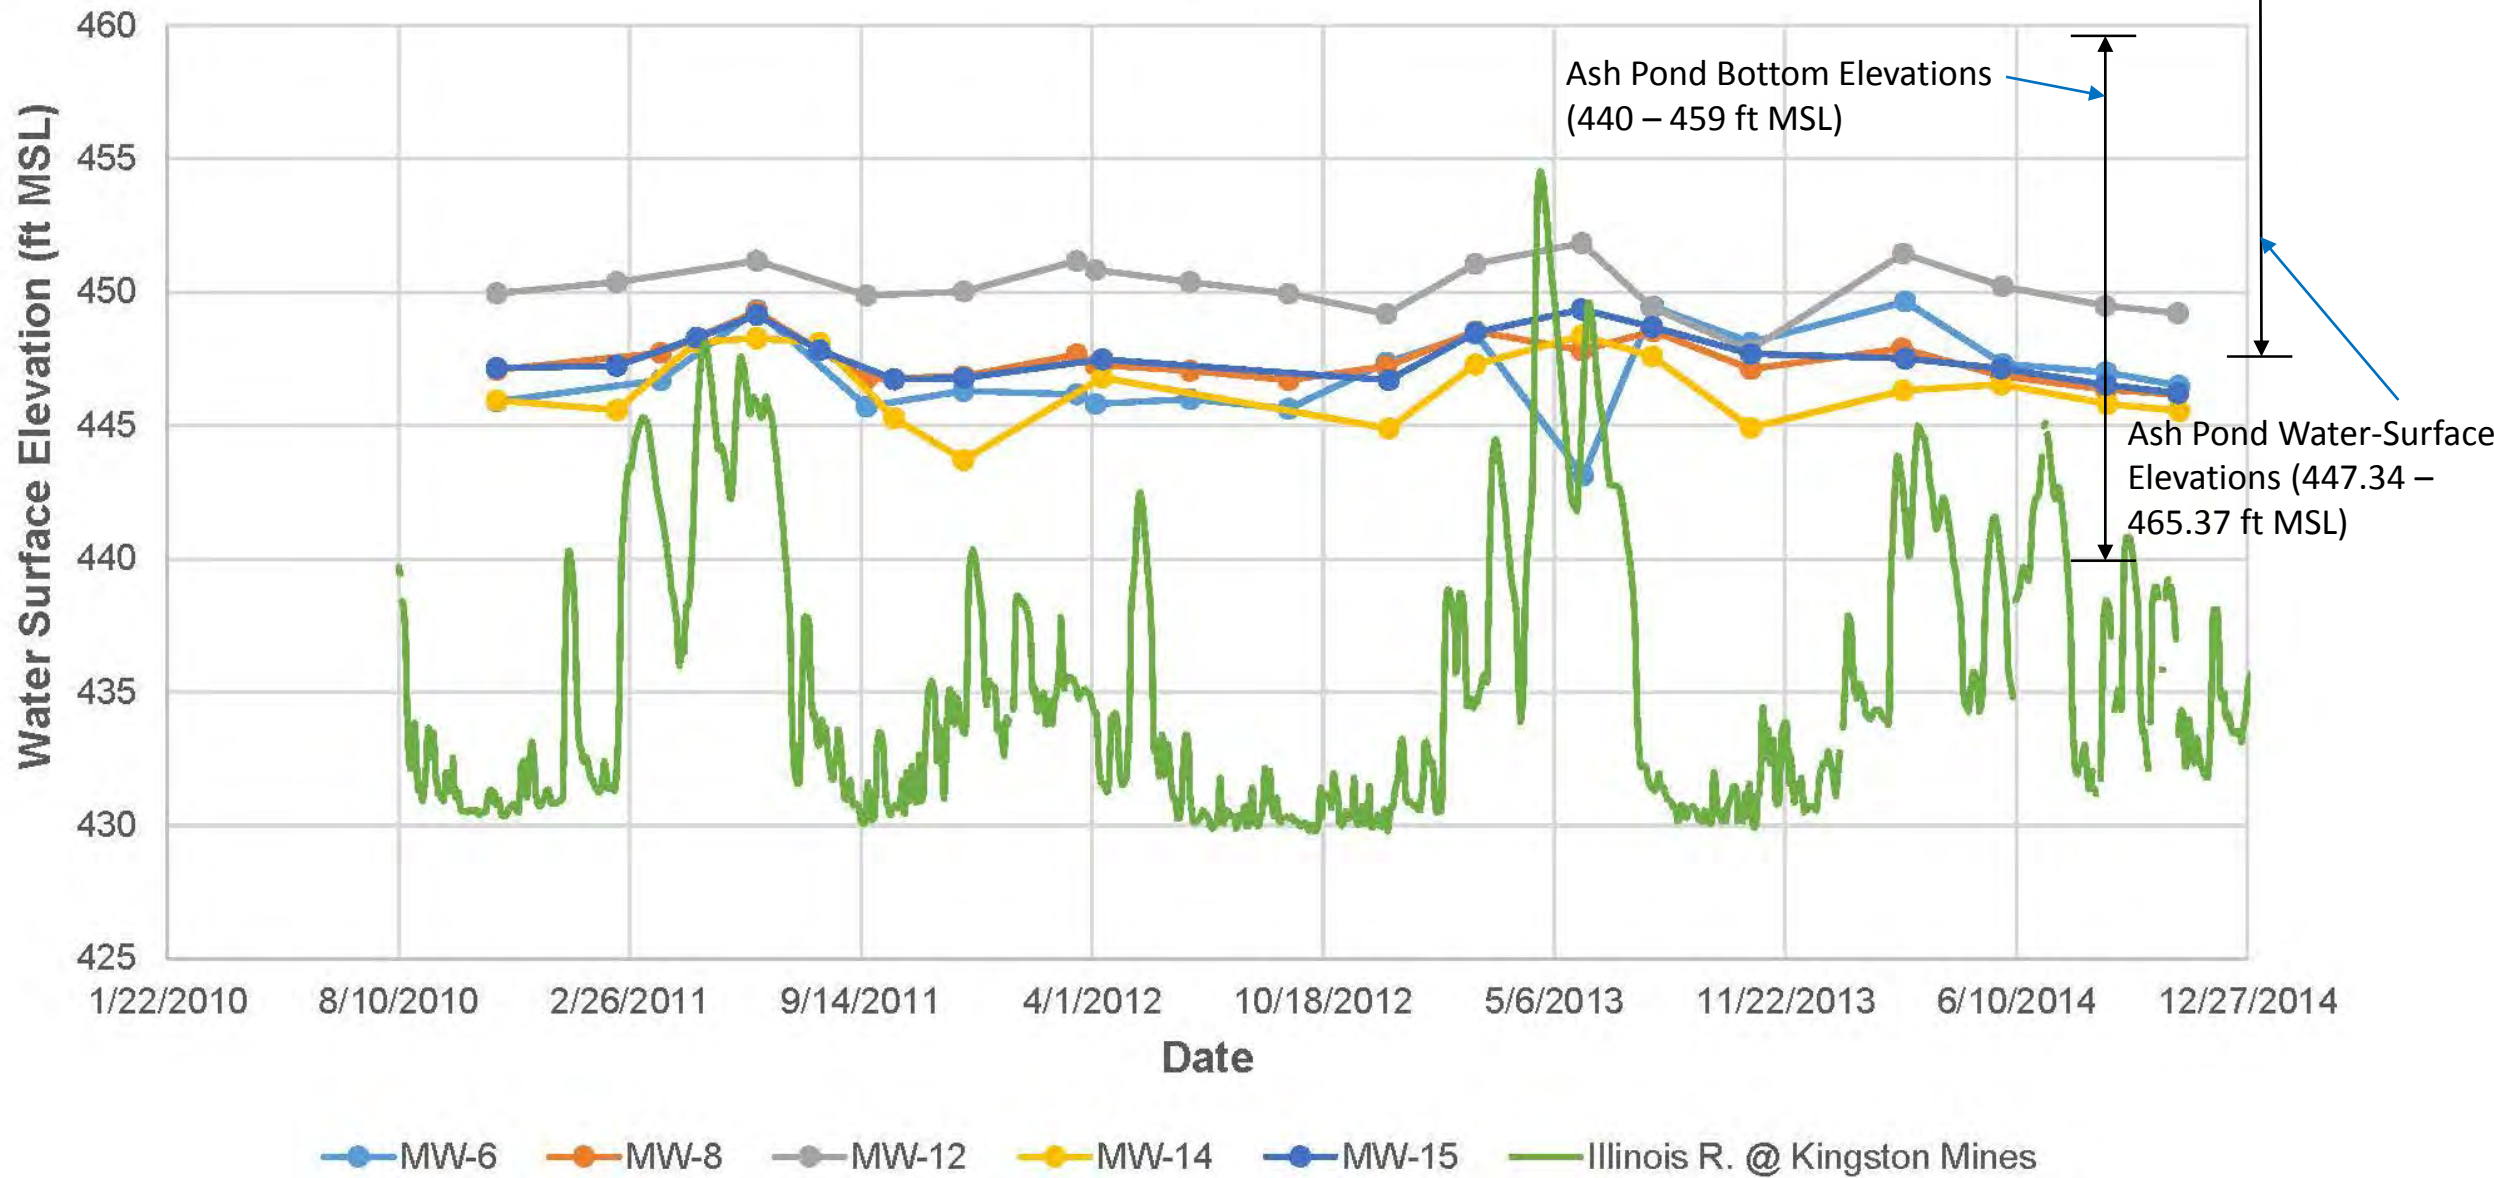
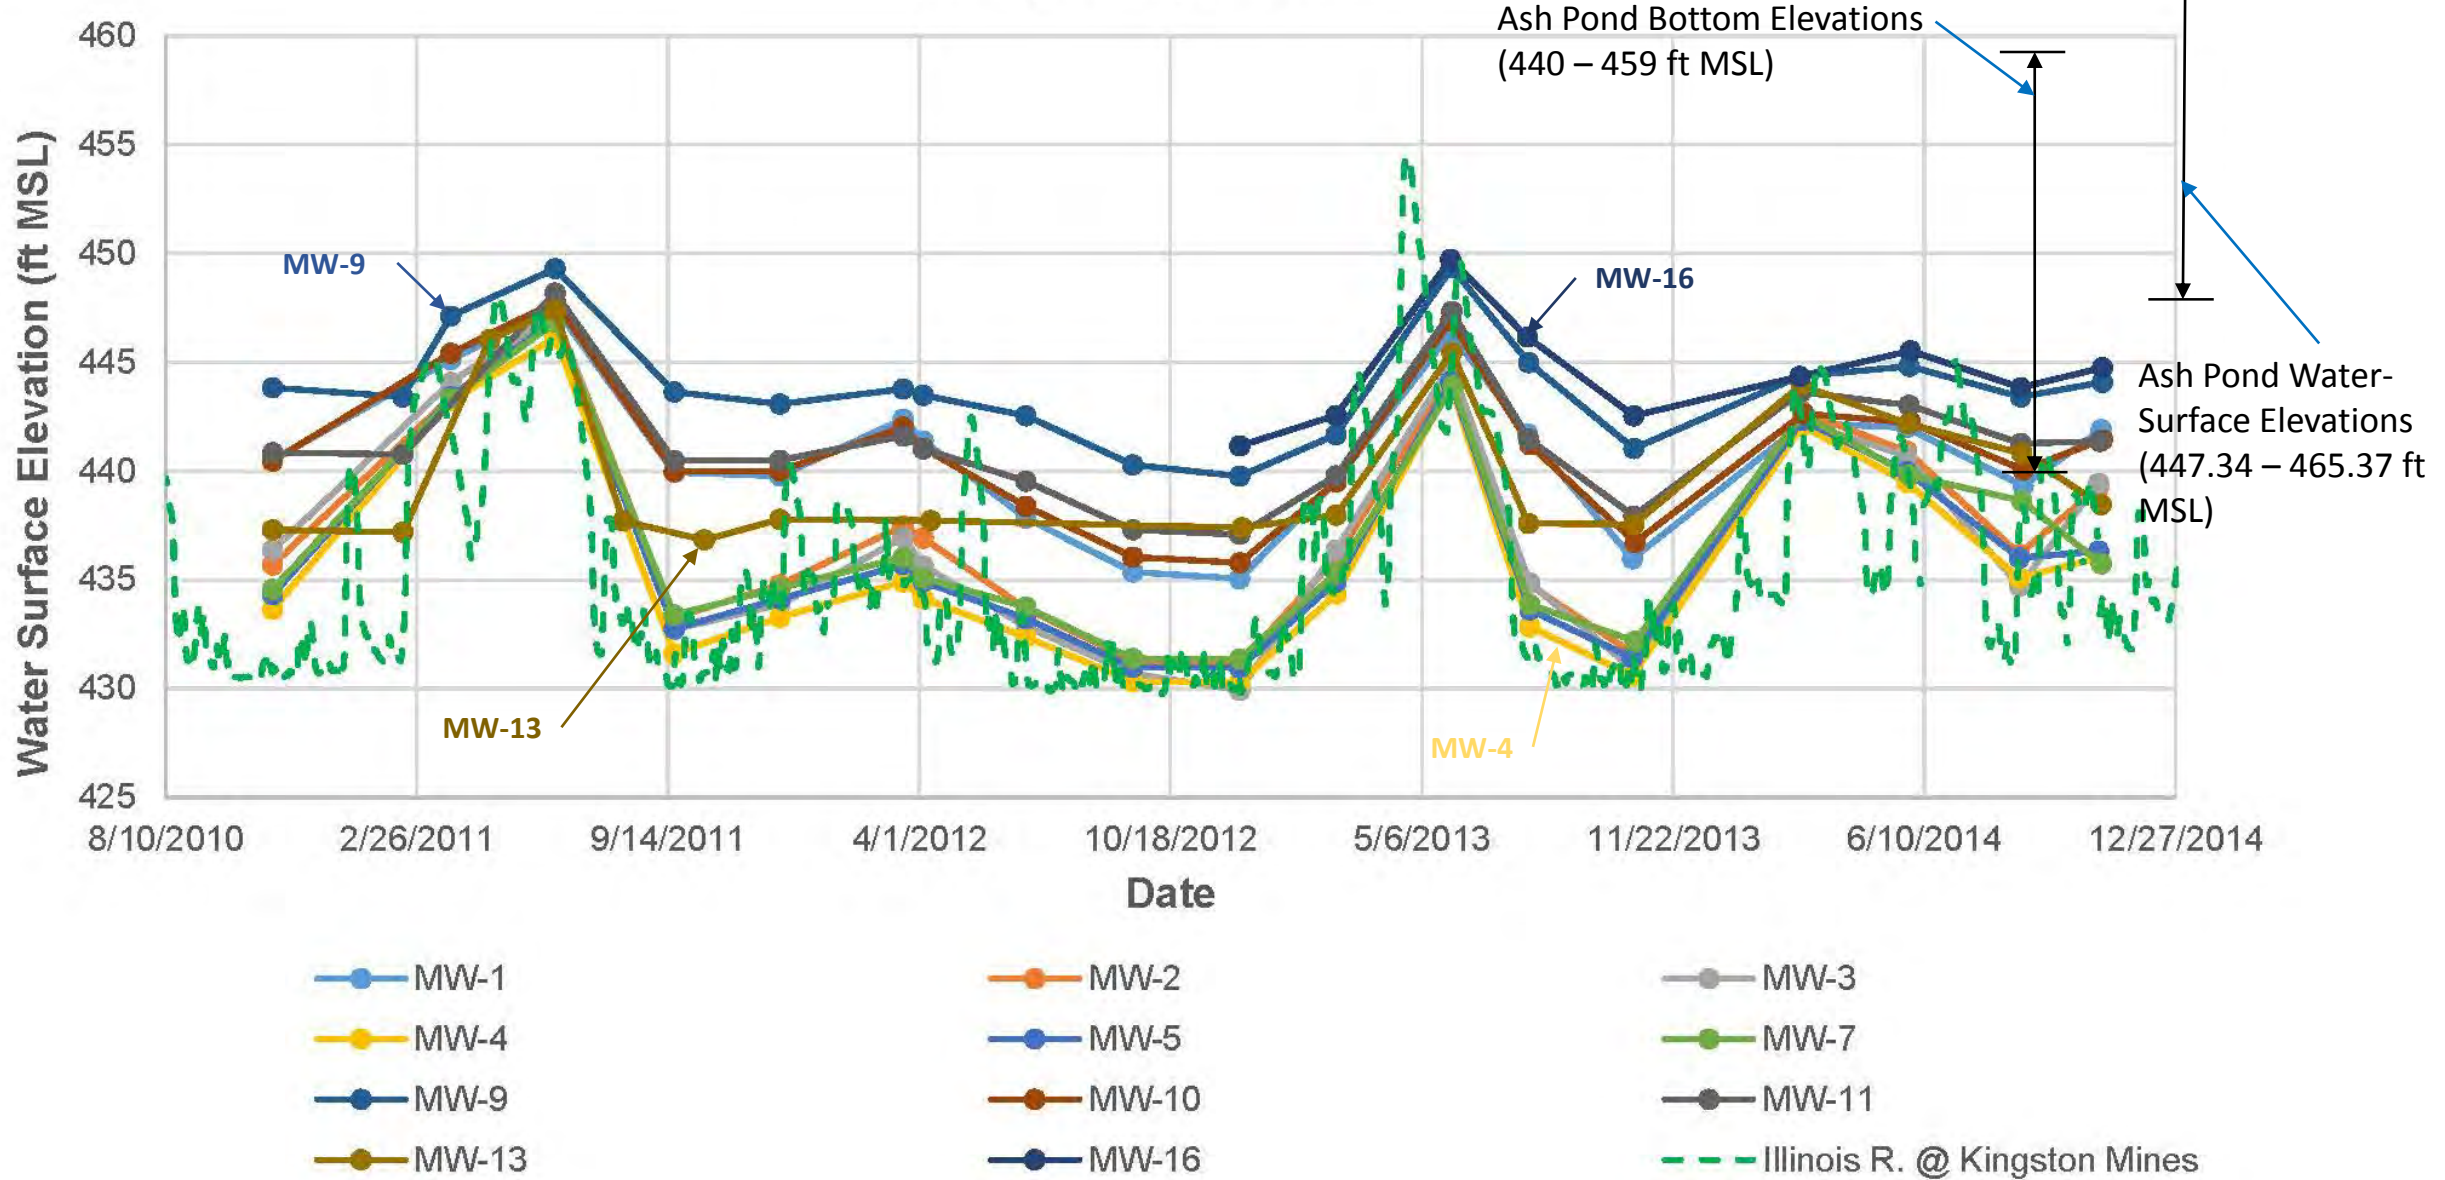
This conclusion is exemplified by the MW-8 and MW-15 time series elevation lines on Figure 11 in the upper silt/clay unit and MW-1 and MW-10 elevation lines on Figure 12 in the lower gravelly sand unit whose ground-water elevation lines cross depending on the season of the year. Therefore, contaminant movements from ash pond leaks and/or leaching of in-place coal ash "slosh" back and forth in the ground-water at the site.
