## ADMINISTRATIVE CITATION

## Open Dump Inspection Checklist

Location/Site Name: Springfield/Curry Ice & Coal

LPC #1671205697 – Sangamon County  
Springfield/Curry Ice & Coal  
Date of Inspection: March 3, 2004  
Prepared by: Rich Johnson, DLPC/FOS, Springfield Region  
FOS File *RCJ*

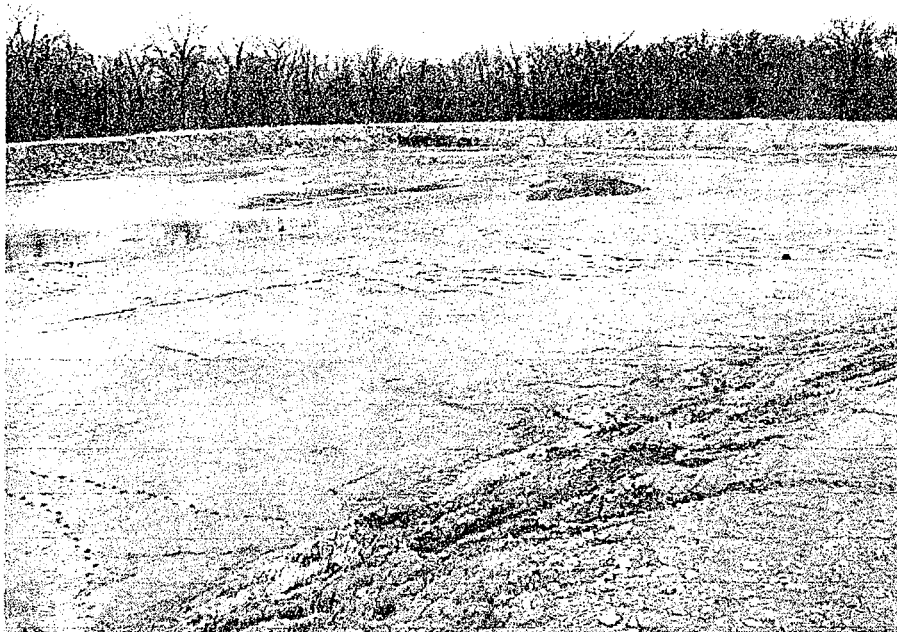
1671205697~03032004-003

**Comments:** Photograph shows the central and northwest regions of a pit excavated along the west side of the north parking lot.

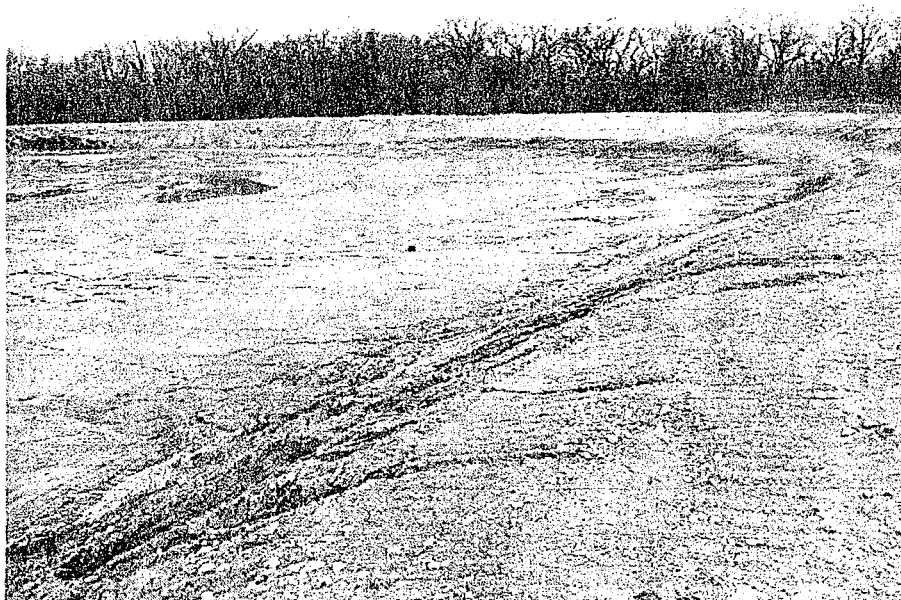
1671205697~03032004-004

**Comments:** Photograph shows the northeast corner of a pit excavated along the west side of the north parking lot.

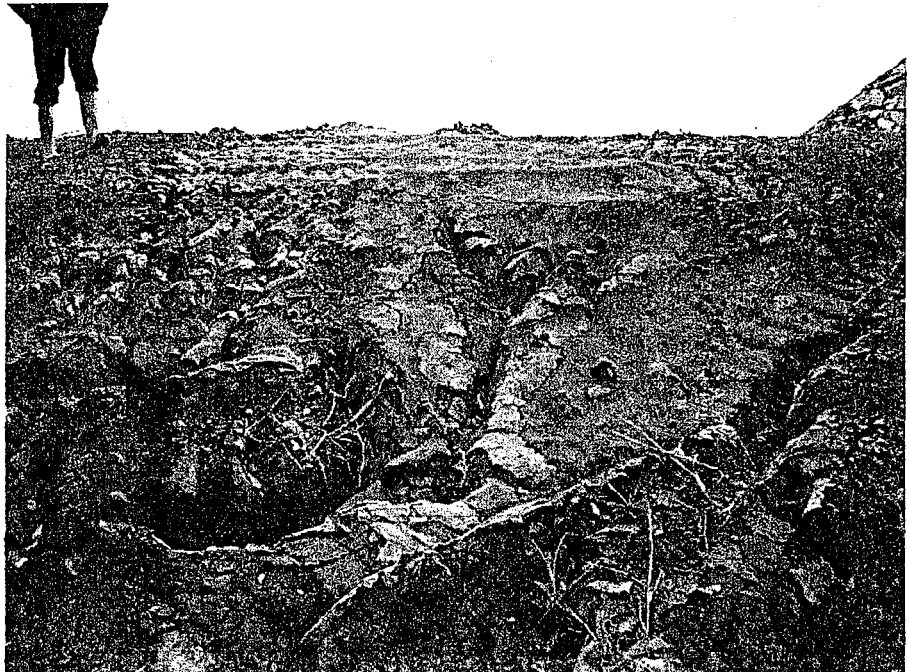
1671205697~03032004-006

North of the ADM ash was a hardened white to gray material along the east edge of the pit (see photos 5 and 6). The material appeared to have been dumped as a liquid and had flowed from the edge of the excavation down the sidewall. From its coloration and its changing from a liquid to a solid state, the material is believed to be concrete or cement cleaned out of a truck.

**Comments:** Photograph shows the east sidewall of a pit excavated along the west side of the north parking lot. Note the hardened white material found on the sidewall.

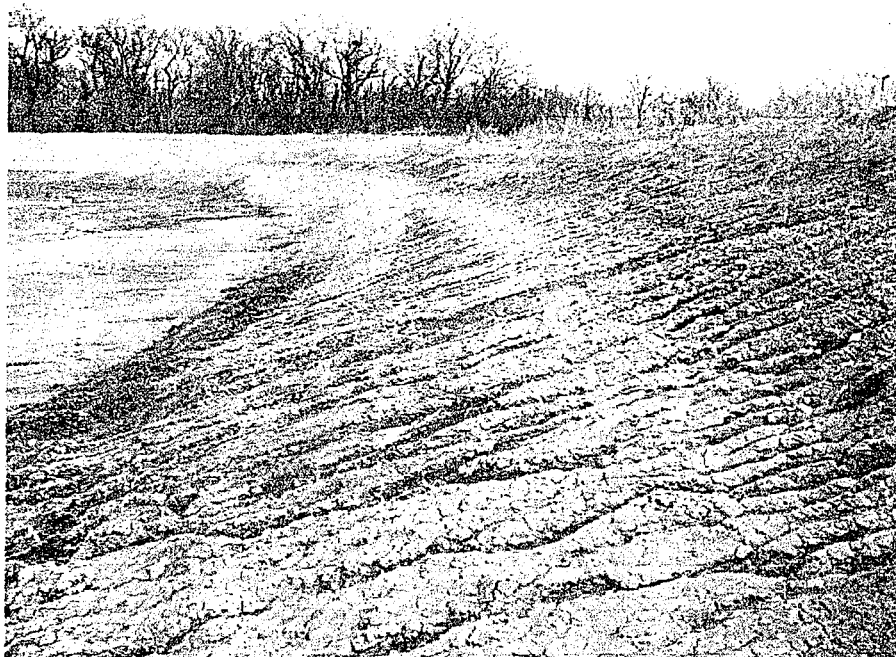
1671205697~03032004-007

**Comments:** Photograph shows the east sidewall of a pit excavated along the west side of the north parking lot. Note the erosion channels found on the sidewall.

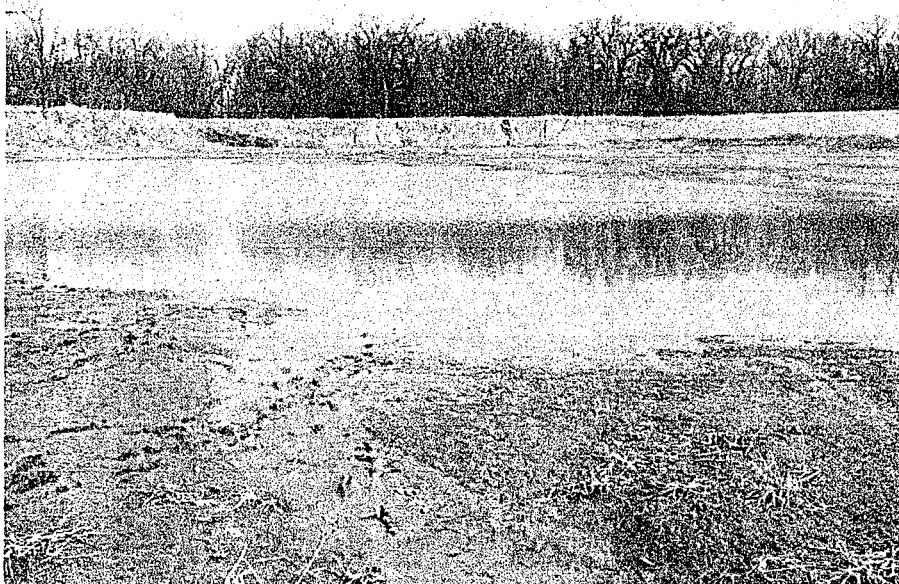
1671205697~03032004-008

**Comments:** Photograph shows the western portion of a pit excavated along the west side of the north parking lot.

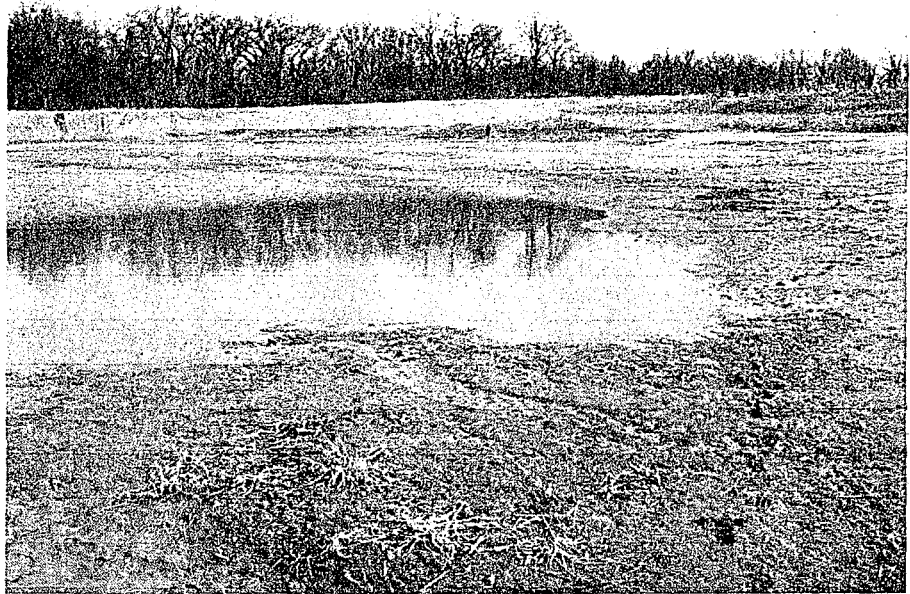
1671205697~03032004-009

**Comments:** Photograph shows the eastern portion of a pit excavated along the west side of the north parking lot.

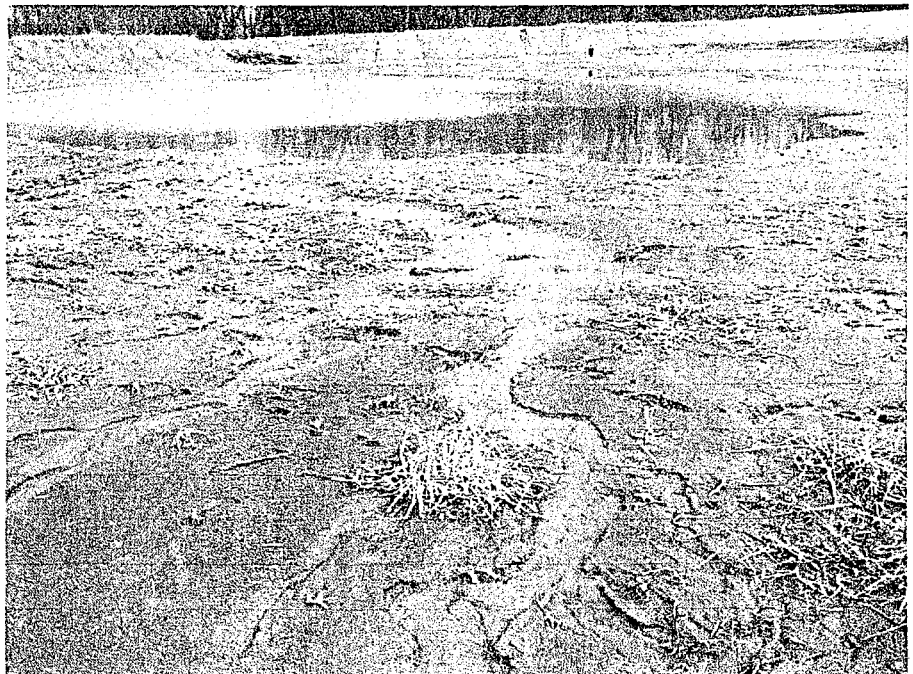
1671205697~03032004-010

**Comments:** Photograph shows the western region of a pit excavated along the west side of the north parking lot.

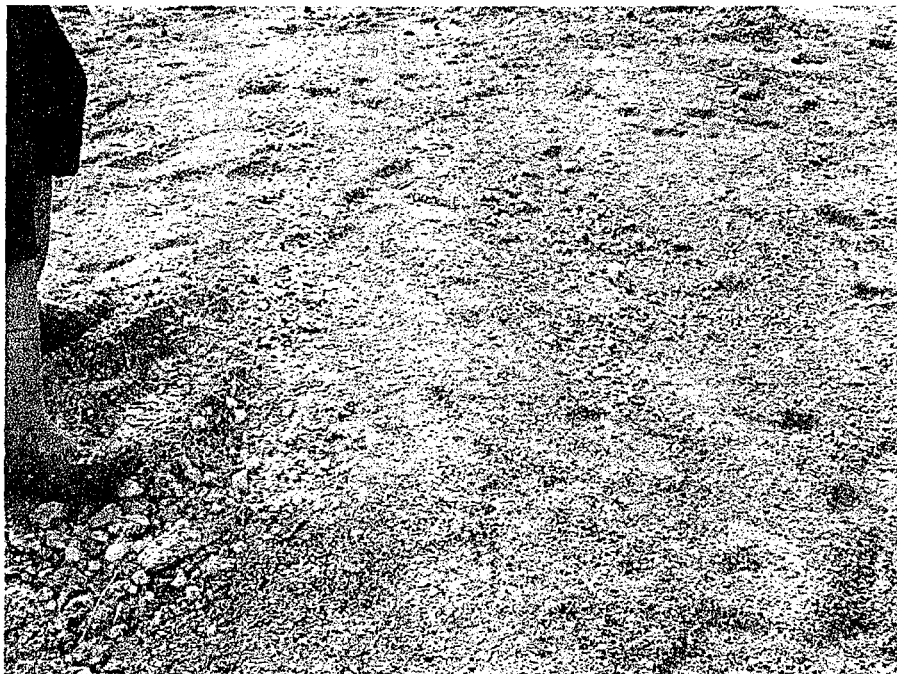
1671205697~03032004-012

Near the northwest region of the excavation was an area of moist, white material on the floor. This material is ADM bed ash that had been deposited last year to help soak up a wet area. Curry is interested in disposing the ADM bed ash in the pit in the future to generate revenue. One of the characteristics of the bed ash is its absorbent properties. Reportedly, once the ash dries out it becomes as hard as concrete. What was found during the inspection is that the ADM bed ash, after it experiencing wet and dry cycles, breaks

down from a hardened state into a mud-like consistency. Photos 12 and 13 show our footprints in the moist, soft bed ash.

**Comments:** Photograph shows the northwest region of a pit excavated along the west side of the north parking lot. Note the white, moist material on the floor of the excavation that is apparently ADM bed ash.

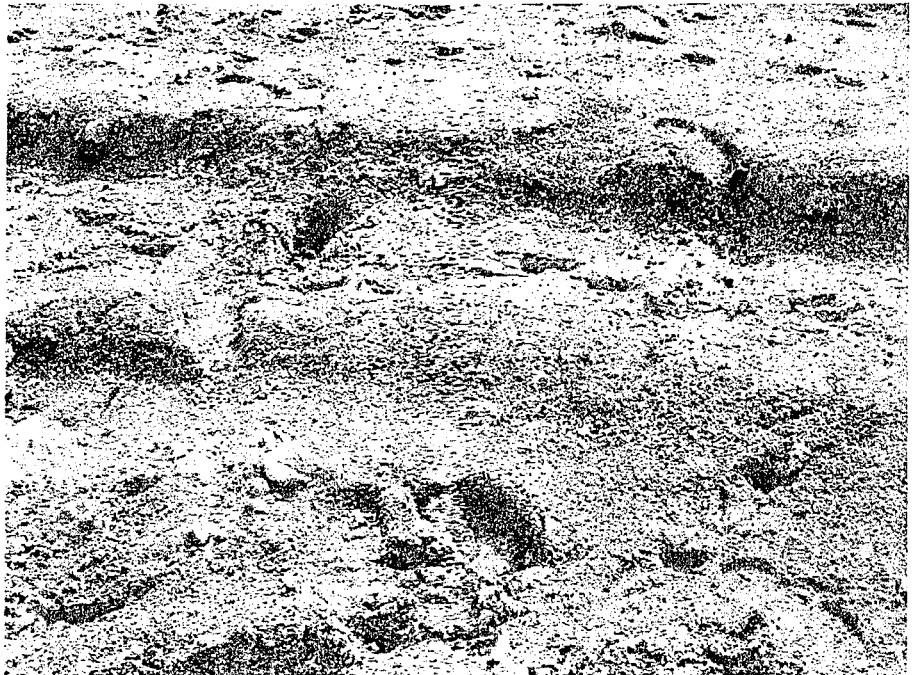
1671205697~03032004-013

**Comments:** Photograph shows the northwest region of a pit excavated along the west side of the north parking lot. Note the white, moist material on the floor of the excavation that is apparently ADM bed ash.

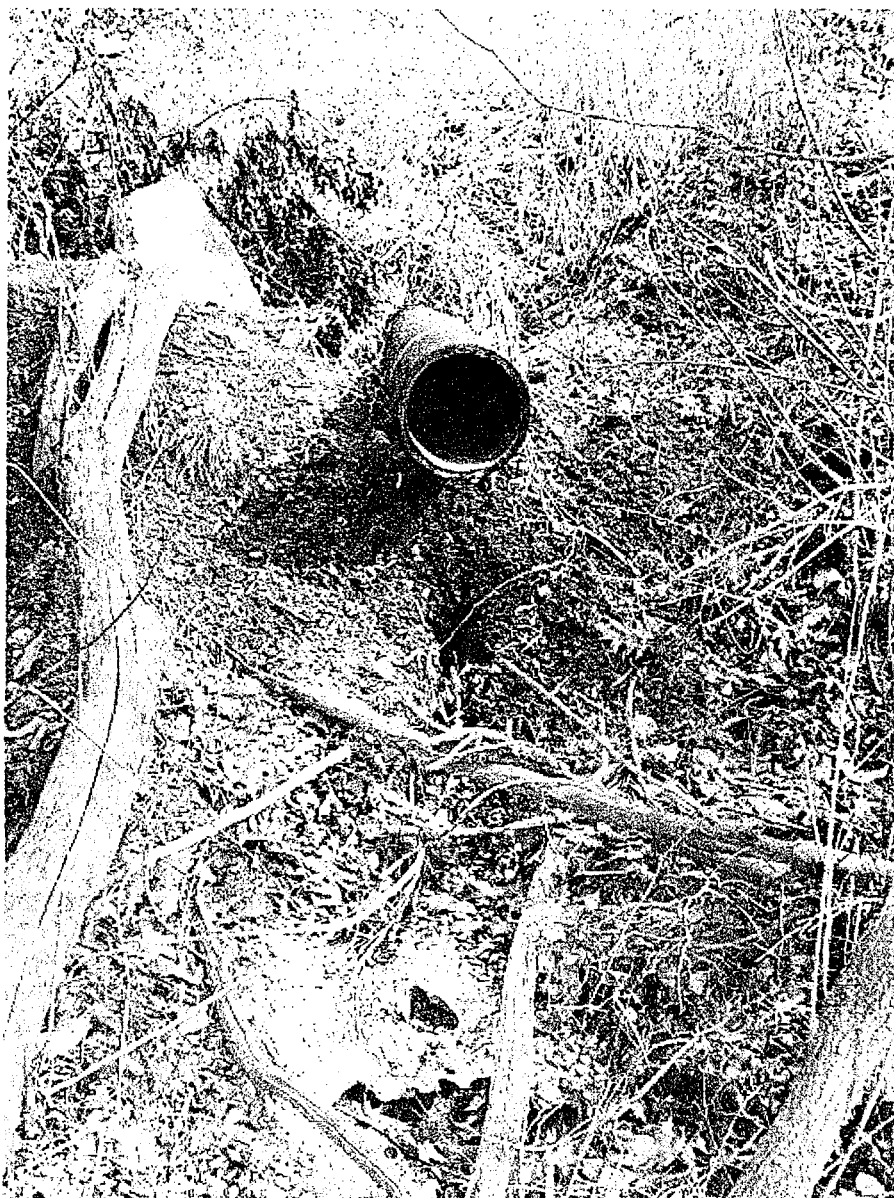
1671205697~03032004-014

**Comments:** Photo taken from the out-let pipe found south and east of the pit excavated along the west side of the north parking lot. The pipe is connected to a stormwater drain located east of the pit.

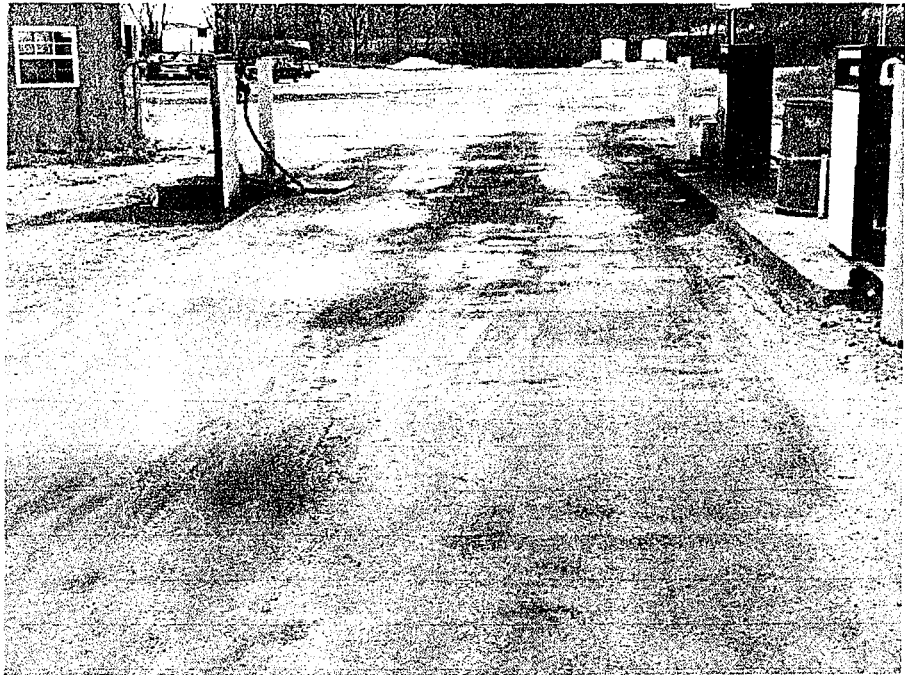
1671205697~03032004-017

During the inspection we observed the fueling station located at the north parking lot near the southeast corner of the excavation. It was noted that there were some staining of the 2 concrete pads where the Curry trucks park to pump diesel fuel (see photo 17). We then observed a dark stain on the gravel south of a concrete pad located north of the pumps (see photo 18). The concrete pad covers an underground tank for diesel. Stained gravel was also observed on the east and north sides of the pad (see photo 19), though dark stains were not evident on top of the concrete. Finally, a large stain on the gravel was observed east and south of the pumps (see photo 20). From the location and configuration of the stain it appeared that fuel had been allowed to overflow from a pump, or from a saddle tank on a truck. A strong diesel smell was detected in the area directly adjacent to the fueling station, and in the stained gravel. If the fuel had continued flowing south and east, it would have eventually reached the creek. The stained gravel indicated it had not reached the creek. Hazardous and special waste determinations will be needed before any stained gravel and/or soil can be removed for proper disposal.

**Comments:** Photo shows a stained concrete pad at the fueling station located at the north parking lot.

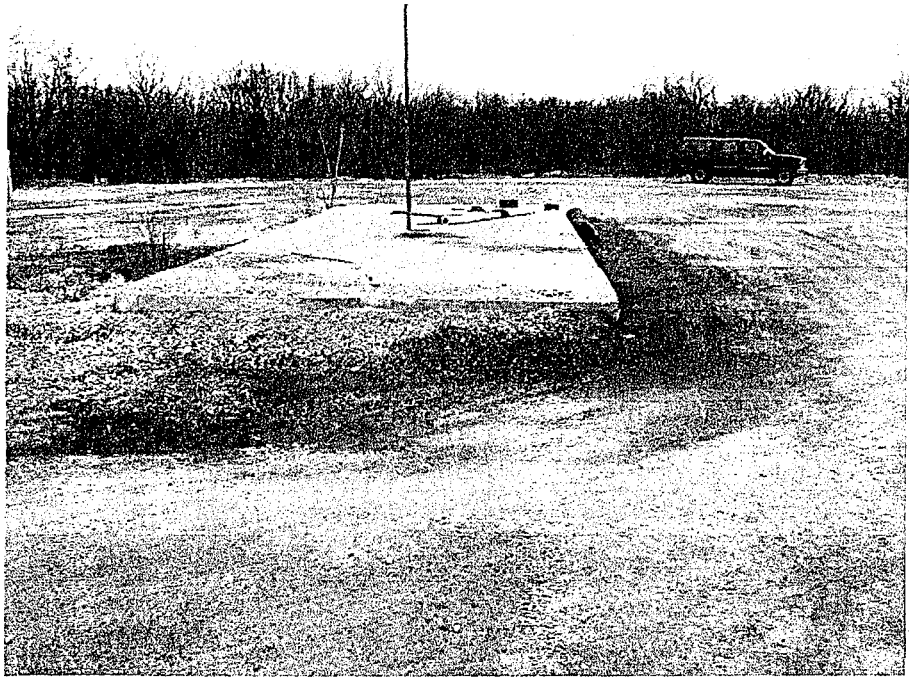
1671205697~03032004-019

**Comments:** Photo shows stained gravel south, east and north of a concrete pad located in the fueling station area of the north parking lot. The concrete pad sets over an underground tank for diesel fuel.

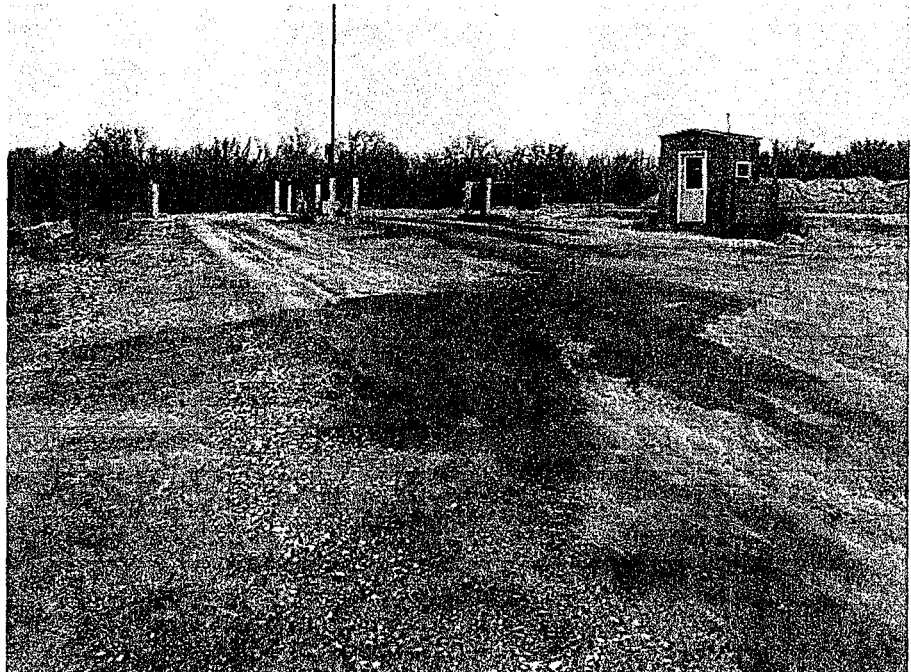
1671205697~03032004-020

**Comments:** Photo shows stained gravel east and south of the fueling station area of the north parking lot.

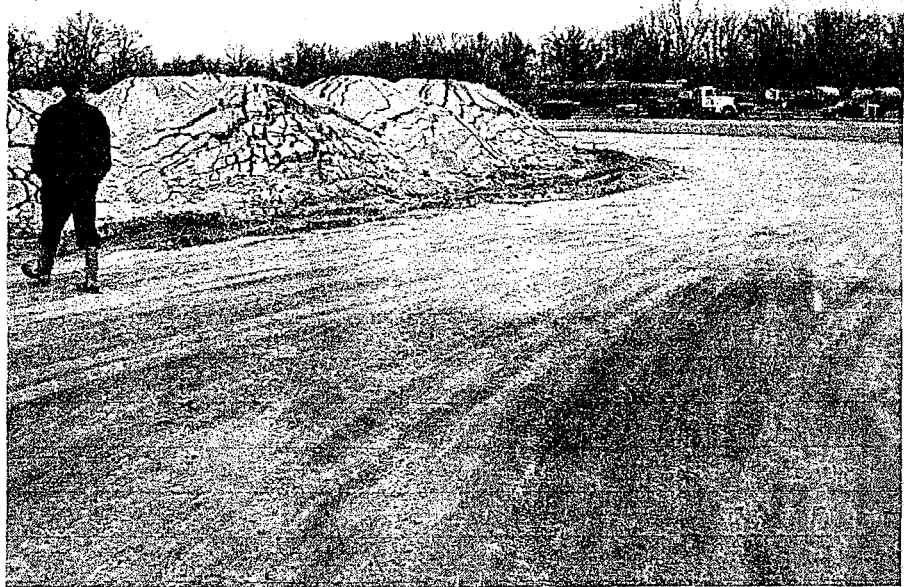
1671205697~03032004-021

At the southwest edge of the north parking lot are piles of ADM bed ash (see photo 21). The stockpiled ash is surrounded on the north, south and east sides by a small un-compacted earthen berm. Truck tire prints in the southeast region of the berm indicate one or more trucks had run over the soil, flattening the berm (see photo 21).

**Comments:** Photo shows ADM bed ash piles, with the remnants of the earthen berm around them, near the east edge of the excavated pit in the north parking lot.

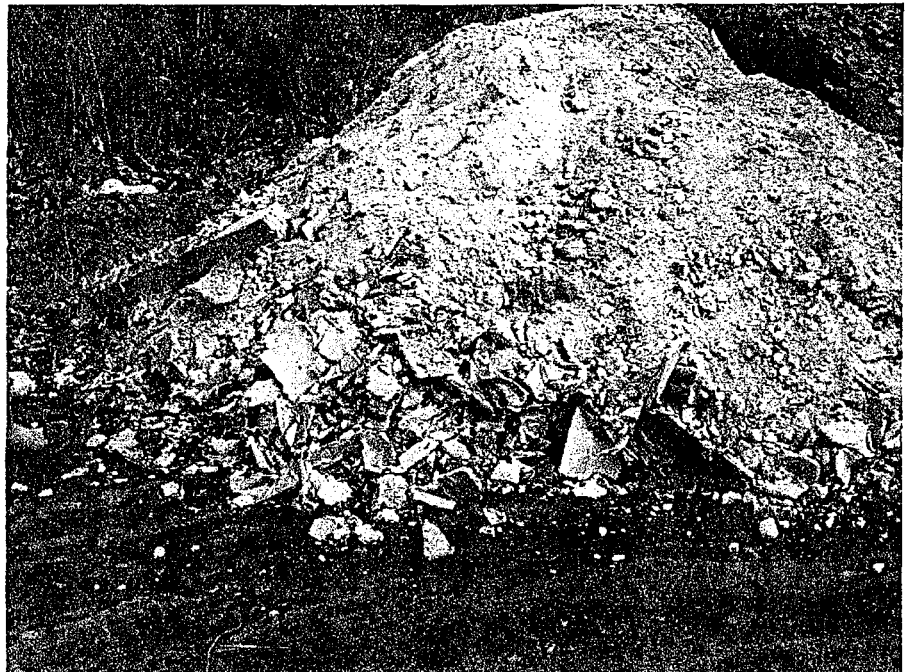
1671205697~03032004-022

Photo 22 was taken of a pile of what appeared to be broken drywall located in the northeast region of the north parking lot. Walking south from the northeast region, more piles of assorted general refuse were found. Photos 23, 24 and 25 are of different piles of waste found in the northeast/eastcentral region of the north parking lot. Photo 23 and 25 show a discarded metal hoist, abandoned hard piping, a used tire, a chain-link fence, a crushed metal 55-gallon drum, etc. Photo 24 shows what may be more broken drywall or gypsum. Further south of these piles was a pile of wood pallets, and near the southeast corner of north parking lot was a large metal tank on its side (see photo 26). The tank was empty except for a small amount of water and rusty scale, and it was observed to have several corrosion holes in it. A pile of general refuse was setting on the ground east of the tank (see photo 27). In the pile were heavy rubber hoses, metal scrap, concrete, wood and some soil.

**Comments:** Photo shows a pile of what appears to be broken up drywall setting in the northeast region of the north parking lot.

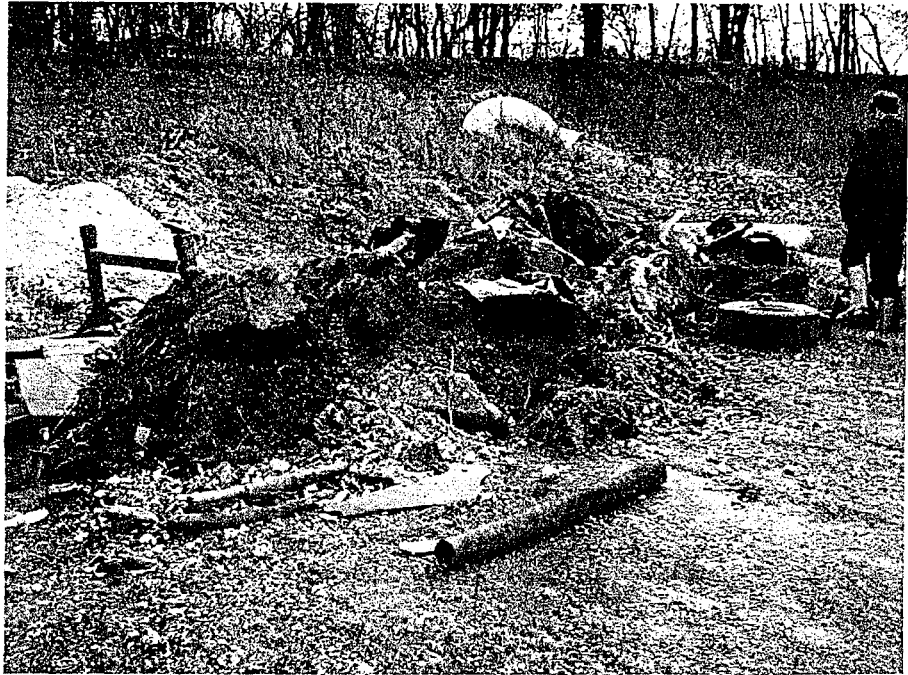
1671205697~03032004-023

**Comments:** Photo shows solid waste dumped in the northeast/eastcentral region of the north parking lot.

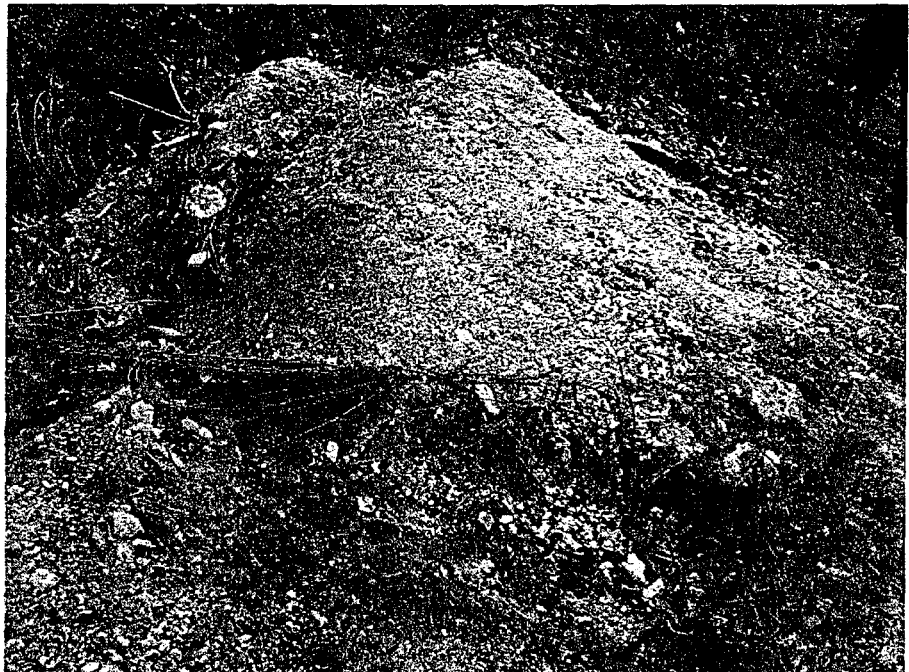
1671205697~03032004-024

**Comments:** Photo shows a pile of white material dumped in the northeast/eastcentral region of the north parking lot.

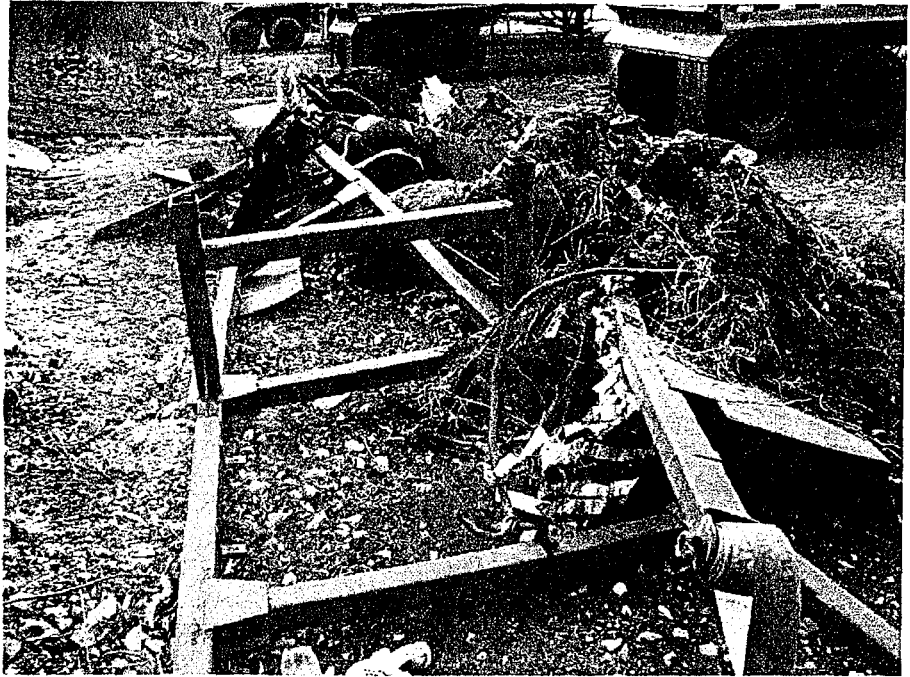
1671205697~03032004-025

**Comments:** Photo shows general refuse dumped on the northeast/eastcentral region of the north parking lot.

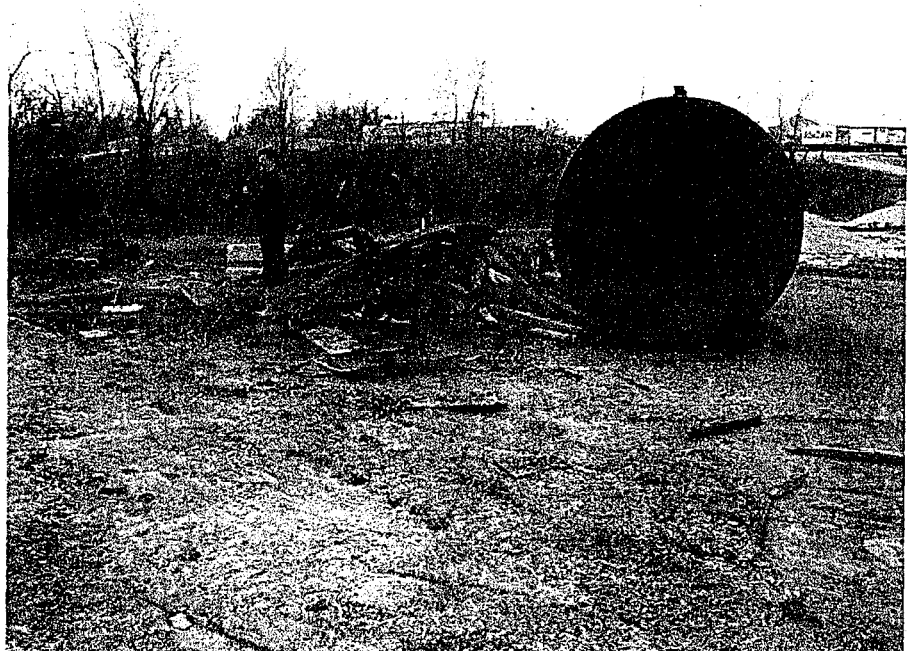
1671205697~03032004-026

**Comments:** Photo shows general refuse and an empty metal tank setting in the southeast region of the north parking lot.

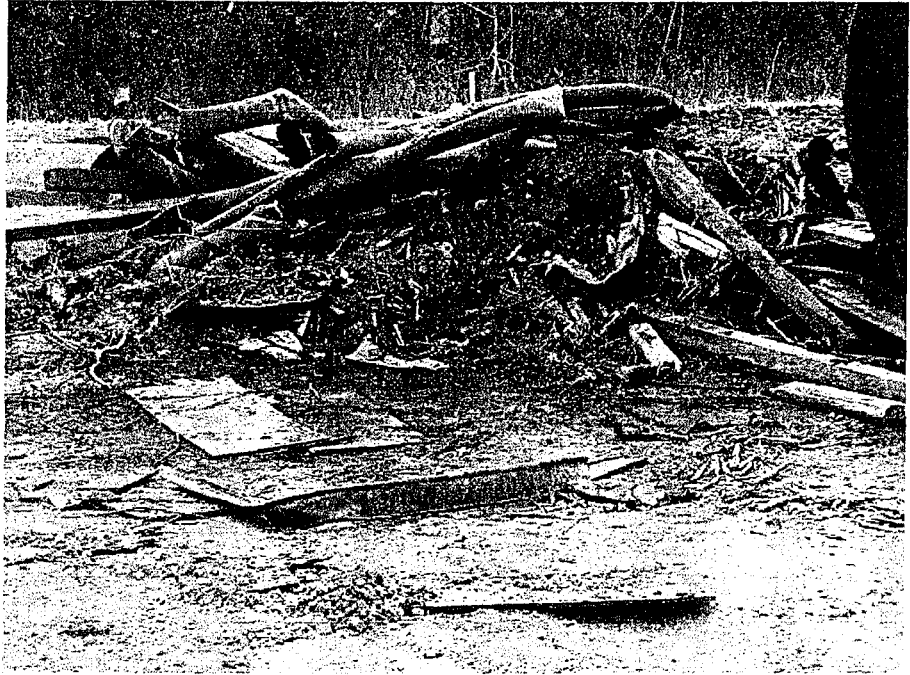
1671205697~03032004-027

**Comments:** Photo shows a pile of general refuse setting by an empty metal tank in the southeast region of the north parking lot.

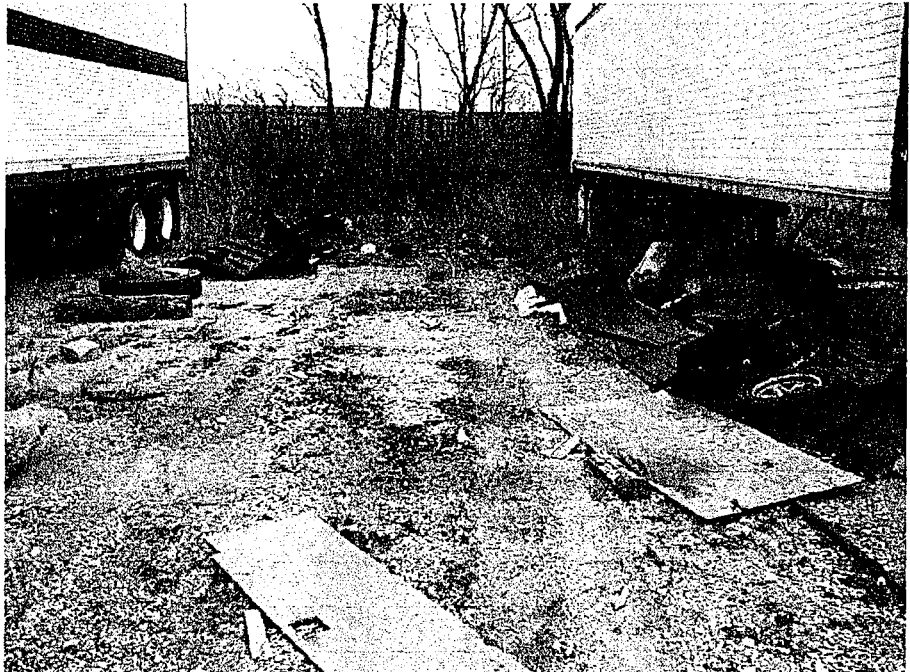
1671205697~03032004-028

Northeast of the metal tank were two trailers parked along the east property line. Between the two trailers were scattered pieces of wood, some heavy plastic sheets that may be some type of mud guard for the trucks, and a couple of used tires. Not pictured, but observed discarded on the south slope of the creek, were 2 used tires, wood, and other debris. This waste appeared to have been dumped down the slope from the northeast corner of the south parking lot.

**Comments:** Photo shows some general refuse setting on the ground between two semi-trailers in the southeast region of the north parking lot.
