## MEMORANDUM

DATE: July 31, 1997  
TO: OCS/ERU Springfield  
FROM: Tom Powell - OCS/ERU Collinsville  
SUBJECT: Marion Co. - Wamac/Mezo  
IEMA 971159 - Crude Oil Spill - 6/30/97

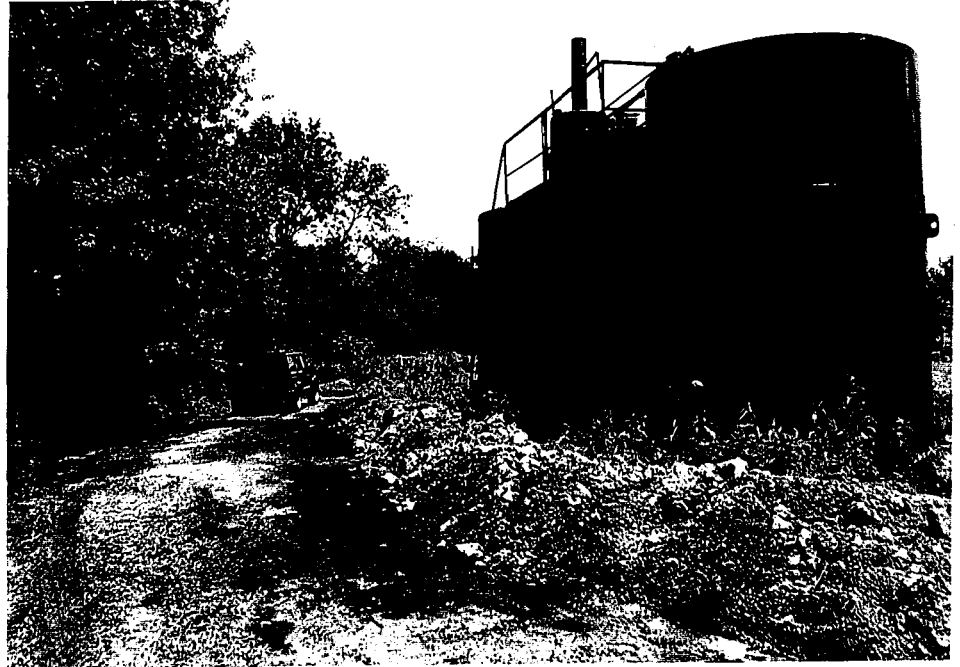
PHOTO#: 1

- Oil stains were observed throughout the Mezo/Oestreich tank battery both on and off site (Photos 1-7). Straw bales and peat moss were observed in the area as well as oil within the drainage ditch that enters Fulton Creek. Recoverable oil was observed within this ditch.

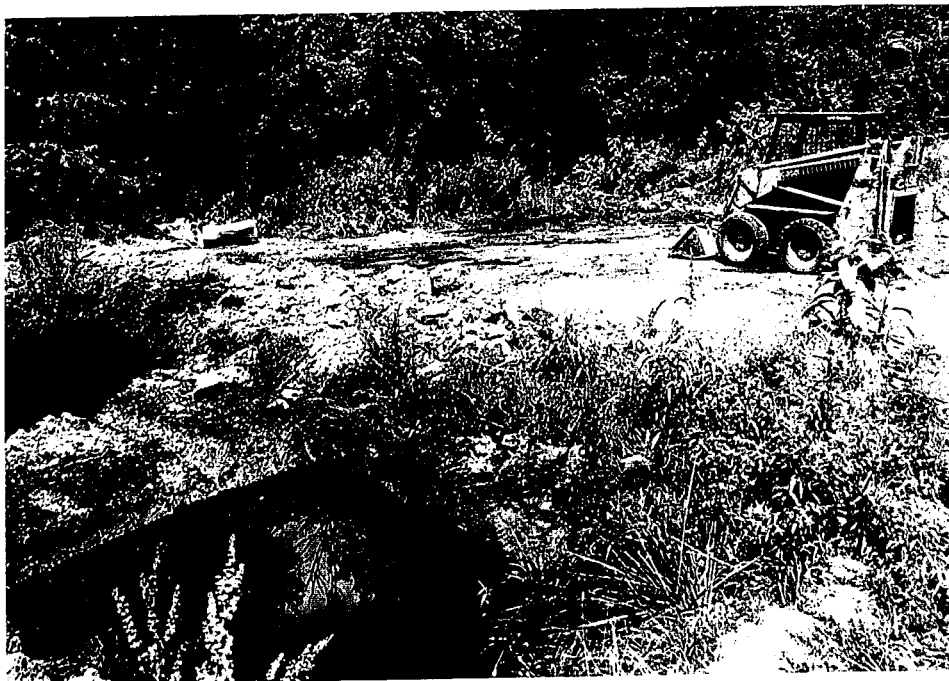
PHOTO#: 5

FIRE WALL WITH OIL SUMP

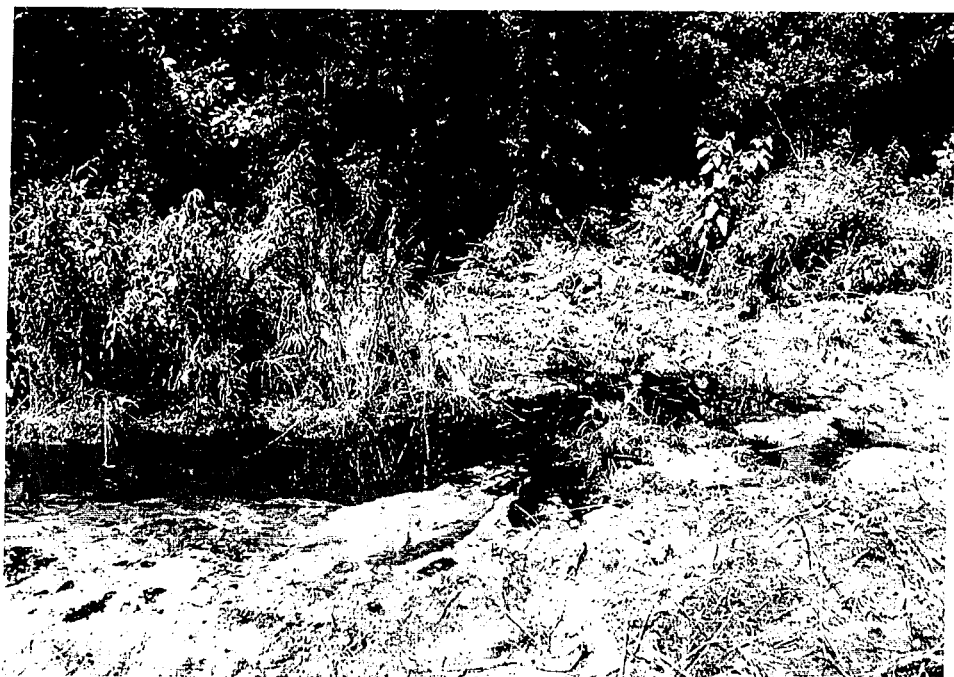
PHOTO#: 6

OIL RUNOFF TO DITCH
