MEMORANDUM

DATE: July 31, 1997
TO: OCS/ERU Springfield
FROM: Tom Powell - OCS/ERU Collinsville
SUBJECT: Marion Co. - Wamac/Mezo
IEMA 971159 - Crude Oil Spill - 6/30/97

INSPECTION PHOTOS

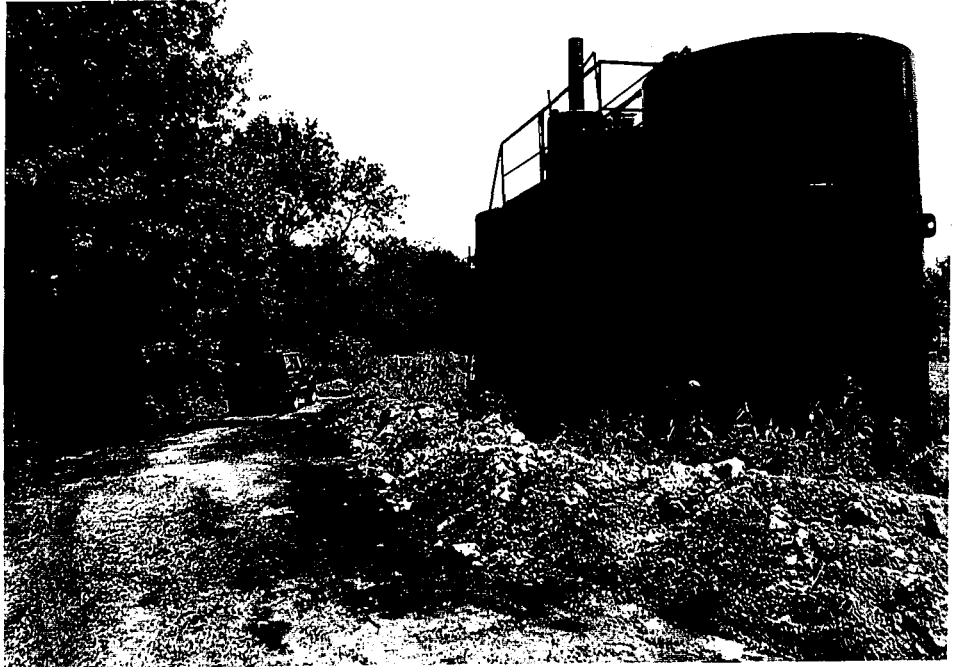
ROLL#: OCS 196	PHOTO#: 1
----------------	-----------

- Oil stains were observed throughout the Mezo/Oestreich tank battery both on and off site (Photos 1-7). Straw bales and peat moss were observed in the area as well as oil within the drainage ditch that enters Fulton Creek. Recoverable oil was observed within this ditch.

CRUDE OIL

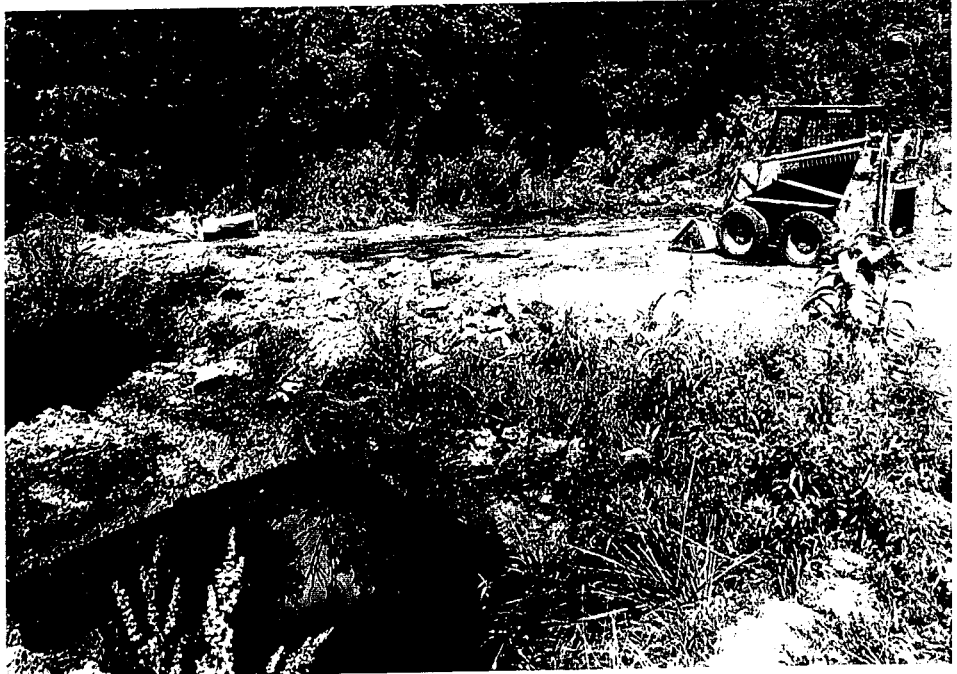
ROLL#: OCS 196	PHOTO#: 5
----------------	-----------

FIRE WALL WITH OIL SUMP

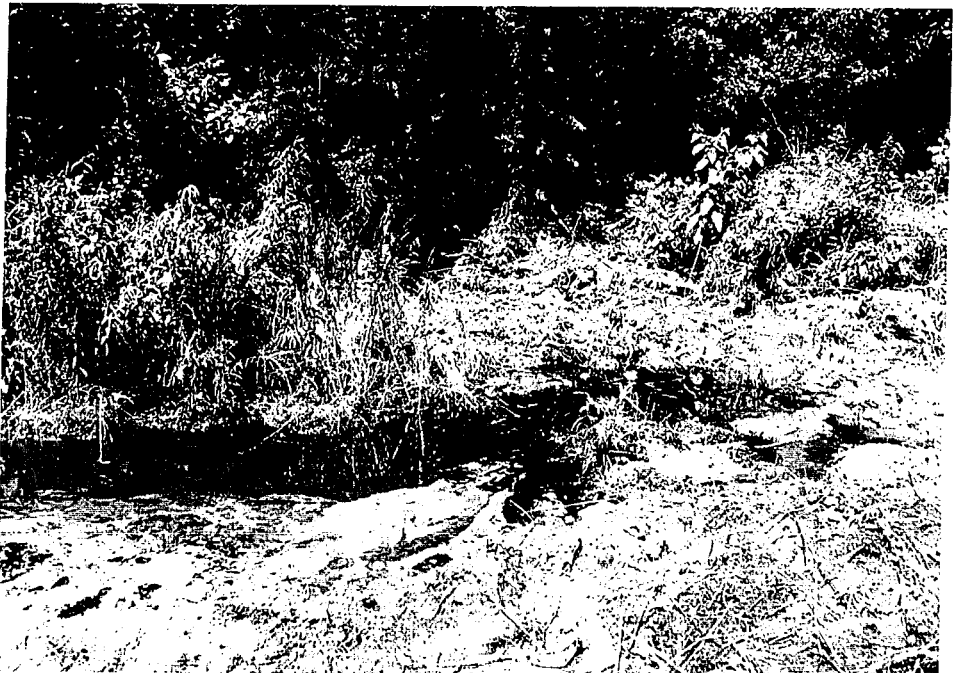
ROLL#: OCS 196	PHOTO#: 6
----------------	-----------

OIL RUNOFF TO DITCH
