Lexington Trace, LLC

COMPLAINANTS MOTION TO AMEND FORMAL COMPLAINT

Whereas on 08/03/2023 The Board ordered Complainant to amend the Formal Complaint to include specifics about alleged violations by Respondent, Lexington Trace, LLC at their development known commercially as "Lexington Trace". The development site was without required signage listing permit information.

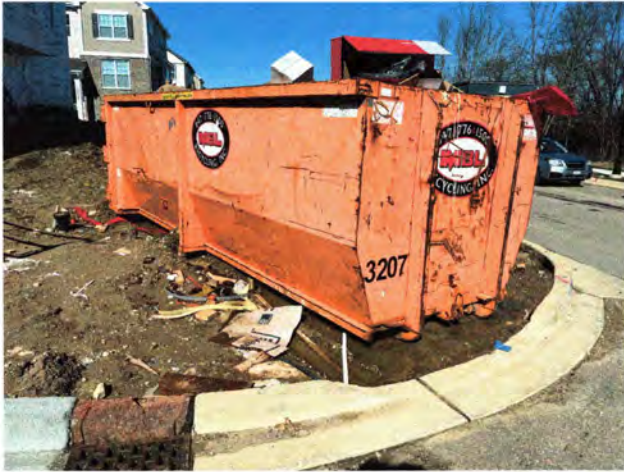
Exhibit A

Pollutants are not controlled. The downslope curb is cut out and without protection. Trash and sediment are free to enter the street.

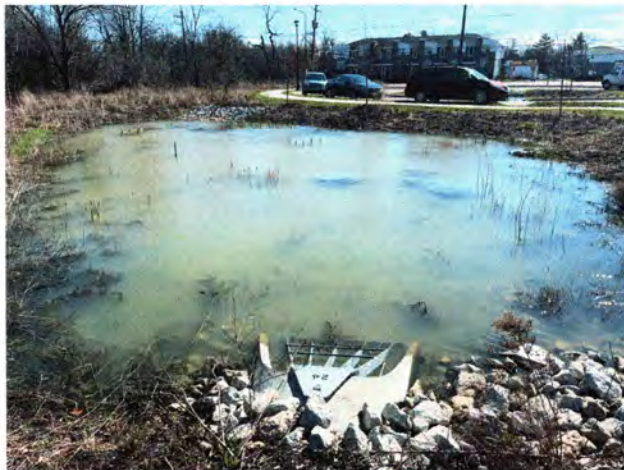
Exhibit B

Sediment laden water carried from street and site indicating pollutants are not controlled, the SWPPP required updating and curbside protection is likely needed

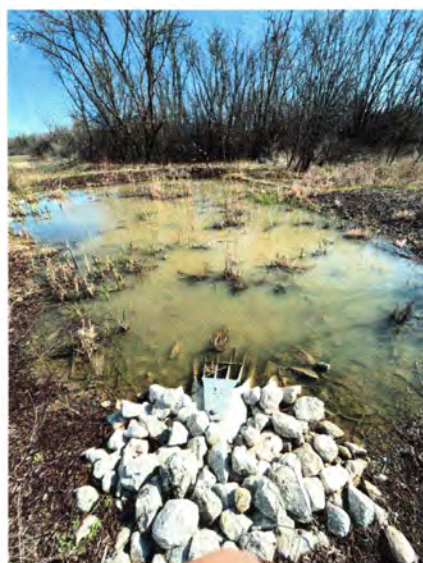
Exhibit C

Sediment laden water discharged into a wetland area which did not have the protections listed in SWPPP which were part of permit approval. Pollutants are not controlled and the failures of active BMPs were not being recorded in SWPPP corrective action reports.

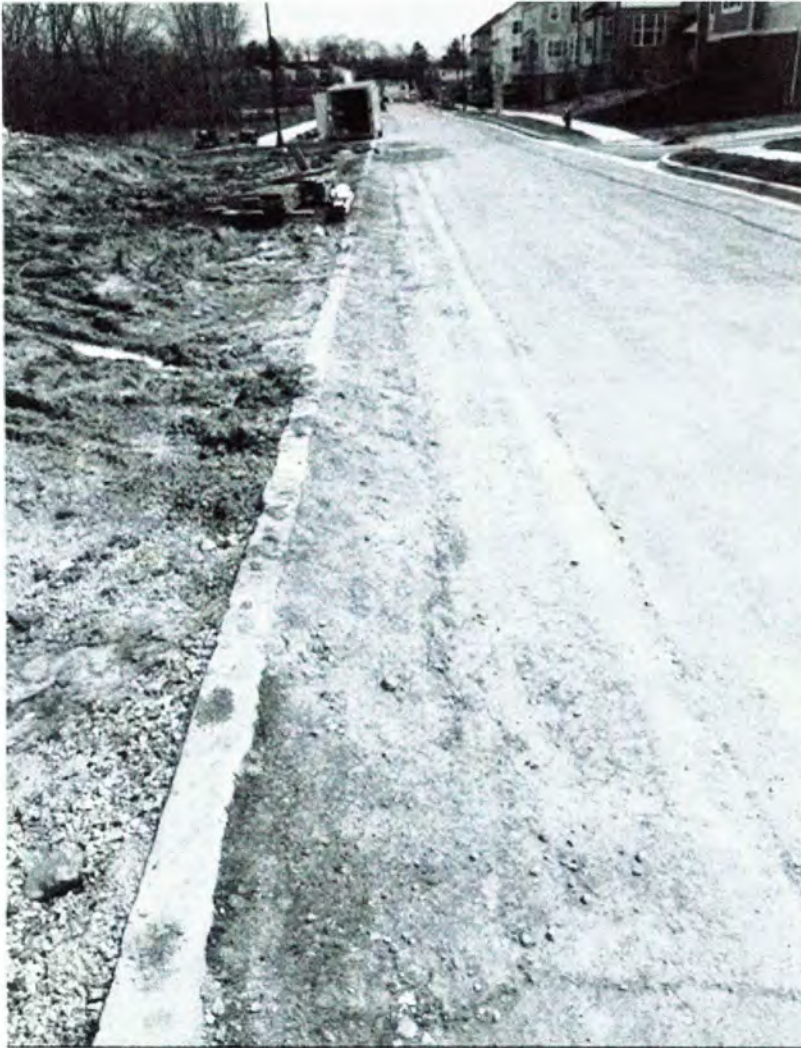
Exhibit D

This was the curb beside of a multifamily home being constructed. Per the engineering plans viewed by Complainant, this type of building would have a stabilized area where the parking area will be from which vehicles work from to avoid getting sediment in the street. This area would have three inch stone to remove sediment from vehicle tires. This minimizes pollutants from becoming uncontrolled and entering the street. Instead, respondent installed a ramp for concrete trucks to enter resulting in maximum soil disturbance, transfer and travel. These trucks would then pull forward and wash their shoots into the curbside inlet. Significant amounts of sediment have entered the street as a result

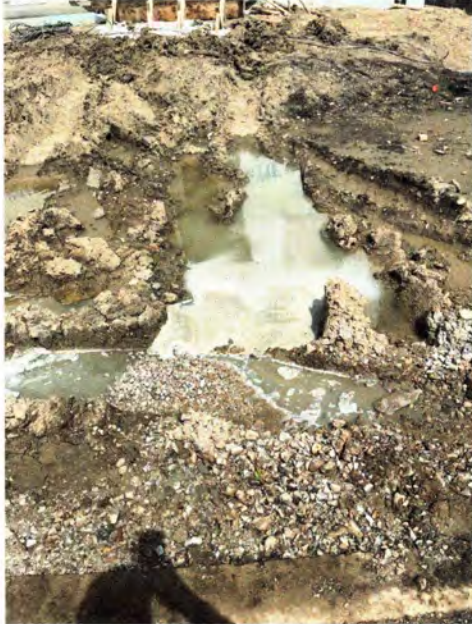
Exhibit E

Concrete washout in tire tracks where the concrete trucks were entering the site via the ramp.

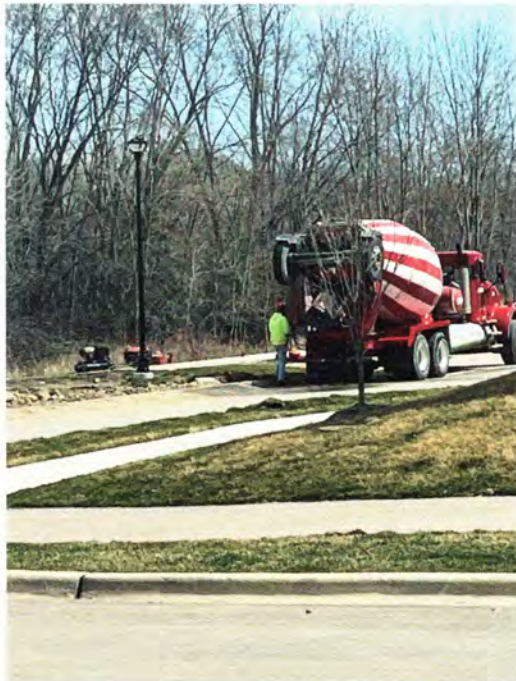
Exhibit F

Ozynga Concrete washing their truck shoot directly into the curbside inlet. This is adjacent to what the SWPPP listed as a protected wetland

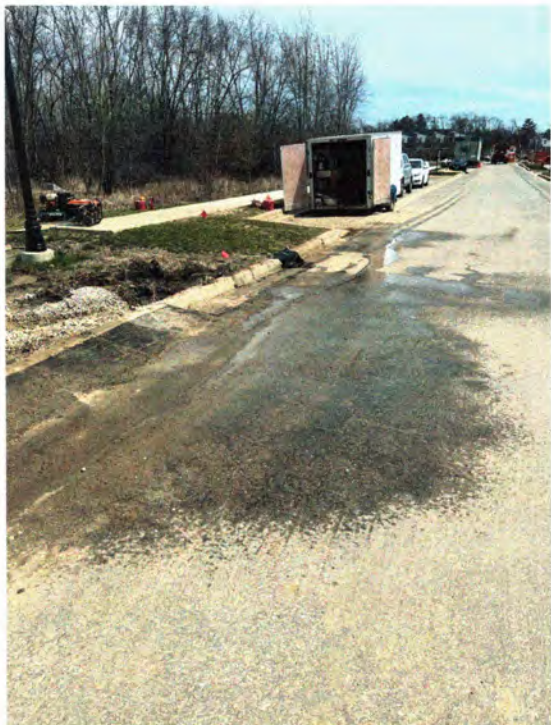
Exhibit F

After the truck in Exhibit E drove away.

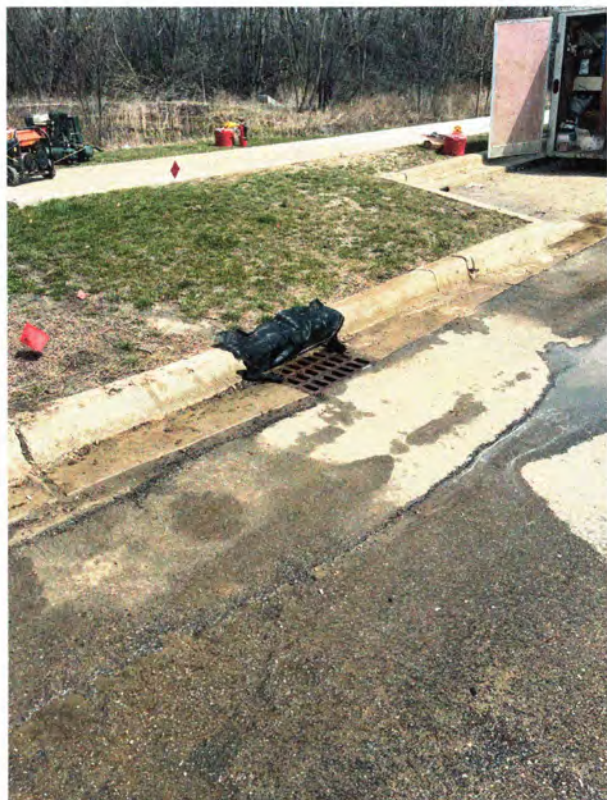
Exhibit G

Closer look of curbside inlet in Exhibit F. The area listed in the SWPPP as a protected wetland can be seen in background.

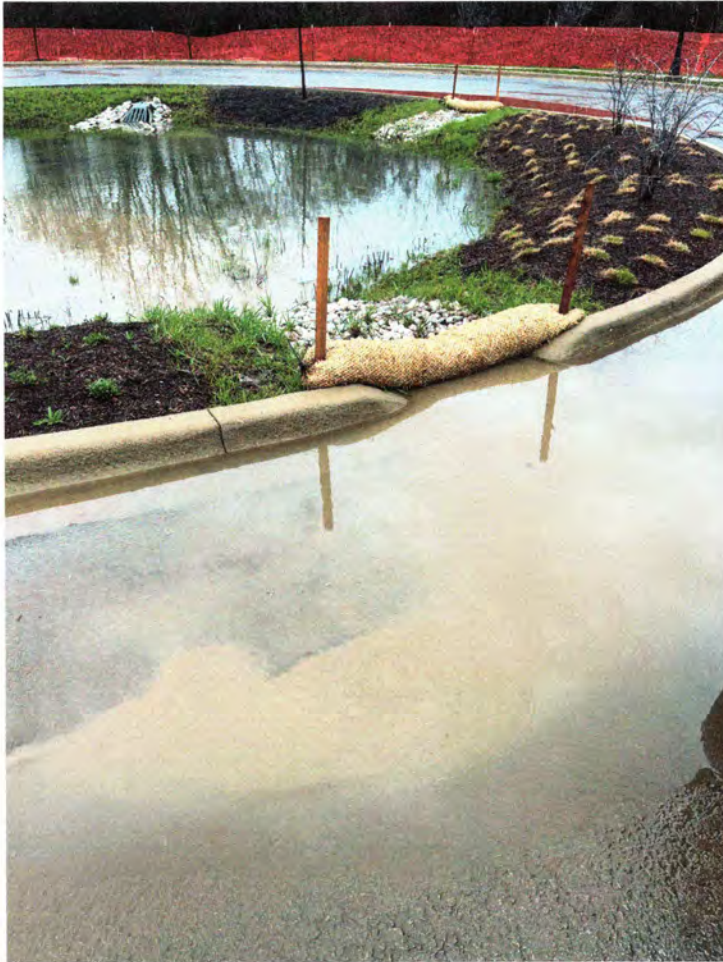
Exhibit H

Pollutants continue to be uncontrolled even after initial informal complaint and corrective actions. The orange fence along the protected wetland is in the background indicating when the photo was taken. The waddles are not working and again a cut out curb was installed without any BMPs. There is a structure seen discharging water from around the site into the retention area which contains sediment laden water.

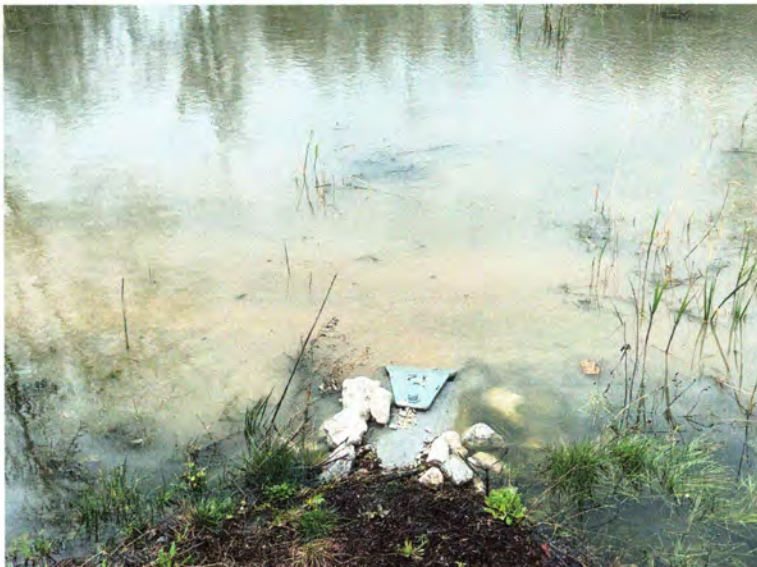
Exhibit F

Another structure on site discharging sediment laden water from inlets around the site indicating pollutants are not controlled.

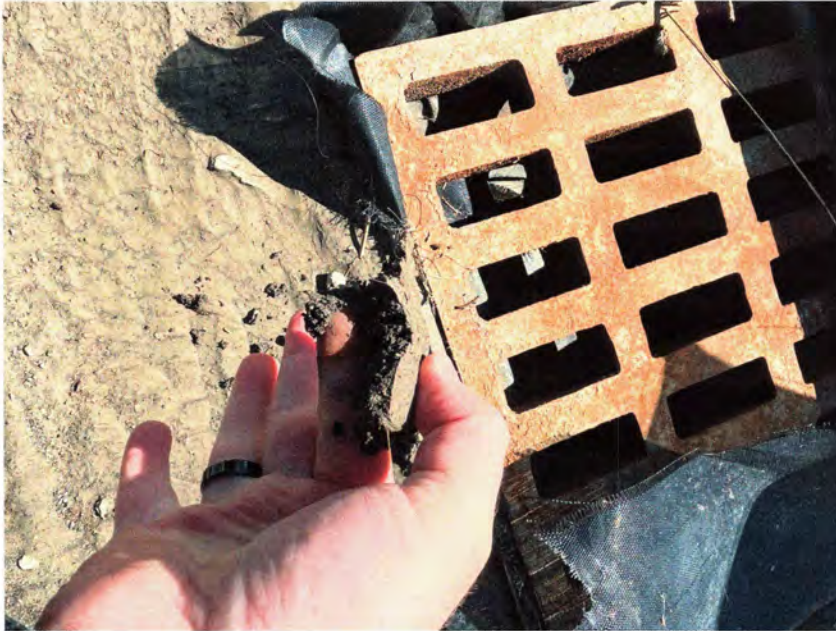
Exhibit G

Sediment accumulation around inlet. Blocking inlets with filter fabric is not an approved BMP, causes flooding and this development was partially occupied and indicates permit holder is unable to control pollutants

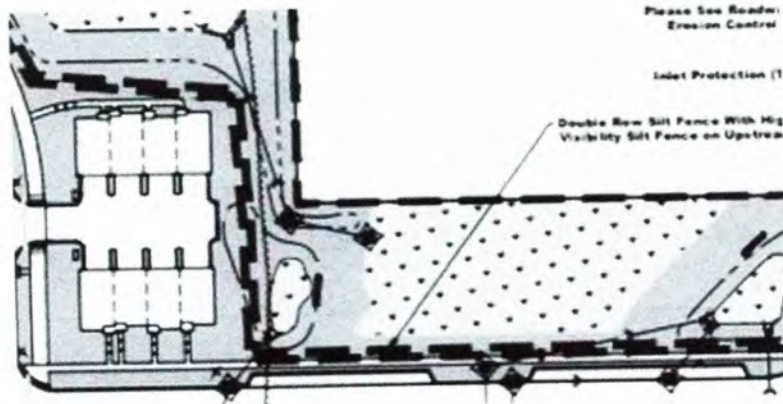
Exhibit H

Screen grab from SWPPP as approved showing where the BMPs were supposed to be which were never installed. Also shows the building next to the ramp with the central parking area.
