Lexington Trace, LLC

COMPLAINANTS 2nd MOTION TO AMEND FORMAL COMPLAINT

Whereas on 08/03/2023 The Board ordered Complainant to amend the Formal Complaint to include specifics about alleged violations by Respondent, Lexington Trace, LLC at their development known commercially as "Lexington Trace". The development site was without required signage listing permit information.

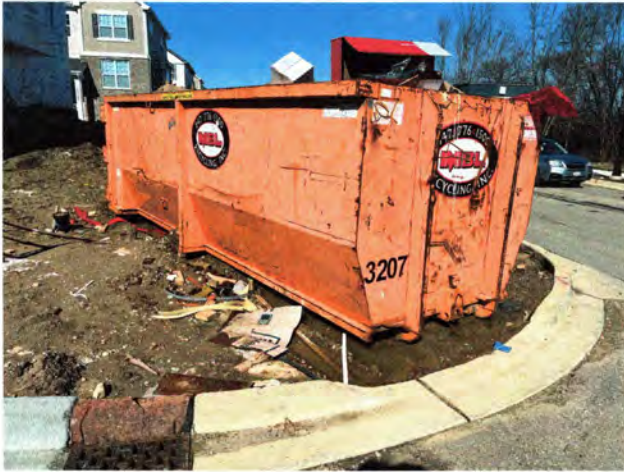
Exhibit A

Pollutants are not controlled. The downslope curb is cut out and without protection. Trash and sediment are free to enter the street.

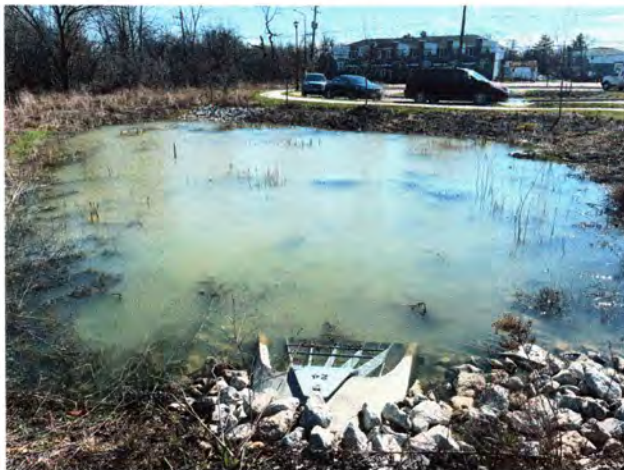
Exhibit B

Sediment laden water carried from street and site indicating pollutants are not controlled, the SWPPP required updating and curbside protection is likely needed

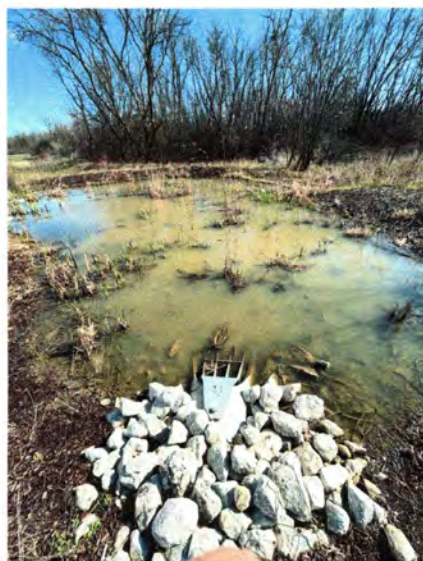
Exhibit C

Sediment laden water discharged into a wetland area which did not have the protections listed in SWPPP which were part of permit approval. Pollutants are not controlled and the failures of active BMPs were not being recorded in SWPPP corrective action reports.

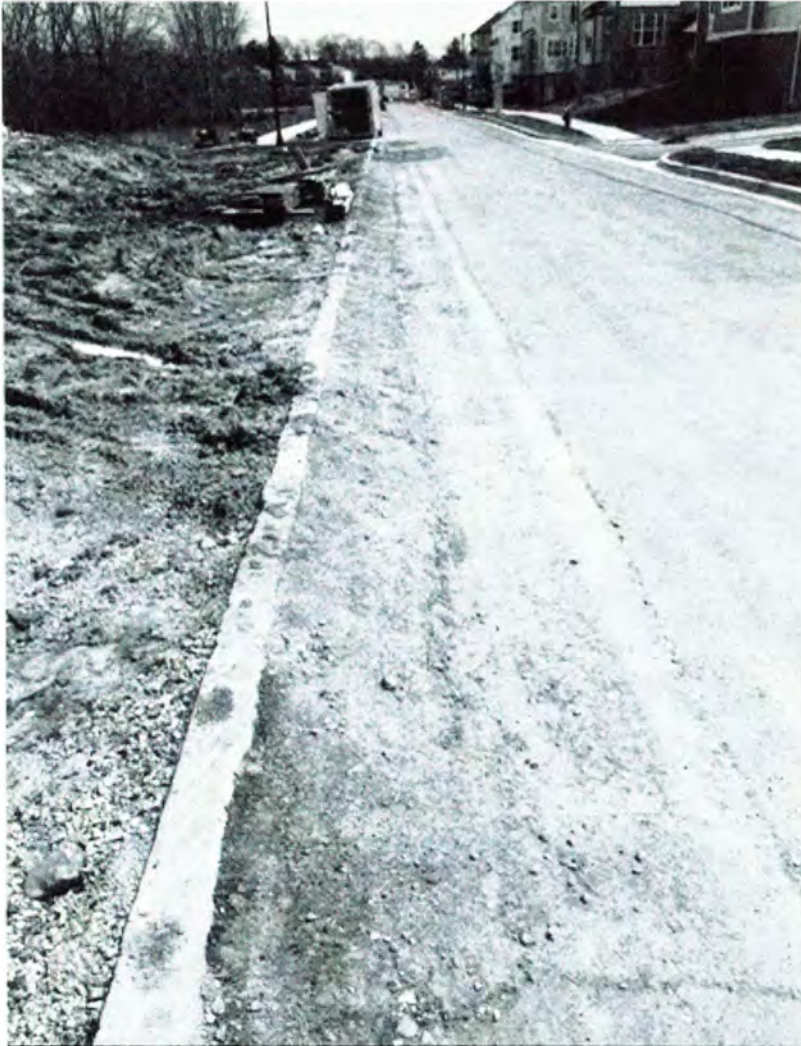
Exhibit D

This was the curb beside of a multifamily home being constructed. Per the engineering plans viewed by Complainant, this type of building would have a stabilized area where the parking area will be from which vehicles work from to avoid getting sediment in the street. This area would have three inch stone to remove sediment from vehicle tires. This minimizes pollutants from becoming uncontrolled and entering the street. Instead, respondent installed a ramp for concrete trucks to enter resulting in maximum soil disturbance, transfer and travel. These trucks would then pull forward and wash their shoots into the curbside inlet. Significant amounts of sediment have entered the street as a result

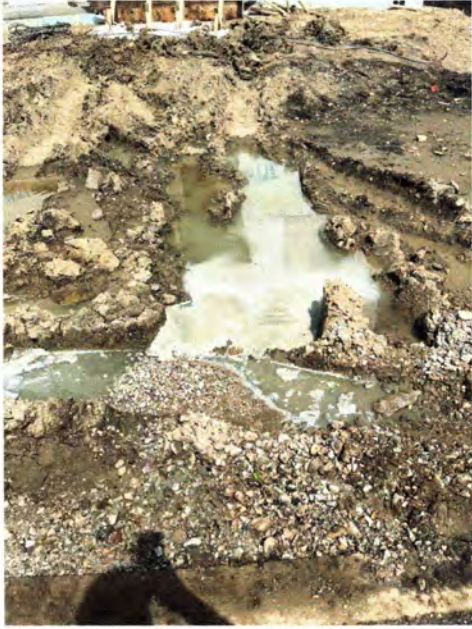
Exhibit E

Concrete washout in tire tracks where the concrete trucks were entering the site via the ramp.

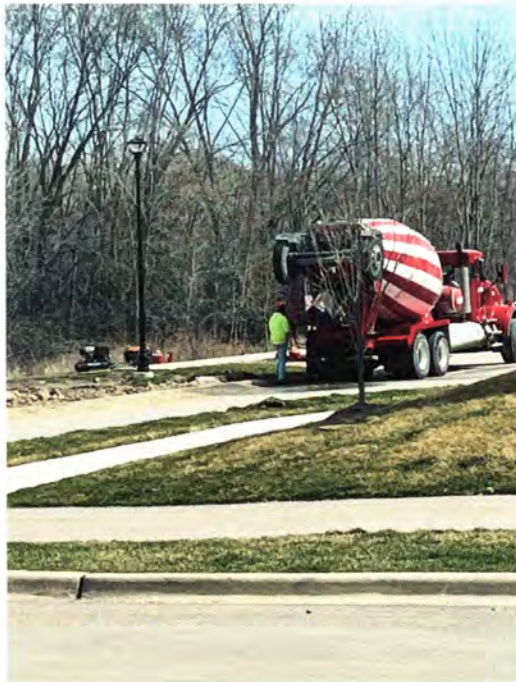
Exhibit F

Ozynga Concrete washing their truck shoot directly into the curbside inlet. This is adjacent to what the SWPPP listed as a protected wetland

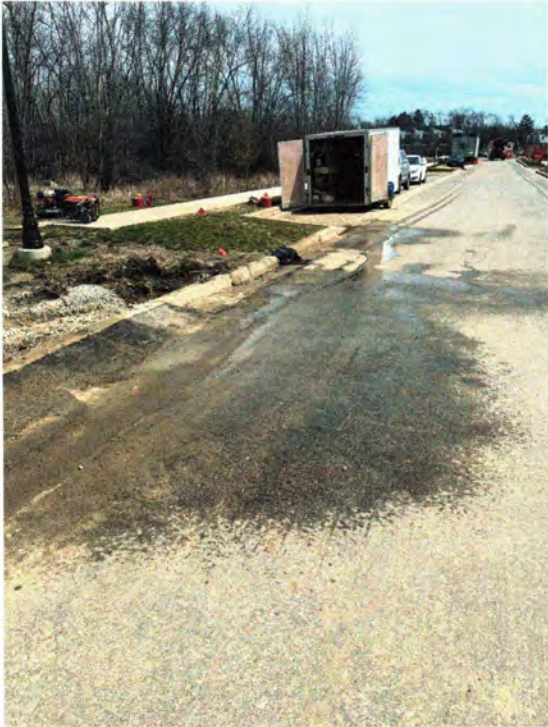
Exhibit G

After the truck in Exhibit F drove away.

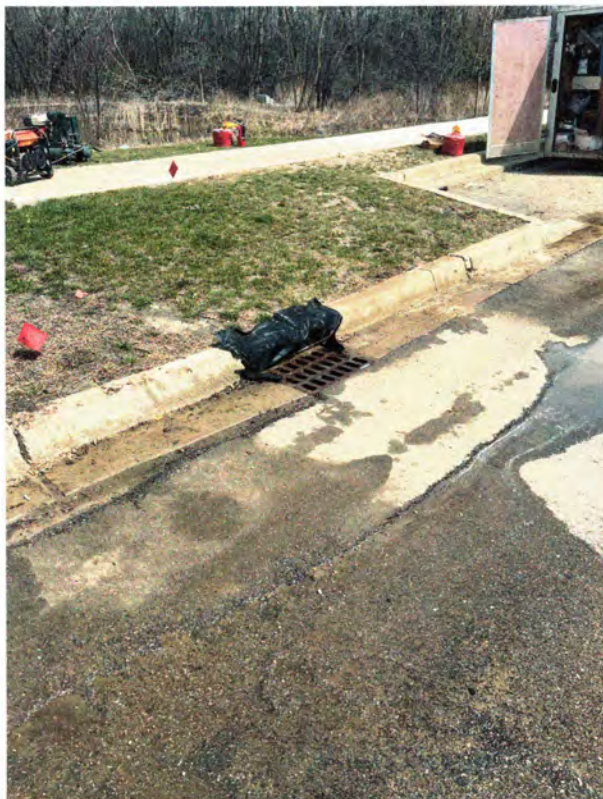
Exhibit H

Closer look of curbside inlet in Exhibit G. The area listed in the SWPPP as a protected wetland can be seen in background.

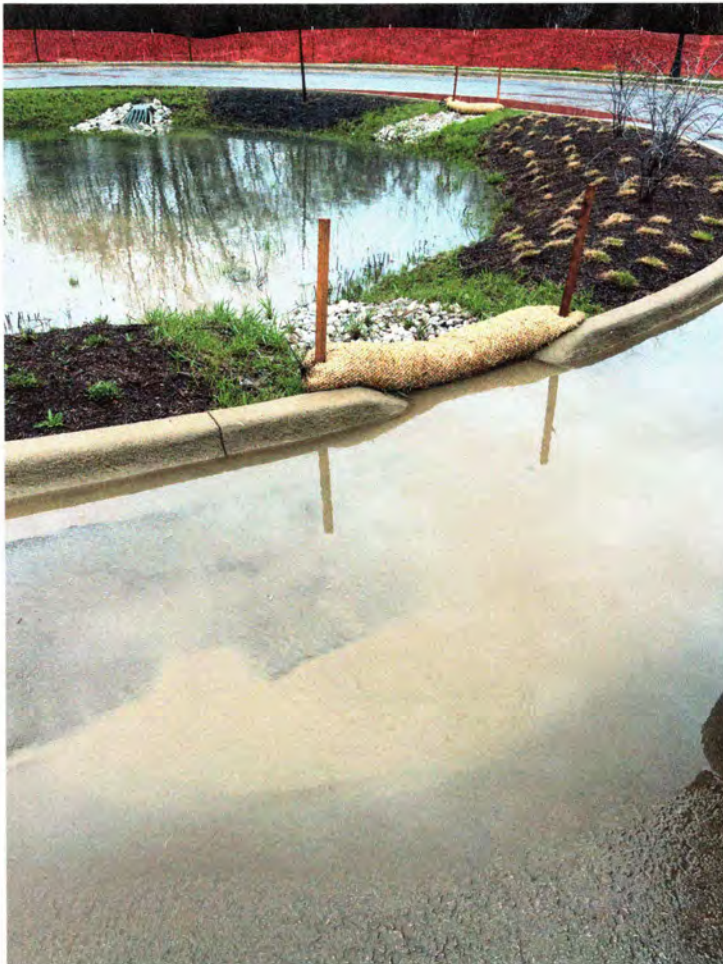
Exhibit I

Pollutants continue to be uncontrolled even after initial informal complaint and corrective actions. The orange fence along the protected wetland is in the background indicating when the photo was taken. The waddles are not working and again a cut out curb was installed without any BMPs. There is a structure seen discharging water from around the site into the retention area which contains sediment laden water.

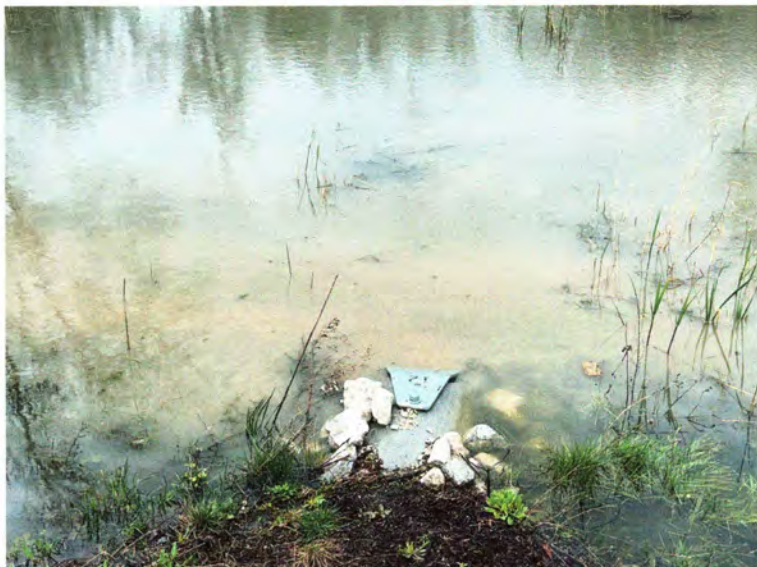
Exhibit J

Another structure on site discharging sediment laden water from inlets around the site indicating pollutants are not controlled.

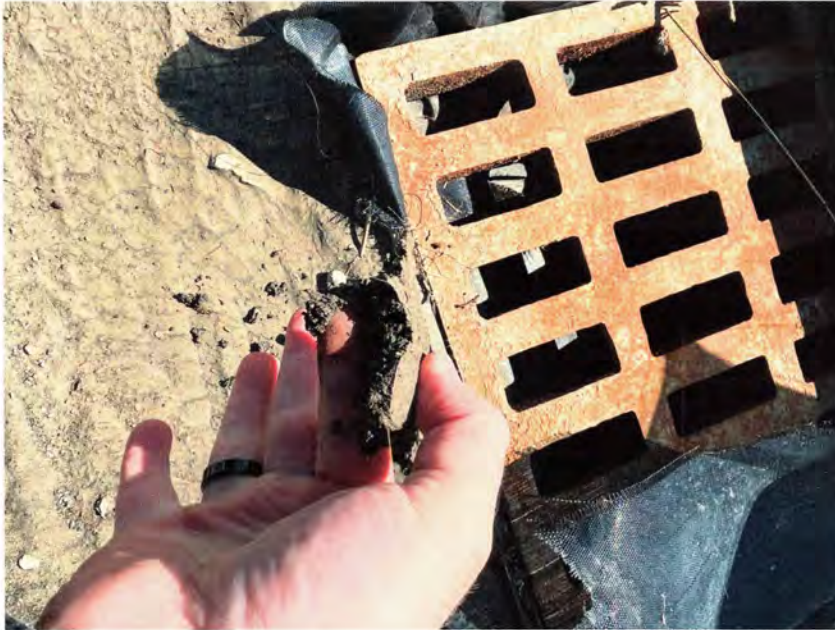
Exhibit K

Sediment accumulation around inlet. Blocking inlets with filter fabric is not an approved BMP, causes flooding and this development was partially occupied and indicates permit holder is unable to control pollutants

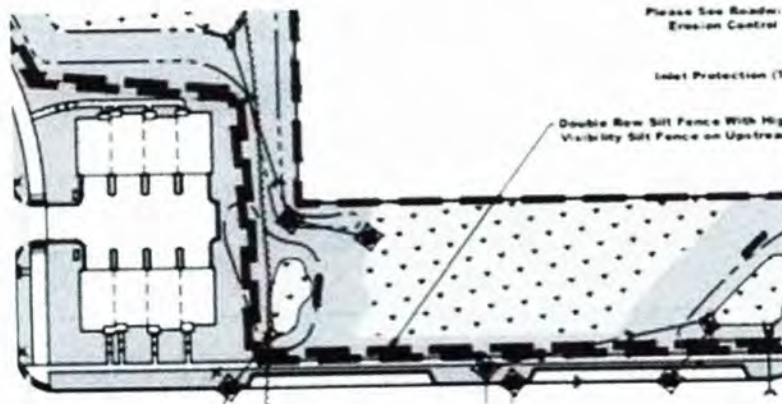
Exhibit L

Screen grab from SWPPP as approved showing where the BMPs were supposed to be which were never installed. Also shows the building next to the ramp with the central parking area.
