May 29, 2015

Re: Ash Pond Berm  
Visual Assessment  
Valdes Project Number 2015-033 BG04

NRG - WAUKEGAN STATION  
ASH POND  
SLOPE REPAIRS  
PLAN AND SECTION

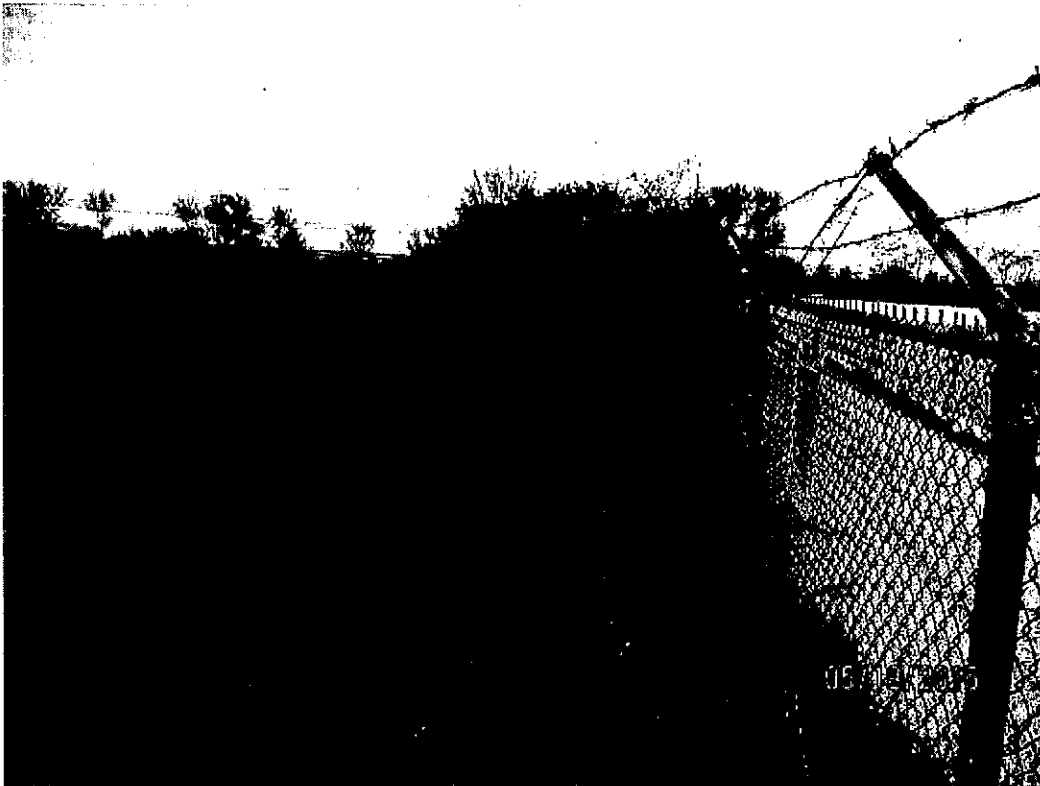
Much of the east berm, especially the north half, was not visible from the toe of the berm because of the tall reeds in the wetland and the dense bushes on the slope. The slope however is more accessible than the slope of the south berm. Photos 12 and 13 show the typical berm looking south and north.

PHOTO 12 - East berm looking south at top of berm near the middle of the east pond

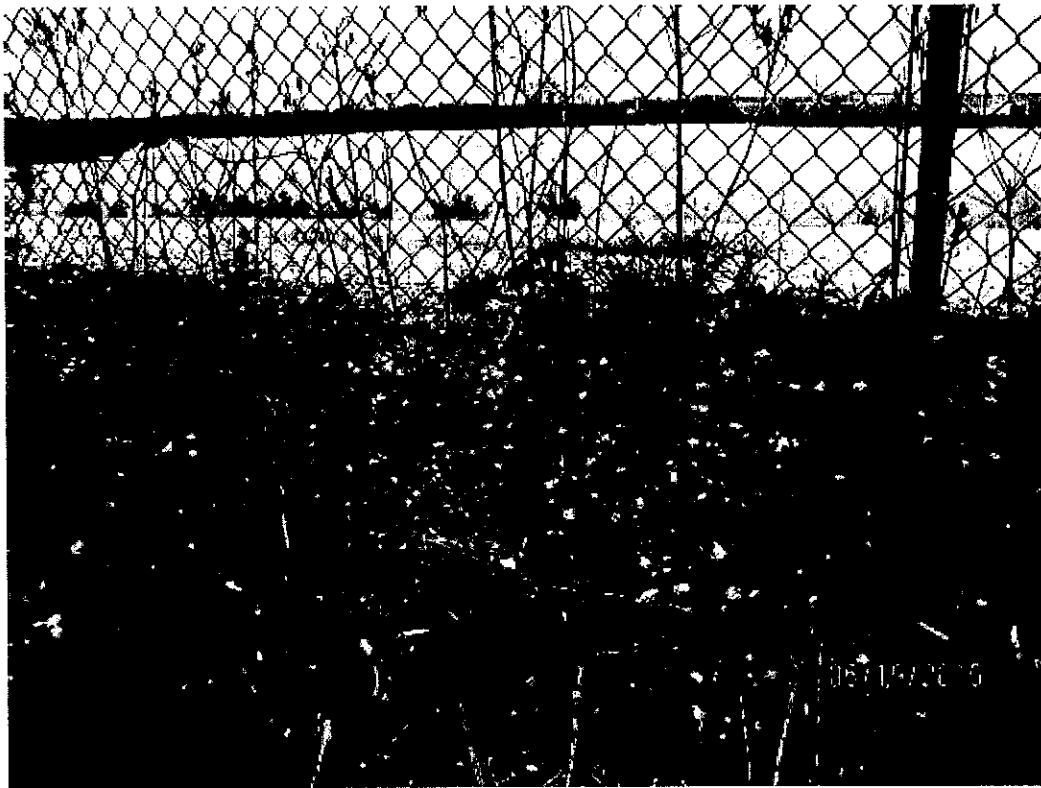
The crushed stone placed to repair a washout in 2008 is in good condition (Photo 10). However most of the rest of the east berm has a one foot flat area between the fence and the top of the slope. The flat area is missing in this repair area (Photo 10). This is also the case near the end of the center dike in Pond II (Photo 14).

PHOTO 14 - Top of east berm across from the end of the center dike in the east pond

Rebuild the areas along the east berm where the top of the slope is at the fence line. Any erosion from the current condition will affect the road which is the design feature that prevents runoff into the wetlands. A sketch of the recommended repair detail is attached.
