INSPECTION SUMMARY LETTER

August 31, 2005

KPRG Project No. 16005

Re: Liner Inspection -- West and East Ash Pond at the Waukegan Generation Station

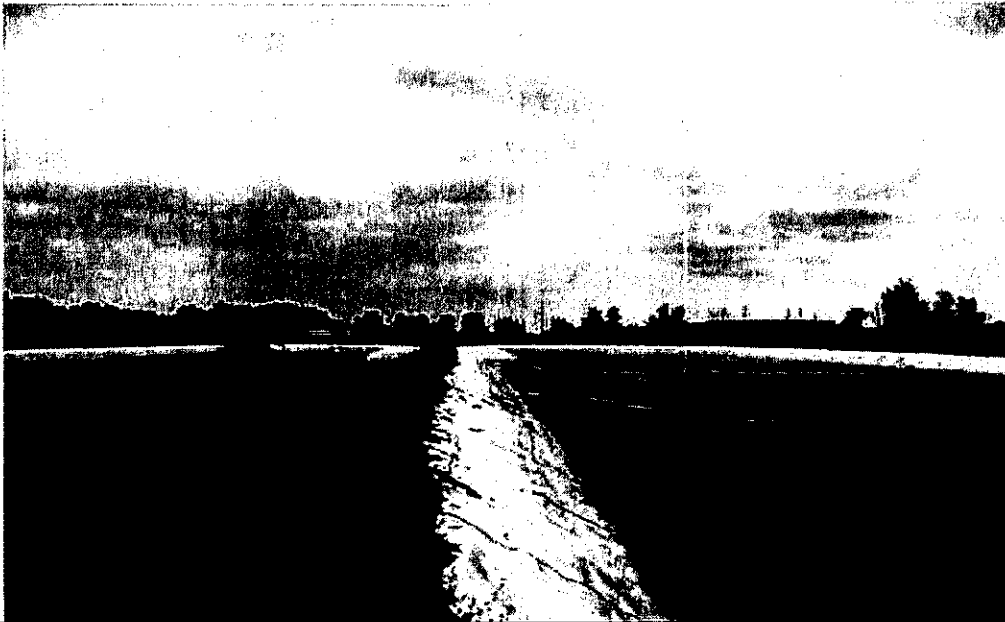
- 5) There is some evidence that the anchor trenches may have settled at the top of the slope. This settling can occur when the anchor trench backfill material is not compacted sufficiently (Photos 3, 4 and 22). This settling appears more prevalent on the west pond anchor trenches than on the east pond. Currently the settling is aesthetic issue only and may actually contribute to the wrinkles on the west pond slopes; however, periodic visual monitoring of the anchor trenches is needed to ensure there is no additional settling.

Photo 3. West Pond, Center Berm, West Wall. Note anchor trench settling.

- Perform regular inspections (semi-annual) of the anchor trench, particularly on the West Pond, to monitor any additional settling that may occur.
- Future design considerations should include a geotextile between the sand base and overlying crushed limestone to preclude aggregate migration through the sand due to pressure (i.e., from equipment traffic during pond clean out) which may cause the aggregate to be in direct contact with the underlying liner. Other protective base materials such as fabric form concrete can also be considered.

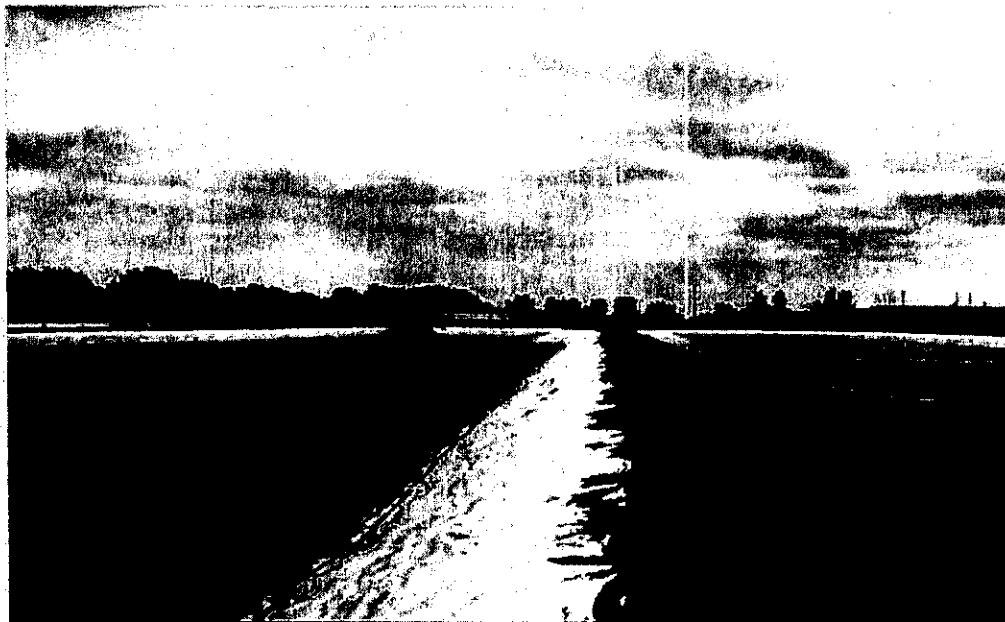
Photo 4. West Pond, Center Berm, East Wall. Note anchor trench settling.

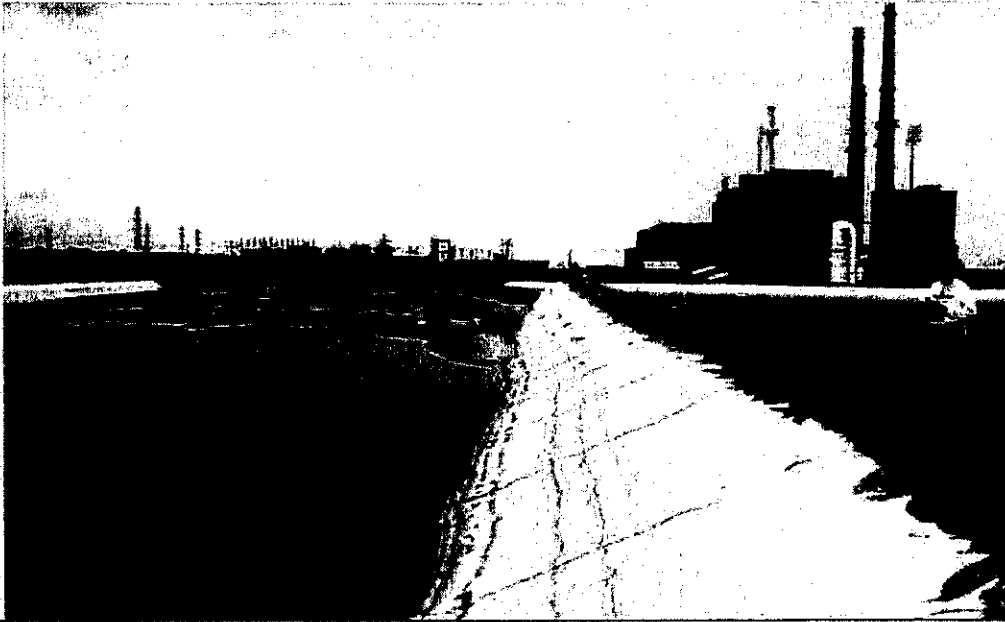
- 6) The stability of the slope subgrade below the liner does not appear to have suffered any major failures. The relative plane of every pond slope appears to be intact. When the subgrade below a lined slope fails, the failed material will create a bulge in the liner at the toe of the slope and there may be a void below the liner at the top of the slope. The only portion of the slopes in the two ponds that showed a slight bulge in the liner was on the west side of the center berm of the west pond (Photo 7). The slopes should be visually monitored to ensure the slope subgrade remains stable.

Photo 7. West Pond, Center Berm. Note slight bulge in liner at water and sediment interface.

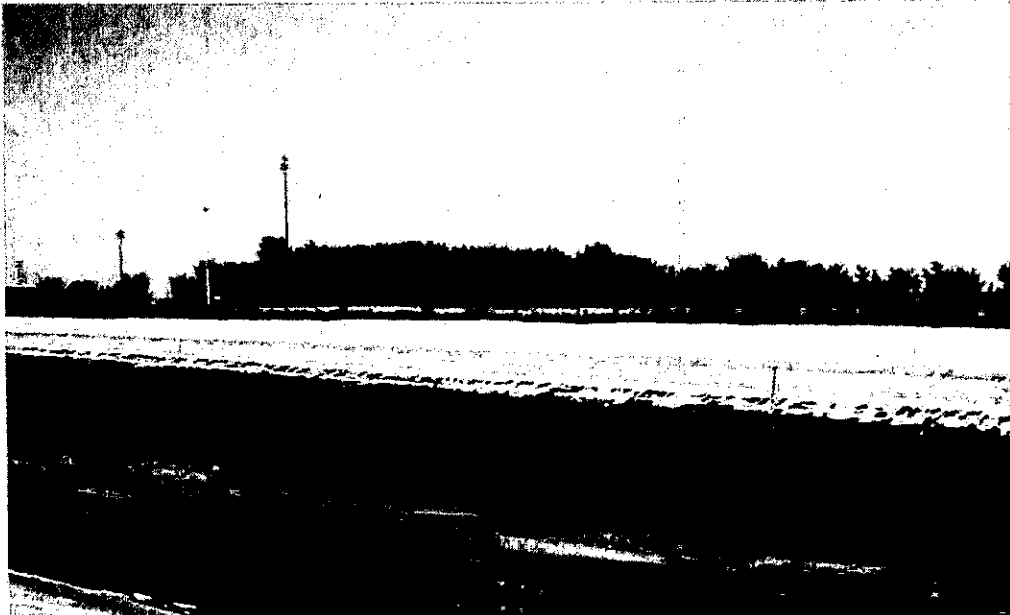
Photo 16. East Pond.

- 3) Installation of HDPE liner during hot weather must include deploying excess material to compensate for the thermal contraction which takes place as the temperature decreases. This excess material is evident as wrinkles in the liner. The wrinkles associated with HDPE Liner are an aesthetic issue only. A liner that is installed without enough excess material may result in tension across the liner seams which can produce stress cracks at seams and/or may pull the liner away from mechanical attachment points or out of the perimeter anchor trench. Based on our research and experience, the liner wrinkles in the east and west pond liners are consistent with similar projects using 60 mil white on black HDPE liner. The wrinkles in the West Pond are probably exacerbated by the having the lower portion of the slope liner loaded with ash and may be isolated to the exposed top portion of the slope liner (refer to Photo 3 for typical wrinkling noted on the exposed liner for the West Pond). This isolation may cause a greater frequency and amplitude in the wrinkles. Please compare the wrinkles in east pond with and without an ash load on the lower portion of the slope (Photos 16 and 20, respectively).
