**FIELD NOTE SUMMARY**

**Project Number / Task:** 1900/6.0  
**Project Names:** South Ash Pond #3 Liner Replacement

<b>Date:</b>	October 13, 2009
<b>Work Scope:</b>	Liner Installation Inspection – South Ash Pond #3
<b>NRT Staff:</b>	Heather Simon
<b>Contractors:</b>	Brieser Construction –Mike Schmidt and Clean Air and Water Systems (CAAWS)
<b>Weather:</b>	Sunny 50s degree F
<b>Equipment:</b>	Digital camera
<b>Field Comments:</b>	<p><u>10/5</u></p> <ul style="list-style-type: none"> <li>• I arrive on site around 10:00, checked in at gate house.</li> <li>• CAAWS on-site placing 12-oz non-woven atop liner, banding marker post, and adding sealant to batten bar attachments.</li> <li>• Brieser backfilling anchor trenches.</li> <li>• CAAWS finished liner work around 1pm.</li> <li>• HDPA Liner installation was completed yesterday. Extra material was brought on-site from Joliet station on Sunday, they were short 1,000sf since the pond is deeper</li> <li>• Left site at 1300</li> </ul>
<b>Scope Changes:</b>	<ul style="list-style-type: none"> <li>• None</li> </ul>

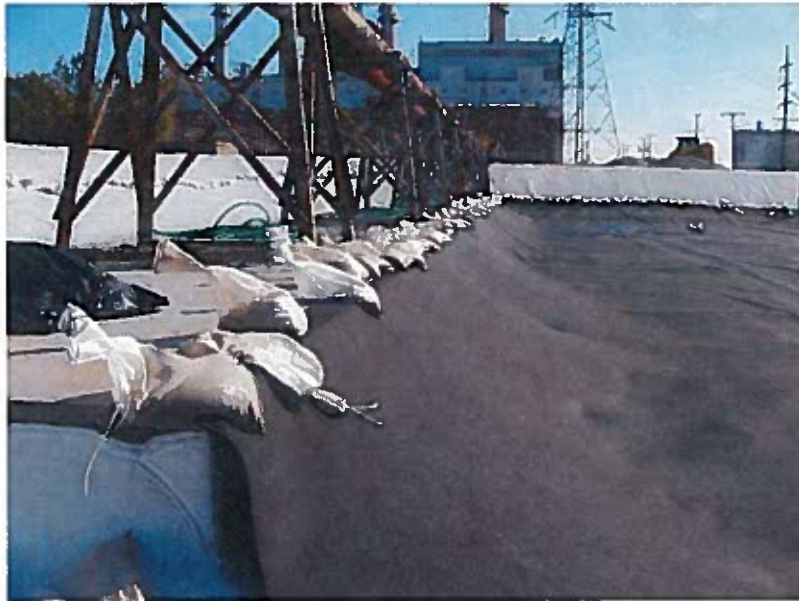
Liner connected to weld strip along concrete pad, and 12oz non-woven geotextile placed above the HDPE liner to protect the connection and liner.

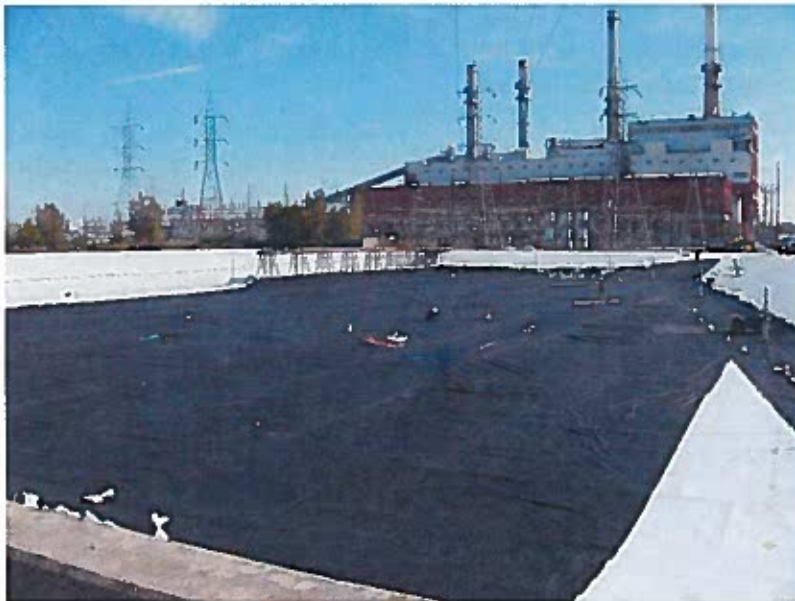
South Ash Pond #3 looking east of the 12oz non-woven geotextile placed above the liner.

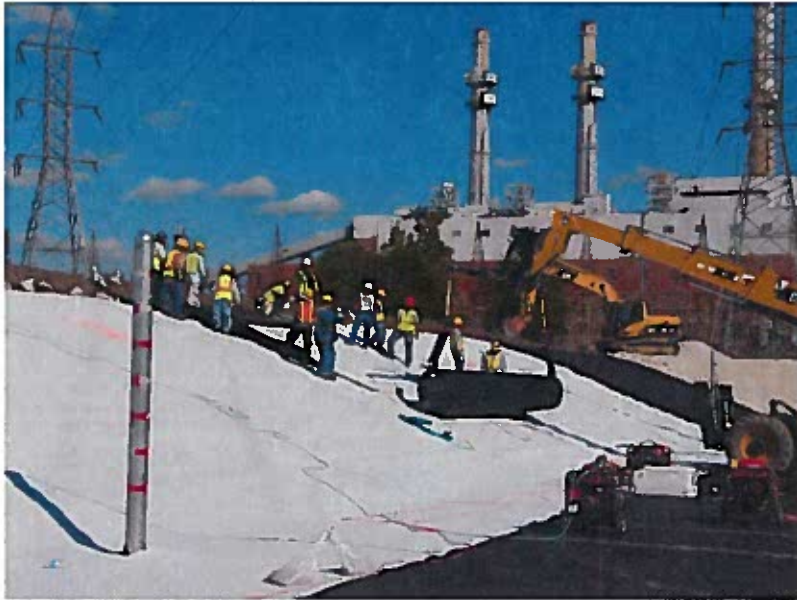
Installation of 16 oz non-woven geotextile and white HDPE liner, looking at northeast corner of South Ash Pond #3.

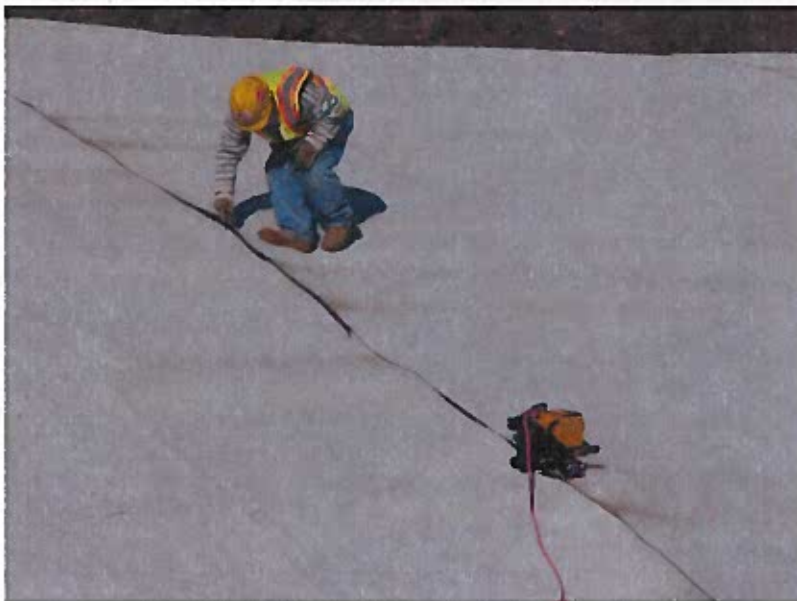
Thermal fusion welding apparatus

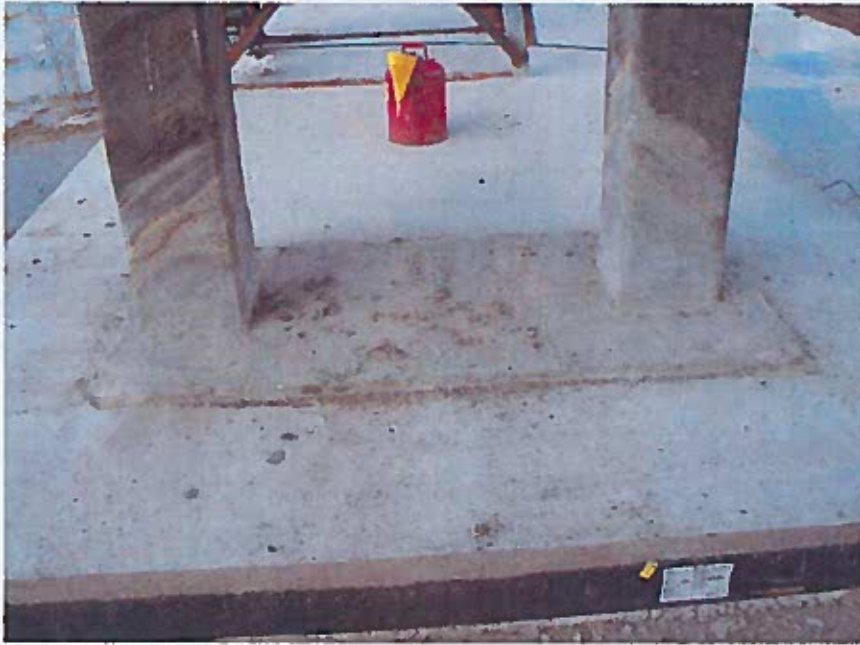
**New concrete base with welding strip around influent pipe support posts (looking west).**

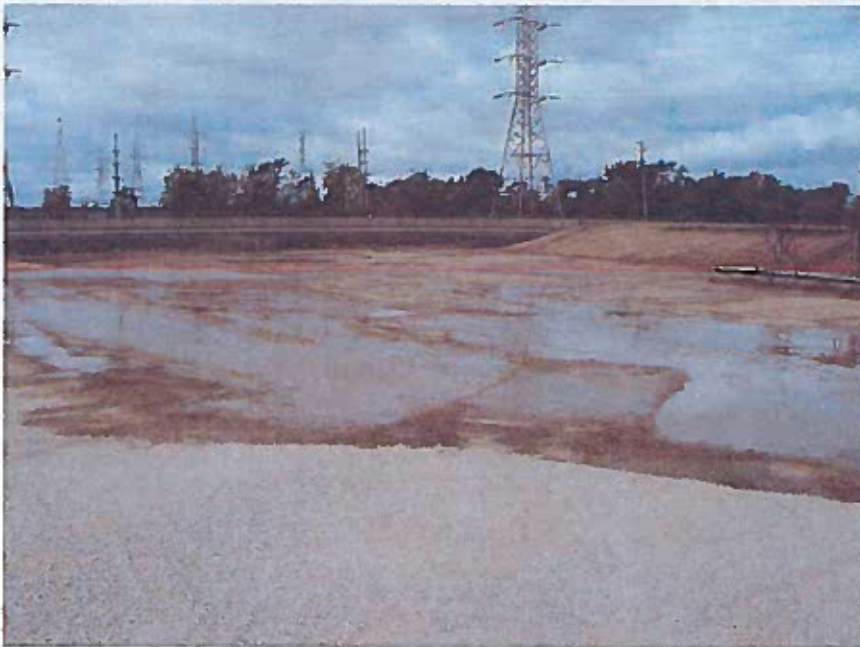
**Looking northwest from top of ramp at pond subgrade.**

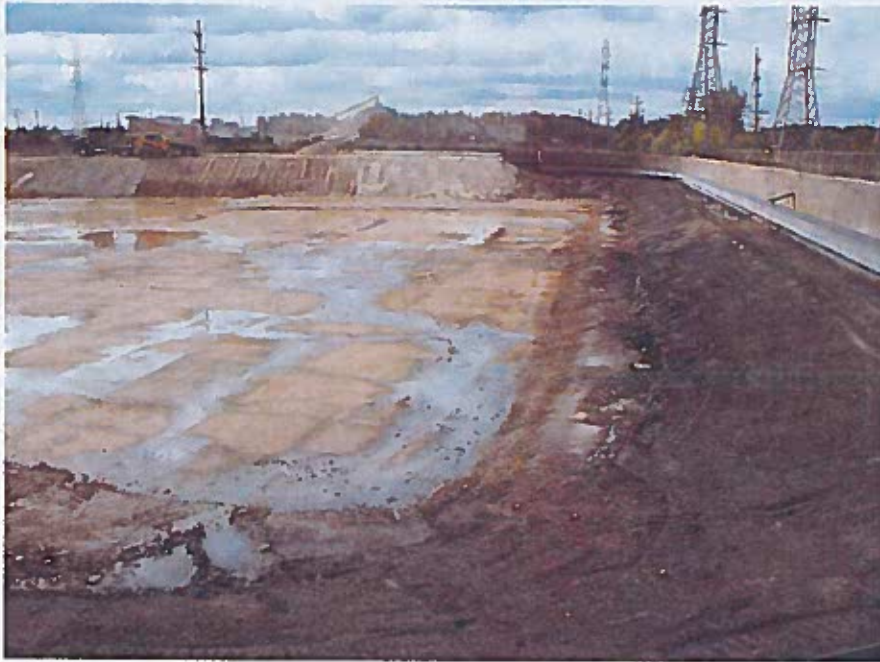
**Looking south along the weir at subgrade.**

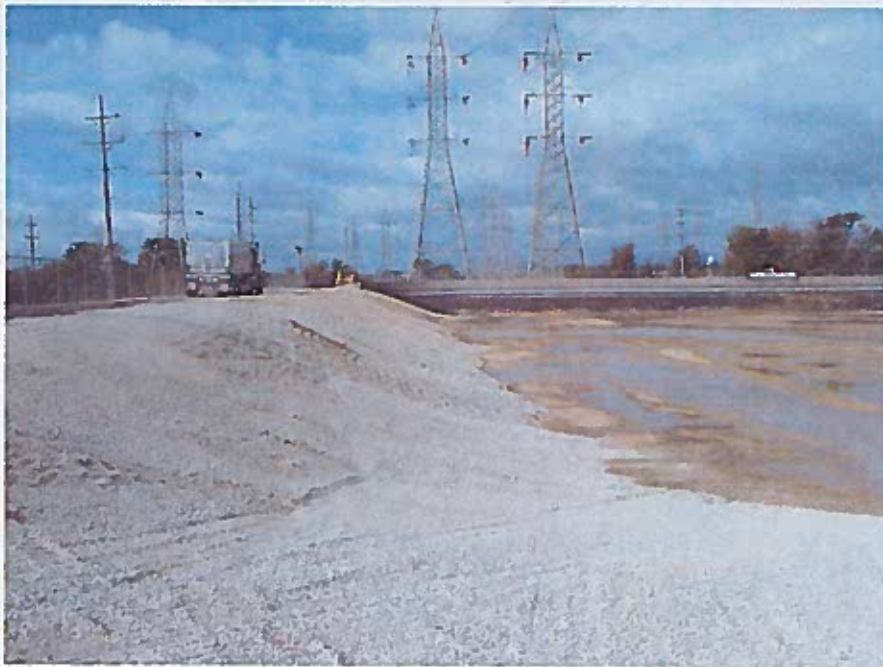
**Looking west along constructed side slope.**

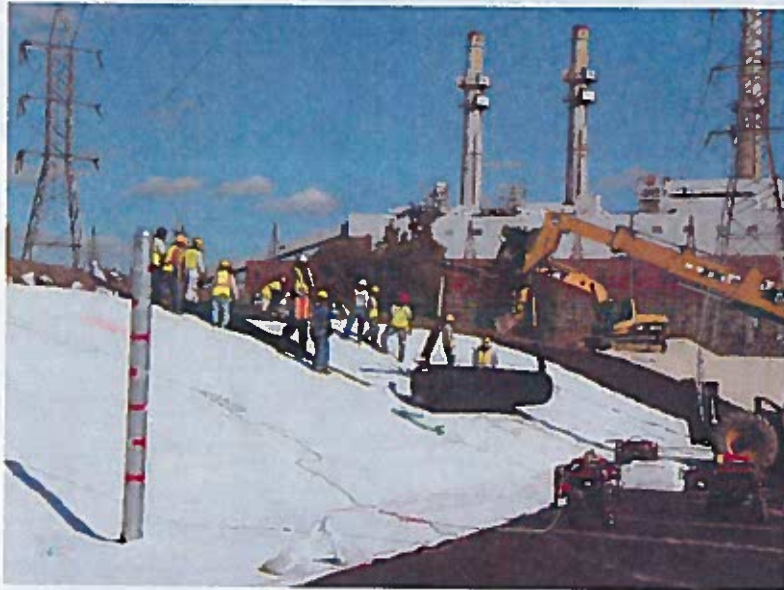
**Installation of 16 oz non-woven geotextile and white HDPE liner, looking at northeast corner of South Ash Pond #3.**

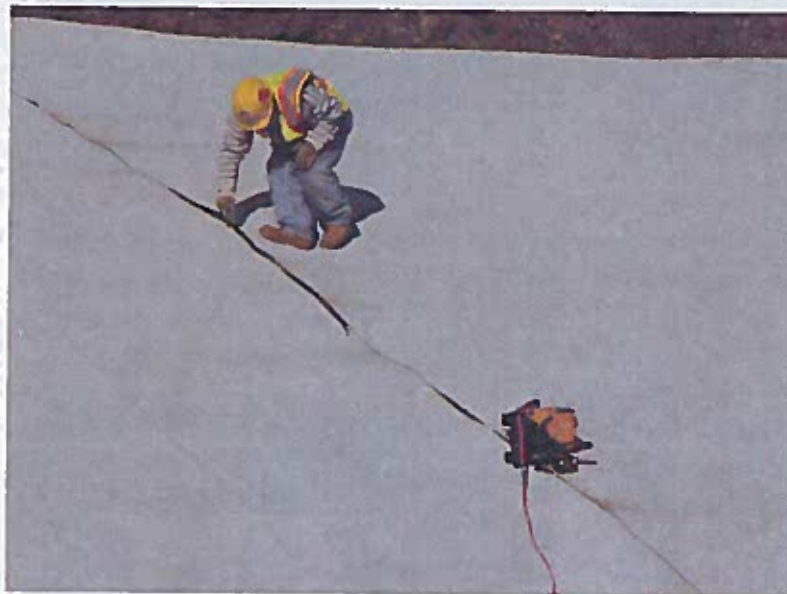
**Thermal fusion welding apparatus**

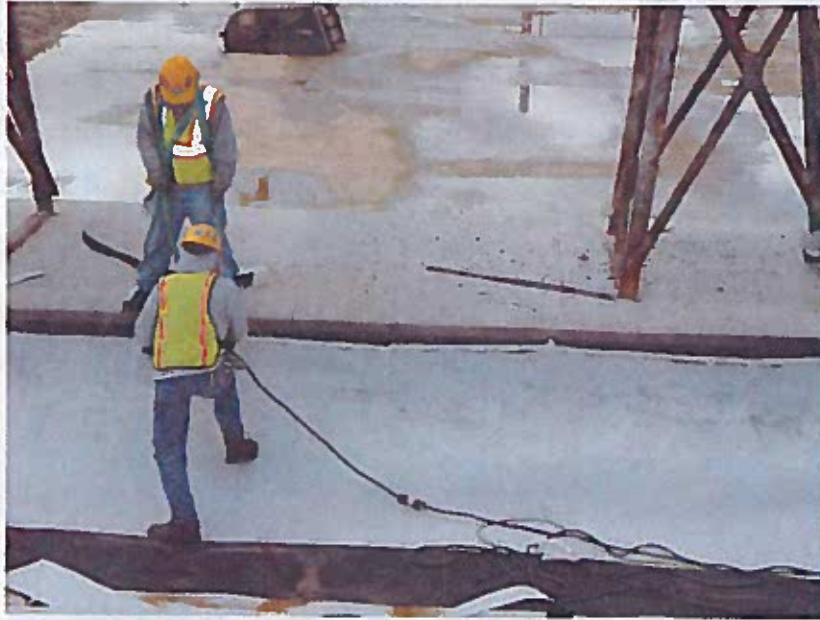
**Welding liner to replaced welding strip (looking south).**

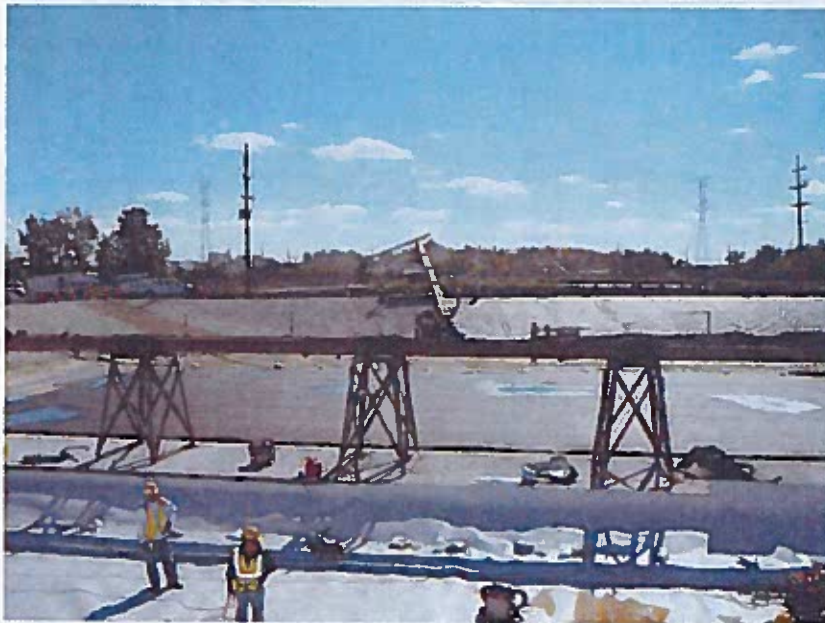
**Looking south, placing liner on south slope and crew working on welding toe of slope.**

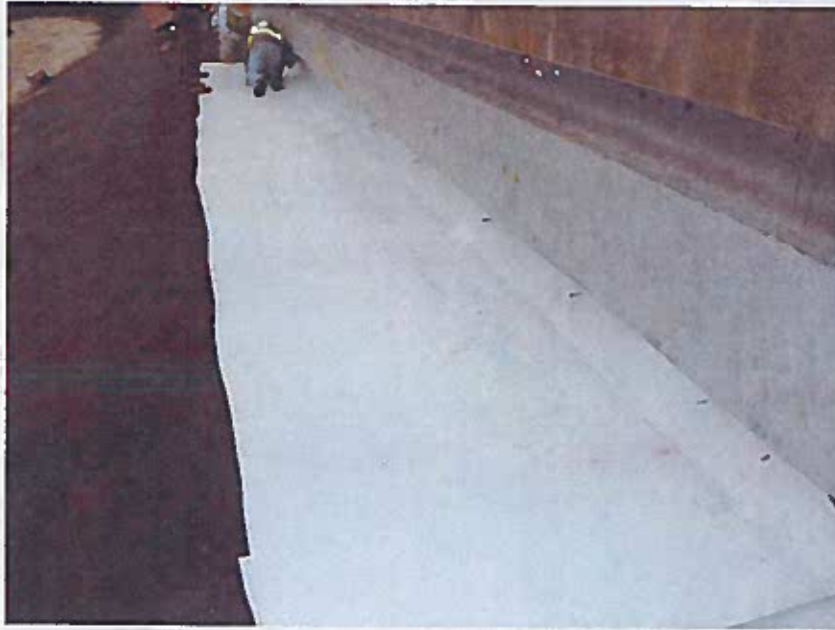
Looking south placing liner at weir.

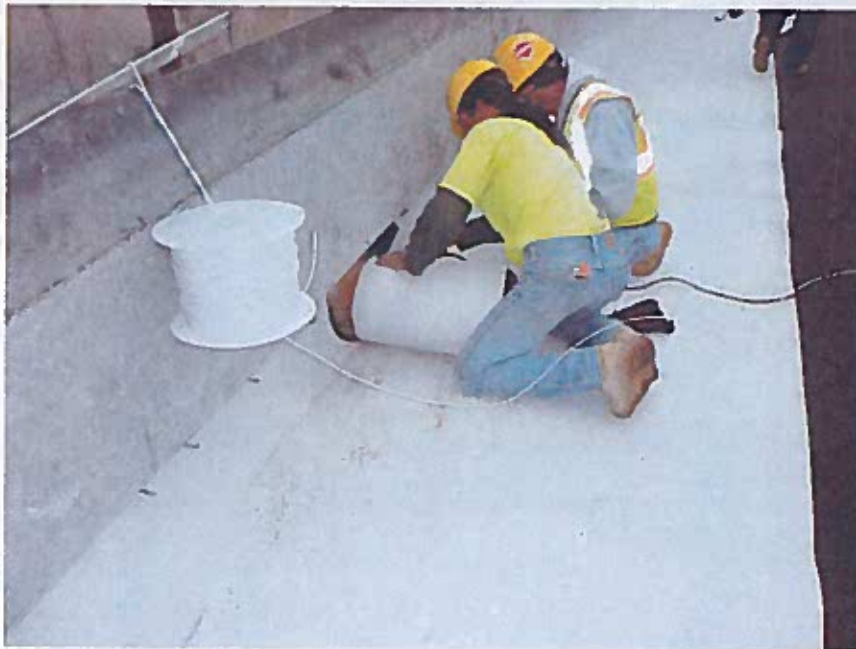
Looking north, working on placement of pipe collar around metal pipe.

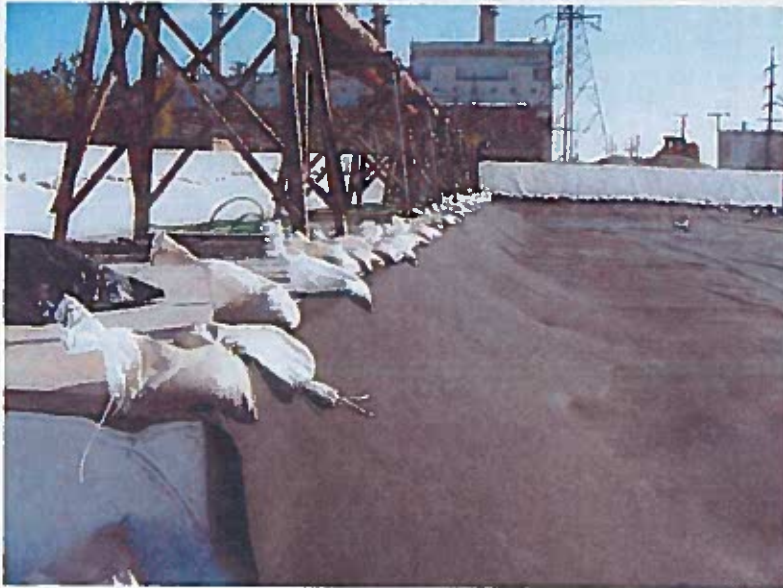
**Liner connected to weld strip along concrete pad, and 12oz non-woven geotextile placed above the HDPE liner to protect the connection and liner.**

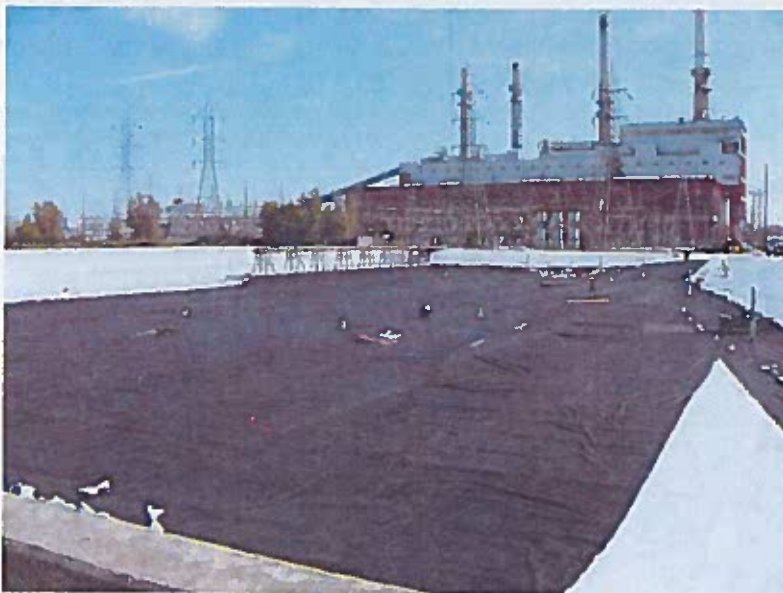
**South Ash Pond #3 looking east of the 12oz non-woven geotextile placed above the liner.**

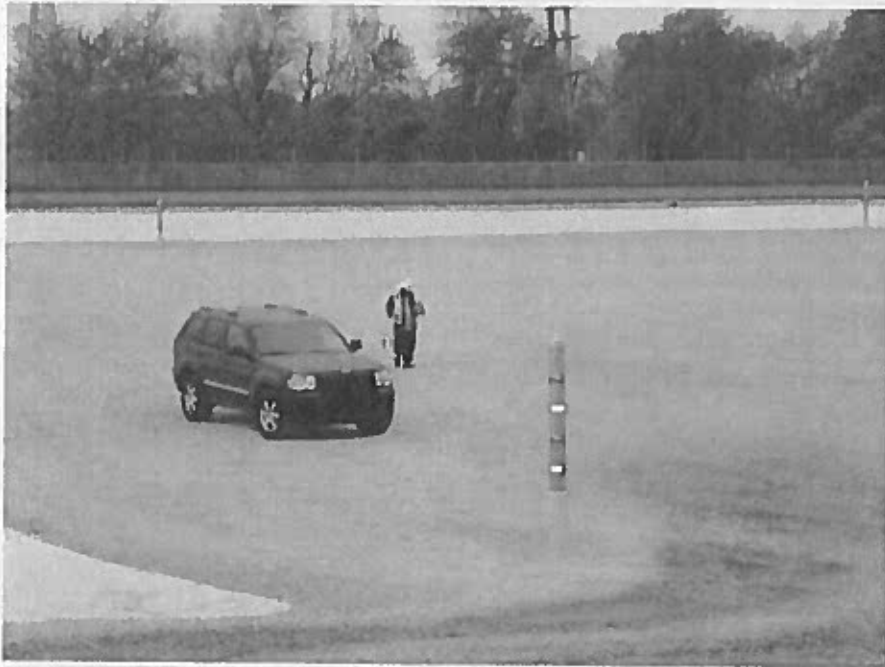
**Leak Detection in process (looking west from ramp).**

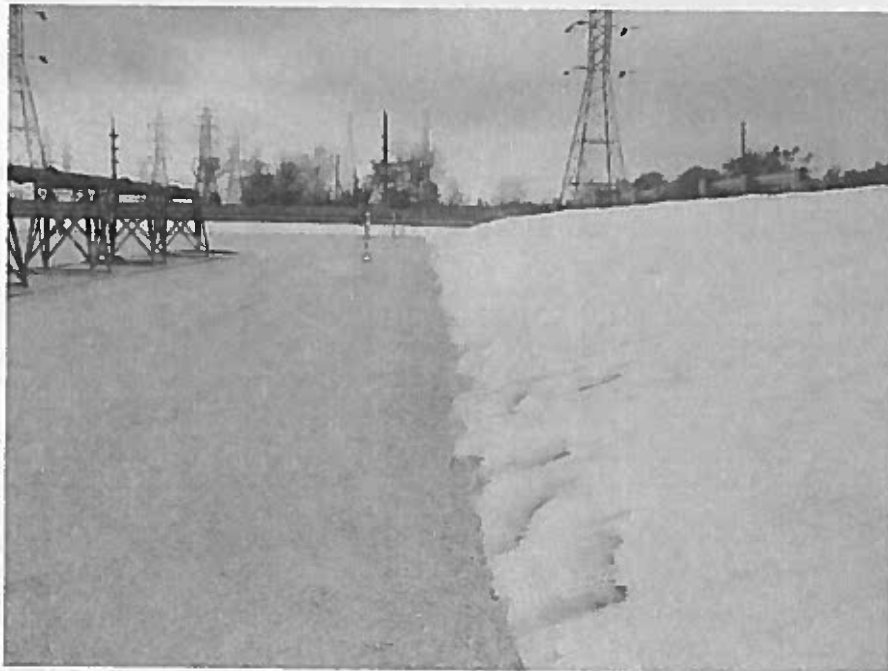
**Warning layer along north slope (looking west).**

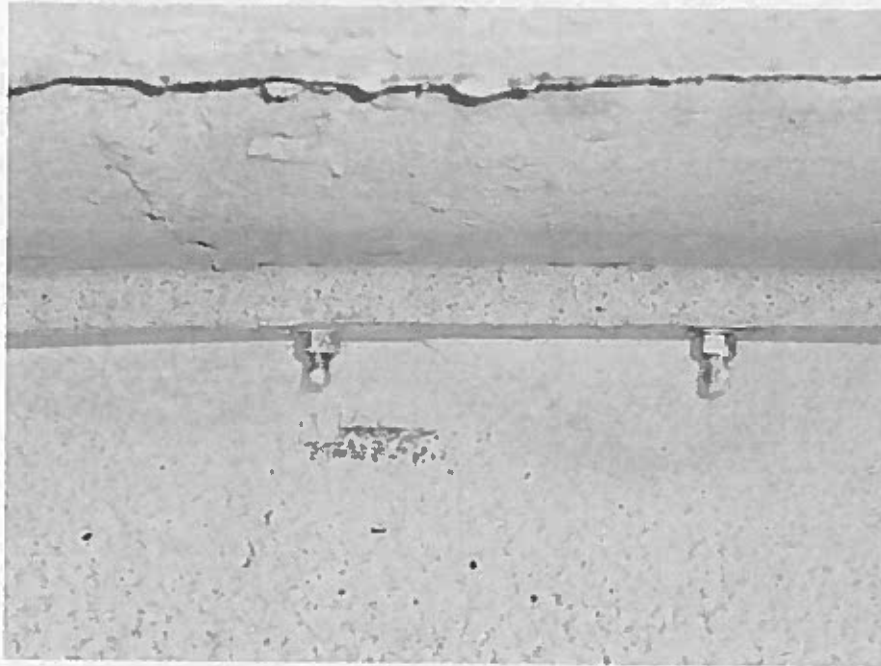
**Batten bar in place on weir with sealant.**

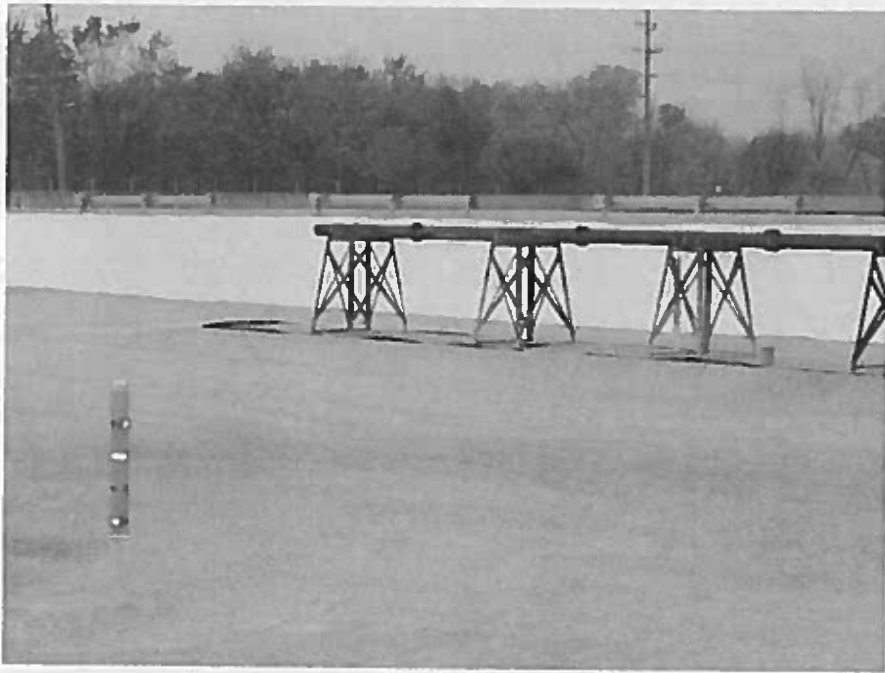
**Warning layer placed against new concrete support structure (looking NW from ramp).**

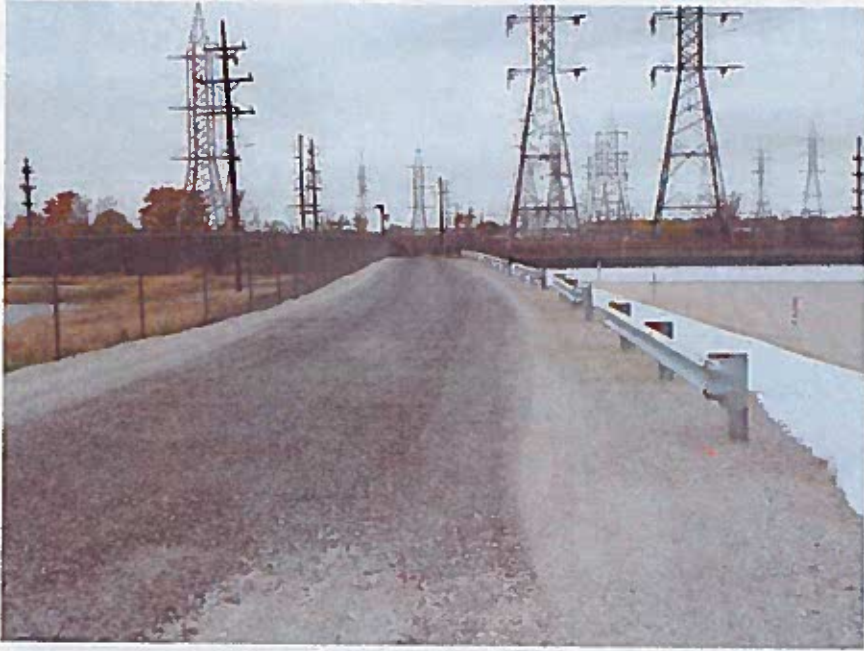
**Guard rails placed along south slope (looking west).**

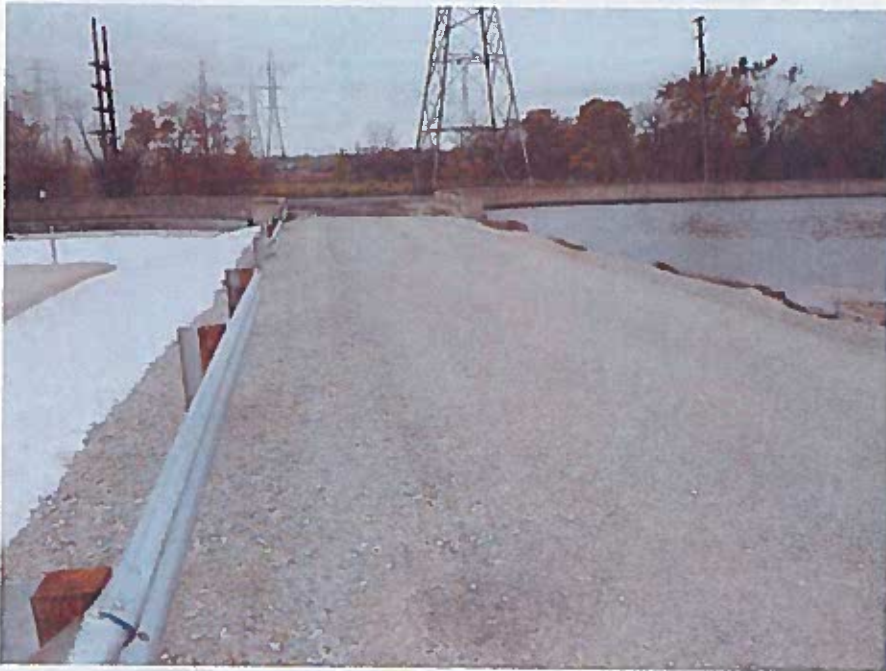
**Guard rail between ash pond 2 and 3 (looking west).**

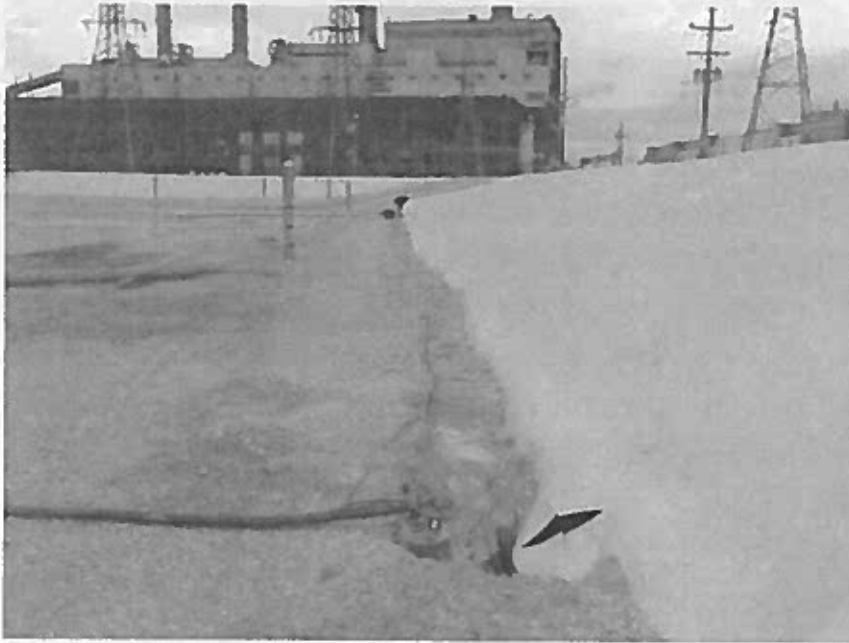
**Hole in liner for water removal on south toe of basin (looking east).**

<b>Date:</b>	November 10, 2009
<b>Work Scope:</b>	Patch Liner from Removal of Water under Liner – South Ash Pond #3
<b>NRT Staff:</b>	Heather Simon
<b>Contractors:</b>	Brieser Construction –Mike Schmidt and Clean Air & Water.
<b>Weather:</b>	11/10 low 50's degree F, scattered clouds
<b>Equipment:</b>	Digital camera
<b>Field Comments:</b>	<u>11/10</u> <ul style="list-style-type: none"><li>• Arrive on site around 8:00, checked in at gate house.</li><li>• Brieser on-site since yesterday to pump water beneath liner along the base of side slopes.</li><li>• When Brieser arrived yesterday the water beneath the liner had dissipated by 70% since last visit 2 weeks ago.</li><li>• Brieser &amp; MWG chose to put 6 holes along toe of slope (2-north end, 2-south end, and 2-west end) to pump water.</li><li>• On arrival pumps working but not much water coming out of holes.</li><li>• CAAW arrived around 11:20.</li><li>• CAAW patched the holes located at panels 19, 27, 52, 47, 41, and 10.</li></ul>

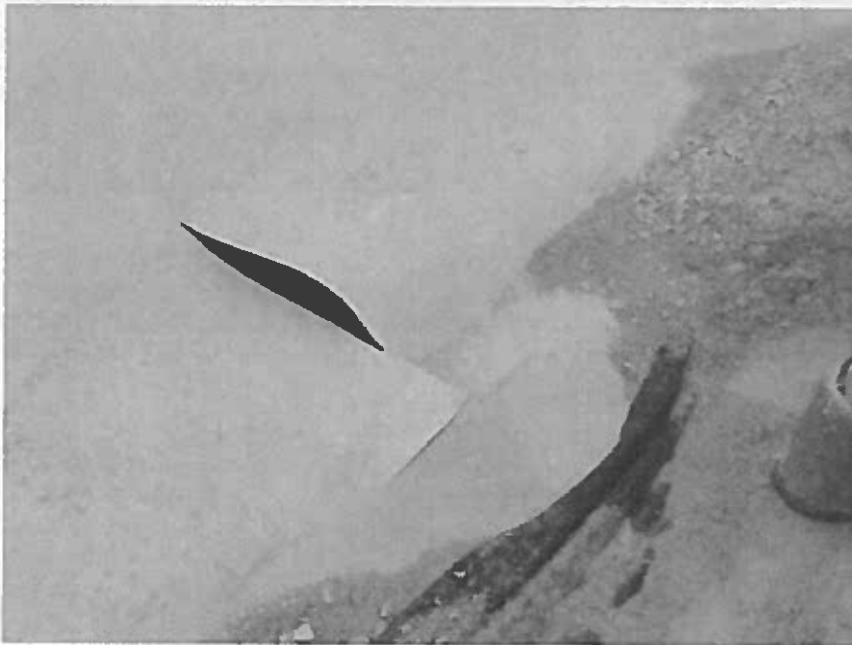
**Close up hole in liner for water removal.**
