RE: Construction Documentation Transmittal
Ash Surge Basin Liner Replacement
Midwest Generation Powerton Generation Station

Natural Resource Technology, Inc. (NRT) has prepared this correspondence to transmit construction record documents for the liner replacement completed in 2013 for the Ash Surge Basin at the Powerton Station.

Project Name: Ash Surge Basin Liner Replacement

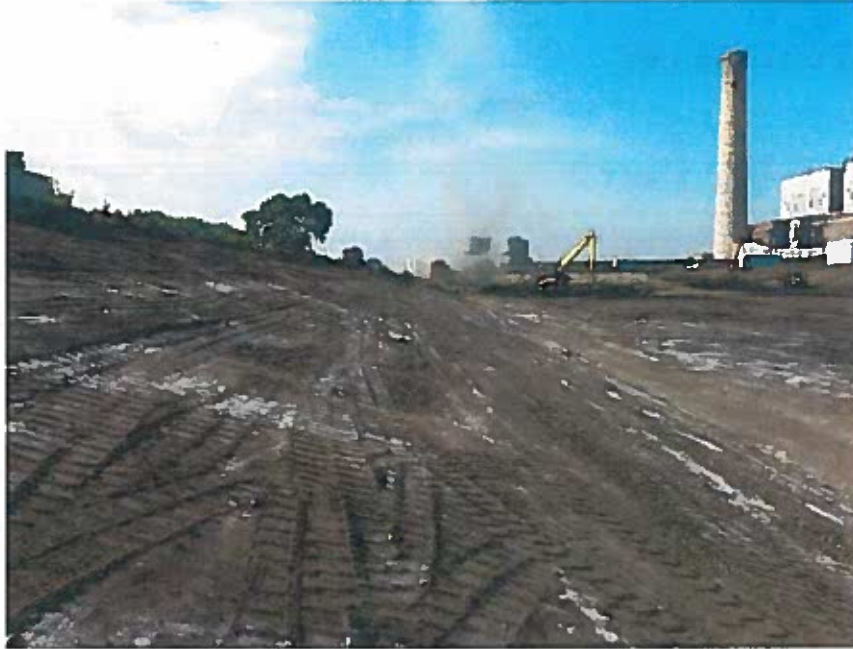
South-facing view of eastern slope, Poz-O-Pac and transition in good condition, some ash remains that will be removed

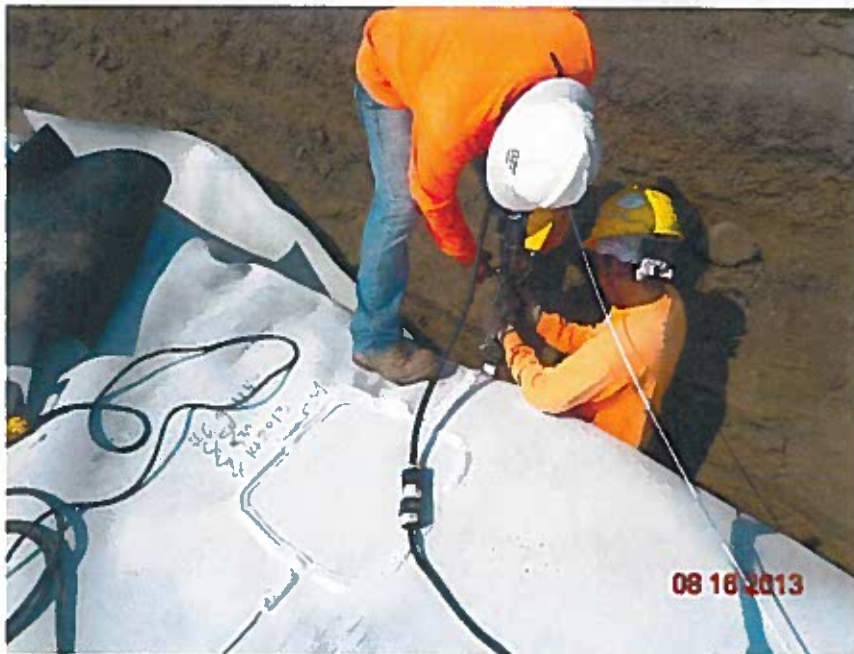
Extrusion weld on a repair location

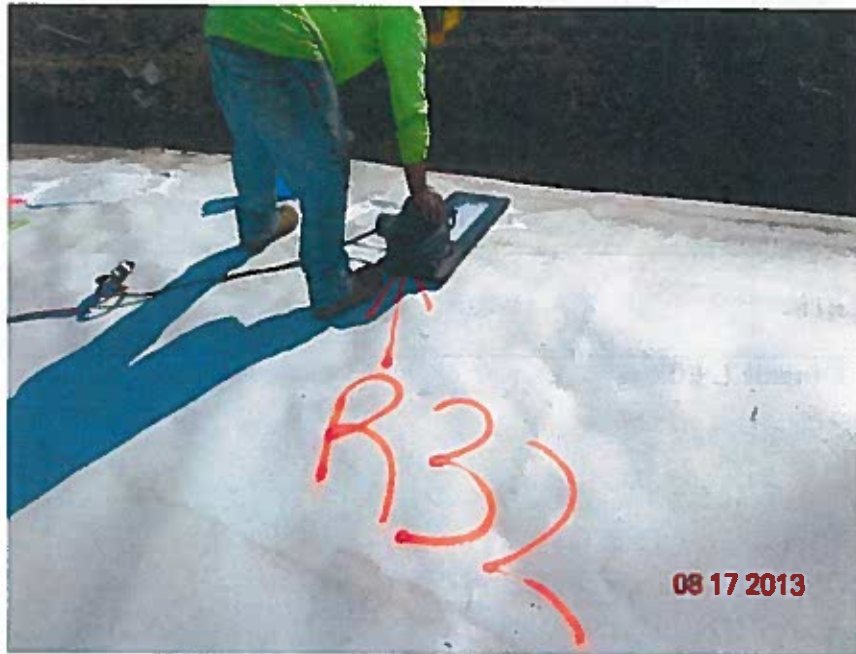
Vacuum testing a repair location

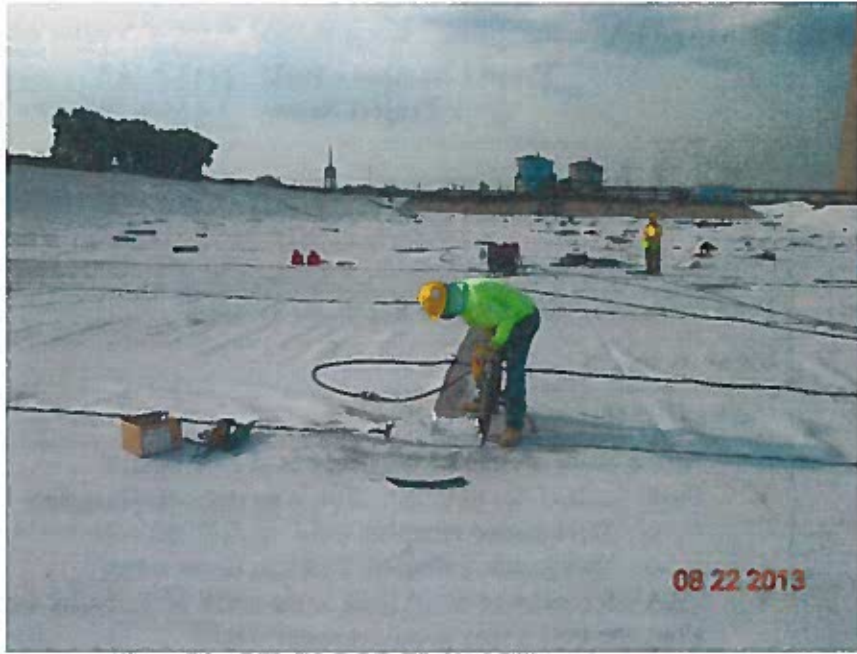
Extrusion welding a geomembrane repair in progress (looking south)

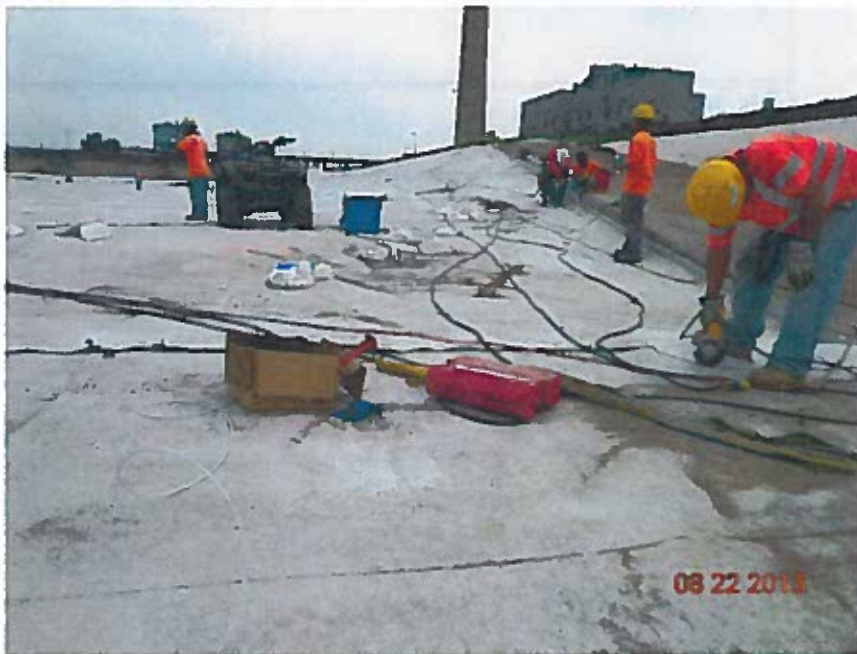
Repairing geomembrane along the ramp (looking southwest)

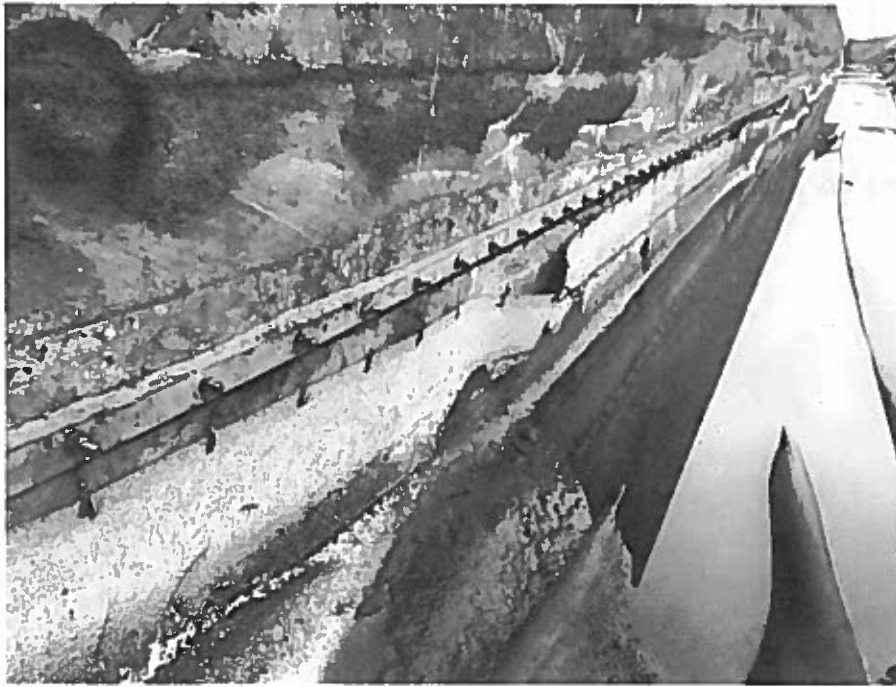
Damaged connection to batten strip on north side of weir wall, facing southwest

Scope Changes:	<ul style="list-style-type: none"> • Repairs to be scheduled for damaged batten bar connection at north side of weir wall • South side of weir wall to be inspected

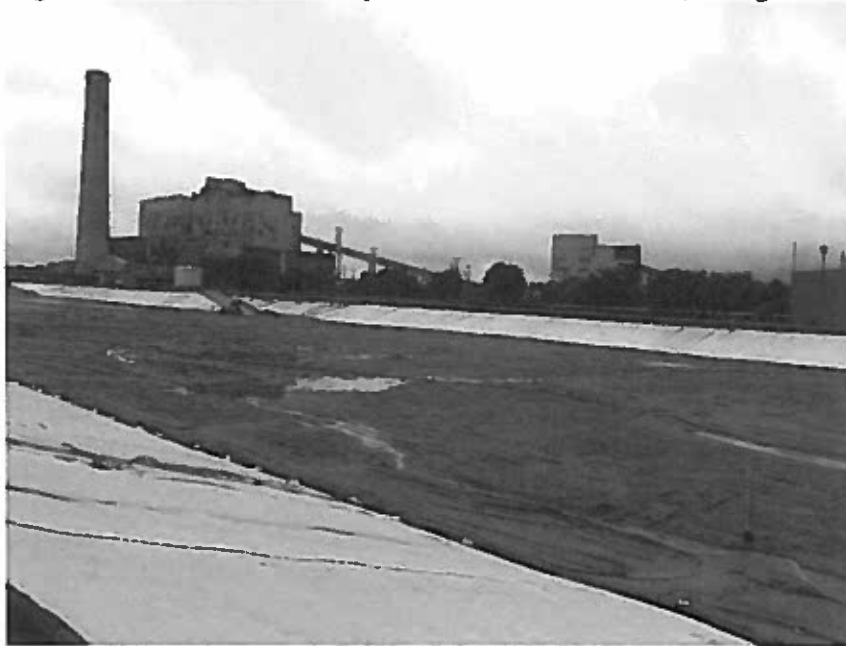
Dewatering basin after plug failure, facing southwest

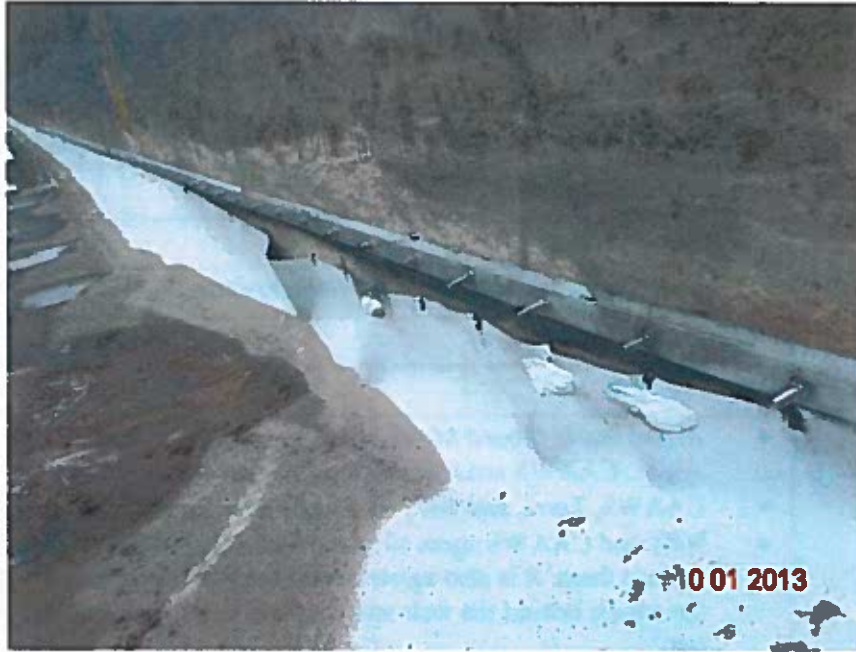
Section of the torn batten strip (looking southeast)

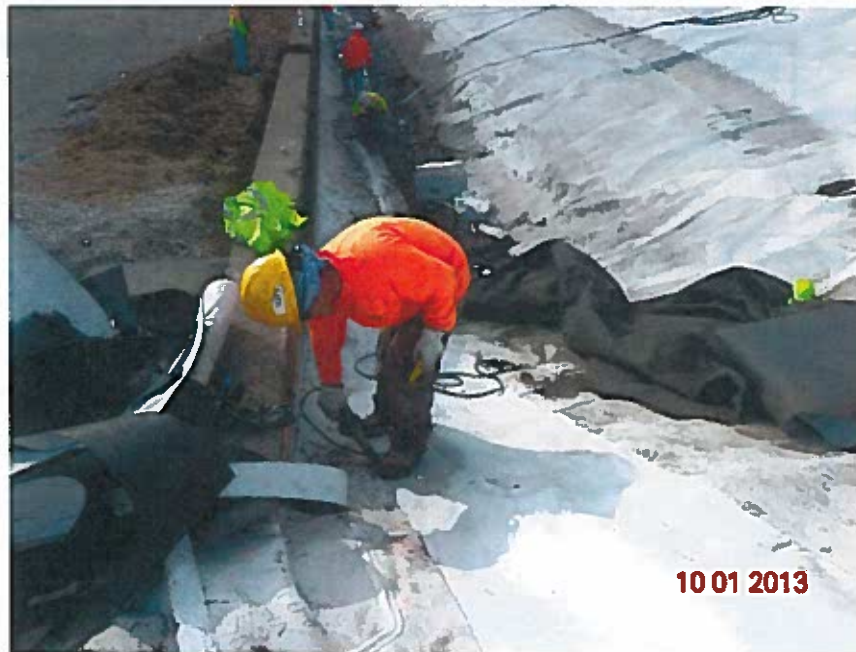
Batten strip repairs underway (looking west)

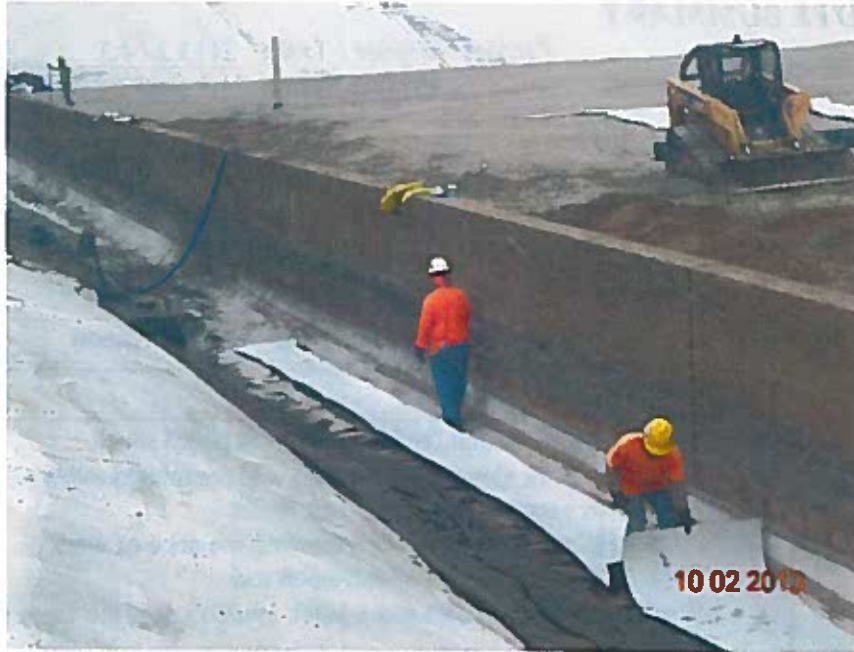
Geomembrane sections being added to the liner to provide slack for the transition between the basin floor and weir wall (looking southeast)

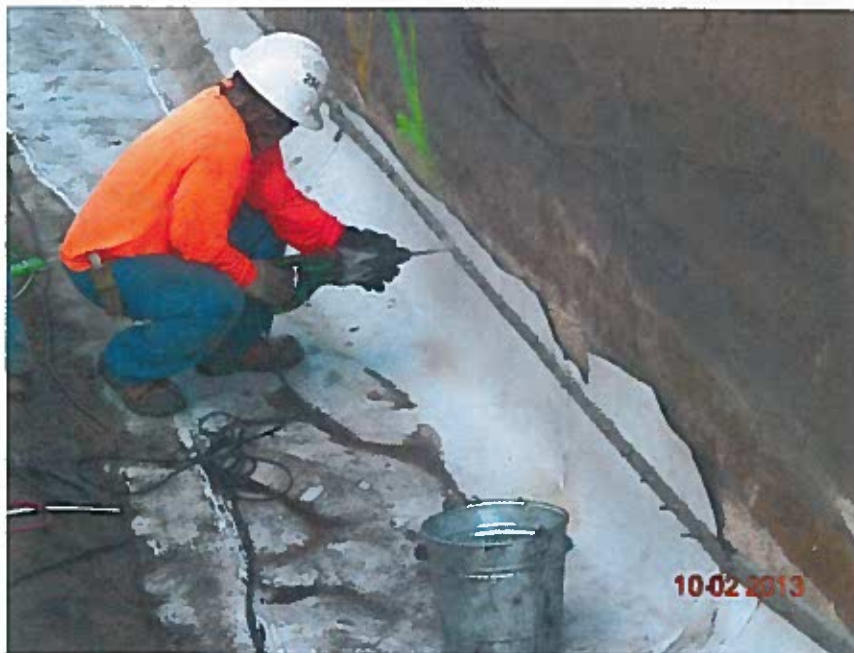
Repairs on batten strip

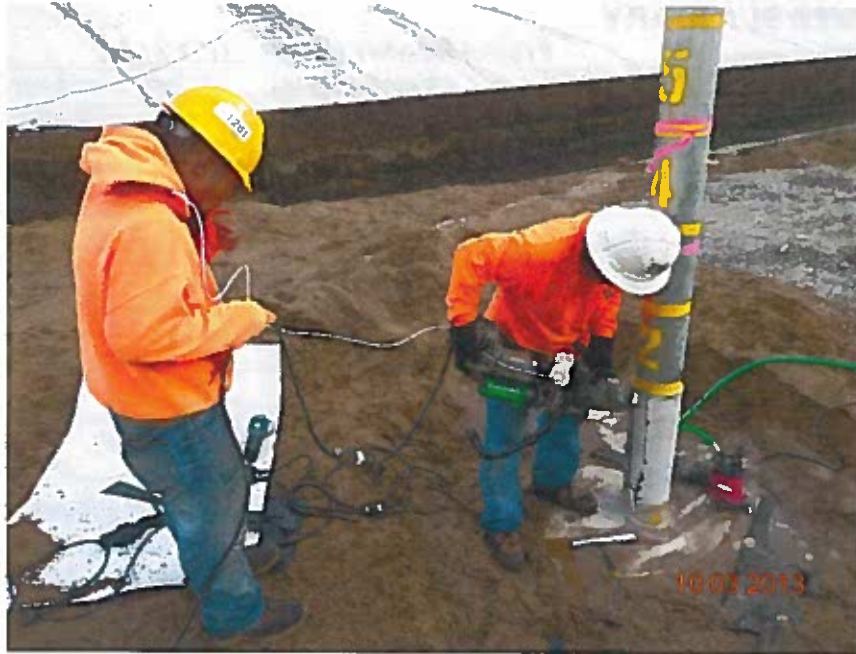
One of the riser pole geomembrane boots being fixed (looking north)

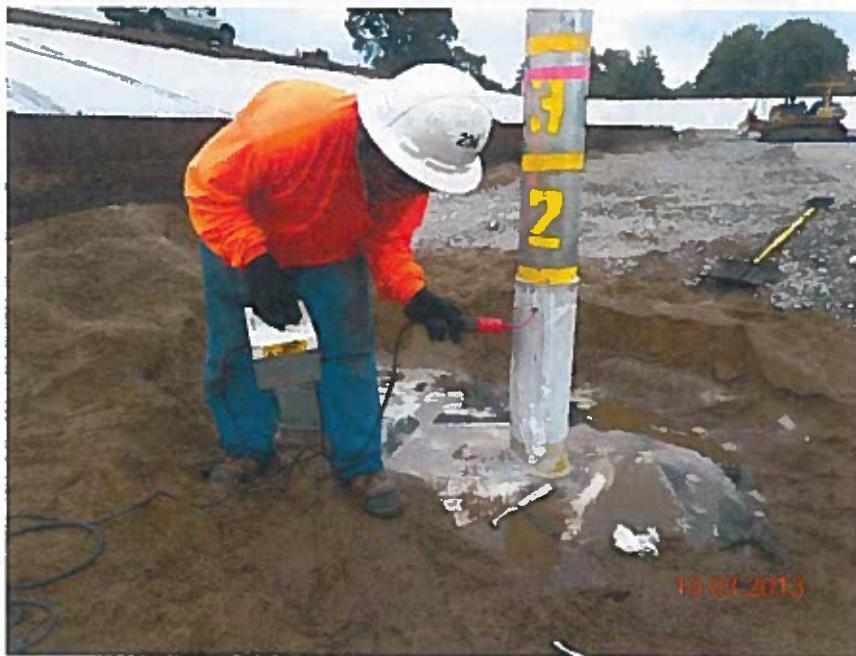
Spark testing the new repairs (looking northeast)

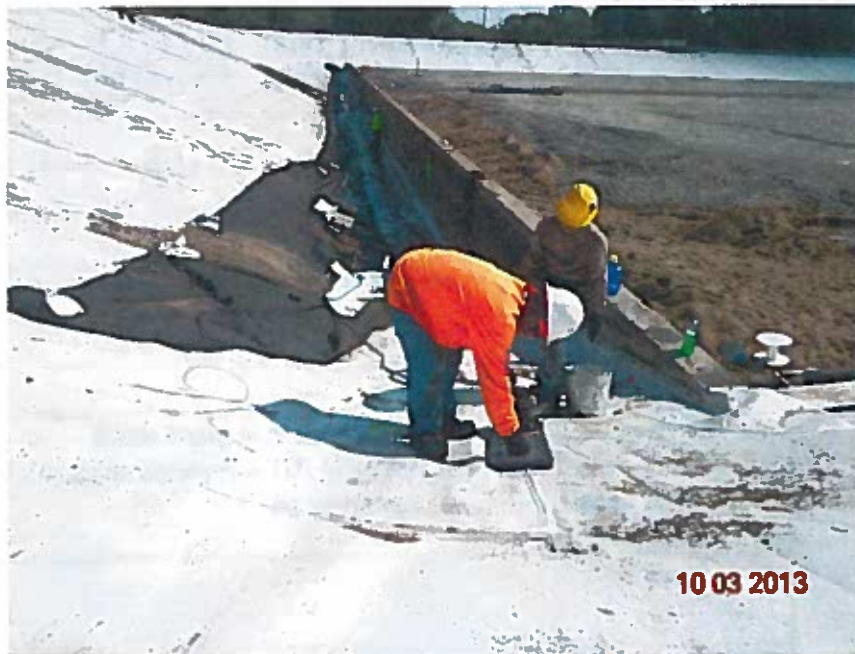
Vacuum testing a new patch along the weir wall (looking east)

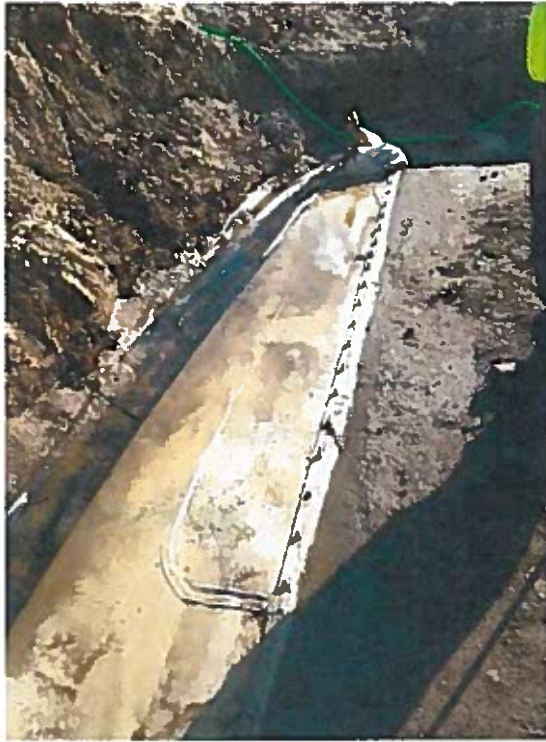
Damaged connection to batten strip on north side of weir wall, facing southwest

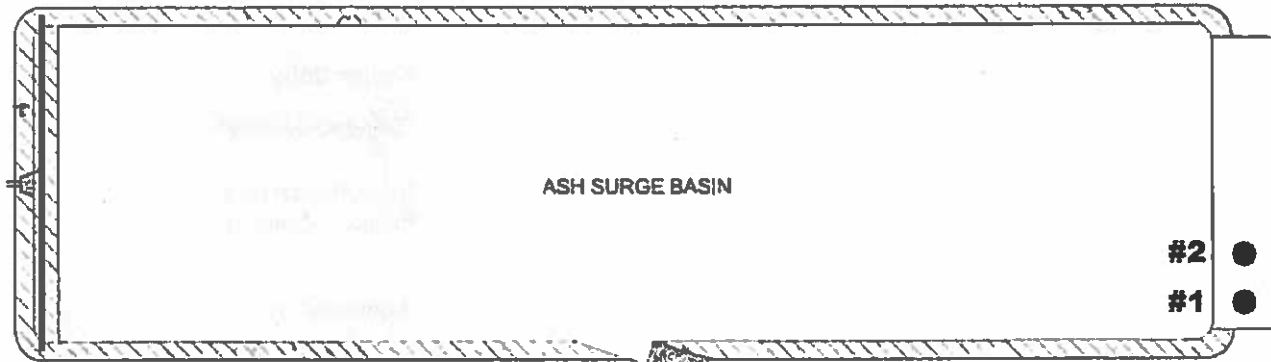
FIGURE 1. APPROXIMATE LOCATIONS OF THE LEAKS FOUND IN THE ASH SURGE BASIN

Table 1. Approximate Locations and Descriptions of the Leaks Found in the Ash Surge Basin

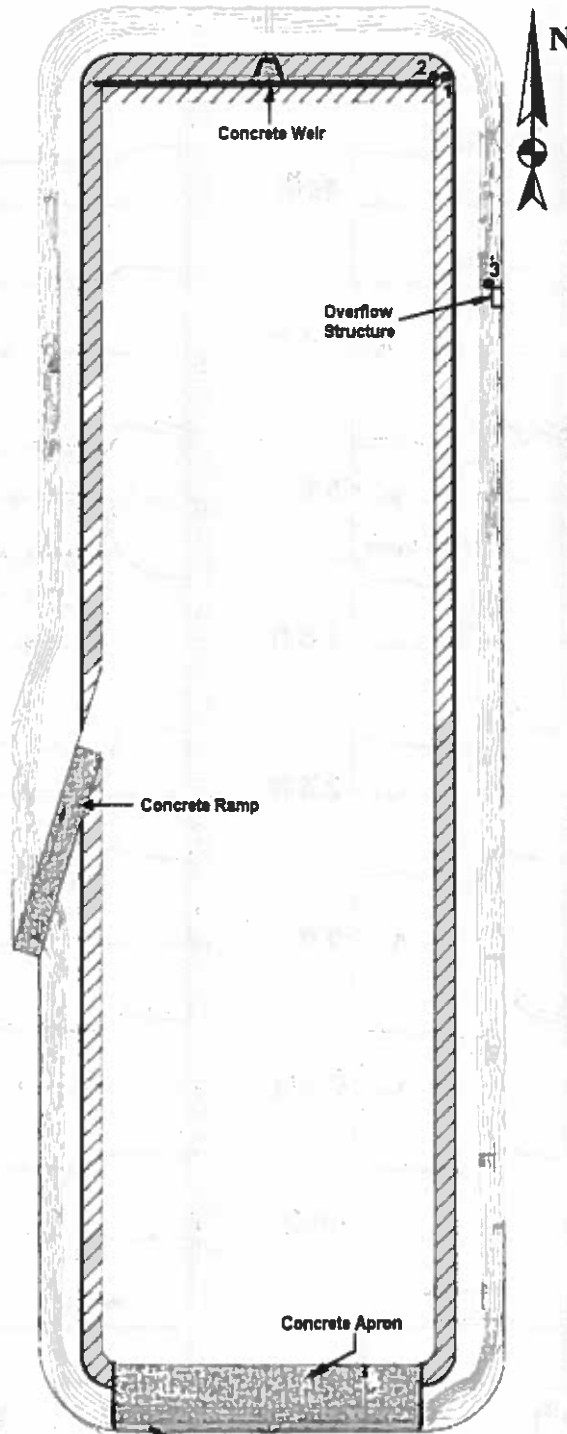
FIGURE 1. APPROXIMATE LOCATIONS OF LEAKS FOUND IN THE BASIN

Table 1. Approximate Locations and Descriptions of Leaks Found in the Basin
