ADMINISTRATIVE CITATION

AC 07-41

**ILLINOIS ENVIRONMENTAL PROTECTION AGENCY  
Open Dump Inspection Checklist**

**DATE:** January 3, 2007  
**TO:** DLPC / Division File  
**FROM:** Paul Eisenbrandt, DLPC/FOS Springfield Region  
**SUBJECT:** LPC #1378675003 – Morgan County  
Waverly/Suttles  
C-04-077-C  
FOS File

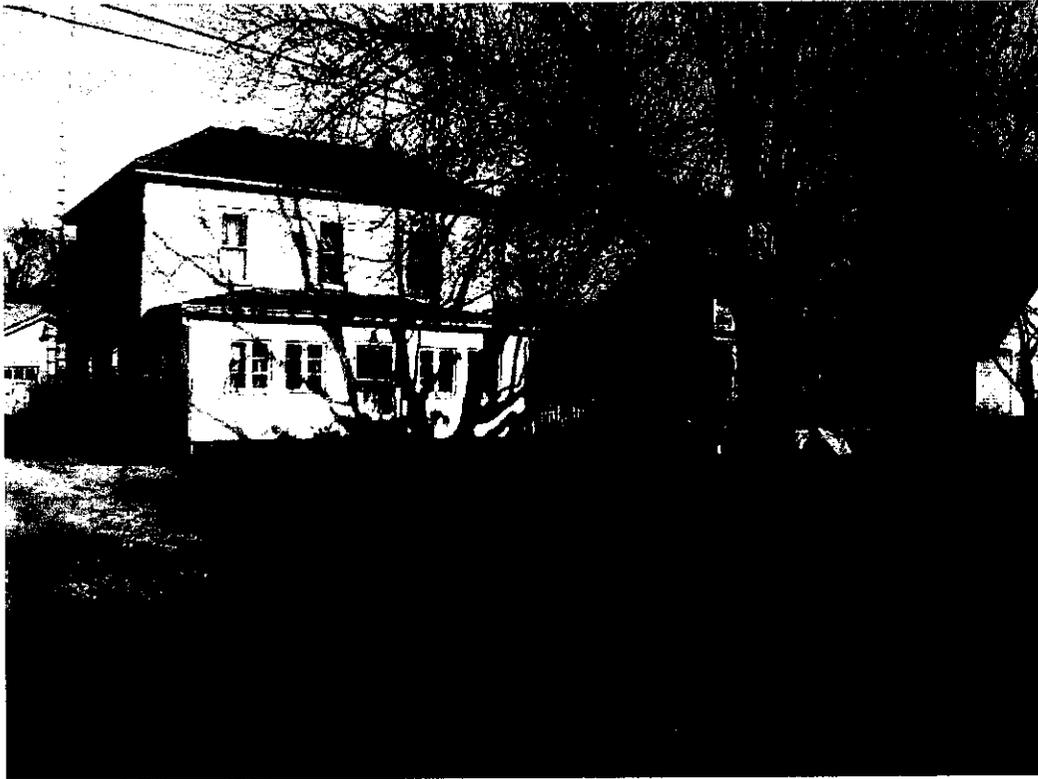
**Date:** December 18, 2006  
**Time:** 10:49 AM  
**Direction:** NE  
**Photo by:** Eisenbrandt  
**Exposure #:** 001  
**Comments:** Street elevation view of the primary residence of Glen and Elizabeth Suttles. Located west of their former residence (also seen in the picture).

Photographs 1 and 2 are street elevation views of the respondent's current and former residence, respectively. The properties are located adjacent to one another on the north side of W. Tremont Street. During the initial inspection Mr. Suttles stated he purchased items from auctions and temporarily stores them at this address as well as his other building on Elm Street. He uses, resells, or scraps out the purchased items, or allows them to go to waste. Mr. Suttles claimed unusable items are disposed of in the garbage. Mr. Suttles previously stated he burns some of the wood to heat his home. Miscellaneous items, scrap metal, and waste are still observed in the front and side yards of the homes.

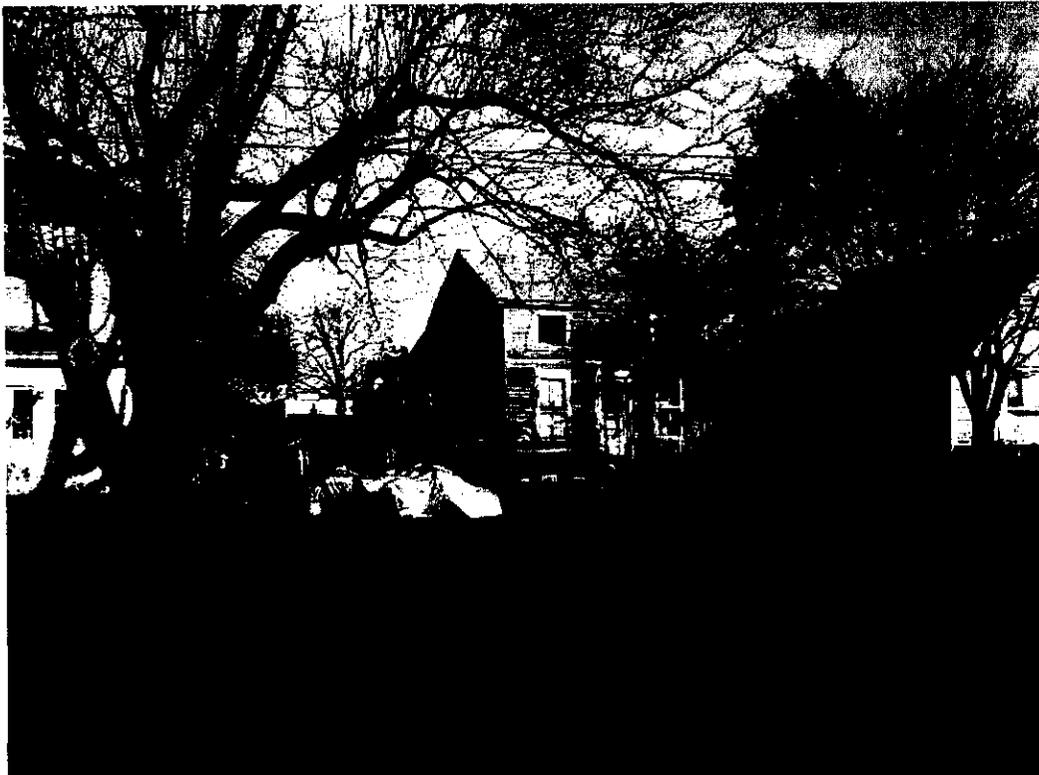
**Date:** December 18, 2006  
**Time:** 10:49 AM  
**Direction:** NE  
**Photo by:** Eisenbrandt  
**Exposure #:** 002  
**Comments:** Street elevation view of the former residence of Glen and Elizabeth Suttles. Miscellaneous items, scrap metal, and waste are still observed in the front and side yard.

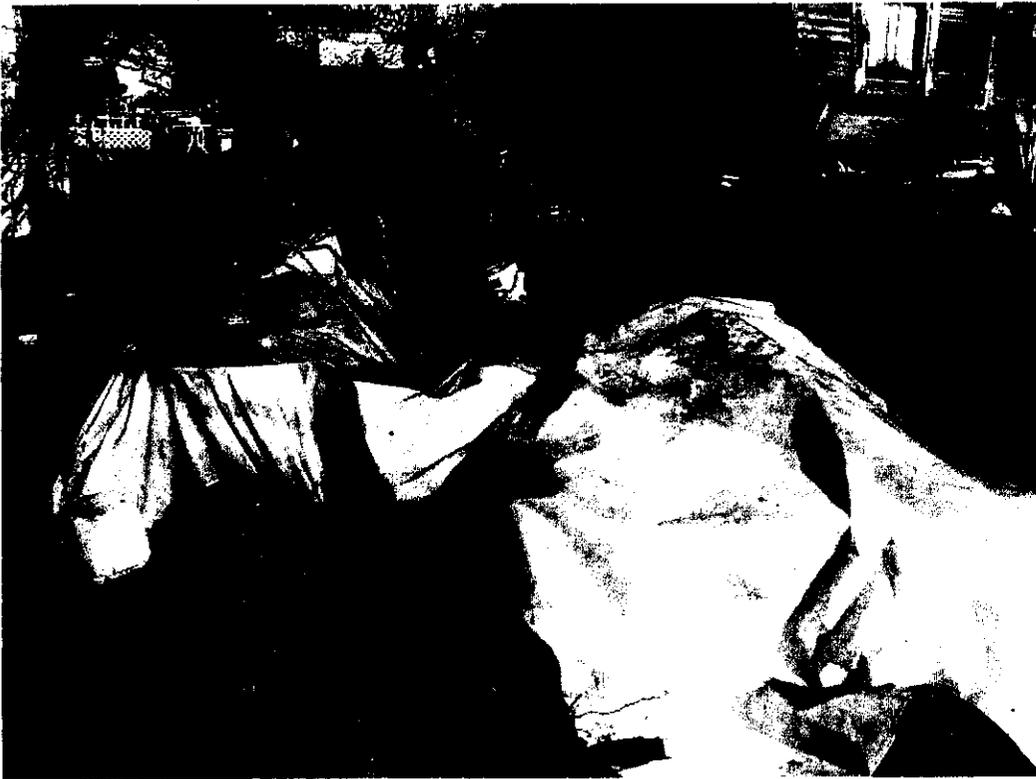
Photograph 3 shows a milk crate, cooking pans, plastic buckets, chair cushions, a dolly, a patio umbrella, a wooden box, a yellow plastic child swing, a flower pot, a plastic bowl, a desk lamp, electric weed eaters, a pink toilet brush, extension cords, folding chairs, Christmas lights, plastic crates, shelving, a cardboard box, dimensional lumber, a wheel barrow under a tarp, along with numerous other items stored in the front yard.

**Date:** December 18, 2006  
**Time:** 10:52 AM  
**Direction:** N  
**Photo by:** Eisenbrandt  
**Exposure #:** 003  
**Comments:** Patio furniture, cooking pans, electrical fixtures, lawn equipment, interior seat cushions, and crates, boxes, and buckets were observed near and under a tarp in the front yard.

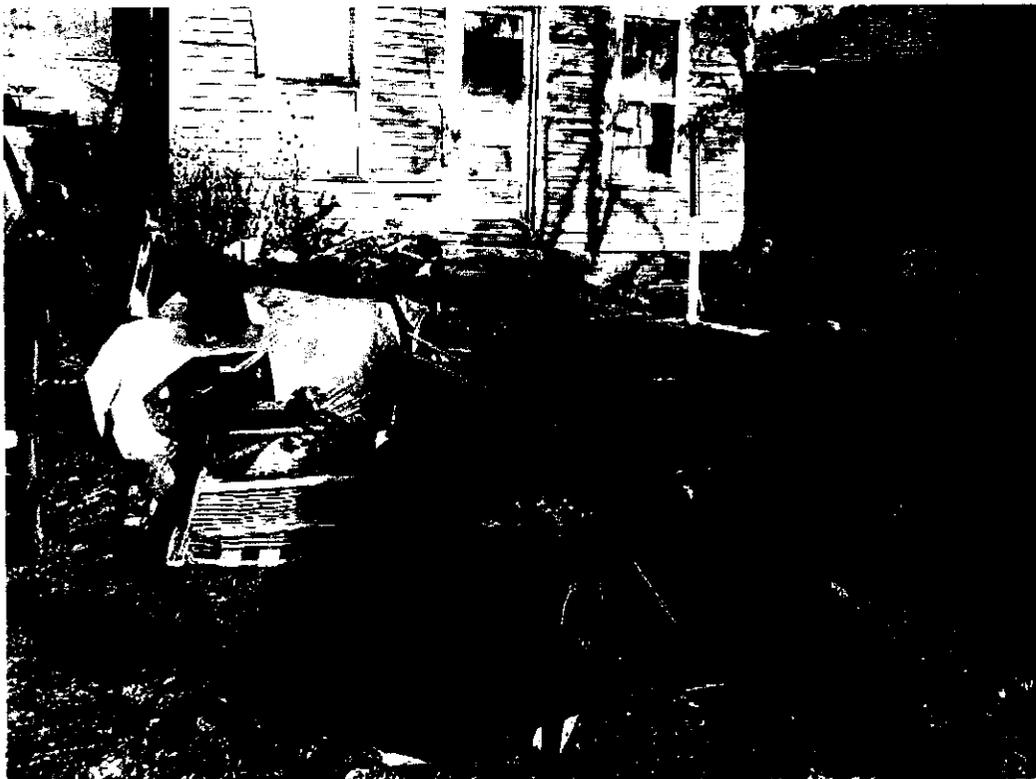
Photograph 4 shows an old sewing machine, wood tables, black rubber hose, a croquette set, umbrellas, lawn chairs, a tee ball stand, metal shelf brackets, a milk crate, a broken Coleman

lantern, plastic buckets, plastic storage boxes, fishing poles, wood siding, green clothes line, a wooden pallet, and numerous other miscellaneous items stored in the front yard of the older residence.

**Date:** December 18, 2006  
**Time:** 10:59 AM  
**Direction:** NE  
**Photo by:** Eisenbrandt  
**Exposure #:** 004  
**Comments:** Lawn chairs, a household table, a sewing machine, a tee-ball stand, plastic storage boxes, fishing poles, umbrellas, and miscellaneous debris were observed tarped in the front yard of the former residence.

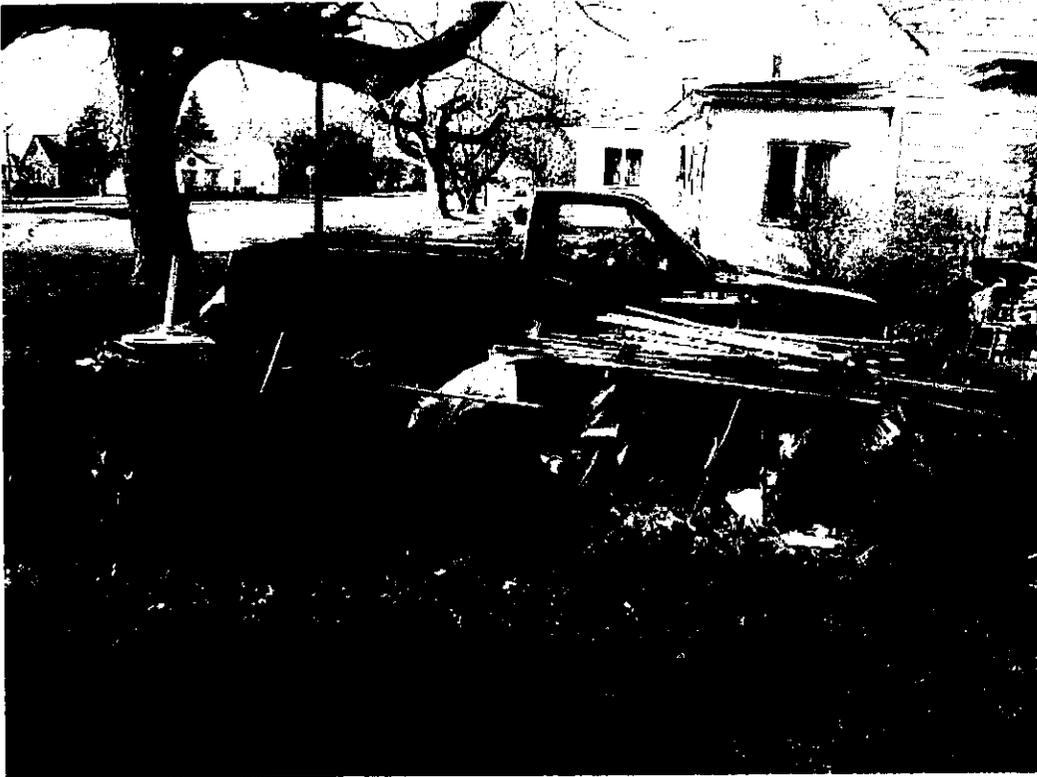
Photograph 5 shows a makeshift table made out of sawhorses, an interior ceiling fan, a shovel, a broken pitch fork, several 1-gallon paint cans, a Hoover vacuum, a rusty tool box, a weed eater, carpet, a wire basket, a circular saw, crutches, storm windows, a satellite dish, and other miscellaneous debris.

**Date:** December 18, 2006  
**Time:** 11:04 AM  
**Direction:** W  
**Photo by:** Eisenbrandt  
**Exposure #:** 005  
**Comments:** An interior ceiling fan, a broken pitch fork, a Hoover vacuum, a rusty tool box, carpet, a circular saw, paint cans, storm windows, a satellite dish, and additional debris in the front yard of the former residence.

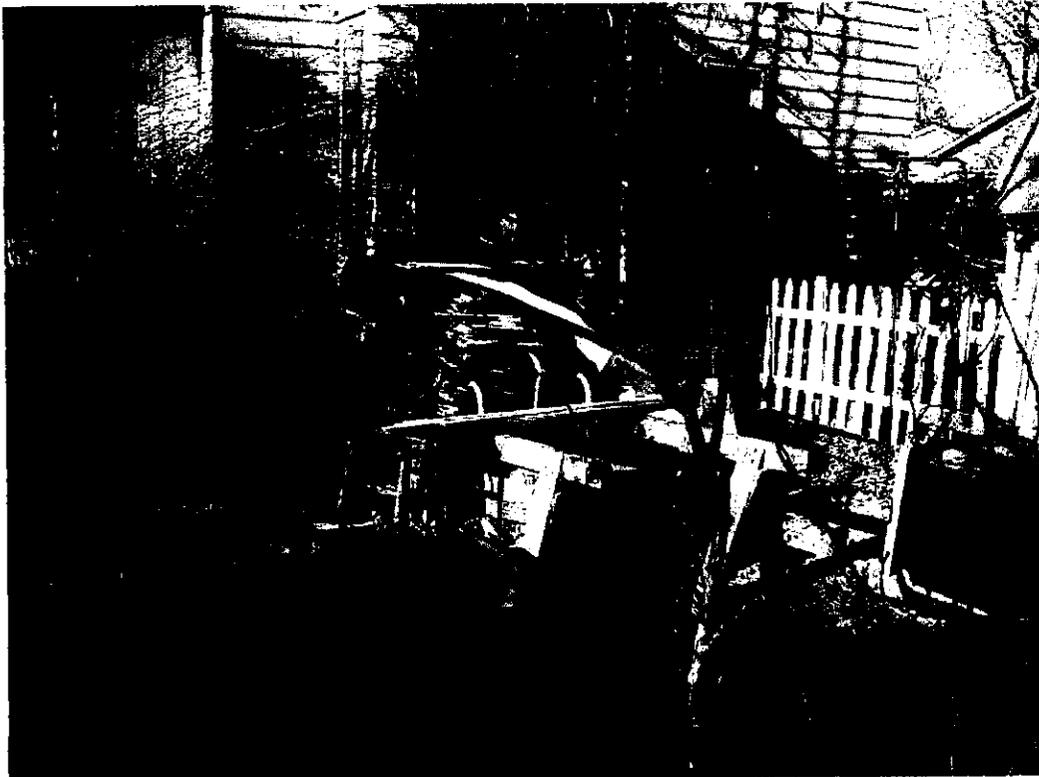
Photograph 6 shows a pile of OSB cutoffs, a plastic bin, a wood stool, sawhorses, a wood end table, plastic buckets, a handicap toilet seat, a metal table base, a wheel barrow, a pink child bicycle, asphalt shingles, and scrap wood that was observed between the two houses.

**Date:** December 18, 2006  
**Time:** 11:07 AM  
**Direction:** NW  
**Photo by:** Eisenbrandt  
**Exposure #:** 006  
**Comments:** Stacked OSB cutoffs, sawhorses, a plastic bin, a wood end table, asphalt shingles, and a wood stool were among other miscellaneous debris observed between the two houses.

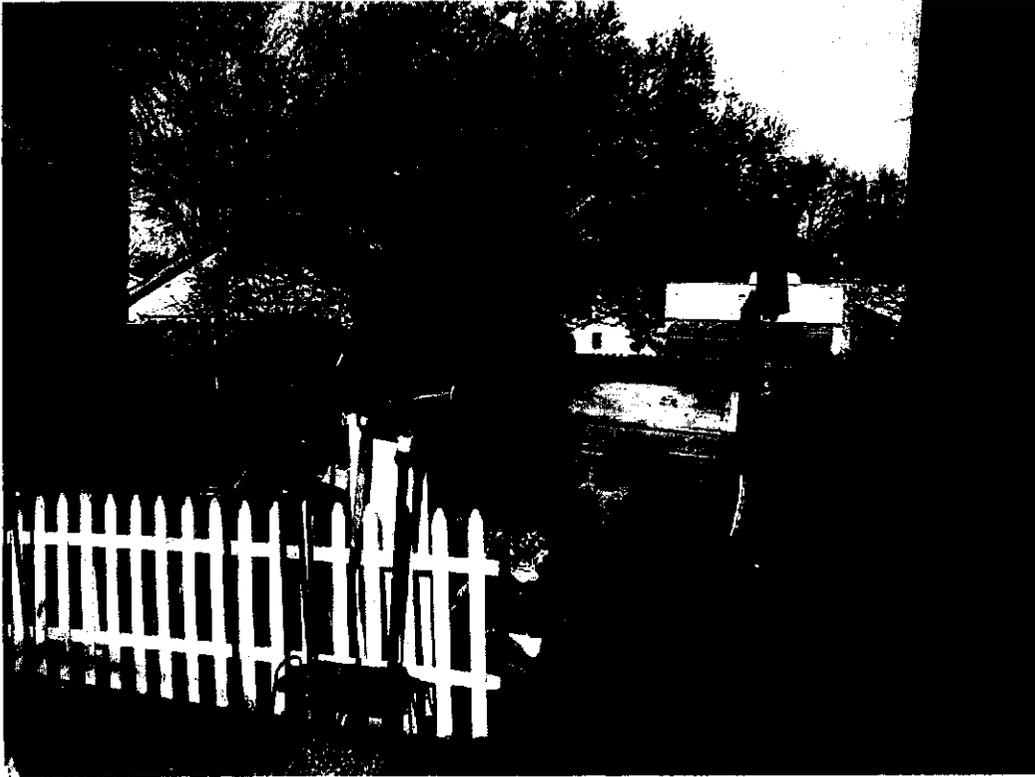
Photograph 7 shows a patio umbrella, a section of white picket fence, a metal clothes rack, a wood bookshelf, a console TV, paint cans, cinder block, hoses, a white stove, two household lamps, and other miscellaneous debris.

**Date:** December 18, 2006  
**Time:** 11:11 AM  
**Direction:** N  
**Photo by:** Eisenbrandt  
**Exposure #:** 007  
**Comments:** A patio umbrella, a section of white picket fence, a metal clothes rack, a wood book shelf, a console TV, a white stove, two household lamps, and other miscellaneous debris were observed between the two houses.

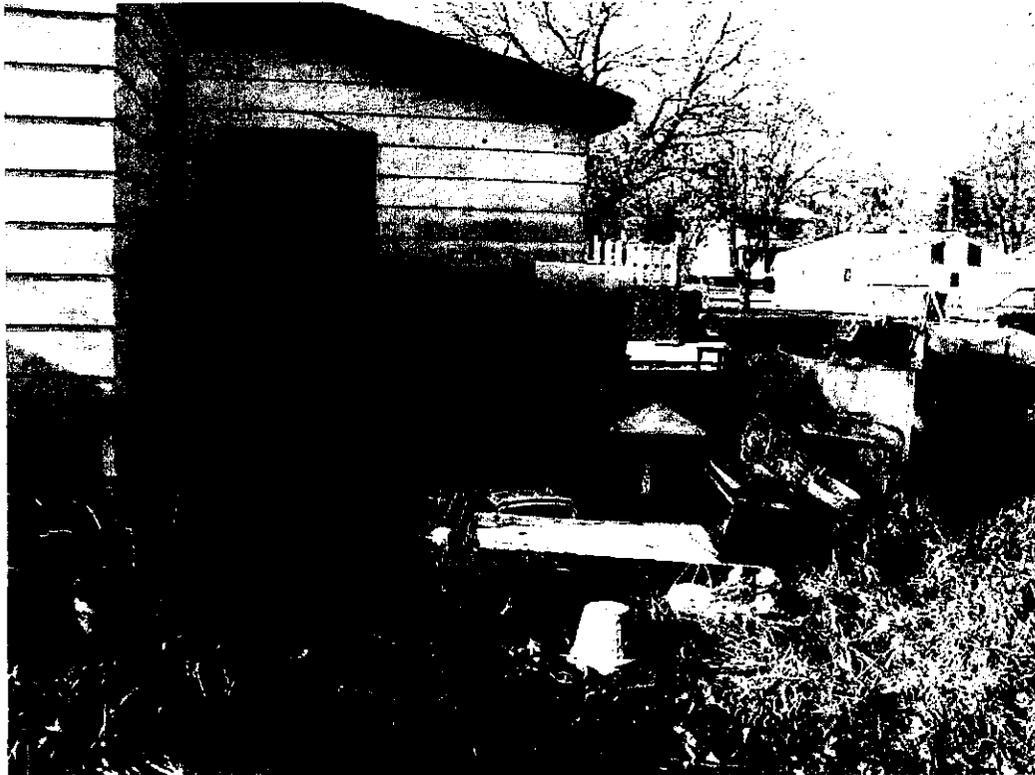
Photograph 8 shows the rear entry to the house that is surrounded by stacks of flower pots, an upright freezer, a Maytag washing machine, a metal rack, glass window panes, and plastic bins among other items.

**Date:** December 18, 2006  
**Time:** 11:15 AM  
**Direction:** W  
**Photo by:** Eisenbrandt  
**Exposure #:** 008  
**Comments:** The rear entry to the house is surrounded by stacks of flower pots, an upright freezer, and numerous other items.

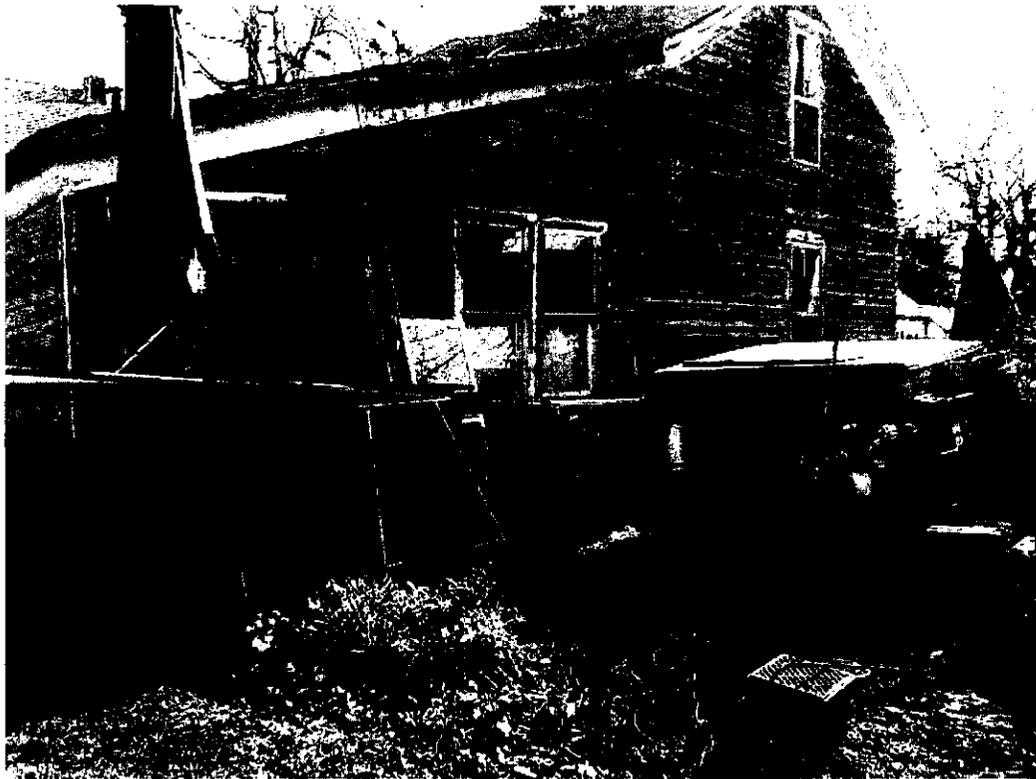
Photograph 9 shows a stack of lumber against the former residence. A patio umbrella, storm windows, black garden edging, a TV antenna, a wooded ladder, piping, rebar, plastic flowers, and a pickup truck bed trailer full of miscellaneous wood scrap and debris was observed near the former residence.

**Date:** December 18, 2006  
**Time:** 11:17 AM  
**Direction:** SE  
**Photo by:** Eisenbrandt  
**Exposure #:** 009  
**Comments:** Lumber is stacked against the old home. A pickup truck bed trailer full of scrap wood, fake flowers, and miscellaneous debris was observed between the two homes.

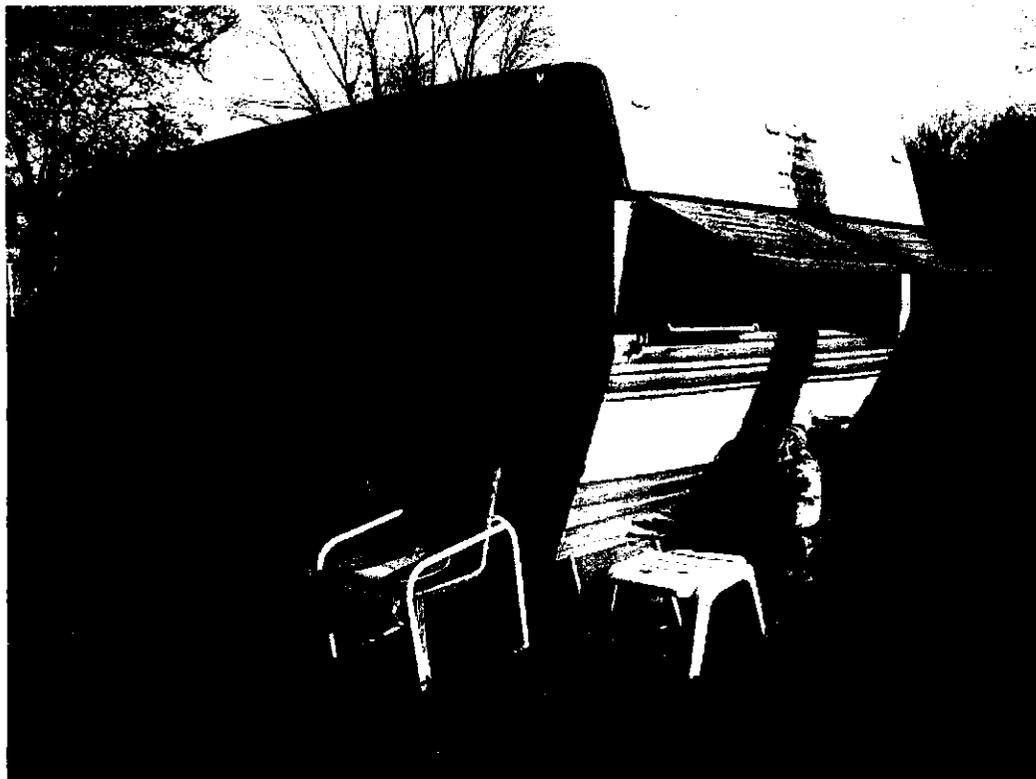
**Date:** December 18, 2006  
**Time:** 11:20 AM  
**Direction:** NE  
**Photo by:** Eisenbrandt  
**Exposure #:** 010  
**Comments:** Travel trailer stored in the back yard.

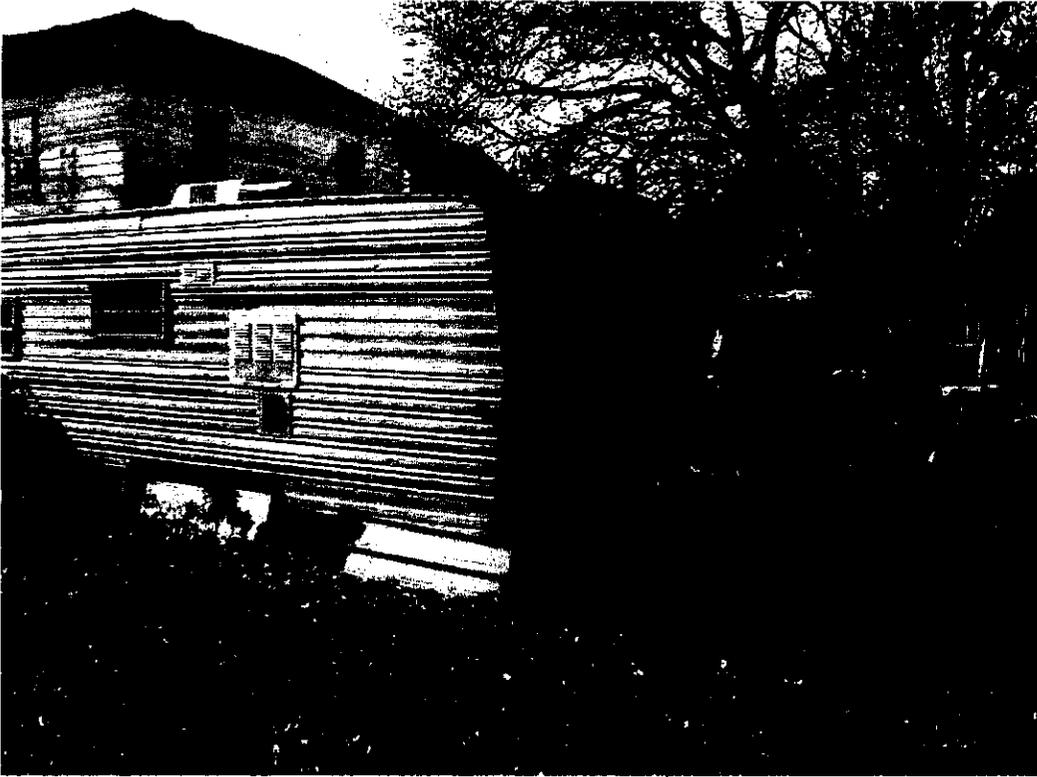
Photograph 10 shows a travel trailer parked in the rear yard of the former residence. Photograph 11 shows miscellaneous debris stored on pallets behind the travel trailer. Two dollies, several wood pallets, rusty lawn chairs, a metal office desk, laundry baskets, scrap wood, plastic buckets, a chain saw case, box fan grills, and saw horses that were some of the items observed. Since the last inspection additional items have accumulated here.

**Date:** December 18, 2006  
**Time:** 11:21 AM  
**Direction:** SW  
**Photo by:** Eisenbrandt  
**Exposure #:** 011  
**Comments:** Behind the travel trailer miscellaneous debris is stored on pallets. The amount of debris has increased since the last inspection.

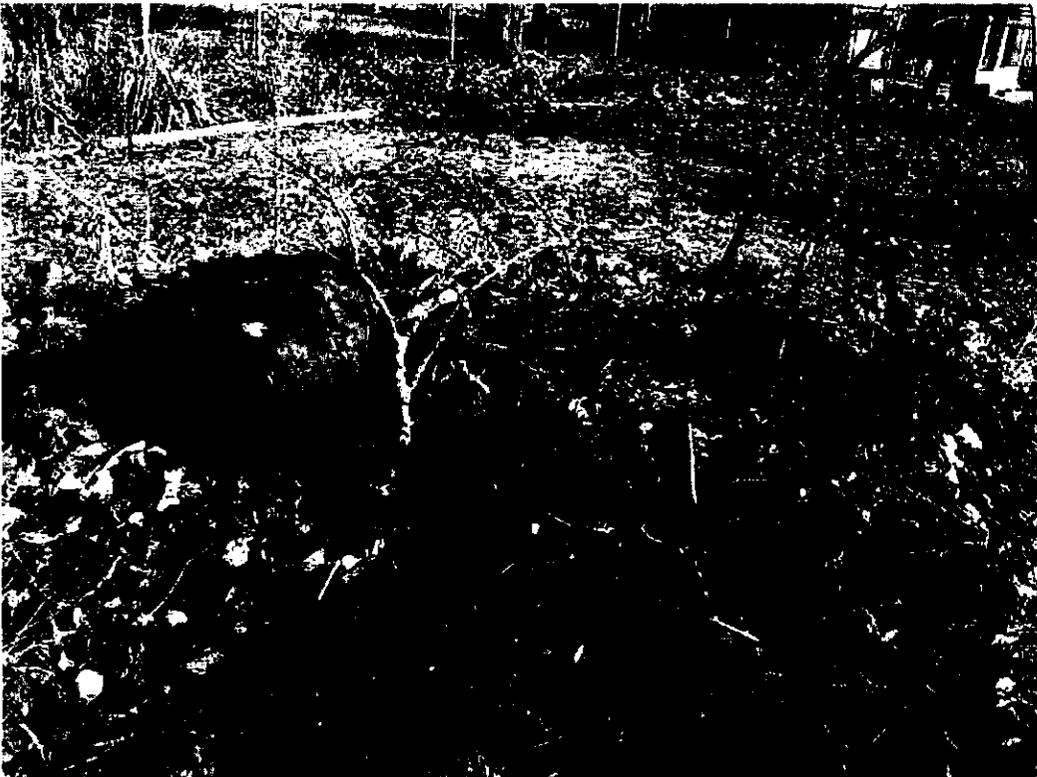
Photographs 12 and 13 show the burn pile located to the rear of the two backyards. A metal frame of a stool, a metal barrel ring, a rusty barrel, scrap metal, pie tins, a Rediwhip aerosol can, a plastic wrapper from a package of oatmeal cookies, plastic milk caps, an egg, a plastic soap dispenser, rusty cushion springs, charred wood, landscape waste, house hold waste, and aluminum cans were among the charred waste observed in the burn pile. Mr. Suttles has not cleaned up the charred waste in the burn pile. The appearance of the burn pile, and the charred waste not previously seen, indicates open burning is still occurring at the Suttles' property. In the background of Photograph 12 is a severely slanted shed and other miscellaneous debris near the east side of the garage.

**Date:** December 18, 2006  
**Time:** 11:24 AM  
**Direction:** NE  
**Photo by:** Eisenbrandt  
**Exposure #:** 012  
**Comments:** The debris in the burn pile has not been cleaned up.

If local ordinance allow a salvage business at the residence, the scrap metal must be kept organized, and moved off-site on a regular basis. No burning of waste, including the burning of insulation off of metal wire, or open dumping of automotive fluids are allowed.

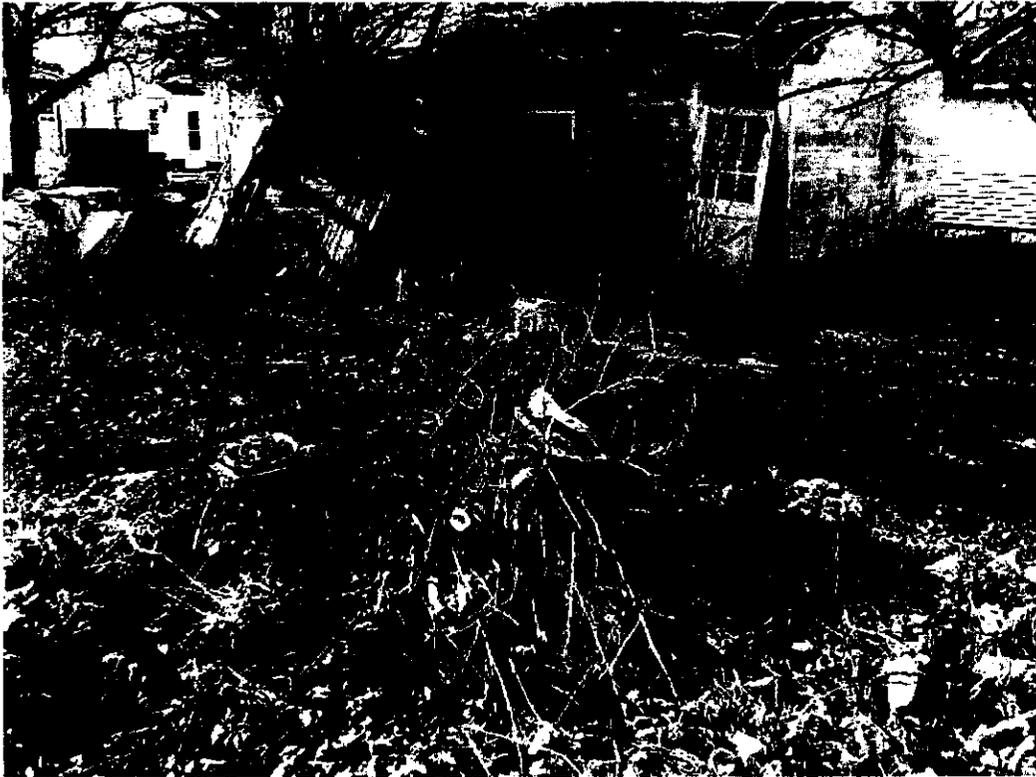
**Date:** December 18, 2006  
**Time:** 11:24 AM  
**Direction:** SW  
**Photo by:** Eisenbrandt  
**Exposure #:** 013  
**Comments:** The appearance of the burn pile, and the charred waste not previously seen, indicates open burning is still occurring at the Suttles' property.

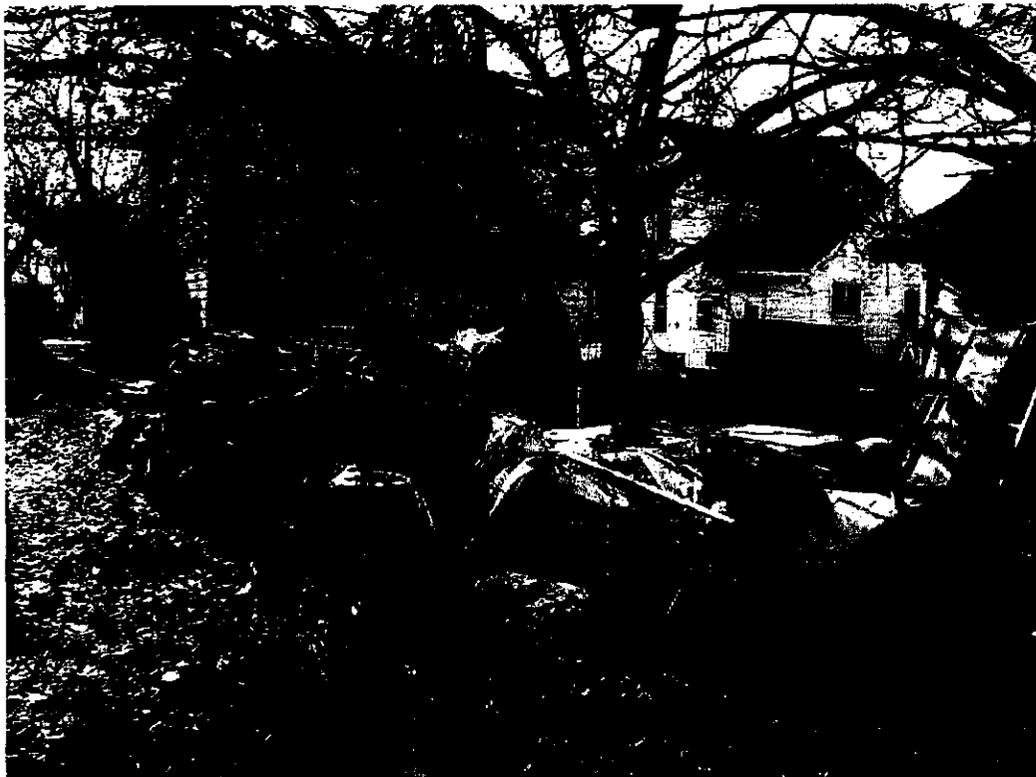
Photograph 14 shows stacks of miscellaneous items and piles of debris under tarps located east of the garage. The amount of debris in this area has not decreased since previous inspections. A rusty shopping cart, a push mower, a dolly, a metal garbage can, lawn tools, funnels, a metal cabinet, red rubber hose, a gas cylinder, and a rotten wood shelf were observed.

**Date:** December 18, 2006  
**Time:** 11:28 AM  
**Direction:** SW  
**Photo by:** Eisenbrandt  
**Exposure #:** 014  
**Comments:** Stacks of miscellaneous items and piles of debris under tarps located east of the garage. The amount of debris in this area has not decreased since previous inspections.

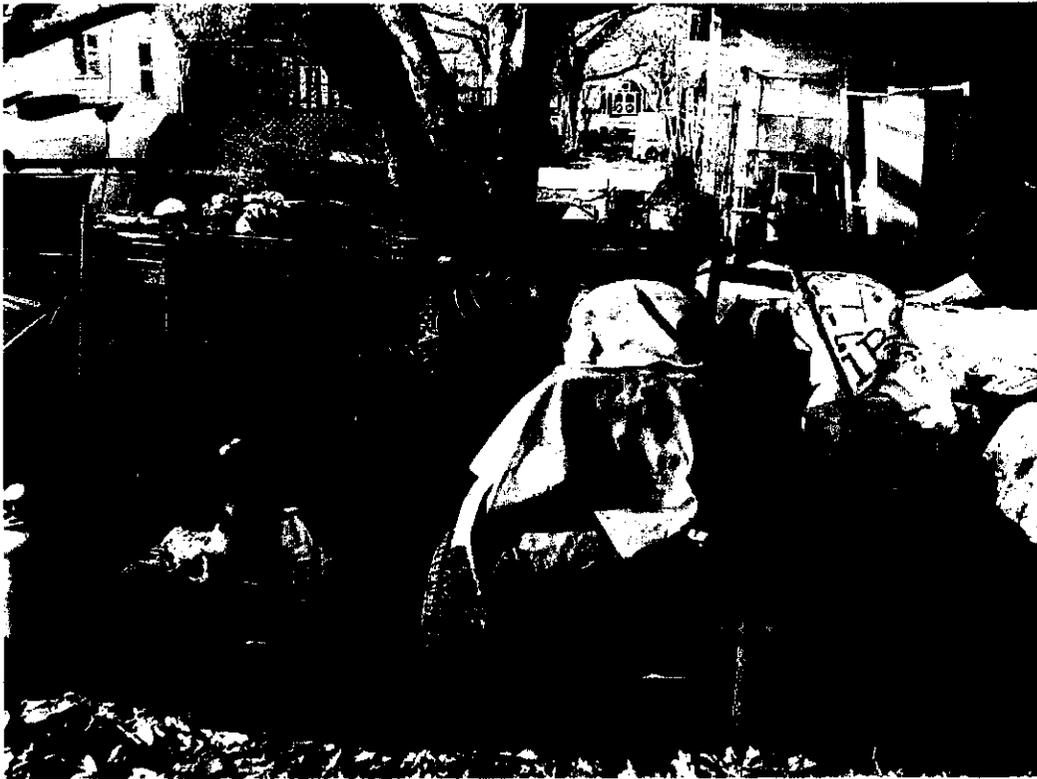
Photograph 15 shows a riding lawnmower, a file cabinet, metal boxes, paint cans, folding chairs, an air tank, dimensional lumber, hoses, a gas cylinder, storm windows, gasoline cans, and pallets of debris, that were observed east of the garage.

**Date:** December 18, 2006  
**Time:** 11:33 AM  
**Direction:** W  
**Photo by:** Eisenbrandt  
**Exposure #:** 015  
**Comments:** A riding lawnmower, a file cabinet, metal boxes, paint cans, folding chairs, an air tank, gasoline cans, and pallets of debris, are some of the items observed east of the garage.

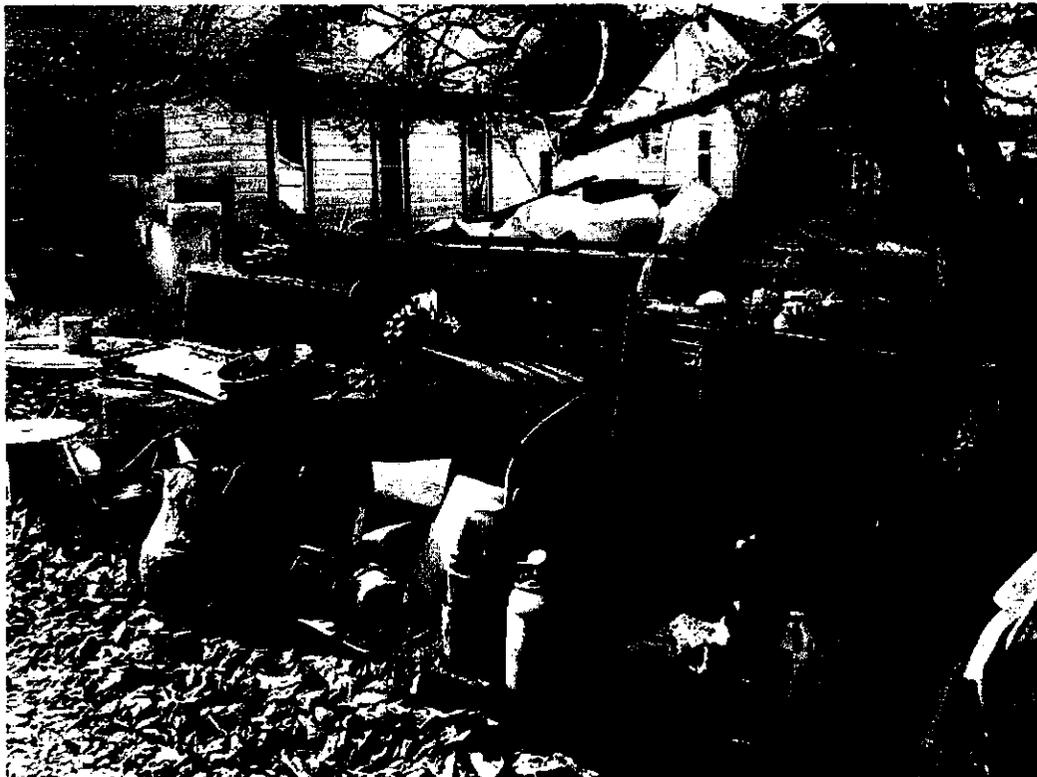
Photograph 16 shows weed eaters, chrome wheel rings, plastic buckets, wire fencing, storm windows, black plastic sheeting, folding tray tables, artificial flowers, corrugated sheet metal, and wood spindles location east of the garage.

**Date:** December 18, 2006  
**Time:** 11:33 AM  
**Direction:** SW  
**Photo by:** Eisenbrandt  
**Exposure #:** 016  
**Comments:** Weed eaters, chrome wheel rings, plastic buckets, wire fencing, storm windows, black plastic sheeting, and folding tray tables are some of the items observed east of the garage.

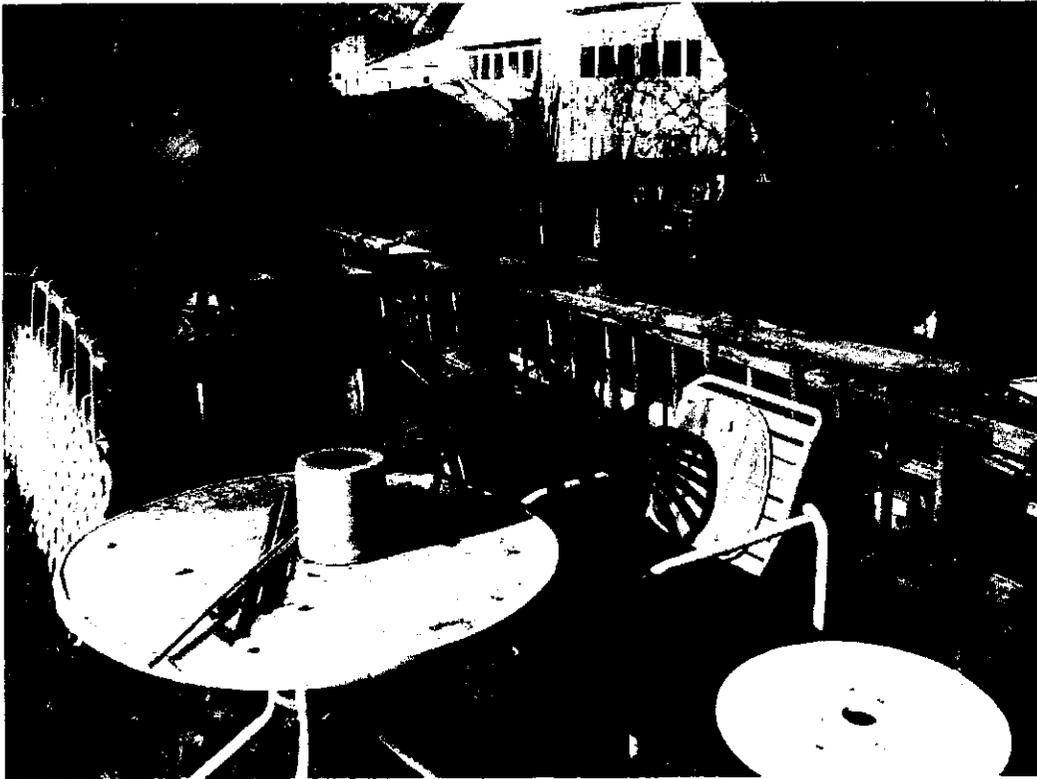
Photograph 17 shows lawn furniture, wooden ladders, aluminum ladders, lattice panels, stacks of dimensional lumber, and scrap lumber.

**Date:** December 18, 2006  
**Time:** 11:33 AM  
**Direction:** NW  
**Photo by:** Eisenbrandt  
**Exposure #:** 017  
**Comments:** Lawn furniture, wood and aluminum ladders, lattice, and stacks of dimensional lumber were observed southeast of the garage. This area has not improved since previous inspections.

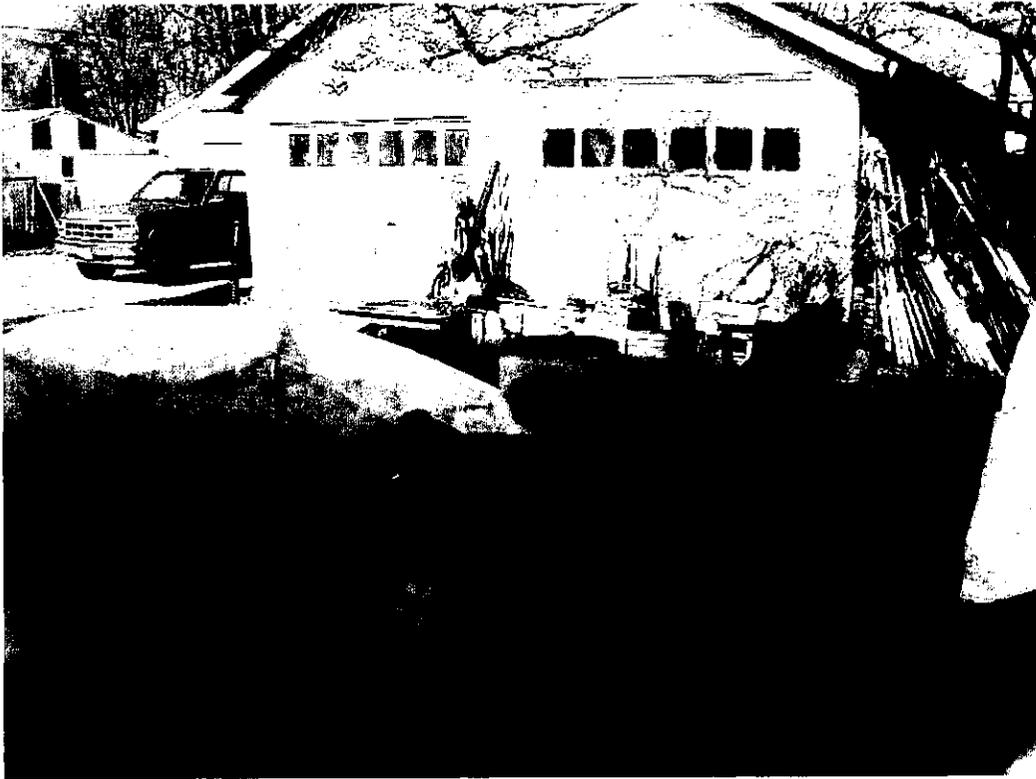
Photograph 19 shows stacks of miscellaneous debris south of the garage. Furniture, lumber, a fiber drum, a patio umbrella, and numerous boxes and bags of items were observed.

**Date:** December 18, 2006  
**Time:** 11:38 AM  
**Direction:** NW  
**Photo by:** Eisenbrandt  
**Exposure #:** 019  
**Comments:** Stacks of miscellaneous debris south of the garage. Furniture, lumber, a fiber drum, a patio umbrella, and boxes and bags of items were observed.

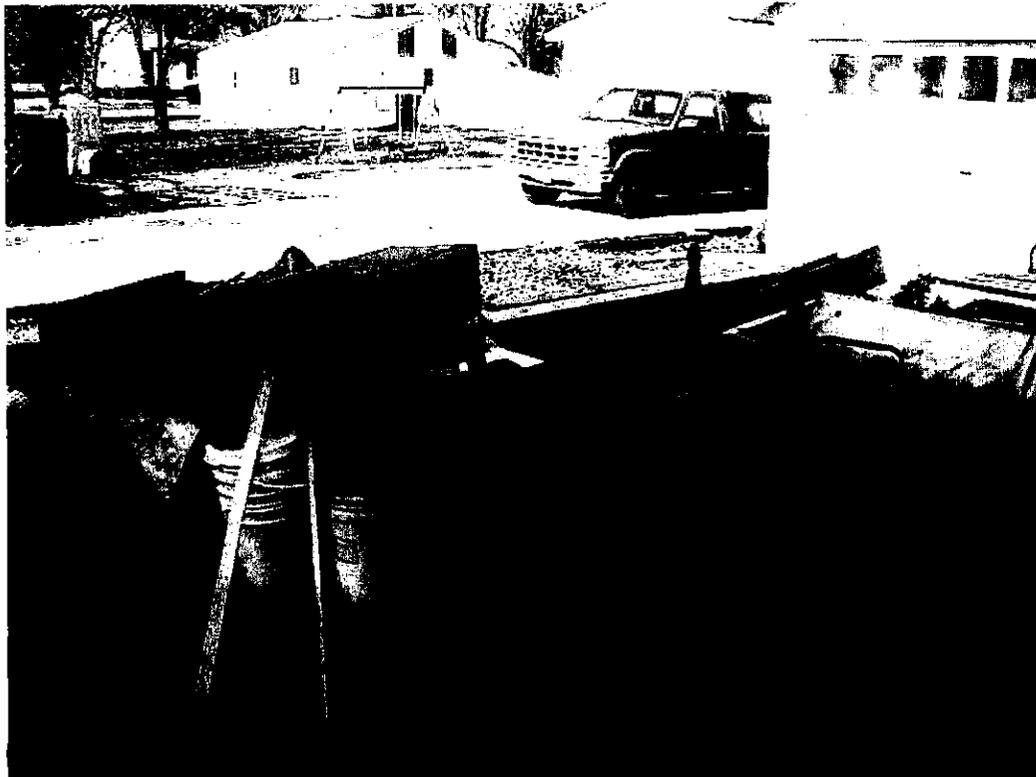
Photograph 20 shows a broken coffee table, several plastic buckets, a wooden box, a wood bookshelf, and a black TV stand that has been brought into the site since the last inspection.

**Date:** December 18, 2006  
**Time:** 11:38 AM  
**Direction:** NW  
**Photo by:** Eisenbrandt  
**Exposure #:** 020  
**Comments:** A broken coffee table, a wooden box, a black TV stand, and plastic buckets appear to be newer items to the Suttles property.

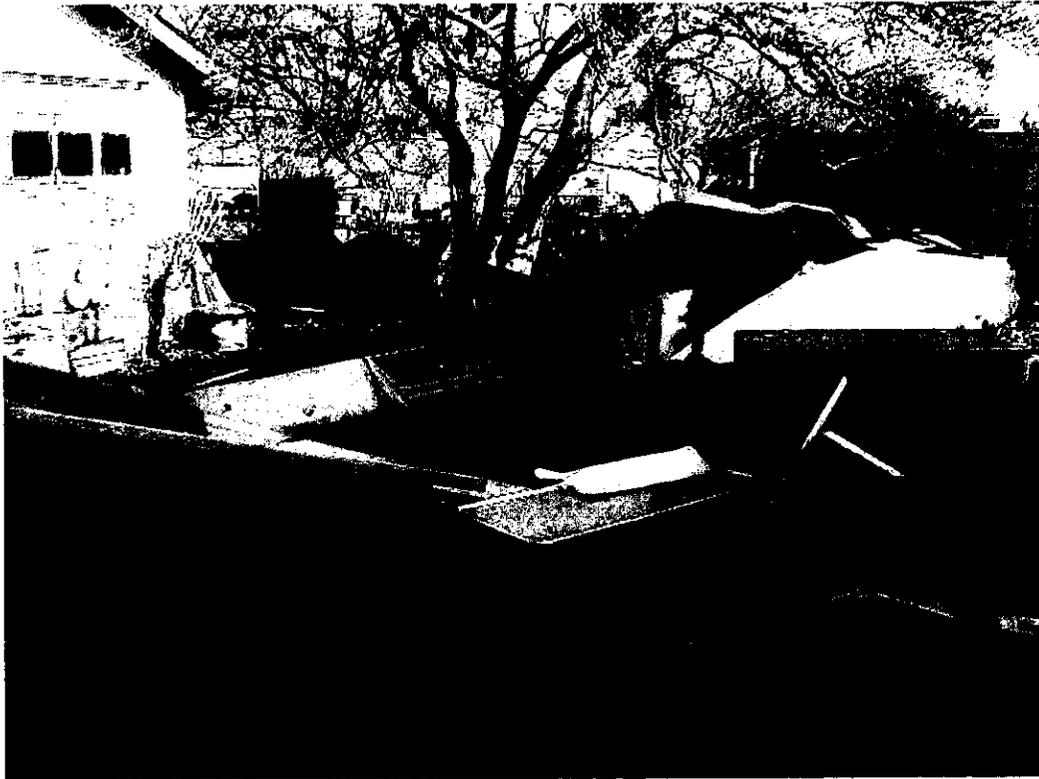
Photograph 21 shows a pile of dimensional lumber, fire wood, and items stacked in front of the garage.

**Date:** December 18, 2006  
**Time:** 11:40 AM  
**Direction:** NE  
**Photo by:** Eisenbrandt  
**Exposure #:** 021  
**Comments:** Stacks of  
lumber in front of the  
garage.

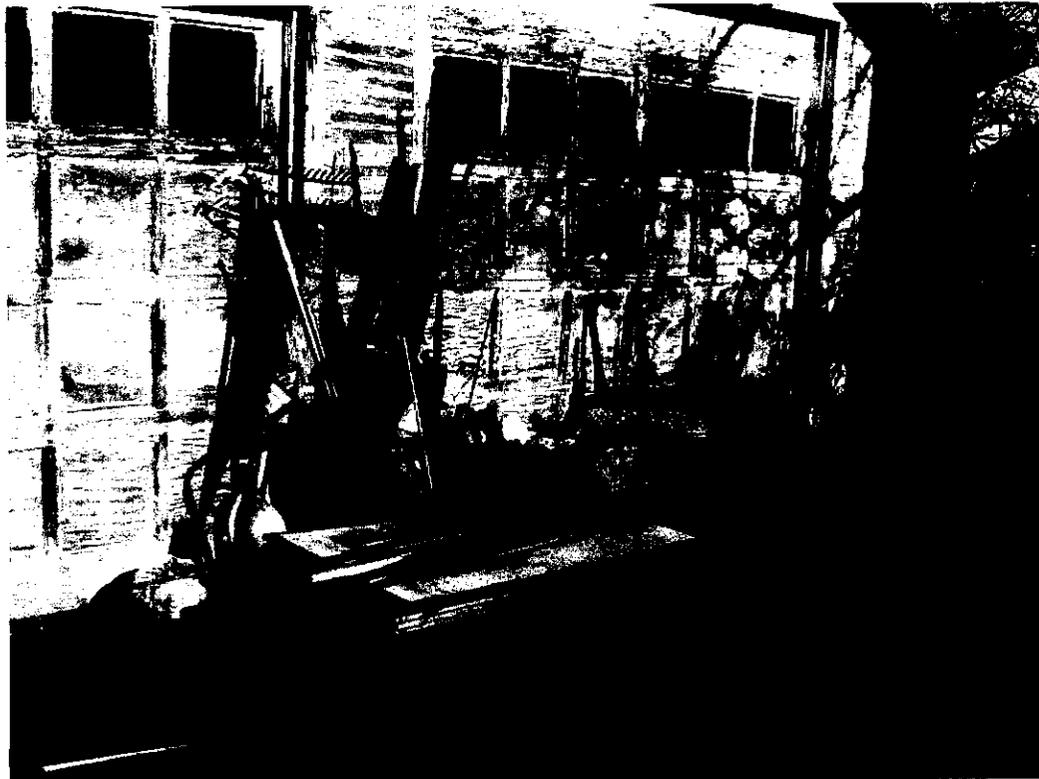
Photograph 22 shows lawn tools, broom, shovels, eraser boards, and miscellaneous items stacked against the garage.

**Date:** December 18, 2006  
**Time:** 11:41 AM  
**Direction:** NE  
**Photo by:** Eisenbrandt  
**Exposure #:** 022  
**Comments:** Lawn tools,  
brooms, eraser boards,  
and miscellaneous items  
stacked against the  
garage.
