Re: Illinois Environmental Protection Agency v. Theodore & Elizabeth Hollembeak and Hollembeak Concrete, Inc.
IEPA File No. 85-08-AC: 0090105033—Brown County

BEFORE THE ILLINOIS POLLUTION CONTROL BOARD
ADMINISTRATIVE CITATION

FACILITY: Mt. Sterling/Hollembeak Concrete SITE CODE NO.: 0090105033
COUNTY: Brown CIVIL PENALTY: \$4,500.00
DATE OF INSPECTION: May 30, 2008

Date: May 30, 2008
To: BOL File
From: William E. Zierath, BOL/FOS - Springfield Region
Subject: LPC# 0090105033 – Brown County
Mt. Sterling/Hollembeak Concrete
C-08-019-C
FOS File

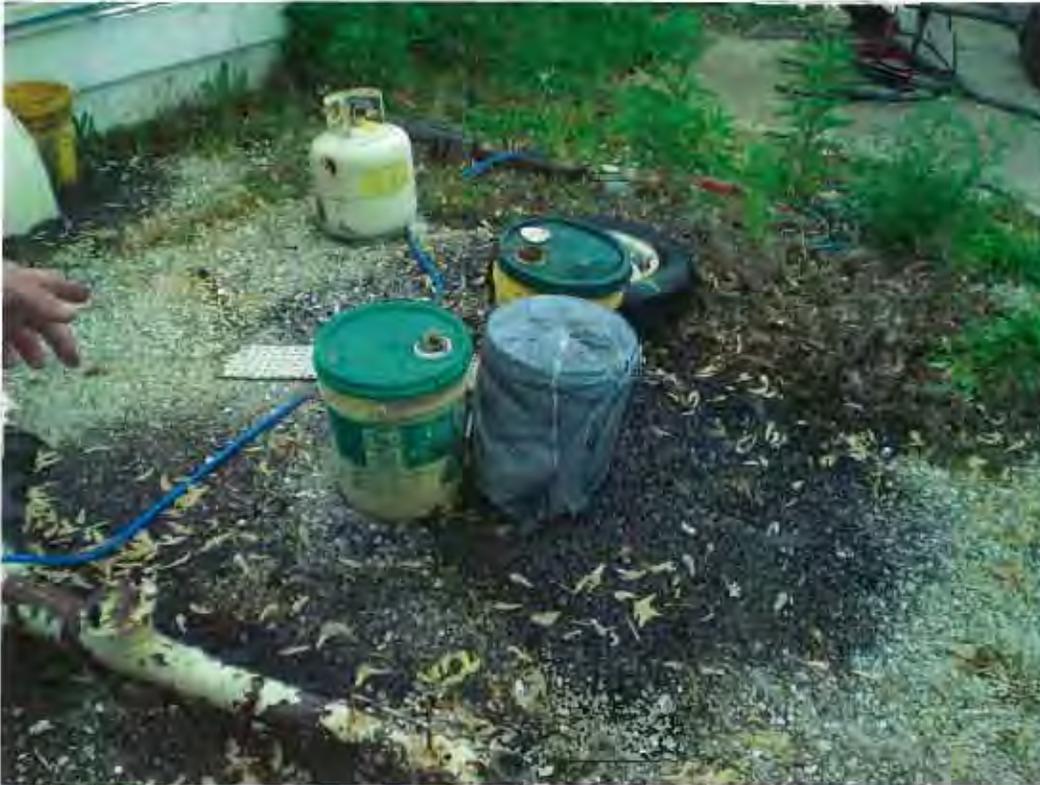
Date: May 30, 2008
Time: 11:16 AM
Direction: Southeast
Photo by: W Zierath
Exposure #: 001
Comments: Three 5-gallon buckets with used oil from do-it-yourself oil changes in the area west of the garage.

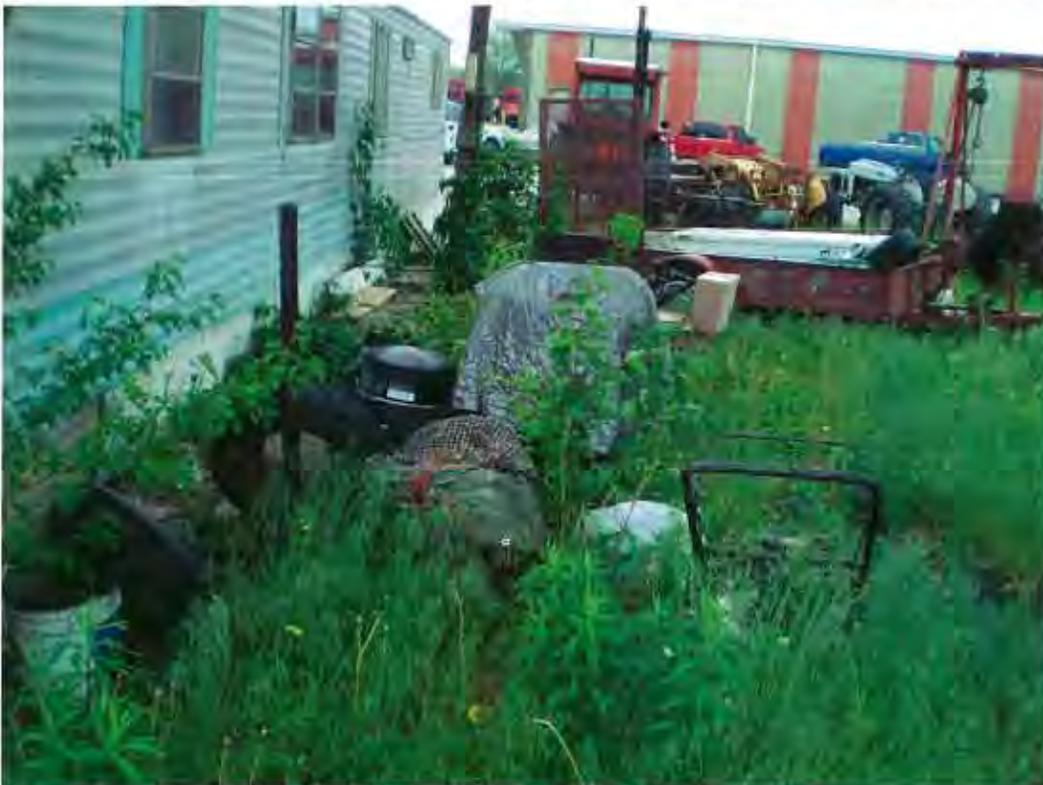
Date: May 30, 2008
Time: 11:17 AM
Direction: North
Photo by: W Zierath
Exposure #: 002
Comments: Accumulated junk including two off-rim tires in the area east of the trailer that serves as the office at this facility. Note: the tractors in the background are on the property of Kuhns Implement.

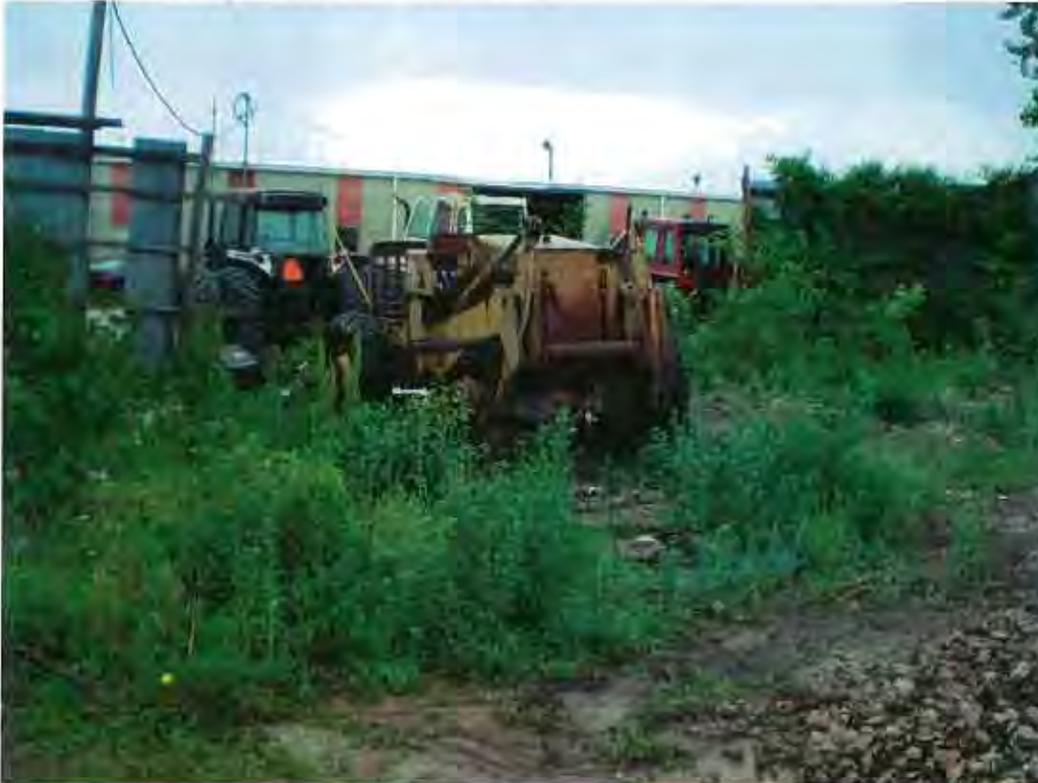
There is the remains of a wood-framed building that was missing most of its walls and its entire roof. Mr. Hollembeak said that the building had been damaged in a storm. He said that an associate was going to scrap the remaining metal on the walls and demolish the structure. The remains of the building are shown in photograph 0090105033~05302008-003.

Date: May 30, 2008
Time: 11:17 AM
Direction: Northeast
Photo by: W Zierath
Exposure #: 003
Comments: The remains of a bulldozer that Mr. Hollembeak said would be sold for scrap. The gray walls shown on both sides of the photograph are the remaining walls of a storm-damaged building that will be demolished.

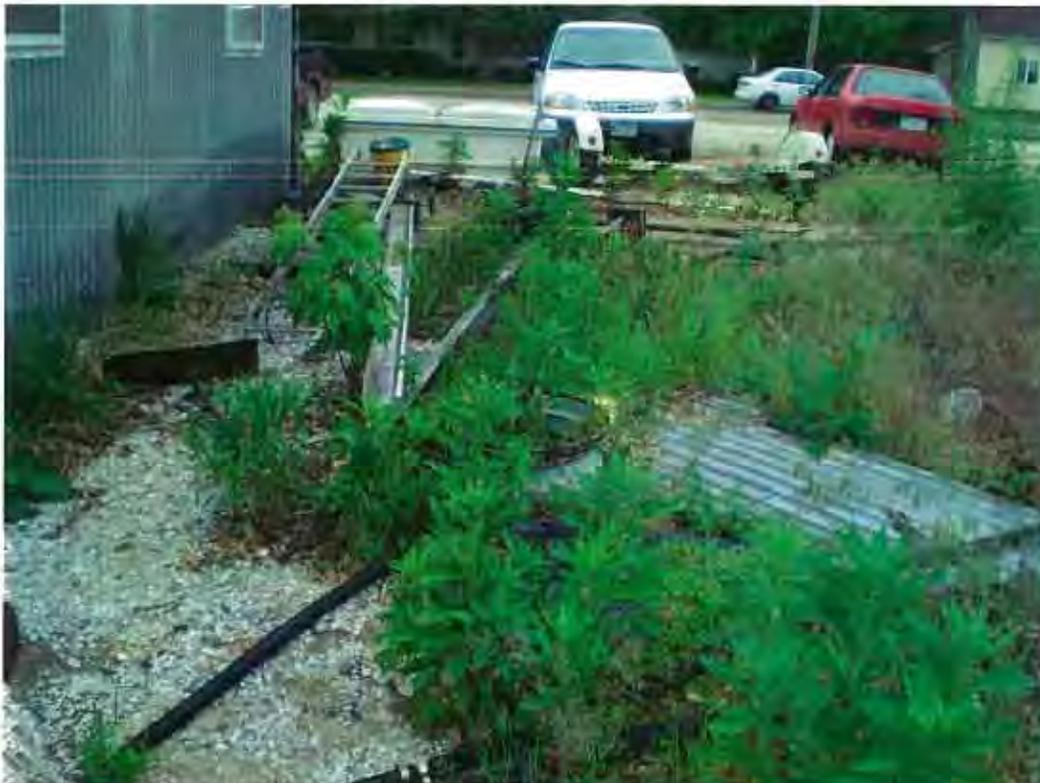
Date: May 30, 2008
Time: 11:18 AM
Direction: West
Photo by: W Zierath
Exposure #: 004
Comments: Junk located north of the garage including metal scrap.

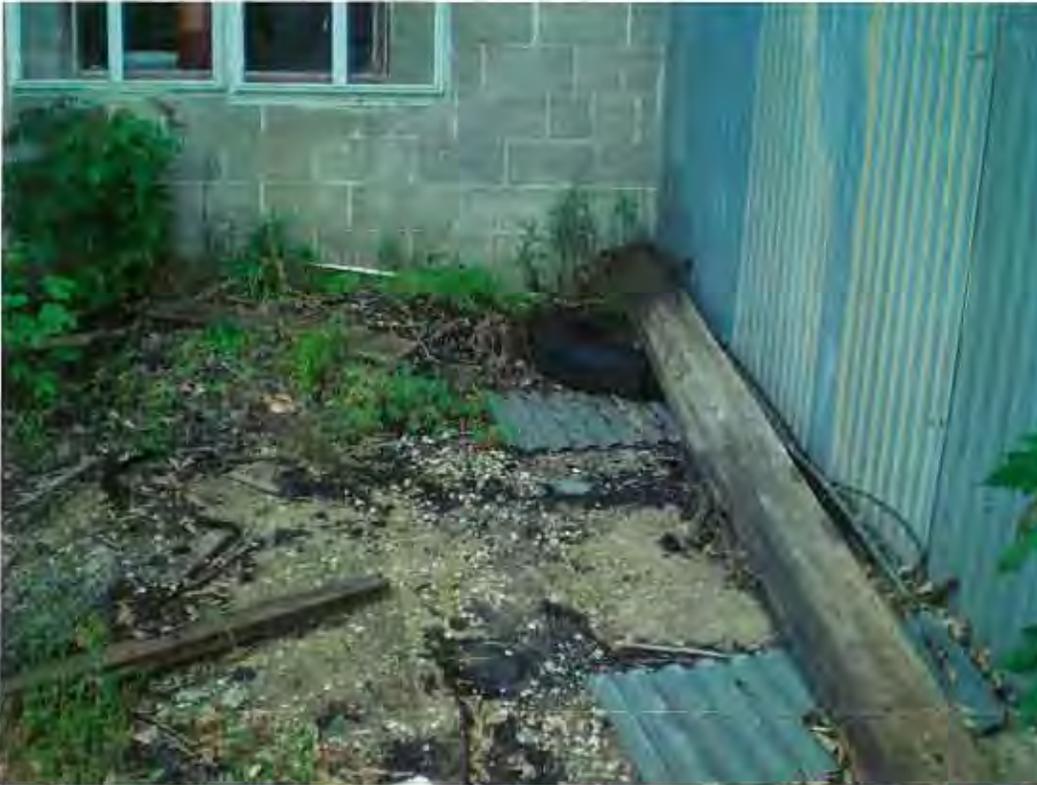
The wastes located north of the garage included scrap metal (including corrugated metal), wood demolition waste and roofing waste. Mr. Hollebeak said that the roofing waste was from the replacement of the roof on the garage several years before. The waste north of the garage is shown in photographs 0090105033~05302008-004, 0090105033~05302008-005, 0090105033~05302008-006, 0090105033~05302008-007, and 0090105033~05302008-008.

Date: May 30, 2008
Time: 11:18 AM
Direction: South
Photo by: W Zierath
Exposure #: 005
Comments: Wastes
north of the garage
including corrugated
metal, wood demolition
waste and roofing
waste.

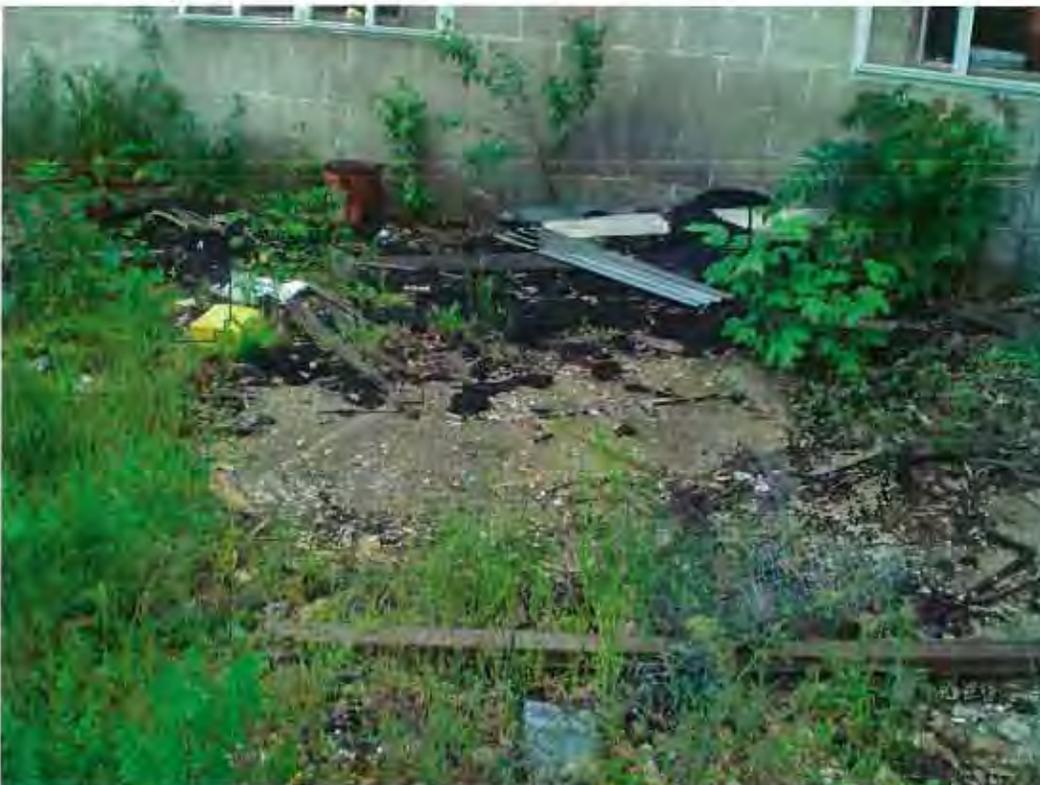
Date: May 30, 2008
Time: 11:18 AM
Direction: Southeast
Photo by: W Zierath
Exposure #: 006
Comments: Wastes
north of the garage
including corrugated
metal, wood demolition
waste and roofing
waste.

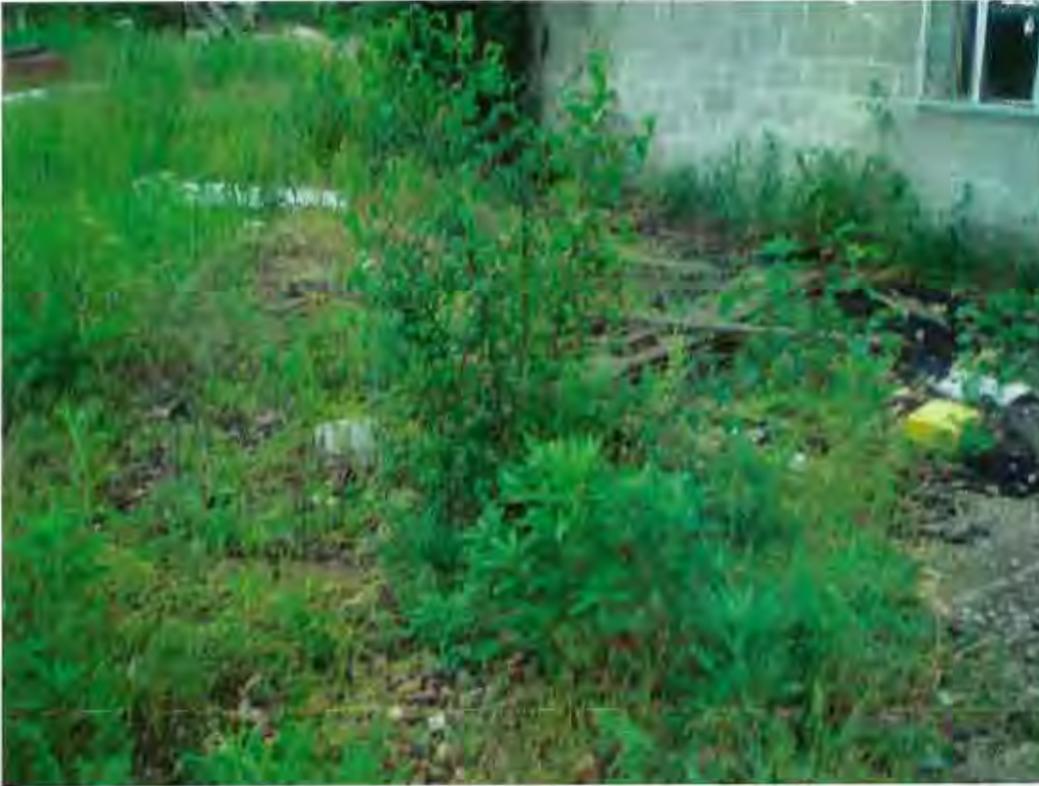
Date: May 30, 2008
Time: 11:18 AM
Direction: East
Photo by: W Zierath
Exposure #: 007
Comments: Wastes north of the garage including corrugated metal, wood demolition waste and roofing waste.

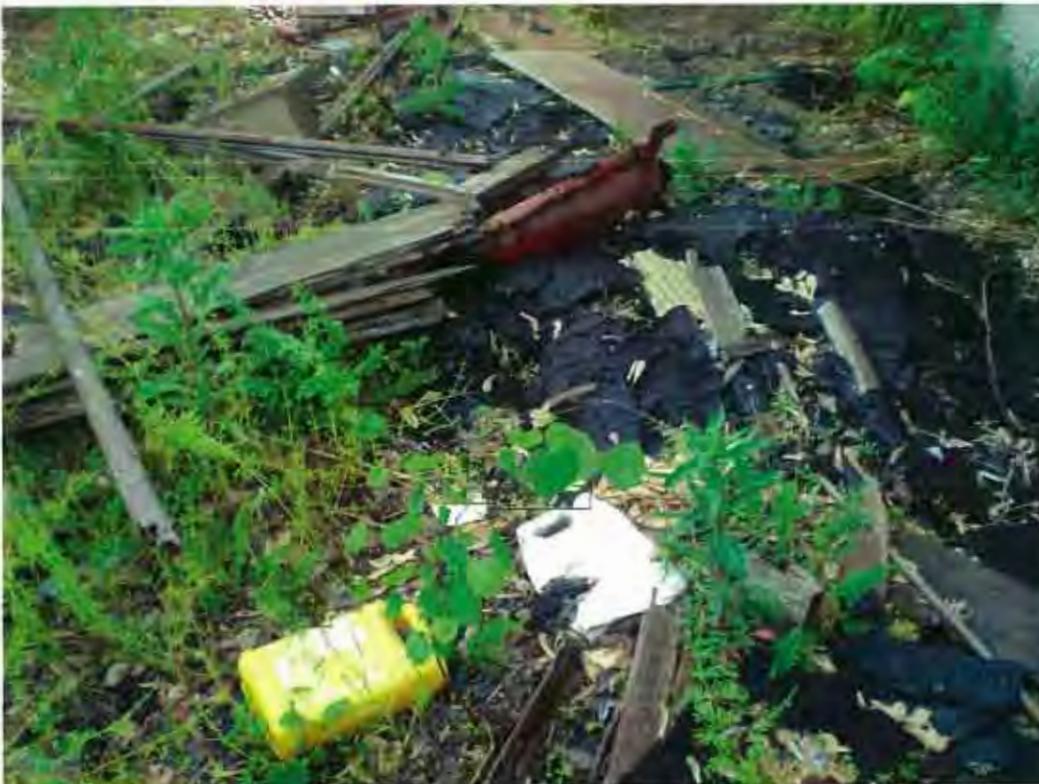
Date: May 30, 2008
Time: 11:18 AM
Direction: Southeast
Photo by: W Zierath
Exposure #: 008
Comments: Wastes north of the garage including corrugated metal, wood demolition waste and roofing waste.

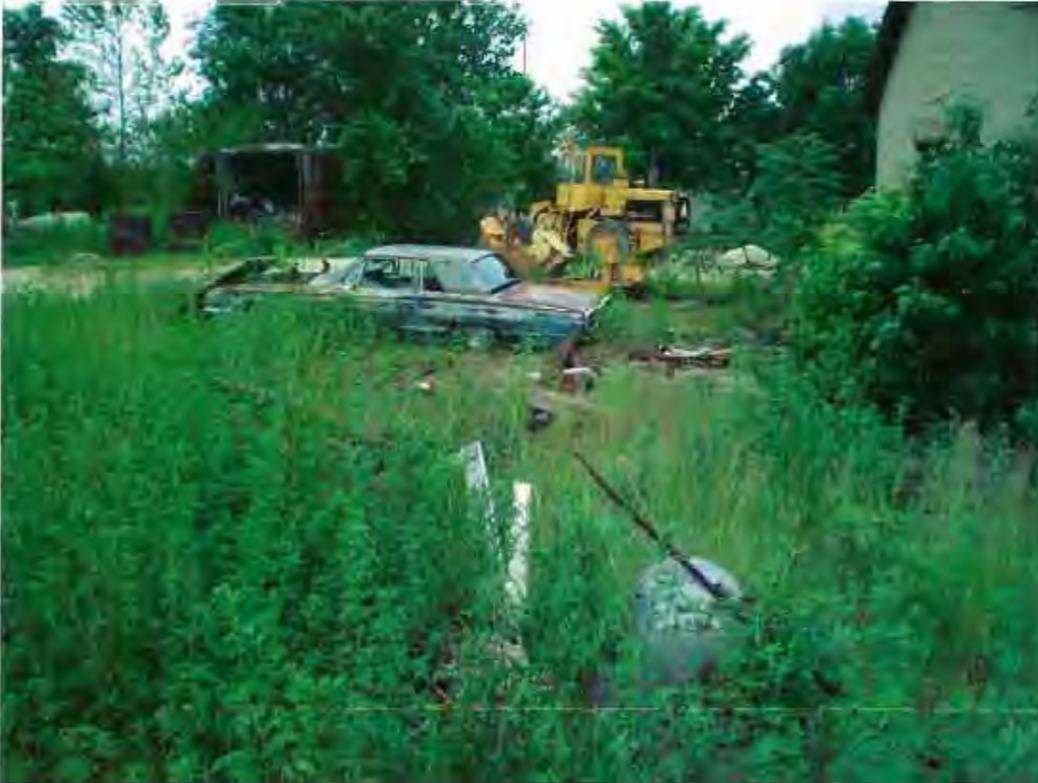
Date: May 30, 2008
Time: 11:19 AM
Direction: South
Photo by: W Zierath
Exposure #: 009
Comments: Scrap metal, wood demolition waste and an abandoned car. Mr. Hollembeak said that he would be using the car for parts.

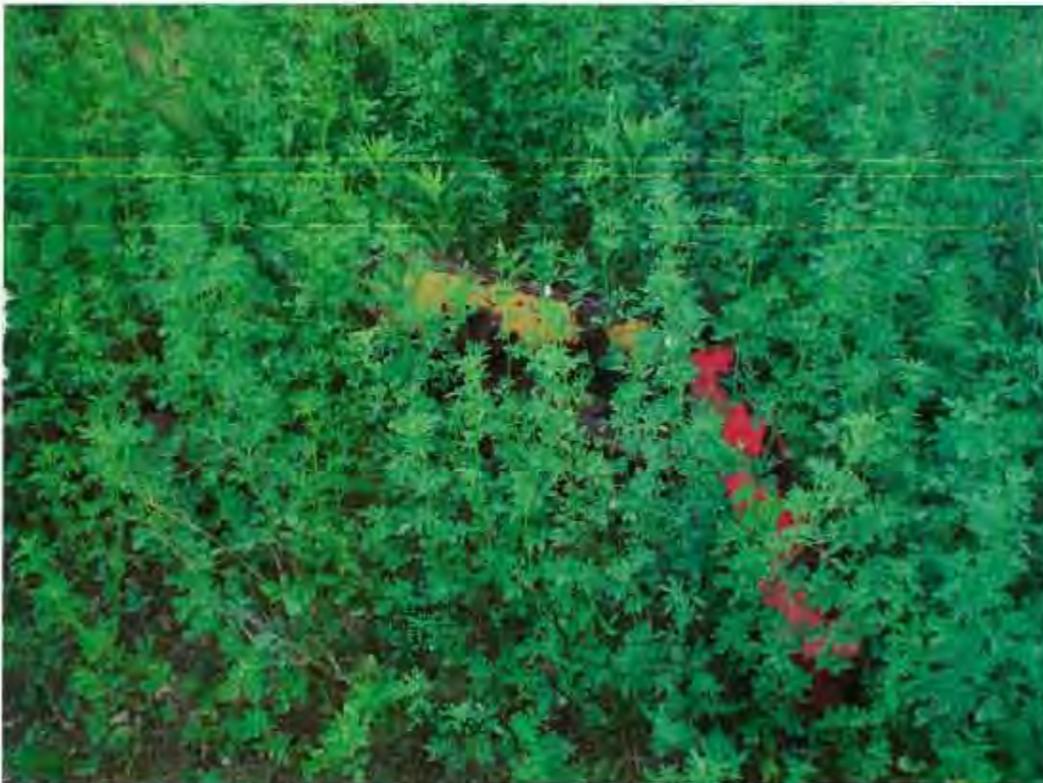
Date: May 30, 2008
Time: 11:20 AM
Direction: North
Photo by: W Zierath
Exposure #: 010
Comments: A single piece of scrap metal in the area northeast of the garage.

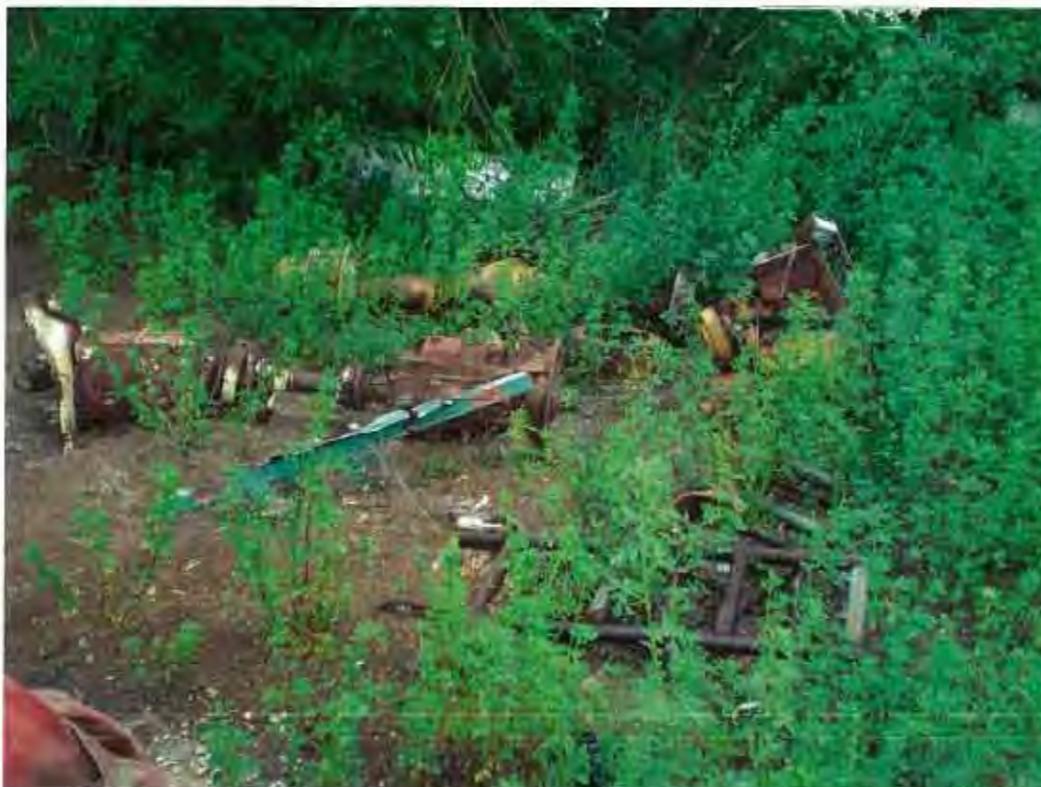
Date: May 30, 2008
Time: 11:20 AM
Direction: Northeast
Photo by: W Zierath
Exposure #: 011
Comments: Old transmissions, other vehicle parts and other scrap metal in the north part of the site.

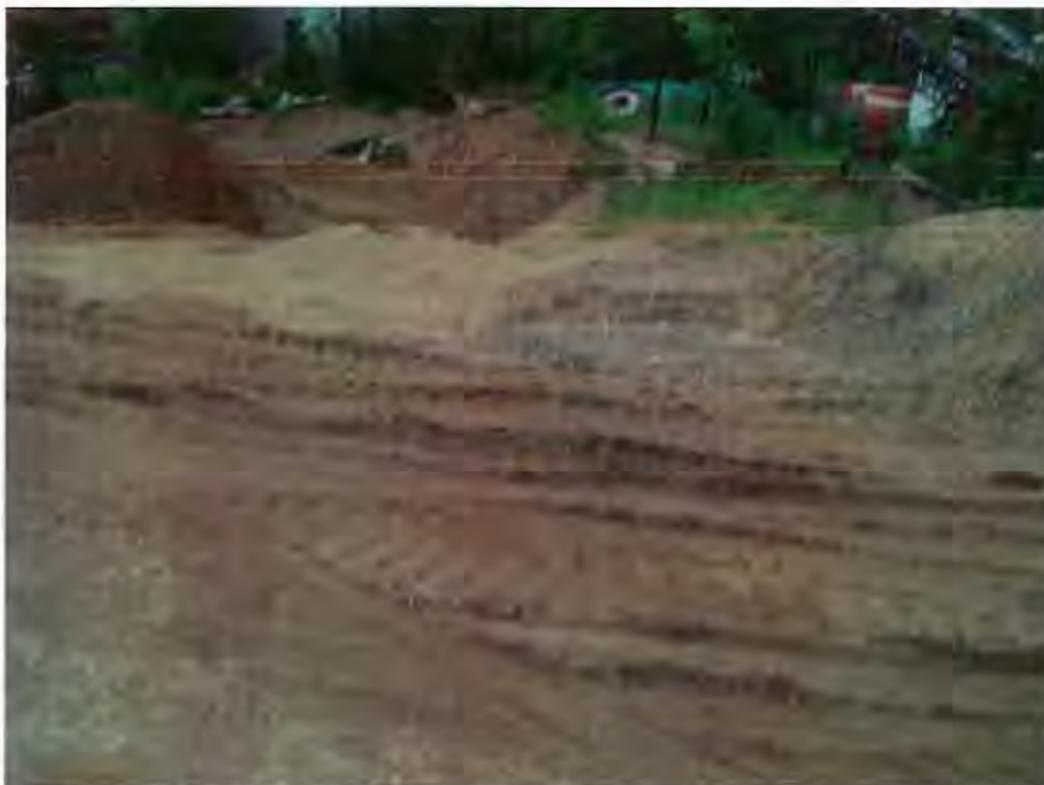
Date: May 30, 2008
Time: 11:21 AM
Direction: Southeast
Photo by: W Zierath
Exposure #: 012
Comments: Sand and gravel in the central part of the site.

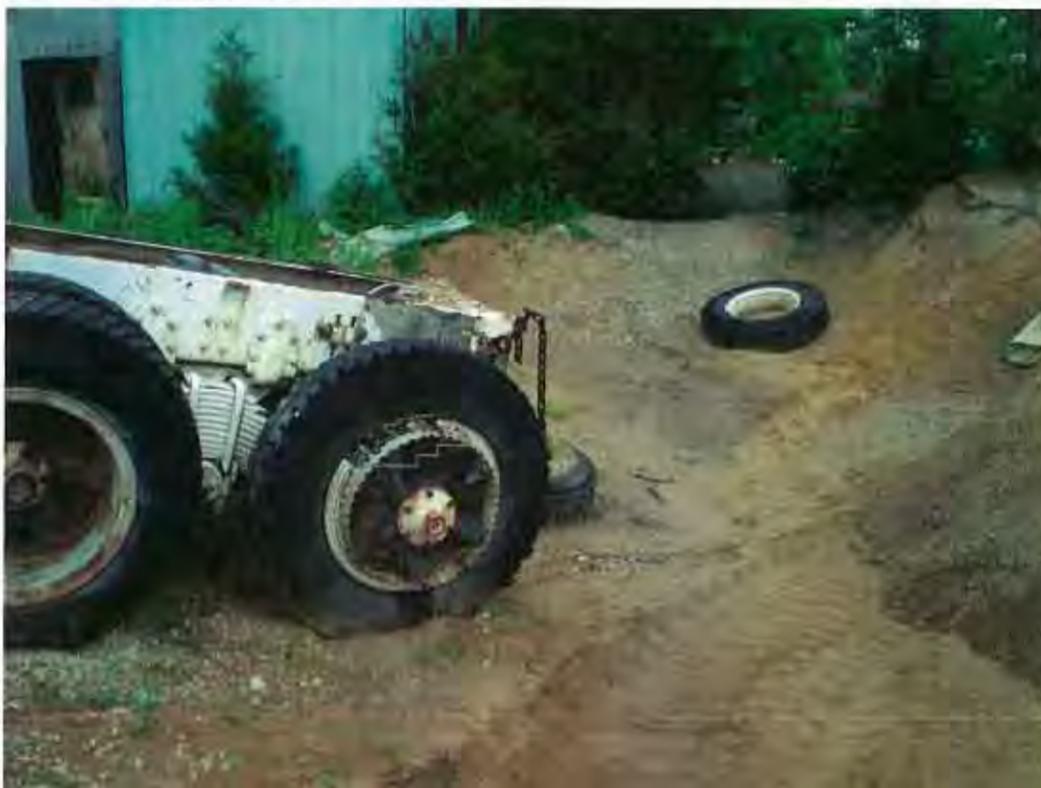
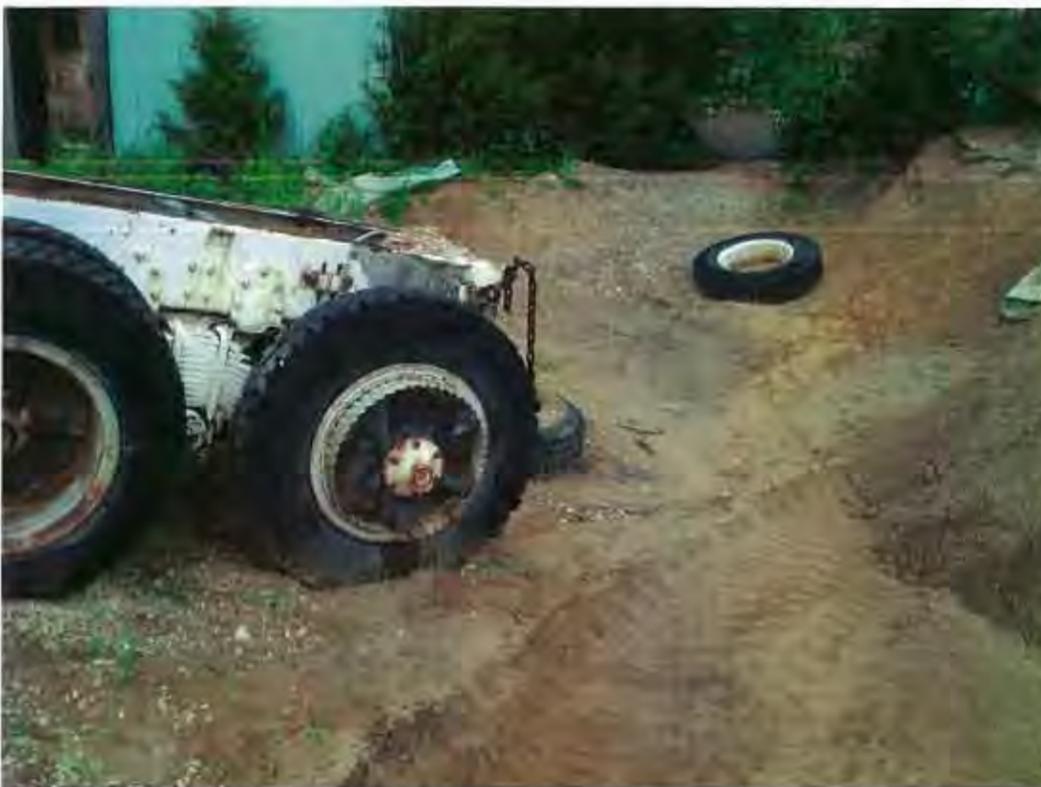
Date: May 30, 2008
Time: 11:23 AM
Direction: South
Photo by: W Zierath
Exposure #: 013
Comments: Scrap metal, a used tire and the remains of a small vehicle.

Date: May 30, 2008
Time: 11:23 AM
Direction: South
Photo by: W Zierath
Exposure #: 014
Comments: Scrap metal, a used tire and the remains of a small vehicle. (Accidental retake of photograph 013)

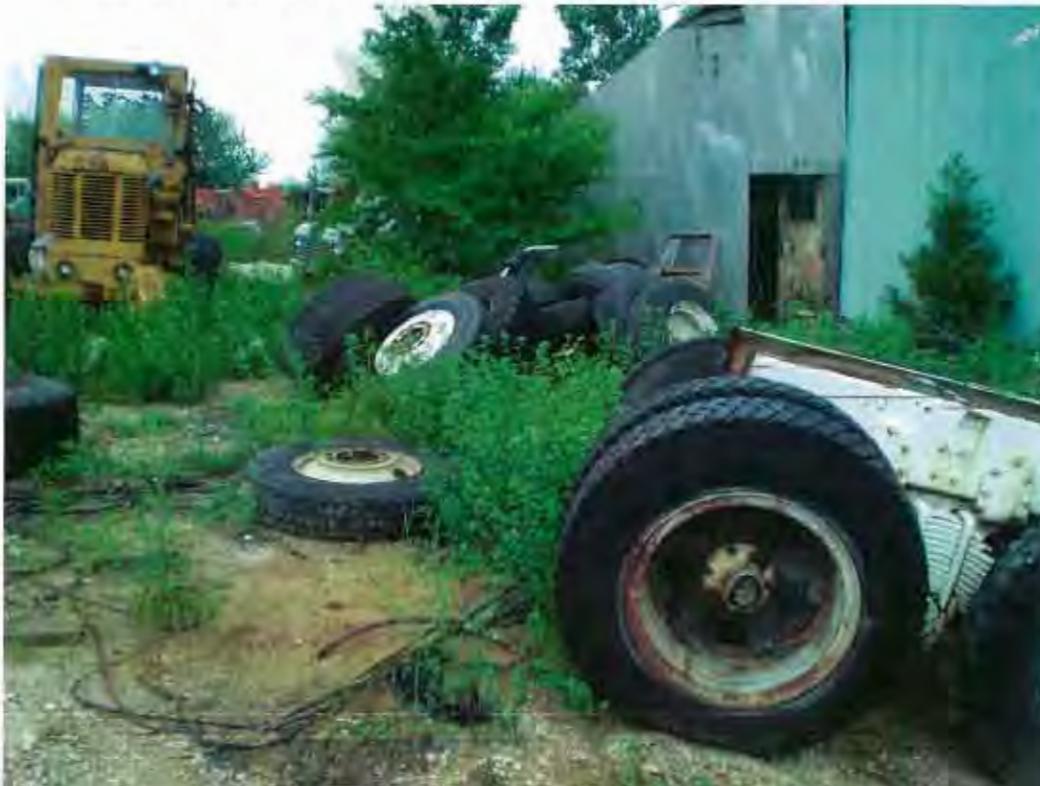
Date: May 30, 2008
Time: 11:24 AM
Direction: Southeast
Photo by: W Zierath
Exposure #: 015
Comments: A pile of used tires, along with a few pieces of scrap metal. Mr. Hollembeak said that the tires were the correct size for his truck and that he would be using them in the future.

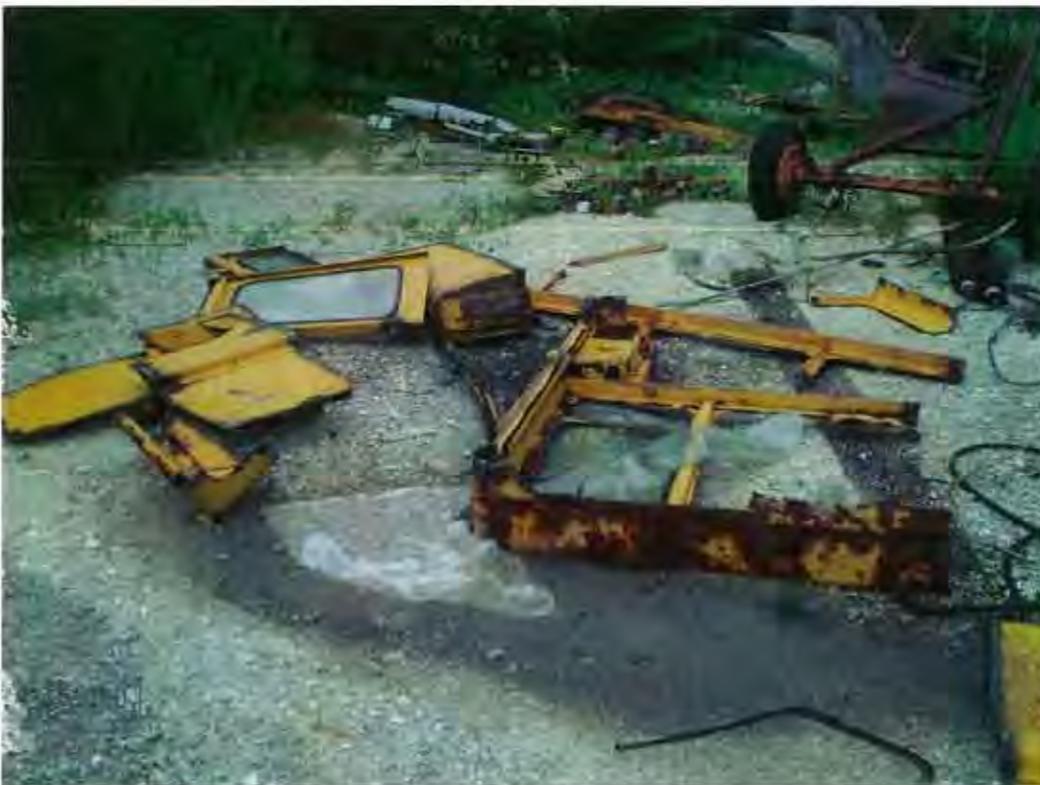
Date: May 30, 2008
Time: 11:25 AM
Direction: Northeast
Photo by: W Zierath
Exposure #: 016
Comments: Pieces of metal from a piece of equipment that was being cut up to allow it to be sold for scrap.

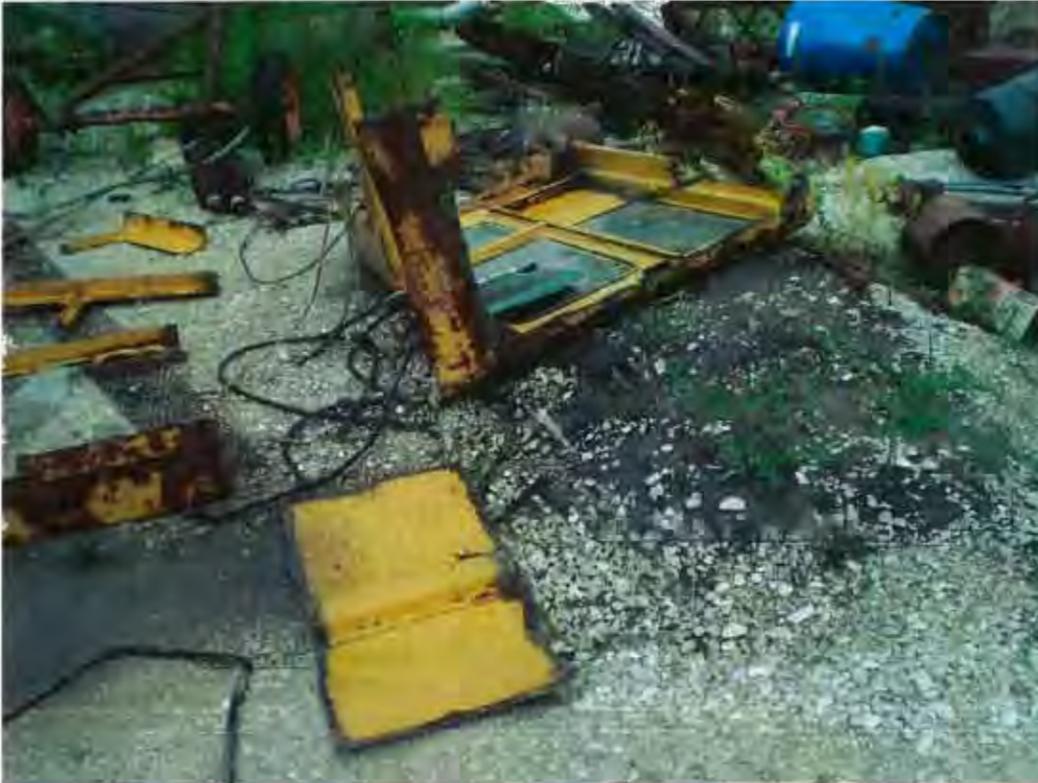
Date: May 30, 2008
Time: 11:25 AM
Direction: East
Photo by: W Zierath
Exposure #: 017
Comments: Pieces of metal from a piece of equipment that was being cut up to allow it to be sold for scrap. The containers in the background are empty.

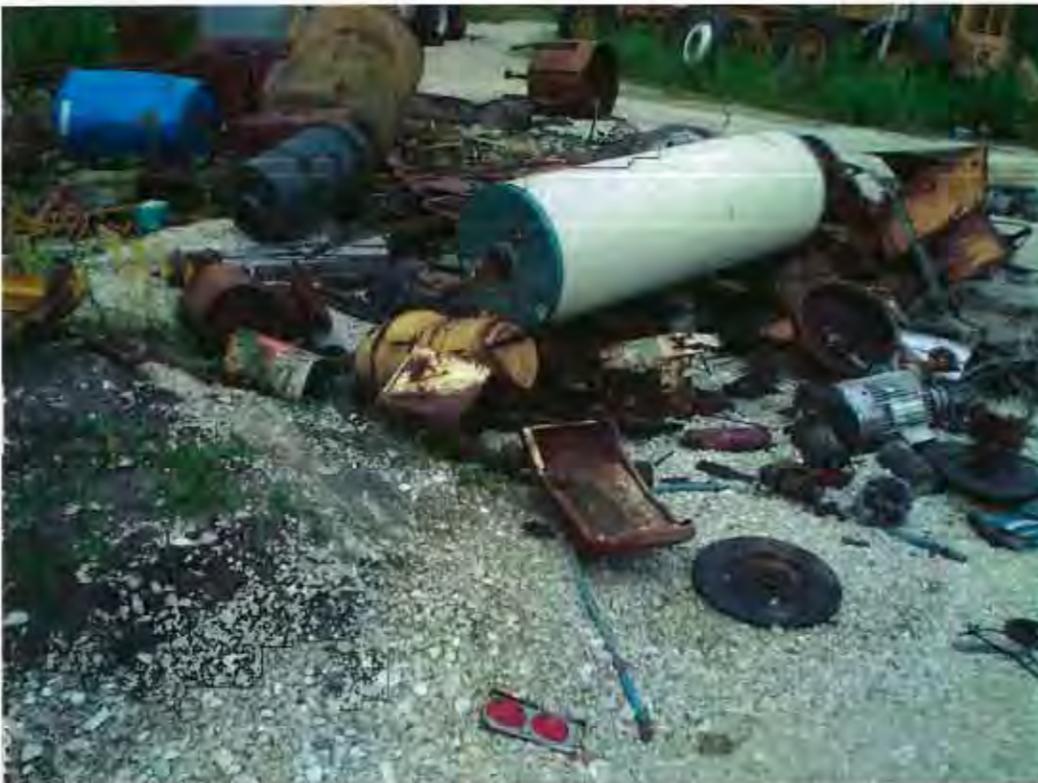
Date: May 30, 2008
Time: 11:25 AM
Direction: Southeast
Photo by: W Zierath
Exposure #: 018
Comments: Scrap metal in the eastern part of the site.

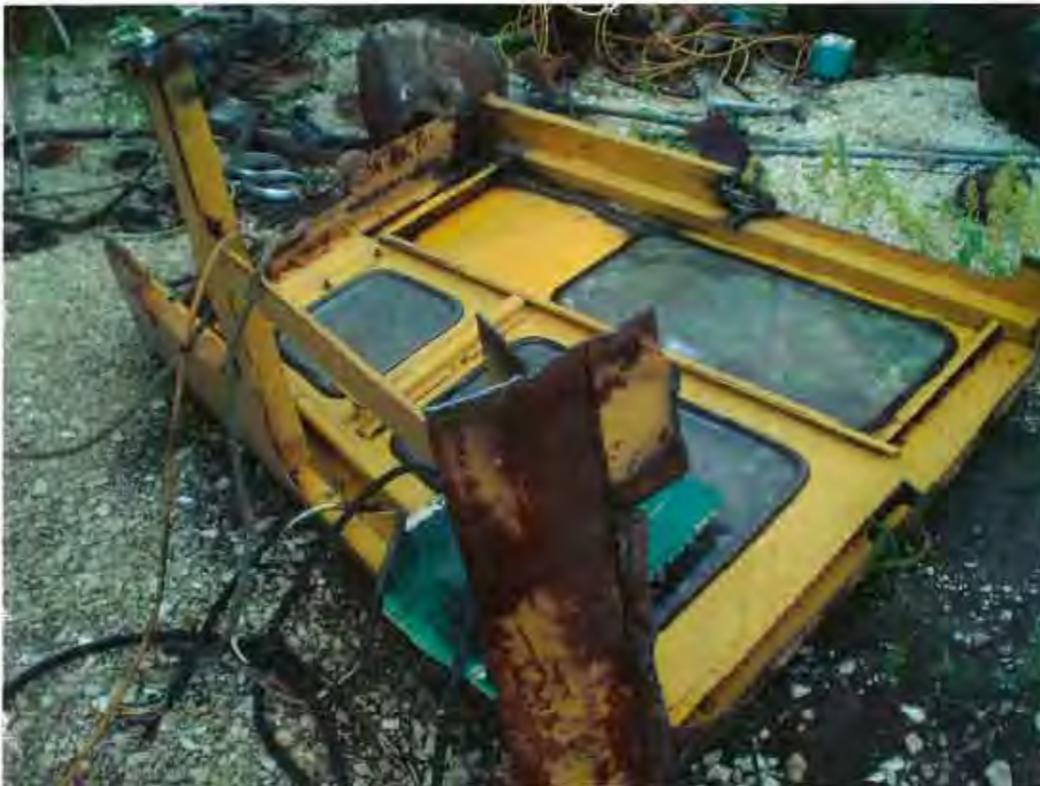
Date: May 30, 2008
Time: 11:25 AM
Direction: East
Photo by: W Zierath
Exposure #: 019
Comments: Pieces of metal from a piece of equipment that was being cut up to allow it to be sold for scrap.

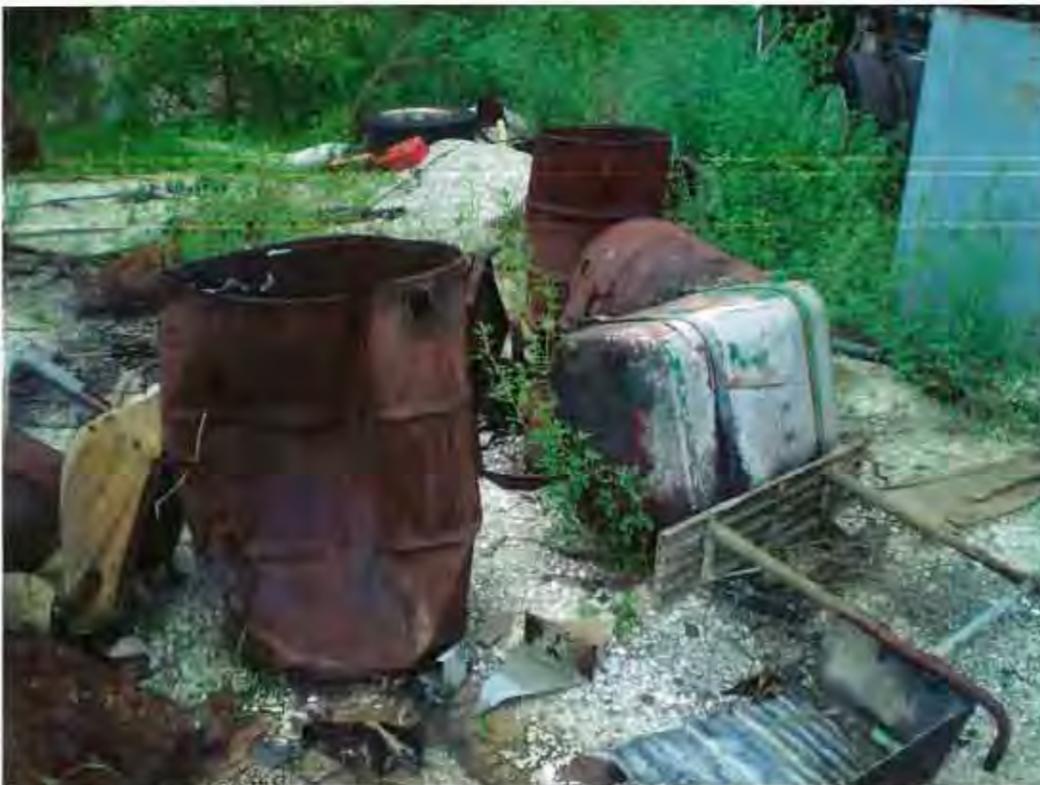
Date: May 30, 2008
Time: 11:26 AM
Direction: East
Photo by: W Zierath
Exposure #: 020
Comments: An empty fuel tank, empty 55-gallon drums and scrap metal in the east part of the site.

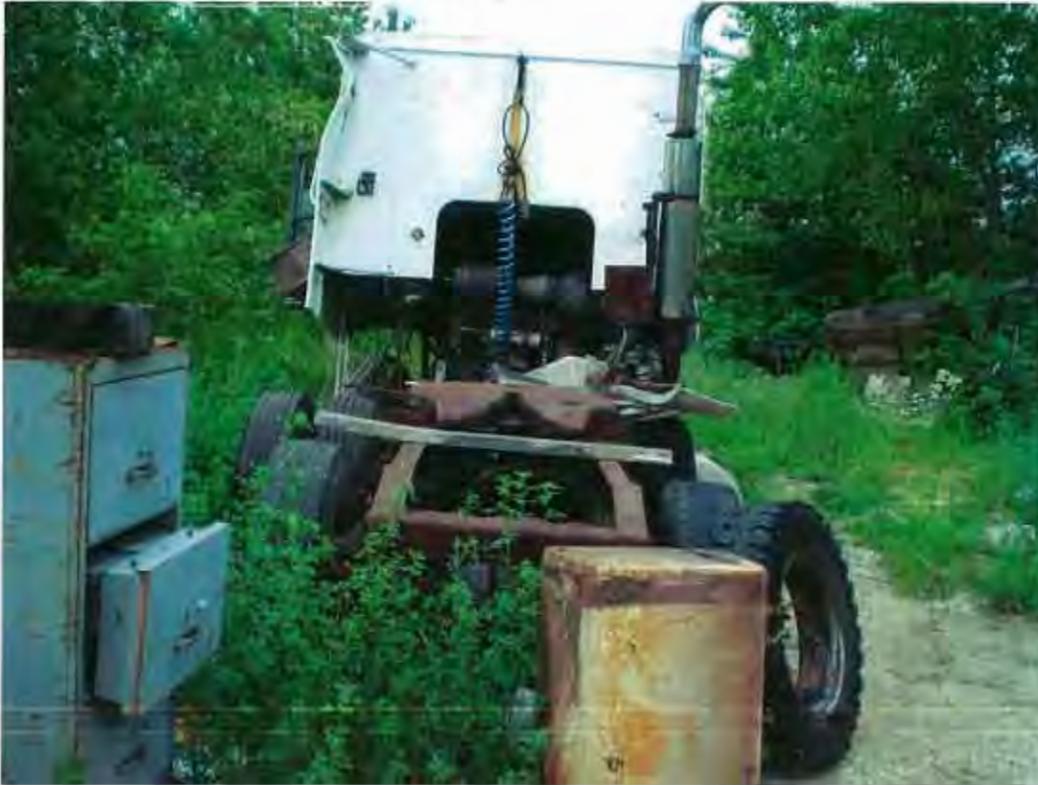
Date: May 30, 2008
Time: 11:27 AM
Direction: East
Photo by: W Zierath
Exposure #: 021
Comments: A non-operable semi tractor in the east part of the site.

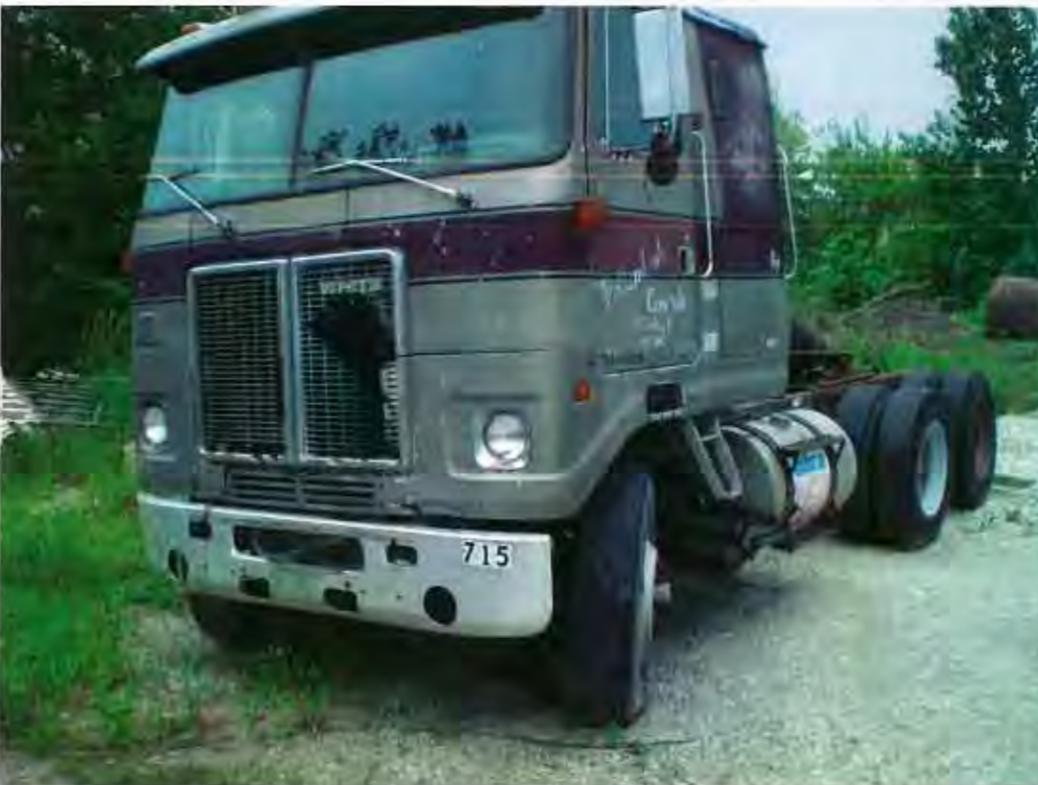
Date: May 30, 2008
Time: 11:27 AM
Direction: Southeast
Photo by: W Zierath
Exposure #: 022
Comments: An operable semi tractor that Mr. Hollembeak said he is trying to sell.

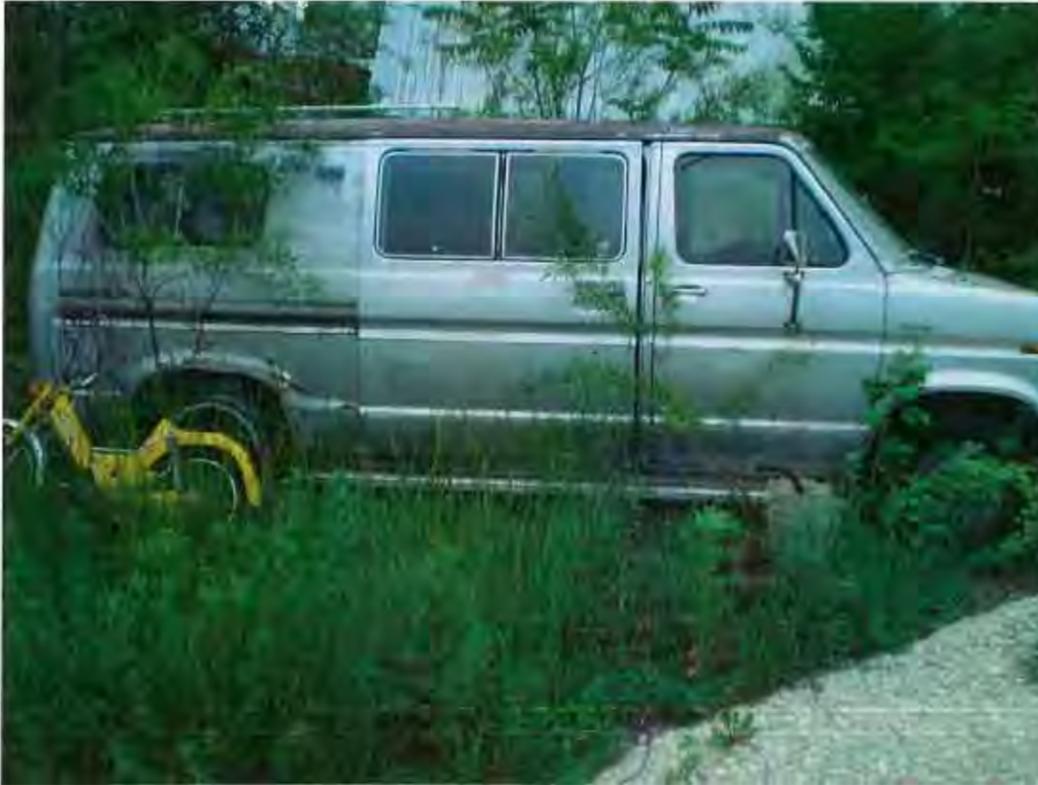
Date: May 30, 2008
Time: 11:28 AM
Direction: West
Photo by: W Zierath
Exposure #: 023
Comments: An abandoned van and an abandoned moped in the central part of the site.

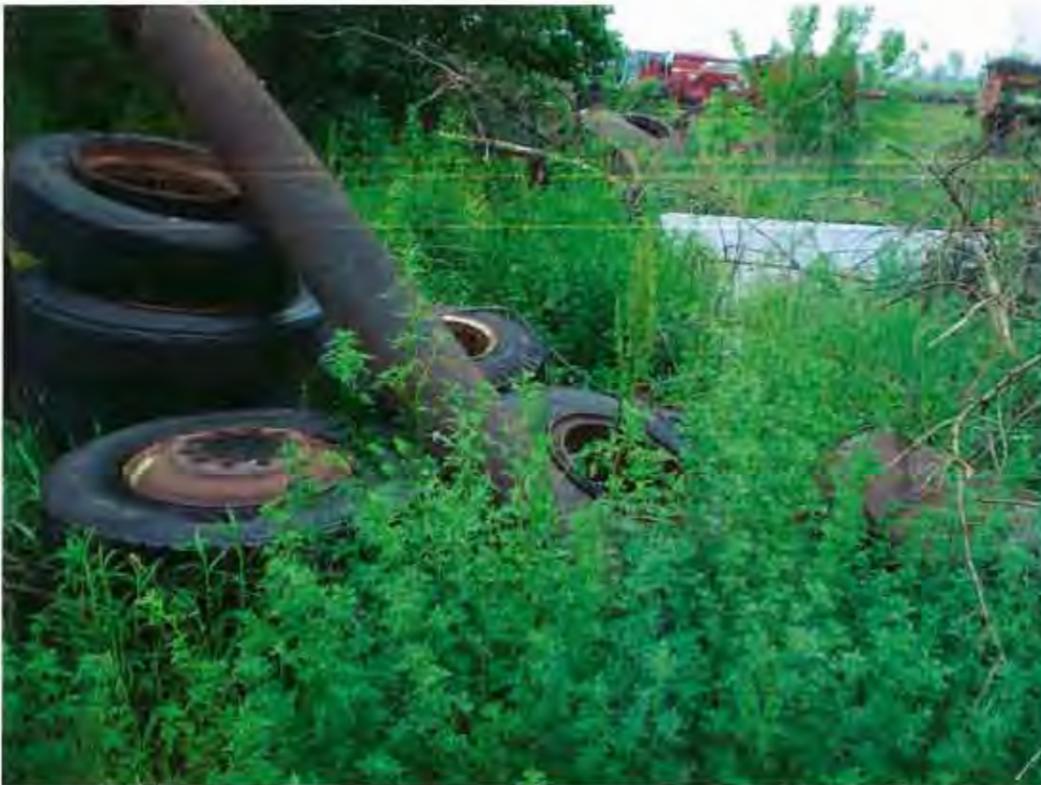
Date: May 30, 2008
Time: 11:28 AM
Direction: East
Photo by: W Zierath
Exposure #: 024
Comments: Used tires on rims.

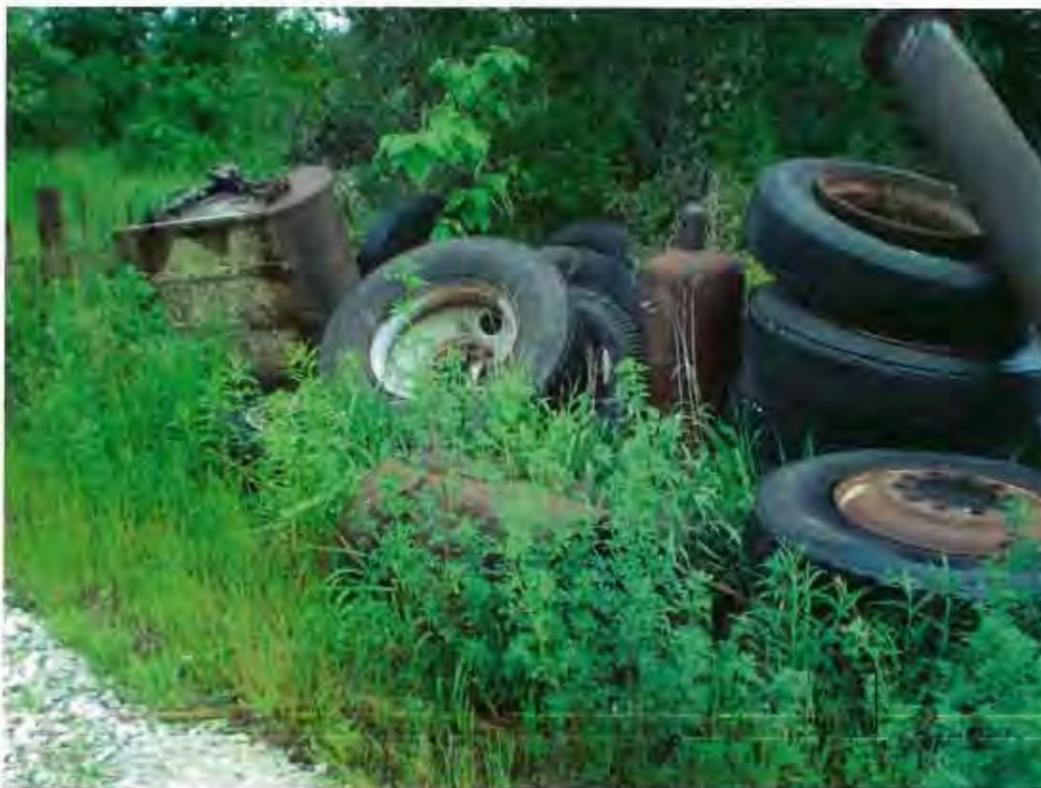
Date: May 30, 2008
Time: 11:28 AM
Direction: Northeast
Photo by: W Zierath
Exposure #: 025
Comments: Used tires on rims, along with other waste metal objects.

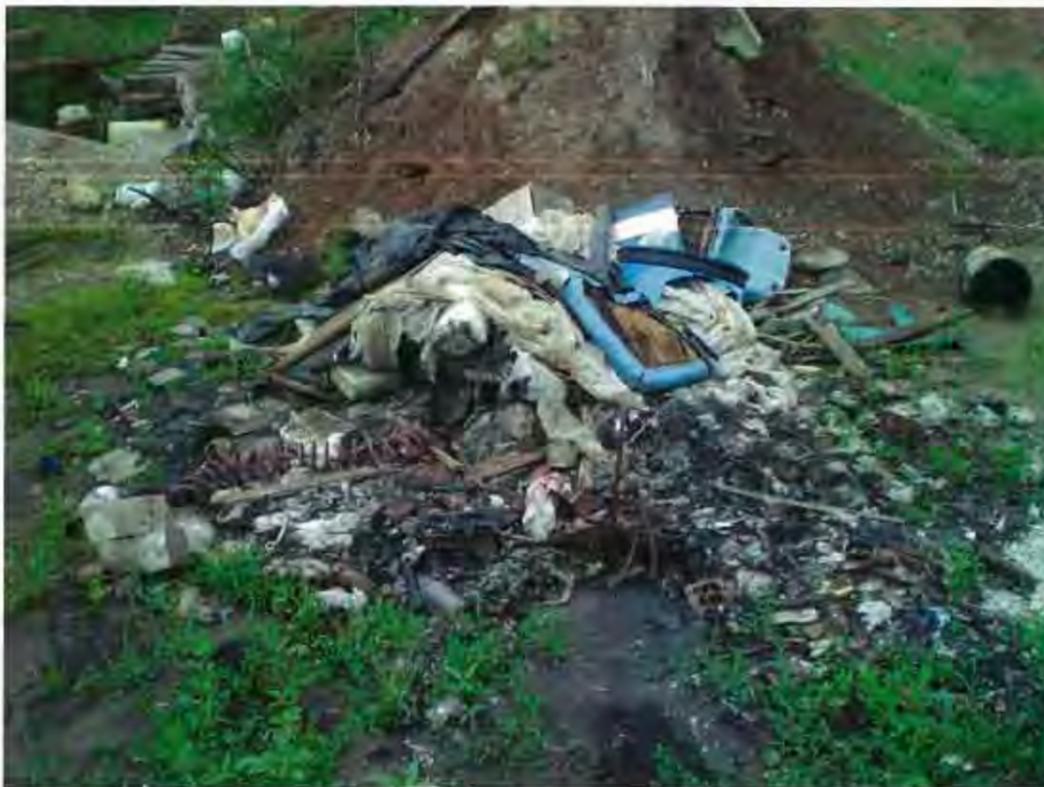
In the southeast part of the site was an old burn pile. The old burn pile was a large pile of ashes and non-burnable material. There was a large amount of unburned waste on the old burn pile. There was no indication that anything had been burned since the January 7, 2008 investigation. The old burn pile is shown in photographs 0090105033~05302008-026, 0090105033~05302008-027, 0090105033~05302008-028, 0090105033~05302008-029, and 0090105033~05302008-030.

Date: May 30, 2008
Time: 11:28 AM
Direction: South
Photo by: W Zierath
Exposure #: 026
Comments: A former burn area with ash, metal, plastic, wood and other wastes.
