Re: Illinois Environmental Protection Agency v. Theodore & Elizabeth Hollembeak and Hollembeak Concrete, Inc.
IEPA File No. 85-08-AC: 0090105033—Brown County

BEFORE THE ILLINOIS POLLUTION CONTROL BOARD
ADMINISTRATIVE CITATION

FACILITY: Mt. Sterling/Hollembeak Concrete SITE CODE NO.: 0090105033
COUNTY: Brown CIVIL PENALTY: \$4,500.00
DATE OF INSPECTION: May 30, 2008

Date: May 30, 2008
To: BOL File
From: William E. Zierath, BOL/FOS - Springfield Region
Subject: LPC# 0090105033 – Brown County
Mt. Sterling/Hollembeak Concrete
C-08-019-C
FOS File

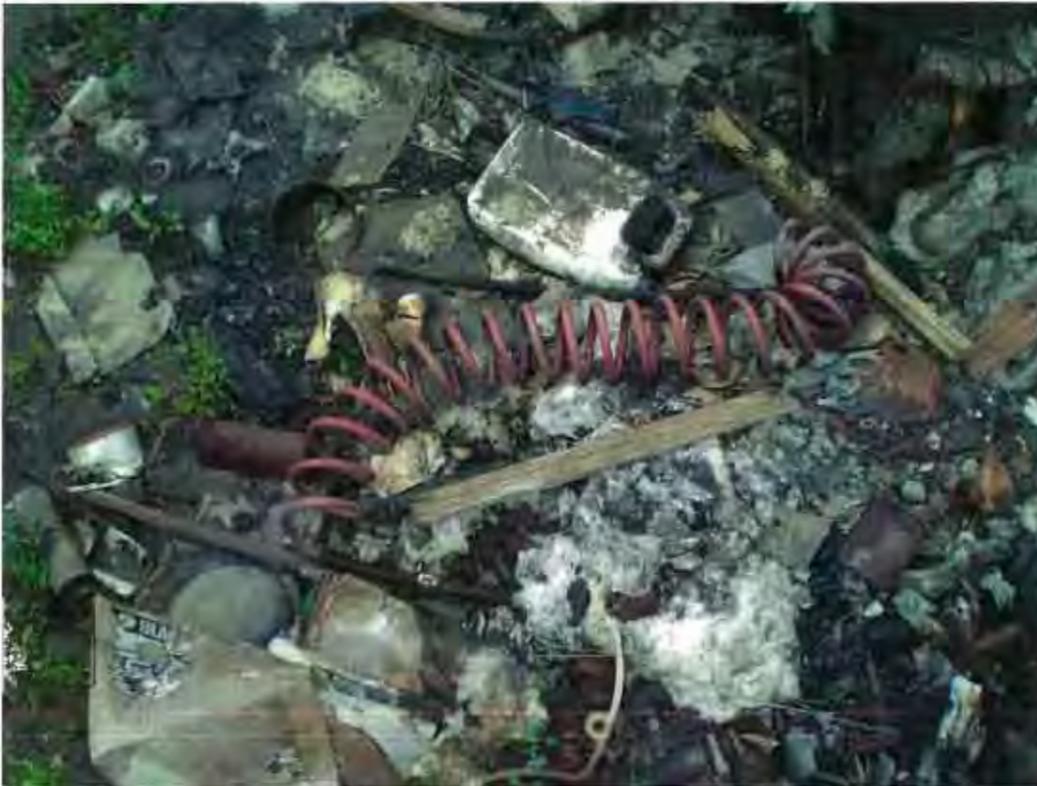
In the southeast part of the site was an old burn pile. The old burn pile was a large pile of ashes and non-burnable material. There was a large amount of unburned waste on the old burn pile. There was no indication that anything had been burned since the January 7, 2008 investigation. The old burn pile is shown in photographs 0090105033~05302008-026, 0090105033~05302008-027, 0090105033~05302008-028, 0090105033~05302008-029, and 0090105033~05302008-030.

Date: May 30, 2008
Time: 11:29 AM
Direction: South
Photo by: W Zierath
Exposure #: 027
Comments: A close-up
of part of the burn pile
shown in photograph
026.

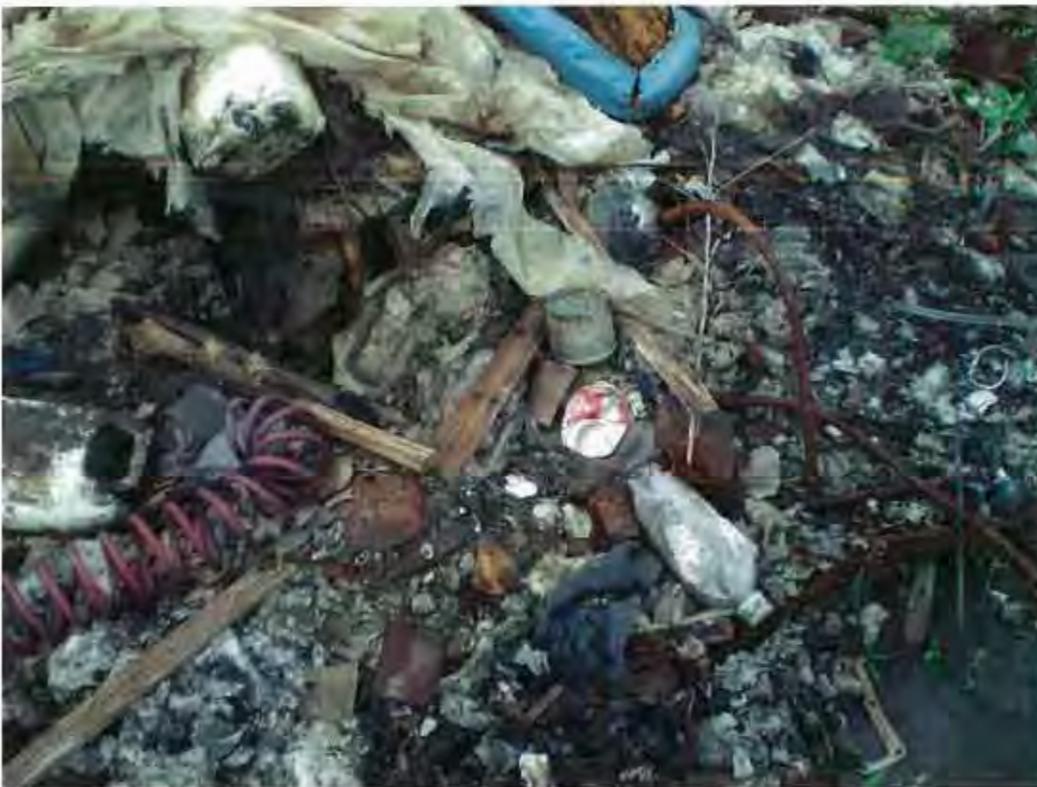
Date: May 30, 2008
Time: 11:29 AM
Direction: South
Photo by: W Zierath
Exposure #: 028
Comments: A close-up
of part of the burn pile
shown in photograph
026.

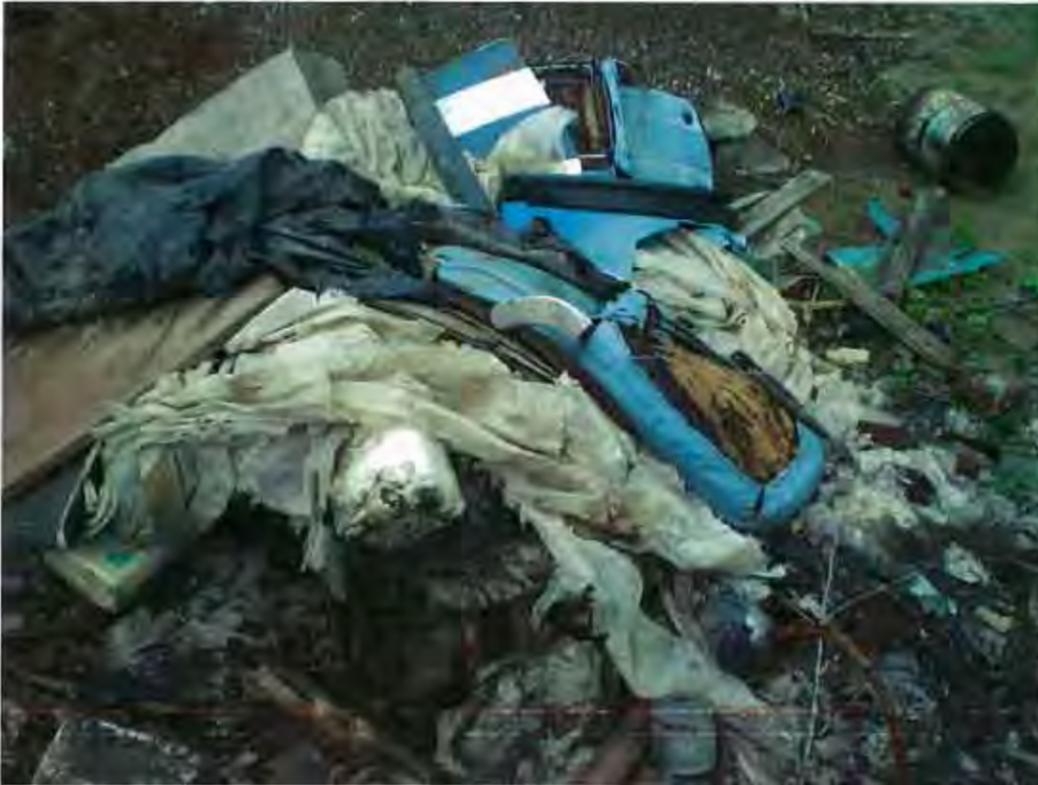
Date: May 30, 2008
Time: 11:29 AM
Direction: Southwest
Photo by: W Zierath
Exposure #: 029
Comments: A close-up
of part of the burn pile
shown in photograph
026.

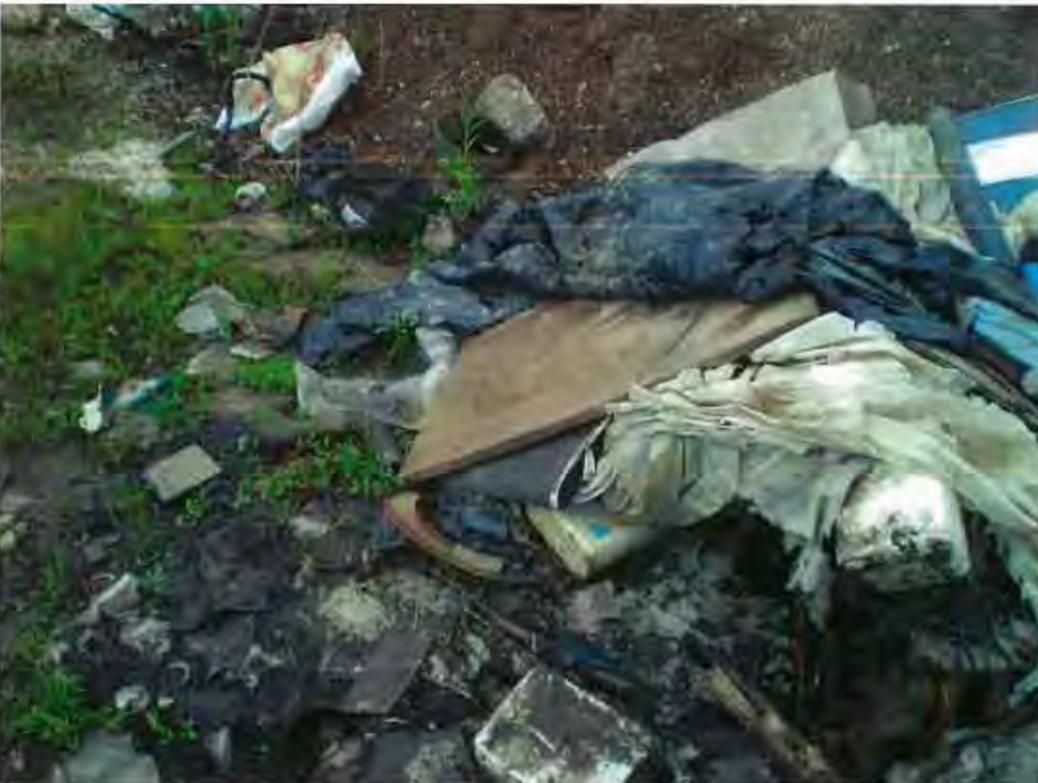
Date: May 30, 2008
Time: 11:29 AM
Direction: South
Photo by: W Zierath
Exposure #: 030
Comments: A close-up
of part of the burn pile
shown in photograph
026.

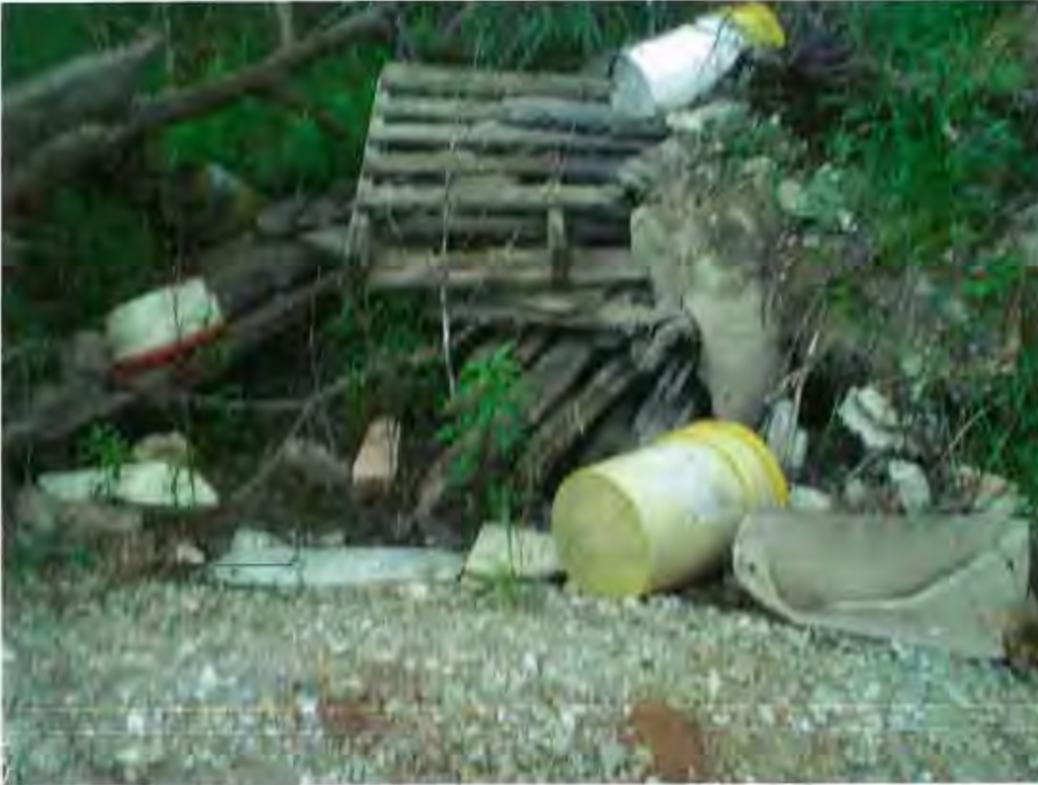
Date: May 30, 2008
Time: 11:29 AM
Direction: South
Photo by: W Zierath
Exposure #: 031
Comments: Waste pallets, demolition waste and waste plastic in the southern part of this site.

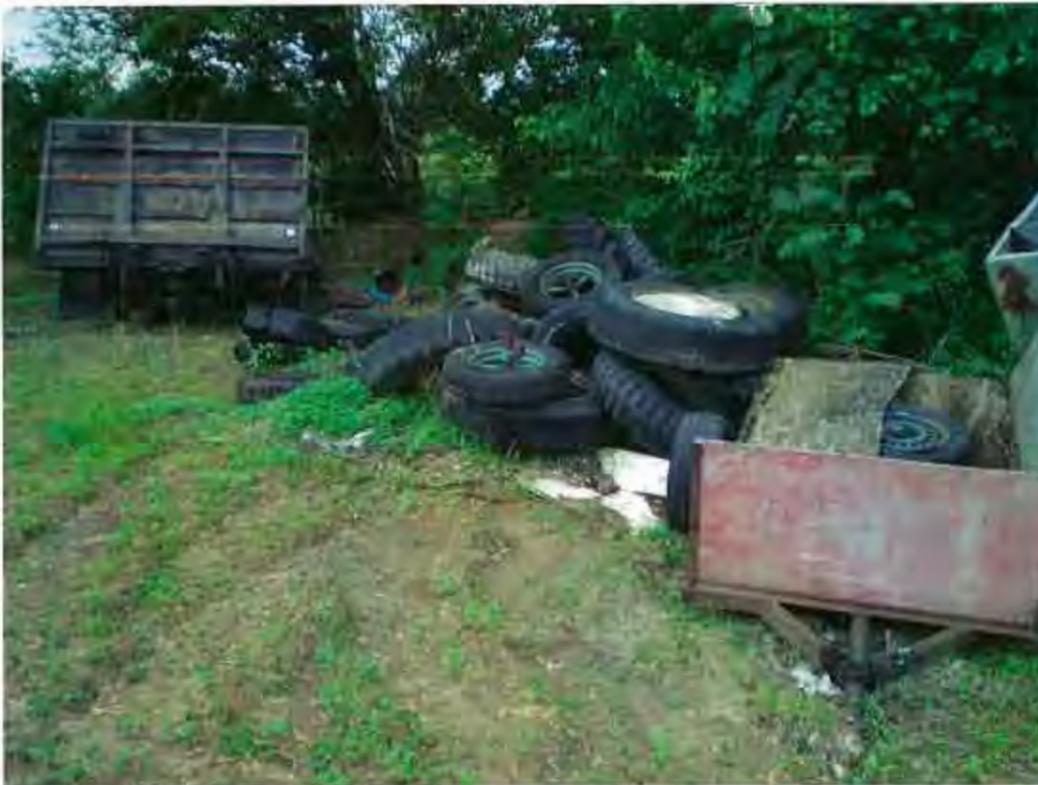
Date: May 30, 2008
Time: 11:30 AM
Direction: South
Photo by: W Zierath
Exposure #: 032
Comments: Used tires (both on and off of rims) in the south part of the site.

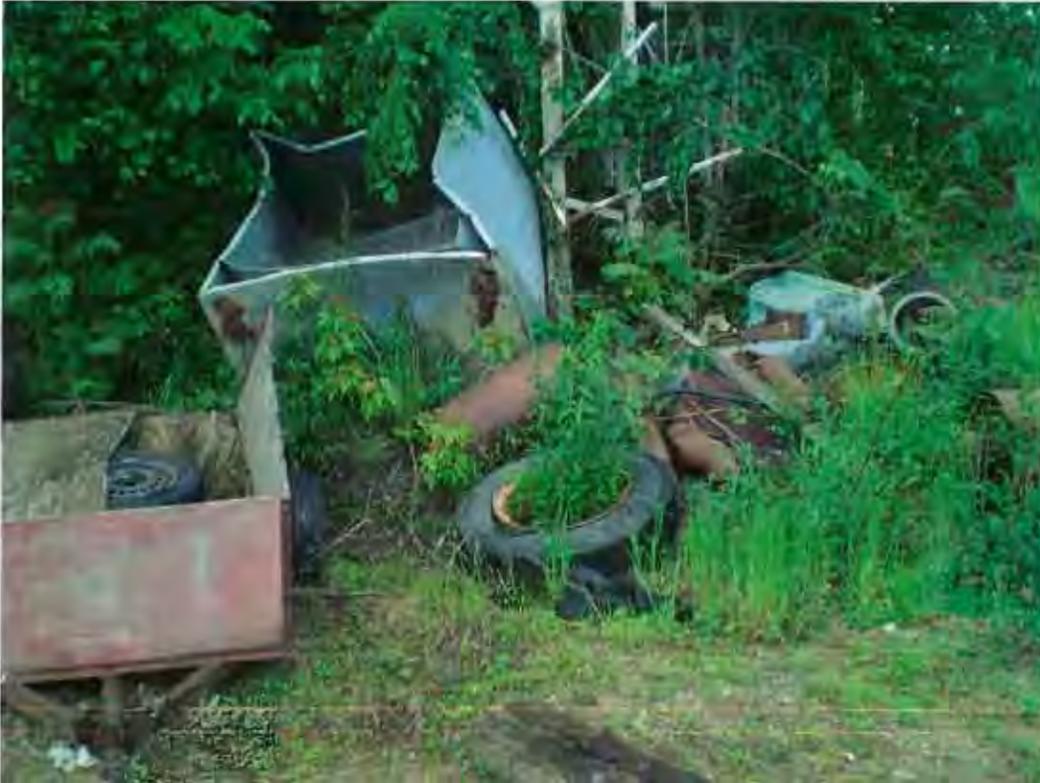
Date: May 30, 2008
Time: 11:30 AM
Direction: Southwest
Photo by: W Zierath
Exposure #: 033
Comments: Scrap metal and used tires (on rims) in the south part of the site.

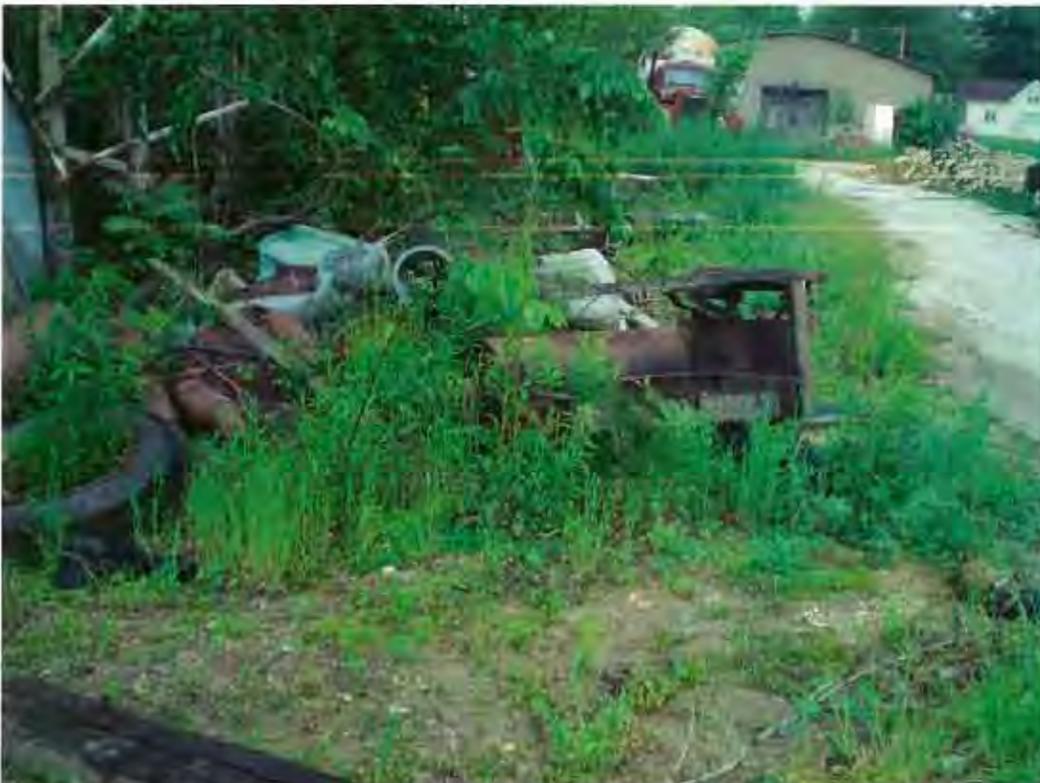
Date: May 30, 2008
Time: 11:30 AM
Direction: West
Photo by: W Zierath
Exposure #: 034
Comments: Scrap metal and used tires (on rims) in the south part of the site.

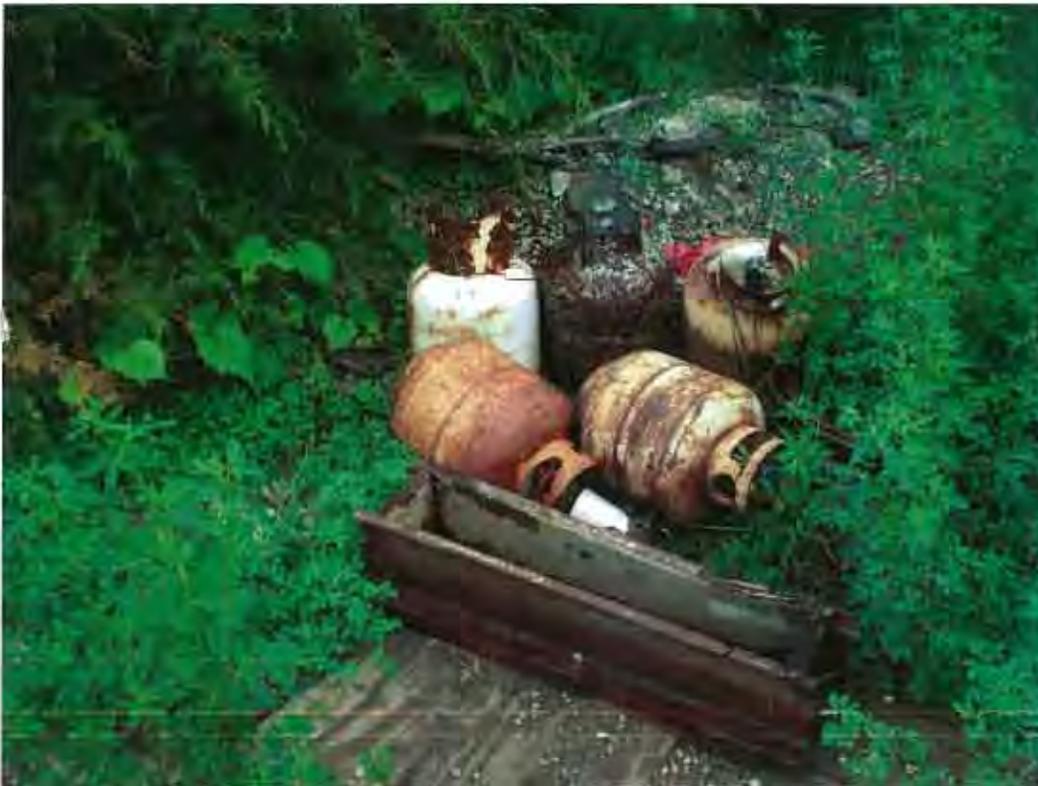
Date: May 30, 2008
Time: 11:31 AM
Direction: North
Photo by: W Zierath
Exposure #: 035
Comments: Old propane containers in the central part of the site.

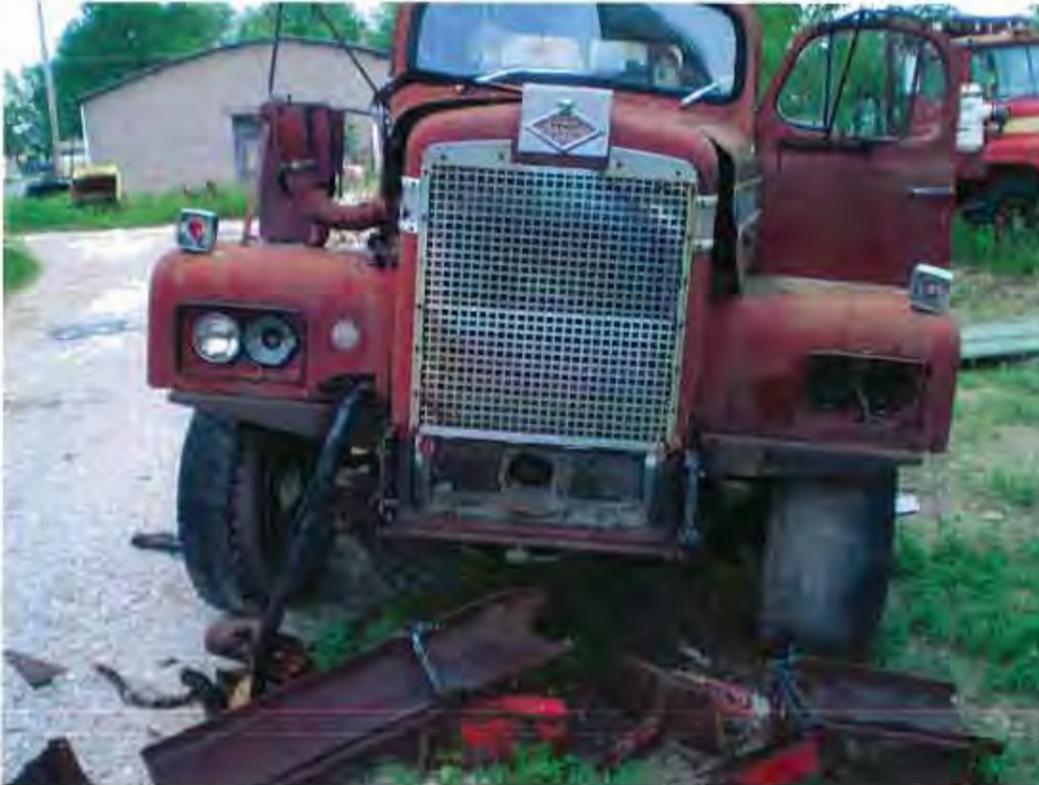
Date: May 30, 2008
Time: 11:31 AM
Direction: West
Photo by: W Zierath
Exposure #: 037
Comments: An old cement truck that was being cut up to allow it to be scrapped.

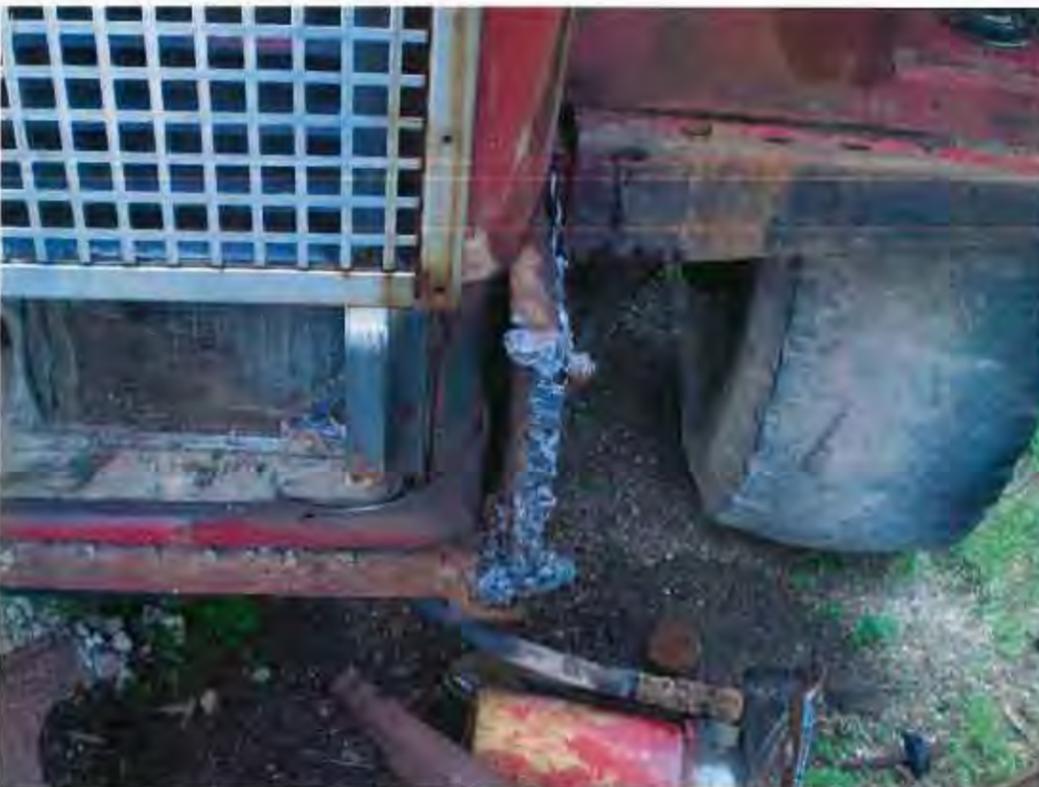
Date: May 30, 2008
Time: 11:31 AM
Direction: West
Photo by: W Zierath
Exposure #: 038
Comments: The front of the truck shown in photograph 037 showing where a torch has been used to cut the bumper off.

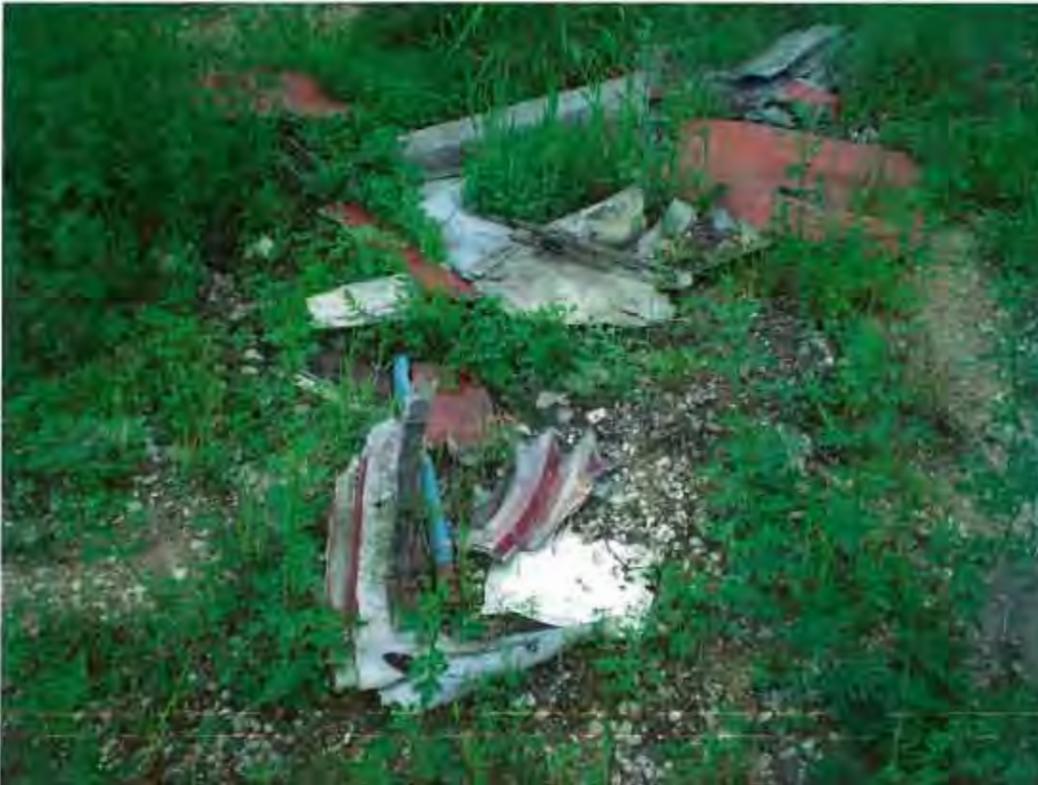
Date: May 30, 2008
Time: 11:32 AM
Direction: South
Photo by: W Zierath
Exposure #: 039
Comments: Scrap metal in the southern part of the site.

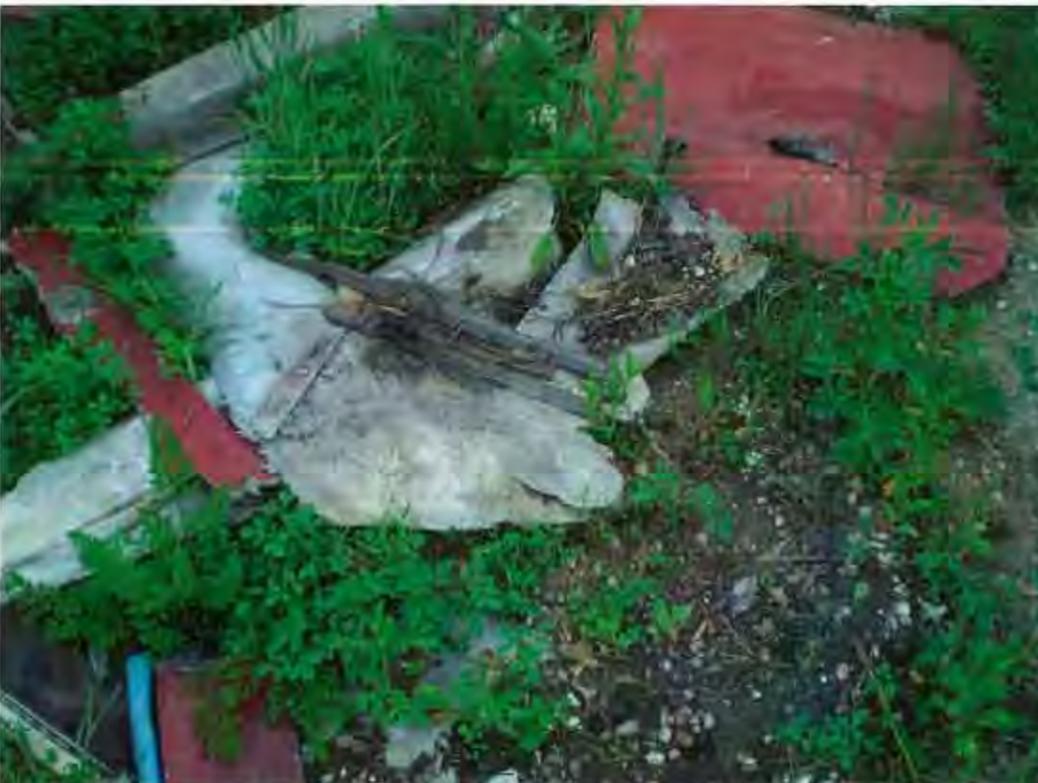
Date: May 30, 2008
Time: 11:32 AM
Direction: South
Photo by: W Zierath
Exposure #: 040
Comments: Close-up of some of the scrap metal shown in photograph 039.

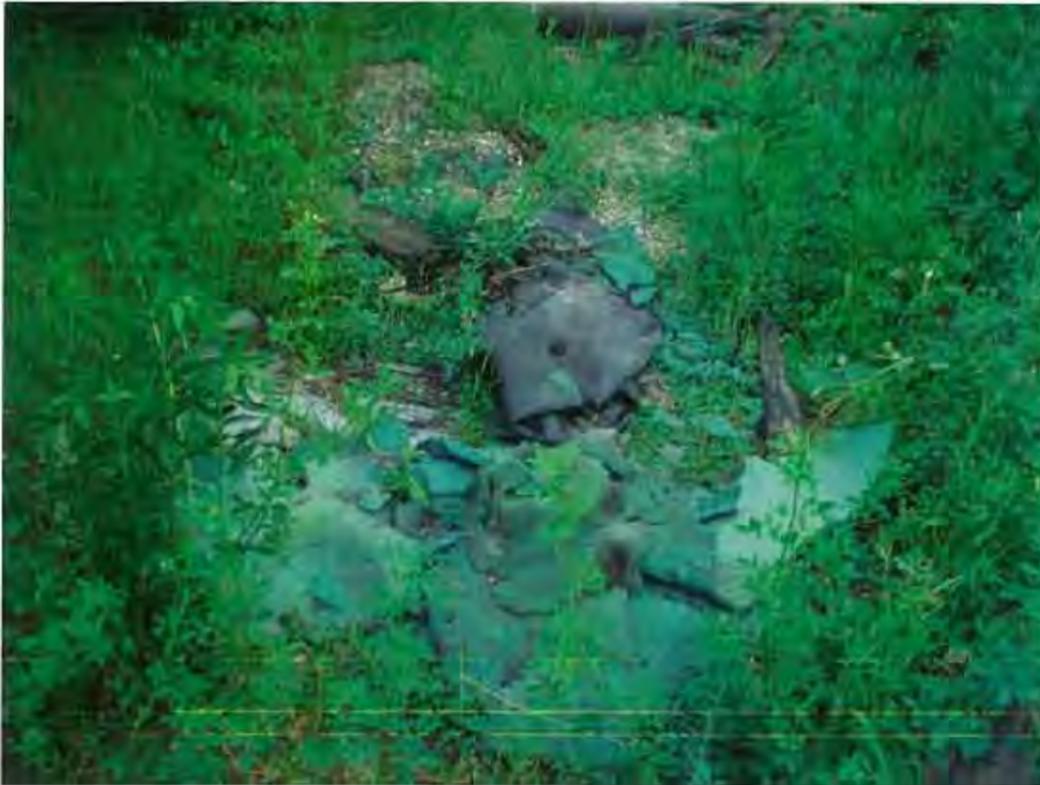
Date: May 30, 2008
Time: 11:32 AM
Direction: South
Photo by: W Zierath
Exposure #: 041
Comments: Plastic waste in the southern part of the site.

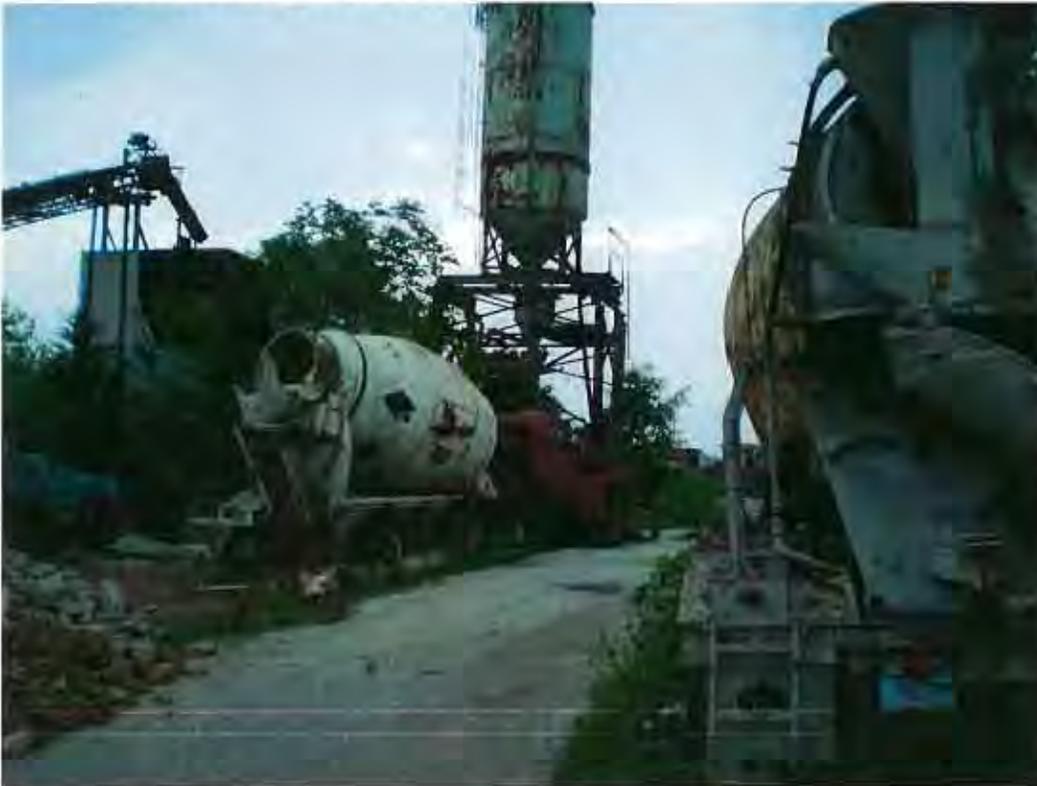
Date: May 30, 2008
Time: 11:33 AM
Direction: East
Photo by: W Zierath
Exposure #: 043
Comments:
Abandoned cement
trucks.

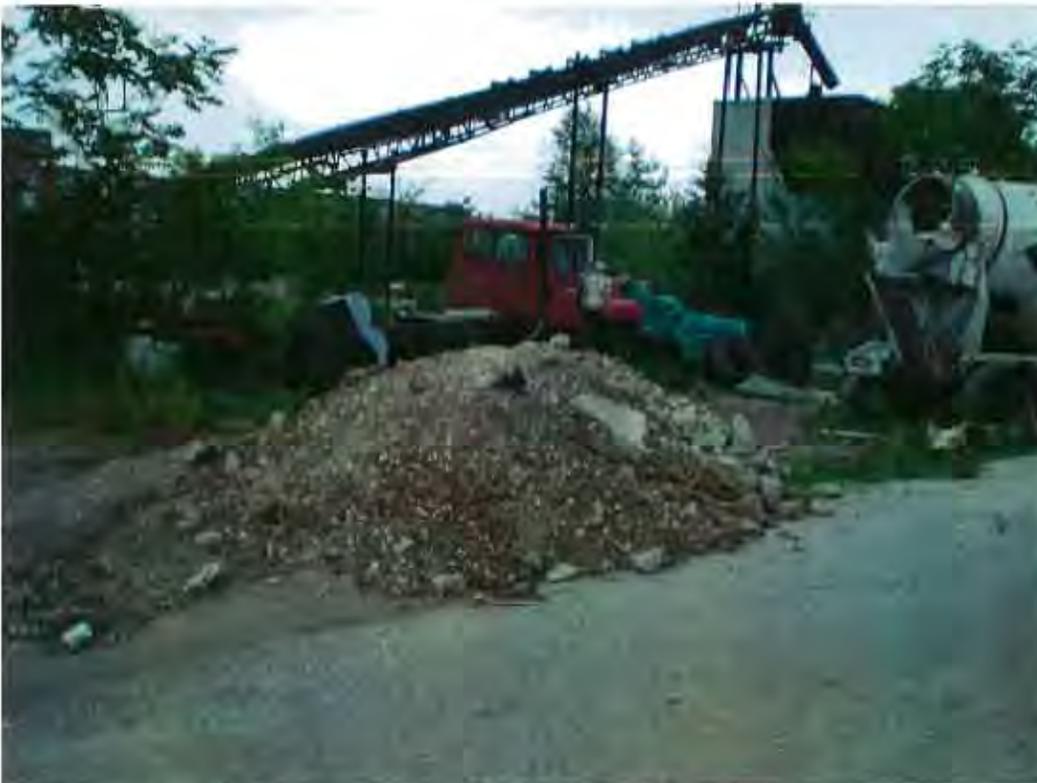
Date: May 30, 2008
Time: 11:33 AM
Direction: Northeast
Photo by: W Zierath
Exposure #: 044
Comments:
Abandoned semi
tractor and used tires
(on rims) in the central
part of the site. Mr.
Hollembeak claims to
use the conveyor belt
shown in this
photograph to move
sand and gravel to a
scale in the greenish
building. The conveyor
belt was off its rollers.

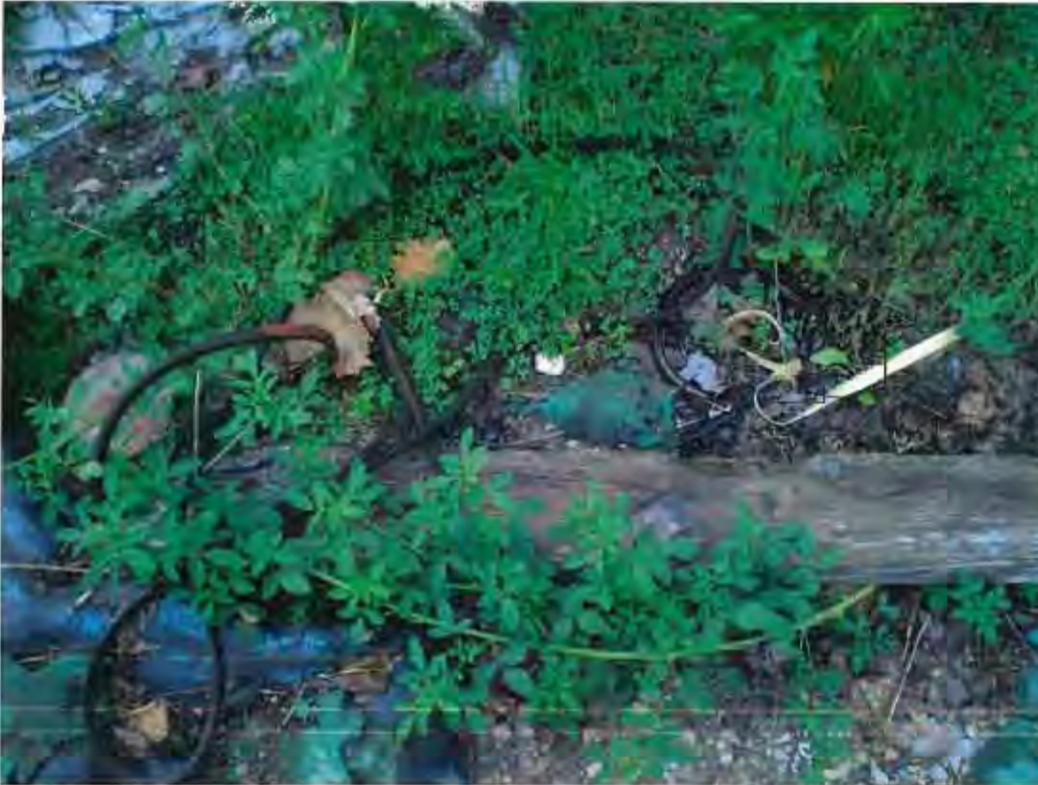
Date: May 30, 2008
Time: 11:33 AM
Direction: South
Photo by: W Zierath
Exposure #: 045
Comments: Old vehicle belts, plastic and demolition waste in the southern part of the site.

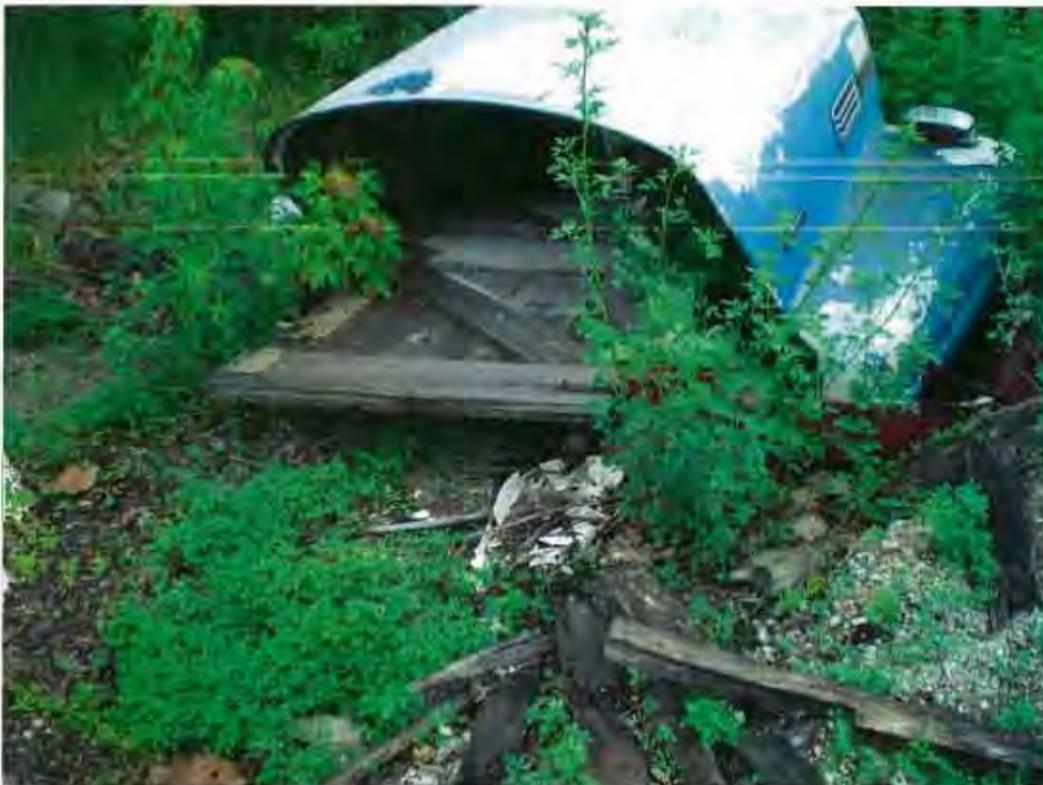
Date: May 30, 2008
Time: 11:33 AM
Direction: South
Photo by: W Zierath
Exposure #: 046
Comments: Demolition waste and an old truck hood in the southern part of the site.

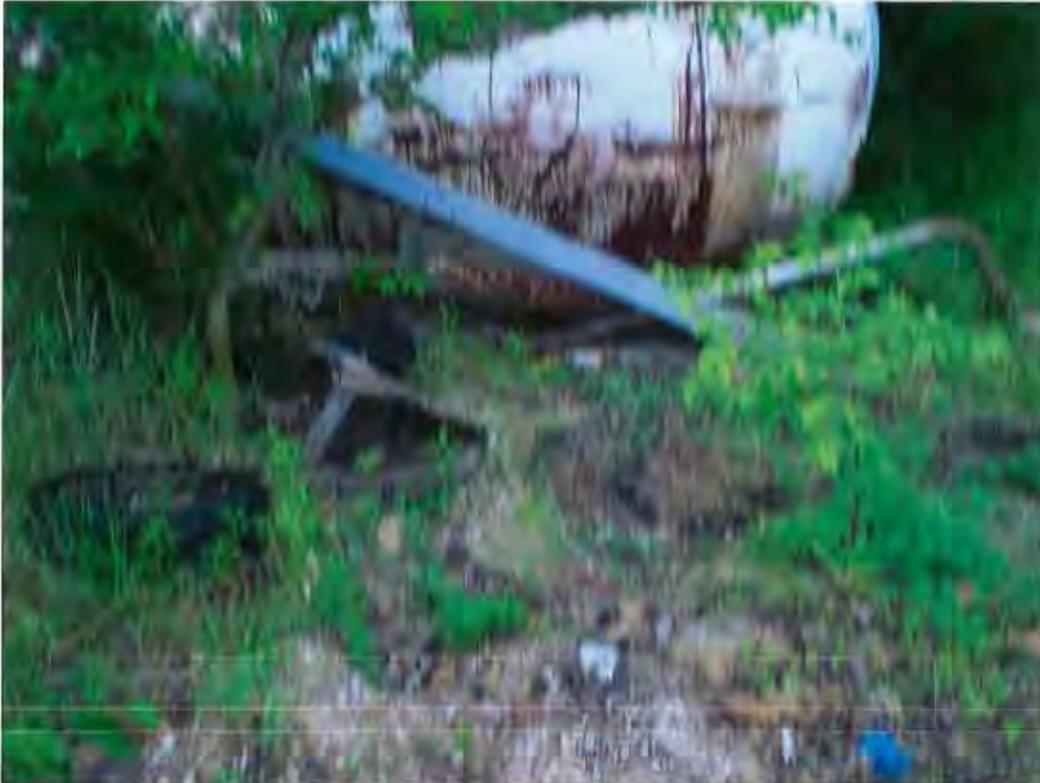
Date: May 30, 2008
Time: 11:33 AM
Direction: South
Photo by: W Zierath
Exposure #: 047
Comments: Used tires
(on rims) and an old
metal tank in the
southern part of the
site.

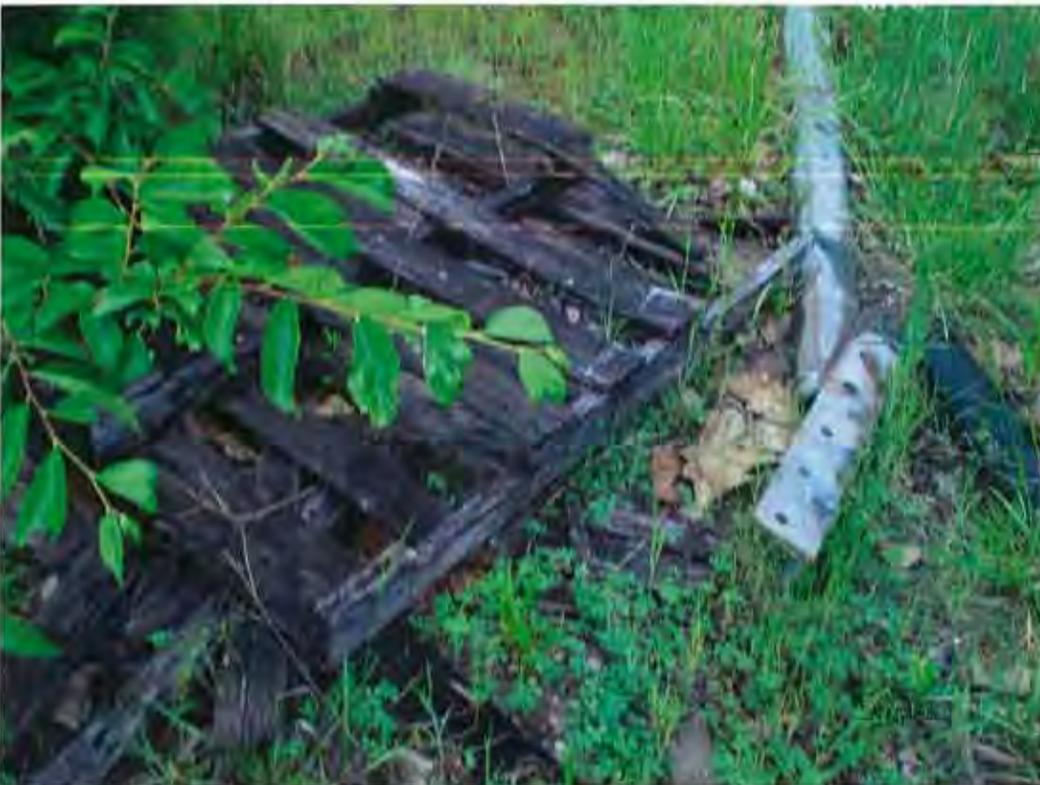
Date: May 30, 2008
Time: 11:34 AM
Direction: South
Photo by: W Zierath
Exposure #: 048
Comments: Old pallets
and scrap metal in the
southern part of the
site.

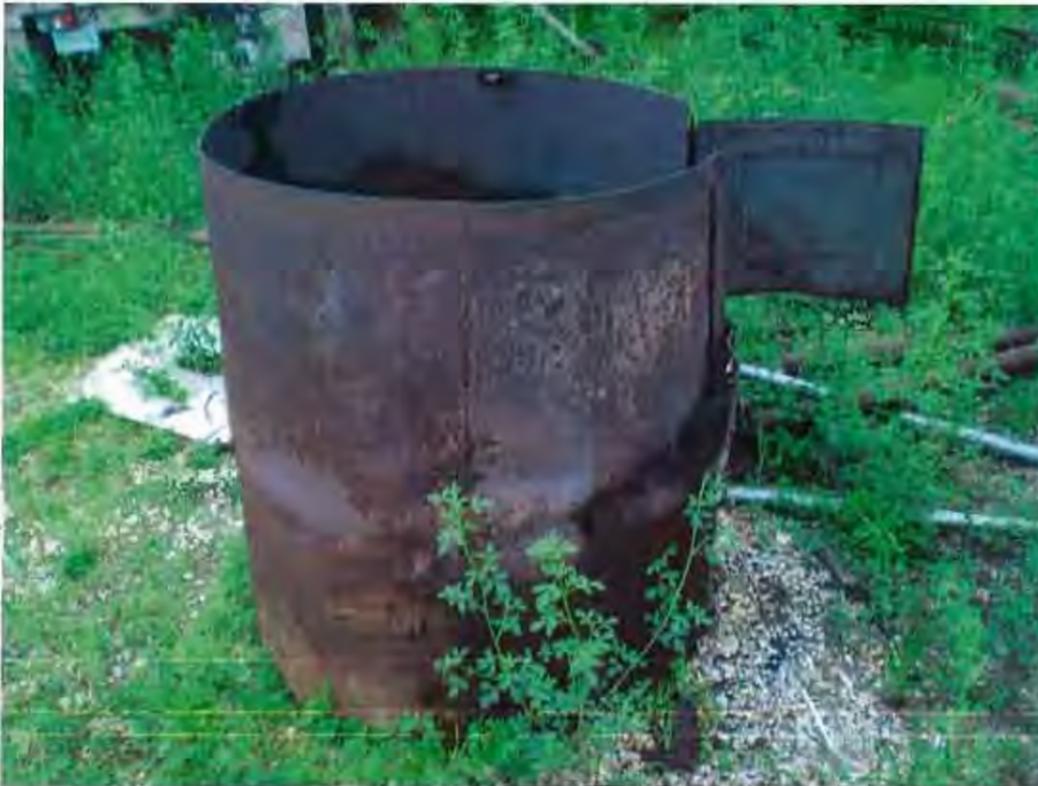
In the south area of the site was a rusty tank that Mr. Hollembeak indicated had been used as a burn barrel. The outside of the tank is shown in photograph 0090105033~05302008-049. The wastes inside the tank are shown in photograph 0090105033~05302008-050.

Date: May 30, 2008
Time: 11:34 AM
Direction: Southeast
Photo by: W Zierath
Exposure #: 049
Comments: An old
burn barrel in the
southern part of the
site.

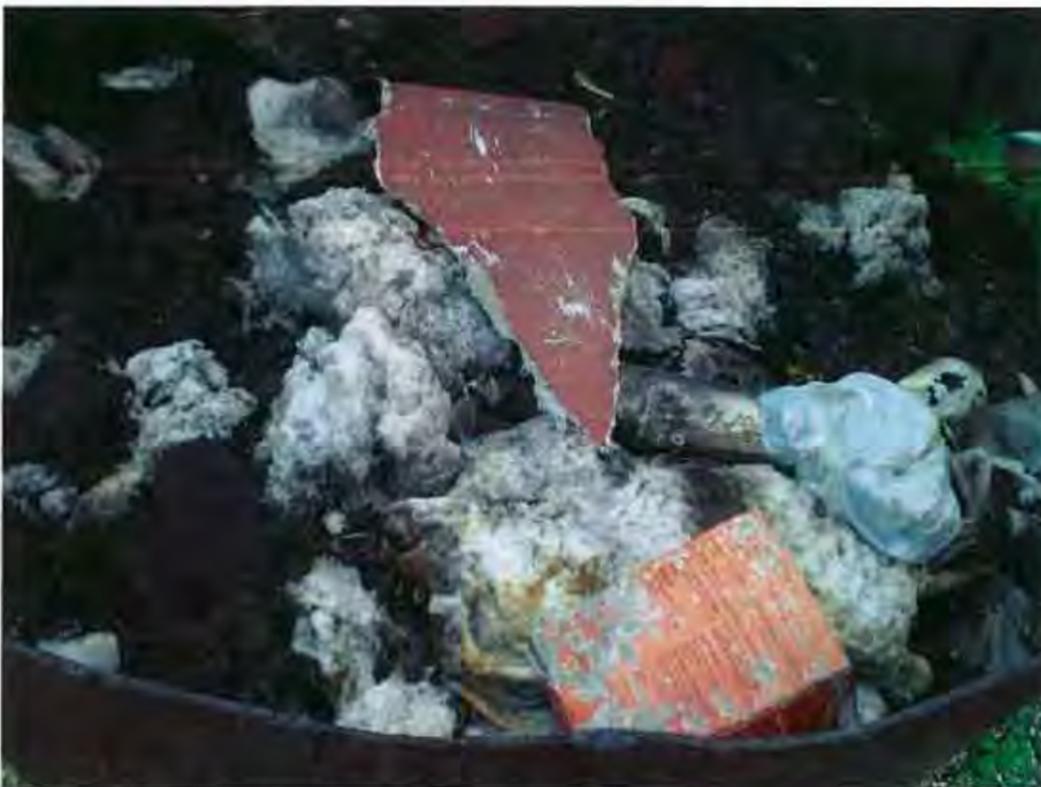
Date: May 30, 2008
Time: 11:34 AM
Direction: East
Photo by: W Zierath
Exposure #: 050
Comments: Wastes
inside the burn barrel
shown in photograph
049.

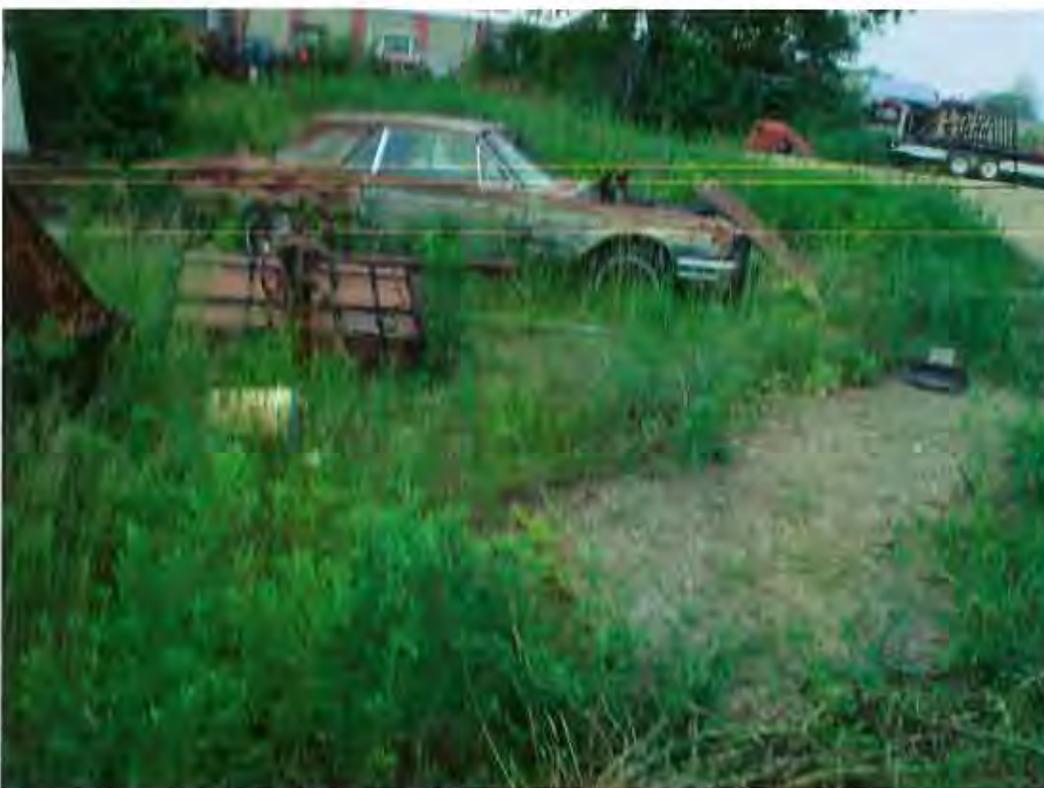
Date: May 30, 2008
Time: 11:36 AM
Direction: North
Photo by: W Zierath
Exposure #: 052
Comments: An abandoned car in the southern part of the site.

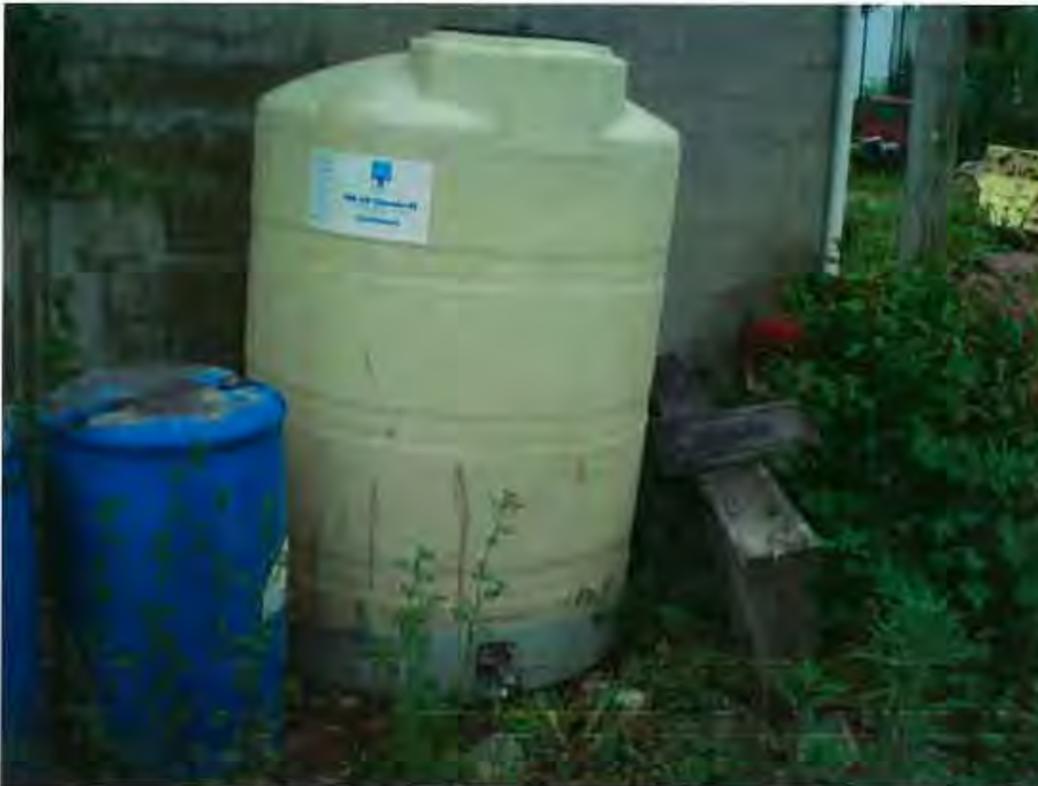
Date: May 30, 2008
Time: 11:37 AM
Direction: Northeast
Photo by: W Zierath
Exposure #: 053
Comments: A tank that Mr. Hollembeak said contained a chemical for treating concrete.

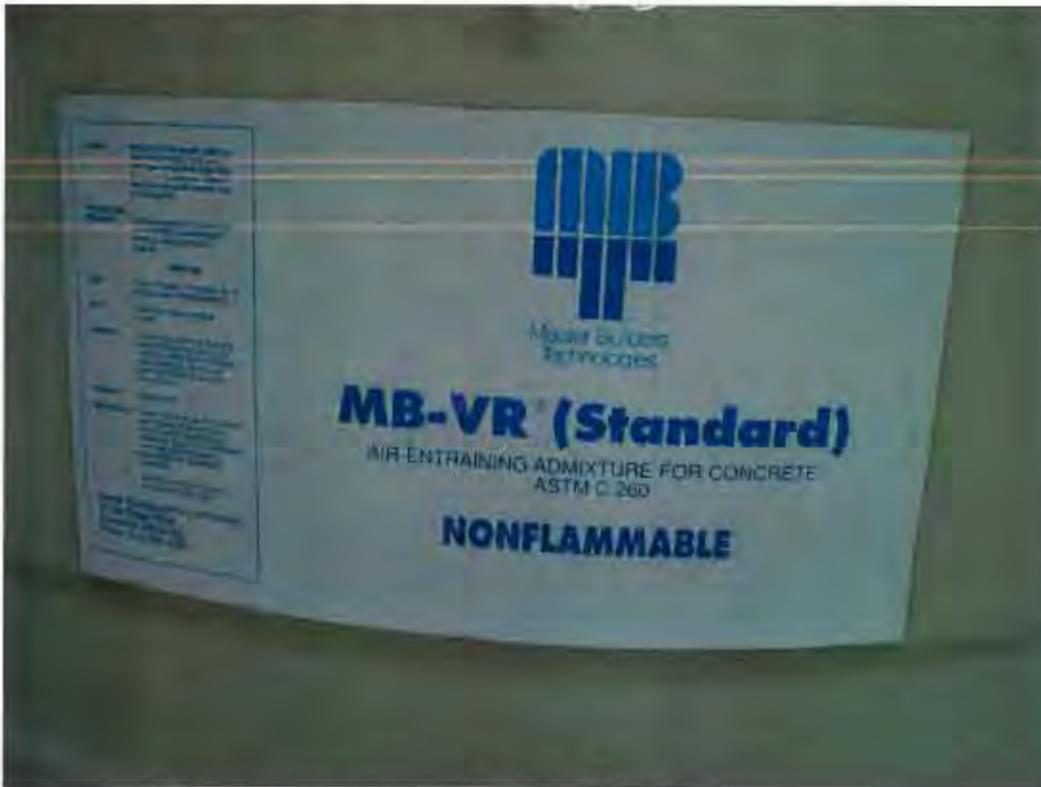
Date: May 30, 2008
Time: 11:37 AM
Direction: East
Photo by: W Zierath
Exposure #: 054
Comments: The label on the tank shown in photograph 053.

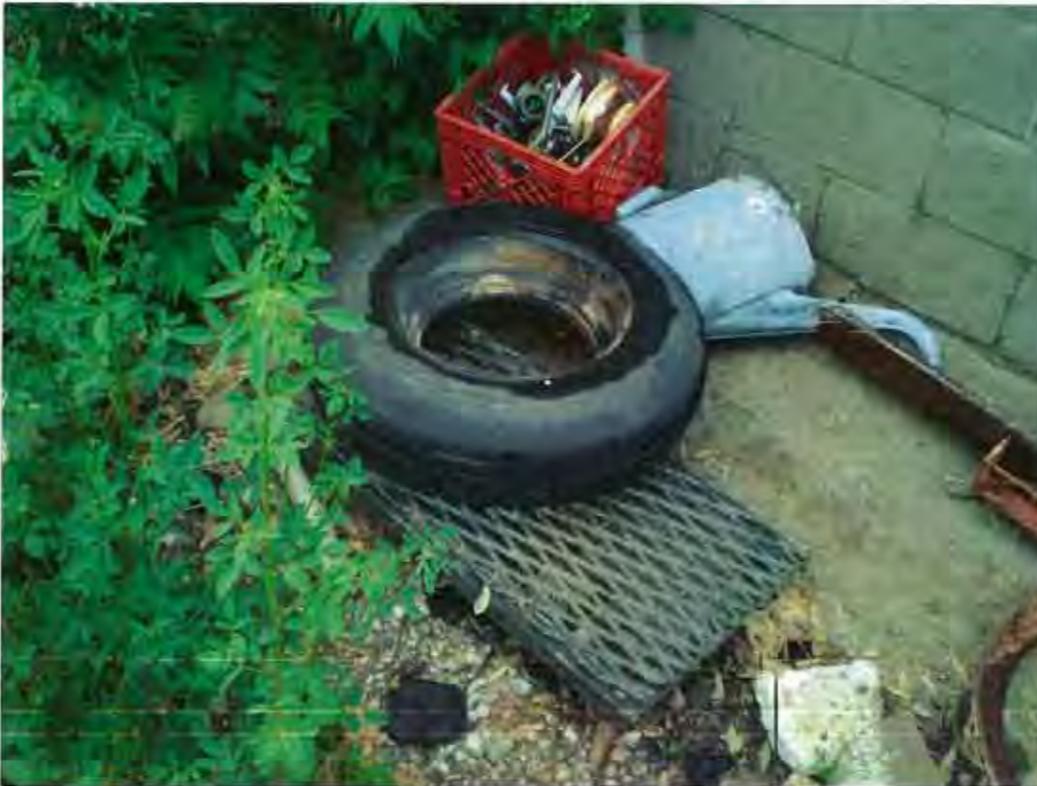
Date: May 30, 2008
Time: 11:38 AM
Direction: Northwest
Photo by: W Zierath
Exposure #: 055
Comments: A used tire located along the south wall of the garage.
