Re: Illinois Environmental Protection Agency v. Theodore & Elizabeth Hollembeak and Hollembeak Concrete, Inc.
IEPA File No. 85-08-AC: 0090105033—Brown County

BEFORE THE ILLINOIS POLLUTION CONTROL BOARD
ADMINISTRATIVE CITATION

FACILITY: Mt. Sterling/Hollembeak Concrete SITE CODE NO.: 0090105033
COUNTY: Brown CIVIL PENALTY: \$4,500.00
DATE OF INSPECTION: May 30, 2008

Date: May 30, 2008
To: BOL File
From: William E. Zierath, BOL/FOS - Springfield Region
Subject: LPC# 0090105033 – Brown County
Mt. Sterling/Hollembeak Concrete
C-08-019-C
FOS File

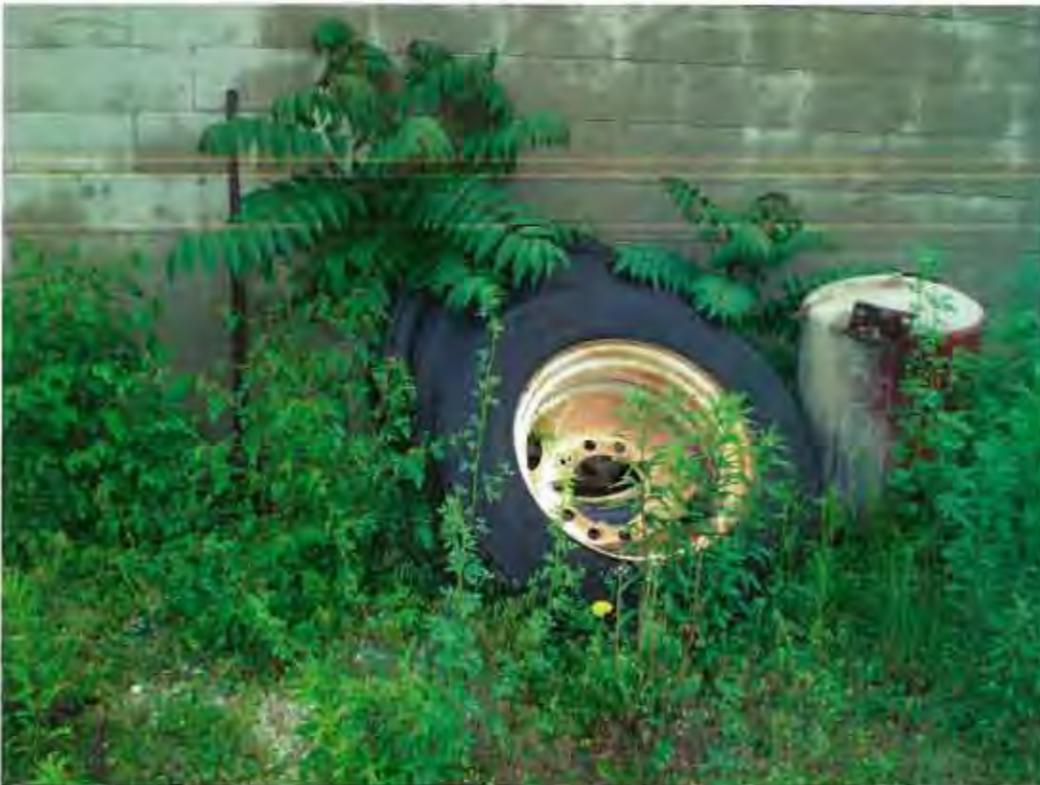
Date: May 30, 2008
Time: 11:38 AM
Direction: North
Photo by: W Zierath
Exposure #: 056
Comments: Used tires leaned against the south wall of the garage.
